February 12, 2009

UTC Job Number 2405

- Site visit was performed on February 6, 2009.
- Location: 3751 SR 4 West, Station #1, Grays River, WA 98621

- In attendance at the inspection were Dmitri Wright PE (engineer), Eugene Strong (Fire Chief).
- The referenced location is a two story firehouse located adjacent to Grays River.
- The original building appeared to be 30 to 50 years old.
- The building is a conventionally framed, constructed on a concrete stem walls with a slab-on-grade first floor. The walls are 2X4 stud framed with a 2X6 mud sill. The exterior sheathing/siding is grooved plywood (T-111), and the interior sheathing is gypboard. The front of the building has 2 large roll-up door openings, leaving 3 tall narrow wall piers on that side of the building. The stem walls retain nearly four feet of the fill under the concrete floor slab.
- For the purposes of reporting, the front of the building is assumed to face North.

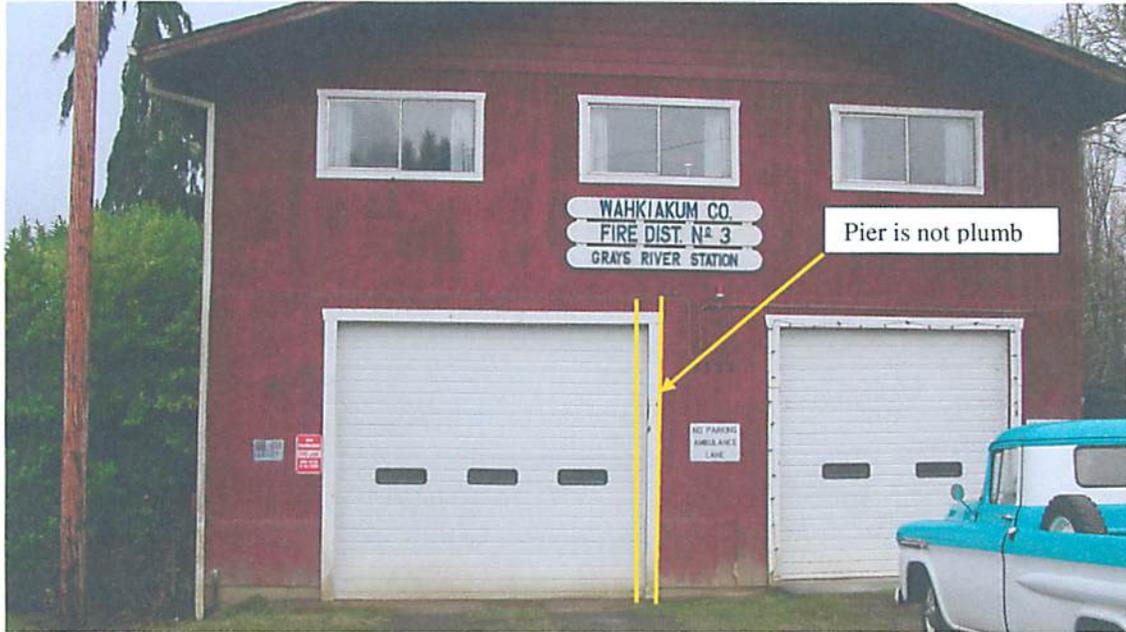
- The first floor walls were visibly leaning to the west. This is consistent with the fact that the flood waters were flowing from east to west. (Photo #1) The deflection at the north end of the building was measured using a plumb bob at more than 2 inches.
- Some sheathing panels pulled away from the wall studs and the door trim was pulled loose. (Photo #2)
- The roll-up doors were popped out of their tracks (Photo #3 & #4).
- The concrete floor slab is cracked across the full width of the room. The crack width is on the order of ½ inch. (Photo #5) There is also a crack at the slab-stem wall joint. (Photo #6)

Photo #1. Roll-up door frames are out of square.

- *Recommend repairs to pre-flood condition for damage caused only by moving surface water and/or hydrostatic pressure.*
Repairs for the leaning north end of the building would require replacing all first floor walls that are out of plumb. The possible repair option to try to pull the structure back to plumb is unlikely to work

effectively, and will cause more damage than it corrects. The replaced north wall piers should have sheathing on both the inside and outside, with adequate shear strength to resist the building code mandated lateral loads. The piers should also have holdowns at both ends to resist the overturning uplift caused by the building code mandated lateral loads.

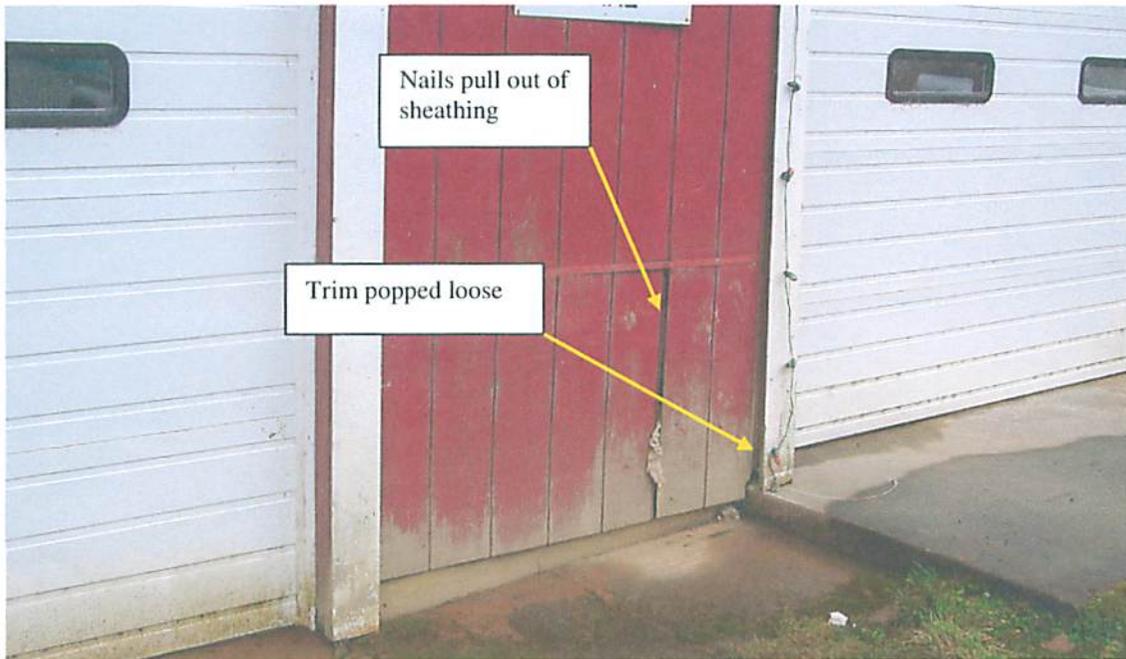
The large shear forces in the piers pushed them out of square (shear deformation), buckling and pulling the nails out of the sheathing. This also caused the roll-up doors to pop out of their tracks. Once the flood water receded, the walls shifted back toward their original position, but some residual shear deformation remained, resulting in the walls at the north end of the building being out of plumb as observed at the time of the inspection. It was not possible to determine the maximum deformation of the walls during the flood, but it was very likely significantly more than the 2 inches observed later.

Photo #2. Shear deformation damaged sheathing and door trim.

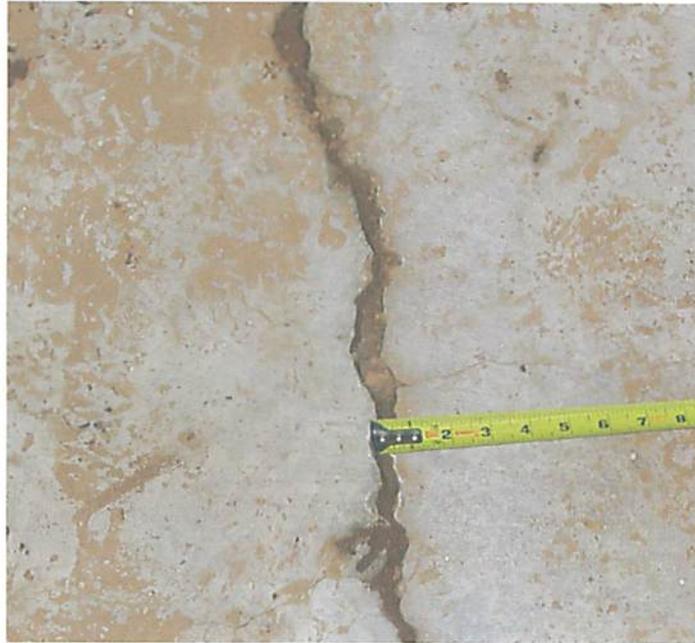
- The crack across the floor and the crack adjacent to the stem wall are likely related. The floor at the south end of the building is several feet above the outside grade. The concrete floor slab is bearing on fill, which is held in place by the concrete stem walls. As the flood saturated the soil supporting the stem walls and saturated the fill under the floor, the soil lost its strength. This resulted in increased outward lateral forces on the stem walls coupled with reduced resistance from the supporting soil. Additionally, the weight of the flood water on the floor slab added downward hydrostatic pressure on the slab and increased the outward forces on the stem walls. The outward lateral force on the stem wall caused it to rotate outward at its top, opening the crack at the joint with the slab. The movement of the wall allowed the fill to settle, leaving the slab unsupported. Without support, the slab cracked and settled.

Photo #5. Crack in concrete floor slab is ½" to 1" wide.

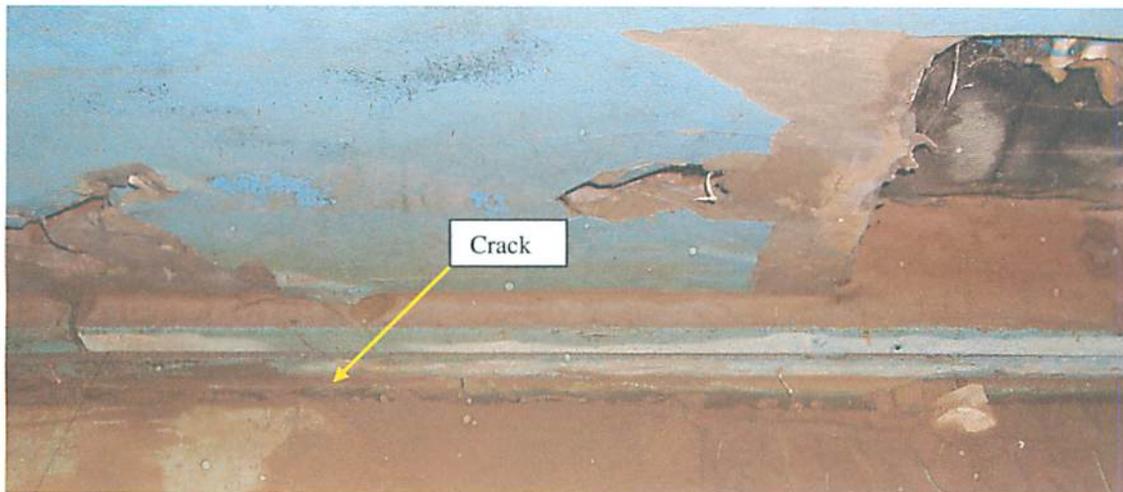
Photo #6. Crack between stem wall and floor slab.

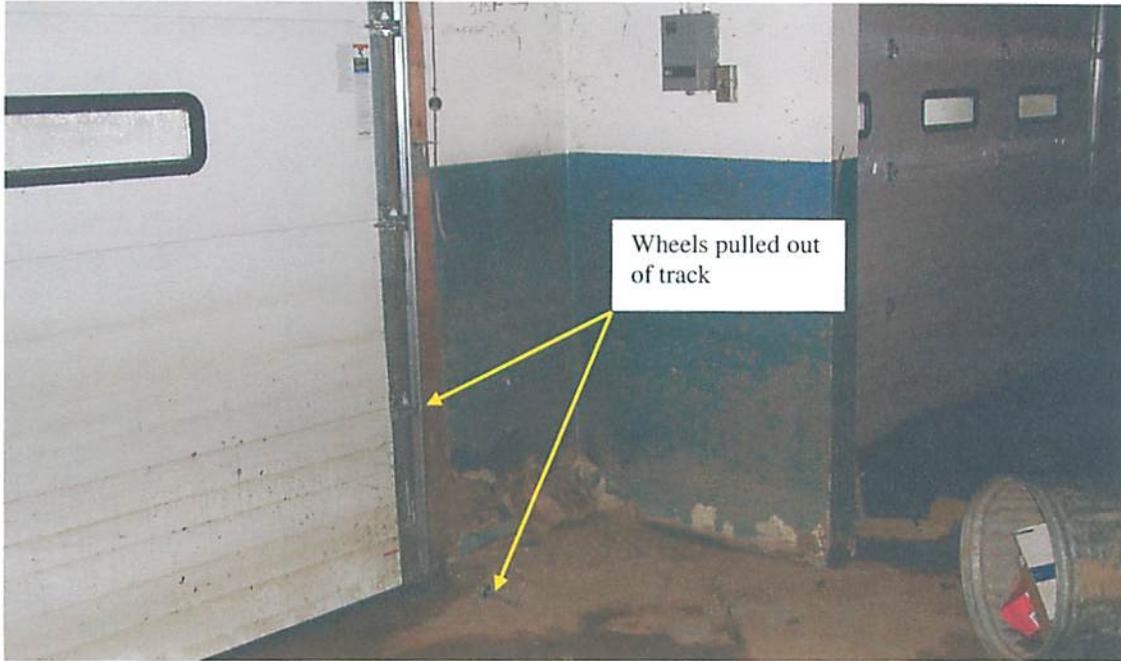
Photo #3. Shear deformation pulled the bottom east door corner out of track.

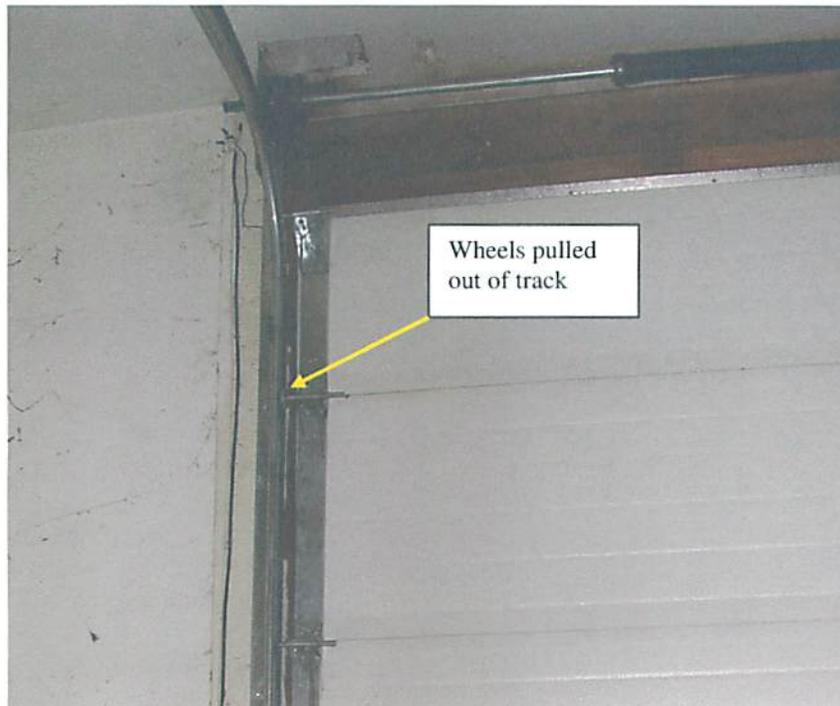
Photo #4. Shear deformation pulled the top west door corner out of track.

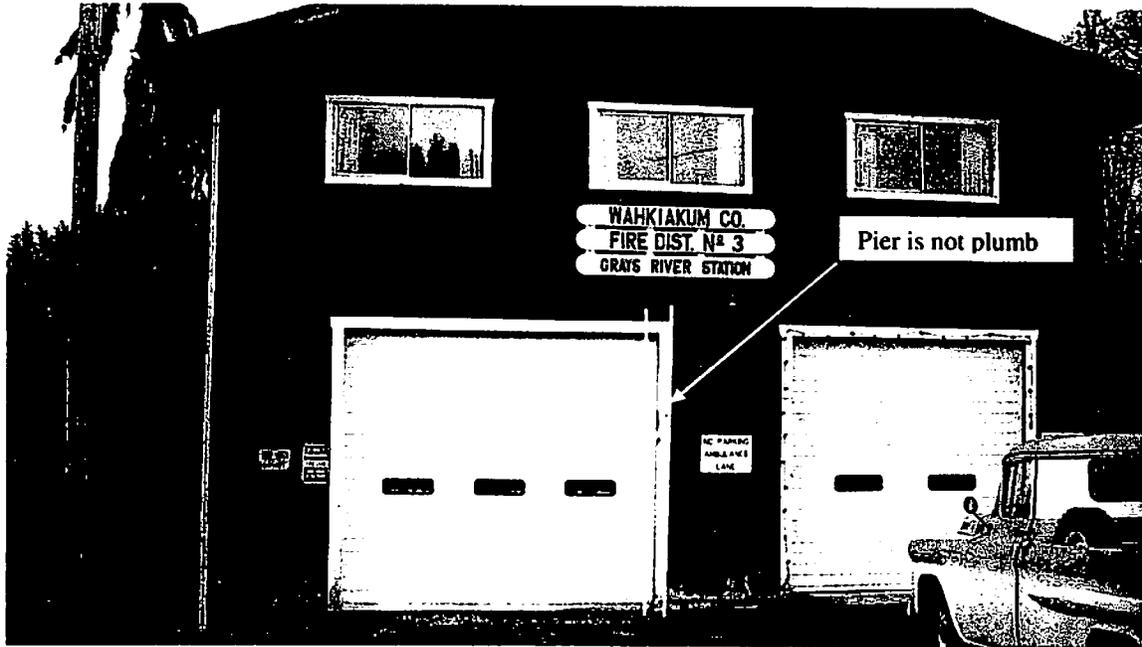
Photo #1. Roll-up door frames are out of square.

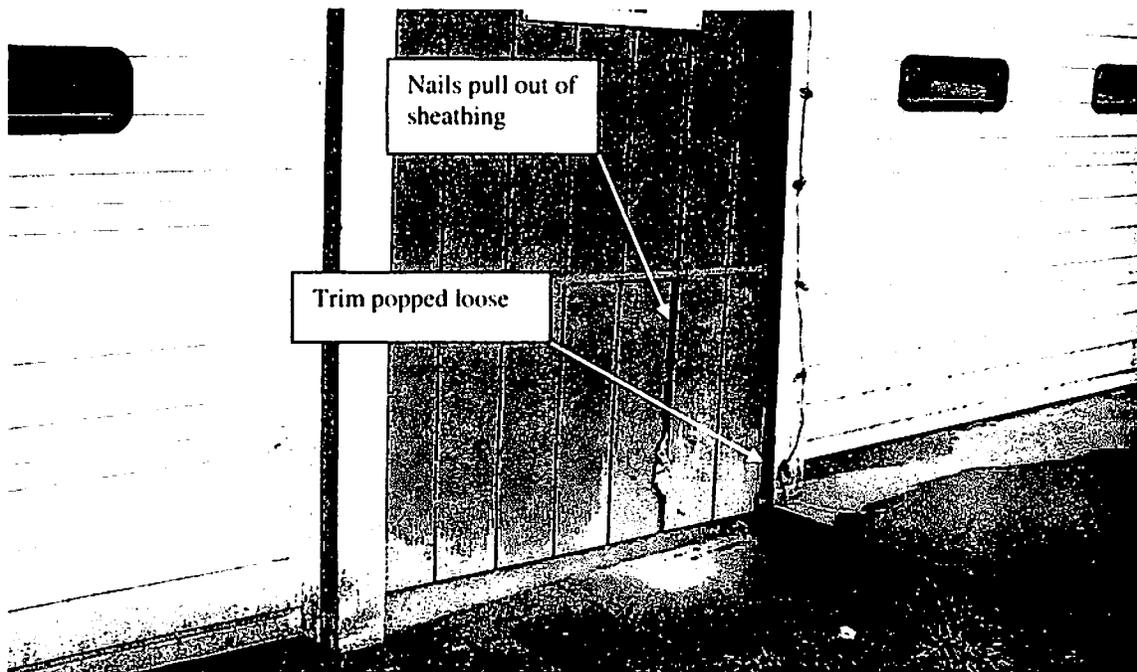
Photo #2. Shear deformation damaged sheathing and door trim.
