## **Southeast Tornado MAT**

### **Daily Report**

**Thursday 12MAY2011**

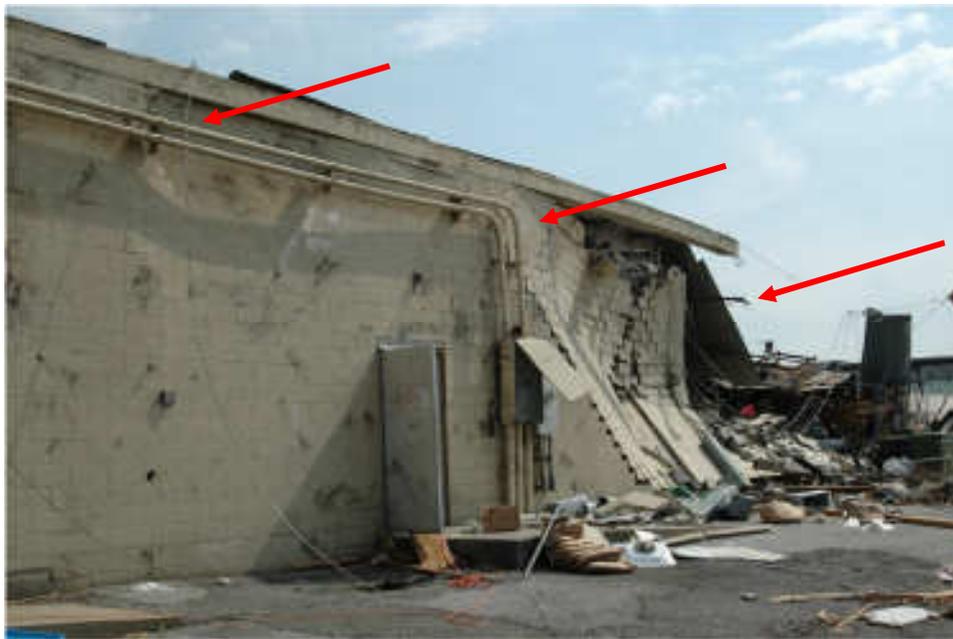
The shopping center that had several national tenants suffered some of the worst damage in the tornado path. The buildings were constructed from Unreinforced masonry and supported bar joist metal deck roof systems. The Chucky Cheese tenant did not have a total collapse. Upon close inspection, there were several cracks and indications that the building was still severely damaged and compromised. The photos below show several stages of what appears to be failure pattern. The first phase is wall buckling and movement away from the bond beam, second phase is complete buckling and bond beam becomes unsupported, third phase is total loss of wall and then loss of roof.

**Tuscaloosa, AL: Adjacent to Chucky Cheese. This photo shows a pattern of failure.**

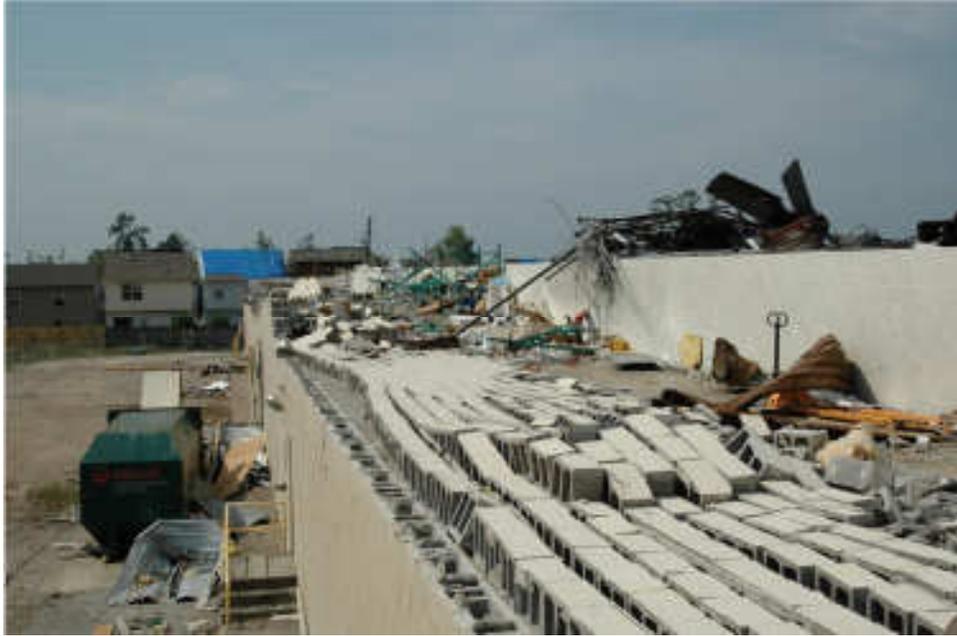
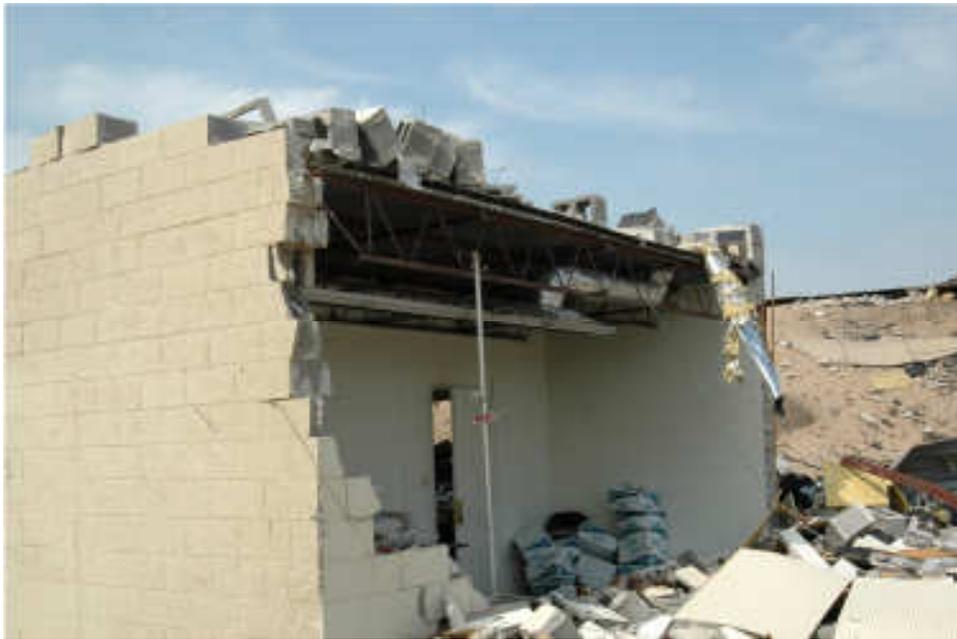
**Tuscaloosa, AL: Hobby Lobby. This structural mezzanine was the only location that did not suffer complete collapse for this big box store.**

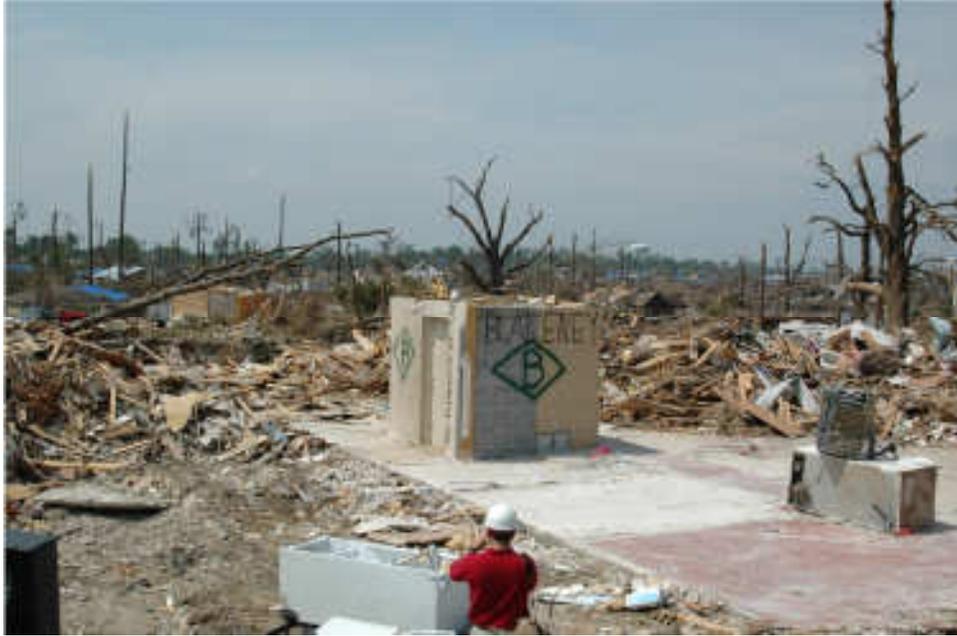
**Tuscaloosa, AL: An above ground safe room directly in the path of the tornado. The slab had been cleaned but the damage in the surrounding area shows the complete destruction of the neighborhood.**

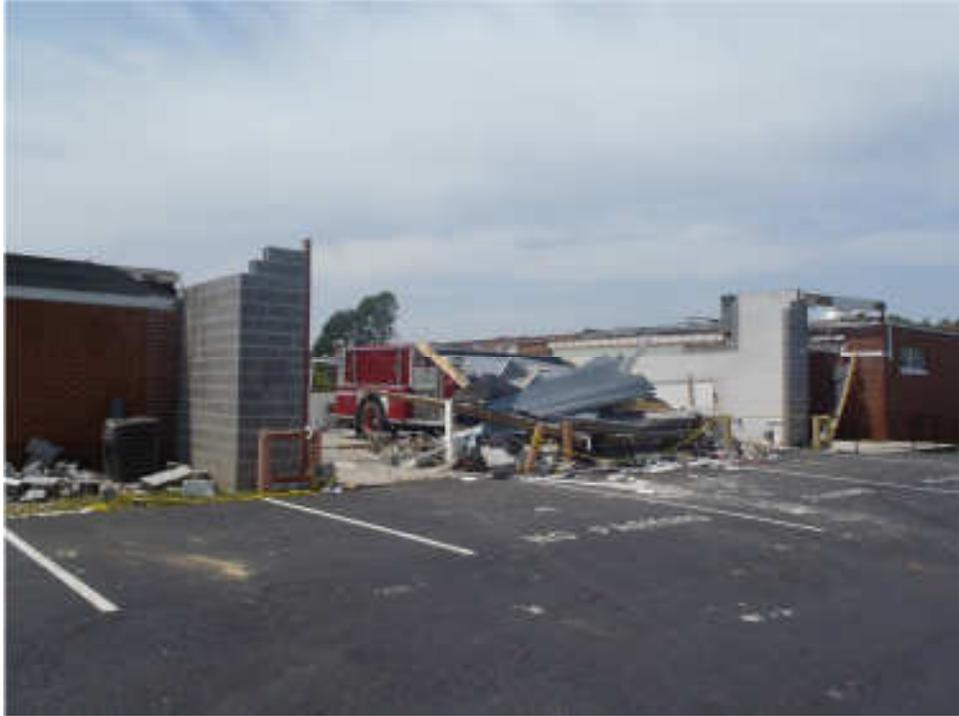
**Location: Webster's Chapel Fire Department (Webster's Chapel, AL)**

The Webster Chapel Fire Department structure was originally an elementary school and had been retrofitted to serve as primary fire station. The right wing at apparatus bay was severely damaged, causing loss of roof and collapse of exterior load bearing walls. Walls were made of unreinforced CMU and roof system was wood framing. There was no shelter area within the fire station. Personnel evacuated to church across the street.
