Southeast Tornado MAT

Daily Report

Monday 09MAY2011

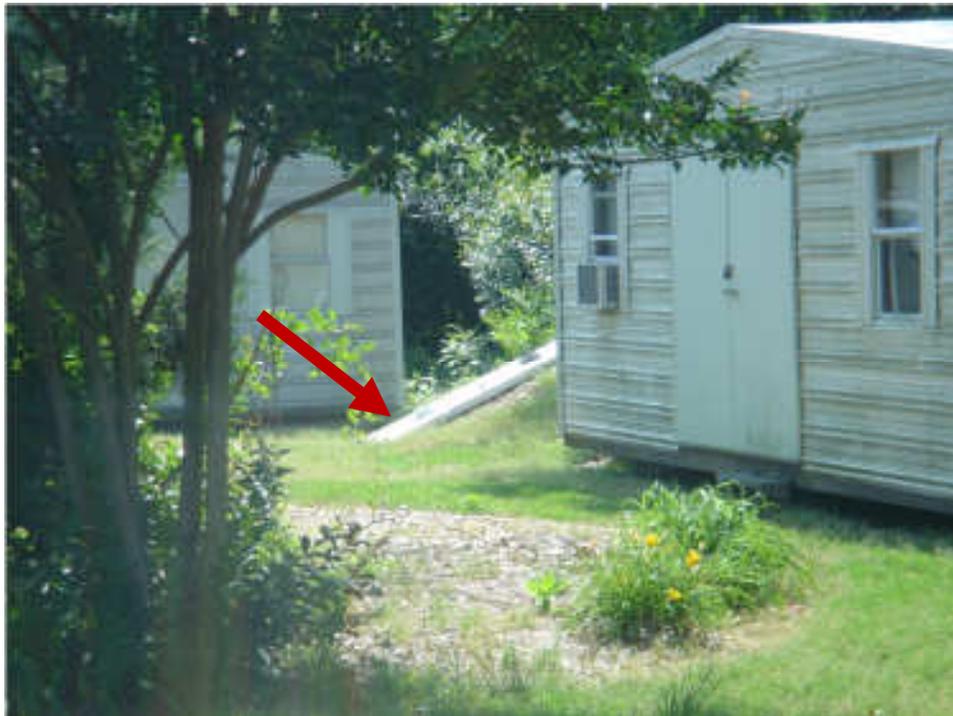
Large portions of Pleasant Grove were completely destroyed. This house in Pleasant Grove was recently purchased. When the owner first identified the home for consideration, they were not aware that there was storm shelter on the property. However, when they looked at the home during a viewing they were informed that not only was there a shelter, but that its construction had been funded in part by FEMA. The homeowners stated they decided to purchase the home because it had the FEMA safe room. The safe room was occupied during the tornado.

Pleasant Grove: FEMA 320 compliant safe room Occupied during Storm

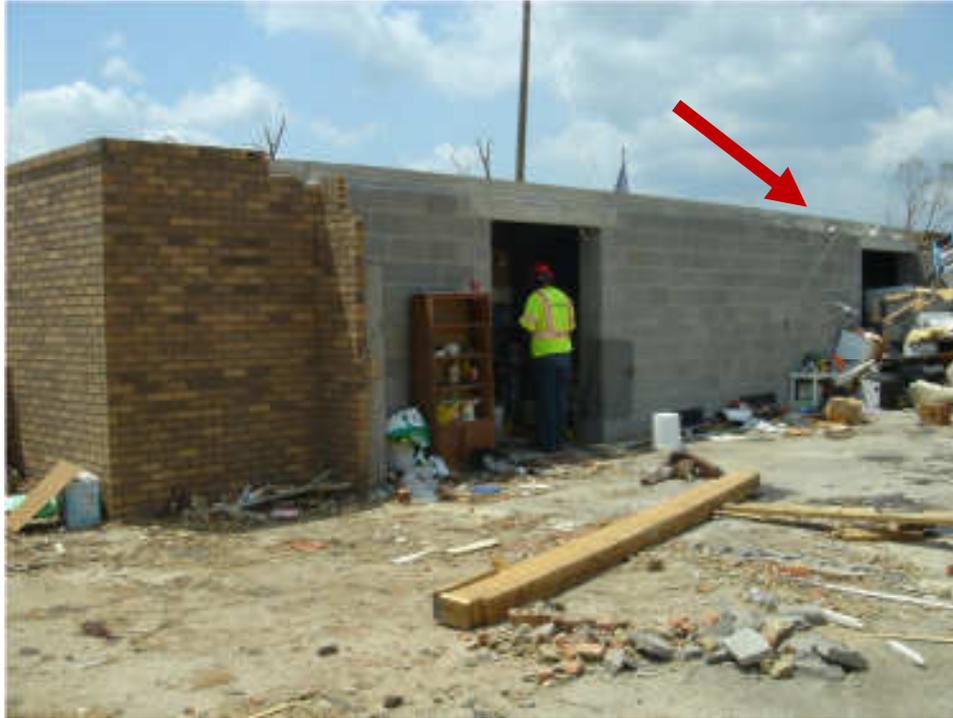
The team also visited a very hard hit area of Pleasant Grove with homes constructed in the 1980s and 1990s. In this neighborhood, several residents worked with their builders to construct hardened refuge areas in the basements of their homes. This two story home was completely destroyed during the tornado, the refuge area housed 3 people during the storm and all occupants of the refuge were unharmed. The owner had the roof slab thickened to 9 inches of concrete and extra reinforcing installed. The walls however are unreinforced CMU.

Pleasant Grove: Home with a planned refuge area in the basement. While not compliant with FEMA 320 safe room design criteria, features of this house (such as the thickened, reinforced concrete slab) helped provide safe refuge during the event.

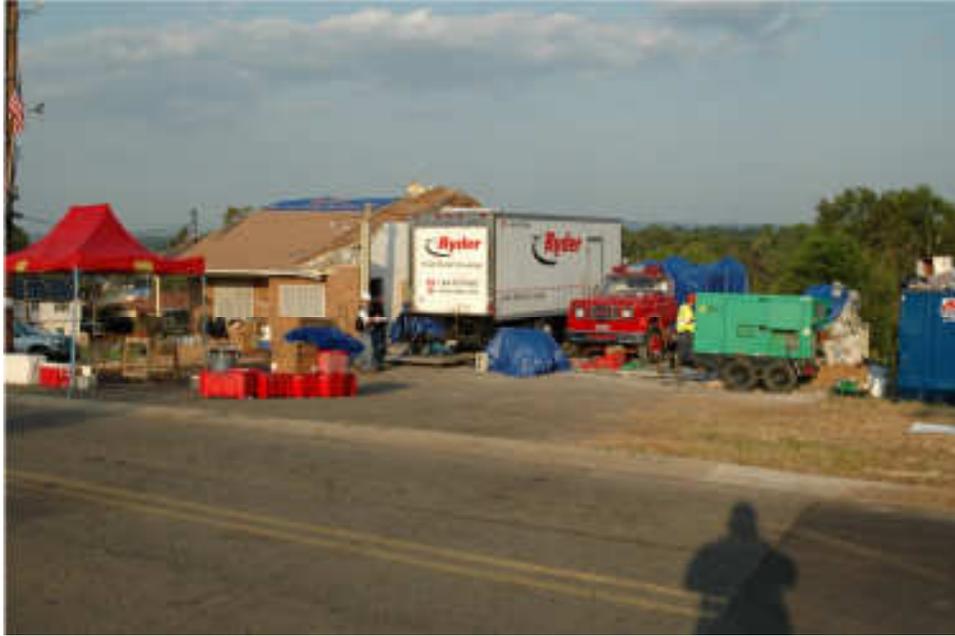
Smithfield Green Leaf Heights Volunteer Fire Department was mostly destroyed. The apparatus bay completely failed but the personnel portion of the station remained standing (with damage).

Smithfield Green Leaf Heights Volunteer Fire Department: The Apparatus Bay was completely destroyed. The Fire Engine is still sitting in what was the apparatus bay. (A rental truck being used for clean-up occupies the second bay.)

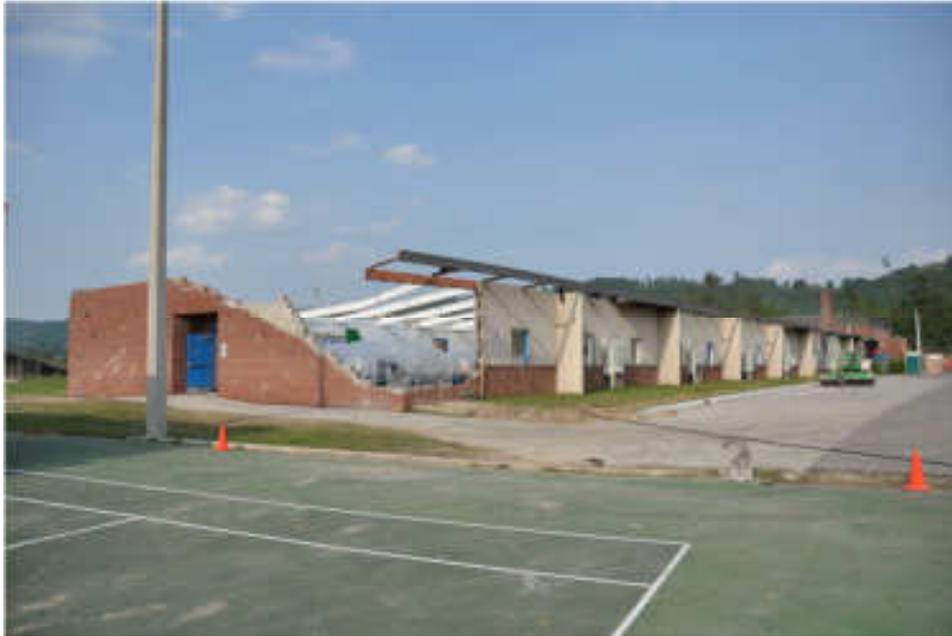
Location: Ringgold Middle School

- Extensive damage to unreinforced exterior end wall and roof deck.
- No students were in the school at the time.
- Clean-up and construction crews already cleaned debris from this area

Ringgold: Severe damage at one wing of the middle school

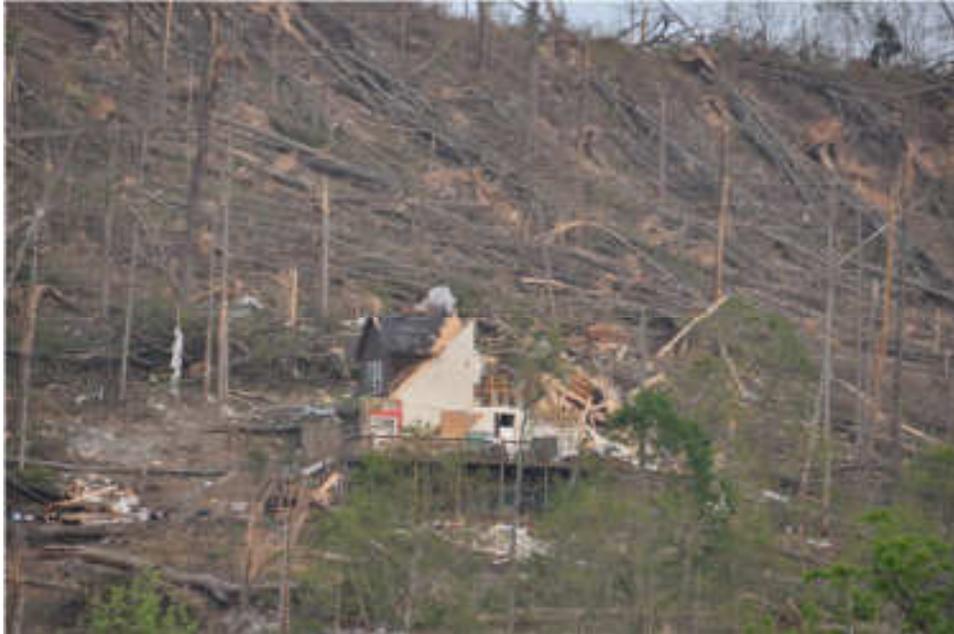
Location: Cherokee Valley Road (Ringgold, GA)

- Residential structures located in between two ridges.
- Residential structures in this area varied from minor damage to completely destroyed.
- Significant tree damage along entire far ridge.

Ringgold: Home on hillside in impacted area of Ringgold. Topography may have affected wind speeds from the tornado in this area.

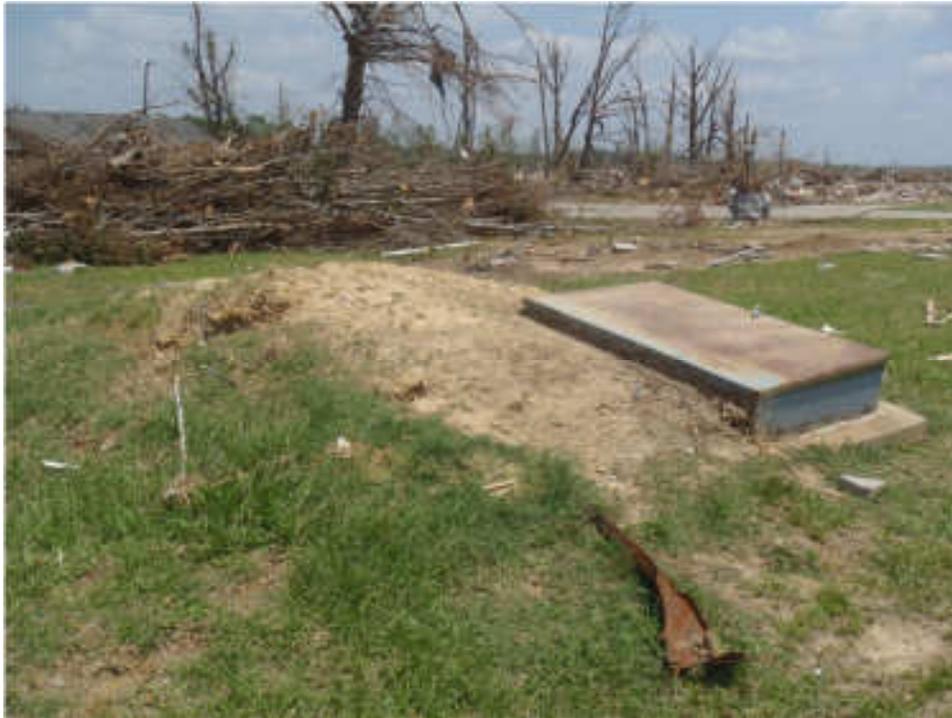
Smithville: FEMA 320 complaint safe room which performed well during the tornado.

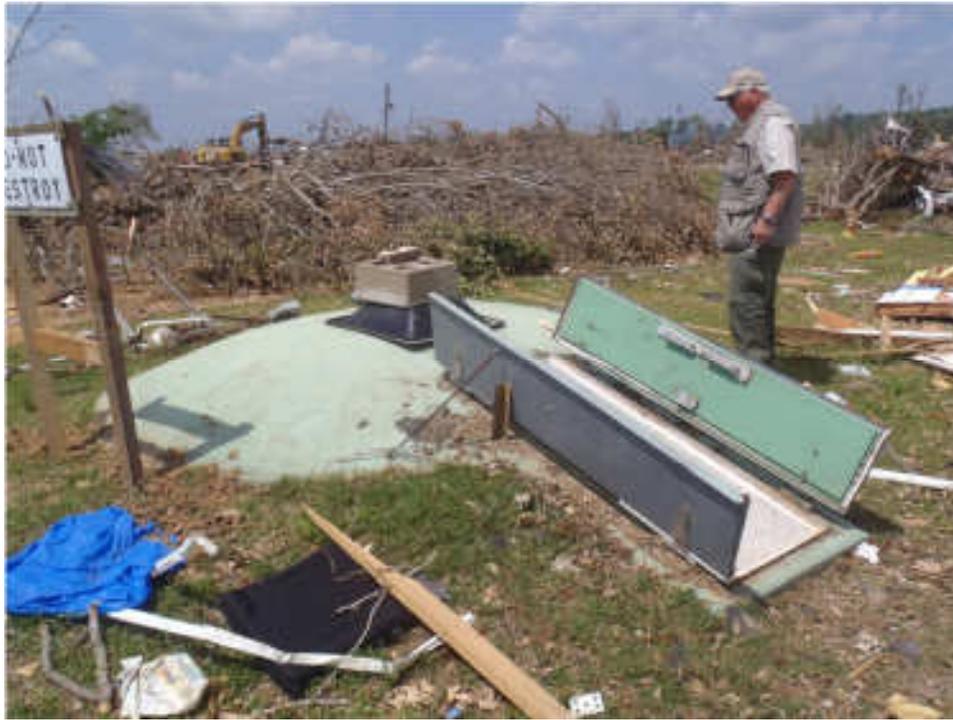
Smithville: Court Street Safe Room

Smithville: Shelter #2: Housed (10) people during the storm – the door had to be held shut
