TORNADO OUTBREAK *of* **2011**

IN ALABAMA, GEORGIA, MISSISSIPPI,
TENNESSEE, AND MISSOURI

5 Observations on Commercial and Industrial Building Performance

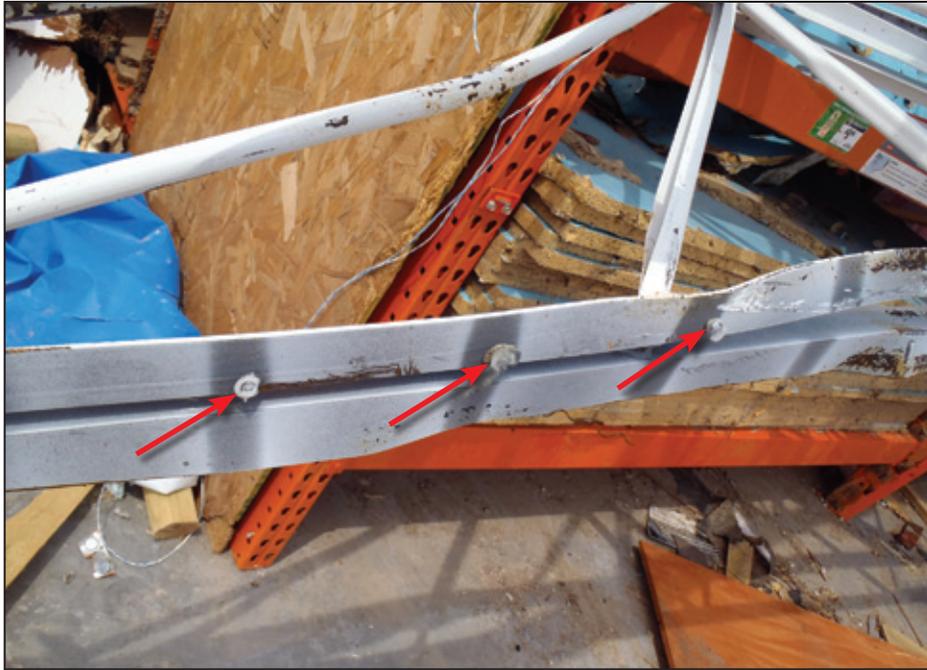
As previously noted, the roof deck is typically connected to the joists by puddle welds. An example of a failed puddle weld used to connect the metal deck to the top chord of the steel joists is shown in Figure 5-6. The MAT noted this type of connection on each of the metal deck structures observed at the Home Depot. The roof metal deck acted as a lateral diaphragm and was the primary load-carrying system for lateral loads in the building. Once the roof deck connections failed the steel open web bar-joists and joist girders lost their lateral support and became unstable.

Figure 5-6:
Failed puddle welds that connected the metal roof deck to the top chord of the joist (red arrows) (Joplin, MO)

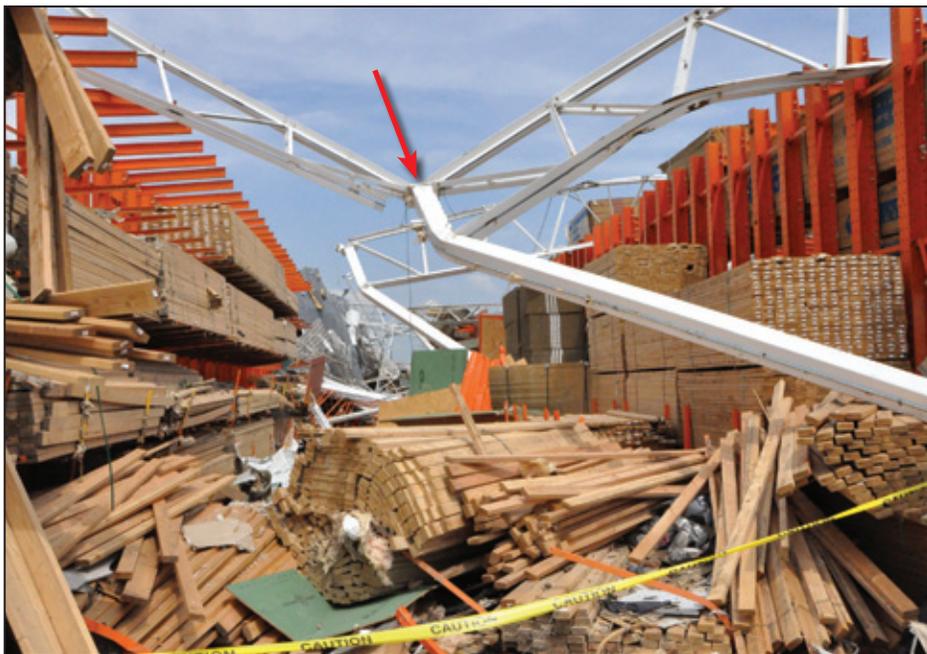
A disadvantage of the system is that the combination of the elements used in constructing the joists and joist girder and its length create members that have little horizontal capacity when loaded laterally in an un-braced condition, as was the case described above when the roof deck connection failed. This weakness is also evident in the joist girders, which became un-braced when the connection between the joists and joist girders failed. Figures 5-7 and 5-8 demonstrate the lack of rigidity in an un-braced joist system.

Figure 5-7:
Joist girder and column failure. The column-to-joist girder is shown by the red arrow (Joplin, MO).

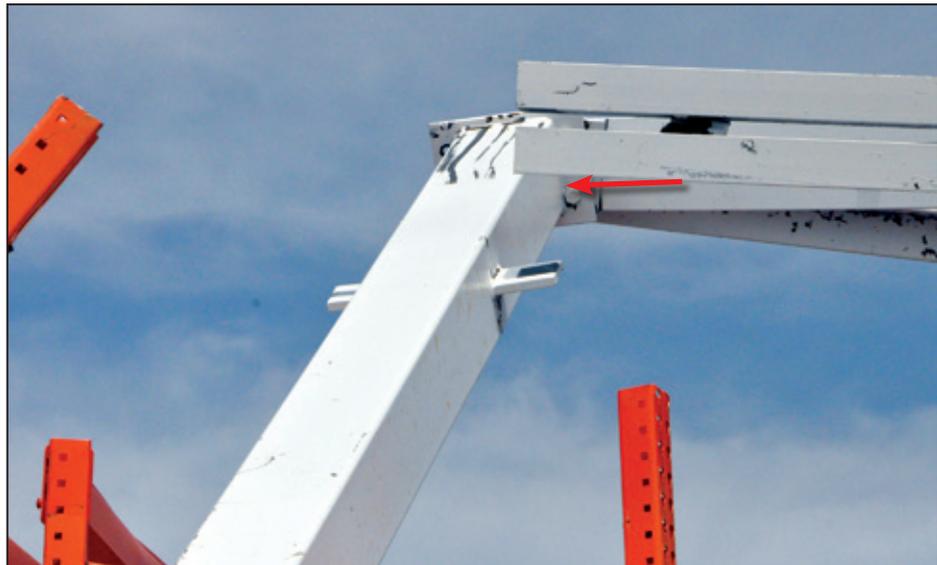
Another common practice in the industry is not welding the bottom chord to the stabilizer plate on joist girders at the column support. The bottom chord was not connected at the Home Depot and the MAT noted several instances of separation at this location (Figure 5-8). In some buildings, the bottom chord is welded if the system is designed as a moment frame system, but if analysis determines that the structure is adequate for the design loads without welding the bottom chord,

Figure 5-8:
Separation at bottom chord
to stabilizer plate (red arrow)
(Joplin, MO)

it is appropriate and encouraged to not make this connection rigid. Alternatively, welding the bottom chord at this location can help keep the bottom chord from buckling provided the connection is capable of resisting the tension induced at this point by the uplift of the joist. However, complications can occur if the construction sequence gets out of order and if snow loads are expected. The bottom plate must be welded after all the dead loads are in place to prevent damage to the lower chord as it deflects and rotates to carry the dead load. If the bottom chord is to be welded to the stabilizer plate, this must be indicated on the plans and considered in the girder design as a special loading condition. Yet another option is to use a loose fit bolt in a slotted hole in lieu of a welded connection at the stabilizer plate.

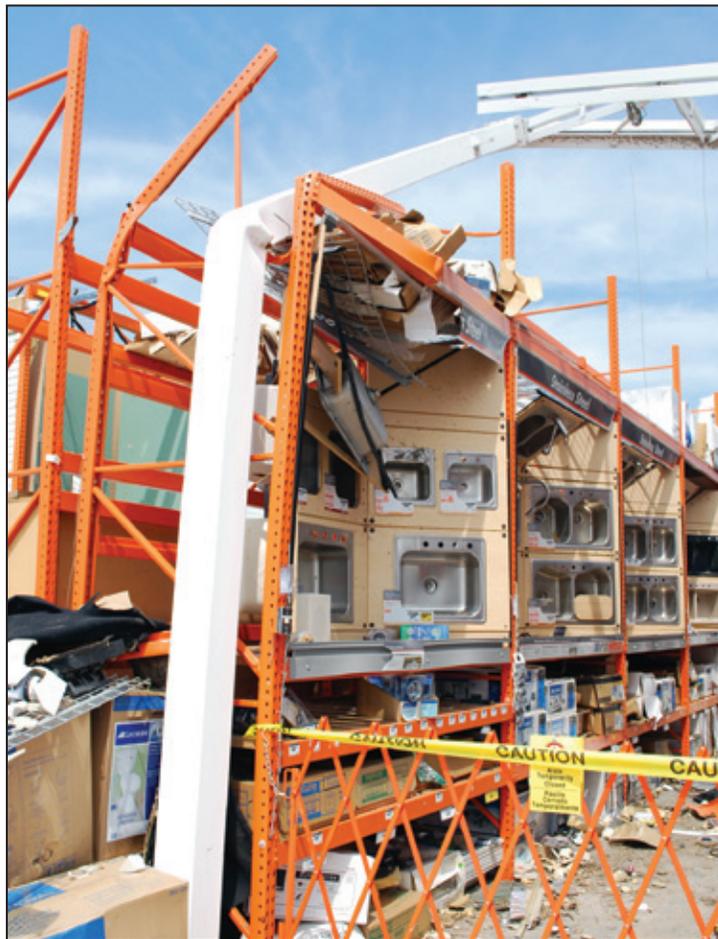
The MAT observed a column that buckled against the racking system (Figure 5-9). Some columns failed when the hooked anchor bolts for the column pulled out of the concrete. Other columns experienced failure at the base plate due to shear and tension (Figure 5-10). As the column rotated, the force on the compression side of the base plate sheared the bolts and the tension side pulled the hooked anchor bolts free. The code allows the use of hooked anchor bolts when columns are subject to compression only. When anchor bolts are subject to tension a more positive anchorage is created by using headed anchor bolts in lieu of hooked anchor bolts.

Figure 5-9:
Buckled column (Joplin, MO)

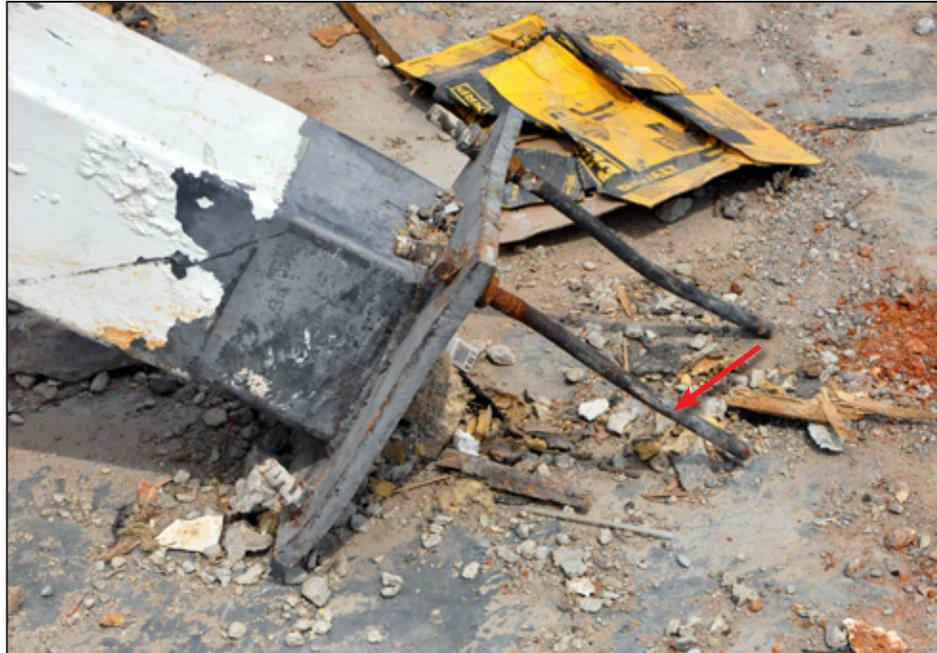
Figure 5-10:
Bolt failure at interior column resulting from shear and tension. The hooked anchor bolts pulled out of the slab (red arrow) (Joplin, MO).

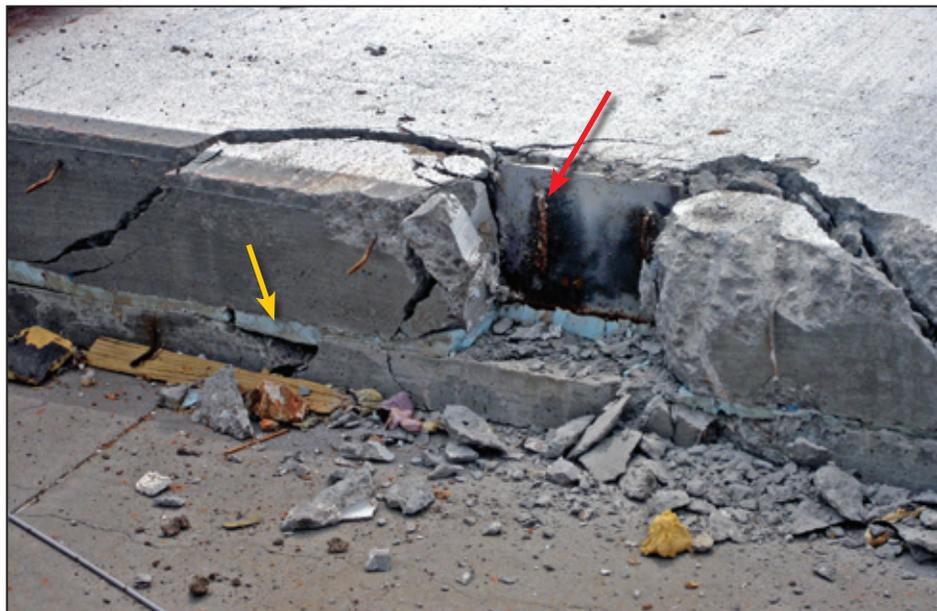
The exterior walls of the Home Depot building were precast tilt-up concrete panels. In this type of construction, the connection at the base of the wall is a steel plate or angle welded to an embedded steel plate in the footing and the wall. The roof connections consist of an embedded steel plate in the wall connected to the roof members. Where the steel joists are perpendicular to the wall, there are pockets or a ledger angle where the wall panels support the joists. Figure 5-11 shows an example of a failed joist support pocket at the Home Depot building.

Figure 5-11:
Joist support pocket at top of a precast wall. The red arrow points to weld marks from the connection to the framing member seat on the embedded plate. The yellow arrow points to the light blue insulation layer between the concrete shells (Joplin, MO).

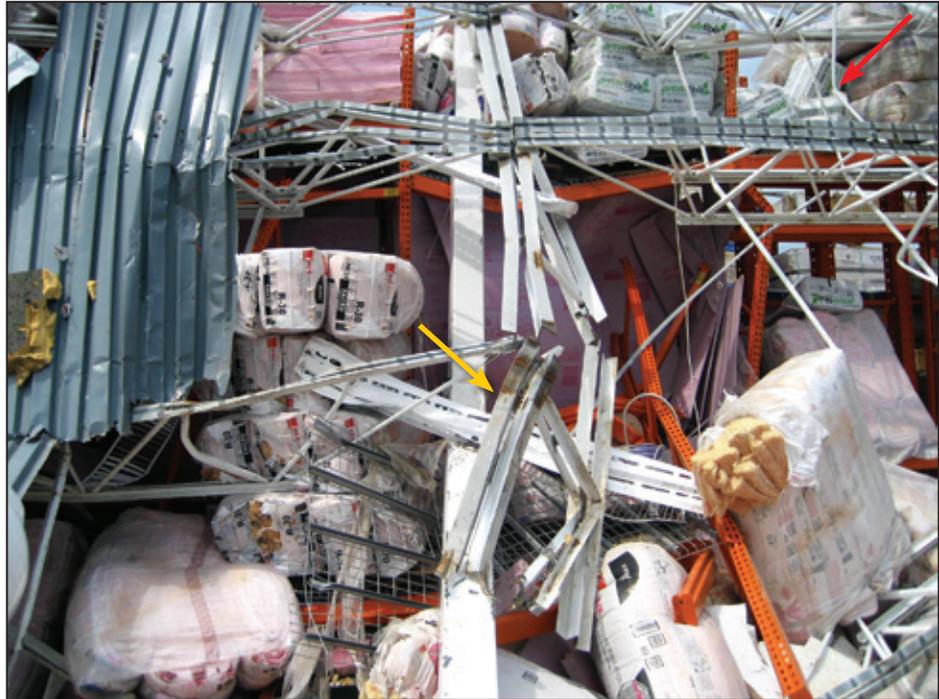
The MAT observed several types of failures of the roof-to-wall connections at the Home Depot building including failures of the joist girder-to-wall connections, failure of the joist-to-joist girder connection (Figure 5-12), failure at joist seats (Figure 5-13), and failures of the weld plates (Figures 5-14 to 5-16). These kinds of failures were part of a chain of failures that led to the collapse of most of the walls.

In the area shown in Figure 5-12 the product racking system maintained some integrity as the building structural elements failed; this area could possibly have been used as a location to take refuge as an option of last resort. However, the level of protection would have been poor, as protection from both wind-borne debris and store contents would have been minimal.

Figure 5-12:
Failure of joist-to-joist girder connection shown by broken welds (yellow arrow); red arrow shows location where bridging angle is touching insulation bundles (Joplin, MO)

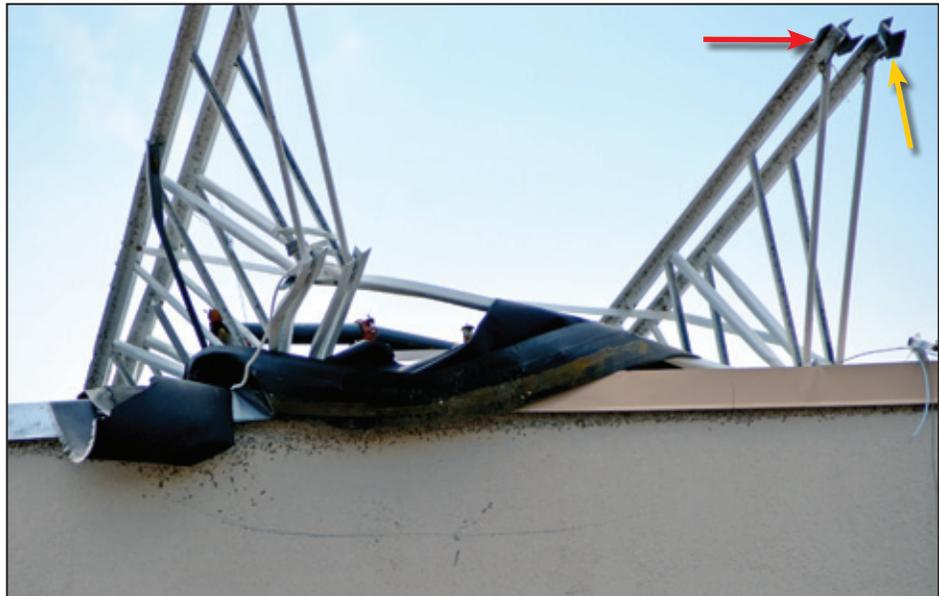
Figure 5-13:
The joist seats came free of their bearing locations when both the seat-to-joist weld (yellow arrow) and the seat-to-embed plate weld (red arrow) broke (Joplin, MO)

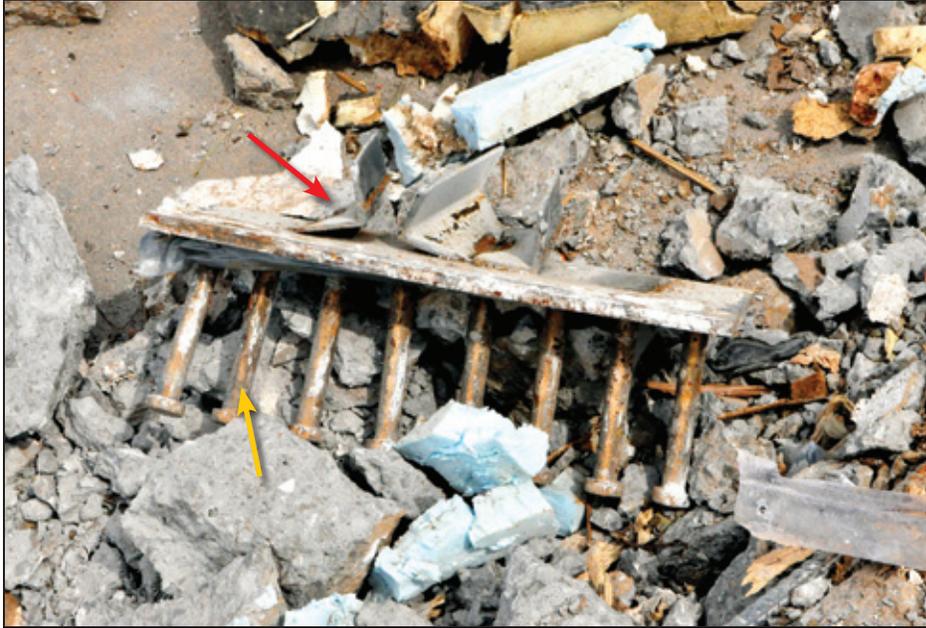
Figure 5-14:
Example of weld plate and joist failure. The joist seat was torn from the joist (red arrow) and the anchor studs from embed plate were torn out of the concrete (yellow arrow) (Joplin, MO).

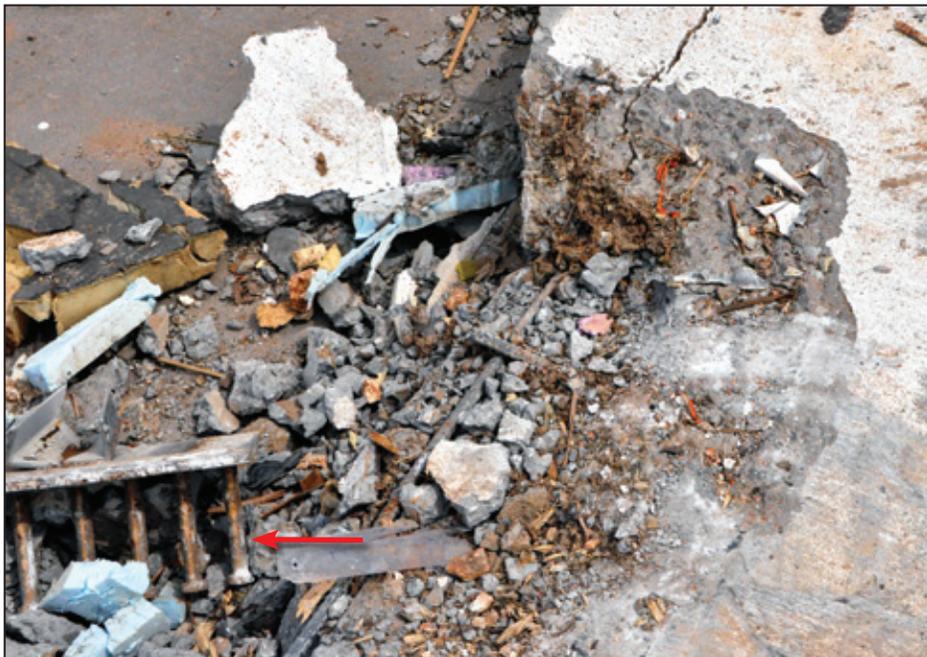
Figure 5-15:
The panel at the weld plate failed (red arrow) (Joplin, MO)

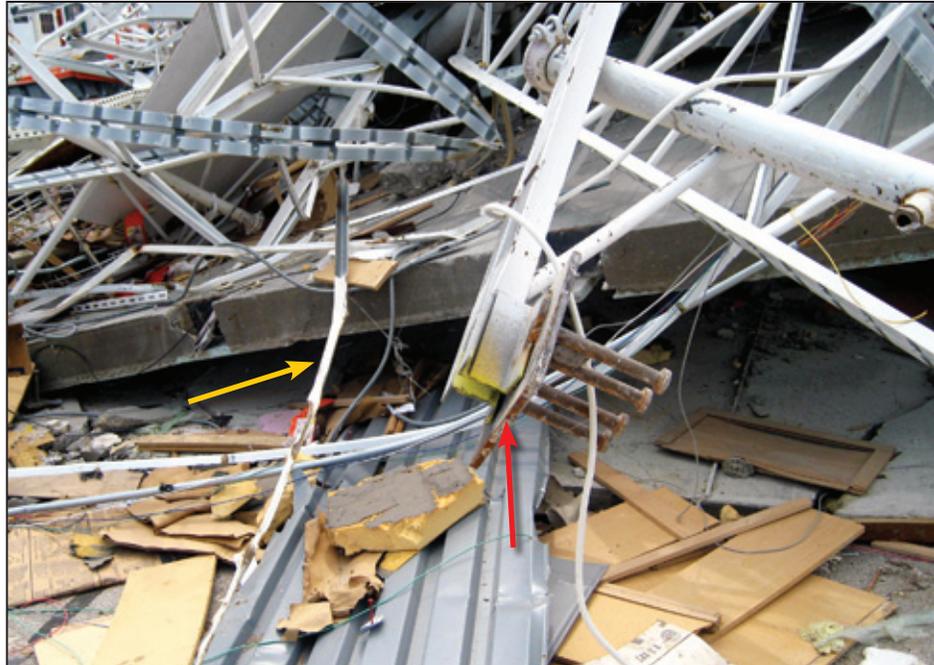
Figure 5-16:
Example of a weld plate failure. Note the attached joist (red arrow) and the joist pocket at the top of the wall panel (yellow arrow) (Joplin, MO)

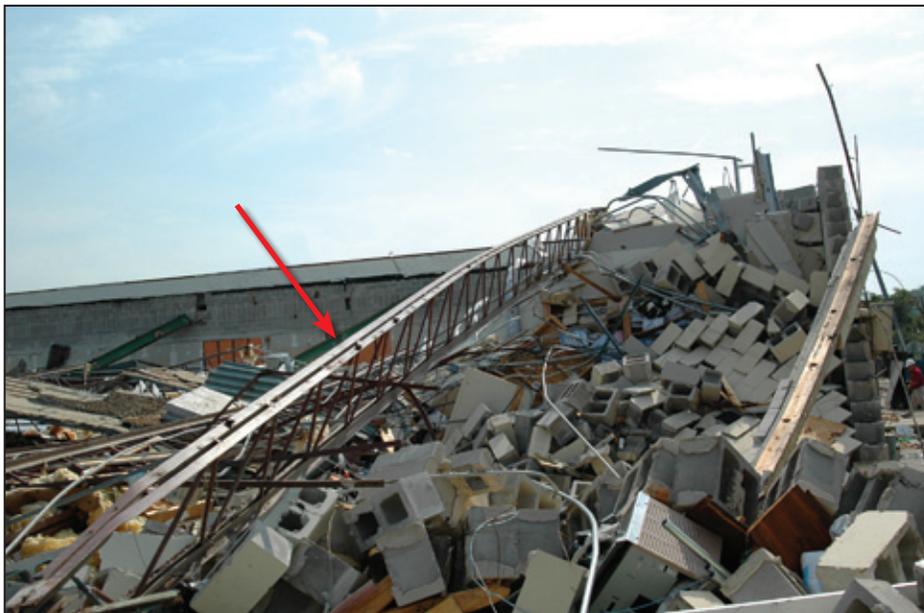
Figure 5-18:
Steel joist (red arrow)
in midst of collapsed
unreinforced masonry wall
at the dry cleaner store
(Tuscaloosa, AL)

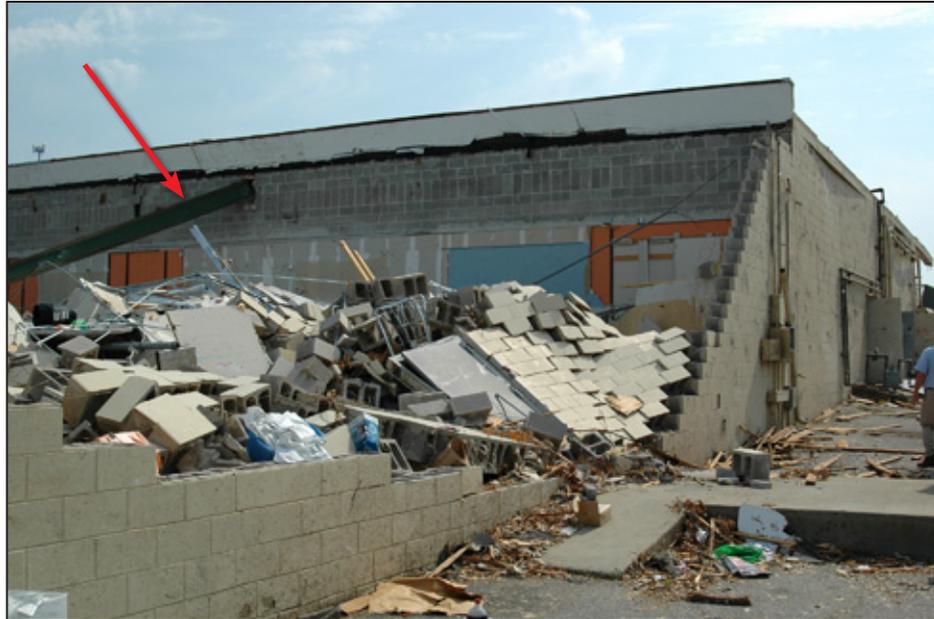
Figure 5-19:
Solid steel hot rolled sections (red arrow) left in beam pockets of CMU building section. These supported the steel joists shown in Figure 5-18. Also note lack of reinforcement in the wall and wall-to-foundation connection (Tuscaloosa, AL).

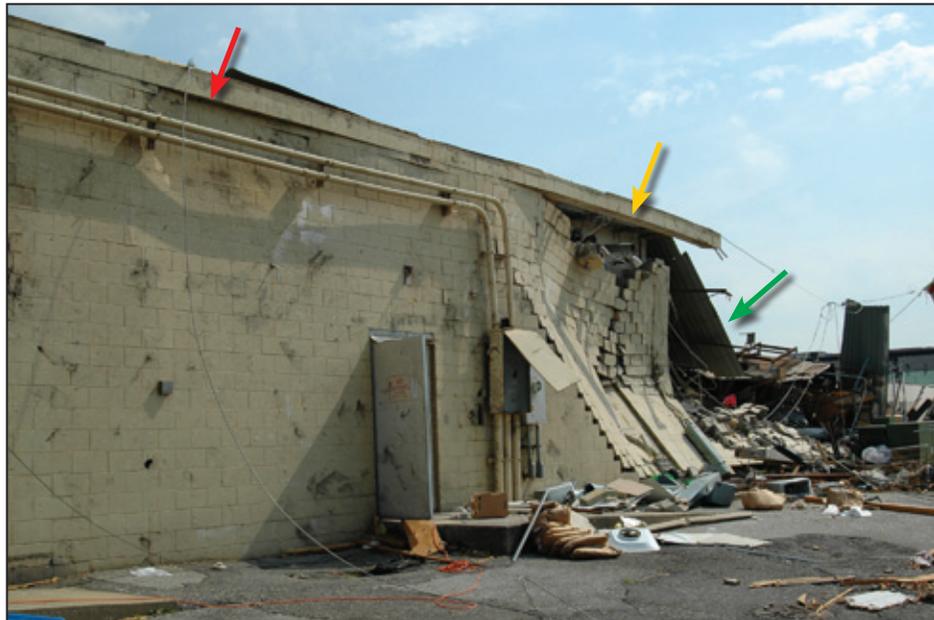
The connection at the base of the wall typically consists of reinforcing steel that is embedded into the foundation and then extended up into the CMU cells. The cells are then grouted, locking the reinforcing in place and allowing it to transfer both lateral and uplift load. The walls of the dry cleaning building did not have any visible steel connection between the base of the CMU wall and the foundation. The CMU walls relied on the block mortar joints and self-weight to support the wall. Figure 5-19 shows the lack of reinforcing in the entire wall and also at the connection between the base of the CMU wall to the foundation. The failure sequence is captured in Figures 5-20 and 5-21.

Figure 5-20:
Sequence of failure for CMU wall at the dry cleaner building: wall buckling and initial separation (red arrow) was followed by complete separation of wall from bond beam (yellow arrow) and then by collapse of wall (green arrow) (Tuscaloosa, AL)

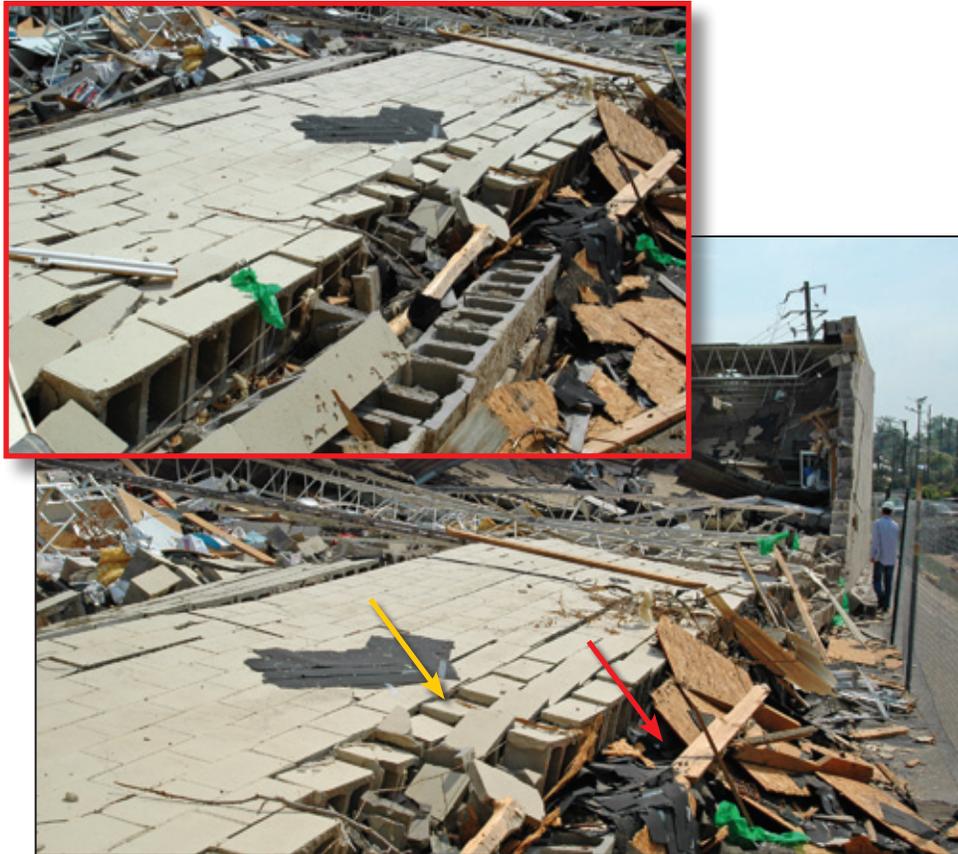
Figure 5-21: Global wall instability failure. The CMU blocks are lying loosely on the ground and many have rotated (yellow arrow) due to the complete separation of all the blocks. Note lack of reinforcement in the wall and especially between wall and footing (red arrow). Inset shows a close-up view of the separation of the blocks (Tuscaloosa, AL).

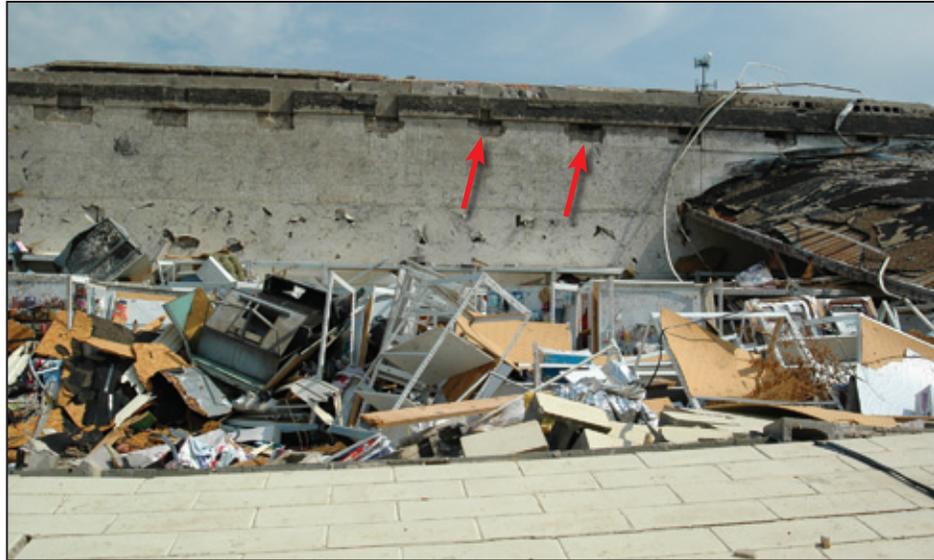
Figure 5-22:
View of steel joist pockets in CMU wall where joists pulled out (red arrows); the exterior CMU wall fell inwards, shown in the foreground (Tuscaloosa, AL)

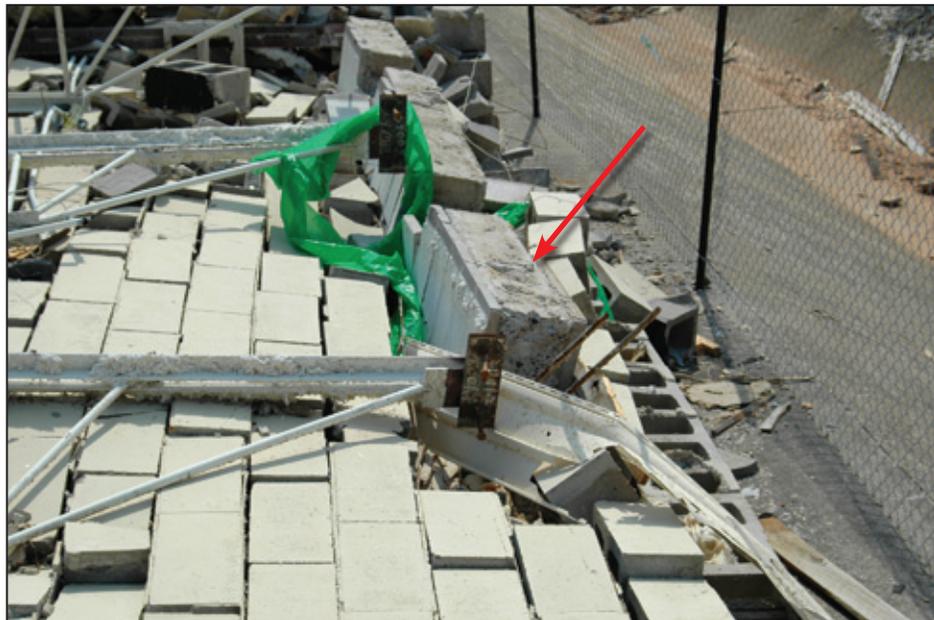
Figure 5-23:
Steel joists with joist seat and bond beam on top of collapsed wall (red arrow). Wall fragmentation shows lack of reinforcement in the wall (Tuscaloosa, AL).

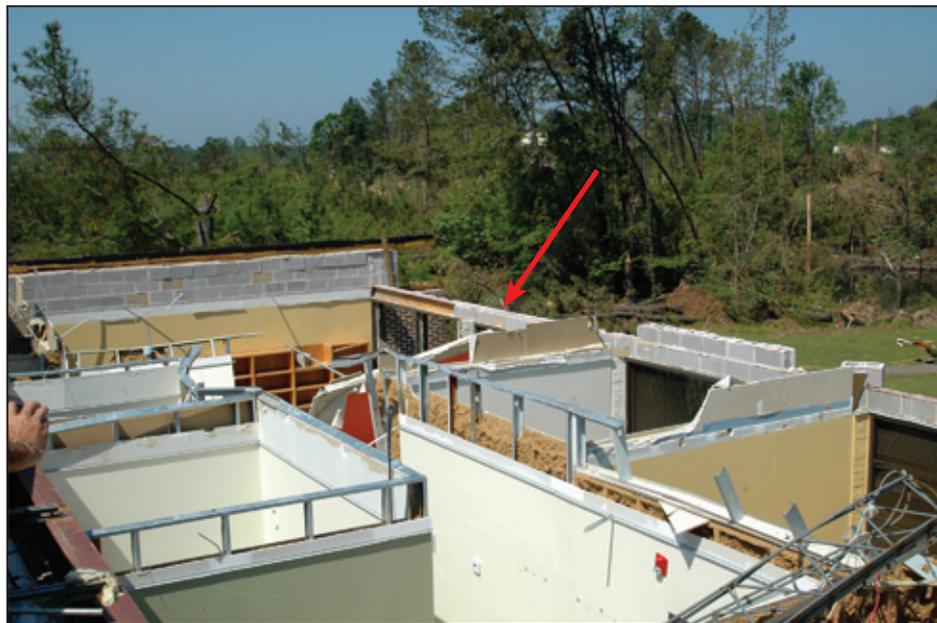
Figure 5-25:
Failed bond beam-to-
structural steel connection
over front windows (red
arrow) (Birmingham, AL)

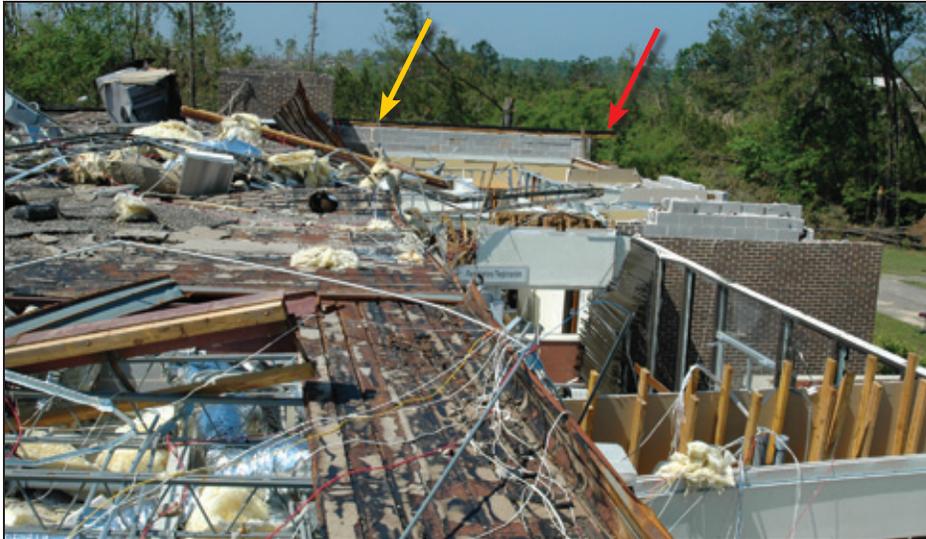
Figure 5-26:
Roof joist lifted off front (red arrow) and folded over rear half of building (yellow arrow) (Birmingham, AL)

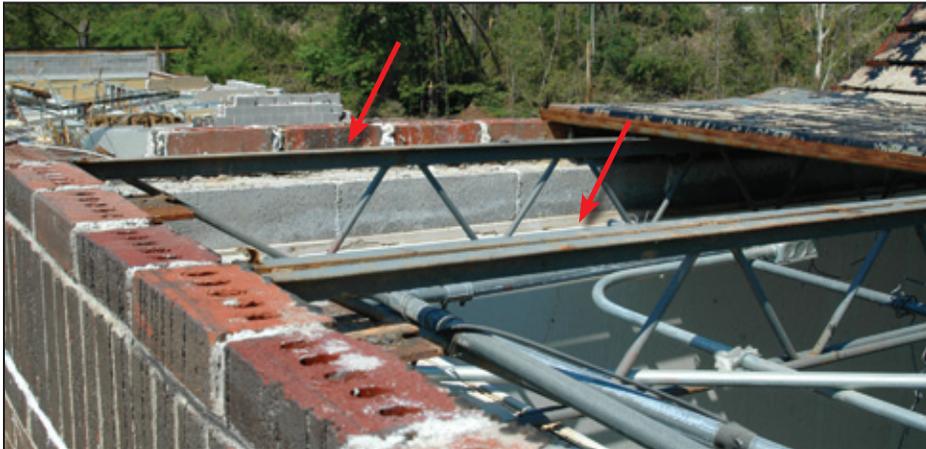
Figure 5-27:
Failed roof deck with no connections between the roof deck and the joists (red arrows) (Birmingham, AL)

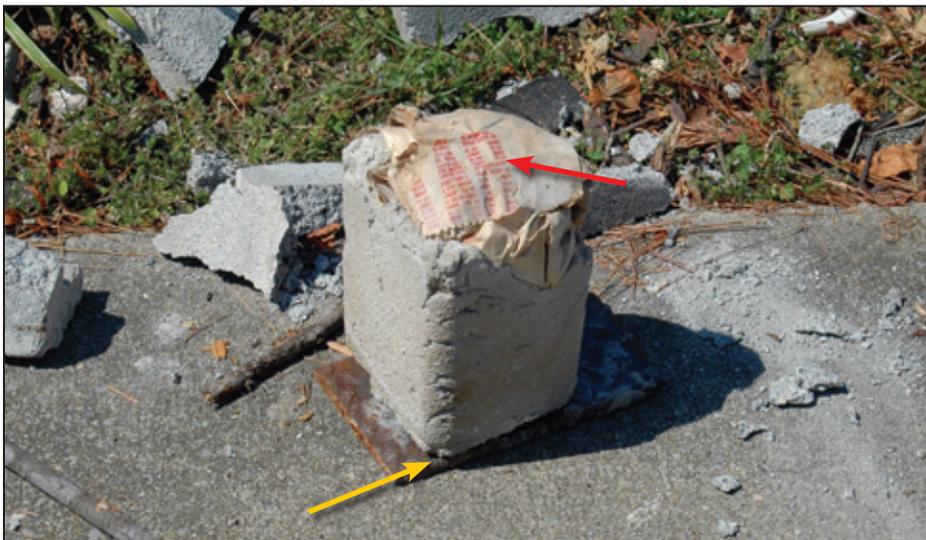
Another failure identified was the lack of continuity between the roof structure and the walls. Figure 5-28 shows where a bond beam cell has been stuffed with paper to limit the flow of the grout indicating a serious quality control issue during construction. Figure 5-29 shows a similar condition where the CMU cell is still attached to the steel joist but detached from the wall. Figure 5-30 shows a CMU bond cell that was torn from both the wall and the steel joist.

Figure 5-28:
This CMU cell was found on the ground adjacent to the structure (shown upside down). The bond beam cell is sealed with paper to keep grout from flowing into lower cells (red arrow) and thus there was no connection to lower elements. The embed plate can be seen attached (yellow arrow) (Birmingham, AL).

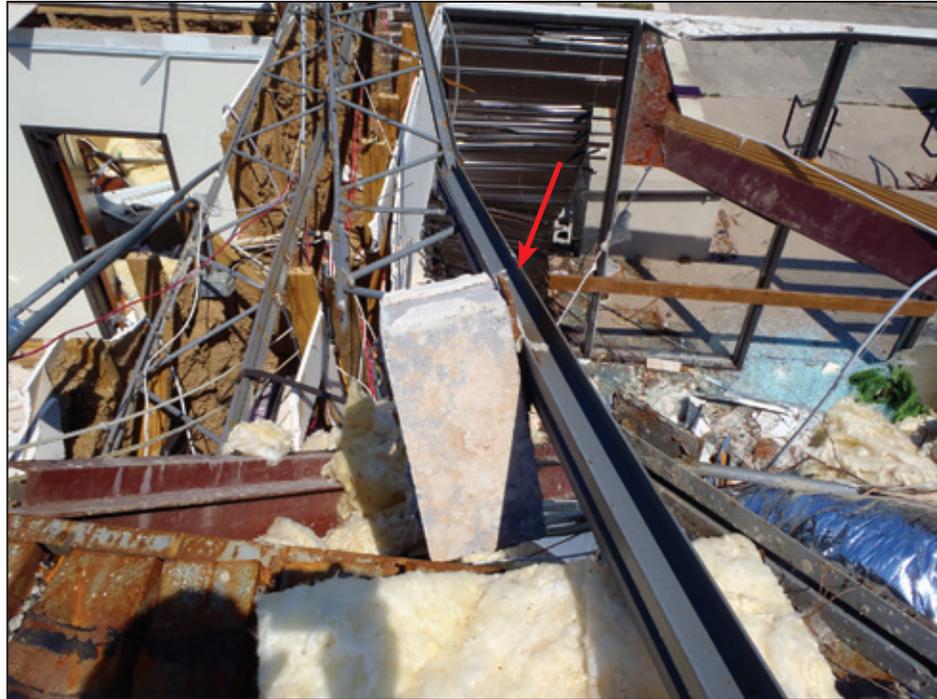
Figure 5-29:
Bar joist with embed
plate and bond beam cell
still attached (red arrow)
(Birmingham, AL)

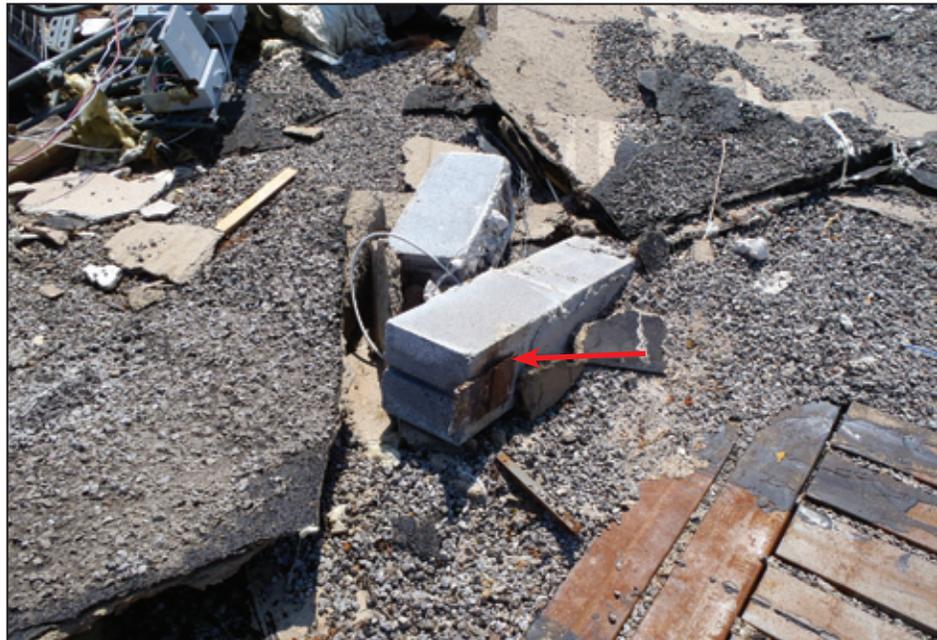
Figure 5-30:
Embed plate with bond beam
cell (red arrow) on roof
(Birmingham, AL)

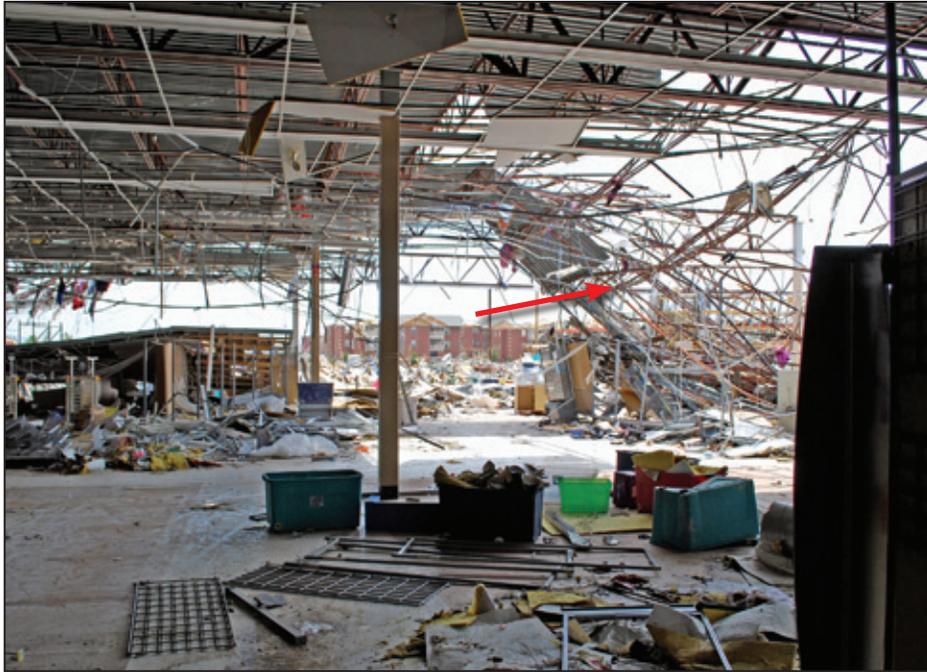
Figure 5-33:
Interior of the north half of
the Walmart, looking east.
Fallen roof structure shown
in right side of the picture
(red arrow) (Joplin, MO).

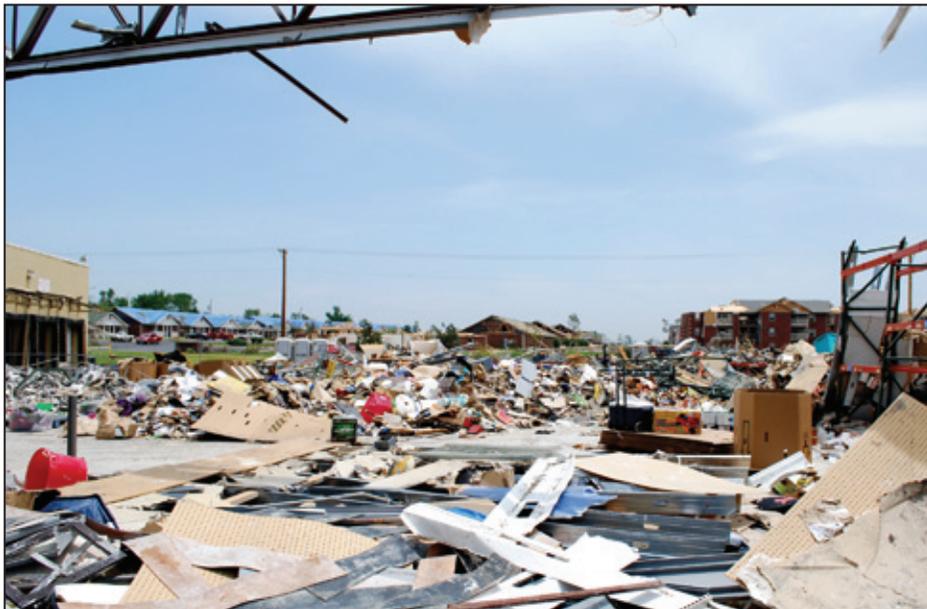
Figure 5-34:
Destroyed east side of north
half of Walmart (note loading
dock facing south) (Joplin,
MO)

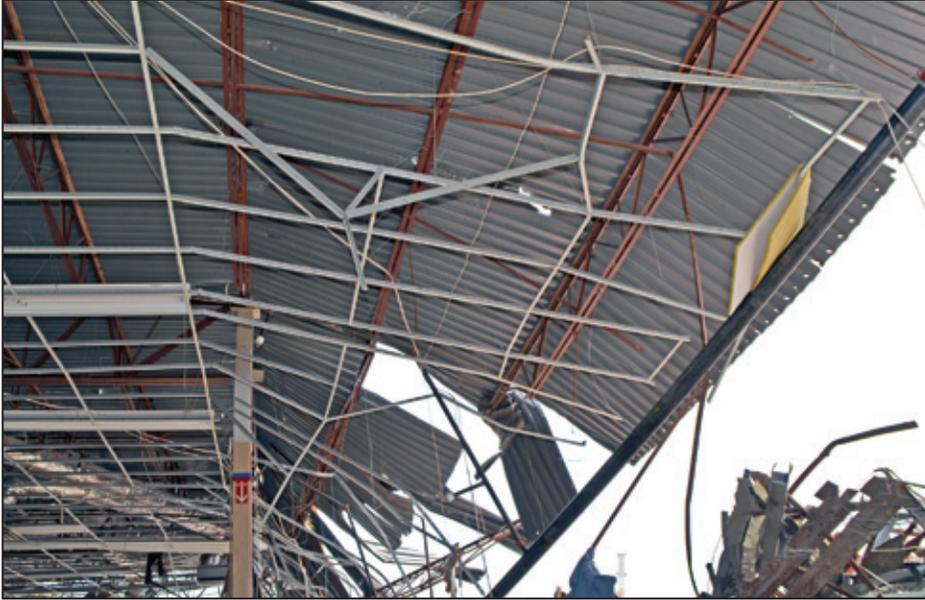
Figure 5-36:
Interior view from the south half of the building looking toward the east. This shows the boundary of roof damage to the south portion of the building. Note deck supported by steel joist (Joplin, MO).

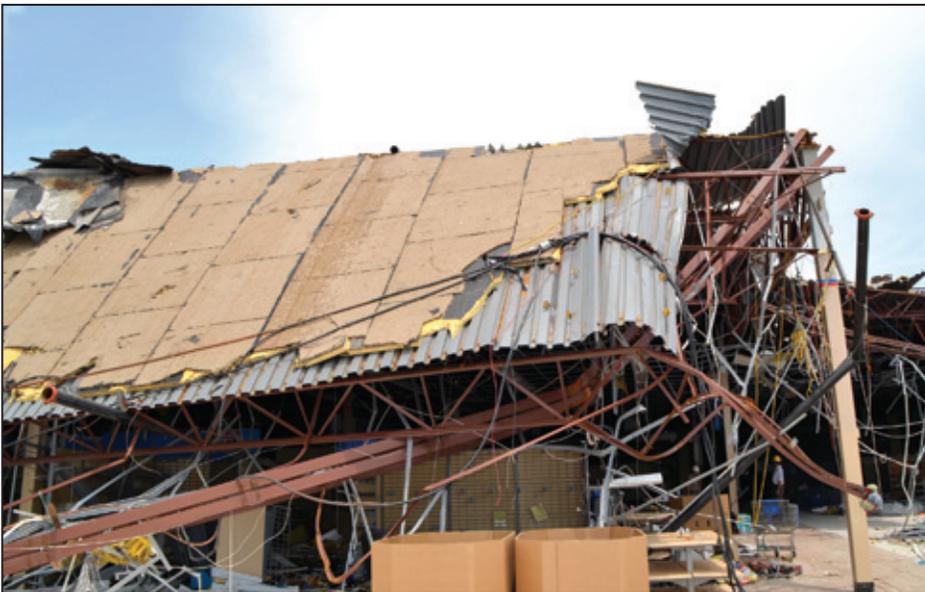
Figure 5-37:
View of the south half of the building looking north showing roof damage. Note the missing roof membrane (Joplin, MO).

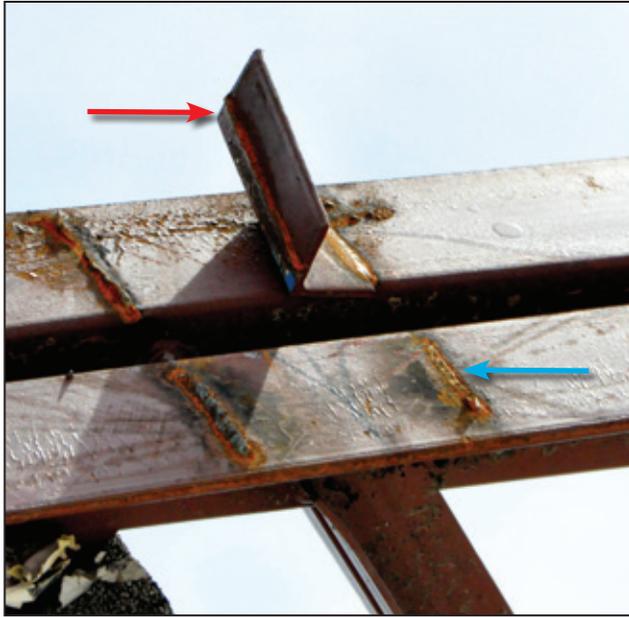
Figure 5-38: Typical connection of two steel joists to joist girder. While the joist seat from one joist remains (red arrow), the weld failed at the other joist seat connection (blue arrow) (Joplin, MO).

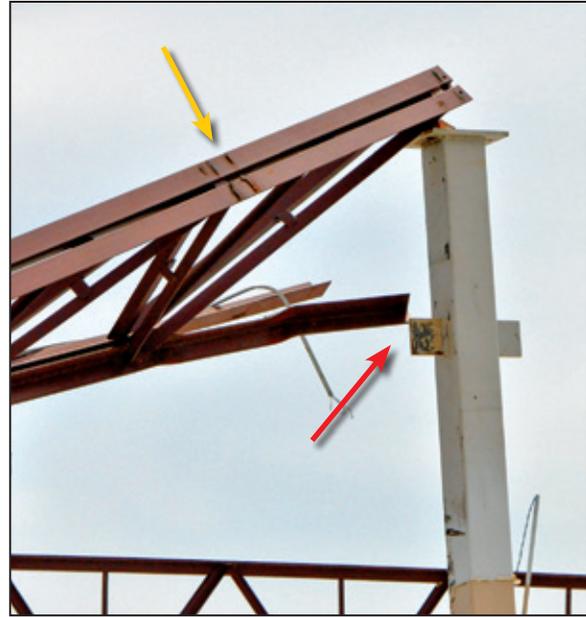
Figure 5-39: Joist girder rotated at the column; the bottom chord was not attached to the stabilizer plate (shown by red arrow). The joists were attached with welds to the joist girder top chord. This weld connection failed in the location shown (yellow arrow) (Joplin, MO).

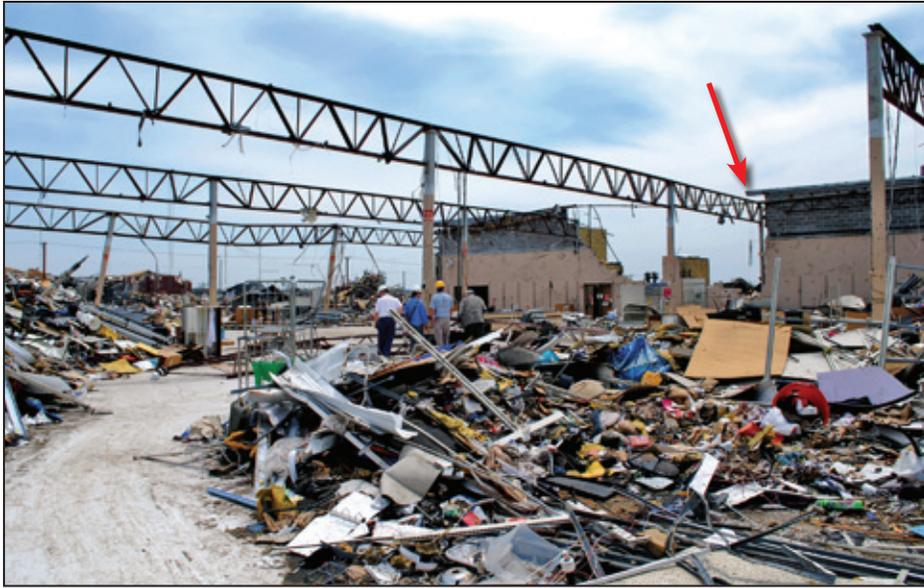
Figure 5-41:
Roof structure remaining in south half of Walmart. The red arrow shows the location of a column embedded in the wall (Joplin, MO).

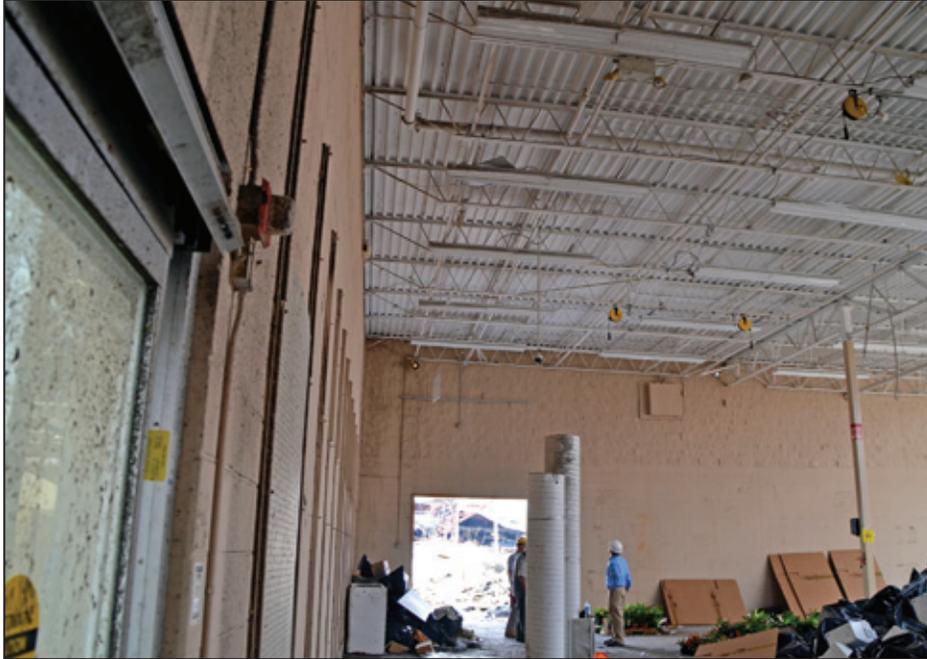
Figure 5-44:
Area of relatively limited
damage. Photograph was
taken looking north (Joplin,
MO).

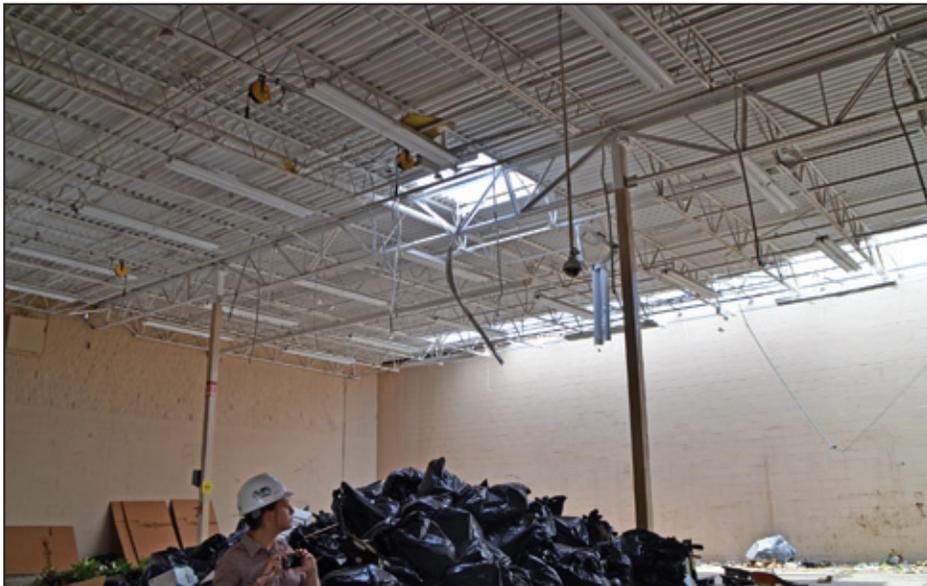
Figure 5-45:
Another view of the area
shown in Figure 5-44.
Photograph was taken
looking east (Joplin, MO).

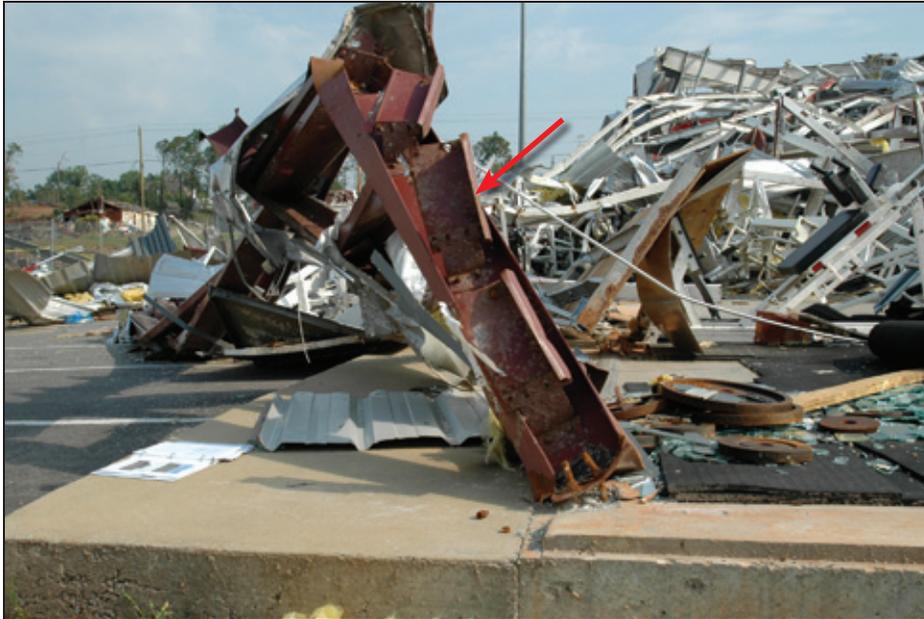
Figure 5-48:
The anchor bolts of this base plate connection performed well while the weld along the base of the steel column failed (red arrow) (Tuscaloosa, AL)

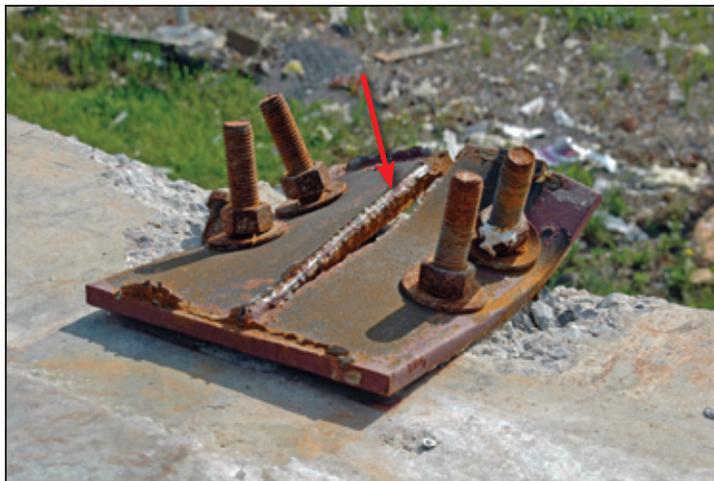
The MWFRS of the north end of this building performed well relative to the buildings in the immediate surroundings and exhibited ductility through much of the failure, providing cavities in which people could survive. The main column frame anchorages to the foundation performed well in the context of extreme overload (Figure 5-48). The column tore free from the base plate at the weld leaving the base plate and anchor rods in place. The steel anchor rods and base plates were stressed to the point of full yield—characterized by exaggerated deformation—which led to a failure of the welds to the columns (Figure 5-49).

Figure 5-49:
Ductile end column at southwest corner of building (red arrow). The anchor bolts remained attached to both the foundation and the column (Tuscaloosa, AL).
