TORNADO OUTBREAK *of* **2011**

IN ALABAMA, GEORGIA, MISSISSIPPI,
TENNESSEE, AND MISSOURI

5 Observations on Commercial and Industrial Building Performance

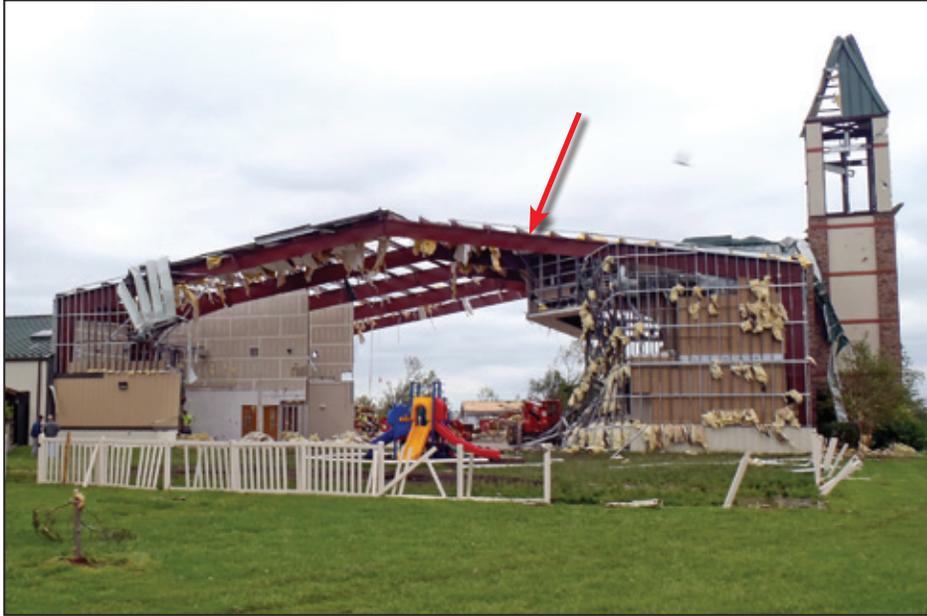
Figure 5-51:
Intact PEMB main frames
(red arrow) (Joplin, MO)

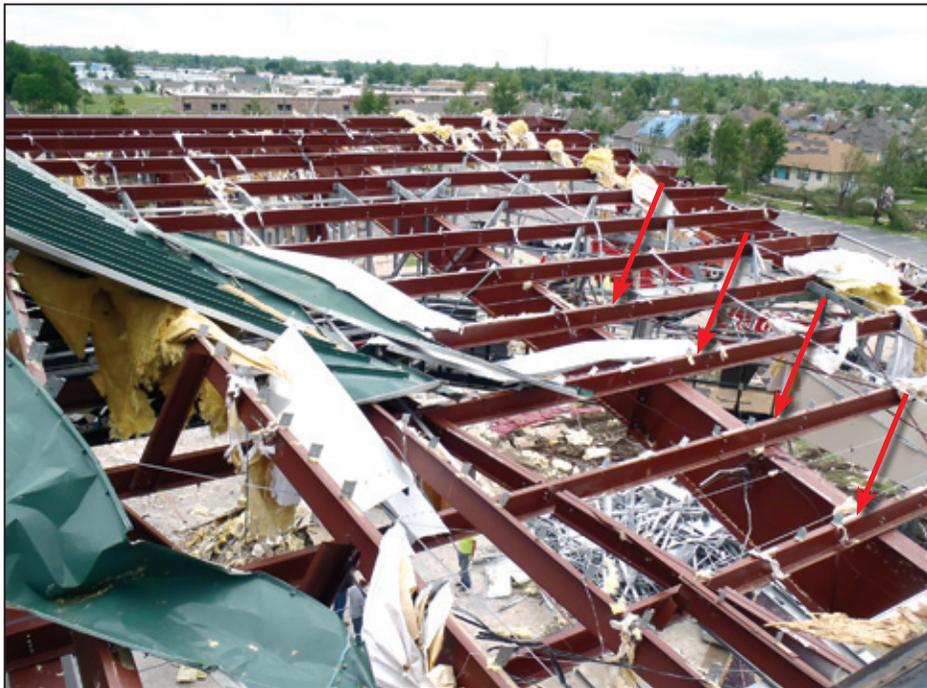
Figure 5-52:
Roof system purlins intact
with metal roof clip released
(red arrows) (Joplin, MO)

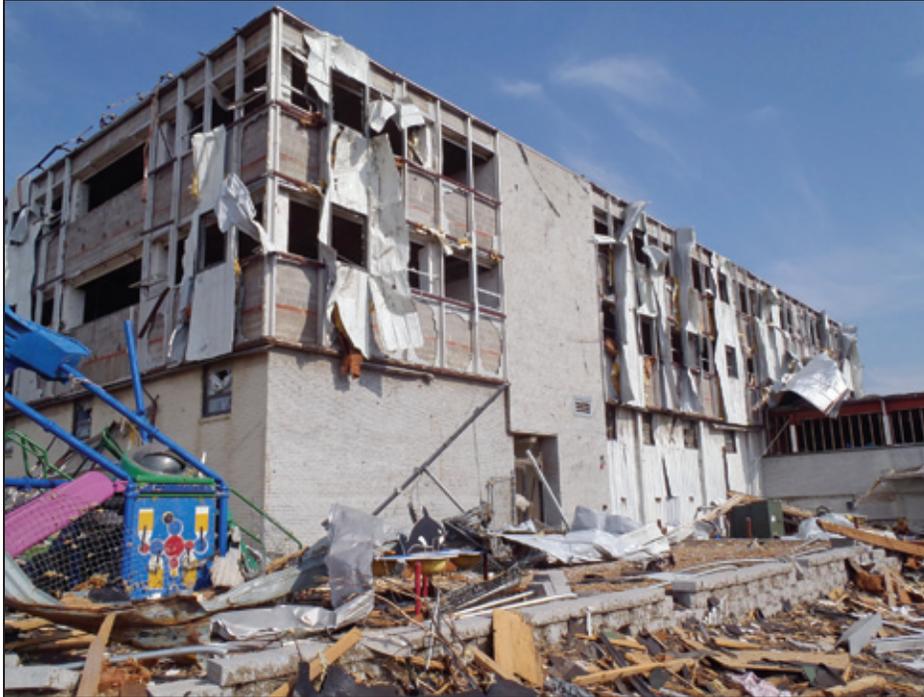
Figure 5-55:
East elevation of the Ozark
Center for Autism showing
damage to glazing and siding
(Joplin, MO).

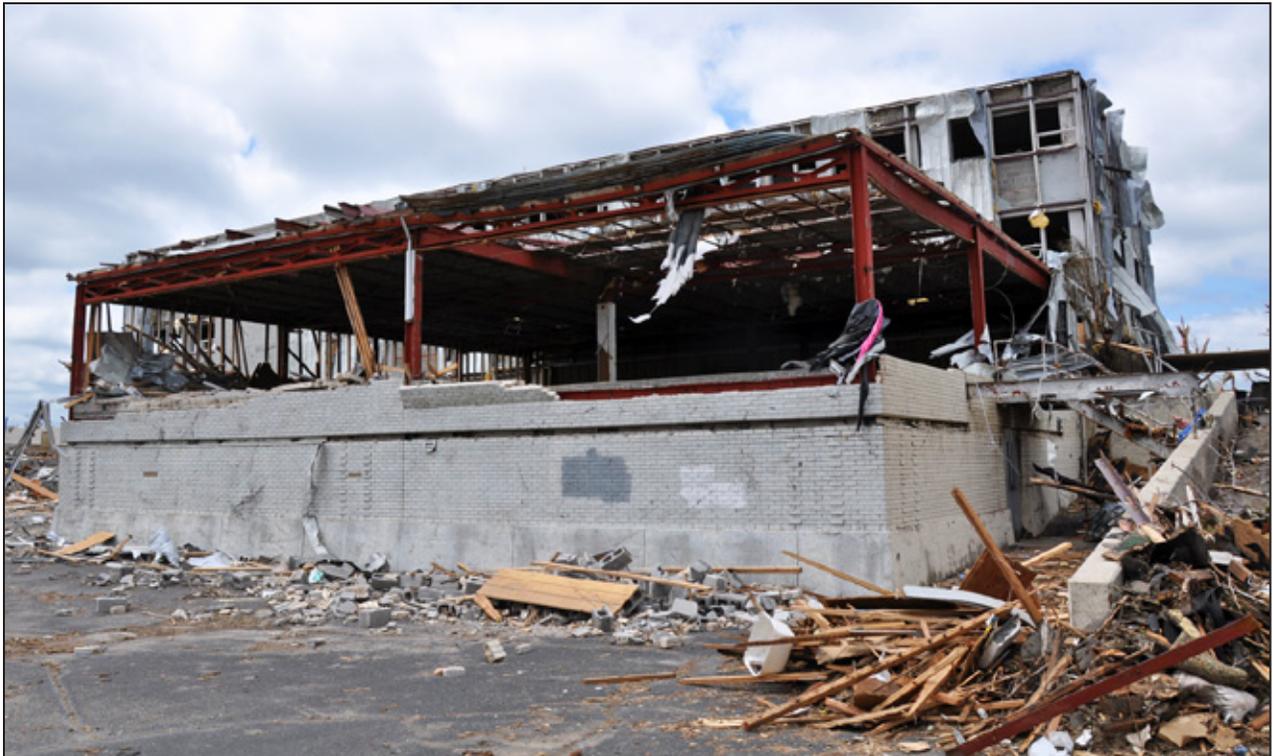
Figure 5-56: East elevation from northeast corner of building. The structural core of the taller building performed well, as did the CMU infill. The wing in the nearside of the figure is a two-story extension. Wood wall-framing debris can be seen in the foreground (Joplin, MO).

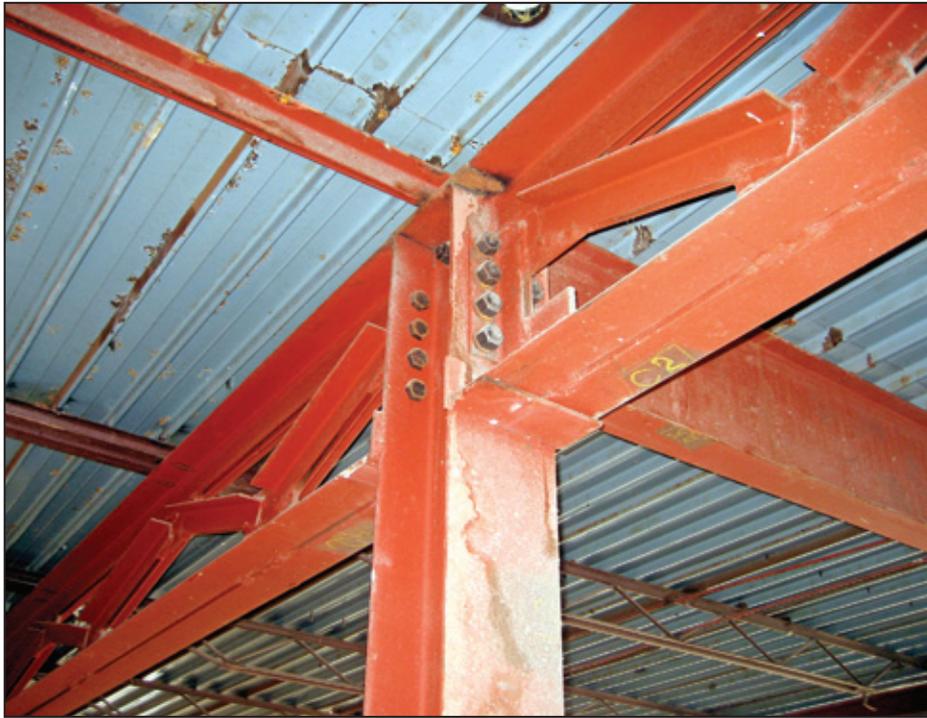
Figure 5-59:
Roof section at two-story extension showing how the metal roof deck diaphragm is connected to the joists (Joplin, MO)

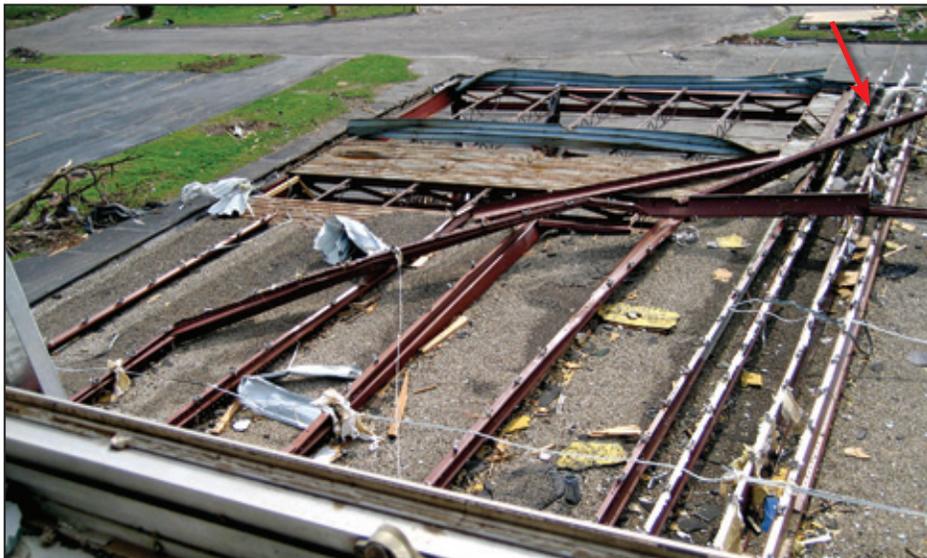
Figure 5-60:
View of roof of the two-story extension observed from the third floor. Note the failed decking at the corner (red arrow) (Joplin, MO)
