TORNADO OUTBREAK *of* **2011**

IN ALABAMA, GEORGIA, MISSISSIPPI,
TENNESSEE, AND MISSOURI

Observations on Tornado Refuge Areas, Hardened Areas, and Safe Rooms

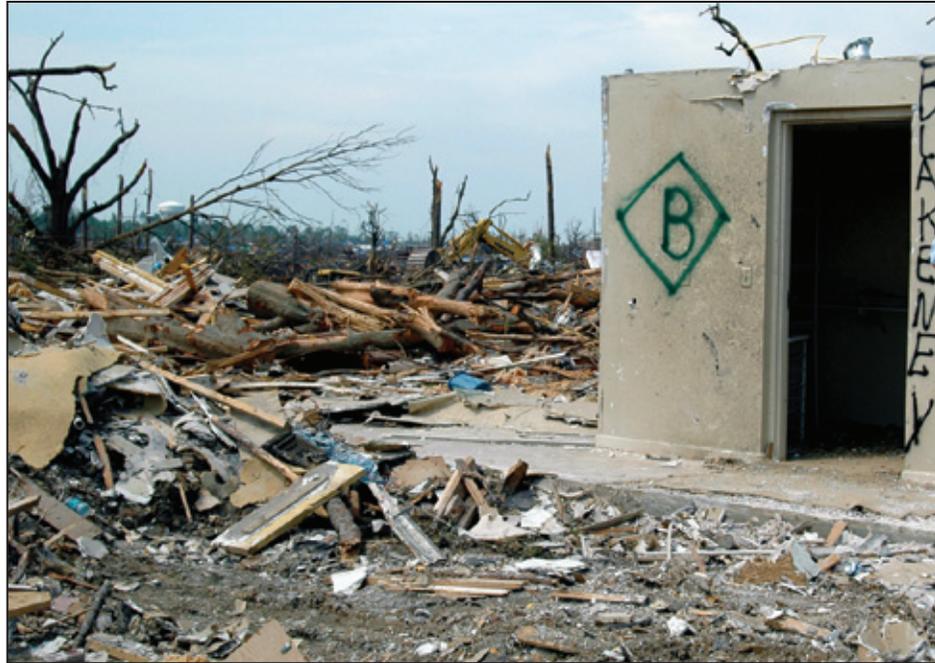
Figure 9-1:
A hardened room in a
residential building in
Tuscaloosa, AL

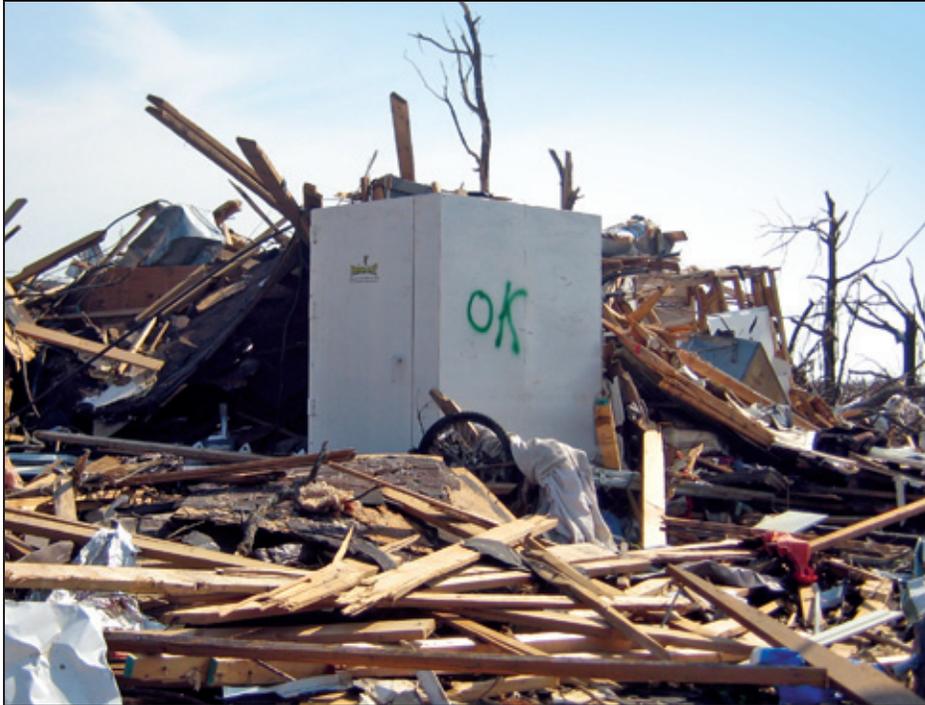
Figure 9-2:
Above-ground residential safe room installed in a garage of a home in Joplin, MO, directly impacted by the tornado (rated EF4 based on the MAT's observations)

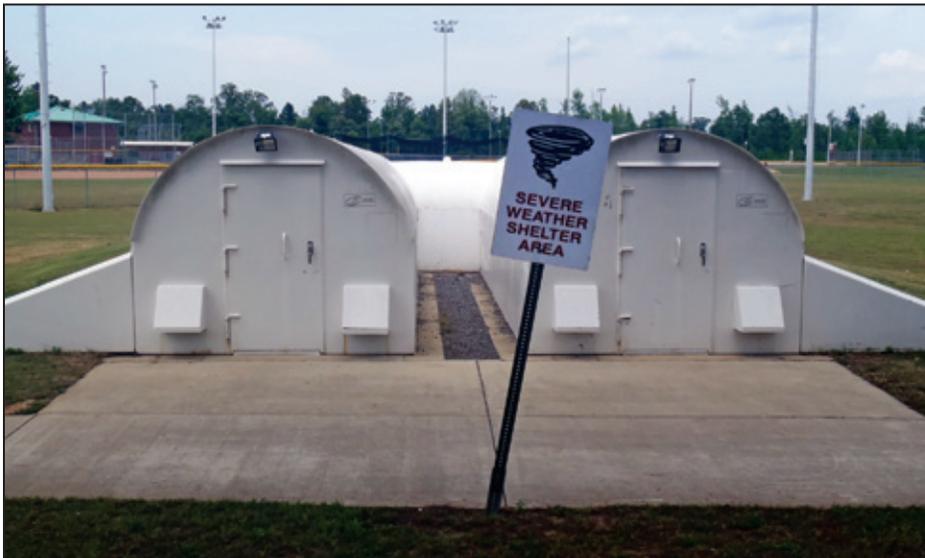
Figure 9-3:
These above-ground community safe rooms in Brookwood, AL, were used during the April 27 tornado outbreak, but were not directly impacted by a tornado

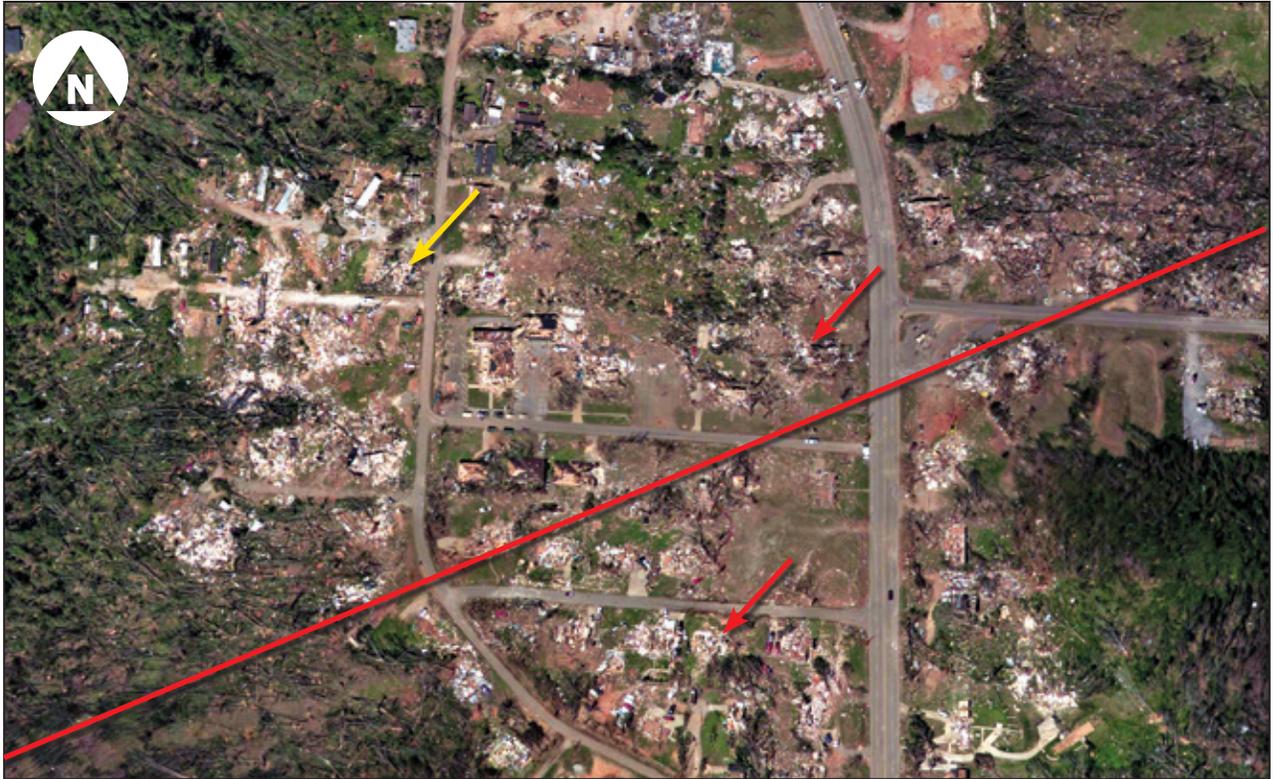
Figure 9-4: Aerial view of tornado damage swath in Crescent Ridge, AL (approximate centerline of swath is indicated by red line).³ Core remnants of homes shown in Figures 9-5 are identified with red arrows. The damaged manufactured homes in Figure 9-7 are identified with a yellow arrow.

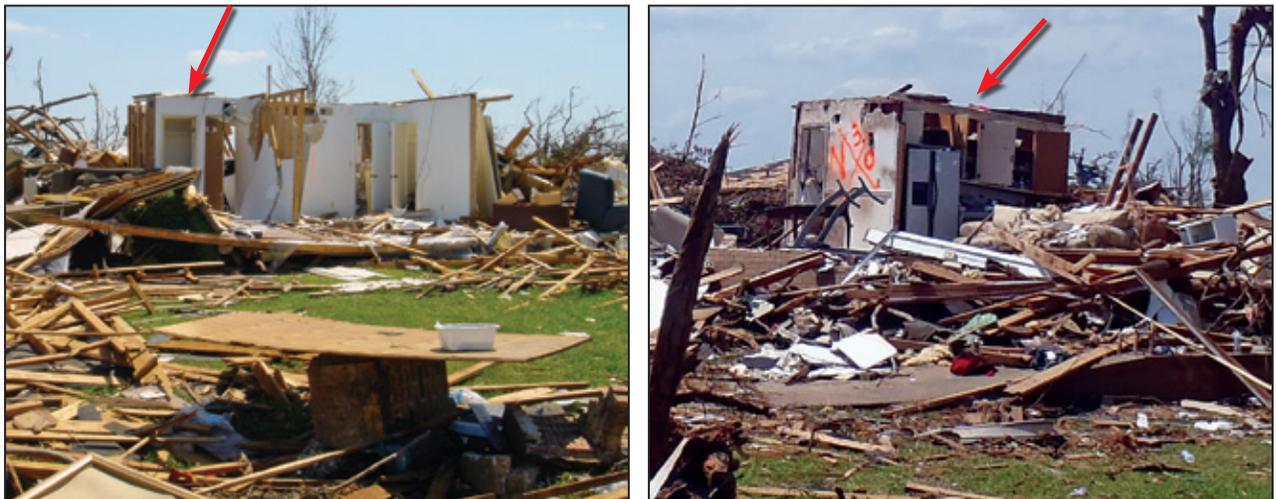
Figure 9-5: Core remnants of homes sometimes survive a tornado as shown in this photograph of site-built homes where a closet (red arrow in left photograph) and a bathroom behind a kitchen (red arrow in right photograph) remained standing after the tornado (Crescent Ridge, AL)

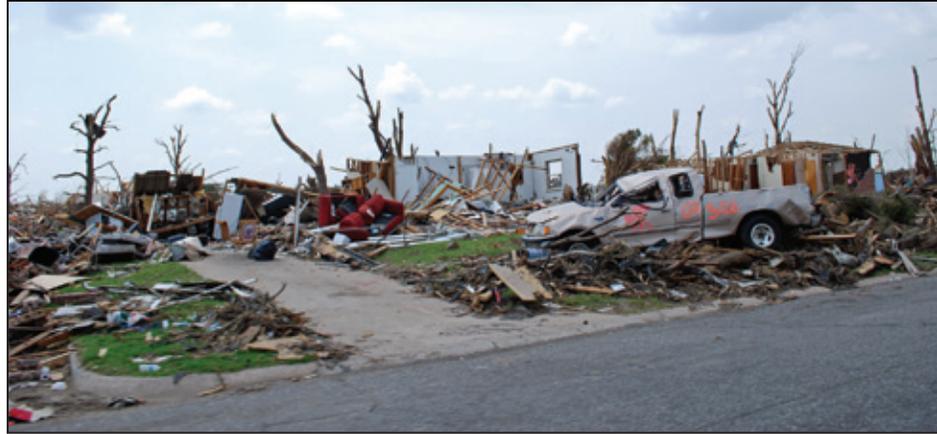
Figure 9-6:
The core remnant of a home
in Joplin, MO

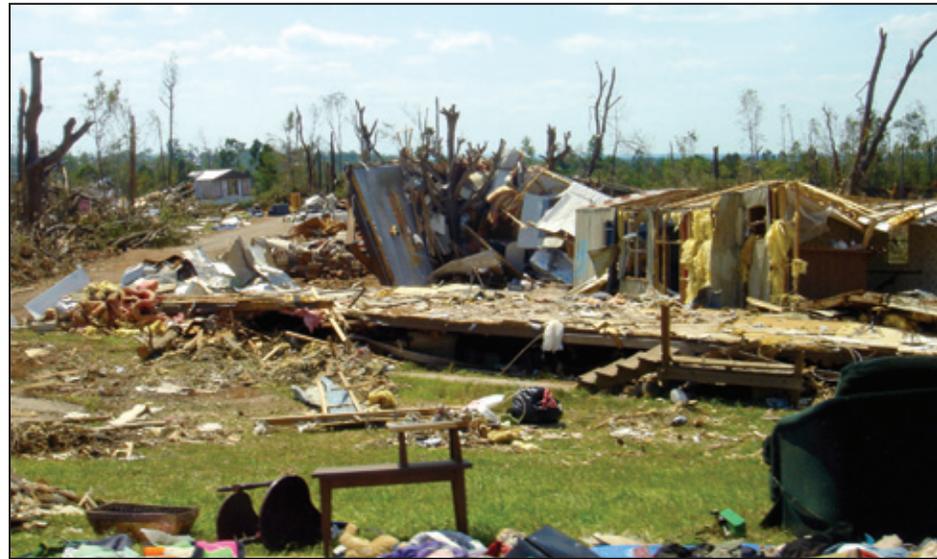
Manufactured Housing: Manufactured housing in Crescent Ridge, AL, did not withstand the tornado that struck the neighborhood. Damage in this neighborhood was ranked as EF4 by the MAT (see Appendix E for additional detail). Although the design and construction of manufactured housing improved greatly after HUD requirements were changed in 1994, manufactured housing is not constructed to survive a tornado event. The long, narrow dimension of the units and different means and methods of securing the units to foundations are a few of the factors that have contributed to overturning and other failures of manufactured home units. Figure 9-7 shows several manufactured homes in the Crescent Ridge, AL, area after the tornado. These homes were displaced off their foundations and also experienced significant damage to the units themselves. No core remnants remained.

Figure 9-7:
Manufactured homes
destroyed in Crescent Ridge,
AL (location shown in
Figure 9-4)

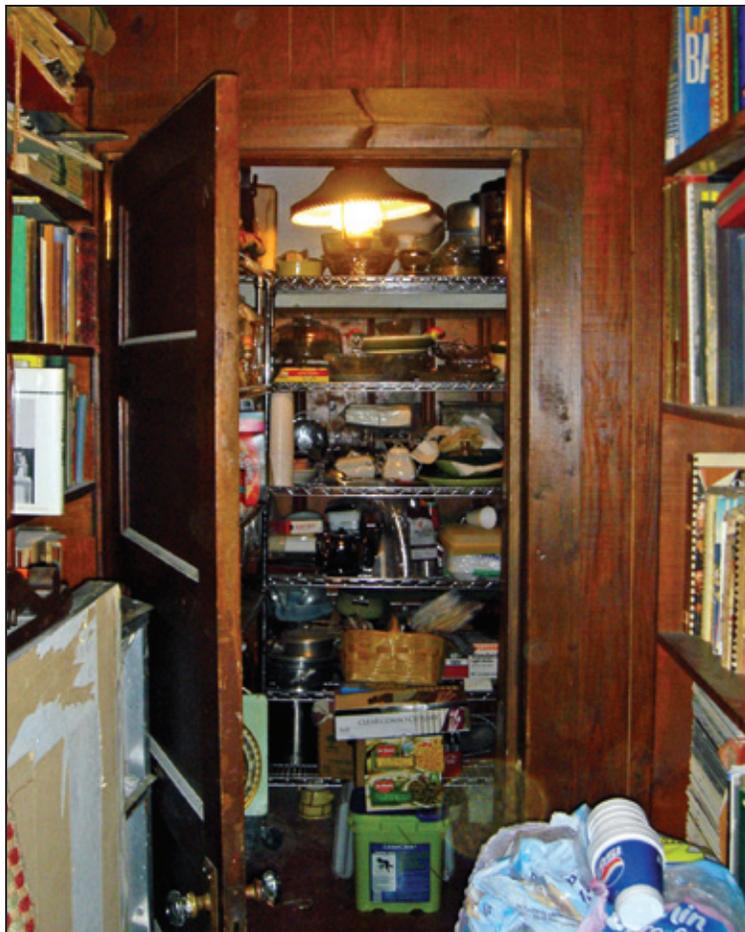
Figure 9-8 shows an interior basement storage room in a Tuscaloosa, AL, home. This unique home was re-constructed in the 1940s from two old cabins that had been re-located to the site. Placed atop a hillside, the masonry foundation supporting the cabins created a walkout basement. When the family constructed the basement, they set aside the storage room to be used during tornadoes. With heavy timber construction and one wall built into the hillside, this space offered some level of protection. Damage in the neighborhood of this home was ranked as EF2 by the MAT (see Appendix E for additional detail). Although not specifically designed for protection, the family

Figure 9-8:
Tornado refuge area in a
Tuscaloosa, AL, basement

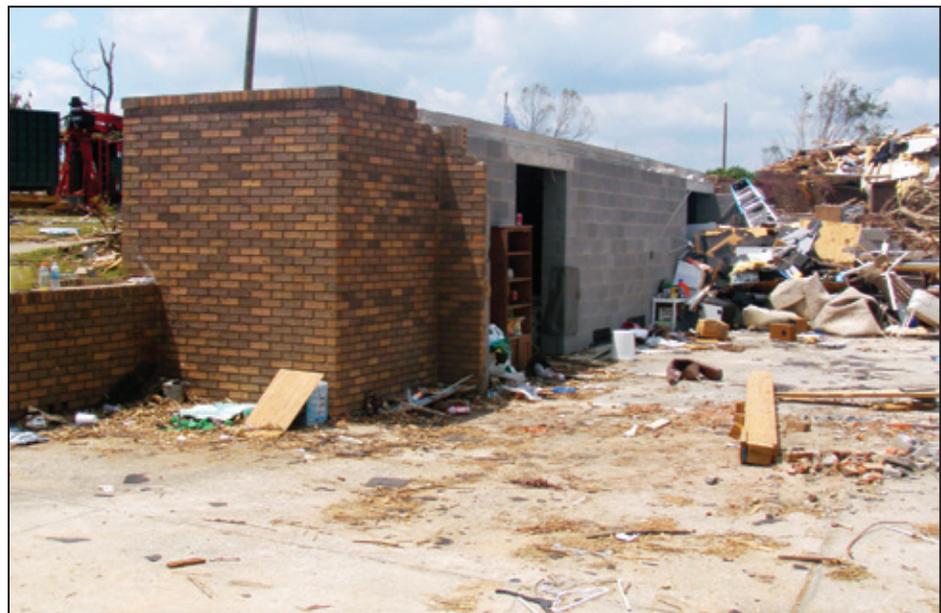
Figure 9-10:
A hardened porch slab over this basement helped to create a tornado refuge area that allowed this family to survive the tornado; location shown in Figure 9-9 (Birmingham, AL)

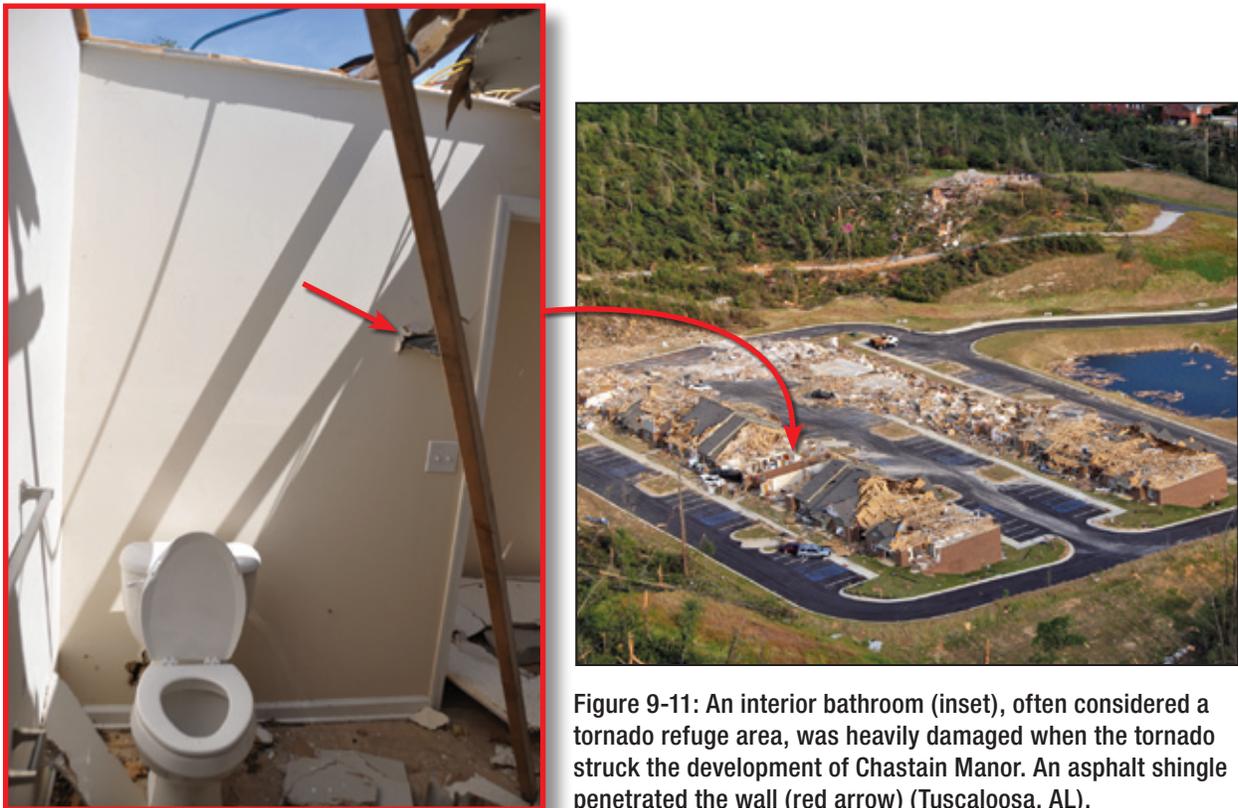
Figure 9-11: An interior bathroom (inset), often considered a tornado refuge area, was heavily damaged when the tornado struck the development of Chastain Manor. An asphalt shingle penetrated the wall (red arrow) (Tuscaloosa, AL).

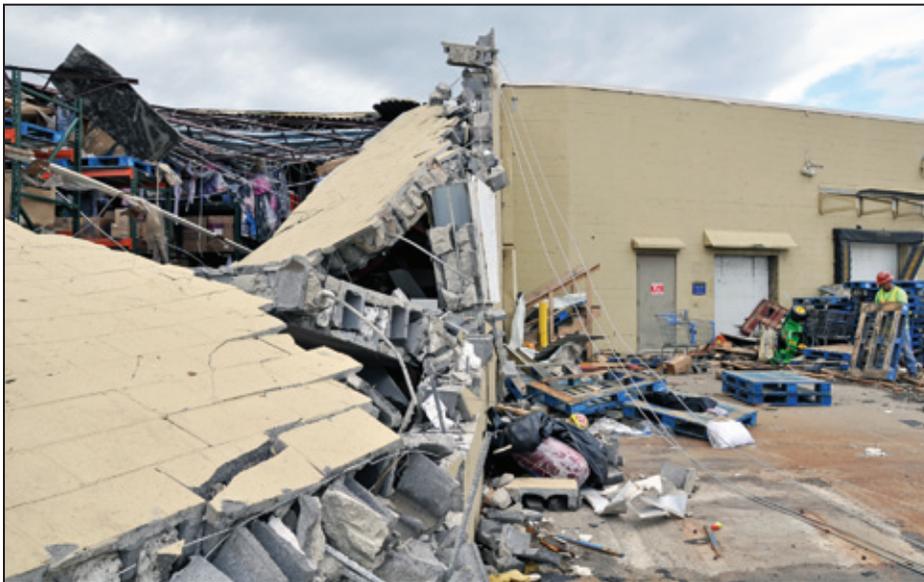
Figure 9-13:
Close-up view of the damage
at the Walmart store in
Joplin, MO

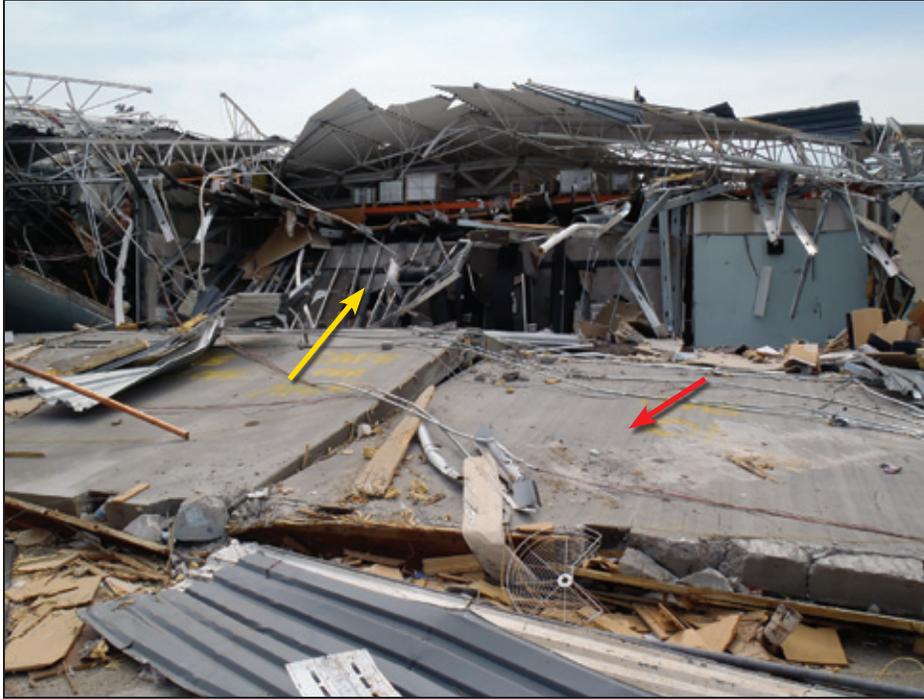
Figure 9-17:
Tornado refuge area (training room) of the Home Depot. Note the collapsed tilt-up wall (red arrow) and the wall leaning into the refuge area (yellow arrow) (Joplin, MO).

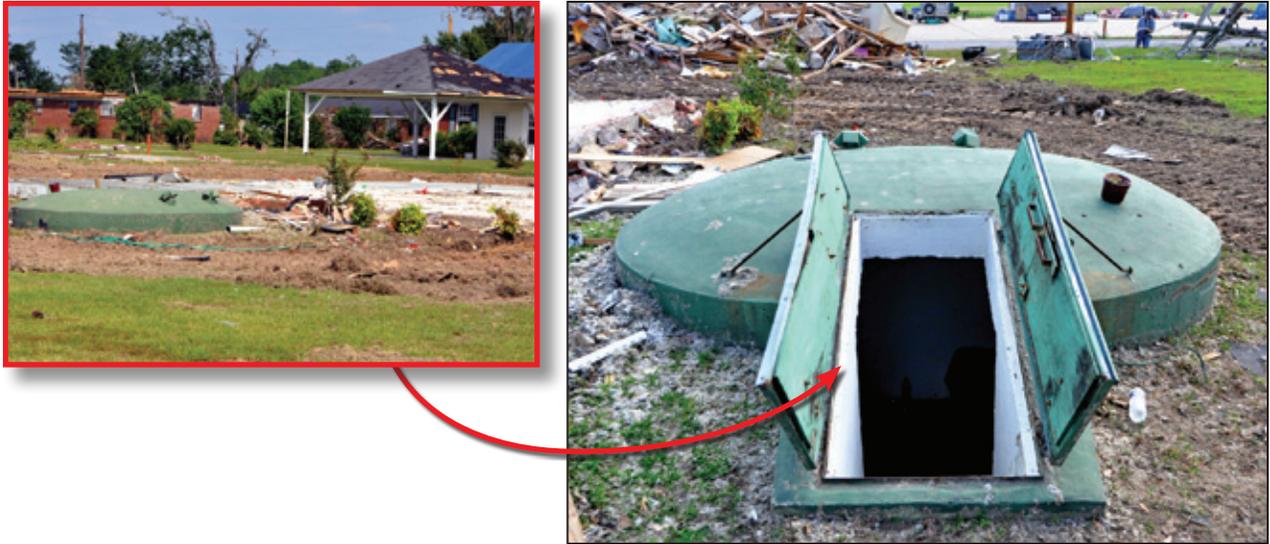
Although constructed of a hardened concrete shell, the “shelter” shown in Figure 9-18 was protected by plywood doors clad with light steel, a single point locking system, and a vent system that was vulnerable to impacts. It is unknown how many occupants using this structure survived, but the adjacent home was destroyed when the tornado passed over Smithville, MS. Although the Smithville tornado was rated higher at different locations along its track (see Section 2.5.1.7 of this report), the MAT derived the tornado rating as EF2 at this location based on damage to this building.

Figure 9-18: Underground shelter that survived a tornado (rated EF2 based on the MAT's observations). Inset shows the location of shelter (Smithville, MS).

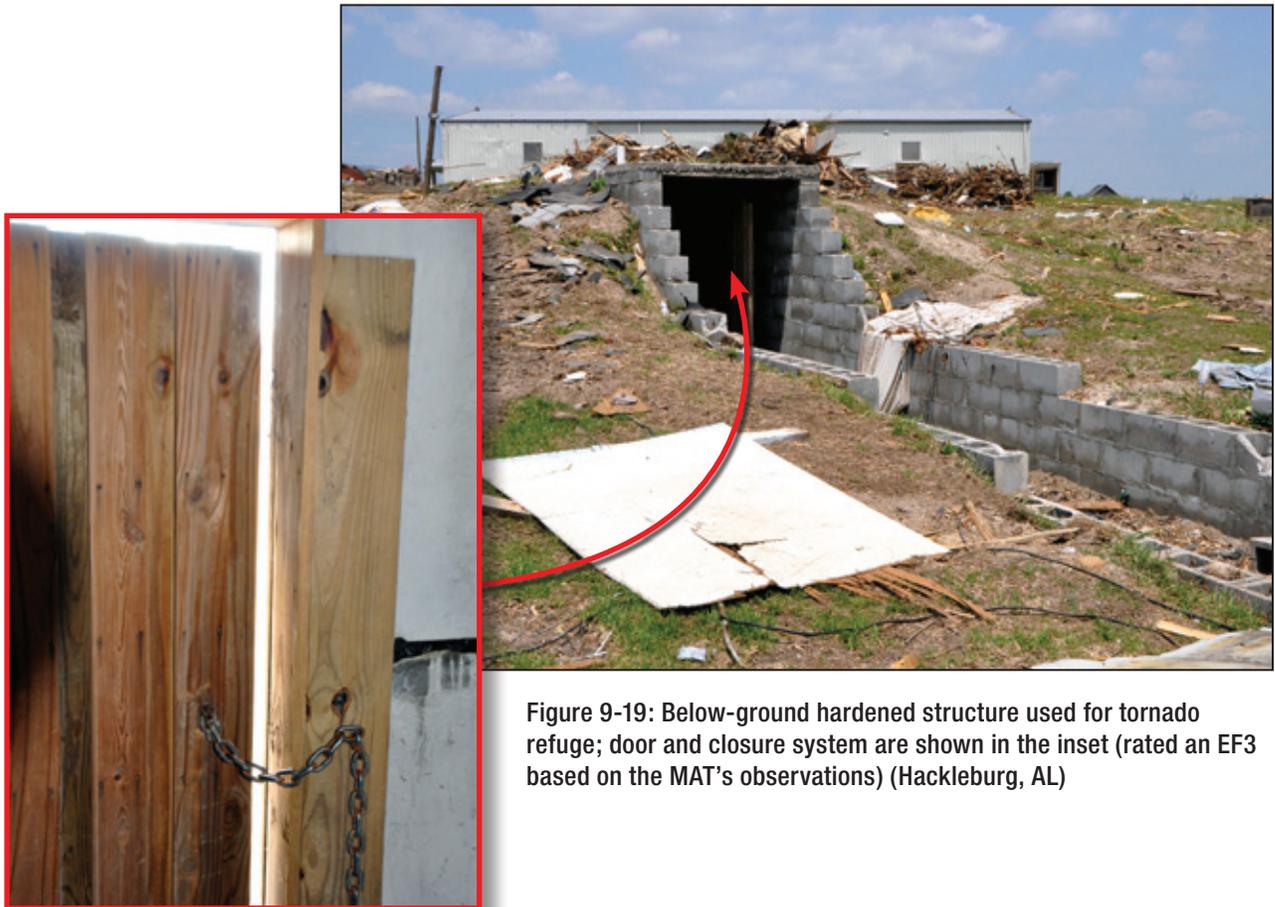
The Hackleburg, AL, below-ground structure shown in Figure 9-19 seemed to be relatively new. The MAT was unable to determine how many sought refuge here, but there was evidence in the shelter that it was used. Damage in the neighborhood of this home was ranked as EF3 by the MAT (see Appendix E for additional detail). Though the structure was mostly underground and had a reinforced concrete roof structure, the door was constructed of wood planks and locked with a chain held by bent nails. This type of door and method of connection is inadequate to resist wind loads and wind-borne debris; occupants who took refuge here were still at risk because of the low quality and characteristics of this door assembly.

Figure 9-19: Below-ground hardened structure used for tornado refuge; door and closure system are shown in the inset (rated an EF3 based on the MAT's observations) (Hackleburg, AL)

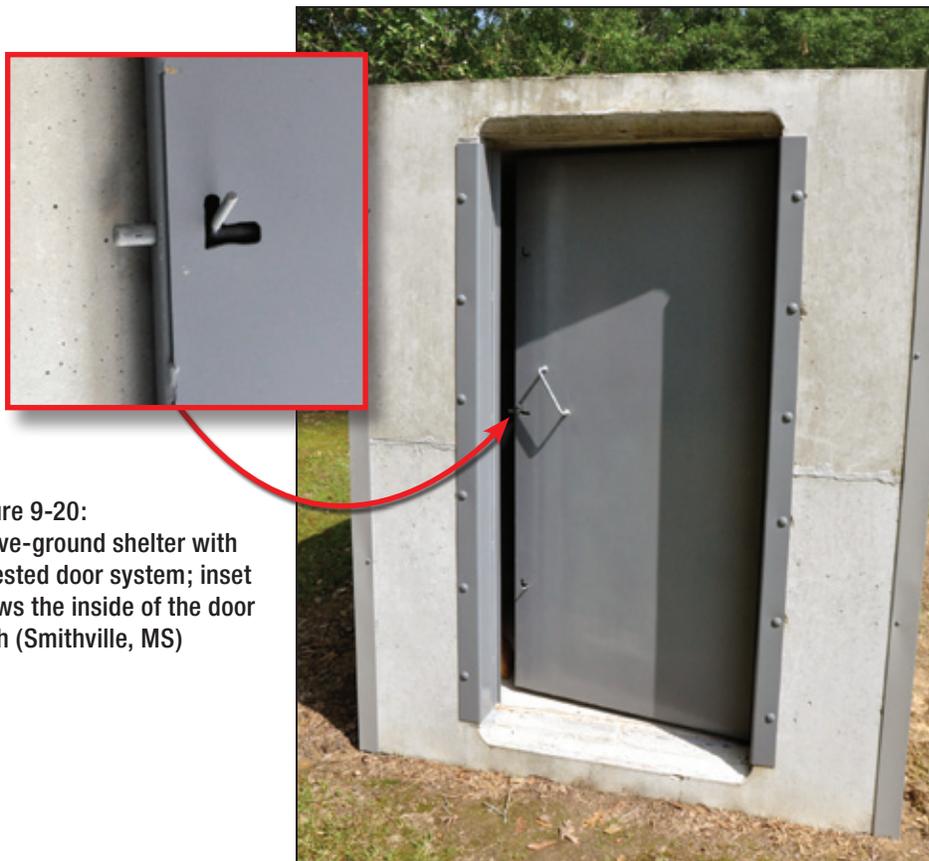
A husband and wife took shelter in their above-ground concrete shelter in Smithville, MS, shown in Figure 9-20. Although the small town of Smithville was devastated by a tornado that reached EF4 intensity in places along its track, this home was on the periphery of the vortex and suffered little damage. The clam-shell concrete structure was anchored to the ground with steel bands and earth anchors. Although the concrete walls were sufficiently thick at 6½ inches, the door system was untested, and the locking system could open when impacted by debris or subjected to high wind pressures. The door locking mechanism used three points of connection on the non-hinge side of the door (as suggested in FEMA 320), but the three individual mechanisms used to keep the door in the closed position were not identified as having been tested to the FEMA or ICC debris impact resistance criteria. Because these latching mechanism were light weight and the door did not appear to be reinforced around the latch points, the door was vulnerable to being forced open from wind or wind-borne debris. Further, this structure did not appear to be anchored to resist wind loads (other than the grounding force resulting from its dead weight).

Figure 9-20:
Above-ground shelter with
untested door system; inset
shows the inside of the door
latch (Smithville, MS)

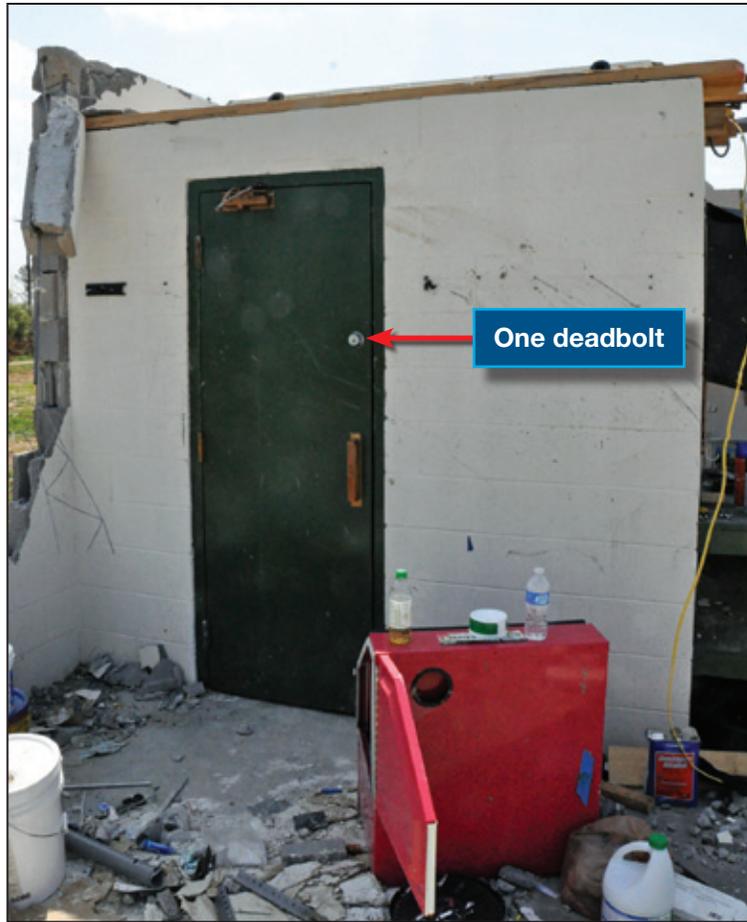
The MAT observed another example of an above-ground “shelter” in Athens, AL (Figure 9-21). A family survived the tornado in a hardened room they had constructed within a shop building east of their home. The hardened room (approximately 8 feet tall, and 6 feet by 9 feet in plan) was constructed with a reinforced CMU wall structure and concrete roof deck. The shop building was totally destroyed by the tornado, as was most of their home. The NWS rated the center of the

Figure 9-21:
A family shelter with a single
deadbolt (Athens, AL)

Although this room successfully provided safe refuge for the family, they were still at risk from high winds and wind-borne debris because of the door system used. The performance of this structure may not have been successful if the door had been impacted by wind-borne debris that caused the door system to fail. Occupants are often unaware of residual risks that remain in these otherwise robustly constructed structures and rooms when structures intended to provide protection from tornadoes are not constructed to the FEMA or ICC criteria.

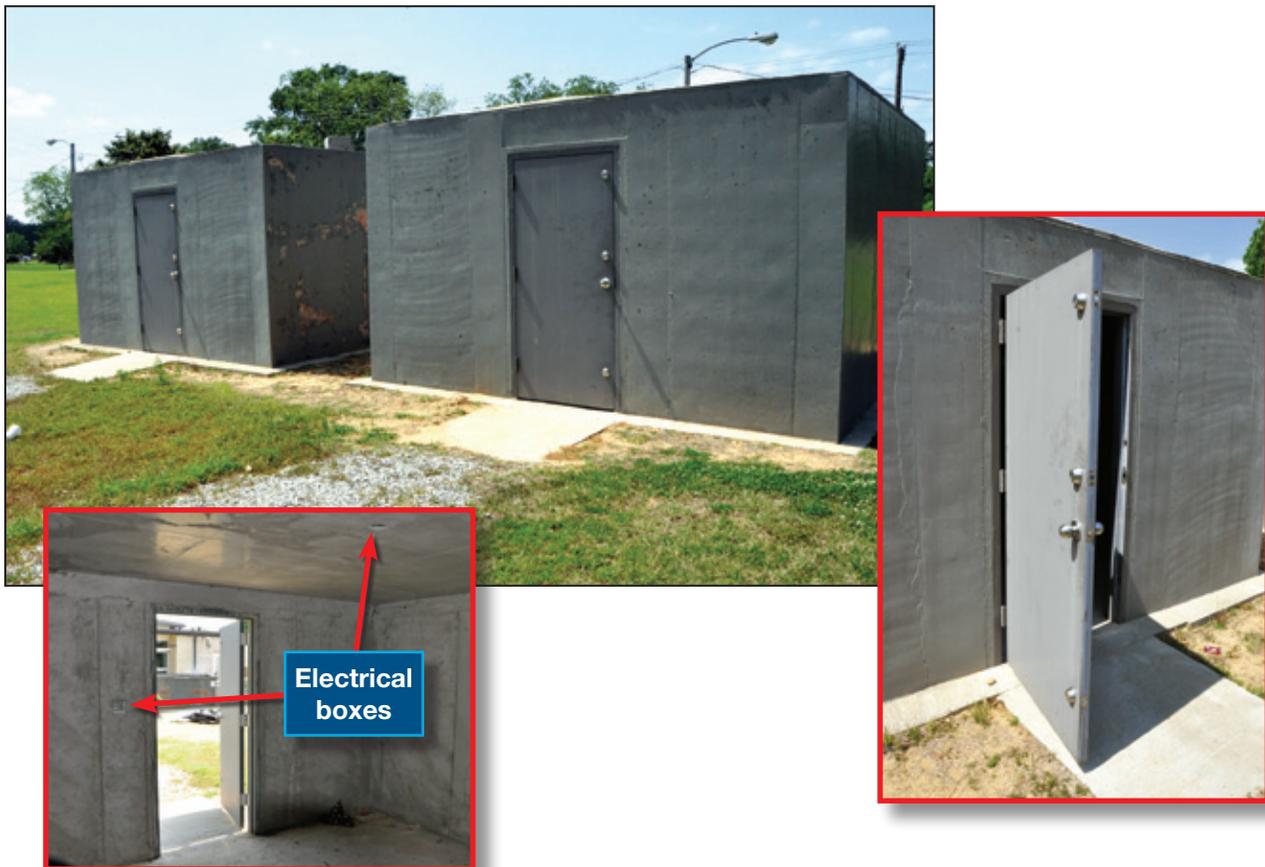
The Town of Amory, MS, was directly struck by the tornadoes of April 25–28, 2011, but its sirens were sounded by their 911 facility and many took refuge in the concrete above-ground structures shown in Figure 9-22. These structures were not in the damage swath of the tornado that struck Amory. It is unknown how many residents occupied these structures during the several days when tornado watches were in effect. Each unit is 13 feet x 13 feet wide and 7.5 feet tall. Although conduit and switch receptacles for lighting were present in the concrete structures when the MAT visited, no wiring or fixtures had been installed. The doors were hollow metal commercial grade with three deadbolts, but it is unknown if they were FEMA-compliant and tested door assemblies. Although the intended use of these structures was clear, the MAT could not verify the design criteria used for these structures and if they were evaluated to any standards or guidelines for tornado protection.

Figure 9-22: Above-ground hardened structures used as community tornado refuge areas. Insets show electrical boxes ready for wiring and fixtures (left) and door assemblies (right) (Amory, MS).

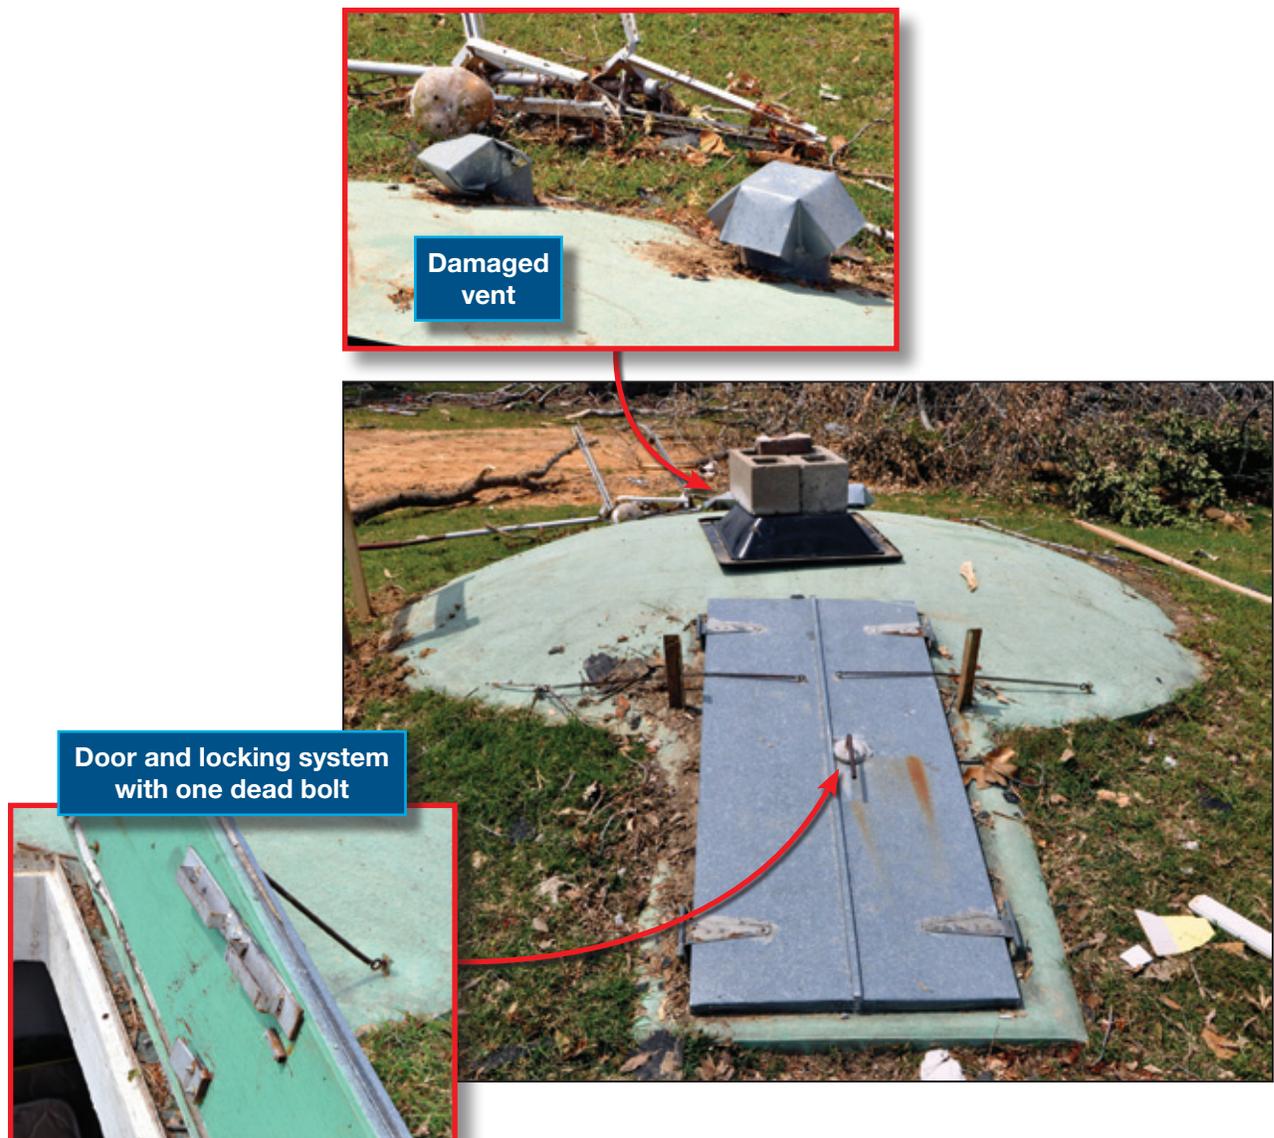
In Smithville, MS, a hardened, underground structure (Figure 9-23) was designated as the “community shelter” to be used during tornadoes. The structure reportedly held 10 individuals during the April 27, 2011 tornado event, rated EF3 by the NWS. Although the structure was robust and constructed from reinforced concrete, the doors were inadequate and did not provide the appropriate level of protection. The doors were constructed of two layers of plywood with a thin sheet steel cladding and only one locking point. This structure also had only one vent for fresh air; the vent was damaged by debris during the storm.

Figure 9-23: Below-ground, hardened structure with poor door and locking system (inset on lower left) and damaged vent (upper inset) (Smithville, MS)

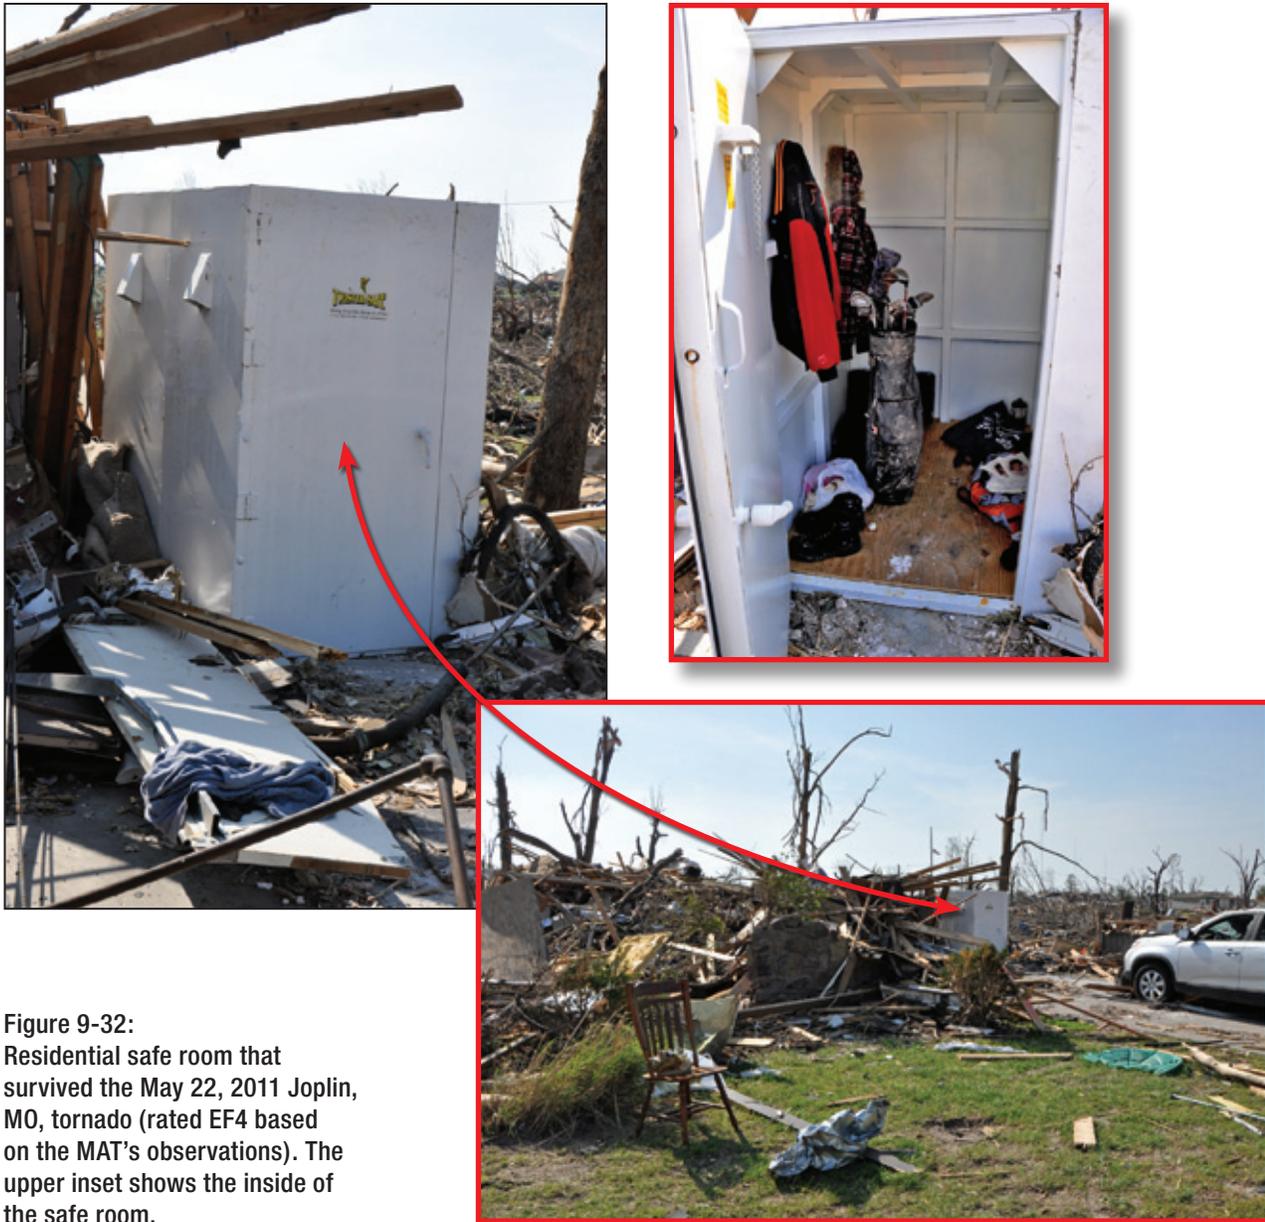
Figure 9-32:
Residential safe room that survived the May 22, 2011 Joplin, MO, tornado (rated EF4 based on the MAT's observations). The upper inset shows the inside of the safe room.

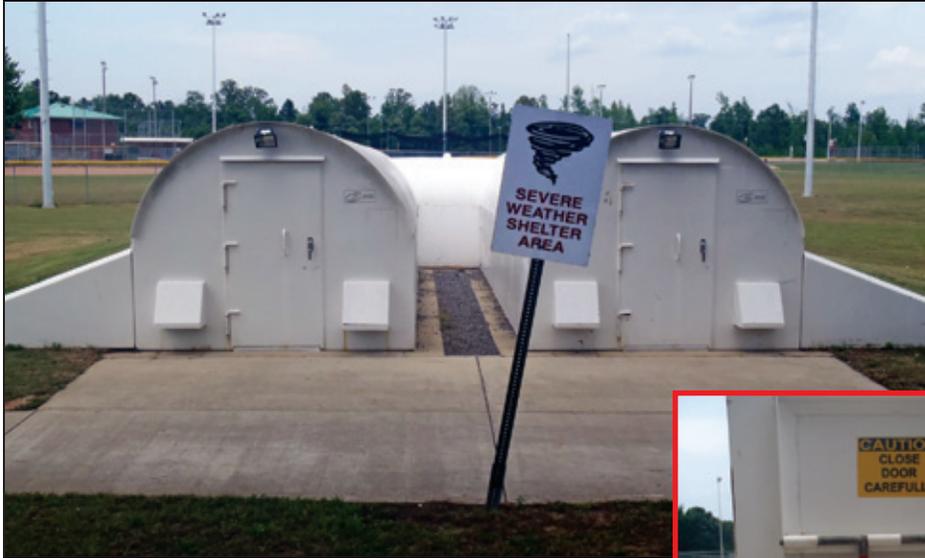
Figure 9-35:
Community safe room with exterior and interior locking mechanism; inset shows the three-point interior locking system (Brookwood, AL)

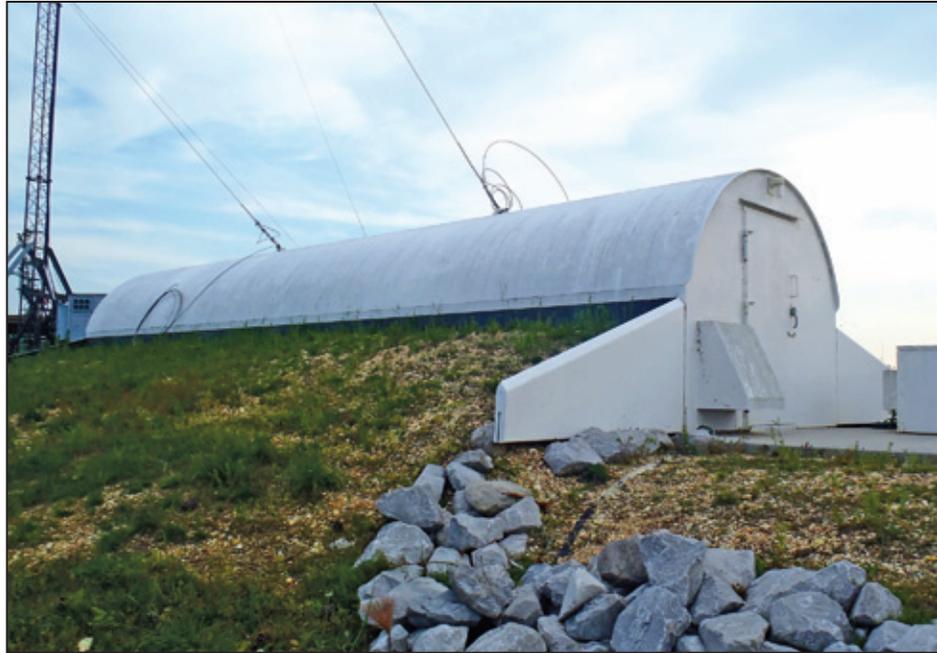
Figure 9-36:
FEMA-funded community
safe room; guy wires for the
temporary communications
tower should not be attached
to the structure (Phil
Campbell, AL)

The temporary communications tower shown in Figure 9-36 was installed after the tornadoes struck the town. The tower should not be connected to the safe room because the structure was not designed to provide foundation support for guy wires for a communications tower.

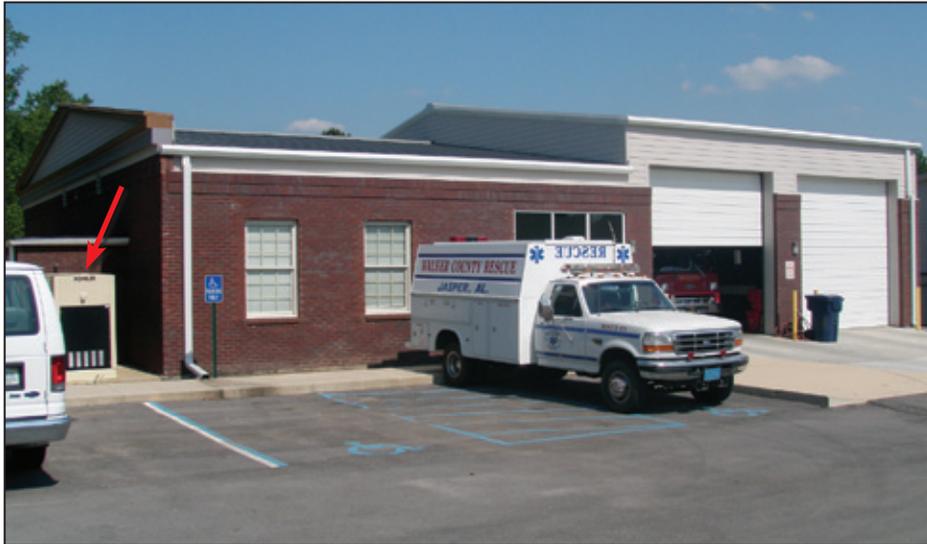
Figure 9-38:
A large site-built, below-grade community safe room is housed below this fire station; the red arrow indicates an unprotected generator (Brookside, AL)
