Appendix B

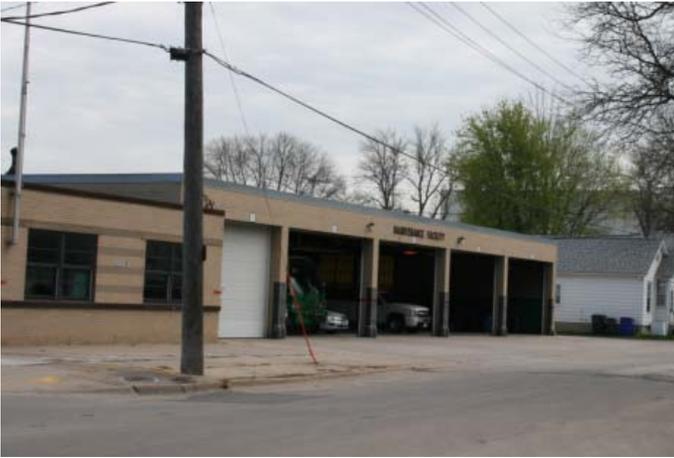
Photograph #1: View of Bus Garage bays opening to 8th Street NW with portion of administrative offices.

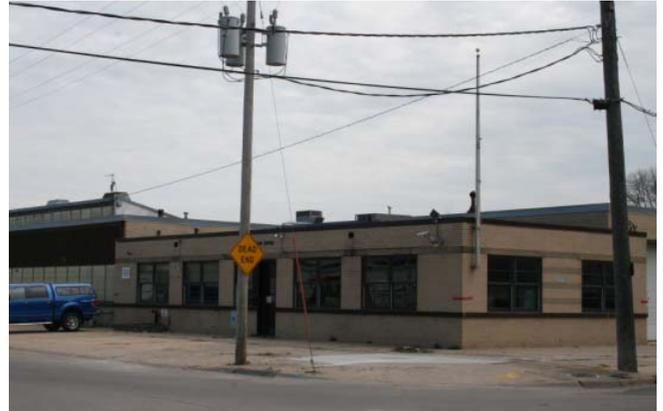
Photograph #2: View of Bus Garage administrative offices from corner of 8th Street NW and D Avenue NW.

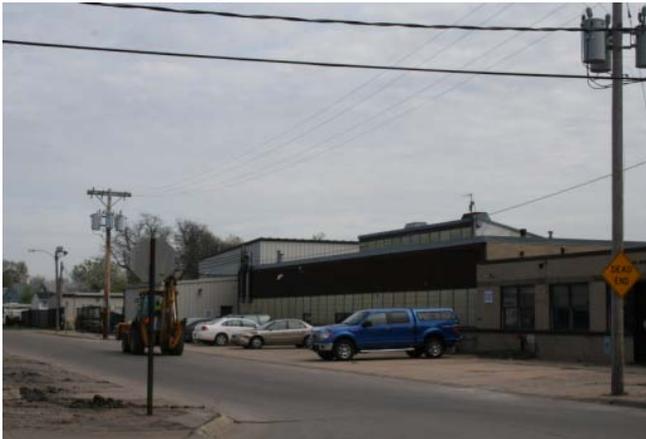
Photograph #3: View of Bus Garage administrative offices and adjoining utilitarian building portions from the corner of 8th Street NW and D Avenue NW.

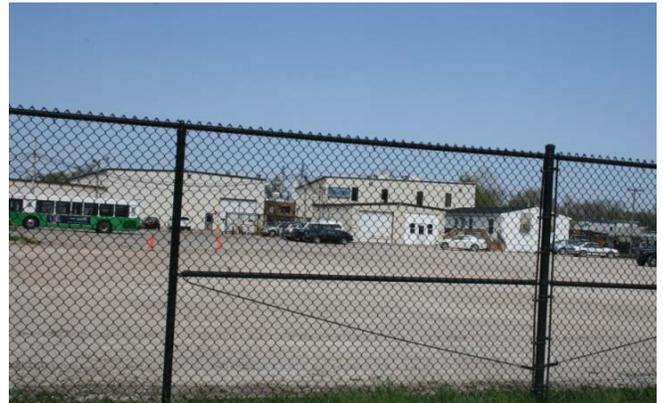
Photograph #4: View of back of Bus Garage facility including trailer currently used as administrative office from C Avenue NW.

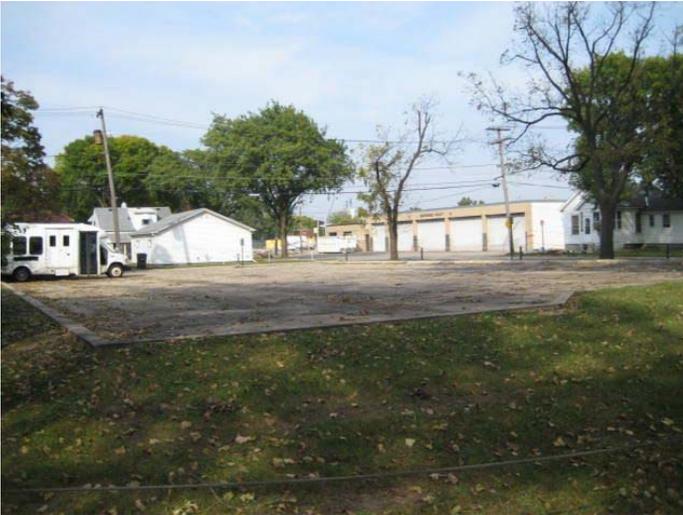
Photograph #5: Parking Lot located at corner of C Street and 8th Street NW with view of Bus Garage beyond. Source: Cedar Rapids Assessor GIS webpage, GPN 14291-31016-00000; http://crgis.cedar-rapids.org/Freeance/Client/PublicAccess1/index.html?apconfig=City_Assessor_GIS

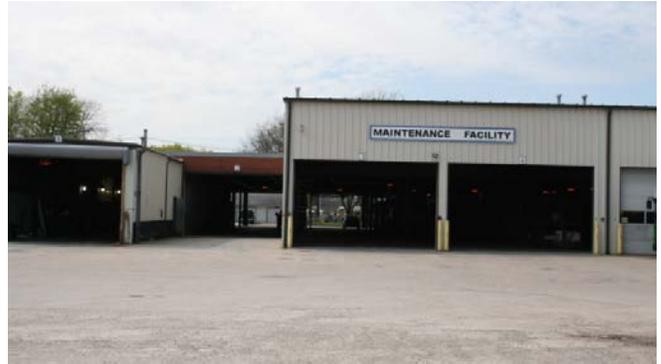
Photograph #6: View of garage bays where buses enter storage and wash bays from yard at back of Bus Garage facility.

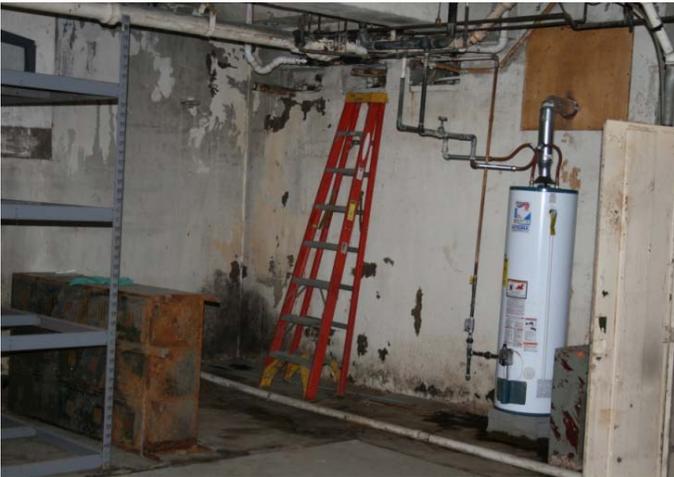
Photograph #7: View of basement of Bus Garage showing minimal recovery work post-disaster.

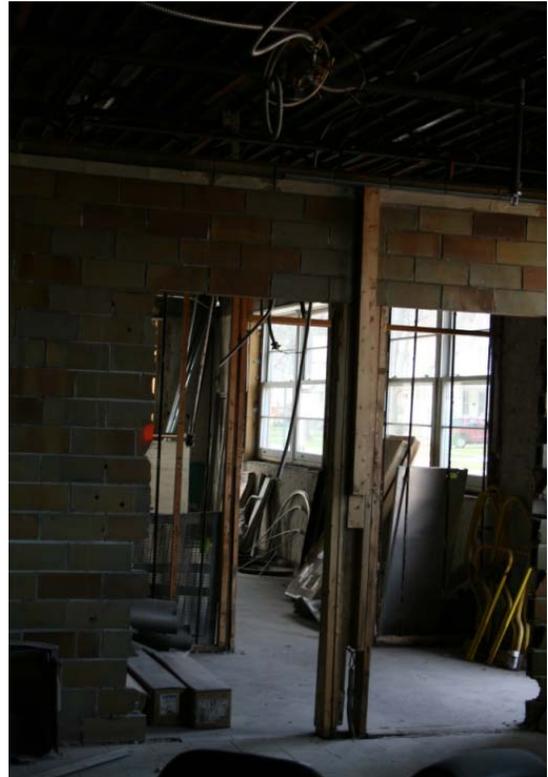
Photograph #8: View of mucked-out, damaged administrative offices within Bus Garage building.

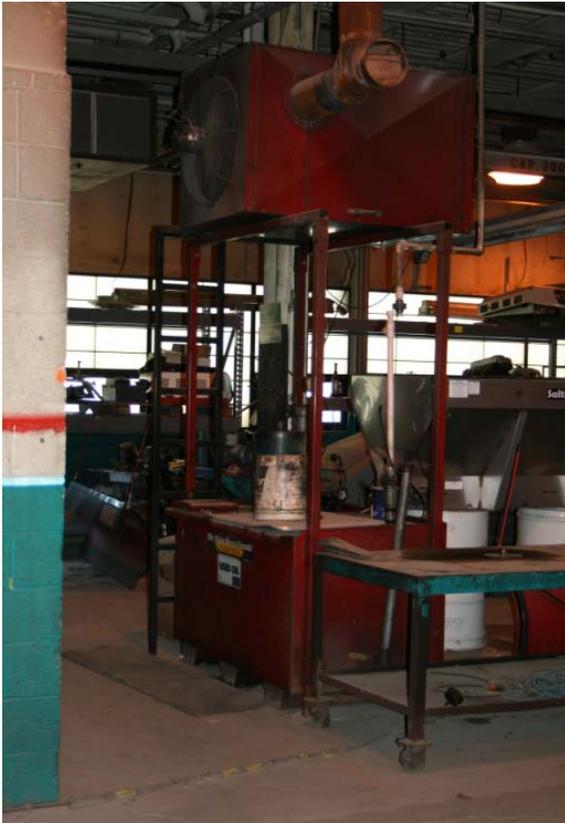
Photograph #9: Partial view of maintenance bay with equipment and used oil receptacle within the Bus Garage building; paint line showing height of flood water is visible on the wall on the left of the picture.

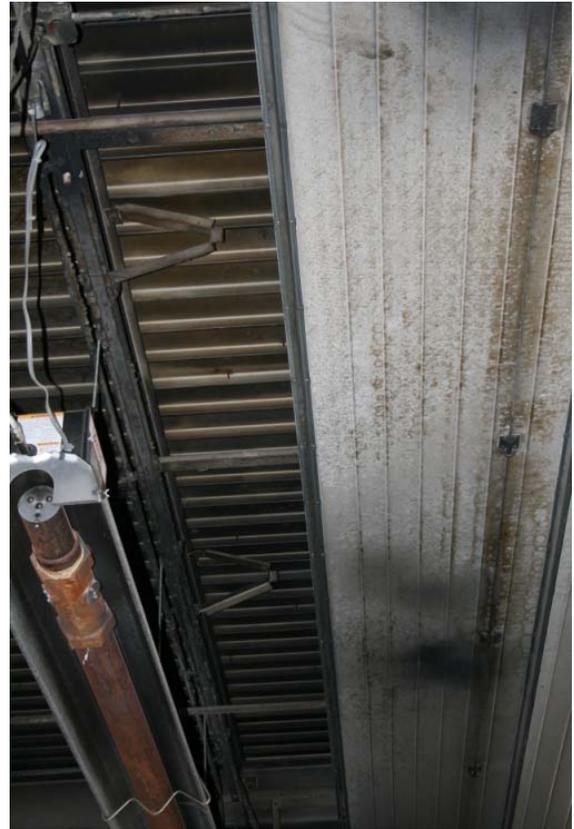
Photograph #10: View of ceiling within storage bay within the Bus Garage showing soot accumulation.

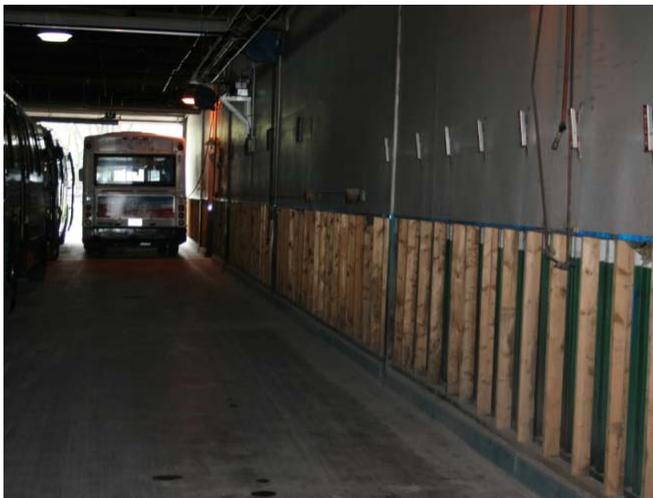
Photograph #11: View within storage bay within the Bus Garage showing walling material removed during muck out not yet replaced.

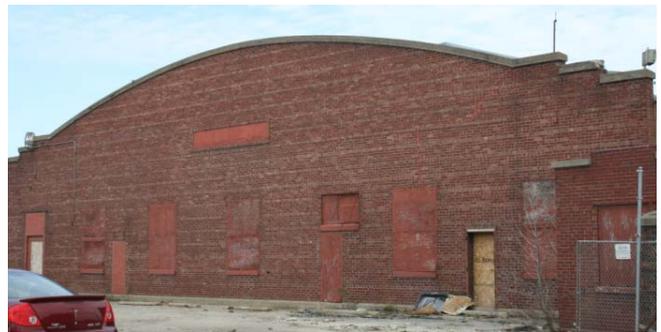
Photograph #12: View of Main Garage at entrance of Sinclair Site.

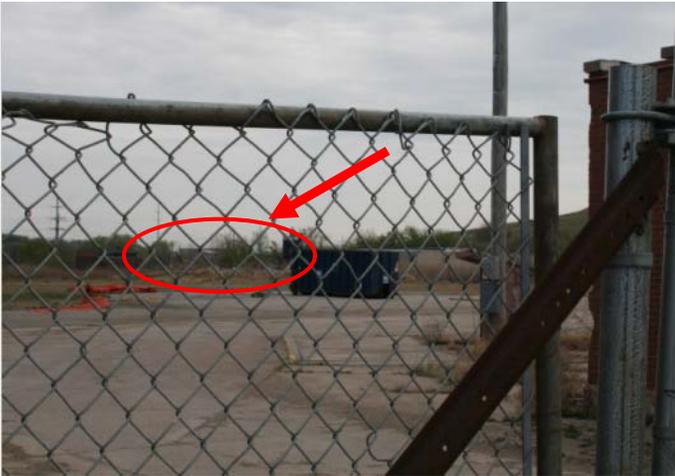
Photograph #13: View of the A&P Feed and Bone Gelatine/Hog Hair-Drying and Baling building #72/73 on the Sinclair site in the distance. Note: gates to site were locked during site visit.

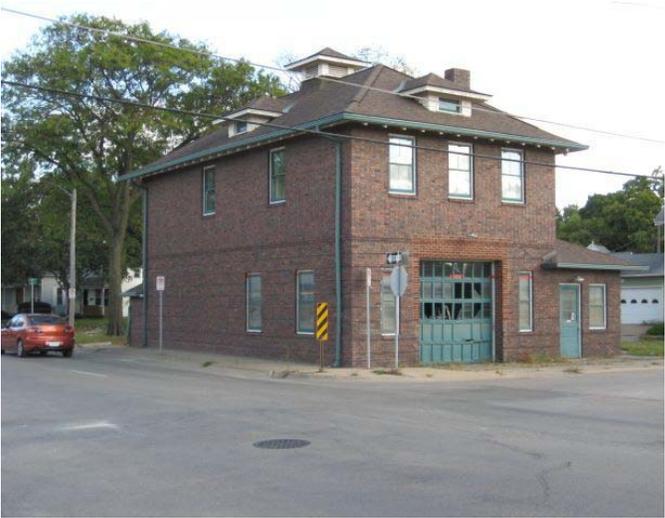
Photograph #14: View of Transit Annex from corner of E Avenue NW and 5th Street NW.
