**BUILDING PERFORMANCE ASSESSMENT TEAM**

# Hurricane Opal in Florida

**OBSERVATIONS,  
RECOMMENDATIONS, AND  
TECHNICAL GUIDANCE**

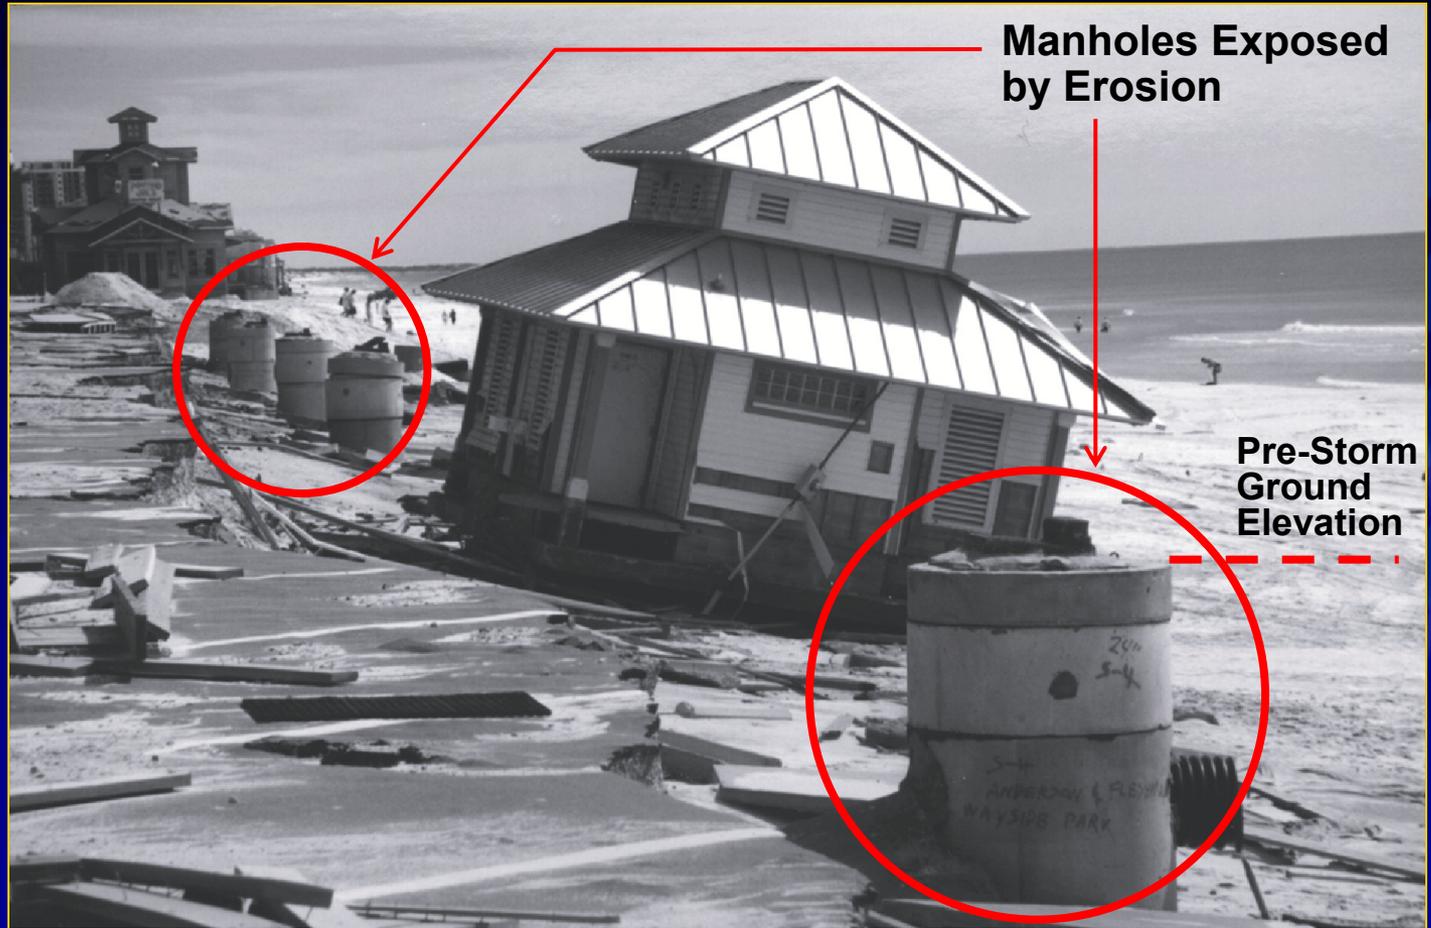
*Beach erosion caused major damage to structures, as well as roads and utilities.*

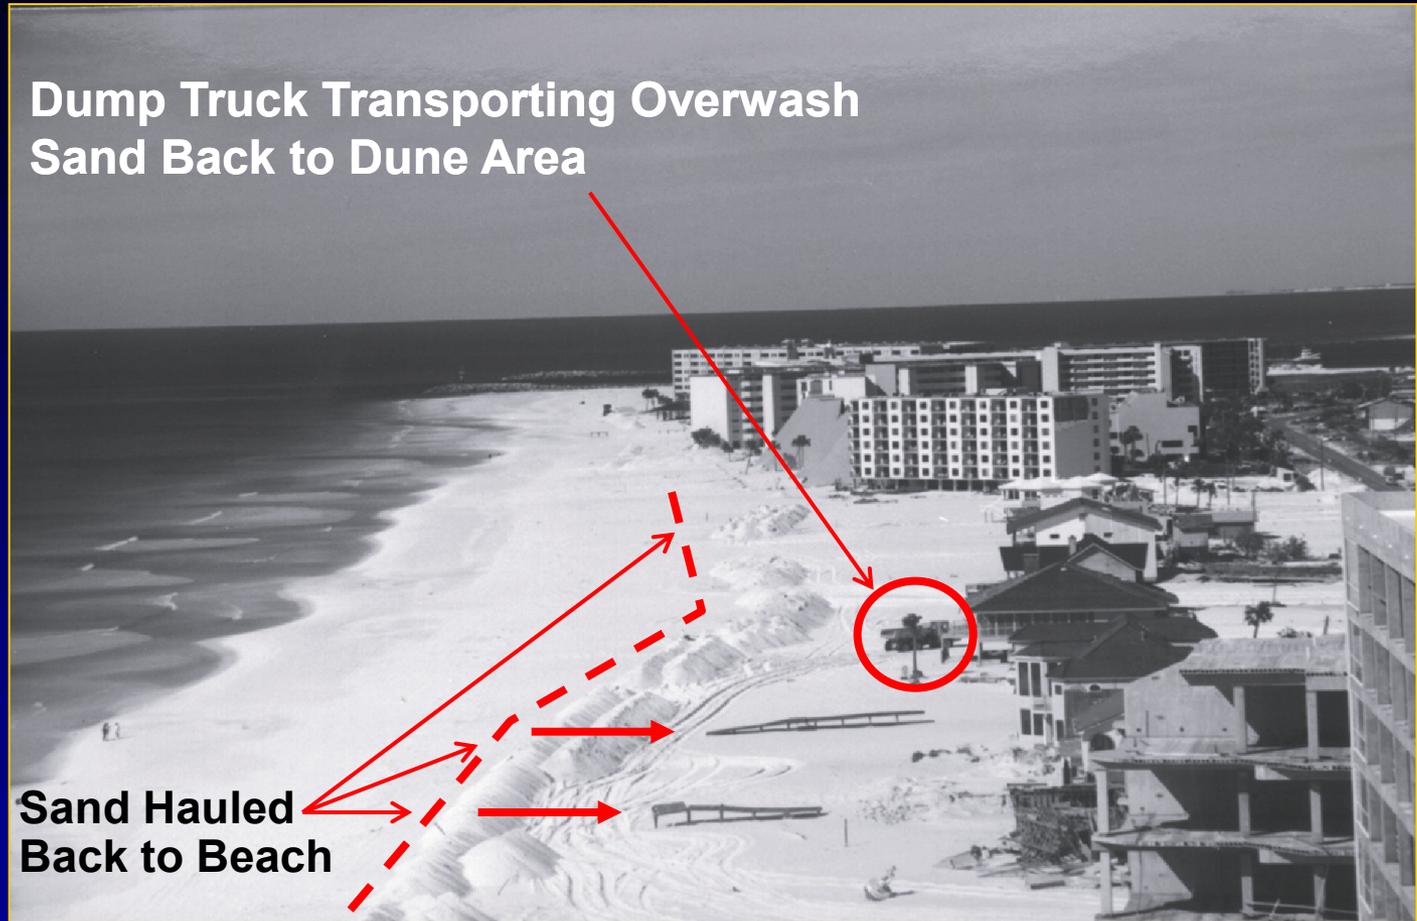
### Dump Truck Transporting Overwash Sand Back to Dune Area

*Beach erosion eliminated protection for structures. It is important that the beach and dunes be rebuilt as soon as possible. Arrows point to walkways used to traverse dune that has been washed away.*

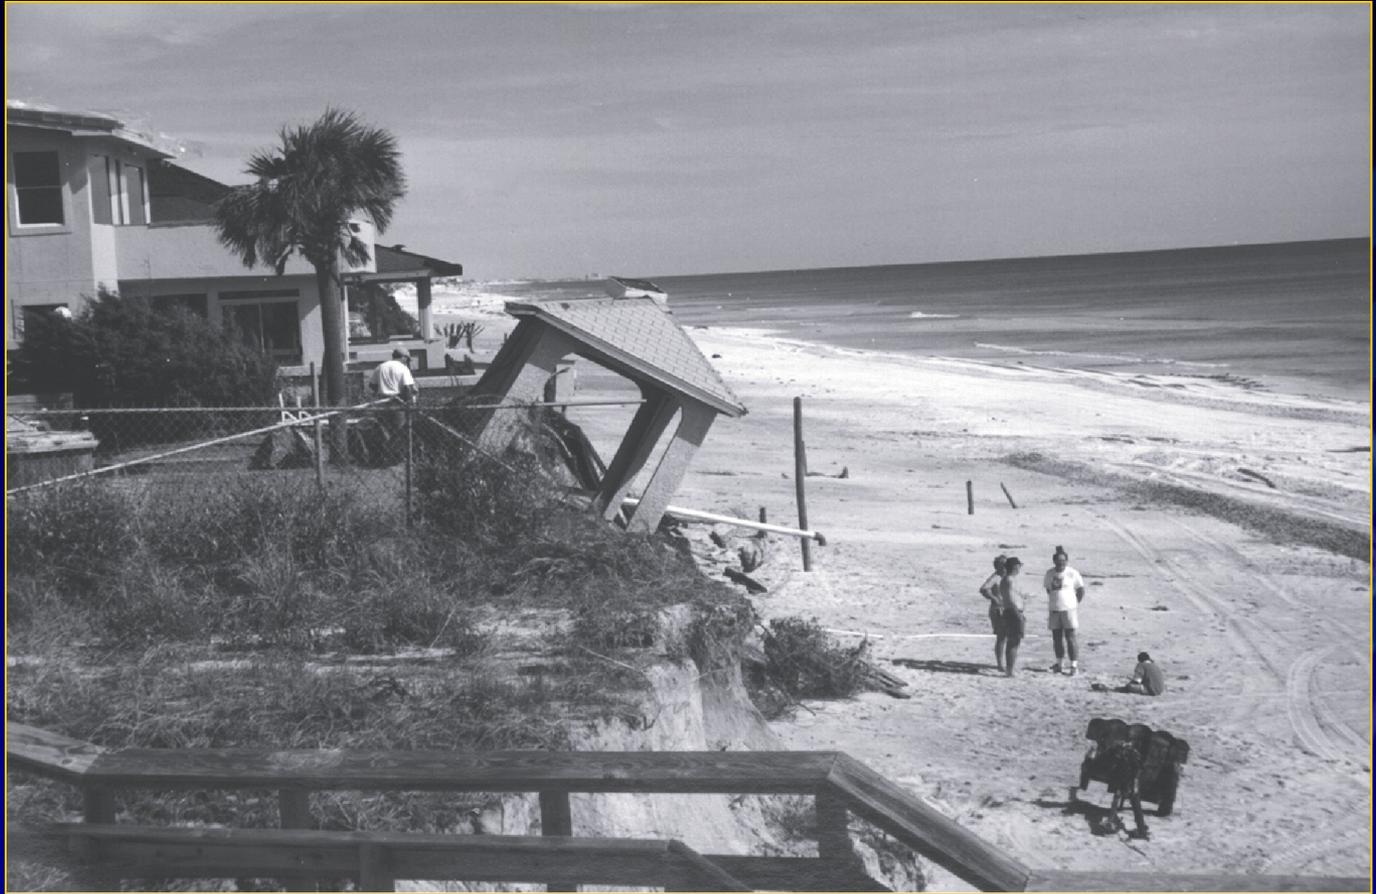
*Erosion such as this took place along the gulf coast, causing structures to be undermined and resulting in damage.*

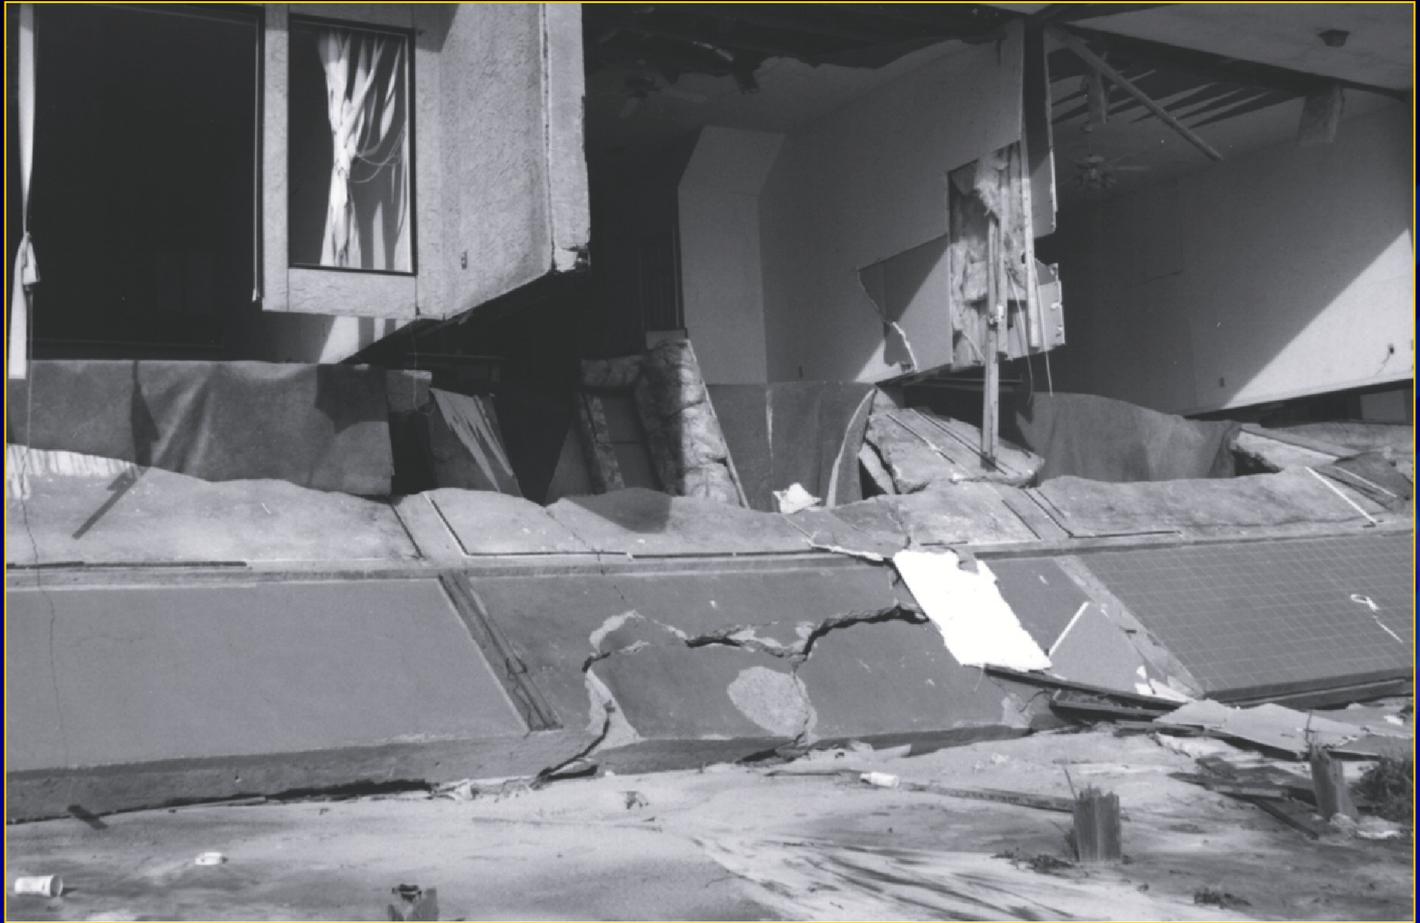
*Undermining of concrete decks and floor slabs caused the failure of many unreinforced concrete structures.*

- Foundation Design Requirements
  - Communities should adopt a multi-hazard approach to reexamine designs
  - Slabs used solely for parking
    - should not be attached to structural members
    - should be designed to break in the event of undermining

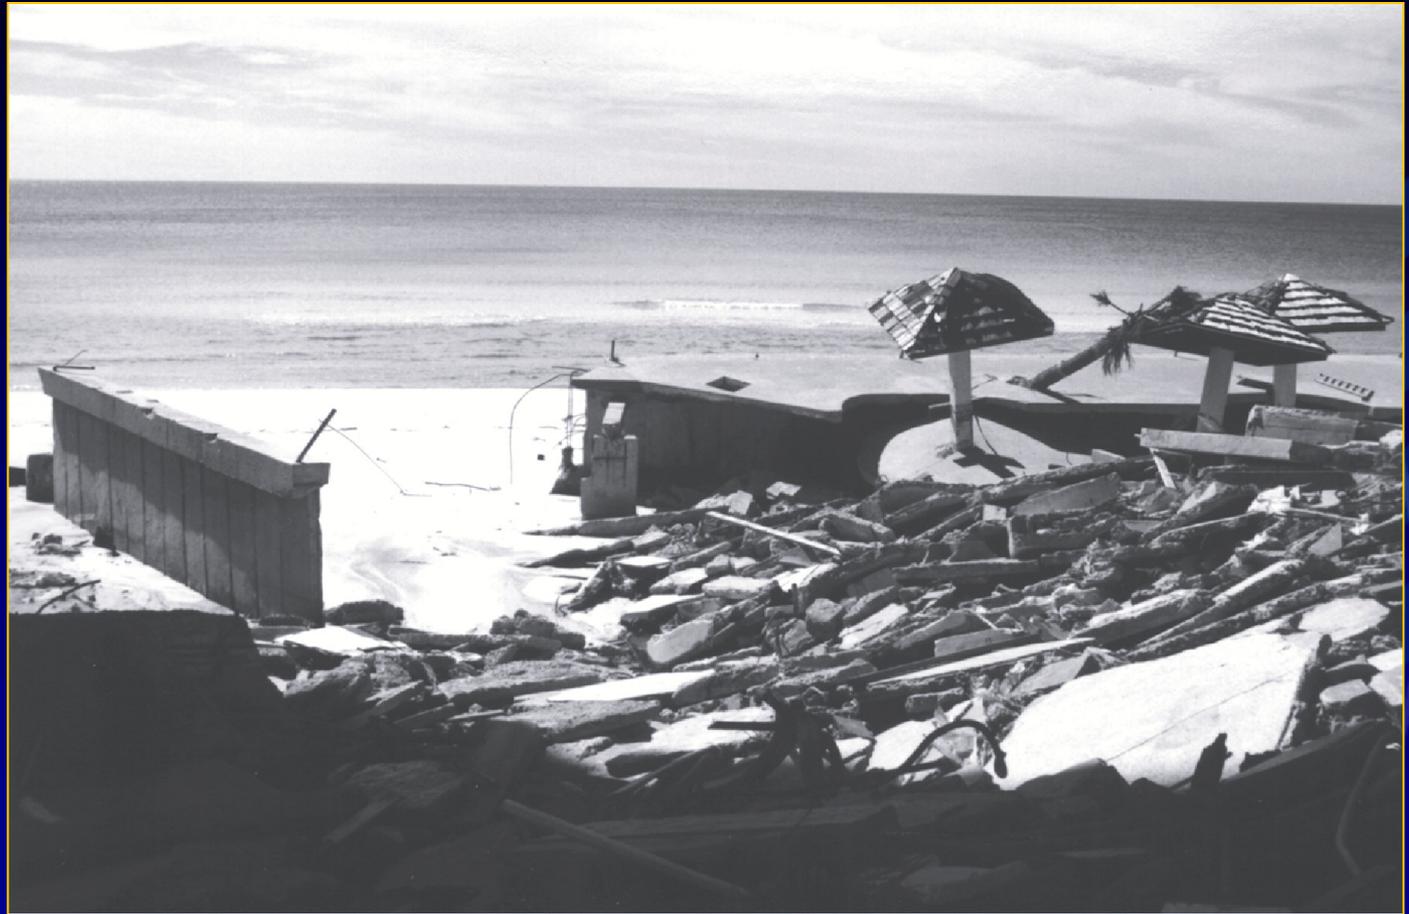
*Debris, consisting of broken concrete and wood framing systems, generated by surge action.*

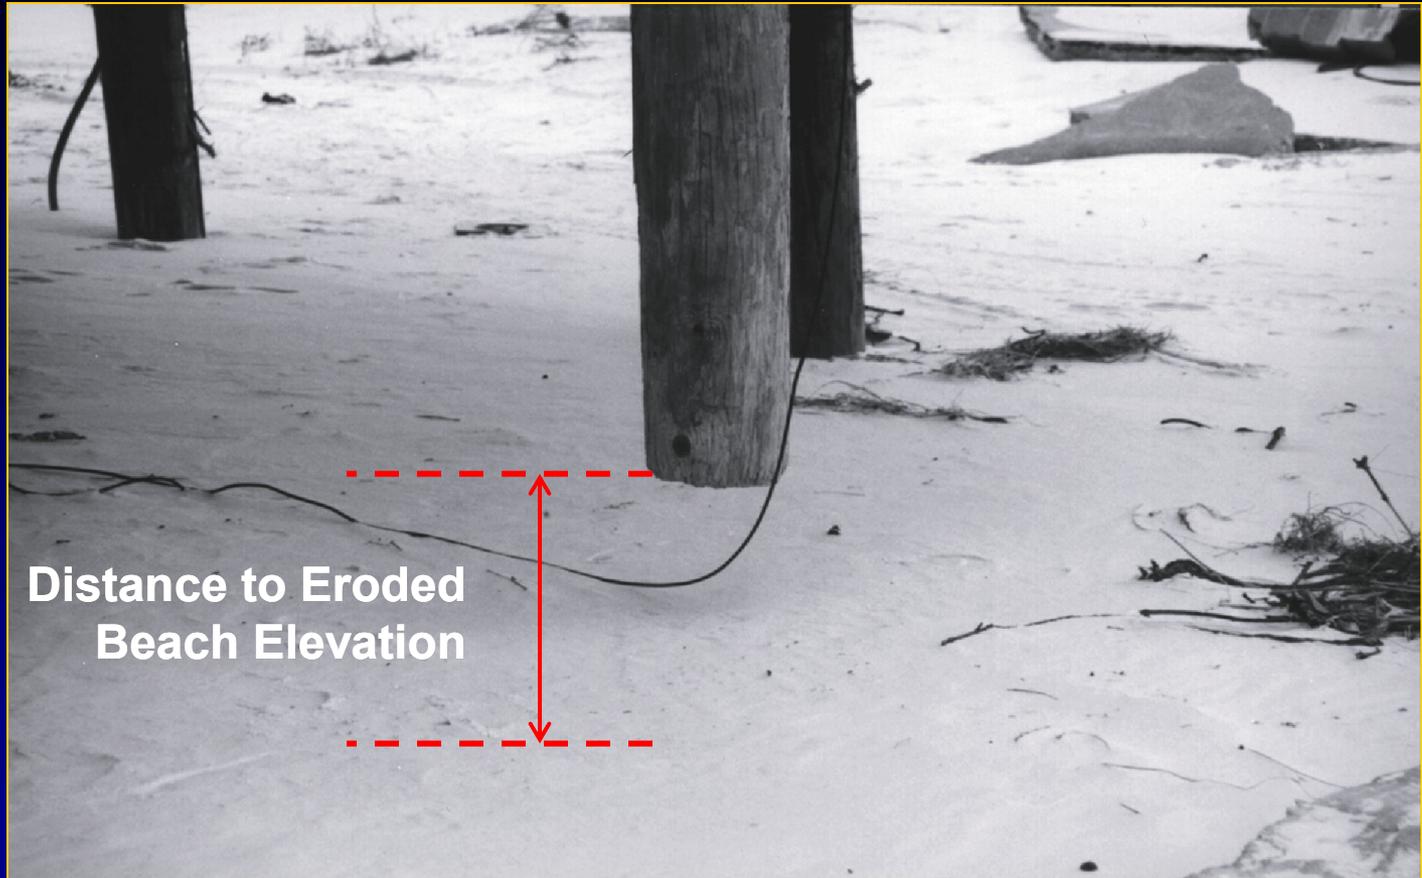
- Pile and Pier Foundations
  - Well designed and constructed piles survived the storm
  - 3-7 feet vertical erosion was common
  - Insufficient penetration of piles led to collapse
  - Many undersized piles failed

*These piles were not embedded deep enough to survive the erosion of the sand. As a result, there is now a large gap between the bottoms of the pilings and the ground surface.*

- Pile, Post, Column and Pier Foundations
  - Should be designed in accordance with ASCE code
  - Use documented erosion and scour values in the design of the foundation embedment
  - BPAT recommended designs

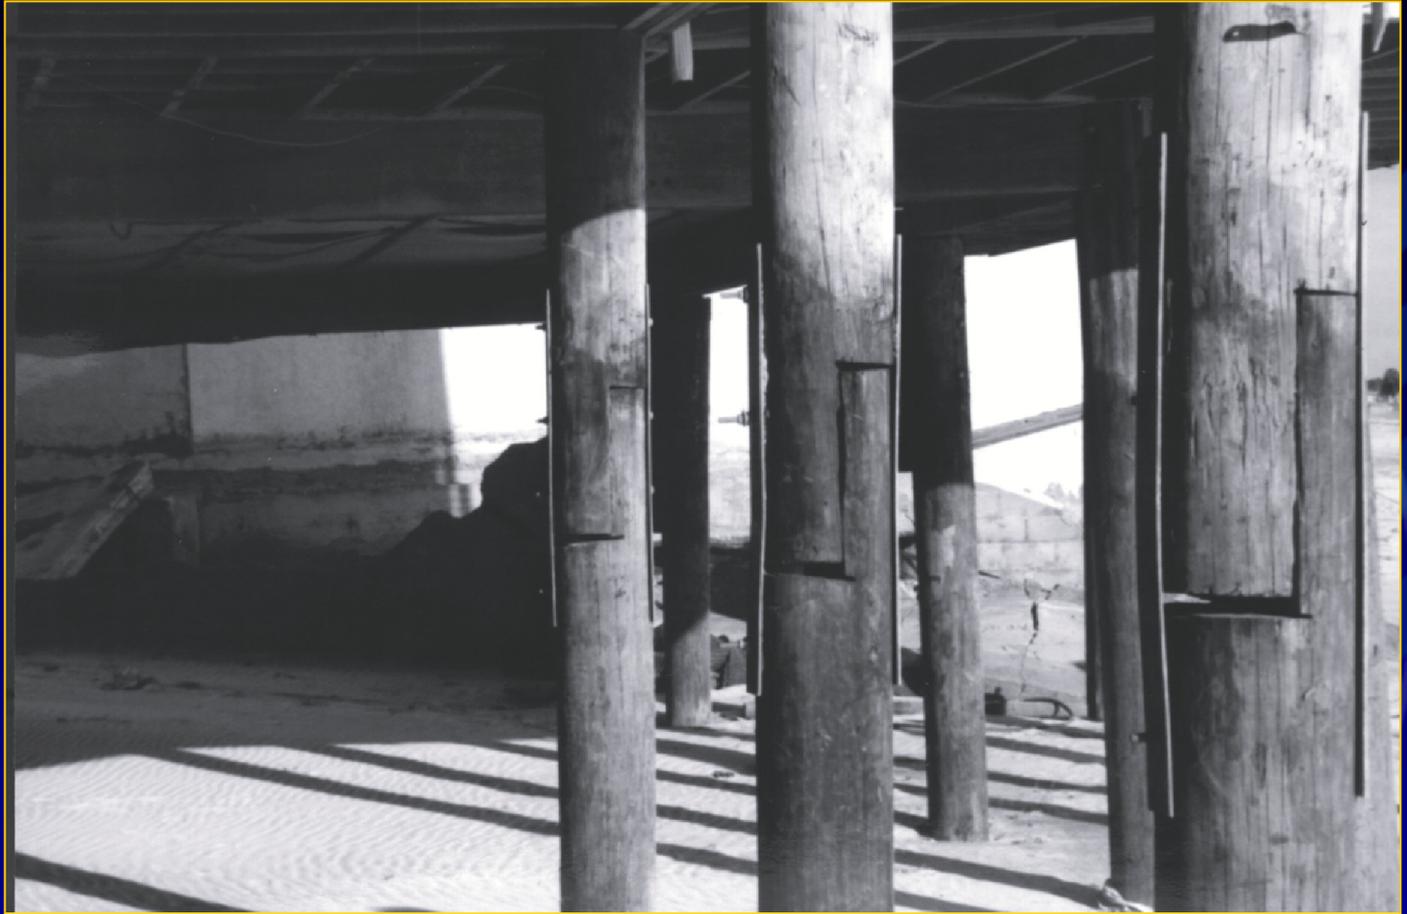
*These piles were not long enough and were spliced to add depth. The splicing was exposed by storm-induced erosion.*

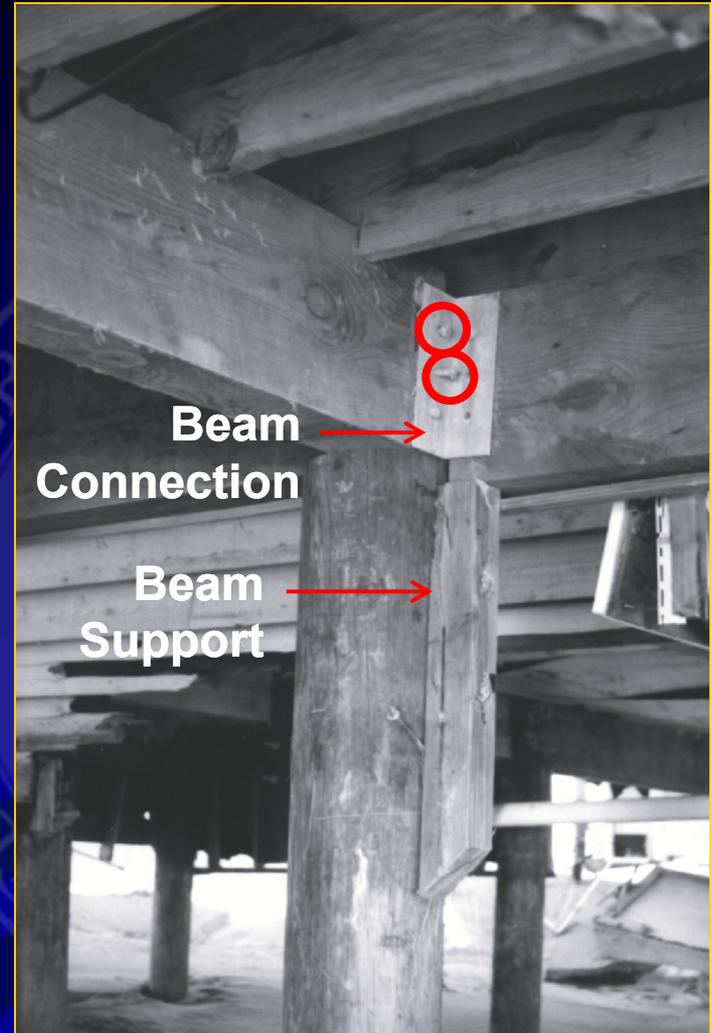
- Connections
  - Many were deficient
    - corrosion of galvanized straps, hangers, and joist-to-beam ties
  - Failure due to insufficient nailing and storm forces exceeding design forces

*The floor beam connection and beam support shown here illustrate the lack of design and proper construction observed on many damaged structures. Note the bolt pullouts (circled). Also, the beam support is attached to the pile with lag bolts rather than bolts that extend through the pile.*

- Connections
  - Minimum standards for connectors
    - hot-dip galvanized steel
    - comply with Standard Building Code specs
    - comply with FEMA TB 8-96
  - Wood should not be used as a shim material

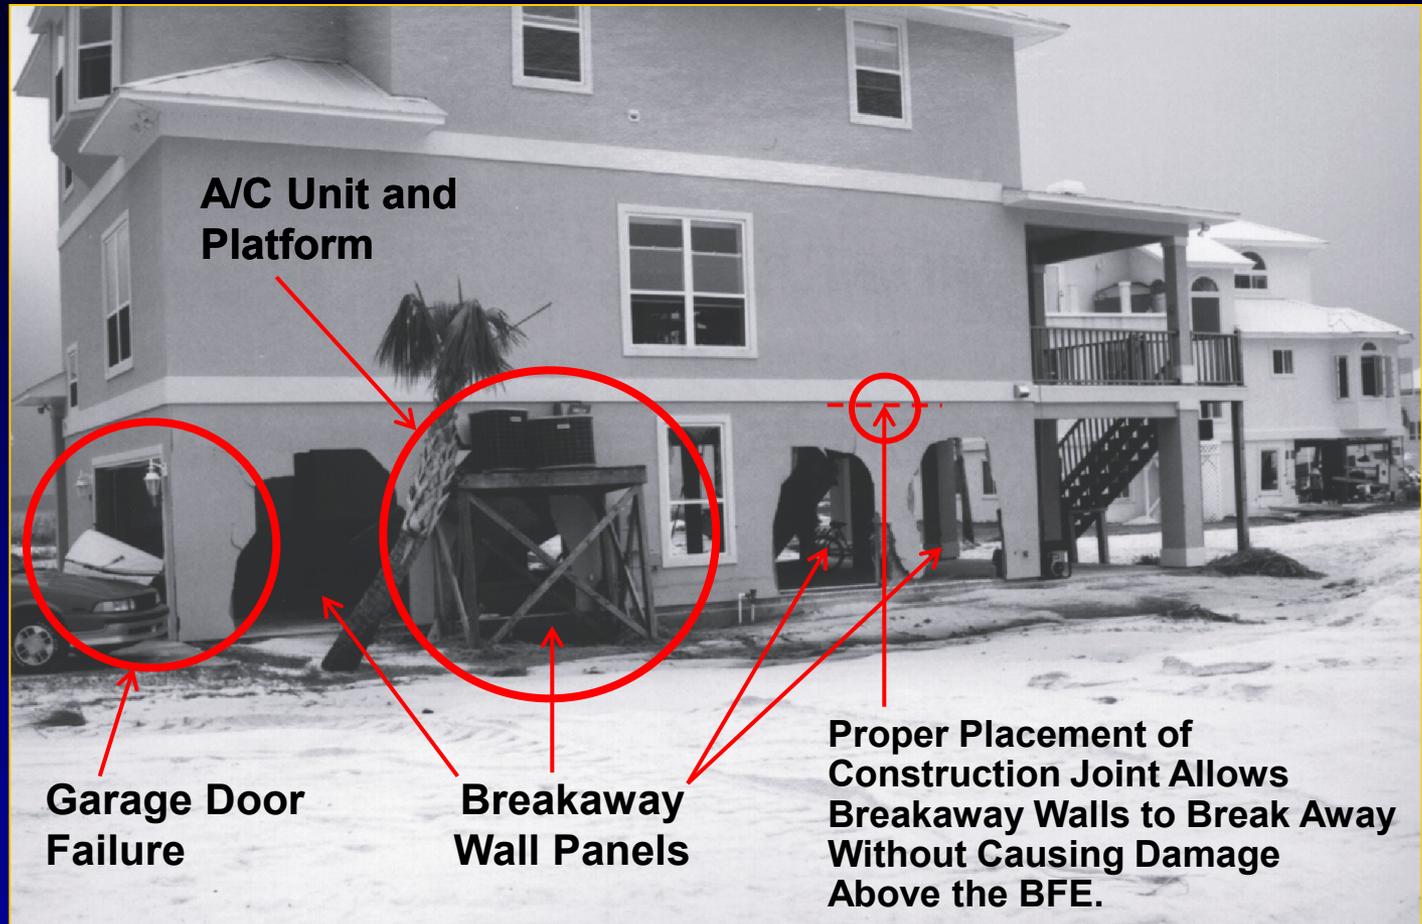
*These breakaway walls functioned as designed, lessening the pressures of water, sand, and debris on the structure.*

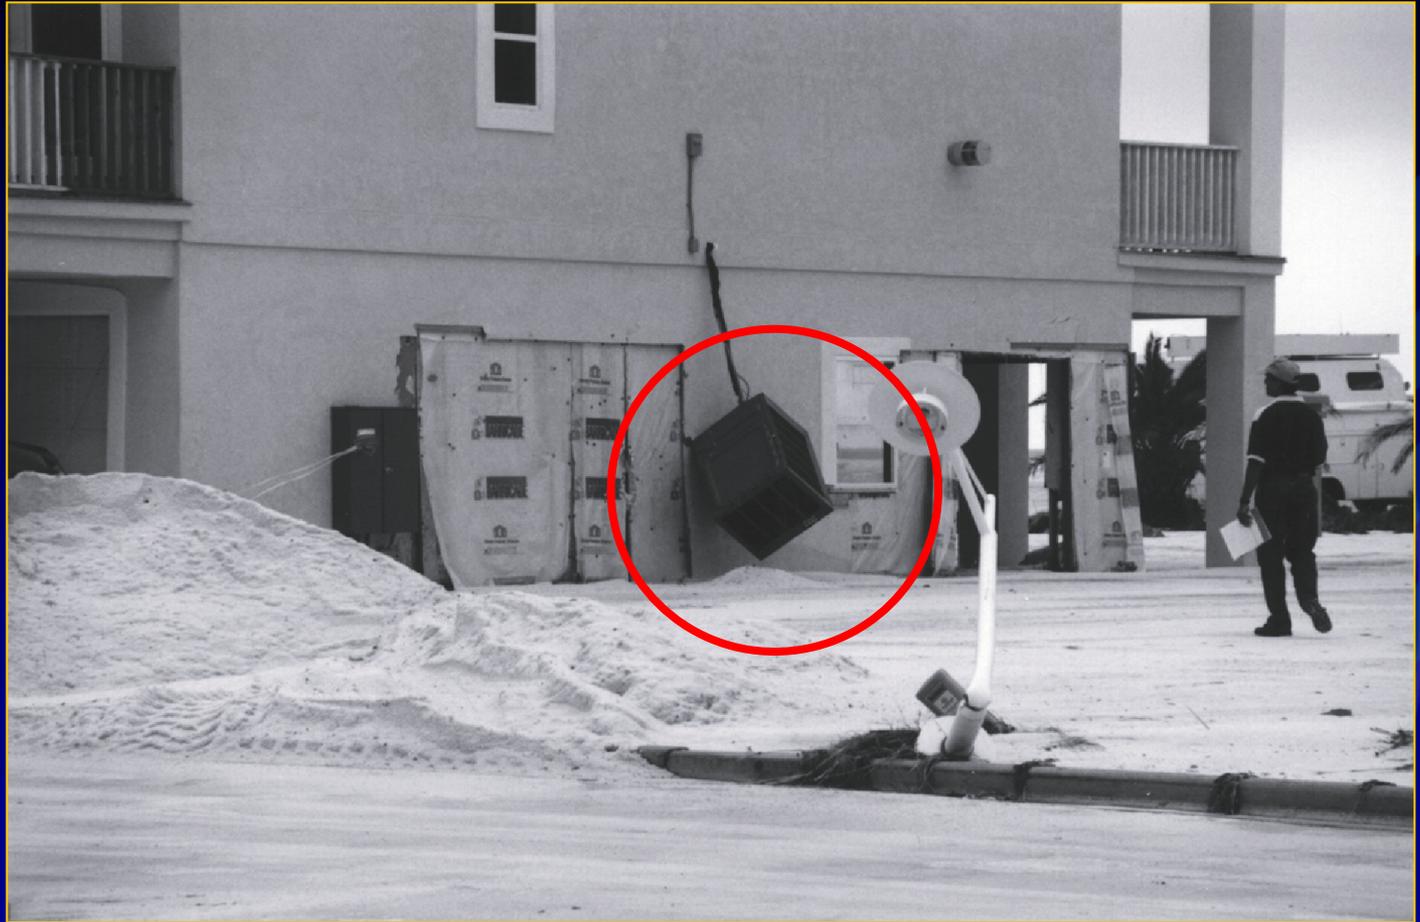
- Utilities
  - The BPAT observed many problems:
    - location of equipment (meters, panels, boxes and wiring) below the lowest habitable floor
    - attachment of utilities to breakaway walls
    - failure to support and fasten air conditioners
    - placement of utility lines and connections on the seaward side of buildings

*These breakaway panels functioned as designed. Note the loss of the air conditioning unit platform.*

- Utilities
  - Recommended placement
    - Landward side of structure for V-Zones
    - Elevated at or above the BFE
    - If below the BFE, utilities should be in floodproof enclosures

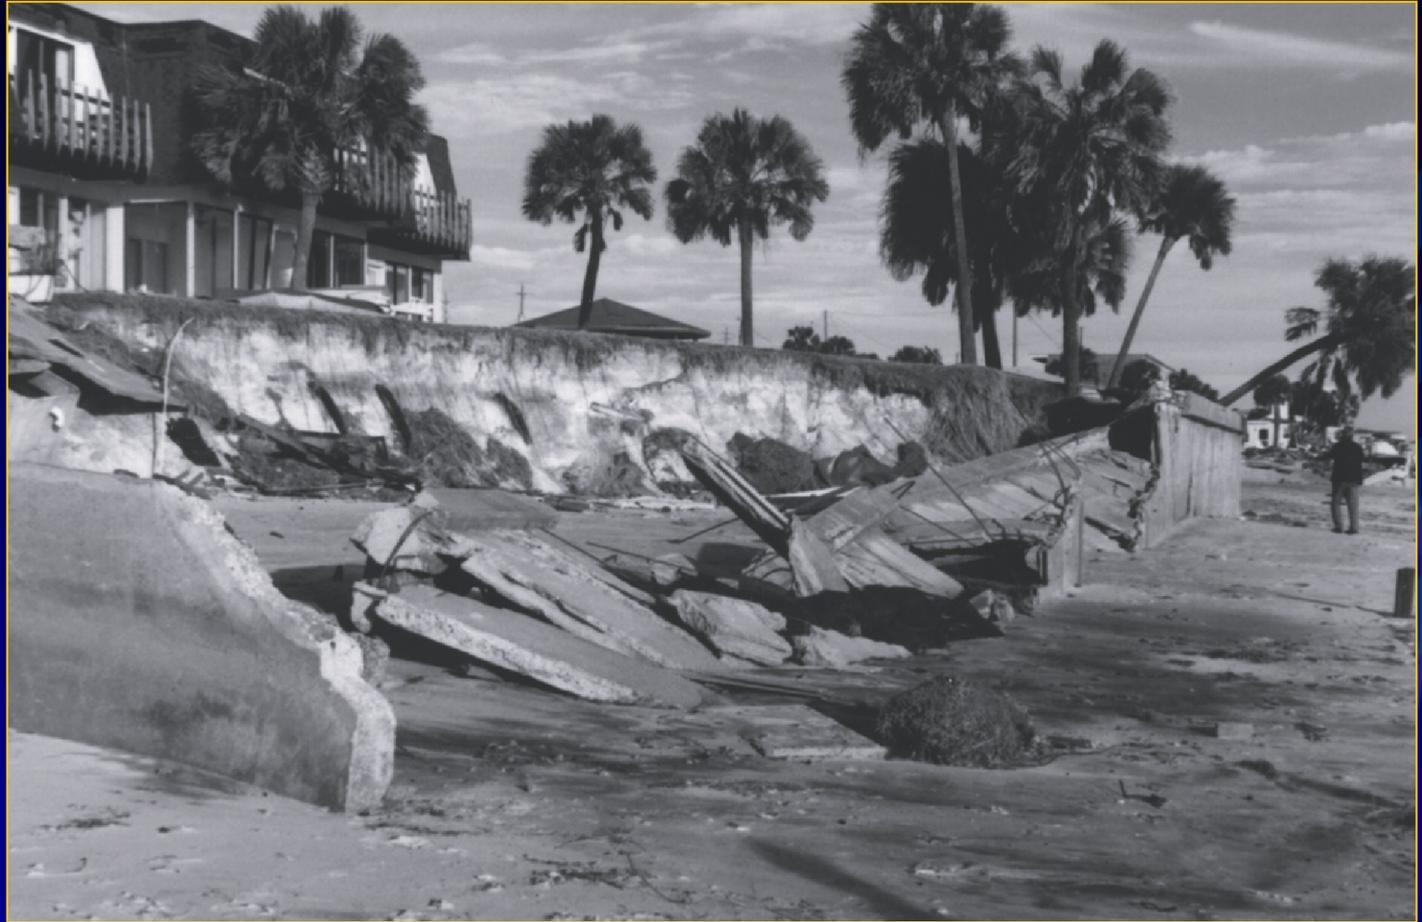
- Seawalls
  - Widespread failure of seawalls and bulkheads
  - Wing walls failed due to flanking by erosion and scour
  - Failed seawalls contributed to other structural and non-structural damage

*Fractured seawall, damaged by storm forces. Not the erosion of the bank behind the wall.*

- Seawalls and Erosion Control Structures
  - Should not be relied upon to contain soil for habitable structures
  - Wing walls should extend beyond storm-induced erosion

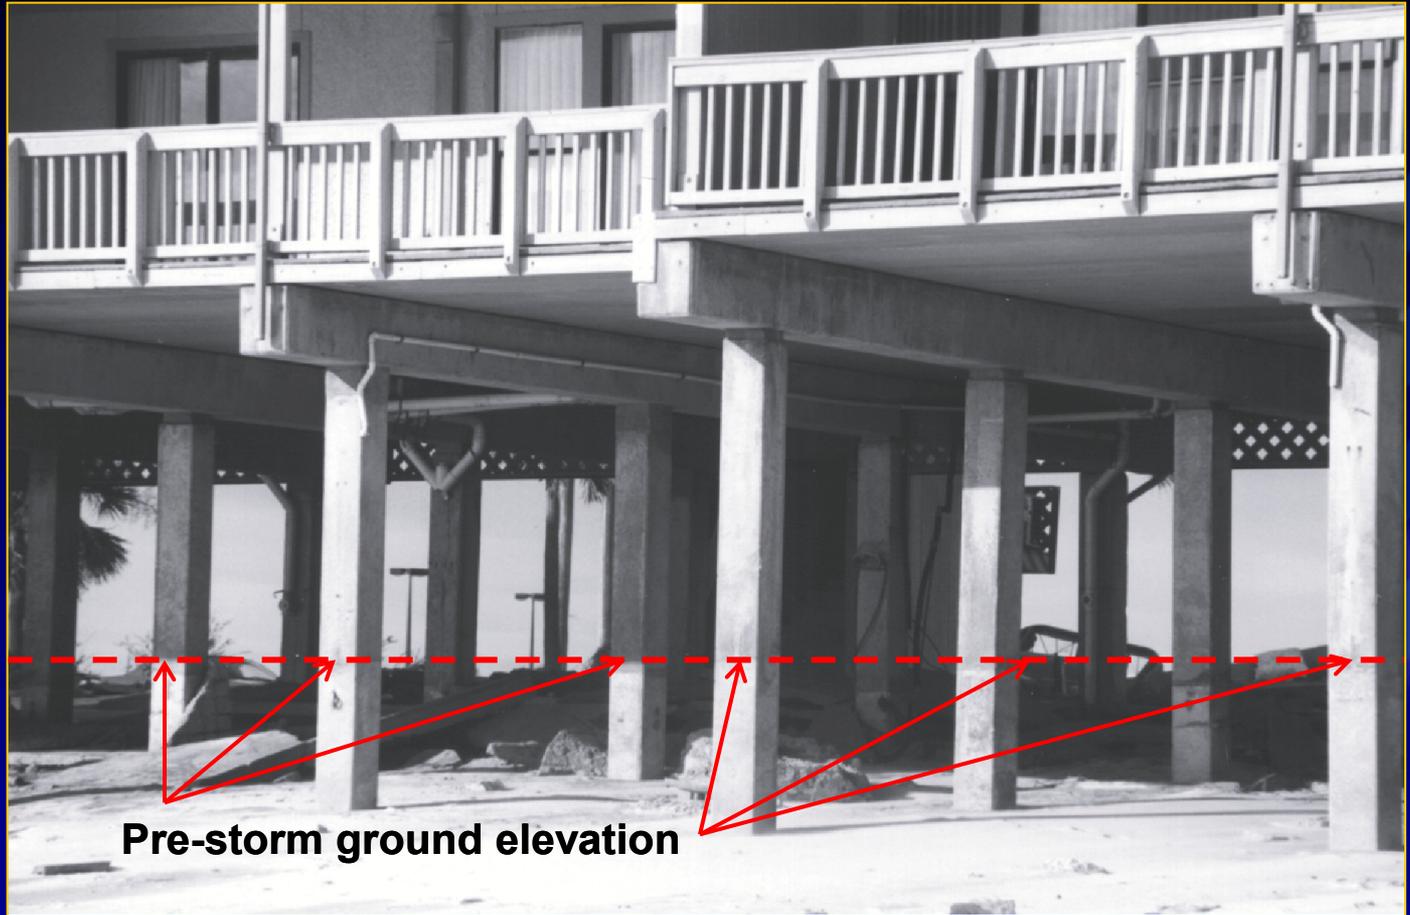
*This well-constructed concrete structure survived the storm with little or no damage, even with 5 feet of erosion*
