# FEMA Mitigation Assessment Team Report on Hurricane Ivan

Bill Coulbourne, P.E.

June 2, 2005

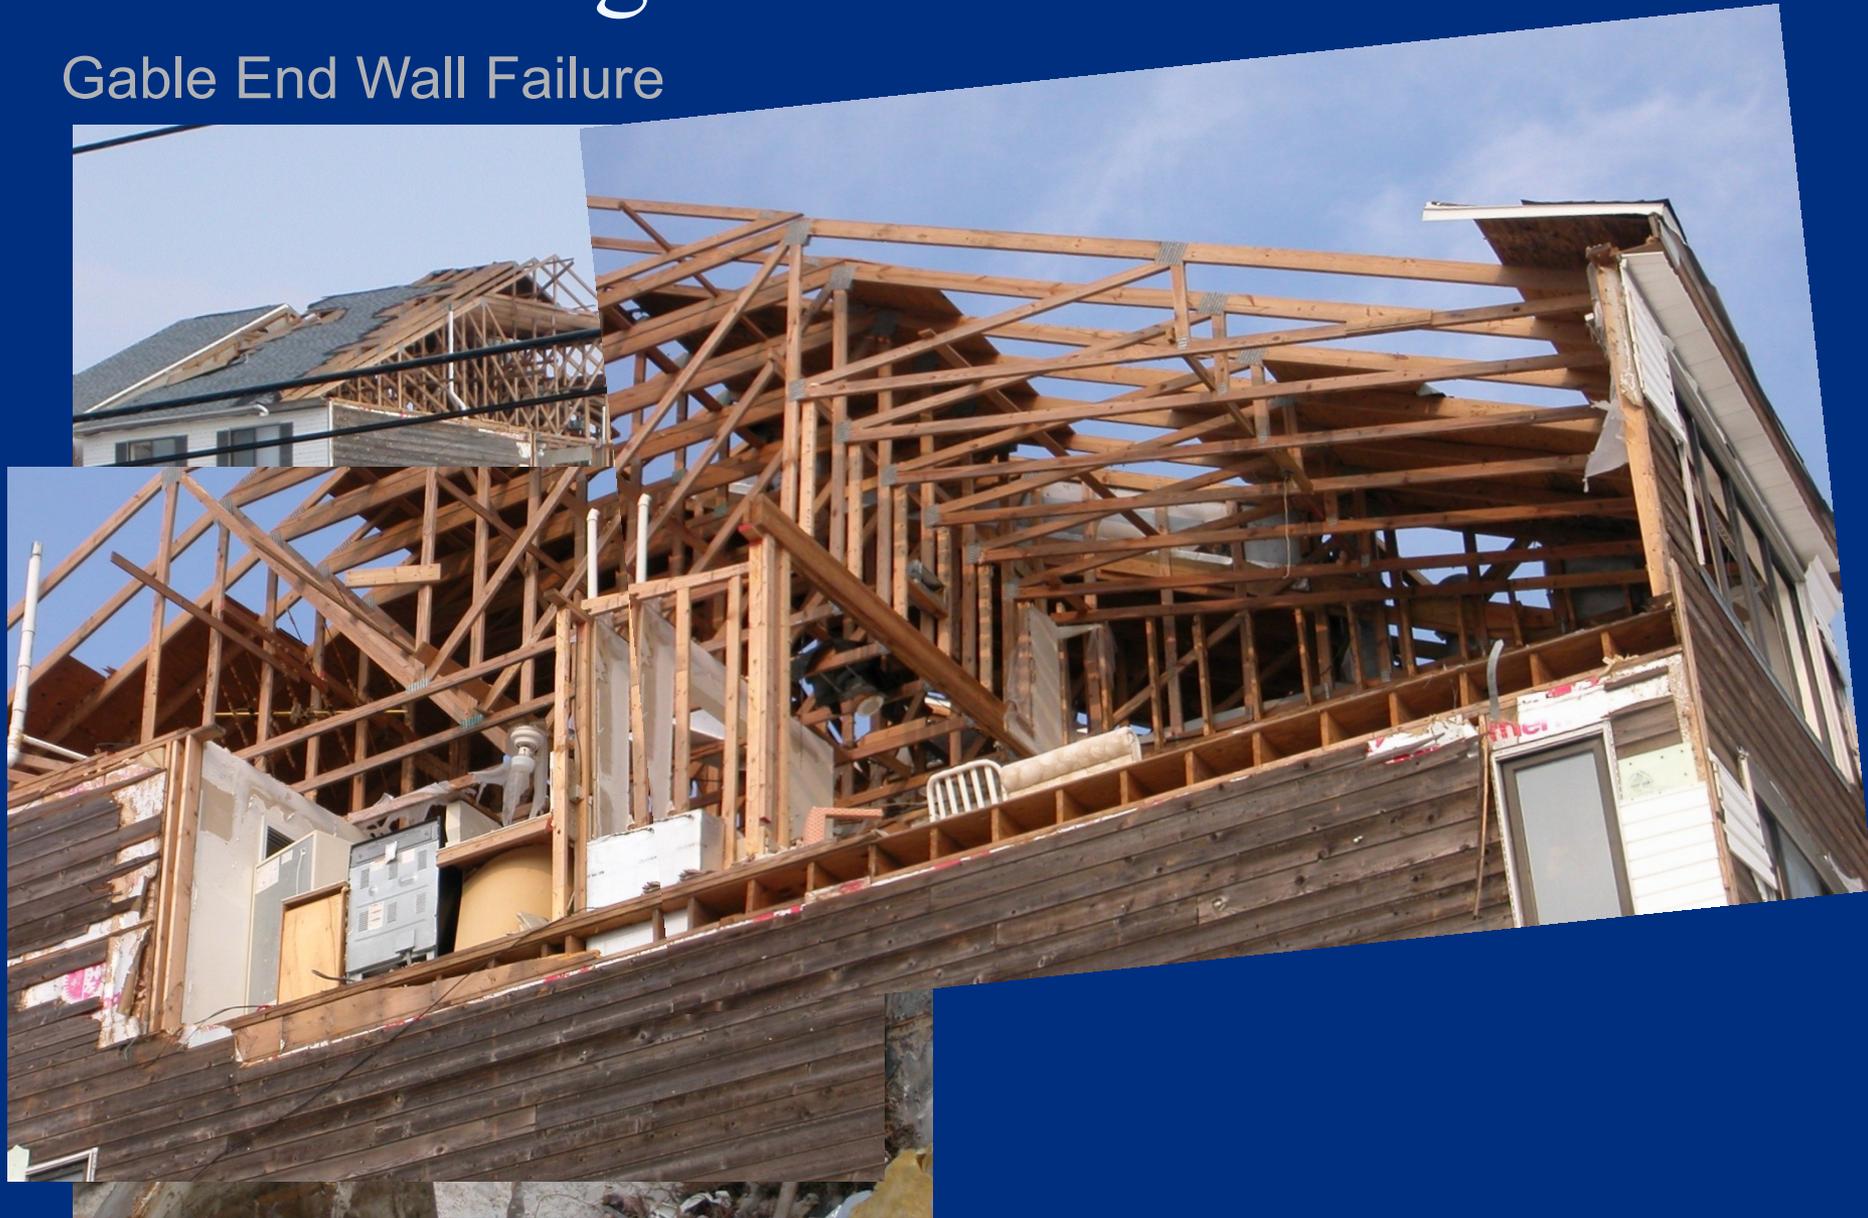
## Gable End Wall Failure

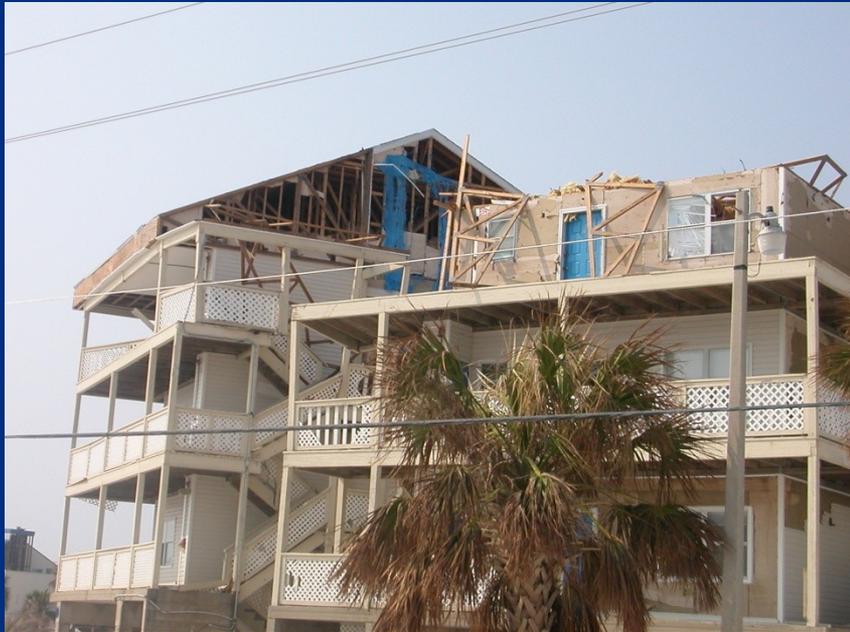
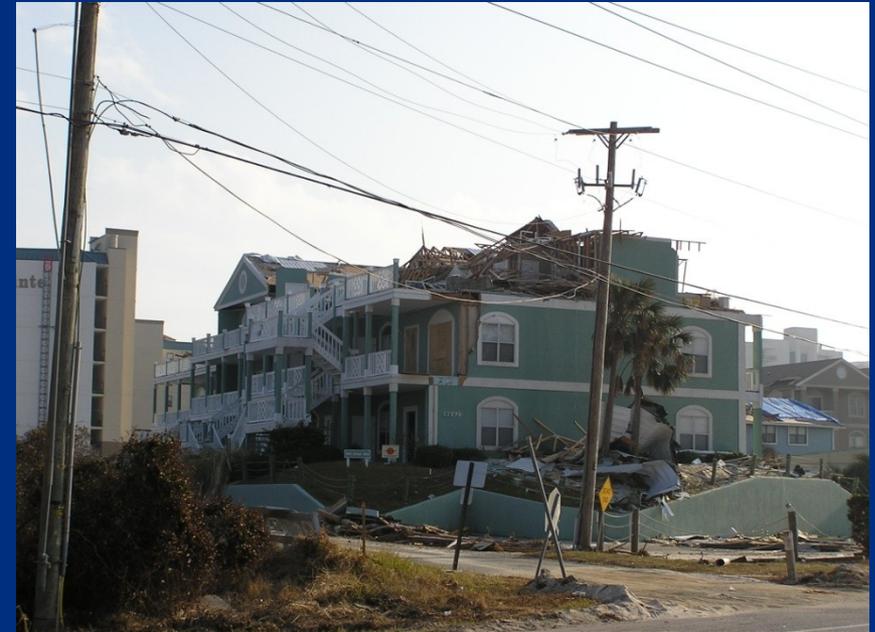
## Wood Roof Framing Failures

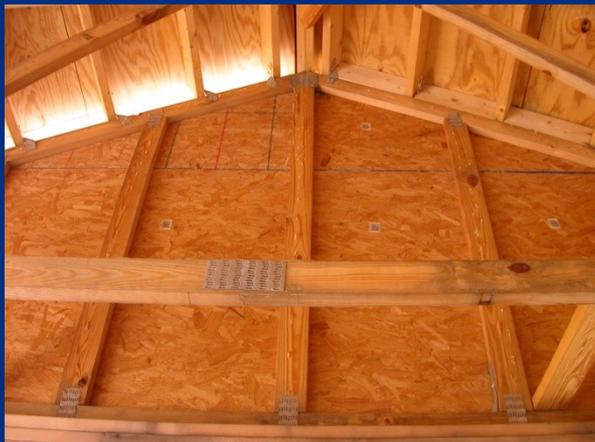
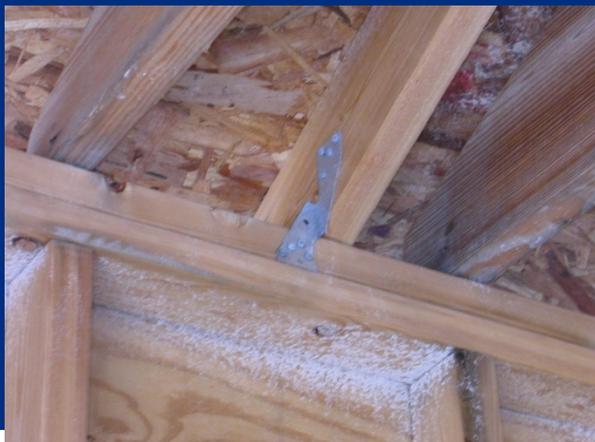
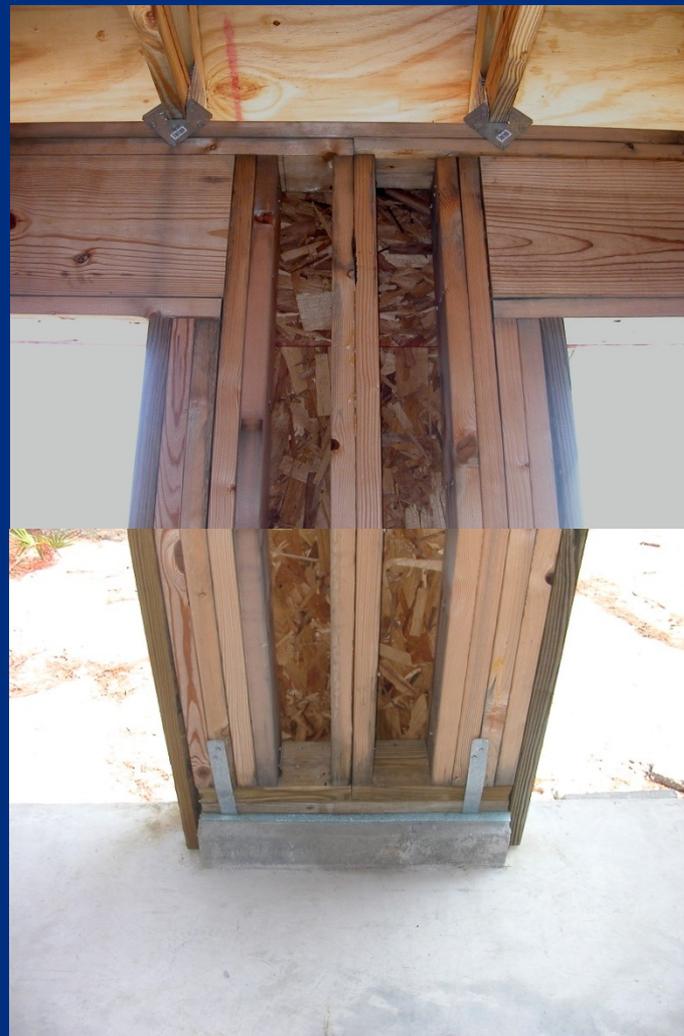
## Poorly Constructed New Homes

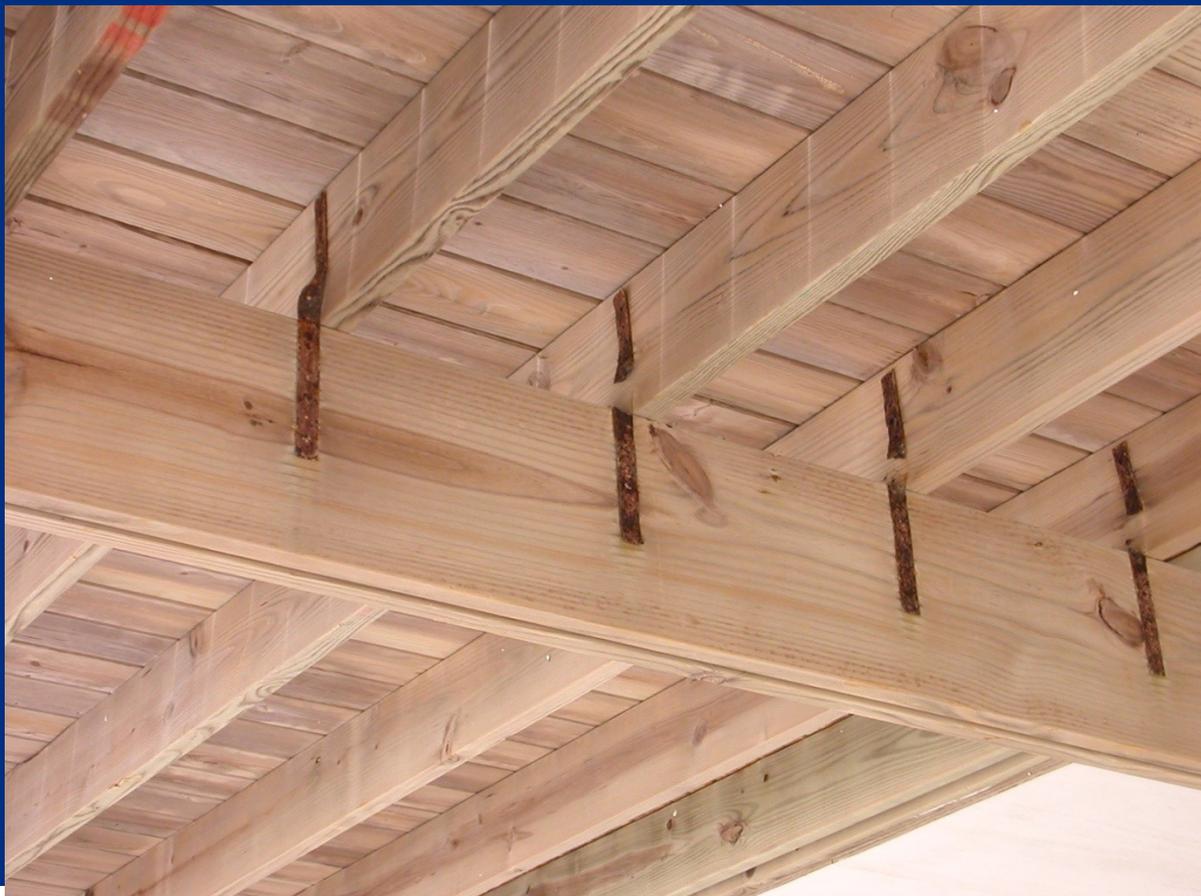
Connectors in a corrosive environment

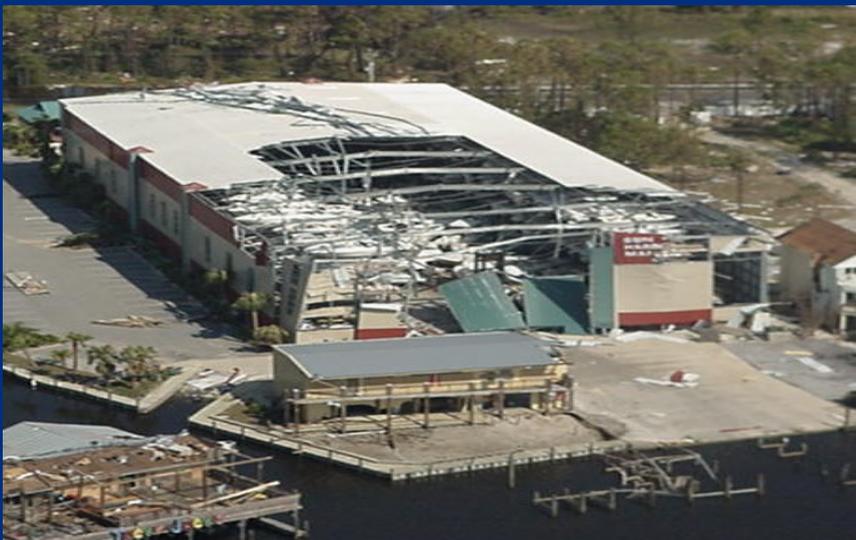
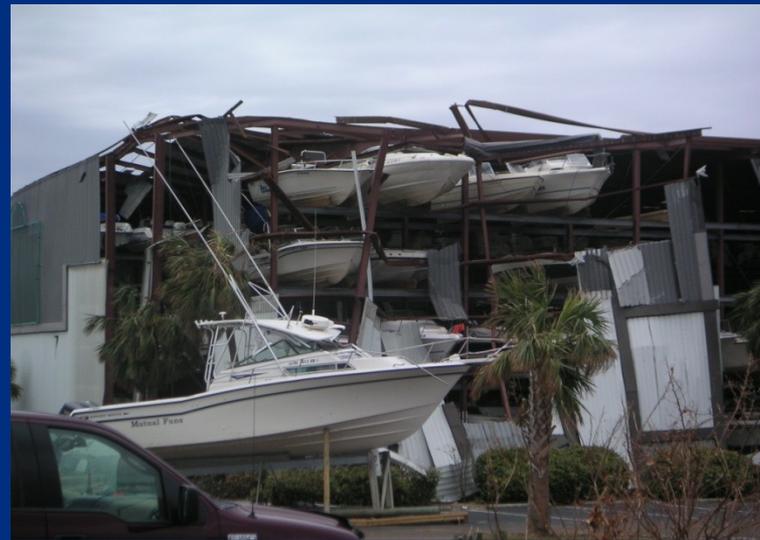
## Metal Building Failures

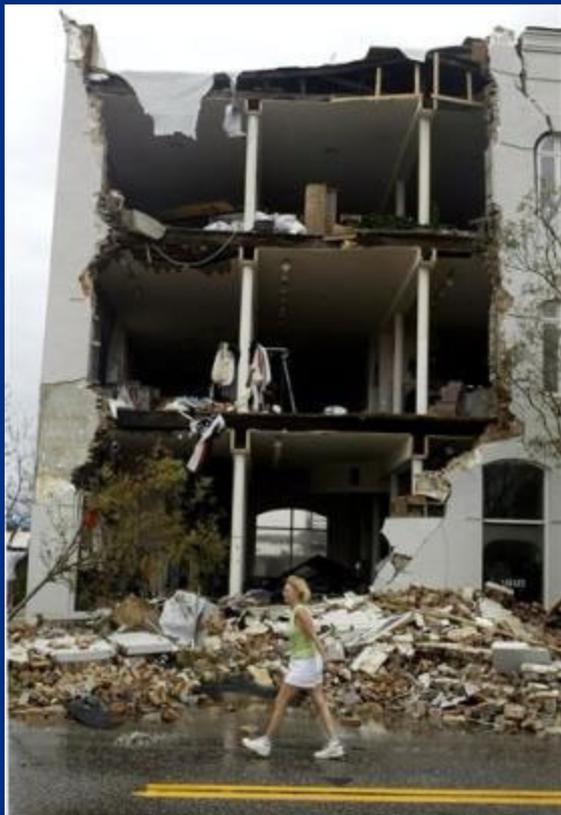
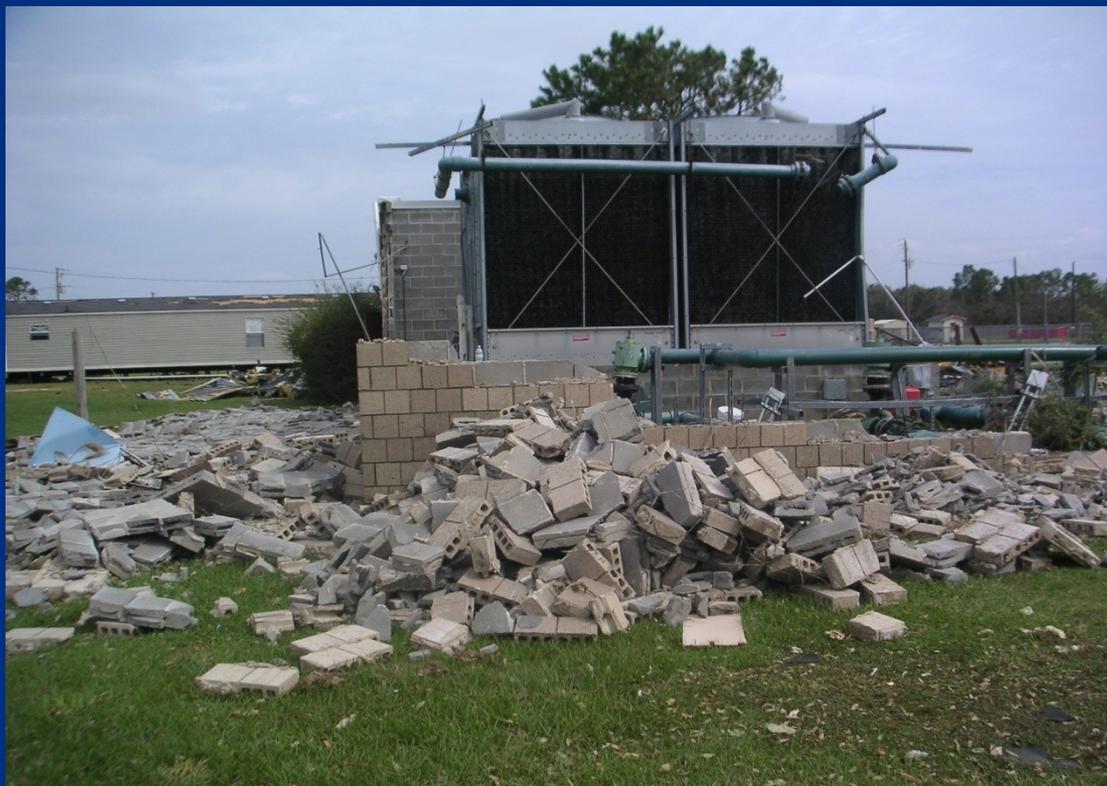
## Unreinforced Masonry Wall Failures

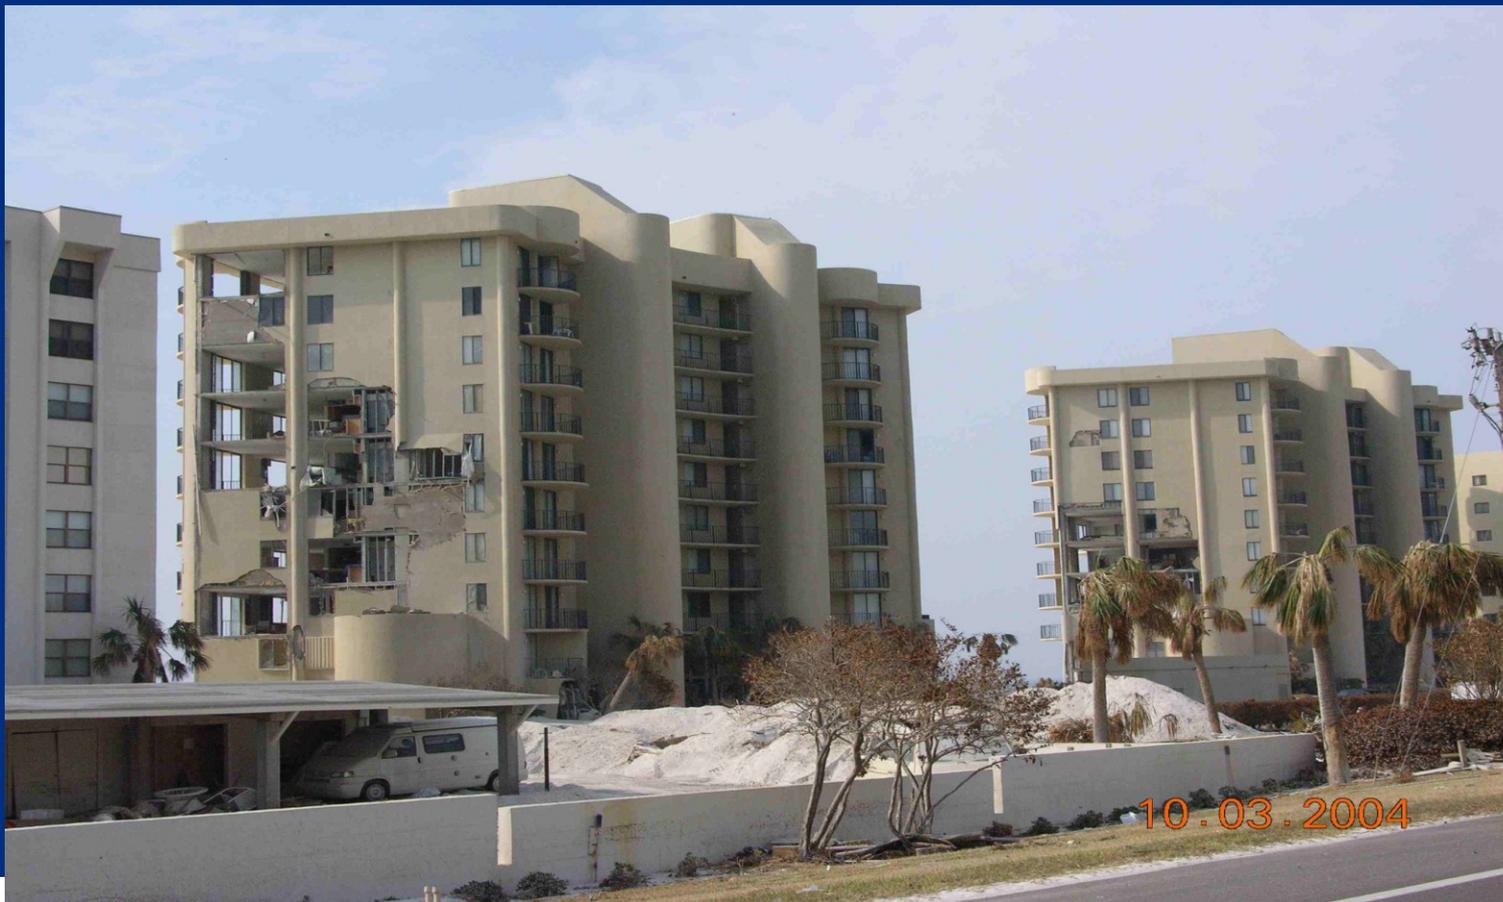
## Wall Framing Failures

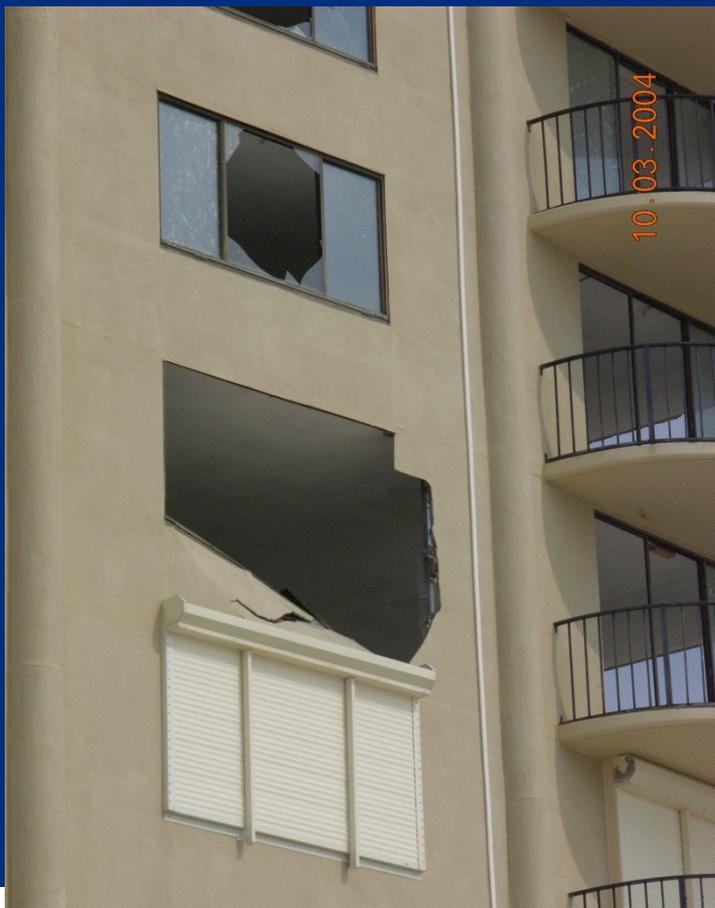
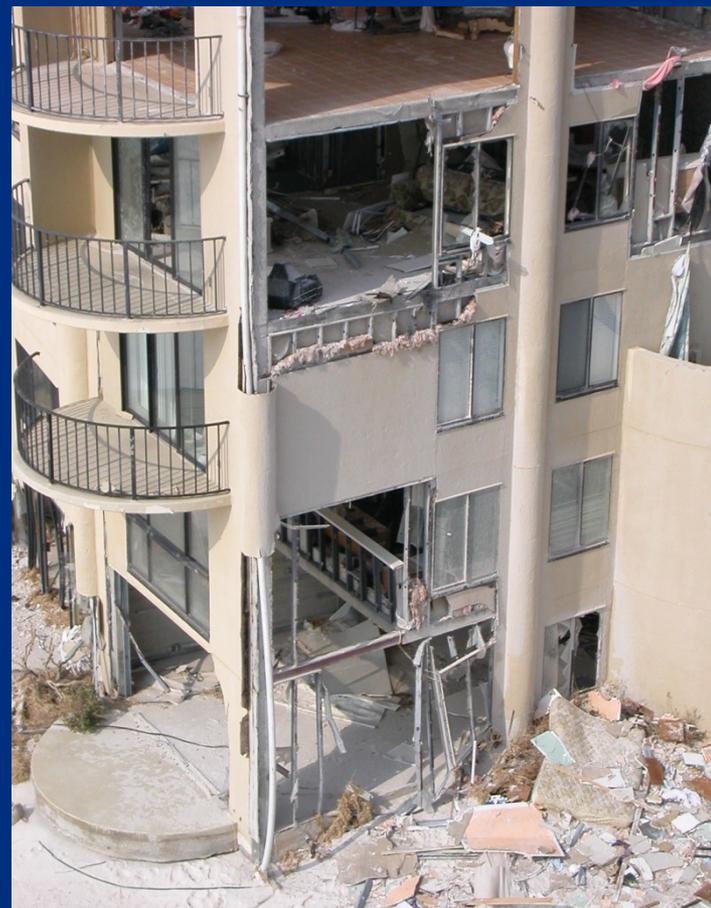
## Wall Framing Failures

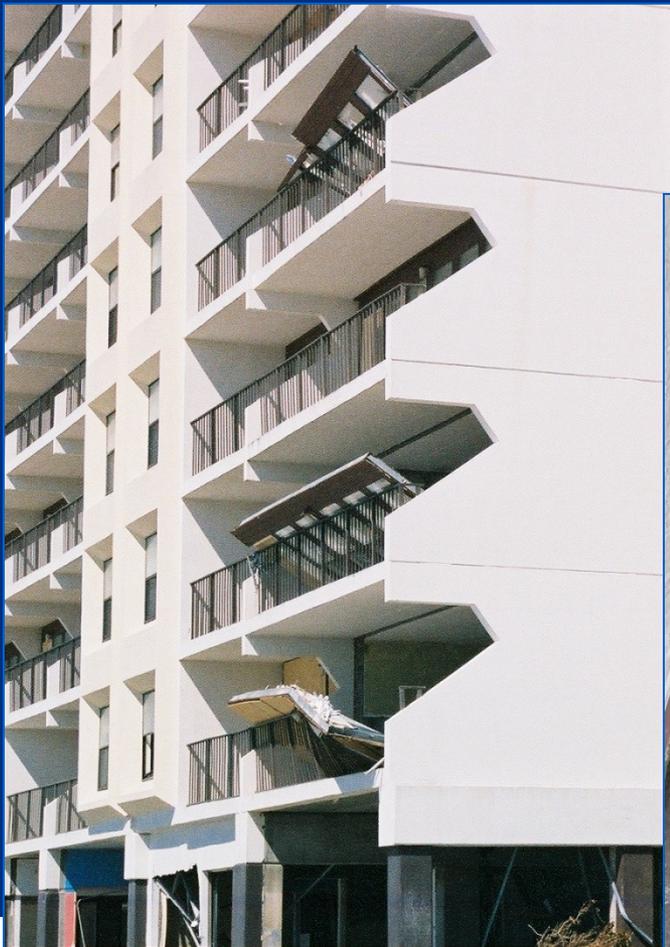
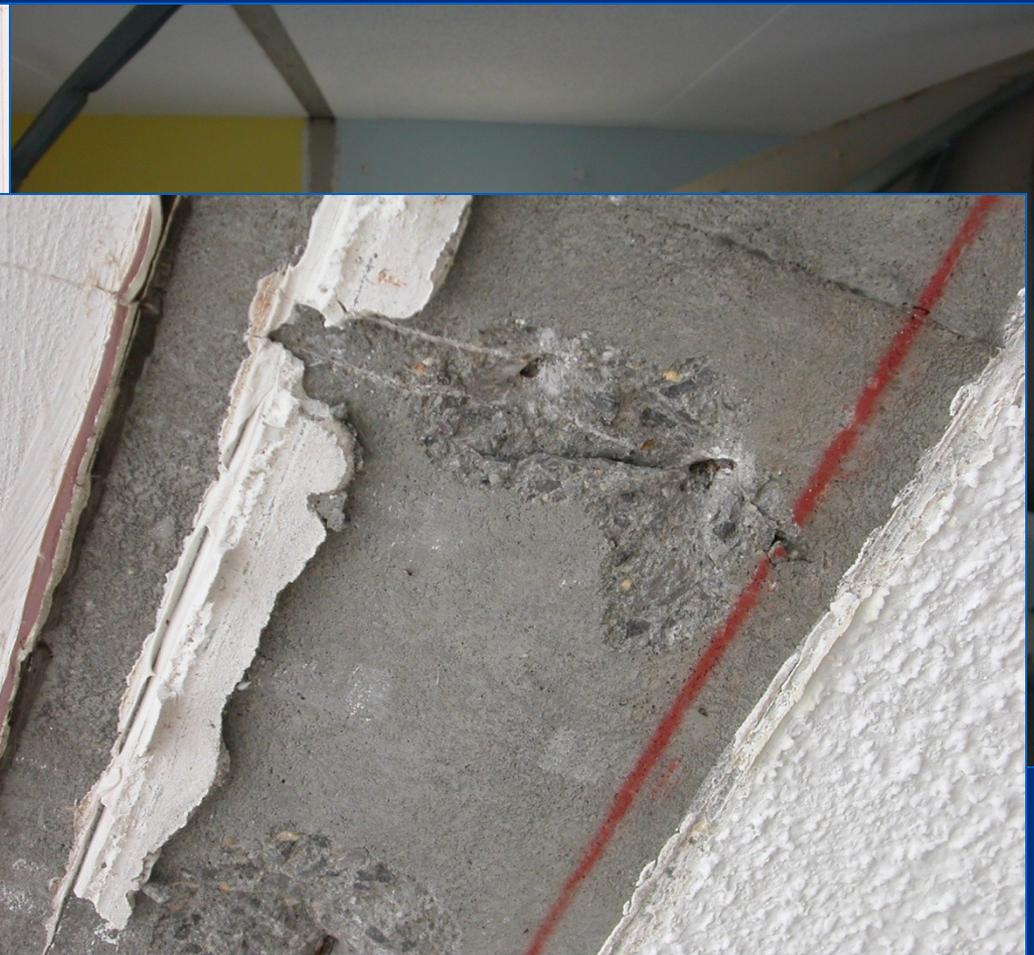
## Wall Framing Failures

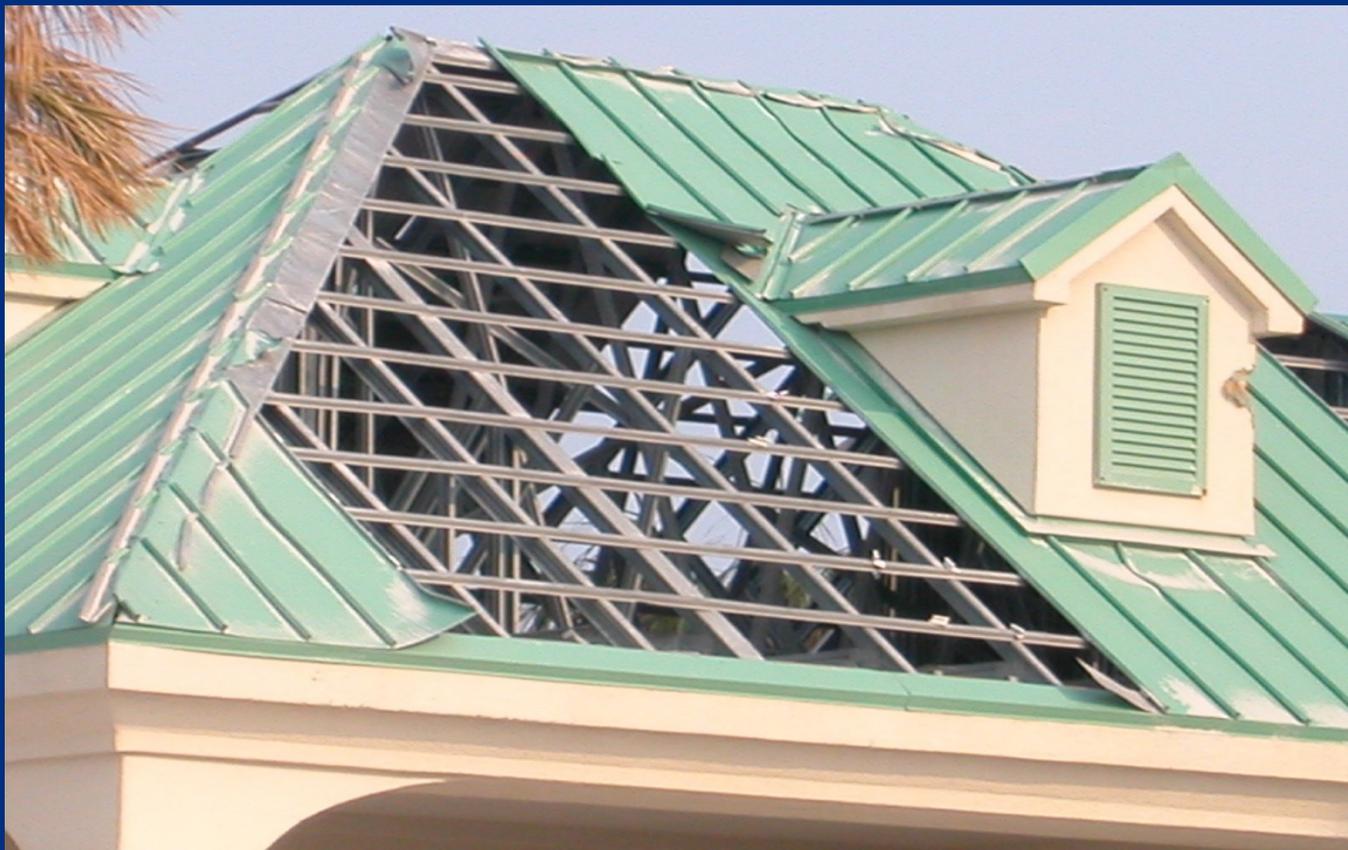
## Roof Deck Failures

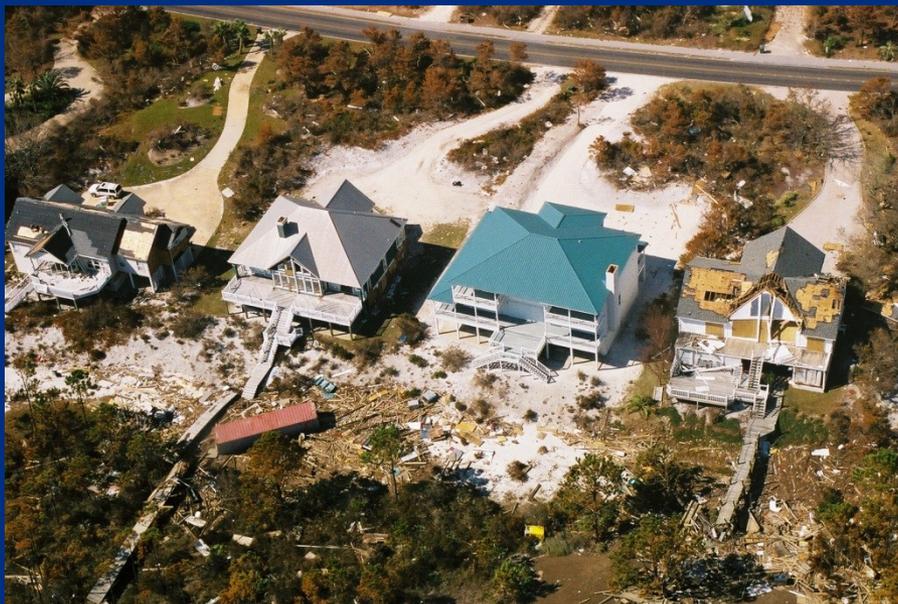
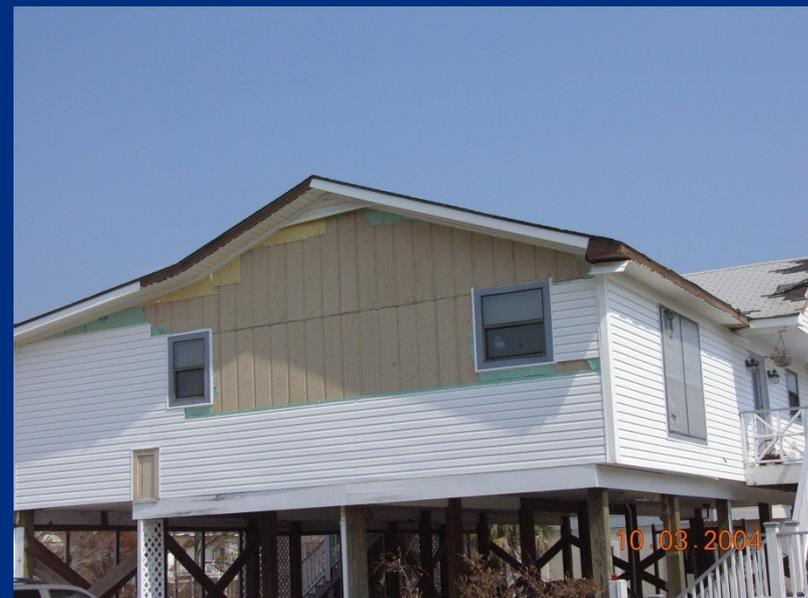
## Cladding Failures

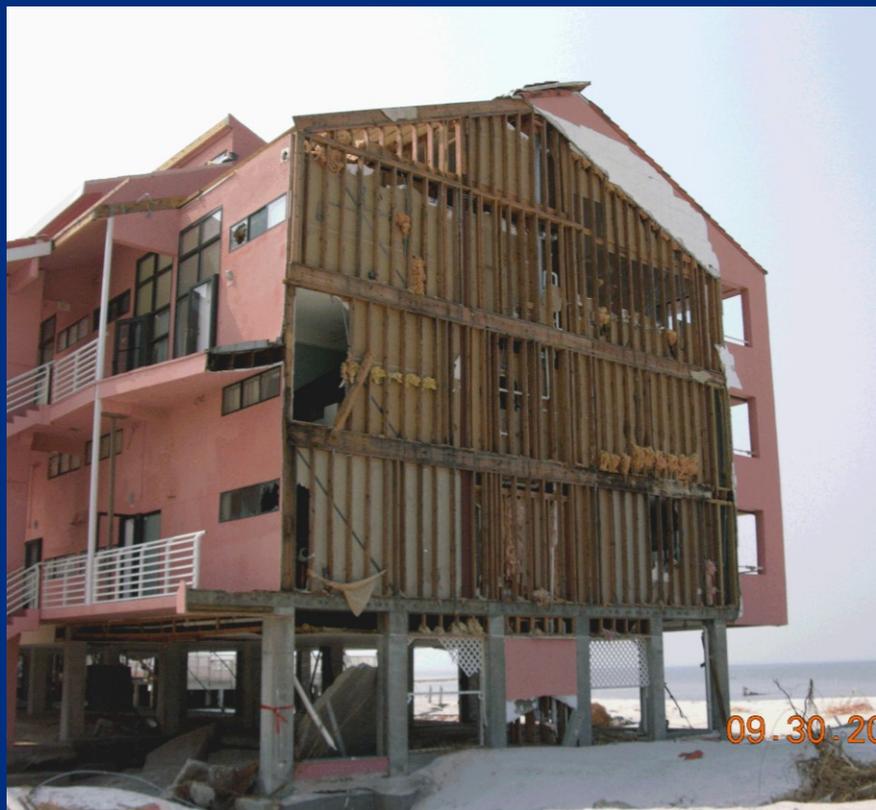
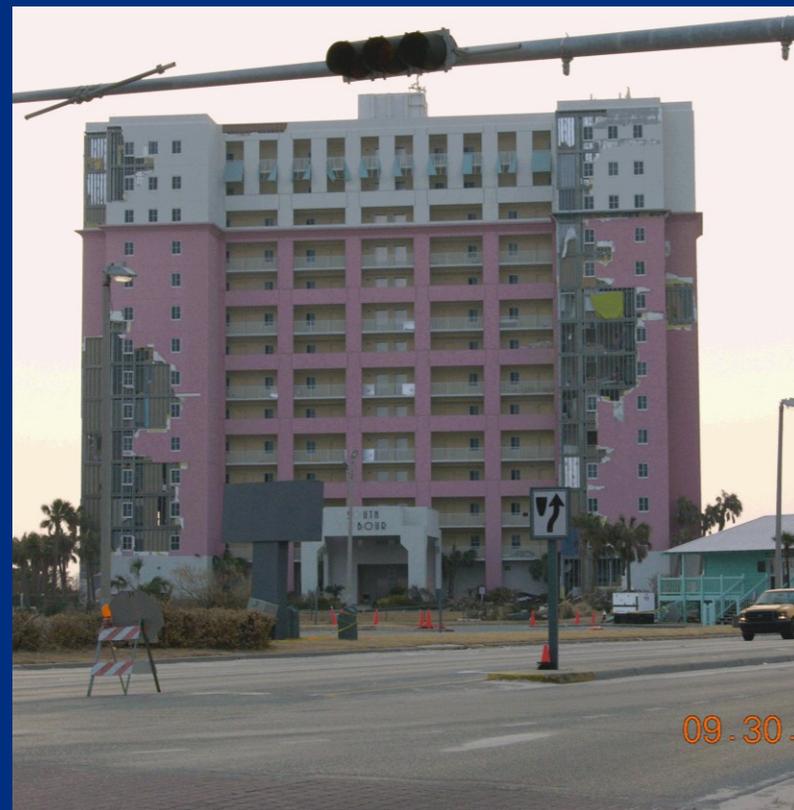
## EIFS Failures

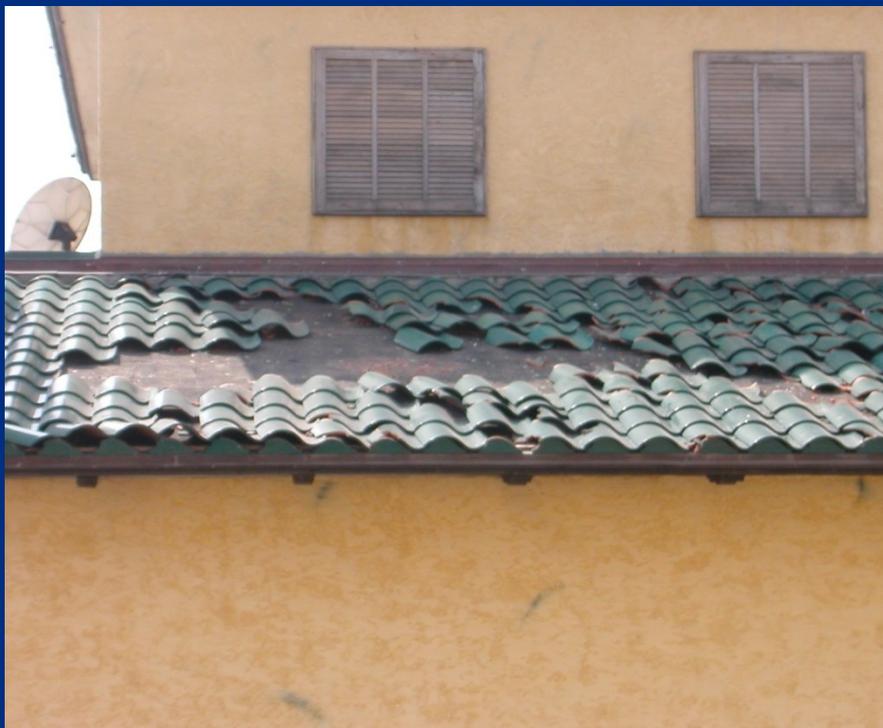
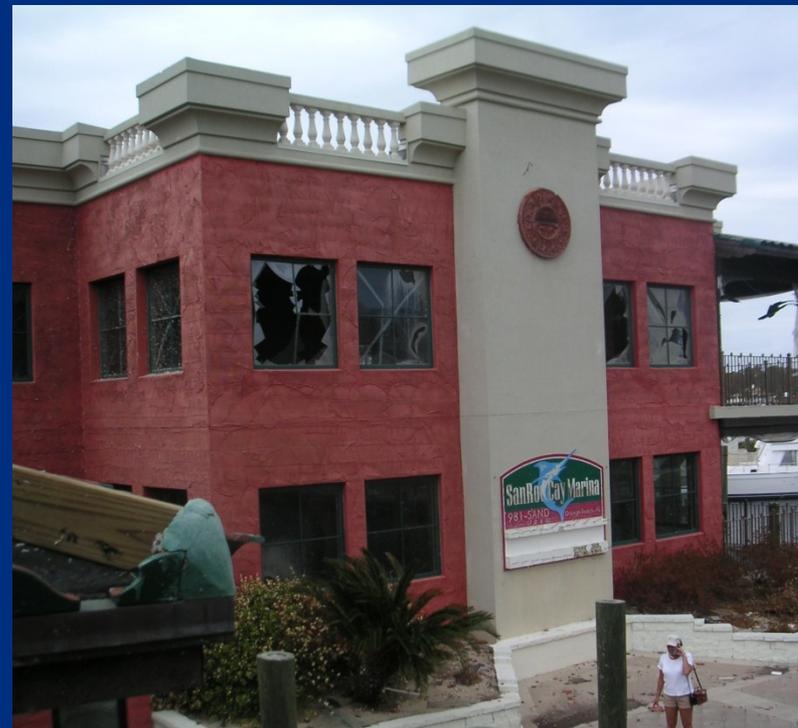
## Roof Tile Failures – Wind-Borne Debris

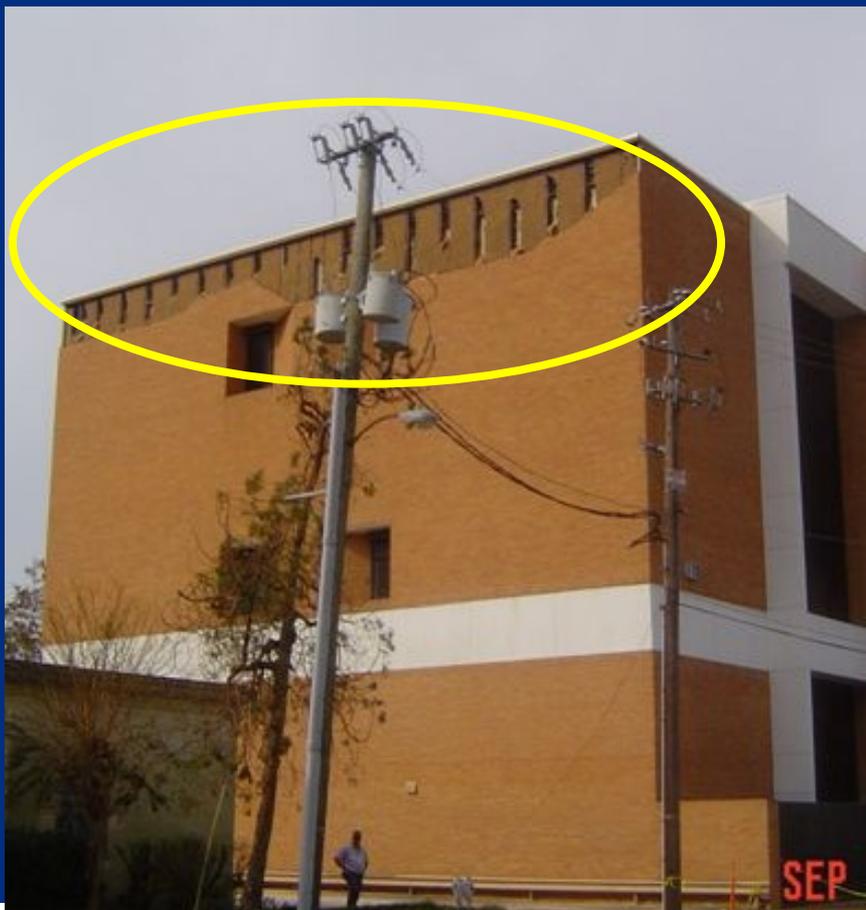
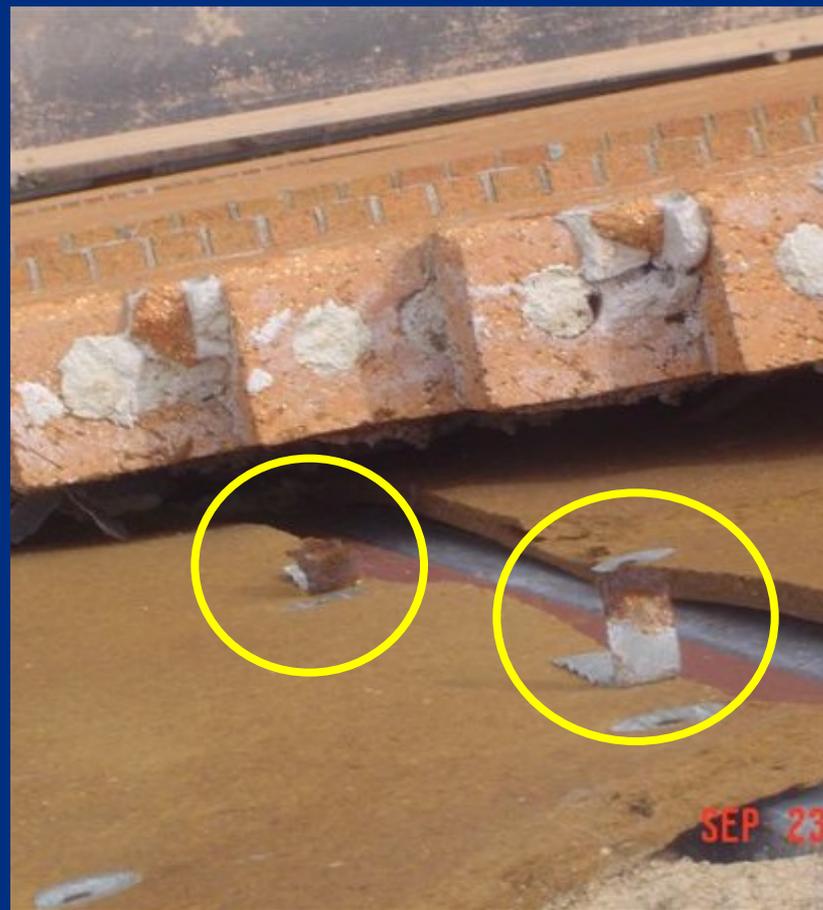
Brick Cladding Failures – Corrosion of Ties

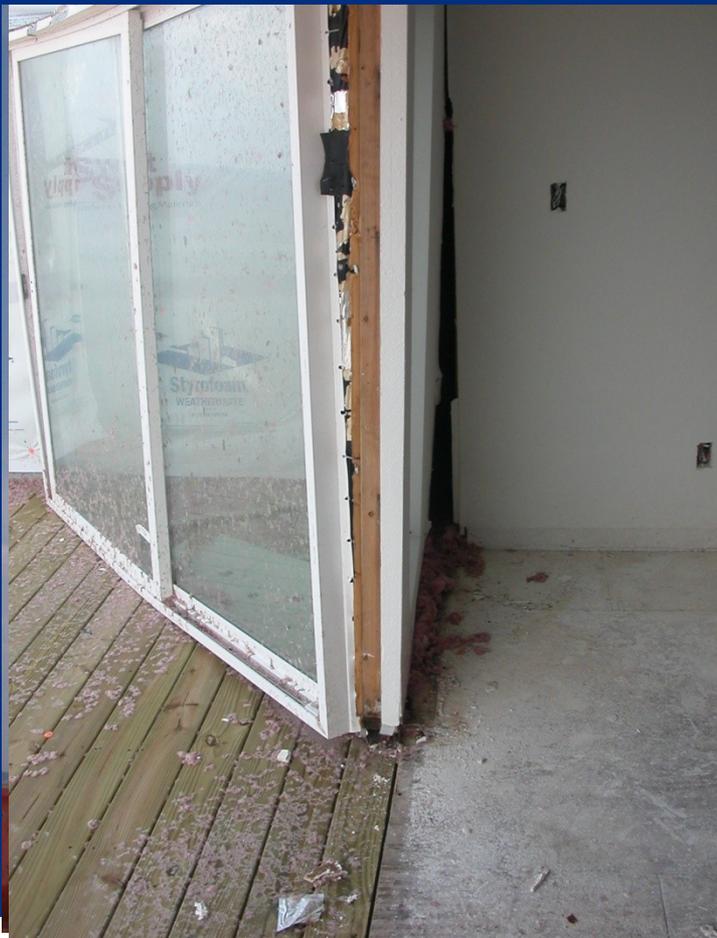
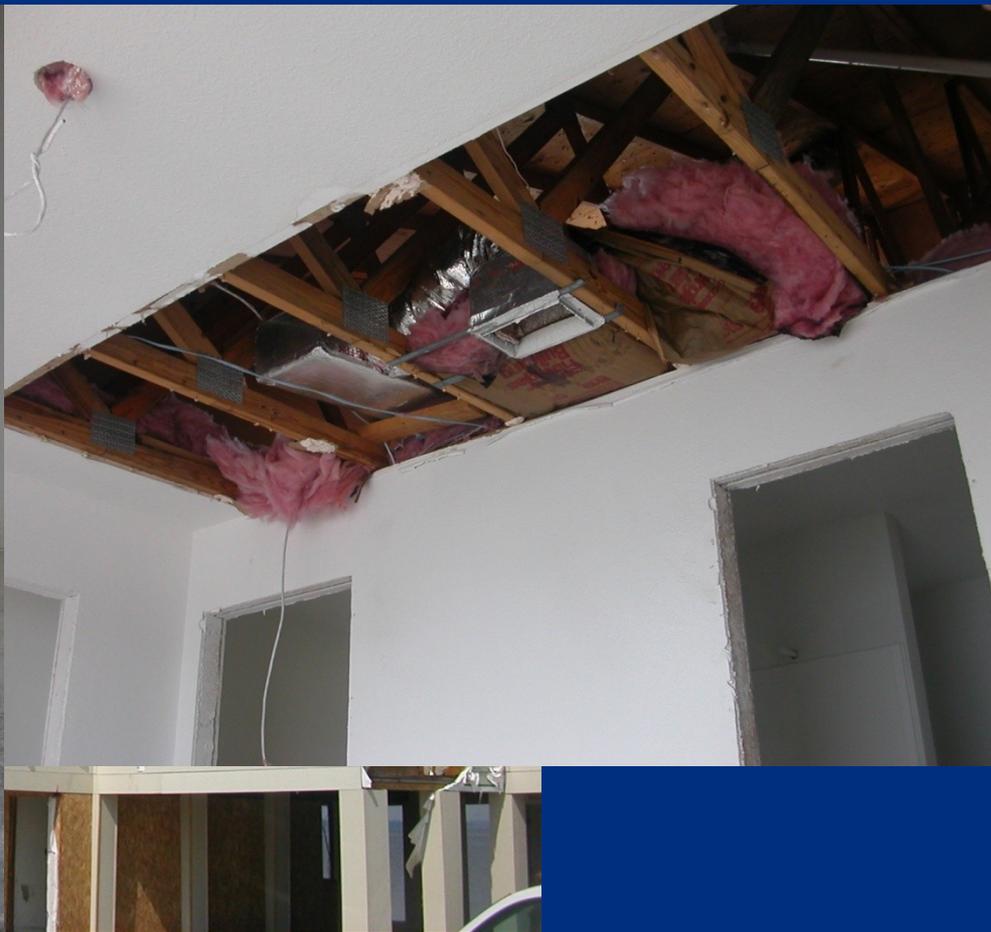
## Internal Pressurization

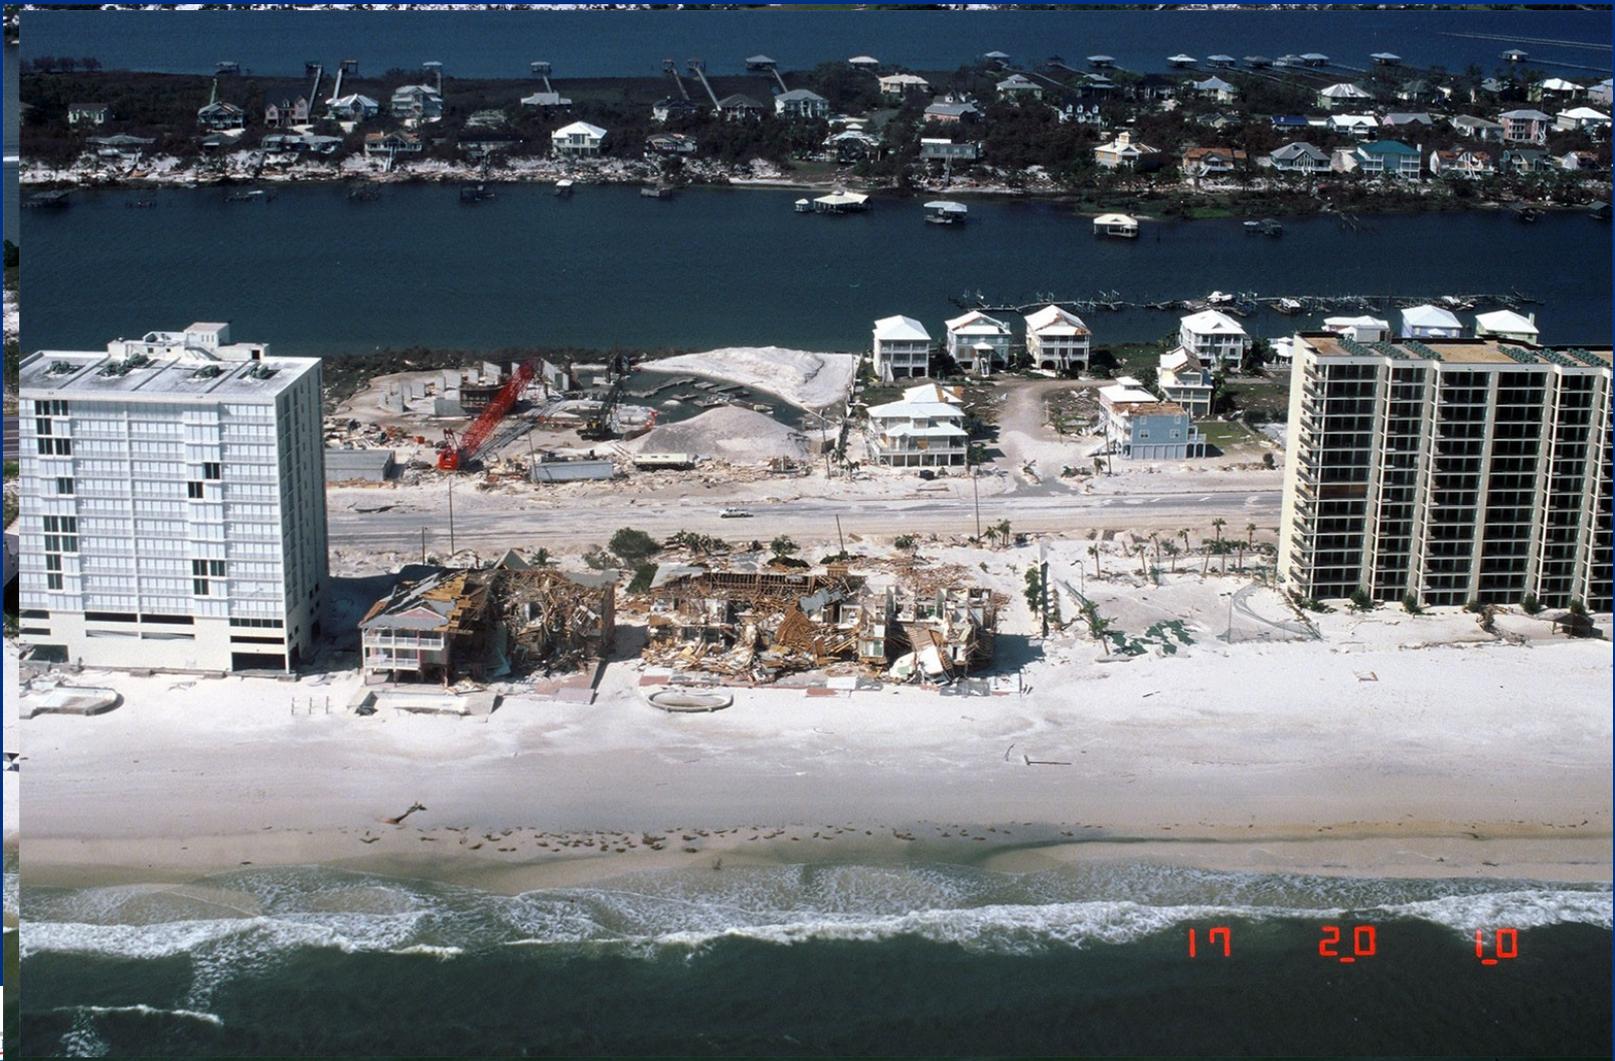
# Flood Damage - Shallow Foundations

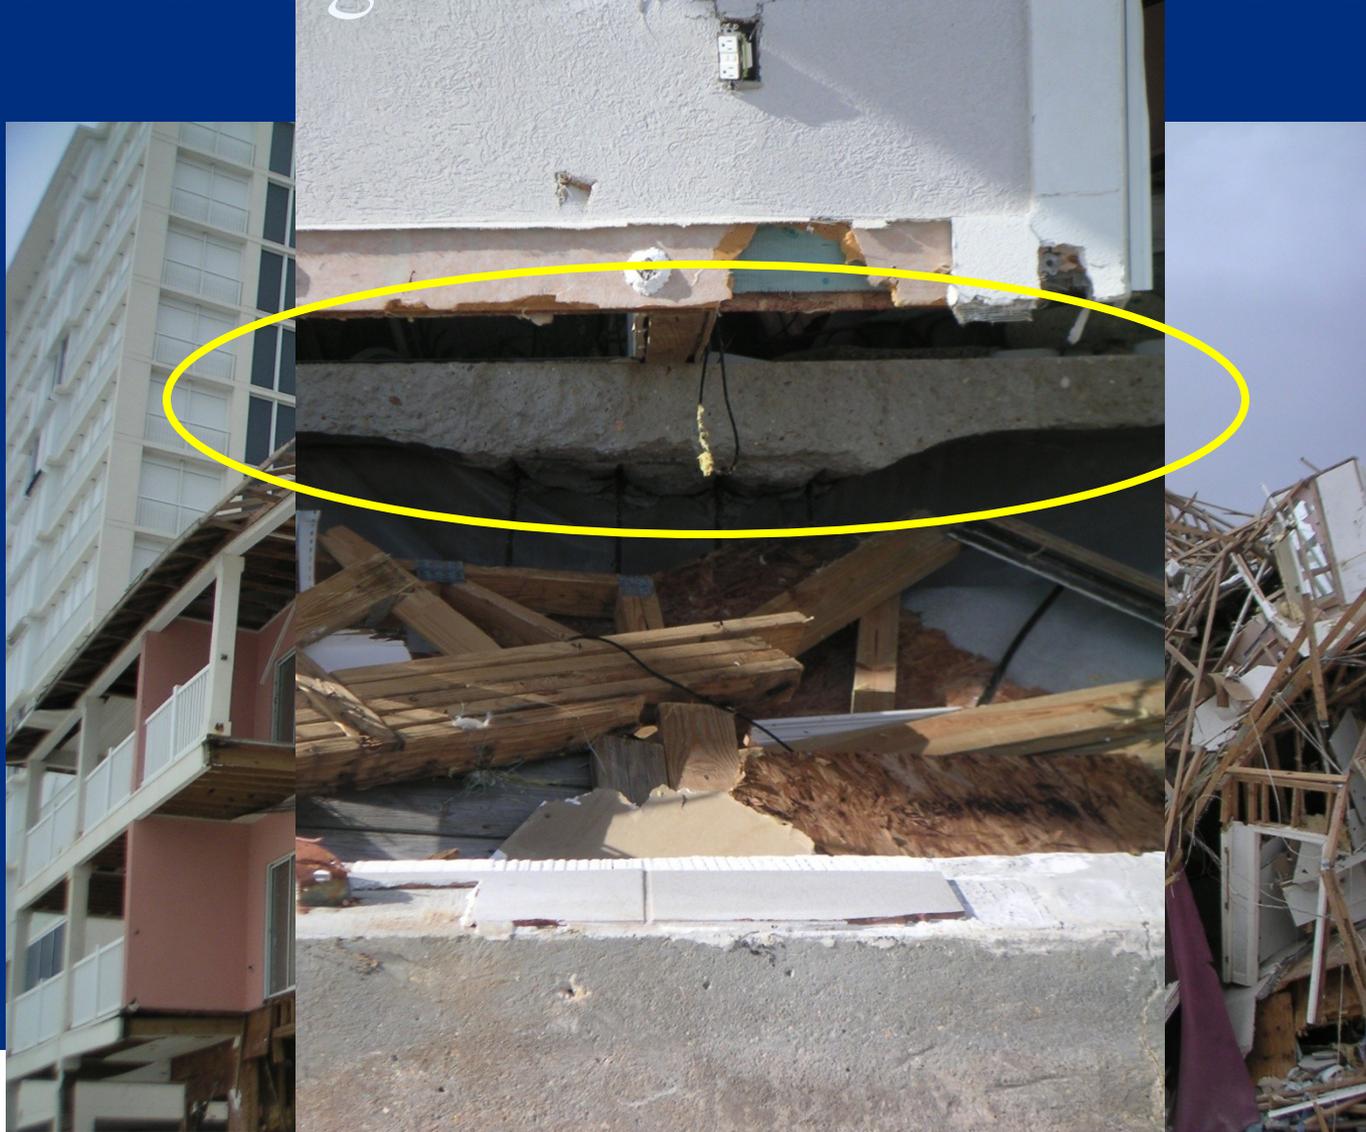
# Flood Damage - Shallow Foundations
