# FEMA Mitigation Assessment Team Report on Hurricane Ivan

Bill Coulbourne, P.E.

June 2, 2005

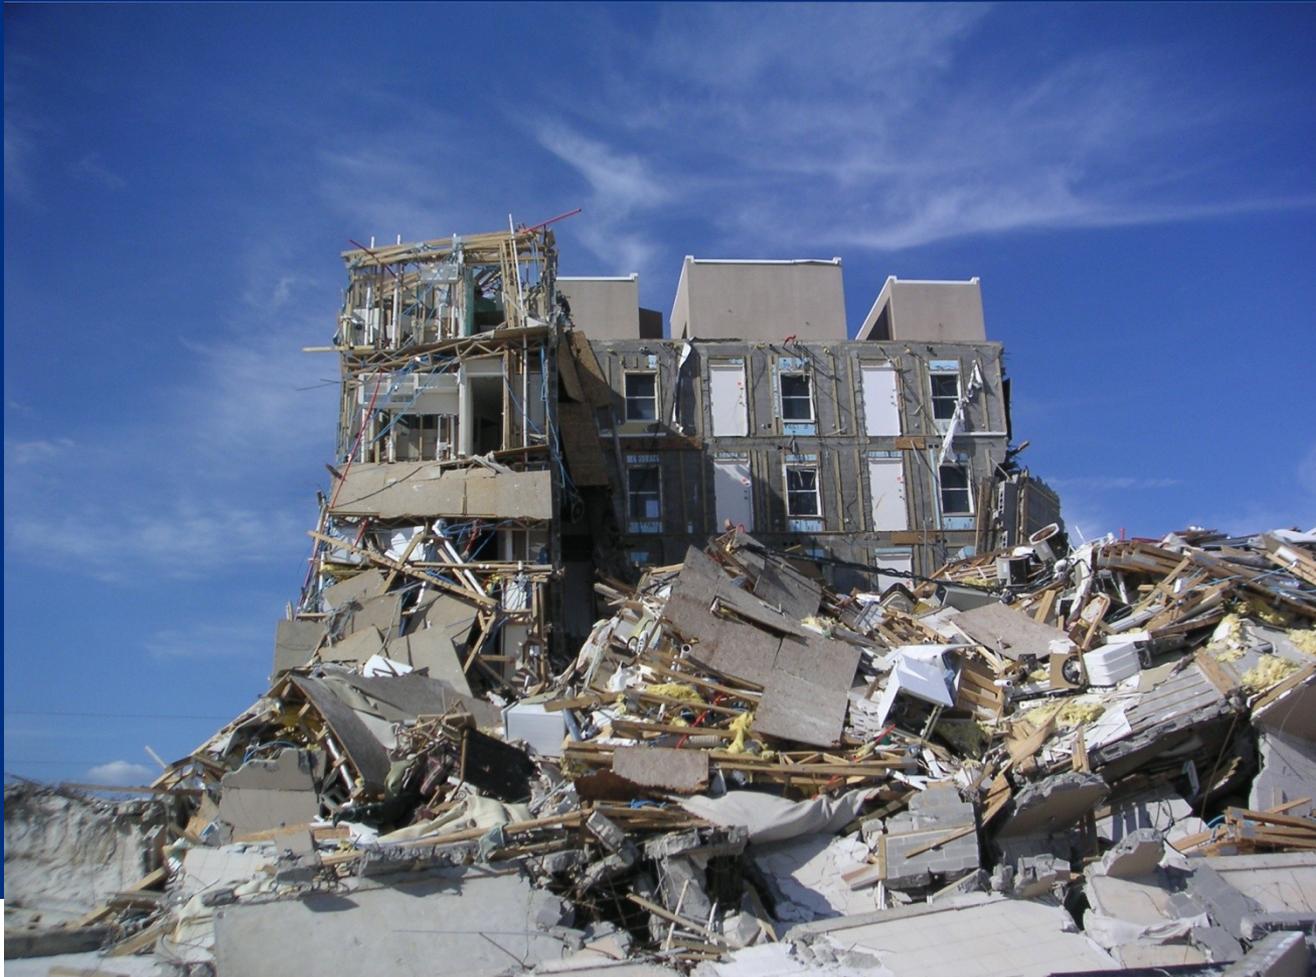
# Flood Damage - Shallow Foundations

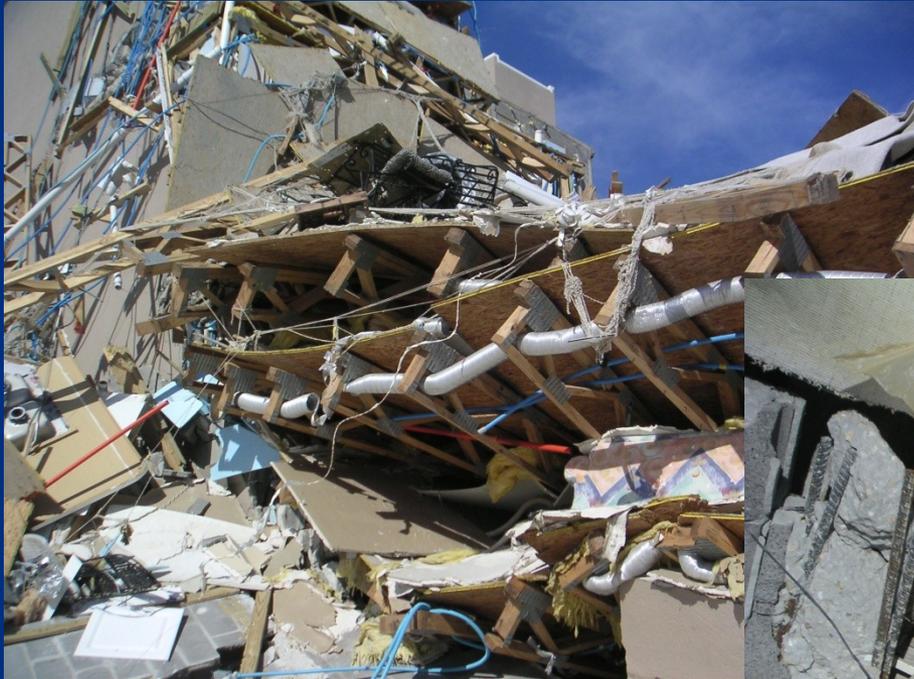
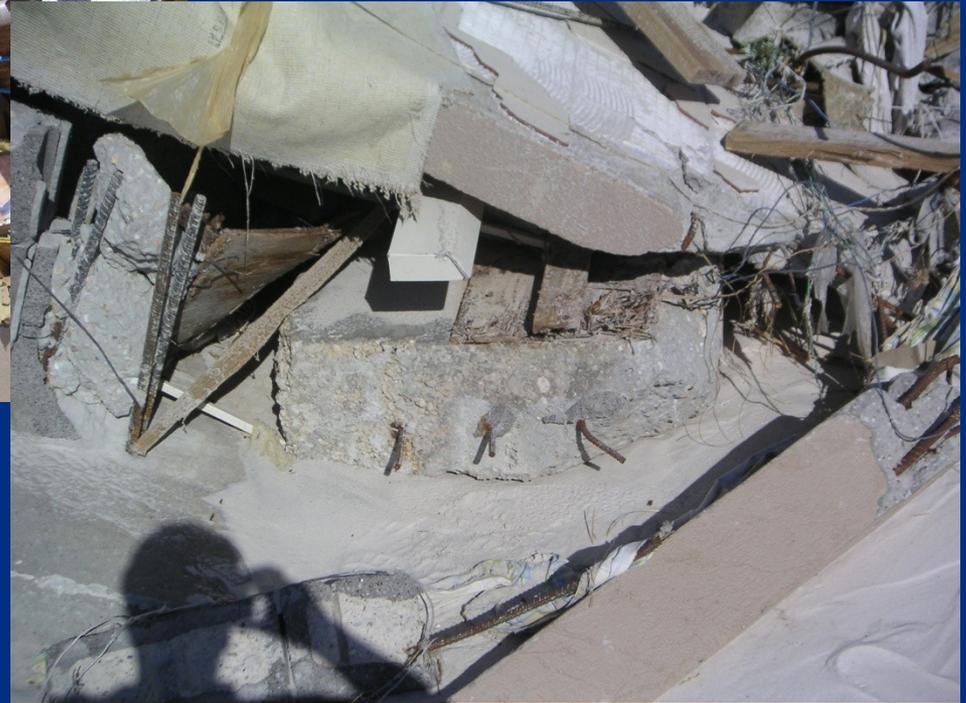
# Flood Damage - Shallow Foundations

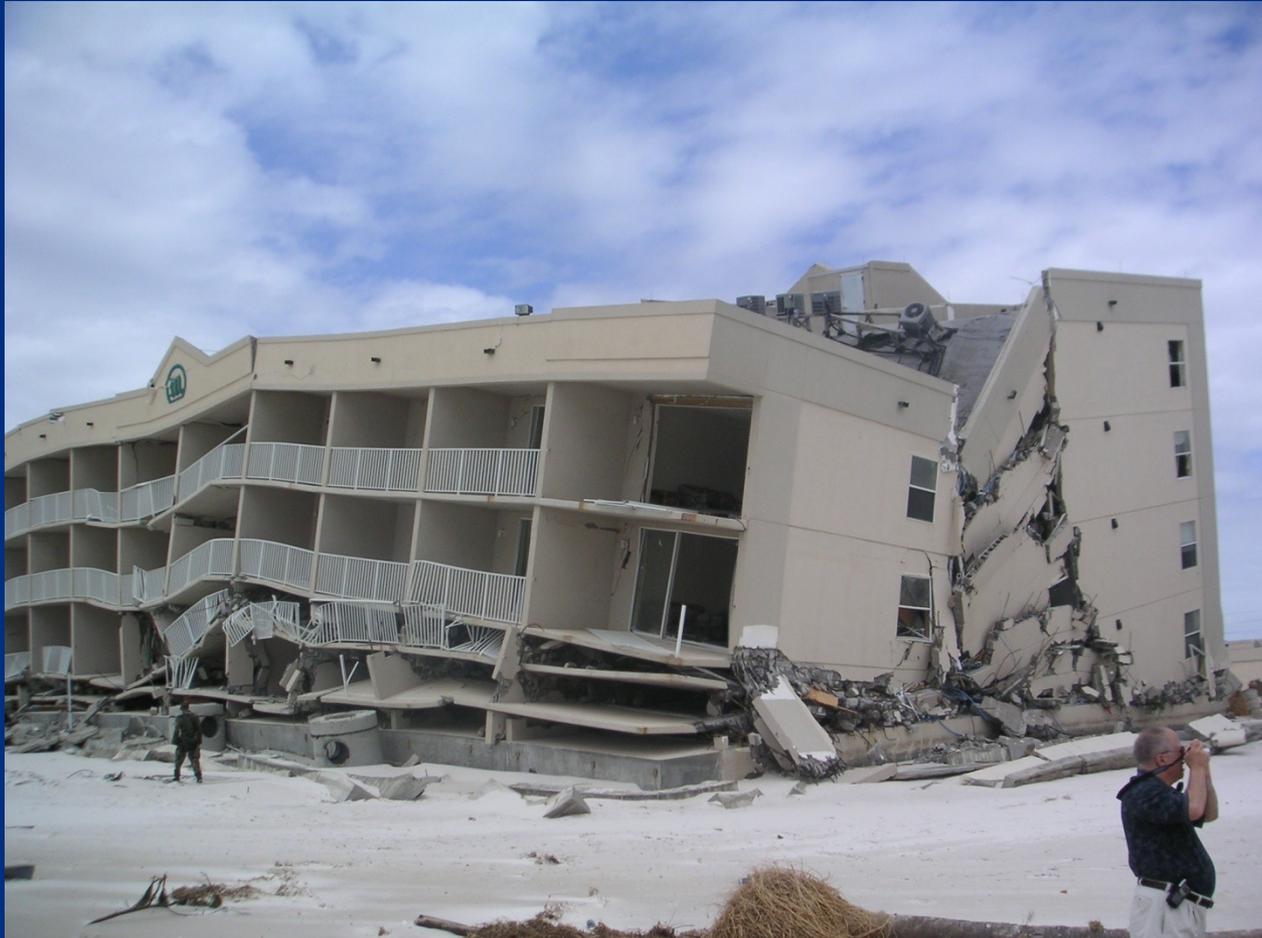
# Flood Damage - Shallow Foundations

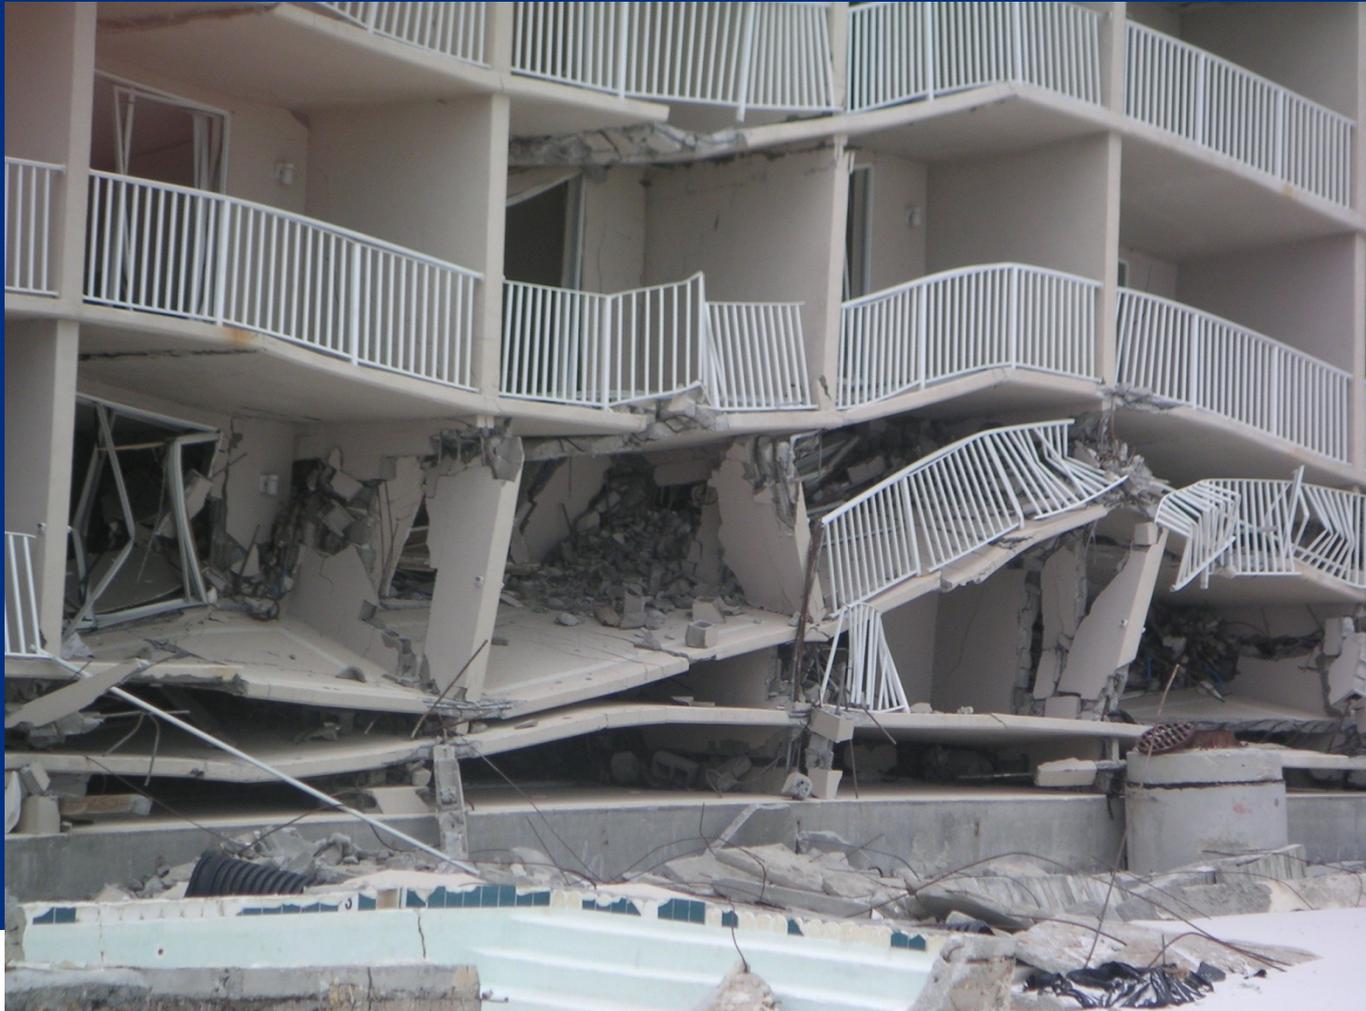
# Flood Damage - Shallow Foundations

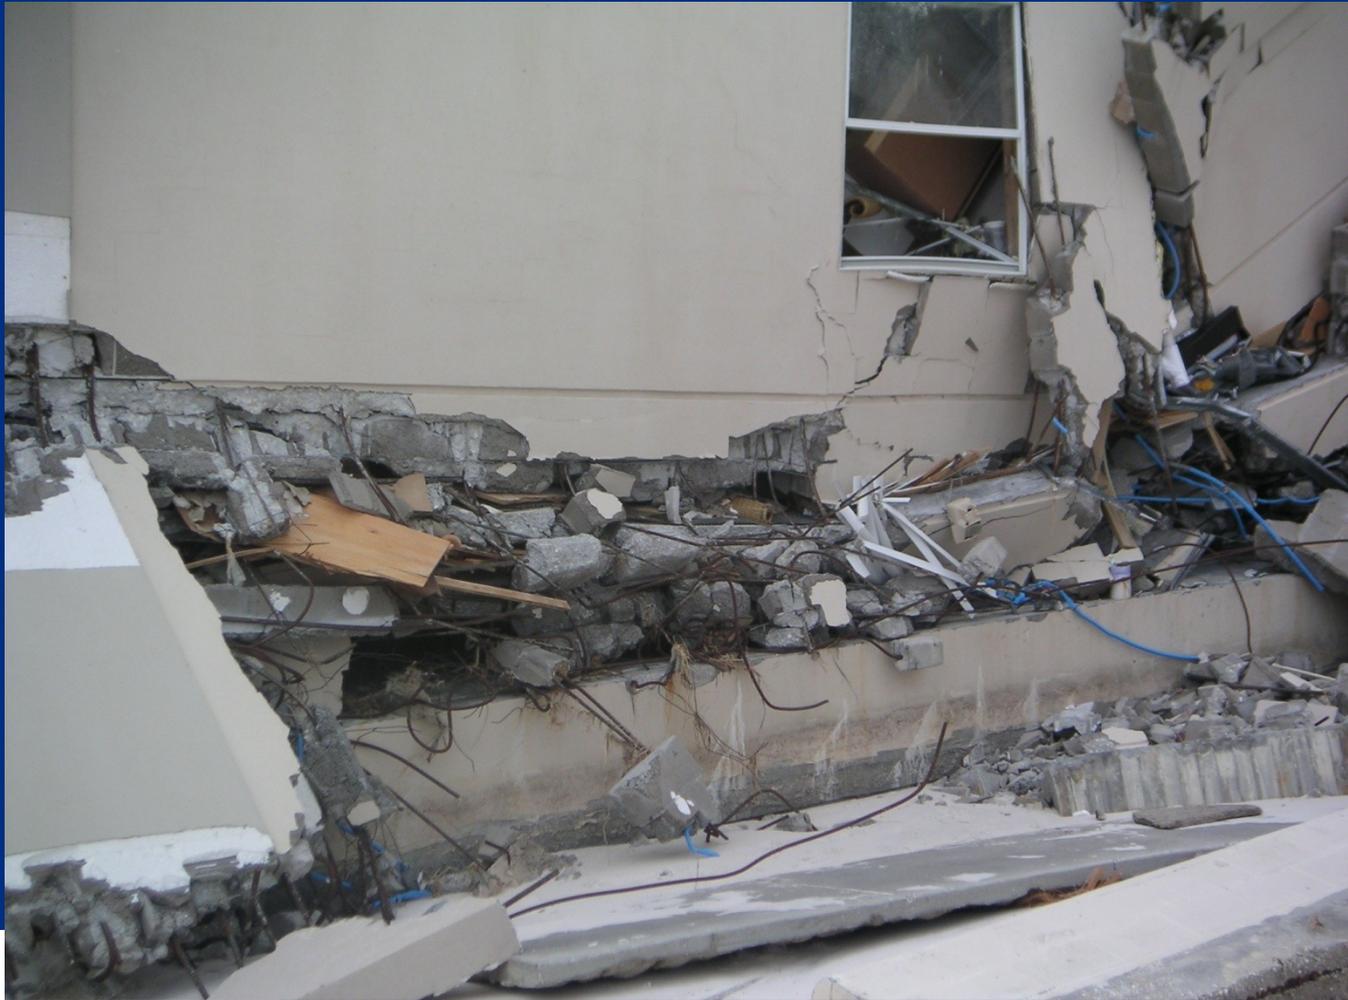
# Flood Damage - Shallow Foundations

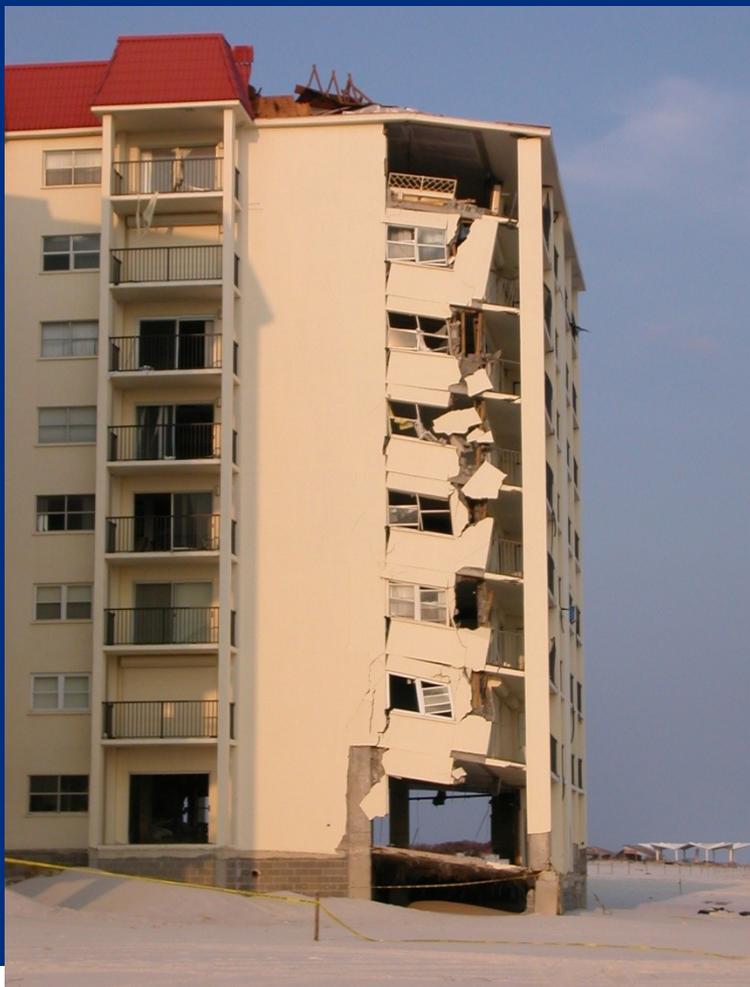
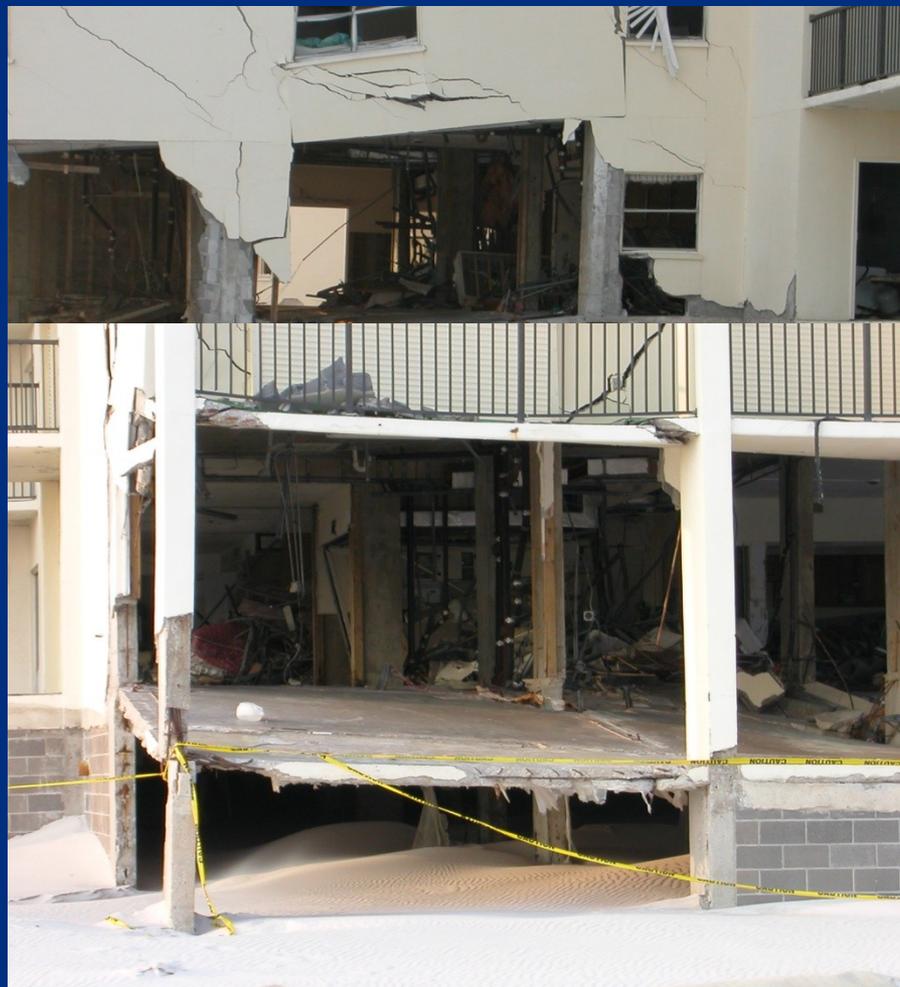
# Flood Damage - Pile Foundations

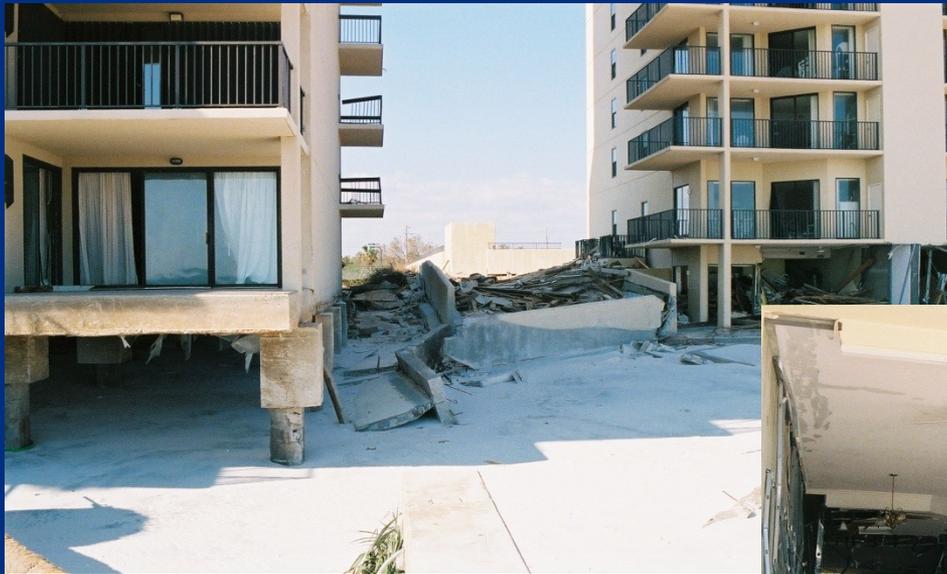
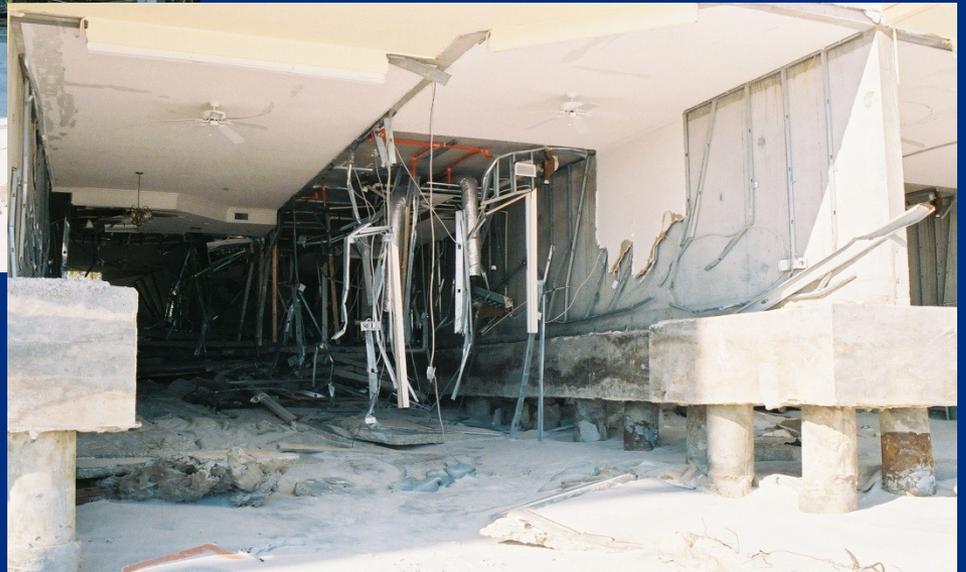
# Flood Damage – Ground Floor Condos

Widespread loss of lower units – Collapse of undermined slabs

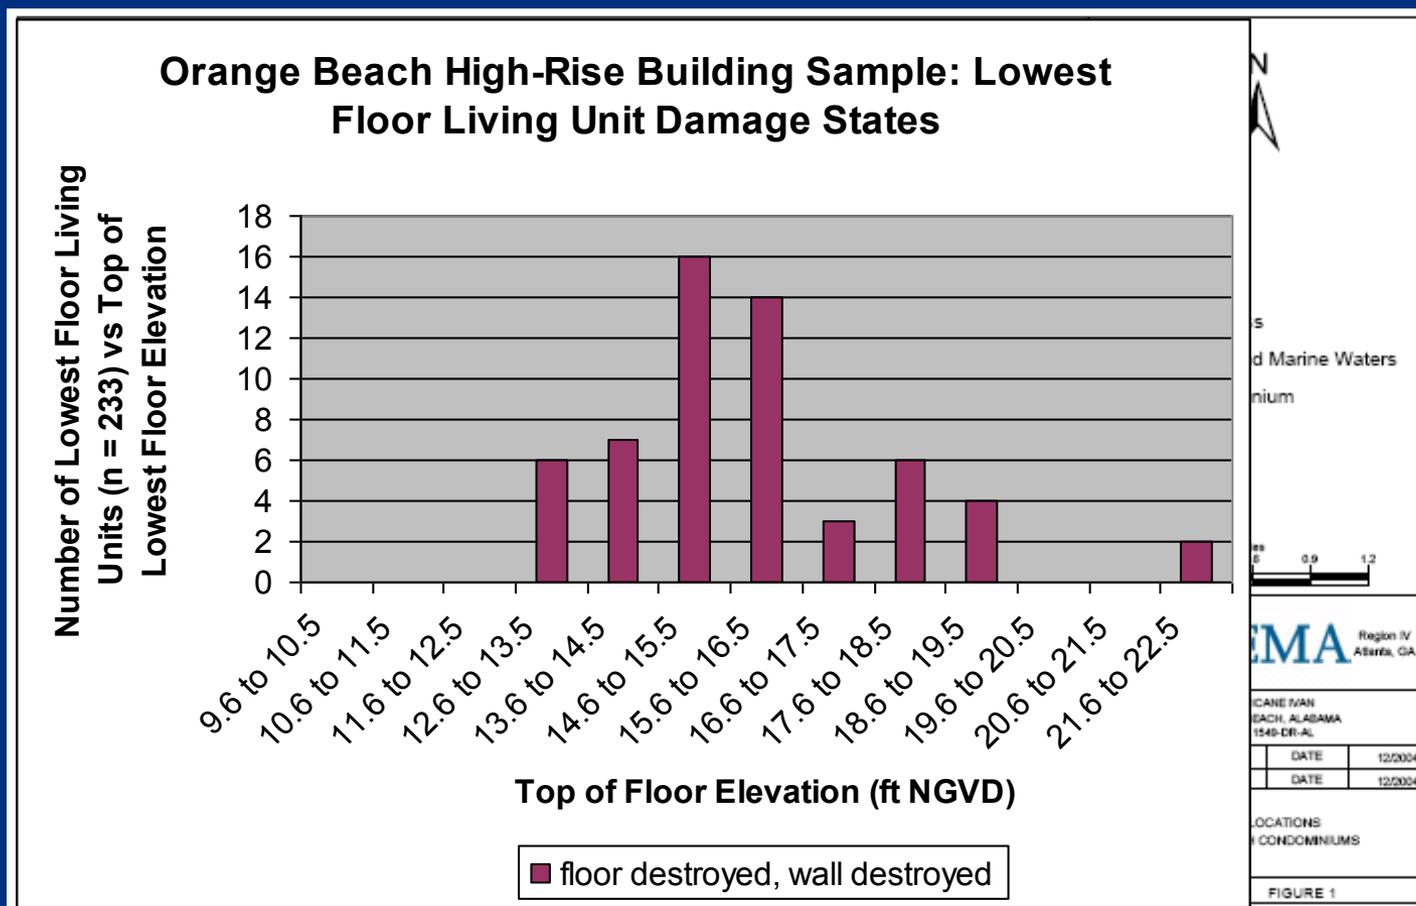
39 of 43 high-rise buildings had ground level units

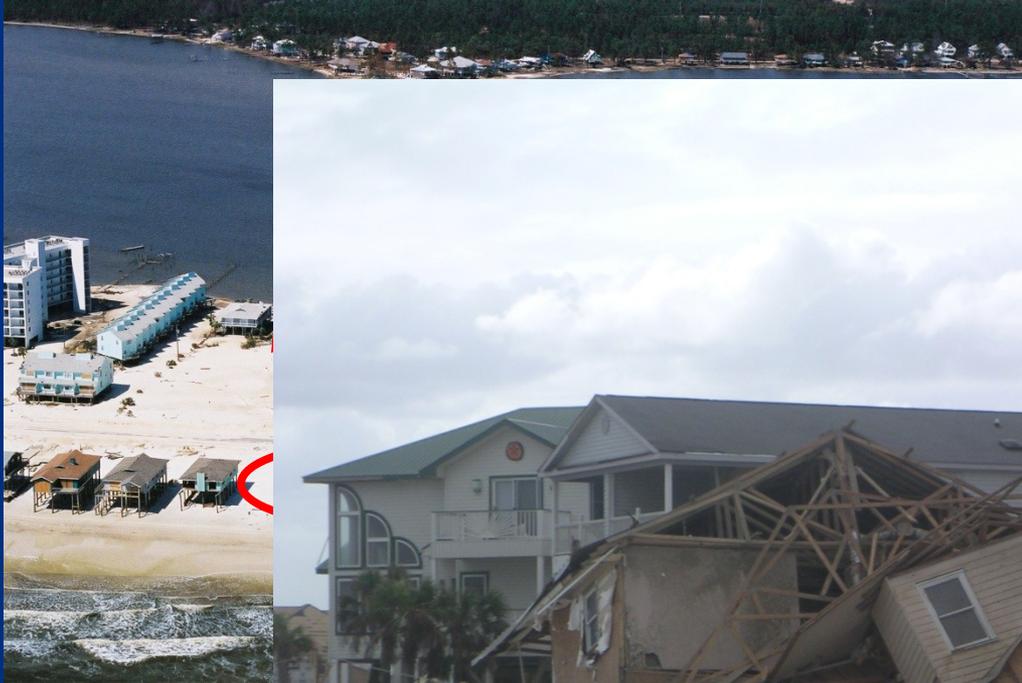
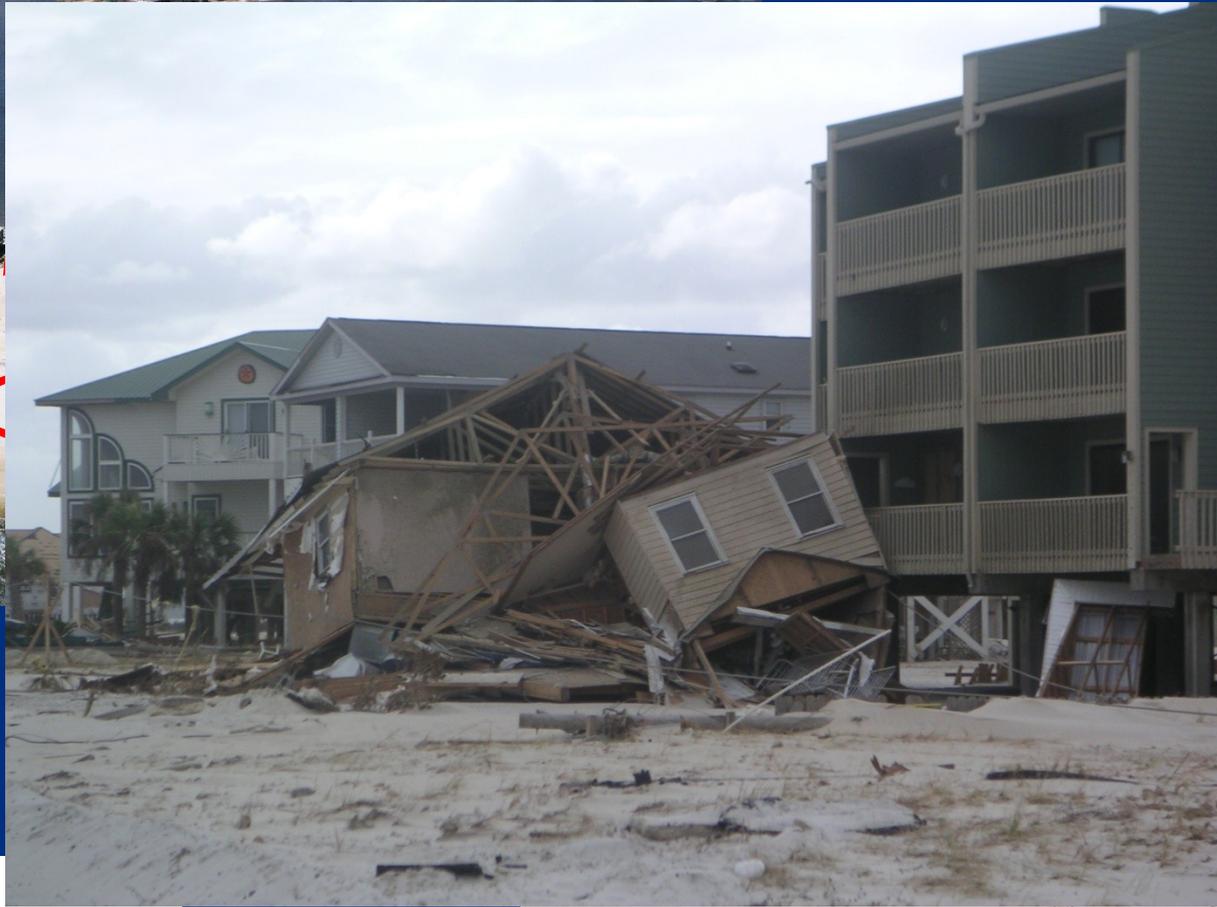
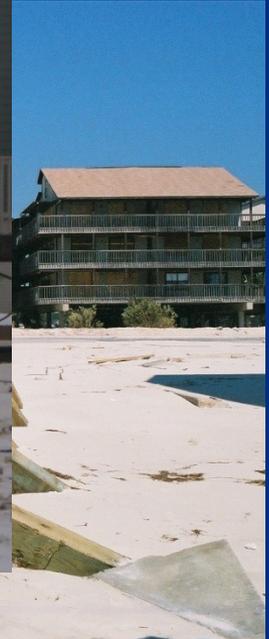
Loss of pile embedment

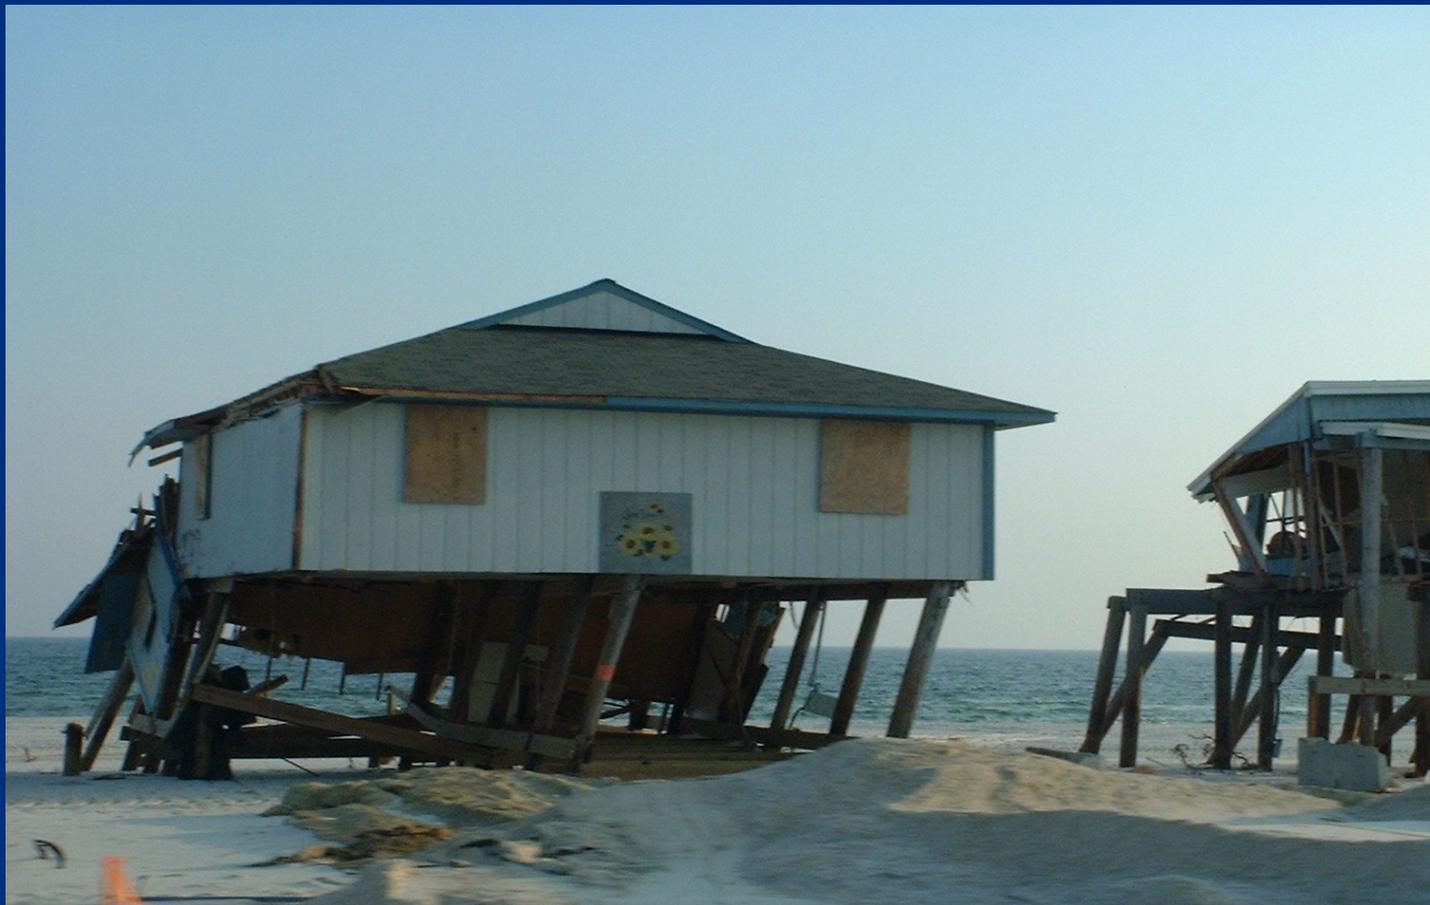
Loss of pile embedment

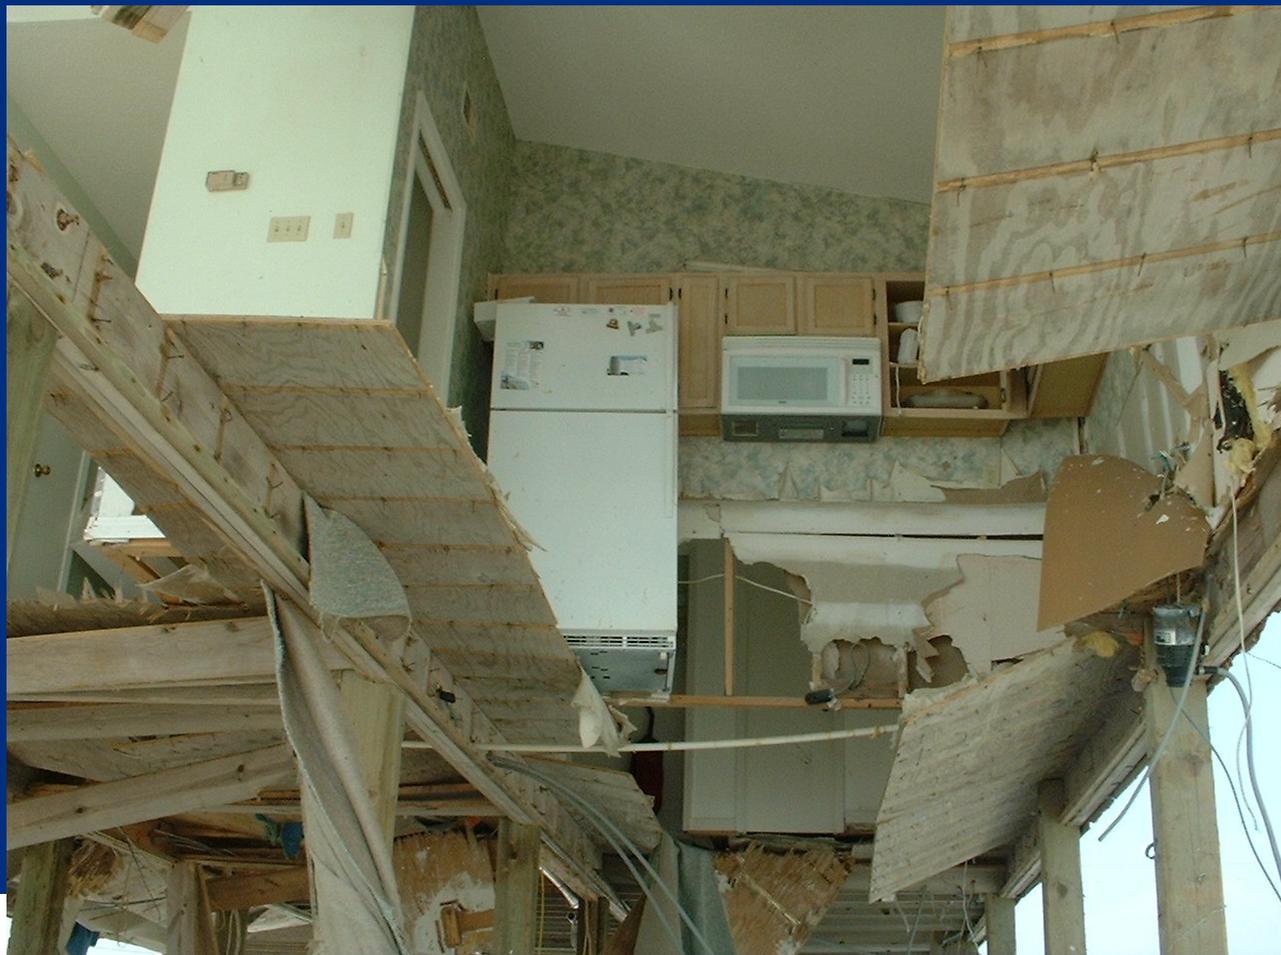
Framing destroyed by wave action

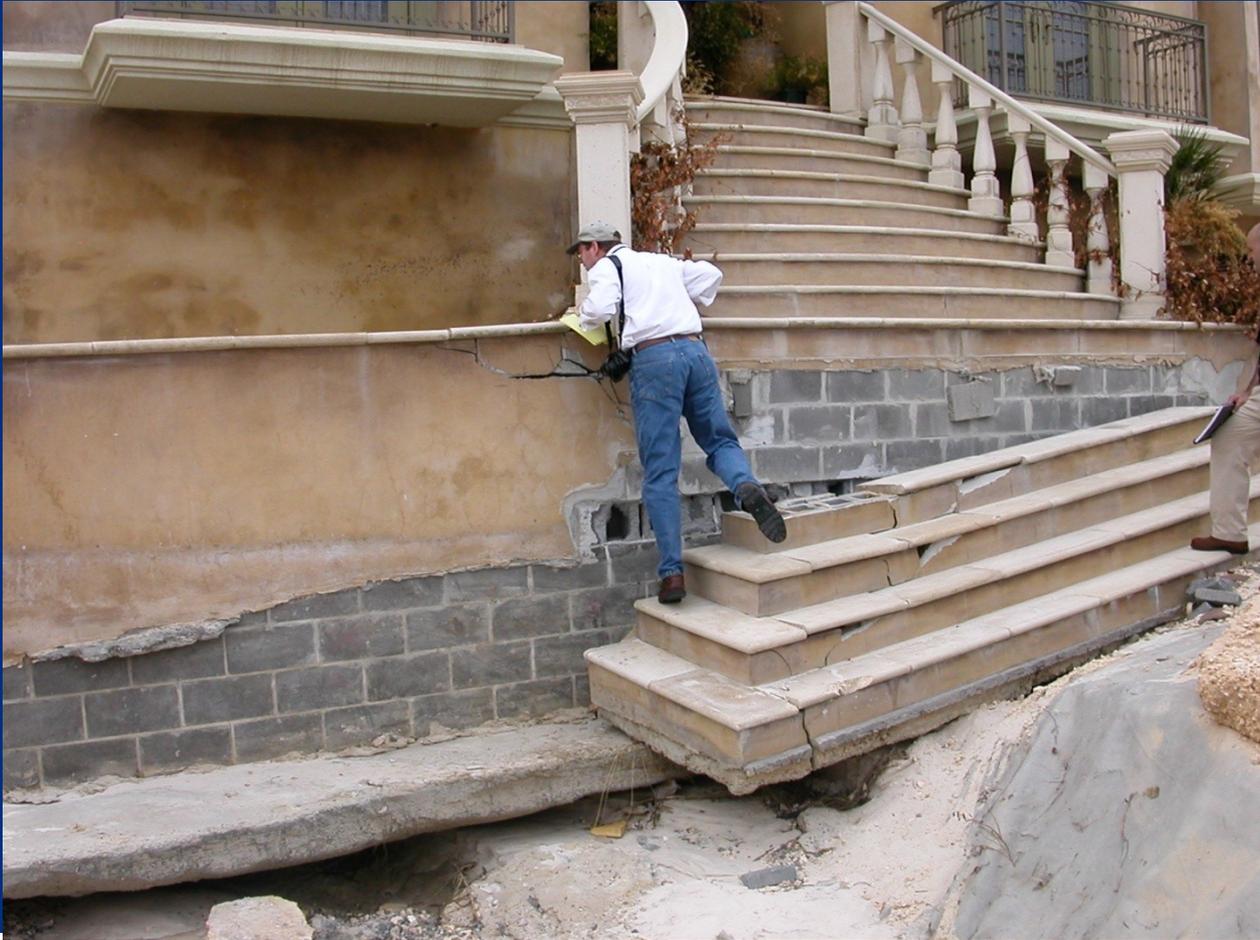
Construction in the V zone

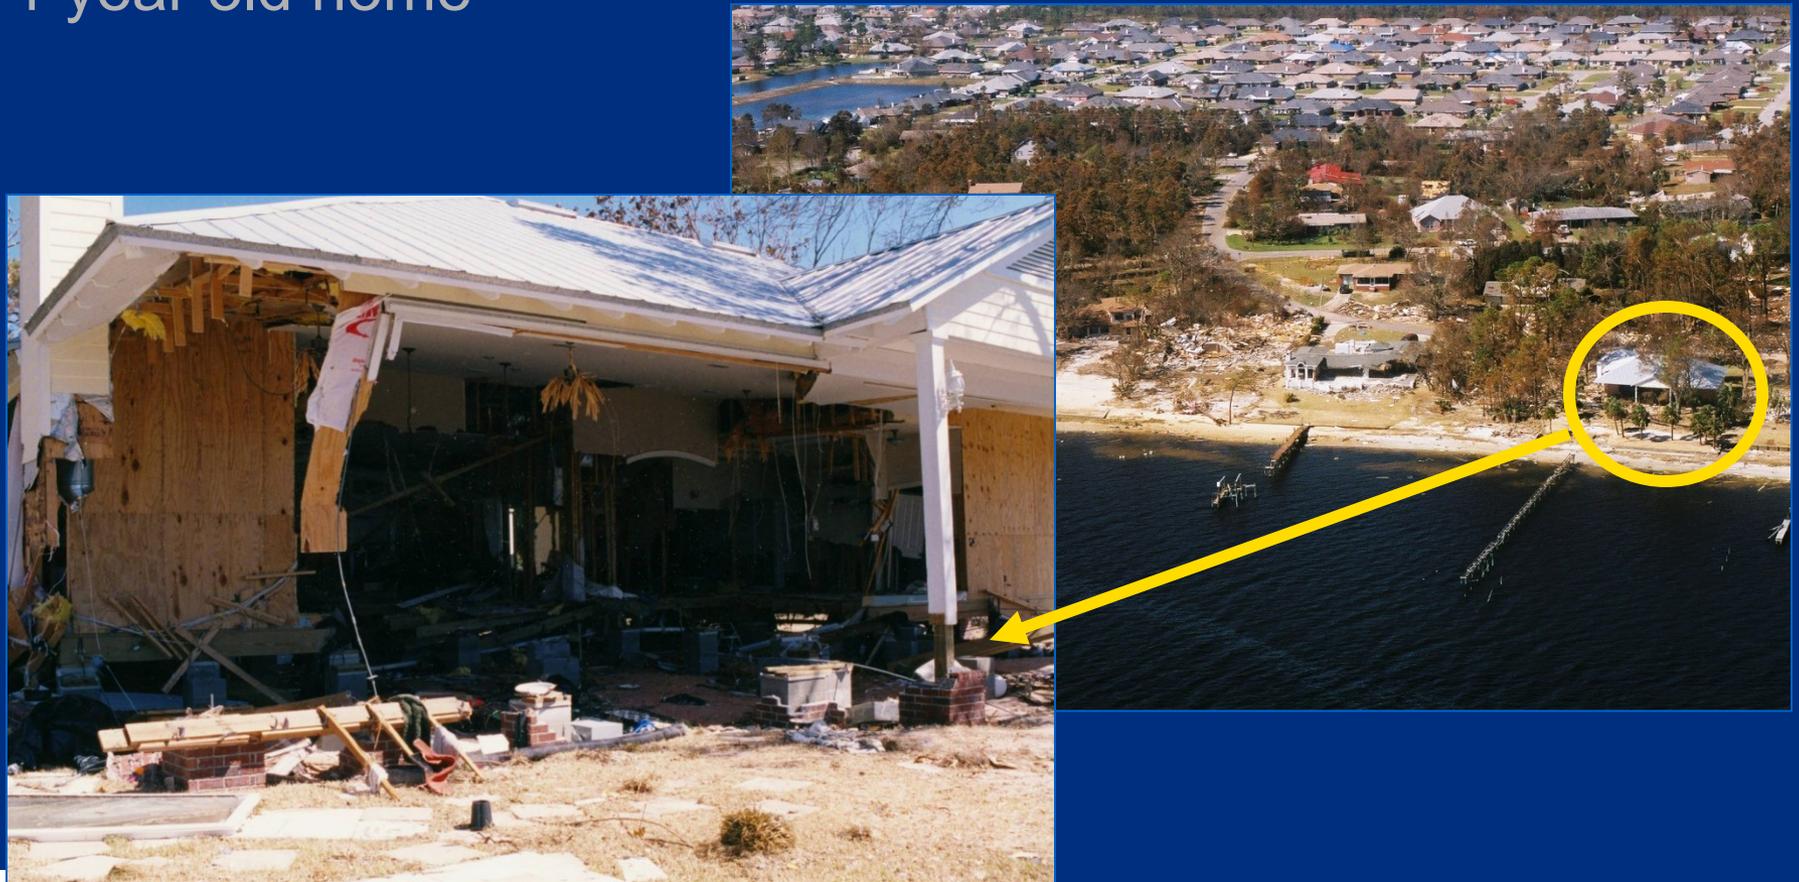
Flood-borne debris damage  
1 year old home

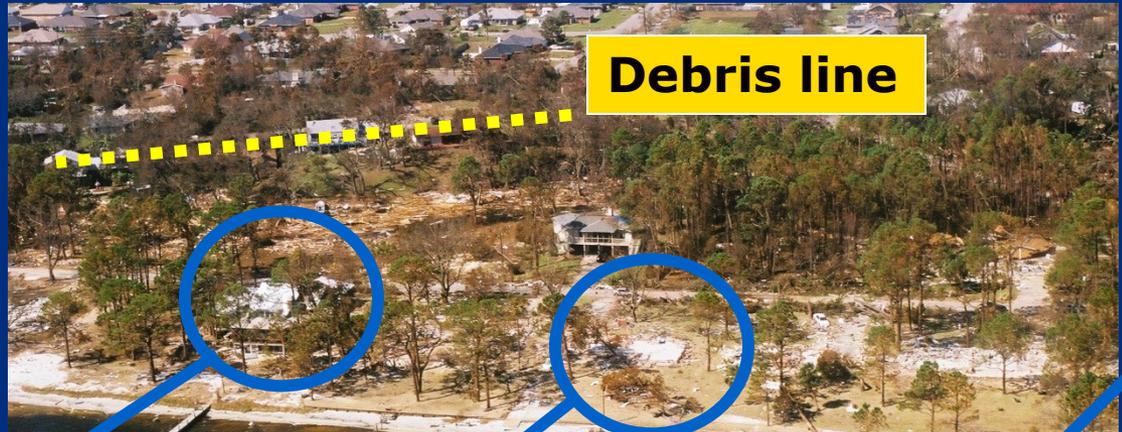
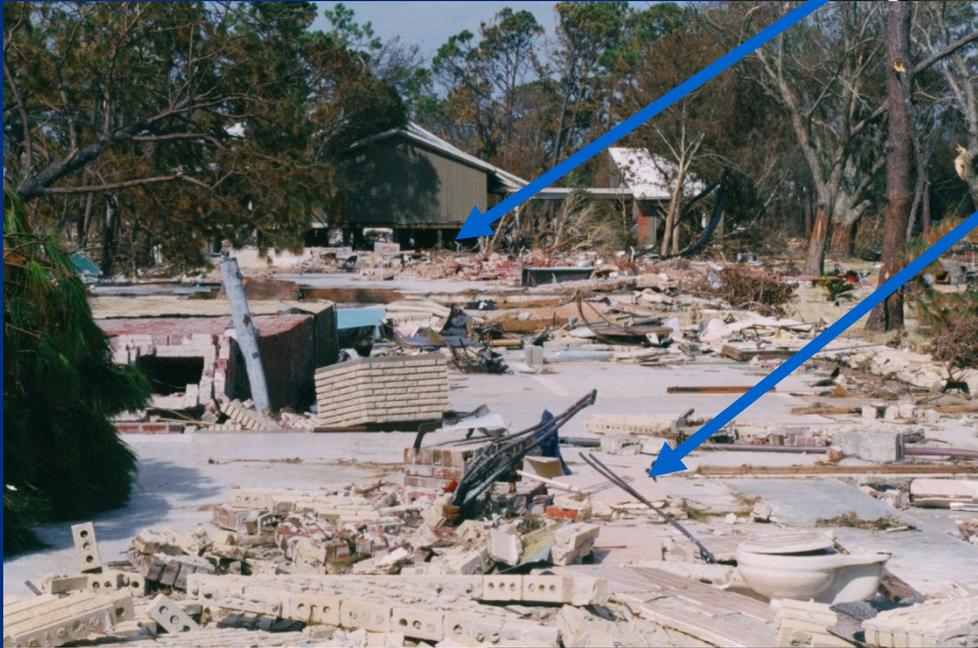
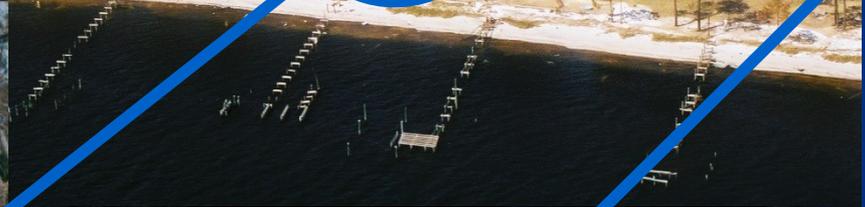
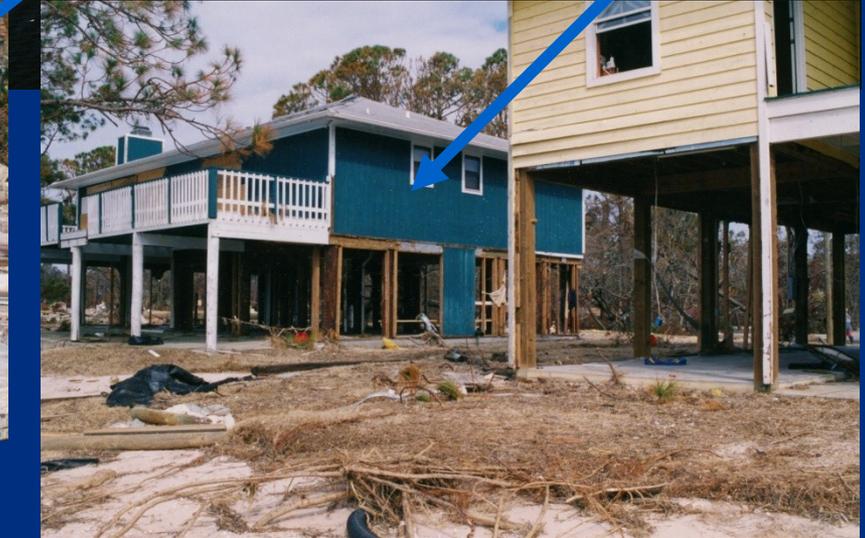
Flood-borne debris damage

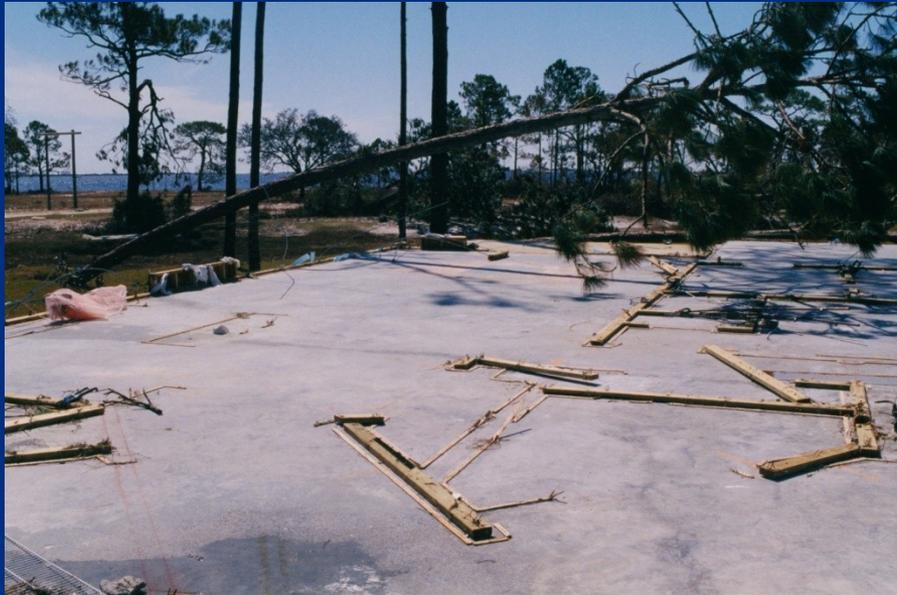
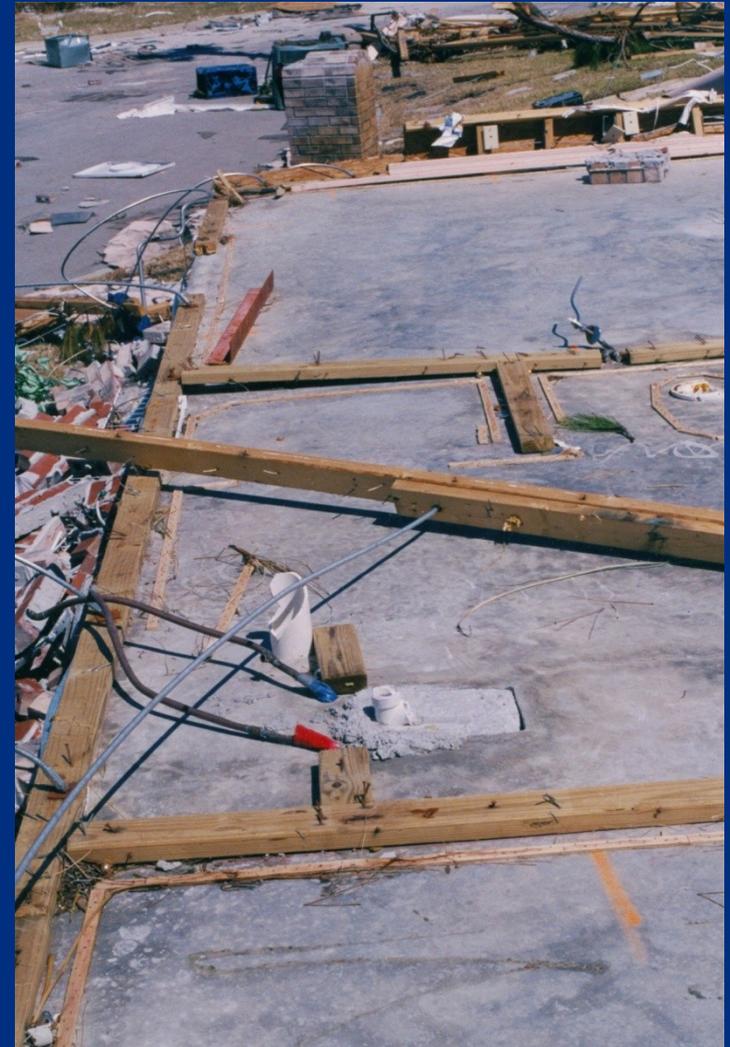
Flood-borne debris damage

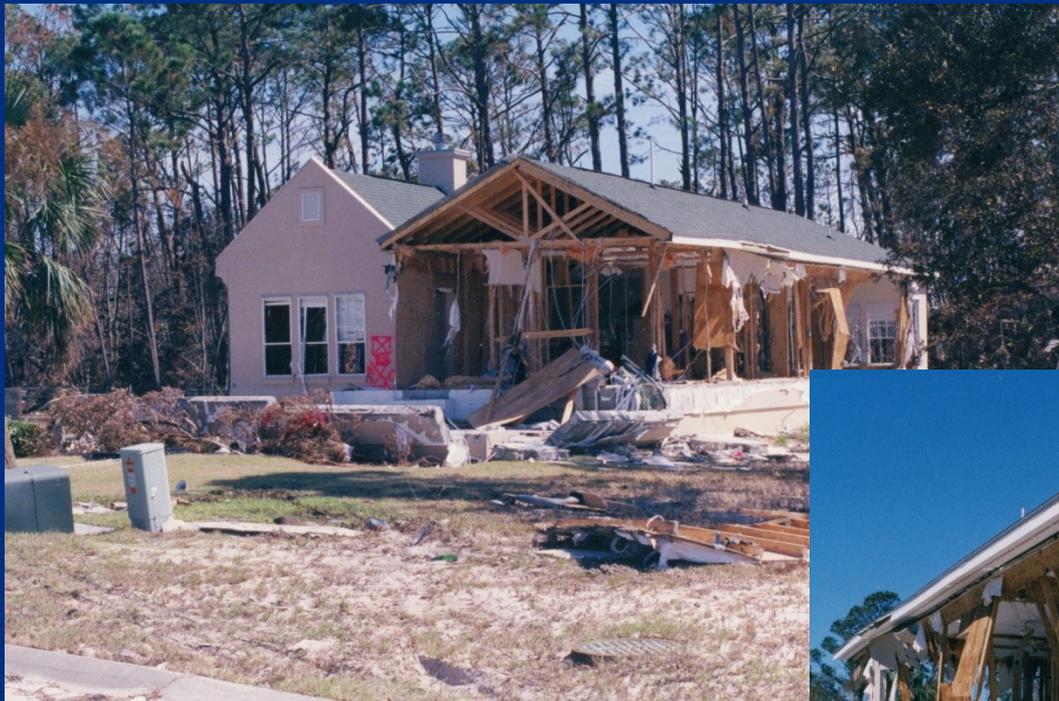
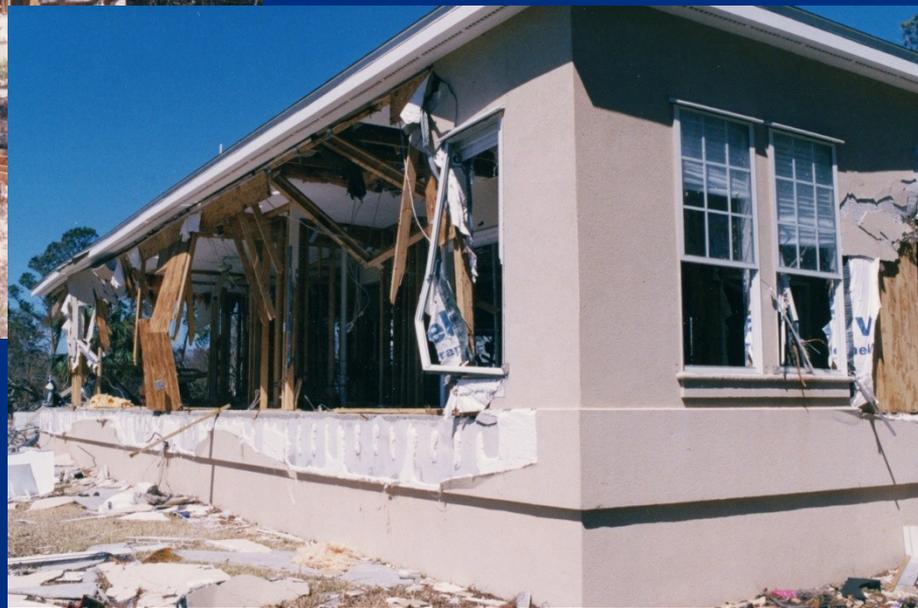
Flood-borne debris damage

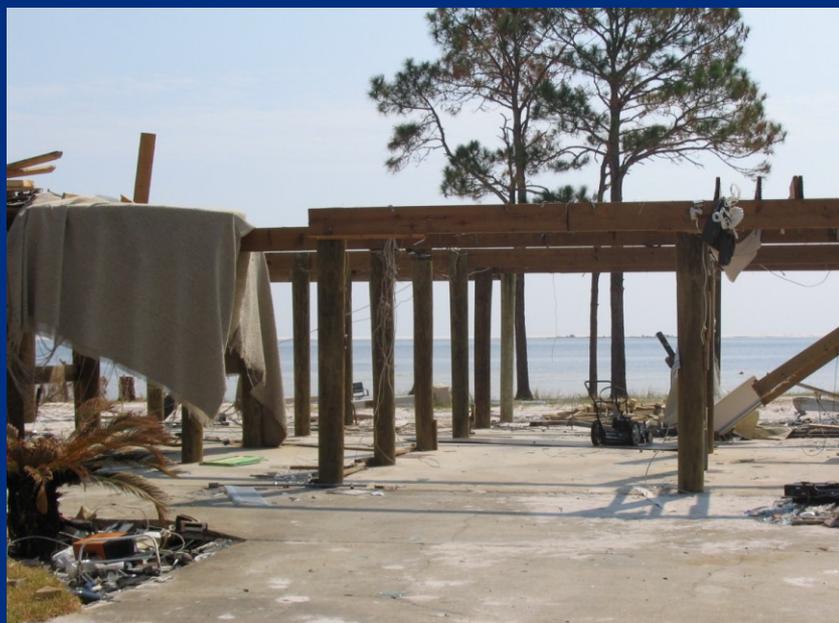
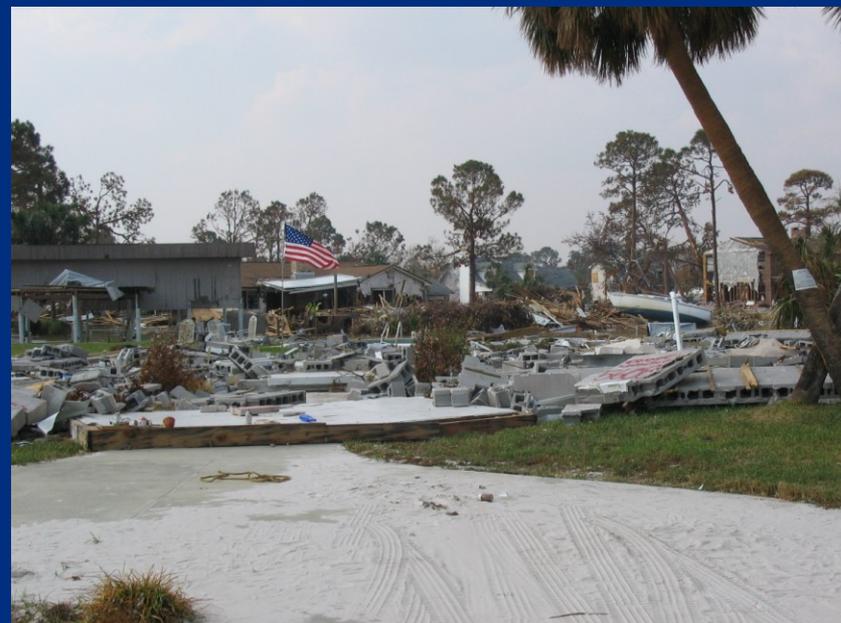
Flood-borne debris damage – Grand Lagoon Neighborhood  
4 fatalities in neighborhood
