# FEMA Mitigation Assessment Team Report on Hurricane Ivan

Bill Coulbourne, P.E.

June 2, 2005

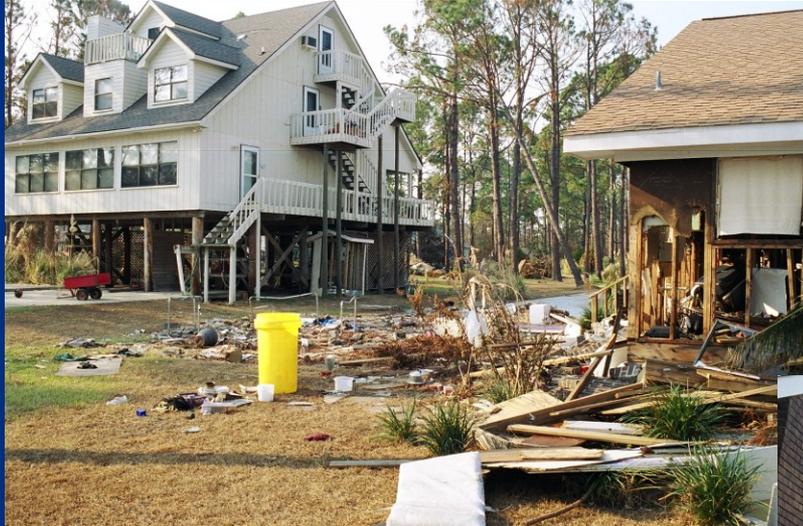
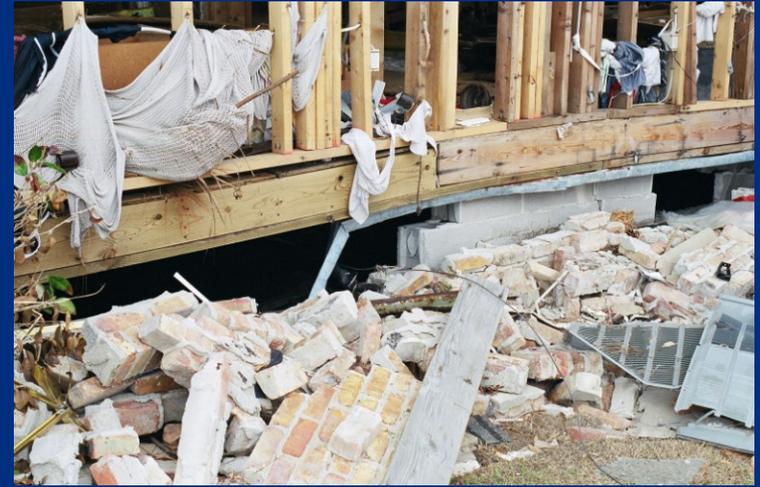
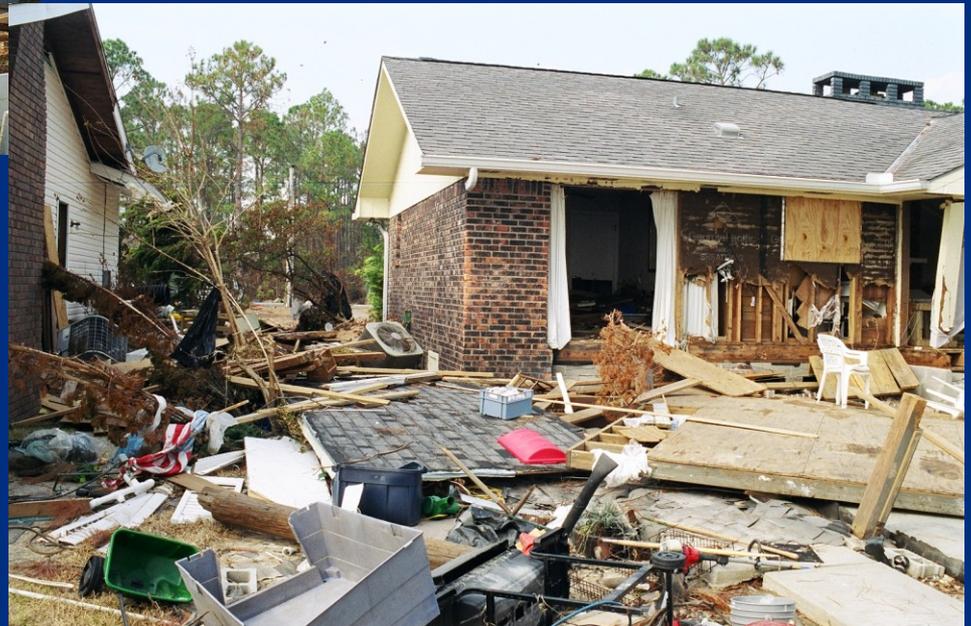
Flood-borne debris damage
