Mitigation Assessment Team Report

Hurricane Isaac in Louisiana

Building Performance Observations,
Recommendations, and Technical Guidance

FEMA P-938 / March 2013

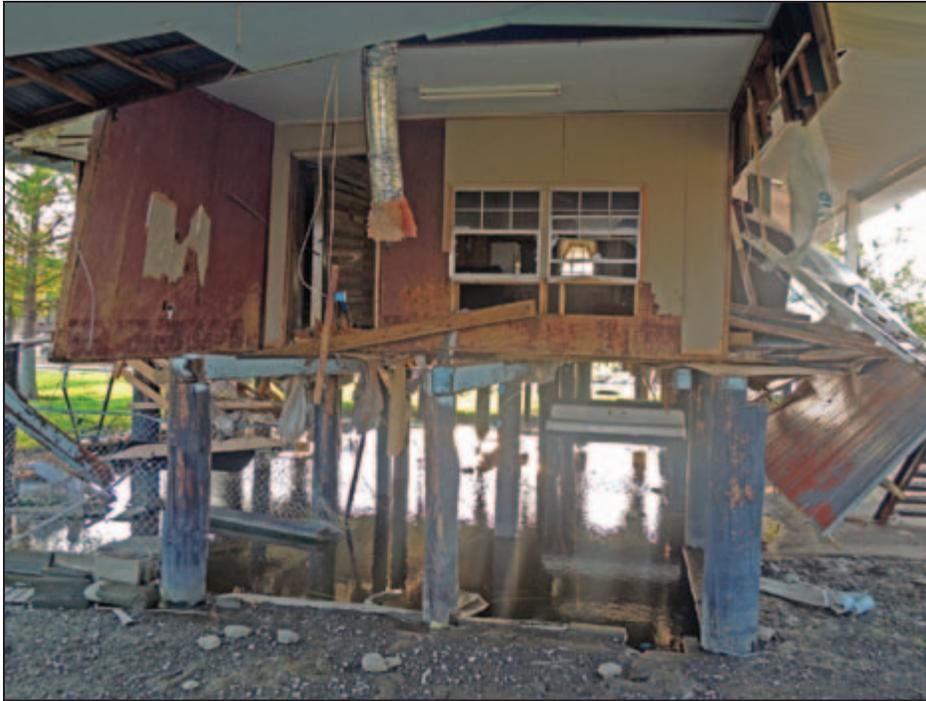
Figure 3-1:
Wave and surge damage to a residential building. The house is located in Zone V along Lake Pontchartrain's western shoreline (Saint John the Baptist Parish, LA).

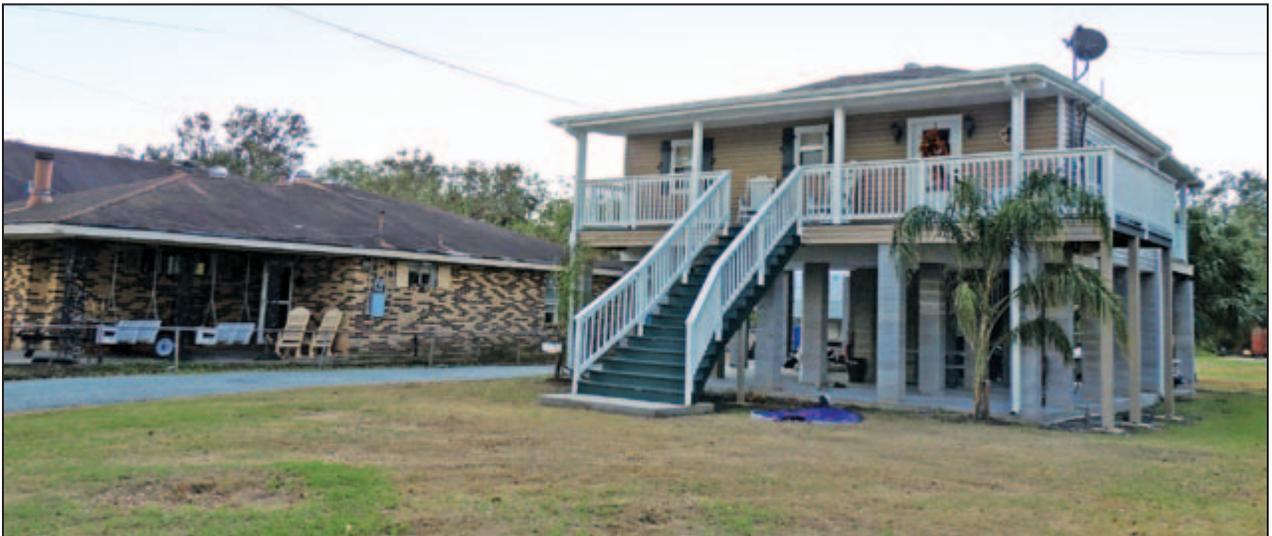
Figure 3-2: Damage was observed in most at-grade slab foundation residences, while minimal damage was observed in adjacent elevated properties (Barataria, LA).

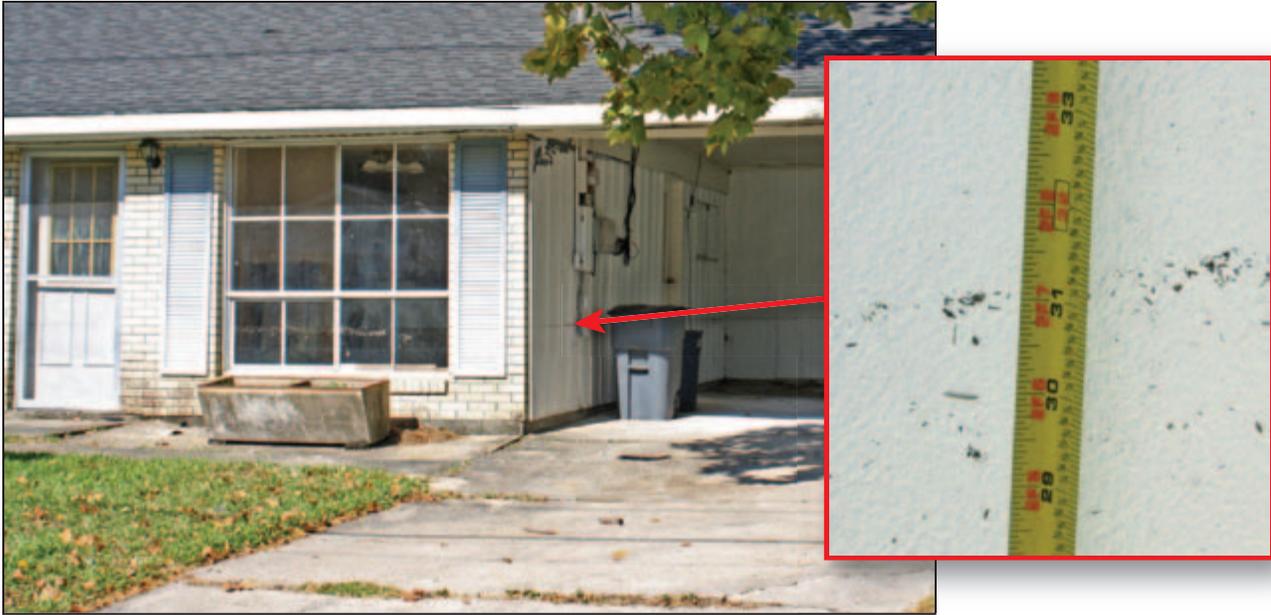
Figure 3-3: Typical flood depth of at-grade slab foundation residences; inset illustrates flood depth of 31 inches above the at-grade slab foundation (Slidell, LA).

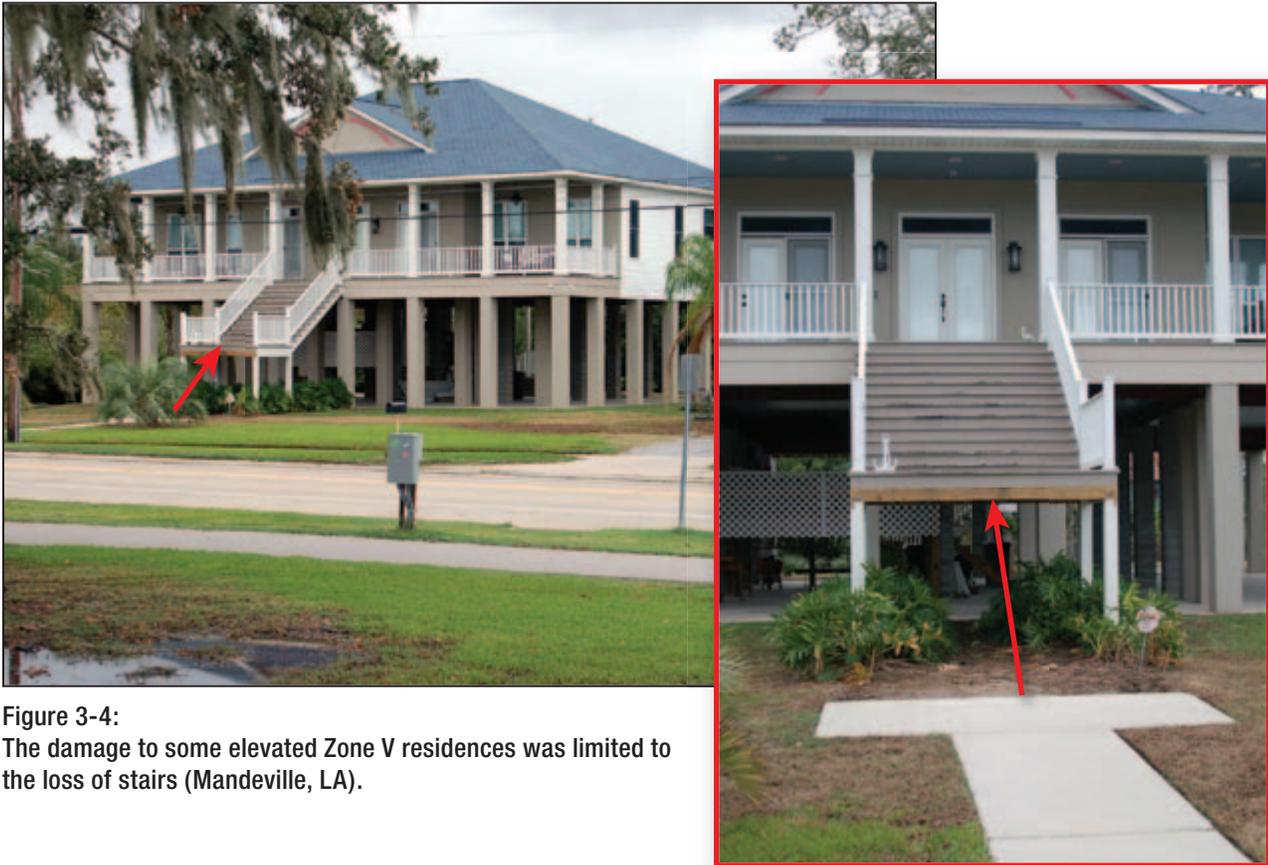
Figure 3-4: The damage to some elevated Zone V residences was limited to the loss of stairs (Mandeville, LA).

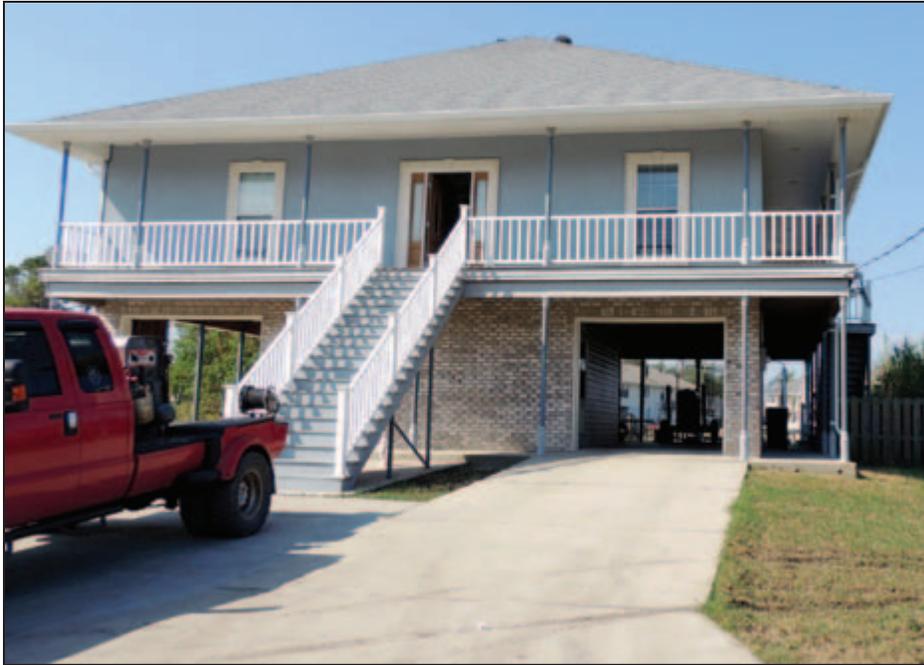
Figure 3-5:
Minimal damage was observed in most elevated residences. The USGS HWM near this location was 9.74 feet, compared to an effective BFE of Zone A14 (EL12), Katrina ABFE of Zone AE (EL13), and preliminary FIRM of Zone VE (EL16) (Orleans Parish, LA).

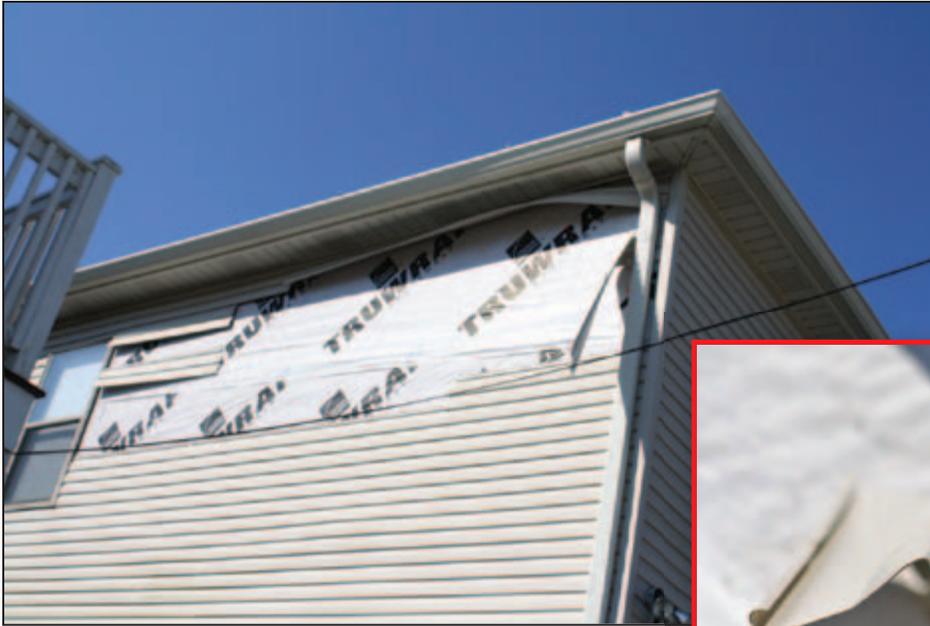
Figure 3-6: Loss of standard vinyl siding to recently elevated residential building; use and/or damage of high-wind siding was not observed by the MAT (Plaquemines Parish, LA).

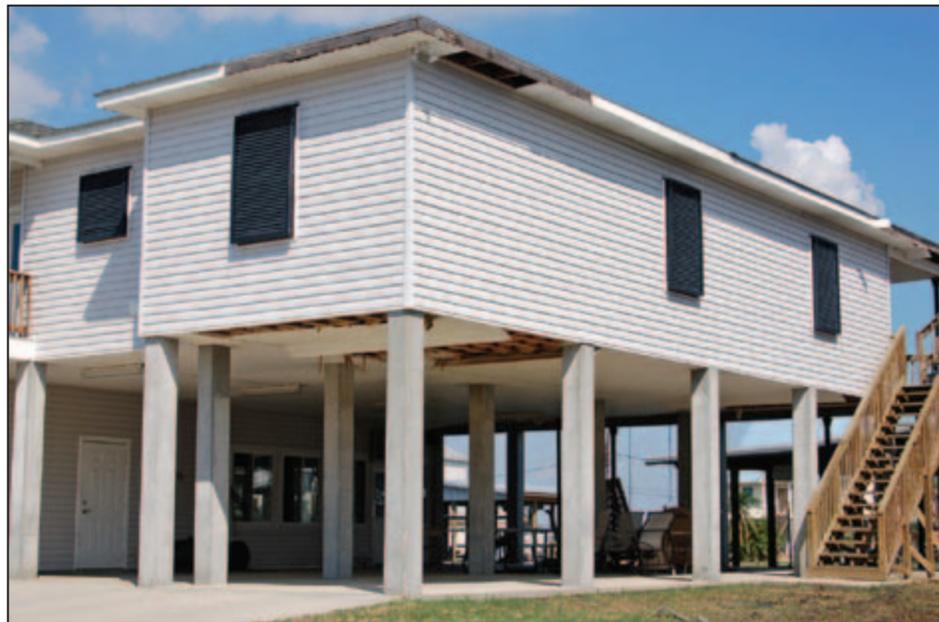
Figure 3-7:
Roof soffit and fascia
damage to Exposure
C residential building
(Plaquemines Parish, LA).

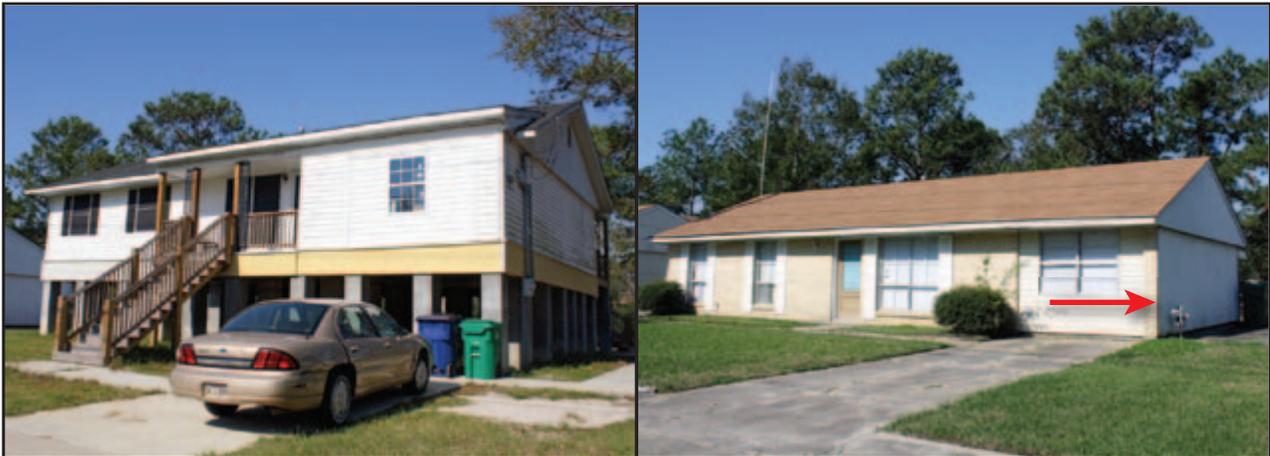
Figure 3-9: Neighboring residential buildings; the elevated residence had no observed damage, while the non-elevated home had significant interior damage caused by more than 2 feet of flooding (red arrow indicates flood depth) (Slidell, LA).

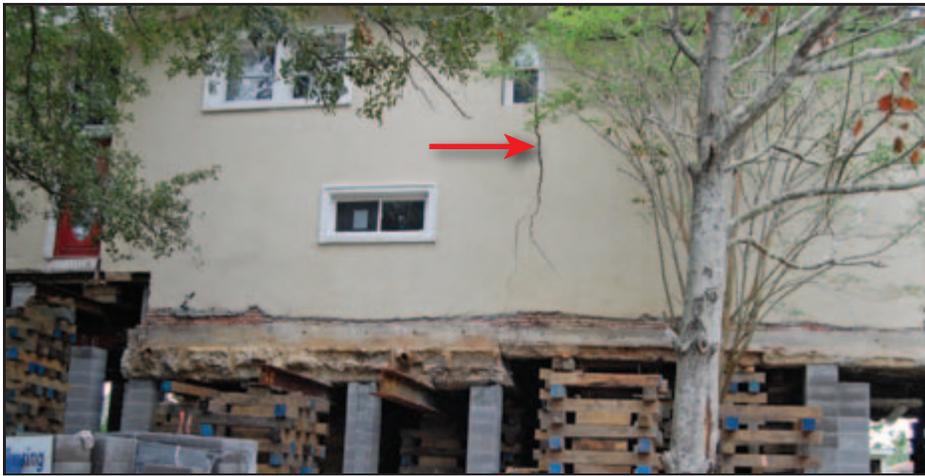
Figure 3-11:
Slab-on-grade elevation
with structural cracks due to
differential lifting
(Slidell, LA).

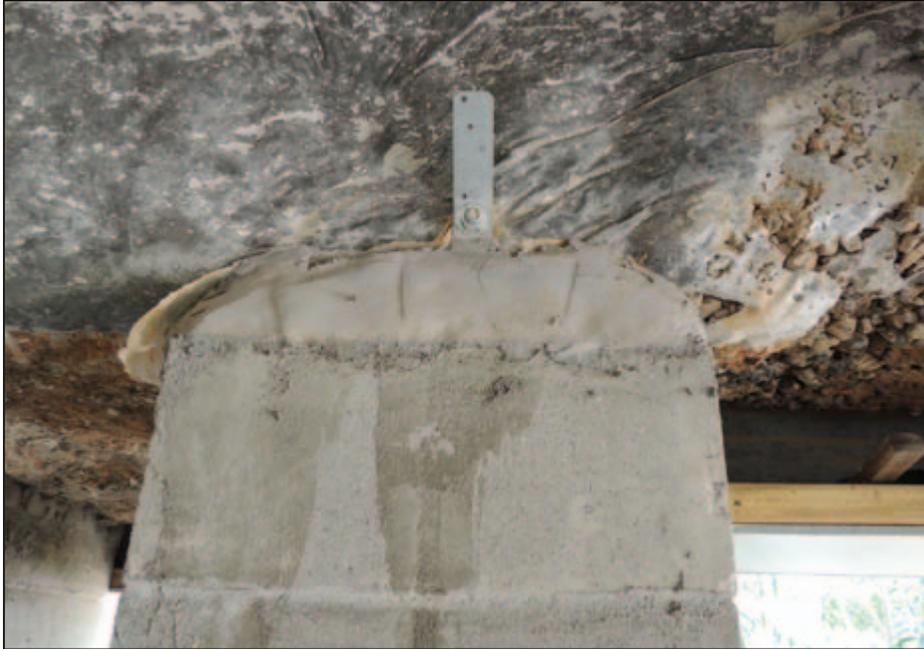
- **Lack of pier-to-slab connections:** Different types of elevated foundation-to-floor framing connections were observed, including bolted connections for pile foundations and grouted connections for pier foundations. However, elevated slabs were often observed to have no visible connection to their piers. Where connections were observed, they appeared to be structurally insufficient, as shown in Figure 3-14.

Figure 3-14: Structurally insufficient connection to pier. This house had a total of 7 such connections out of 17 piers supporting the structure (Mandeville, LA).

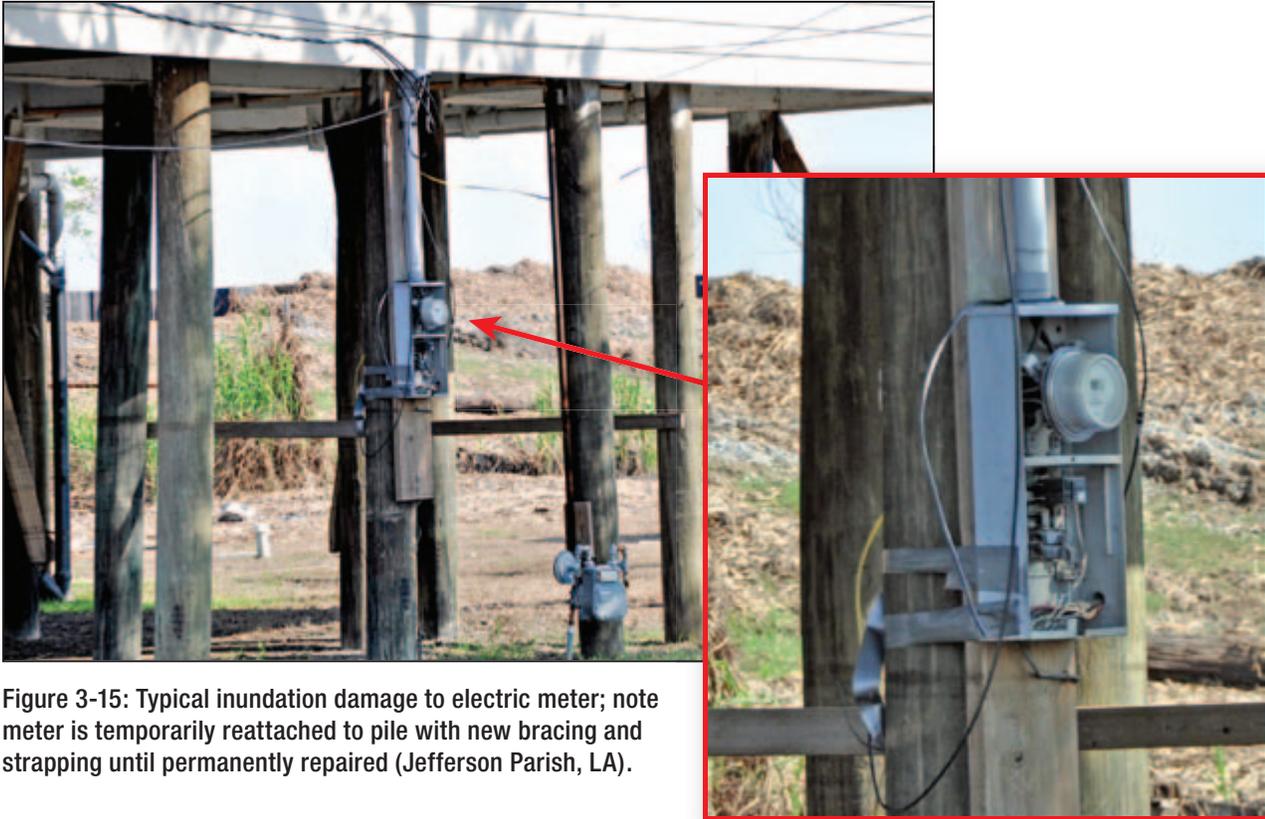
Figure 3-15: Typical inundation damage to electric meter; note meter is temporarily reattached to pile with new bracing and strapping until permanently repaired (Jefferson Parish, LA).

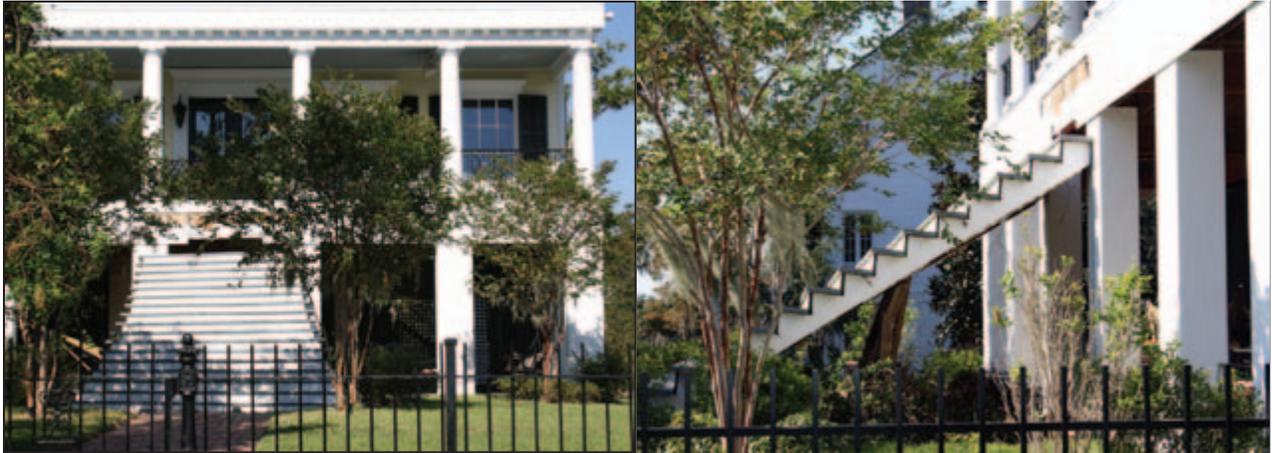
Figure 3-20: Front and side view of stair damage to elevated waterfront residential building due to closed riser, inadequate foot anchoring, and insufficient connection with the building frame (Mandeville, LA).

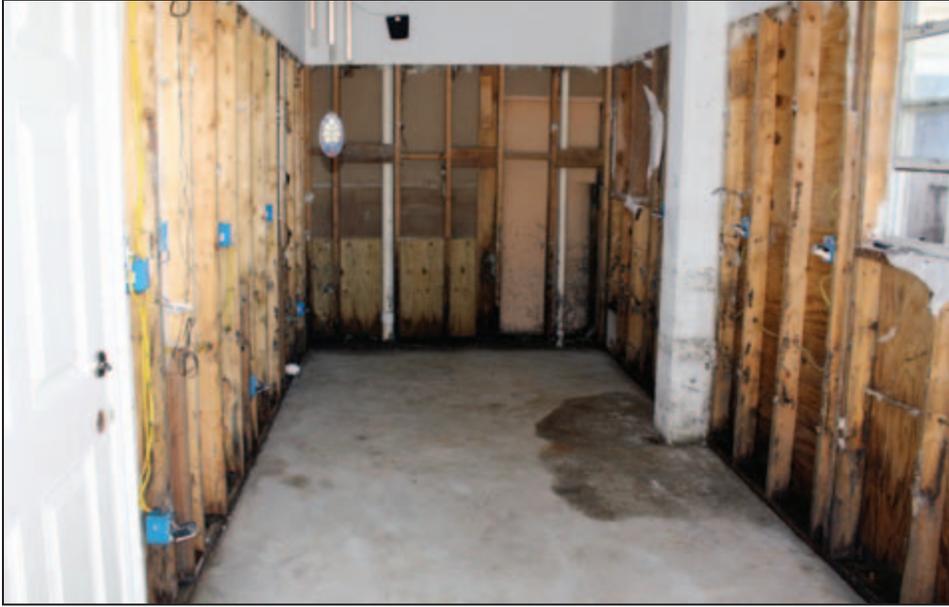
Figure 3-23:
Enclosed area that was not finished with flood-resistant materials, nor did it have flood openings (Plaquemines Parish, LA).

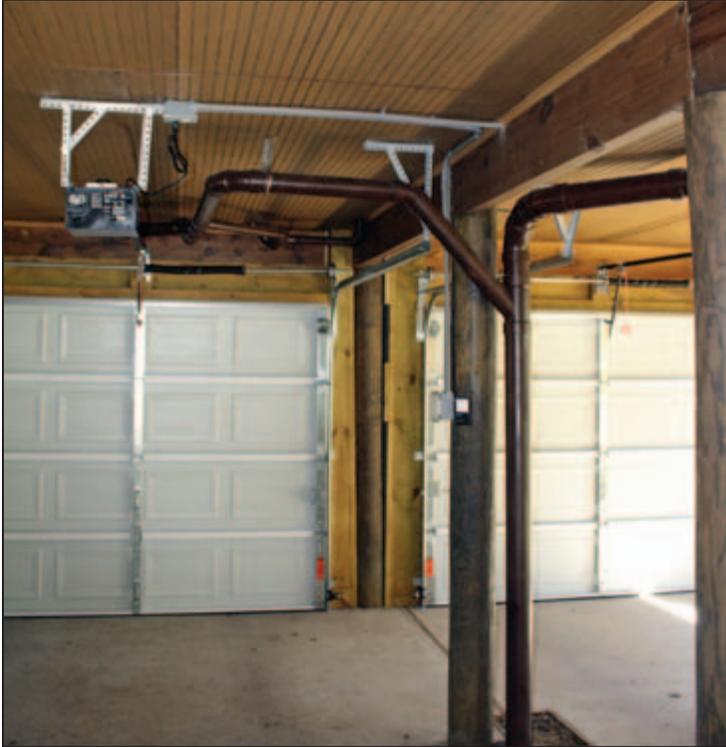
Figure 3-25:
Elevated house with combustibile materials and vehicle parking below elevated space (Mandeville, LA).

- + **Fire separation and flood damage-resistant materials.** For elevated buildings on open foundations with enclosed parking underneath, introduce fire separation on the exposed underside of the building. Fire separation should meet the guidelines of the 2012 International Residential Code Table R302.6 for habitable rooms above a garage, which requires not less than 5/8-inch Type X gypsum board or equivalent. Considerations should be made to ensure that this material is also flood damage resistant.

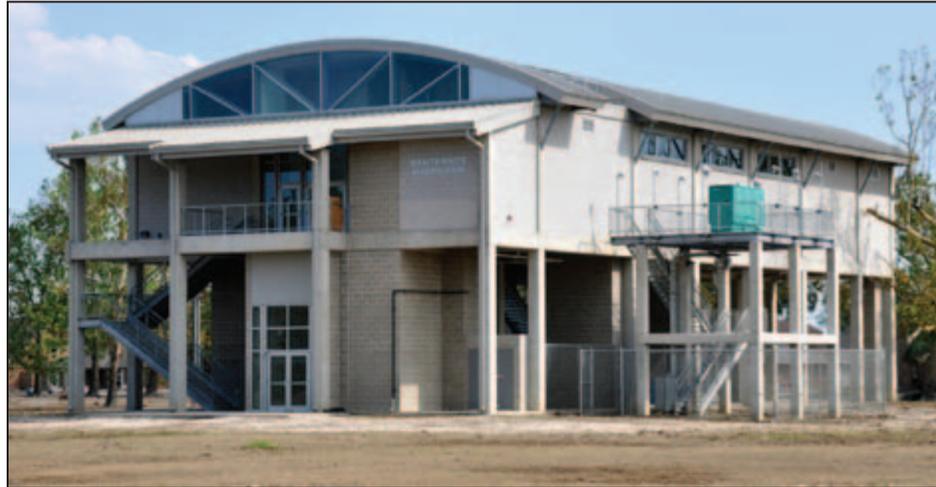
Figure 4-2:
HWM visible on glass at entrance to elevators below lowest floor of Braithwaite Auditorium (Braithwaite Park [East Bank] – Plaquemines Parish, LA).

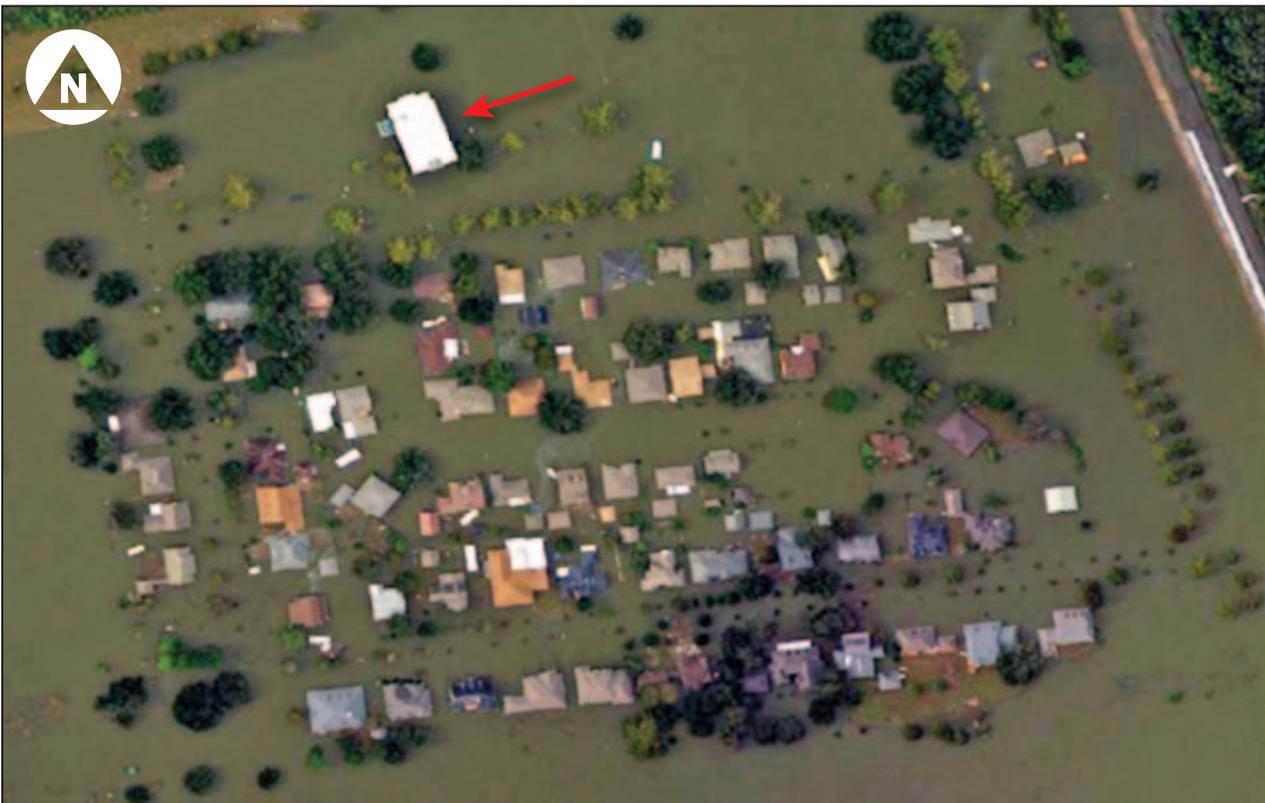
Figure 4-5: Residences in the Braithwaite Park subdivision were inundated with more than 8 feet of water; the auditorium (red arrow) is at the north end of the subdivision (Braithwaite Park [East Bank] – Plaquemines Parish, LA).

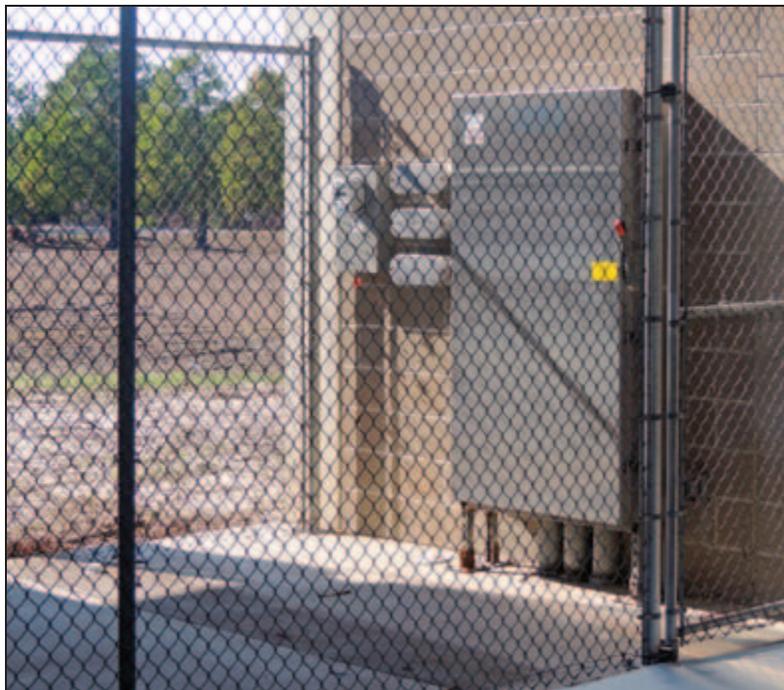
Figure 4-6:
The Braithwaite Auditorium generator transfer switch and other electrical components were built at grade and damaged by floodwaters (Braithwaite Park [East Bank] – Plaquemines Parish, LA).

- + **Siting of critical facilities, community centers, and schools.** Site new and replacement community centers, critical facilities, and schools outside the 500-year floodplain where possible; where not possible, elevate the critical facilities and all utility equipment above the 500-year elevation or the best available BFE information.
- + **Infrastructure.** Where possible, site electrical substations, pump stations, and cellular towers outside the 500-year floodplain; where not possible, elevate facilities and electrical equipment above the 500-year elevation.

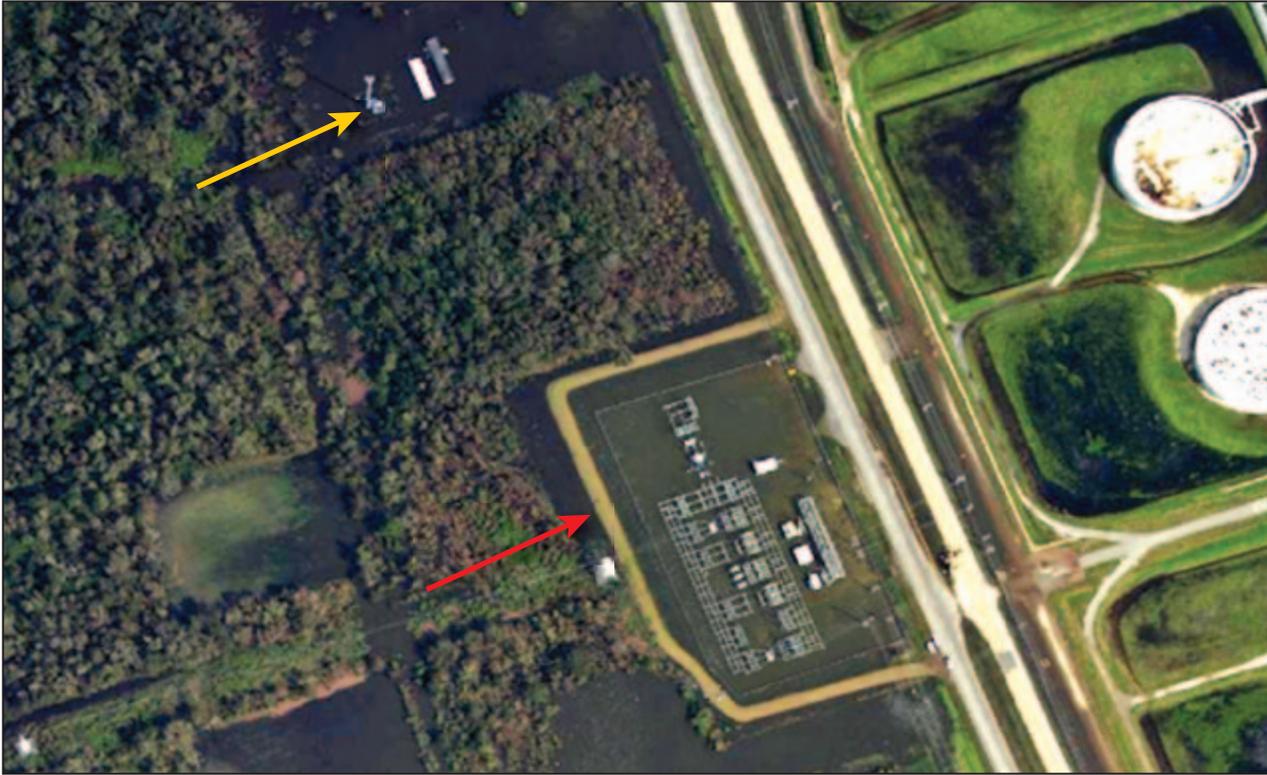
Figure 4-17: The protective berm (red arrow) was overtopped, resulting in damage to the substation; note cellular tower (yellow arrow) northwest of the substation (Belle Chase [West Bank] – Plaquemines Parish, LA).

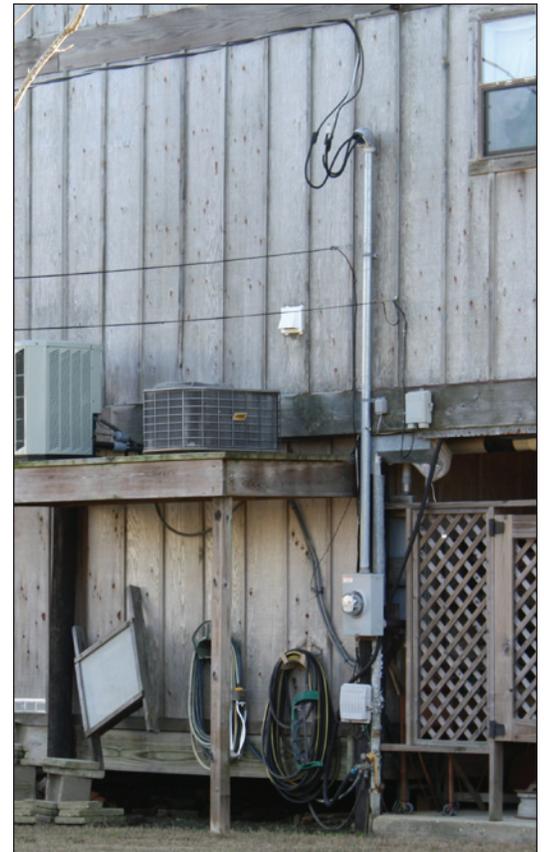
Figure 1. Electrical components installed below the lowest floor system are subject to increased flood damages and lengthy outage durations (St. Tammany Parish, LA)
