HURRICANE ISAAC IN LOUISIANA

4 Nonresidential Construction and Infrastructure

4.1 Community Centers

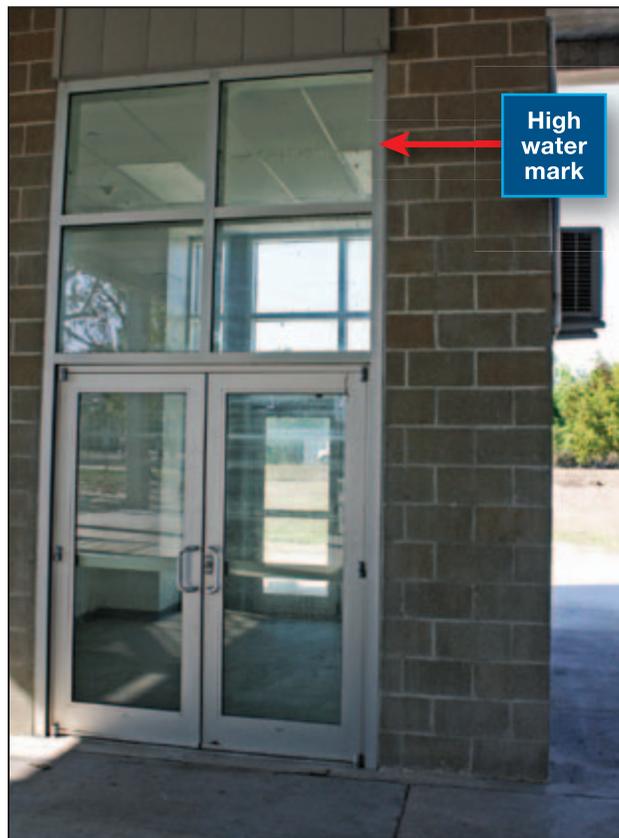
Figure 4-2:
HWM visible on glass at entrance to elevators below lowest floor of Braithwaite Auditorium (Braithwaite Park [East Bank] – Plaquemines Parish, LA).

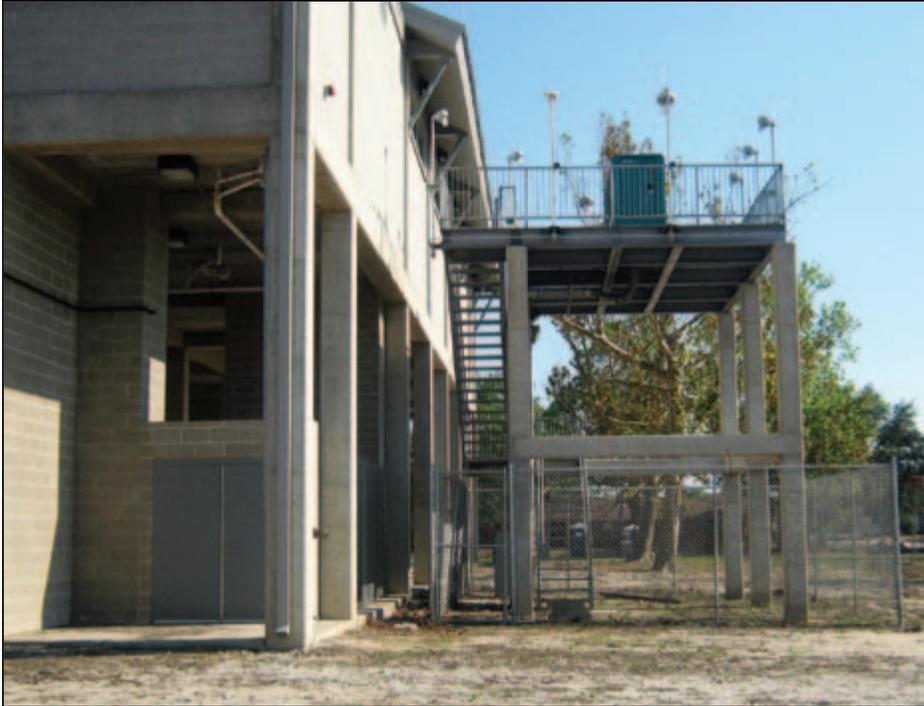
equipment were elevated to the same height as the structure. The building has an elevator for handicap access as well as a generator for emergency power (see Figure 4-3); the automatic transfer switch and other electrical service components for this equipment were both damaged by Hurricane Isaac. No damage was observed inside the auditorium (see Figure 4-4).

Figure 4-3:
The Braithwaite Auditorium has an elevated generator for emergency power (Braithwaite Park [East Bank] – Plaquemines Parish, LA).

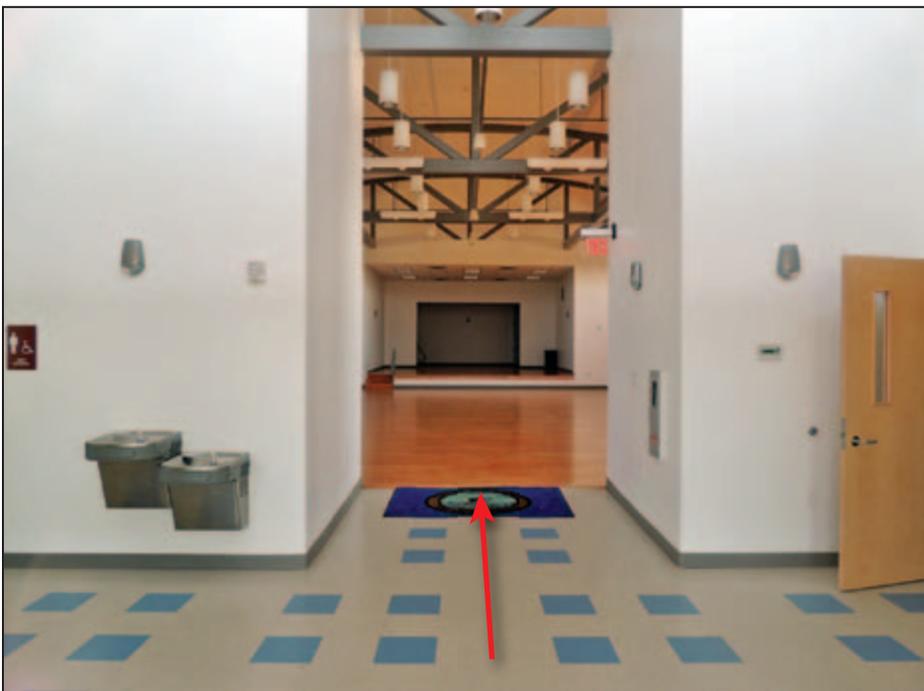
Figure 4-4:
No damage was observed in the auditorium (Braithwaite Park [East Bank] – Plaquemines Parish, LA).

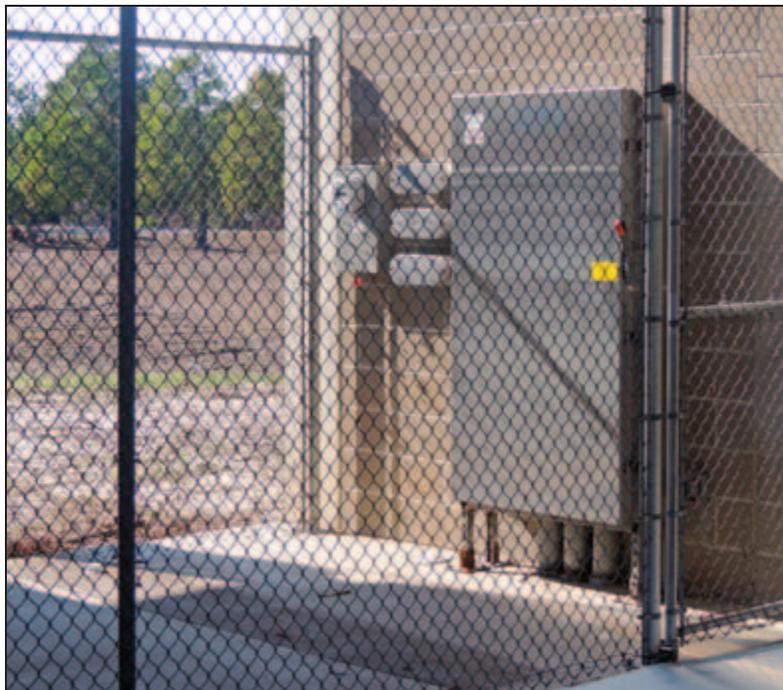
Figure 4-6:
The Braithwaite Auditorium generator transfer switch and other electrical components were built at grade and damaged by floodwaters (Braithwaite Park [East Bank] – Plaquemines Parish, LA).

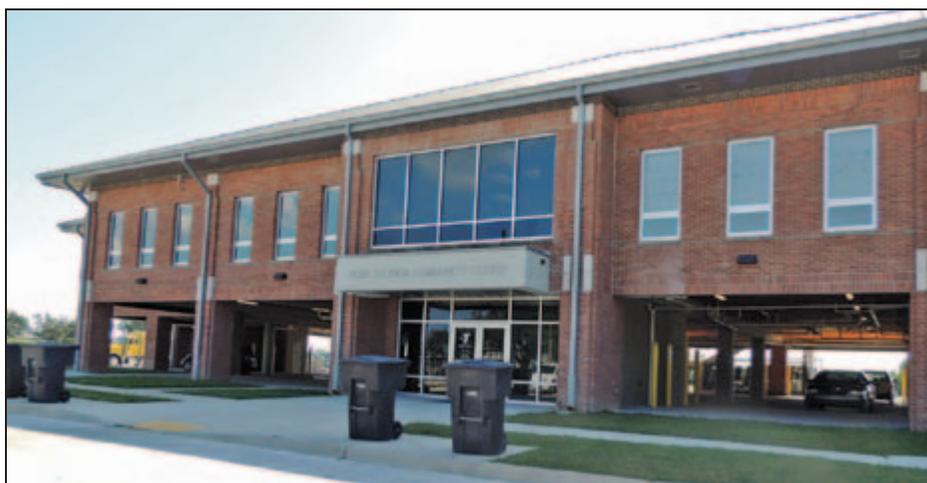
Figure 4-7:
Recently constructed Port Sulphur Community Center; no damage was observed or reported for the elevated facility (Port Sulphur [West Bank] – Plaquemines Parish, LA).

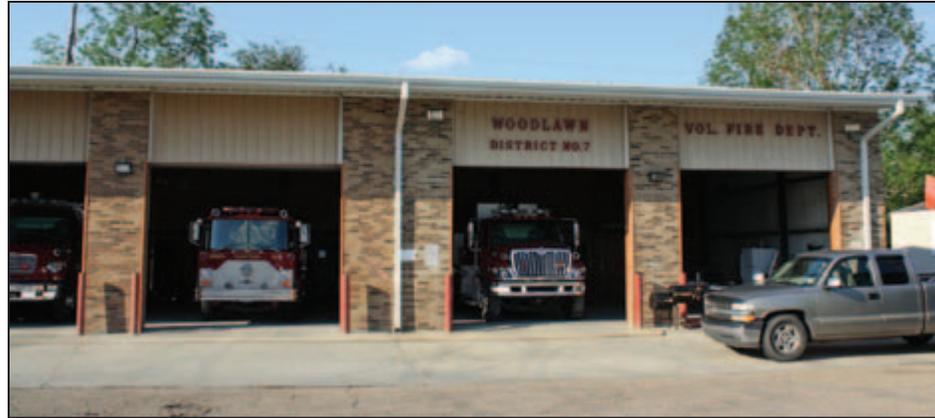
The MAT observed the Woodlawn Fire Station in Plaquemines Parish (Figure 4-8). The Woodlawn Fire Station was built on the site of an abandoned high school. The fire station bay is a pre-engineered metal building with a metal roof and walls and brick façade. The fire station has four apparatus bays but housed 10 emergency vehicles prior to the hurricane. Firefighters serving the Woodlawn Fire Station said that the site of the station was selected because “it has never been flooded before.” Although the MAT did not observe visible structural damage, the station did receive flooding of approximately 8 feet.

Figure 4-8:
Woodlawn Fire Station
(Woodlawn [East Bank] –
Plaquemines Parish, LA).

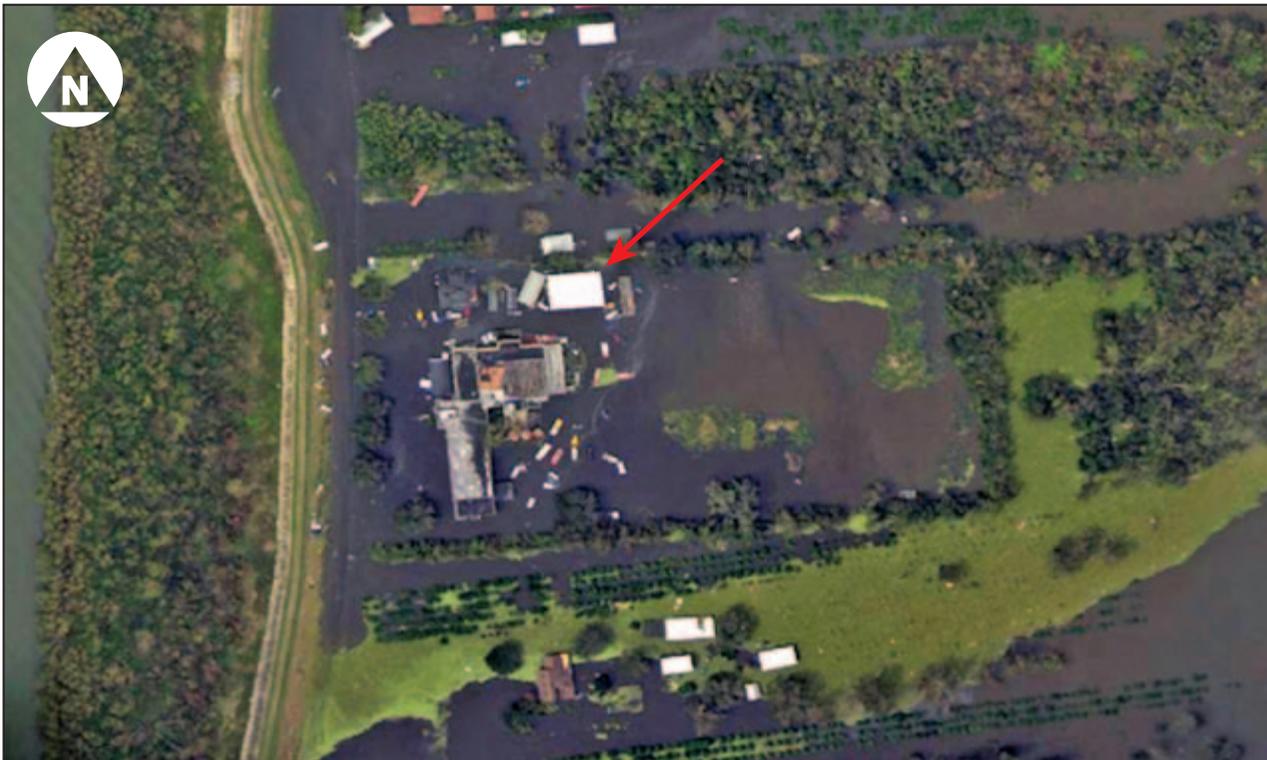
Figure 4-9: Post-Hurricane Isaac aerial of Woodlawn Fire Station (Woodlawn [East Bank] – Plaquemines Parish, LA).
AERIAL COURTESY OF NOAA; GENERATED FROM HURRICANE ISAAC RESPONSE IMAGERY VIEWER AT [HTTP://STORMS.NGS.NOAA.GOV/STORMS/ISAAC/](http://storms.ngs.noaa.gov/storms/isaac/).

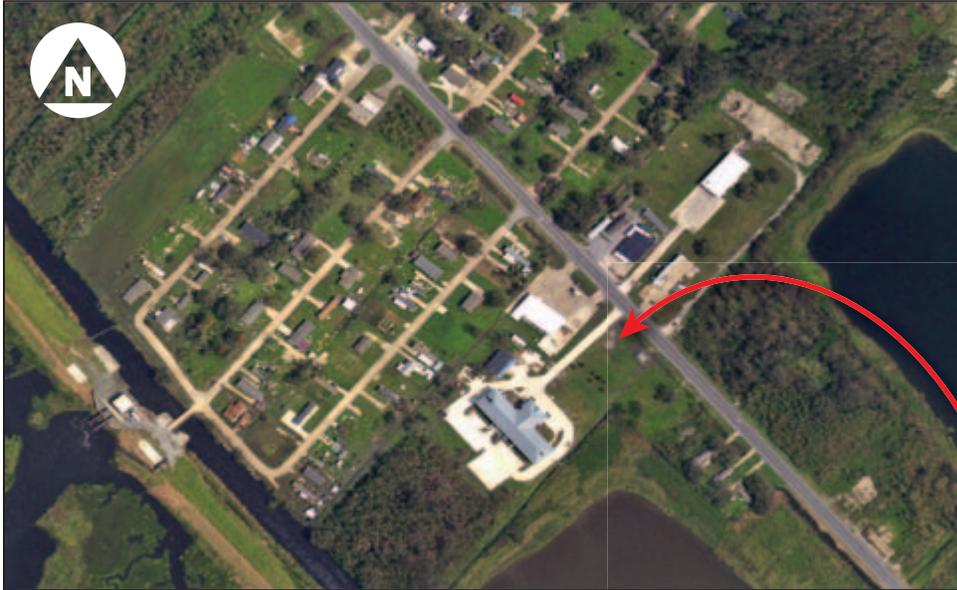
Figure 4-10:
The recently completed Parish Learning Center was constructed approximately 10 feet above grade (Port Sulphur [West Bank] – Plaquemines Parish, LA).

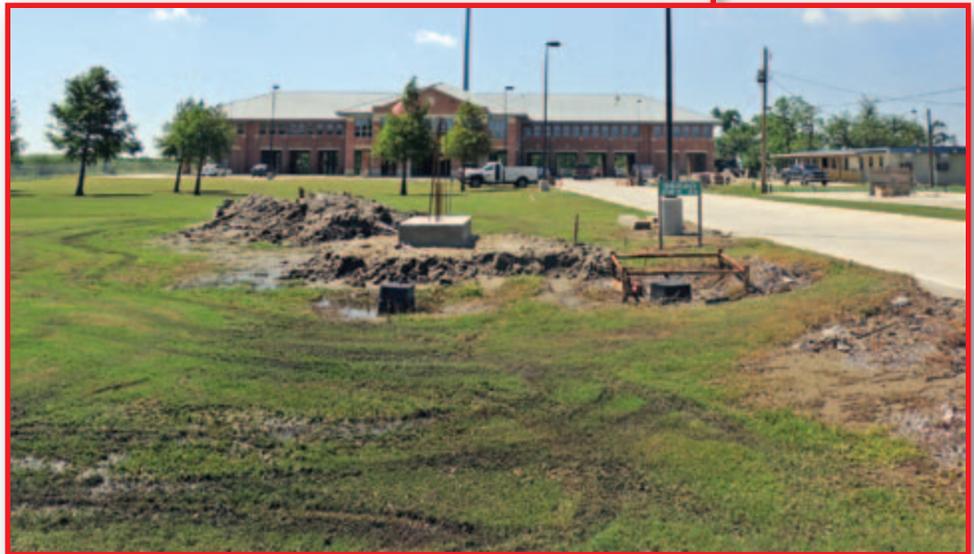
Figure 4-11:
South Plaquemines High School under construction;
the preliminary BFE at this site is Zone VE (EL 15)
(Boothville [West Bank] –
Plaquemines Parish, LA).

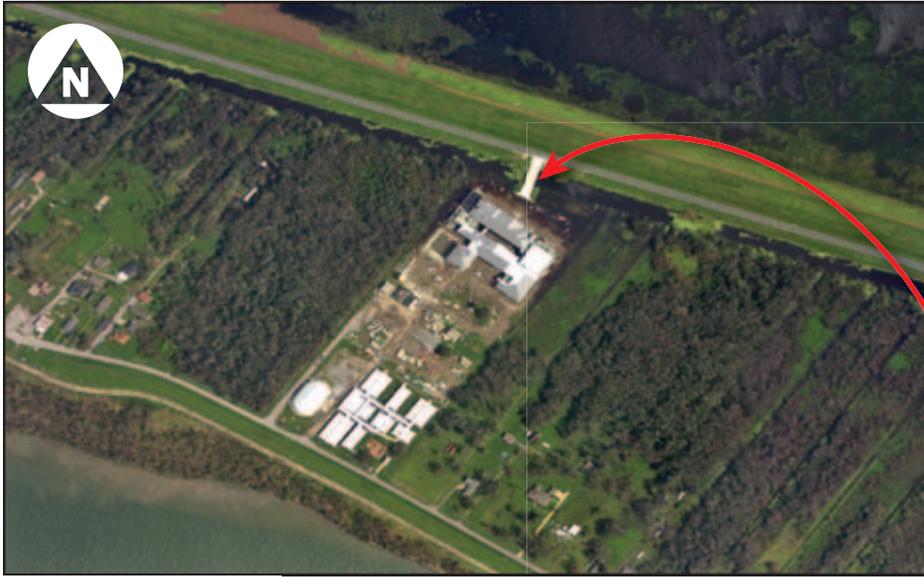
Figure 4-12:
The Phoenix Pre-K-12
School under construction;
the preliminary BFE at this
site is Zone AE (EL 17)
(Phoenix [East Bank] –
Plaquemines Parish, LA).

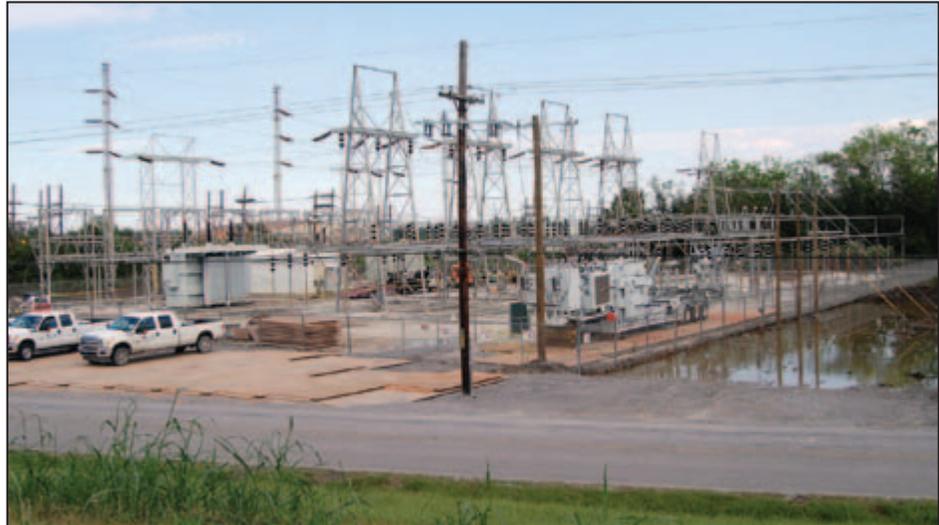
The MAT visited three substations in Plaquemines Parish, as well as various pump stations and cellular towers, throughout areas impacted by Hurricane Isaac. The three substations were inundated by floodwater, and the damage forced the utility companies to de-energize them. In two of the three substations, utility companies used temporary trailer-mounted substations to energize downstream electrical distribution lines while repairs were made (see Figure 4-13).

Figure 4-13:
Electrical repairs being completed after substation equipment was inundated by floodwaters (Braithwaite [East Bank] – Plaquemines Parish, LA).

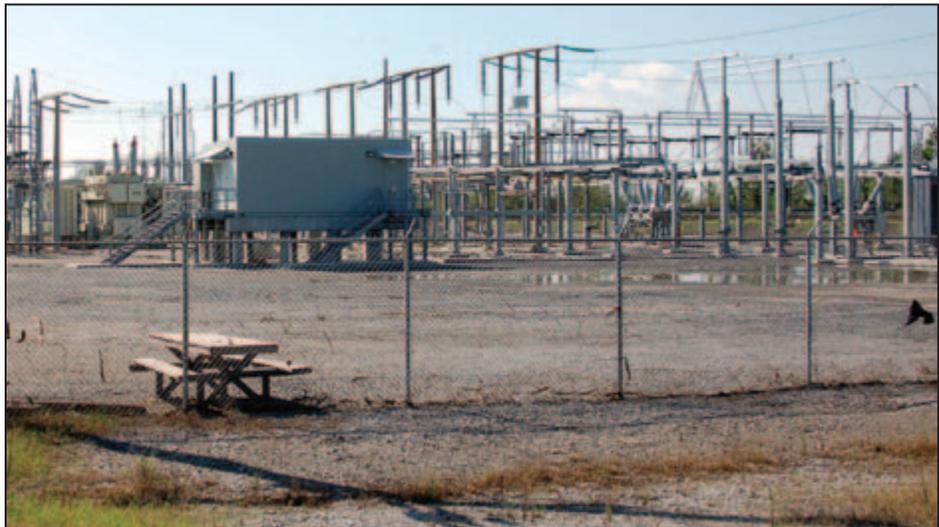
In two of the substations, most electrical equipment was placed at or near grade, and the placement offered little protection from floods. In the third substation, some flood protection was evident. In that substation, several pieces of electrical equipment were elevated on steel frames, some several feet above grade (Figure 4-14). Also, a protective berm was constructed around the perimeter of that

Figure 4-14:
Substation equipment elevated several feet above grade (Belle Chase [West Bank] – Plaquemines Parish, LA).

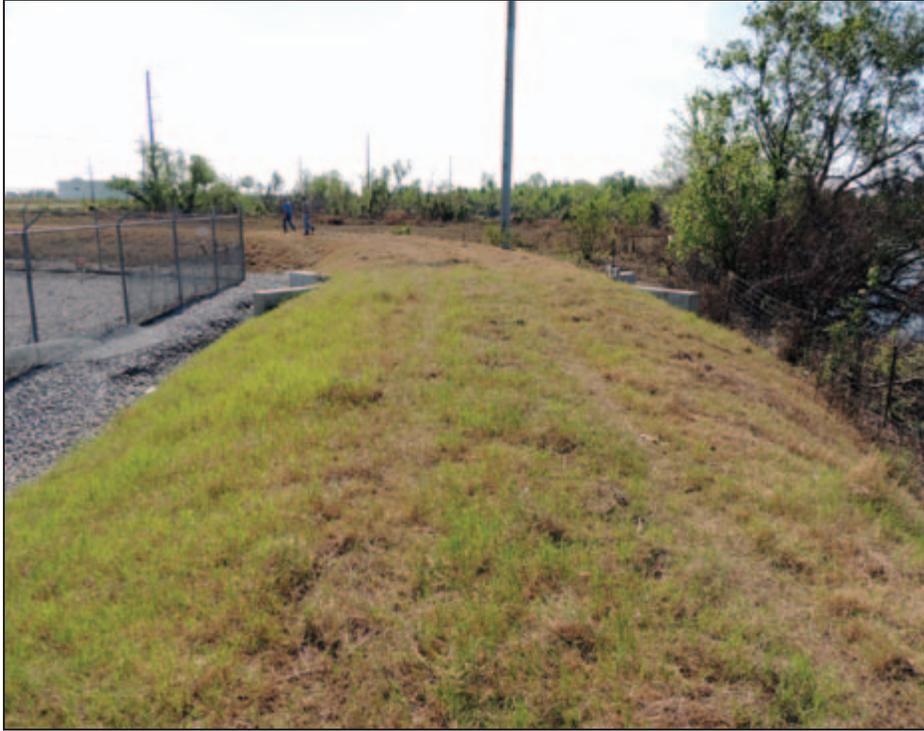
substation. The berm was reportedly constructed after the substation flooded during Hurricane Katrina. During Hurricane Isaac, the berm was overtopped and the substation was inundated (see Figures 4-15 through 4-17).

Figure 4-15:
A berm was constructed around the perimeter of this substation to protect it after Hurricane Katrina (Belle Chase [West Bank] – Plaquemines Parish, LA).

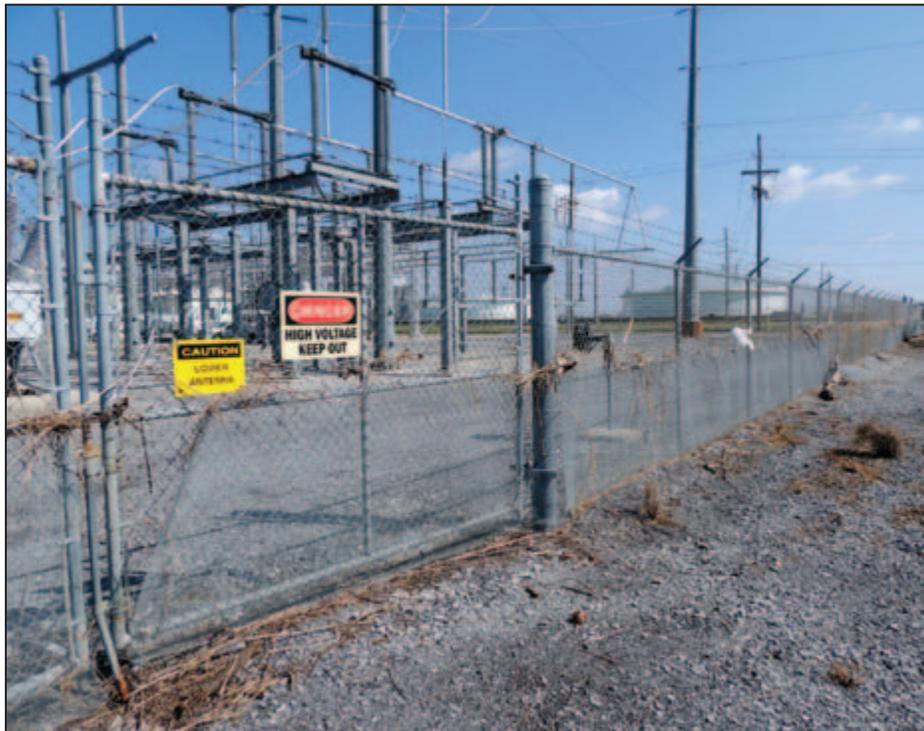
Figure 4-16:
Flood inundation depths were 4 to 5 feet above grade at the substation protected by the berm that was overtopped (Belle Chase [West Bank] – Plaquemines Parish, LA).

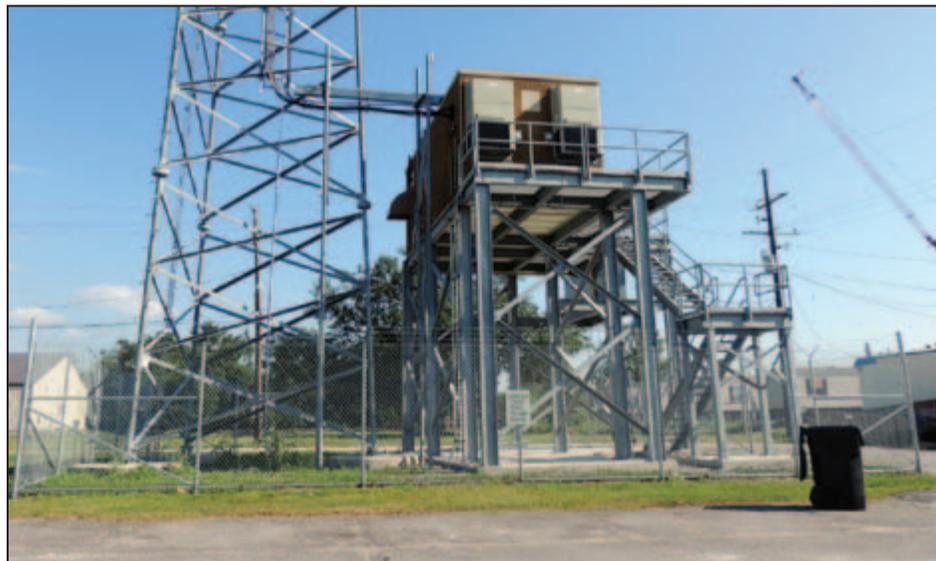
The MAT observed several cellular towers with equipment elevated on platforms (see Figure 4-18). The MAT did not observe flood damage to the cellular tower equipment.

Figure 4-18:
Cellular tower equipment on elevated platform near Port Sulphur Community Center (Port Sulphur [West Bank] – Plaquemines Parish, LA).

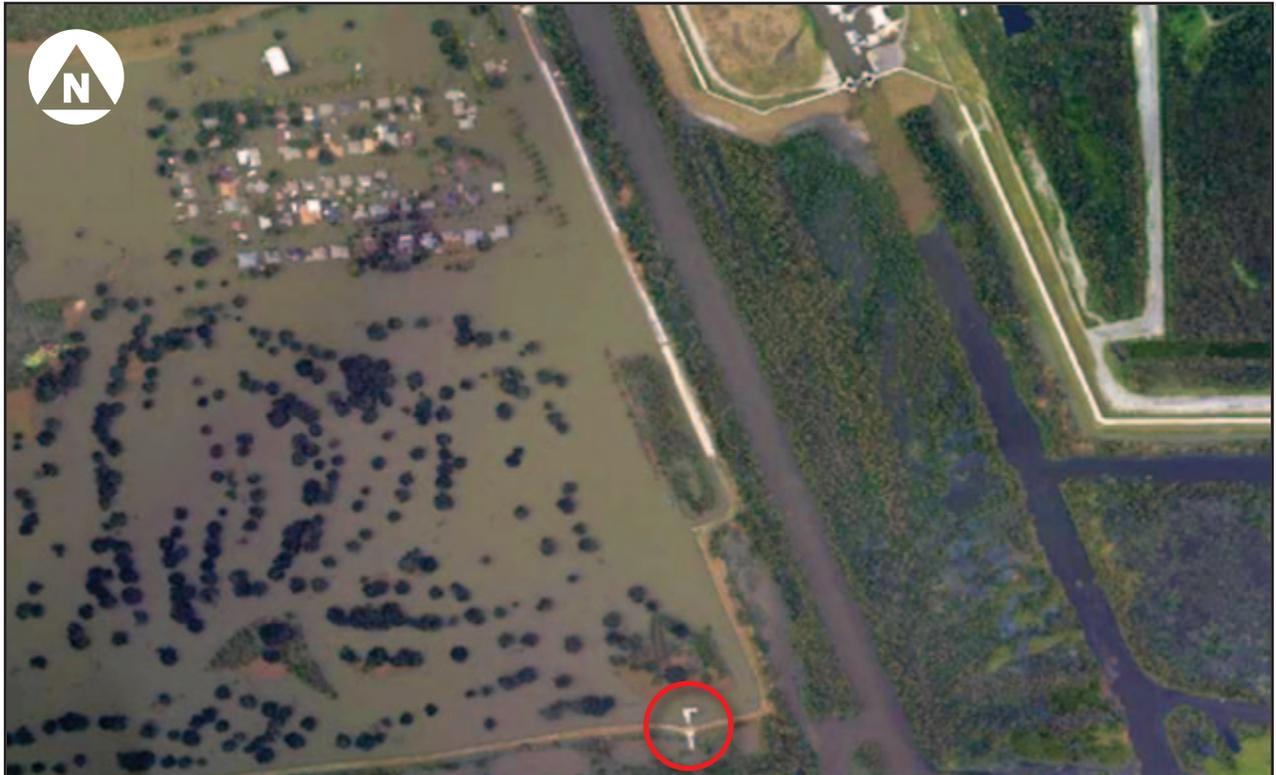
Figure 4-19: Post-Hurricane Isaac aerial of the pump station south of Braithwaite Park (Braithwaite Park [East Bank] – Plaquemines Parish, LA).

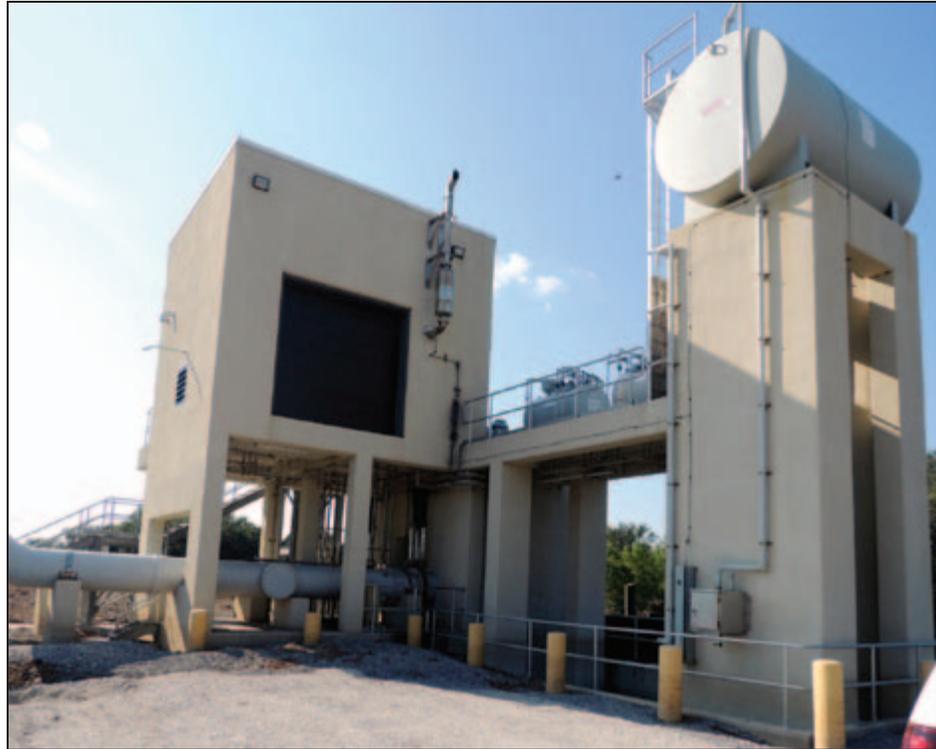
The MAT visited stormwater pumping stations in Slidell and Plaquemines Parish. Both were located in SFHAs, and both were repaired and mitigated after Hurricane Katrina under FEMA's Public Assistance Program. The elevation projects included installing new equipment and foundations, relocating control panels, and installing a generator with fuel tank and transfer switch for emergency power generation (see Figures 4-19 through 4-21). The MAT did not observe damage at either pump station, and both remained operational during the storm.

Figure 4-20:
Elevated stormwater pump station south of Braithwaite Park reconstructed after Hurricane Katrina with FEMA Public Assistance funds (Braithwaite [East Bank] – Plaquemines Parish, LA).

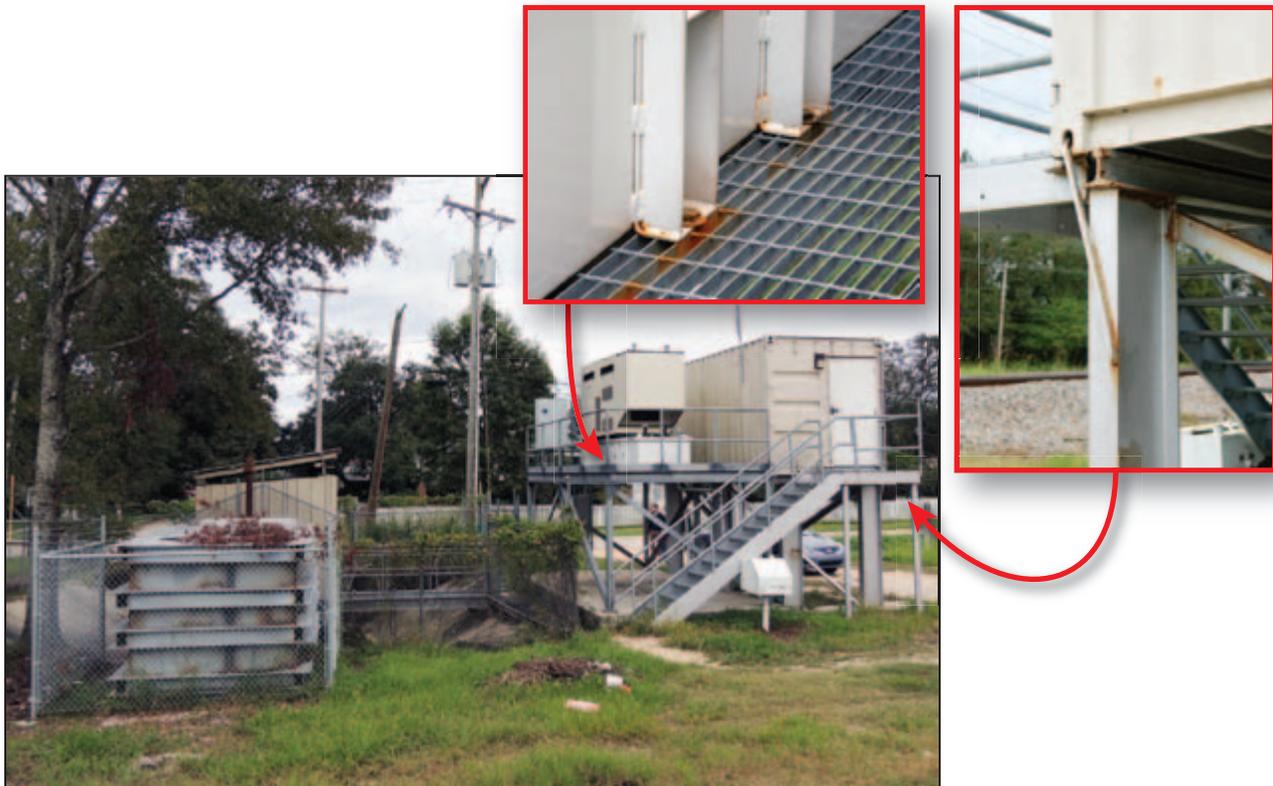
Figure 4-21: The control panels and generator at this pump station were elevated as part of a mitigation measure with FEMA Public Assistance funds; insets illustrate connections between equipment and platform (Slidell, LA).
