Mitigation Assessment Team Report

Hurricane Isaac in Louisiana

Building Performance Observations,
Recommendations, and Technical Guidance

FEMA P-938 / March 2013

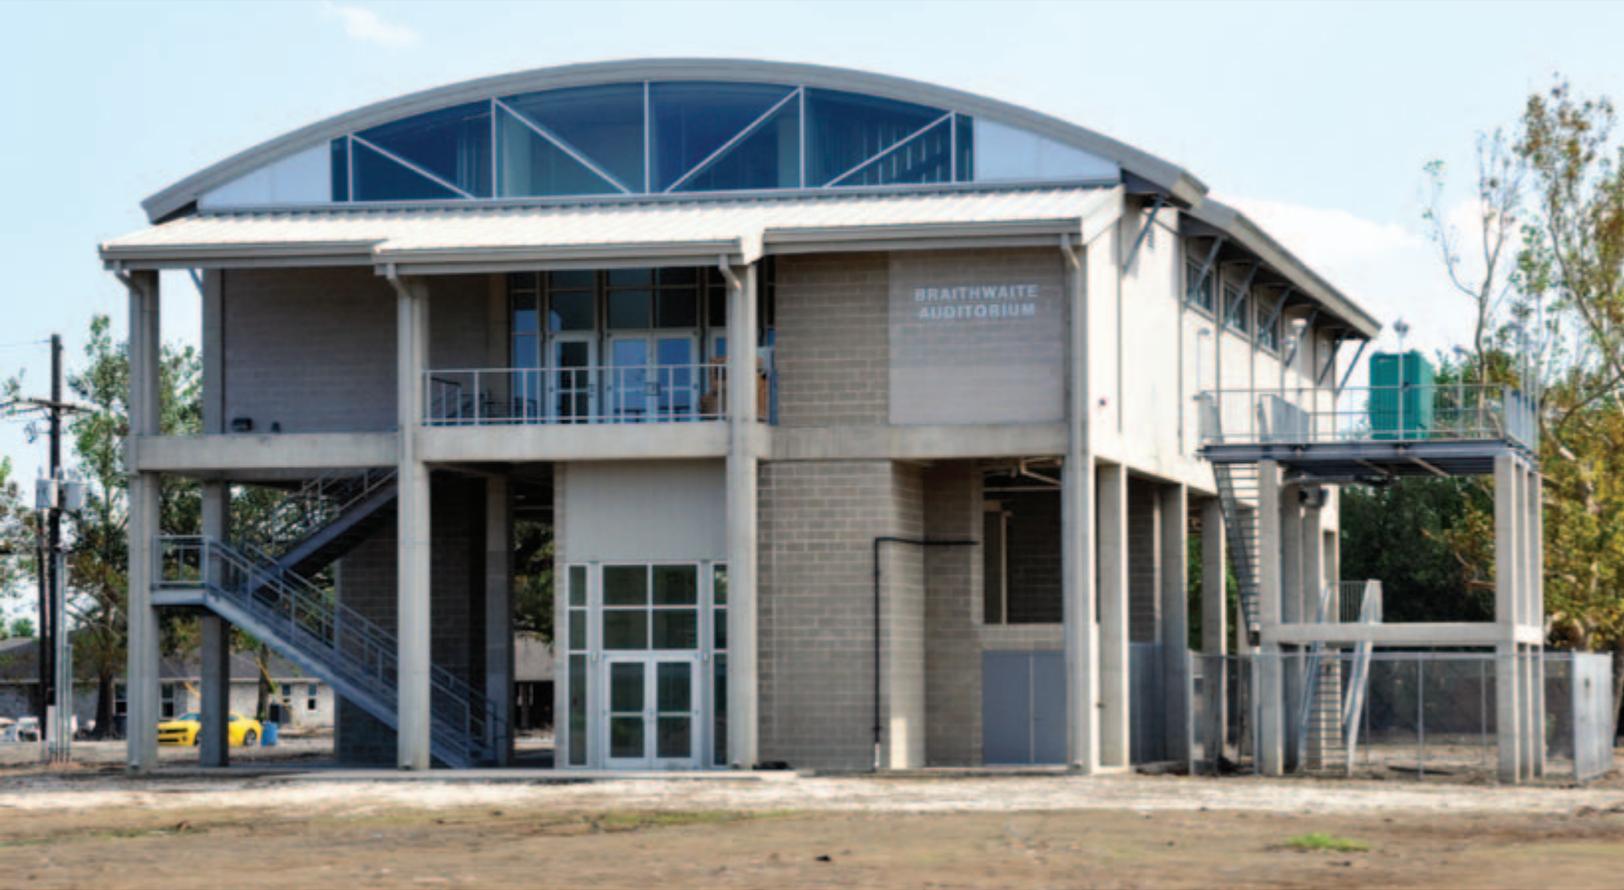
The Braithwaite Auditorium was rebuilt after it was damaged by Hurricane Katrina. The facility was built based on the preliminary Flood Insurance Rate Map base flood elevation (VE 21) and sustained minimal damage during Hurricane Isaac.
