HURRICANE ISAAC IN LOUISIANA

5 Evaluation of Elevation Projects

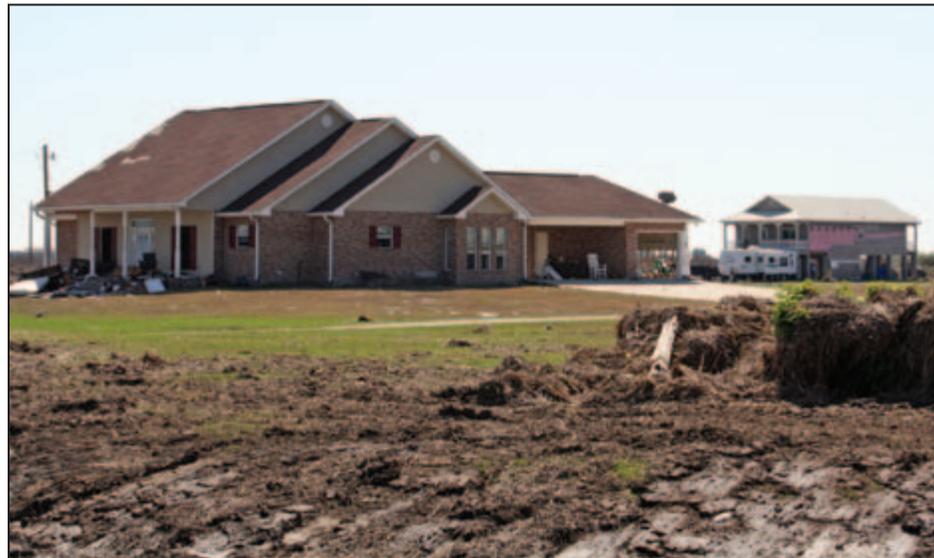
The two adjacent properties (see Figures 5-1 and 5-2) along Highway 23 in Plaquemines Parish were in the inundation area during Hurricane Isaac and located within the SFHA (effective FIRM – Zone A13 [EL5] 05/01/1985; Katrina ABFE – Zone AE [EL10]; Post-Katrina Preliminary FIRM – Zone VE [EL16]). The slab-on-grade house was built about 2004/2005 and was severely damaged during Hurricane Isaac. Winds caused roof cover loss, and approximately 5 feet of flood inundation damaged interior and exterior finishes (see Figures 5-3 through 5-7). The elevated wood-frame house was built on masonry piers about 2007 and received minor damage during Hurricane Isaac. Most of the damage to the elevated house was limited to the exterior finishes, including roof cover loss, and was caused by wind (see Figure 5-8); water did not reach the first floor. Estimated damages based on depth-damage functions are included in Table 5-1.

Figure 5-1:
Comparison of elevated
versus at-grade
constructions (Plaquemines
Parish, LA).

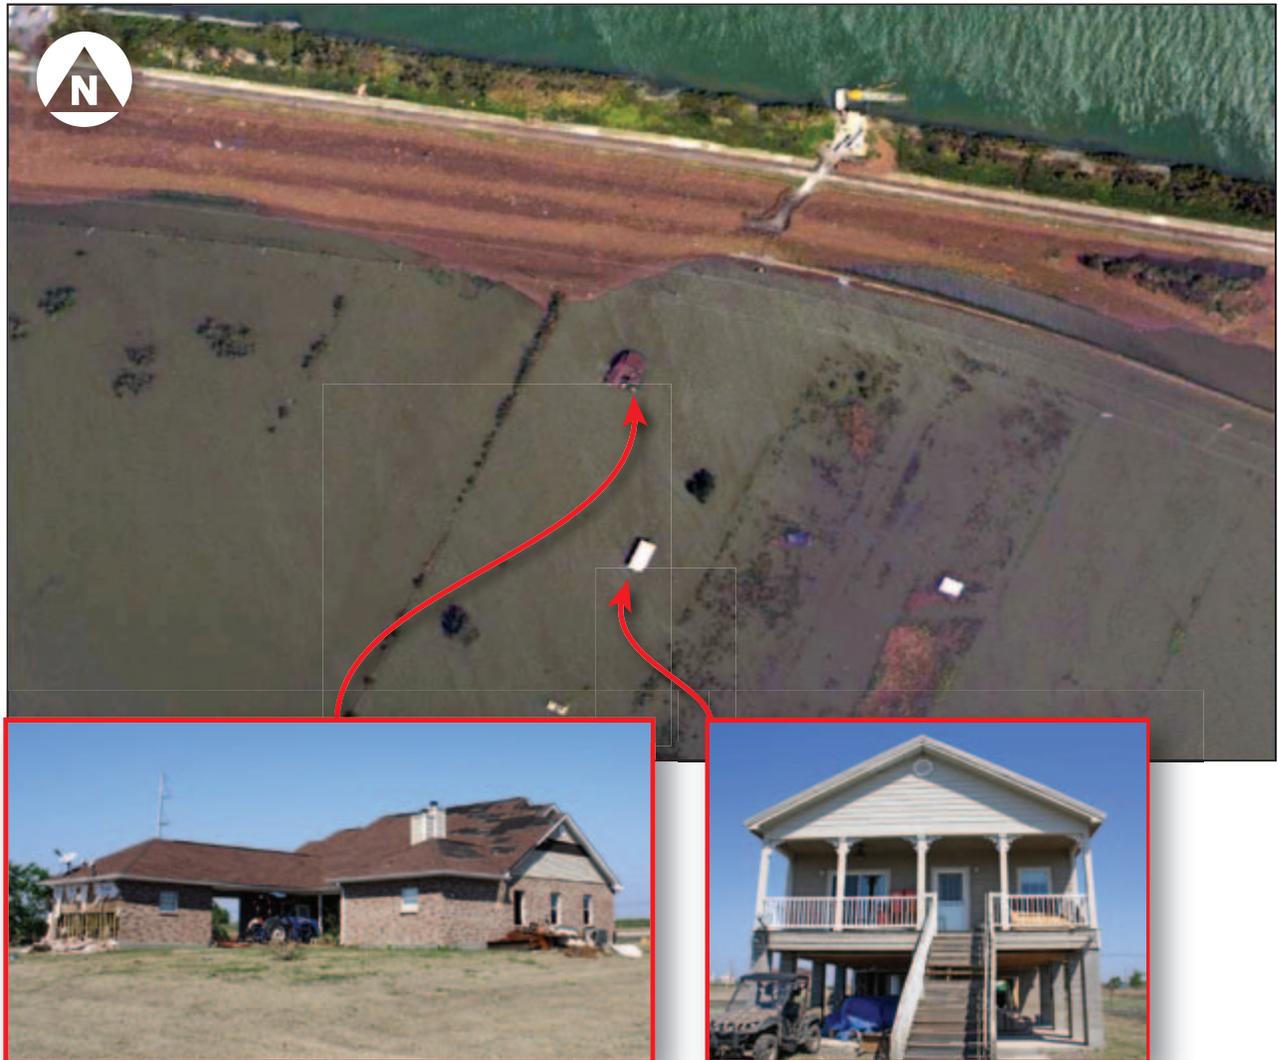
Figure 5-2: Post-Hurricane Isaac aerial of the residences in Figure 5-1 (Plaquemines Parish, LA).

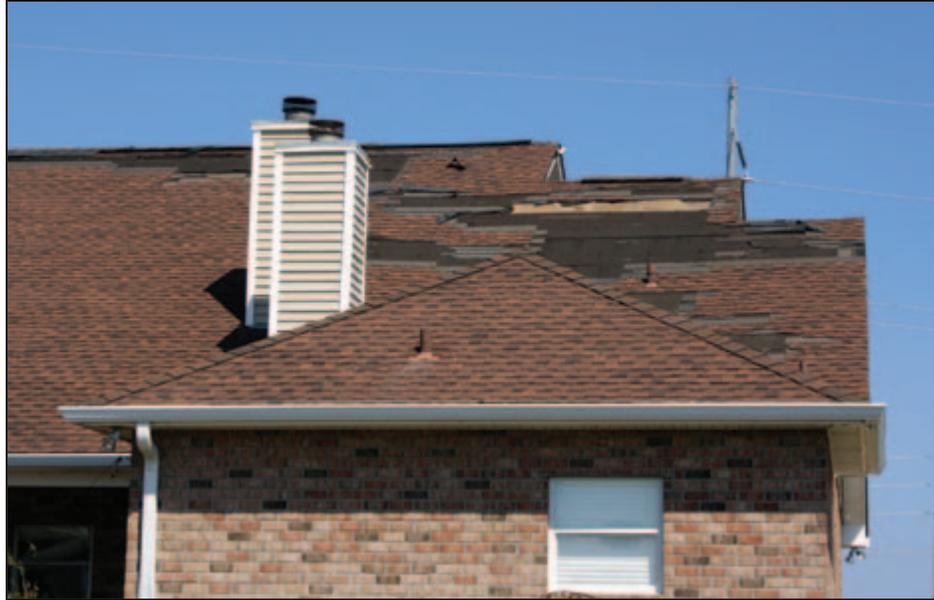
Figure 5-3:
Roof cover loss at non-elevated residential building (Plaquemines Parish, LA).

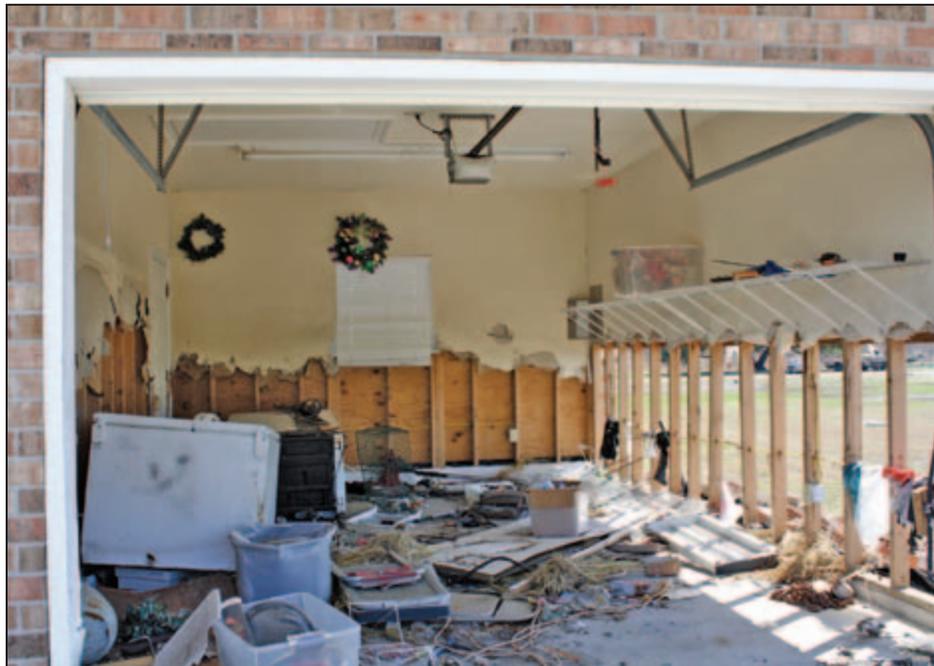
Figure 5-4:
Interior damage to the garage of the non-elevated residence (Plaquemines Parish, LA).

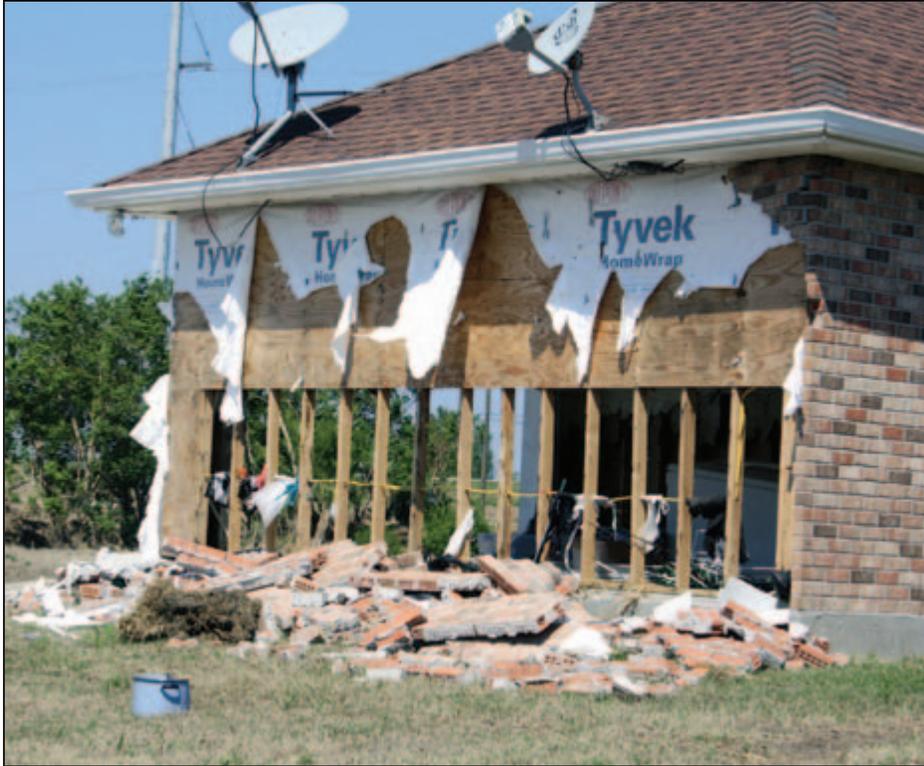
Figure 5-5:
Exterior damage to the
garage of the non-elevated
residence (Plaquemines
Parish, LA).

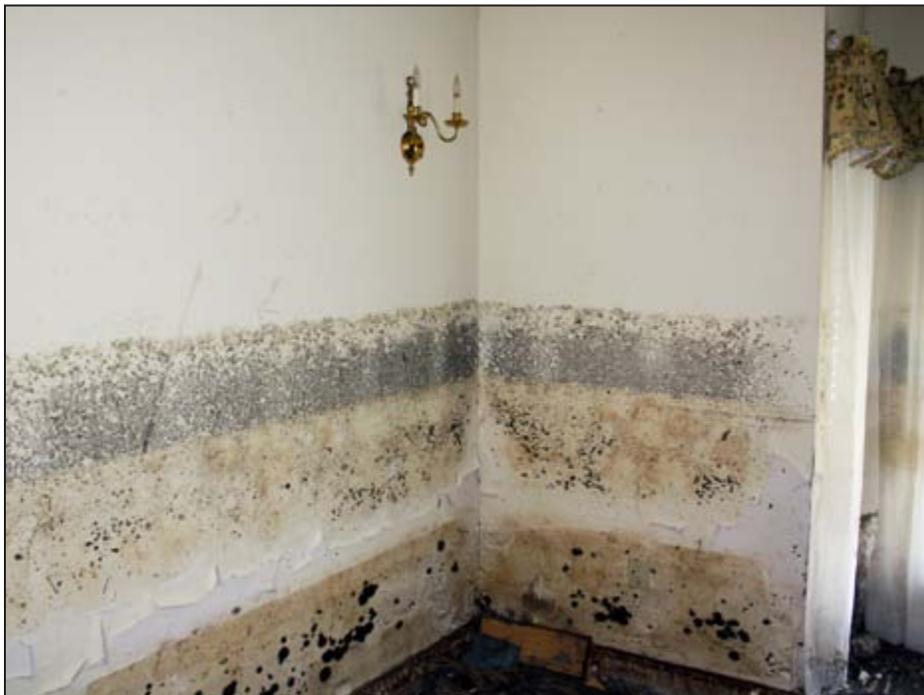
Figure 5-6:
Interior damage to the
non-elevated residence
(Plaquemines Parish, LA).

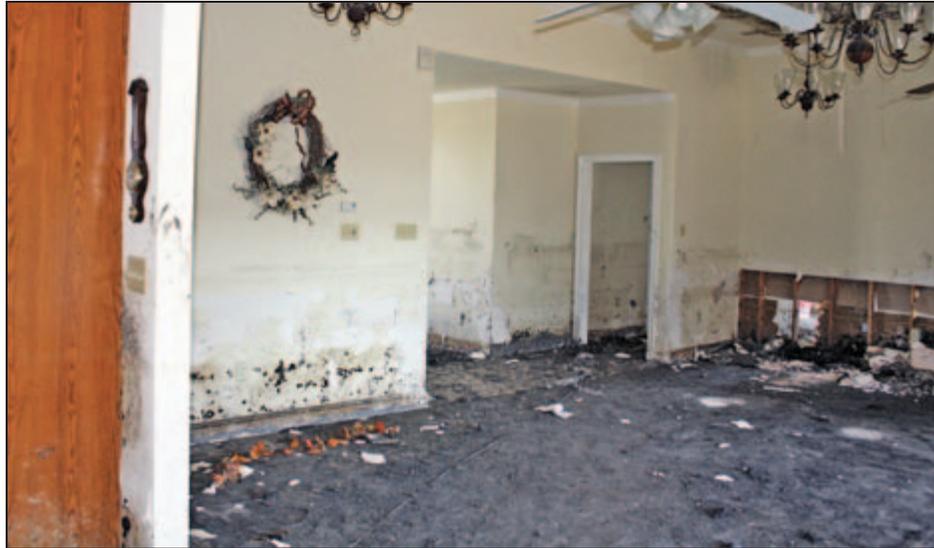
Figure 5-7:
Interior damage to the non-elevated residence (Plaquemines Parish, LA).

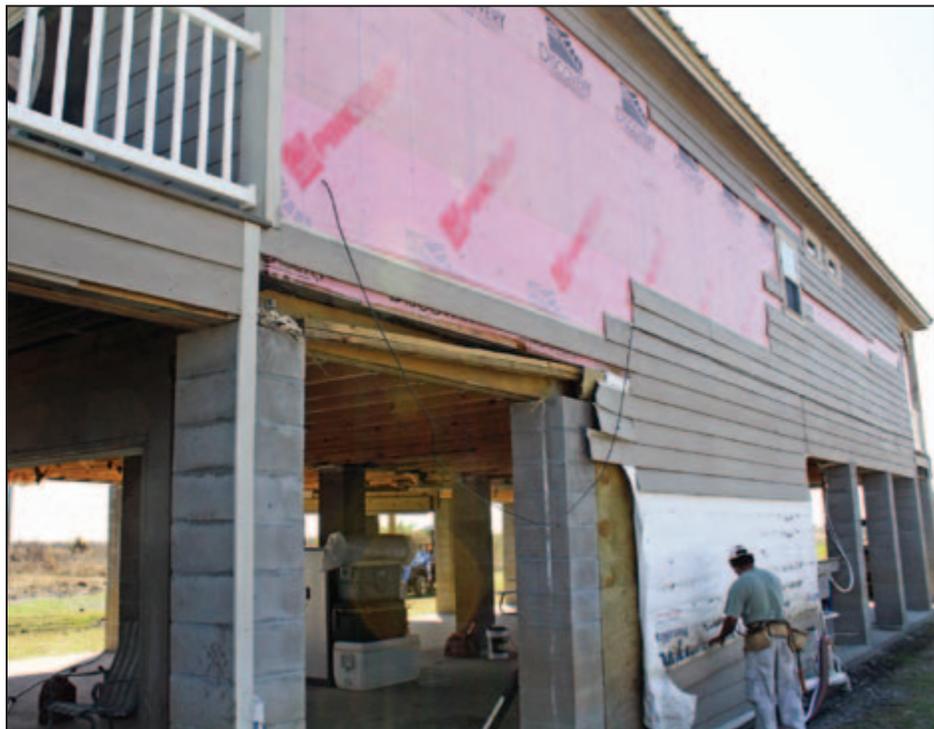
Figure 5-8:
Exterior damage (wood siding) to the elevated house (Plaquemines Parish, LA).

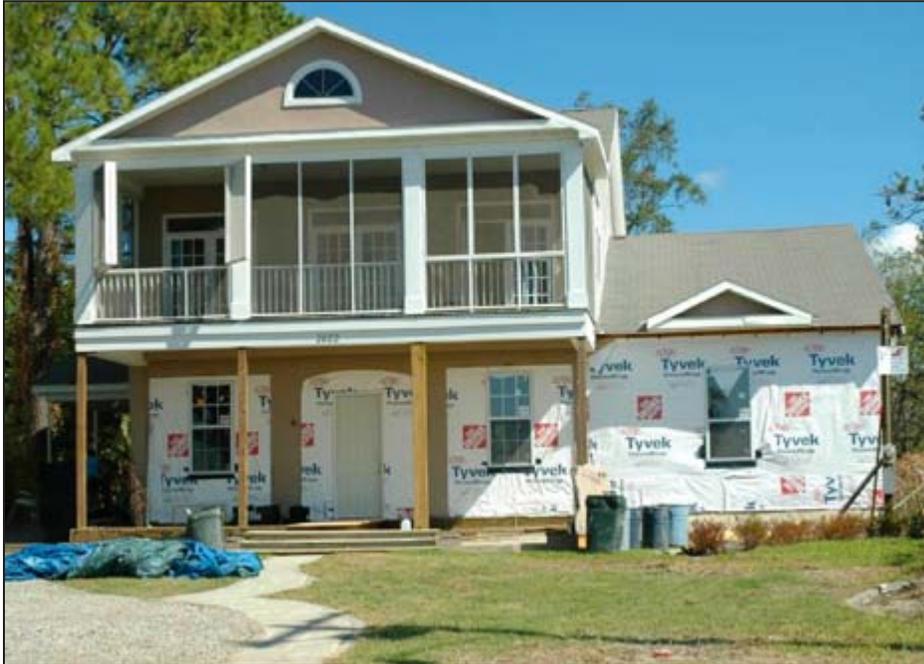
The single-family residence on Lakeshore Drive in Mandeville was a slab-on-grade property during Hurricane Katrina (see Figure 5-9) and had 3 to 4 feet of flooding in 2005. The property is in the SFHA (effective FIRM – VE [EL12] 05/16/2012; Katrina ABFE – Zone VE [EL15]) after Hurricane Katrina (see Figure 5-10). The building was not inundated during Hurricane Isaac. See Table 5-2 for a comparison of estimated damages.

Figure 5-9:
Single-family residence
post-Katrina
(Mandeville, LA).

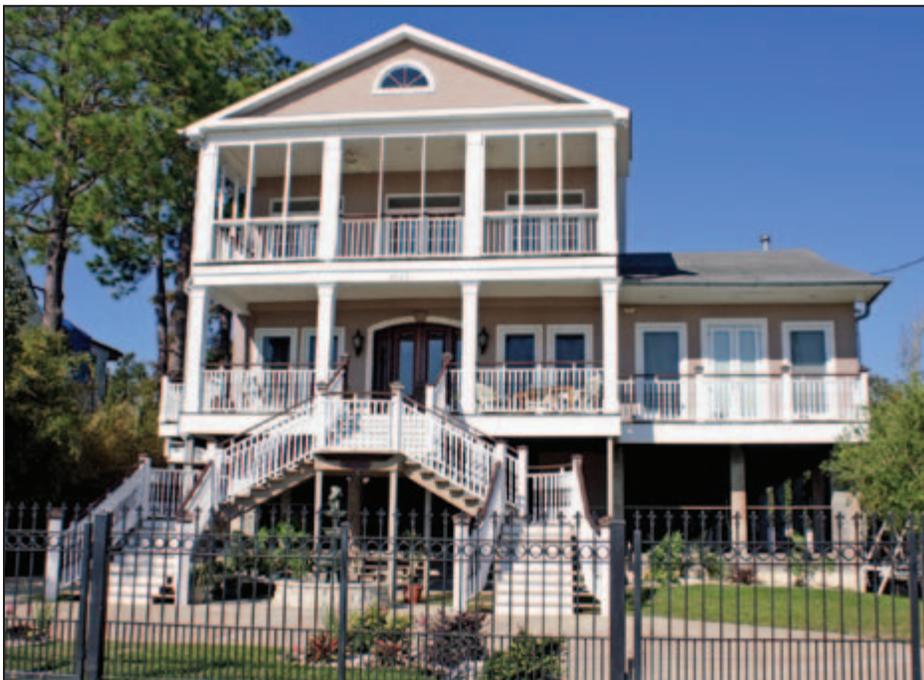
Figure 5-10:
Single-family residence
elevated post-Katrina
(Mandeville, LA).

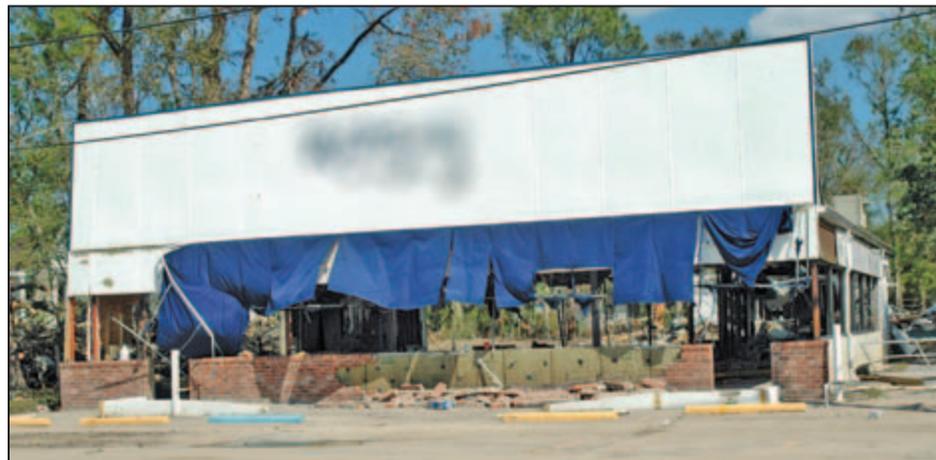
A nonresidential building along Lakeshore Drive in Mandeville was floodproofed 2 to 3 feet above ground level prior to Hurricane Katrina but experienced flooding of 7 feet that overtopped the floodproofed elevation by 4 feet (see Figures 5-11 through 5-13). After being Substantially Damaged by Hurricane Katrina, the building was reconstructed on an open foundation (see Figure 5-14). The building was not inundated during Hurricane Isaac. See Table 5-3 for a comparison of estimated damages. The property is located within the SFHA (effective FIRM – Zone VE [EL12] 05/16/2012; Katrina ABFE – Zone VE [EL15]).

Figure 5-11:
A nonresidential building on Lakeshore Drive in Mandeville post-Hurricane Katrina (Mandeville, LA).

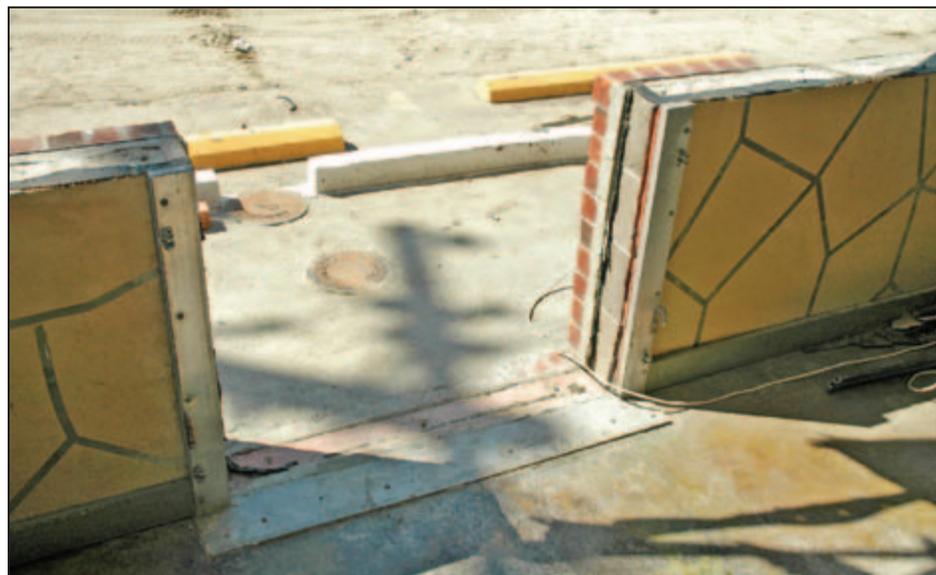
Figure 5-12:
Entrance to nonresidential building on Lakeshore Drive in Mandeville post-Hurricane Katrina (Mandeville, LA).

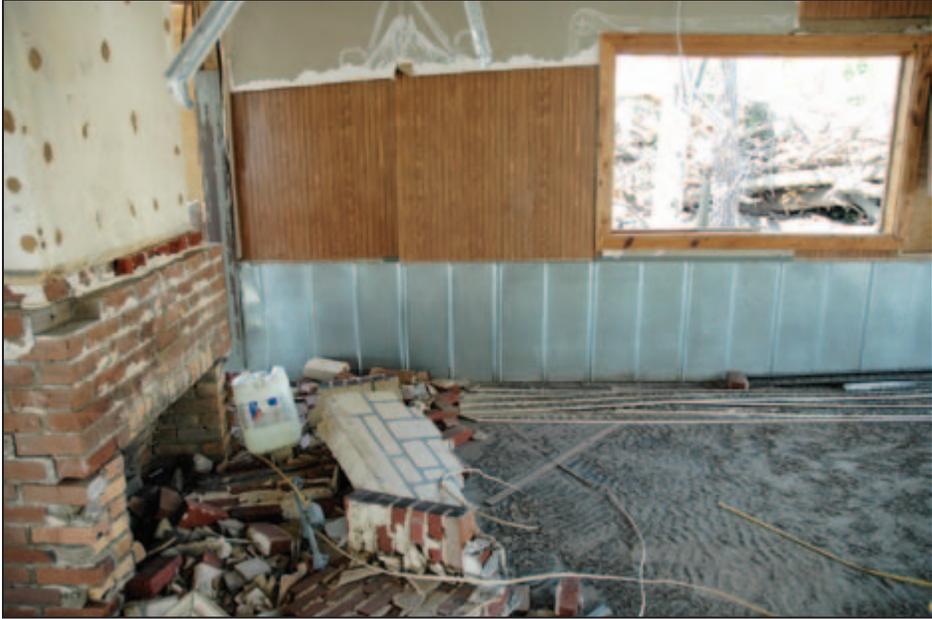
Figure 5-13: Interior damage from Hurricane Katrina to nonresidential building on Lakeshore Drive (Mandeville, LA).

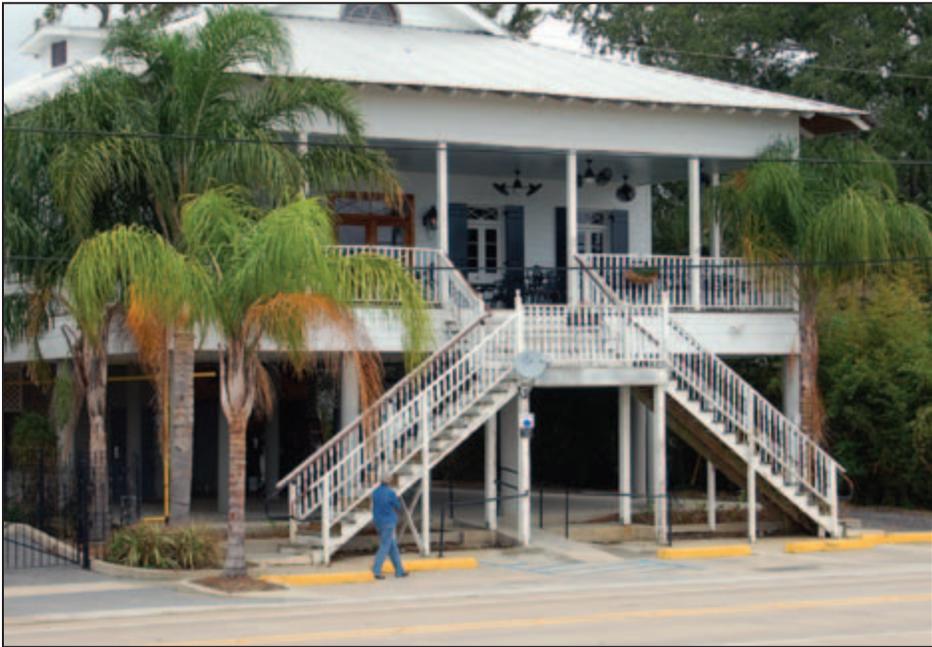
Figure 5-14: The same nonresidential building along Lakeshore Drive in Mandeville elevated post-Hurricane Katrina (Mandeville, LA).

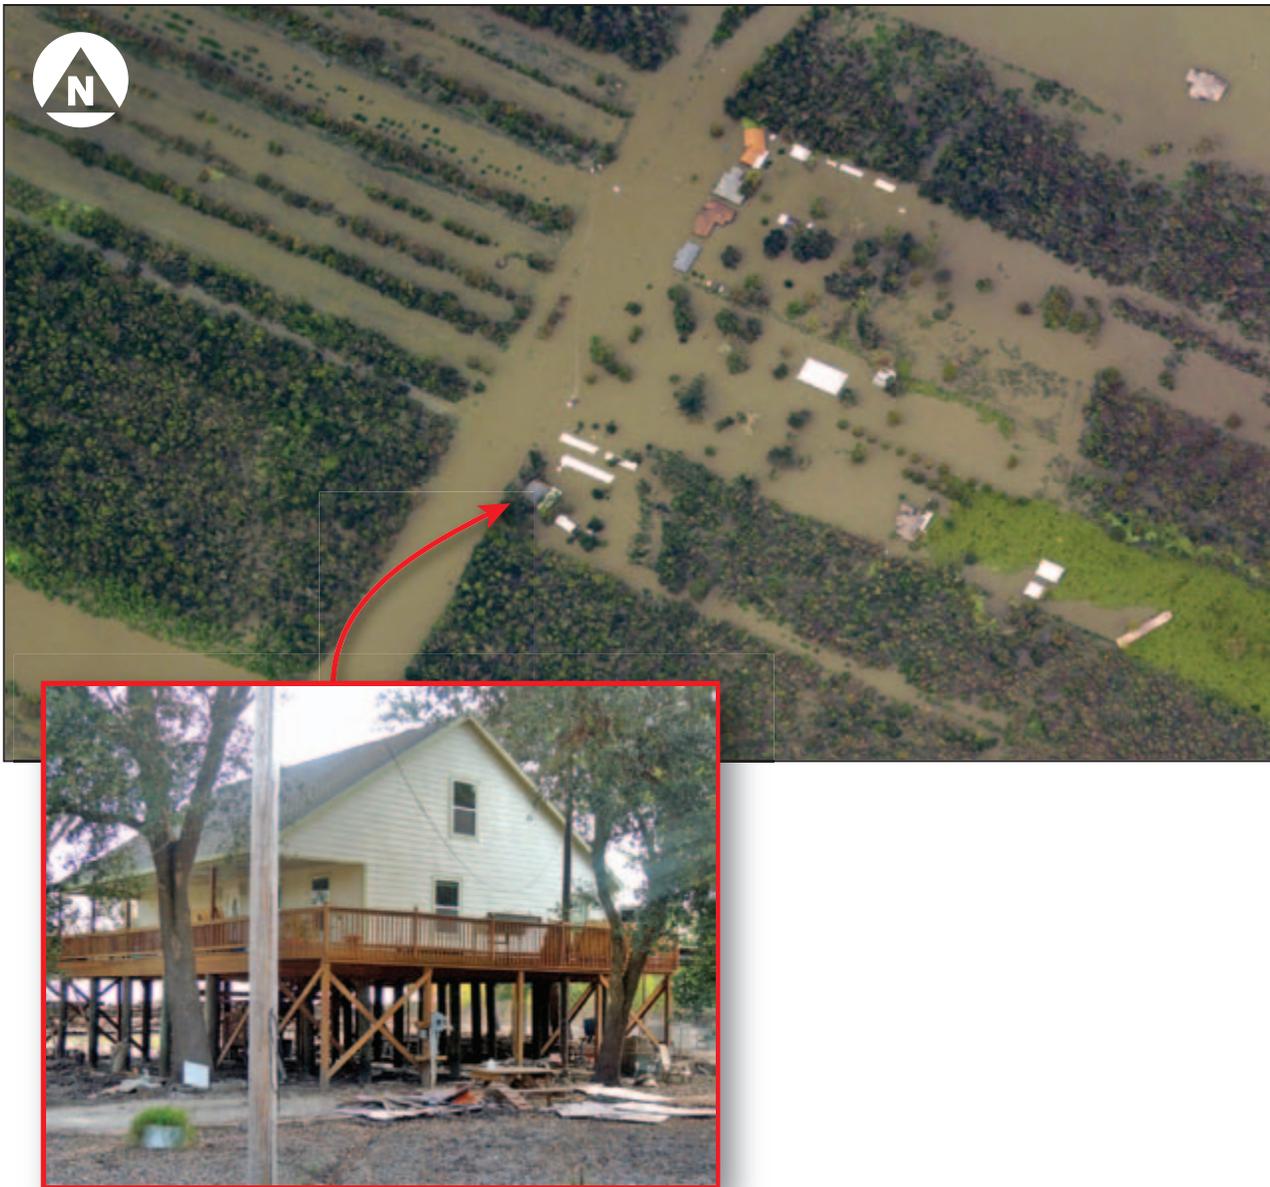
In one of the areas with the deepest inundation from Hurricane Isaac, the MAT visited an elevated property that almost avoided flood damage. This residence along Highway 39 was built in 2009 and is located within the SFHA (effective FIRM – Zone A6 [EL3] 05/01/1985; Katrina ABFE – Zone AE [EL18]; Post-Katrina Preliminary FIRM – AE [EL17]). Although the house was inundated with 2 feet of water, the damage was much less compared to older homes nearby that were built at grade (see Figures 5-15 through 5-17). Estimated damages based on depth-damage functions are shown in Table 5-4.

Figure 5-15: Post-Hurricane Isaac aerial of elevated residence along Highway 39 (Plaquemines Parish, LA).
SOURCE: NOAA; GENERATED FROM HURRICANE ISAAC RESPONSE IMAGERY VIEWER AT [HTTP://STORMS.NGS.NOAA.GOV/STORMS/ISAAC/](http://storms.ngs.noaa.gov/storms/isaac/)

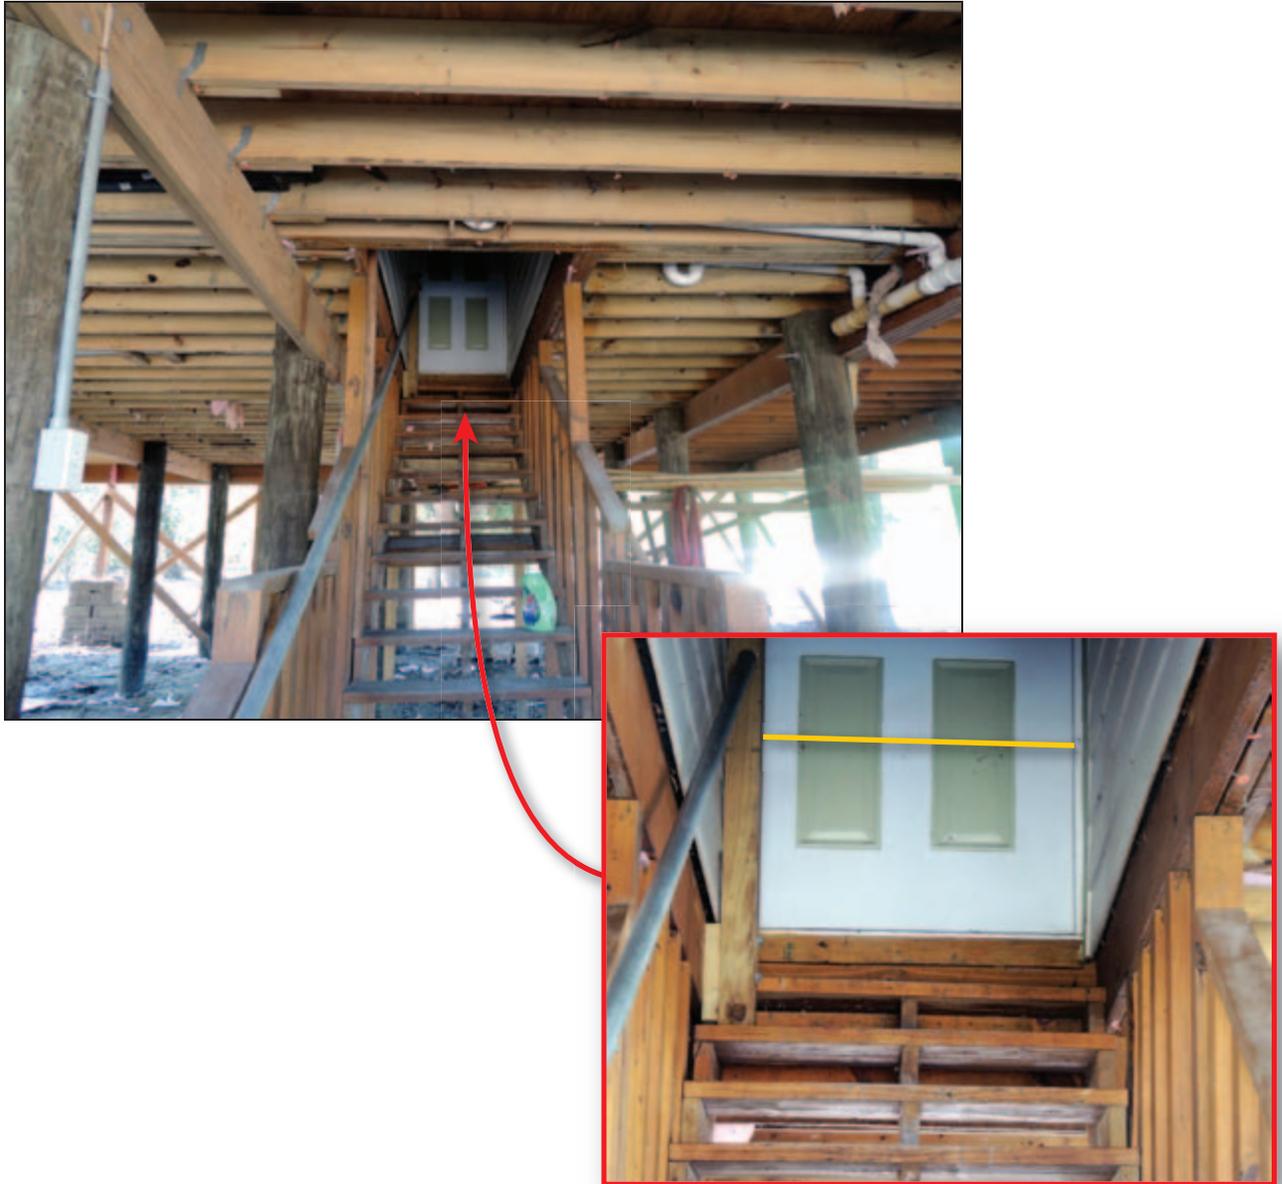
Figure 5-16: Elevated house built in 2009 on Highway 39 had approximately 2 feet of water infiltrate the first floor; inset: yellow line illustrates observed HWM on door (Plaquemines Parish, LA).

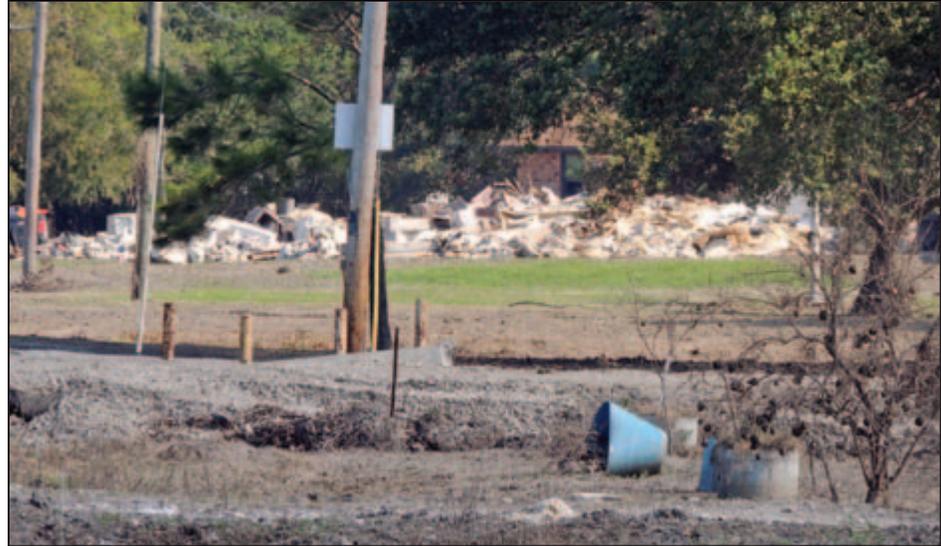
Figure 5-17:
Debris pile near at-grade residence (Plaquemines Parish, LA).

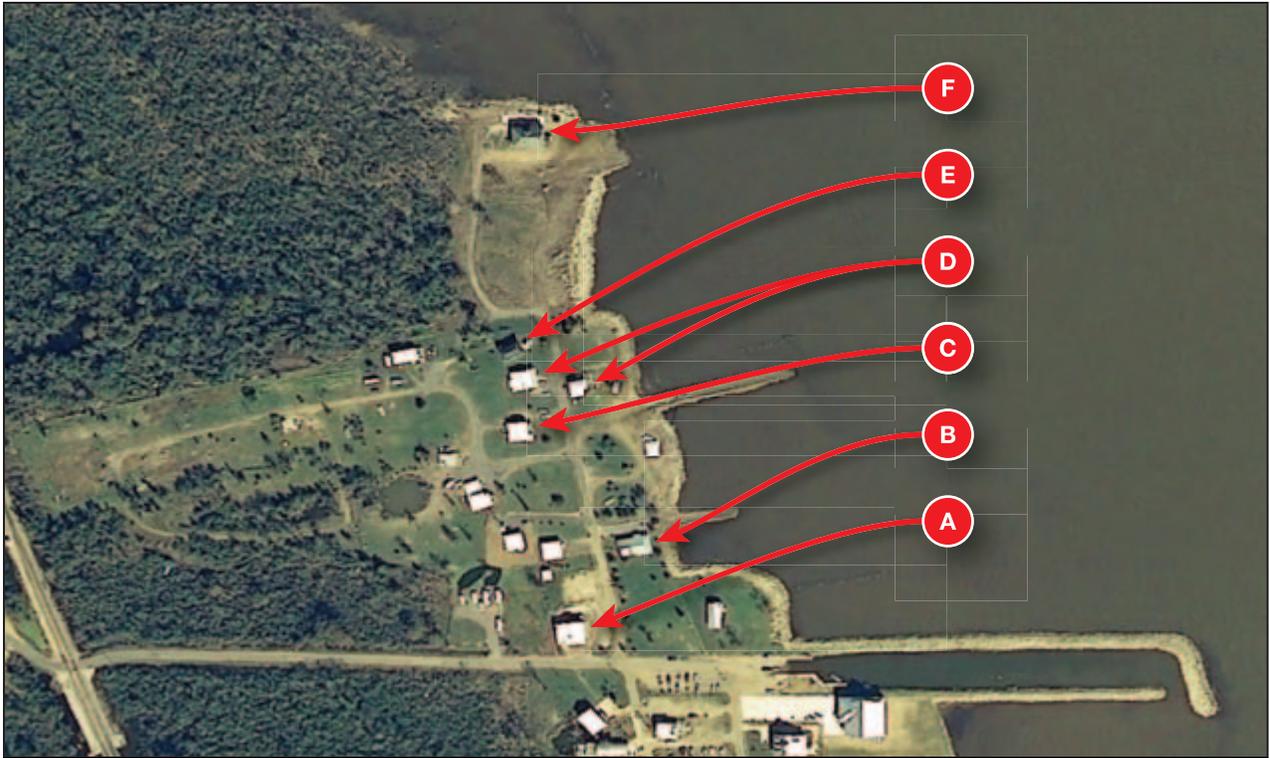
The MAT visited the Frenier Fishing Village, a small community along the west bank of Lake Pontchartrain, with estimated building ages ranging from less than 5 years to more than 30 years old. The entire community is located in the Coastal High Hazard Area (effective FIRM – Zone VE [EL16] 11/04/2010; Katrina ABFE – N/A; Historic FIRM – Zone VI6 [EL16]) and consists of about a dozen residential and nonresidential buildings. All buildings were constructed on an open foundation; however, the first floor elevations vary from approximately 1 to 12 feet above grade. As a result, the magnitude of flood damage from Isaac varied from collapse/failure to no damage (see Figures 5-18 through 5-25). See Table 5-5 for a comparison of estimated damage.

Figure 5-18: 2008 aerial of the Frenier Fishing Village (St. John the Baptist Parish, LA).

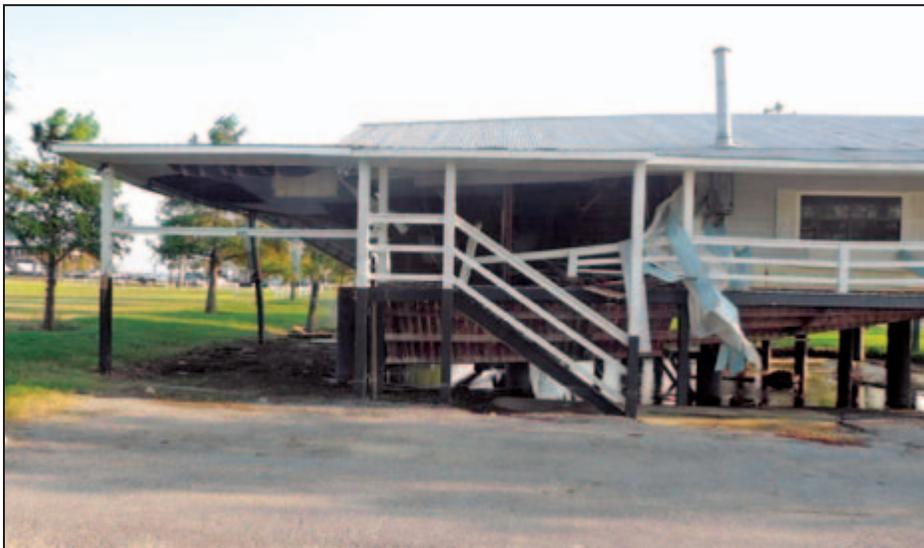
Figure 5-19: Surge damage to lakefront residential structure (Structure B in Figure 5-18) (St. John the Baptist Parish, LA).

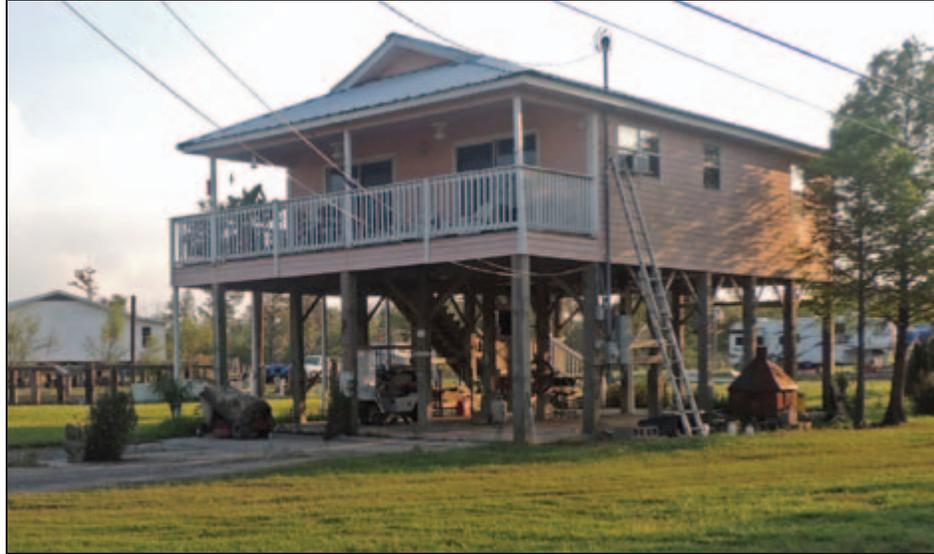
Figure 5-20:
Elevated residence with no observed damage (Structure E in Figure 5-18) (St. John the Baptist Parish, LA).

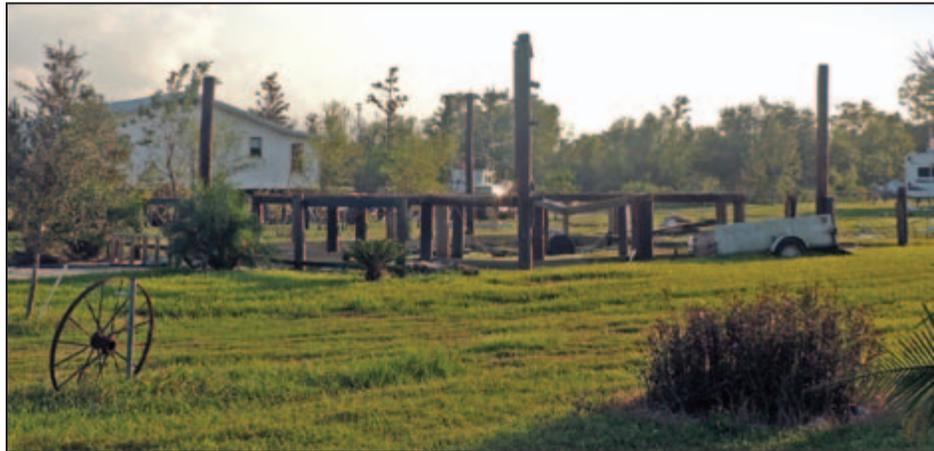
Figure 5-21:
Remains of residential building that was approximately 2 to 3 feet above grade (Structure D in Figure 5-18) (St. John the Baptist Parish, LA).

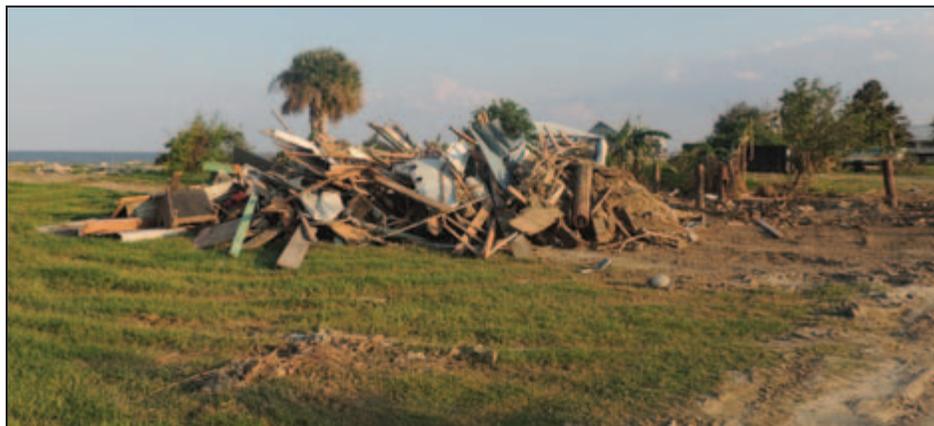
Figure 5-22:
Debris pile of waterfront single-family residence along the west bank of Lake Pontchartrain (Structure D in Figure 5-18) (St. John the Baptist Parish, LA).

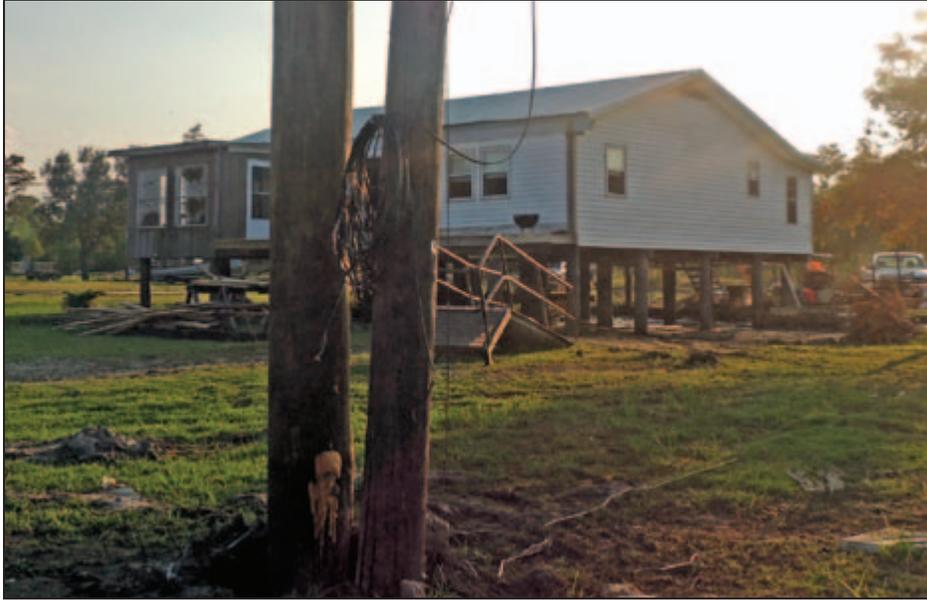
Figure 5-23:
Residential building elevated approximately 3 to 4 feet above grade that lost stairs and received other damage below the lowest floor (Structure C in Figure 5-18) (St. John the Baptist Parish, LA).

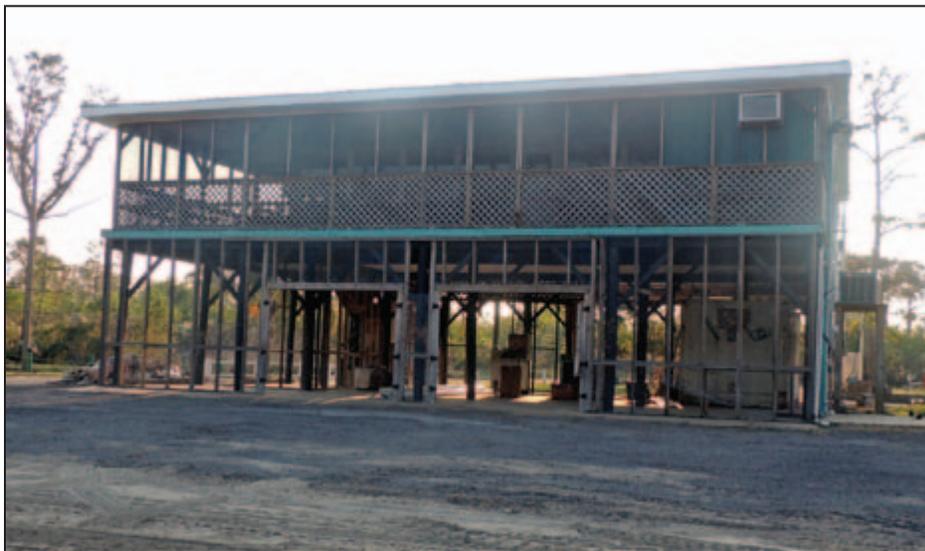
Figure 5-24:
Nonresidential structure with damage to the screen surrounding the area under the lowest floor (Structure A in Figure 5-18) (St. John the Baptist Parish, LA).

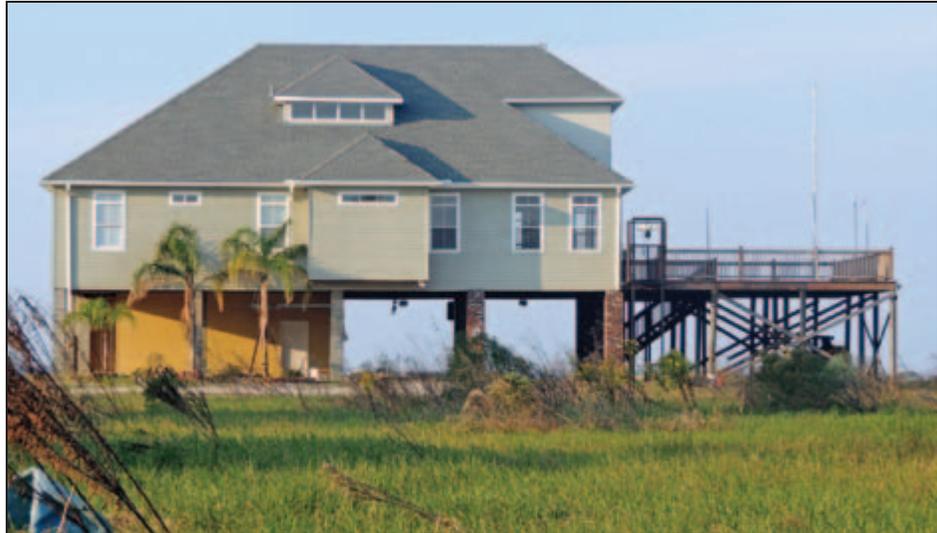
Figure 5-25:
Residence built about 2000
with minimal damage to
partially enclosed areas
below the lowest floor
(Structure F in Figure 5-18)
(St. John the Baptist
Parish, LA).
