HURRICANE

Katrina

IN THE GULF COAST

6. Historic Buildings

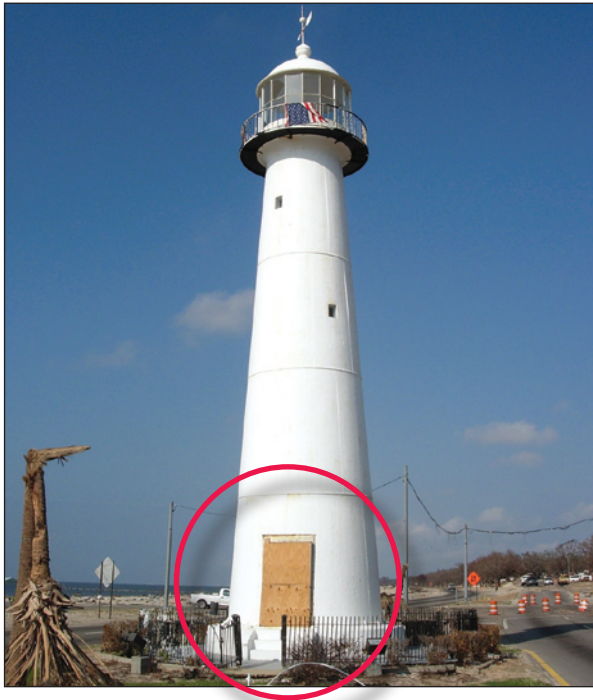
Figure 6-1.

The Biloxi lighthouse was built in 1848 just off the beach waterfront. It is constructed of brick encased by cast iron painted white. The height of the tower is 61 feet. Other than losing the door and one piece of glass, the Biloxi lighthouse suffered little damage and was one of the few successes (Figure 6-1).

Other than losing the door (circled) and one piece of glass, the Biloxi lighthouse suffered little damage from Hurricane Katrina (Biloxi, Mississippi).

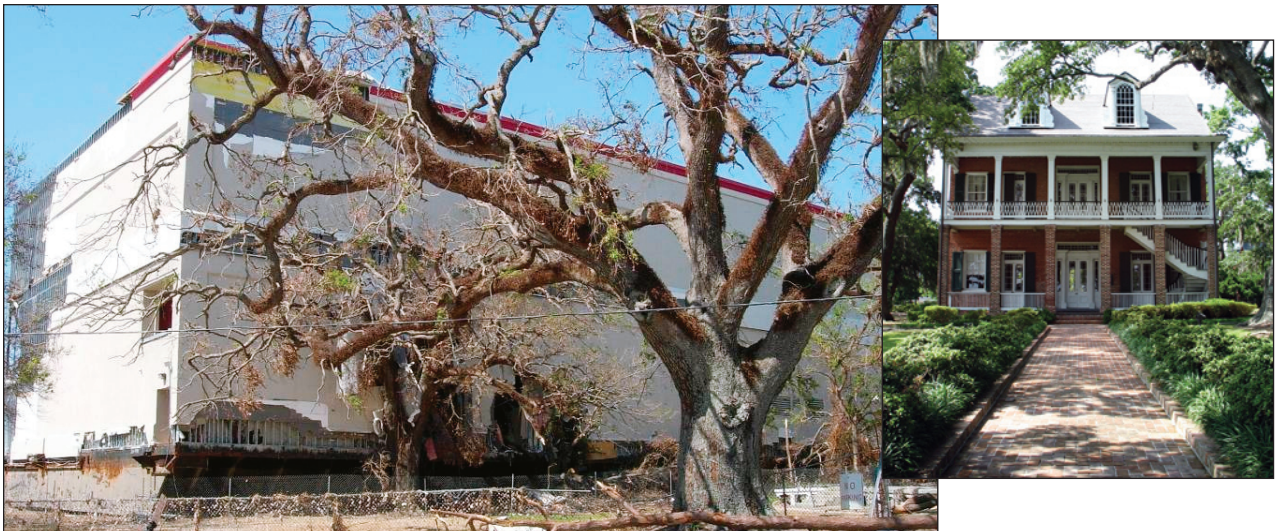
Figure 6-2.

Built in 1856, the Tullis-Toledano House was an example of Greek Revival architecture with rich architectural detail. The house was furnished in a period style to interpret Biloxi's antebellum history. Badly damaged by Hurricane Camille, it was purchased by the City of Biloxi in 1975 and restored as a historic house museum and recreational area. The house was completely destroyed by a casino barge during Hurricane Katrina (see Figure 6-2). It is likely the house would have survived, although heavily damaged, had it not been struck by the barge.

A casino barge moved by high surge completely destroyed the Tullis-Toledano House and now sits where the house was located. The inset shows the house prior to Hurricane Katrina (Biloxi, Mississippi).

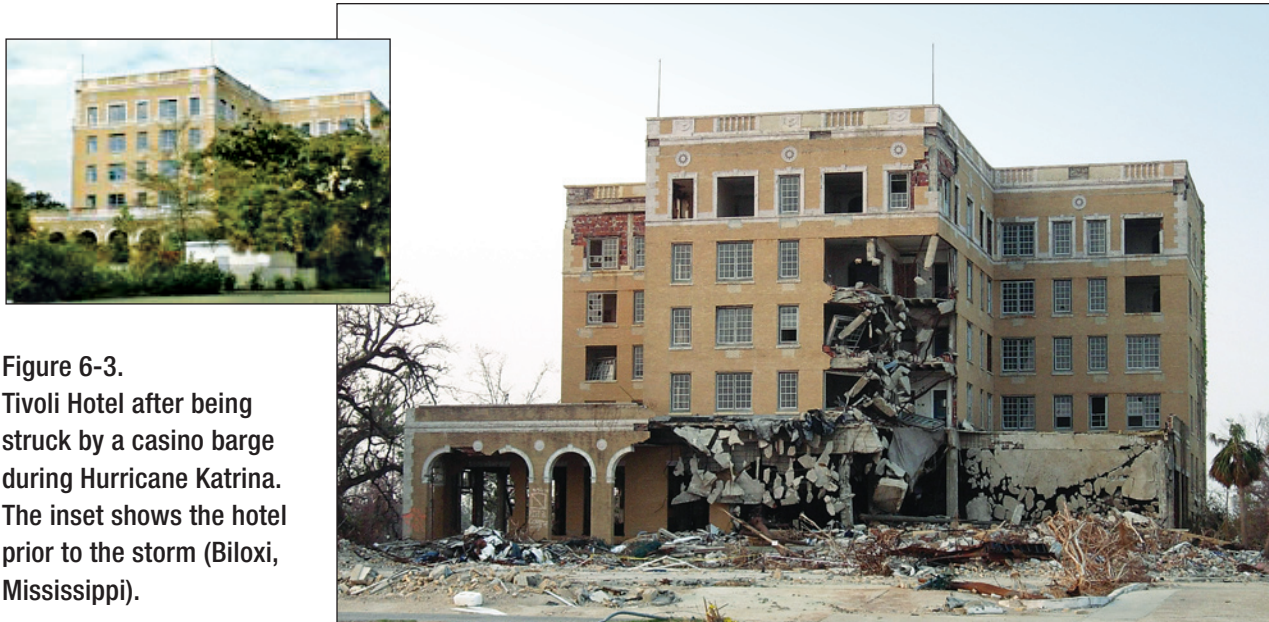
Built in 1927, the Tivoli Hotel, a 64-room luxury hotel, sat abandoned prior to Hurricane Katrina, waiting to be restored to its former glory. In 2003, the Mississippi Heritage Trust called the Tivoli Hotel one of the state's 10 most endangered historic places. With the surge from Katrina, a casino barge struck and destroyed the colonnade and four floors at the southeast corner of the hotel (see Figure 6-3).

Figure 6-3.
Tivoli Hotel after being struck by a casino barge during Hurricane Katrina. The inset shows the hotel prior to the storm (Biloxi, Mississippi).

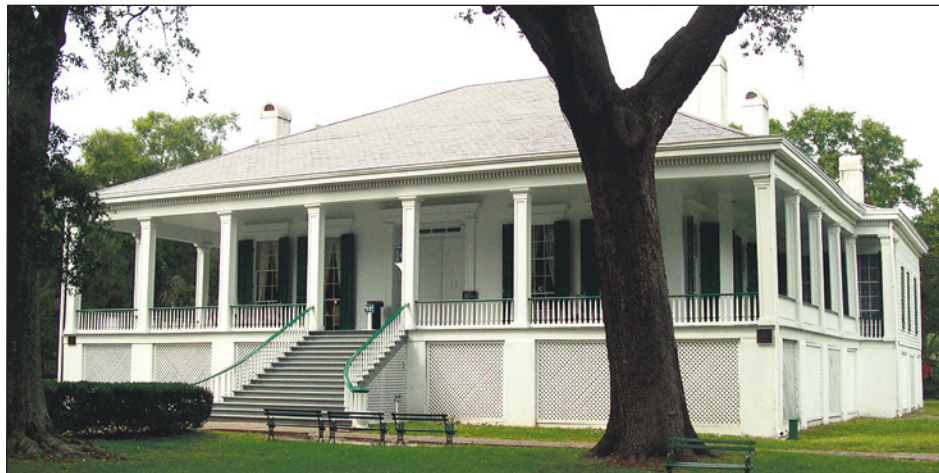
Figure 6-4.
Front elevation of Beauvoir before Hurricane Katrina (Biloxi, Mississippi)

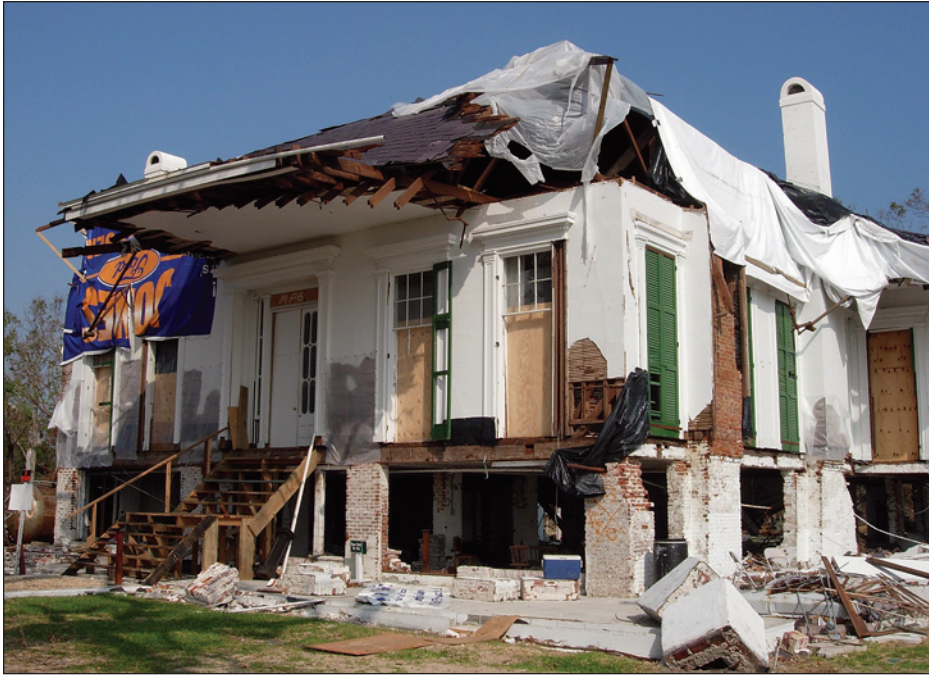
Built in 1848, Beauvoir (see Figure 6-4) and the surrounding structures sustained serious flood (velocity flow) damage from Hurricane Katrina. Approximately 75 percent of the main house still stands, except for the front, side, and rear porches (see Figures 6-5 and 6-6). Many windows, doors, and columns are also gone.

Figure 6-5.
Front elevation of
Beauvoir after Hurricane
Katrina (Biloxi,
Mississippi)

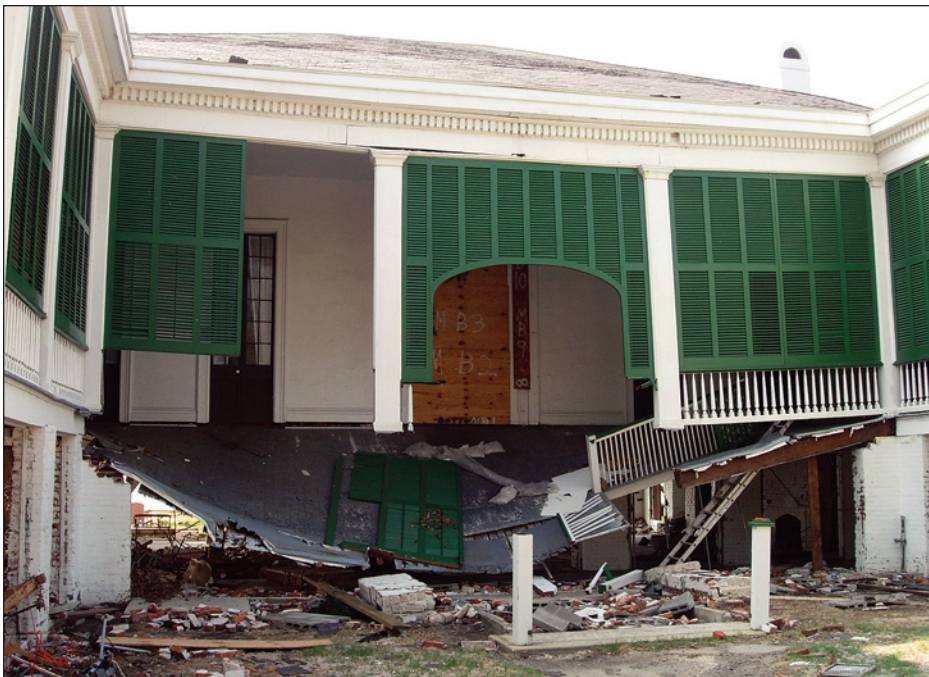
Figure 6-6.
Rear elevation of
Beauvoir after Hurricane
Katrina (Biloxi,
Mississippi)

The main house at Beauvoir is raised approximately 8 feet above grade with brick piers. The space between the piers was in-filled with break-away panels, allowing the surge to pass under the house, minimizing the damage to the main structure and preventing the house from collapsing. The surrounding porches and several piers were lost due to the uplift of the surge. Although not historic, the gift shop, a brick structure built slab-on-grade located approximately 200 feet east of the main house, was completely washed off its foundation (see Figure 6-7).

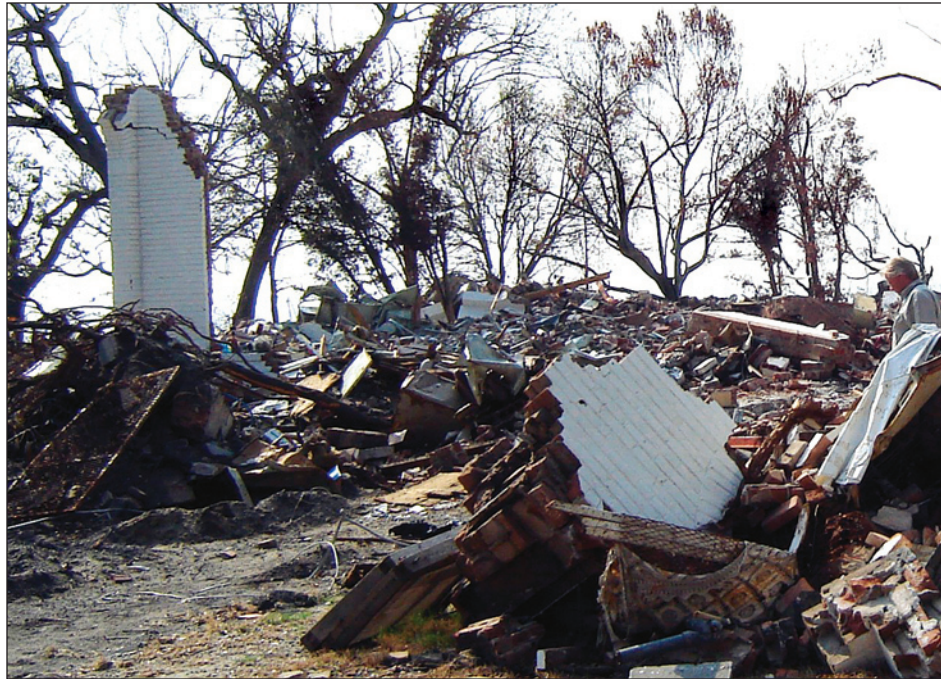
Figure 6-7.
Gift shop at Beauvoir
completely destroyed by
Hurricane Katrina (Biloxi,
Mississippi)

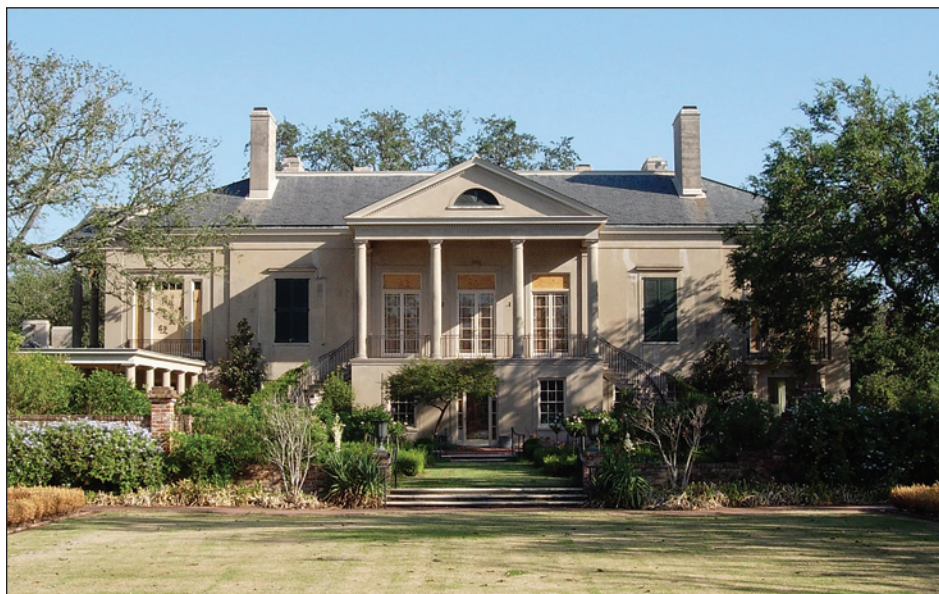
Built in 1924, and rebuilt between 1939 and 1942 to its present state, the Longue Vue House and Gardens property borders the 17th Street Canal about 2 miles south of where the levee failed. The basement was completely flooded and water was within inches of the main level. During the MAT's visit, the water was being pumped out and staff members were working to stabilize the condition of the resident collection of museum pieces, composed of paintings, books, and other artifacts. The gardens, after a multi-year restoration, were badly damaged from immersion. Figures 6-8 and 6-9 show the front elevation and garden areas of this site, respectively.

Figure 6-8.
Front elevation of Longue
Vue after Hurricane
Katrina (New Orleans,
Louisiana)

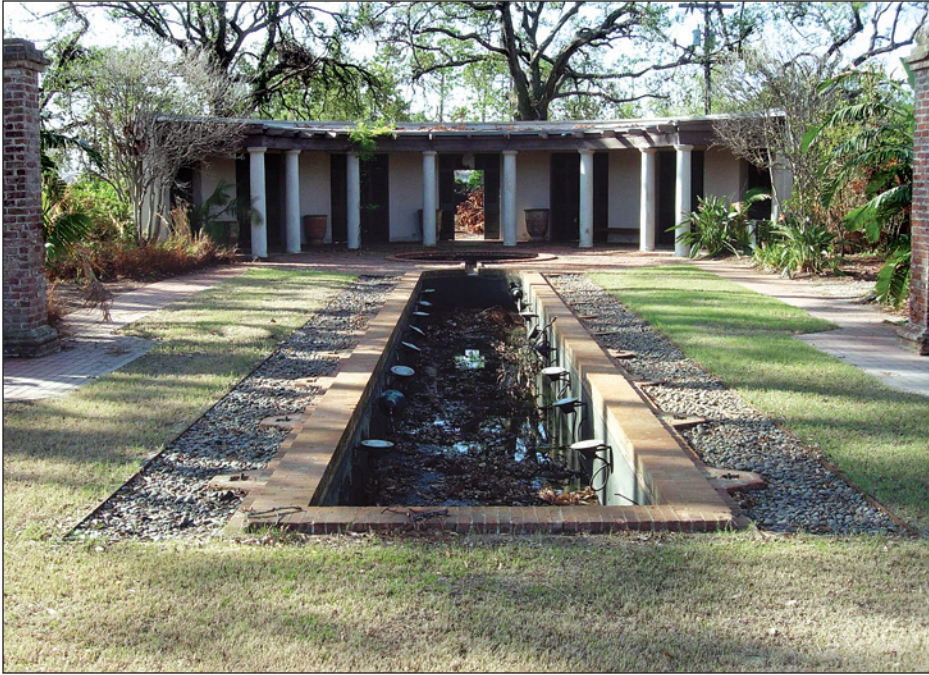
Figure 6-9.
Garden and fountain
at Longue Vue after
Hurricane Katrina (New
Orleans, Louisiana)

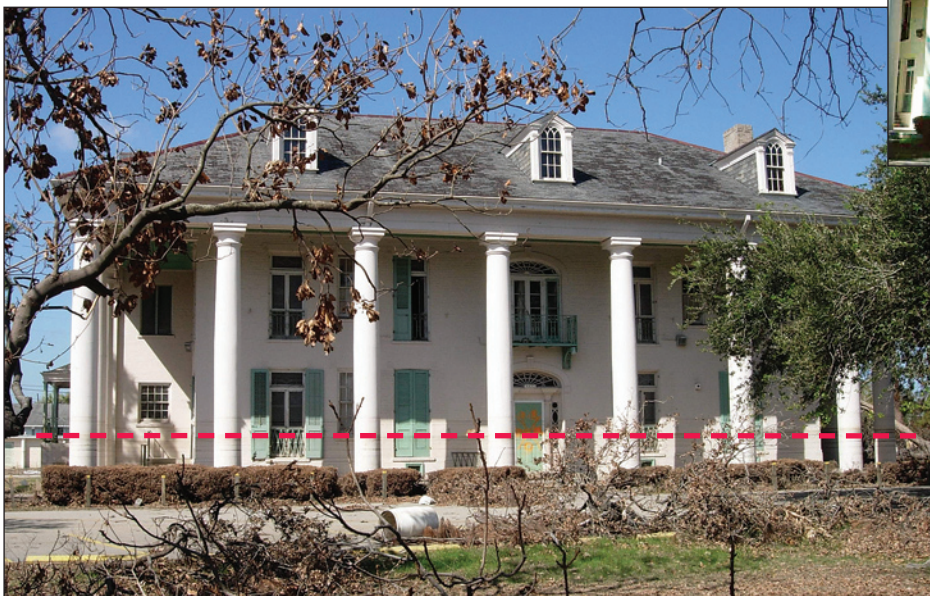
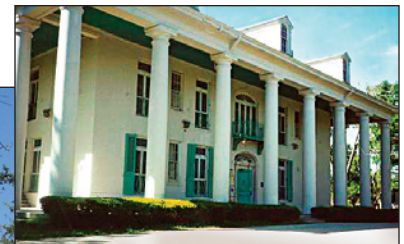
Figure 6-10.
Front elevation of
Milne Boys Home after
Hurricane Katrina. Note
the high water line
midway up the front
door. The inset shows the
home prior to the storm
(New Orleans, Louisiana).

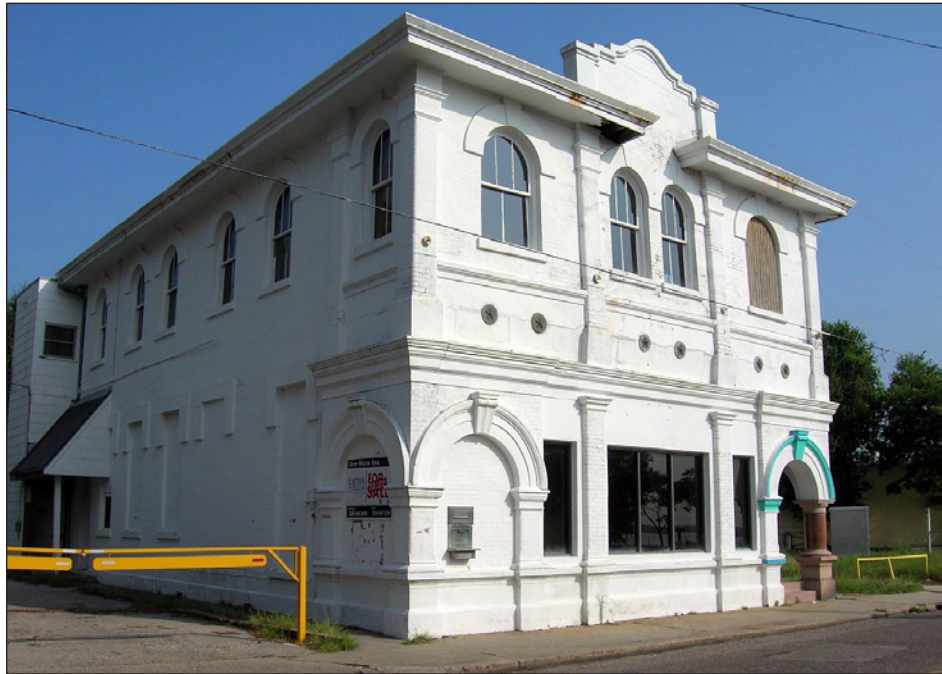
Figure 6-11.
View of front elevation
of bank before Hurricane
Katrina (Bay St. Louis,
Mississippi)

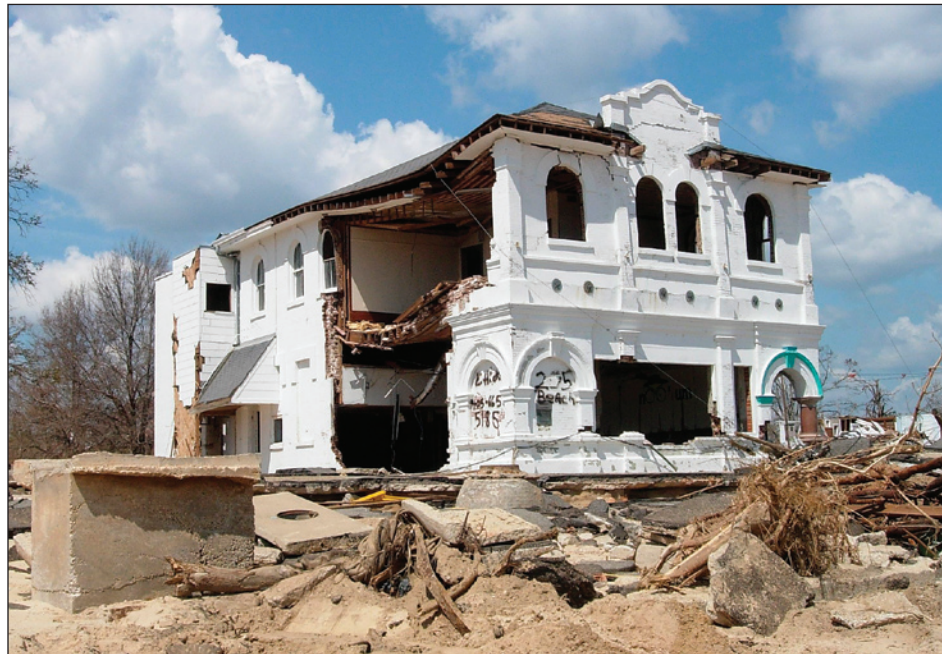
The "before" picture of this empty bank building (see Figure 6-11) was taken 2 weeks before Hurricane Katrina. Surge waters moved through the front windows and door, collapsing the side elevation and part of the second floor (see Figure 6-12).

Figure 6-12.
View of front and side
elevations of bank after
Hurricane Katrina (Bay St.
Louis, Mississippi)

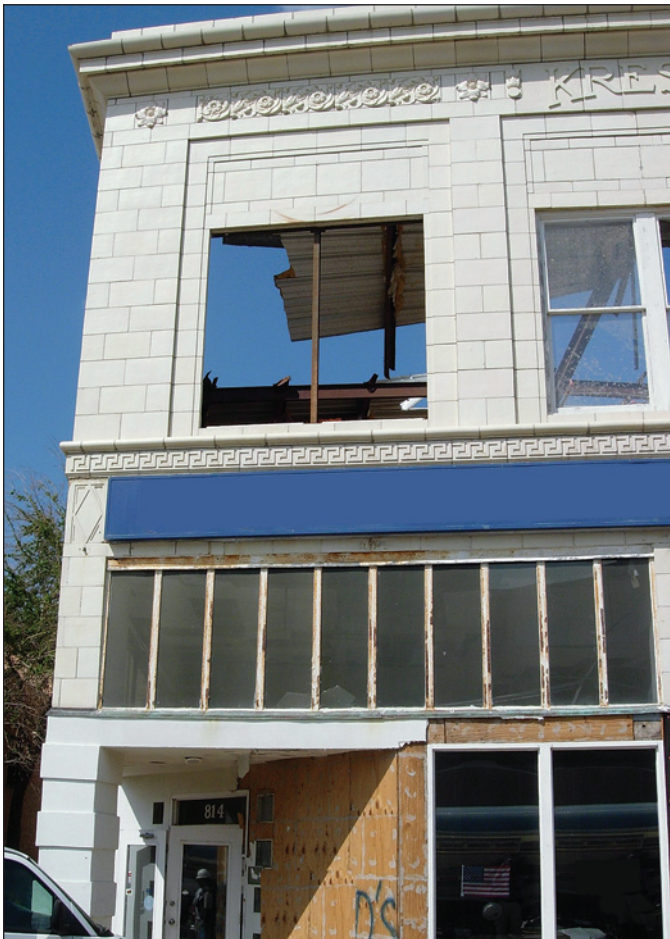
Figure 6-13.

Built in 1920, the Kress Building lost its exterior windows, allowing the wind to lift and tear off the roof. The original roof of the Kress Building was wood joist/rafters at 16 inches on center, which was lost in a fire. The replacement roof is light gauge steel framing with purlins at 4 feet on center and a standing seam metal roof covering. When the roof was replaced, the spacing of the fasteners holding down the roof covering was increased from 16 inches on center to 4 feet on center, contributing to its failure from uplift.

Internal pressure from wind through the broken windows lifted the roof (Biloxi, Mississippi).

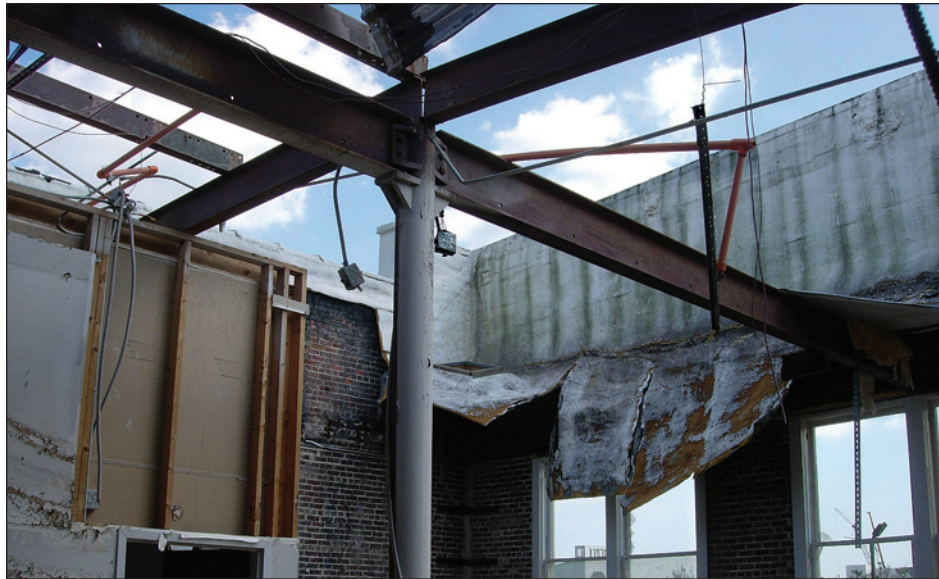
Figure 6-14.
Interior view of the Kress
Building showing roof torn
away (Biloxi, Mississippi)

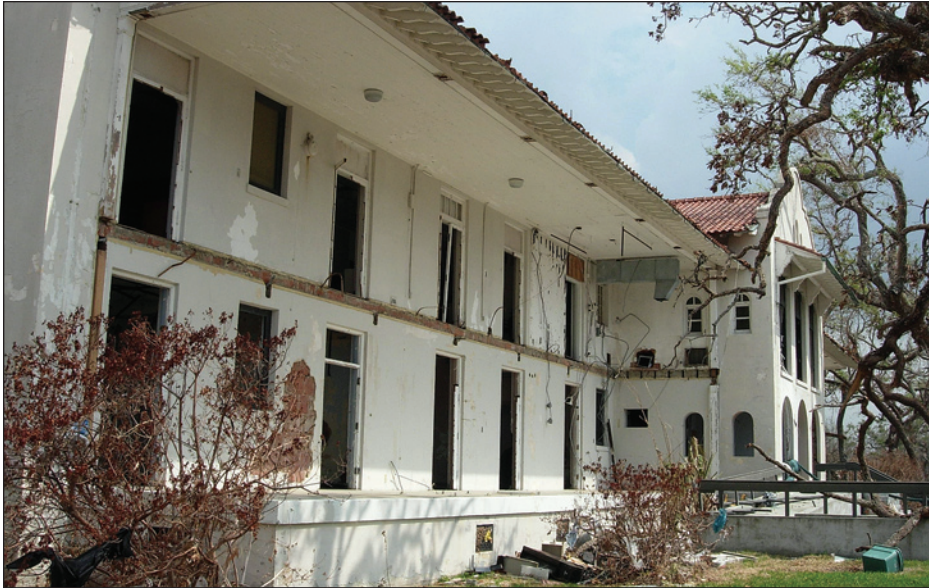
Built in 1917, the Gulfport Veterans Affairs Medical Center (VAMC) is a campus plan of a dozen historic structures. Although the VAMC in Gulfport lost the entire second floor porch and roof supports to velocity-flow floodwaters, the integral framing of the roof structure allowed the overhang to successfully survive the wind uplift from Hurricane Katrina (see Figure 6-15).

Figure 6-15. Loss of the entire second floor porch and roof supports to flooding; the main roof stayed successfully intact due to integral framing of the roof structure (Gulfport, Mississippi).

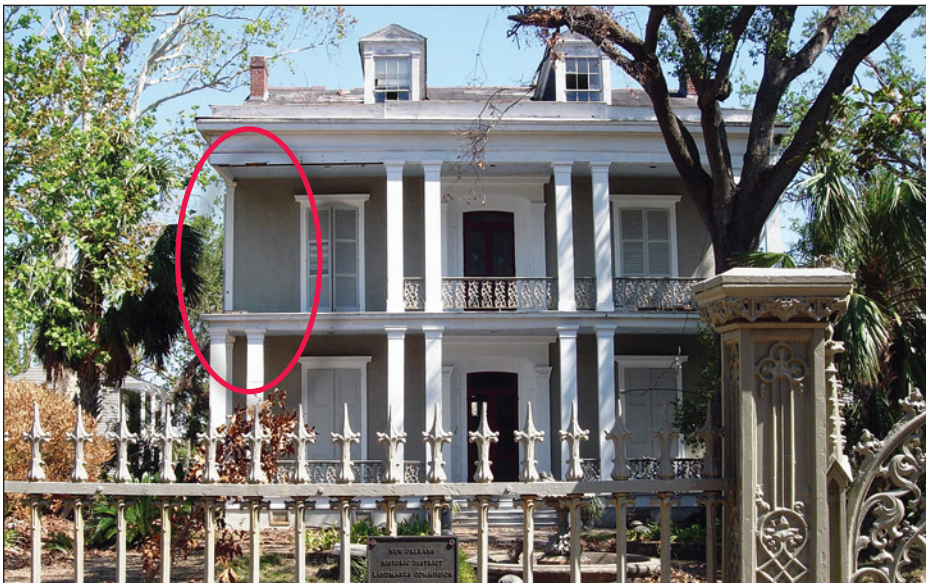
Built in 1858, the Benachi House lost two columns from the second floor front elevation from wind forces, as well as roof covering (see Figure 6-16). Its cottage house sustained structural damage from fallen trees (see Figure 6-17). The dead lawn and shrubs are an indication of long-term flooding.

Figure 6-16. Wind damage to the second floor columns of the Benachi House. Note missing columns (circle) (New Orleans, Louisiana).

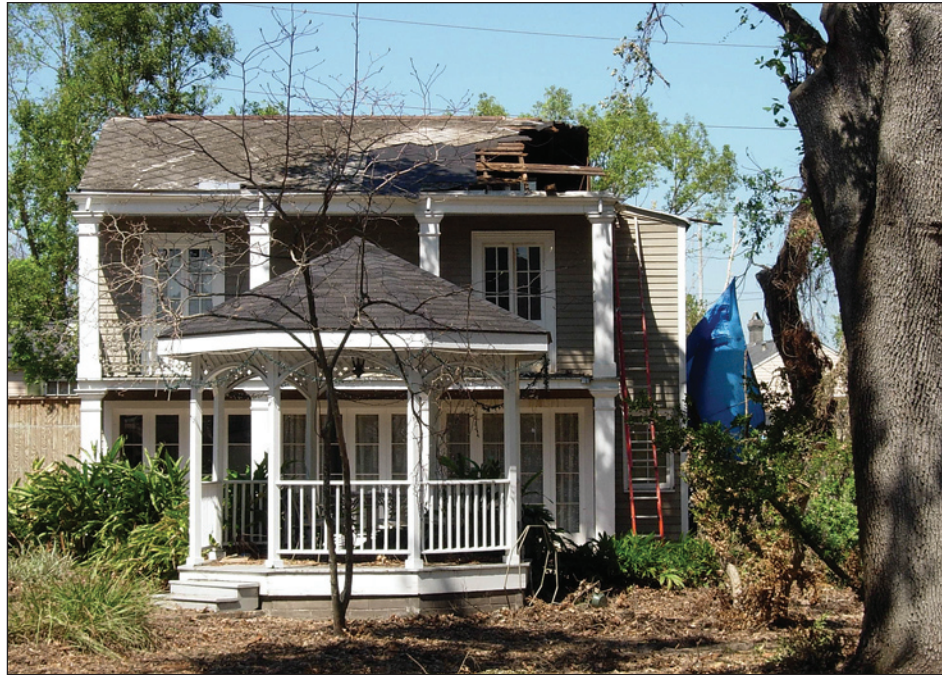
Figure 6-17.
Tree damage to the rear
cottage house of the
Benachi House (New
Orleans, Louisiana)

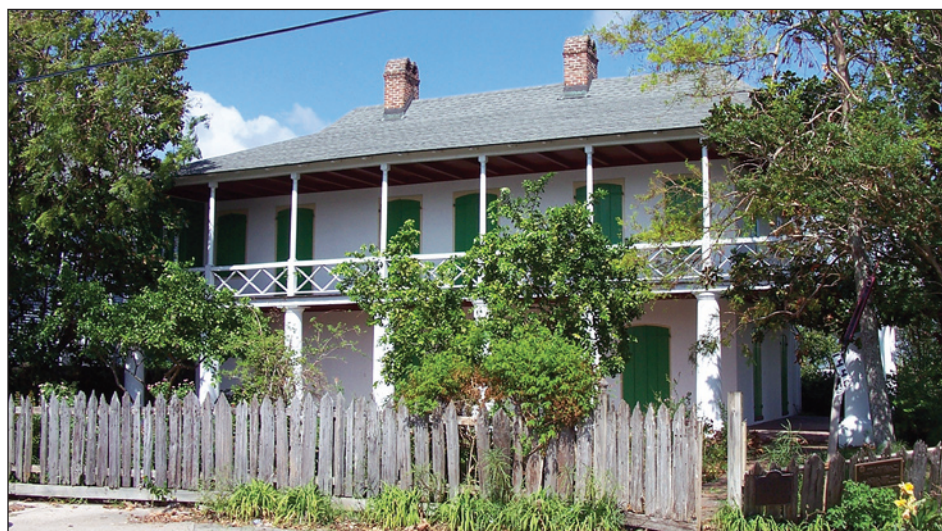
The Pitot House Museum successfully weathered Hurricane Katrina in part due to the presence of shutters on the windows, which protected the building's glazings and prevented wind penetration into the museum (see Figures 6-18 and 6-19).

Figure 6-18.
Front elevation of Pitot
House showing damage to
the front wood fence. The
house survived very well,
with no evidence of flood
damage and little wind
damage (New Orleans,
Louisiana).

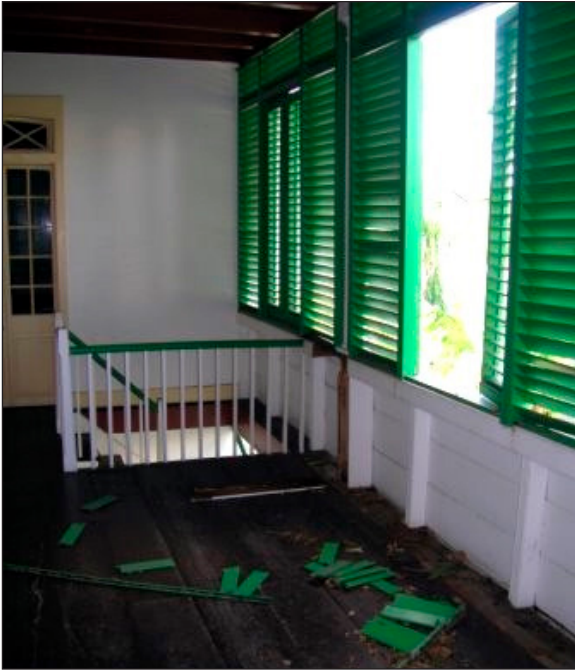
Figure 6-19.

Although one window did sustain damage from windborne debris, the remaining windows of the Pitot House were not damaged (New Orleans, Louisiana).

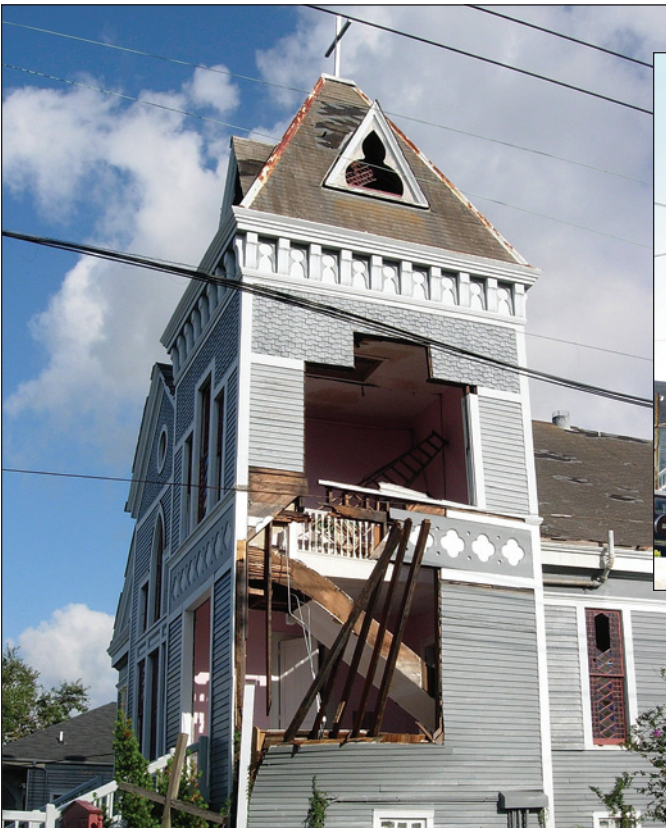
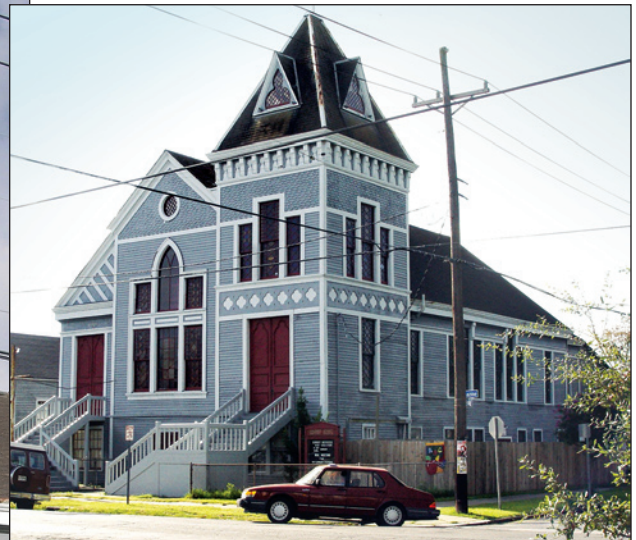
Figure 6-20.

Built in 1886, the wood-framed Valence Street Baptist Church, registered as a historic building, sustained wind damage, which allowed water intrusion (see Figure 6-20).

Hurricane Katrina wind damage to steeple, front door, and windows. The inset shows the church prior to Katrina (New Orleans, Louisiana).

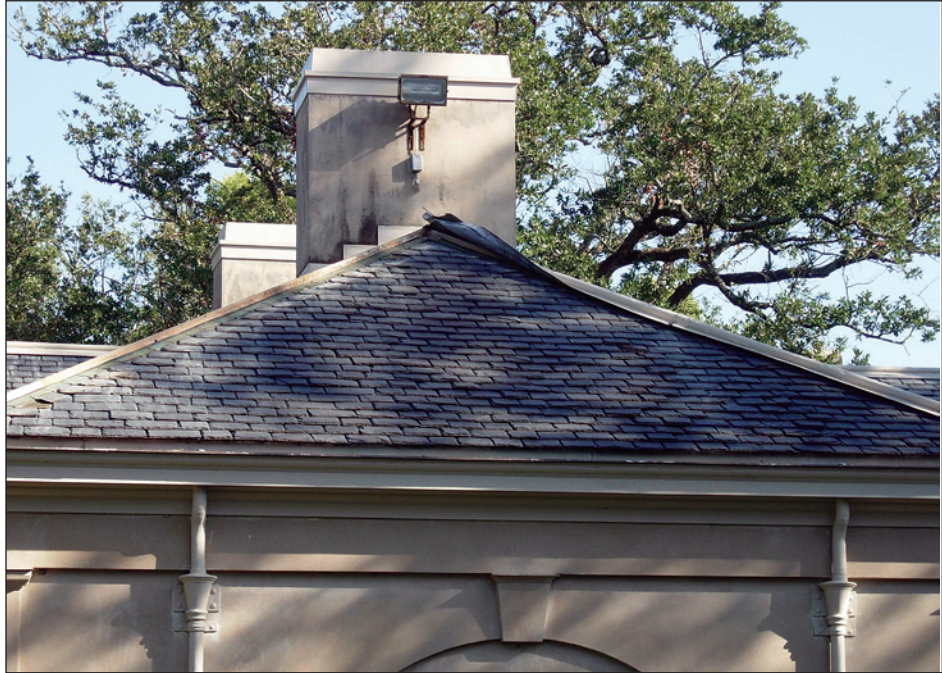
Longue Vue House and Gardens, described in Section 6.1.5, suffered wind damage to shutters and roof covering materials during Hurricane Katrina (see Figures 6-21 and 6-22).

Figure 6-21.
View of wind damage
to flashing along rake
of Longue Vue after
Hurricane Katrina (New
Orleans, Louisiana)

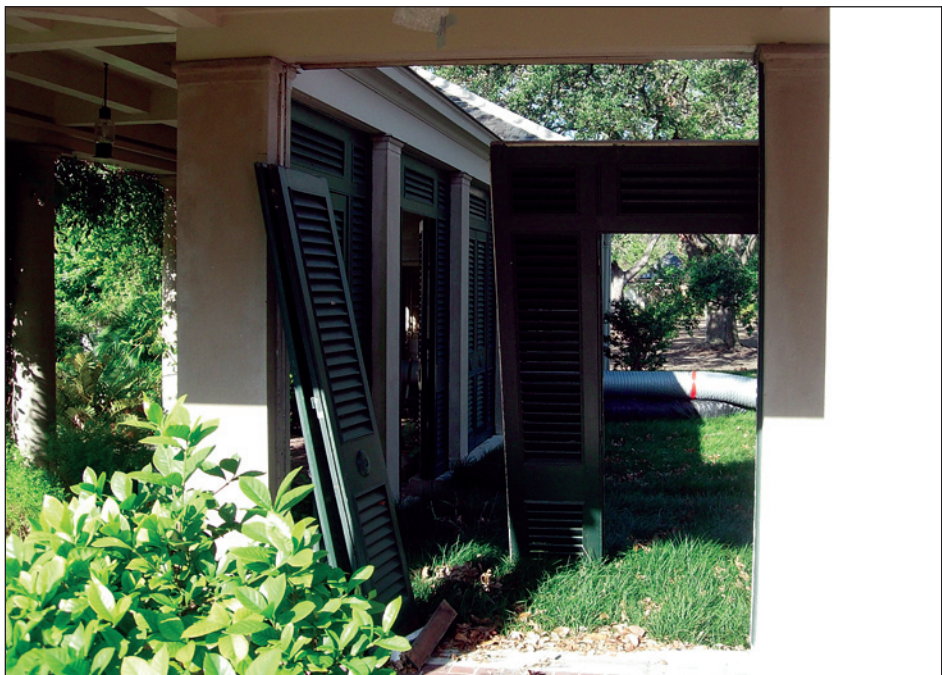
Figure 6-22.
View of wind damage to
shutters of Longue Vue
after Hurricane Katrina
(New Orleans, Louisiana)
