## 9. Mitigation Successes and Best Practices

*In addition to the wide range of damage observed, the MAT also found a series of mitigation projects and activities implemented prior to Hurricane Katrina that showcased the successes of mitigation in the affected area.*

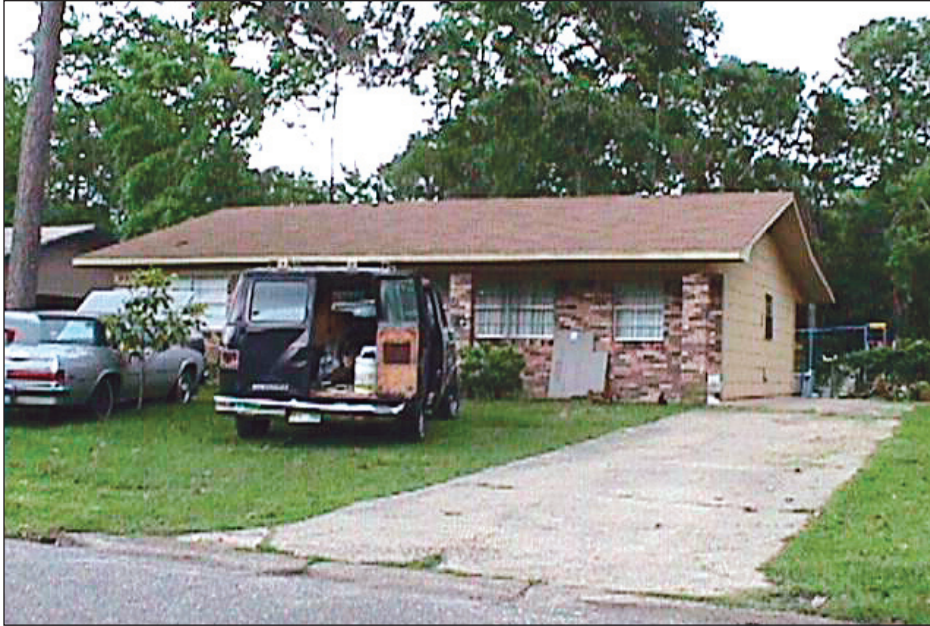
Figure 9-2.  
Pre-acquisition/pre-demolition photo of representative building included in project (photo ca. 1999/2000) (Gulfport, Mississippi)

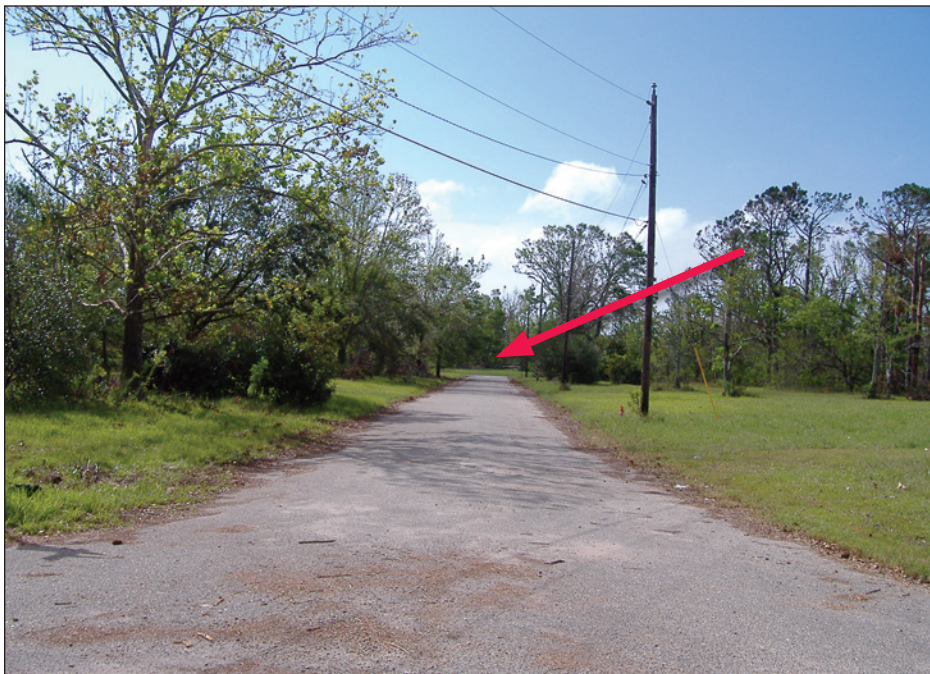
The community's goal in administering this project was to acquire as many properties as possible along these streets to avoid a "checkerboard" approach to mitigation, by uniformly removing all at-risk buildings from the target area. A number of the buildings acquired were repetitive loss properties (at least 17 of these had 4 or more insured losses since 1978 according to NFIP data). Several were also on State of Mississippi and Federal target repetitive loss lists. Based on MAT observations in the area (post-Katrina), the initial indication was that the majority of the acquired homes would have been flooded by up to 6 feet of water had they not been removed. As further evidence of this, houses just outside the project area appeared to have sustained significant damage from flooding.

Figure 9-3.  
This photo, taken post-Katrina, shows a few of the vacant lots after the acquisition project removed approximately 230 residential buildings from the flood hazard area. The primary source of flooding (Brickyard Bayou) is located just beyond and running perpendicular to the south end of this street (arrow) (Gulfport, Mississippi).

Approximately \$19 million in Hazard Mitigation Grant Program (HMGP), Flood Mitigation Assistance (FMA) program, and supplemental funding was used. (This total may include some additional buildings in Gulfport that have been approved, but not yet mitigated.) This project has essentially paid for itself with losses avoided in this one event.

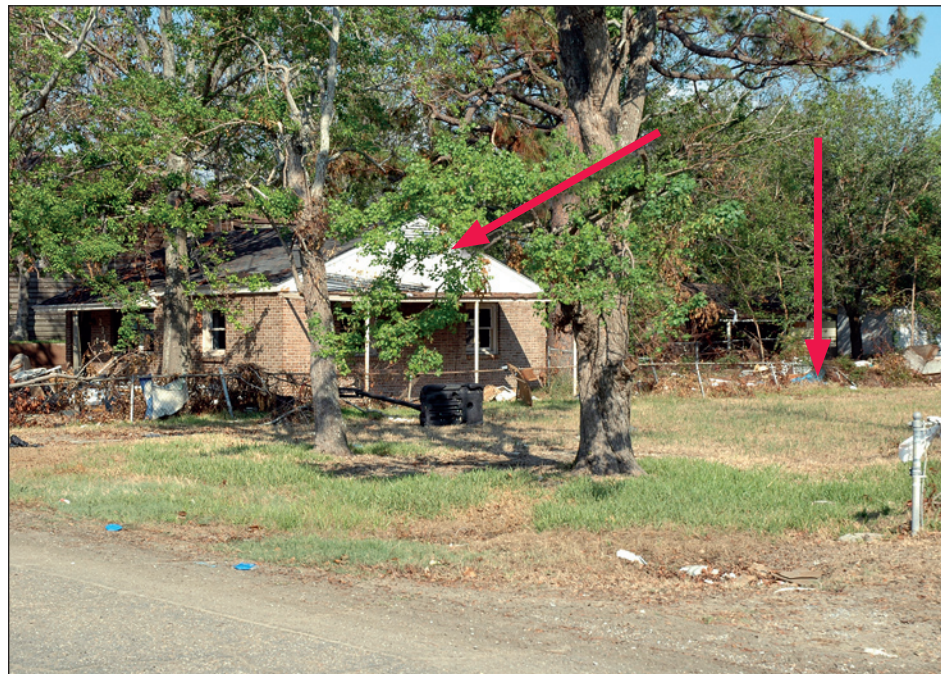
The City of Pascagoula used a combination of HMGP and supplemental funding (approved in 2001) to acquire and demolish approximately 10 at-risk buildings on Parsley Avenue, Chickasaw Avenue, Edgewood Avenue, Canty Street, Sherwood Street, Tupelo Avenue, 11th Street, and 14th Street (see Figure 9-4). Over half of the buildings included in this project were repetitive loss properties. Structures within the area that were not part of this project sustained damages from up to 6 feet of water.

Figure 9-4.  
An example of a vacant lot resulting from the acquisition/demolition project (right arrow) next to a property that did not participate in the program and that was damaged by Hurricane Katrina (left arrow) (Pascagoula, Mississippi).

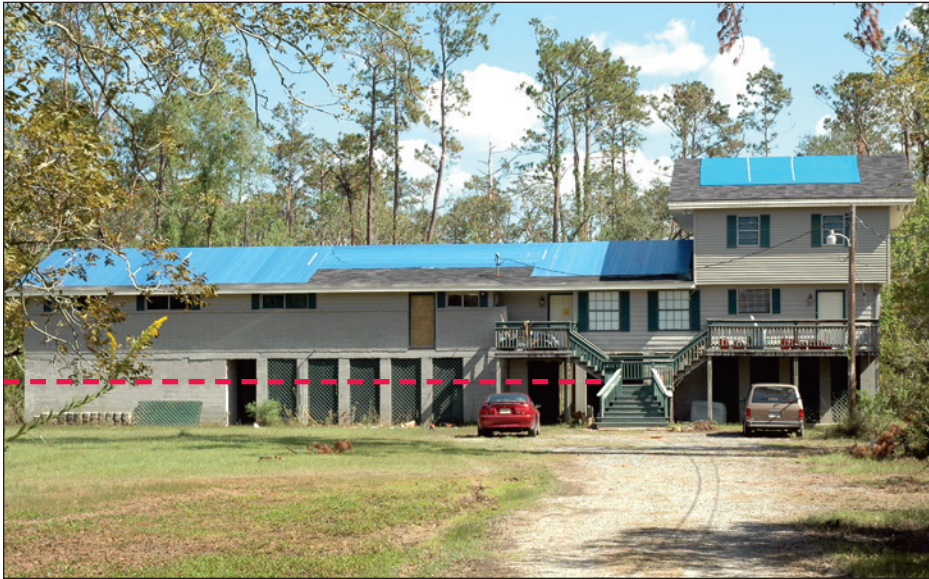
The residential property shown in Figure 9-5, located in Lacombe, Louisiana (in St. Tammany Parish southwest of Slidell), was elevated using HMGP funding to a height well above the flood depth associated with Hurricane Katrina. No flood damage was observed to the lowest finished floor. Some wind damage was noted to the roof, as evidenced by the blue roof covering.

Figure 9-5.  
Post-Katrina photo of an  
HMGP-elevated house.  
Note the estimated  
water line associated  
with Hurricane Katrina  
(red line) (Lacombe,  
Louisiana).

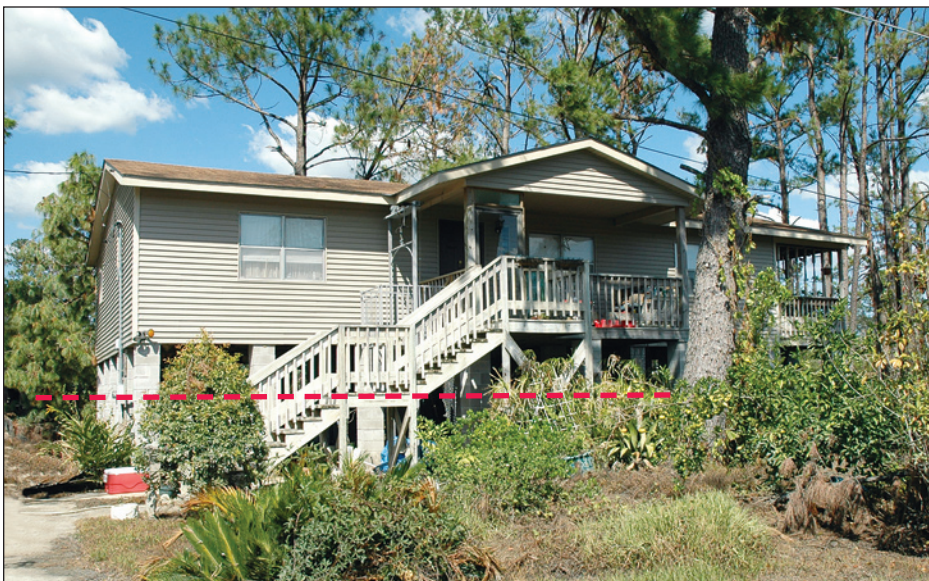
The house shown in Figure 9-6 was also elevated (using HMGP funding) above the flood depths associated with Katrina.

Figure 9-6.  
Another post-Katrina  
photo of an HMGP-  
elevated house. Note  
the estimated water  
line associated with  
Hurricane Katrina  
(red line) (Lacombe,  
Louisiana).

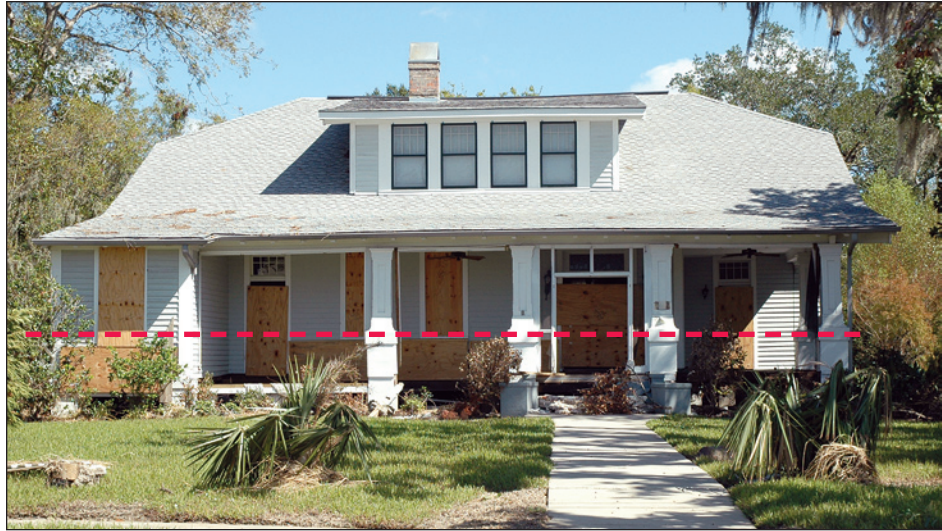
Figure 9-7.

This building, elevated only a few feet above ground level, was heavily damaged by storm surge and flooding during Hurricane Katrina. Note the estimated flood depth in relation to the first floor (red line) (Mandeville, Louisiana).

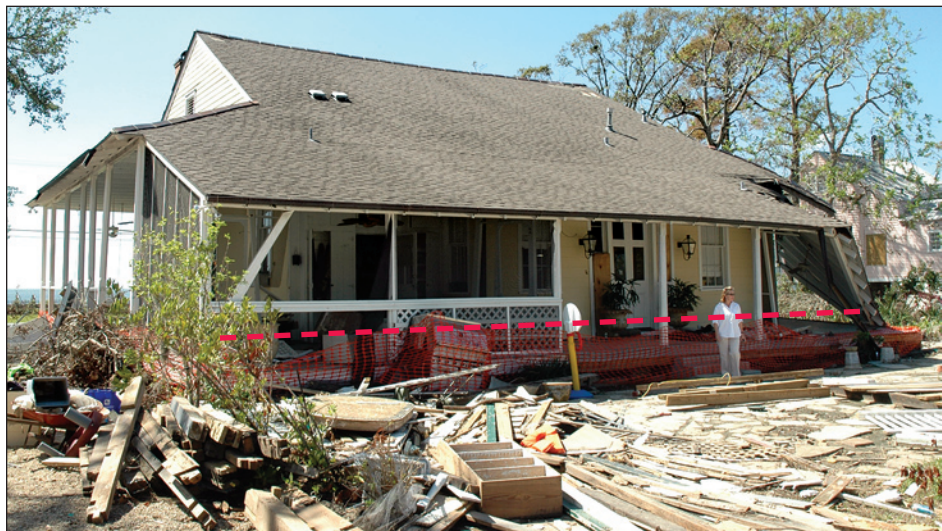
Figure 9-8.

This building is the oldest house in Mandeville (built in 1836) and is on the National Register of Historic Places. The house is elevated 3 feet on piers and suffered wave damage to 18 inches above the floor. Note the estimated flood depth in relation to the first floor (red line) (Mandeville, Louisiana).

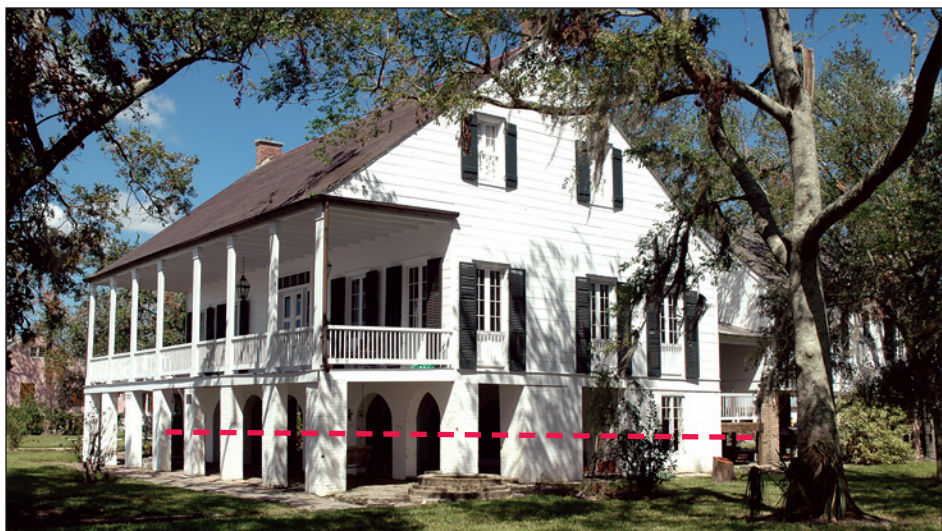
Figure 9-9.

In contrast to the preceding examples, this 100-year-old building, also on the National Register of Historic Places and located next door to the house in Figure 9-7, received minimal damage. Note the estimated flood depth in relation to the first floor (red line) (Mandeville, Louisiana).

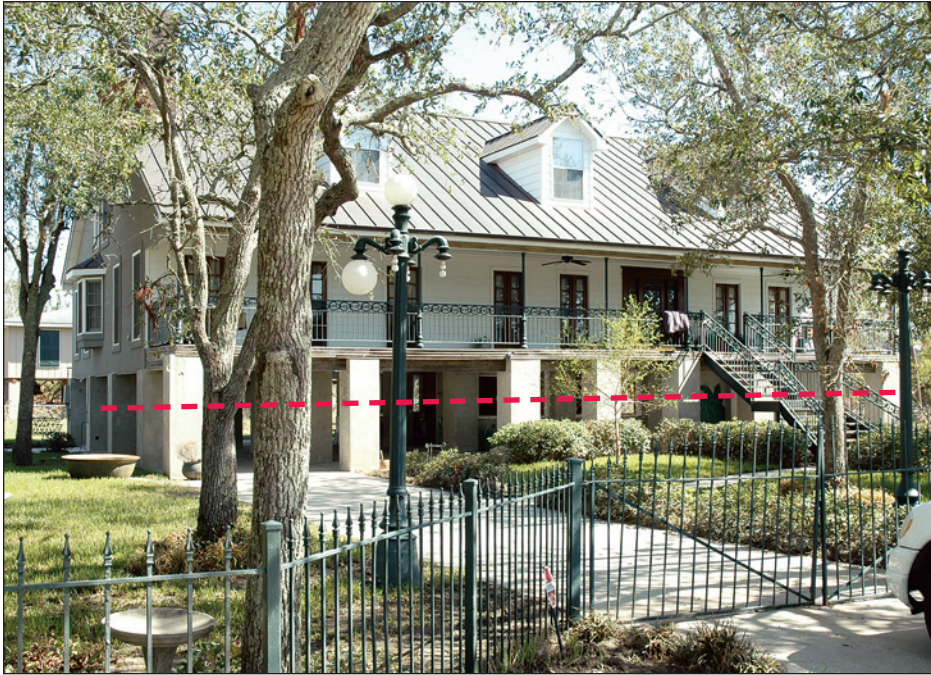
Figure 9-10. Another example of an elevated house that sustained only minor damage. Note the estimated flood depth in relation to the first floor (red line) (Mandeville, Louisiana).

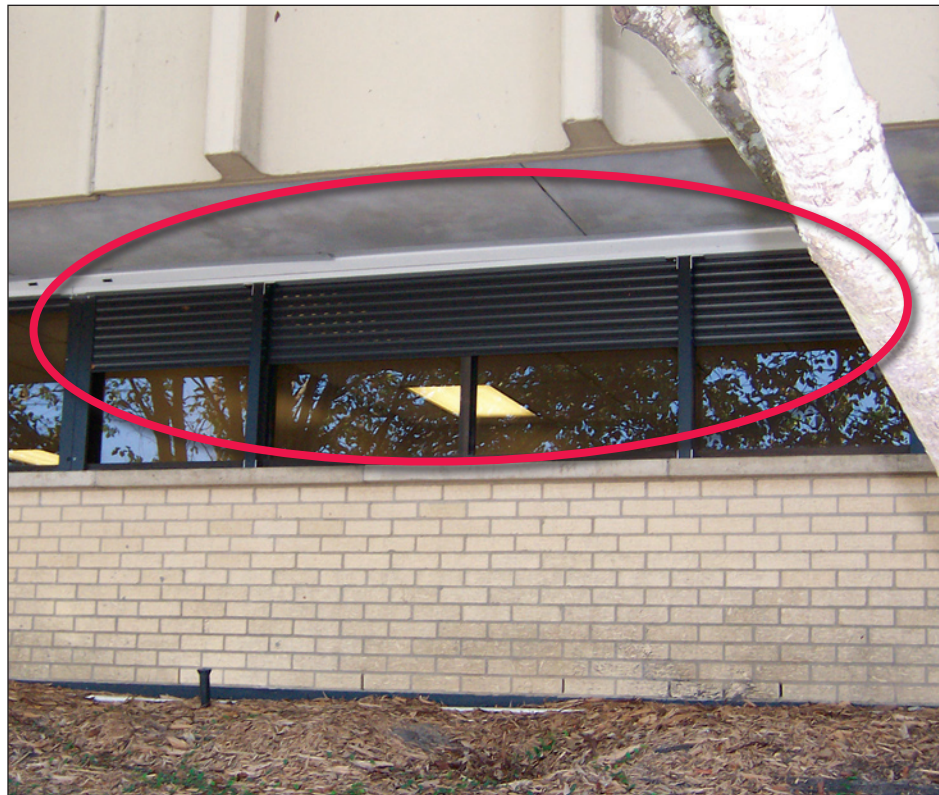
During Hurricane Katrina, windows of vehicles located in the building's parking lot were broken by windborne aggregate blown from the roof of the building. At least some of this aggregate, along with branches from nearby trees, is likely to have struck the shutters and may have broken the glass had the windows not been protected. The estimated wind speed for this location is 130 mph. (See Section 7.1.2 for additional information on this building.)

**Figure 9-12.**  
Closeup of the roll-down metal shutters on the Harrison County Courthouse building. Note the partially lowered shutters on the middle windows (circle) (estimated wind speed: 130 mph. Gulfport, Mississippi).

In 1999/2000 (following Hurricane Georges in 1998, which heavily impacted the Mississippi Gulf Coast), officials from Harrison County, Mississippi Emergency Management Agency, and FEMA's Building Sciences division met to evaluate the Harrison County Courthouse, which also currently houses the Harrison County EOC, as an opportunity for a potential hurricane wind retrofit project. Among other observations, the team noted rows of unprotected windows around the building, under which were stored valuable records and documents (some dating back to 1841), computers, and other electrical equipment. Roll-down metal shutters were installed using HMGP funding (see Figure 9-12).

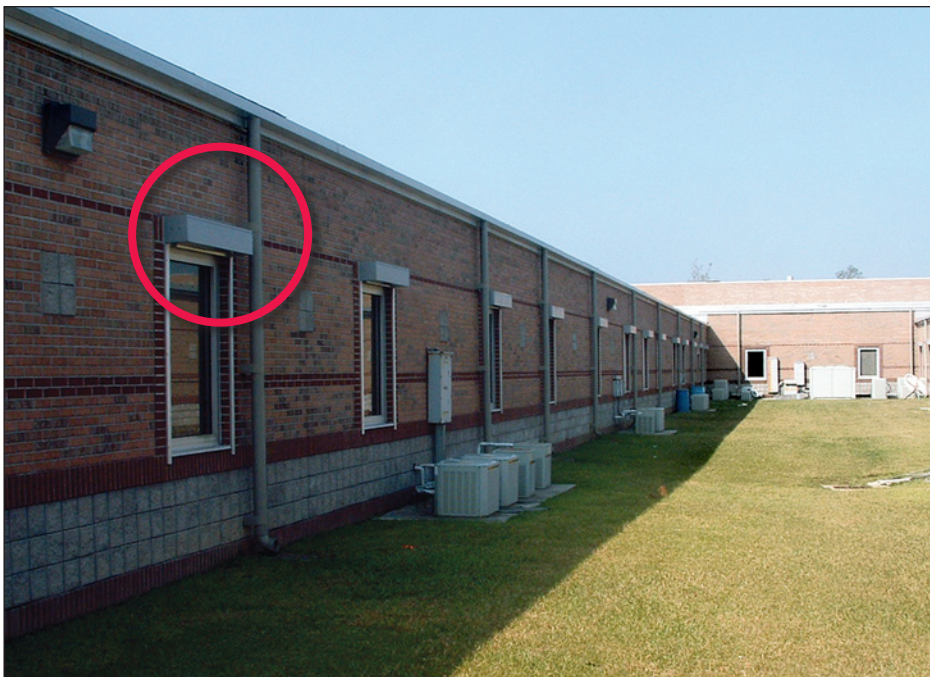
Figure 9-13.  
View of the Ocean Springs Middle School. Note the roll-down shutters over the windows (one example circled) (estimated wind speed: 120 mph. Ocean Springs, Mississippi).

In September 1998, Ocean Springs Middle School was awarded \$49,477 in HMGP funding for the installation of roll-down shutters to protect all exterior classroom windows from windborne debris (see Figure 9-13). Without glazing protection, occupants would be susceptible to injury from glass shards, and the building interior would be susceptible to damage from wind and wind-driven rain. The school was used as a shelter during Hurricane Katrina for as many as 400 people. Homeowners, urban search and rescue, police and fire personnel, and the National Guard used the facility as a shelter for up to a week. Following Hurricane Katrina, the MAT observed only minimal damage to the facility. In addition to the use of the shutters, other windows on the building were observed to have polycarbonate glazing.

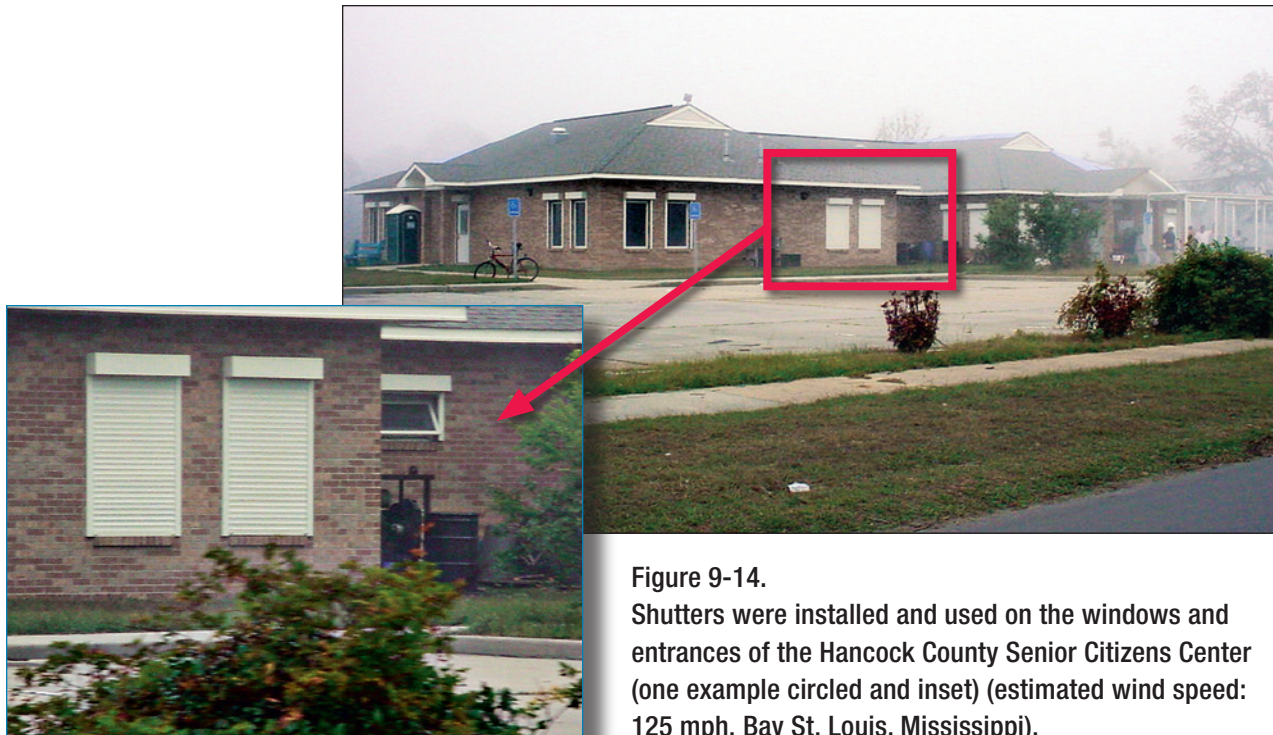
Hancock County Civil Defense ordered an evacuation of the facility as Hurricane Katrina approached. Water did not enter the building from the ground (e.g., stillwater flooding or storm surge), but water did enter the building via the roof, although structurally the roof remained intact.

Figure 9-14.  
Shutters were installed and used on the windows and entrances of the Hancock County Senior Citizens Center (one example circled and inset) (estimated wind speed: 125 mph. Bay St. Louis, Mississippi).

The Hancock County Senior Citizens Center received HMGP funding for the installation of shutters in 1999/2000 to protect windows and glazed doors from windborne debris (see Figure 9-14). The facility was identified in the local Hazard Identification and Risk Assessment Plan as a critical and essential facility, and was designated for use as a local shelter.

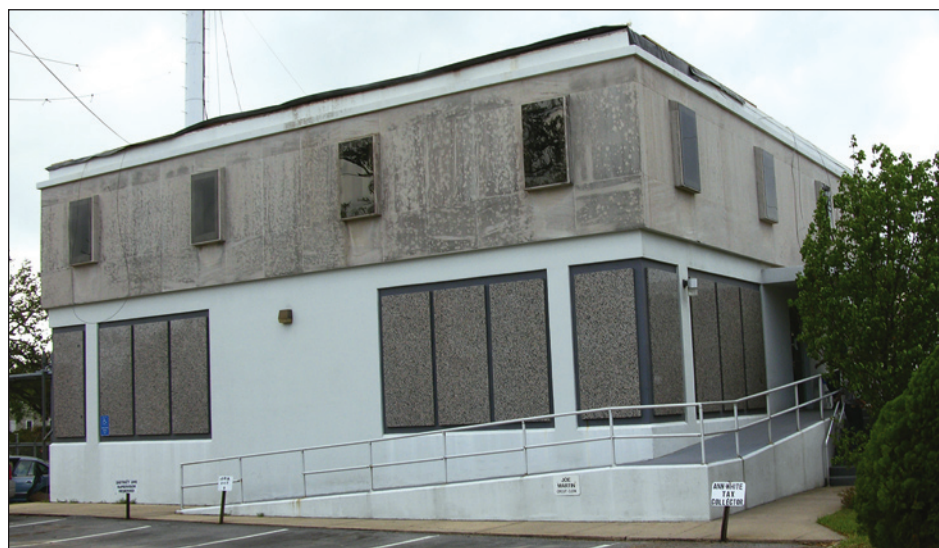
The Jackson County EOC facility was observed by the MAT to have several prudent retrofit/wind-hardening features that helped the building survive Katrina. Polycarbonate shutters had been permanently mounted over the exterior windows and glazed door at this facility (see Figure 9-15). The roof deck and walls were constructed of concrete, which provided substantial wind resistance and excellent protection from windborne debris. In addition, the emergency generator had been sufficiently elevated to keep it from being inundated by Katrina's floodwaters. (See Section 7.1.1 for more detailed information.)

Figure 9-15.  
Exterior view of the Jackson County EOC. Note the polycarbonate shutters over the windows (estimated wind speed: 105 mph. Pascagoula, Mississippi).

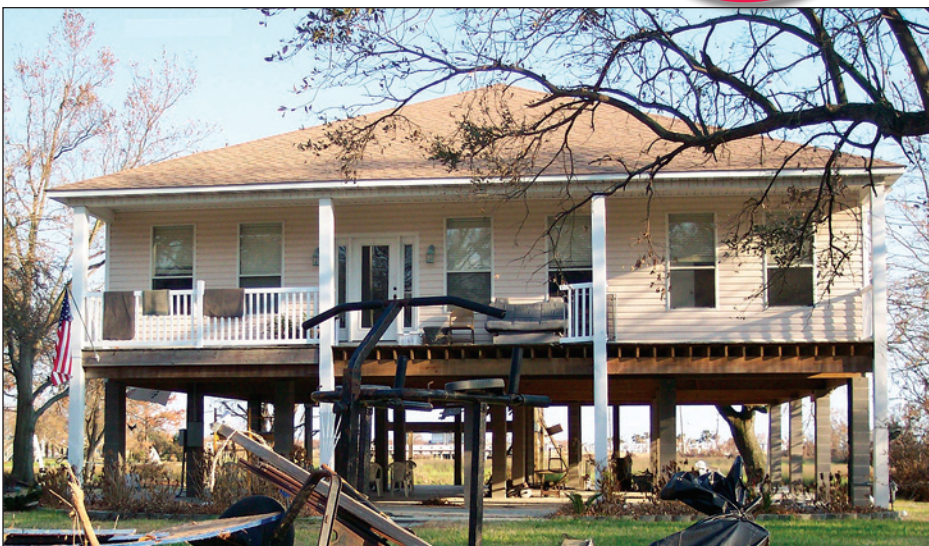
Figure 9-17. This photo was taken post-Katrina, illustrating the successful survival of this elevated building. The house was elevated to the citywide standard of 13.1’ msl using Increased Cost of Compliance funding (Pascagoula, Mississippi).

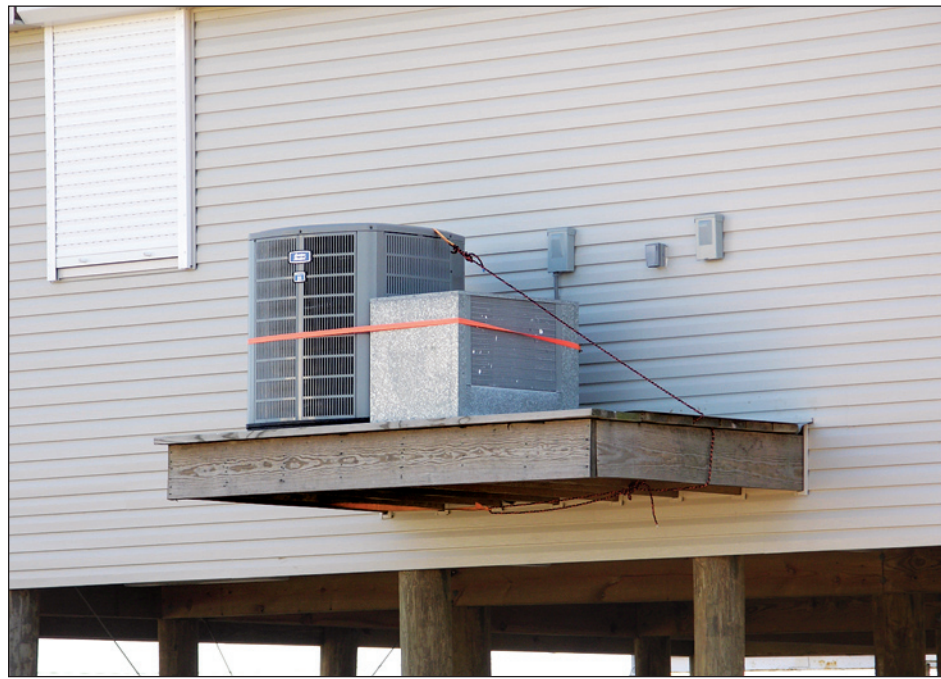
**Figure 9-18.**  
This condenser was strapped to a cantilevered platform to enhance blow-off resistance (estimated wind speed: 125 mph. Plaquemines Parish, Louisiana).

Condensers placed at ground level or elevated but not secured typically fail from hurricane wind and flood forces. Cantilevered platforms are preferable over knee-brace platforms and platforms that use piles at the outward corners, because knee-braces can be broken by flood-borne debris and piles for condenser platforms are usually smaller in diameter than the piles used for the building itself, and are more easily broken. Figure 9-18 shows a cantilevered condenser platform that performed successfully during Hurricane Katrina.

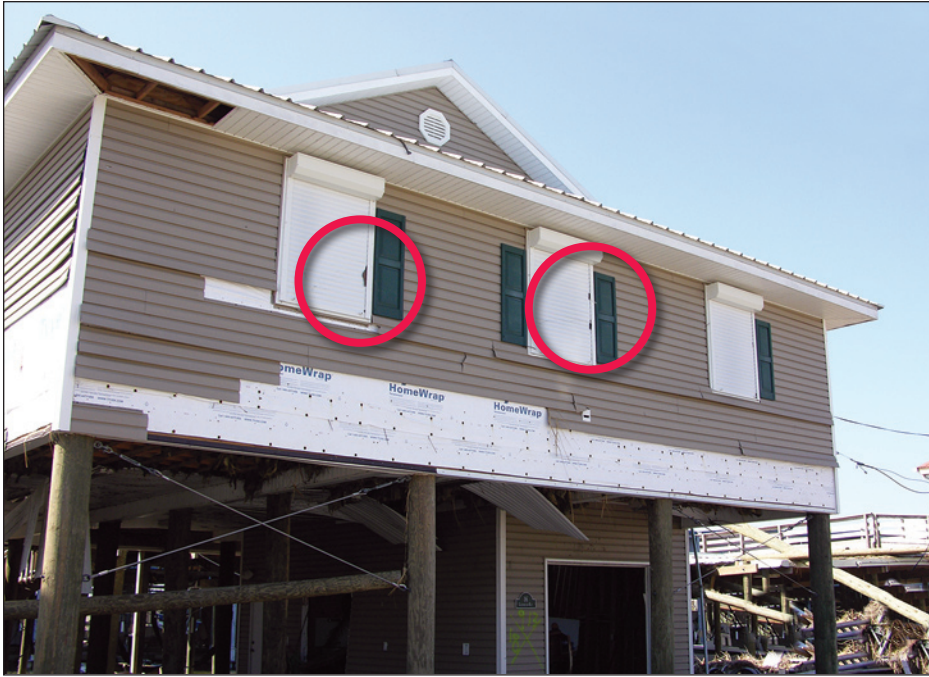
Shutters protected vulnerable glazing in the home shown in Figure 9-19. The home is located in St. Bernard Parish near Hurricane Katrina's path. The wind speeds in the area were sufficient to create damaging windborne debris; however, the shutters successfully protected the vulnerable glazing from breakage.

**Figure 9-19.**  
The black area at the left window and the two black areas at the middle window (circles) are pieces of asphalt shingle debris. Had the windows not been protected by shutters, they would have likely been broken by windborne debris (estimated wind speed: 125 mph. Shell Beach, Louisiana).
