HURRICANE

Katrina

8. Overview of Hurricane Katrina in the New Orleans Area

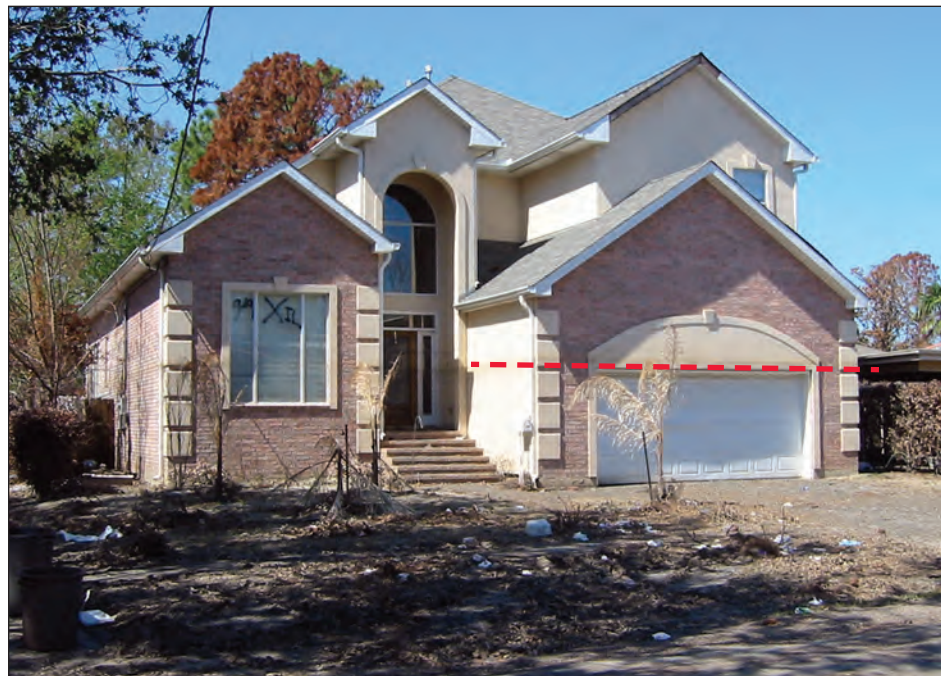
Figure 8-3.
Residential building
constructed
approximately 1 foot
above the BFE in
accordance with current
codes. Note flood depths
were even with the top of
the garage door, or about
3-5 feet above the first
floor (red line).

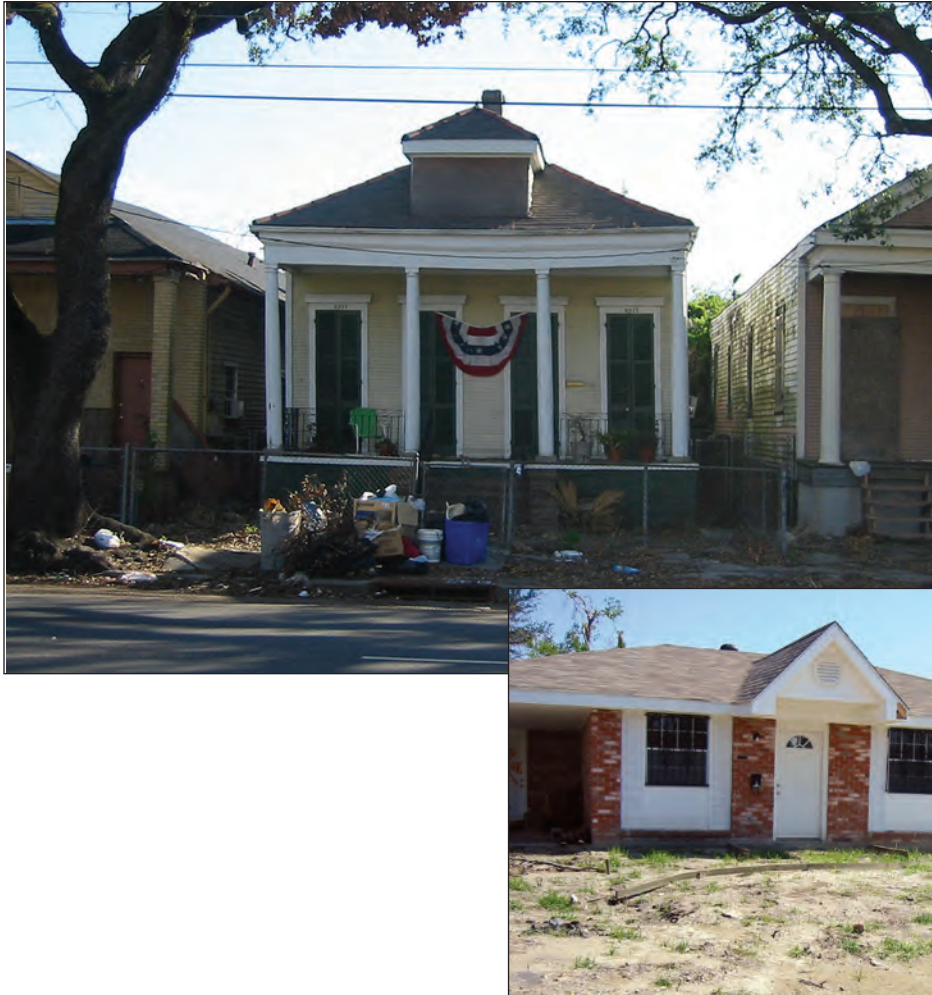
Figure 8-4. Comparison of building techniques in New Orleans. The older residence on the upper left has the first finished floor constructed several feet above grade. The newer residence on the lower right is constructed with a slab-on-grade foundation.

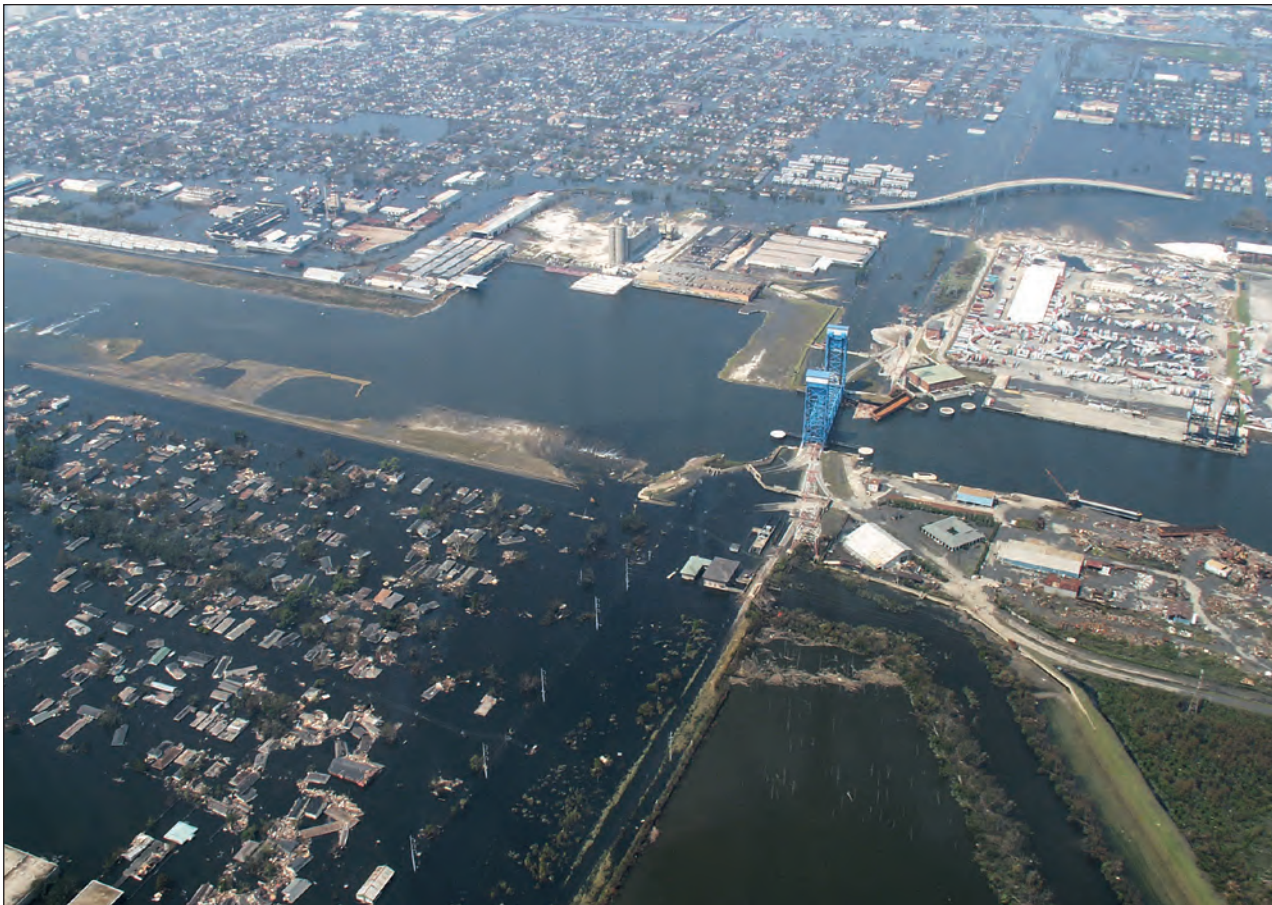
- First, the failure of the Industrial Canal (see Figure 8-5) and coastal levees produced intense flooding in eastern New Orleans and St. Bernard Parish, resulting in severe structural damage in the Lower Ninth Ward of New Orleans and Chalmette in St. Bernard Parish. Observations by the New Orleans Flood team indicated widespread destruction of

residential buildings in the Lower Ninth Ward from high velocity floodwaters and strong winds, waves, and high floodwaters that knocked buildings off their foundations, collapsed load-bearing walls, and caused other structural failures.

Figure 8-5. The Industrial Canal levee breach in New Orleans

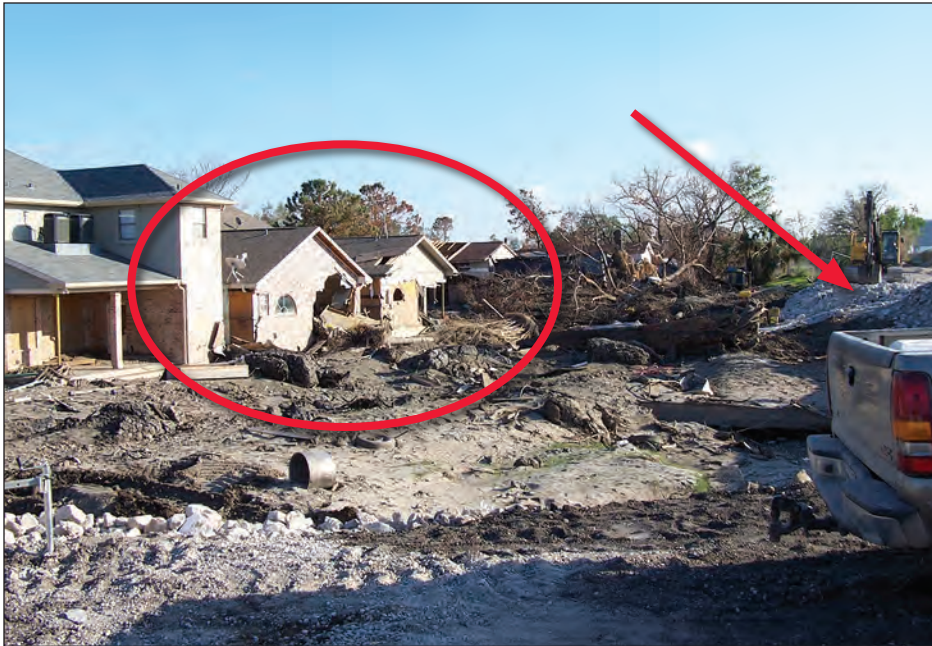
- Second, residential buildings sited immediately behind failed sections of levees or other flood control structures such as the 17th Street Canal levee breach suffered significant structural damage, failure of load-bearing walls, and excessive scour around slab foundations from large hydrodynamic forces generated by the levee breach (see Figure 8-6). However, these forces and impacts were quickly dissipated within a few blocks of the breach.

Figure 8-6. Structural damage to residential buildings (circle) in New Orleans located immediately behind the site of 17th Street Canal levee breach (arrow)

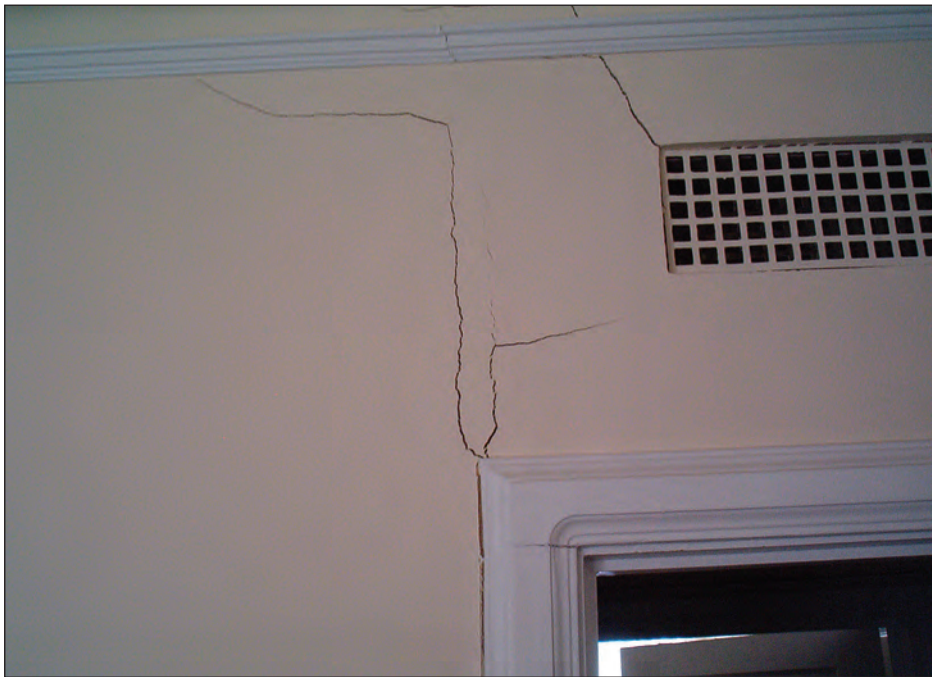
- Third, buildings sited on poor foundation soils suffered significant structural damage and cracking of load-bearing walls and sagging floors due to subsidence or differential settlement of saturated soils that support one or more foundation walls and/or piers (see Figure 8-7). While most of the observed structural damages triggered by soil settlement or subsidence did not constitute an imminent danger of collapse, such damages (and the underlying soil problems behind them) typically require analysis by a foundation engineer and can be expensive to isolate and repair.

Figure 8-7. Settlement cracks in upper floor wall of New Orleans residence due to subsidence/differential settlement of underlying foundation soils during long-duration flooding

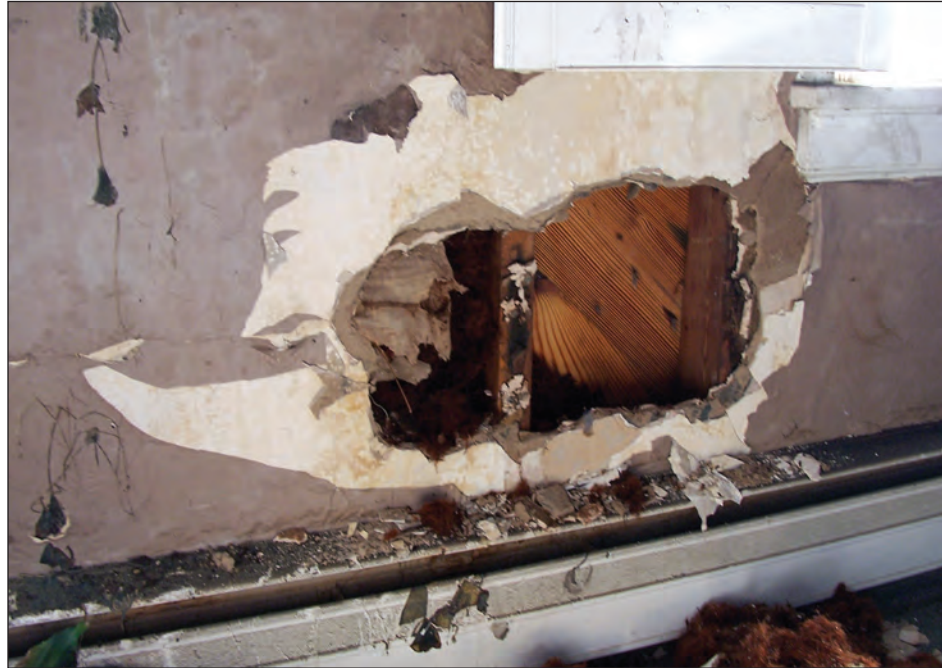
Figure 8-9.
Exposed wall studs and sheathing boards in 2-year-old New Orleans residential building, showing no significant deterioration from long-duration flooding.

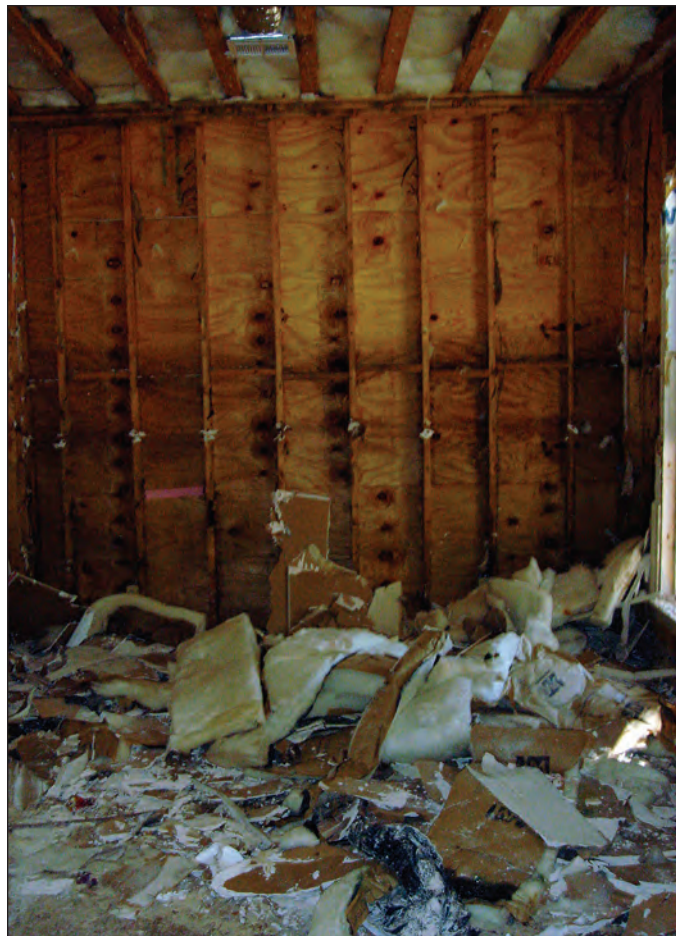
Figure 8-8.
Exposed wall studs and sheathing boards in 74-year-old New Orleans residential building, showing no significant deterioration from long-duration flooding

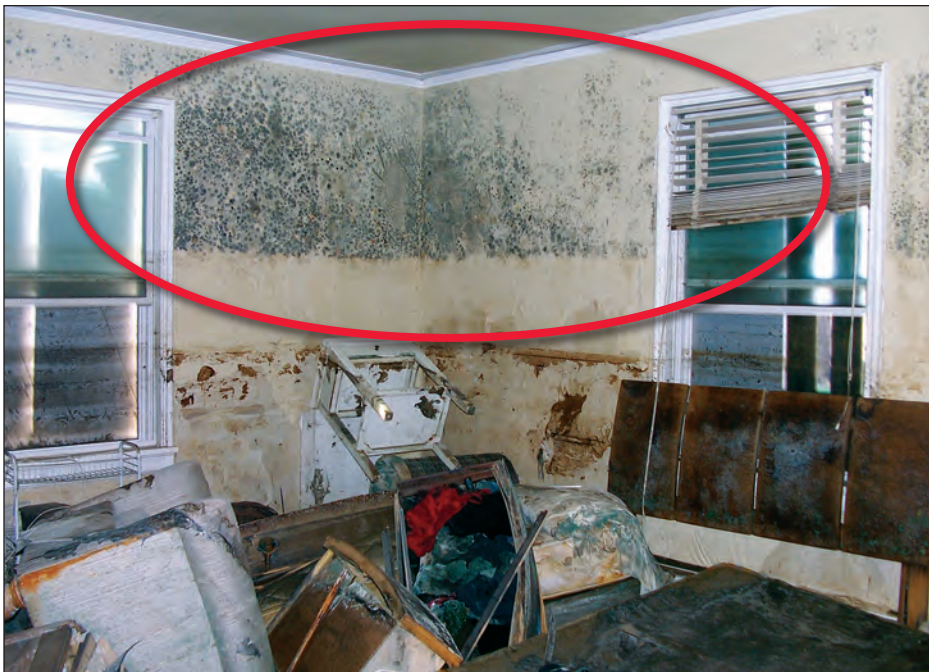
Figure 8-10.
Typical interior flood damage to residential building in New Orleans, showing extensive mold growth (circle)

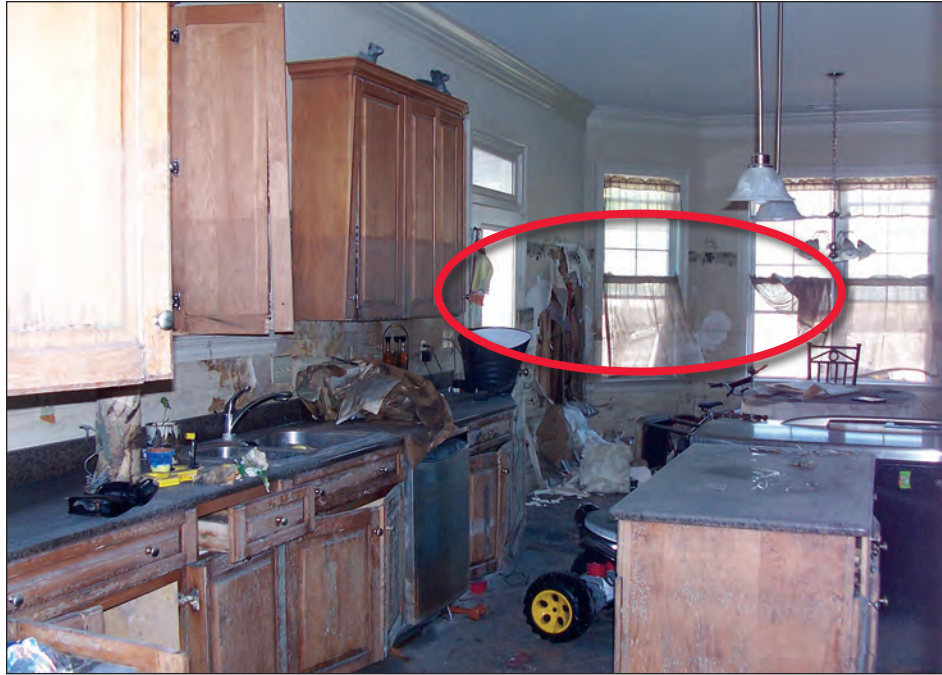
Figure 8-11.
Typical interior flood damage to residential building in New Orleans, showing light mold growth (compare to Figure 8-10)

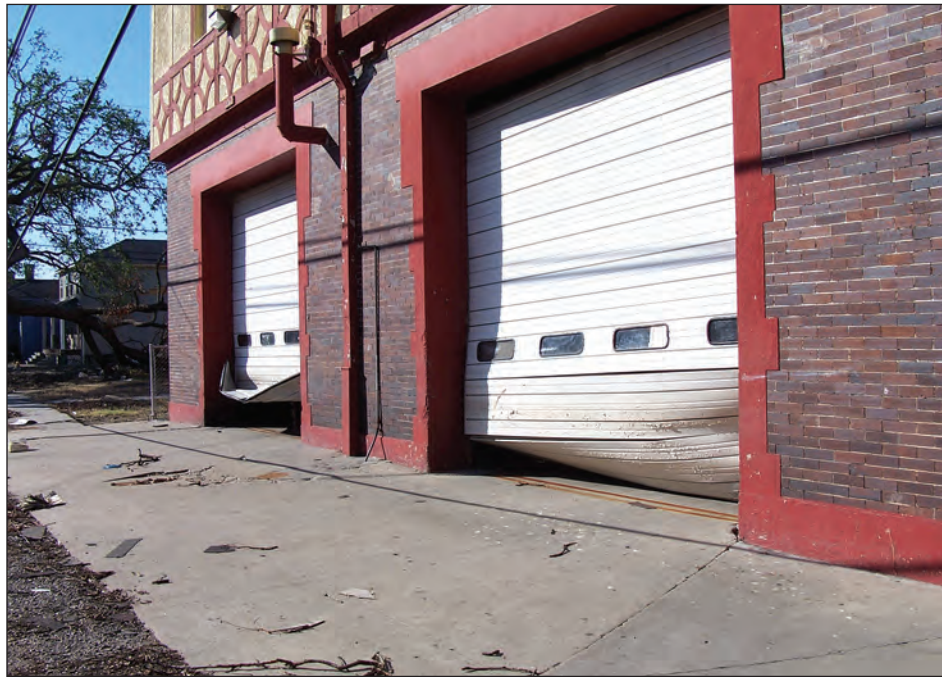
Several fire stations in New Orleans suffered flood damage to garage bay doors (see Figure 8-12). The fire stations in New Orleans observed by the MAT did not contain fire trucks or other heavy equipment; these appear to have been relocated prior to the flood. Many New Orleans hospitals suffered interior damage such as collapsed drop ceilings due to a loss of emergency power generators, which shut down HVAC systems used to control temperature and humidity. In some hospitals, the loss of emergency generators resulted from flooding of the generator controls or the fuel storage tanks (see Figure 8-13). However, in most hospitals, the loss of emergency generators occurred as a result of mechanical breakdown from extended use following Hurricanes Katrina or Rita.

Figure 8-12.
Damage to garage bay doors at fire station in New Orleans. The door on the right was pushed in by flooding; the door on the left appears to have been pulled open from the outside by looters.

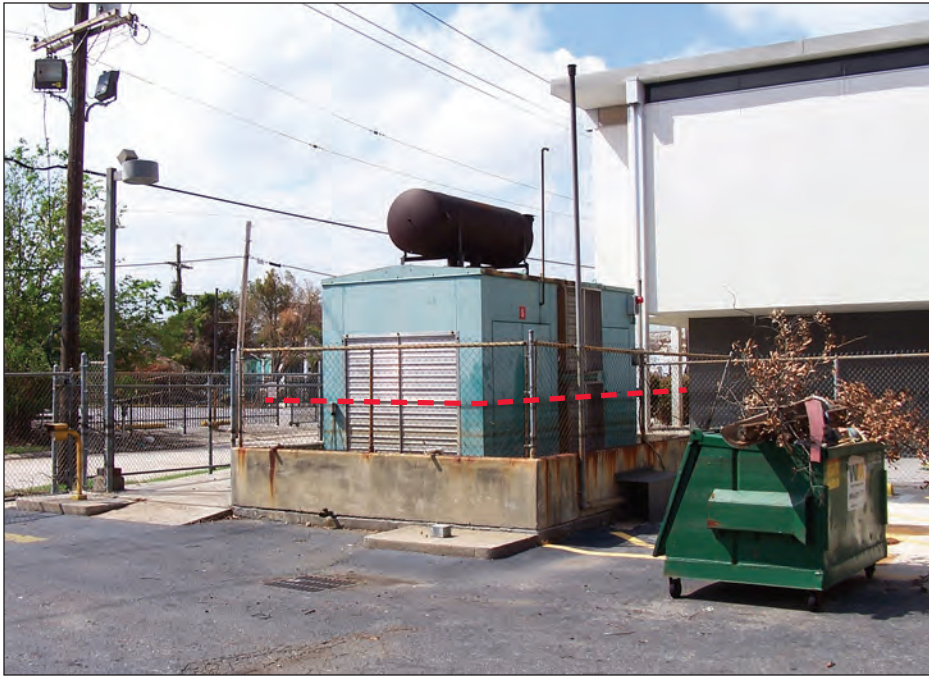
Figure 8-13.
Flooded emergency
generator at hospital in
New Orleans (note flood
line in red)

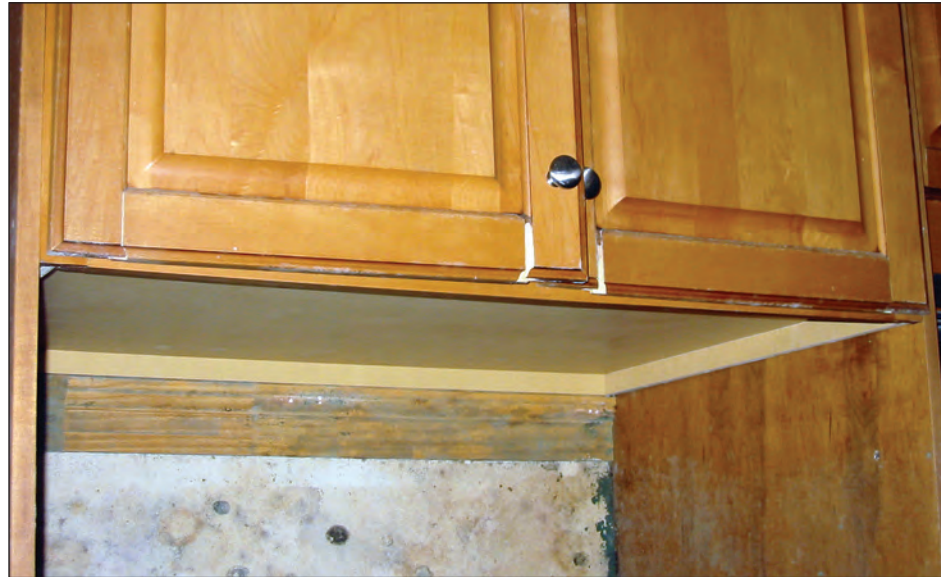
Figure 8-14.
Kitchen cabinet doors
above the flood level
were damaged from the
excessive moisture in the
house from long-duration
flooding.

- **Interior doors and cabinets.** The majority of interior doors and cabinets observed in New Orleans buildings were constructed of laminated wood products. The water vapor migration that occurred throughout many building interiors caused countless laminated wood passage doors, and cabinet doors and drawers to swell shut (see Figure 8-14).

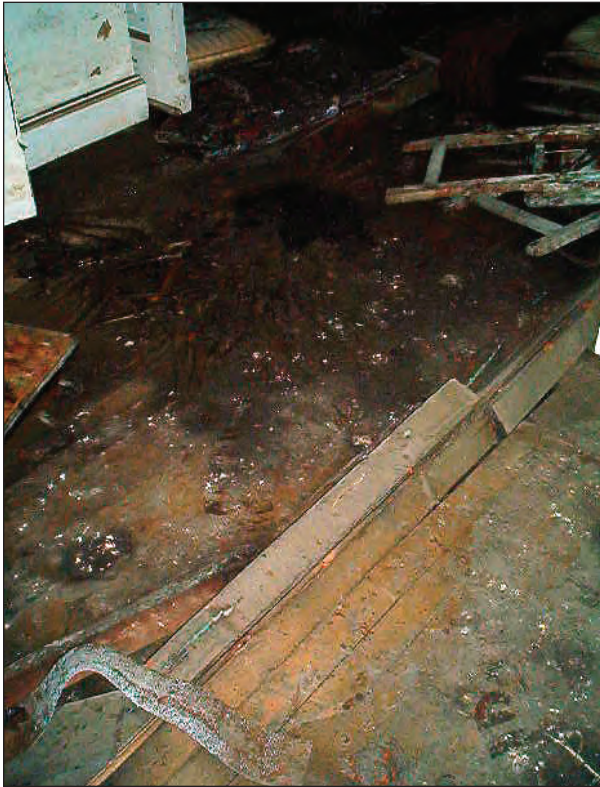
Figure 8-15.
Flood residue and buckled floor observed on General Diaz Street. A sample of the flood residue was collected for analysis.

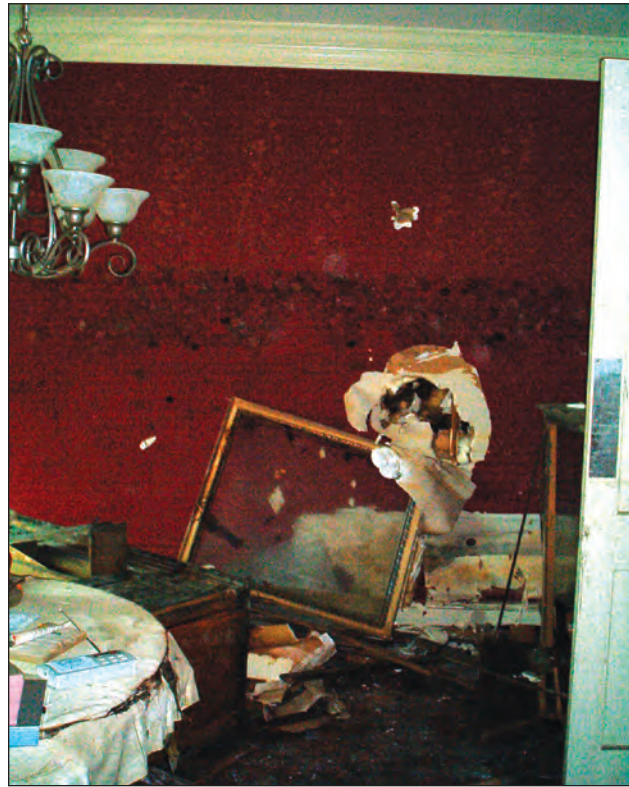
Figure 8-16.
Samples were collected from wall materials both above and below the waterline as shown on this wall of a house on Memphis Street. Where practical, samples were collected from surfaces that were already substantially damaged or scheduled for tear-out.

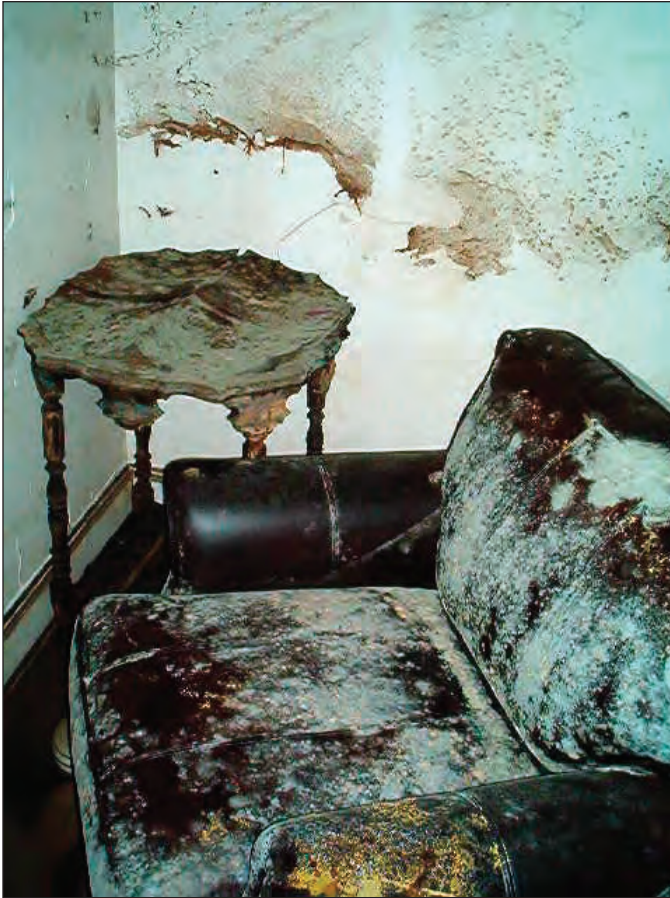
Figure 8-18.
Prolific mold growth was seen on porous contents in most inspected buildings.

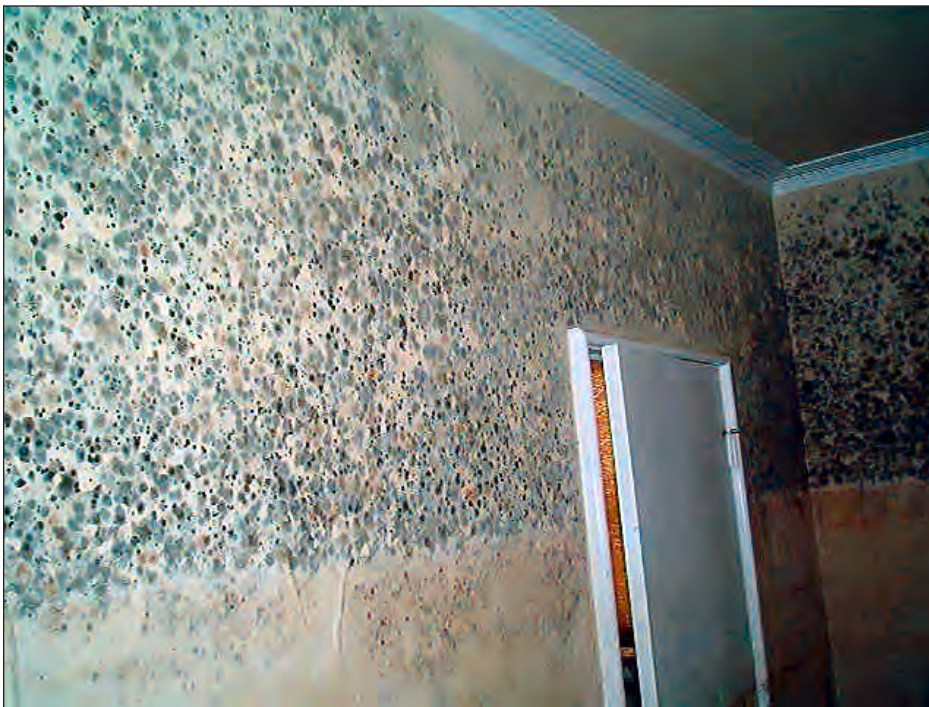
Figure 8-19.
The mold growth on the walls was generally much more vigorous above the floodwater level than below it. Sediments, heavy metal contamination, and oil film residue, as well as material moisture content and lack of exposure to air during flooding, may contribute to minimizing the fungal growth on the saturated wall materials.

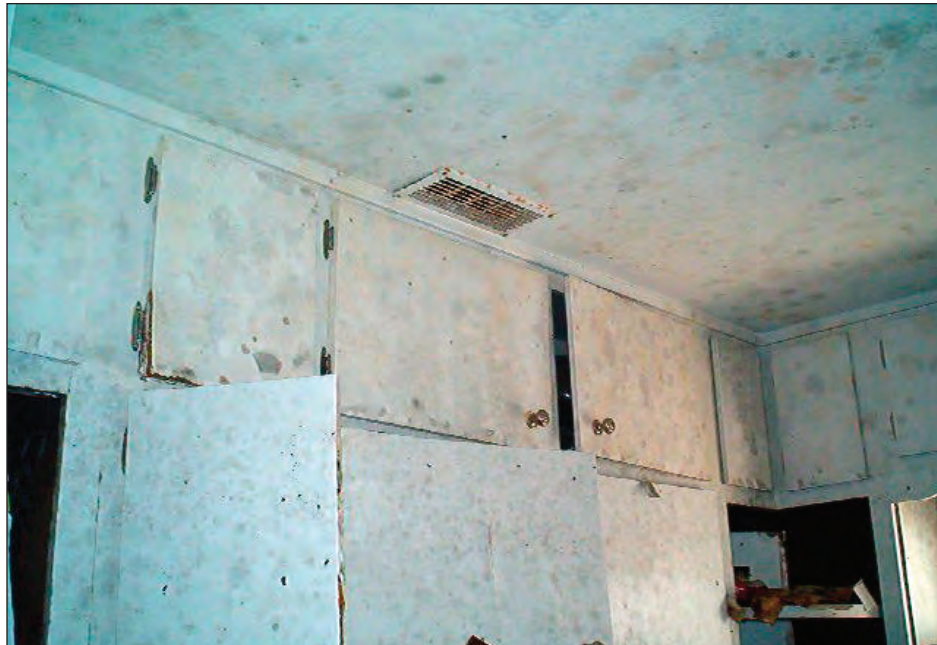
Figure 8-20.

In many buildings, the mold growth above the waterline appears to have been fueled by condensation of moisture in addition to water “wicking.” The upper cabinets and kitchen ceiling in the building on General Diaz Street were well above the floodwater line, yet showed extensive fungal growth.

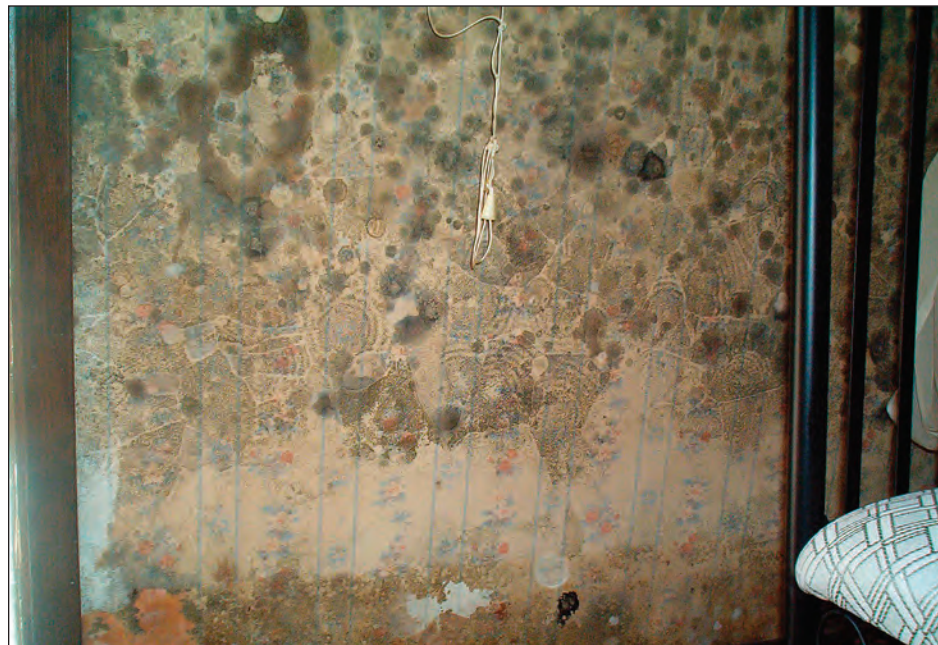
Figure 8-21.

On Savoie Court, fungal growth was observed up to the ceiling on some walls, despite the fact that floodwaters only reached up 18-24 inches. This wall showed thick mold growth both above and below the high water mark.
