HURRICANE

Katrina

IN THE GULF COAST

7. Performance of Critical and Essential Facilities

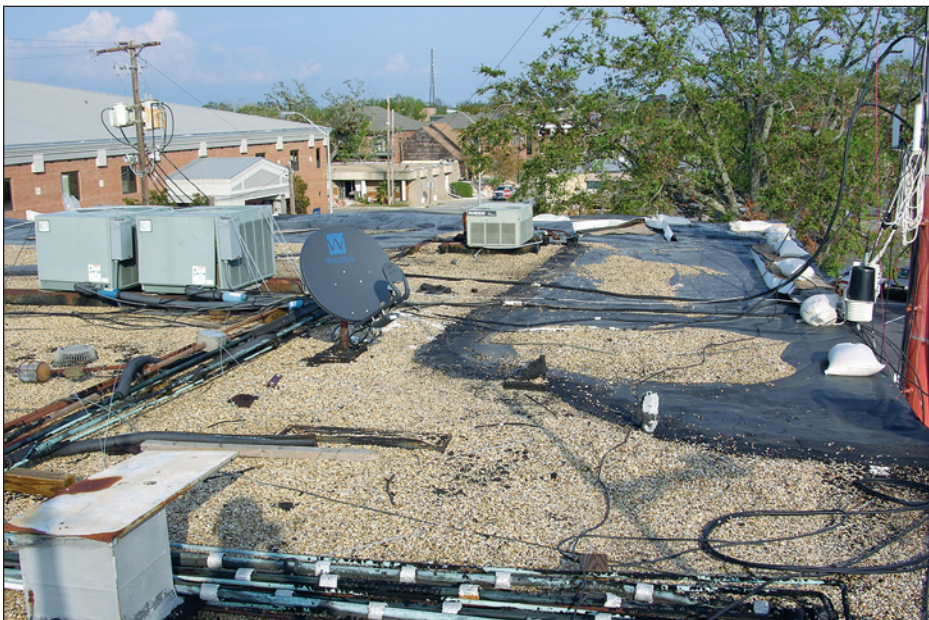
Figure 7-1.

Floodwater rose to about an inch below the first floor, which is approximately 4-1/2 feet above grade. Wind blew off a portion of the roof membrane and blew aggregate from the roof (see Figure 7-1). The roof blow-off initiated with the metal edge flashing, which had a 5-inch vertical face that was uncleated, making it susceptible to lifting and peeling. The communications tower was also toppled (see Figure 7-2). The rooftop condensers were strapped to their curbs (Figure 7-2 inset), but the straps and their connections appeared inadequate; the condensers would have likely blown away if the winds had approached the current design wind speed.

The roof membrane blew off at the far end and along a portion of the right side of the roof. Aggregate was also blown off. An emergency roof repair was made prior to the MAT's observation (estimated wind speed: 105 mph. Pascagoula, Mississippi).¹

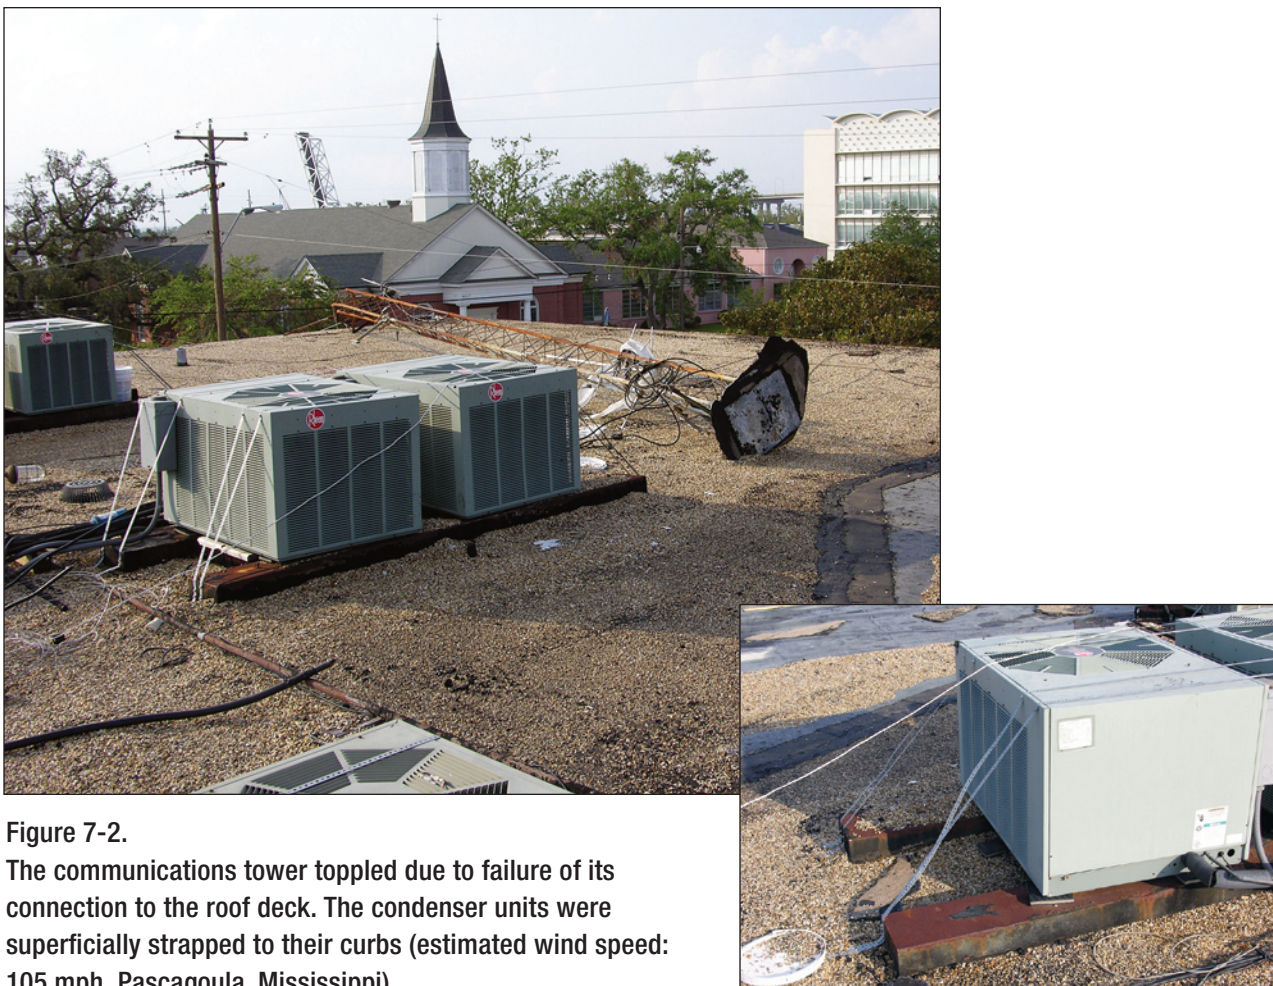
Figure 7-2.
The communications tower toppled due to failure of its connection to the roof deck. The condenser units were superficially strapped to their curbs (estimated wind speed: 105 mph. Pascagoula, Mississippi).

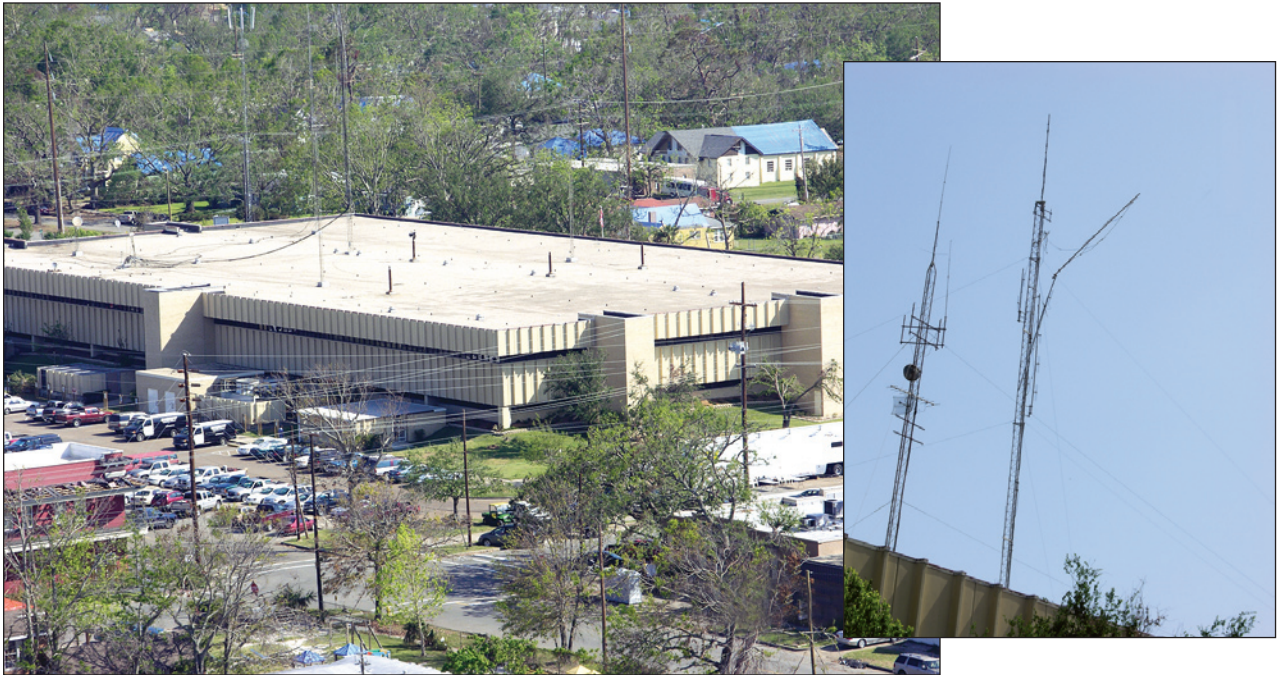
Figure 7-3.

The EOC is located near the center of the first floor of the First Judicial District Courthouse. A portion of one of the communications towers was damaged by wind (estimated wind speed: 130 mph. Gulfport, Mississippi).

Even though there was a parapet, aggregate was blown from the roof and broke the windows of a large number of vehicles in the parking lot. The parapet height varied; at the roof highpoint, the parapet was 14 inches high. A few sections of coping blew off the parapet, but a progressive roof membrane failure did not occur. A small satellite dish was blown off the roof and it appeared to have been mounted on wood sleepers. Rather than anchoring the sleepers to the deck, small blocks of concrete had been placed over the sleepers. A portion of the communications tower was damaged by wind. Some rainwater leakage occurred along a portion of the east wall, but

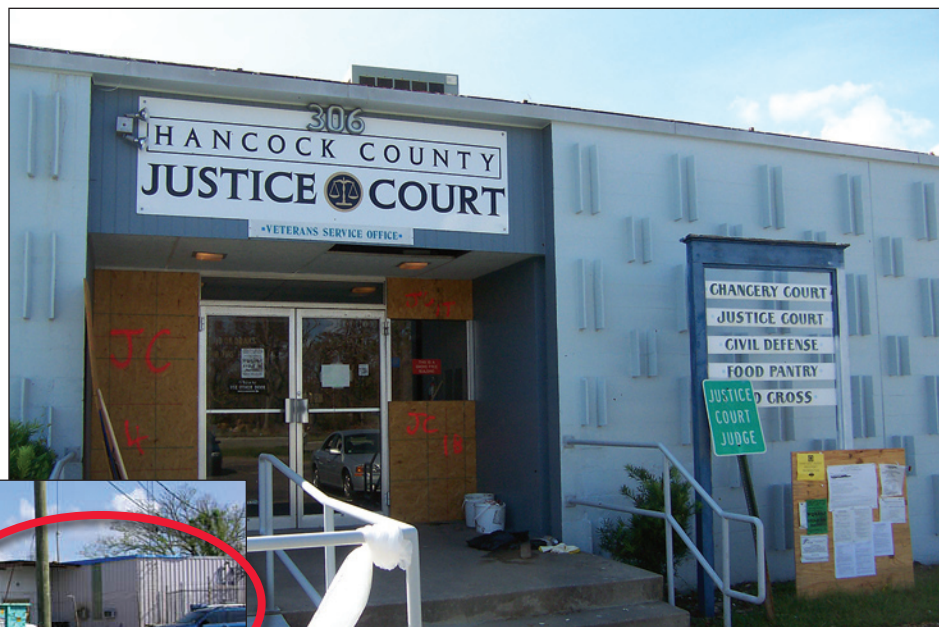
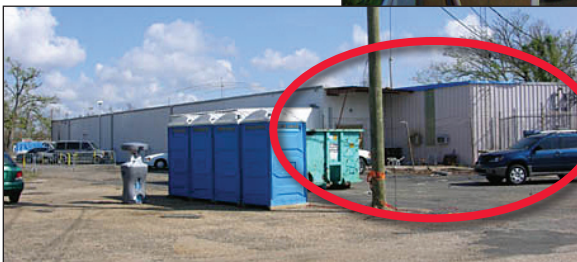
Figure 7-4.

The EOC lost a portion of its roof covering, and was flooded and totally isolated by floodwater. The EOC was located in the rear portion of the building (red oval) (estimated wind speed: 125 mph. Bay St. Louis, Mississippi).

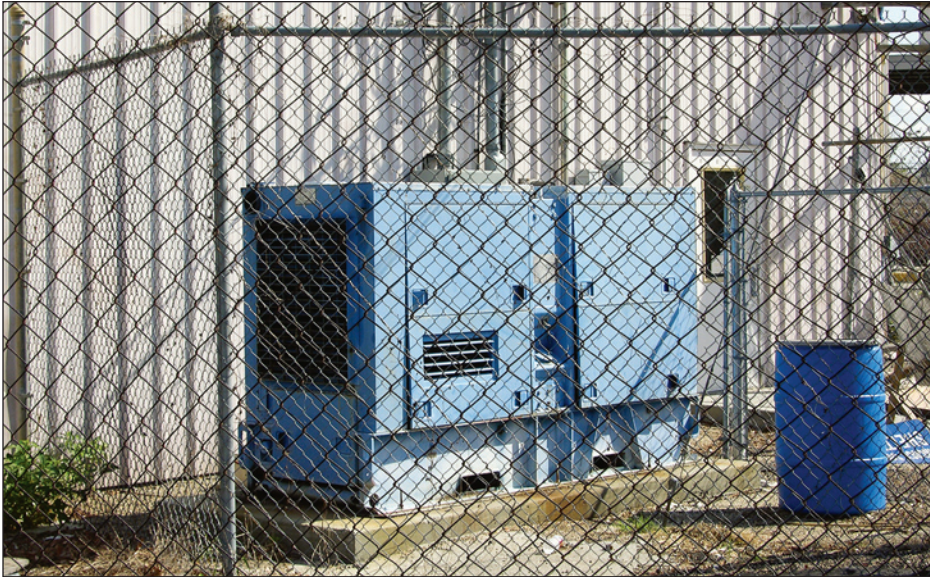
Figure 7-5.
The EOC's emergency generator was exposed and inundated by floodwater (Bay St. Louis, Mississippi).

With inundation of the emergency generator, the EOC was without electrical power. Placing the generator in an exposed area was a poor practice. When exposed, a generator is susceptible to windborne debris damage. The generator was also susceptible to flooding, because it was mounted only a few inches above grade.

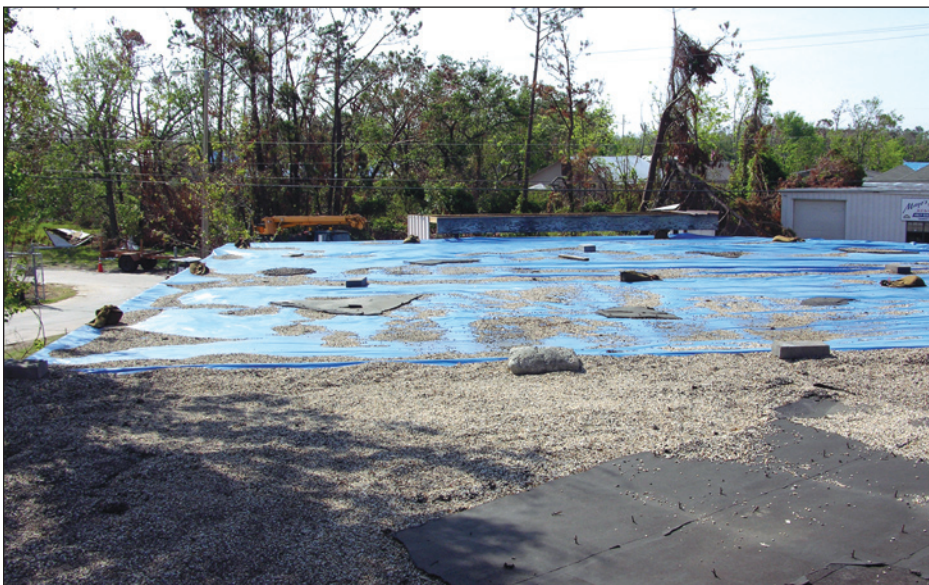
Floodwater rose to about 2 feet above the EOC floor. Wind blew off most of the roof membrane over the EOC and also blew aggregate from the roof (see Figure 7-6). The roof blow-off initiated with the metal edge flashing. It had a 5-1/4-inch vertical face that was uncledated; therefore, it was susceptible to lifting and peeling. Hardware on the exterior door to the EOC failed and the door blew inward. A communications tower buckled and a satellite dish was blown off its support post. The satellite dish was mounted to a wooden sleeper assembly that rested on the roof surface, with small blocks of concrete over the sleepers.

Note: Had the winds been stronger, it is likely that some of the cementitious wood-fiber deck panels would have been blown from the steel joists. (At the time this building was constructed, the typical attachment for this type of decking offered limited uplift resistance.) Some of the wall panels may have also been blown away.

Figure 7-6.
The blue tarp was used as an emergency repair where the roof membrane blew off the EOC. Although the membrane's base sheet fasteners were too far apart, the failure initiated with lifting and peeling of the metal edge flashing (estimated wind speed: 125 mph. Bay St. Louis, Mississippi).

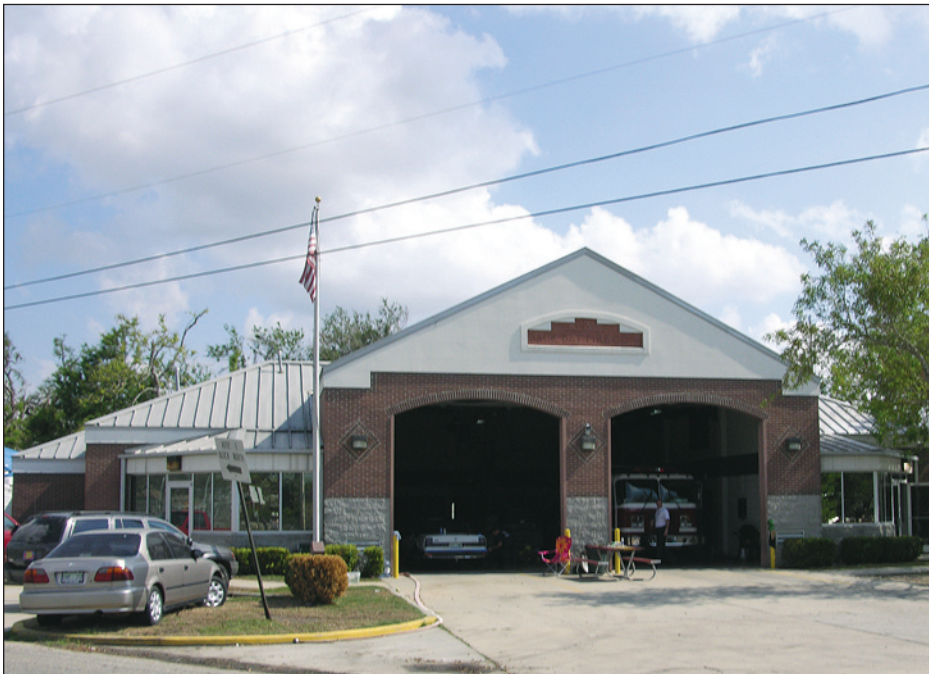
This is a relatively new one-story building with CMU and brick veneer walls and a standing seam metal roof with 16-inch rib spacing (see Figure 7-7). Floodwater rose to about 5-1/2 feet above the floor. The apparatus bay doors were bowed in (this was likely caused by floodwater, rather than wind pressure).

Figure 7-7.
General view of Back
Bay Fire Co. #4.
Floodwater was about
5-1/2 feet deep inside
the station (Biloxi,
Mississippi).

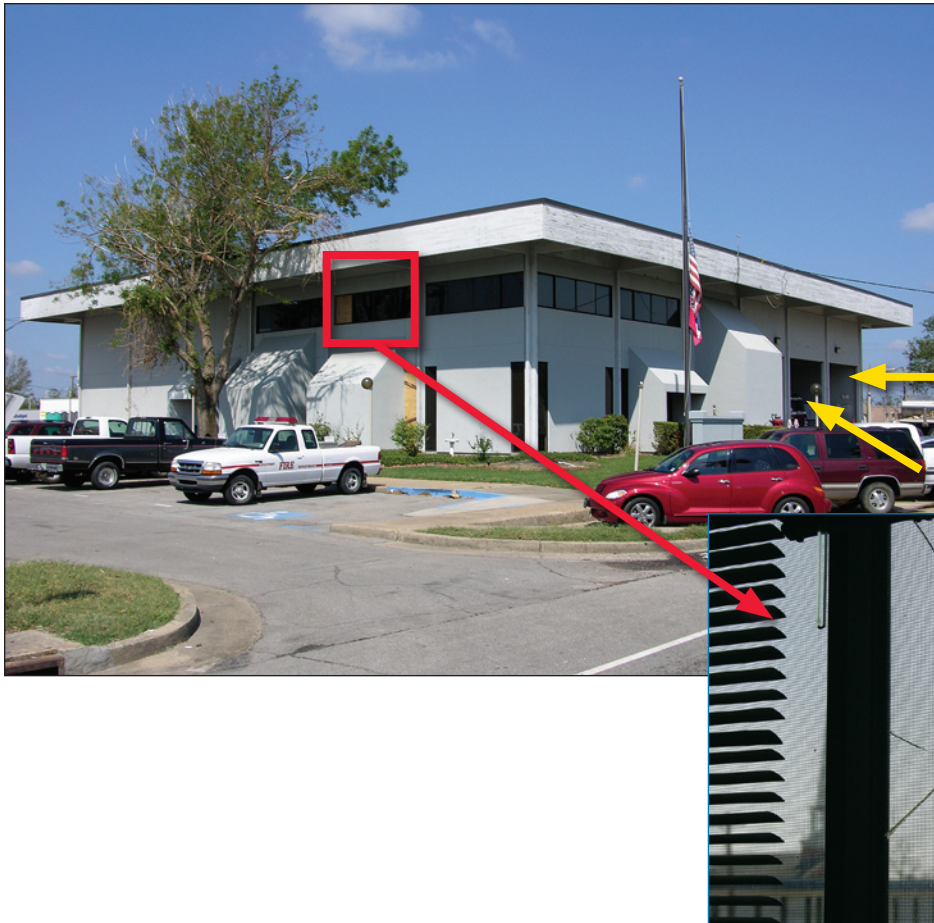
The three windward (east-facing) sectional doors were damaged by wind (see Section 5.2.3). The door damage occurred before winds peaked. In response, fire engines were moved against the damaged doors to brace them, and the three westward doors were opened. Opening the doors likely prevented them from being damaged.³ With the doors at each end of the apparatus bay open or partially open, uplift load on the roof assembly was likely reduced. Had the westward doors not been opened, there likely would have been sufficient wind load to cause uplifting of the cementitious wood-fiber decking. (At the time this building was constructed, the typical attachment for this type of decking offered limited uplift resistance.) One of the deck panels at an overhang had a major crack across its entire width; however, the panel may have been cracked before the storm.

Three of the 12 upper windows on the south side of the building were broken by aggregate blown from a BUR across the street (Figure 7-8 inset). One of the lower windows was also broken.

Figure 7-8.
General view of Gulfport Fire Station #1. Three of the sectional doors blew in (yellow arrows), and four windows were broken on the left side of the building (square/inset) (estimated wind speed: 130 mph. Gulfport, Mississippi).

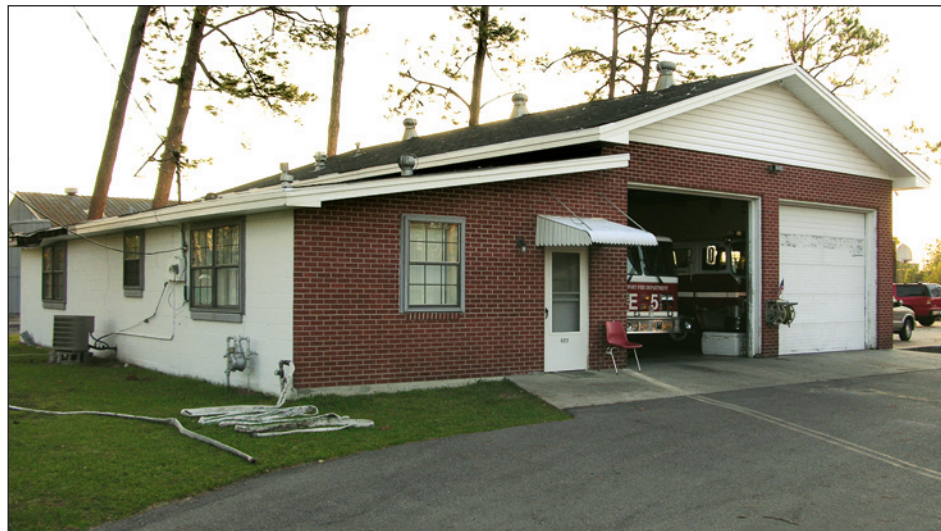
Figure 7-9 shows a general view of the building. It has CMU and brick veneer walls, wood roof framing, plywood decking, and an asphalt shingle roof. A tree fell on the lower roof and caused modest damage to the shingles, decking, fascia, and soffit. Some of the shingle tabs were also blown off.

Figure 7-9.
General view of Gulfport Fire Station #5. A tree fell on the left side of the building (the tree had been removed prior to the MAT's observations) (estimated wind speed: 130 mph. Gulfport, Mississippi).

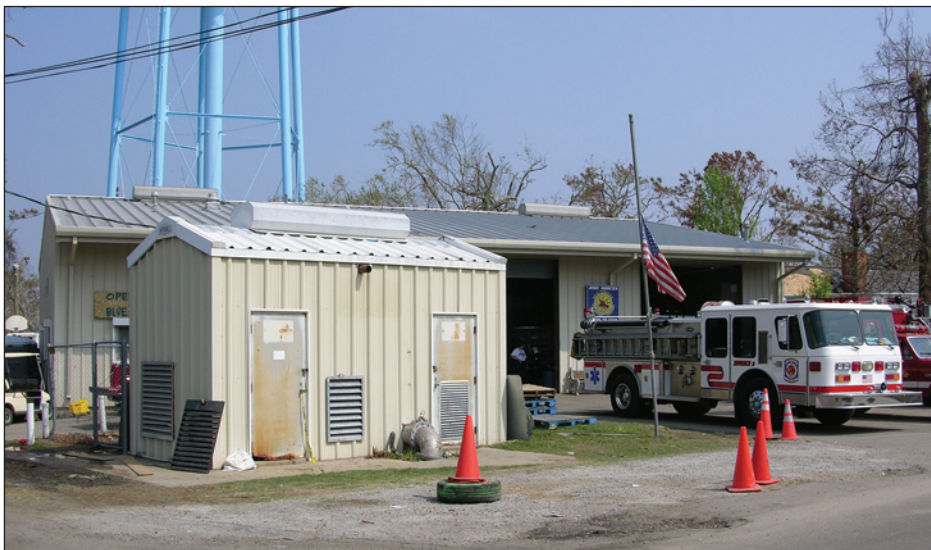
The Pass Christian Fire Department is a PEMB with metal wall panels and a structural standing-seam trapezoidal metal panel roof (see Figure 7-10). The emergency generator is housed in a free-standing PEMB. Although the walls and roof of the generator building could be penetrated by windborne debris, placing a generator in a marginal enclosure such as this is better than having it exposed as shown in Figure 7-5. Roll-down metal shutters had been installed around 1999 at the exterior windows. (This work was funded via the FEMA Hazard Mitigation Grant Program.) However, the glazing in the personnel doors was not protected from windborne debris. Some new steel columns were also located on the backside of the building; they were anchored to the structural frame to provide additional wind resistance to meet current wind loads.

In an effort to keep the doors from blowing inward, fire engines had been positioned so that they were in contact with the rolling doors. However, the slats from at least one of the rolling doors were blown out of the door track. Placing apparatus against bay doors does not increase the resistance of the doors to outward failure, nor does this practice necessarily keep doors from blowing inward on the apparatus. In lieu of using apparatus to buttress doors, doors that possess inadequate wind resistance should be replaced with doors that have sufficient strength to resist design wind loads.

Figure 7-10. General view of the Pass Christian Fire Department. The building in the foreground houses the emergency generator (estimated wind speed: 130 mph. Pass Christian, Mississippi).

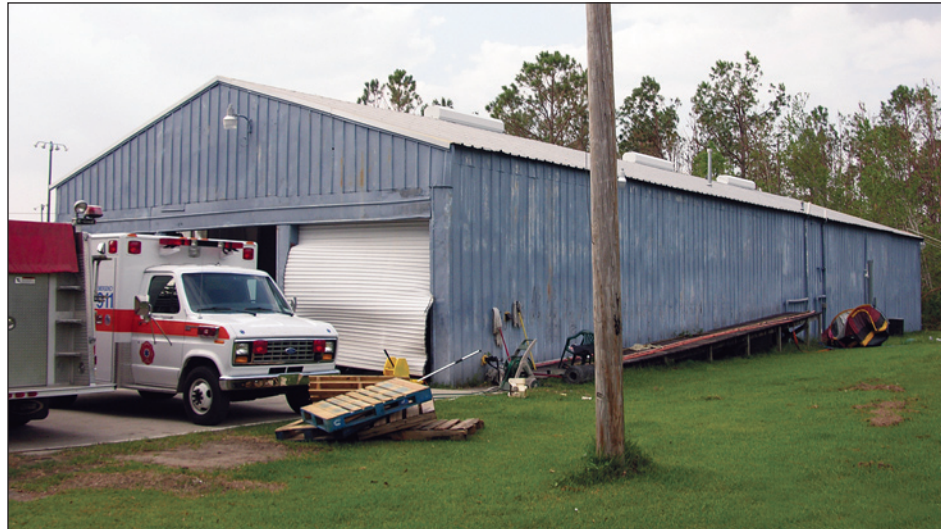
This is a PEMB with an exposed fastener metal panel roof (see Figure 7-11). It appeared that floodwater rose to about 1 foot above the floor line; however, it was reported that the water rose to a depth of 2 to 3 feet. The slats from at least one of the rolling doors at the apparatus bay dislodged from the door track (this was likely caused by wind, but may have been initiated by floodwater). The communications tower was also toppled.

Figure 7-11.
General view of the Cuevas Volunteer Fire Department. Note the damaged apparatus bay door (estimated wind speed: 130 mph. Pass Christian, Mississippi).

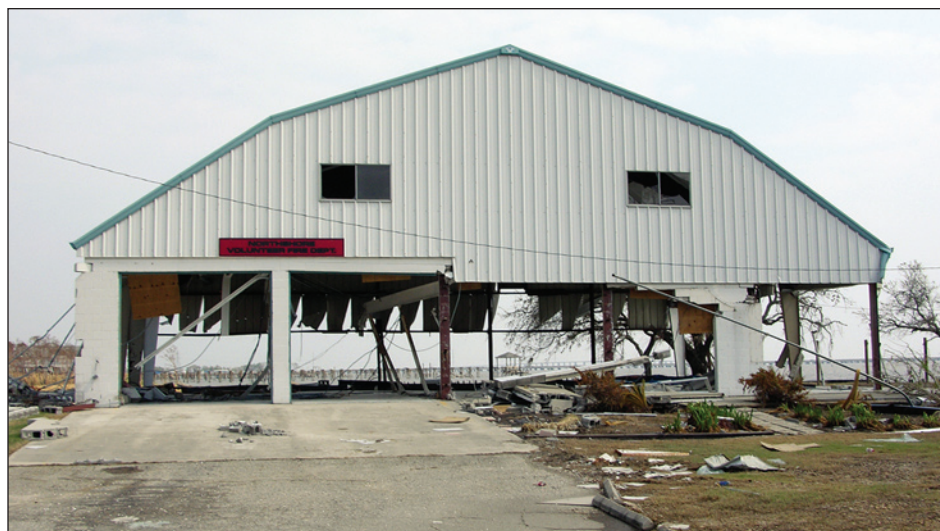
This is a PEMB with unreinforced CMU walls and metal wall panels. The building was severely damaged by storm surge and waves from nearby Lake Pontchartrain (see Figure 7-12).

Figure 7-12.
General view of the Northshore Volunteer Fire Department. Exposure C (estimated wind speed: 115 mph. Slidell, Louisiana).

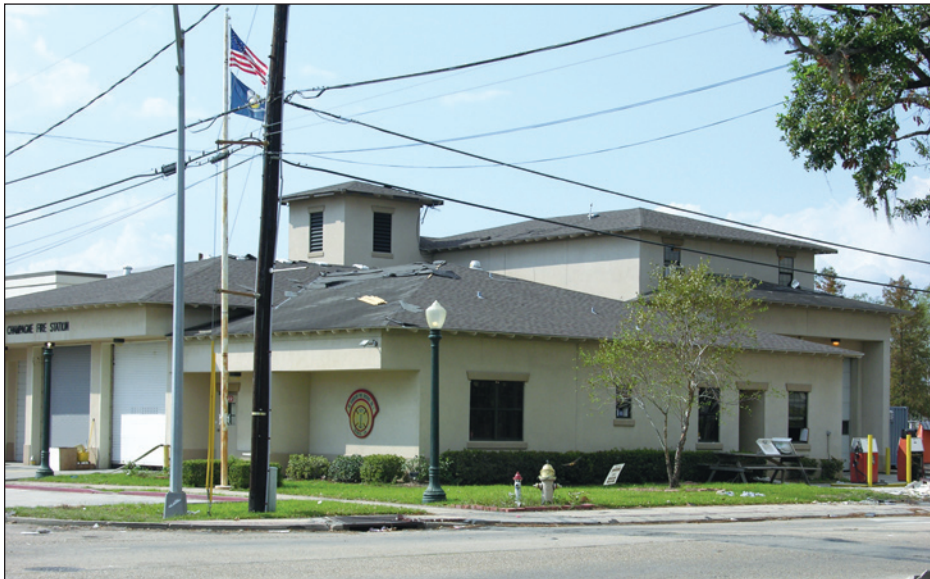
This two-story building was constructed in 1952 and remodeled in 1989 (see Figure 7-13). It has a wood-frame structure, EIFS over unreinforced CMU and brick veneer, a cementitious wood-fiber deck, and asphalt shingles. Floodwater rose to several feet above the floor line. There was flood/flotation damage to pad-mounted mechanical equipment located outside the building. Several of the shingles were blown away, some rooftop exhaust fans were damaged, and the communications tower collapsed.

Figure 7-13.
General view of the
A. J. Champagne Fire
Station (estimated wind
speed: 115 mph. Slidell,
Louisiana)

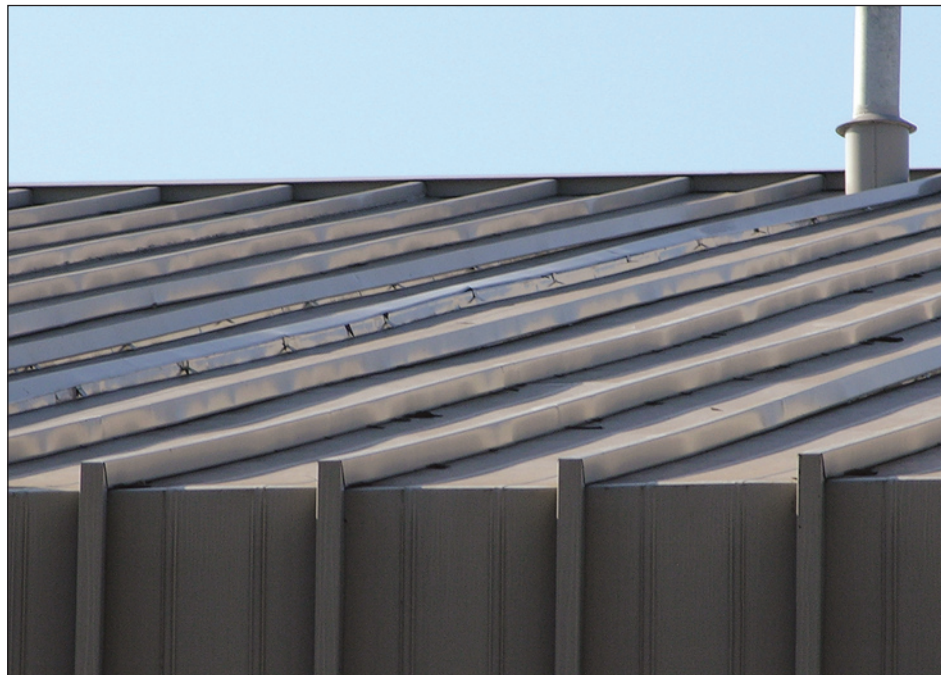
were still attached, but they had lifted and it appeared that fatigue cracks occurred along the standing seams (see Figure 7-14).

Figure 7-14.
This portion of the roof was not blown off, but some of the batten covers lifted. It appeared that fatigue cracks occurred along the standing seams (estimated wind speed: 105 mph. New Orleans, Louisiana).

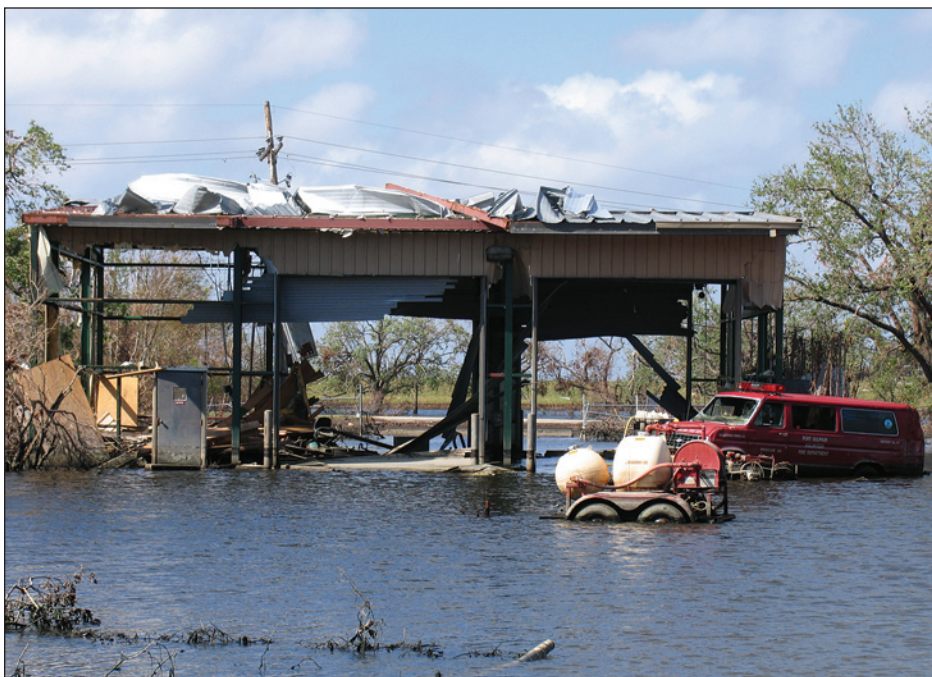
This is a PEMB with metal wall panels and a structural standing-seam trapezoidal metal panel roof (see Figure 7-15). Storm surge severely damaged the rolling doors and walls. Wind blew off a portion of the roof panels.

Figure 7-15.
General view of the Port Sulphur Volunteer Fire Department showing damage caused by storm surge and wind. Note the inundated apparatus in the foreground (estimated wind speed: 125 mph. Port Sulphur, Louisiana).

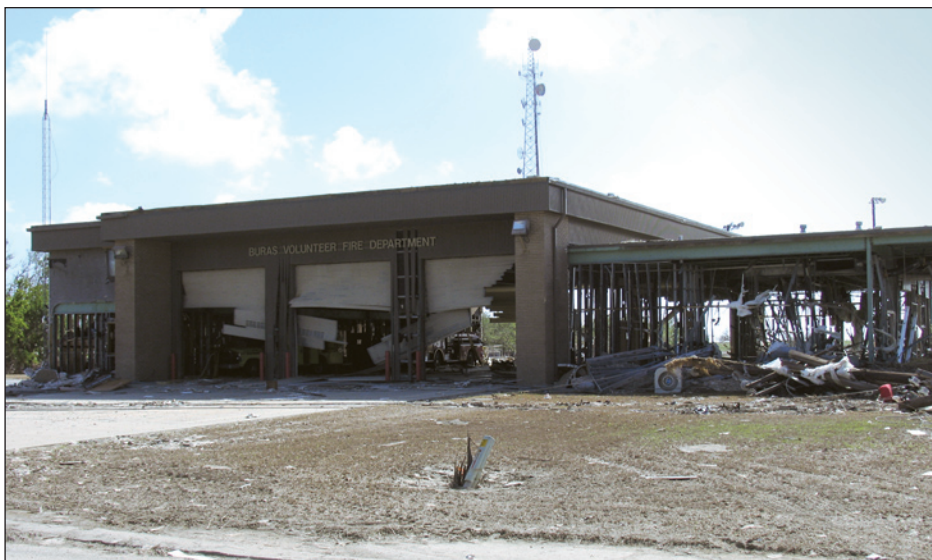
Storm surge severely damaged the rolling doors and walls (see Figure 7-16).

Figure 7-16.
General view of the Buras Volunteer Fire Department (estimated wind speed: 130 mph. Buras, Louisiana)

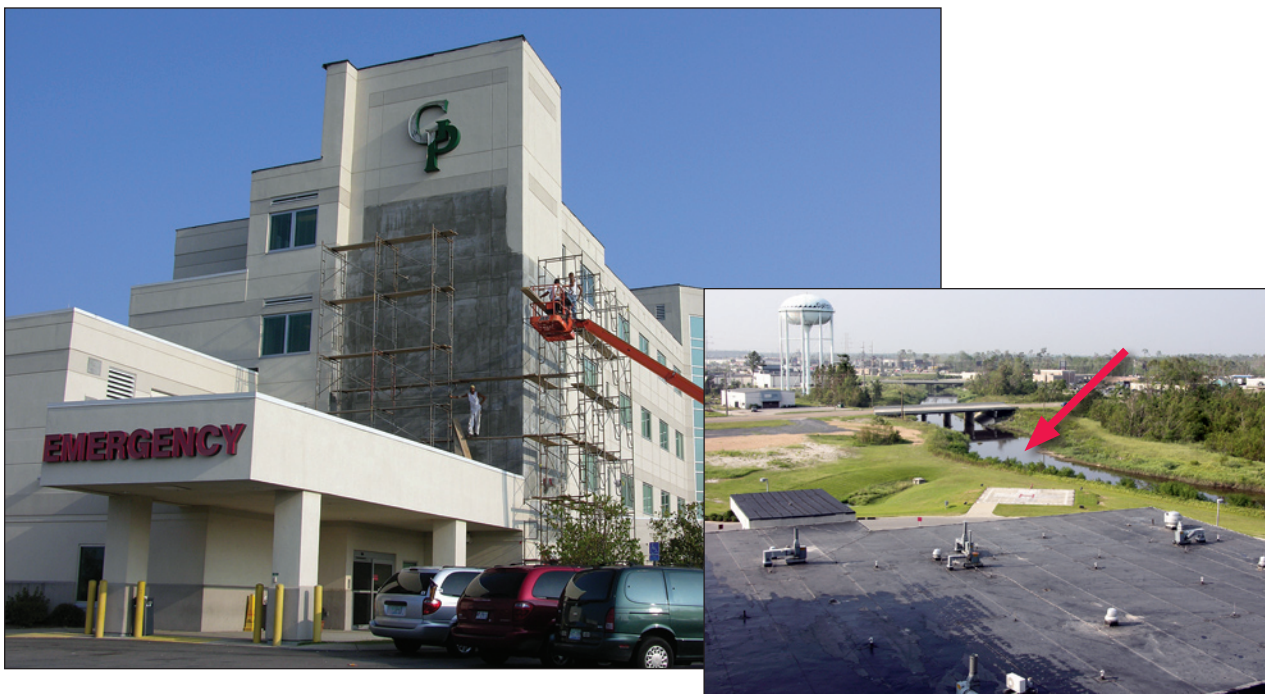
Figure 7-17.

The nearby Flat Branch Creek (Figure 7-17 inset) rose above its banks and reached a depth of about 6 inches inside the hospital. The EIFS blew off the hospital in a few areas (detachment of the gypsum board from the studs was the primary failure mode). With loss of the EIFS, water was able to enter the wall cavities. A penthouse door was blown off its hinges (see Figure 5-5). The roof membrane lifted and peeled back in some areas, and in other areas it ballooned. Rubber walkway pads were blown away and the roof membrane was punctured in several areas (some of the punctures were likely caused by the lightning protection conductors and/or air terminals that became detached; see Figures 5-122 and 5-123). Some of the vents for the lightweight insulating concrete (LWIC) and an exhaust fan were damaged by windborne debris (see Figure 7-18). (Note: unless in a penthouse or protected by screen walls, rooftop equipment is vulnerable to debris damage.) Some fan cowlings were blown off (see Figure 5-114) and several of the storm caps over exhaust ducts were blown away (Figure 7-18 inset).

General view of Garden Park Medical Center. EIFS repairs were underway at the time the photo was taken. The inset shows one of the hospital's lower roofs and Flat Branch Creek beyond (arrow) (estimated wind speed: 130 mph. Gulfport, Mississippi).

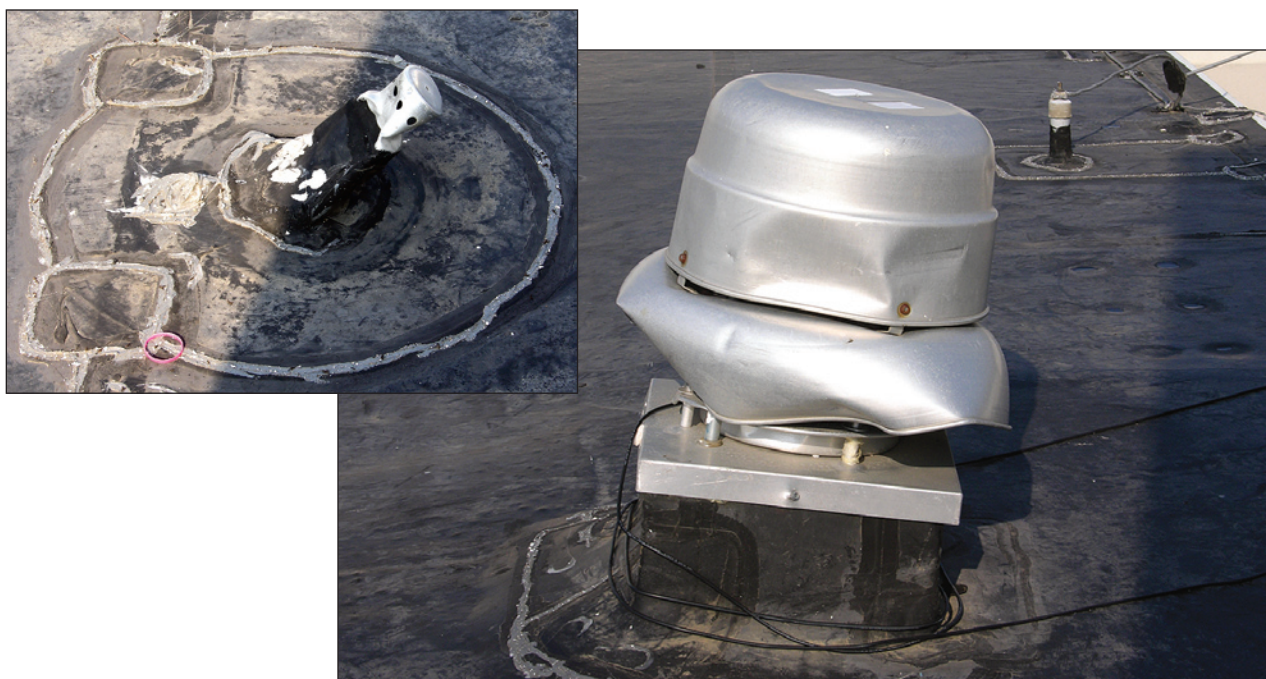
Figure 7-18.

This exhaust fan was struck by windborne debris. The inset shows a LWIC vent that was also hit by debris. Water could enter the roof where the vent cap was knocked off (estimated wind speed: 130 mph. Gulfport, Mississippi).

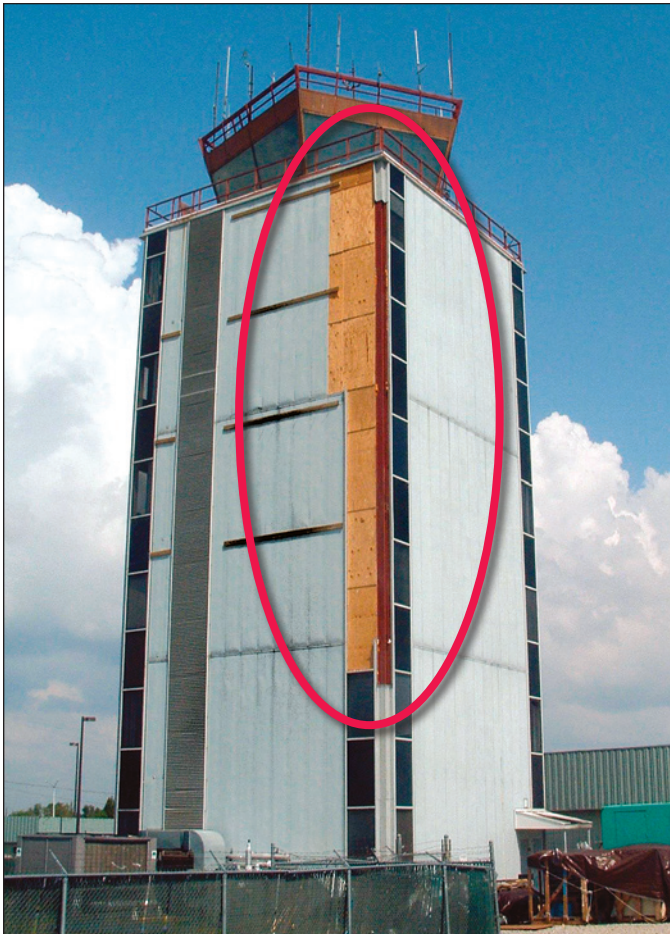
Damage to the airport control tower is shown in Figure 7-19. Wind pressure and windborne debris broke about 30 percent of the tower wall glazing and damaged the metal wall cladding.

Figure 7-19.
Airport control tower. Note damaged glazing and cladding (circle) (estimated wind speed: 130 mph. Gulfport, Mississippi).

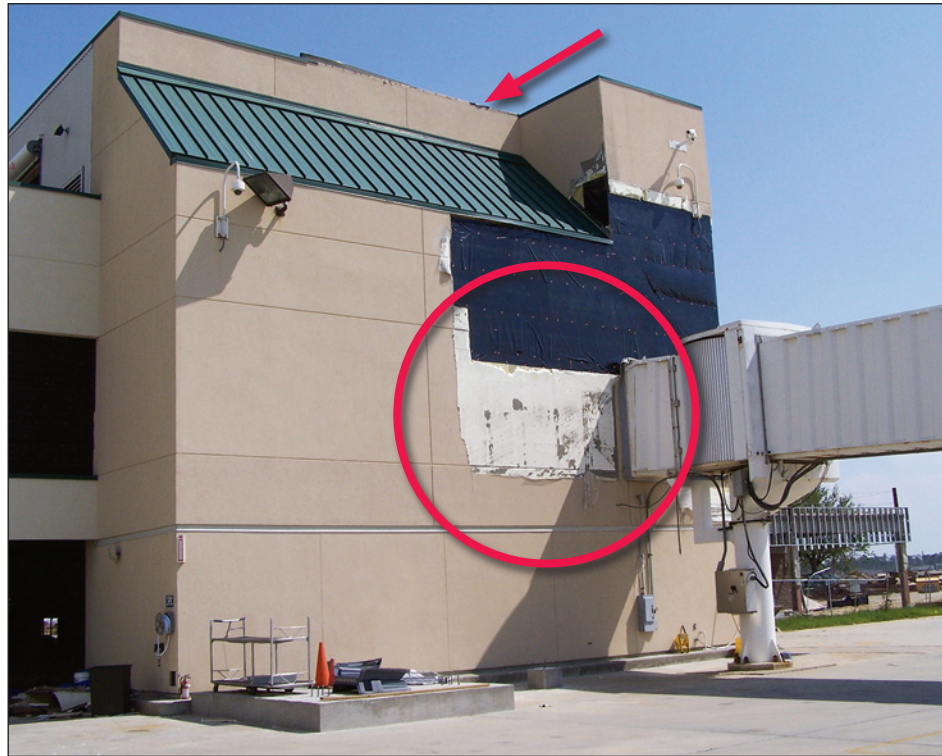
Figure 7-20.
 Damaged terminal gate at the Gulfport-Biloxi International Airport. Note the damaged roof coping (arrow) and the wind damaged EIFS (circle) (estimated wind speed: 130 mph. Gulfport, Mississippi).

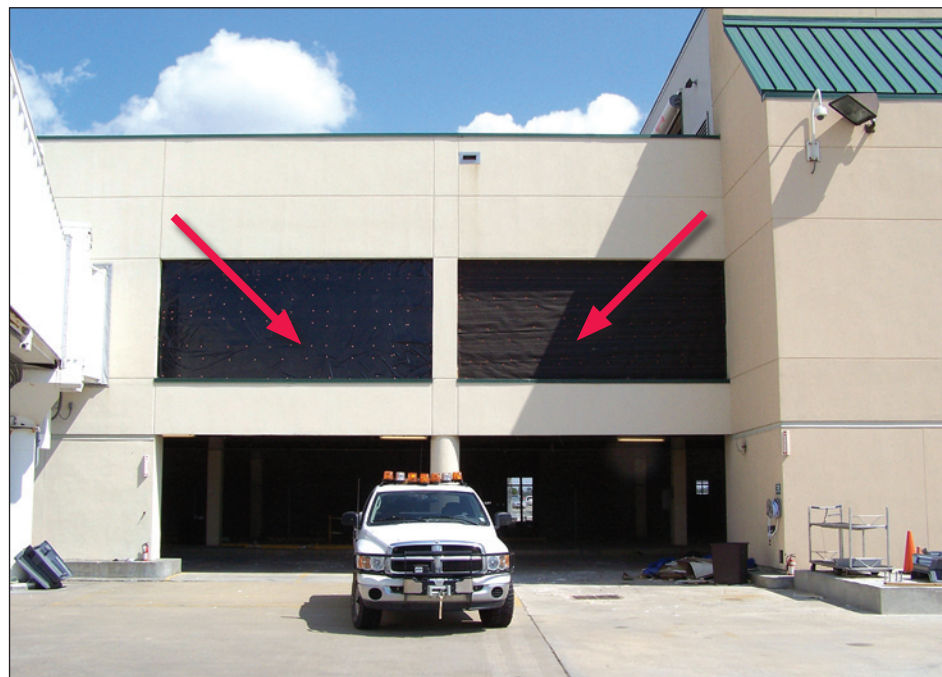
Figure 7-21.
 Glazed curtain wall pushed inward by wind pressure. Note the location of damaged curtain walls with temporary weather seal (arrows) (estimated wind speed: 130 mph. Gulfport, Mississippi).

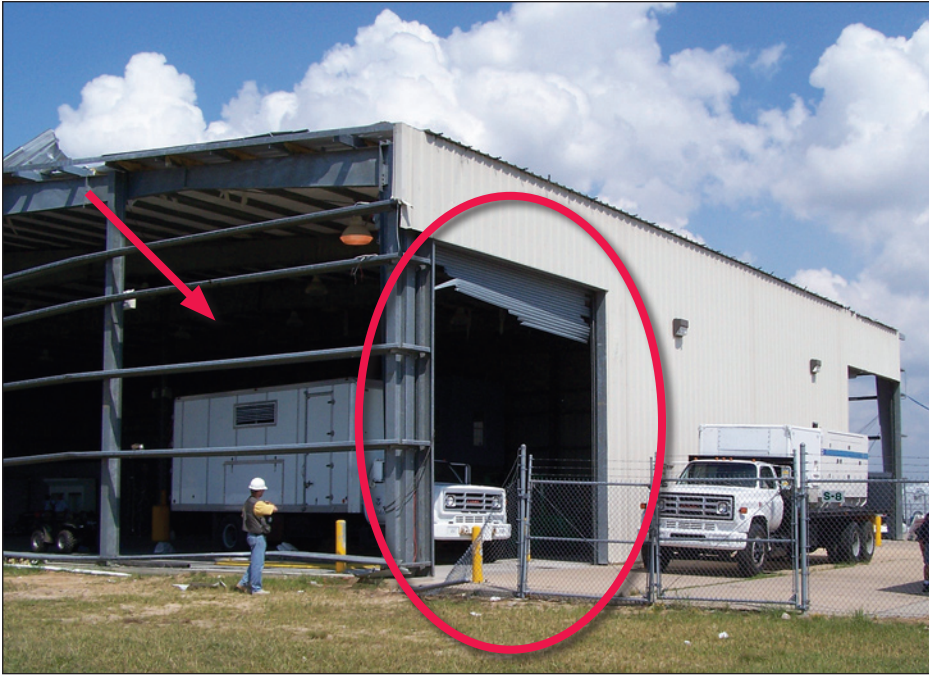
Figures 7-22 and 7-23 portray the wind damage to the airport cargo building. The building was constructed with a pre-engineered metal building frame with metal siding. Damage to the building resulted when positive wind forces pushed in the two large rolling doors. The building became internally pressurized, causing the loss of most of the wall panels on the west side of the building and some of the roof panels.

Figure 7-22.
Wind damage to the southwest corner of the airport cargo building. Note the pressure damaged rolling door (circle) and the west wall panels removed by combined internal and external pressures (arrow) (estimated wind speed: 130 mph. Gulfport, Mississippi).

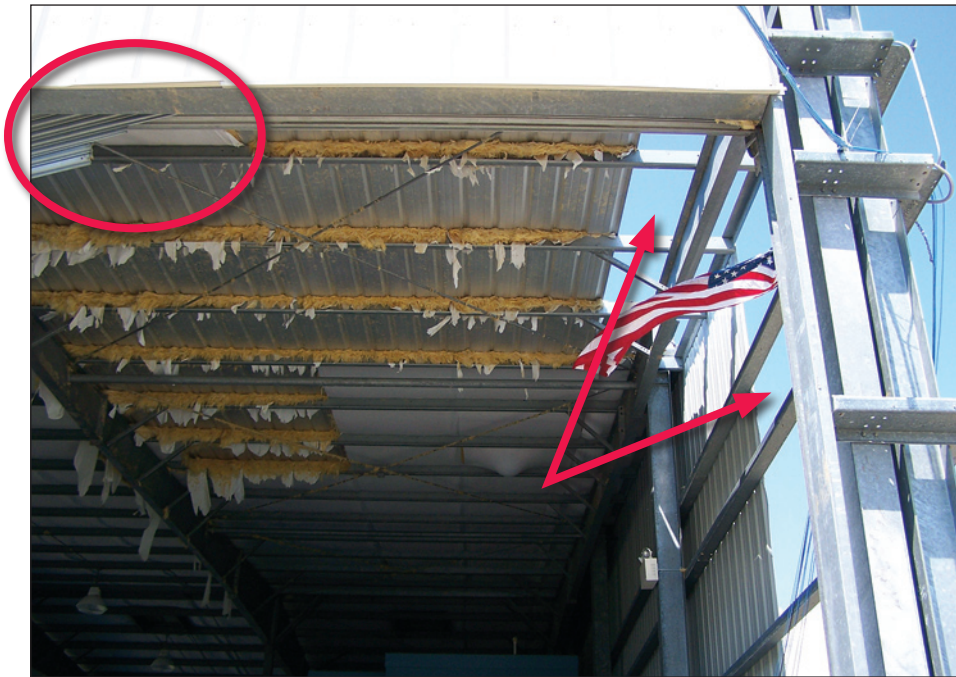
Figure 7-23.
Roof and wall panel damage at the airport cargo building. Note the damaged rolling door at the southeast corner (circle) and roof and wall damage (arrows) (estimated wind speed: 130 mph. Gulfport, Mississippi).

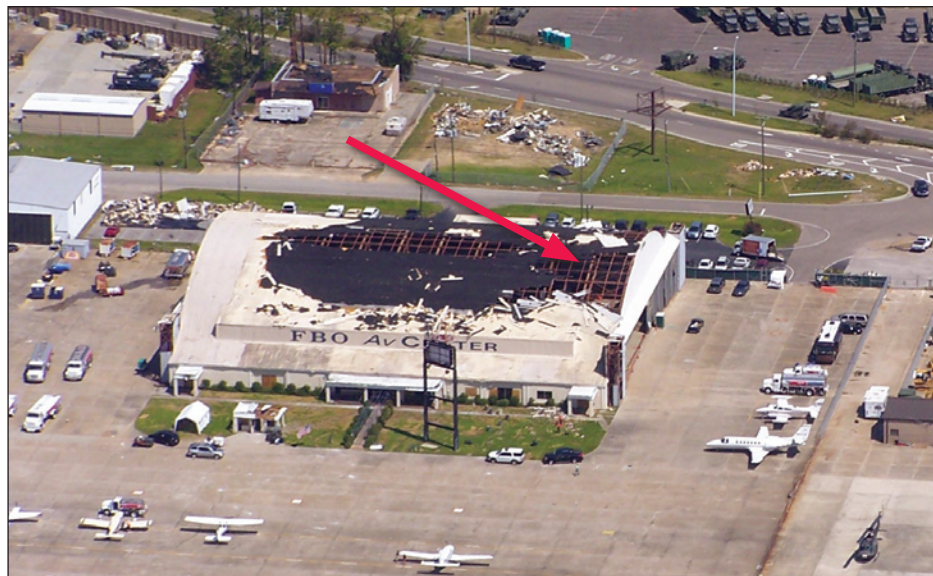
The airport Fixed Based Operator (FBO) building servicing general aviation experienced roof decking and roofing removal when one of its large sliding hangar doors was blown into the building. This failure allowed the building to become internally pressurized. Figure 7-24, an aerial view, portrays the extent of the roof damage. Figure 7-25 shows the hangar door on the ground.

Figure 7-24.
Airport FBO building. Note
the decking and roofing
materials removed by
wind pressure (arrow)
(estimated wind speed:
130 mph. Gulfport,
Mississippi).

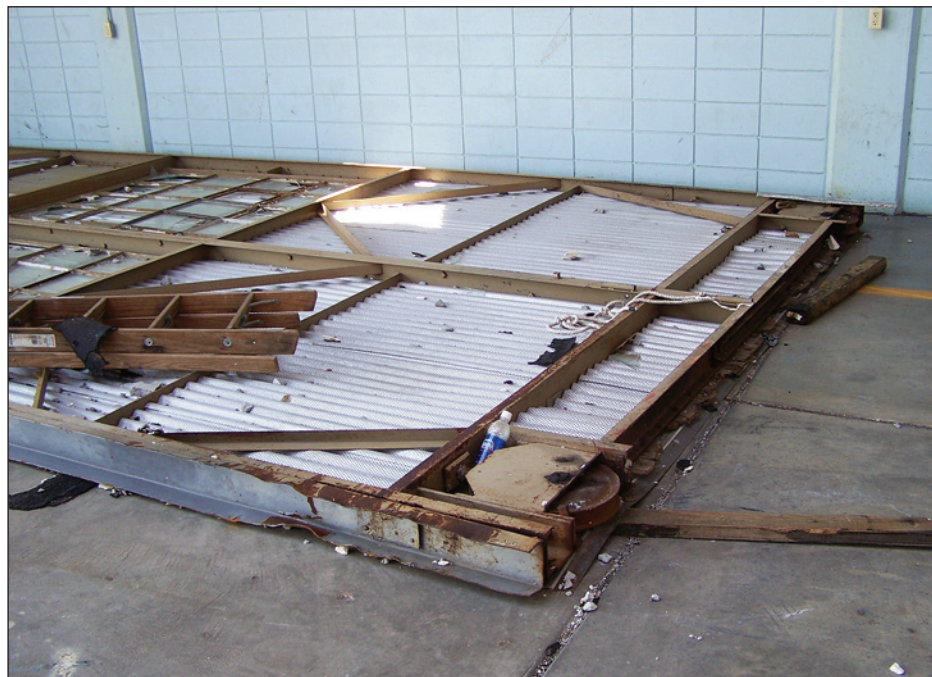
Figure 7-25.
Sliding door blown into
hangar (estimated wind
speed: 130 mph. Gulfport,
Mississippi)
