**BUILDING PERFORMANCE ASSESSMENT REPORT**

# *Midwest Tornadoes of May 3, 1999*

**OBSERVATIONS, RECOMMENDATIONS,  
AND TECHNICAL GUIDANCE**

**FEDERAL EMERGENCY MANAGEMENT AGENCY**

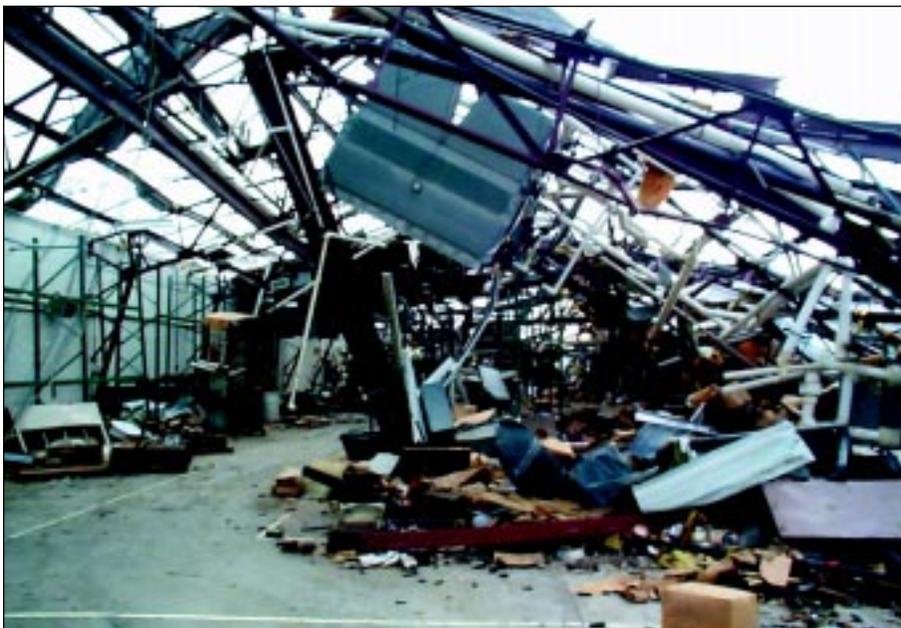
**FIGURE 3-12:** *The vortex of a violent tornado passed within 100 yards of this plastics manufacturing plant in the city of Haysville, Kansas. The wind forces caused the failure of its primary structural system: a pre-engineered steel frame with masonry infill walls.*

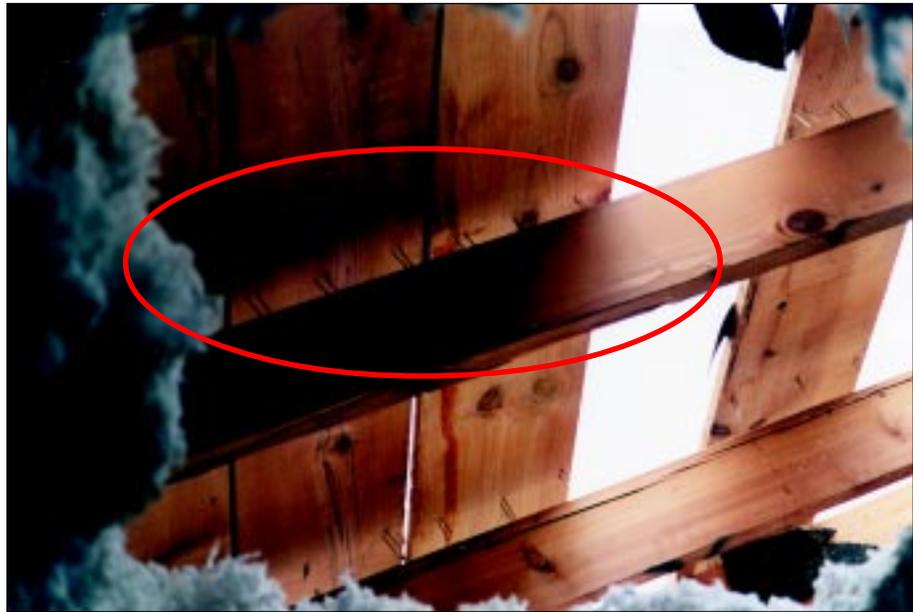
**FIGURE 4-4:** Although roof sheathing was lost at this Wichita, Kansas, home, code requirements of staggering joints in sheathing applications was observed. This house experienced inflow winds from a strong tornado.

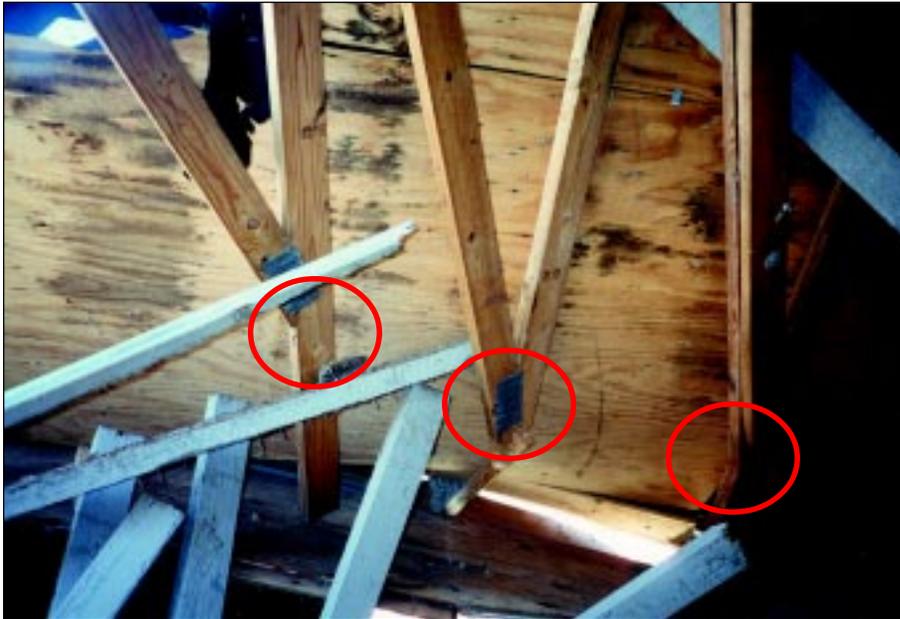
**FIGURE 4-7: Roof truss failure. A single nail (circled) was used to connect each truss to the top plate. This house was in Midwest City, Oklahoma, and experienced inflow winds from a violent tornado.**

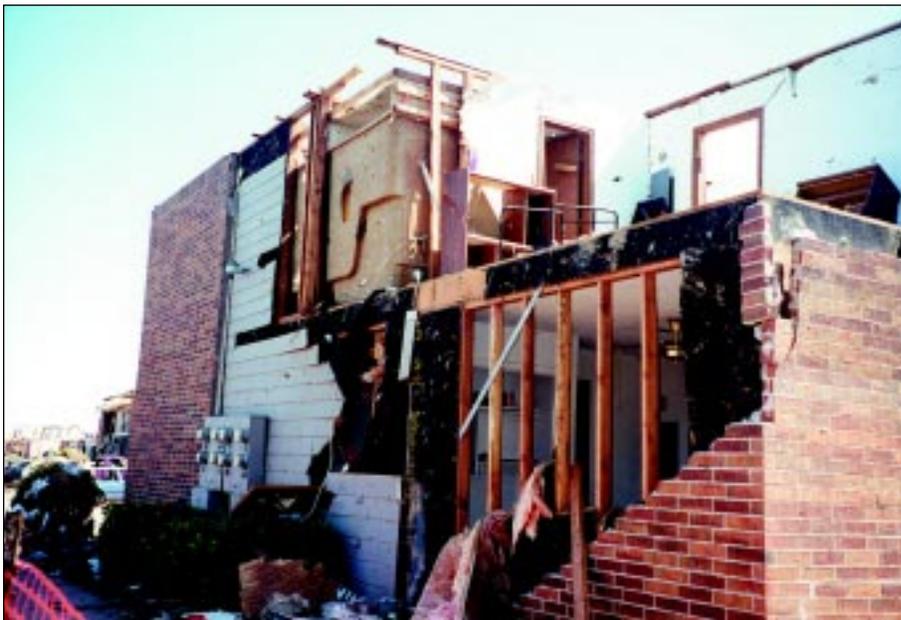
**FIGURE 4-11:** Stud-wall and sole-plate-to-floor failure on a second story wall. This multi-family residence in Moore, Oklahoma, was located a few hundred feet from the vortex of a violent tornado and was exposed to inflow winds.

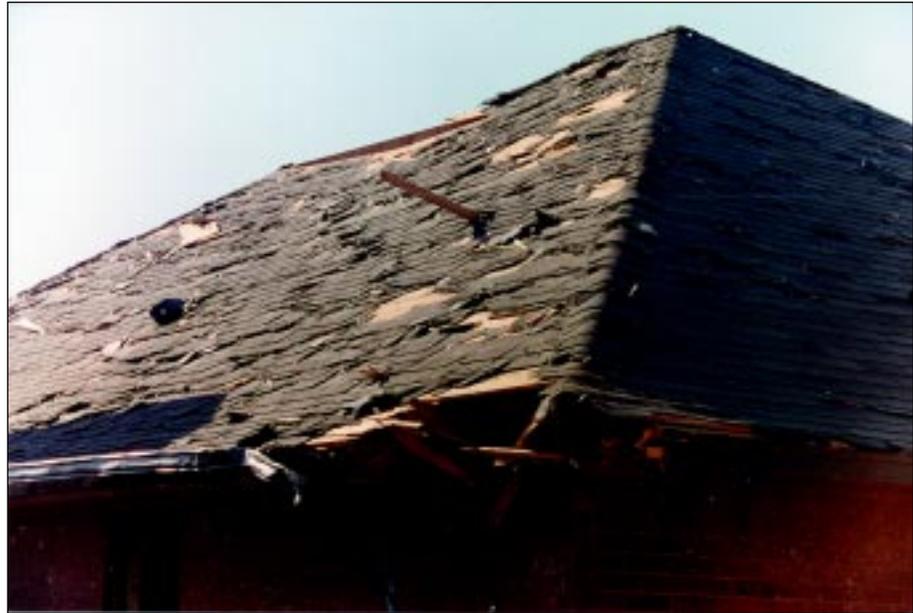
**FIGURE 4-15:** *Several T-lock shingles on this house were lifted and torn. This house was on the periphery of a weak tornado in Wichita, Kansas.*

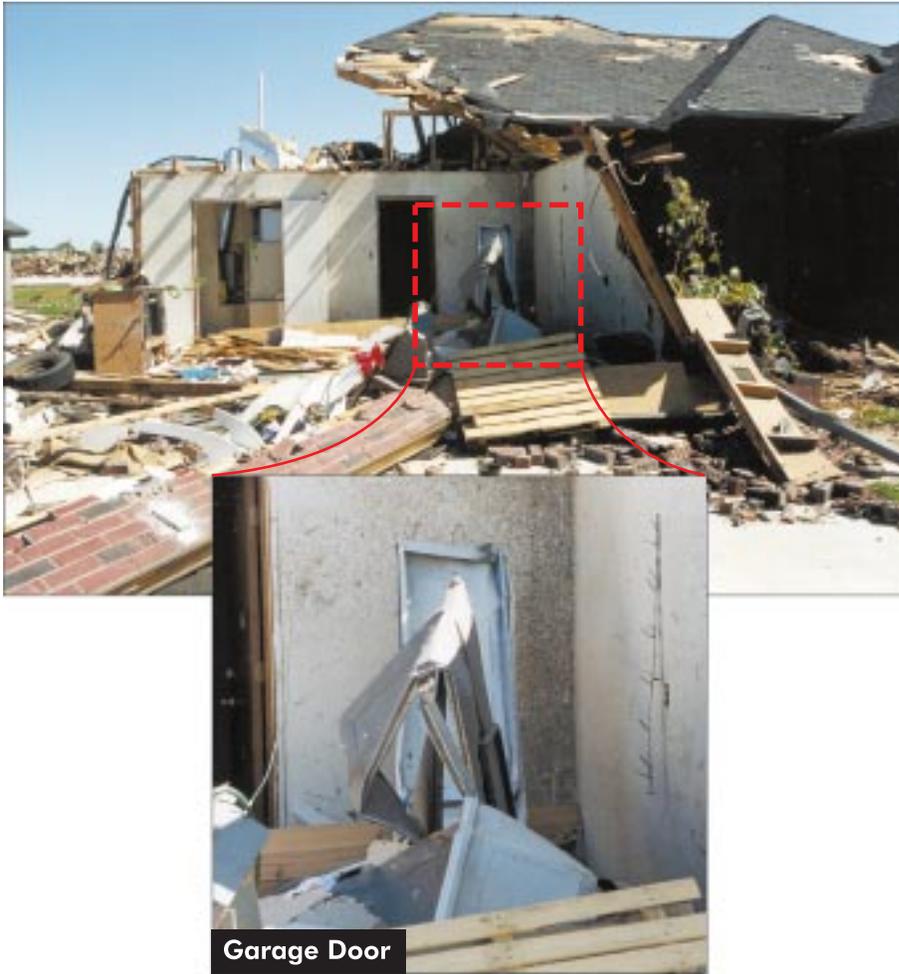
**FIGURE 4-23:** Garage door failure possibly resulting in the localized partial roof failure on the left side of this home located in Moore, Oklahoma.

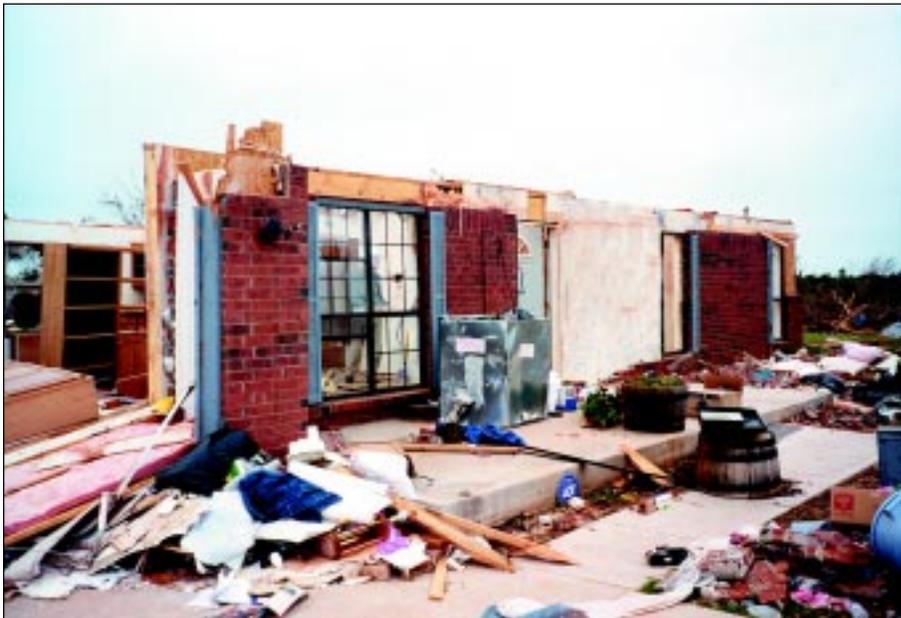
**FIGURE 4-33:** Brick veneer failure at the house shown in Figure 4-32.

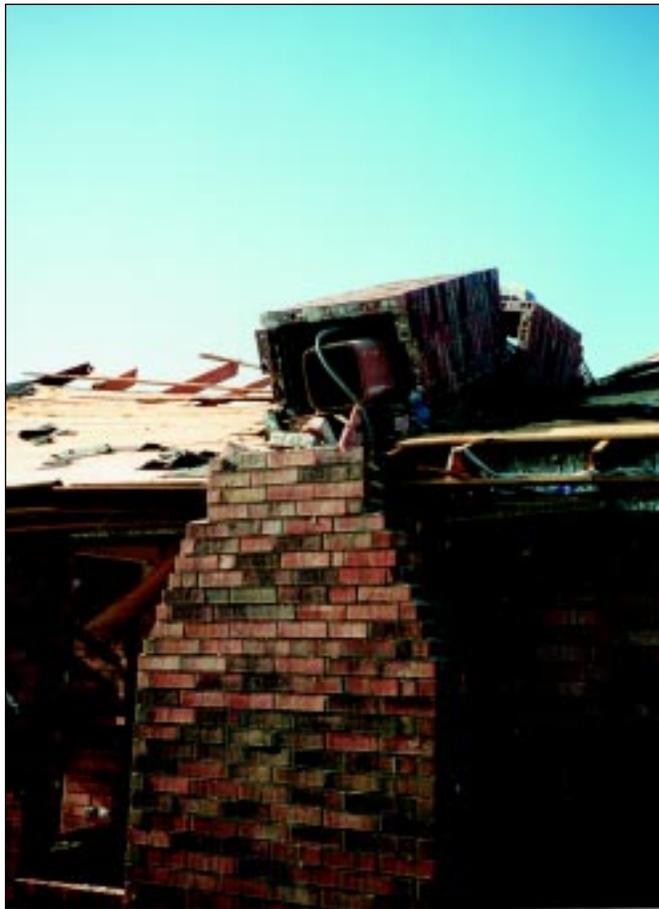
**FIGURE 4-41:** Close-up view of brick chimney failure in Figure 4-40.

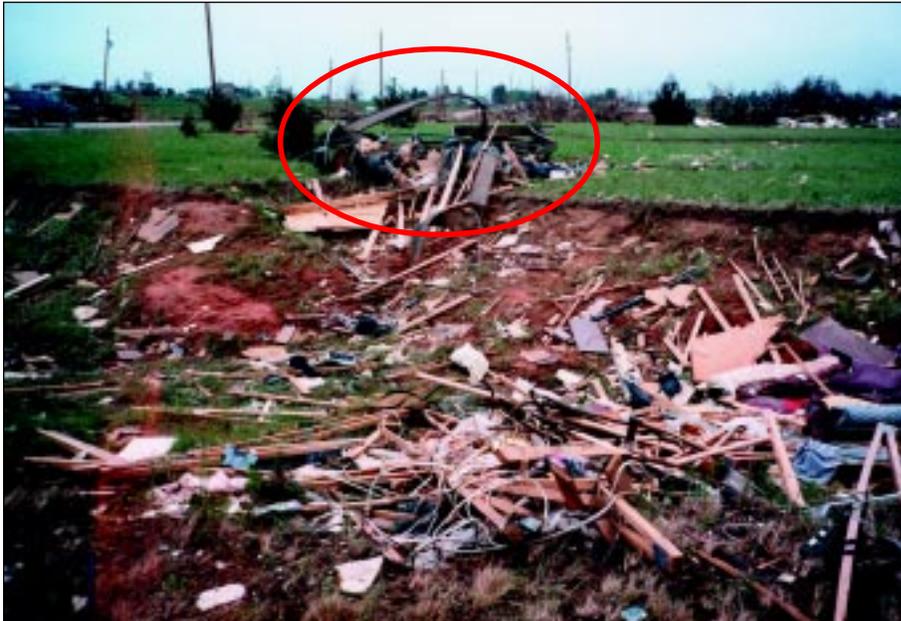
**FIGURE 4-47:** This 14-ft x 60-ft manufactured home chassis in the background of this photo moved about 200 yards from its original anchoring site in Figure 4-49, Bridge Creek, Oklahoma.

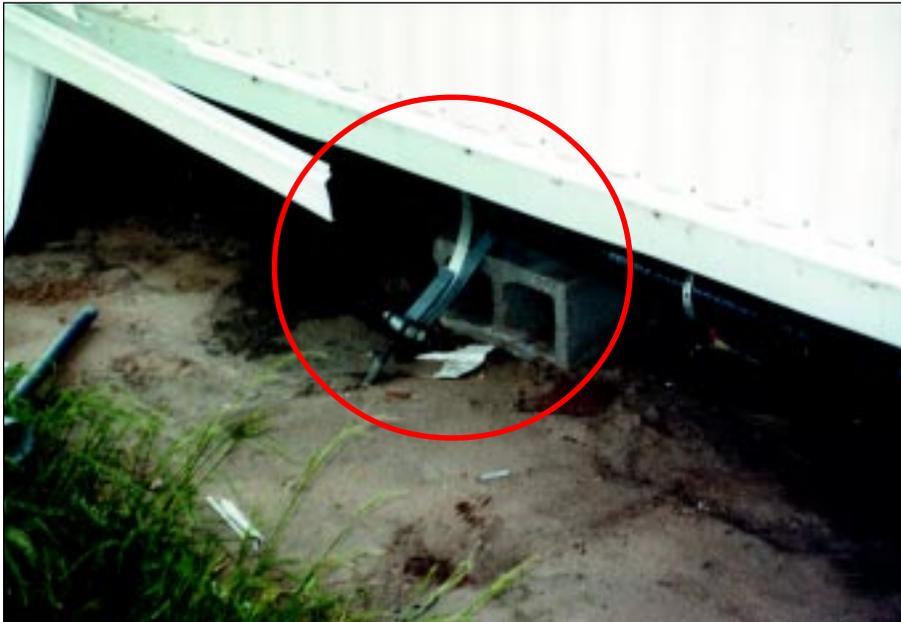
**FIGURE 4-51:** Anchor of manufactured home bent and pulled up from soil. This home in Wichita, Kansas, was located within the inflow area of a strong tornado.

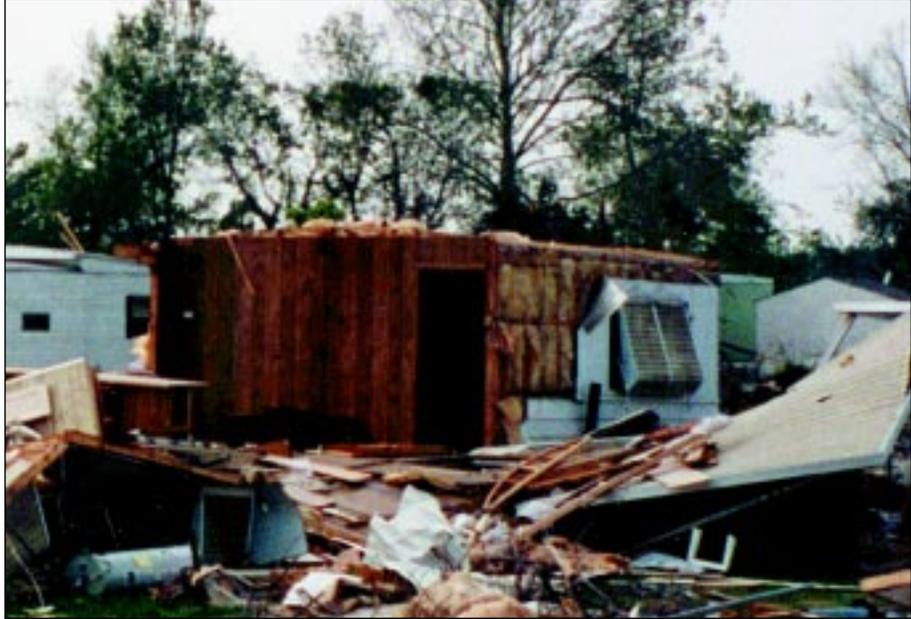
**FIGURE 4-54:** *Damage to a manufactured home located on the periphery of a strong tornado, Wichita, Kansas.*

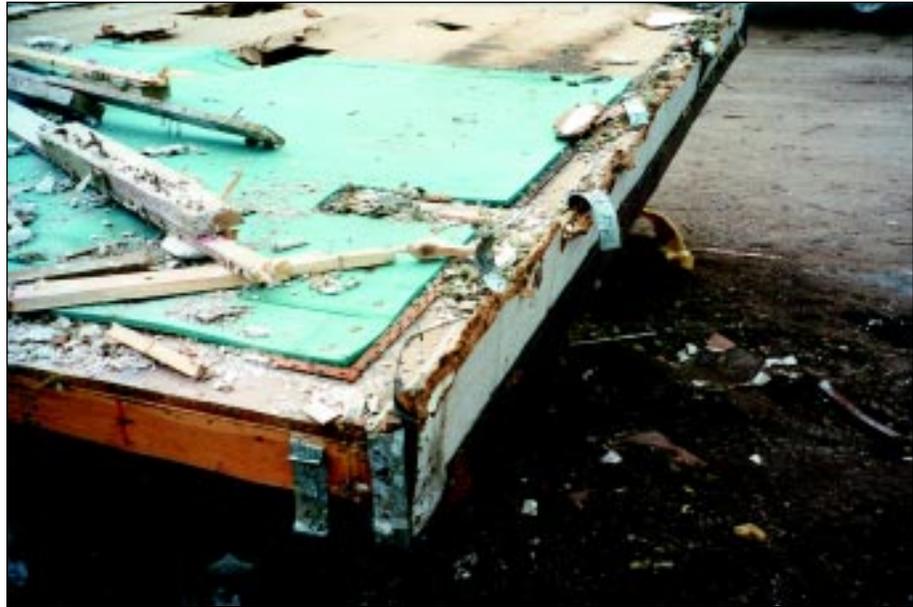
**FIGURE 4-57:** This manufactured home laterally shifted from wind force generated along the periphery of a violent tornado, Haysville, Kansas.

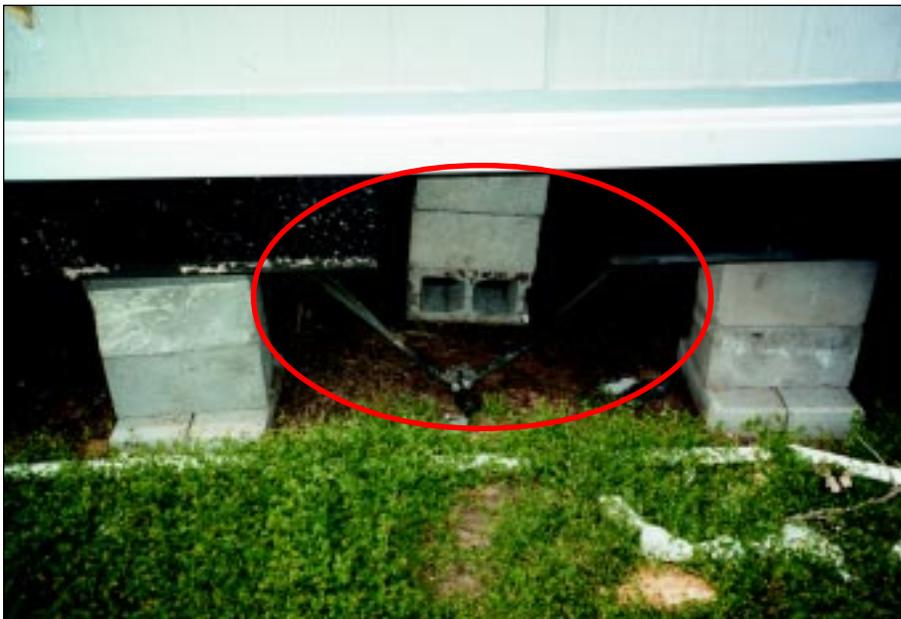
**FIGURE 4-59:** View of anchor strap and attachment indicating some lateral shifting of a manufactured home located along the periphery of a violent tornado, Wichita, Kansas.

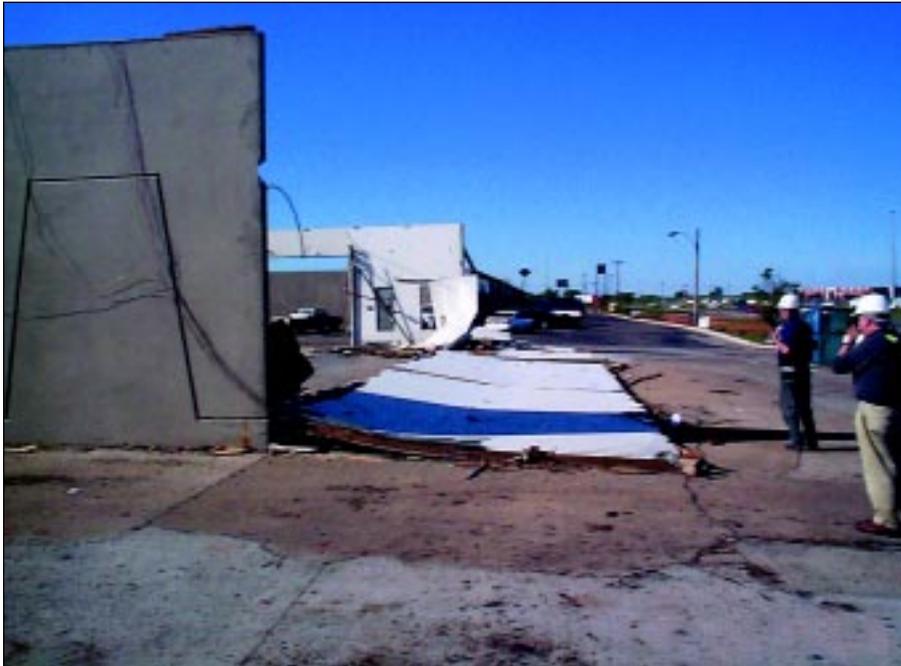
**FIGURE 5-2:** Tilt-up precast concrete walls at a storage building located outside Del City, Oklahoma. After the roof joists separated from the walls, this end wall became unable to withstand suction forces and failed.

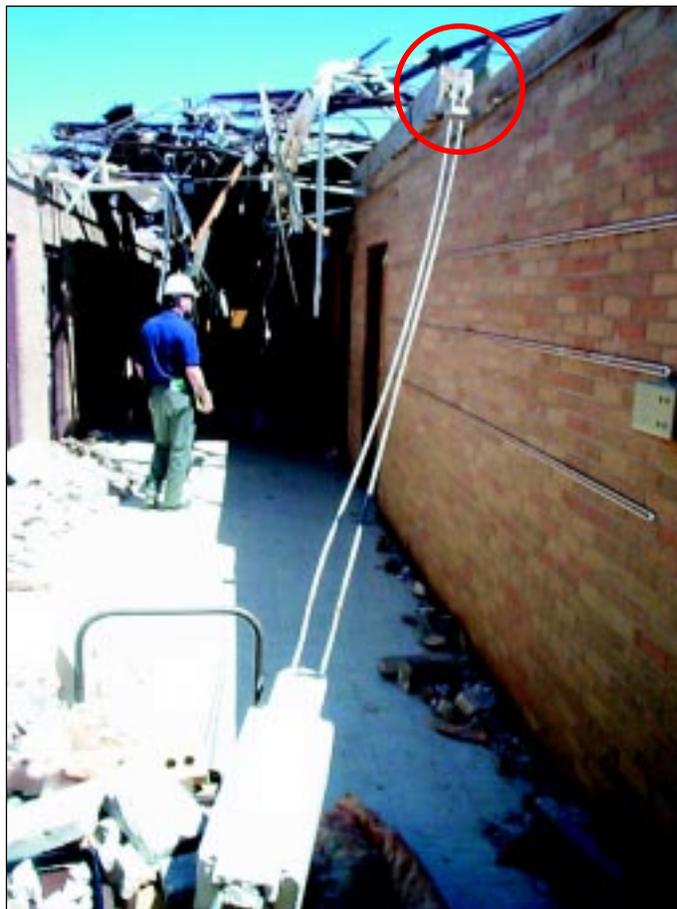
**FIGURE 5-3:** Kelly Elementary School, in Moore, Oklahoma, hit by vortex of violent tornado. Damage to school displaying separation between the bond beam and supporting wall and separation between bond beam and roof bar joists.

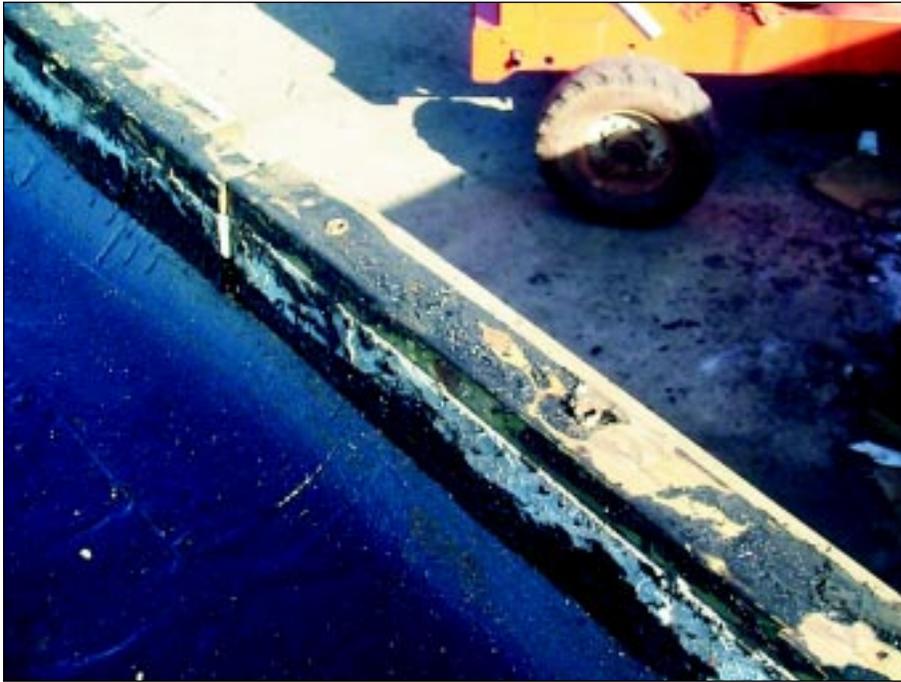
Investigations revealed poor connections between wood nailers (used for flashing attachment) and the structure at roof perimeters. In one case, roofing nails were used to attach perlite insulation. This type of attachment offered very little uplift resistance.

**FIGURE 5-27:** *Nailer at the roof of the hospital in Stroud, Oklahoma. The roof surface in this photo was replaced prior to this photo, but the same nailer was used again during repairs.*

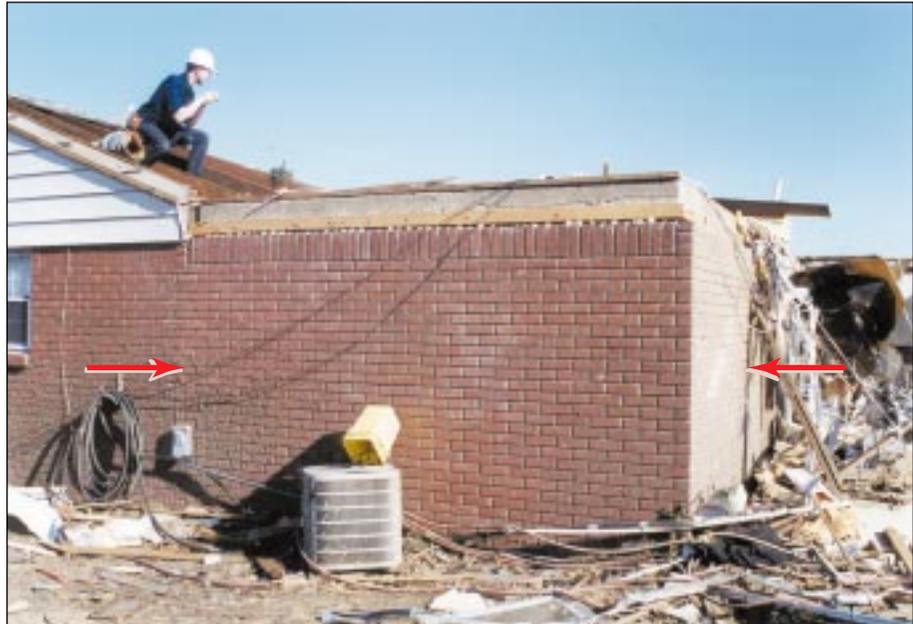
**FIGURE 6-2:** Damage to houses near the home in Figure 6-1. This photo is taken from the roof of the concrete shelter.

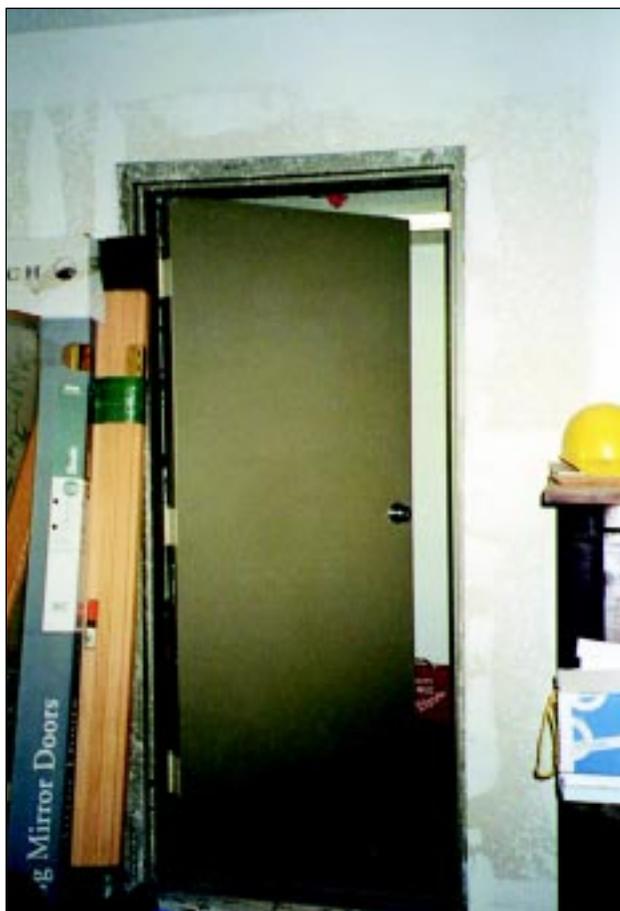
**FIGURE 6-3:** Entrance to the ICF shelter in Bridge Creek, Oklahoma. This residence and shelter were on the periphery of the inflow winds of a strong tornado, and damage was limited to light missile impacts.

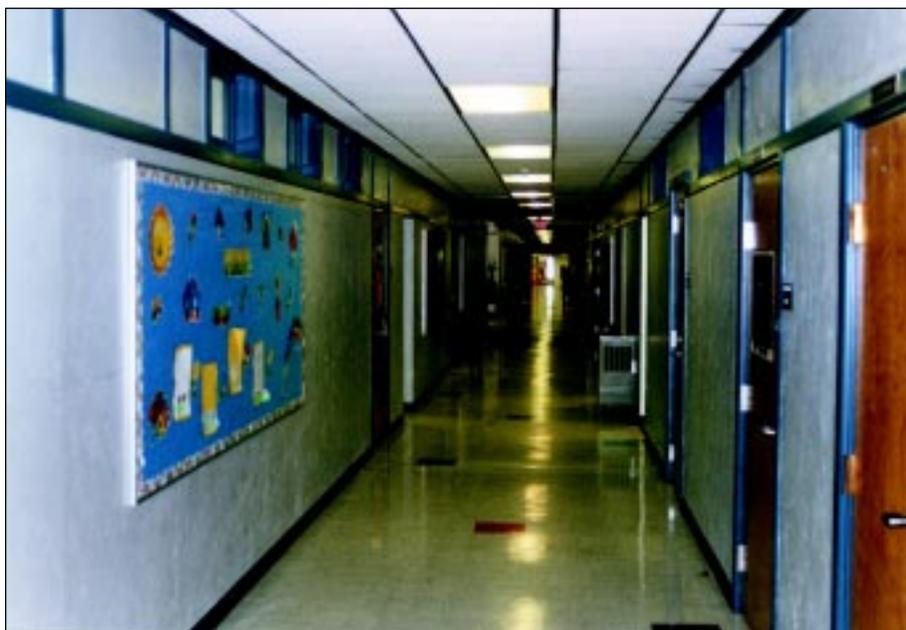
**FIGURE 6-36:** *Sooner Rose Elementary School, Midwest City, Oklahoma. According to the tornado plan for this school, this hallway is designated as a place of refuge.*
