Nebraska Public Power District Minimizes Damage to Transmission System

Full Mitigation Best Practice Story

State-wide, Nebraska

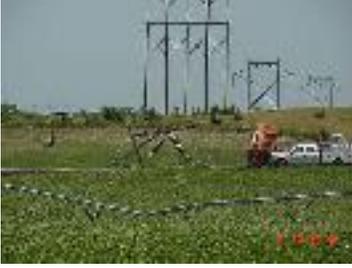
This project proved to be successful when extreme winds and tornadoes caused failure of five standard two-pole wood structures, setting up a cascading effect from the Columbus to Grand Island transmission line. The cascade ended at the dead-end structure funded through FEMA’s HMGP, demonstrating that these structures performed as designed.

Damage to pole structures from June 2003 tornadoes.

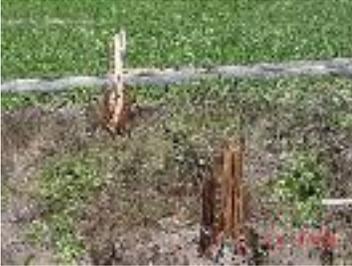
Remains of a sheared off two-pole wood structure.
