Water Storage Tank Seismic Retrofit

Full Mitigation Best Practice Story

King County, Washington

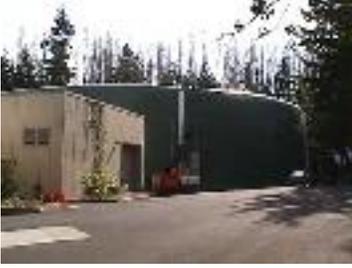
One of two above ground steel water reservoirs and pump station that have been seismically retrofitted.

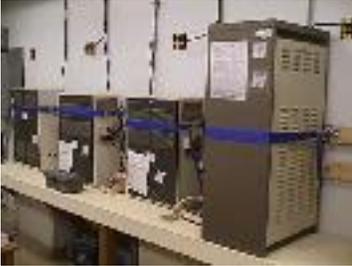
Critical equipment is secured by strapping. Service was not interrupted.
