Building Codes Helped Bolivar Peninsula Homes Survive

Full Mitigation Best Practice Story

Galveston County, Texas

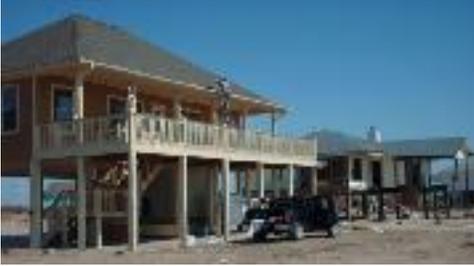
Why did the Bishops' house survive while neighbors' homes did not? The Bishops' house was the newest occupied home in the subdivision. Their builder has a nearby new house, still for sale, that also held up well in the storm. Both were built under the new coastal building codes and followed specifications provided by a structural engineer. In keeping with the letter and the spirit of the code, the Bishop house is elevated high above the water, located back from the coast, held together with steel connectors, fortified with sturdy materials, and shielded by a storm-resistant roof. Impact-resistant glass on windows also helps protect the interior.

The building elevation may have been the most important safety factor. The required elevation was 16 feet, but the house was raised an additional 7 feet, as a margin of safety. The additional amount of height above the required elevation is called "freeboard." It provides added protection and helps lower flood insurance premiums.

Jimmy and Debbie Bishop's house, left, survived Hurricane Ike nearly unscathed.
