D WTC Steel Data Collection

D.1 Introduction

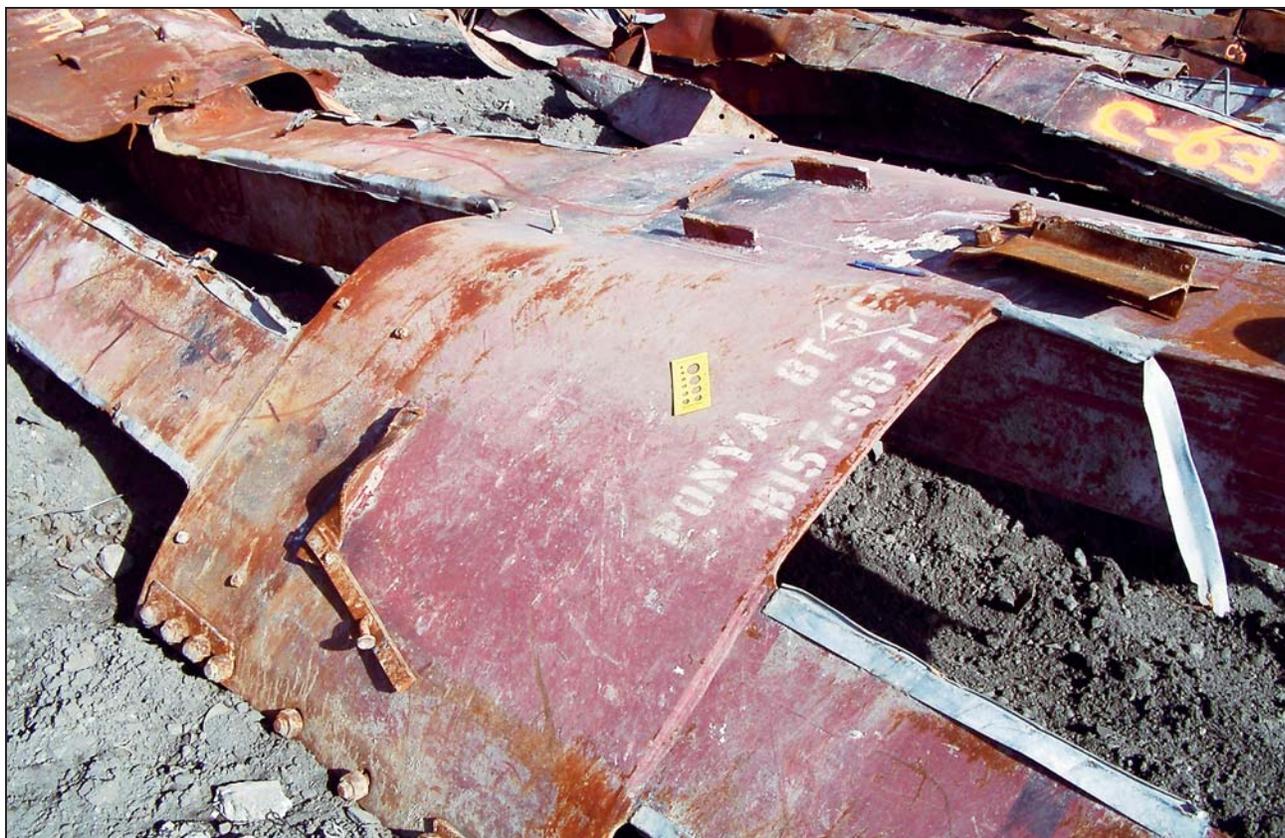
Figure D-5 Stenciled markings on WTC 2 perimeter column from floors 68–71.

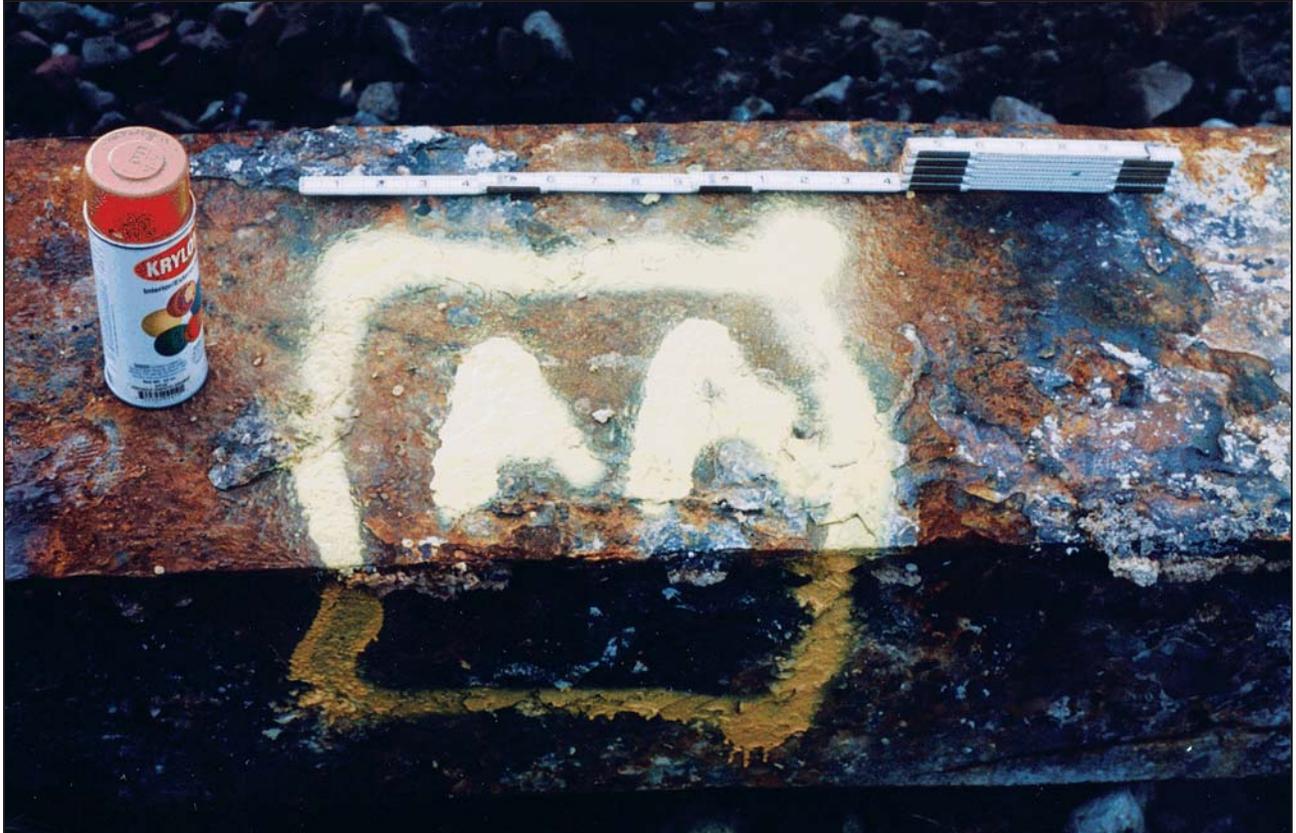
Figure D-11 Burnt steel piece marked for cutting of coupon.

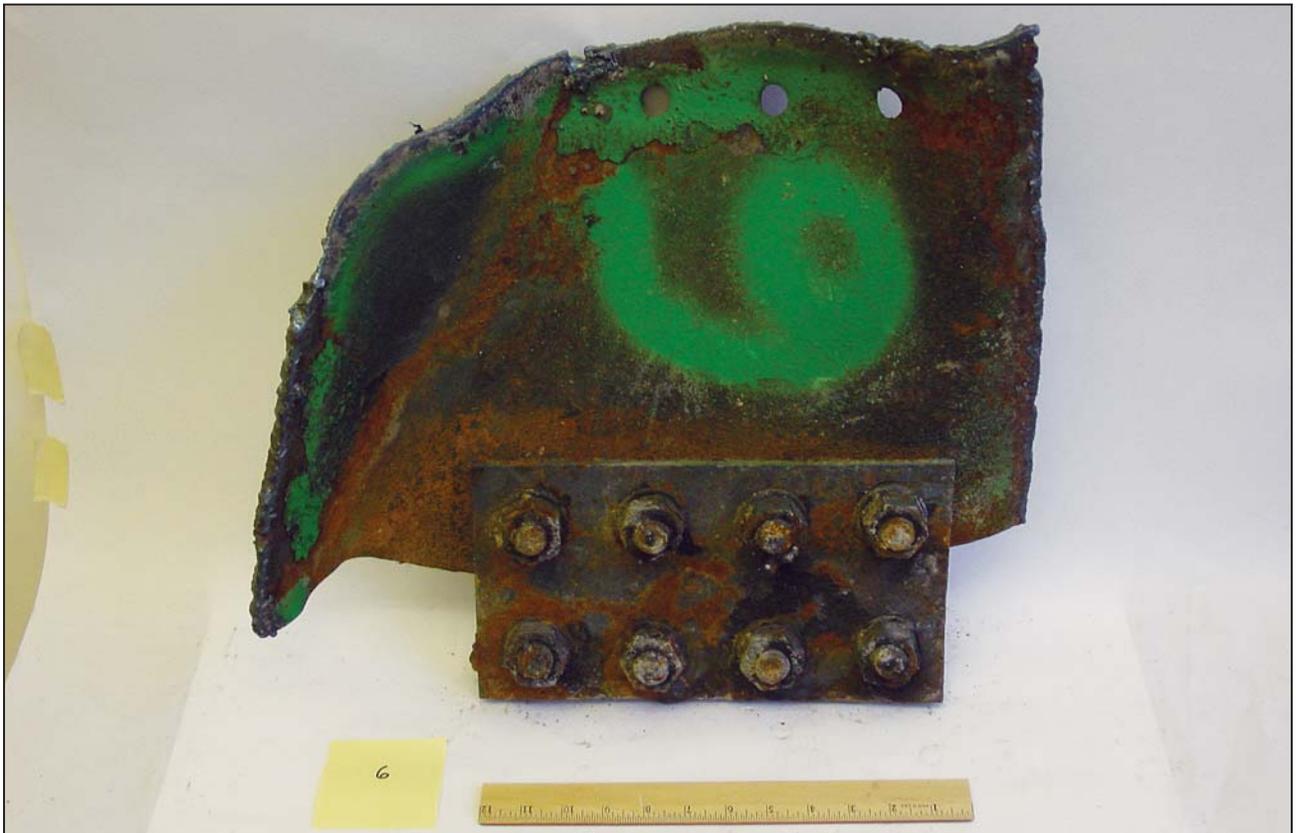
Figure D-12 Coupon cut from WTC 5 showing web tear-out at bolts.

153	GZ	~11/27/01	Eschenasy	-				See Remarks			Connection coupon recovered from WTC#5, 6th floor, and brought to GMS offices. Web tear-out at bolts. Coupon photo by AMassa. Sketch with dimensions and photo in this WTC BPS report, Fig. 4-22.
154	GZ	~11/27/01	Eschenasy	-				See Remarks			Connection coupon recovered from WTC#5, 8th floor, and brought to GMS offices. Plate tear-out at bolts. Coupon photo by AMassa. Sketch with dimensions and photo in this WTC BPS report, Fig. 4-22.
155	GZ	~11/27/01	Eschenasy	-				See Remarks			Connection coupon recovered from WTC#5, 7th floor, and brought to GMS offices. Connection web-plate or splice-block shear. Coupon photo by AMassa. Sketch with dimensions and photo in this WTC BPS report, Fig. 4-22.

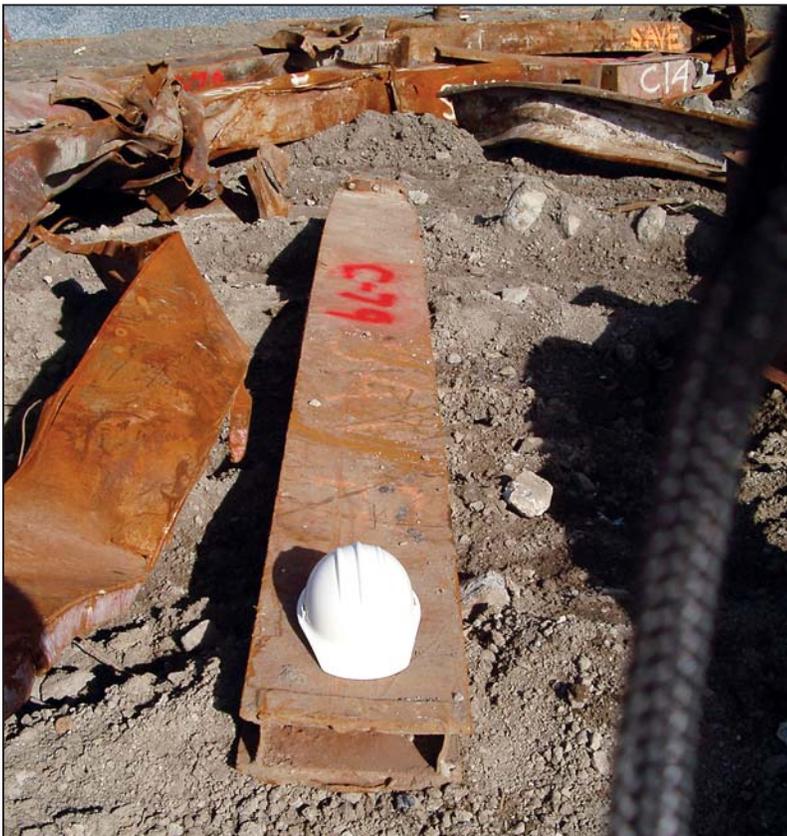
Figure D-13
WTC 1 or WTC 2 core column (C-74).

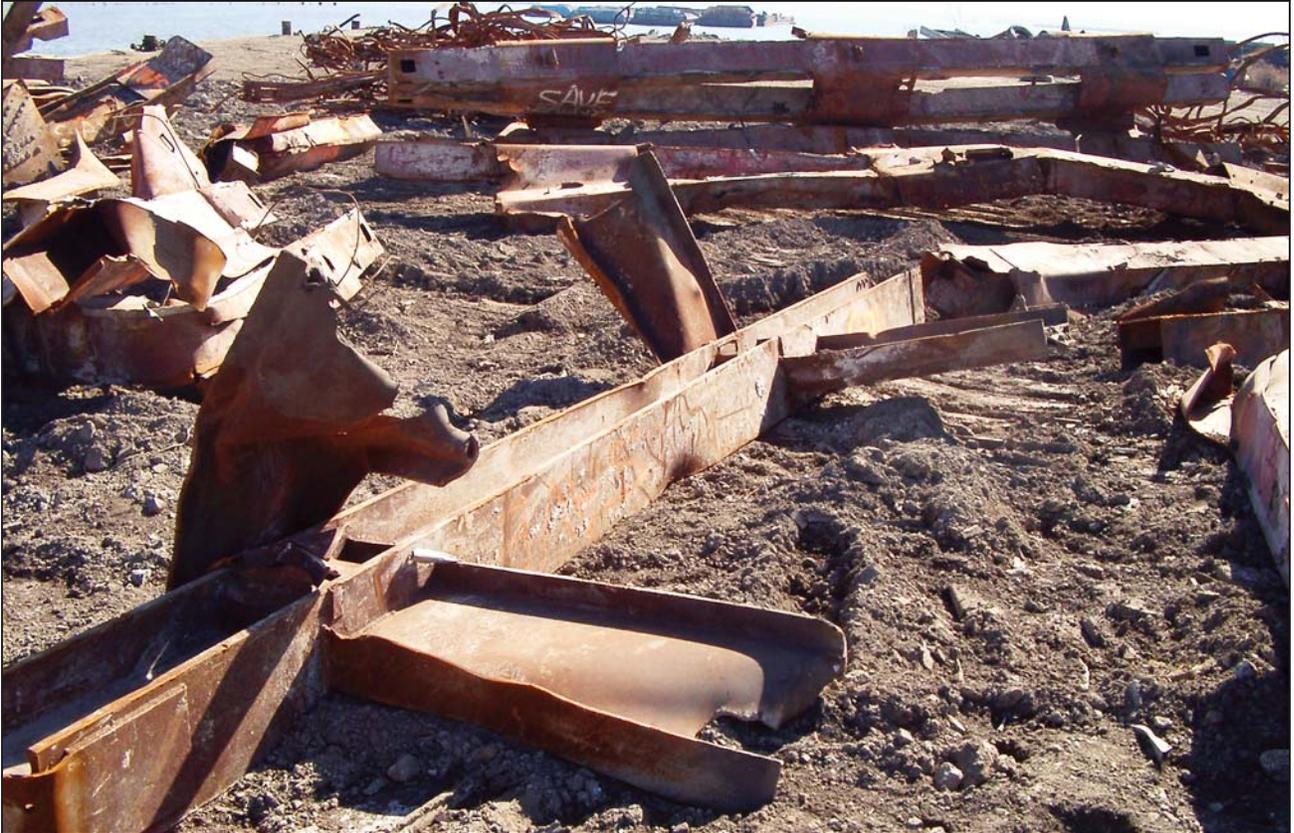
Figure D-14 WTC 7 W14 column tree with beams attached to two floors.

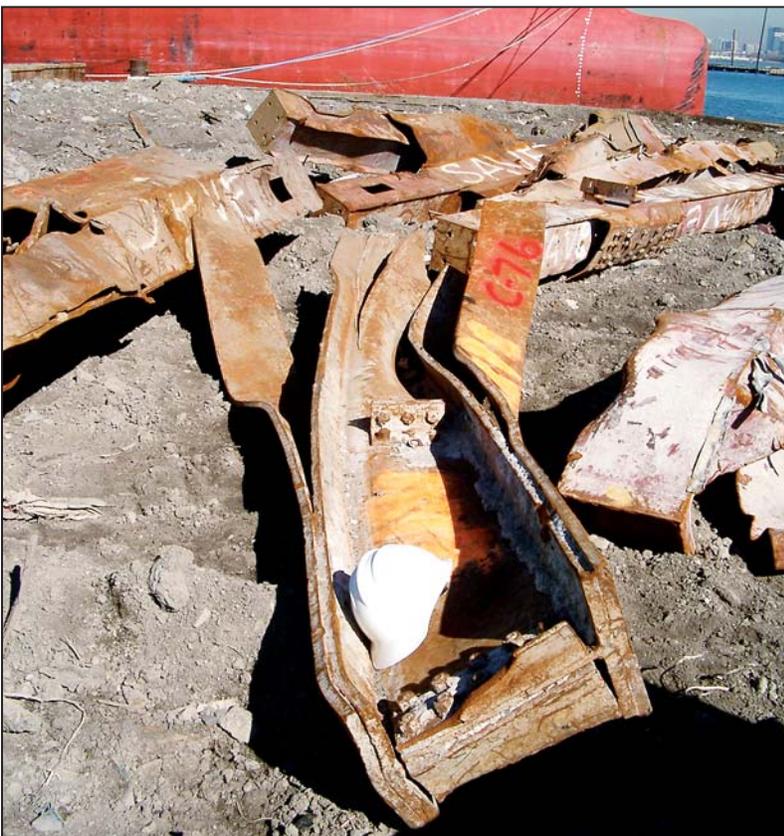
Figure D-15
Built-up member with failure along stitch
welding.

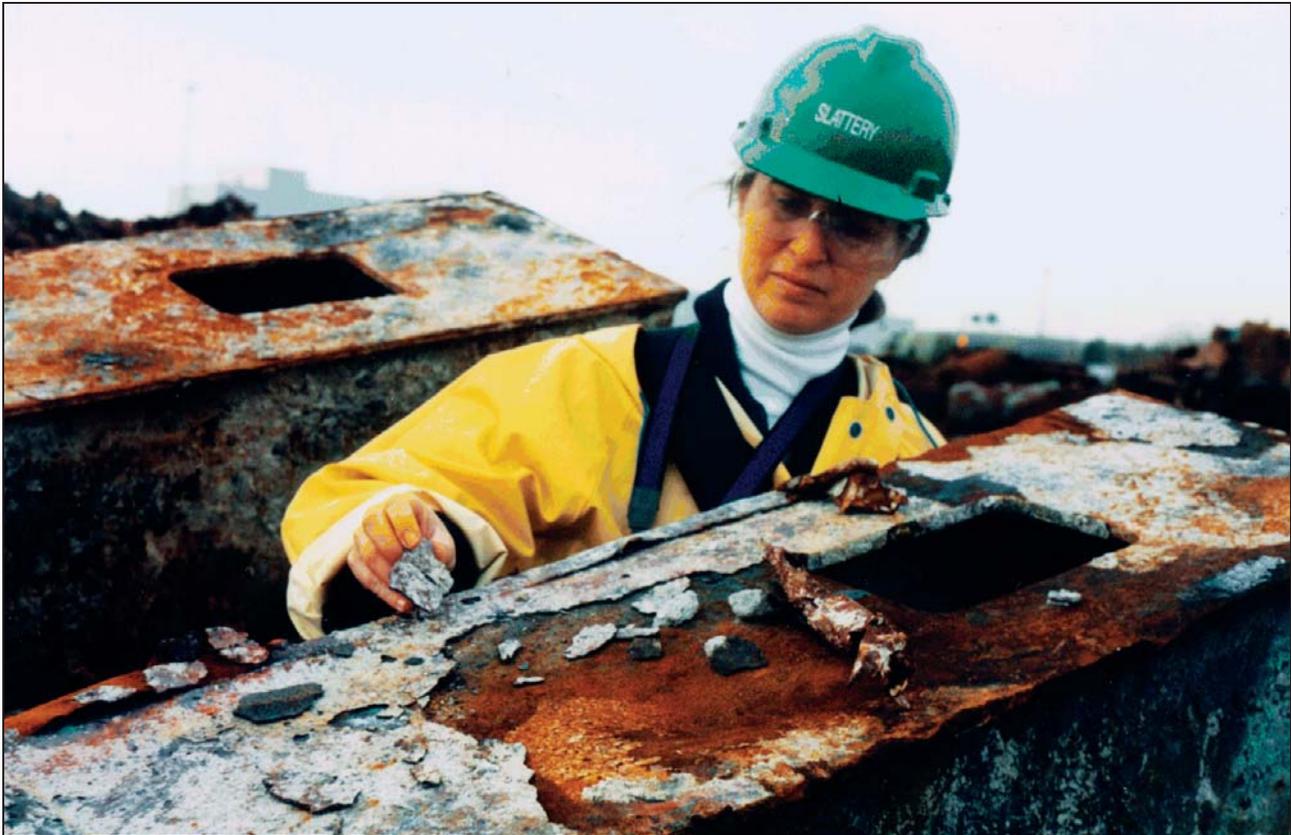
Figure D-16 Engineer inspecting fire damage of perimeter column tree from WTC 1 or WTC 2.

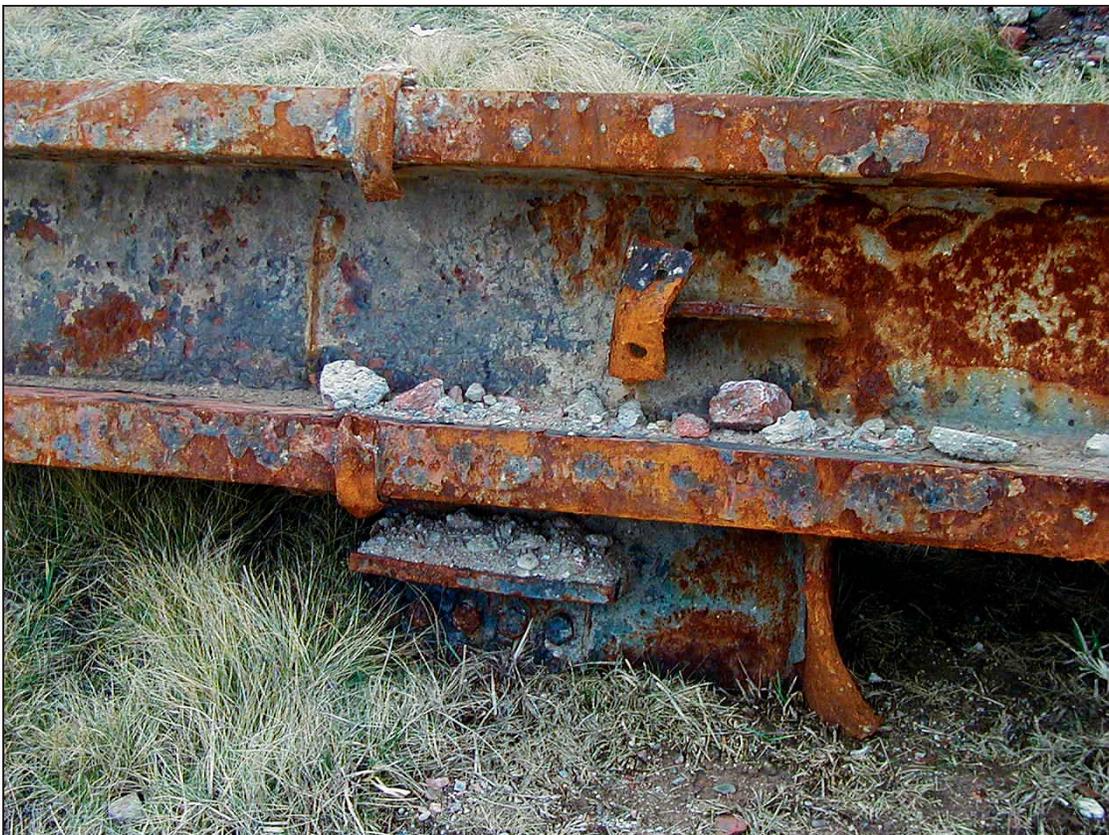
Figure D-17 Seat connection in fire-damaged W14 column from WTC 7.

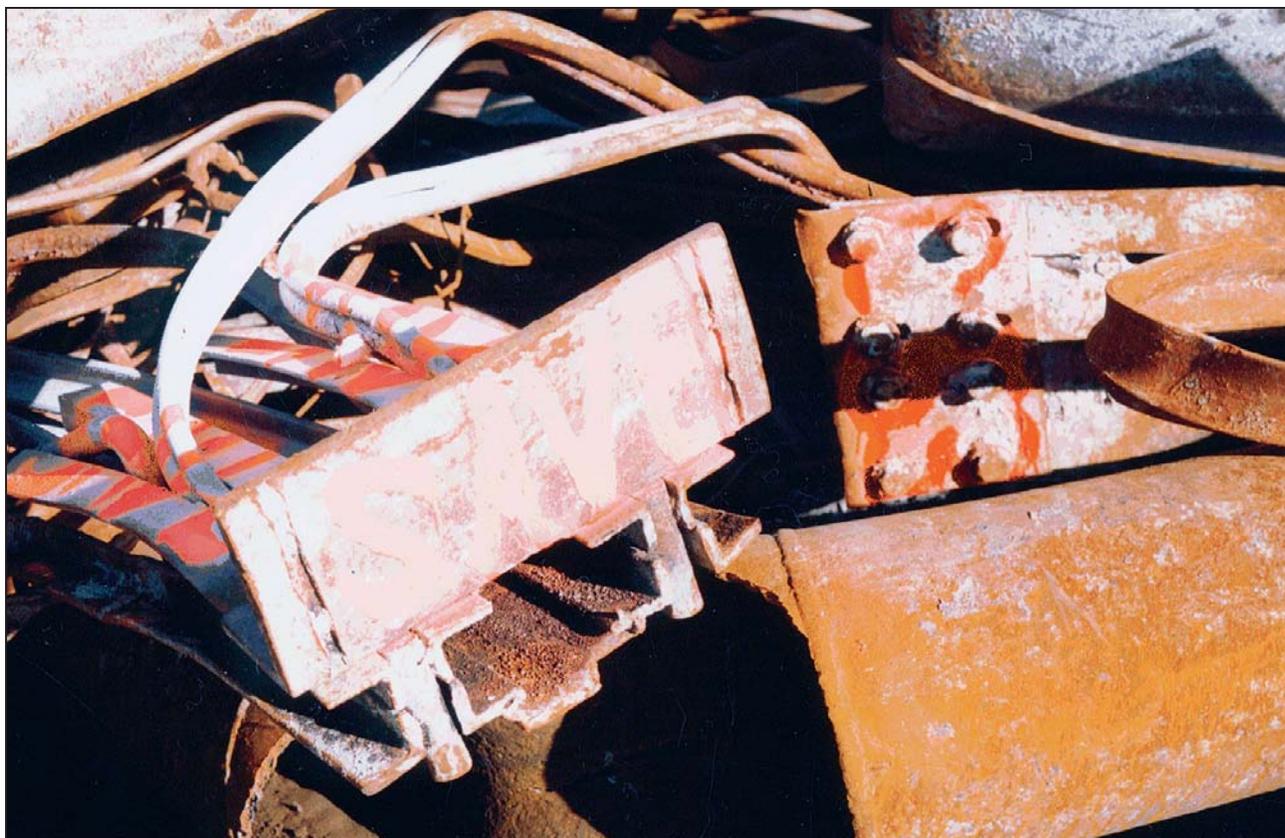
Figure D-18 WTC 1 or WTC 2 floor-truss section with seat connection fractured along welds.
