3 WTC 3

3.1 Design and Construction Features

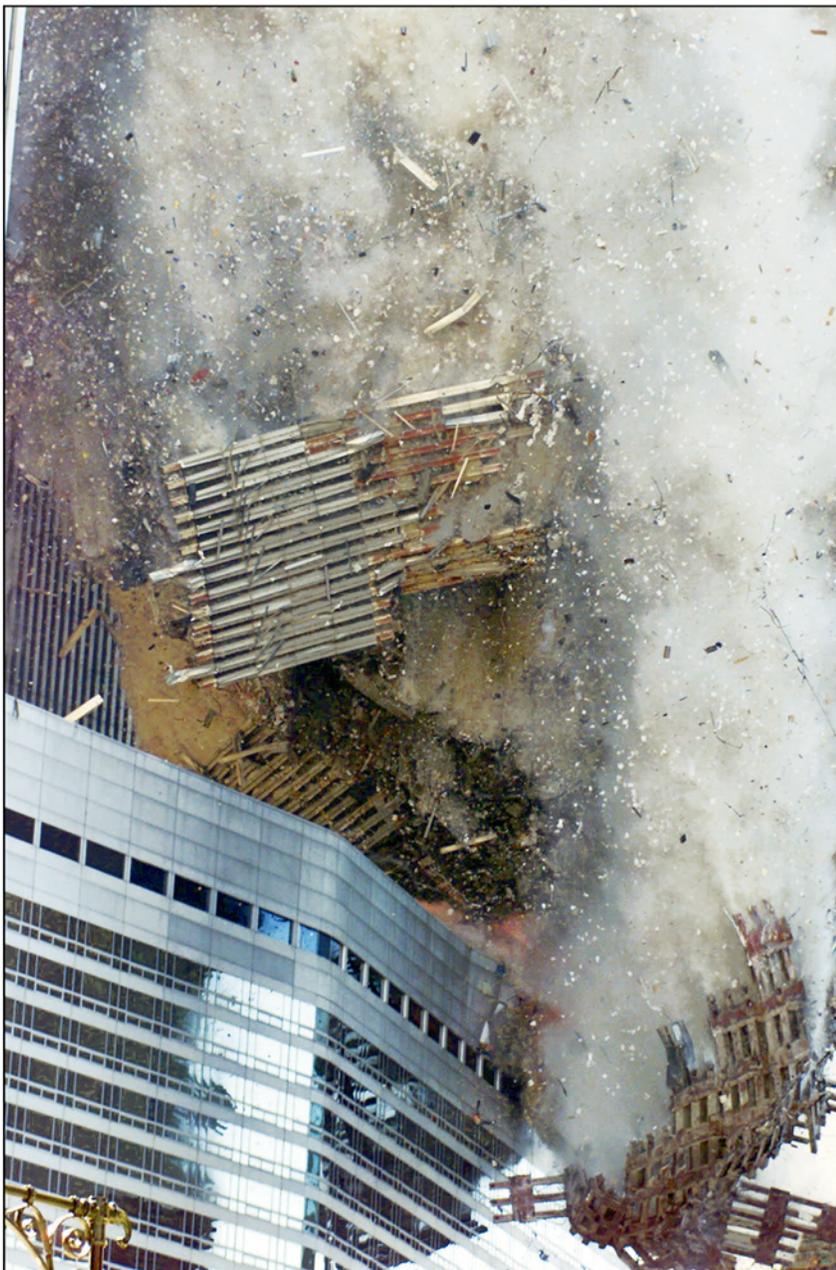
The response of WTC 3 to the September 11 events is complex and noteworthy. WTC 3 was subjected to two loading events. The first event involved the collapse of WTC 2, which stood immediately east of WTC 3. Due to its proximity to WTC 2, substantial amounts of debris fell directly on the roof of WTC 3. Figure 3-6 shows large portions of the prefabricated assemblies from WTC 2 falling on top of WTC 3.

*Figure 3-6
Exterior columns from the collapse of WTC
2 falling on the southern part of WTC 3.*

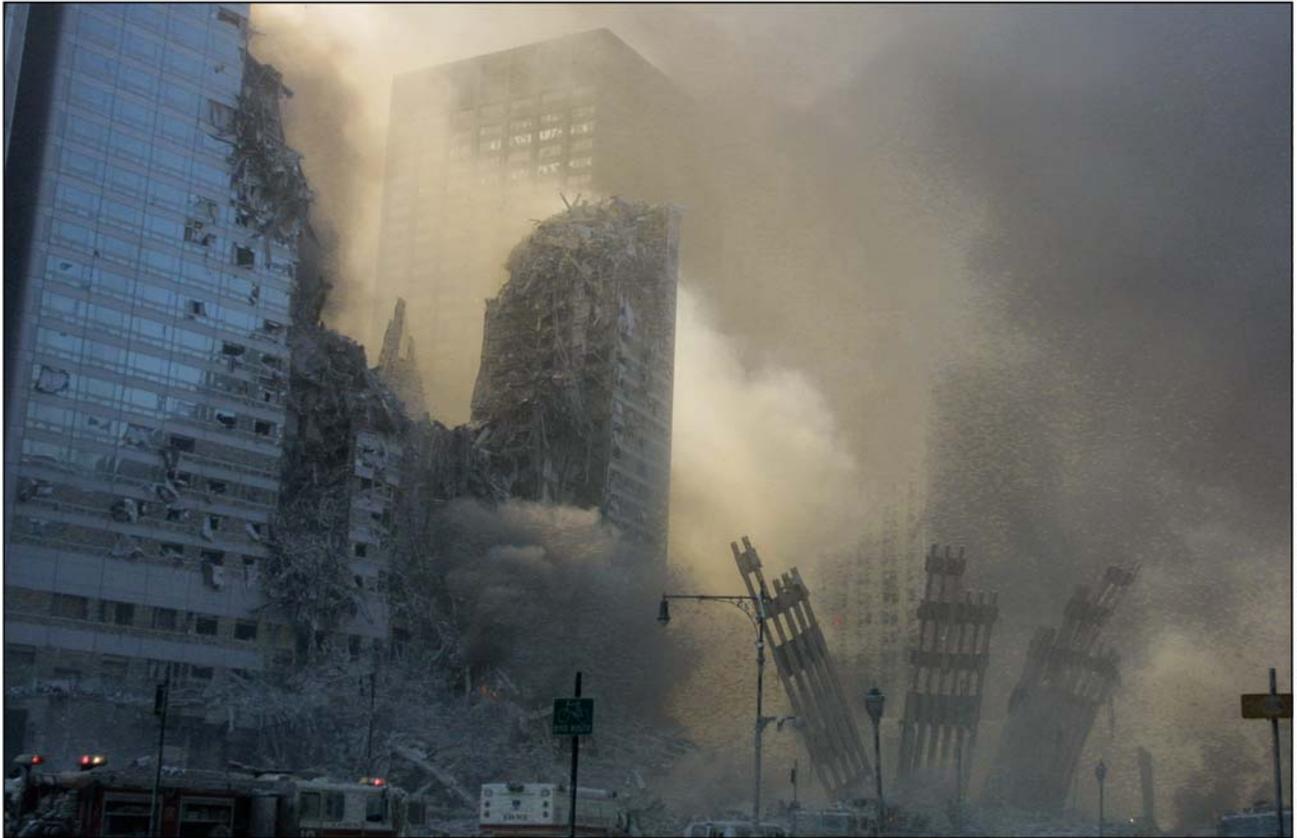
Debris from WTC 2 struck the building with sufficient force to crush approximately 16 stories in the center of the building, as shown in Figure 3-7. In spite of this extensive damage, the collapse did not

Figure 3-7 Partial collapse of WTC 3 after collapse of WTC 2.

continue down to the foundations or extend horizontally to the edges of the structure. In fact, the two northernmost bays (approximately 60 feet) remained intact all the way to the roof. A similar, but lesser condition existed in the southern bays. Even in the center of the building, the collapse stopped at approximately the 7th floor. This arrested collapse implies that the structure was sufficiently strong and robust to absorb the energy of the falling debris and collapsed floors, but at the same time the connections between the destroyed and remaining framing were able to break apart without pulling down the rest of the structure. This complex behavior resulted in the survival of large portions of the building following the collapse of WTC 2.

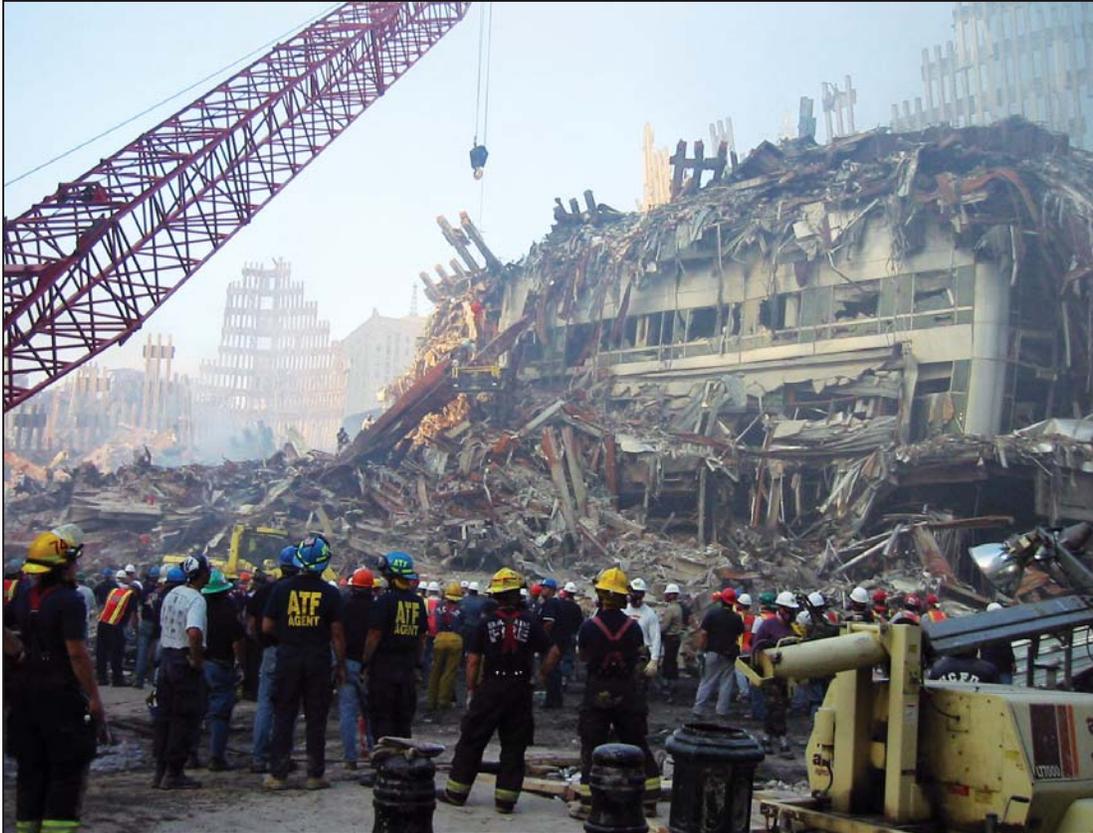
The second loading event was the collapse of WTC 1. Debris from WTC 1 fell along the entire length of the hotel. Lower floors at the southwest end of WTC 3 survived although they suffered extensive damage. The remaining portions of the building after both collapses of WTC 1 and WTC 2 are shown in Figure 3-8.

Figure 3-8 Remains of WTC 3 after collapse of WTC 1 and WTC 2.

WTC 3 was subjected to extraordinary loading from the impact and weight of debris from the two adjacent 110-story towers. It is noteworthy that the building resisted both horizontal and vertical progressive collapse when subjected to debris from WTC 2. The overloaded portions were able to break away from the rest of the structure without pulling it down, and the remaining structural system was able to remain stable and support the debris load. The structure was even capable of protecting occupants on lower floors after the collapse of WTC 1.

WTC 3 should be studied further to understand how it resisted progressive collapse.
