4 *WTC 4, 5, and 6*

4.1 Design and Construction Features

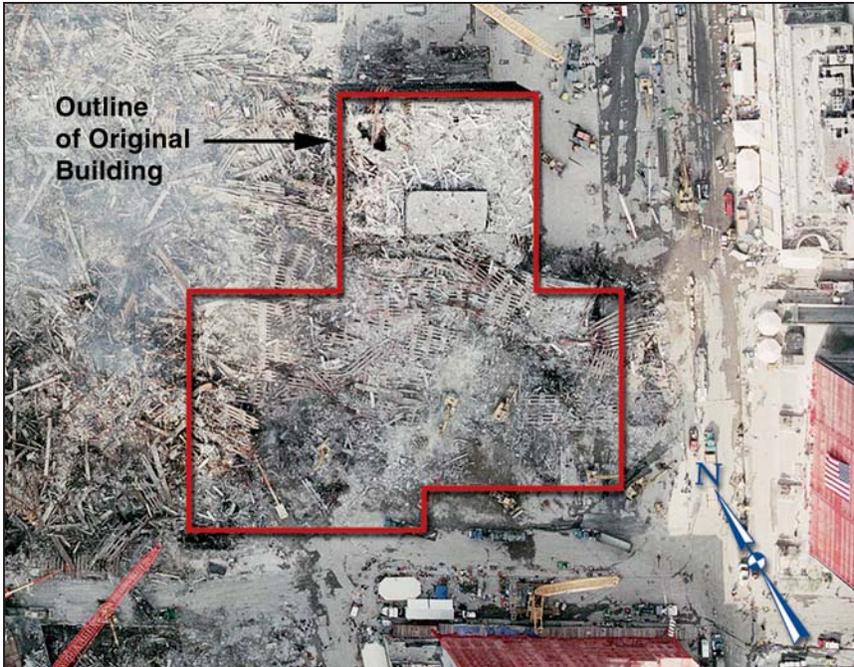
There was major impact to WTC 4 from the collapse of one or both of the WTC towers (most likely WTC 2) that destroyed all but the northern 50 feet of the building. Extensive damage is evident in Figure 4-5.

Figure 4-5 Damage to WTC 4.

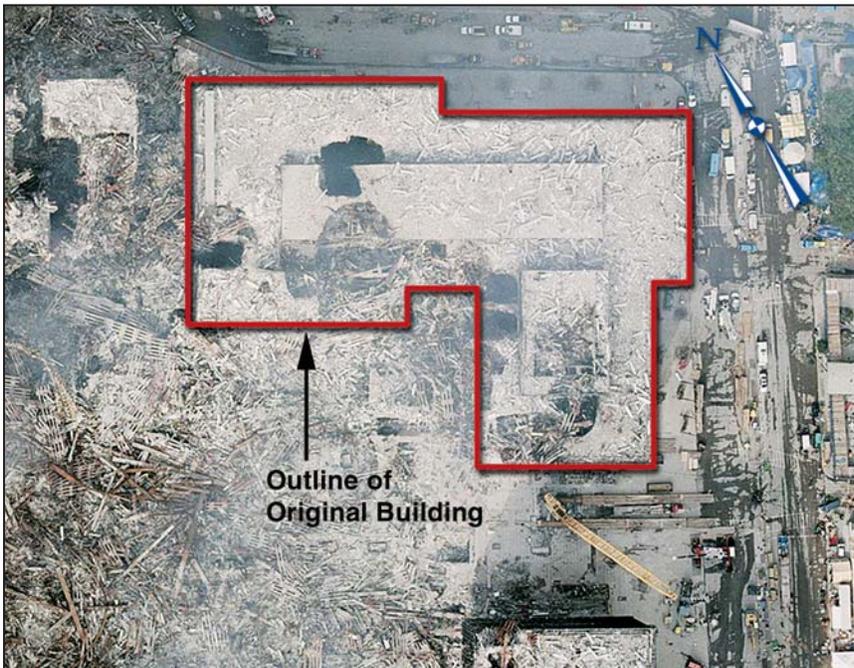
WTC 5 was damaged by impact and subsequent fires. The impact damage areas in WTC 5 are shown in Figure 4-6. The debris damage caused localized collapses from the roof to the 3rd floor in most of the areas where exterior columns impacted the structure. Ensuing fires that burned unchecked in the building caused a localized collapse from the 9th floor to the 4th floor. Figure 4-7 diagrammatically shows the damaged and collapsed areas of WTC 5 due to impact and fire.

Figure 4-6 Damage to WTC 5.

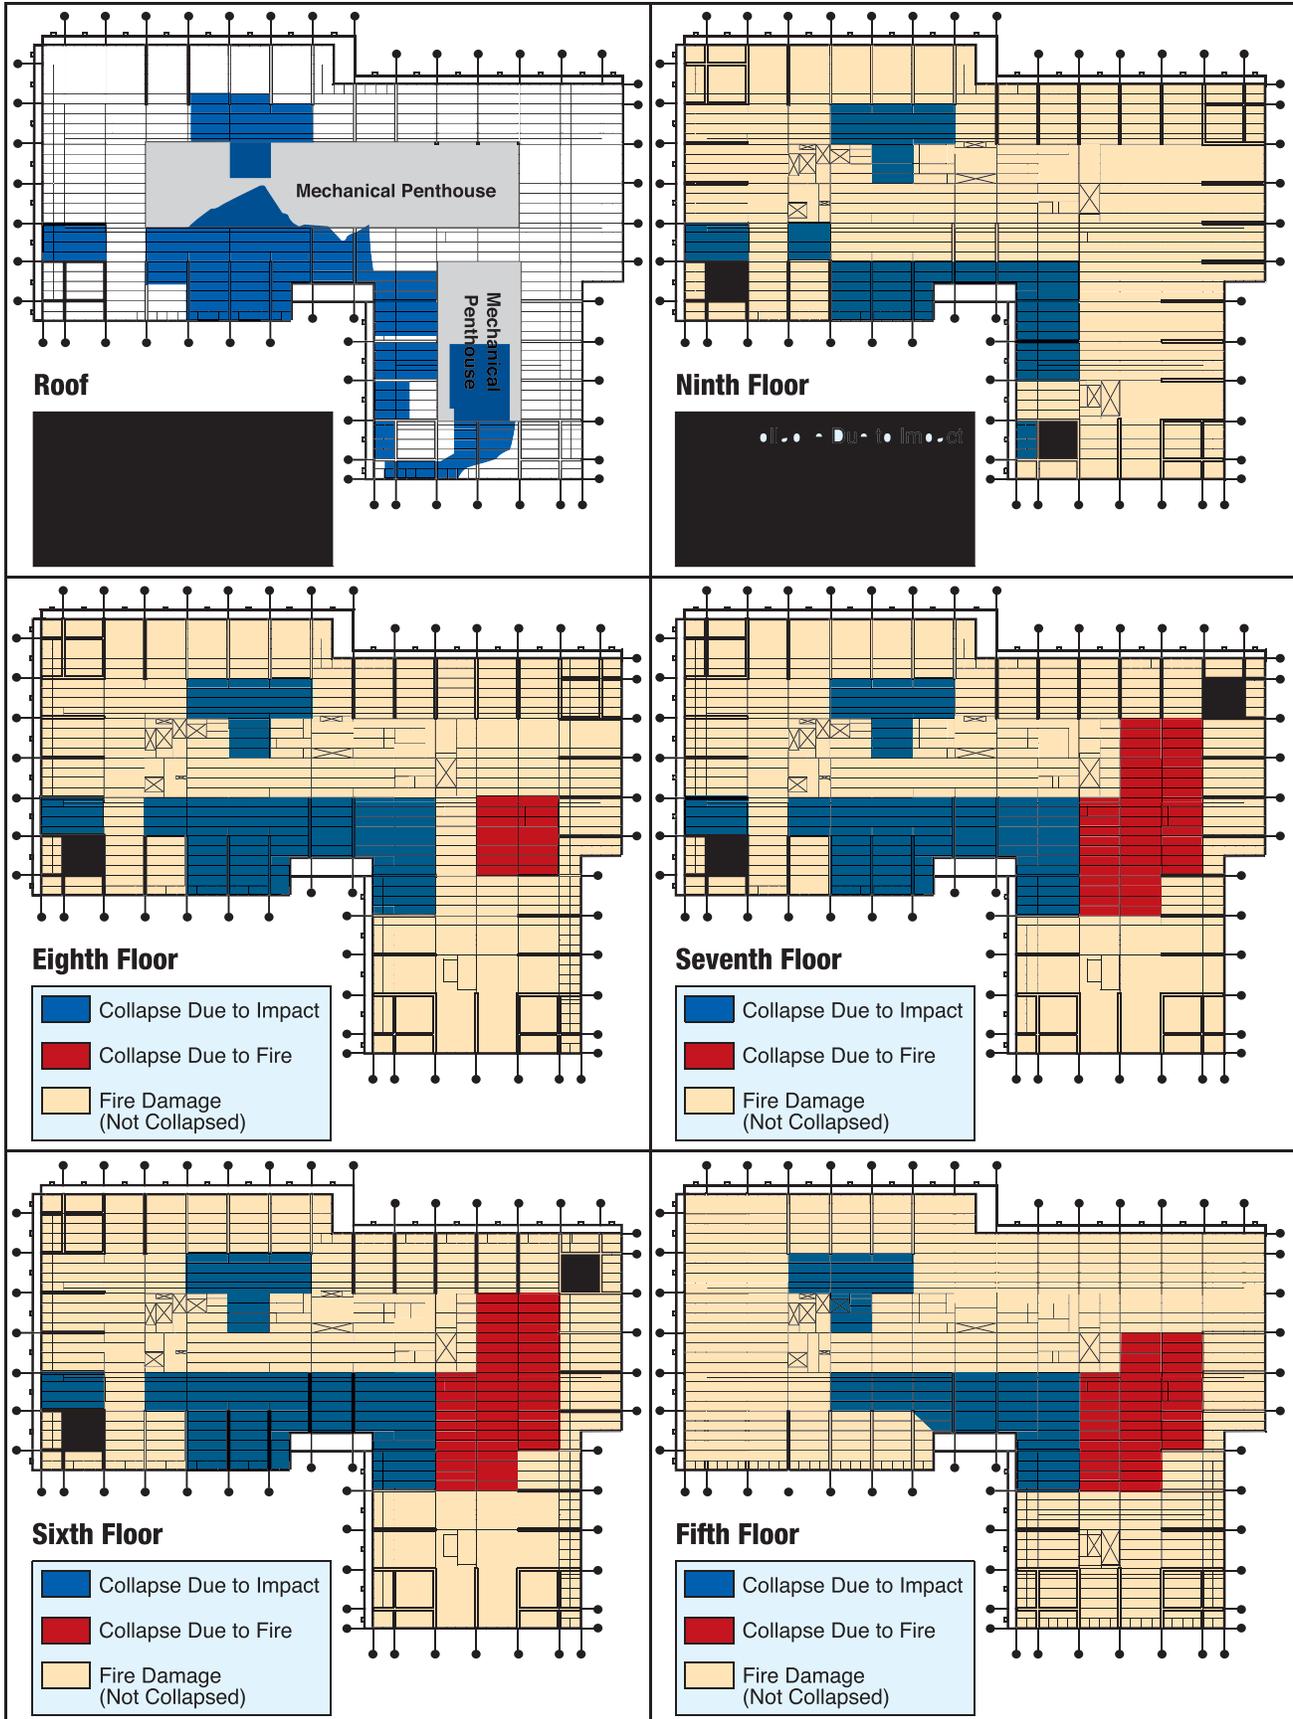
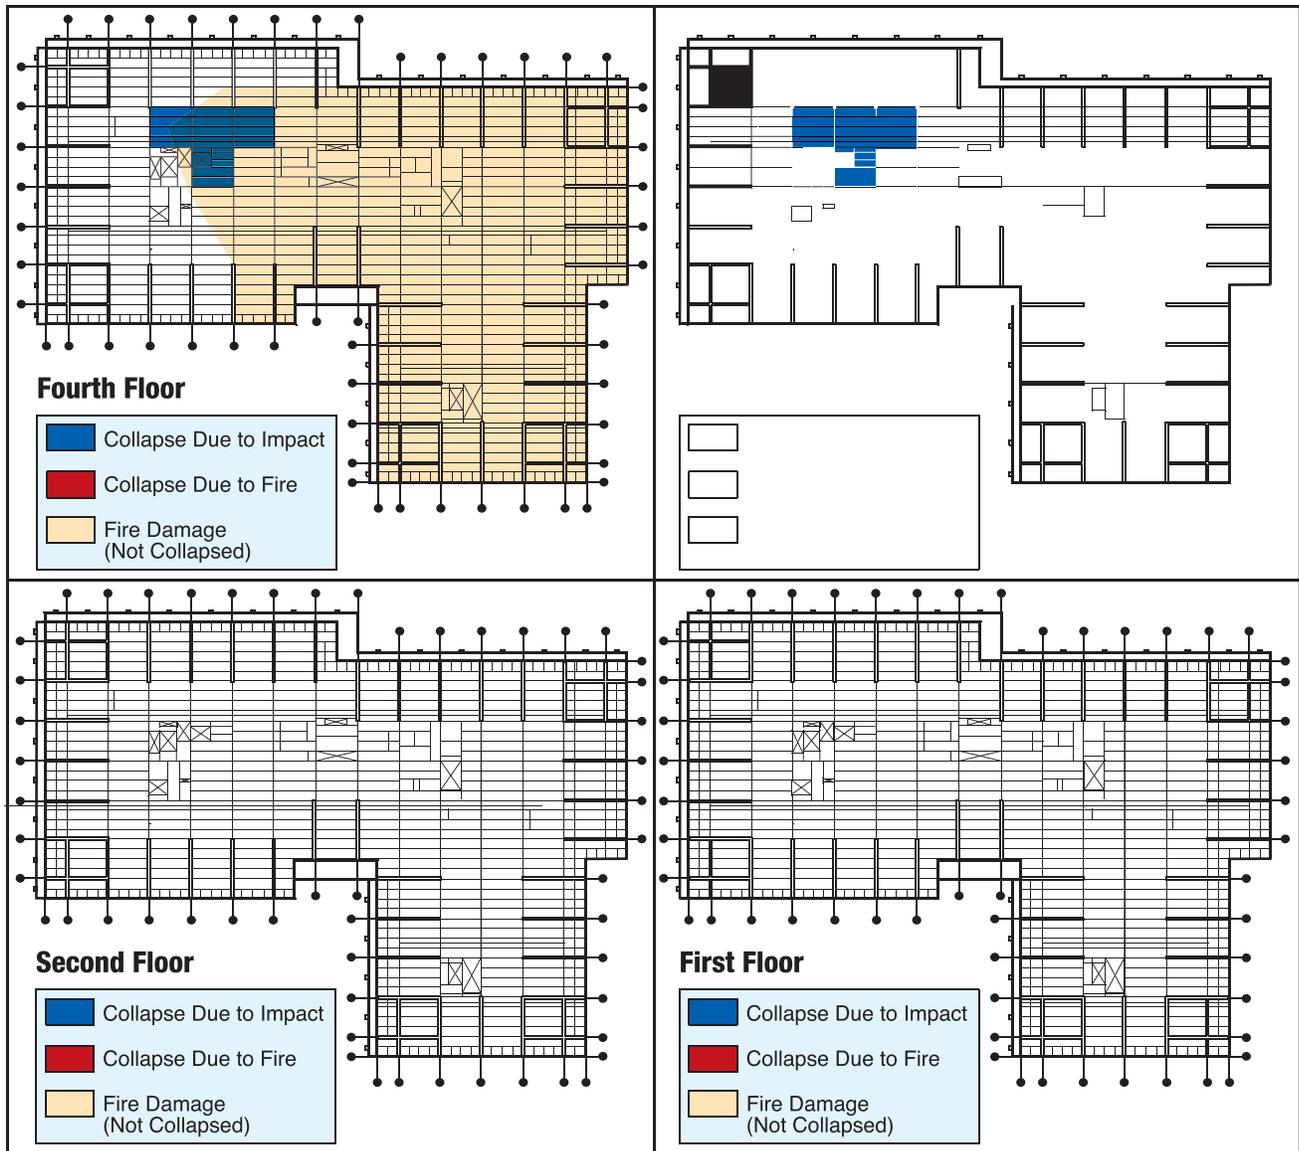
Figure 4-7 Approximate locations of damaged floor areas in WTC 5.

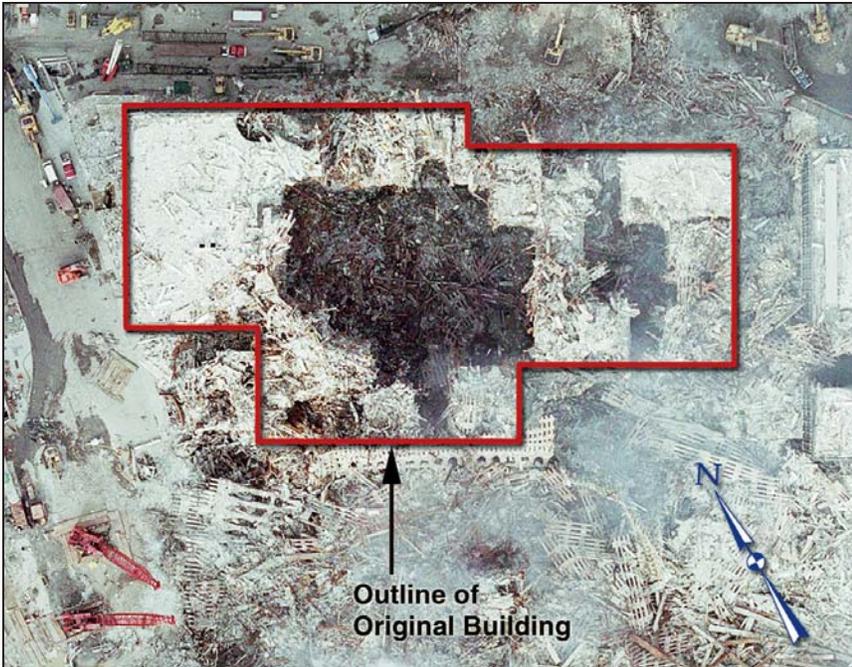
WTC 6 suffered significant impact and fire damage from the collapse of WTC 1, as shown in Figure 4-8. Most of the impact appears to have been in the center of the building, where the damage extended to the ground level. Figures 4-9 and 4-10 illustrate the magnitude of the damage.

Figure 4-8 Damage to WTC 6. Note the edge of WTC 5 on the right hand side.

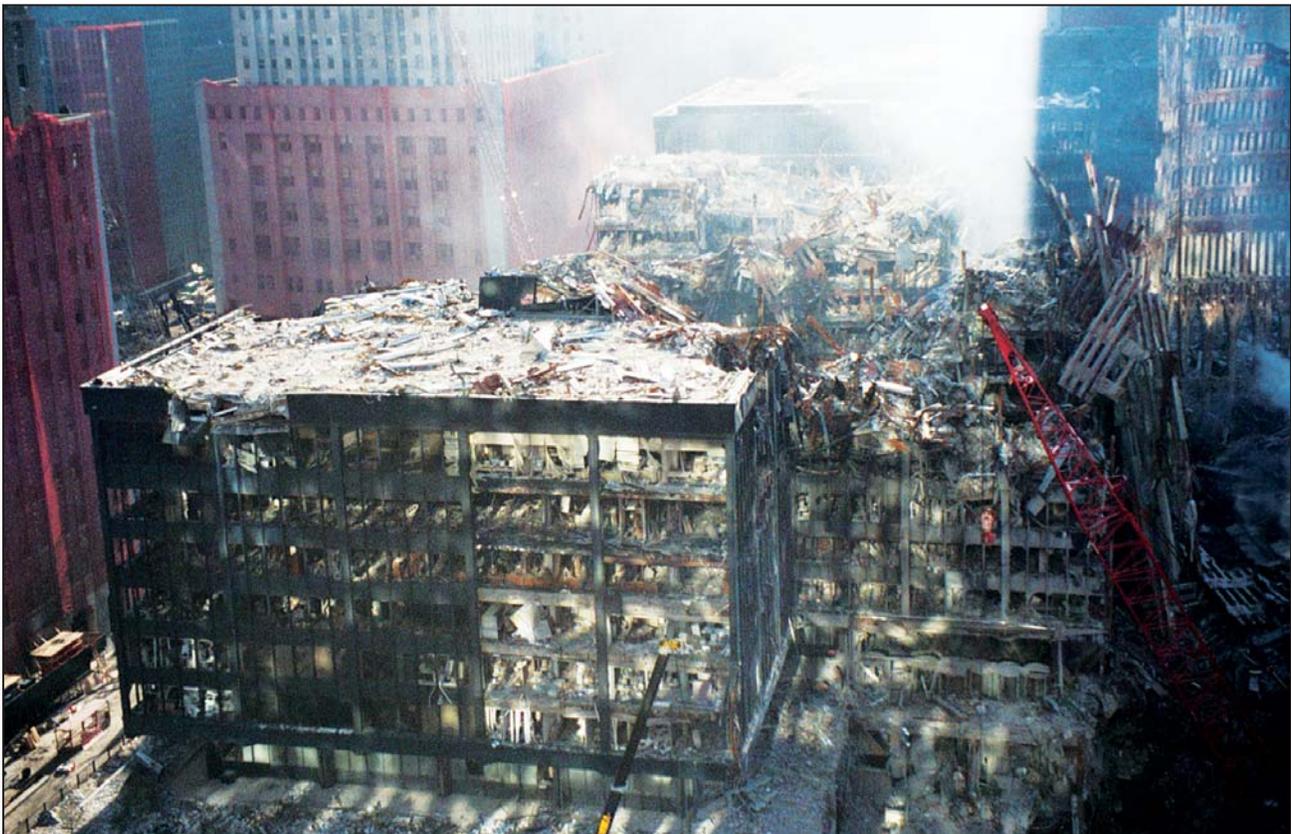
Figure 4-9 Impact damage to WTC 6.

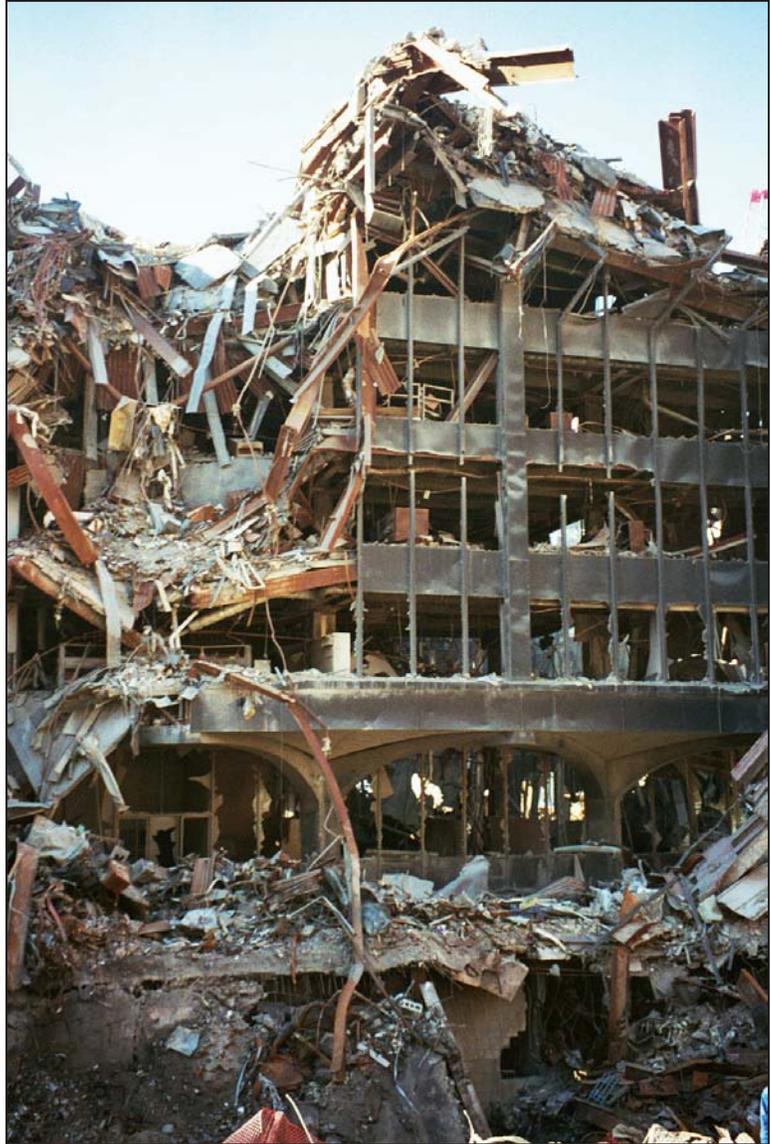
Figure 4-10 Impact damage to the exterior façade of WTC 6.

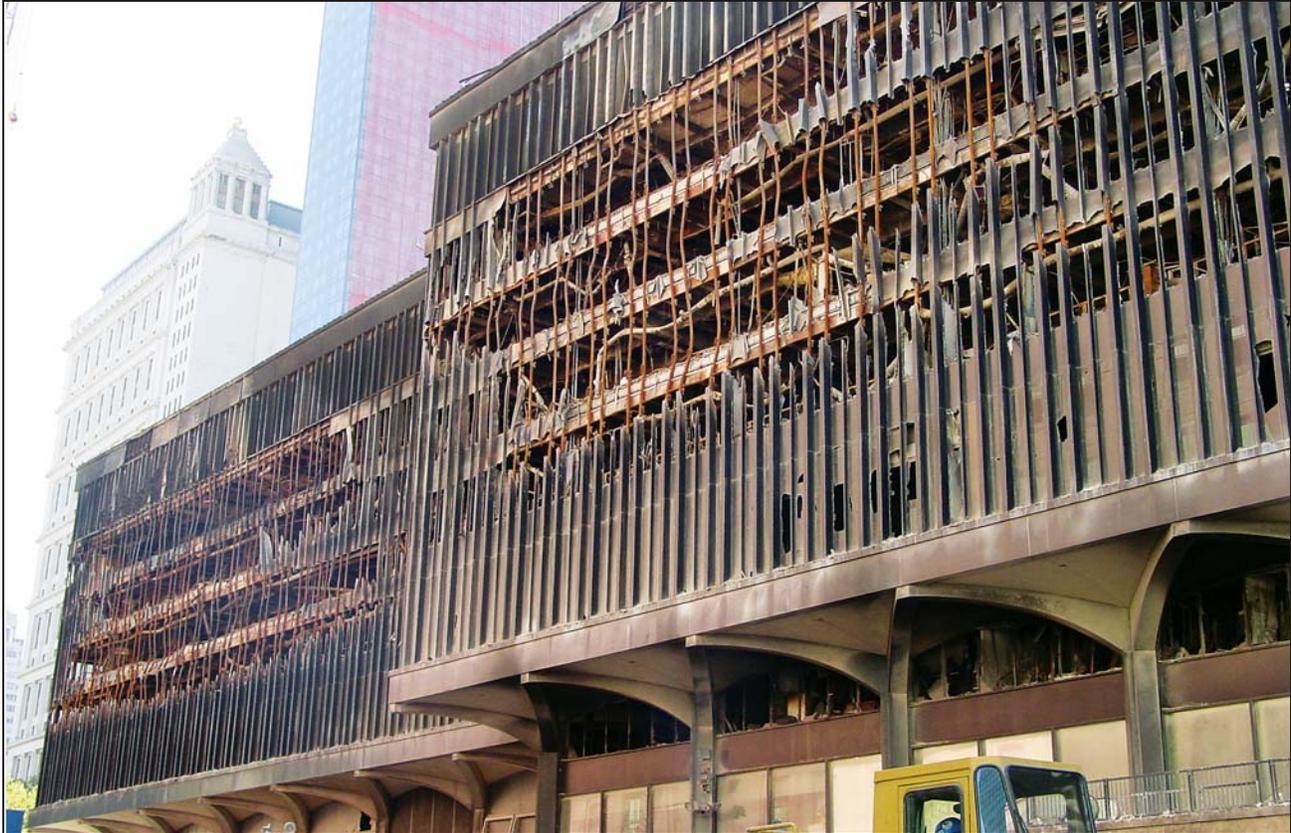
Many areas of buckled steel-beam flanges appeared to have been caused by debris impact. There were 3-1/2 inch steel pipe façade supports along the building perimeter, many of which had buckled from taking part of the collapsed floor loads above the pipe supports (see Figure 4-11). In areas that locally collapsed from

Figure 4-11 WTC 5 façade damage.

The debris from the towers caused damage to the outside wall steel framing of WTC 5, but this damage did not cause any additional collapse of the floors. In fact, the steel pipe façade supports (mullions) provided structural redundancy to the floor framing and redistributed some portion of the cantilevered floors to other levels.

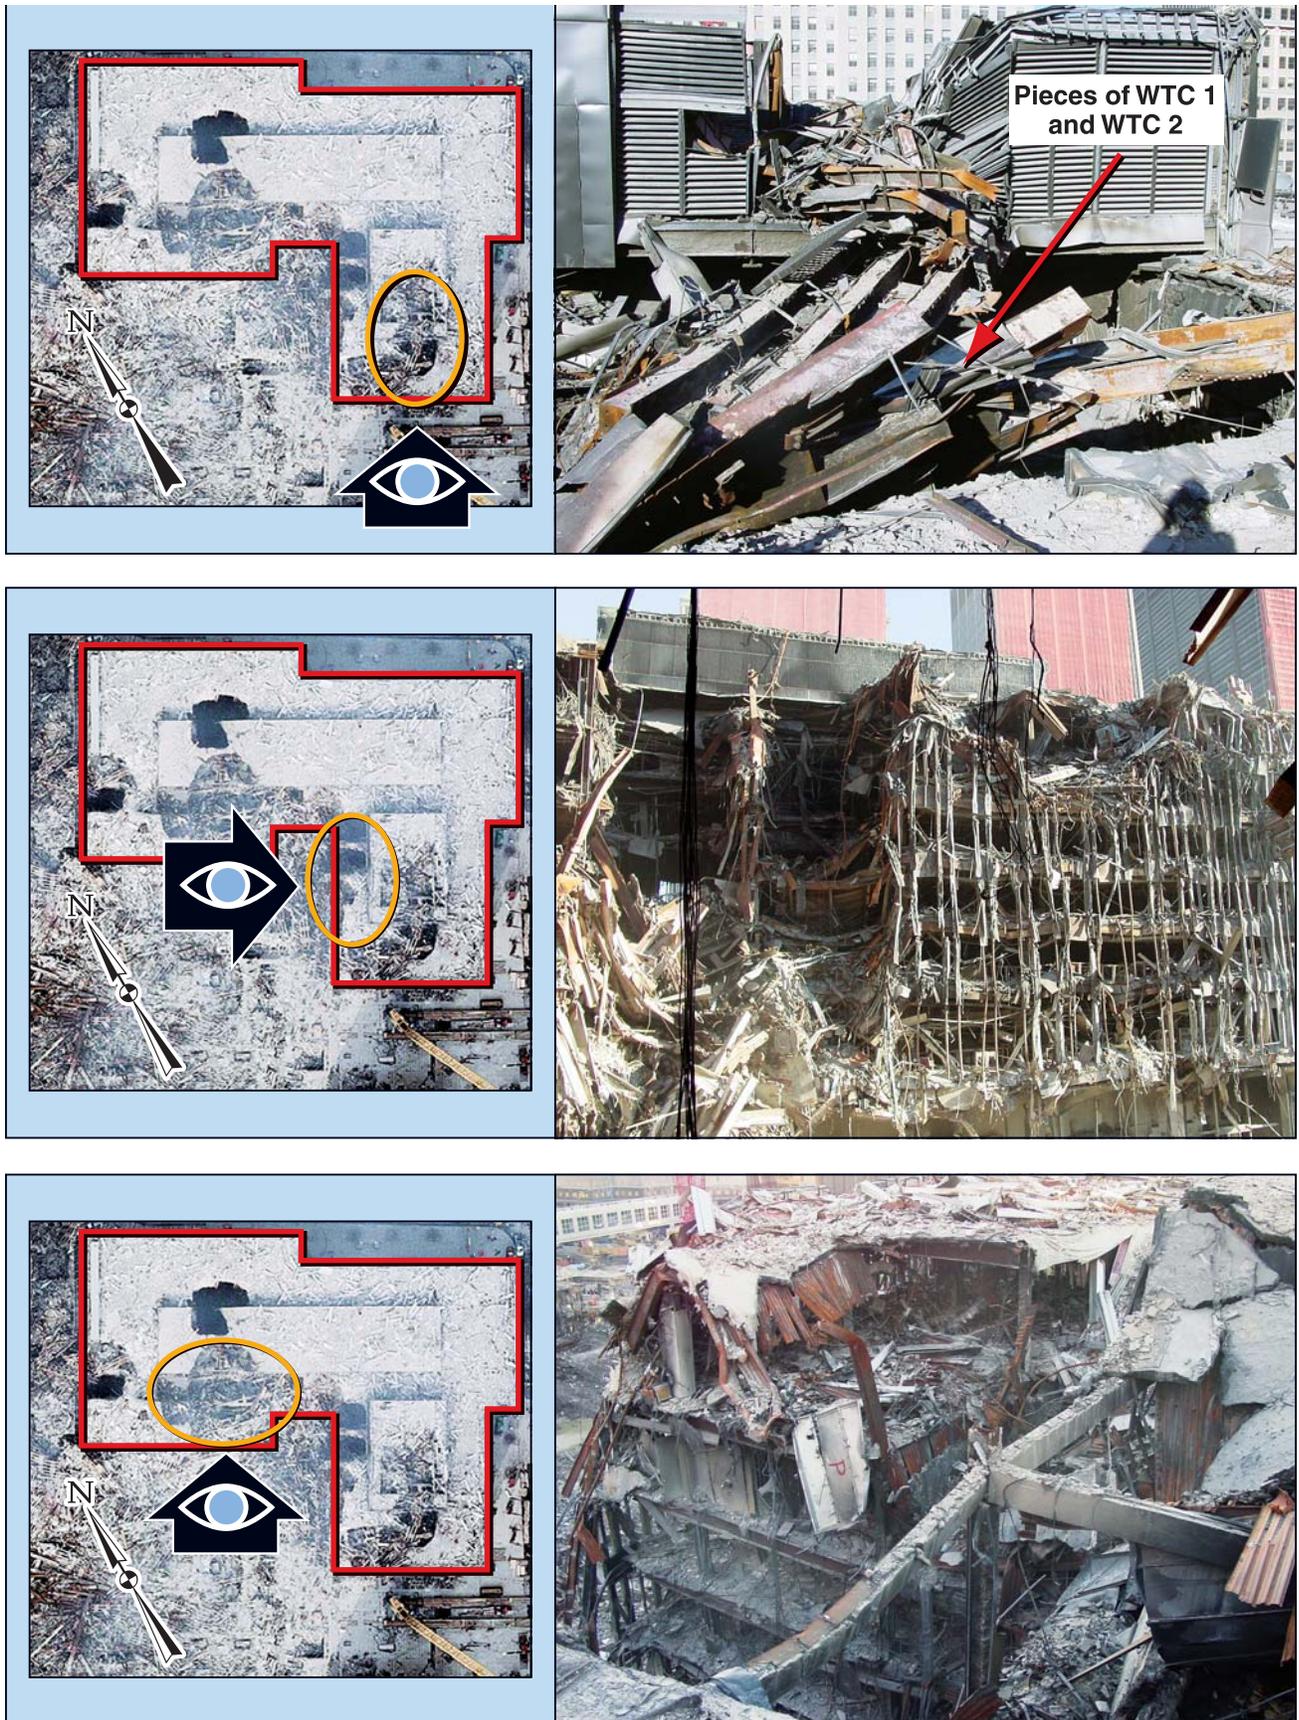
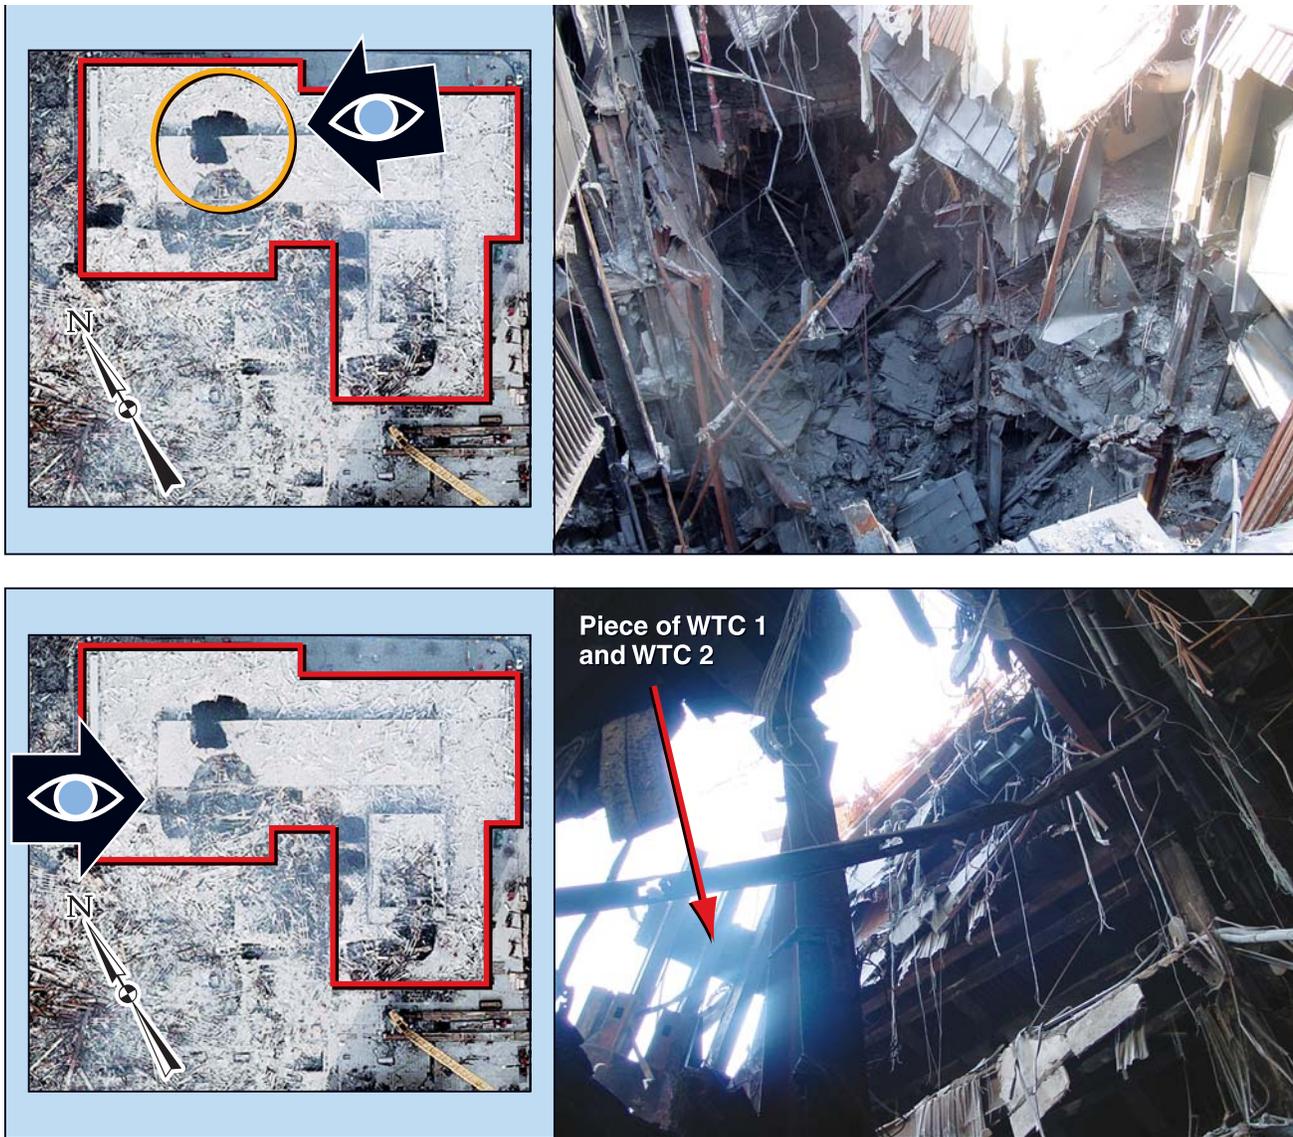
Significant impact damage to WTC 5 is shown in Figure 4-12. The damage was concentrated on the west side of the building.

Figure 4-12 Impact damage to WTC 5.

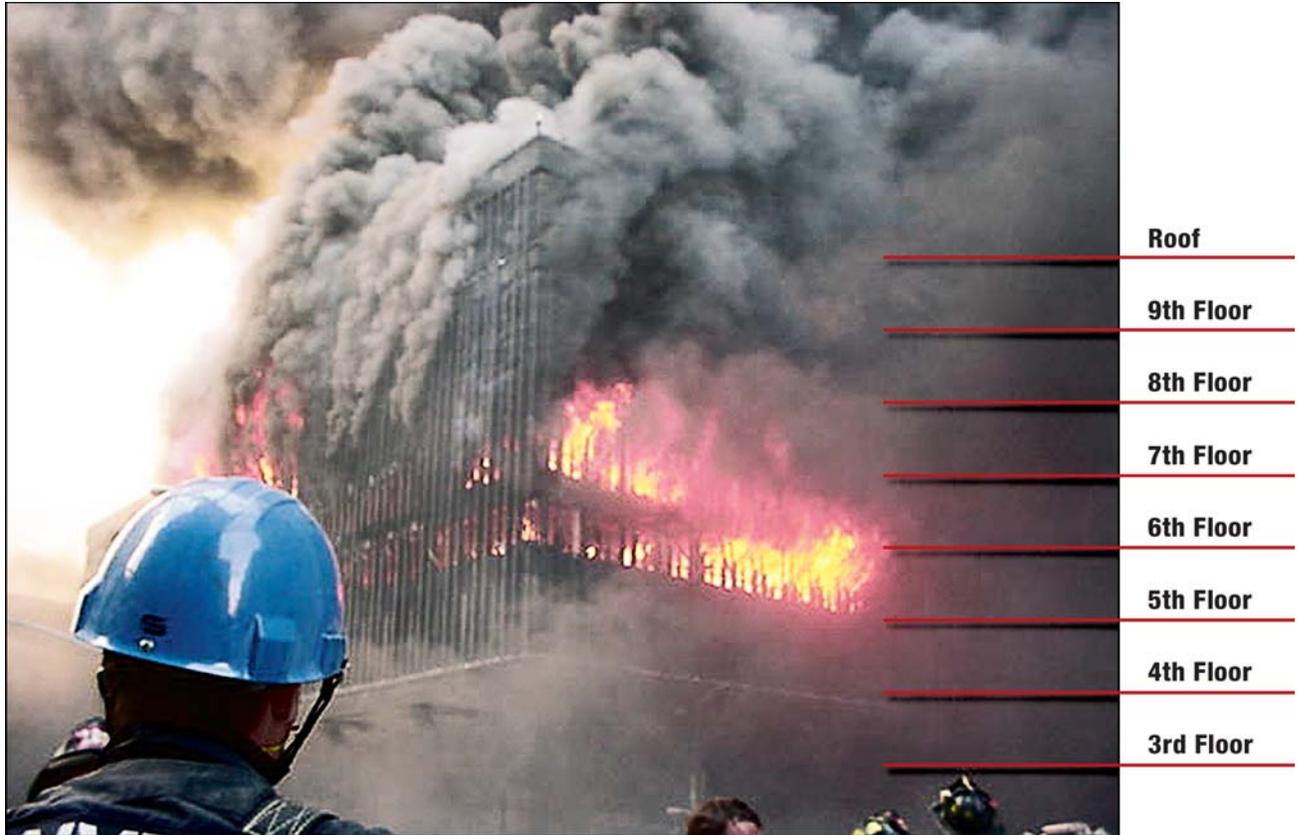
Figure 4-13 shows WTC 5 on fire. The source of ignition has not been identified. It is likely that it was due to flaming debris entering the building from WTC 1 and WTC 2. There was a complete burnout of all combustibles from the 5th floor and above. Some steel beams supporting the roof were deformed due to the heat, as illustrated in Figure 4-14, and some local buckling occurred as well. Roof tar entered the floor through the drains. There is no indication that this roof tar played a major role in the fires. One area below the roof at the 8th floor collapsed onto the 7th floor and then both onto the 6th, and so on, down to the 4th floor.

Figure 4-13 WTC 5 on fire.

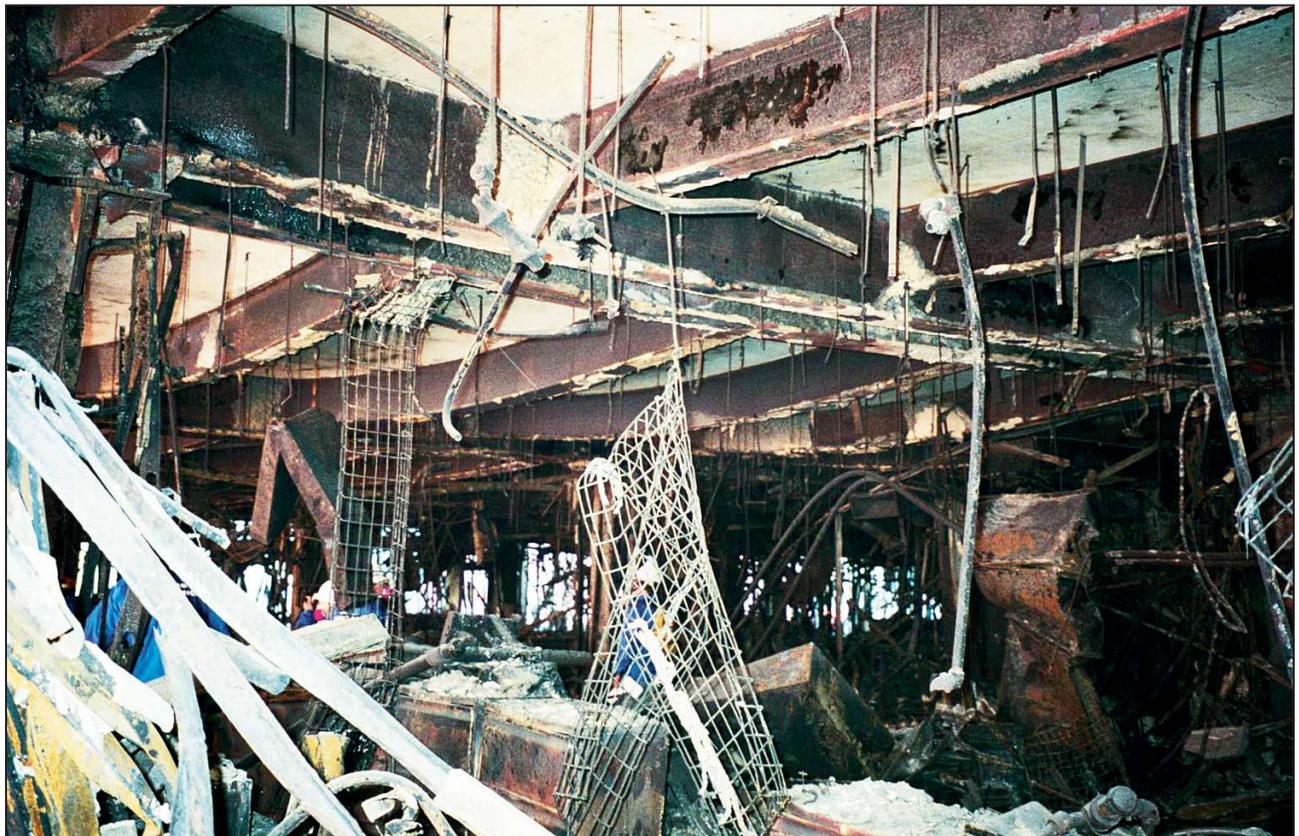
Figure 4-14 Deformed beams in WTC 5.

The steel generally behaved as expected given the fire conditions in WTC 5. Many beams developed catenary action as illustrated in Figure 4-14. Some columns buckled, as shown in Figure 4-17. The one exception is the limited internal structural collapse in WTC 5. The fire-induced failure that led to this collapse was unexpected. As in the rest of the building, the steel beams were expected to deflect significantly, yet carry the load. This was not the case where the beam connections failed. The failure most likely occurred during the heating of the structure because the columns remained straight and freestanding after the collapse.

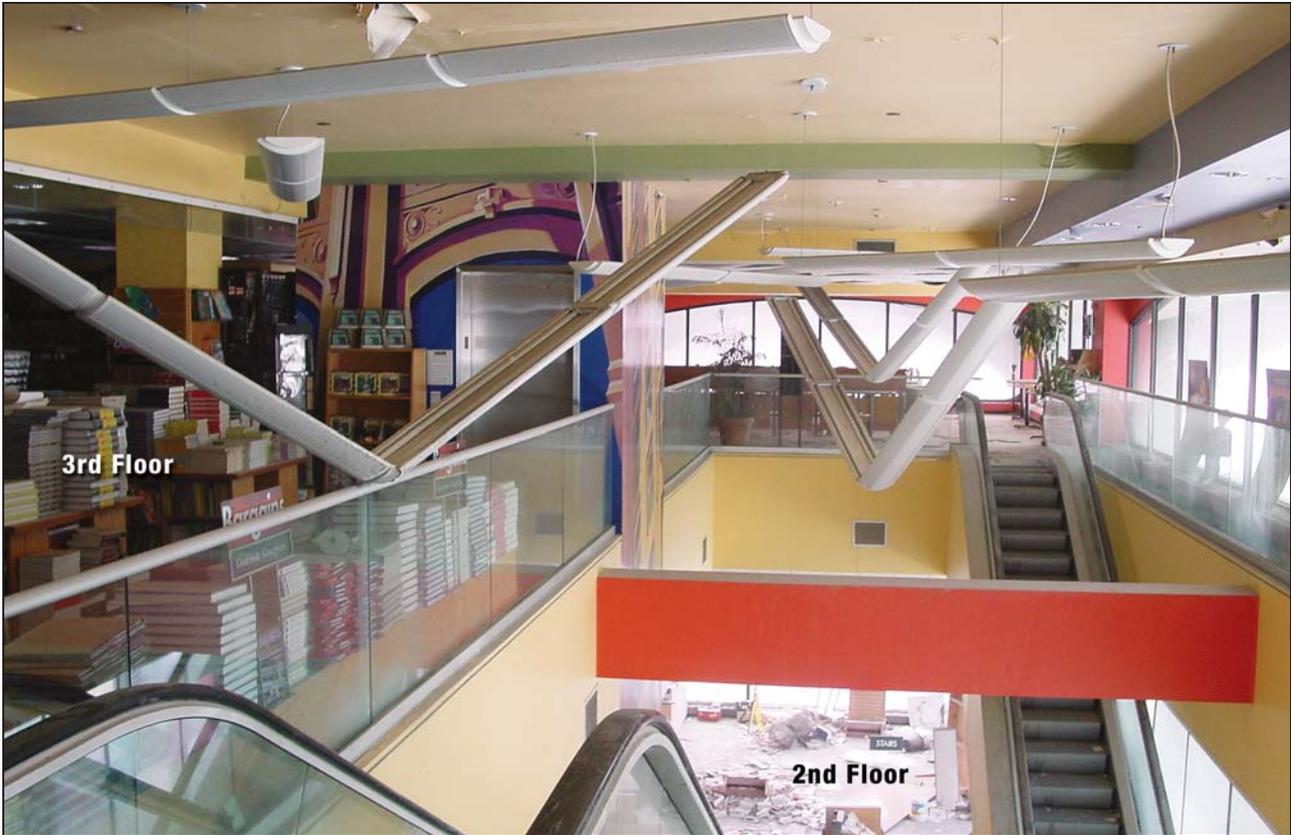
The sprinkler system appears not to have operated at all. This was evident due to the lack of water damage throughout, but especially in the lower level bookstore shown in Figure 4-15. Many sprinkler heads were damaged; some even melted and fell off the sprinkler piping in the fire areas.

Figure 4-15 Unburned bookstore in WTC 5.

The automatic sprinkler system did not control the fires. Some sprinkler heads fused, but there was no evidence of significant water damage, due to a lack of water. This is consistent with the lack of water damage in the bookstore on the lower level and the complete burnout of the upper floors.

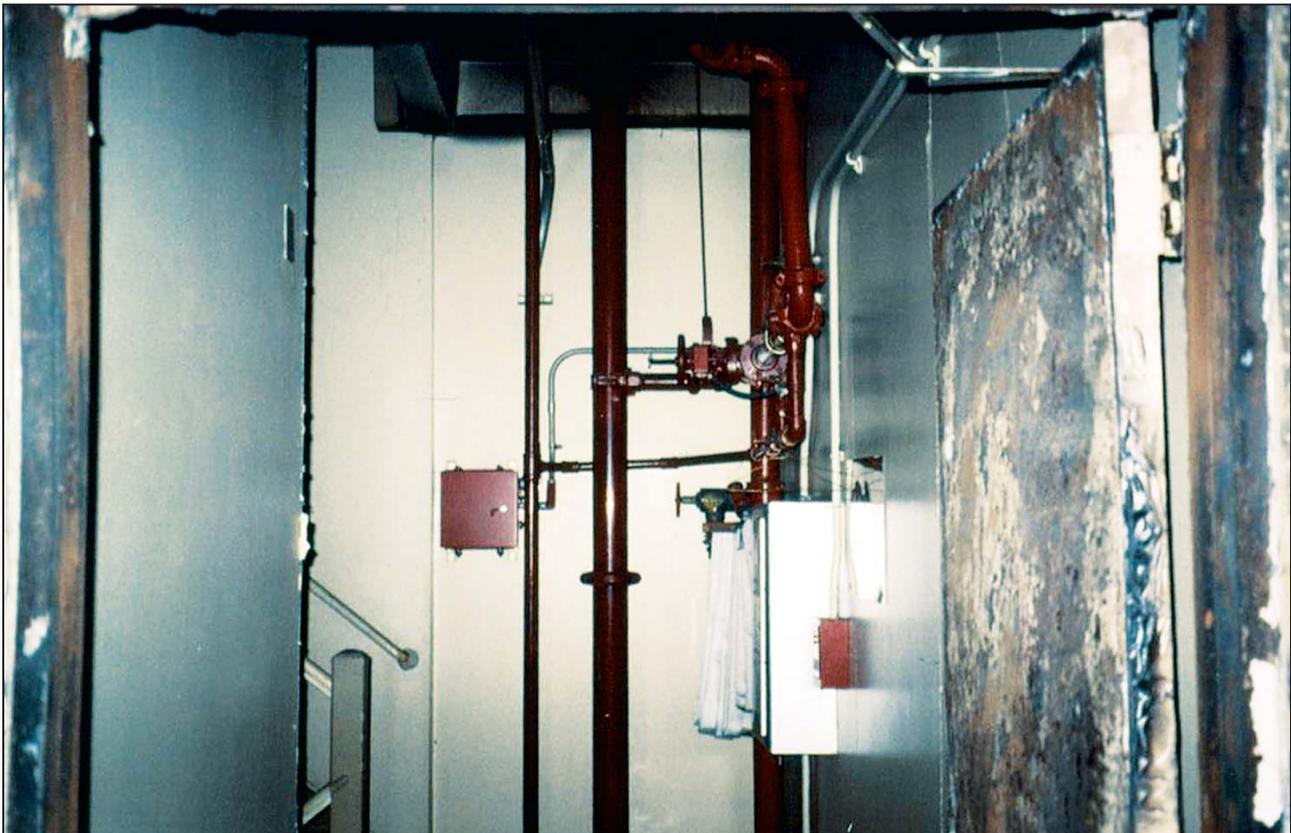
As illustrated in Figure 4-16, the interior of the exit stair tower at the southwest corner was practically untouched by the fire. There were no burn marks or smoke damage in this exit tower, or on the “safe” or stairwell side of the fire door. At one location, a piece of paper was found taped to the exit stairwall just inside the fire door with no evidence of smoke or charring from fire.

Figure 4-16 Looking through the door into the undamaged stair tower in WTC 5.

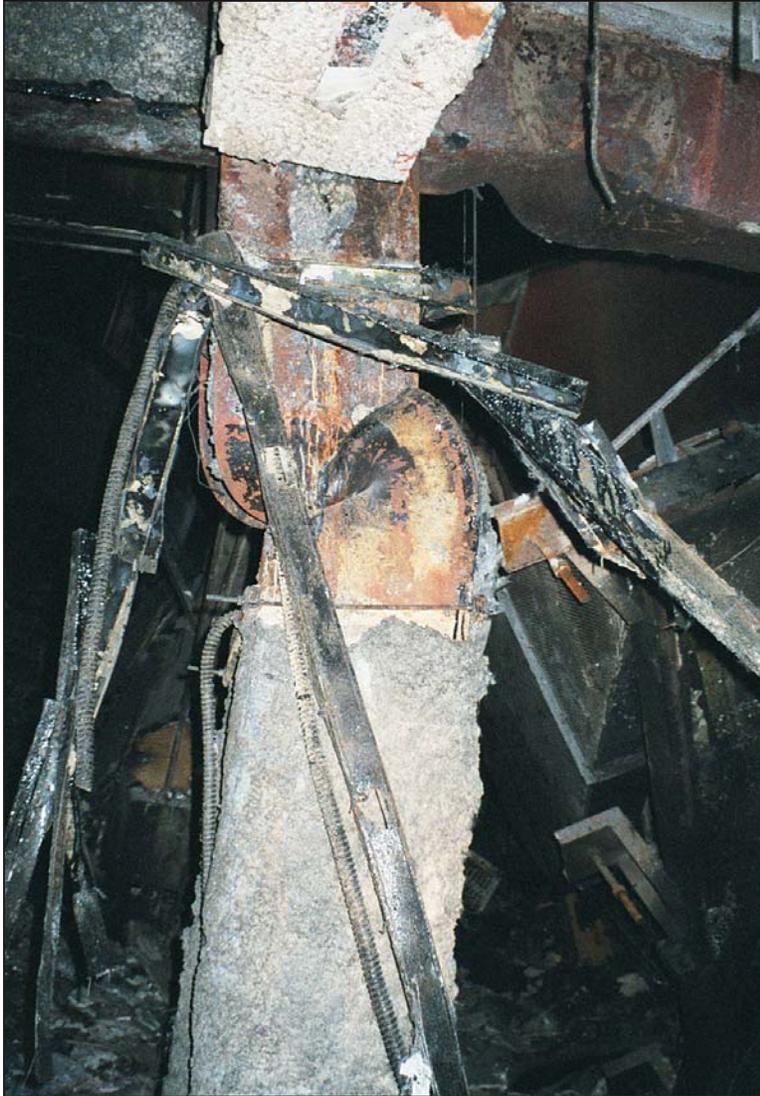
As illustrated in Figure 4-17, there was local buckling of interior columns. This buckling was most likely due to a combination of fire-induced reductions in strength and a possible increase in stress due to restrained thermal expansion. A detailed explanation of these issues is presented in Appendix A, Section A.3.1.4.

*Figure 4-17
Buckled beam flange and column on the 8th floor
of WTC 5 that was weakened by fire.*

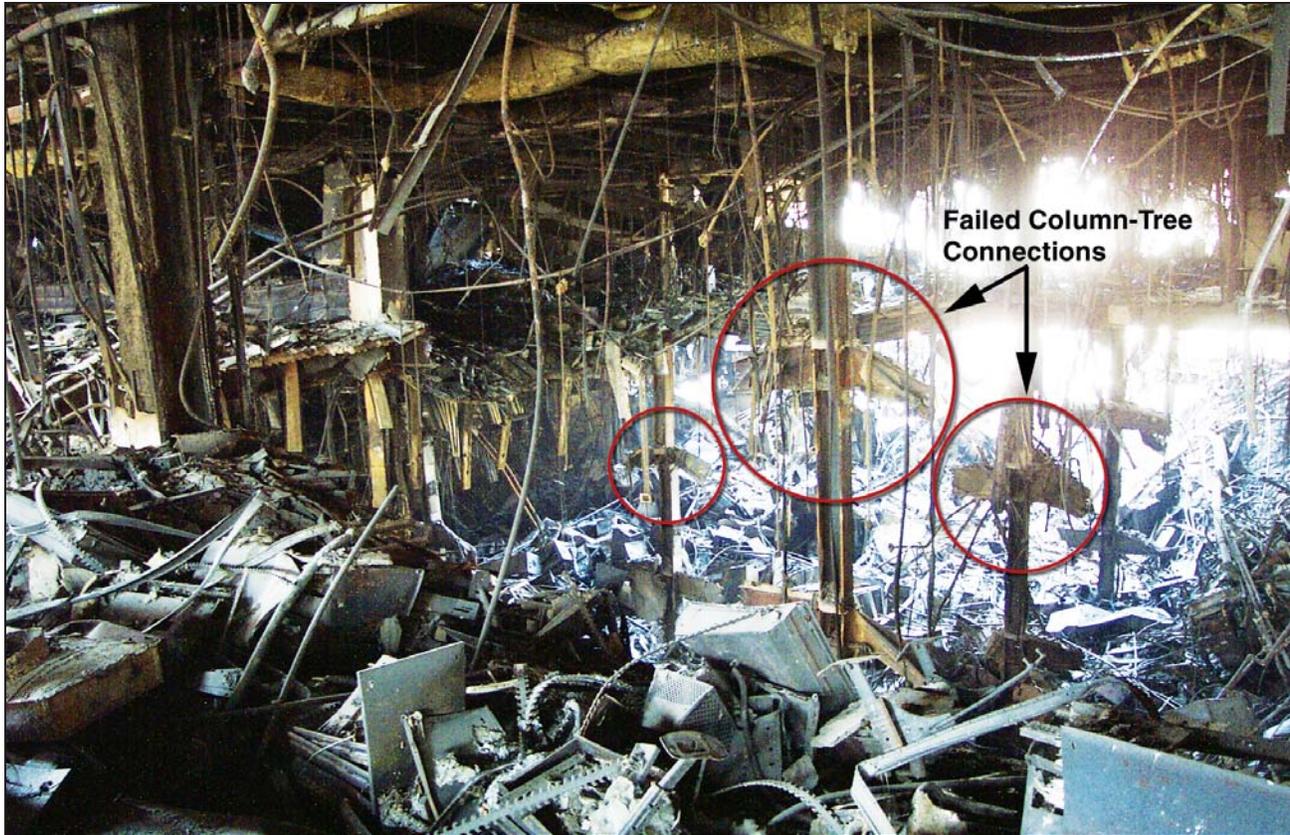
beam stub cantilevers that formed diagonal tension field mechanisms in the cantilever webs and plastic moments at the column, as seen in Figure 4-18.

It is apparent that fire weakened the steel, contributing to the large shear-induced deformations observed in several of the cantilever beams. The shear failures observed at connection ends in several of the beam web samples shown in Figure 4-18 are indicative of the tensile forces that developed. The end bearing resistance of the beam web was found to be less than the double shear strength of the high-strength bolts, based on the analysis presented in Appendix B.

Figure 4-18 Internal collapsed area in WTC 5.

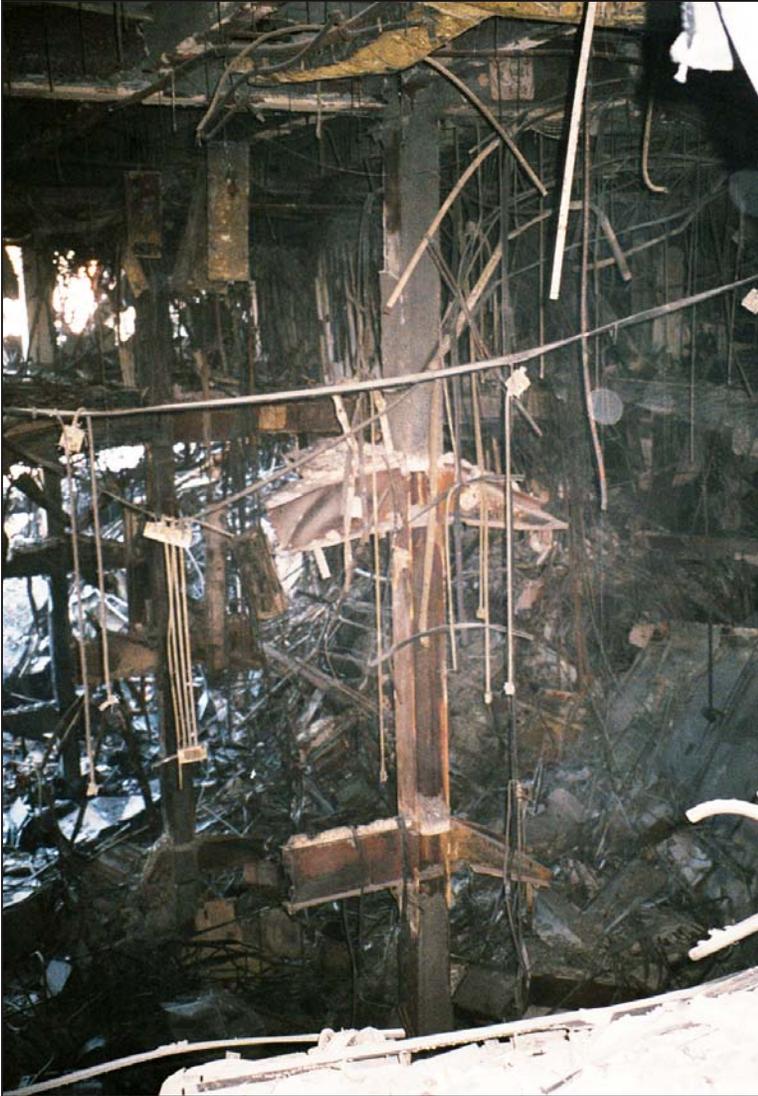
Two areas in WTC 5 experienced local collapse under an intact portion of the roof. Although there was debris impact near this area, the symmetrical nature of the collapse strongly suggests that the failures were due to the uncontrolled fires. This is supported by the observation that the columns in this area remained straight and freestanding (see Figure 4-18). This local collapse appeared to have begun at the field connection where beams were connected to shop-fabricated beam stubs and column assemblies as illustrated in Figures 4-19, 4-20, and 4-21.

Figure 4-19
Internal collapsed area in WTC 5.

The limited structural collapse in WTC 5 due to fire impact as described in Section 4.3.2 appeared to be caused by a combination of excessive shear loads and tensile forces acting on the simple shear connections of the infill beams. The existence of high shear loads was evident in many of the column tree beam stub cantilevers that formed diagonal tension field failure mechanisms in the cantilever webs, as seen in Figure 4-19.

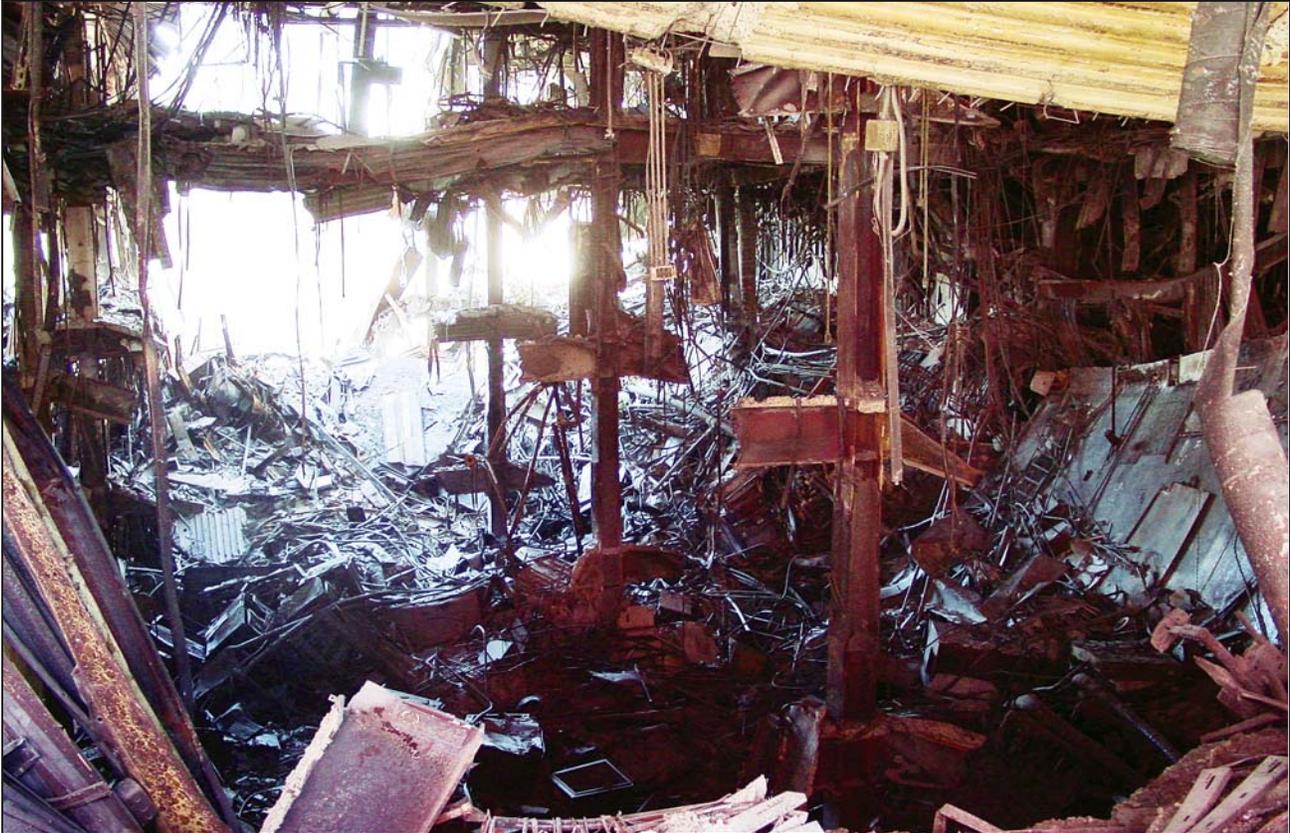
Figure 4-20 Internal collapsed area in WTC 5.
