4 *WTC 4, 5, and 6*

4.1 Design and Construction Features

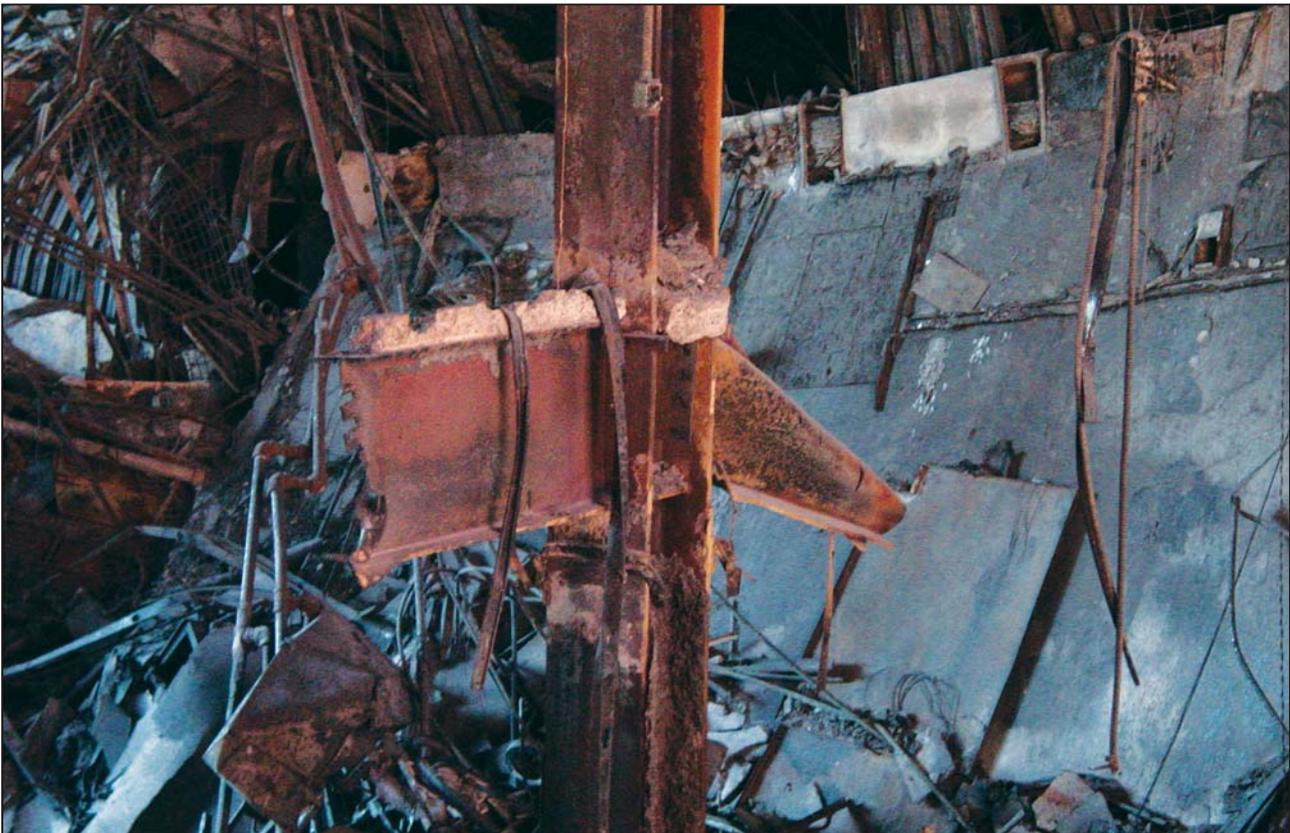
Two areas in WTC 5 experienced local collapse under an intact portion of the roof. Although there was debris impact near this area, the symmetrical nature of the collapse strongly suggests that the failures were due to the uncontrolled fires. This is supported by the observation that the columns in this area remained straight and freestanding (see Figure 4-18). This local collapse appeared to have begun at the field connection where beams were connected to shop-fabricated beam stubs and column assemblies as illustrated in Figures 4-19, 4-20, and 4-21.

The structural collapse appeared to be due to a combination of excessive shear loads on bolted connections and unanticipated tensile forces resulting from catenary sagging of the beams. The existence of high shear loads, likely due to collapsing floor loads from above, was evident in many of the column-tree

Figure 4-21 Internal collapsed area in WTC 5 with closeup of connection failure at column tree.

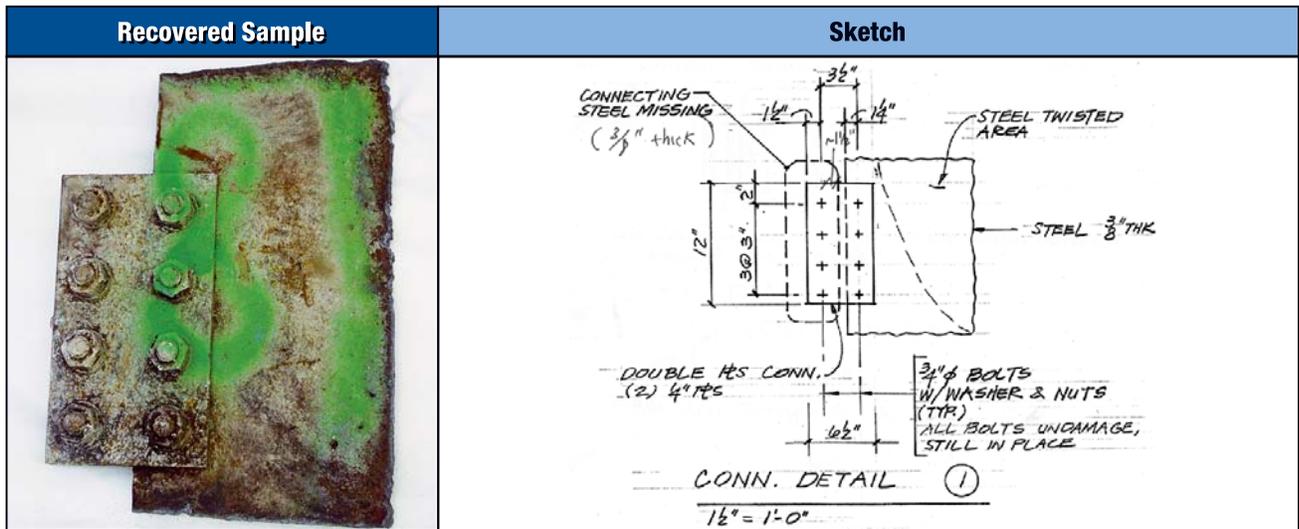
Recovered From: WTC 5, 8th Floor

Failure Mode: Web tear-out at bolts

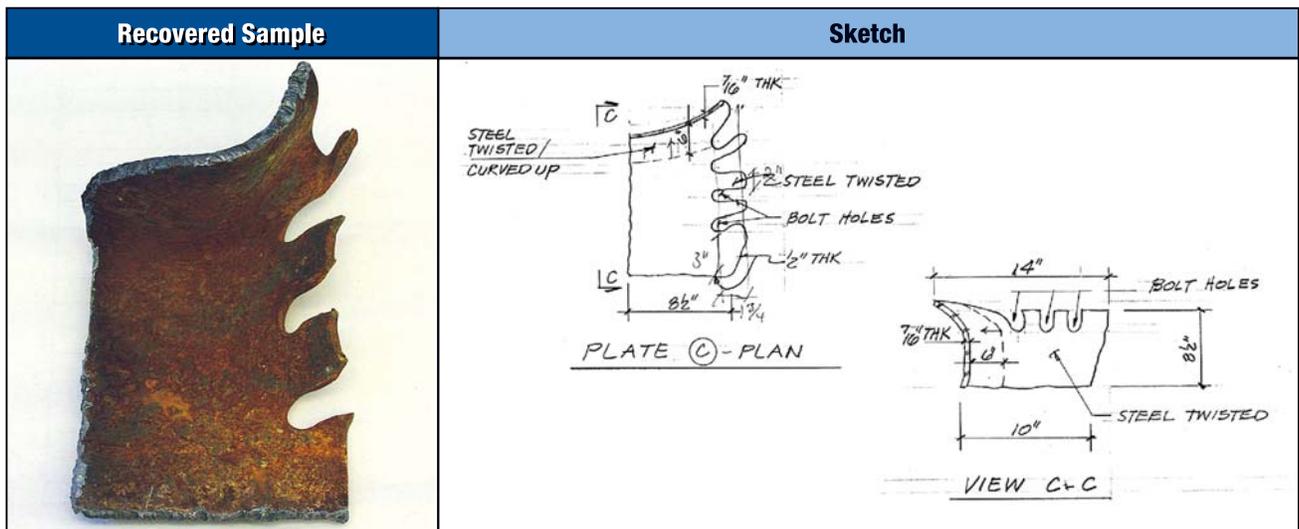
Recovered From: WTC 5, 7th Floor

Failure Mode: Web tear-out at bolts

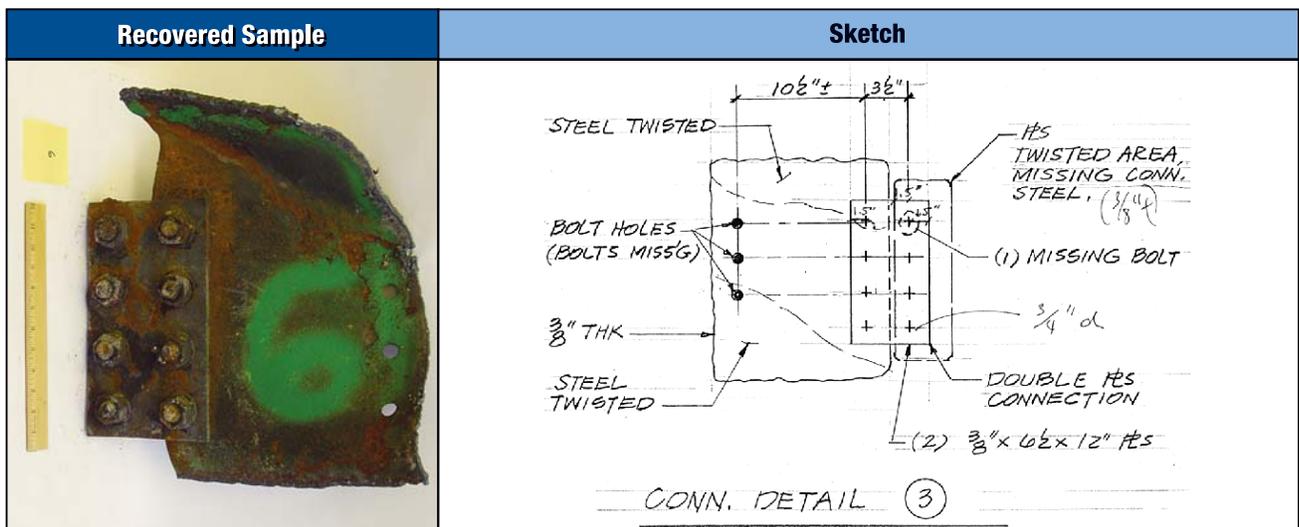
Recovered From: WTC 5, 6th Floor

Failure Mode: Web tear-out at bolts

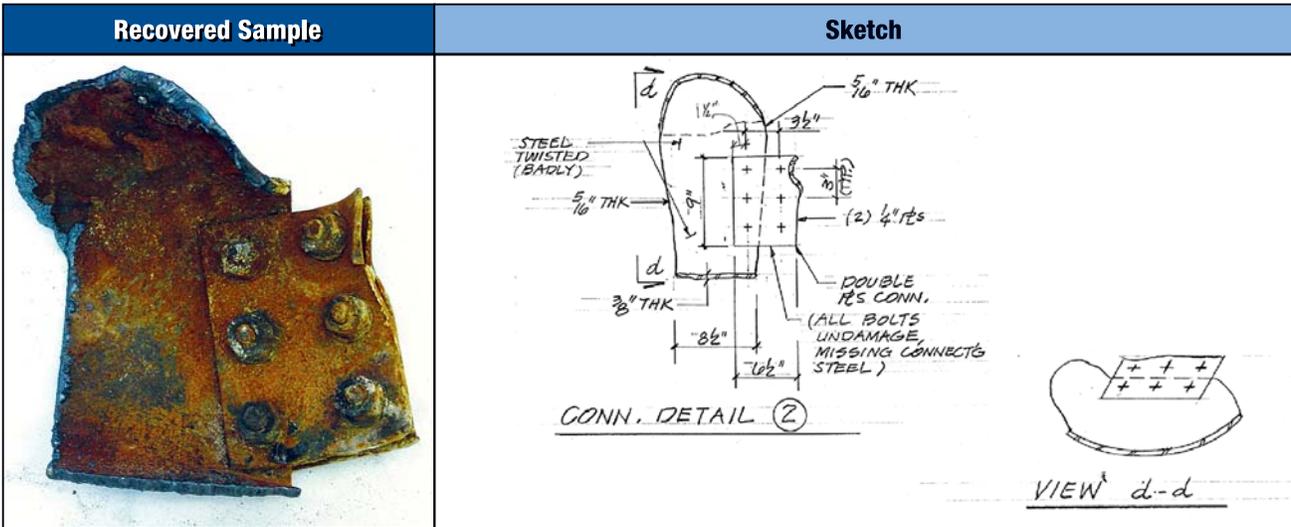
Recovered From: WTC 5, 6th Floor

Failure Mode: Web tear-out at bolts

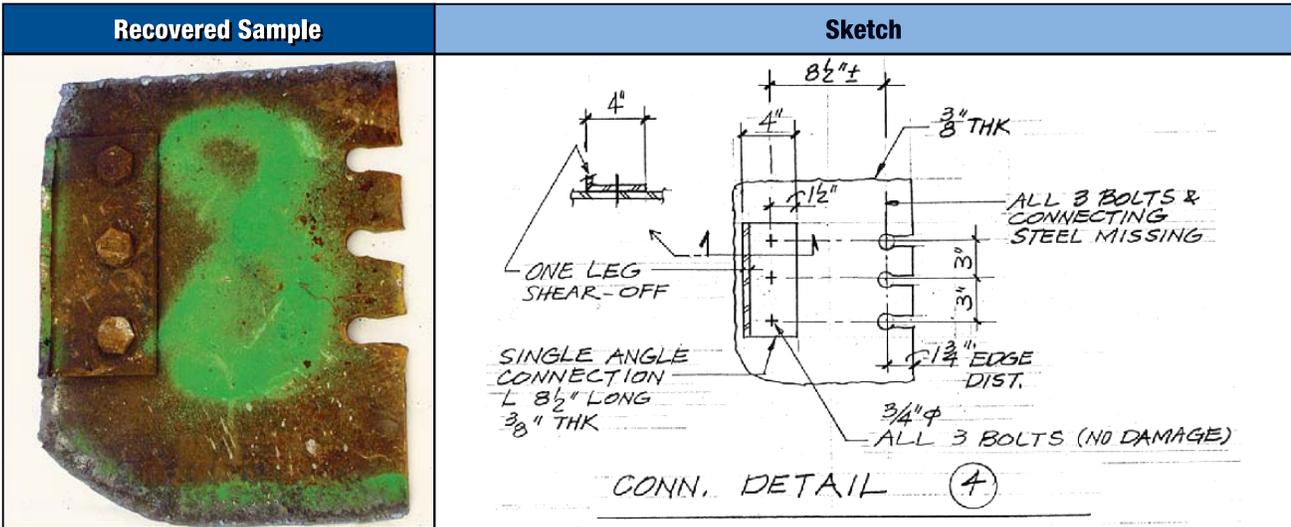
Recovered From: WTC 5, 8th Floor

Failure Mode: Plate tear-out at bolts

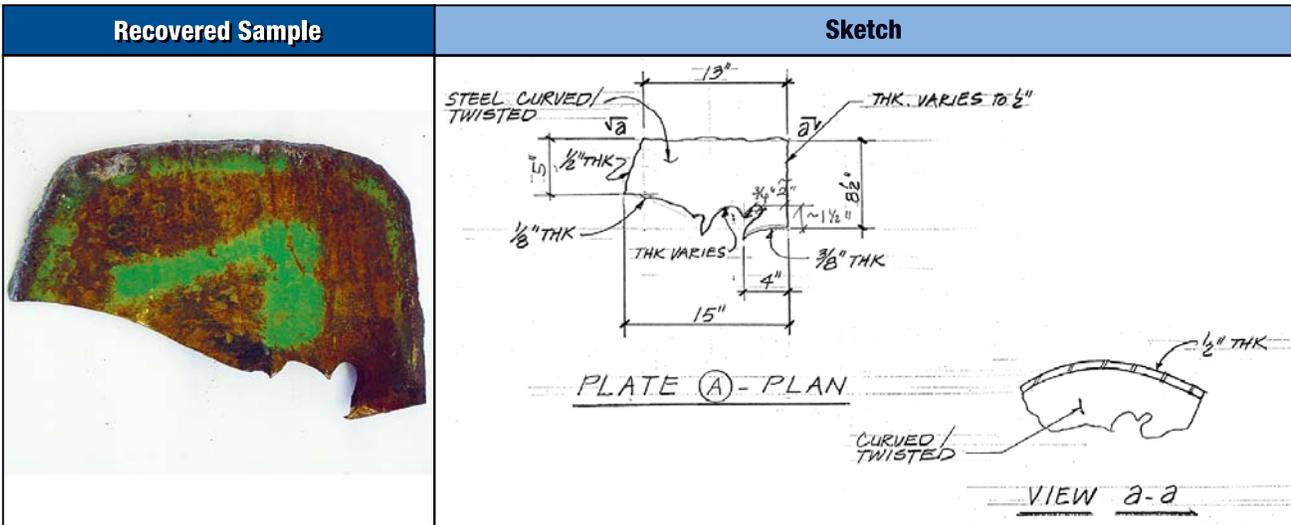
Recovered From: WTC 5, 7th Floor

Failure Mode: Connection web plate or splice block shear

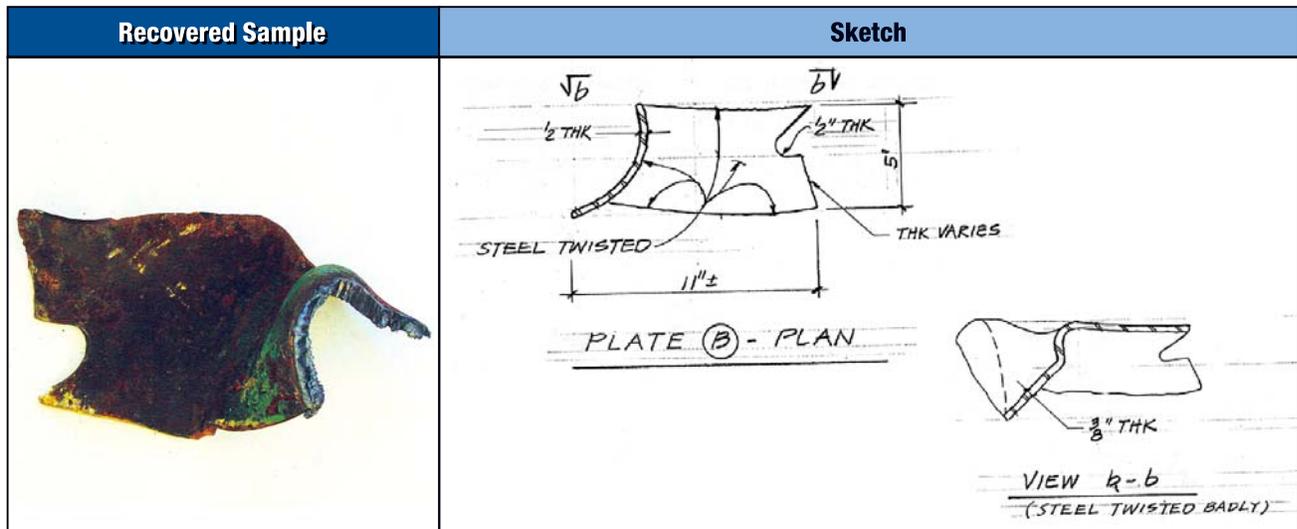
Recovered From: WTC 5, Floor undetermined

Failure Mode: Column buckling due to heat exposure
