Mitigation Assessment Team Report

Hurricane Irma in Florida

Building Performance Observations,
Recommendations, and Technical Guidance

FEMA P-2023 / December 2018

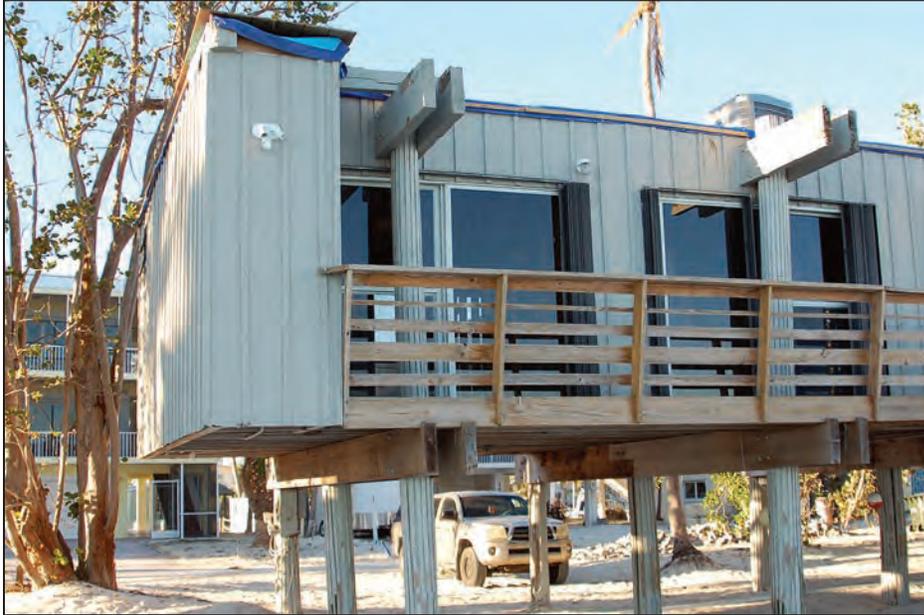
Figure 3-7:
Example of a breakaway wall that was reported by a local code official to have performed as intended (Lower Matecumbe Key, FL)

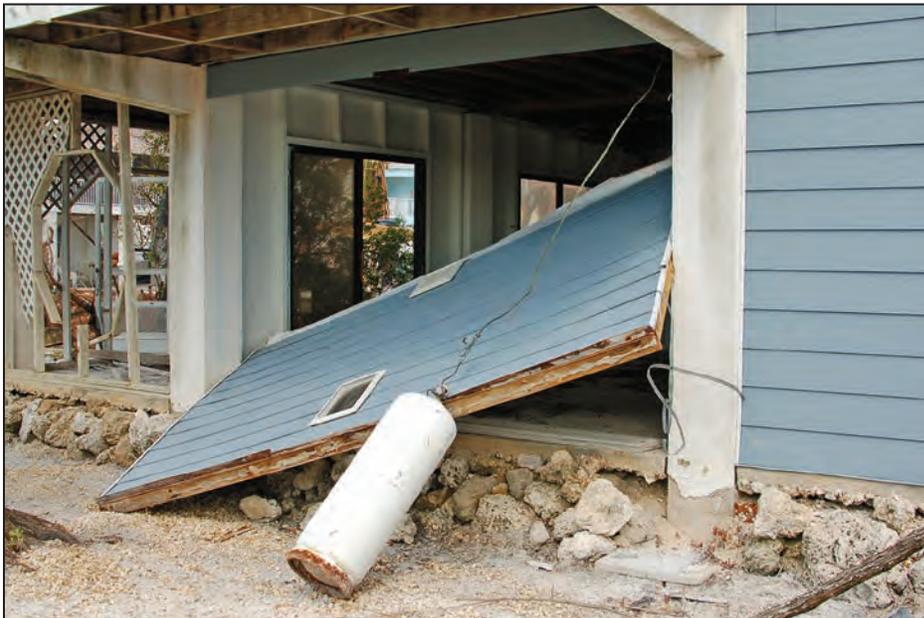
Figure 3-8:
Example of partial failure of breakaway wall, with no associated damage to main structure observed (Cudjoe Key, FL)

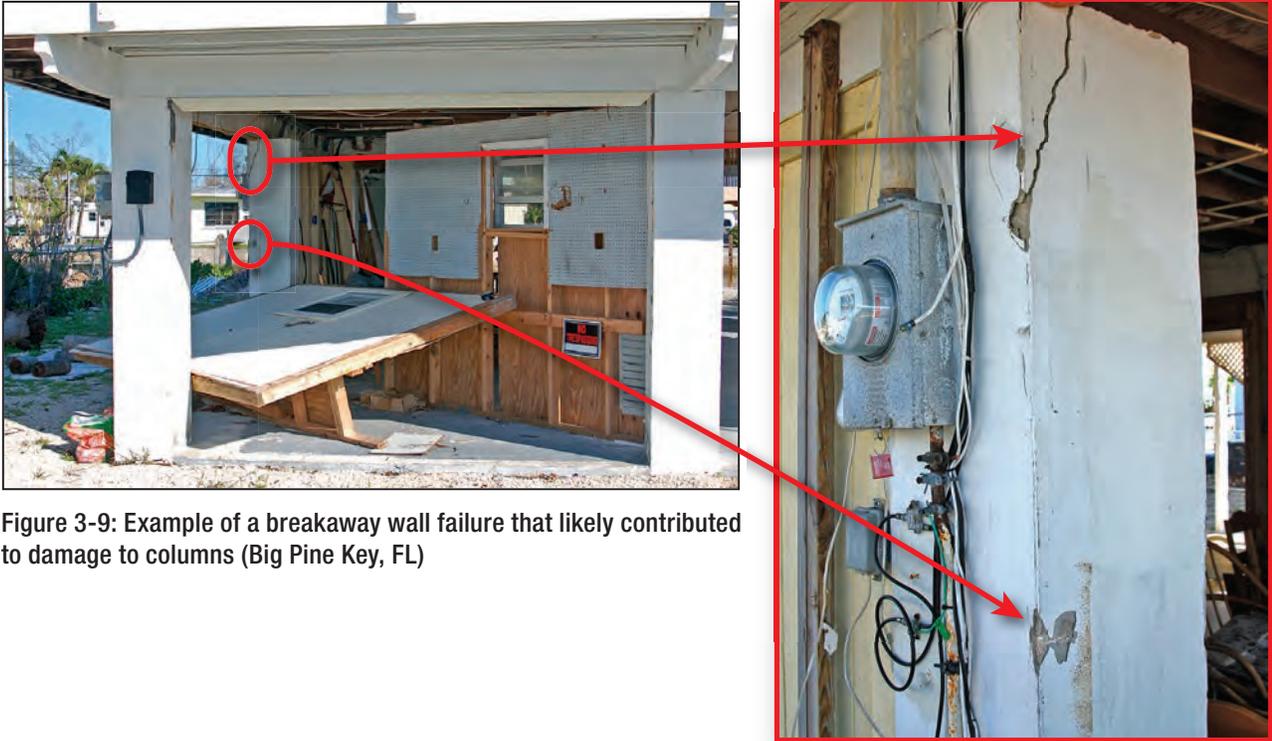
Figure 3-9: Example of a breakaway wall failure that likely contributed to damage to columns (Big Pine Key, FL)

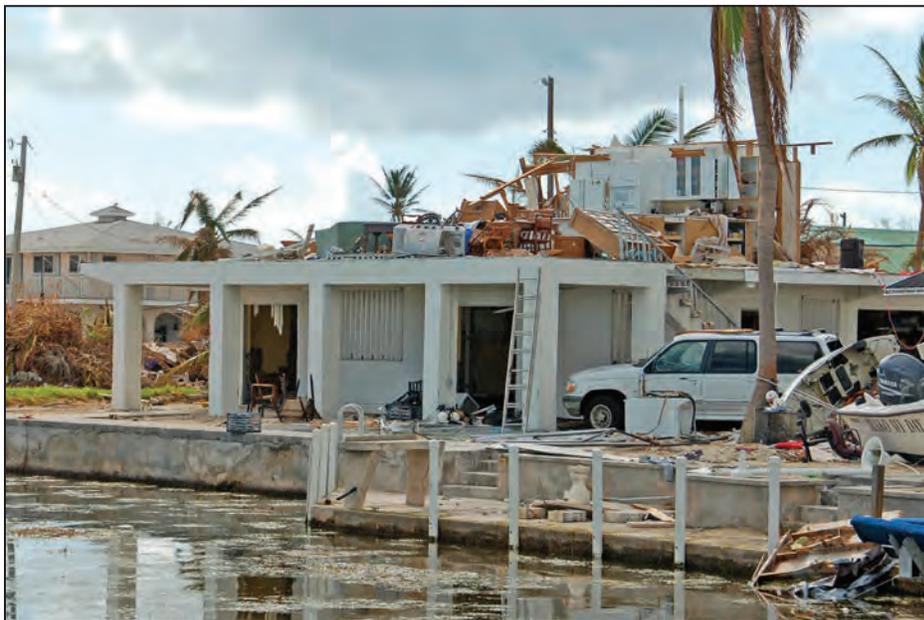
Figure 3-12:
Car and debris that washed
into a house
(Big Pine Key, FL)

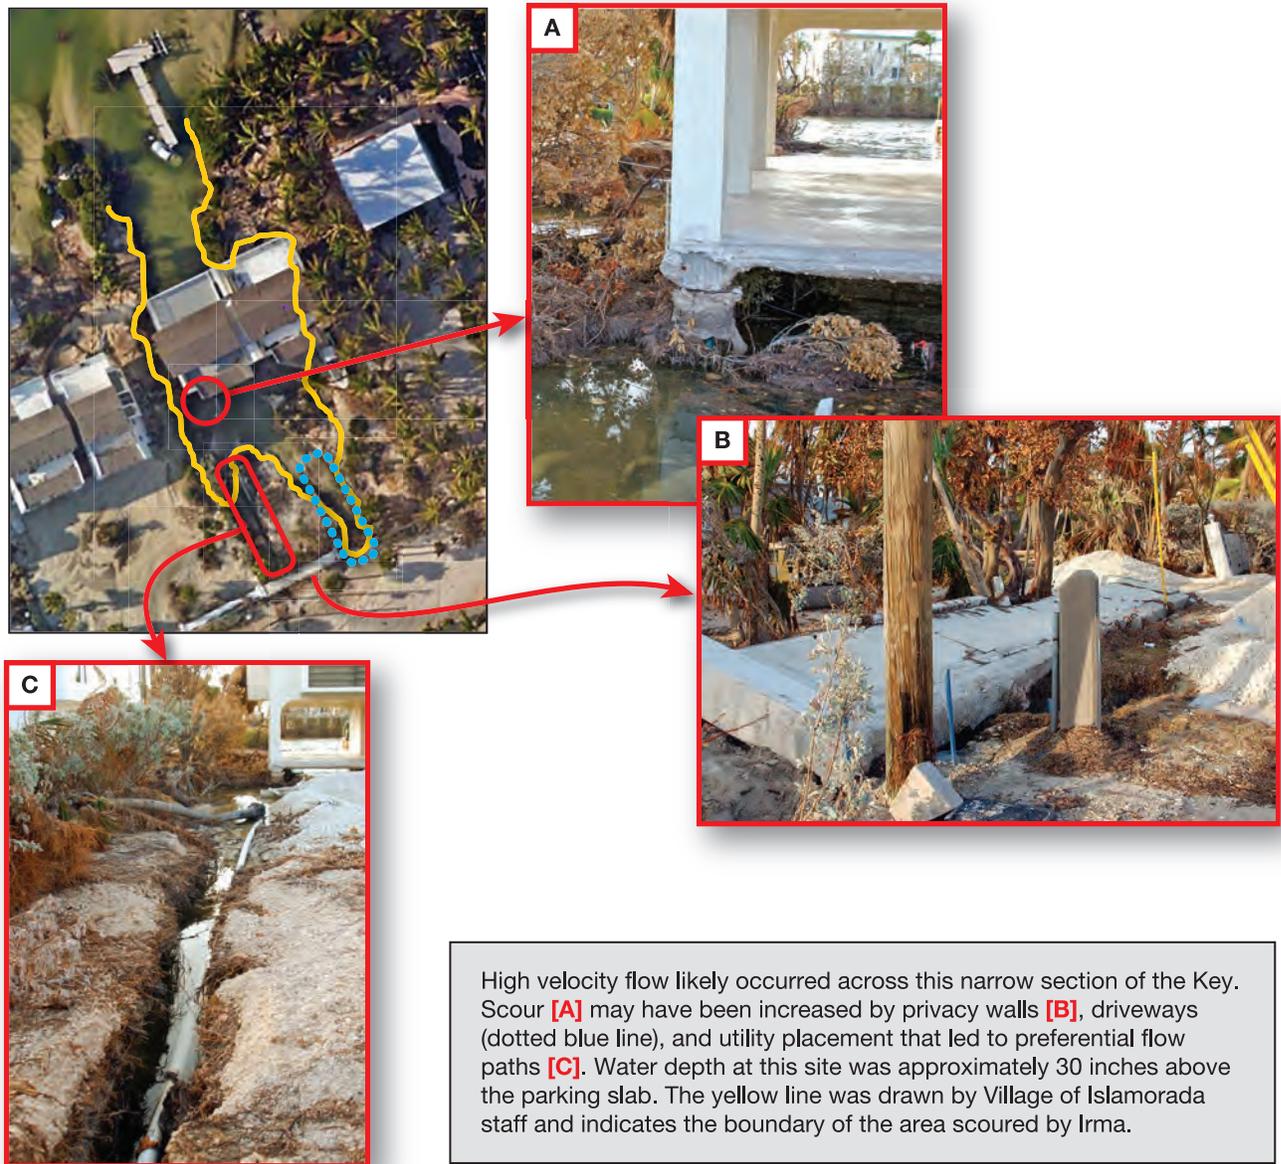
Figure 3-14: Scour near and around building foundation (Lower Matecumbe Key, FL)

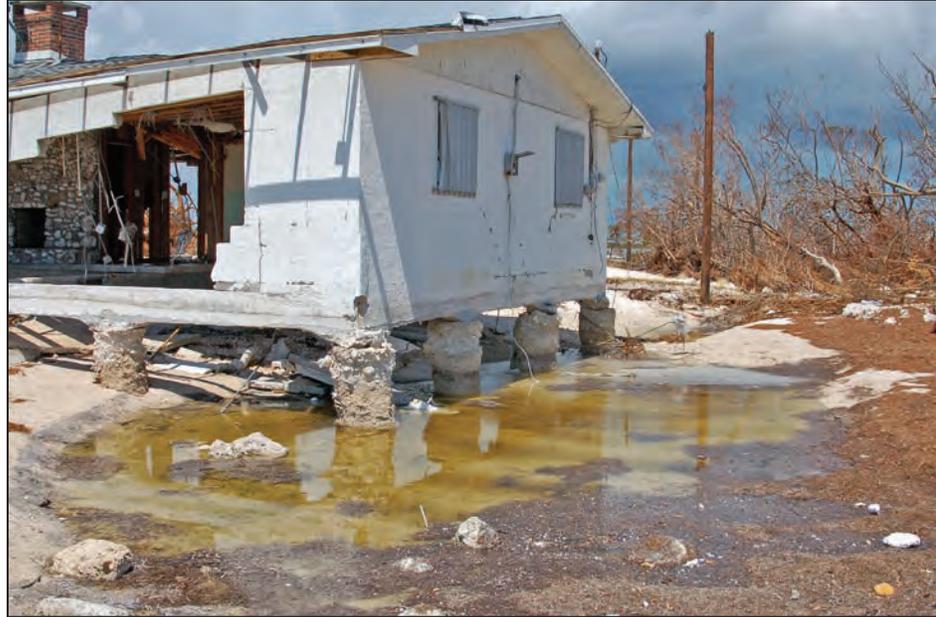
Figure 3-16:
Erosion was likely due to wave attack around the foundation of this house on Sombrero Beach Road (Marathon, FL)

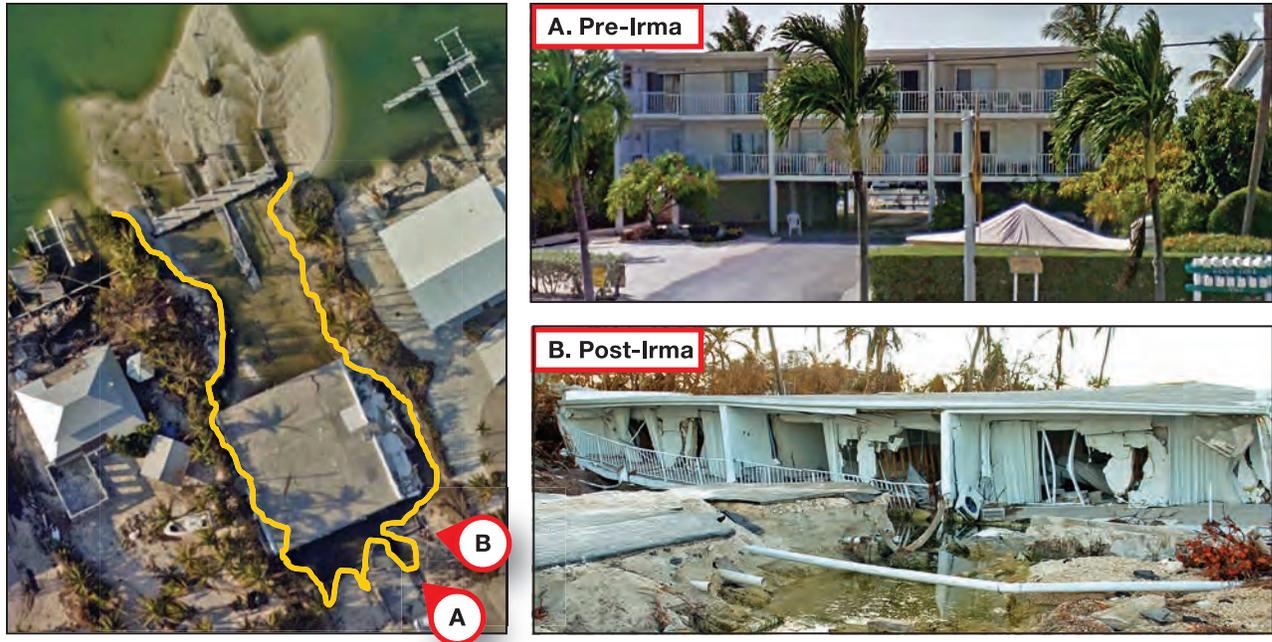
The yellow line in the aerial image was drawn by Village of Islamorada staff and indicates the boundary of the area scoured by Irma. The MAT did not determine whether scour contributed to the collapse.

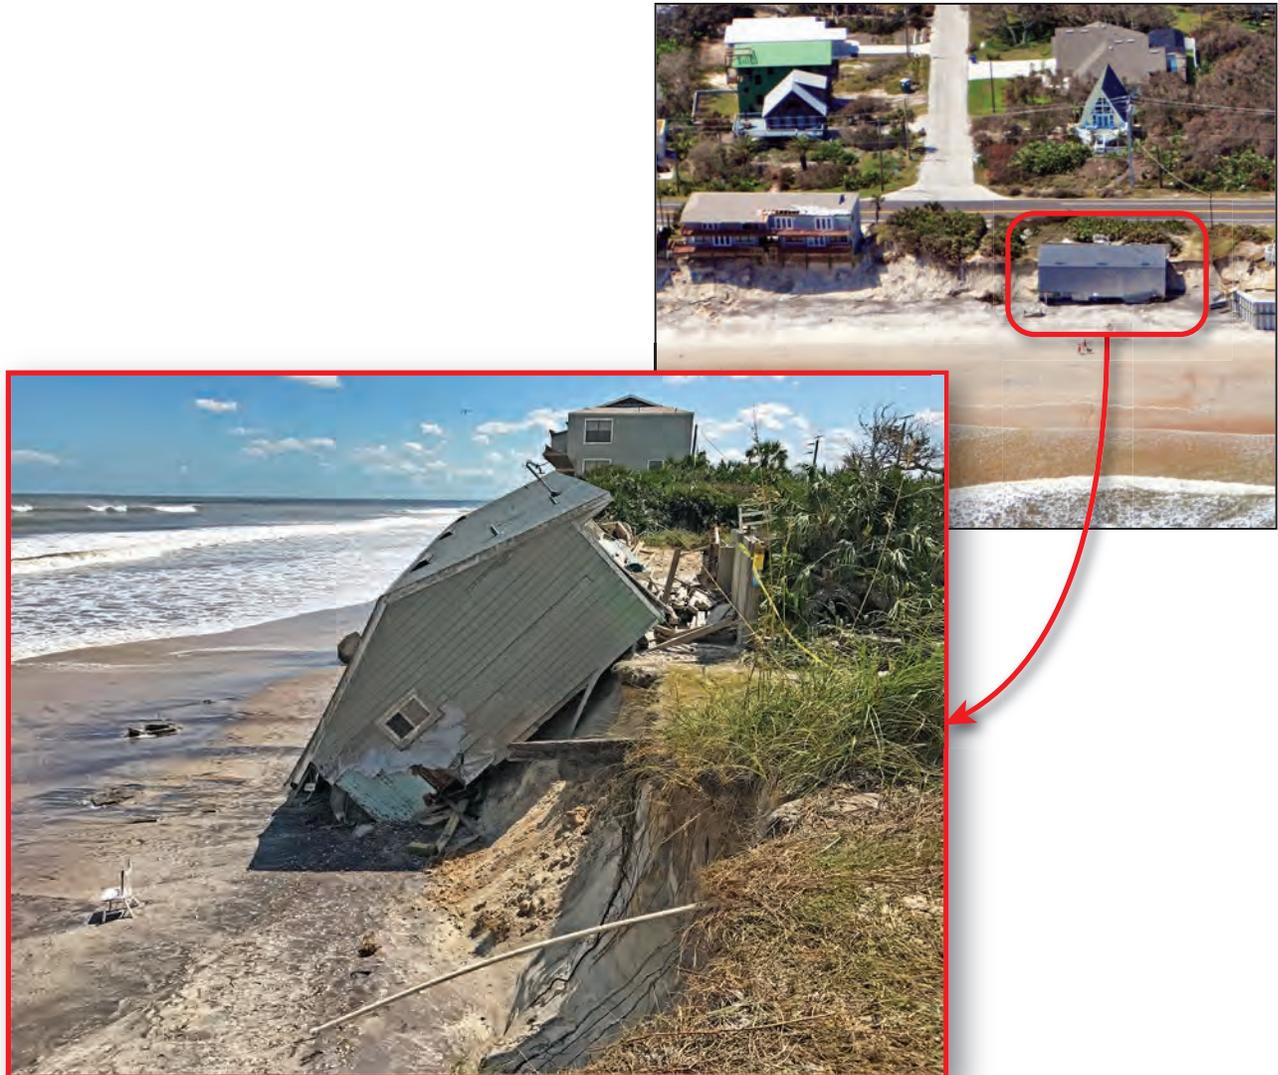
Figure 3-20: Collapsed house on shallow foundation that was undermined by erosion induced by Hurricane Irma (Vilano Beach, FL)

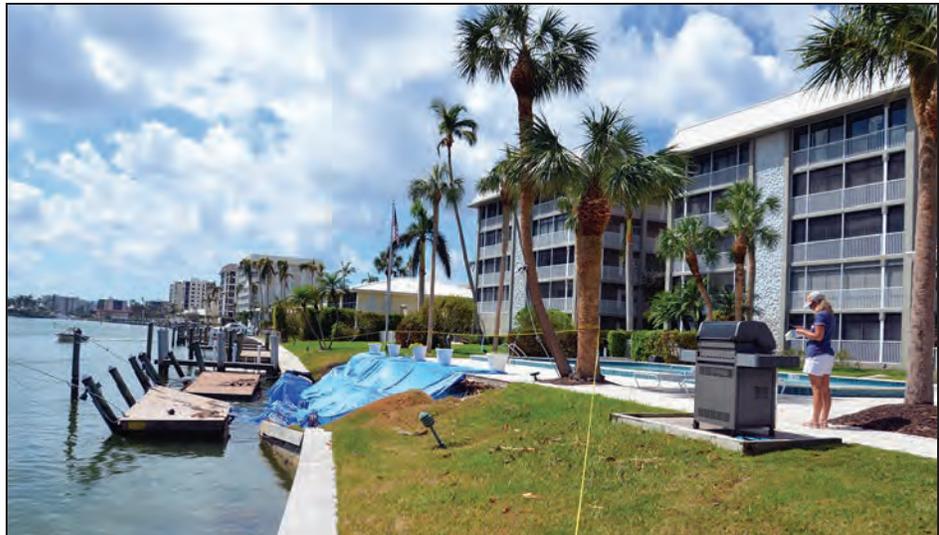
Figure 3-27:
Failure of bulkhead (anchor system) (Naples, FL)

The failure of this bulkhead likely originated at its anchor system. This type of failure allows the top of a bulkhead to rotate toward the water.

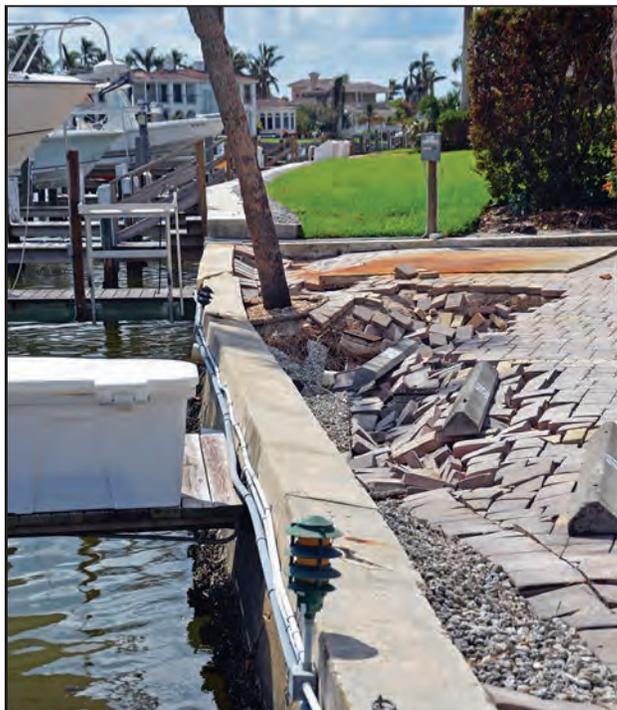
Figure 3-28:
Bulkhead toe failure (insufficient embedment) (Naples, FL)

The failure of this bulkhead was likely due to insufficient embedment of the bulkhead toe into the ground. This type of failure allows the bottom of a bulkhead to rotate toward the water.

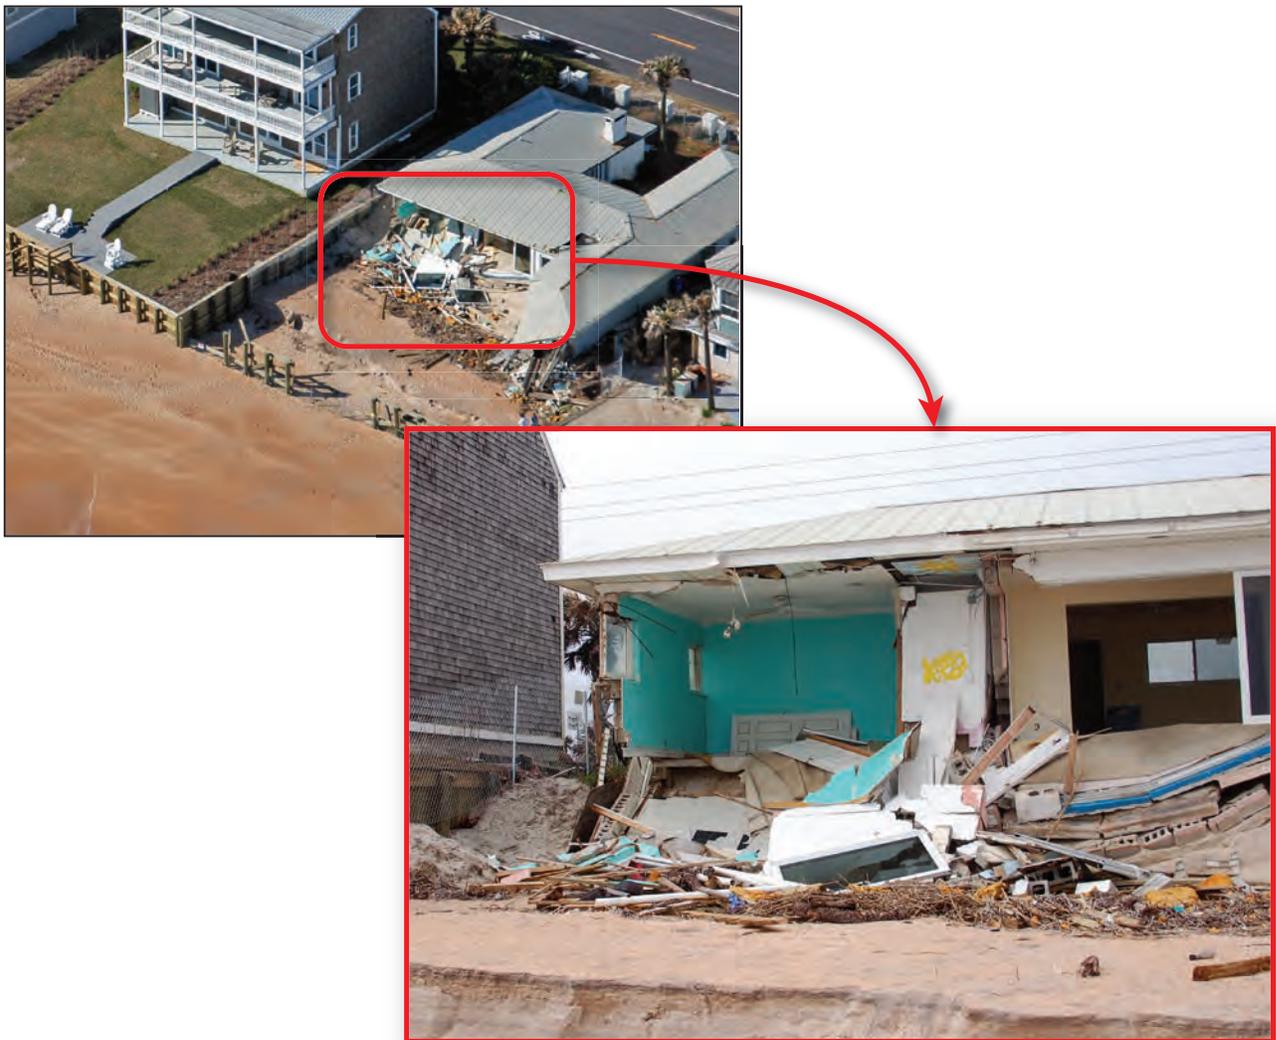
Figure 3-29: House on a shallow foundation that collapsed after it was undermined following failure of the bulkhead during Hurricane Irma (St. Johns County, FL)

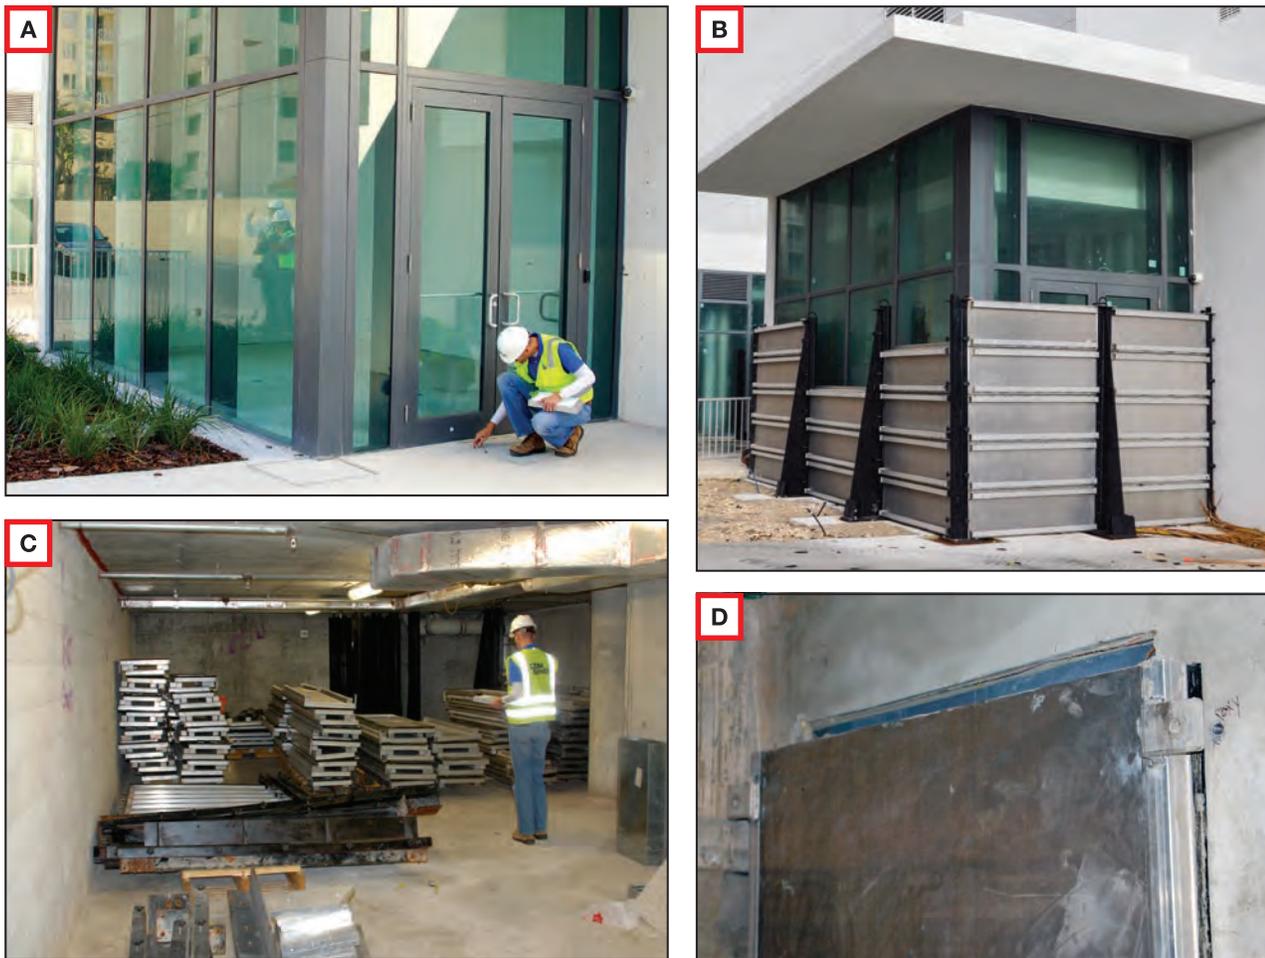
The doors without [A] and with [B] the floodproofing system deployed. The system took 10 workers with heavy equipment 2 full days to install prior to Hurricane Irma.
 [C] shows the panel and post storage room.
 [D] shows a gap at the top of a doorway flood shield.

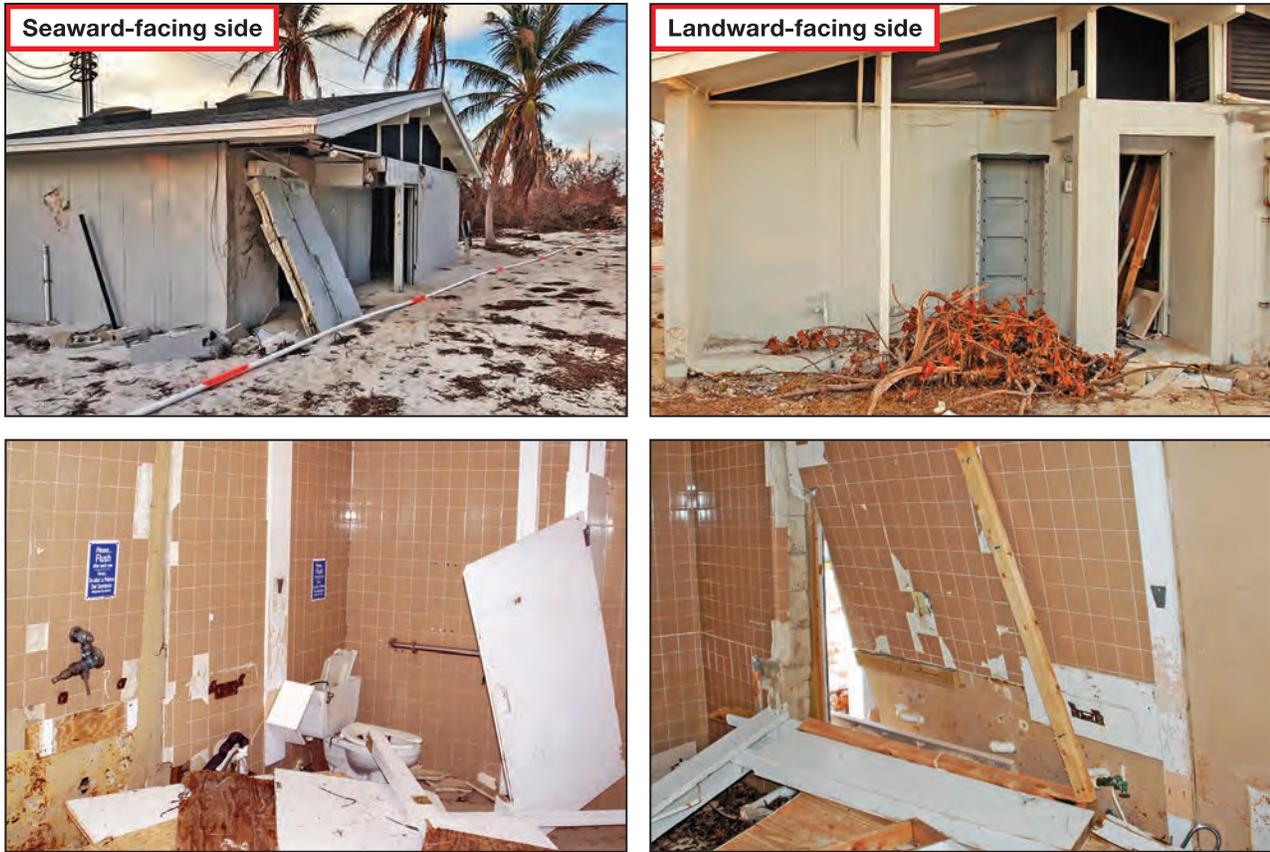
The bottom photos show damage to fixtures, partitions, and walls that was likely caused by waves and high-velocity flow. The restroom was demolished between the pre-MAT and MAT visits.

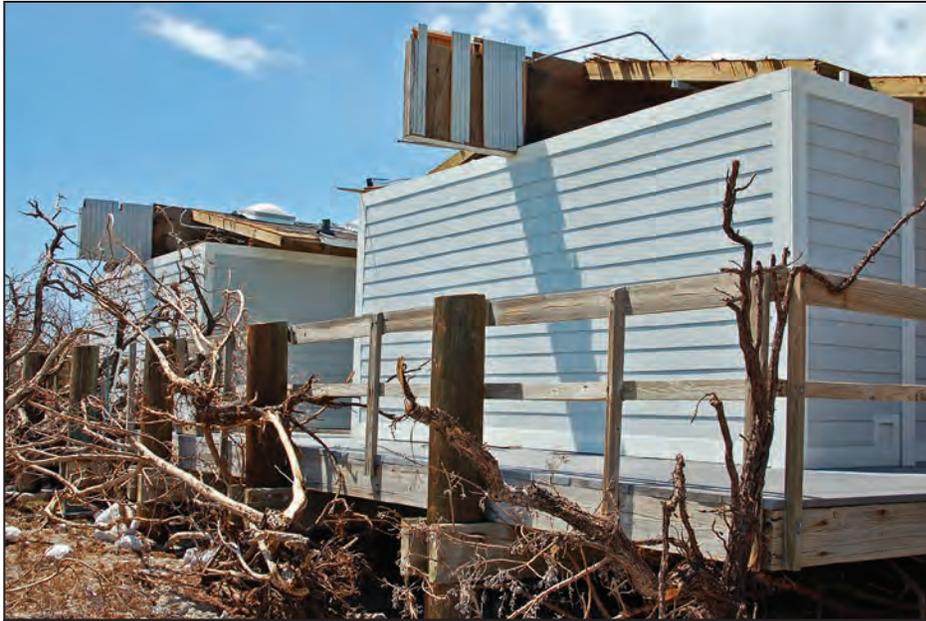
Figure 3-43:
Elevated restroom at
Bahia Honda State
Park, Loggerhead
(Site 13; Monroe County)

The elevated restroom sustained wind damage.

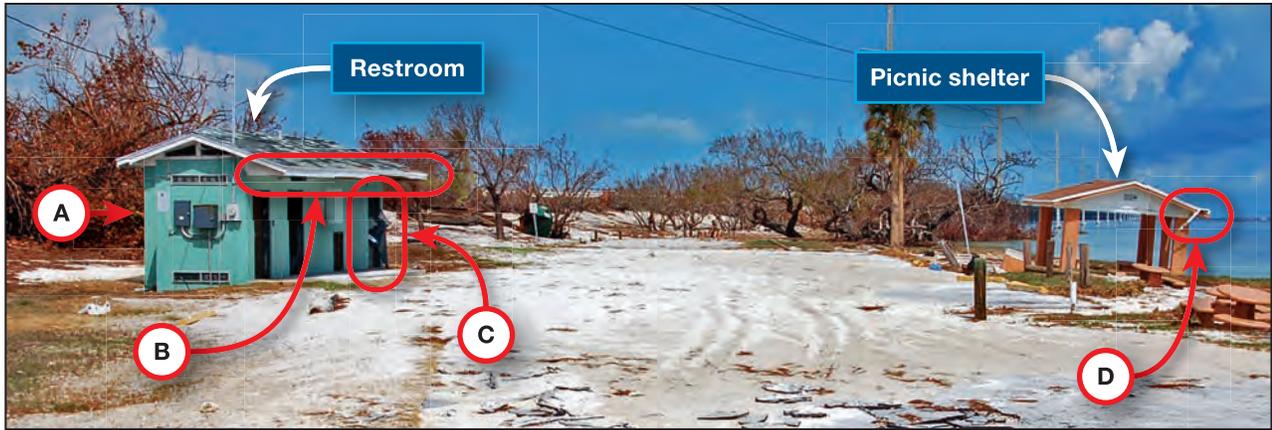
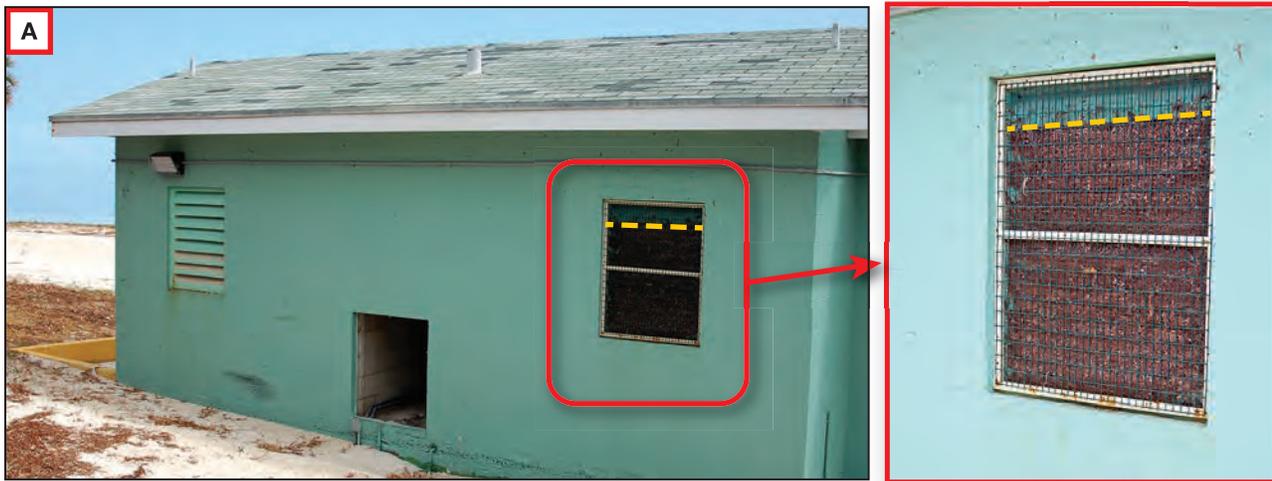
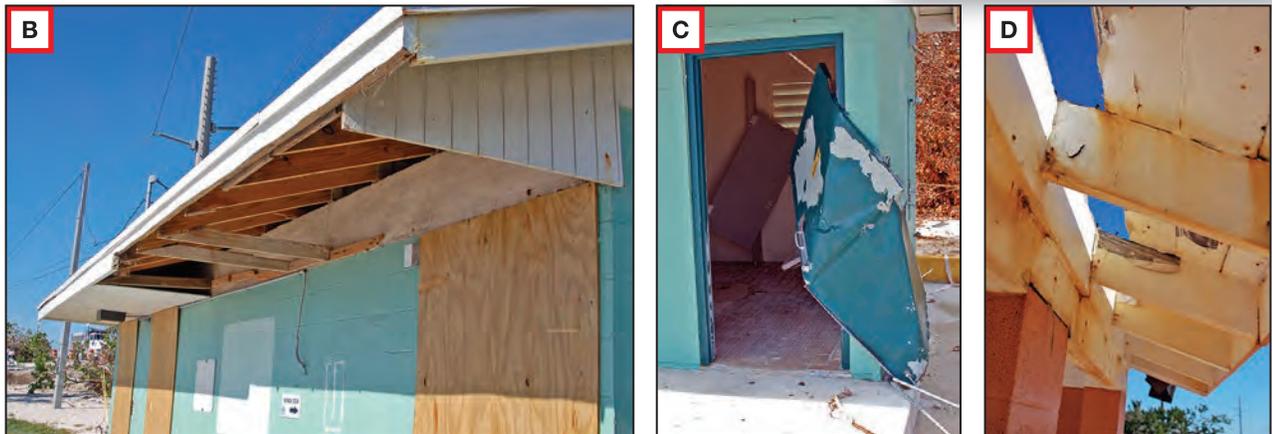
- [A]** Rear of restroom showing debris trapped inside vent—debris level was approximately 7 feet above grade and would have accounted for stillwater plus sloshing waves trapped inside restrooms
- [B]** Wave splash against seaward restroom wall likely damaged soffit
- [C]** Exterior door damaged by waves
- [D]** Wave crests were likely just below the shelter soffit and lifted the roof deck off

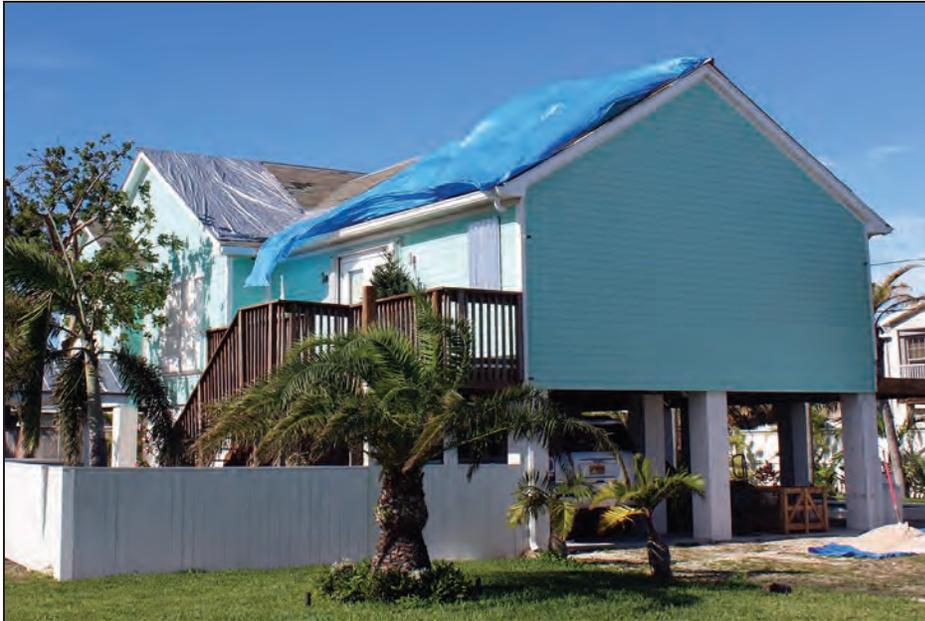
Figure 4-7:
The MAT could not observe much of the asphalt roof damage on this house because it was covered by a tarp (EWS = 111 mph; EDWS = 180 mph) (Big Coppitt Key)

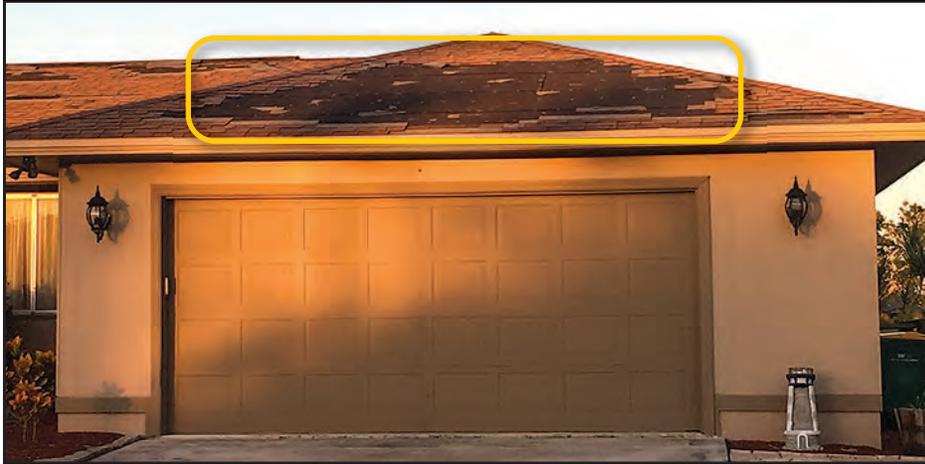
Figure 4-12:
House with shingle loss
near main ridge and
between roof hips (yellow
oval) (EWS = 109 mph;
EDWS = 170 mph)
(Marco Island)

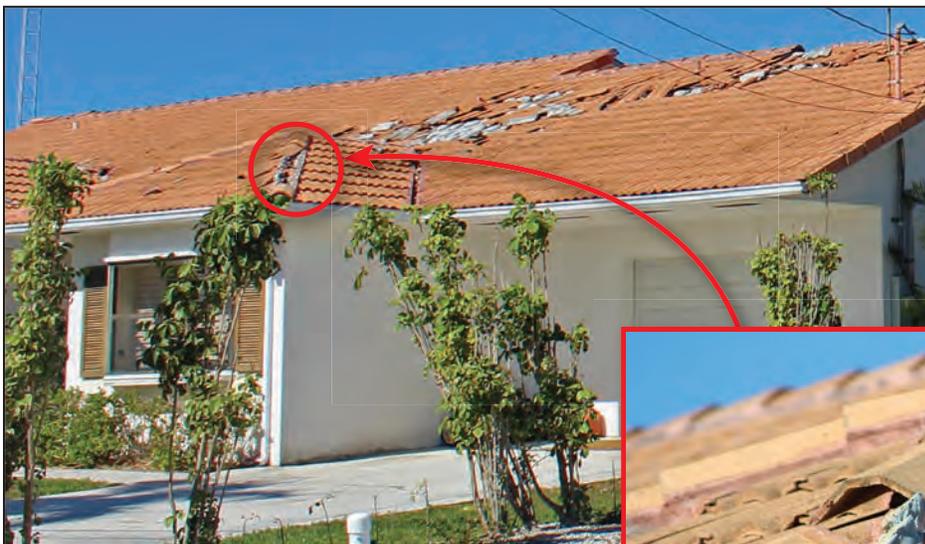
Figure 4-13:
Roof tile failure (EWS = 113
mph; EDWS = 180 mph)
(Cudjoe Key)

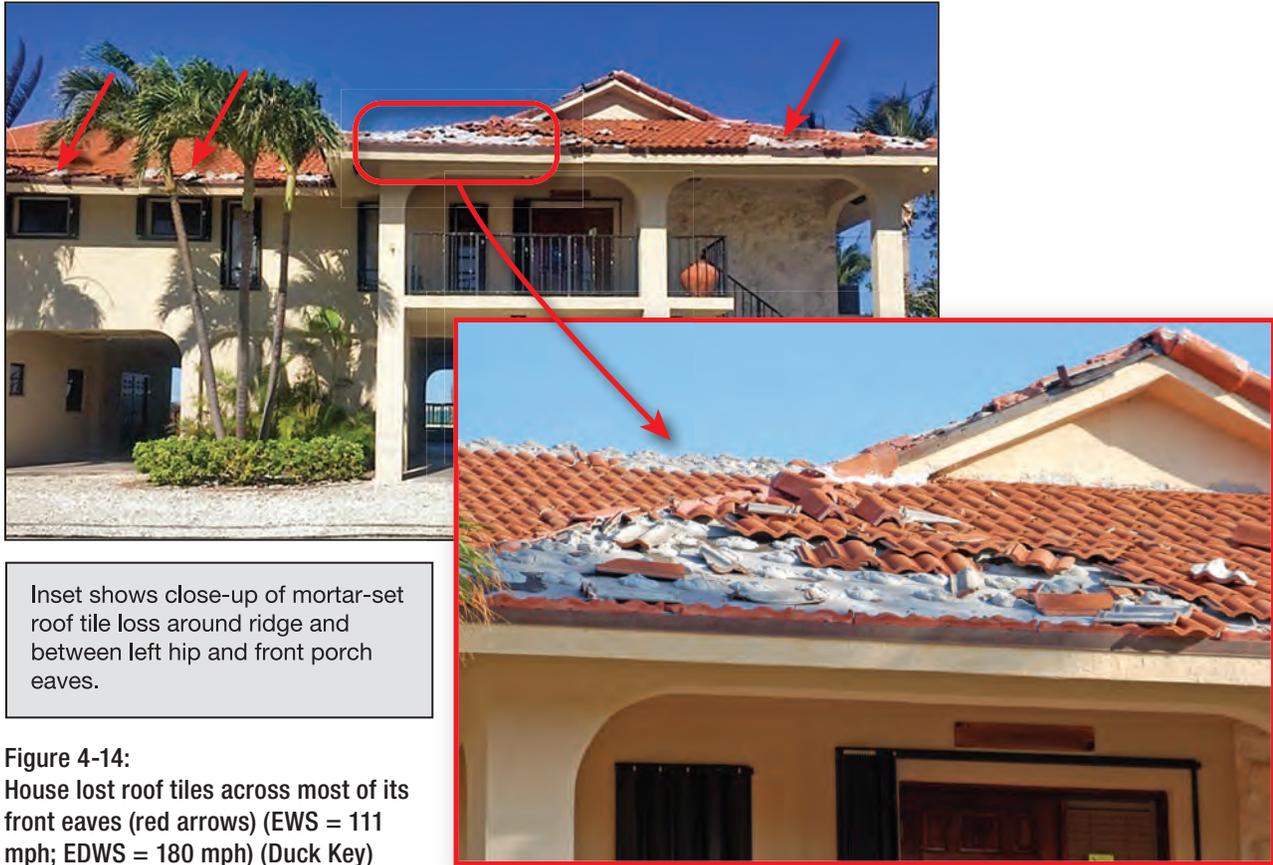
Figure 4-14:
House lost roof tiles across most of its front eaves (red arrows) (EWS = 111 mph; EDWS = 180 mph) (Duck Key)

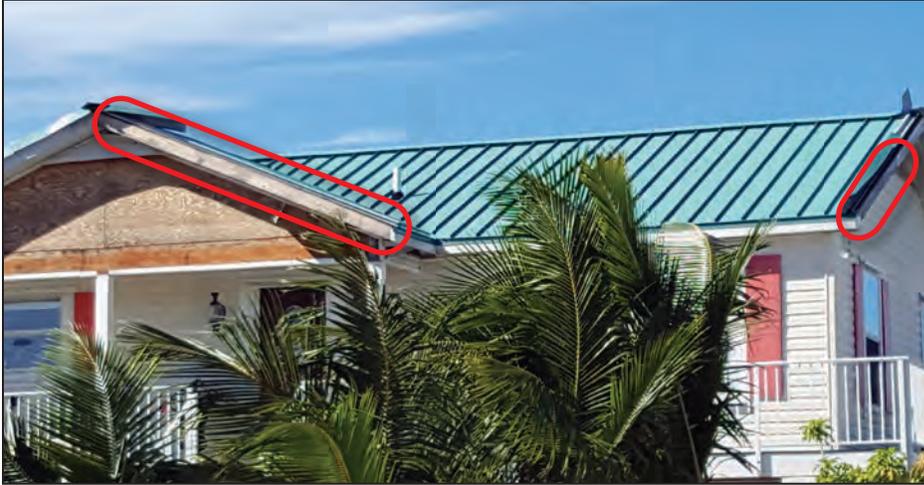
Figure 4-15:
House with separated metal roof trim and missing fascia cover (red ovals) along gable end. (EWS = 113 mph; EDWS = 180 mph) (Sugarloaf Key)

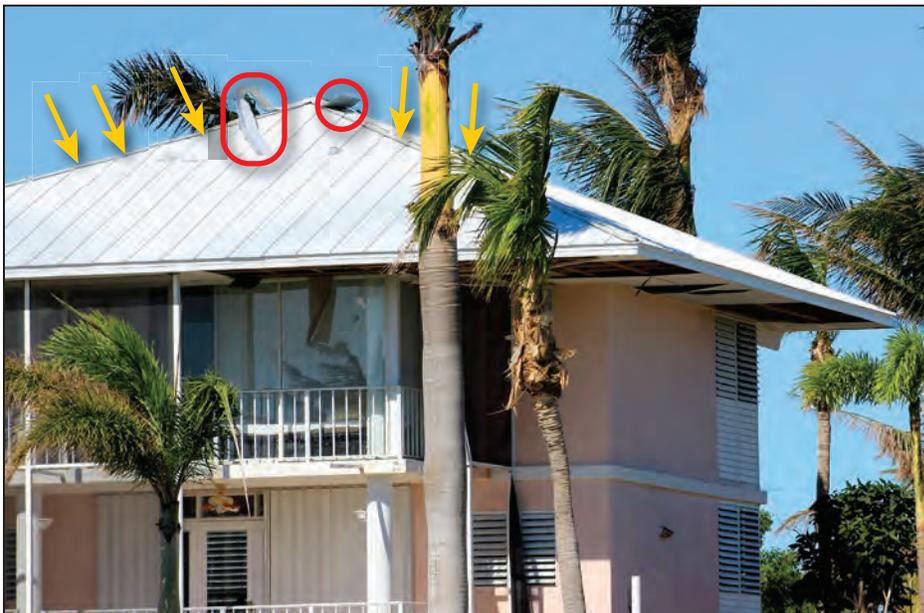
Figure 4-16:
House with damaged metal roof system (EWS = 113 mph; EDWS = 180 mph) (Sugarloaf Key)

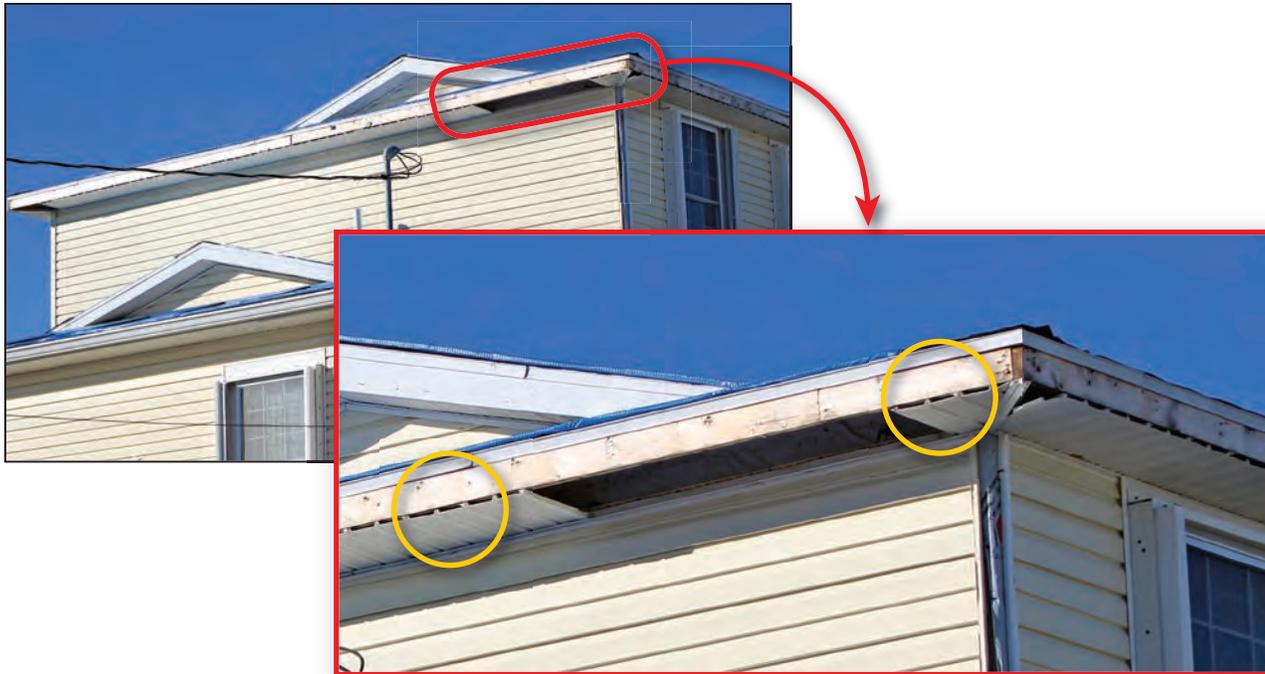
Figure 4-17:
House that lost its vinyl soffit panel (EWS = 113 mph; EDWS = 180 mph) (Summerland Key)

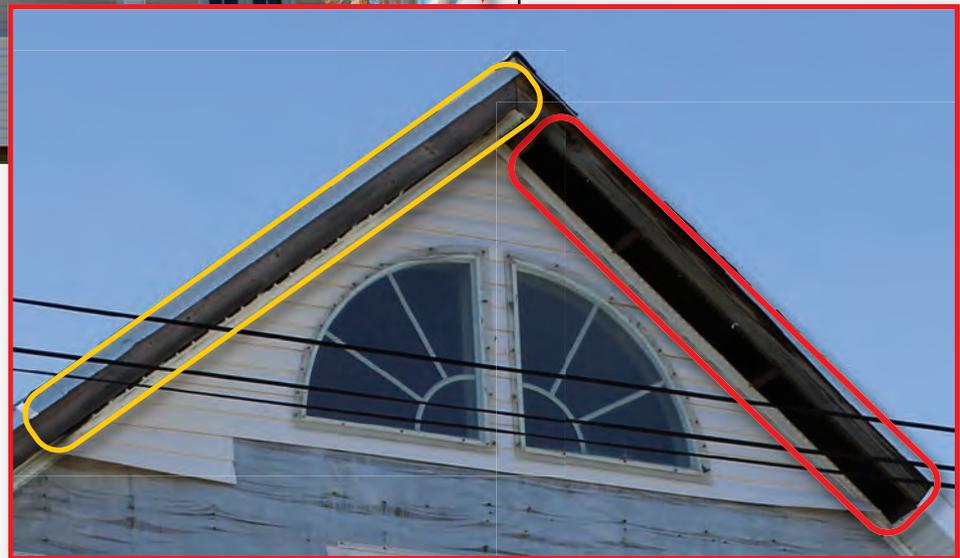
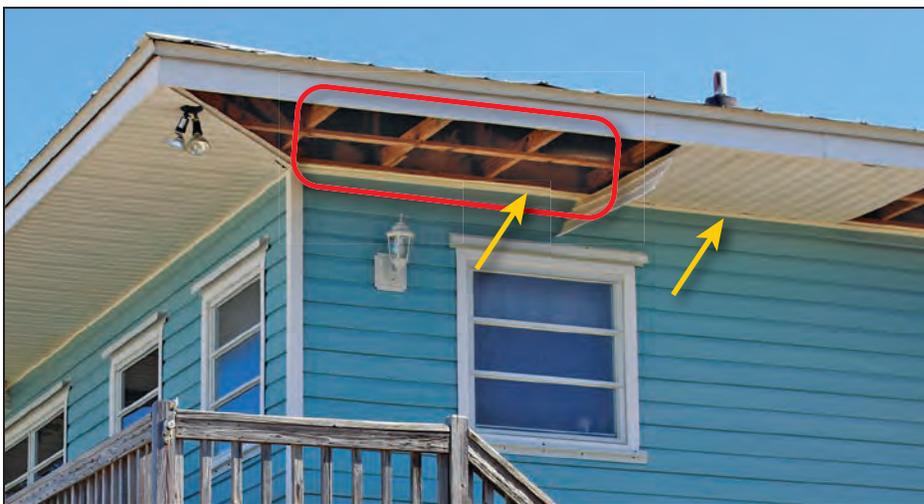
Figure 4-19:
House with vinyl soffit damage not caused by fascia loss (EWS = 113 mph; EDWS = 180 mph) (Sugarloaf Key)

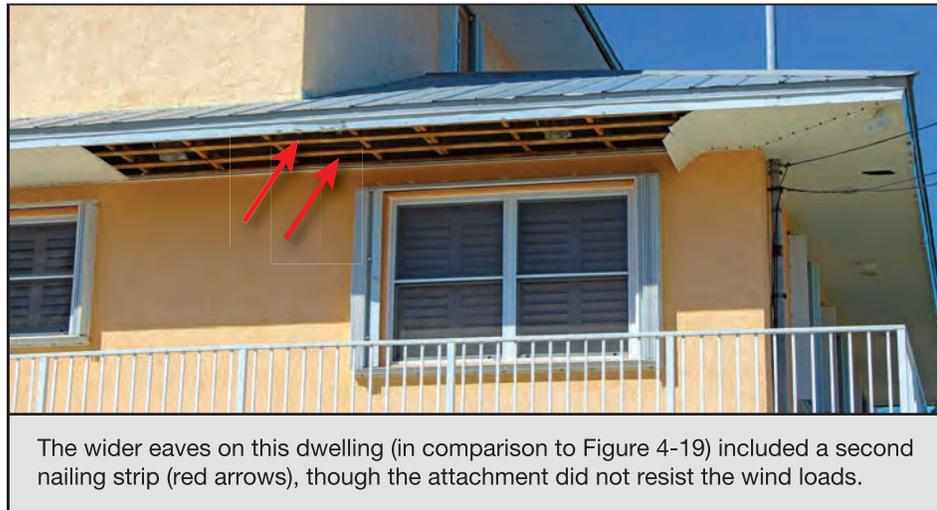
Figure 4-21:
House with soffit loss (EWS = 110 mph; EDWS = 169 mph) (Goodland)

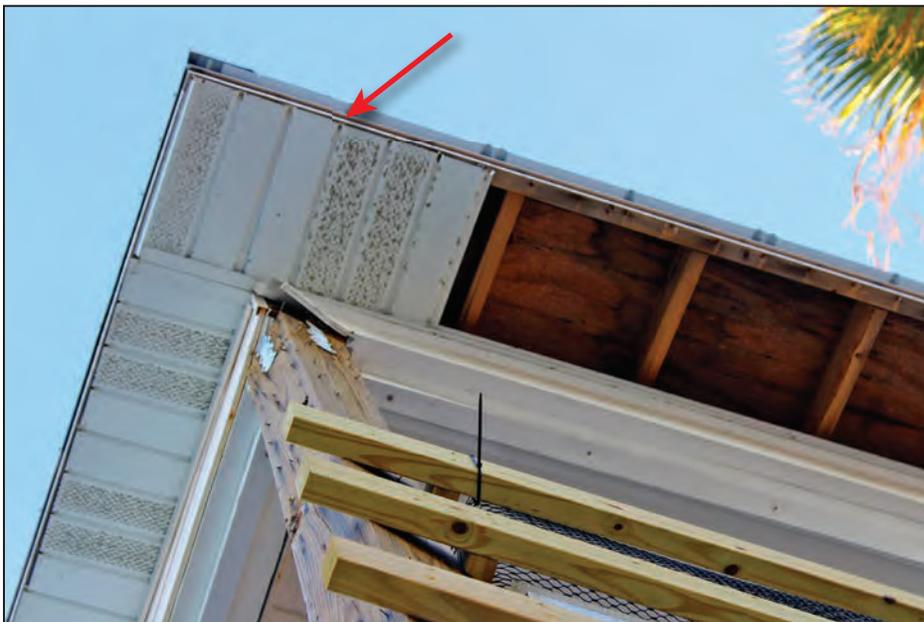
The red arrow shows direct attachment of soffit to framing along the outside edge of eaves only; panels are secured by a channel only above the porch opening.

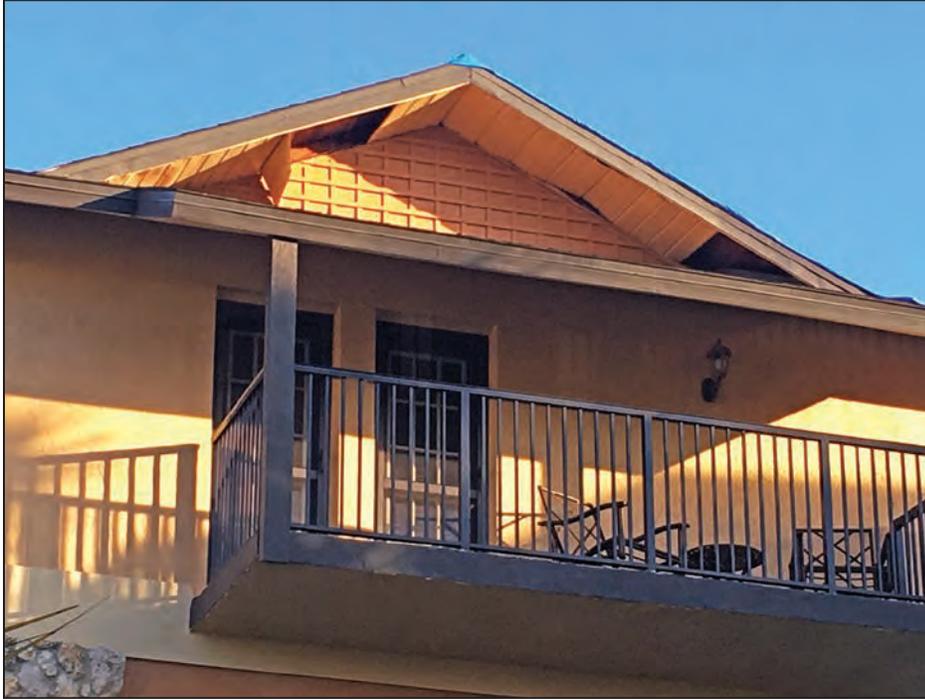
Figure 4-25:
Metal soffit panel loss
apartment gable end
overhang (EWS = 104 mph;
EDWS = 166 mph) (Naples)

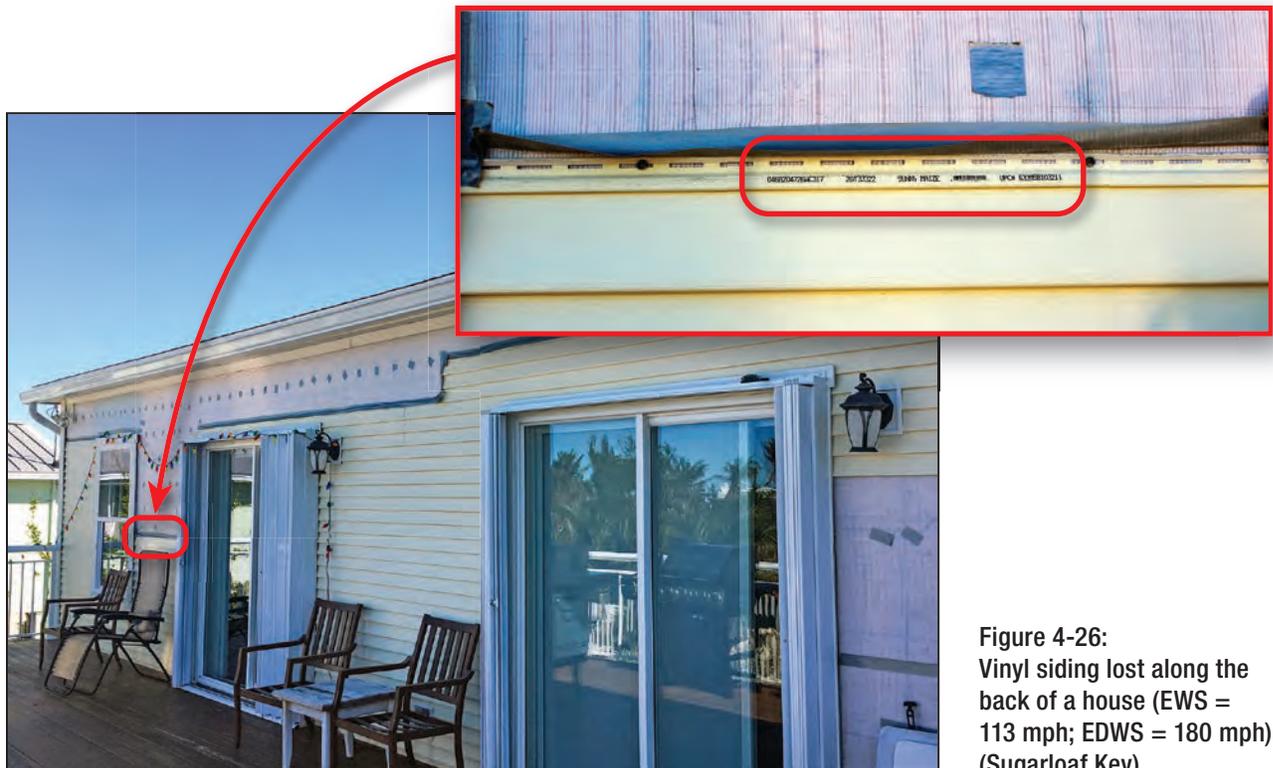
Figure 4-26:
Vinyl siding lost along the back of a house (EWS = 113 mph; EDWS = 180 mph) (Sugarloaf Key)
