Mitigation Assessment Team Report

Hurricane Irma in Florida

Building Performance Observations,
Recommendations, and Technical Guidance

FEMA P-2023 / December 2018

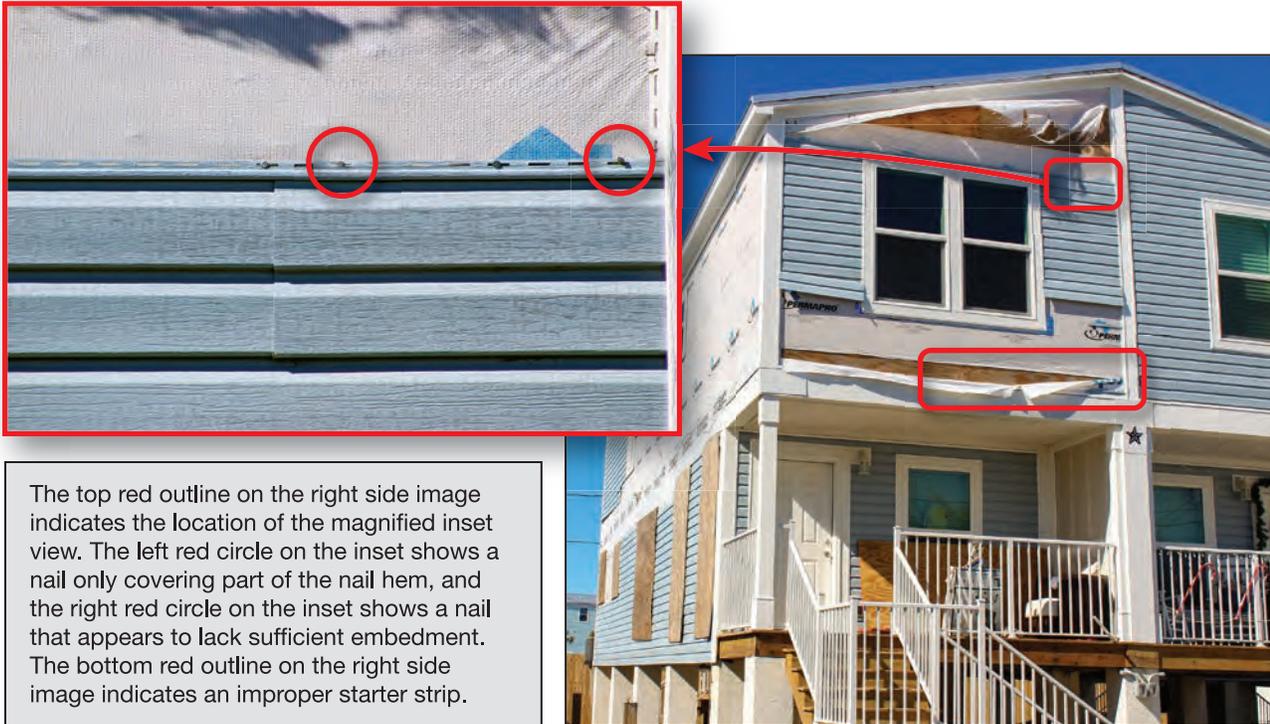
Figure 4-28: Duplex where vinyl siding above the front porch did not comply with manufacturer's installation instructions (EWS = 120 mph; EDWS = 180 mph) (Marathon Key)

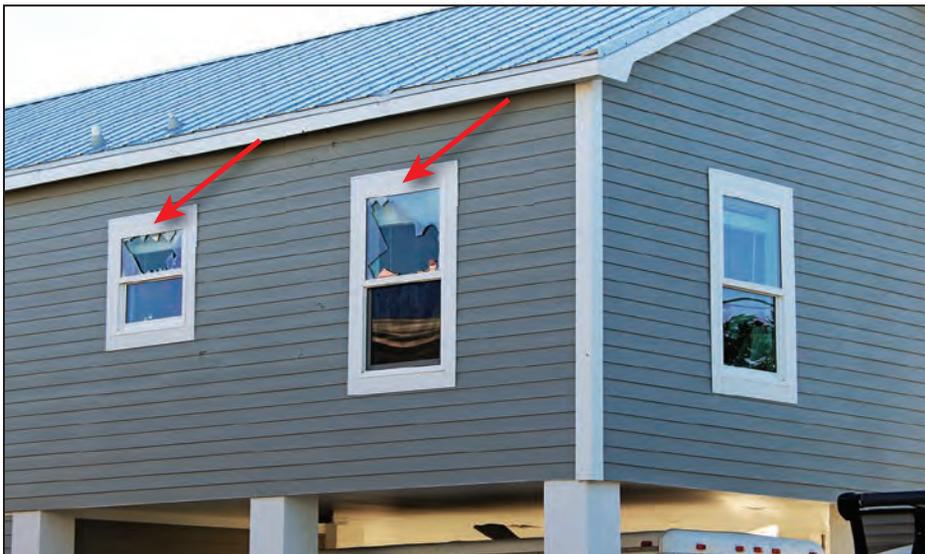
Figure 4-32: Residence with two windows where the outer panes were broken (see red arrows) but the inner panes stayed intact (EWS = 113 mph; EDWS = 180 mph) (Ramrod Key)

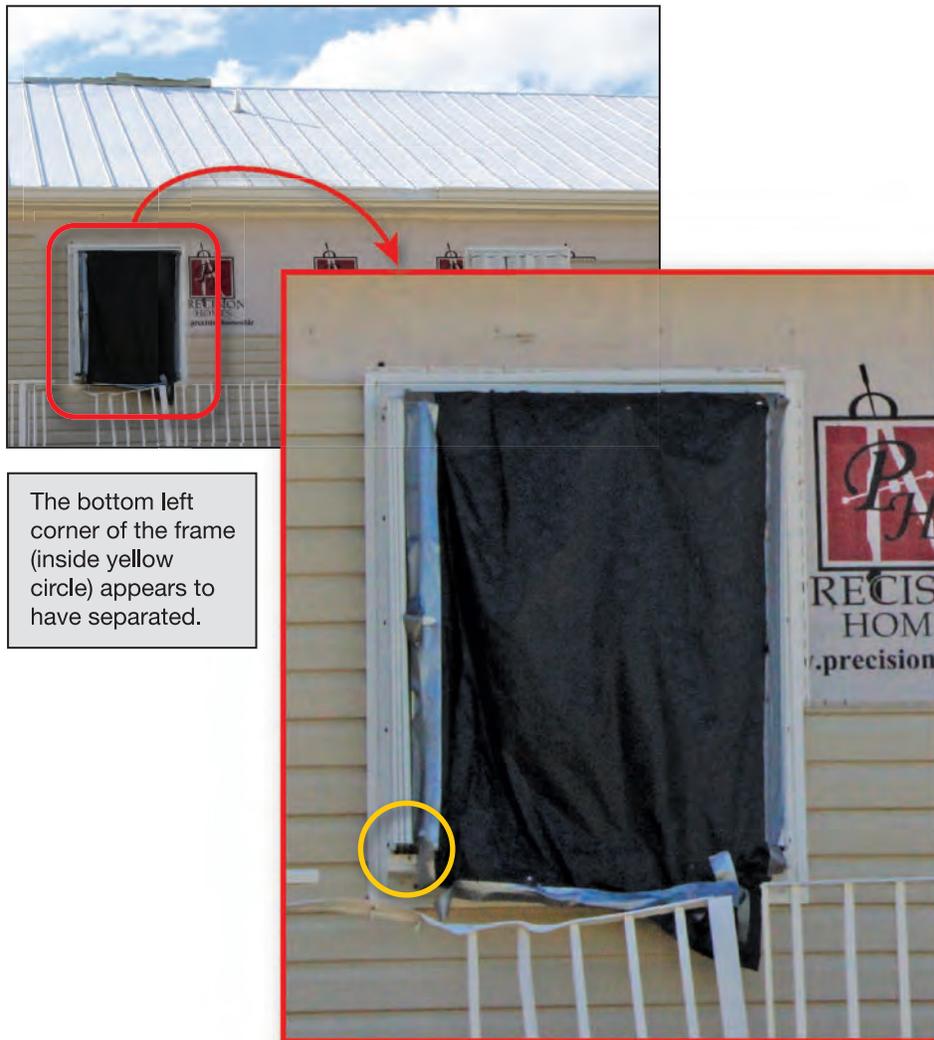
Figure 4-35: House with impact-resistant shutter system damaged by wind-borne debris; opening was covered at the time the MAT visited (EWS = 114 mph; EDWS = 180 mph) (Little Torch Key)

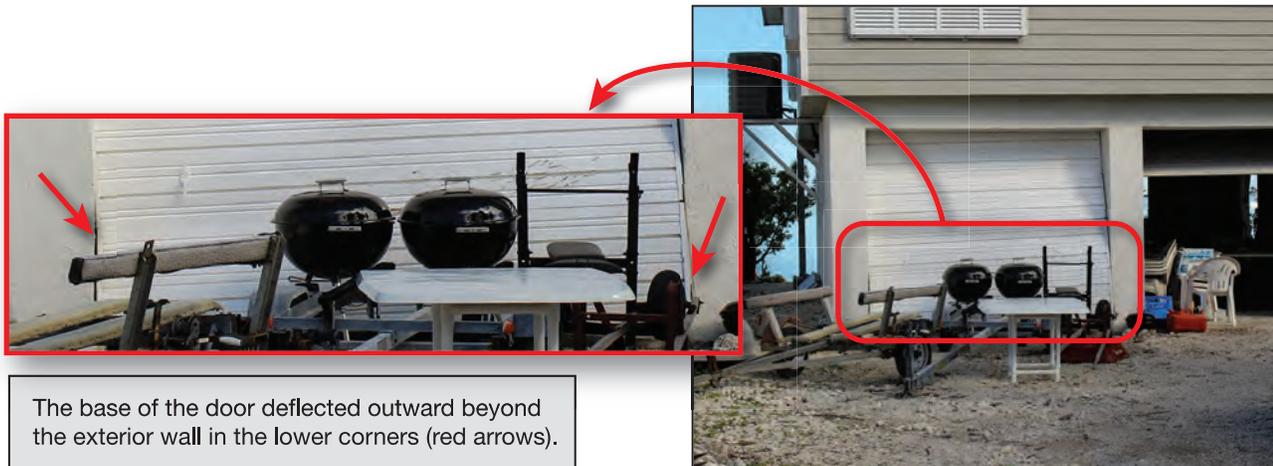
Figure 4-37: Damaged overhead garage doors (EWS = 114 mph; EDWS = 180 mph) (Little Torch Key)

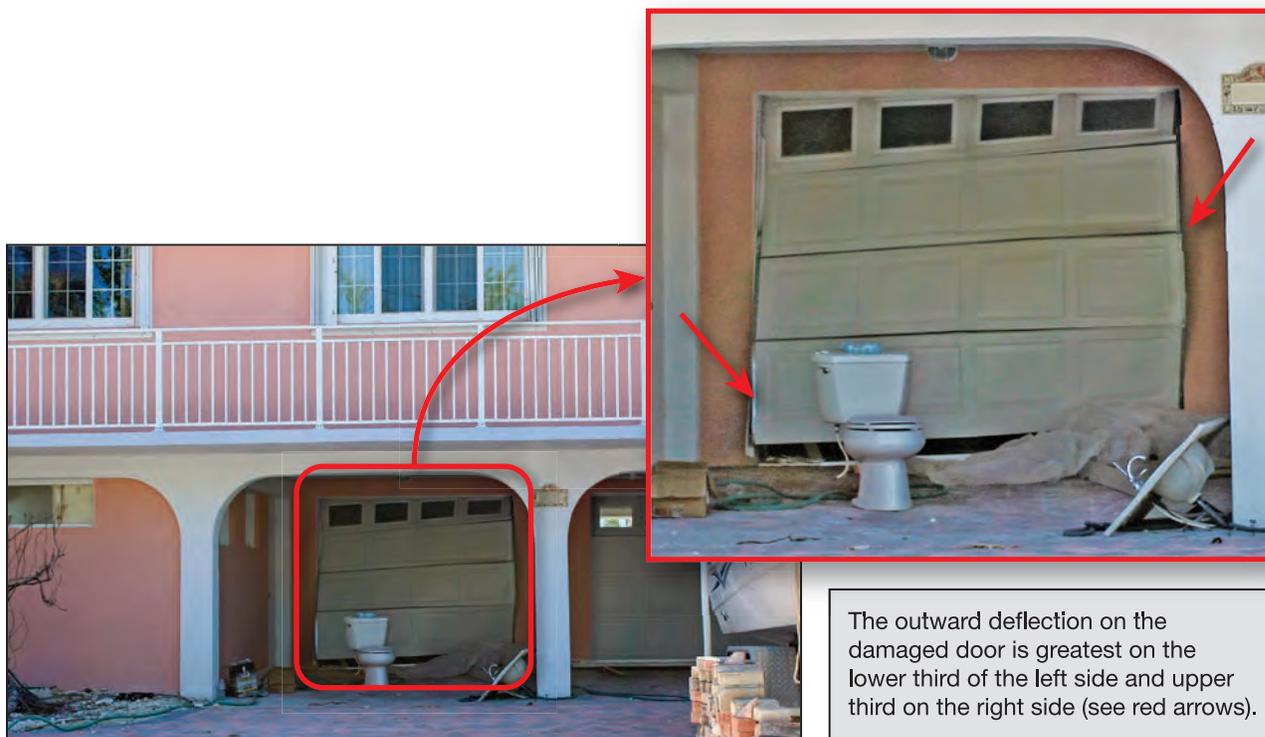
Figure 4-38: Damaged overhead garage door on a house (EWS = 111 mph; EDWS = 180 mph) (Duck Key)

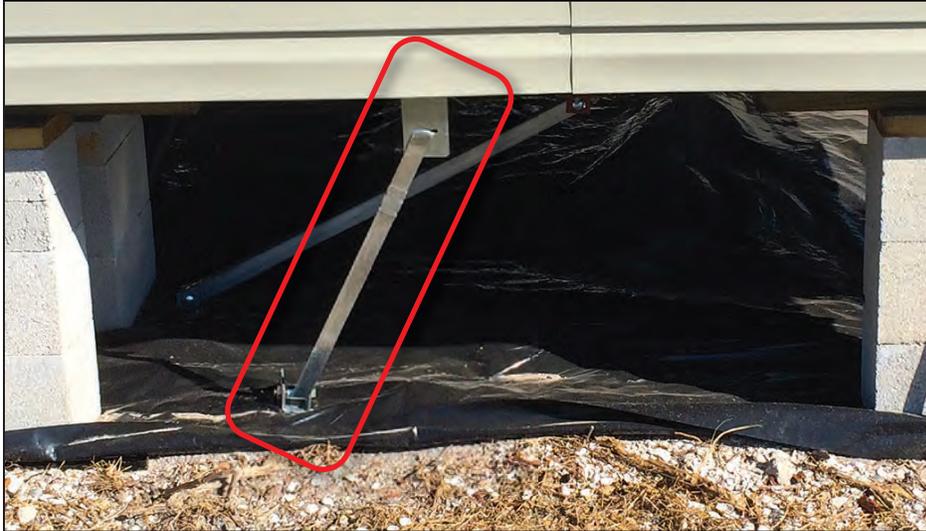
Figure 4-41:
New MH unit installation with misaligned anchor strap installation (red outline) was otherwise anchored consistently with other post-Irma examples (EWS = 105 mph; EDWS = 164 mph) (Collier County)

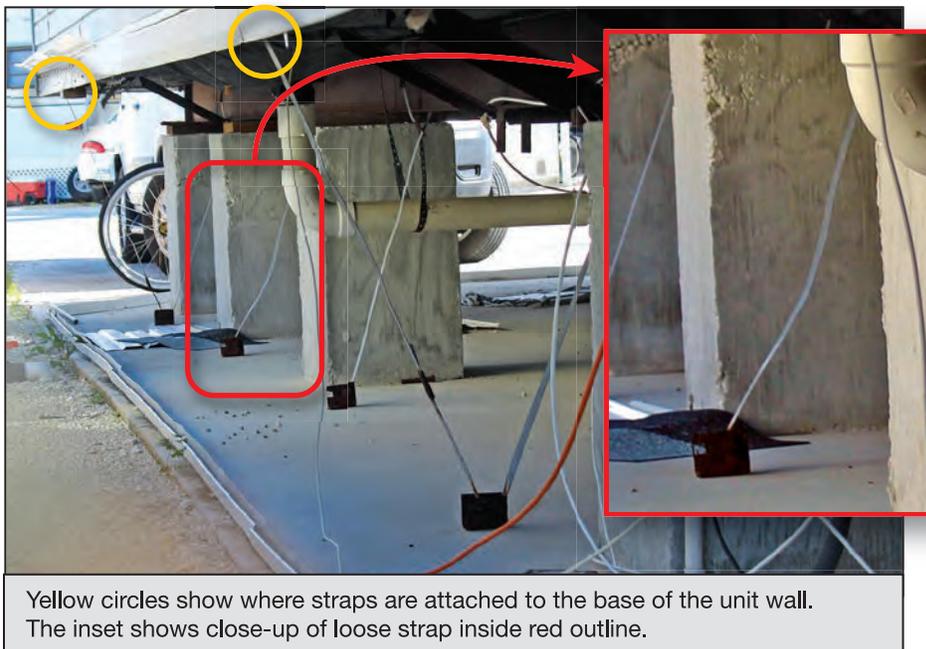
Figure 4-42:
MH unit installation where only the first and fourth straps are attached to the exterior wall base (EWS = 111 mph; EDWS = 180 mph) (Big Coppitt Key)

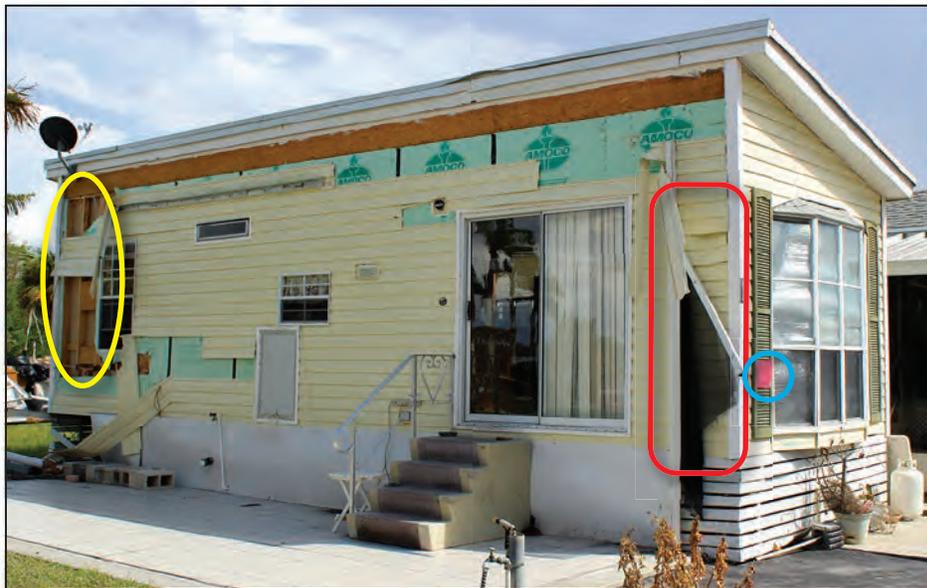
A remnant of the porch is shown in the red outline, and the red tag indicating condemnation by local officials is shown in the blue circle. The yellow oval shows missing sheathing and insulation characteristic of interior walls.
