Mitigation Assessment Team Report

Hurricane Michael in Florida

Building Performance Observations,
Recommendations, and Technical Guidance

FEMA P-2077 / February 2020

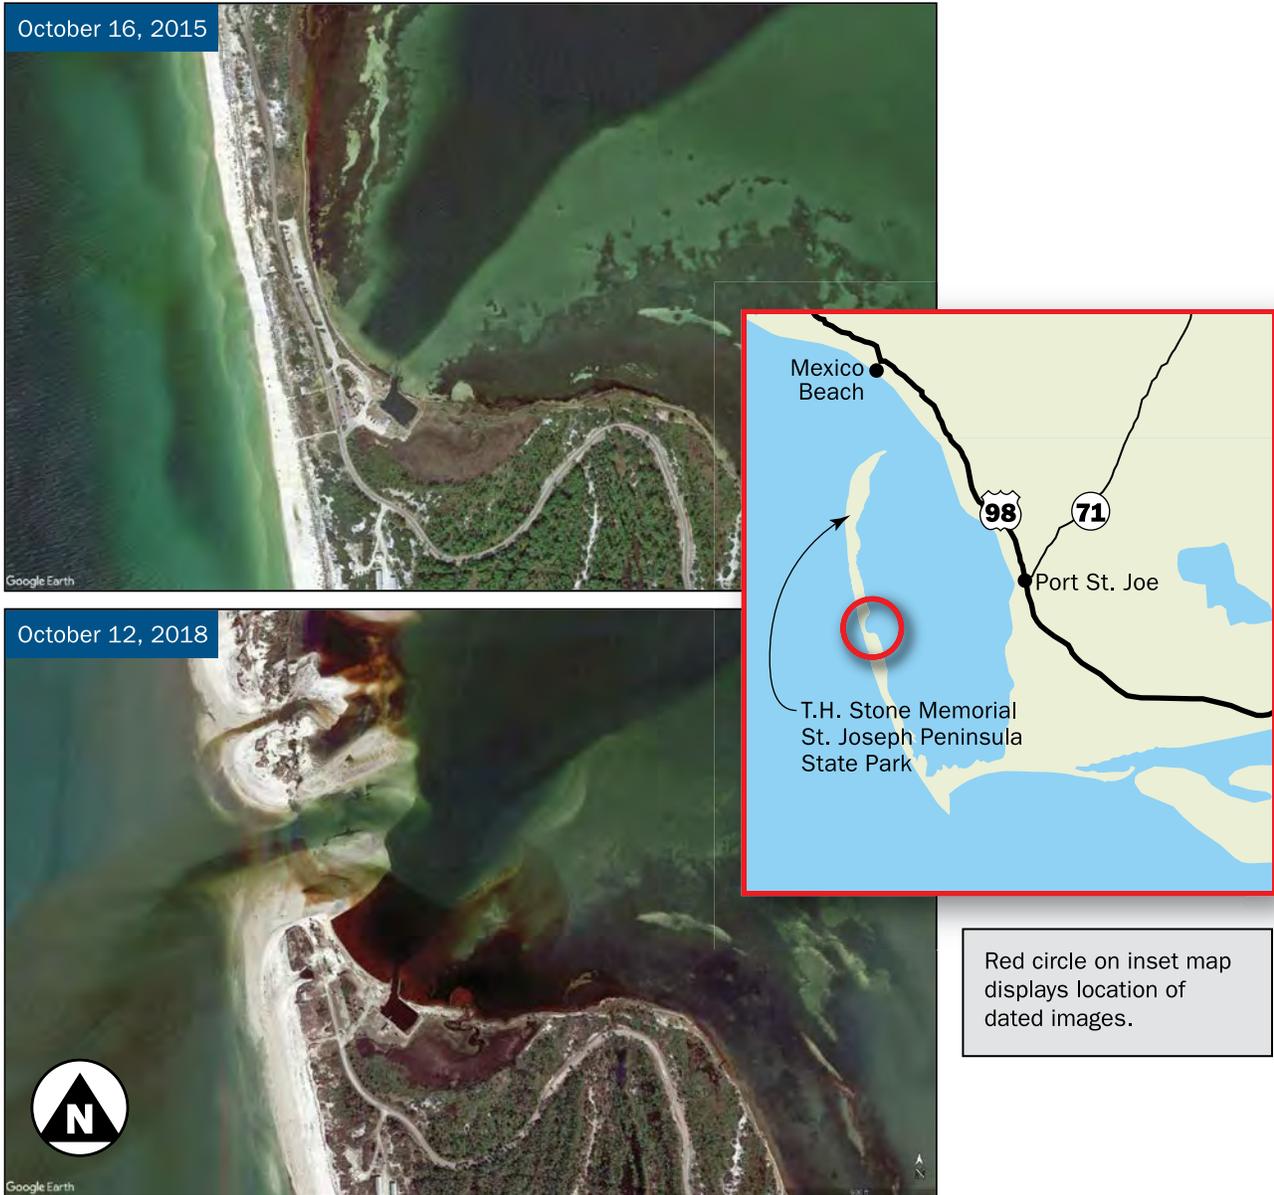
Figure 1-4: Aerial images of the barrier island in T.H. Stone Memorial St. Joseph Peninsula State Park before and after Hurricane Michael showing a breach

The storm surge brought high waves that caused significant erosion of barrier islands and primary frontal dunes. The barrier islands were breached by storm surge at numerous locations. Figure 1-4 shows an example.

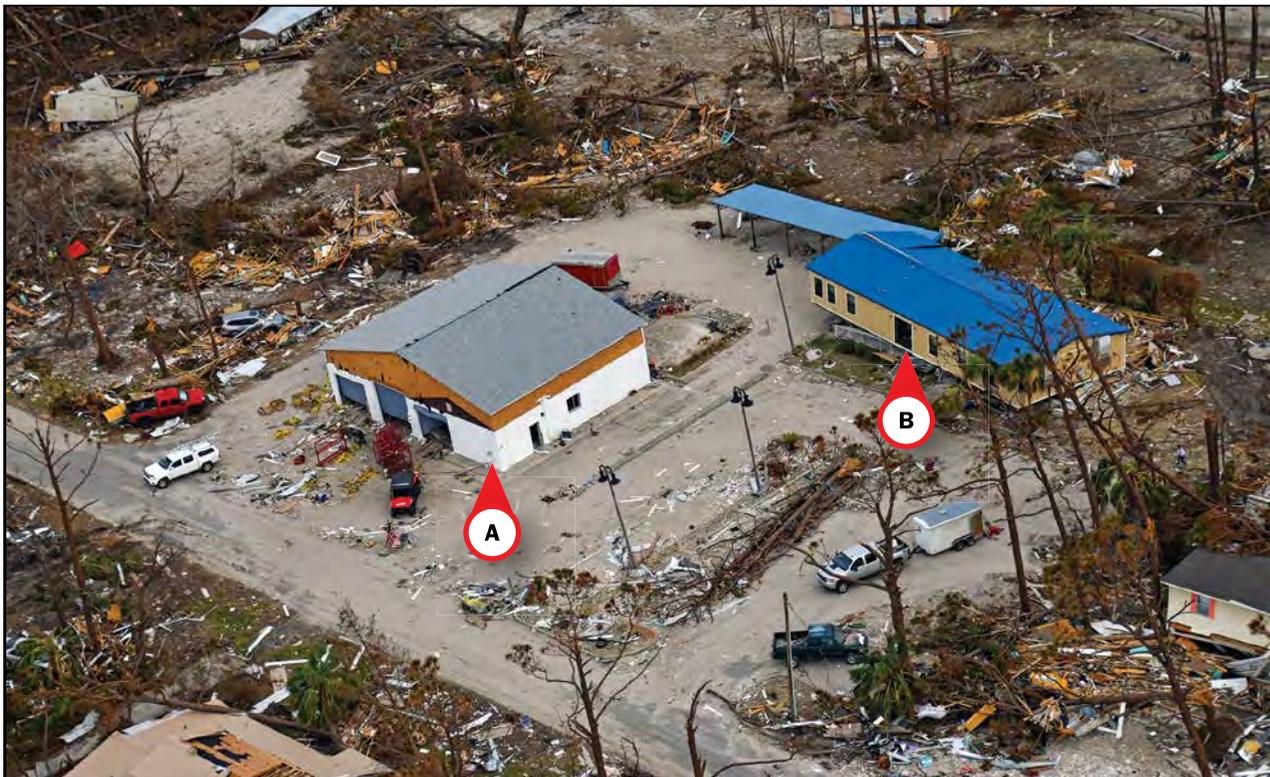
The fire station [A] had interior damage due to water infiltration and flooding, but also had wind envelope damage. The police station [B] was lifted from its foundation and eventually demolished due to the extent of damage.

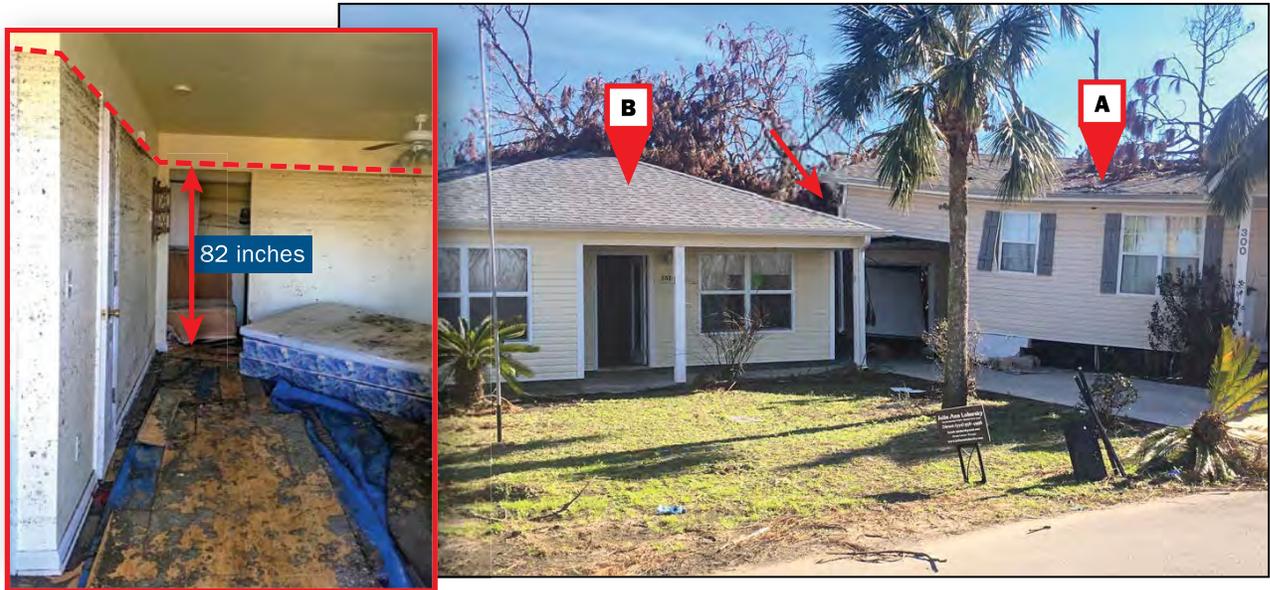
[A] This single-family house (built in 1986) in Mexico Beach floated off its foundation and into the neighboring structure **[B]** (red arrow).

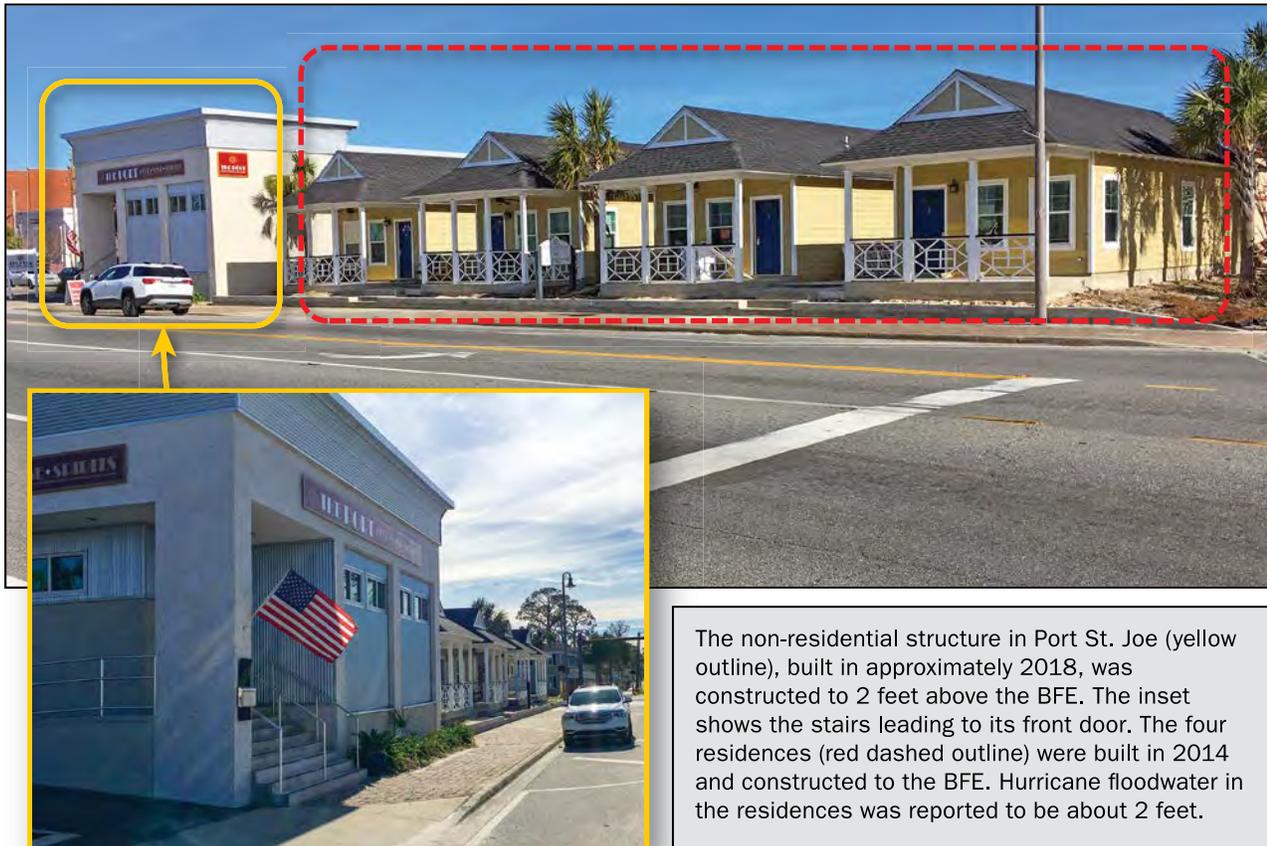
The non-residential structure in Port St. Joe (yellow outline), built in approximately 2018, was constructed to 2 feet above the BFE. The inset shows the stairs leading to its front door. The four residences (red dashed outline) were built in 2014 and constructed to the BFE. Hurricane floodwater in the residences was reported to be about 2 feet.

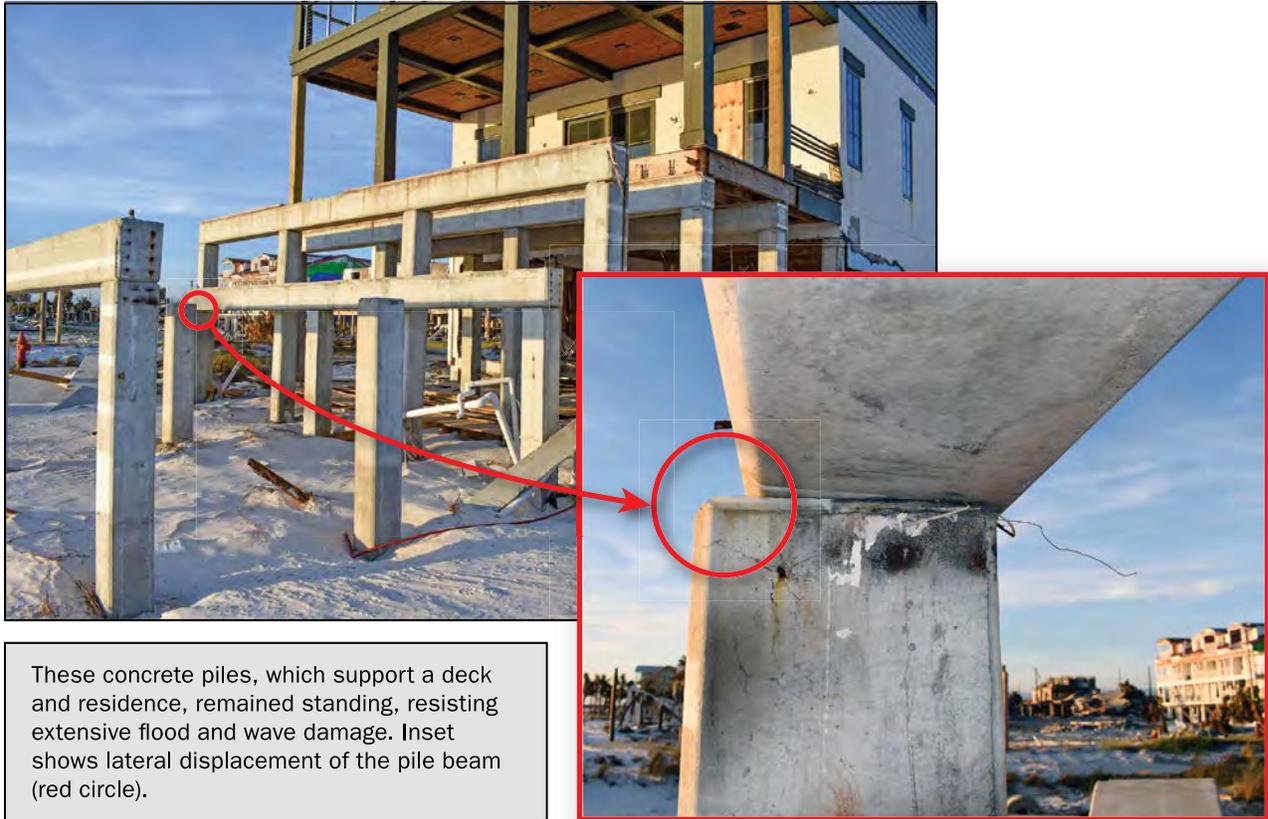
These concrete piles, which support a deck and residence, remained standing, resisting extensive flood and wave damage. Inset shows lateral displacement of the pile beam (red circle).

- FL-10a. Industry groups, interested stakeholders, and/or academia should further evaluate the performance of the concrete pile foundations that failed during Hurricane Michael to determine why they failed.

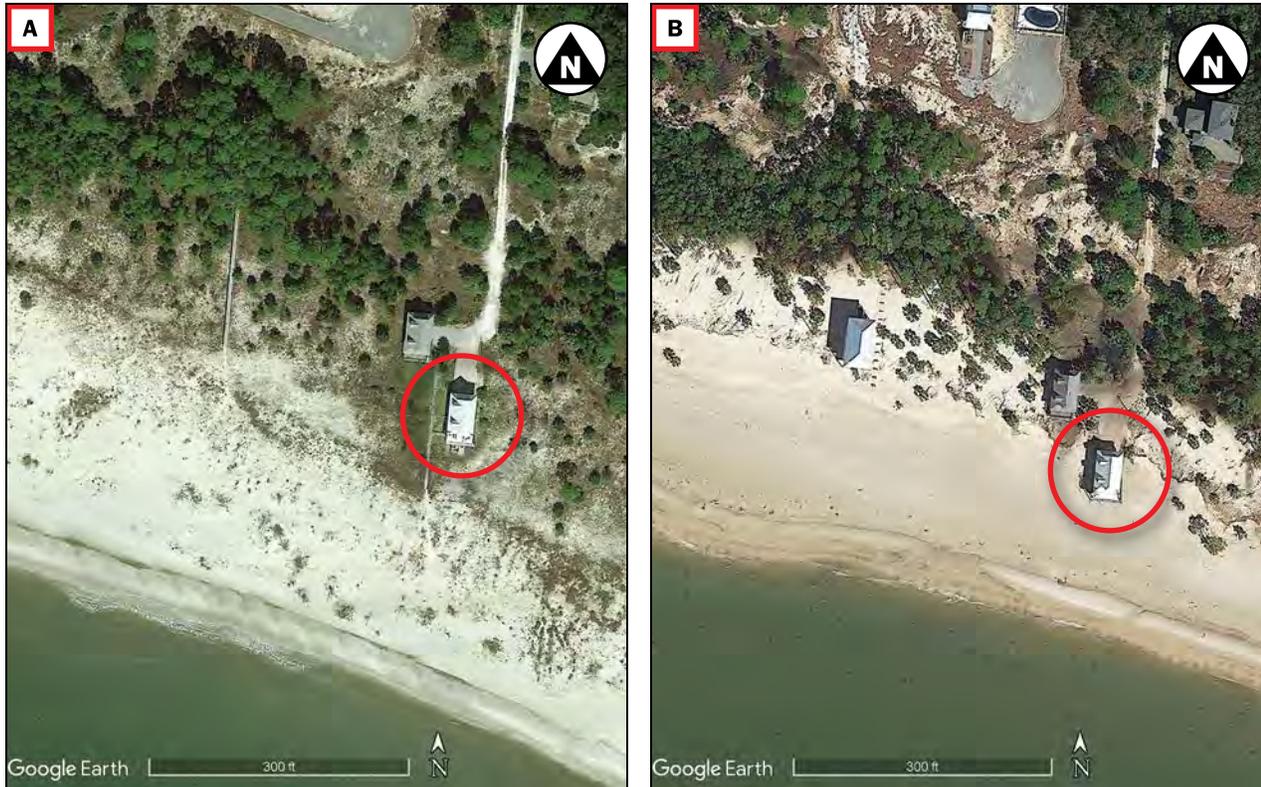
Imagery from October 16, 2015 [A], and October 11, 2018 [B]. The distance of the home in the red circle from the water's edge in 2015 was more than 250 feet from the water's edge, whereas in 2018, this distance was less than 150 feet (Indian Peninsula).

The CCM recommends siting coastal residential structures based on the larger of the published erosion rate, or 1 foot per year.

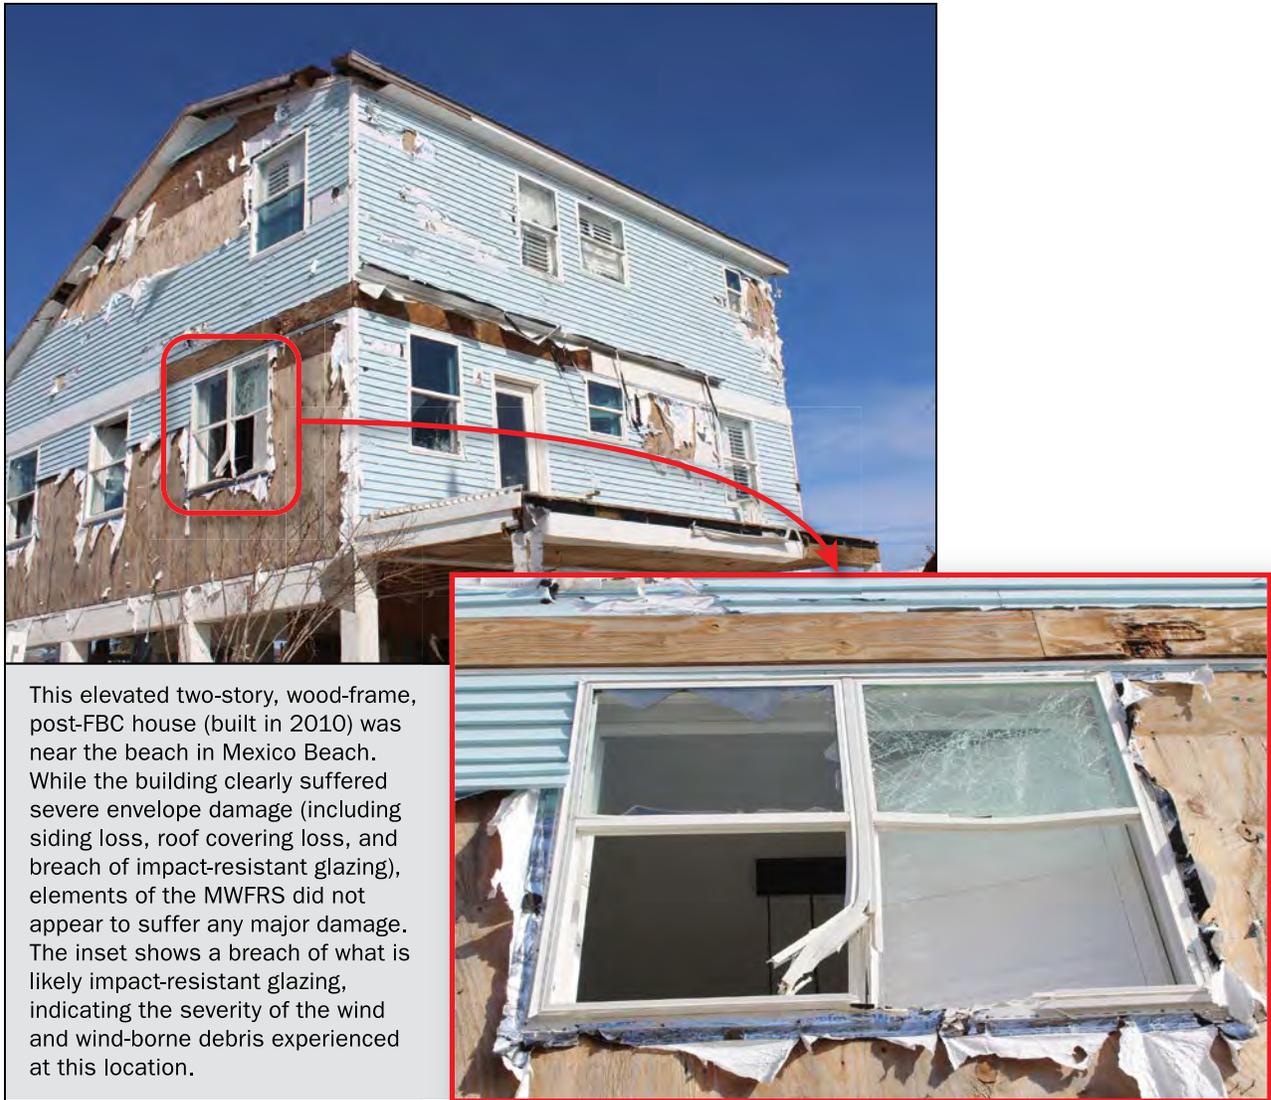
This elevated two-story, wood-frame, post-FBC house (built in 2010) was near the beach in Mexico Beach. While the building clearly suffered severe envelope damage (including siding loss, roof covering loss, and breach of impact-resistant glazing), elements of the MWFRS did not appear to suffer any major damage. The inset shows a breach of what is likely impact-resistant glazing, indicating the severity of the wind and wind-borne debris experienced at this location.

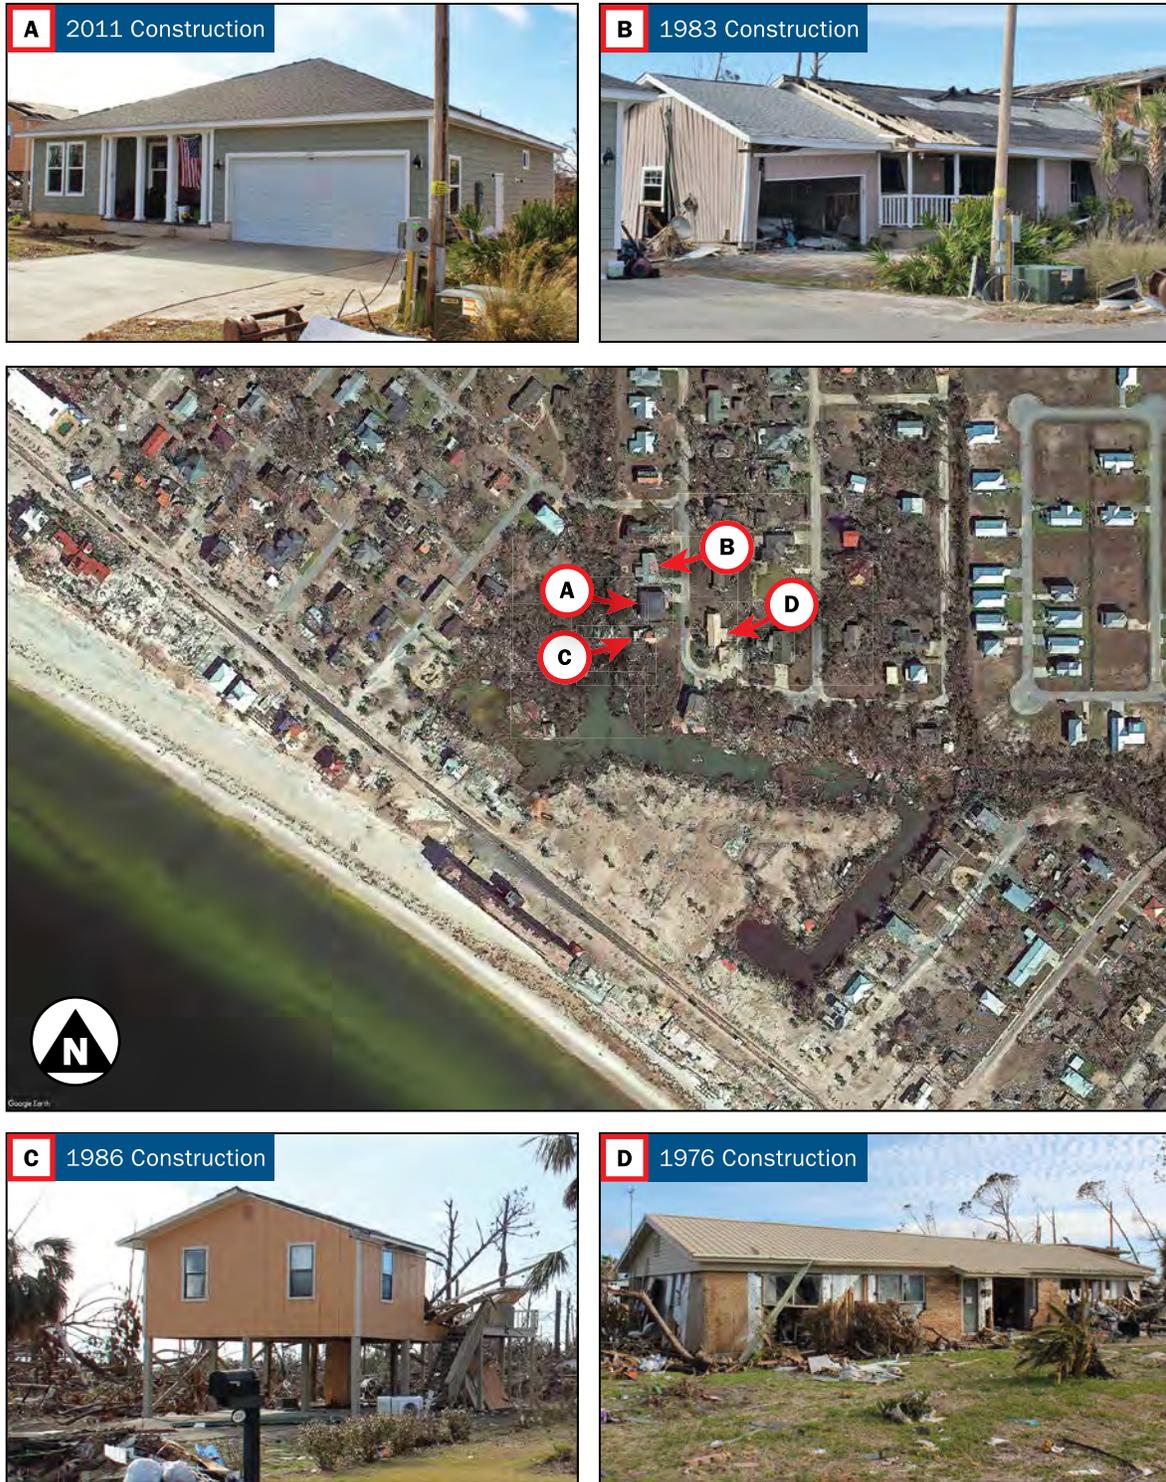
Building [A], built in 2011, had asphalt shingle failure on the south slope but no other damage was observed.

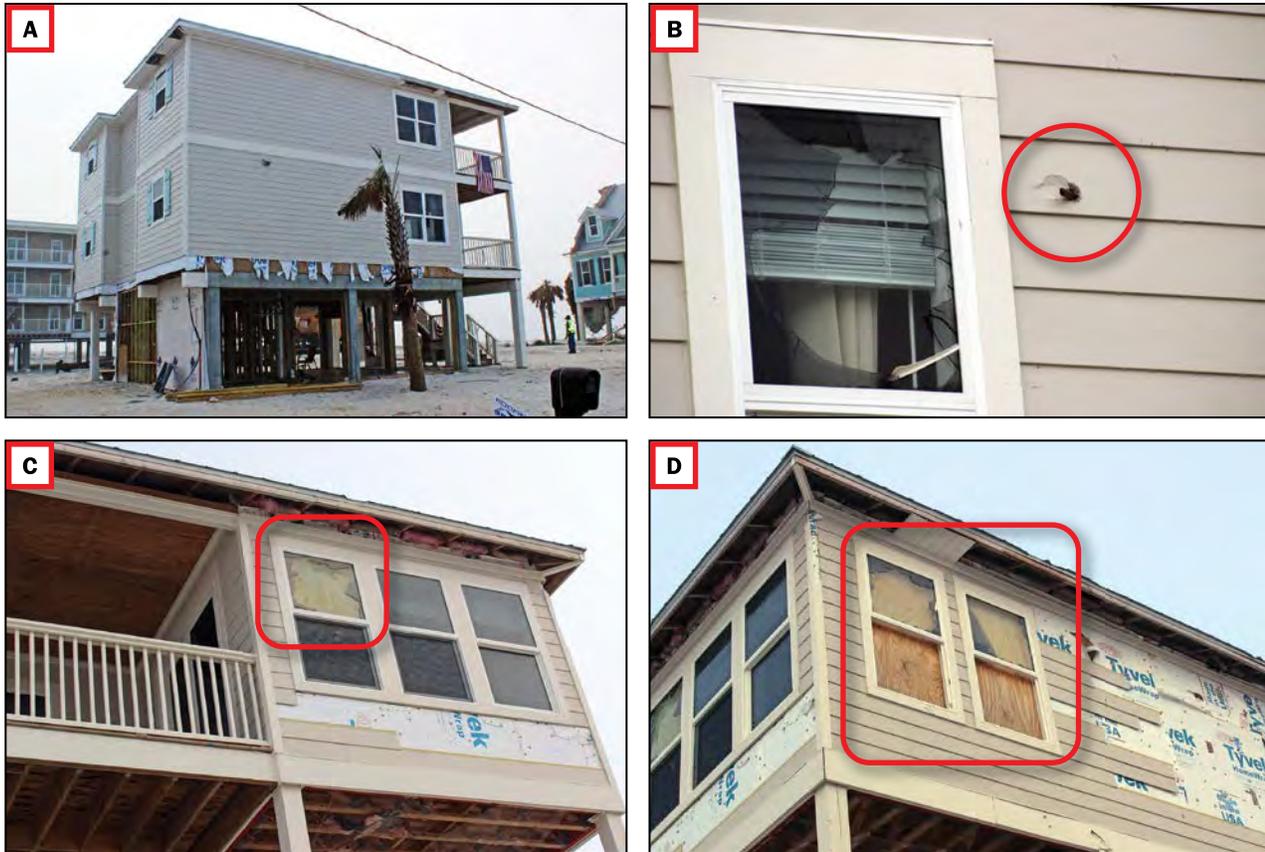
In images [B], [C], and [D], the outer upper sash layer of the double-glazed assembly is broken. In [C], the inner layer is also cracked and displays the classic “spider-web” appearance that occurs when an impact-resistant assembly is struck and broken by debris. Also noteworthy is that the bottom sashes in [D] are gone and plywood is installed over the opening from the inside. It is unclear what happened to the lower sashes on these windows. A close inspection of the photograph shows no sign of damage to the frame. The lower sashes appear to have been knocked out due to wind pressure or debris.

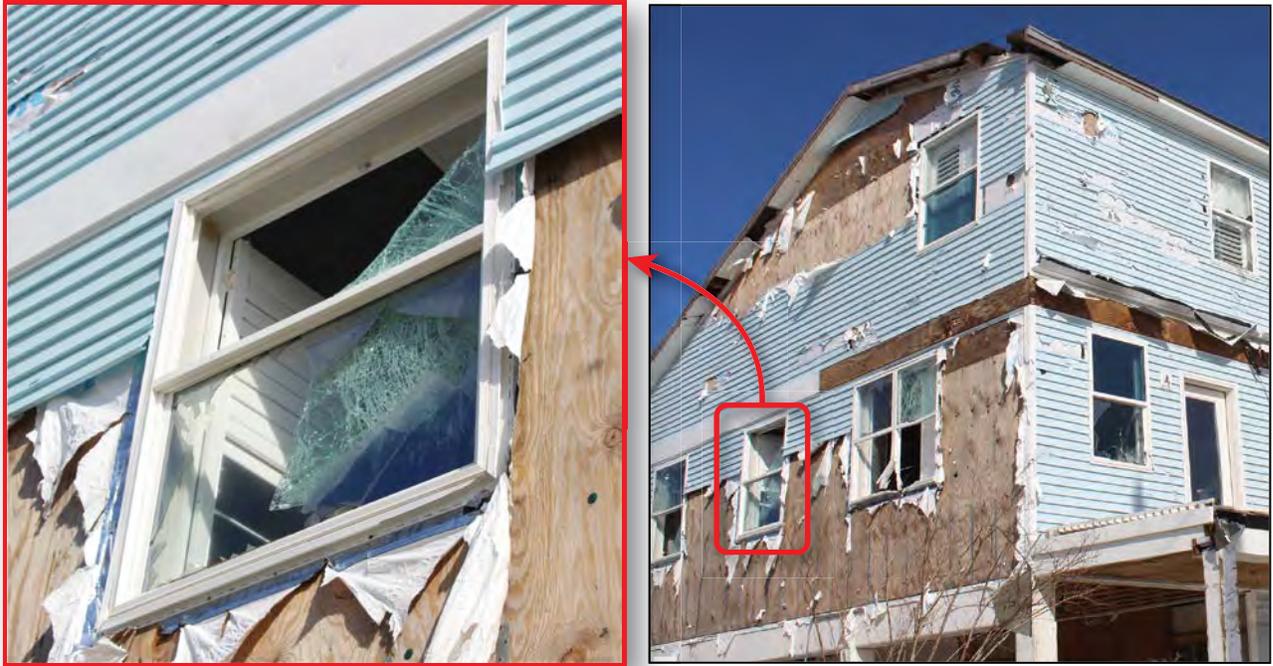
Located a few blocks east of the building in Figure 4-38. Note the broken pieces of glass being held together by an interlayer that was likely impact-resistant.

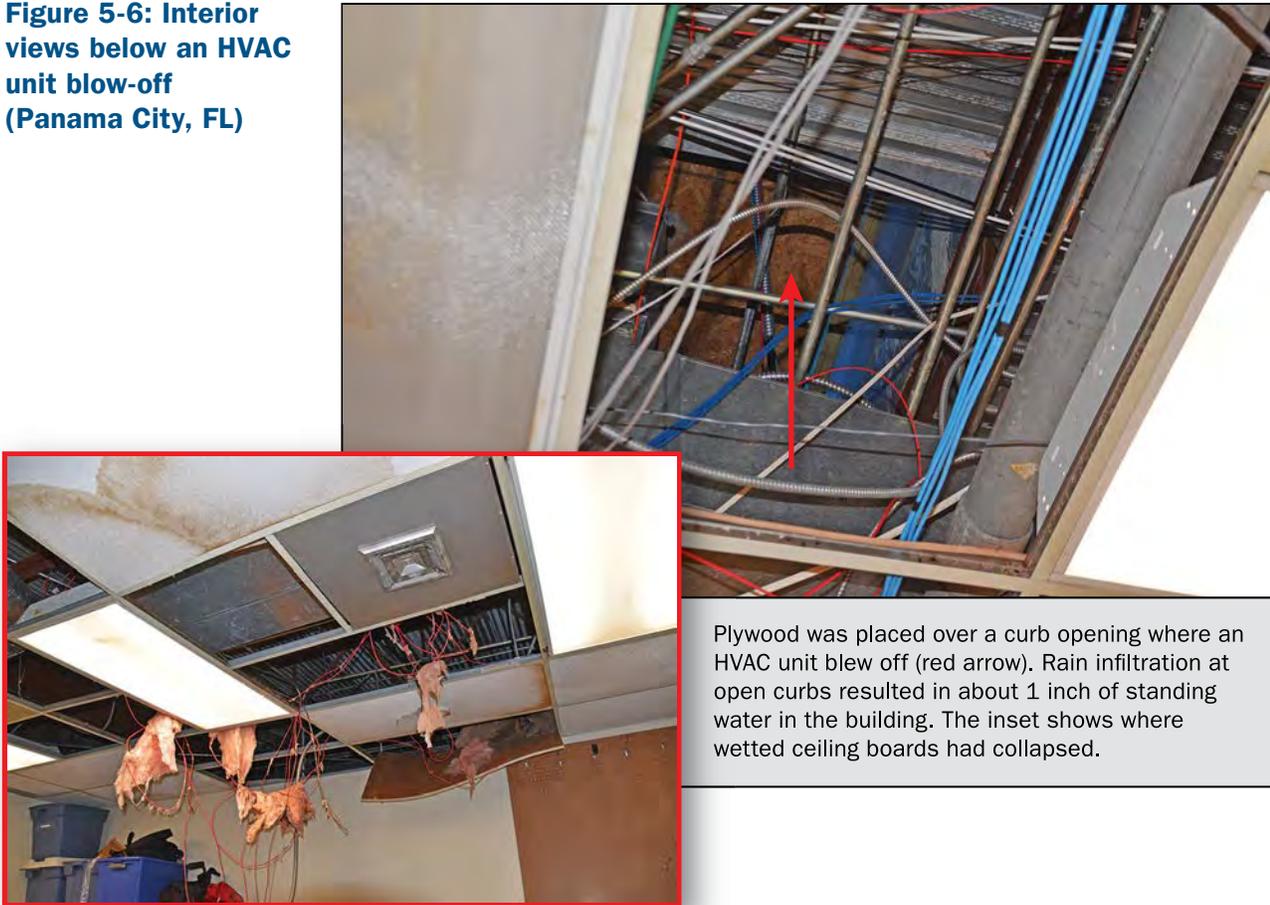
Plywood was placed over a curb opening where an HVAC unit blew off (red arrow). Rain infiltration at open curbs resulted in about 1 inch of standing water in the building. The inset shows where wetted ceiling boards had collapsed.

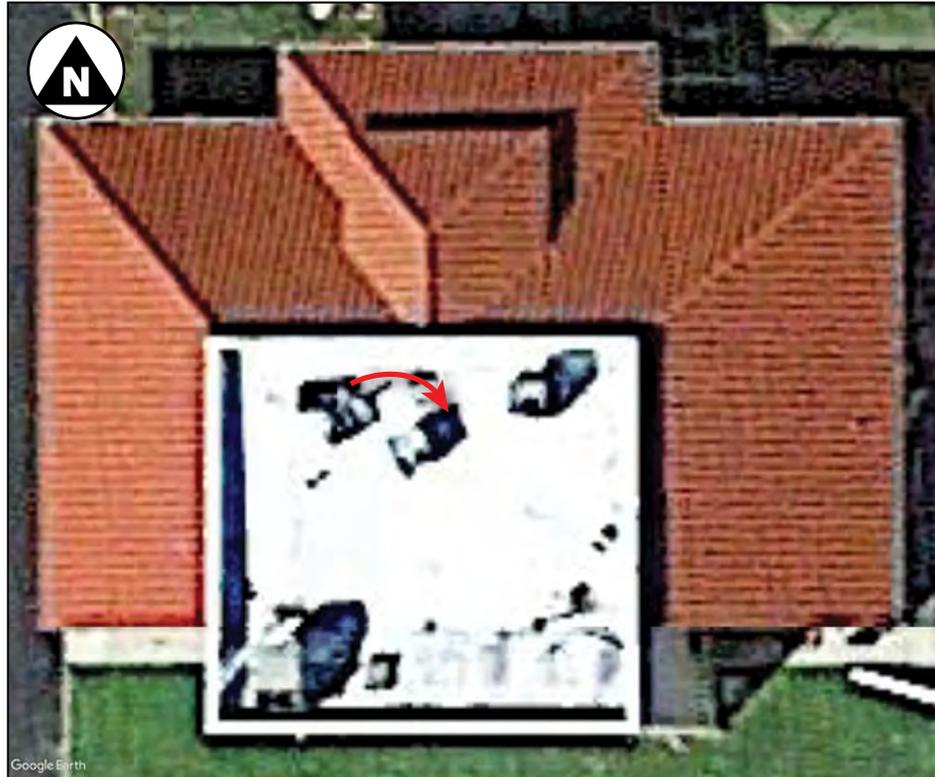
One of the HVAC units blew off its curb (red arrow), allowing rain to enter the building.

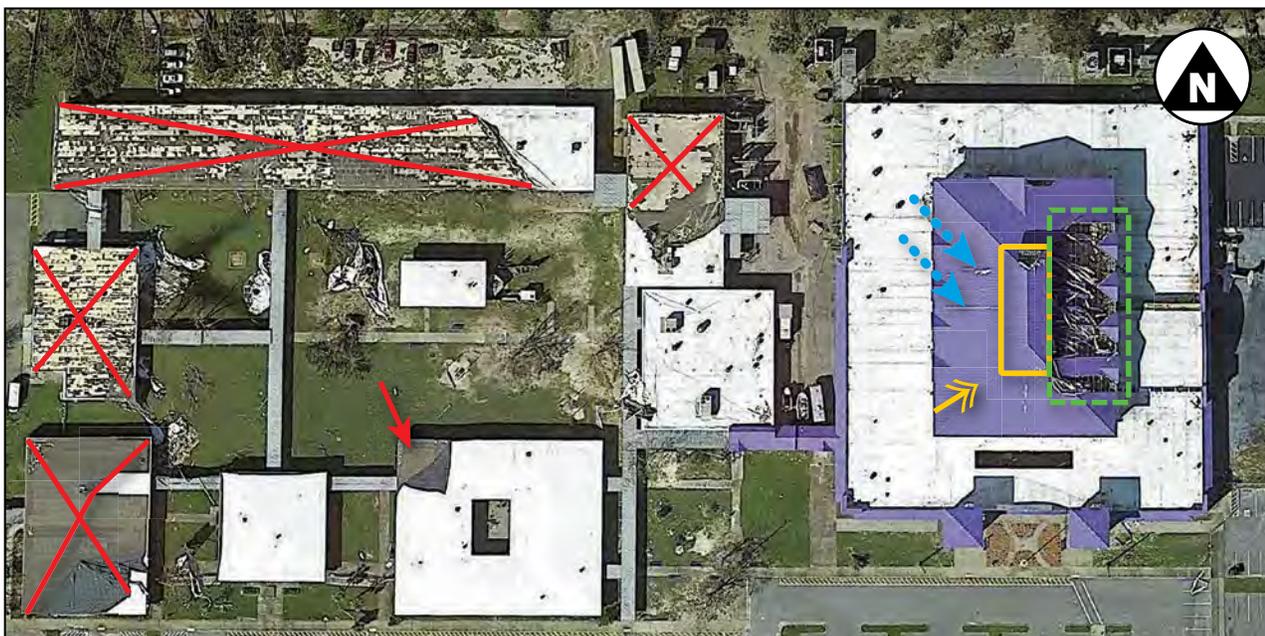
The red lines and arrow indicate where the single-ply roof membranes blew off. The yellow double arrow indicates the steep-slope conversion. The area within the yellow rectangle is a separate upper level roof. The green dashed rectangle indicates where roof panels blew off (Figure 5-21). The blue dotted arrows indicate where standing seams opened up (Figure 5-23).

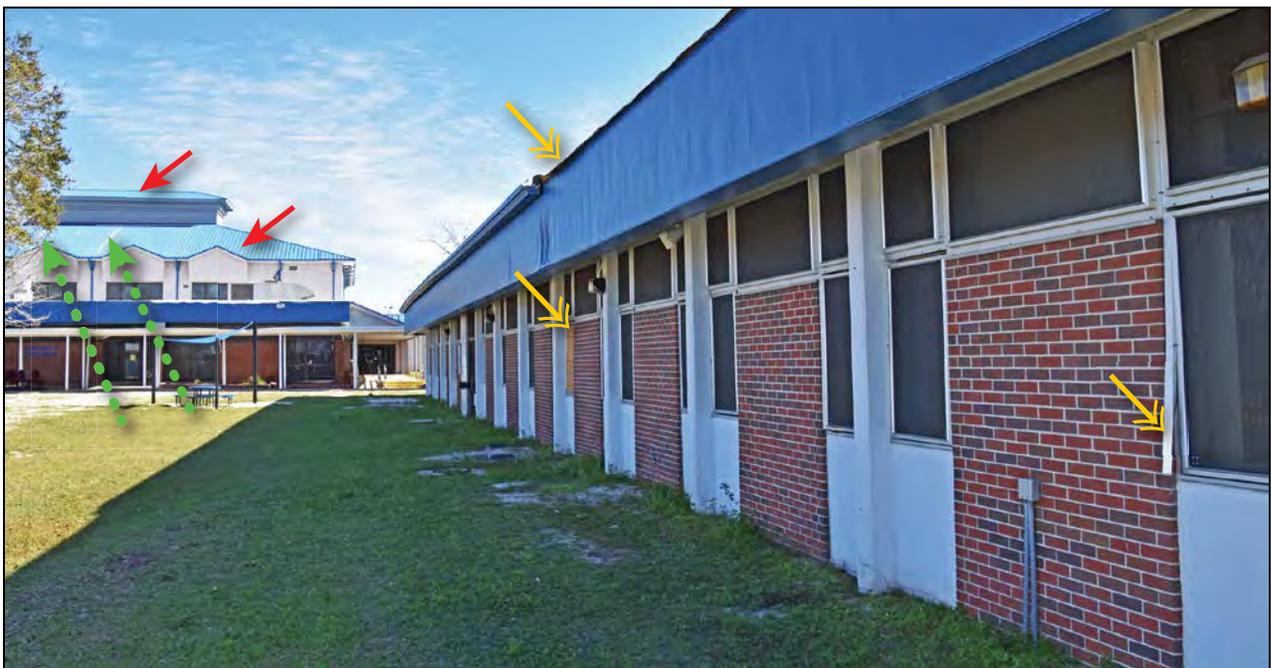
The red arrows indicate the steep-slope conversion. The green dotted arrows indicate where standing seams opened up (Figure 5-23). The yellow double arrows indicate a blown-off gutter, broken glazing, and a damaged screen shutter frame.

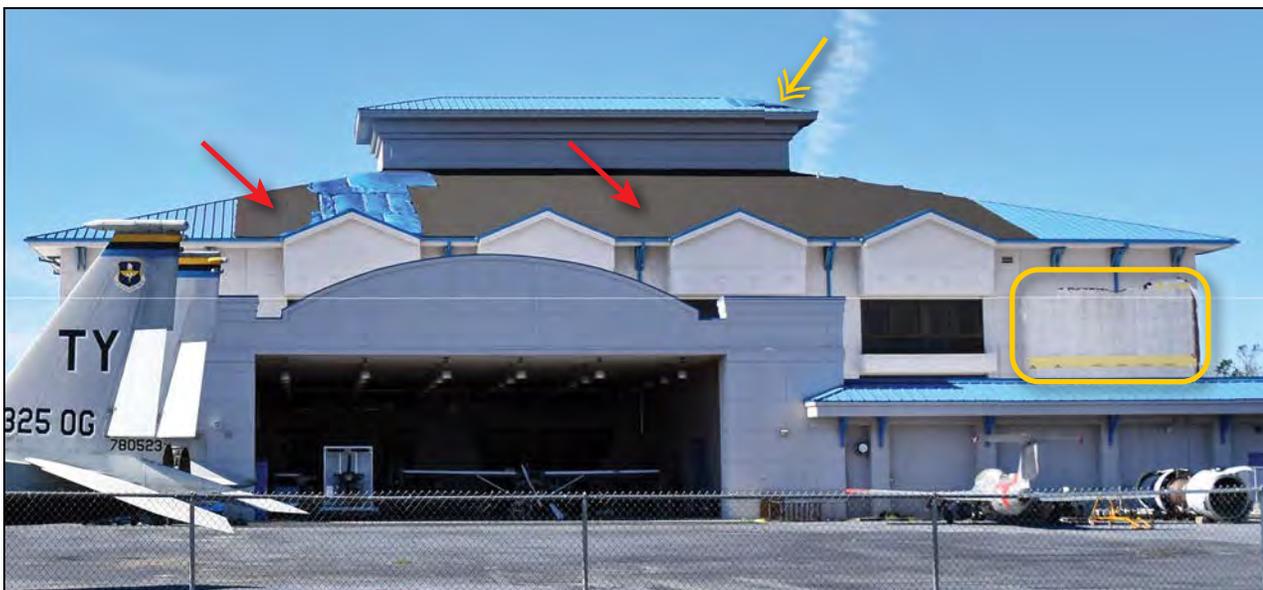
The black area (red arrows) is where emergency roof repairs were made. The yellow double arrow indicates a tarped area. The yellow outlined area indicates where stucco blew off.

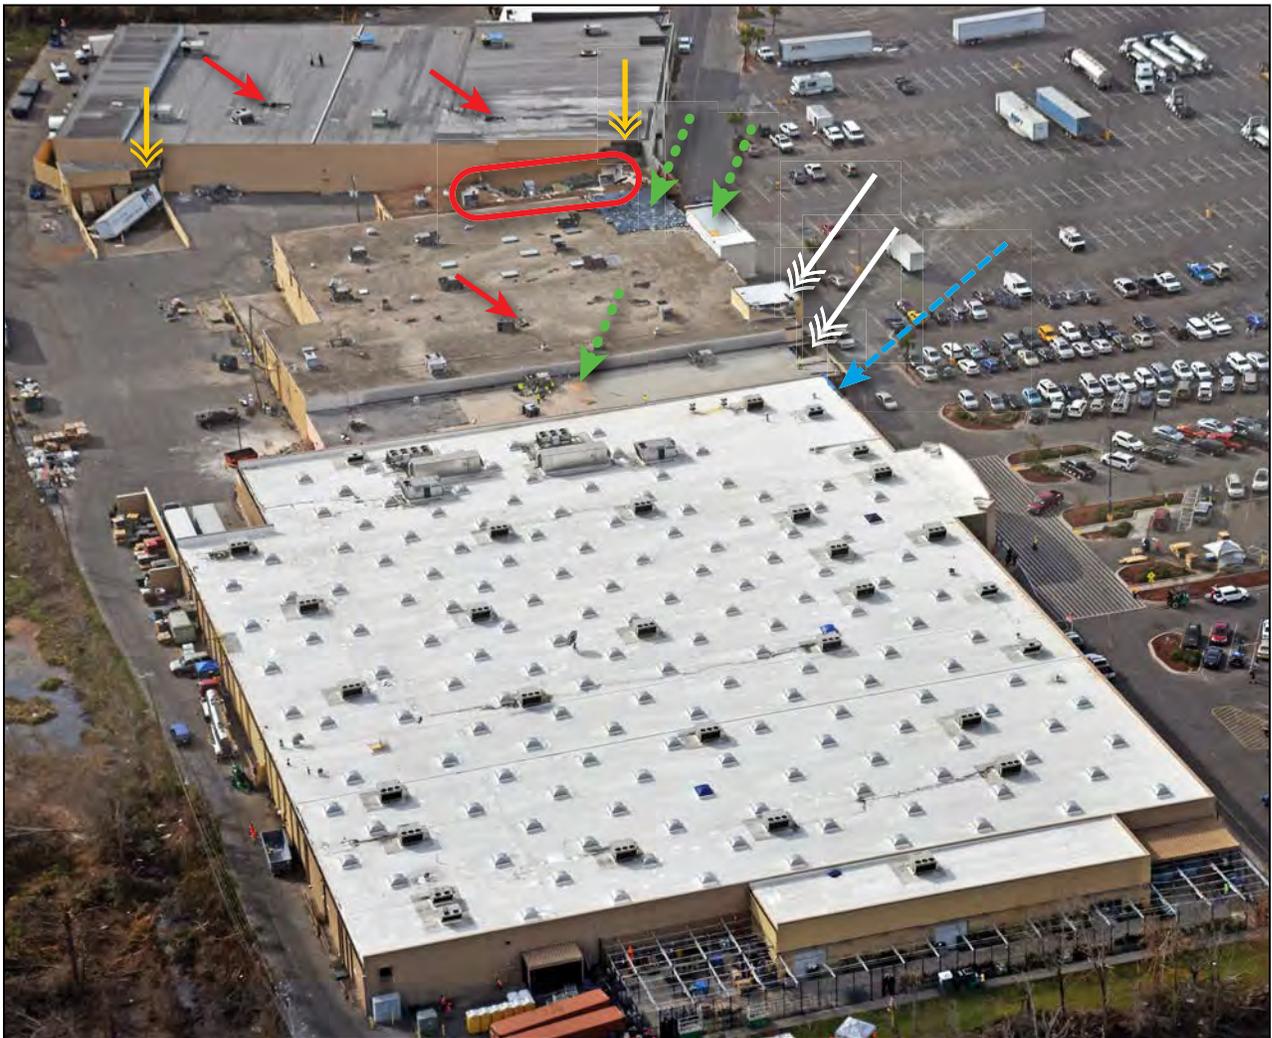
The red oval indicates where the roof structure collapsed. The red arrows indicate where HVAC units blew off. The yellow double arrows indicate where an EIFS blew off the studs. The green dotted arrows indicate where the roof membrane blew off. The white triple arrows indicate where the decking blew off of the two roofs. The blue dashed arrow indicates coping damage. The portion of the shopping center shown at the bottom of the figure has a large number of skylights. Three of the skylights were damaged. See Figure 5-30 for a close-up of this roof.

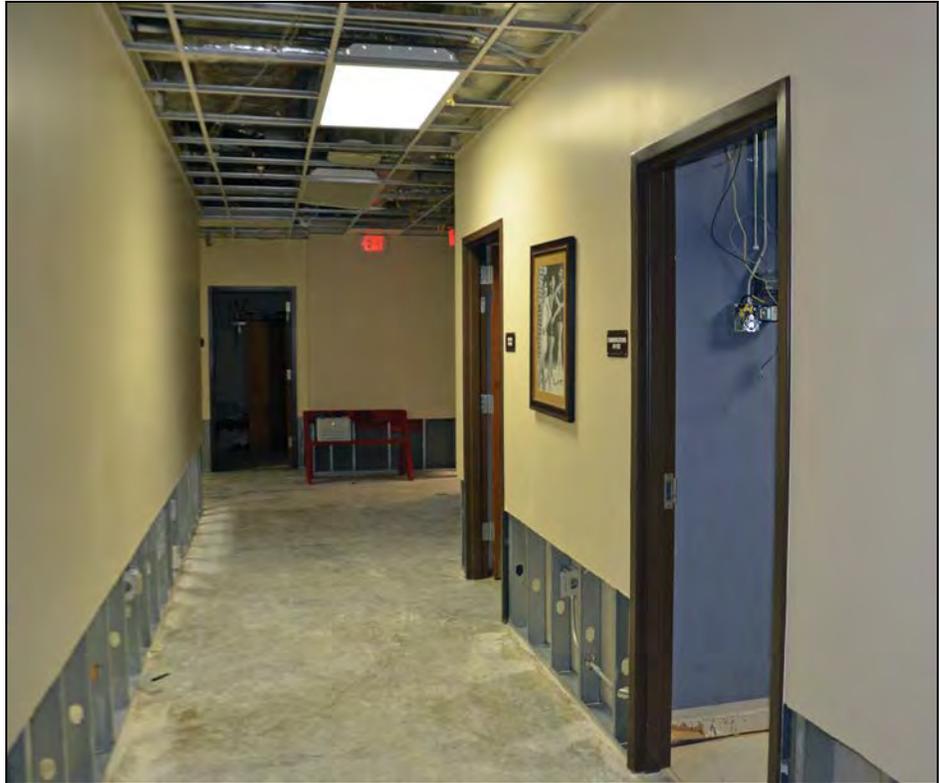
Interior of Building 1 in which wetted ceiling boards collapsed and then were cut and removed.

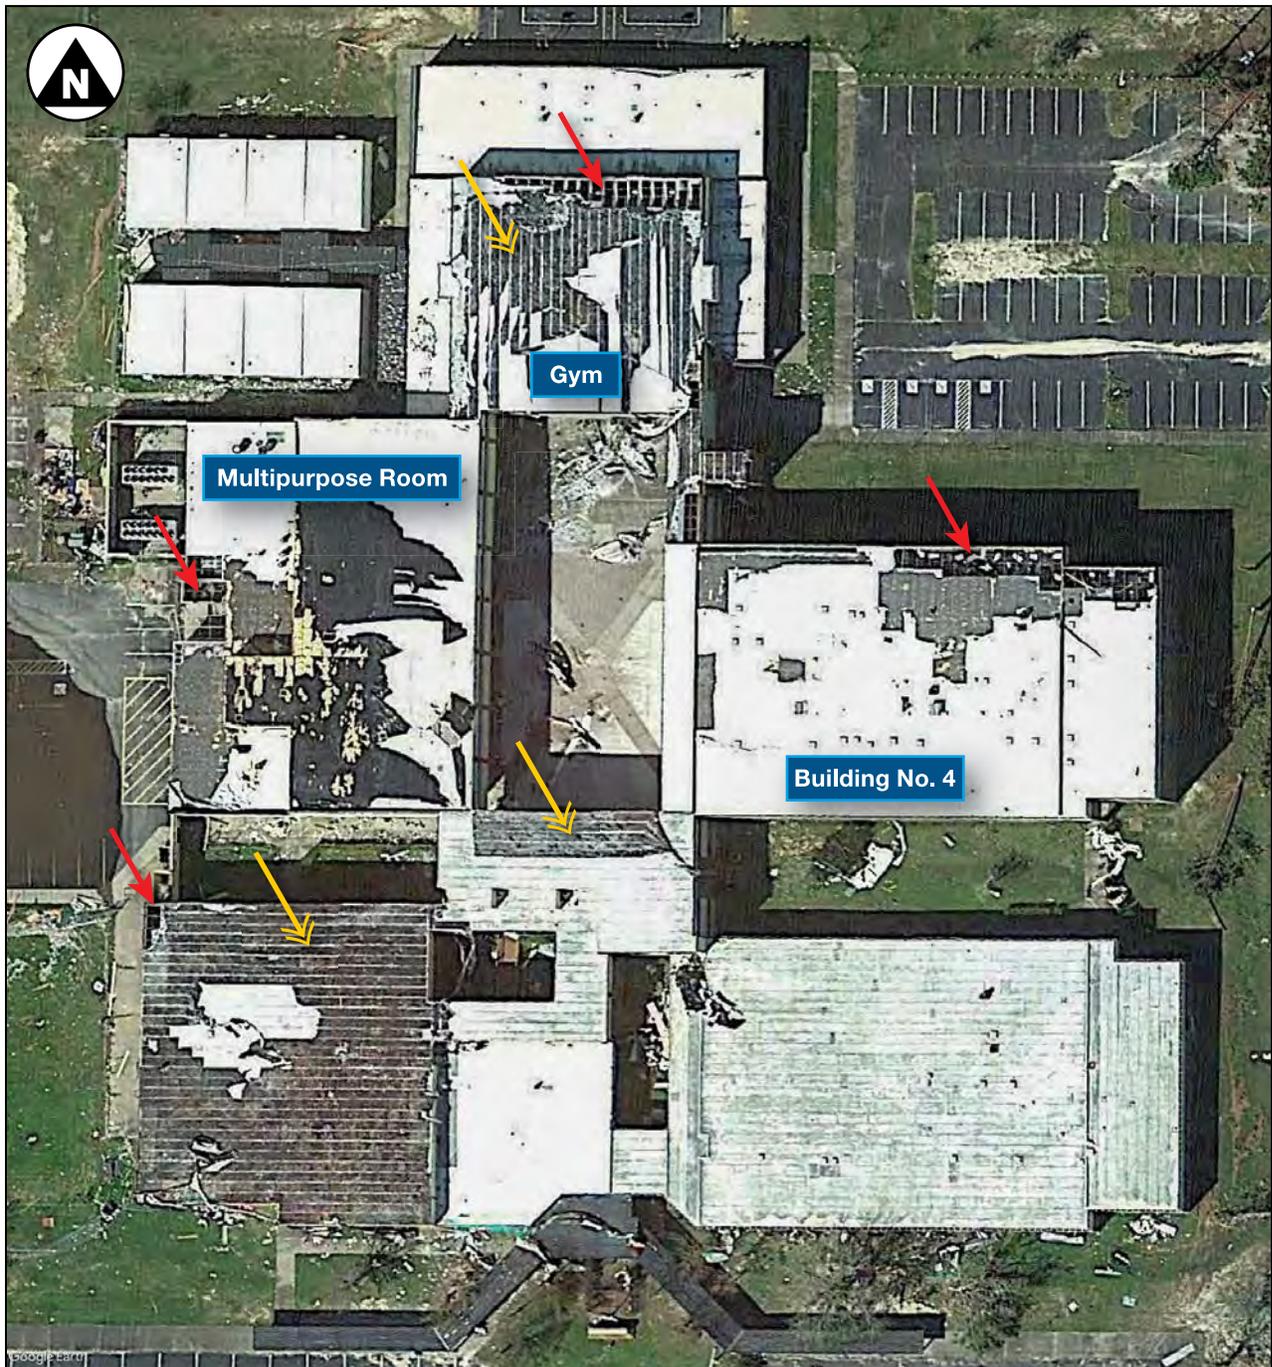
The red arrows indicate where steel deck blew off. The yellow double arrows indicate damaged mechanically attached single-ply membranes. The single-ply membranes at Building No. 4 and the multipurpose room were adhered. The first floor of Building No. 4 was the designated shelter area.

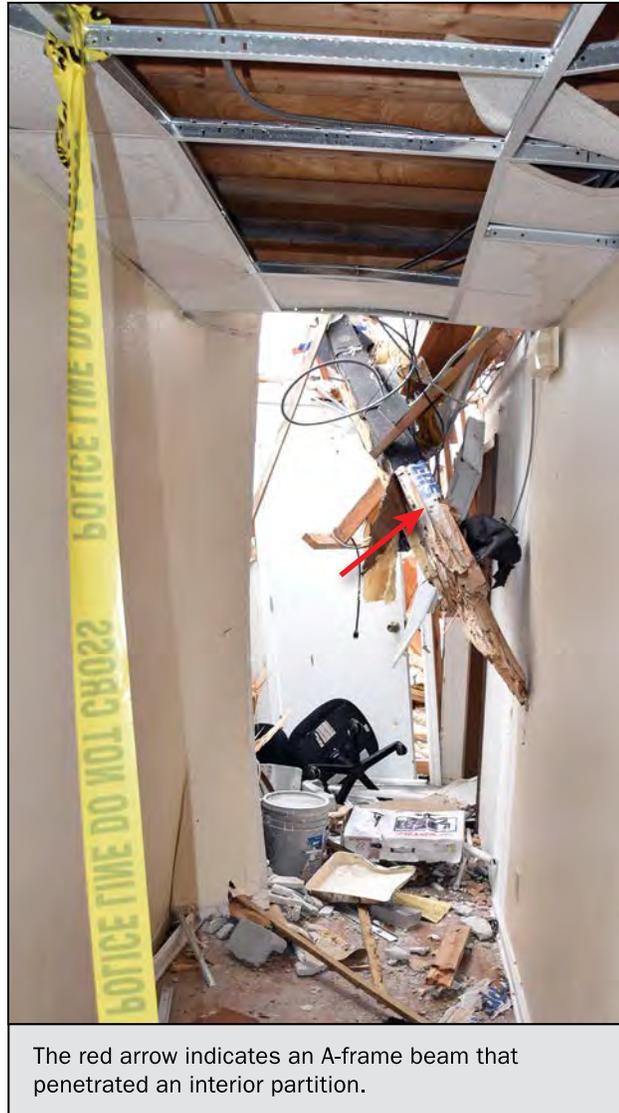
The red arrow indicates an A-frame beam that penetrated an interior partition.

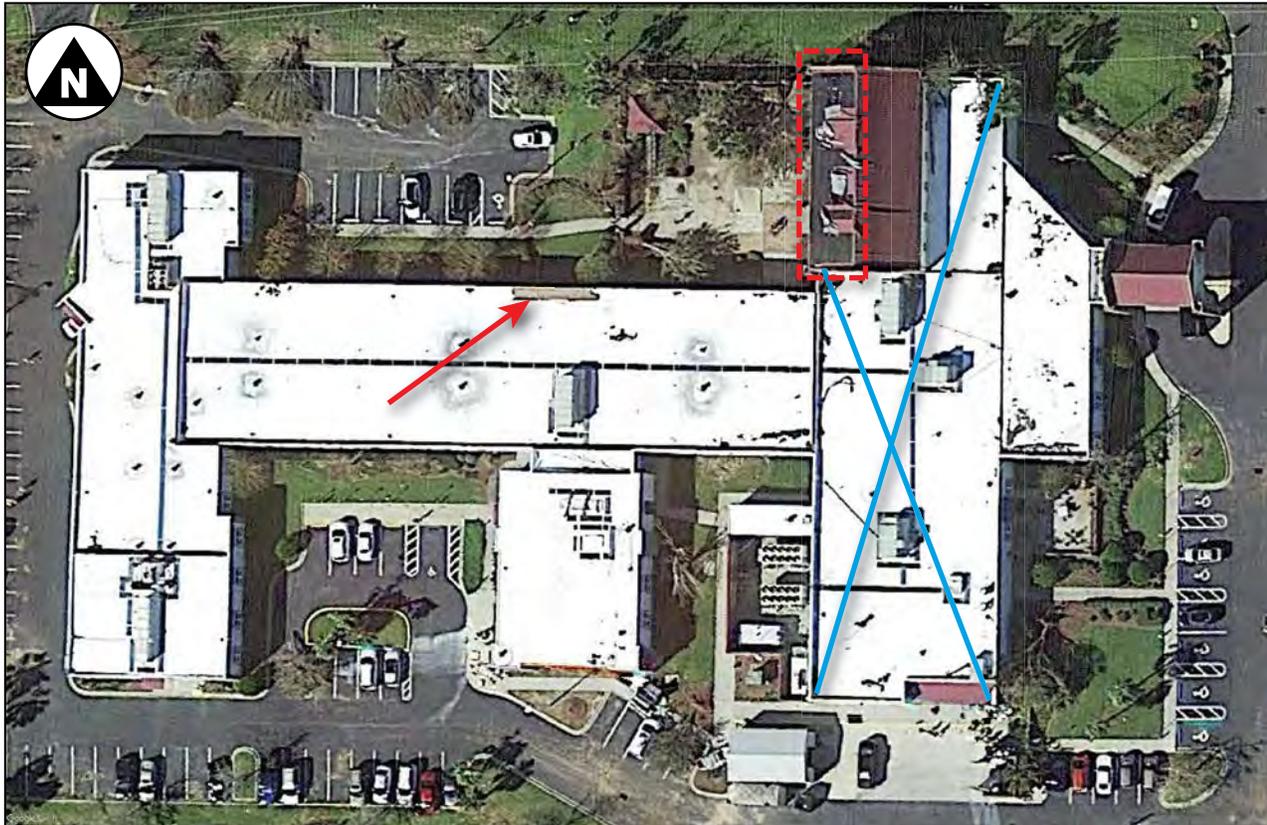
The red dashed rectangle indicates where the metal roof panels blew off the gym. Installation of a new roof system at the area shown by the blue X was underway at the time of the MAT visit. The red arrow indicates parapet base flashing damage shown in Figure 5-88.
