Mitigation Assessment Team Report

Hurricane Michael in Florida

Building Performance Observations,
Recommendations, and Technical Guidance

FEMA P-2077 / February 2020

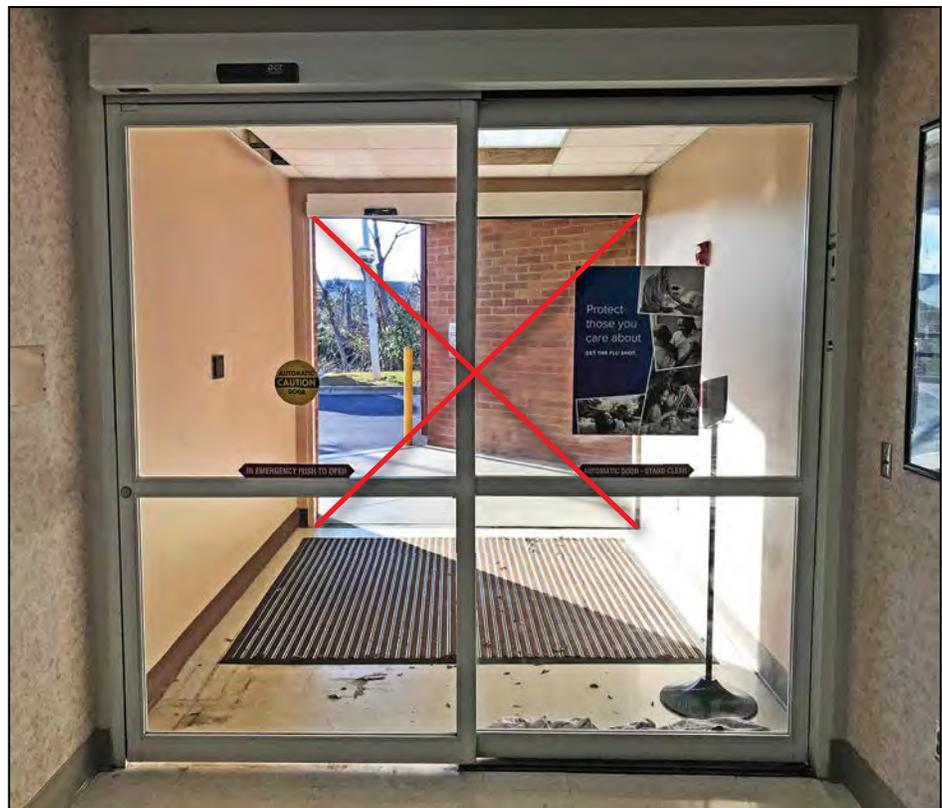
The exterior glass sliding automatic door and sidelite were blown away (red X). The interior door and sidelite remained in place and prevented free entry of wind and rain into the interior of the hospital. Although the interior walls of the lobby were exposed to increased air pressure after the door failure, they apparently were not over-stressed.
