Coastal Flood and Wind Event Summaries

COASTAL FLOOD AND WIND EVENT SUMMARIES

This resource supplements Chapter 2 of *Coastal Construction Manual*. It summarizes coastal flood and wind events that have affected the continental United States, Alaska, Hawaii, and U.S. Territories since the beginning of this century.

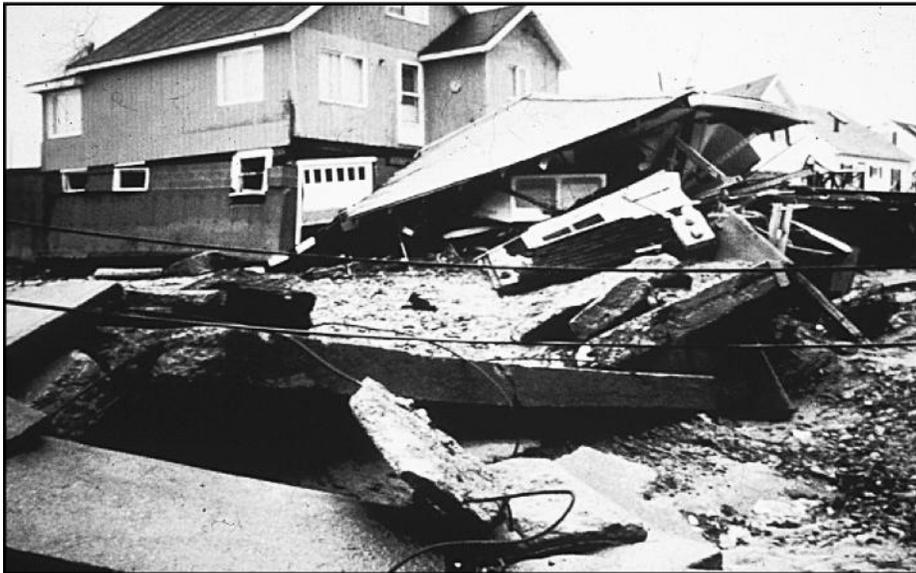
Buildings on continuous masonry block foundations (such as those permitted in Zone A) were commonly damaged or destroyed when exposed to flooding, wave action, erosion, and/or localized scour (see Figure 3).

Figure 3. October 1991 nor'easter damage to homes at Scituate, MA.

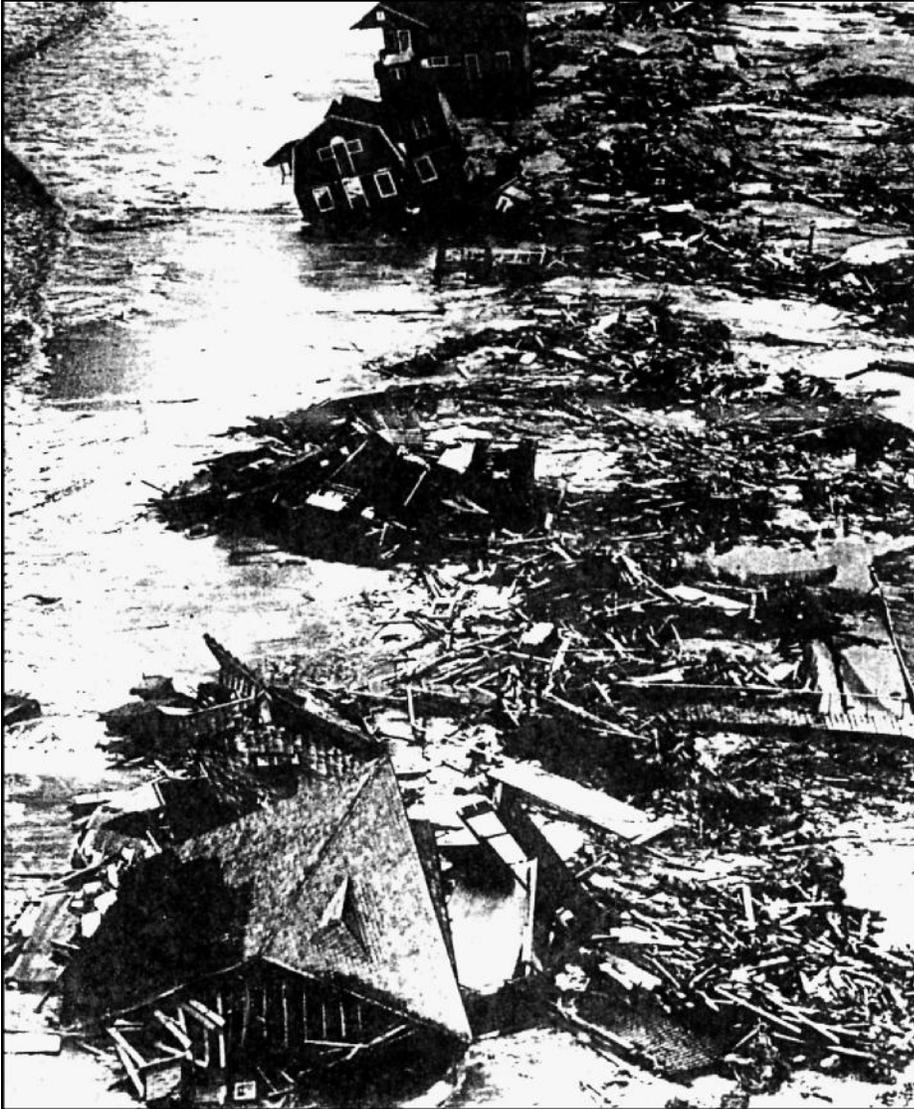
Figure 4. 1962 Mid-Atlantic storm. Extreme damage to homes along the beach at Point-o-Woods, Fire Island, NY.

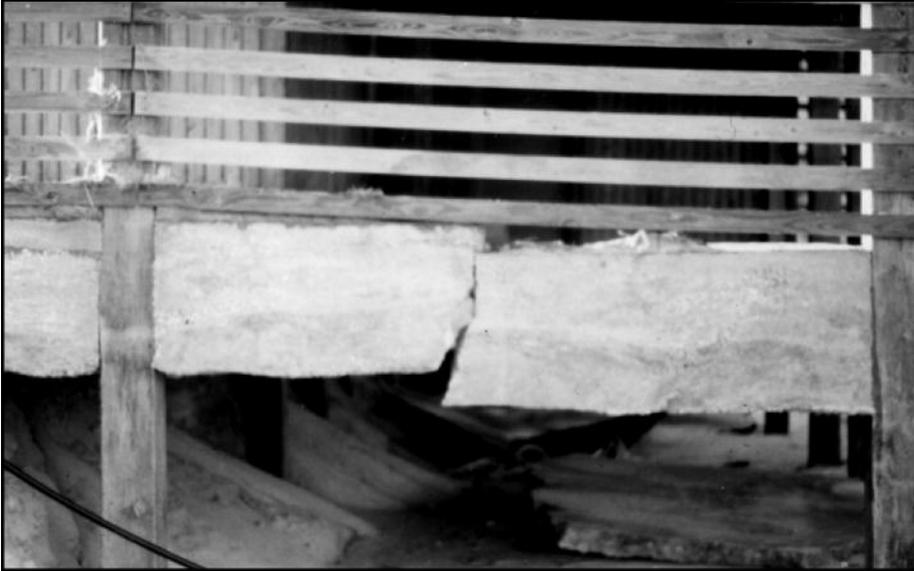
- Once undermined, plain concrete slabs, and grade beams cast monolithically with them, failed under their own weight or as a result of wave and debris loads (see Figure 5).
- Failure of the pile-to-beam connection was observed where a bolt head lacked a washer and pulled through the beam.

Figure 5. March 1989 nor'easter. This plain concrete perimeter grade beam cracked in several places.

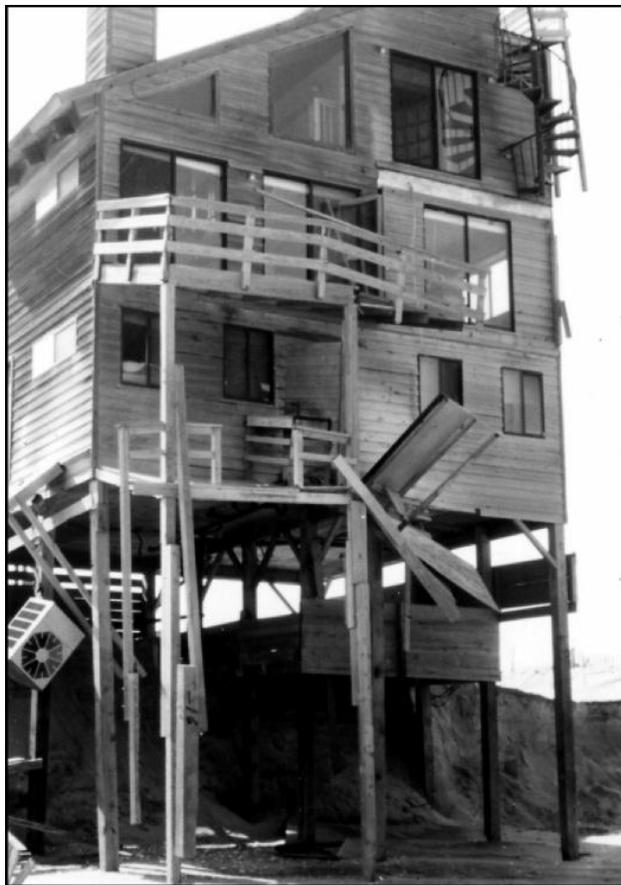
Figure 6. March 1989 nor'easter. Although this house seems only to have lost decks and a porch, the loss of supporting soil compromises its structural integrity.

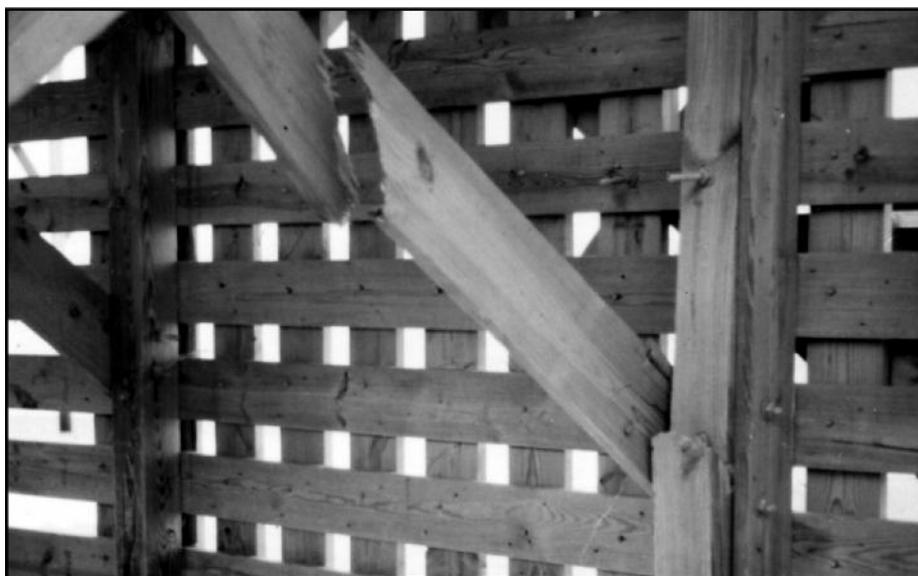
- Cracks in piles and deck posts, or failed connections to them, were in some cases attributed to cross-bracing oriented parallel to the shore or the attachment of closely spaced horizontal planks.
- Construction in areas subject to high rates of long-term erosion is problematic. Buildings become increasingly vulnerable to the effects of even minor storms (see Figure 6). This process eventually necessitates their removal or results in their destruction.
- Many of the buildings affected during the April 1988 storm were further damaged during the March 1989 storm, either because of additional erosion and undermining or debris damage to cross-bracing and foundation piles (see Figure 7 and Figure 8).

Figure 7. March 1989 nor'easter. Failure of cross-bracing.

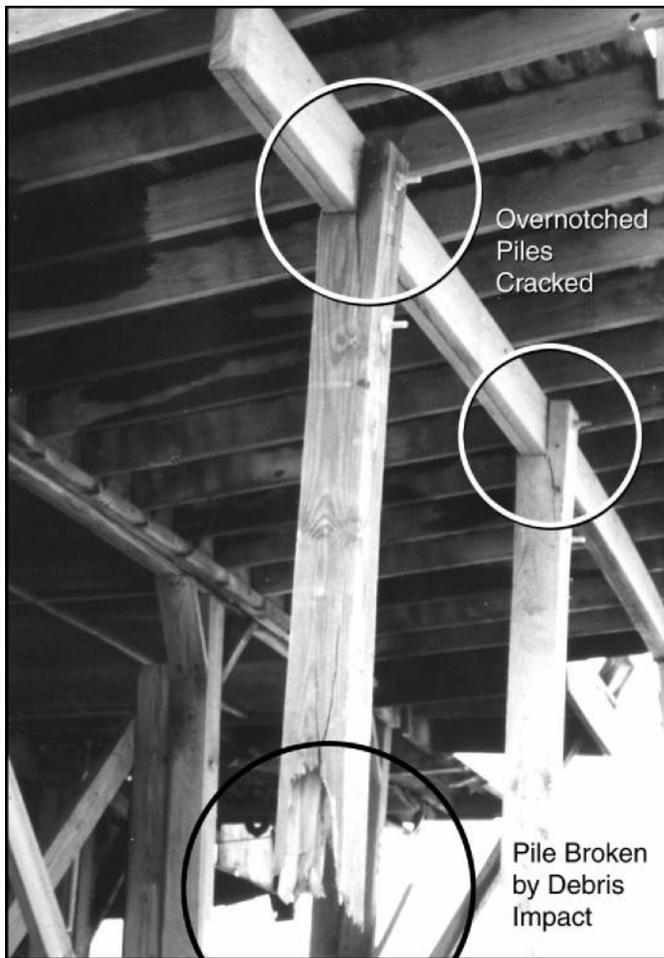
Figure 8. March 1989 nor'easter. Deck pile broken by debris impact. Flood forces also caused piles to crack at overnotched connections to floor beam.

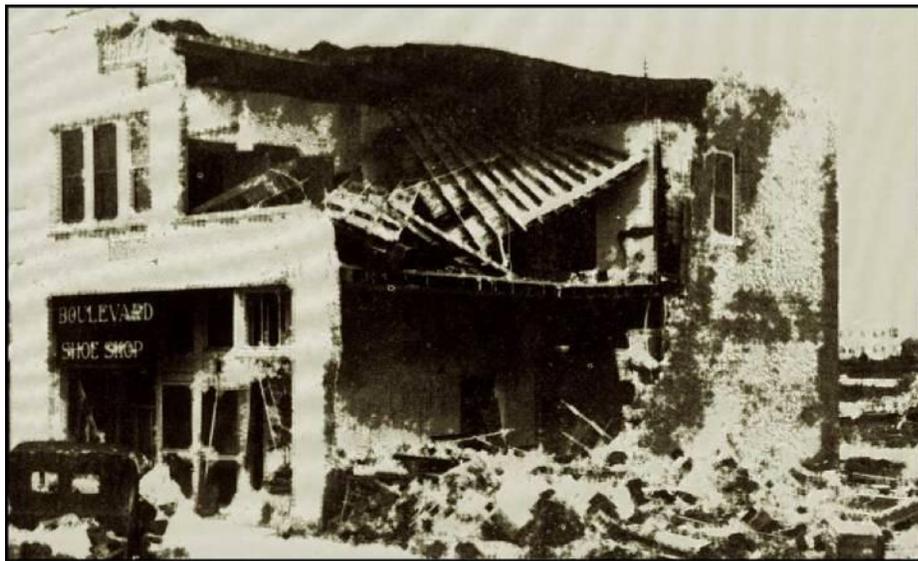
Figure 10. Building damage from 1926 hurricane, Miami, FL.

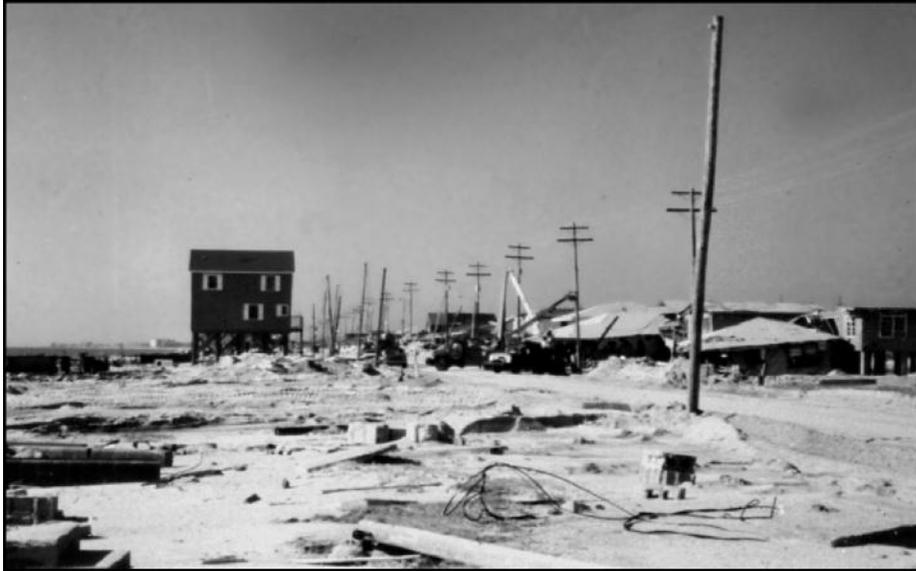
- Post-FIRM buildings that were both properly constructed and elevated survived the storm (see Figure 11). These buildings stood in sharp contrast to pre-FIRM buildings and to post-FIRM buildings that were poorly designed or constructed.

Figure 11. Hurricane Hugo (1989), Garden City Beach, SC. House on pilings survived while others did not.

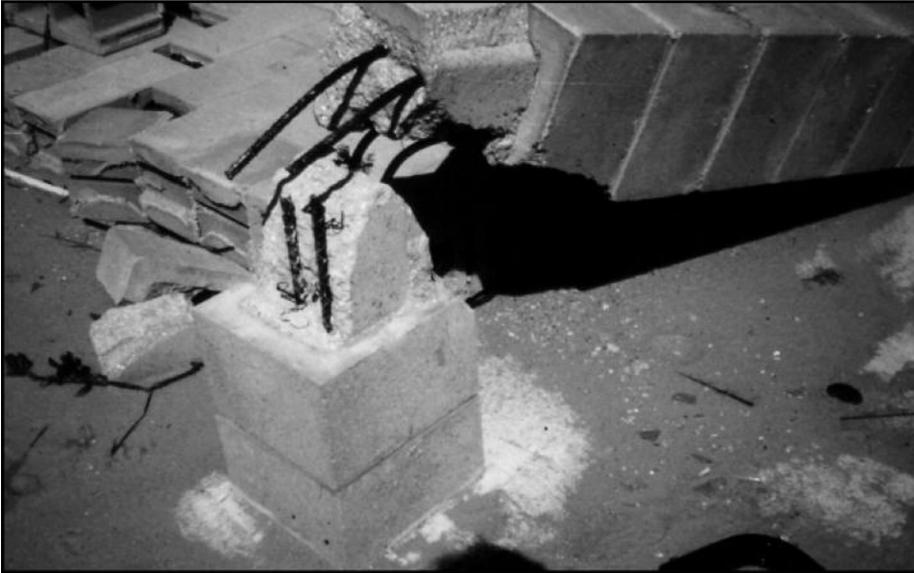
- Many buildings elevated on masonry or reinforced concrete columns supported by shallow footings failed. In some instances, the columns were undermined; in others, the columns failed as a result of poor construction (see Figure 12).
- Several pile-supported buildings not elevated entirely above the wave crest showed damage or destruction of floor beams, floor joists, floors, and exterior walls.
- Some of the most severely damaged buildings were in the second, third, and fourth rows back from the shoreline. These areas were mapped as Zone A on the FIRMs for the affected communities. Consideration should be given to more stringent design standards for Coastal A Zones.
- The storm exposed many deficiencies in residential roofing practices: improper flashing, lack of weather-resistant ridge vents, improper shingle attachment, and failure to replace aging roofing materials.

Figure 12. Hurricane Hugo (1989), South Carolina. Failure of reinforced masonry column.

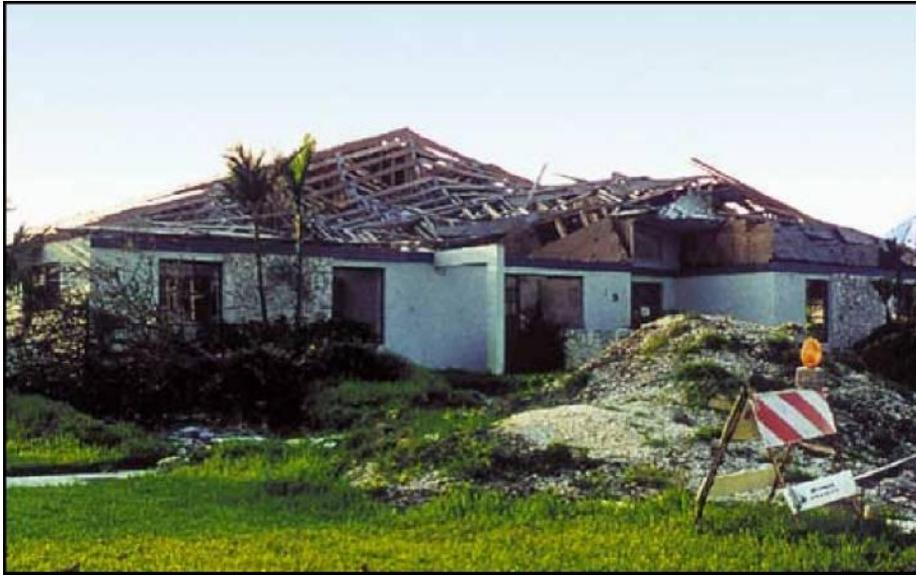
Figure 13. Hurricane Andrew (1992). Roof failure due to inadequate bracing.

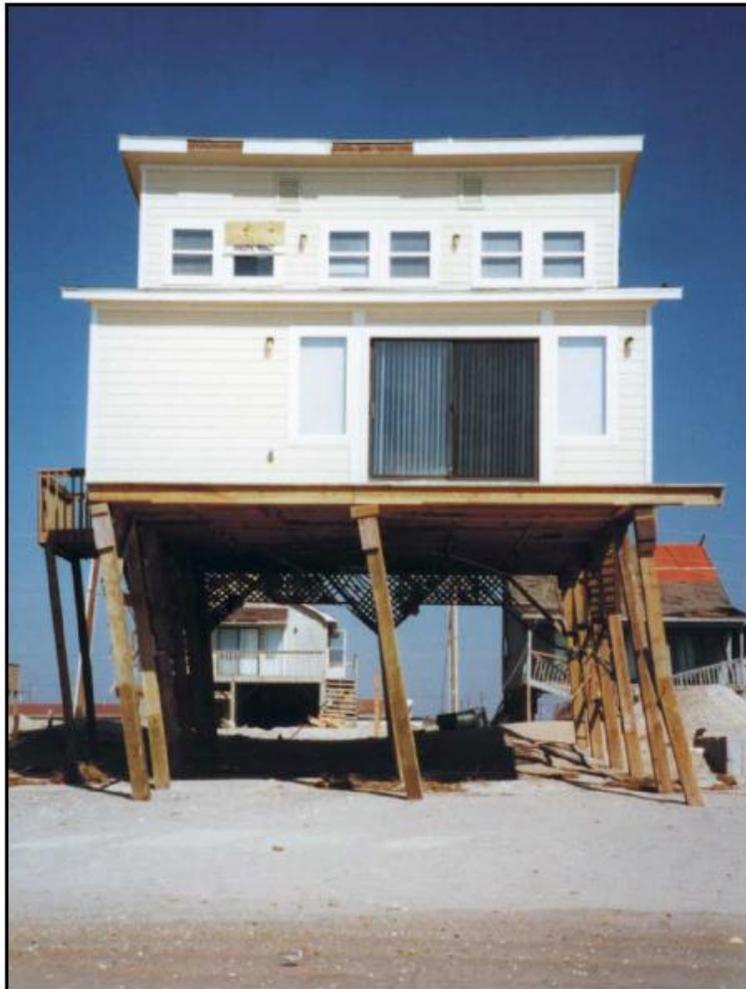
- A significant reduction in building losses was observed in similarly sized oceanfront buildings constructed after the North Carolina Building Code was amended in 1986 to require a minimum embedment to –5.0 feet National Geodetic Vertical Datum (NGVD) or 16 feet below the original ground elevation, whichever is shallower, for pilings near the ocean. A study of Topsail Island found that 98 percent of post-1986 oceanfront houses (200 of 205) remained after the hurricane. Ninety-two percent of the total displayed no significant damage to the integrity of the piling foundation. However, 5 percent (11) were found to have leaning foundations (see Figure 16). A non-destructive test used to measure piling length in a partial sample of the leaning buildings revealed that none of the leaning pilings tested met the required piling embedment standard. Many were much shorter. However, given the uncertainty of predicting future erosion, the BPAT recommended that consideration be given to a piling embedment standard of –10.0 feet NGVD.

Figure 14: Hurricane Fran (1996). Many oceanfront houses built before the enactment of the 1986 North Carolina State Code were found to be leaning or destroyed.

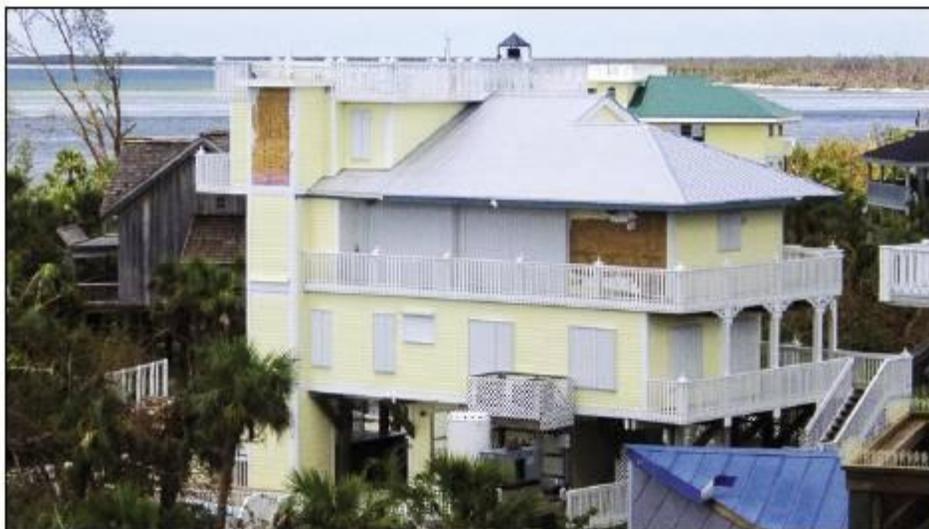
Figure 15. No structural damage was observed to homes built to the 2001 FBC (North Captiva Island, FL, 2004).

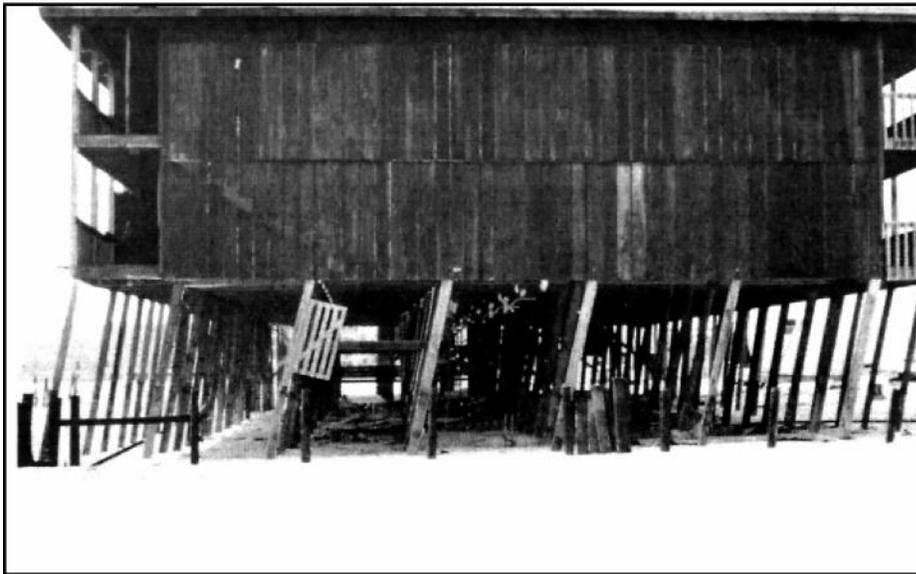
Figure 17. Hurricane Frederic (1979). Effects of wind and water forces on unbraced pile foundation.

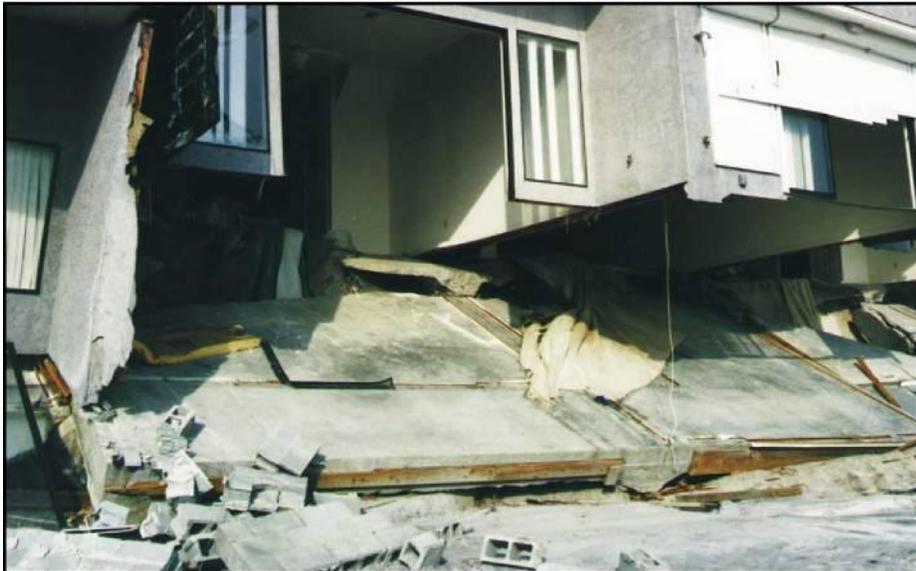
Figure 18. Hurricane Opal (1995), Bay County, Florida. Building damage from erosion and undermining.

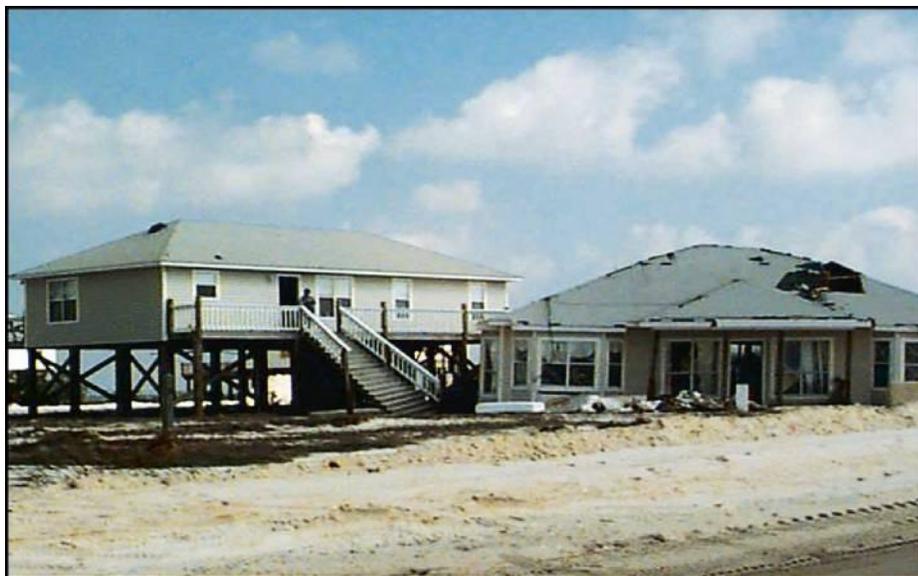
Figure 19. Hurricane Georges (1998), Dauphin Island, AL. As a result of erosion, scour, and inadequate pile embedment, the house on the right was washed off its foundation and into the house on the left.

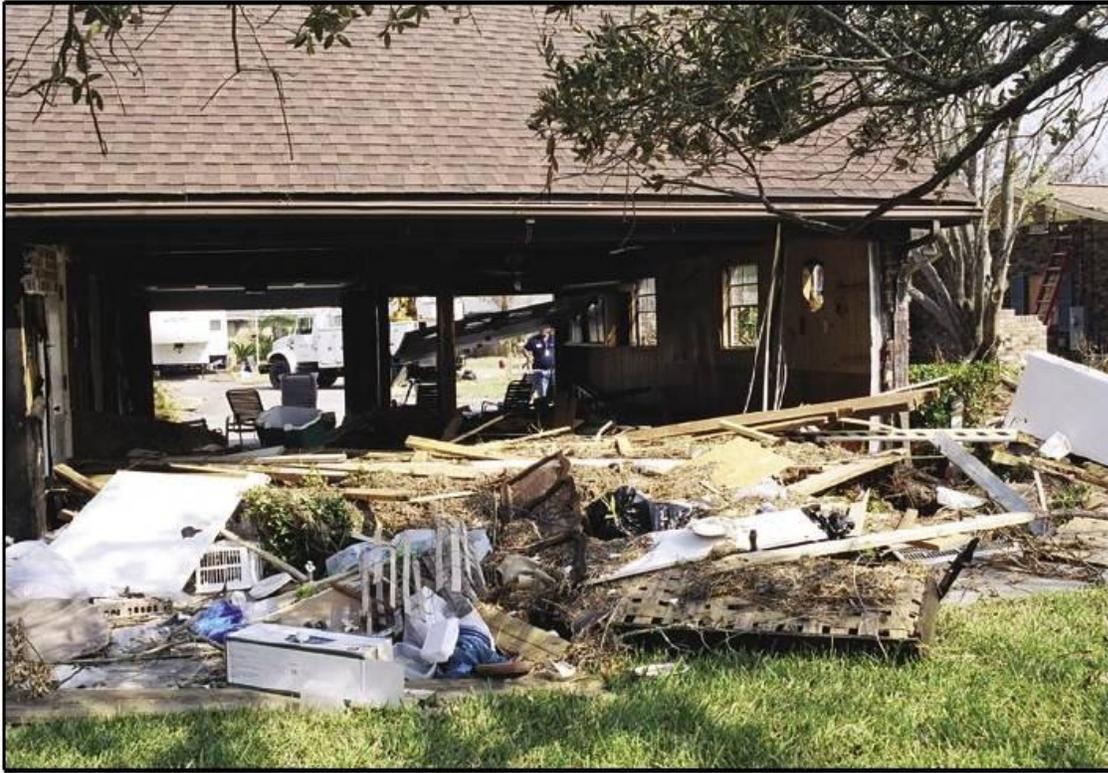
Figure 20. This house, located in Zone AE, experienced Zone V surge and wave conditions (Santa Rosa Sound, FL, 2004).

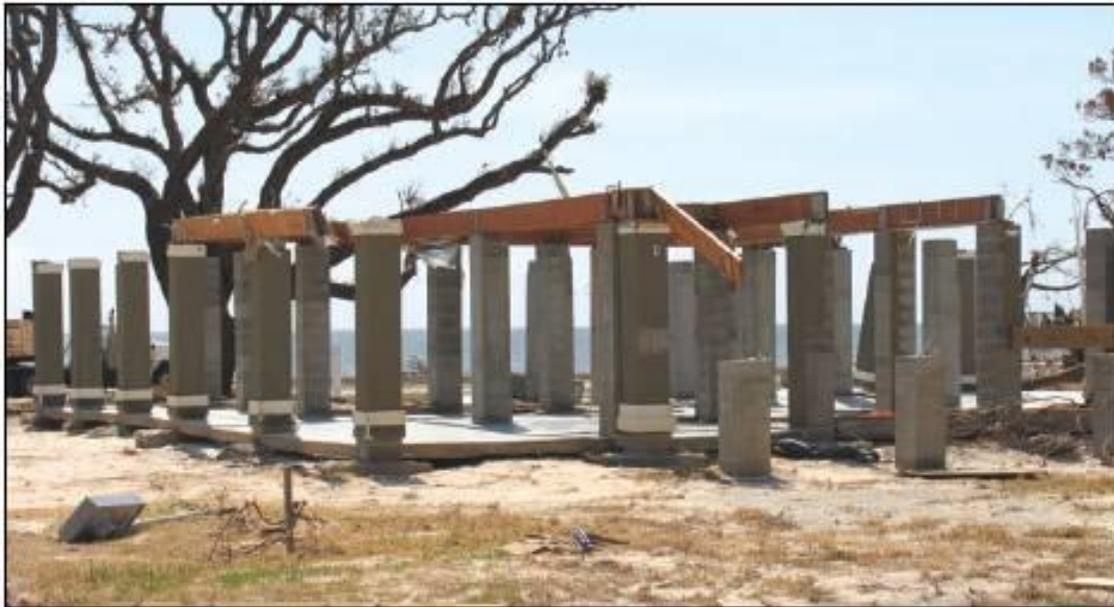
Figure 21. This elevated house on a masonry pier foundation was lost, probably due to waves and storm surge overtopping the foundation (Long Beach, MS, 2005).

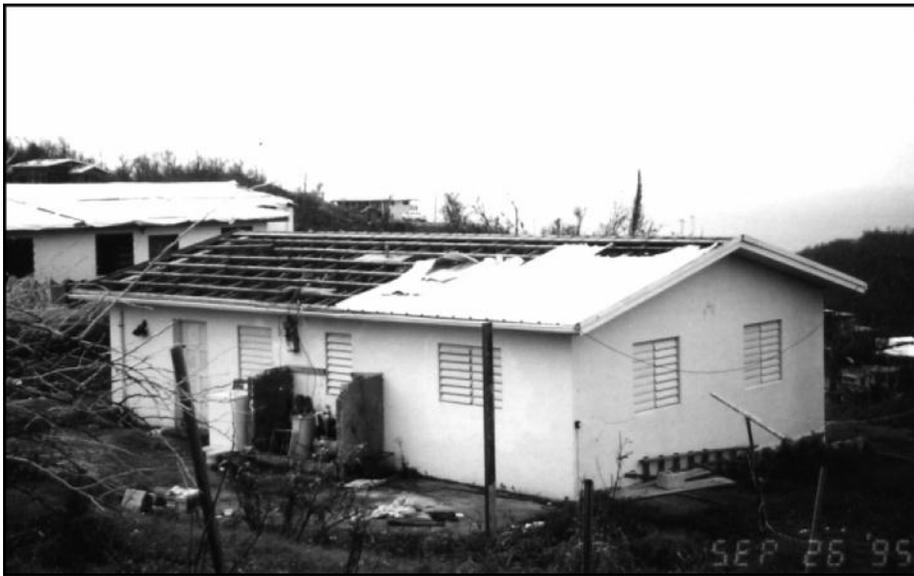
Figure 22. Hurricane Marilyn (1995). This house lost most of the metal roof covering.

Neighbors stated that the house also lost its roof covering during Hurricane Hugo, in 1989.

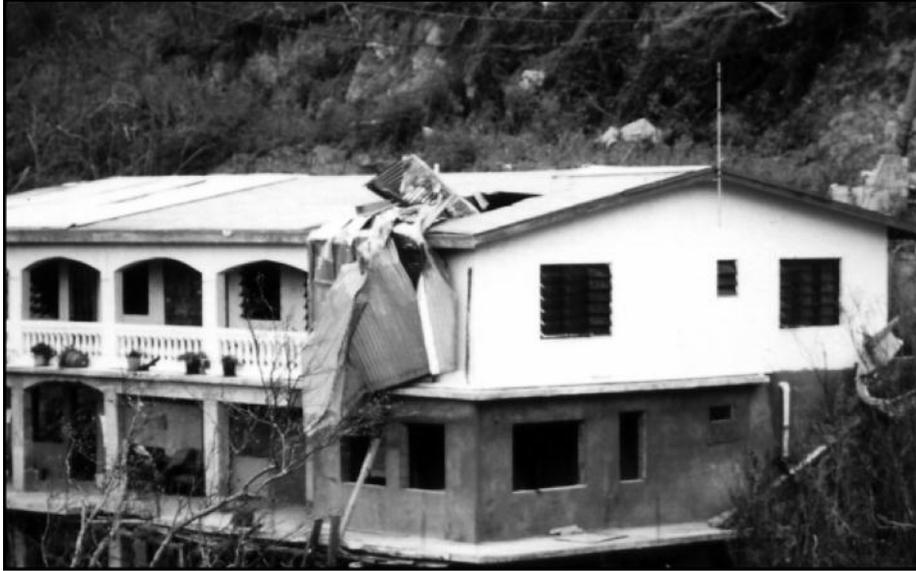
Figure 23. Hurricane Marilyn (1995). The roof of this house was penetrated by a large wind-driven missile (metal roof covering).

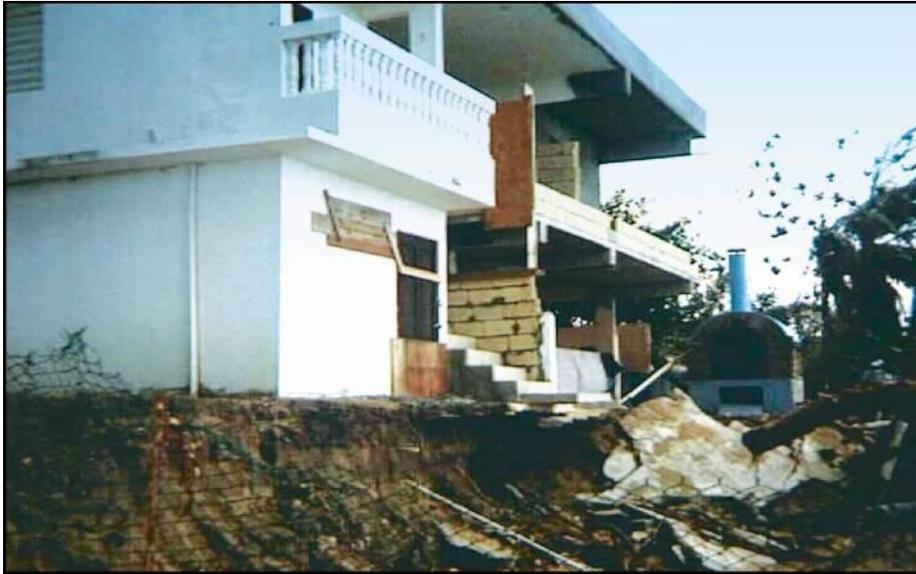
Figure 24. Hurricane Georges (1998). Coastal building in Puerto Rico damaged by storm surge and waves.

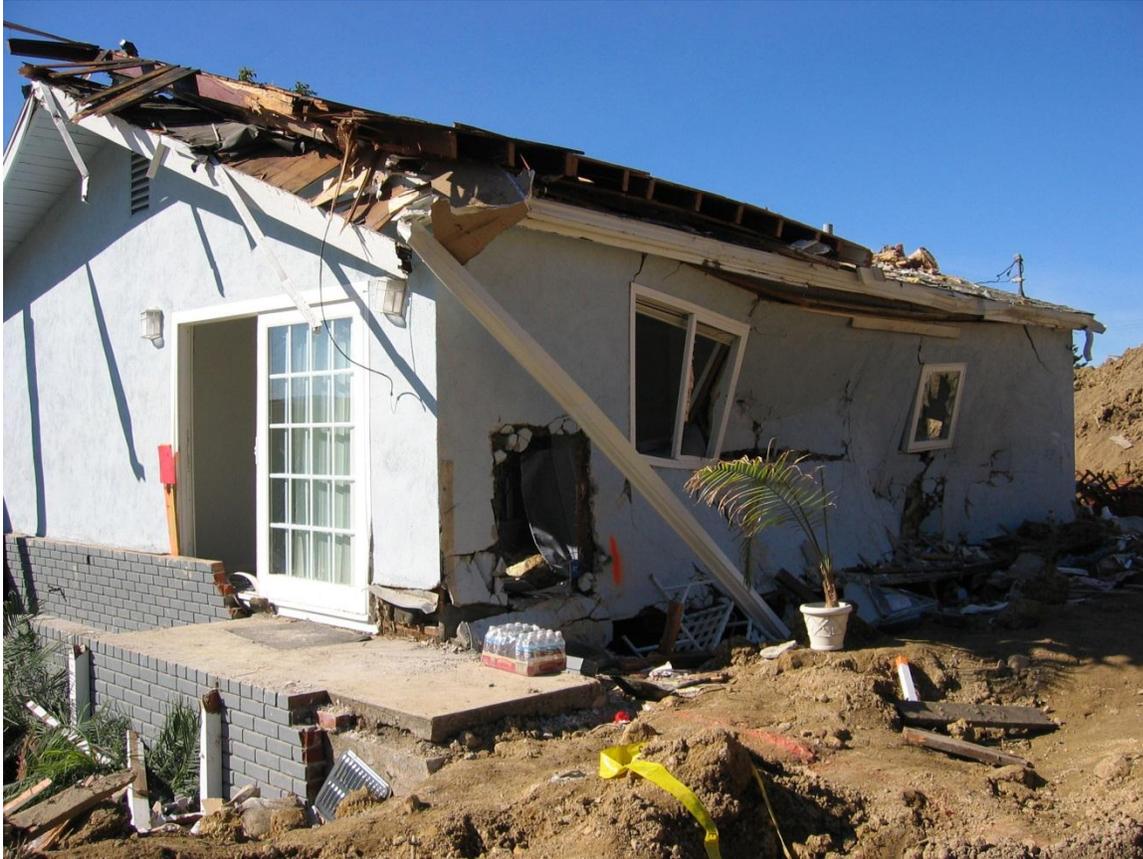
Figure 28. Damaged building braced for structural support in La Conchita, CA, after January 2005 storm event.

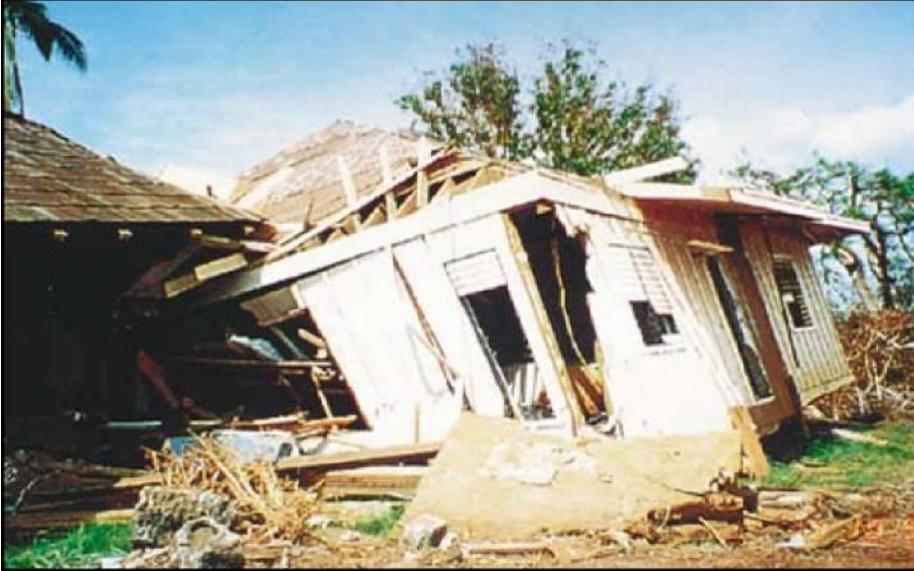
Figure 29. Hurricane Iniki (1992). Non-elevated house at Poipu Beach that floated off its foundation and was pinned against another house and destroyed by waves.

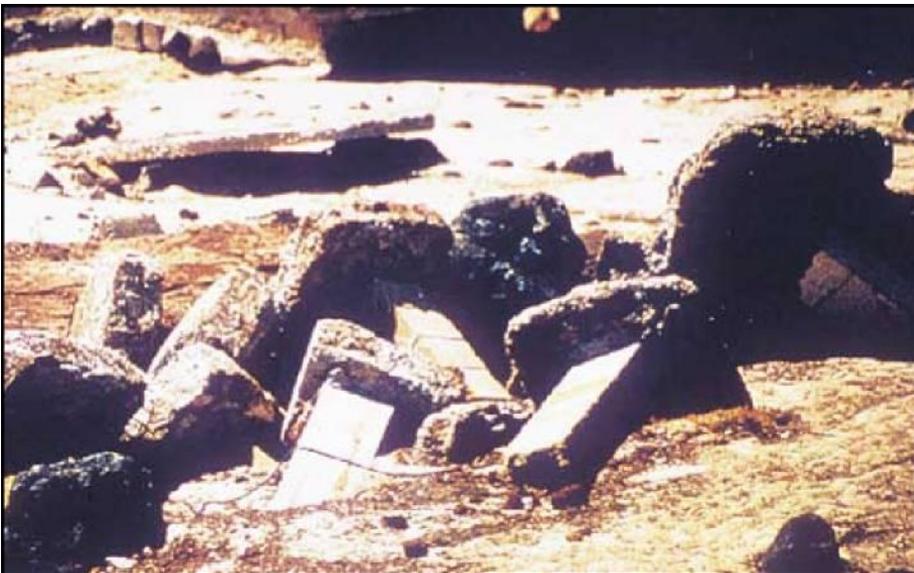
Figure 30. Hurricane Iniki (1992). Undermining of shallow footings supporting columns at Poipu Beach due to lack of sufficient embedment below erosion level.

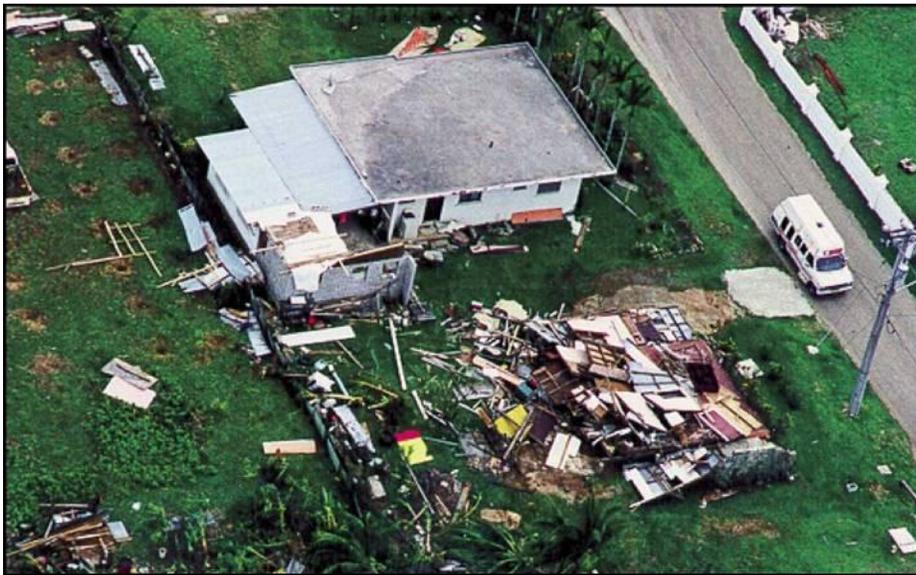
Figure 31. Typhoon Paka (1997). Although damaged by the storm, the concrete house in the upper part of the photograph survived, while the wood-frame house next to it was destroyed.
