FEMA 339 / March 1999

Building Performance Assessment Report

Hurricane Georges In Puerto Rico

**Observations,
Recommendations,
and Technical Guidance**

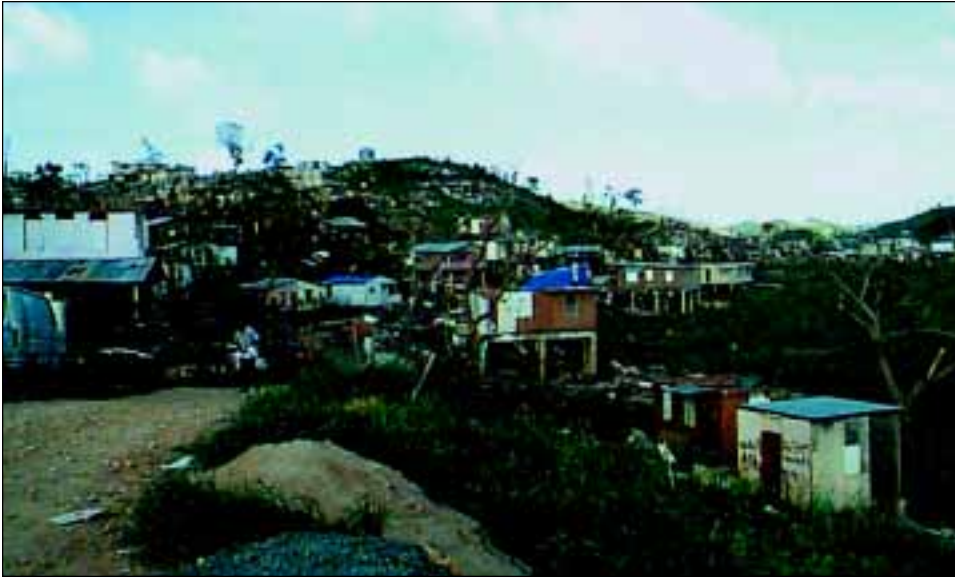
FIGURE 3-1 The abrupt change in topography in this community outside Loiza caused a speedup in the wind that flows over and around the buildings located on the hill beyond. The wind load provisions of Planning Regulation 7 did not account for wind speedup caused by abrupt changes in topography, and therefore underestimated wind loads on buildings situated on hills, mountains, or escarpments.

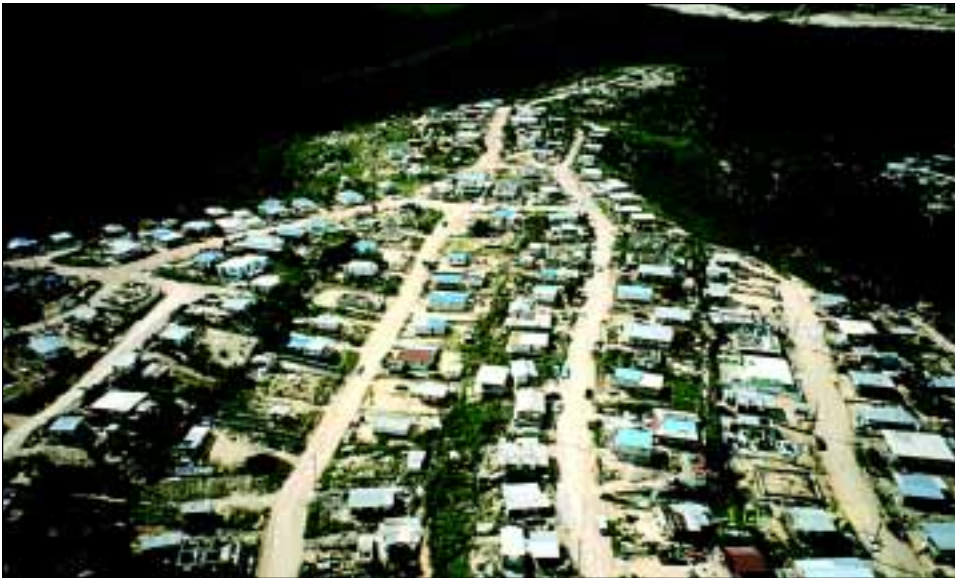
FIGURE 3-2 Wind damage from Hurricane Georges to residential buildings in Puerto Rico. Blue FEMA tarps have been placed on many of the roofs that sustained damage.

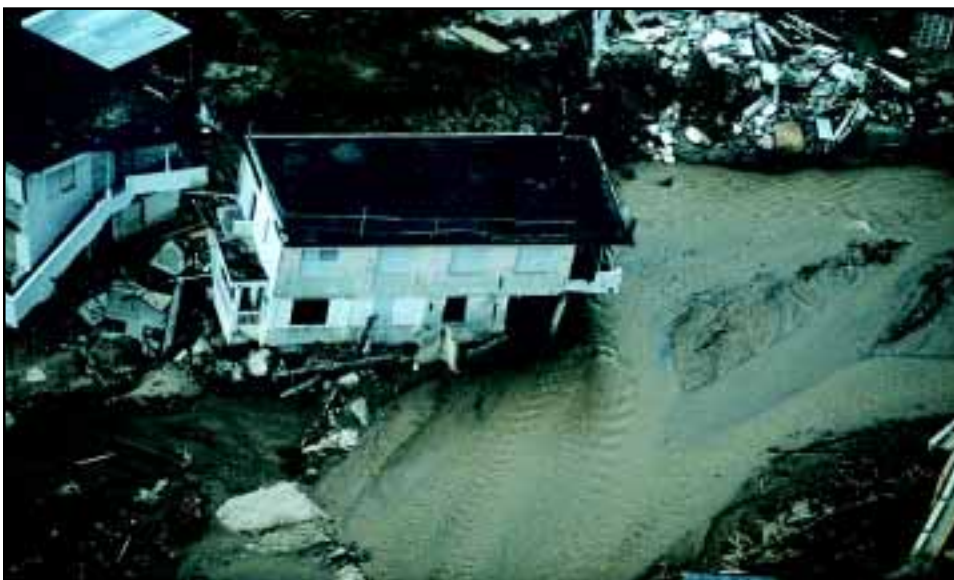
FIGURE 3-6 Floodwaters eroded soil and undermined the foundation system of this building.

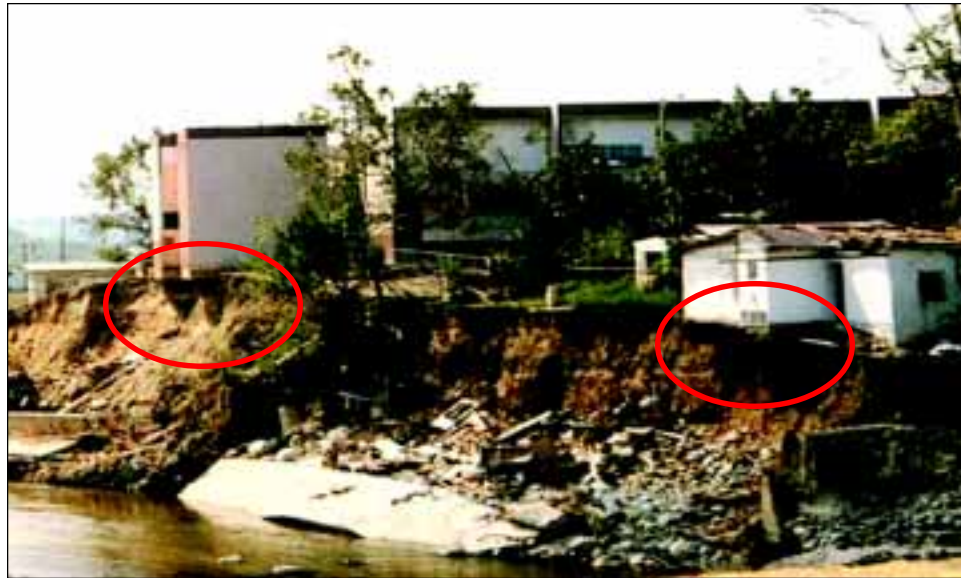
FIGURE 3-7 Riverbank erosion resulted in the undermining of the building foundations of a school (pink building) and house (white building) in Jayuya.

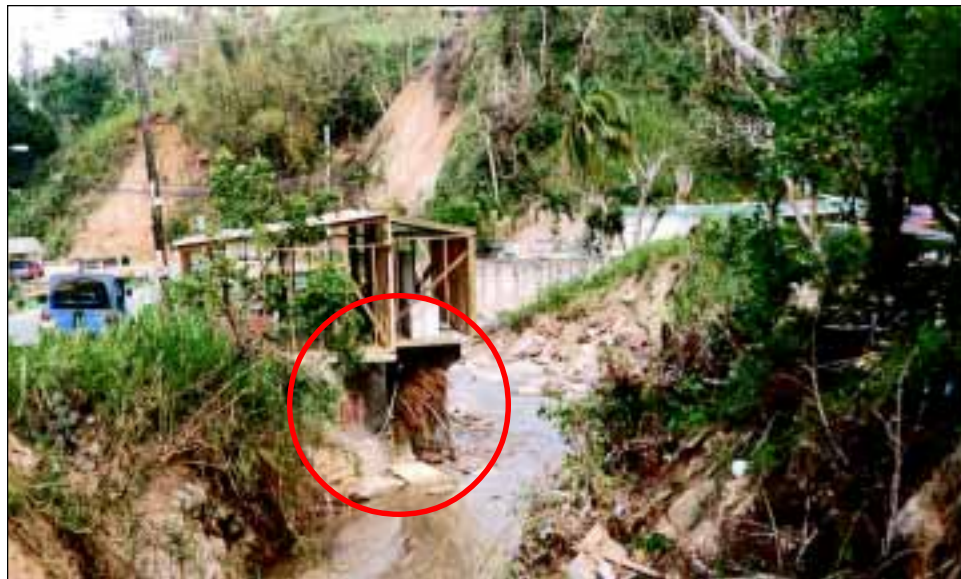
FIGURE 3-8 Typical construction adjacent to and over the river. Note the debris trapped under the concrete foundation and between the framing.

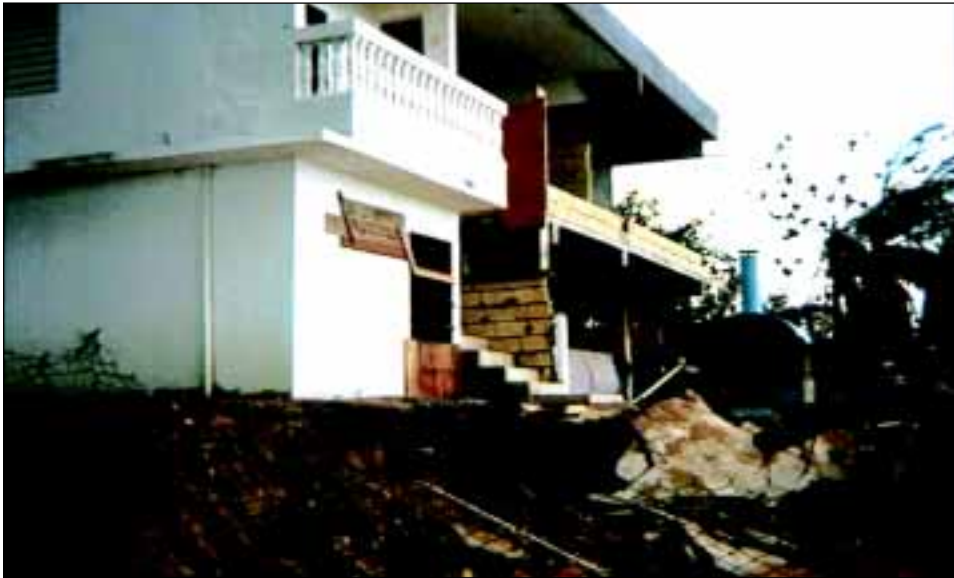
FIGURE 3-9 Structure along the coast damaged by storm surge and wave action.

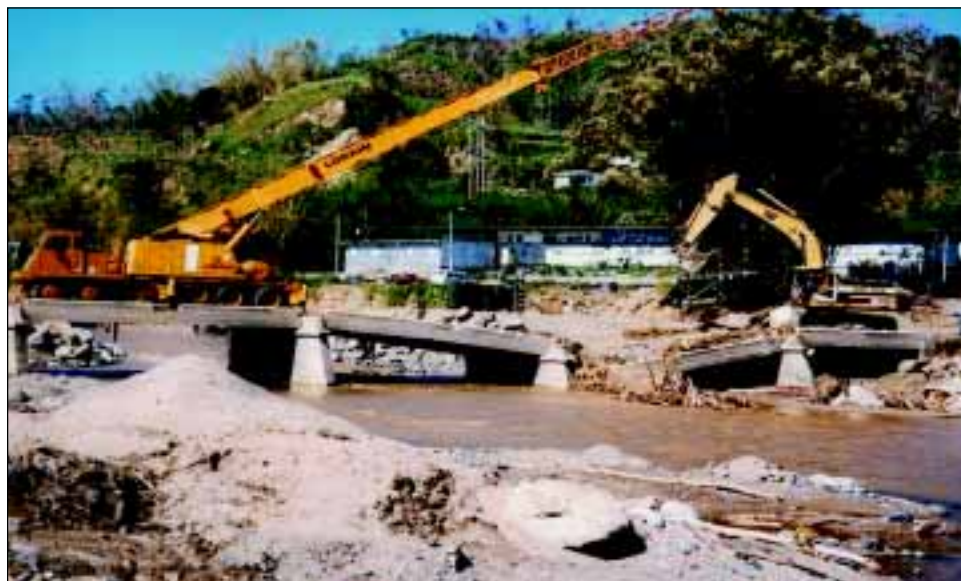
FIGURE 3-12 This bridge outside Adjuntas collapsed due to insufficient design to resist the effects of floodwaters.

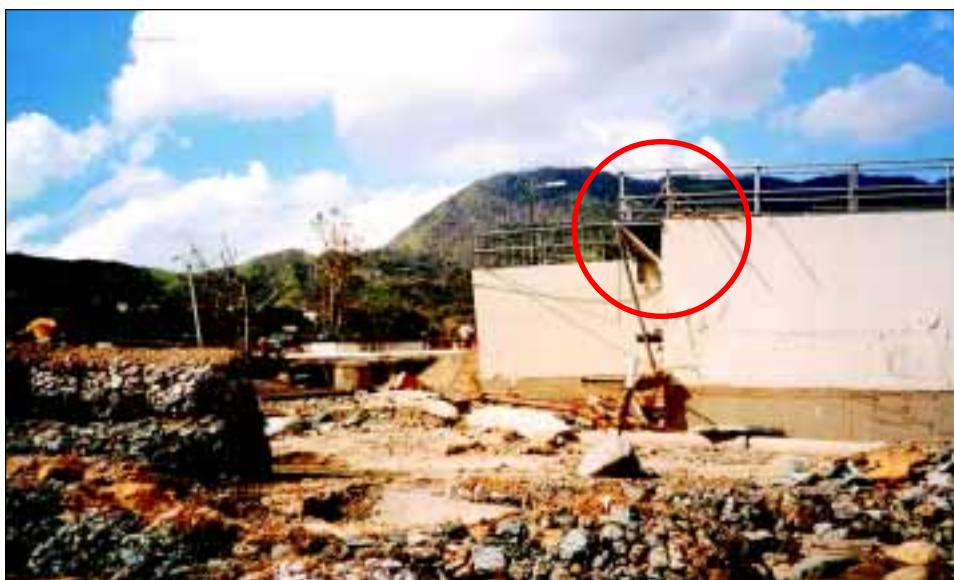
FIGURE 3-13 Severely damaged water treatment facility located in the floodplain in Jayuya; floodwaters overtopped the concrete wall.

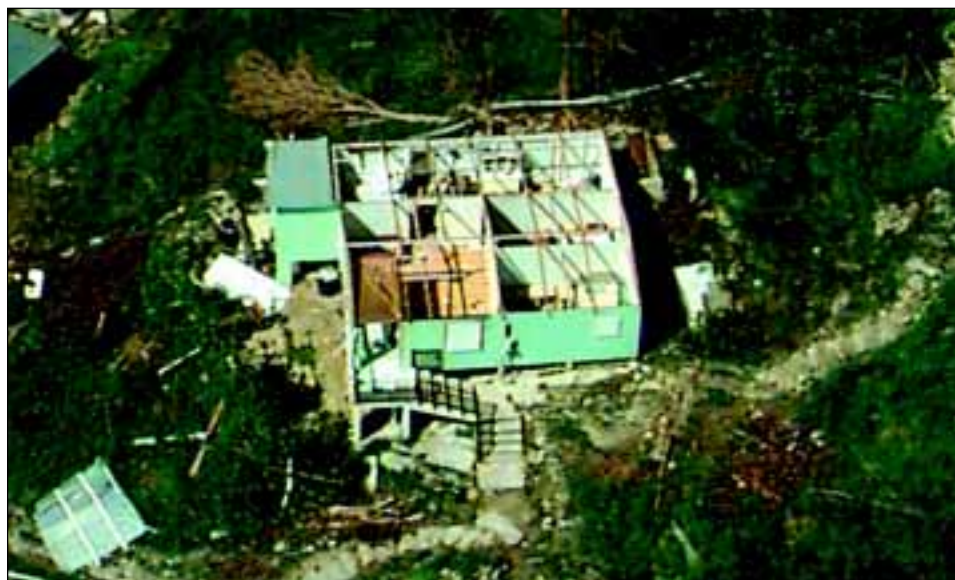
FIGURE 3-20 Aerial view of a residential concrete/masonry structure with a wood-frame roof structure; only the roof rafters remain. The wood nailers and metal panels were blown off.

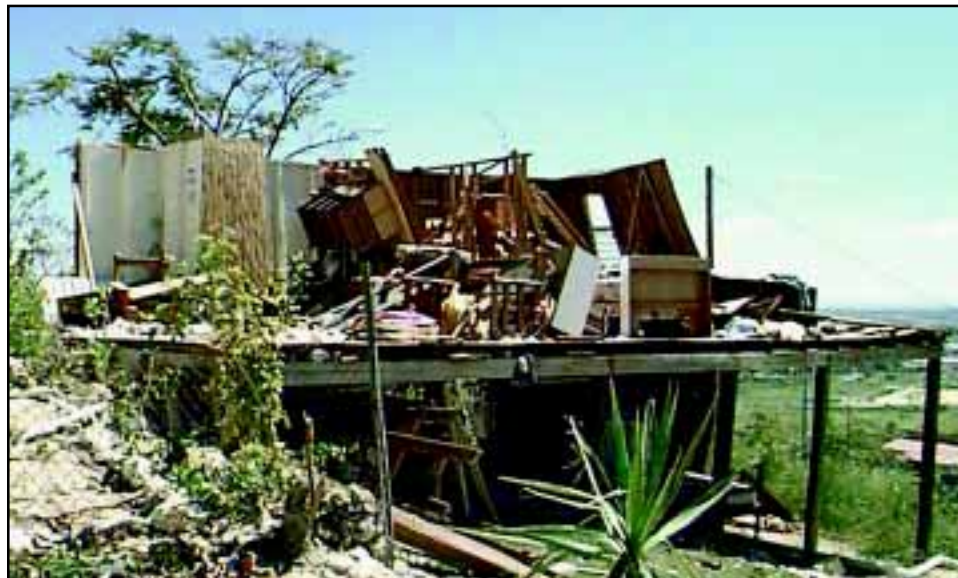
FIGURE 3-23 A residential wood structure located on the hilltops west of Ponce destroyed by wind. The roof system has been removed and the wall system partially collapsed.

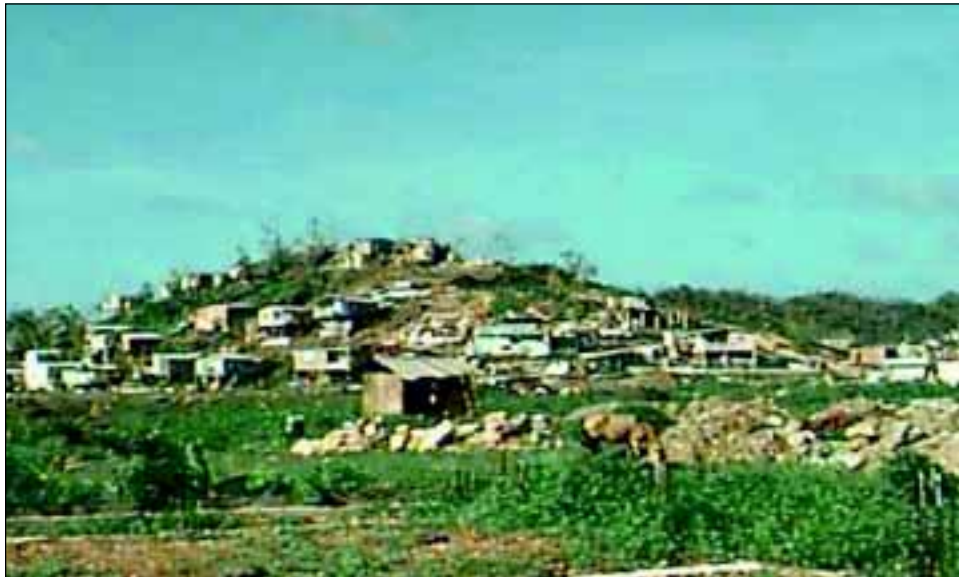
FIGURE 4-3 A residential community constructed of wood-frame structures only. This community located to the north of Canóvanas, experienced significant structural damage and failure to almost all of its buildings. The eye of the hurricane also passed to the south of this community, which is located approximately the same distance from the path of the hurricane as the community in Figure 4-2.

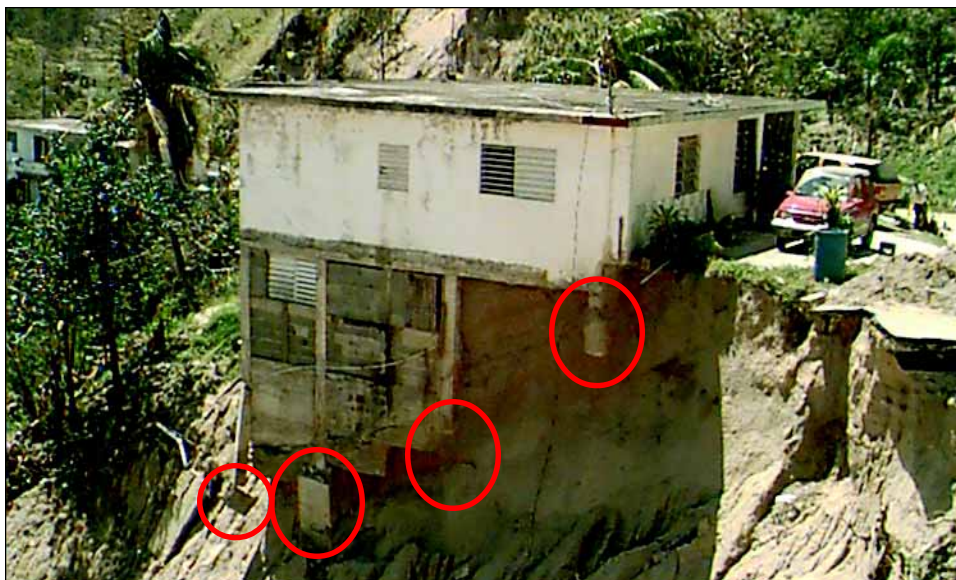
FIGURE 4-4 Concrete residential structure with foundation damage caused by a landslide. Note unstable footings (circled).

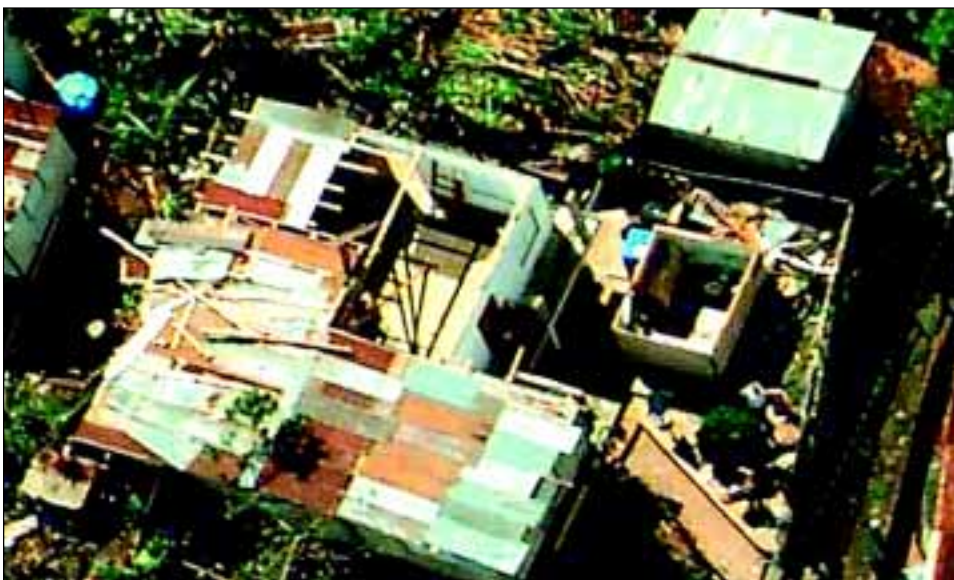
FIGURE 4-7 Typical roof system failure between wooden roof system and concrete or masonry wall system.

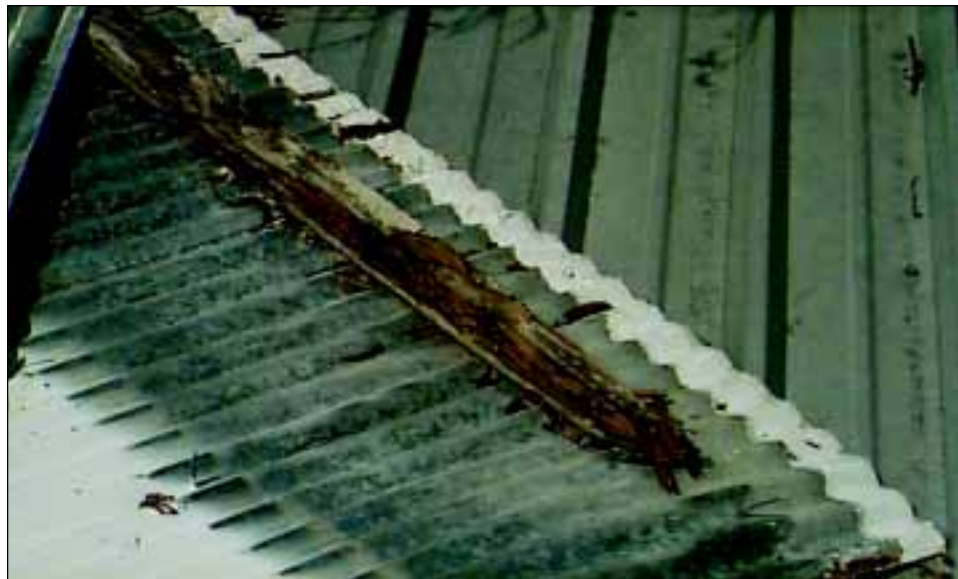
FIGURE 4-8 Termite-damaged wood purlin attached to metal roof panel. The entire roof system of this building failed and is shown in Figure 4-9.

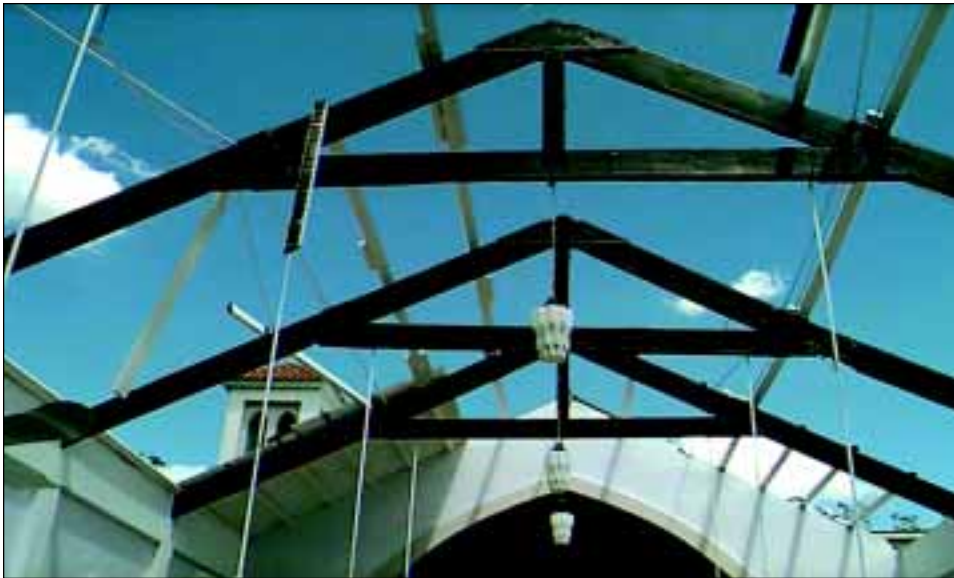
FIGURE 4-9 Masonry wall church that lost roof purlins and its corrugated metal roof. Nails were the only connections used to resist wind loads. The gable ends of this church were unsupported except for purlins resting in the masonry.

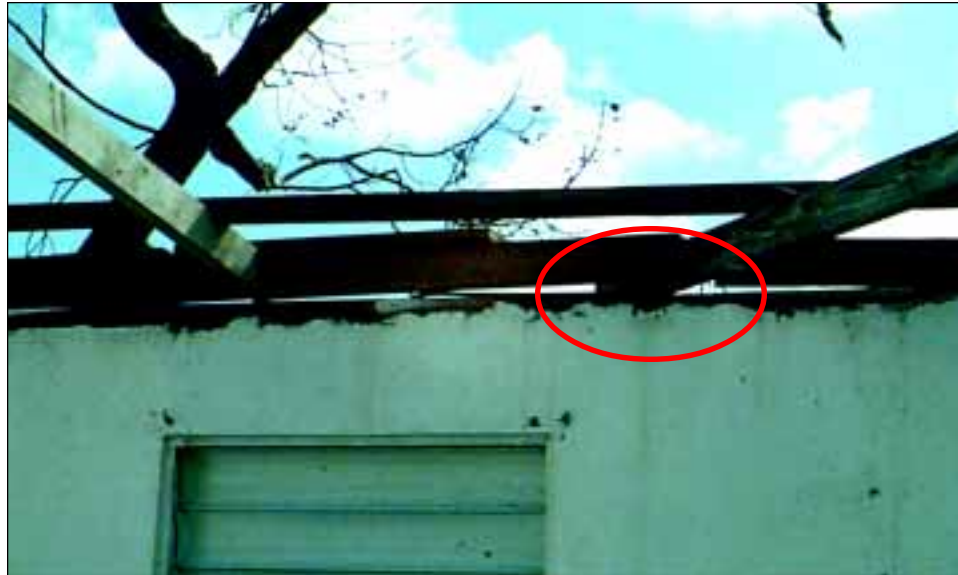
FIGURE 4-11 Typical nail withdrawal failure in a wood-frame structure supported by a masonry wall with little uplift capacity at the connection.

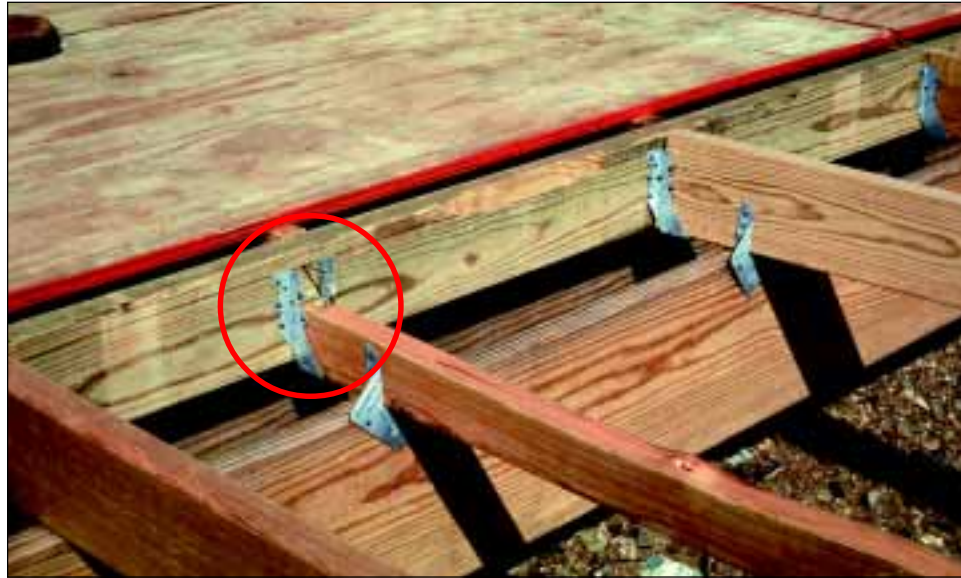
FIGURE 4-13 Example of the failure of wood member in the floor joist hanger due to the use of improper nails. The hurricane clip was used to secure the floor joist to the support beam. This house was located on the island of Culebra.

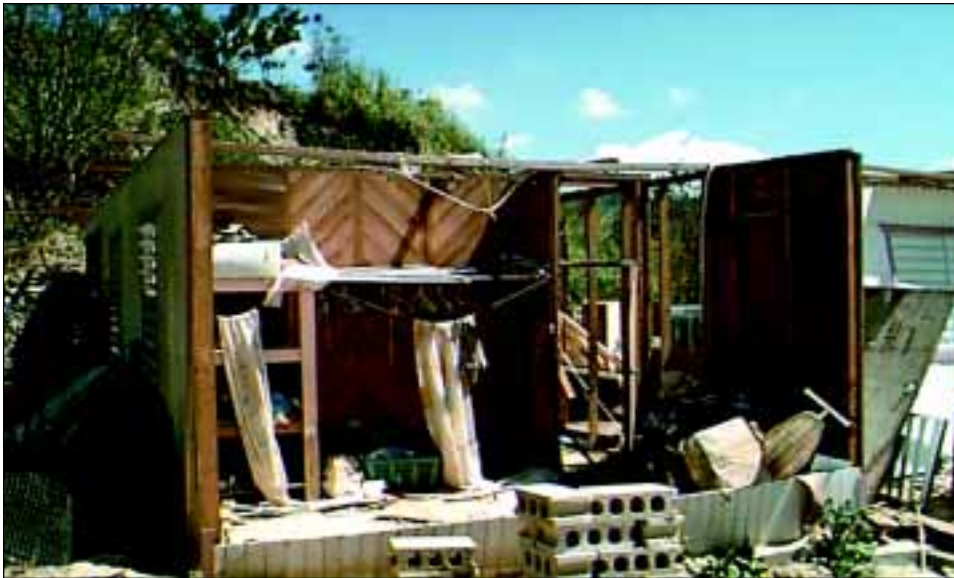
FIGURE 4-14 Example of wood-frame wall construction that failed during Hurricane Georges. This building was not constructed with any hurricane clips or straps.

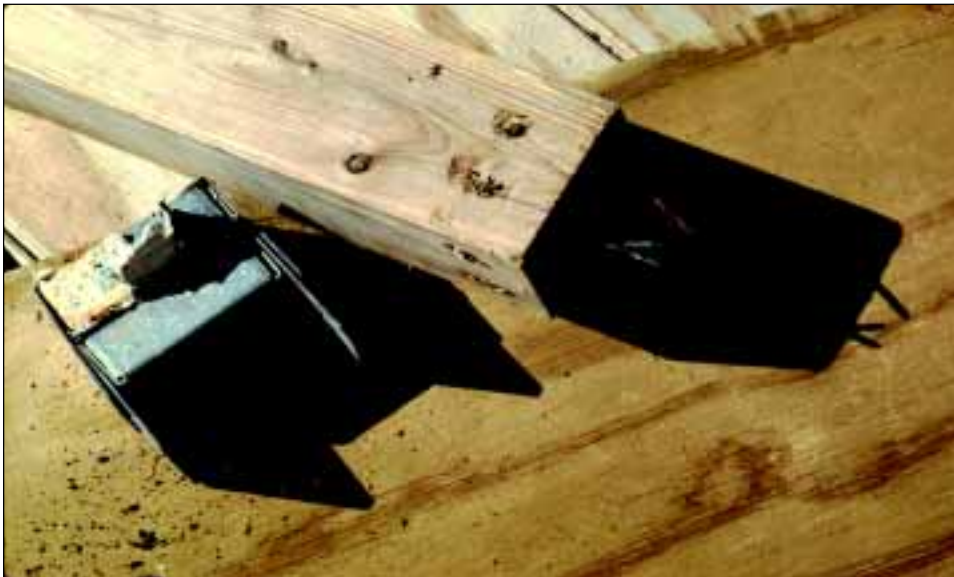
FIGURE 4-15 Wood wall column that failed at connection to sill plate. This building was only two months old but was only partially constructed with clips, straps, and fasteners. The proper column fastener in the photograph was found unused beneath the house. This column was from the same house presented in Figure 3-13.

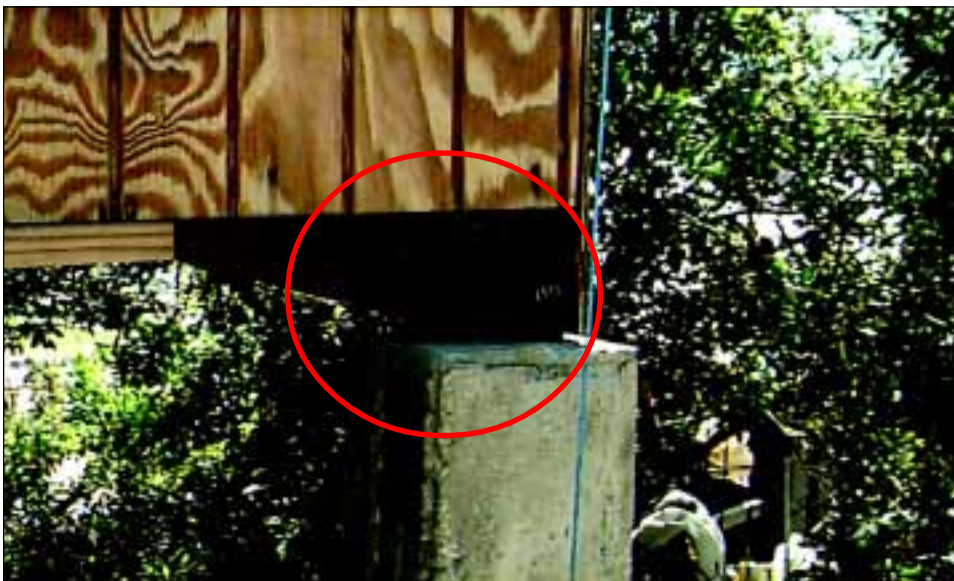
FIGURE 4-18 Example of a non-engineered connection between the building foundation (concrete column) and the floor system. The wooden floor beam is connected to foundation rebar with an improper nailed connection.

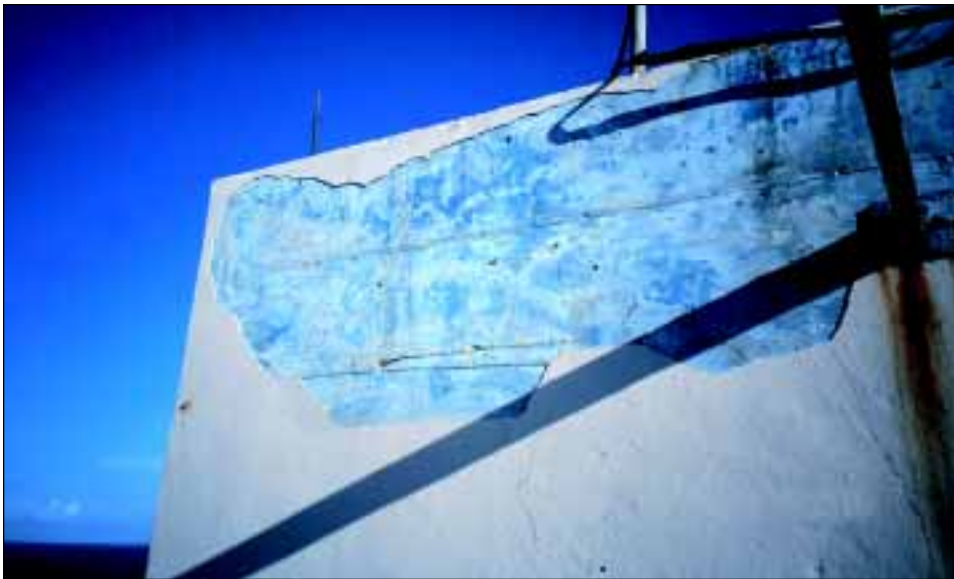
FIGURE 5-9 The stucco was blown off the corner area of this wall, where the suction pressures were high. Note the rough texture of the concrete.

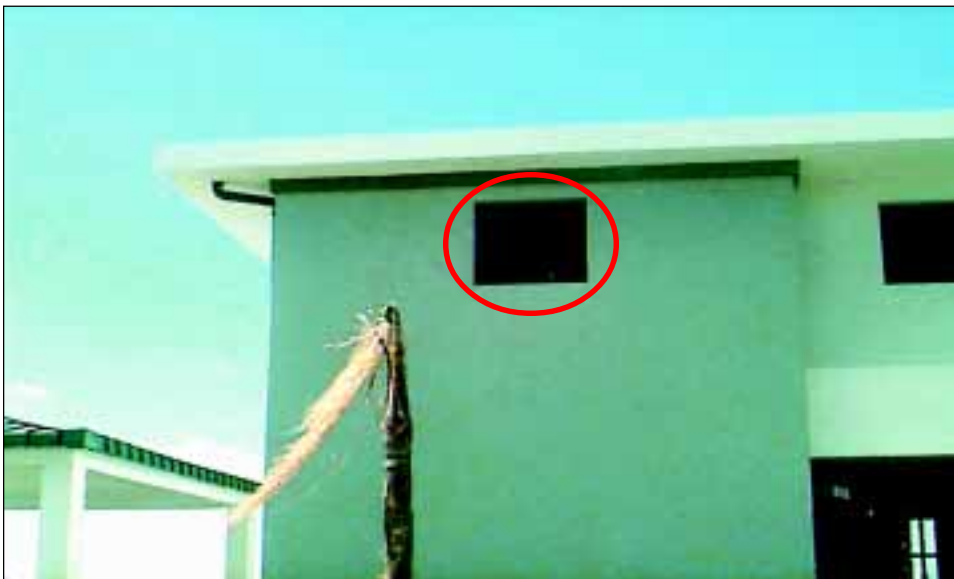
FIGURE 5-27 One pane in this window was broken by a missile, perhaps from the palm in the foreground.

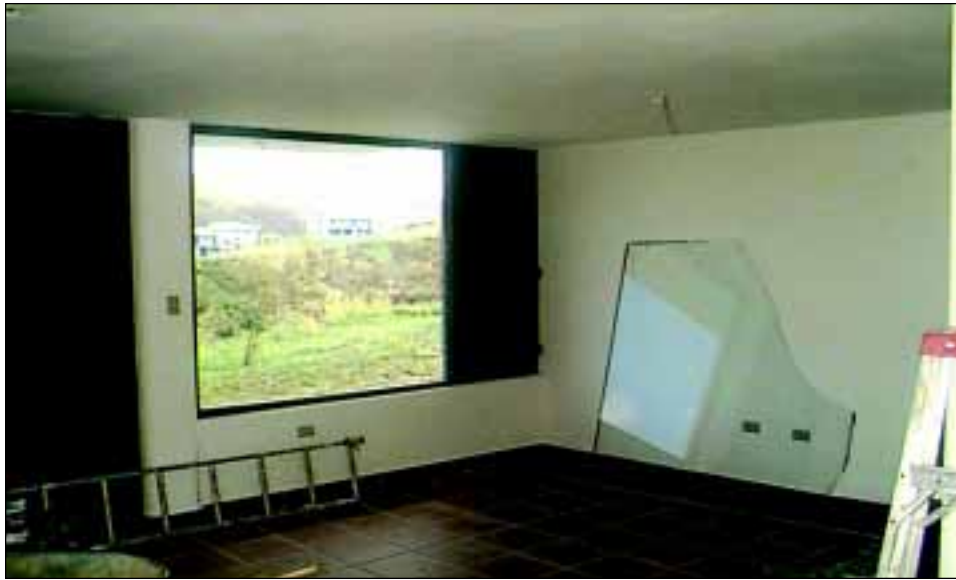
FIGURE 5-28 This large window, which was removed and leaned against the wall after the storm, was broken by a missile, most likely a tree limb.

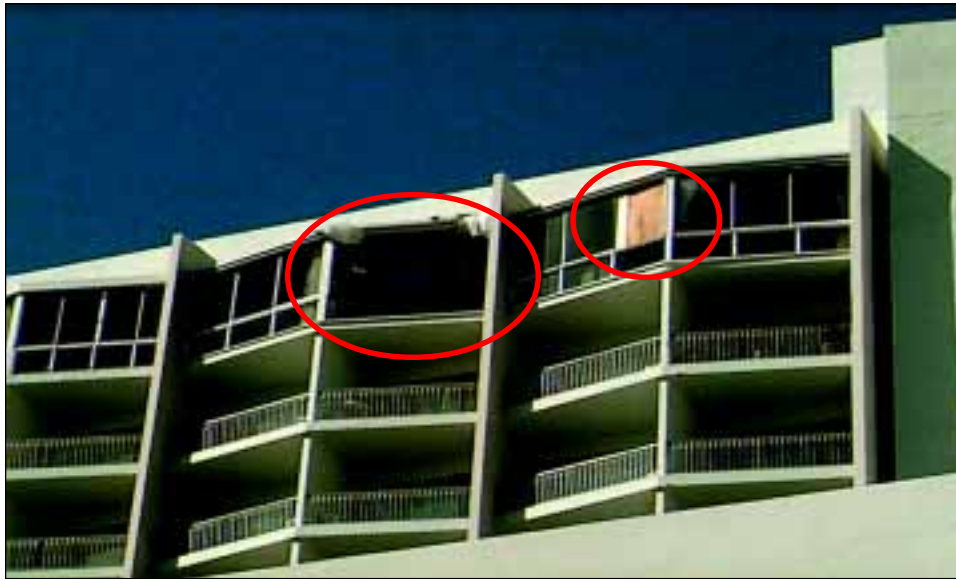
FIGURE 5-29 The glass and frames were blown out at the center room on the top floor. At the room to the right, one of the glass panes was blown out.

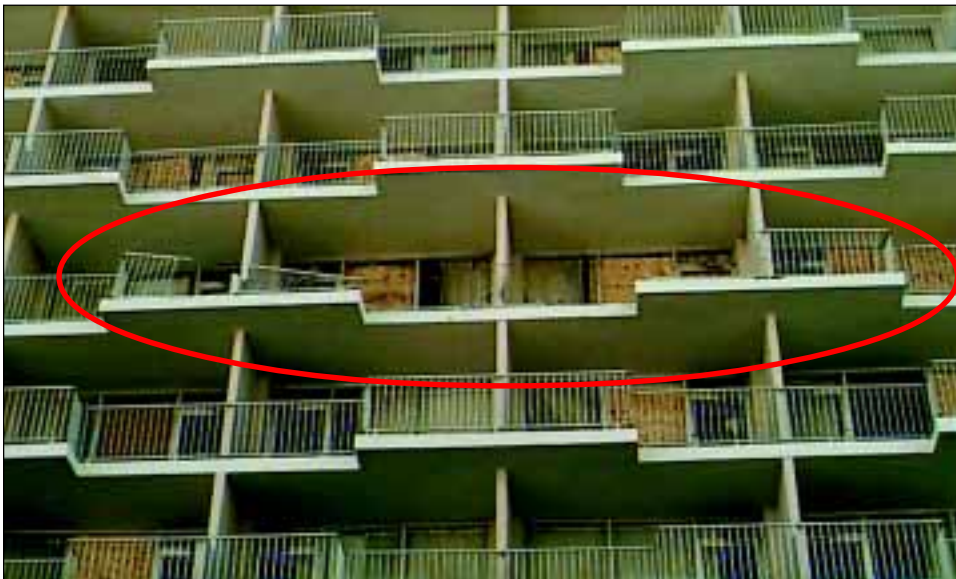
FIGURE 5-31 High-energy missiles from a nearby building damaged several railings of this building.

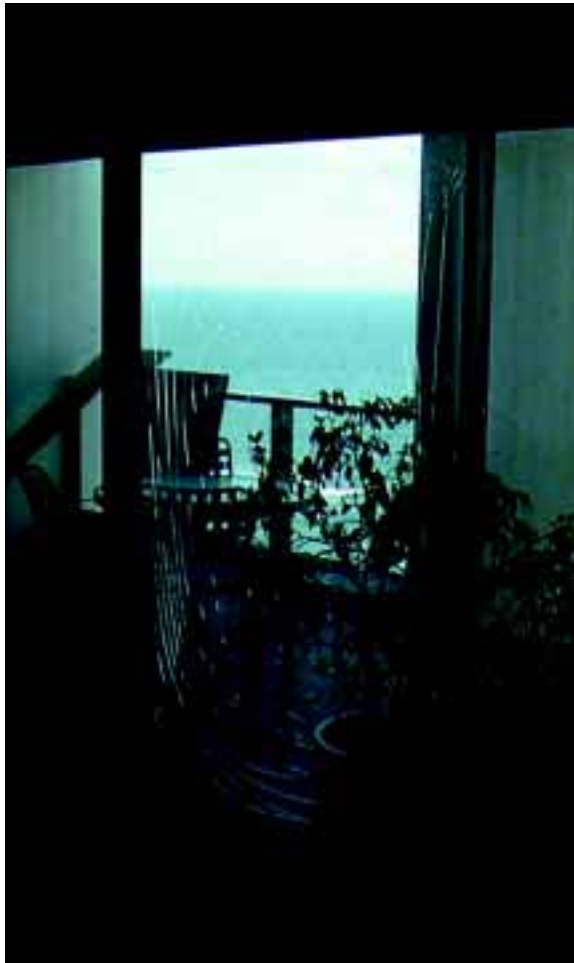
FIGURE 5-32 The broken light in the center is laminated. A sliding glass door located to the left had tempered glass, which was blown out of the frame.

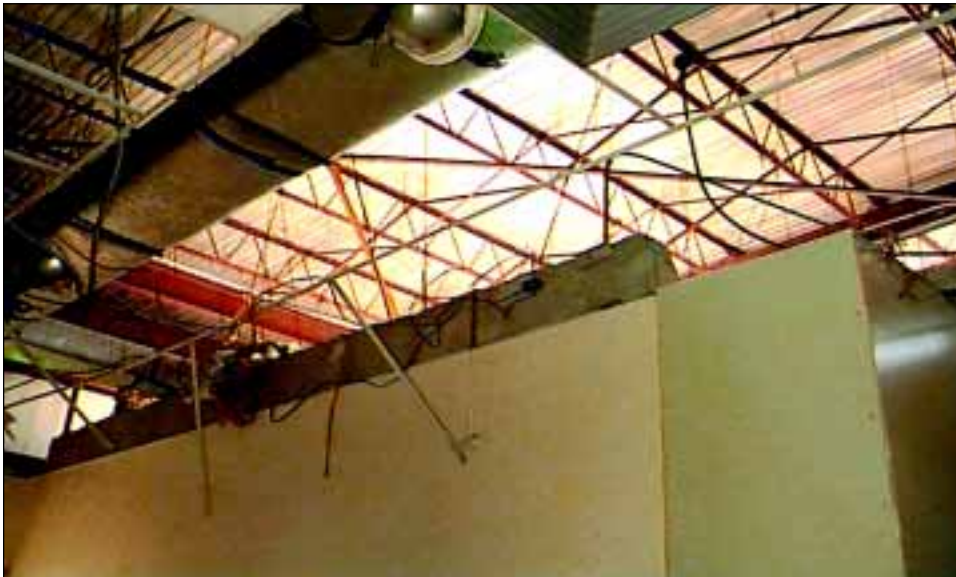
FIGURE 5-41 Part of the exterior envelope of this building blew away, resulting in damage to the acoustical ceiling. This revealed a lack of seismic resistance of the ceiling system, light fixtures, and ductwork.

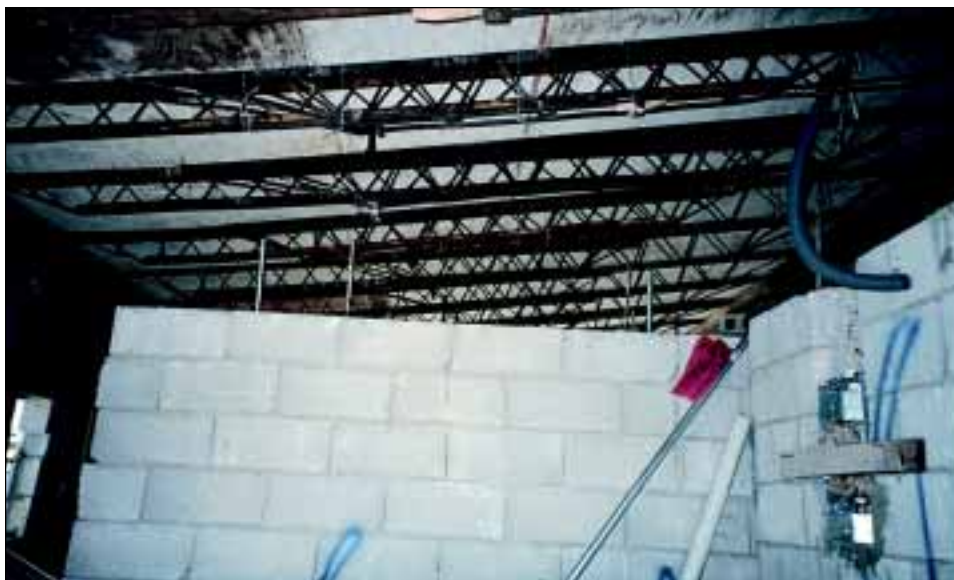
FIGURE 5-42 An interior view of a house under construction (the steel joists are supporting formwork for the concrete slab). The CMU partition is inadequately reinforced and is not supported or laterally braced at the top of the wall.

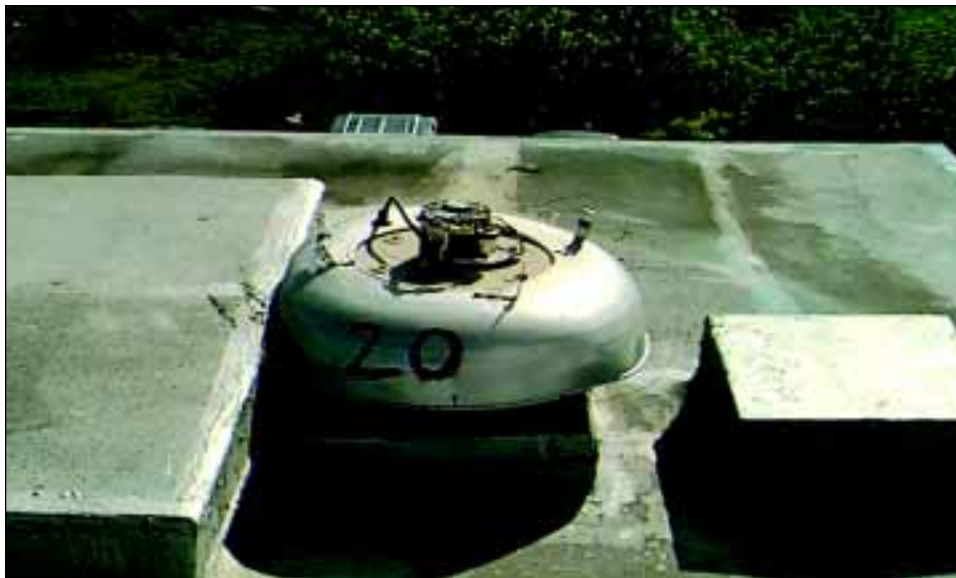
FIGURE 6-1 This exhaust fan lost its cowling.

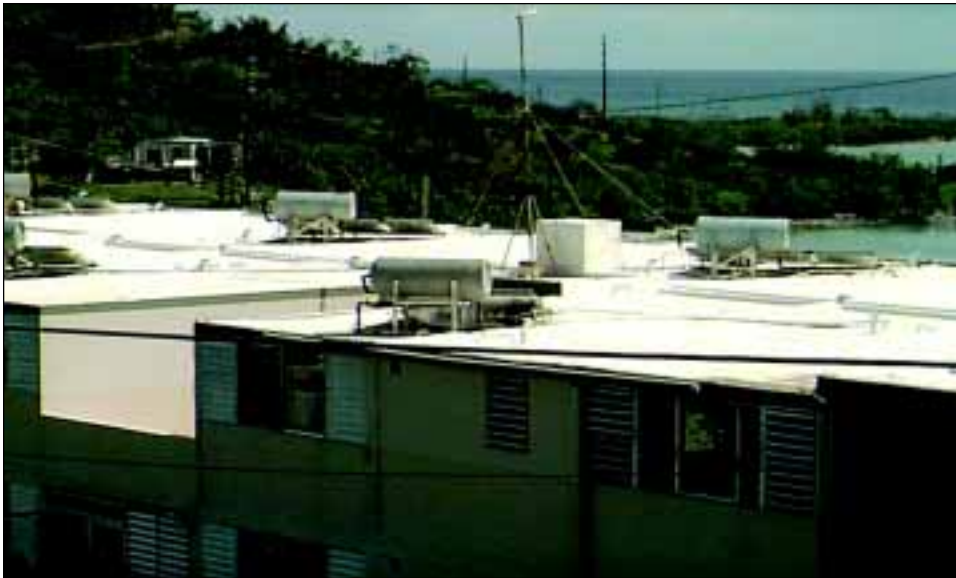
FIGURE 6-2 This roof had several solar hot water heaters that successfully weathered Hurricane Georges. However, the unit in the foreground was damaged.

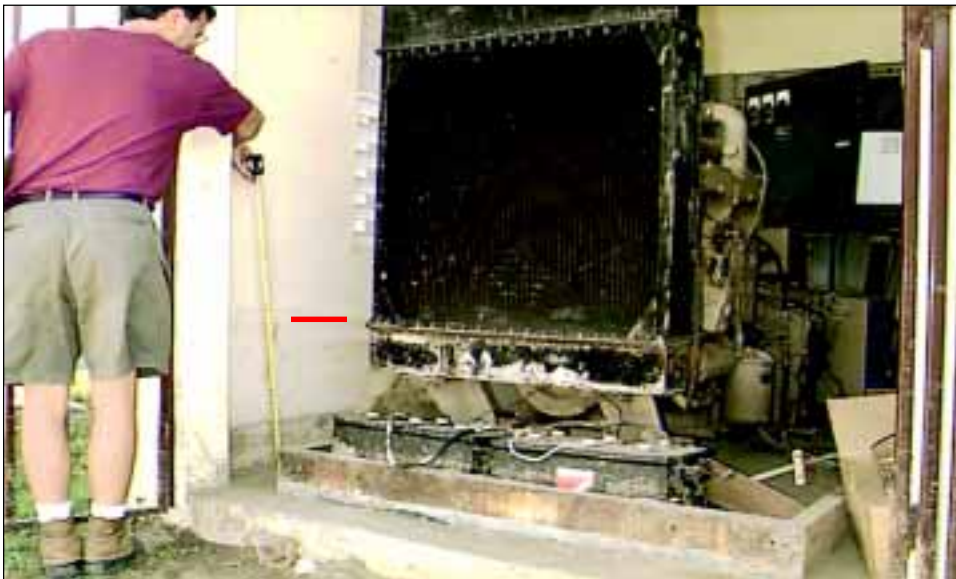
FIGURE 6-3 Flood water entered this generator room and reached a height of about 2 feet, as indicated by the red line. This facility is located in Jayuya.

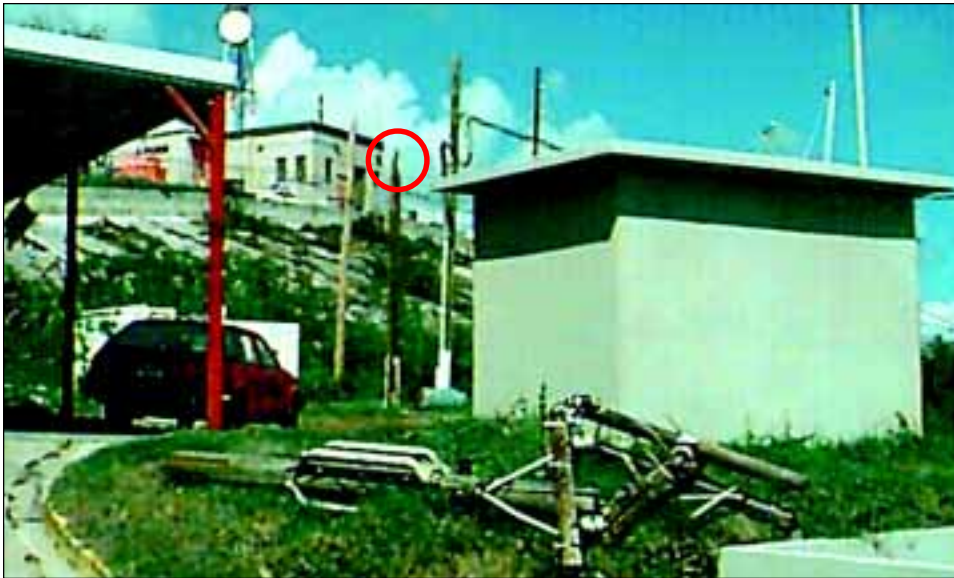
FIGURE 7-1 Damaged wood pole. The portion of the wood pole in the foreground broke from the pole (circled) in the back of the picture.

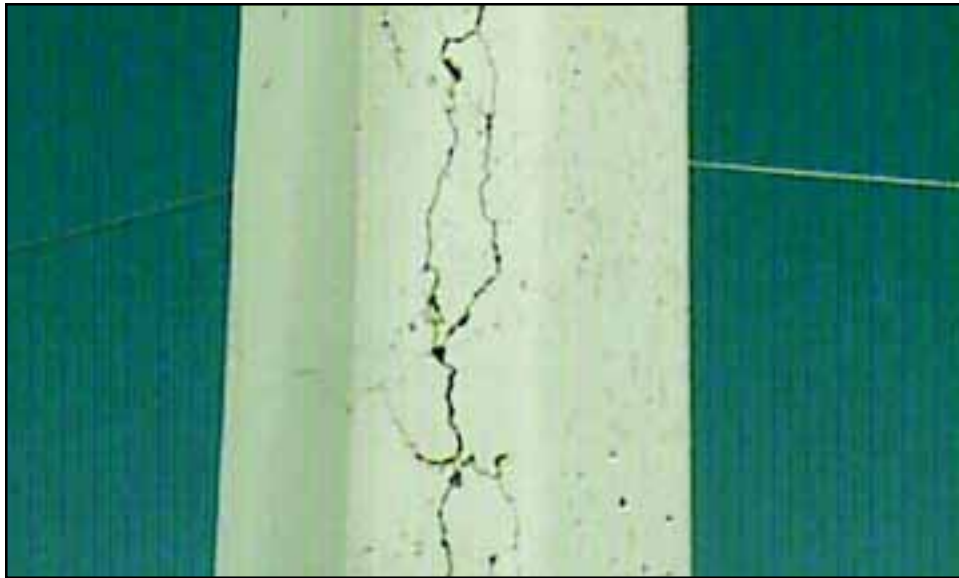
FIGURE 7-3 Observed crack in concrete pole that appears to be a quality control problem.

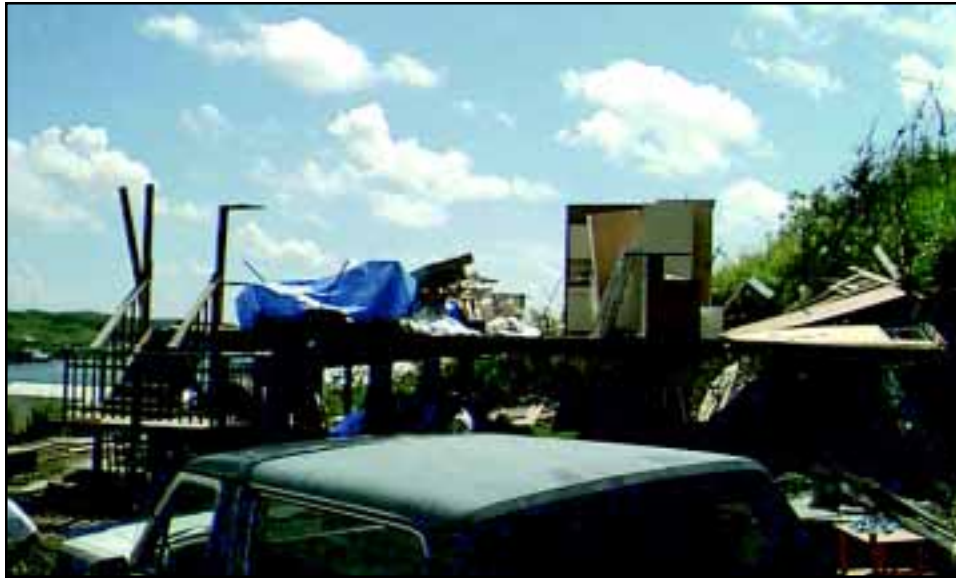
FIGURE 8-2 This wood-framed house was nearly totally destroyed. This is in remarkable contrast to the nearby building shown in Figure 8-3.
