South Carolina Dam Failure Assessment and Advisement

DR-SC-4241

FEMA P-1801 / December 2016

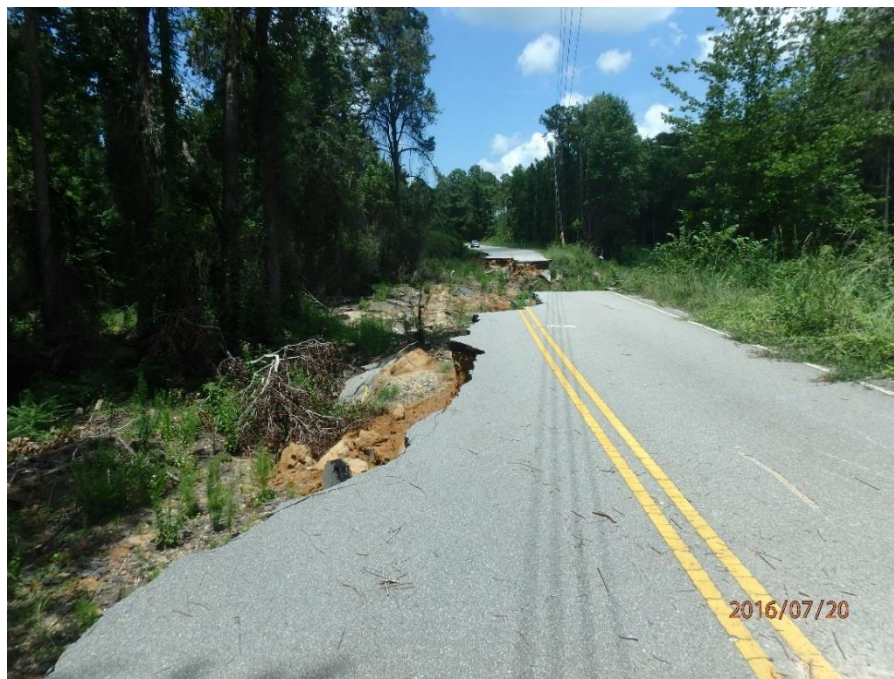
Figure 12 shows an example of overtopping failure at dam SCNONAME 14008. The foreground of the photo shows head cutting at the downstream toe and the background shows a complete failure where the head-cutting has propagated upstream through the road/dam embankment.

Figure 12: Head-Cutting of the Embankment at SCNONAME 14008 (Source: FEMA 2016)

The risk of overtopping failures can be reduced by increasing the spillway capacity. This will require a licensed and qualified engineer review the spillway capacity of the dam and develop a design to upgrade the spillway. The engineer should compare the design assumptions to current and projected watershed conditions to ensure that the dam height and spillway capacities are sufficient to meet projected needs. If the dam design is insufficient for projected future flows and downstream hazard creep, the engineer can recommend methods of upgrading the dam.

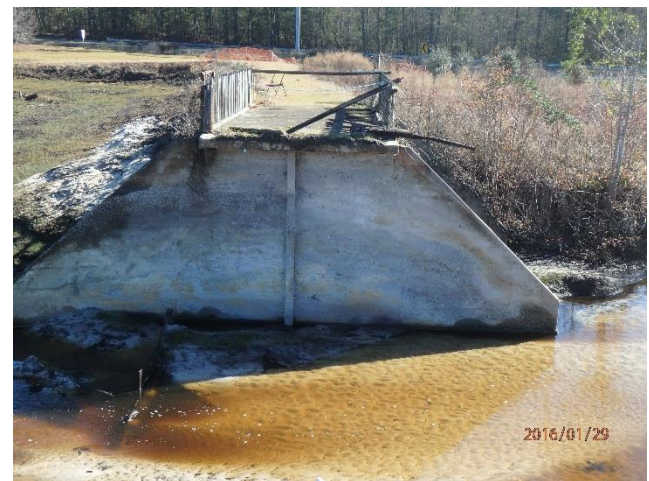
Structural failure was observed to contribute to the failure of 12 dams. Structural failures of earth dams can occur in the embankment itself or in its associated structures. The most apparent signs of embankment failure are cracking, settlement, and sliding. Sloughs, bulges, and cracks are indications of potential failure. Failures of spillways and drains can also cause an embankment to fail. Spillways, which are often constructed of concrete or stones and mortar, can fail when soils supporting their foundations erode, resulting in settlement and cracking of the spillway. Processes such as freezing and thawing, chemical reactions, and erosion can weaken the spillway materials, which also could lead to failure. An example of a structural failure where the connection between the concrete spillway and earthen embankment deteriorated can be seen at JW Smoaks Pond in Figure 15. This dam did not exhibit any significant signs of overtopping and had an open channel emergency spillway that was engaged and functioned properly. Another example of a structural failure can be seen on the next page in Figure 16 from Duffies Pond Dam. While this dam exhibited signs of overtopping, it was deemed a structural failure after discussion with the owner indicated that the dam was manually breached for a repair in that same location years ago, indicating the repair was likely the cause of failure.

Figure 15. Example of Structural Failure at JW Smoaks Pond (Source: FEMA 2016)

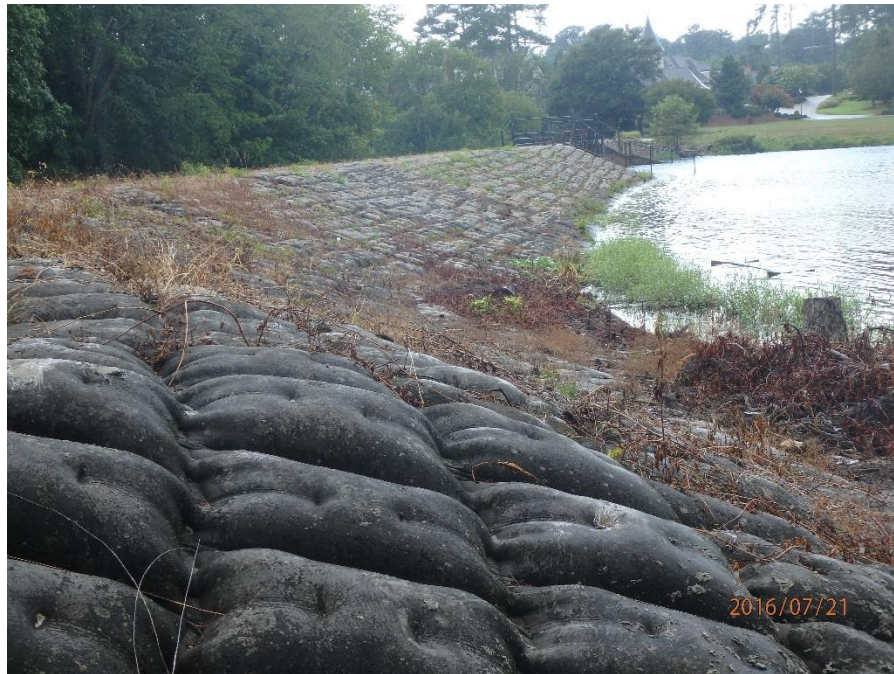
Figure 24: Concrete Armoring at Forest Lake Dam (Source: FEMA)

Structural approaches to mitigating overtopping of the dams are technically feasible and vary in cost. It is recommended that any designs completed to mitigate future overtopping incorporate planned land use changes so that designs account for future conditions both upstream of downstream of the dam over the life of the dam and not just current conditions. A licensed engineer should review the projected future flows and make design recommendations. FEMA 1015 “*Overtopping Protection for Dams*”, (which can be found online at <https://www.fema.gov/media-library/assets/documents/97888>) provides extensive, detailed information about the approaches that can be used. The most common structural approaches to mitigating dam failure from overtopping includes armoring of the downstream dam face and increasing the spillway capacity. Additional information about armoring is available in the associated FEMA Recovery Advisory “*Embankment Armoring*”. Forest Lake Dam, which is located in Columbia, is an example of concrete armoring to mitigate overtopping failure and can be seen below in Figure 24.

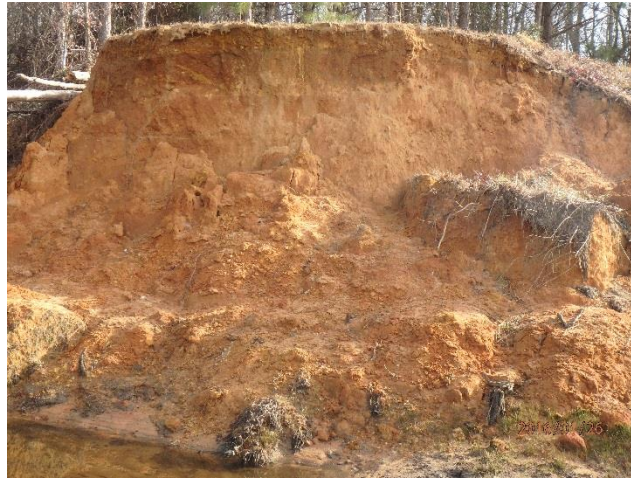
Figure 25: Typical Soil Profile of Failed Dam. Able/Corbett Pond Dam shown (Source: FEMA)

- **Ensure proper compaction** – Foundation soils should be well-compacted and able to support the weight of the dam as well as the water being retained behind the dam. The soils that comprise the dam also should be well-compacted in accordance with the recommendations of the design engineer. Achieving the proper compaction at or slightly above the optimum moisture content is critical to ensuring the stability and proper performance of the dam.
