# **BUILDING PERFORMANCE: HURRICANE ANDREW IN FLORIDA**

OBSERVATIONS, RECOMMENDATIONS,  
AND TECHNICAL GUIDANCE

FEDERAL EMERGENCY MANAGEMENT AGENCY  
FEDERAL INSURANCE ADMINISTRATION

**DECEMBER 21, 1992**

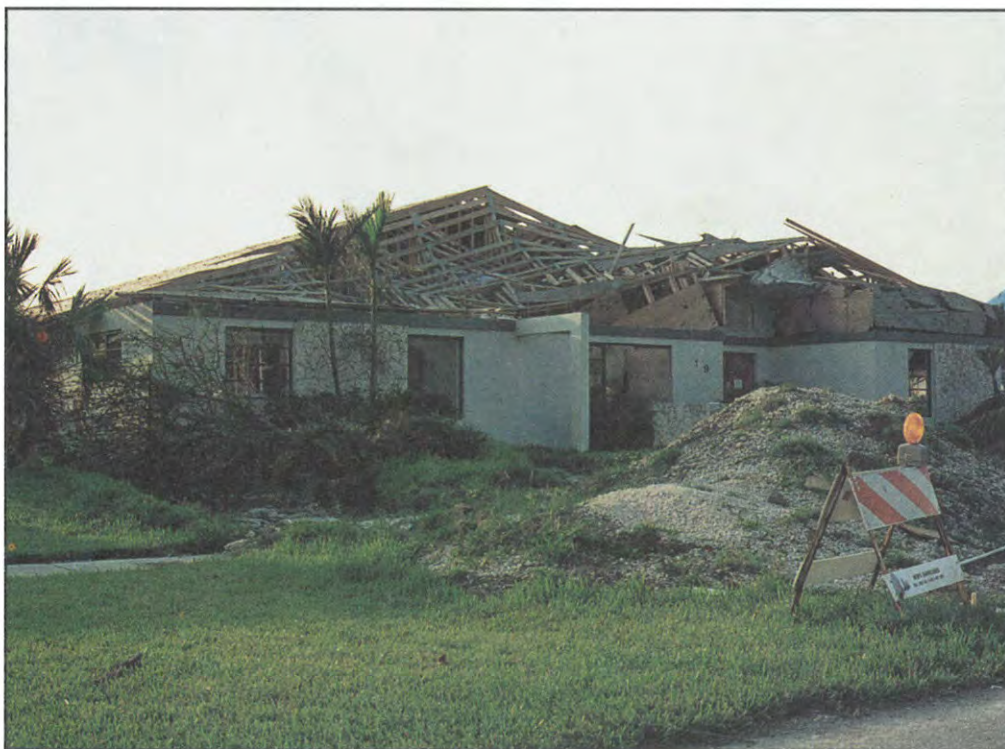
FIGURE 7. *Typical gable failure. Inadequate bracing support and ridge blocking evident in inward collapse.*

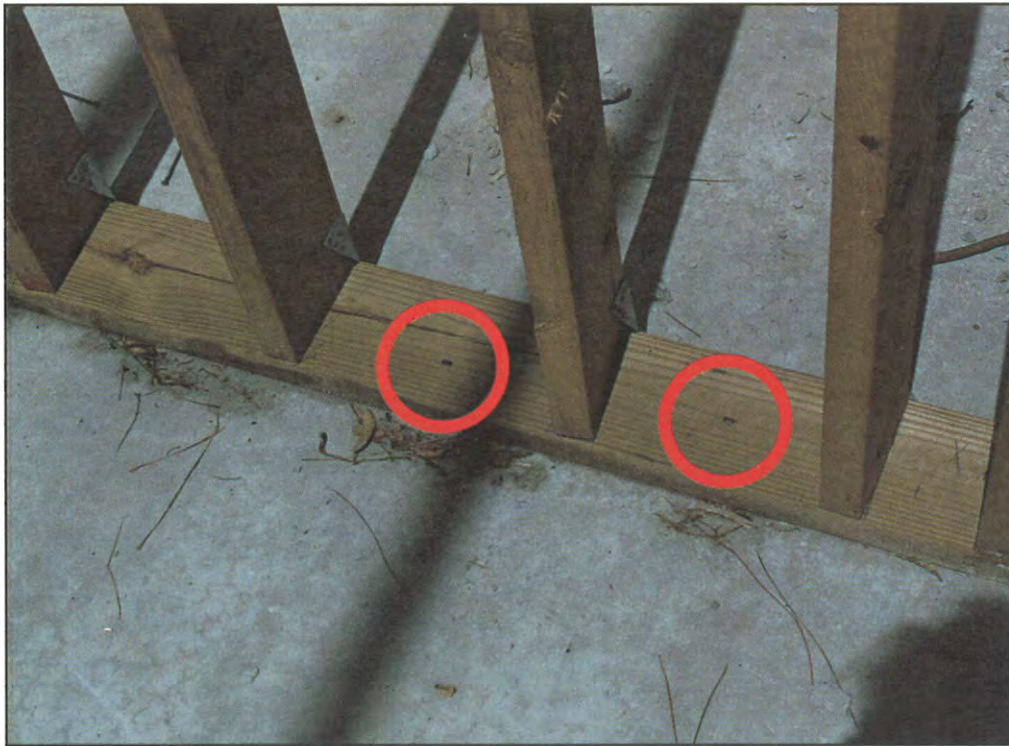
FIGURE 8. *Bolts not used in sill plate. Cut nails had no capacity to prevent pullout.*

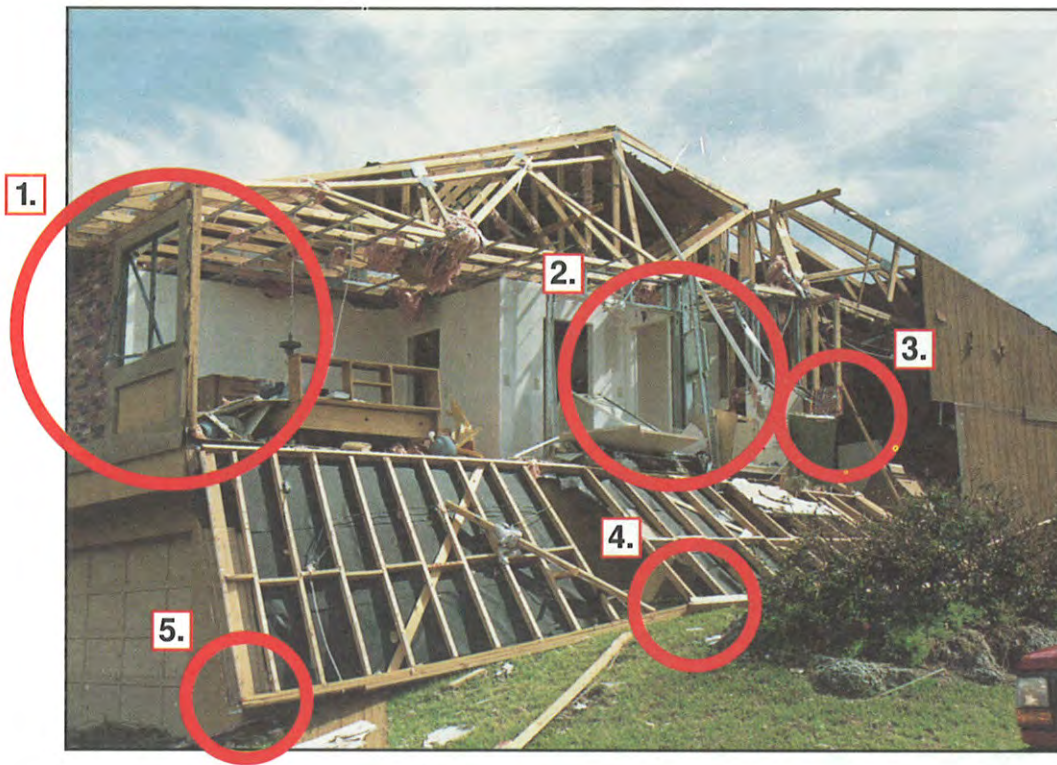
FIGURE 9. *Failure of non-loadbearing wall. Connections of exterior wall were not adequate.*

- 1. End column separated from roof.*
- 2. Load transfer from outside wall to interior shear wall inadequate.*
- 3. Beam separated from beam seat/connector.*
- 4. Improperly spliced composite tie-beam/connector.*
- 5. End of top plate connection inadequate.*

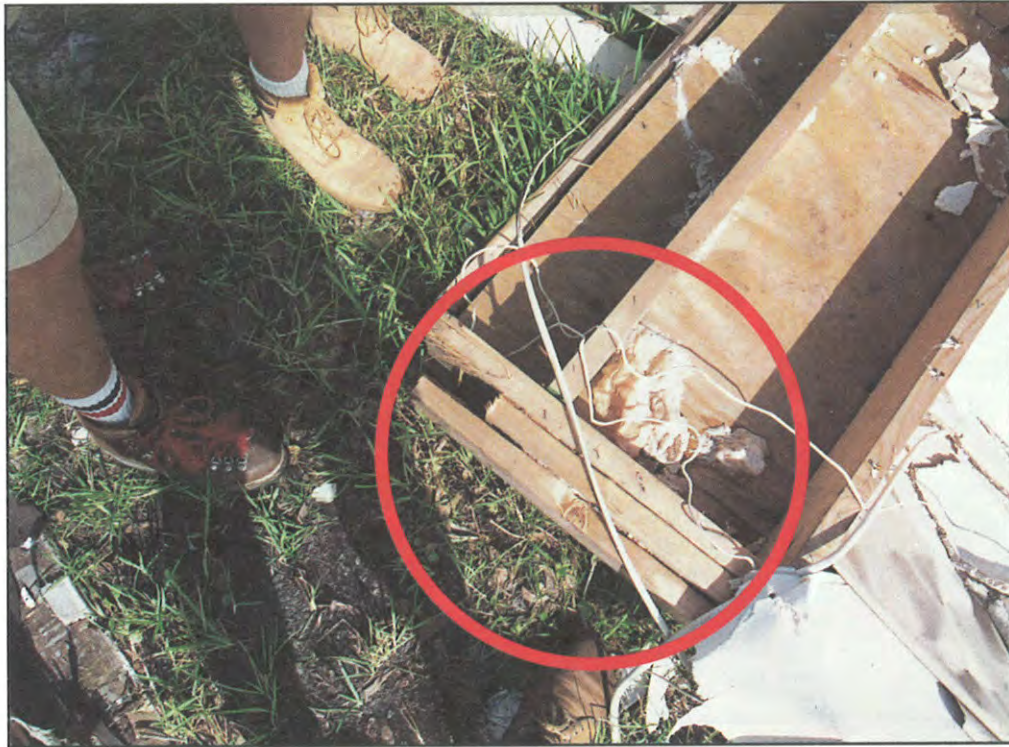
FIGURE 10. *Top plate splice not able to transfer horizontal loads.*

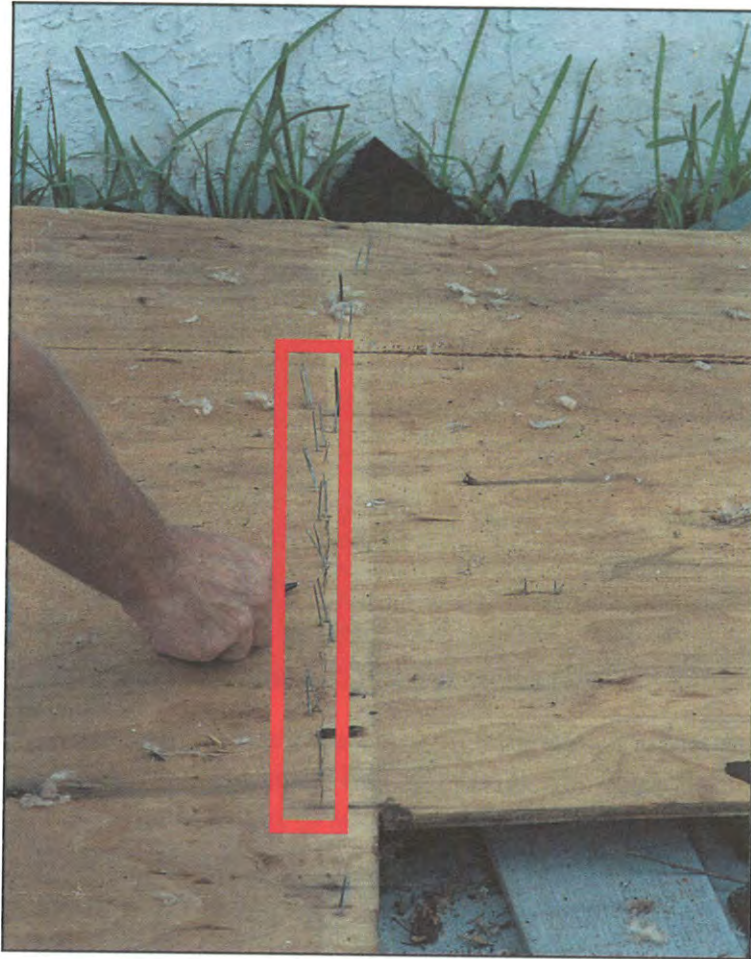
The roof framing systems observed were composed typically of prefabricated light wood trusses and plywood sheathing. While the trusses were found to have performed well under the wind forces, the connection of the sheathing (which forms the horizontal diaphragm of the building system) to the trusses was inadequate. Substandard workmanship in the anchoring of sheathing to trusses (by either improper stapling or improper nailing) was evident (SEE FIGURE 11).

**FIGURE 11.**  
*Roof sheathing found in debris. Staples were off-line and therefore not connected to supporting truss top chord.*

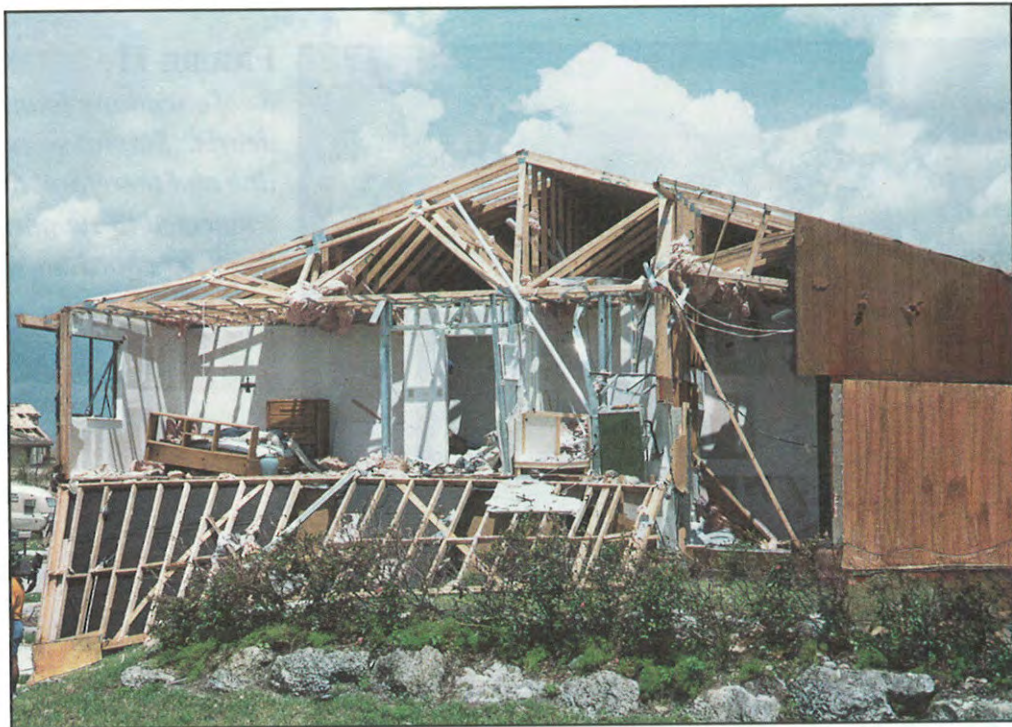
The lack of adequate truss bridging, improper system-wide lateral bracing, inadequate cross-bracing at end trusses, and the lack of stiffening of gable ends were determined to have compromised the integrity of the structural roof systems. It is the opinion of the assessment team that reliance on sheathing for truss-roof bracing, and the corresponding loss of the sheathing, was a major cause of the total damage of the building systems. (SEE FIGURES 12, 13, AND 14.)

FIGURE 12. *End wall failure of typical first floor masonry/second floor wood-frame building. Truss bridging and lateral bracing, and adequately installed roof sheathing, would have greatly reduced the likelihood of such a failure.*

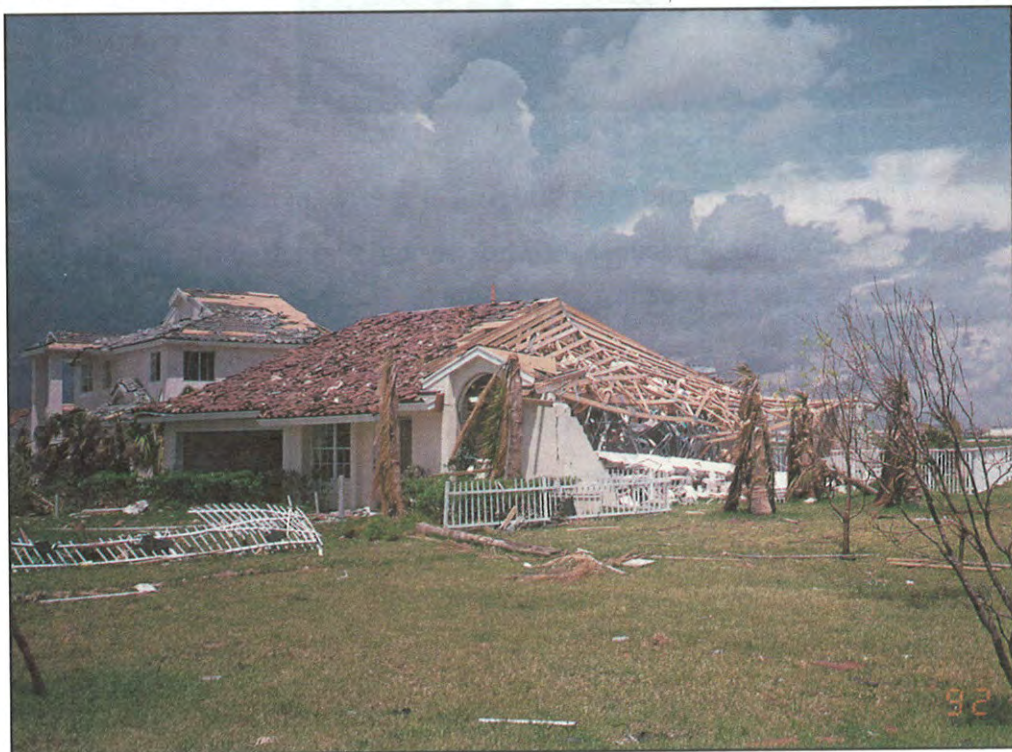
FIGURE 13. *Roof structure failure due to inadequate bracing.*

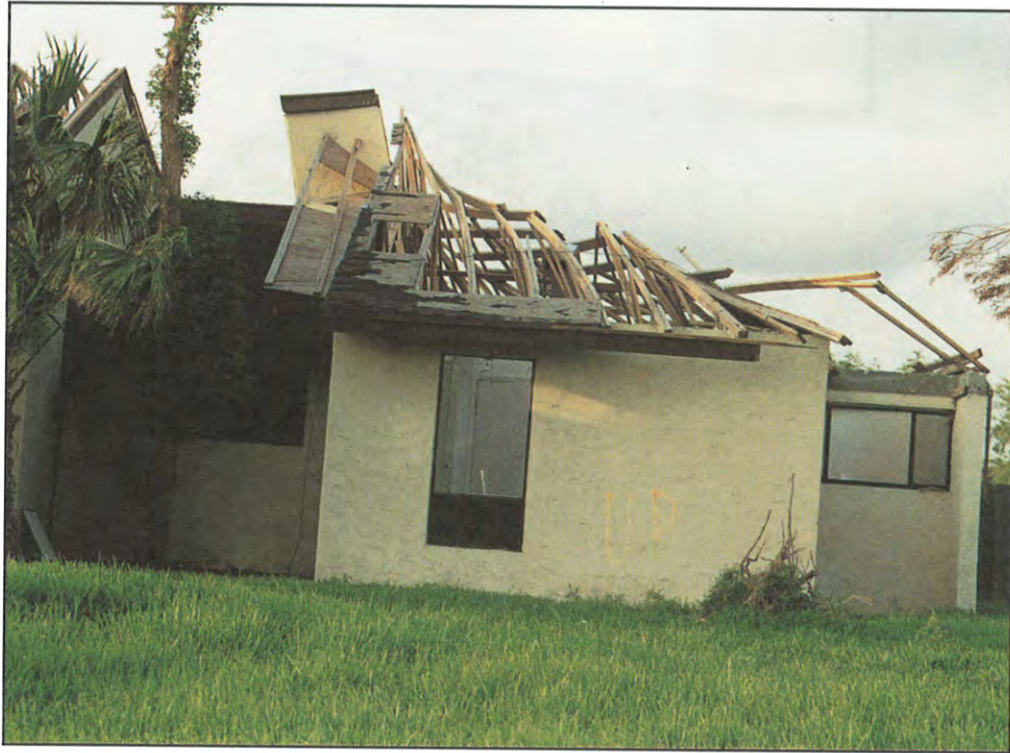
FIGURE 14. *Roof structure failure due to inadequate bracing.*

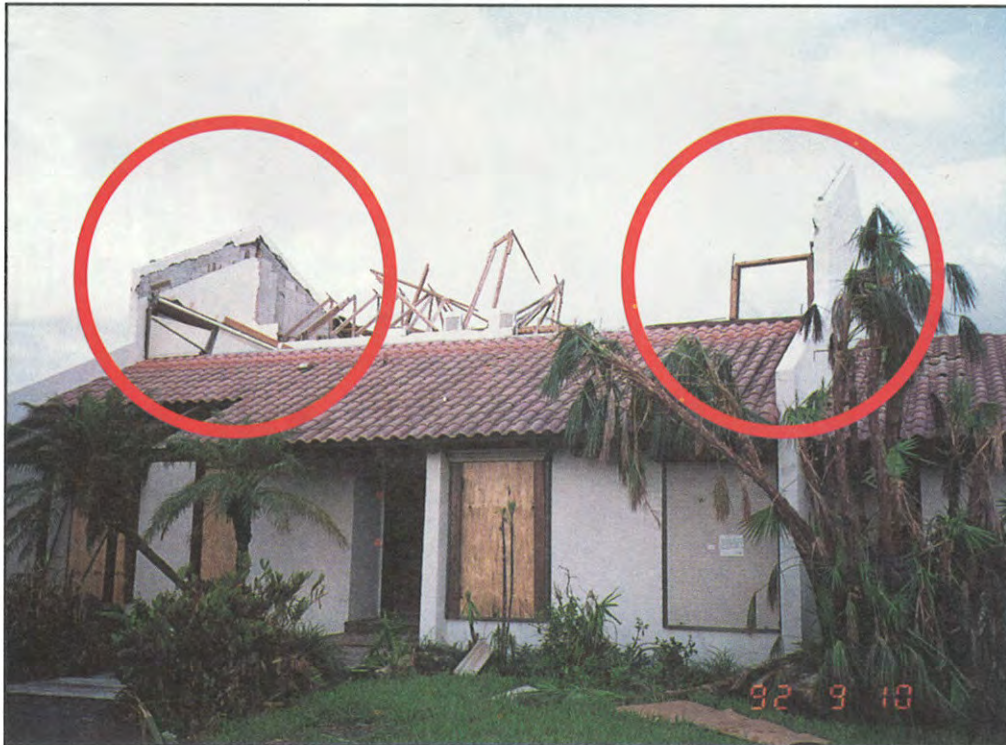
Discontinuous second-story CBS walls (typical firewall design) were prone to failure at their connecting edges and suffered separation from various building envelopes. Improved wall performance through continuous CBS construction was observed in the performance of gable ends that were CBS-constructed (SEE FIGURE 17).

FIGURE 17. Two-story masonry building. While forces were sufficient to blow off entire roof structure, continuous masonry gables held.

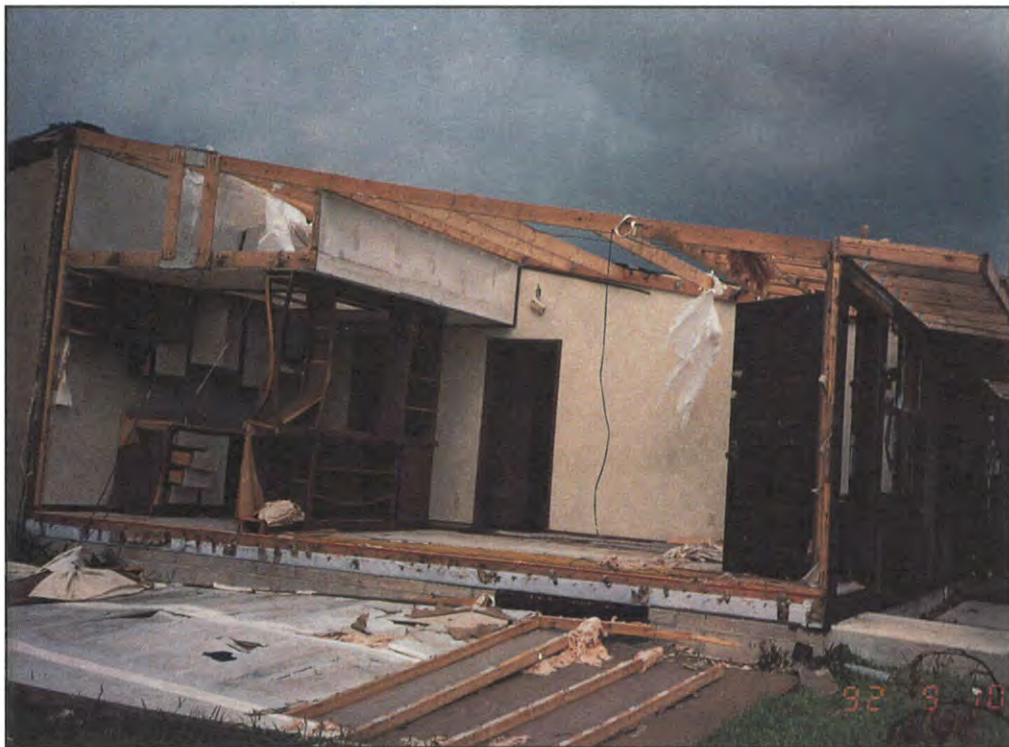
Two end-wall (end wall of end modules) failures were observed in a modular home subdivision. Poor connection of the tops of the walls to the roof diaphragms was evident in these instances. Some roof sheathing was observed missing from rafters, judged to be due either to building envelope breach (window and/or door failure) or to external wind and debris. Generally, the rafters themselves were left entirely intact, because of the inherent rigidity developed by the relatively short spans and secure connections. (SEE FIGURES 19 AND 20.)

FIGURE 19. *Modular home. End wall of end unit separated from unit; withdrawal of nails along eave line and roof sheathing failure were also observed.*

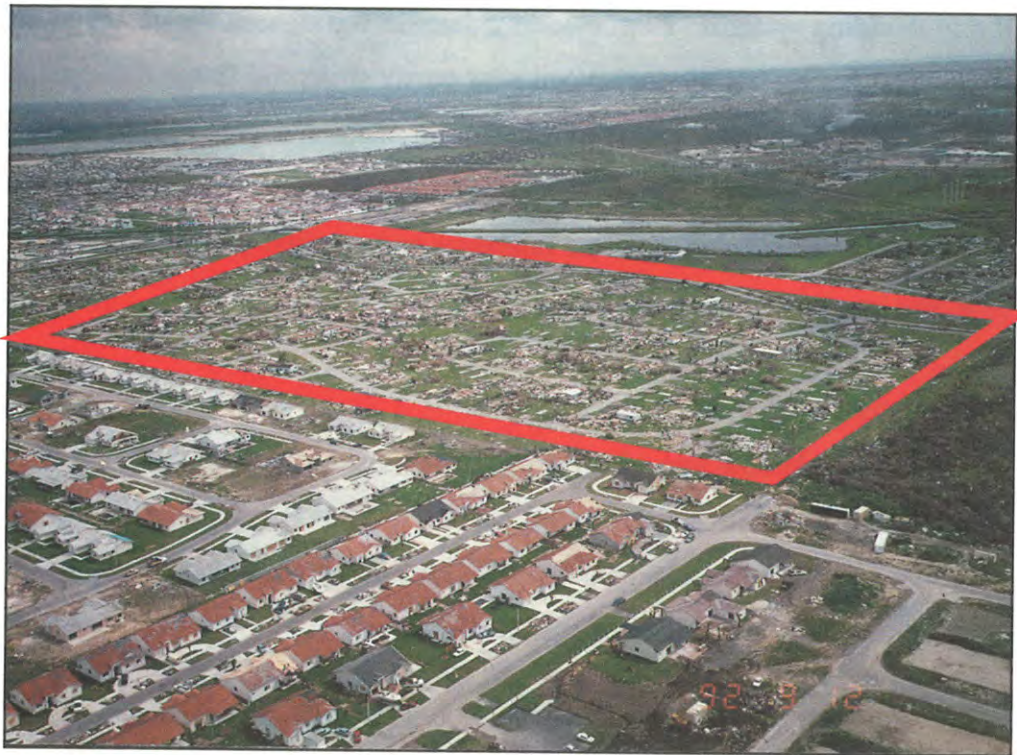
FIGURE 21. Aerial photo of damage area. Shows building performance difference between manufactured homes (outlined in center) and conventional residential buildings (lower left).

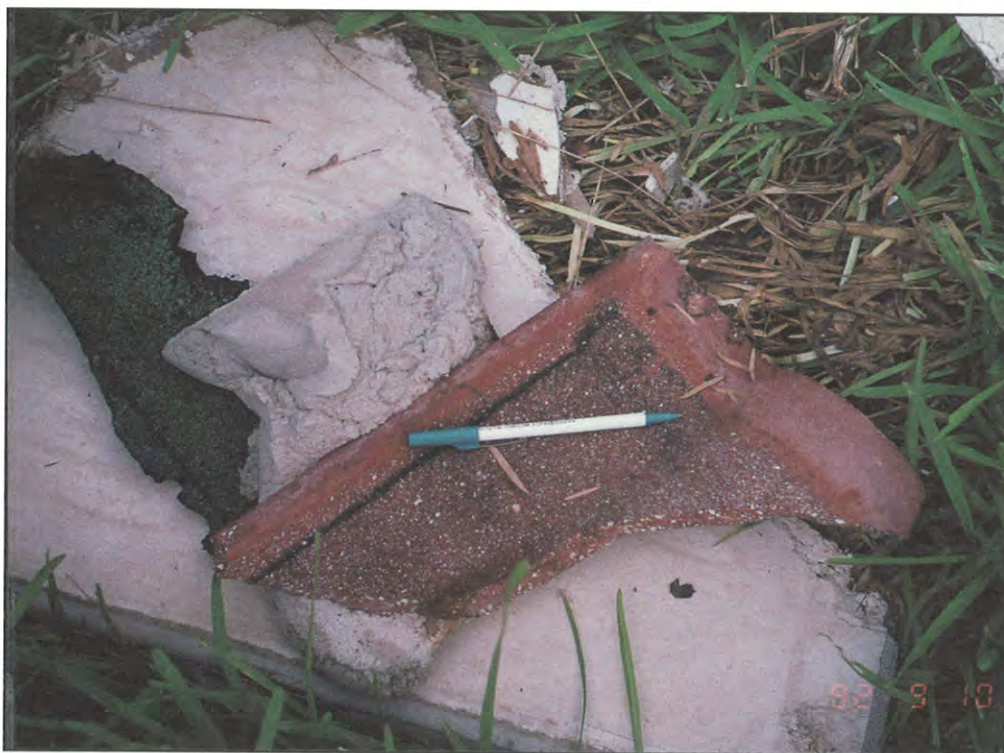
FIGURE 22. *Typical failure of roof sheathing-to-underlayment attachment. (Bond between underlayment and mortar pad, and between mortar pad and tile effective.)*

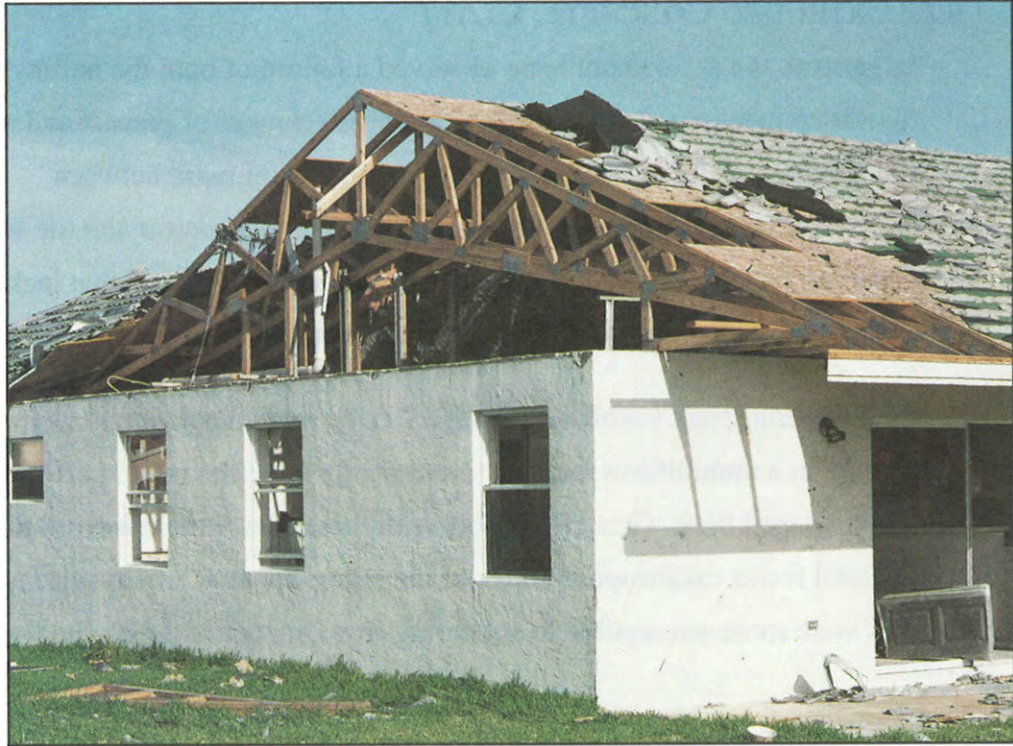
FIGURE 23. *Typical roofing failure. Failure of sheathing, underlayment, and extruded concrete tiles.*

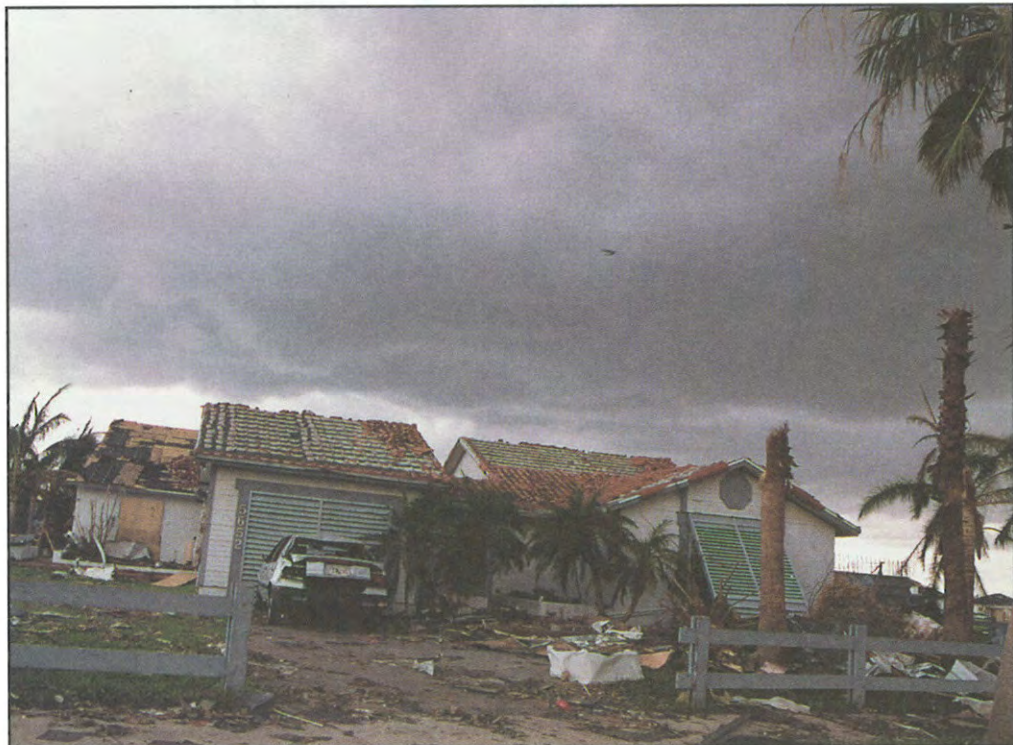
FIGURE 24. *Typical roofing failure. Failure between tiles and mortar pads.*

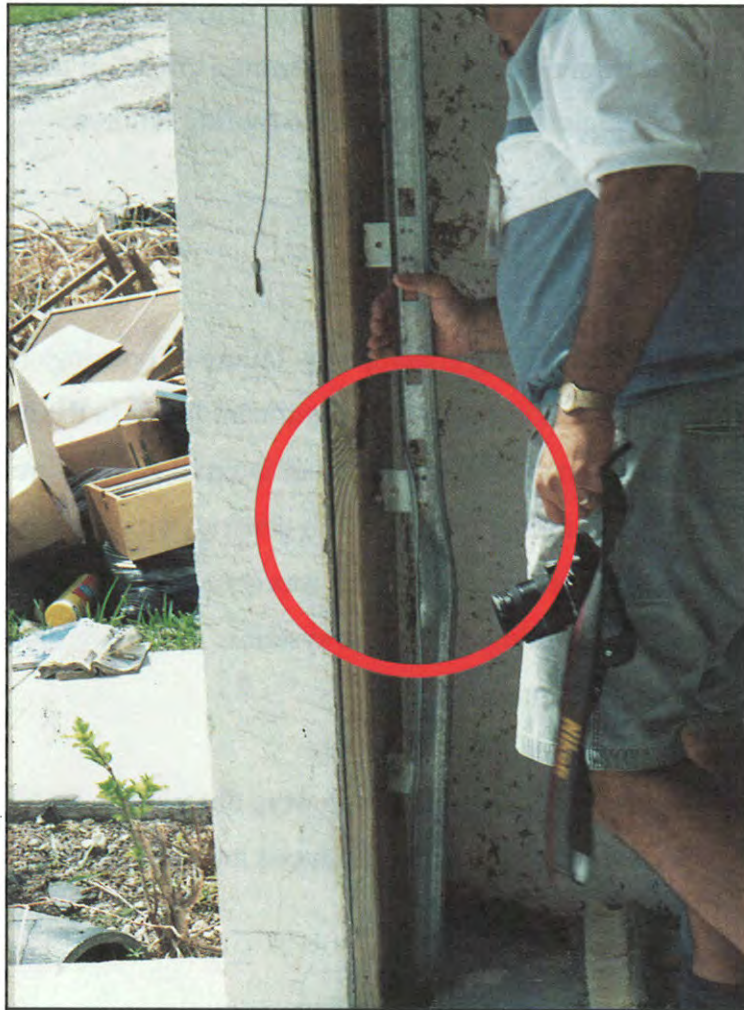
FIGURE 25. *Garage door failure. Rotation of track, and pullout of brackets at wall support.*

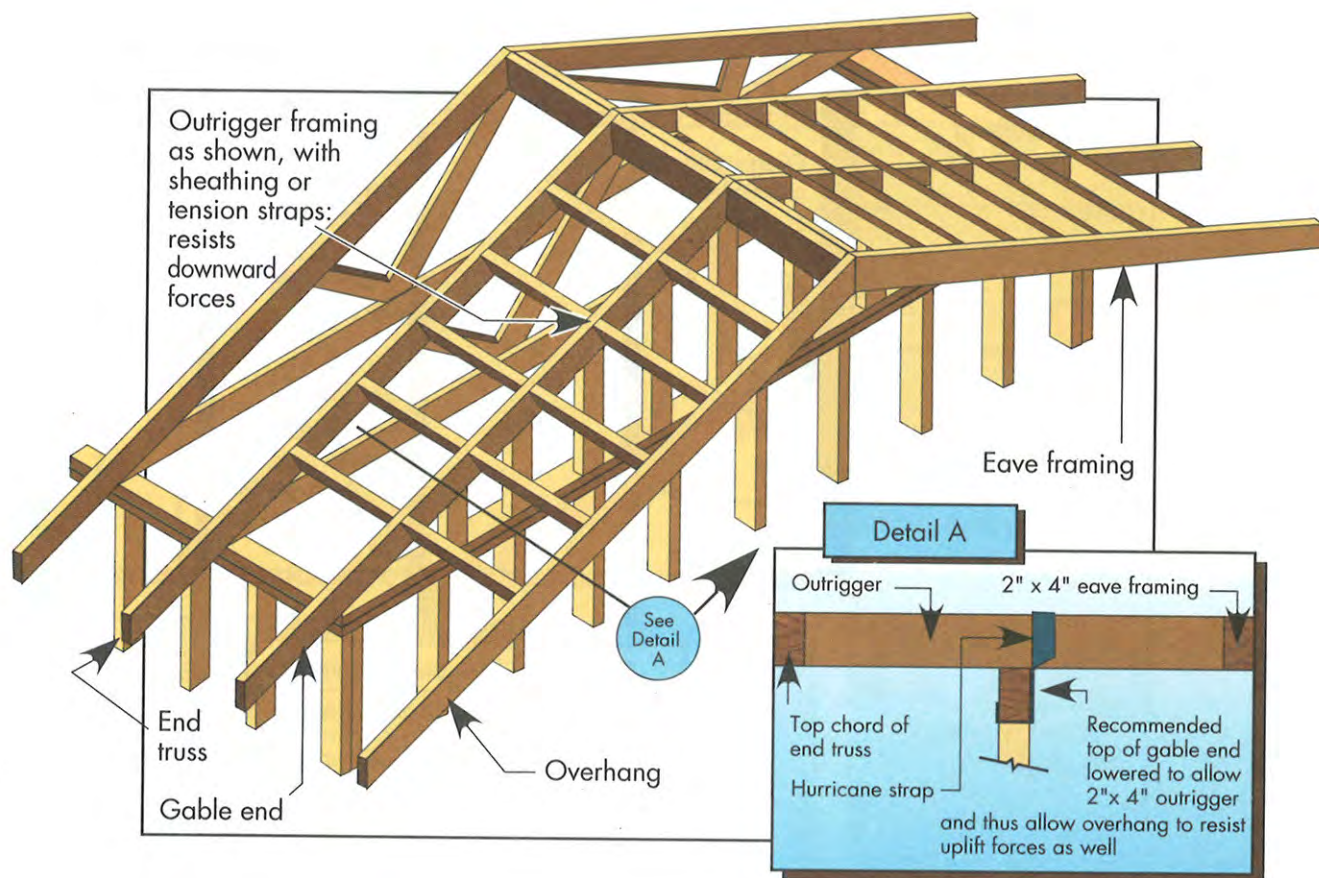
FIGURE 29. *Observed roof bracing for gable roof overhang and recommended modification.*

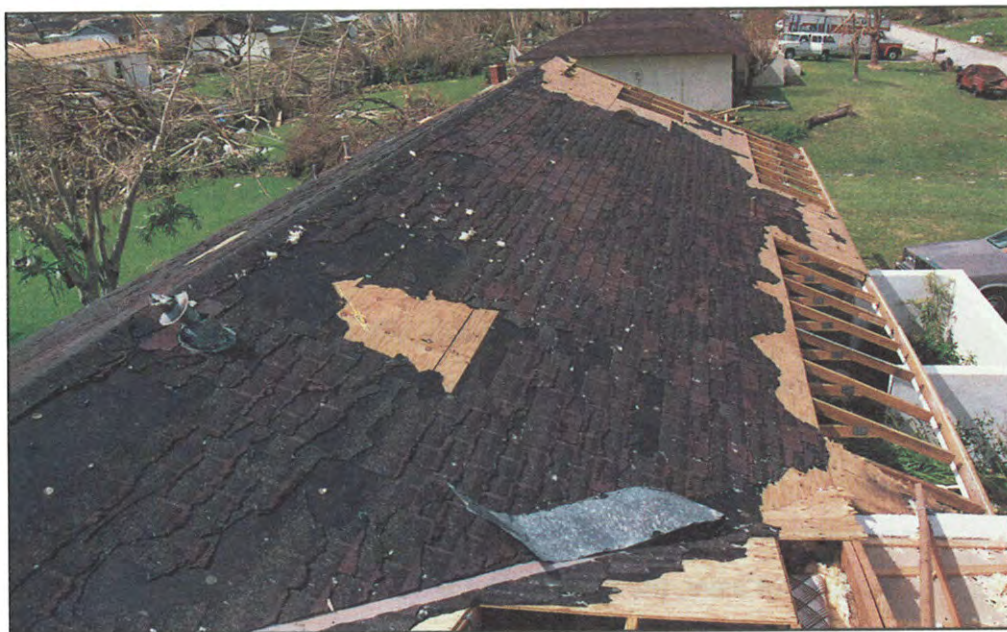
FIGURE 30. *Composition shingle and underlayment failure.*

2. Composition shingles should be manufactured and rated as satisfactory for high-wind areas. In the absence of this, a water-resistant membrane, e.g., a hot-mopped underlayment, should be installed to provide protection from the water infiltration that may result from the loss of roofing material during high-wind storms (SEE FIGURES 30 AND 31).
  3. Manufacturers of roof tile products should provide testing and verification of tile performances under realistic conditions (as addressed by the Code).
- Manufactures should verify that mortar used with extruded concrete tiles can be installed to Code requirements.

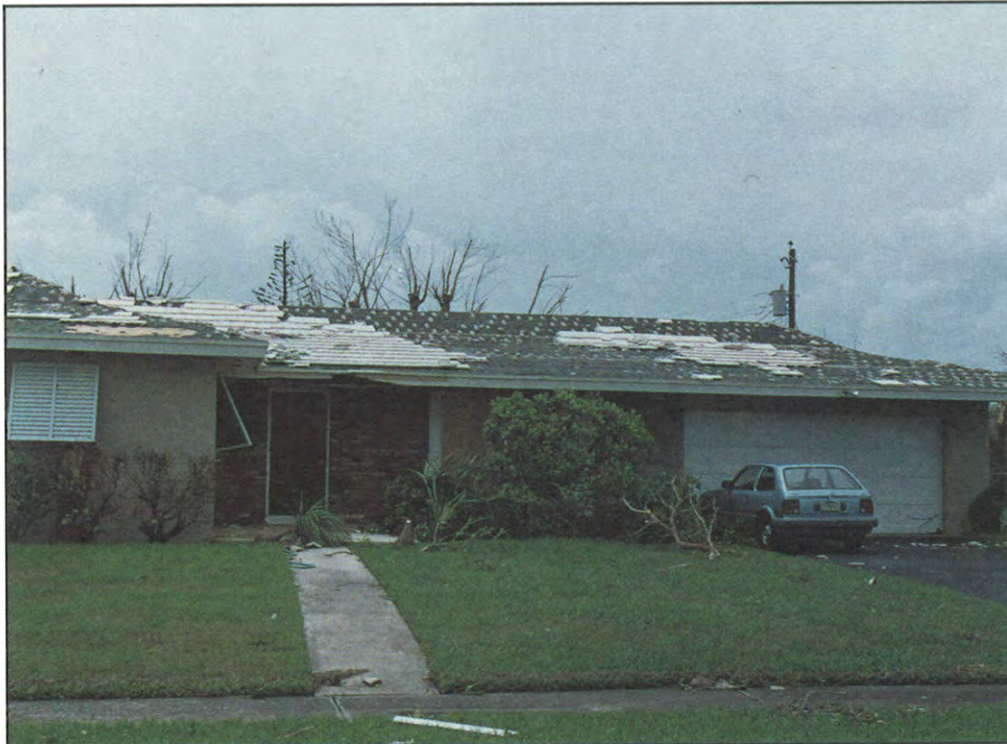
FIGURE 32. *Failure of extruded concrete flat tile roofing. Bond failure between tile and mortar and between mortar and underlayment was observed.*

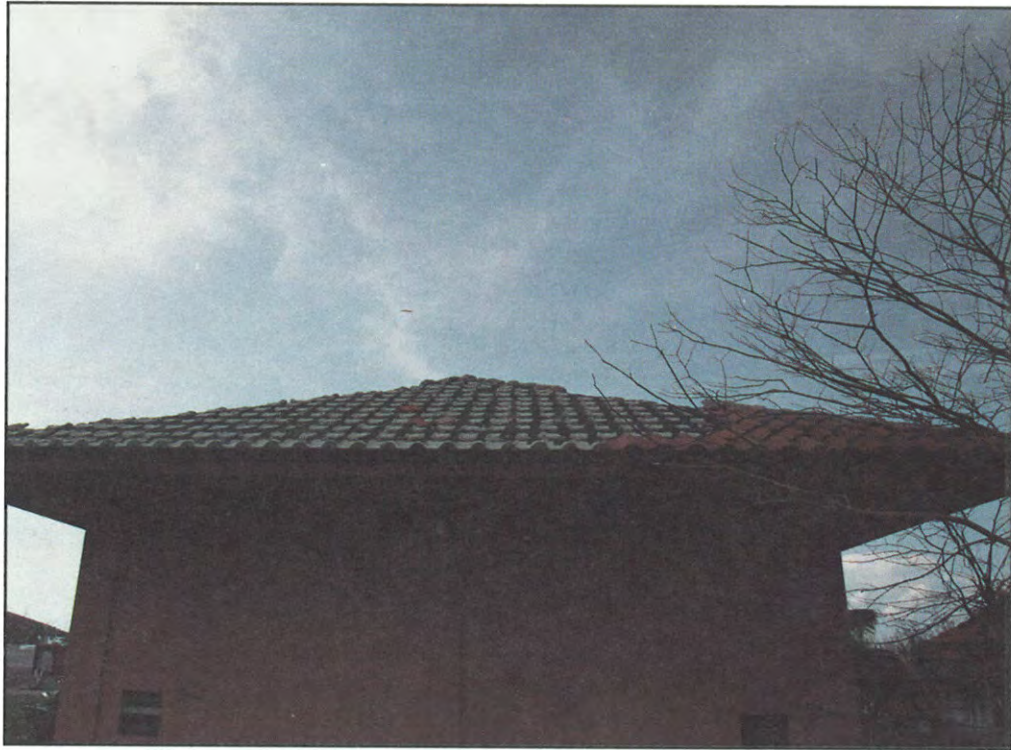
FIGURE 34. *Failure of "S" tile roofing. Bond failure between mortar and tile was observed.*

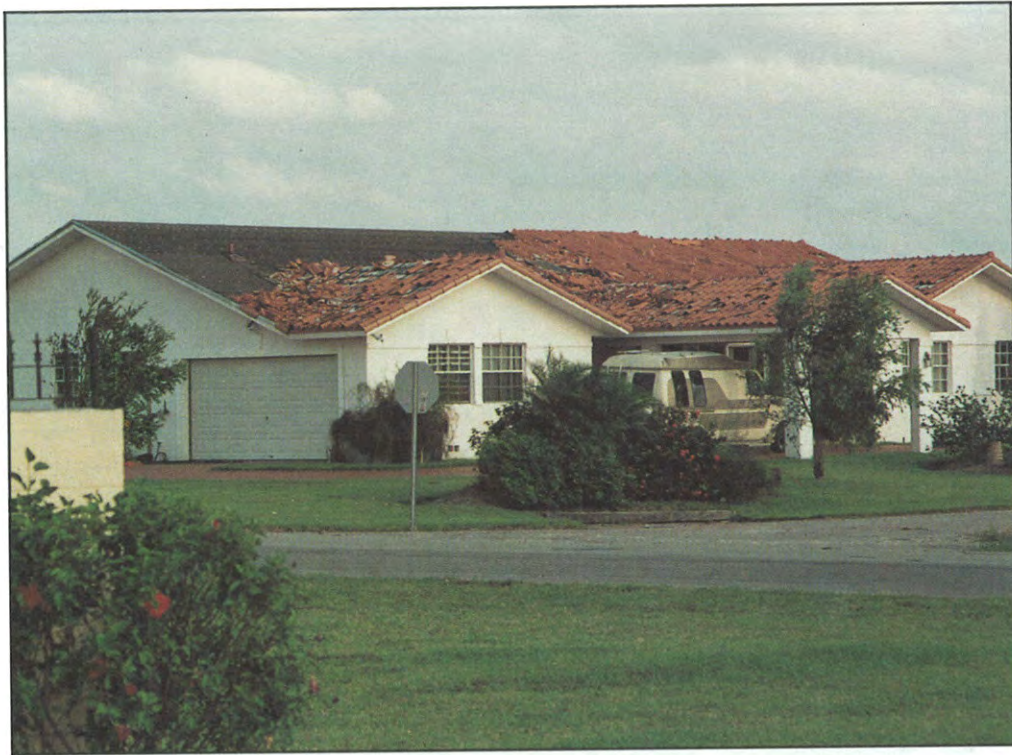
FIGURE 36. *Failure of barrel tile roofing. Bond failure between underlayment and mortar and between mortar and tile was observed.*

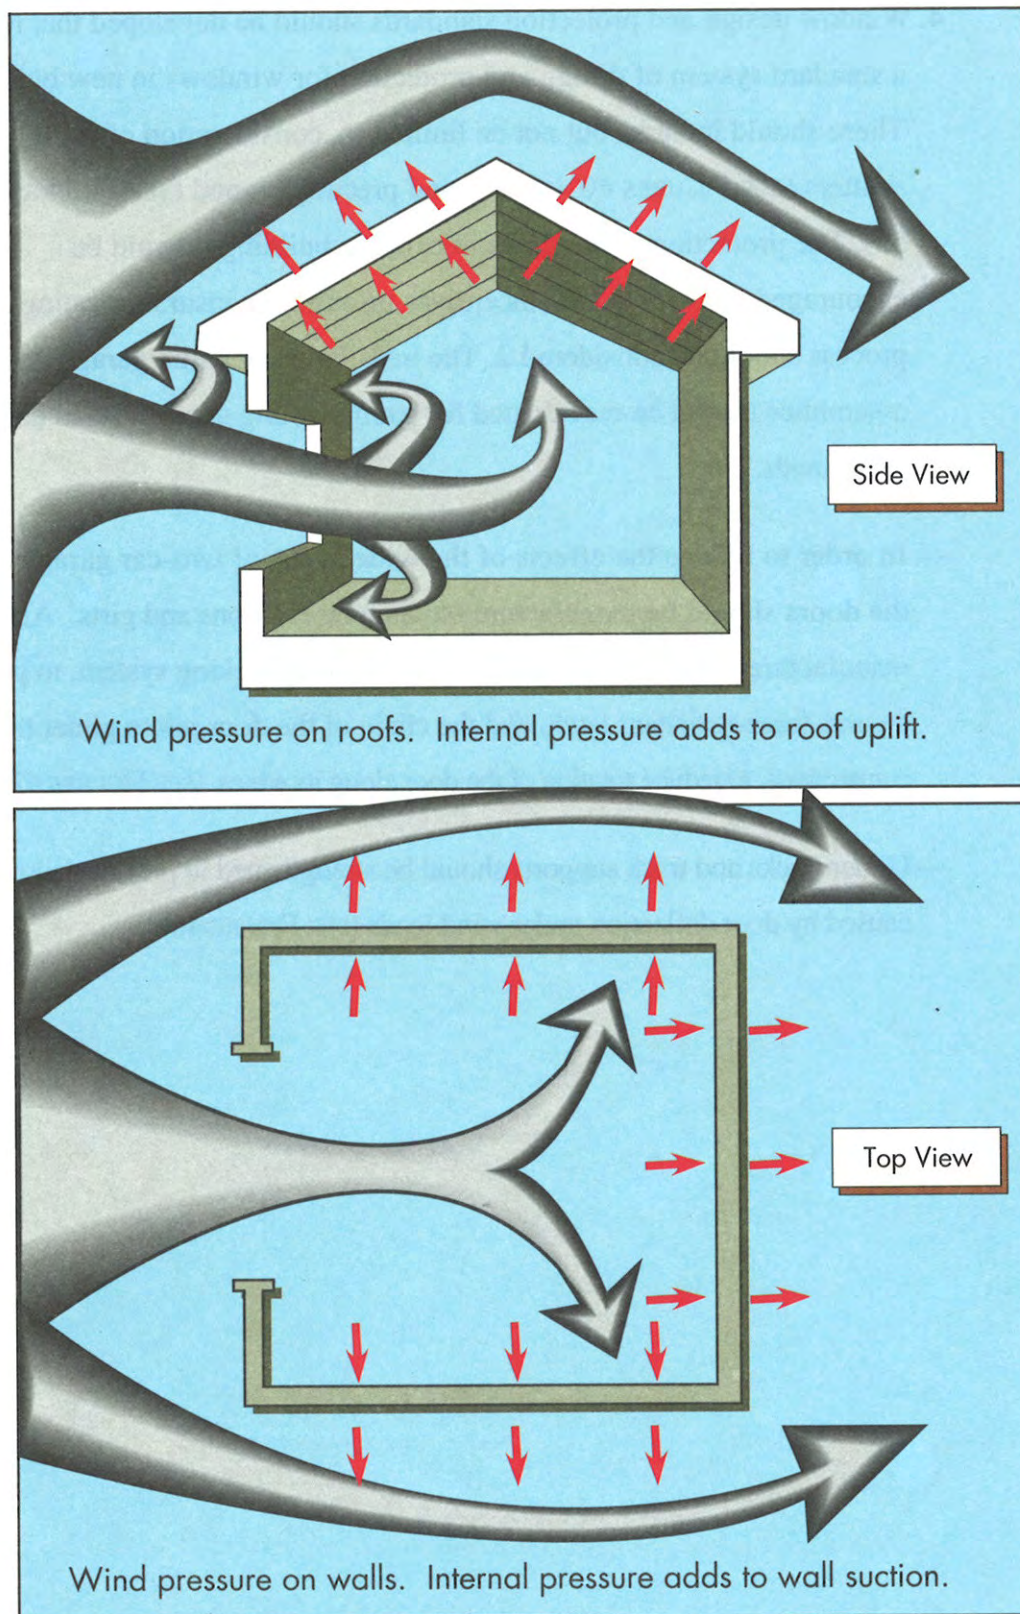
FIGURE 41. Results of building envelope breach due to failure of external doors and windows.

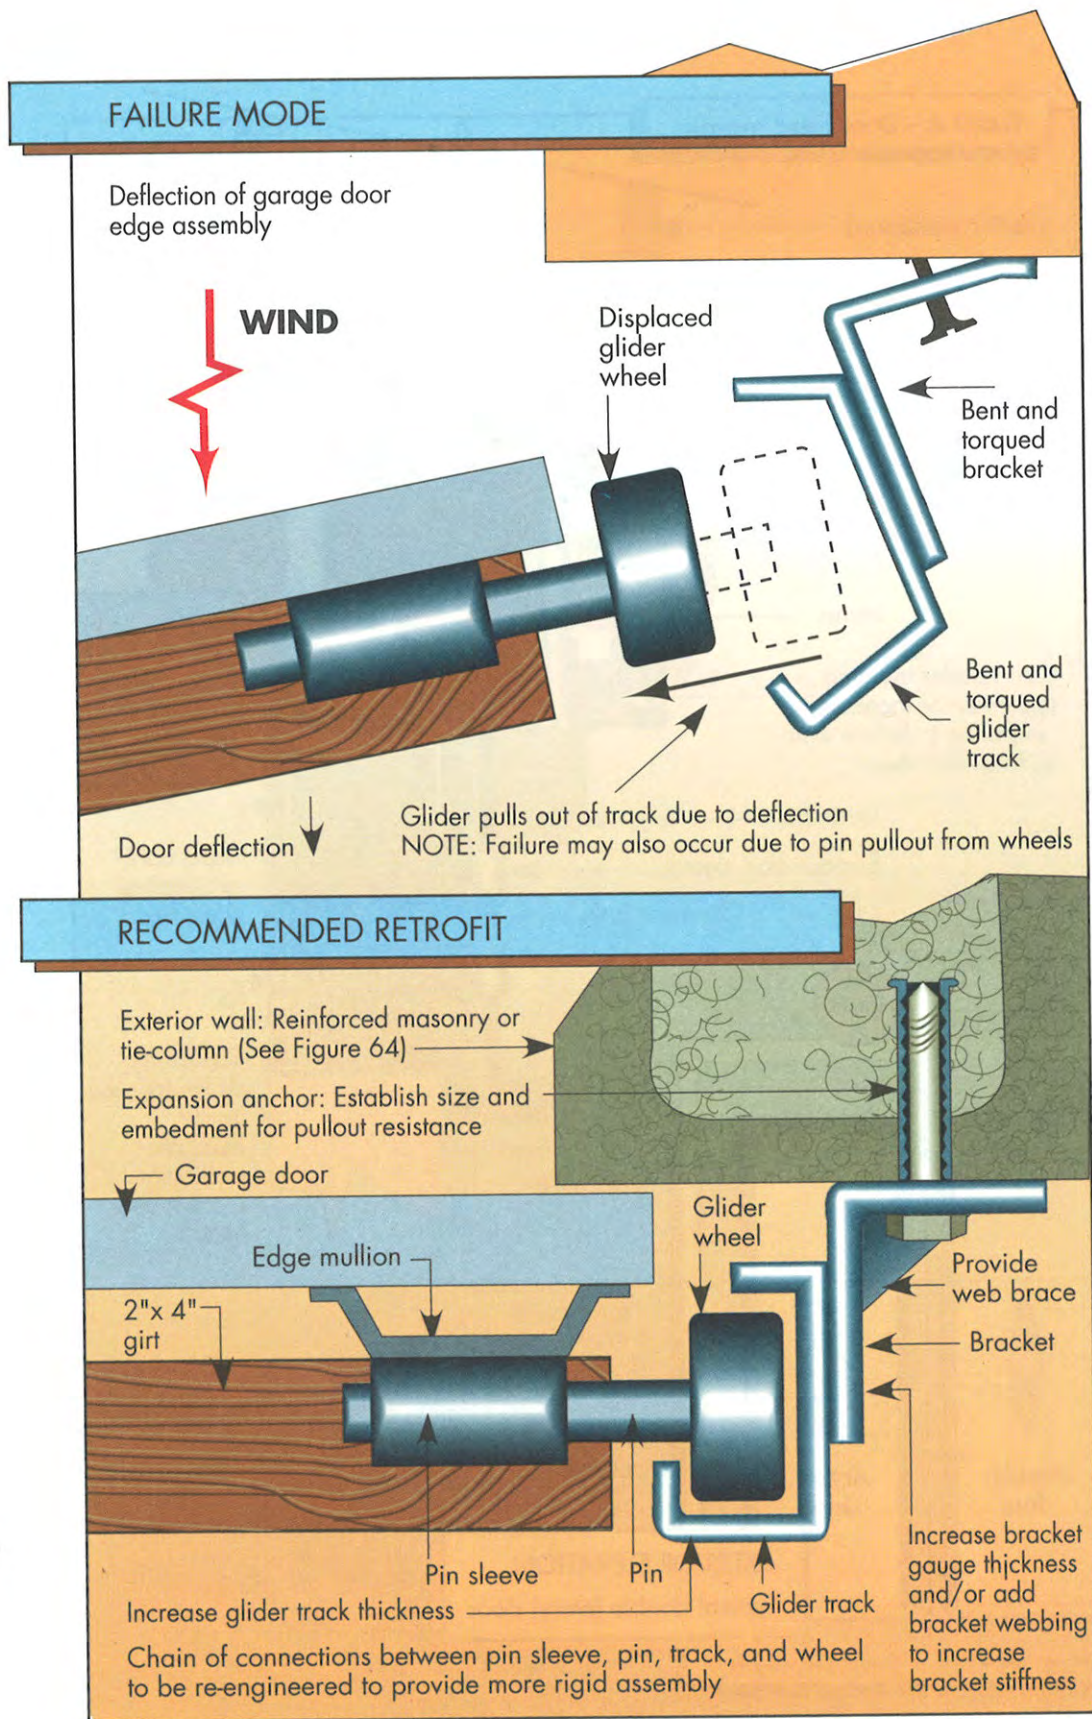
FIGURE 46. Detail B—Garage door failure at edge and recommended assembly improvements.

- Glider tracks and track supports should be strengthened to prevent failure caused by door deflection under wind loads (SEE FIGURE 46).

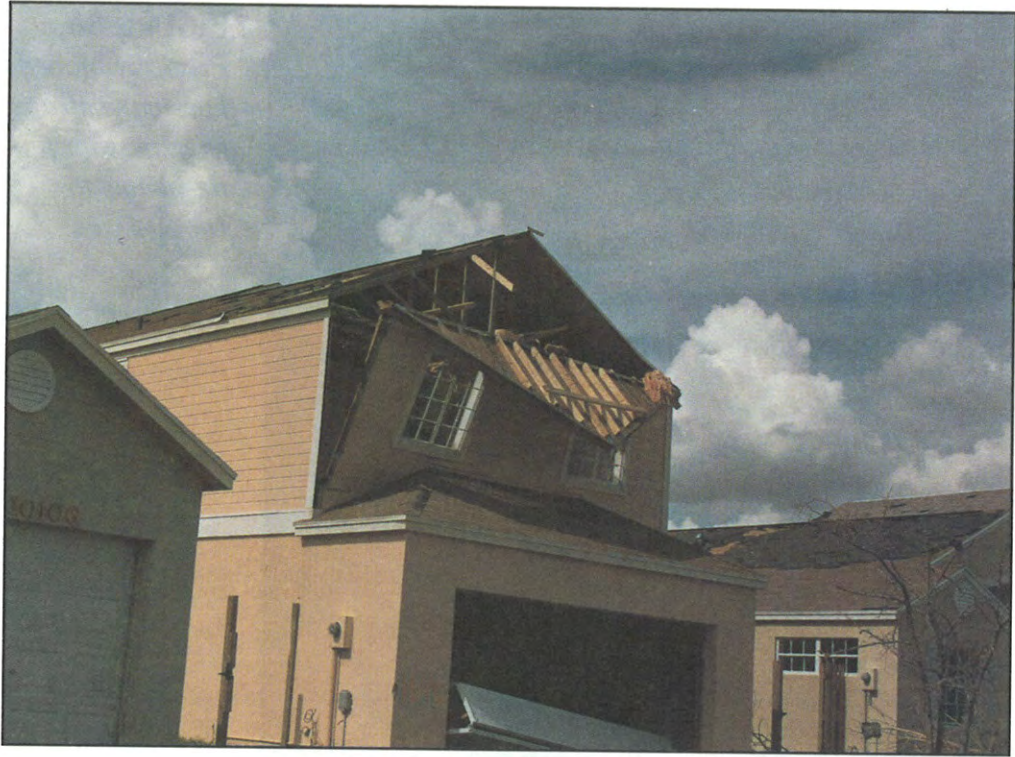
FIGURE 58. *End wall failure. Example of lack of load transfer capacity after separation.*

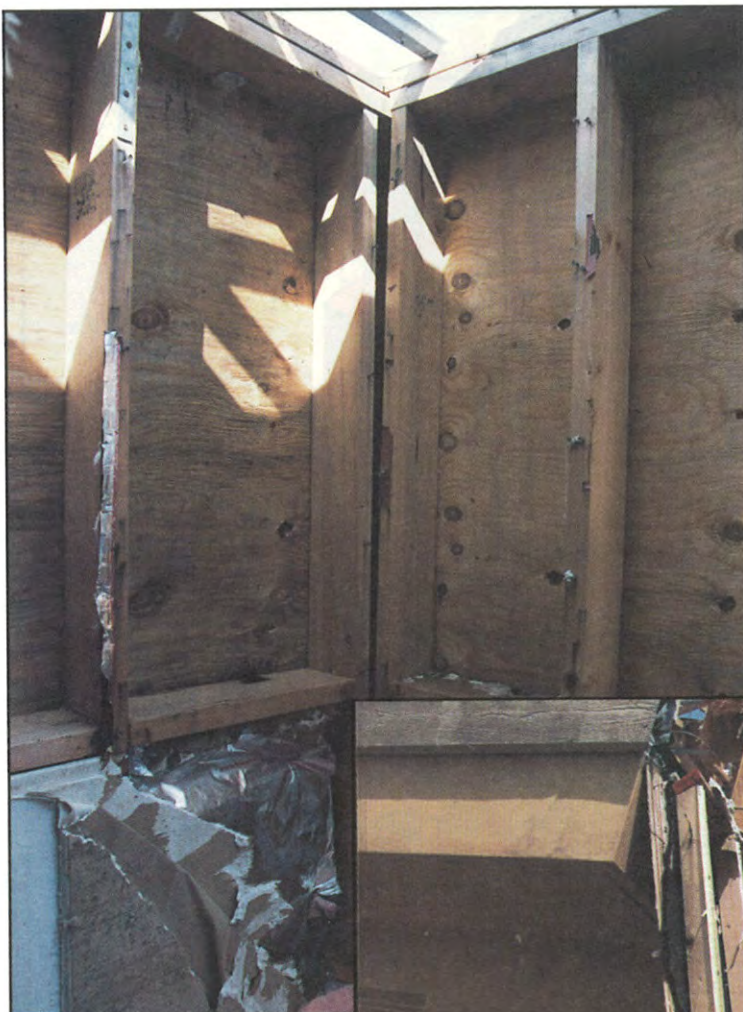
FIGURE 59.  
*End column/corner post  
missing from  
wall.*

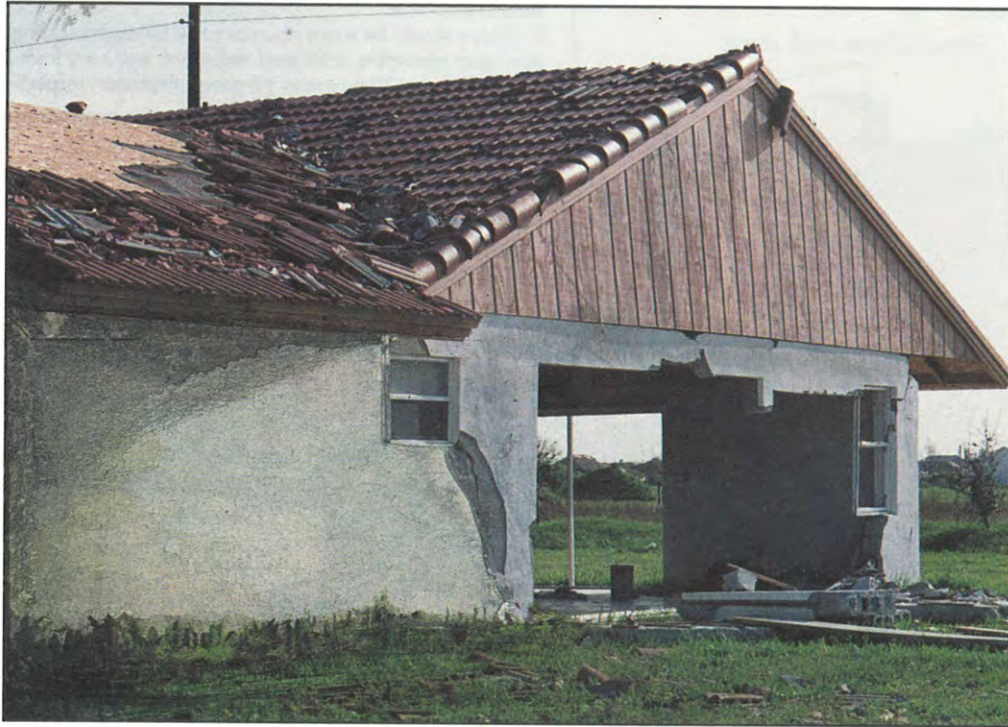
FIGURE 63. *Example of masonry construction. Wall separated from building envelope due to inadequate vertical wall reinforcing in connection to horizontal tie-beam.*
