# **BUILDING PERFORMANCE: HURRICANE ANDREW IN FLORIDA**

OBSERVATIONS, RECOMMENDATIONS,  
AND TECHNICAL GUIDANCE

FEDERAL EMERGENCY MANAGEMENT AGENCY  
FEDERAL INSURANCE ADMINISTRATION

**DECEMBER 21, 1992**

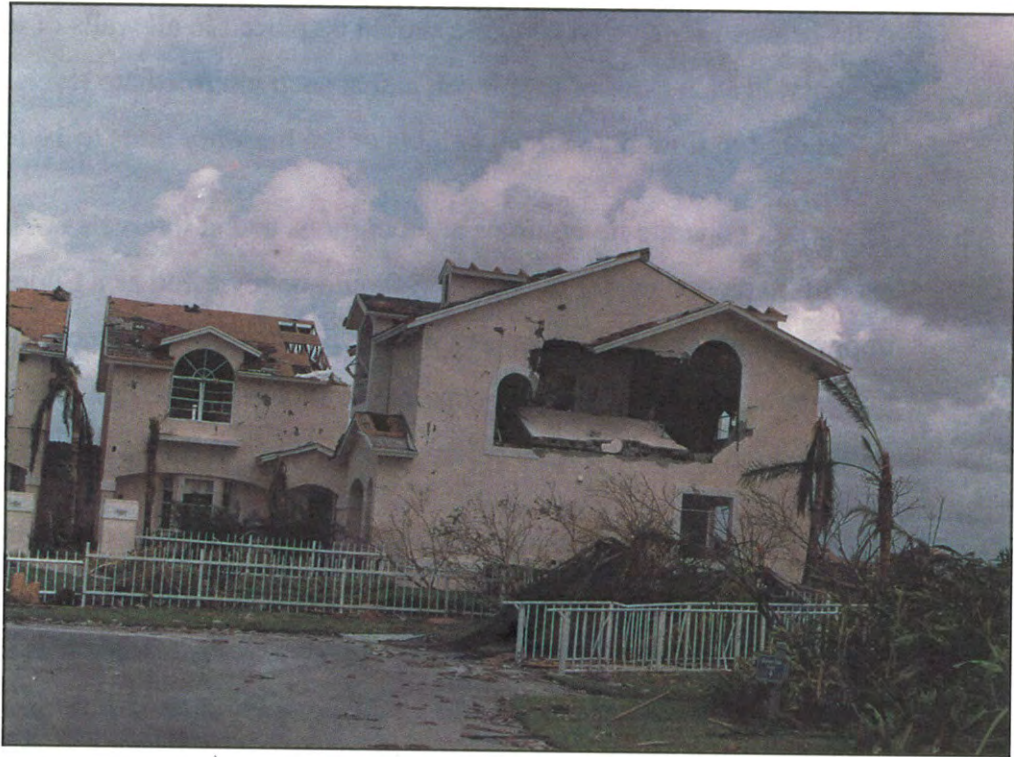
FIGURE 65. *End wall failure. Freestanding concrete masonry wall has discontinuous tie-beam.*

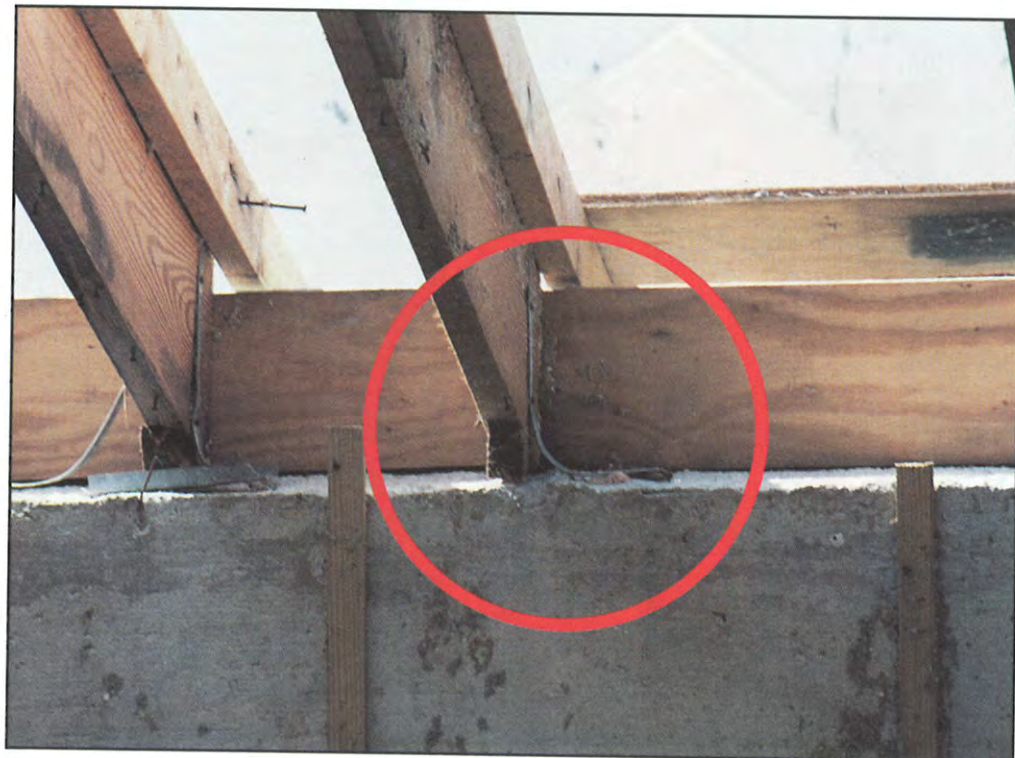
FIGURE 70. Improperly located masonry-wall-to-wood-frame straps.

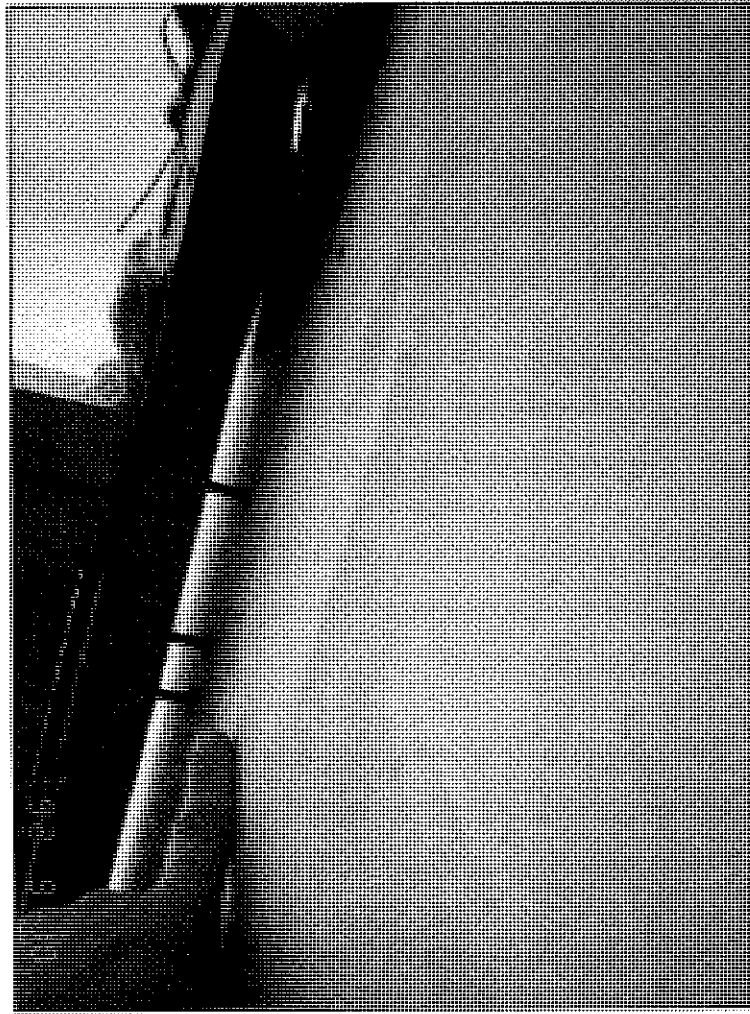
FIGURE 71. *Modular home. Partial separation of end panel (right) from roof structure (left). Evidence of failure due to nail withdrawal.*
