BUILDING PERFORMANCE: HURRICANE INIKI IN HAWAII

OBSERVATIONS, RECOMMENDATIONS,
AND TECHNICAL GUIDANCE

FEDERAL EMERGENCY MANAGEMENT AGENCY
FEDERAL INSURANCE ADMINISTRATION

JANUARY 29, 1993

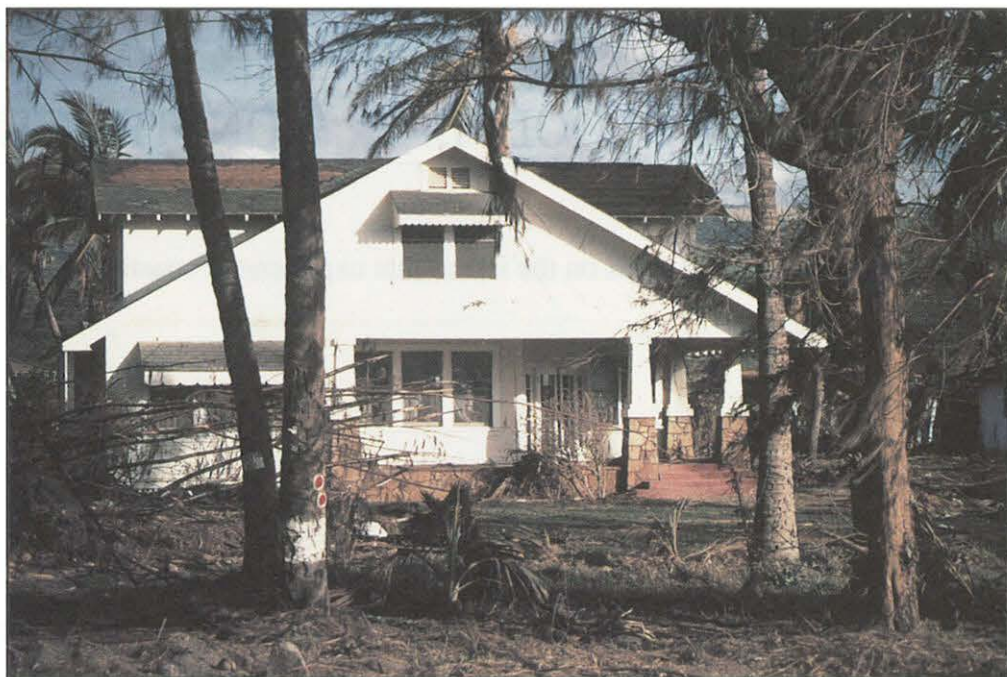
- The lowest floors of some buildings were elevated above the ground surface. While the elevation was only 2 to 3 feet above grade on a crawlspace foundation, it was sufficient in this area to prevent water from entering several homes (FIGURE 5).

FIGURE 5. *Flood damage to this coastal house in Kekaha was minimized because the house is elevated 2 to 3 feet off the ground and is located a considerable distance from the shoreline.*

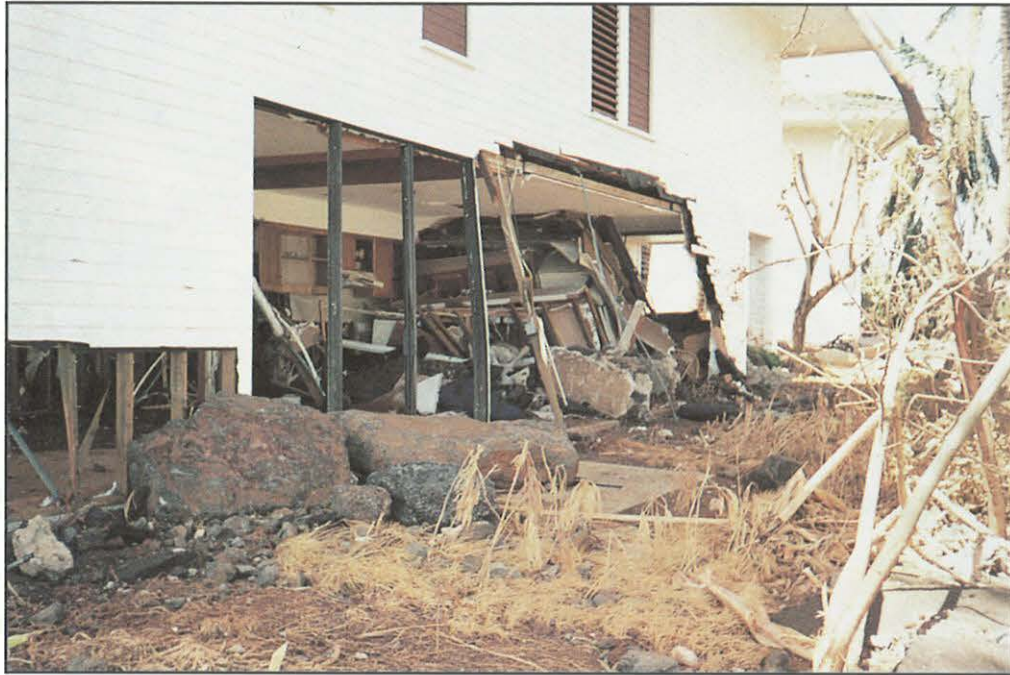
FIGURE 7. *Waterborne debris resulted in significant damage to non-elevated buildings along Poipu Beach.*

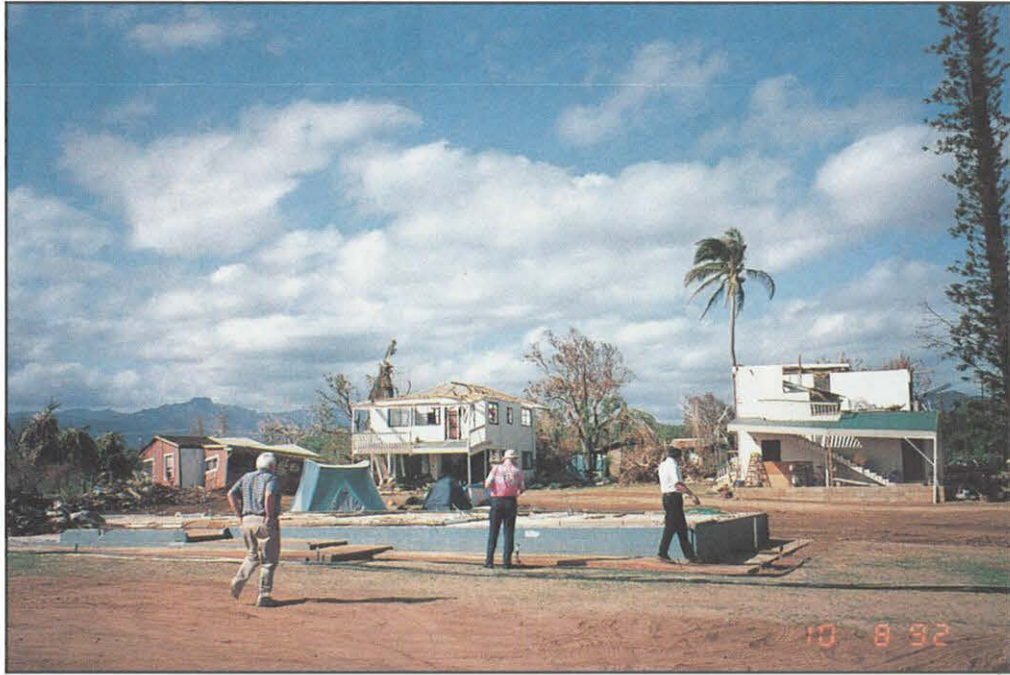
FIGURE 8. *Typical example of residential construction along Poipu Beach that was destroyed because it was not elevated above the flood hazard.*

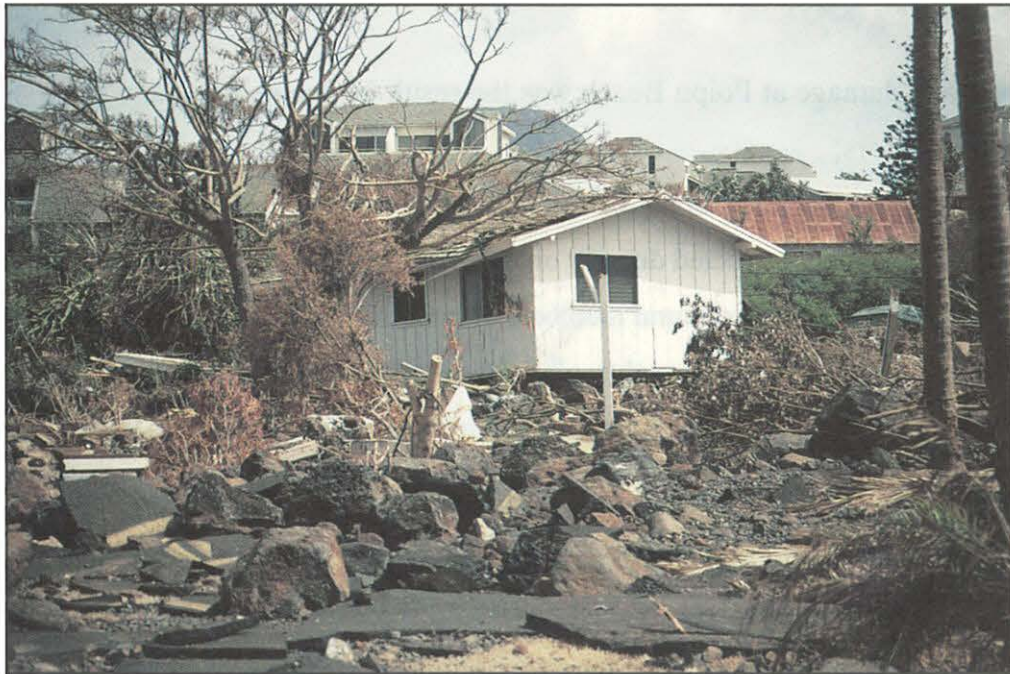
FIGURE 9. *Non-elevated house at Poipu Beach that floated off its foundation and was transported well inland.*

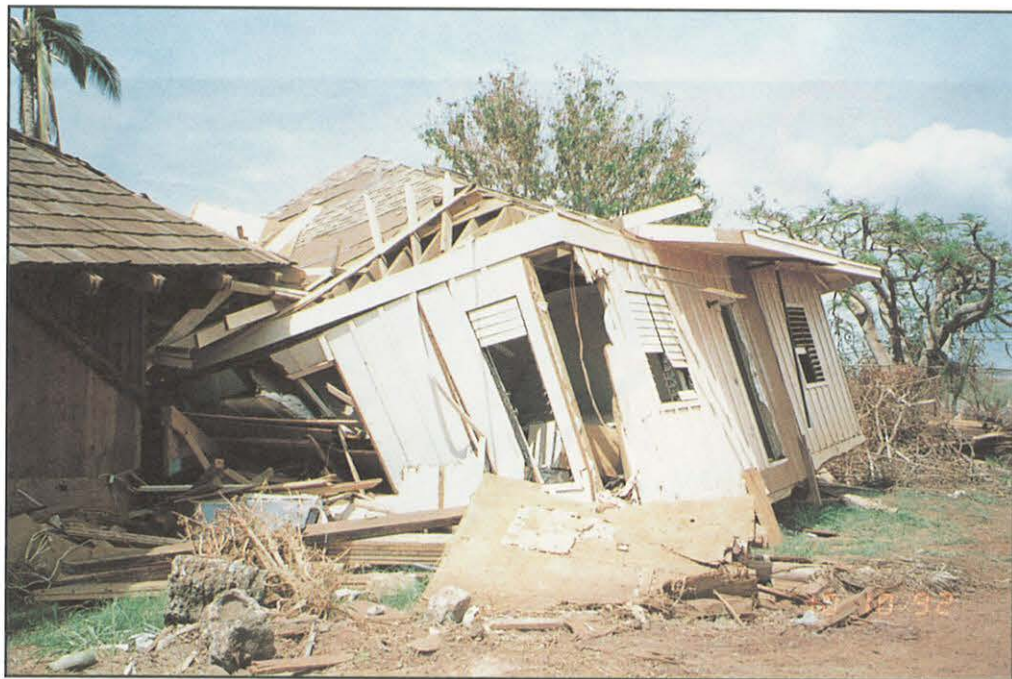
FIGURE 10. *Non-elevated house at Poipu Beach that floated off its foundation was pinned against another house and destroyed by waves.*

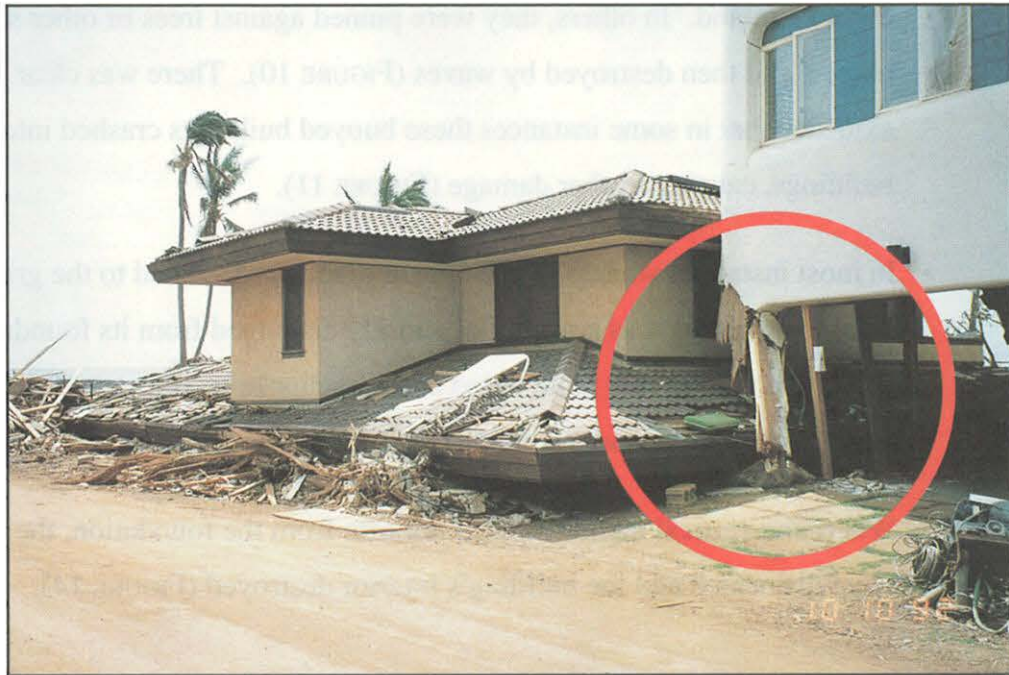
FIGURE 11. *Non-elevated building at Poipu Beach that rammed and increased damage to an adjacent building.*

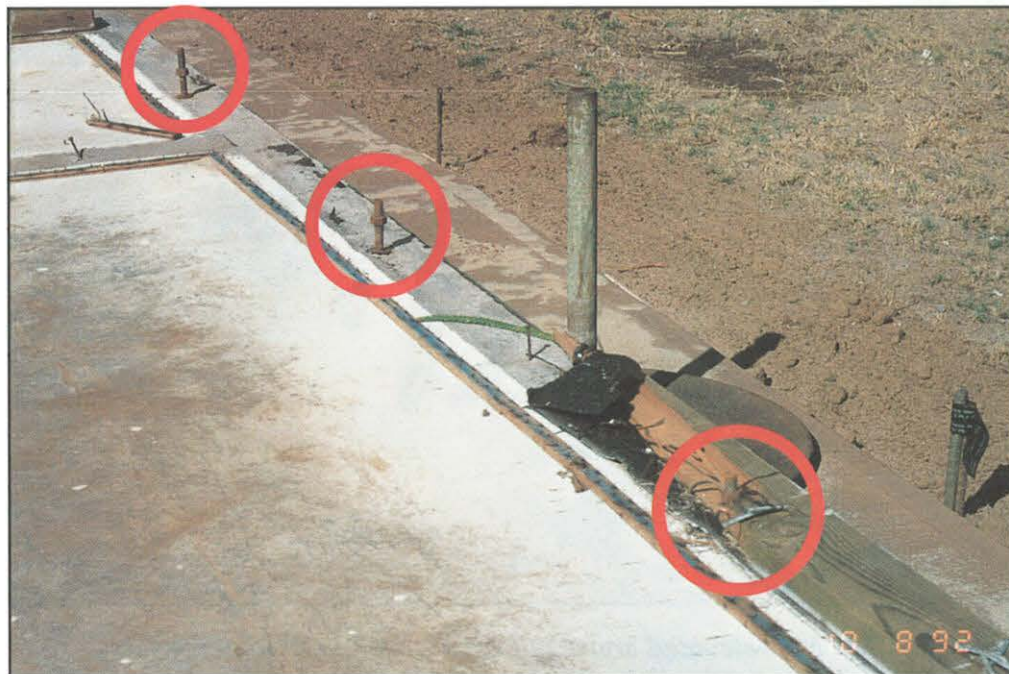
FIGURE 12. *Non-elevated building at Poipu Beach destroyed by coastal flooding. Sill plate ripped from anchor bolts.*

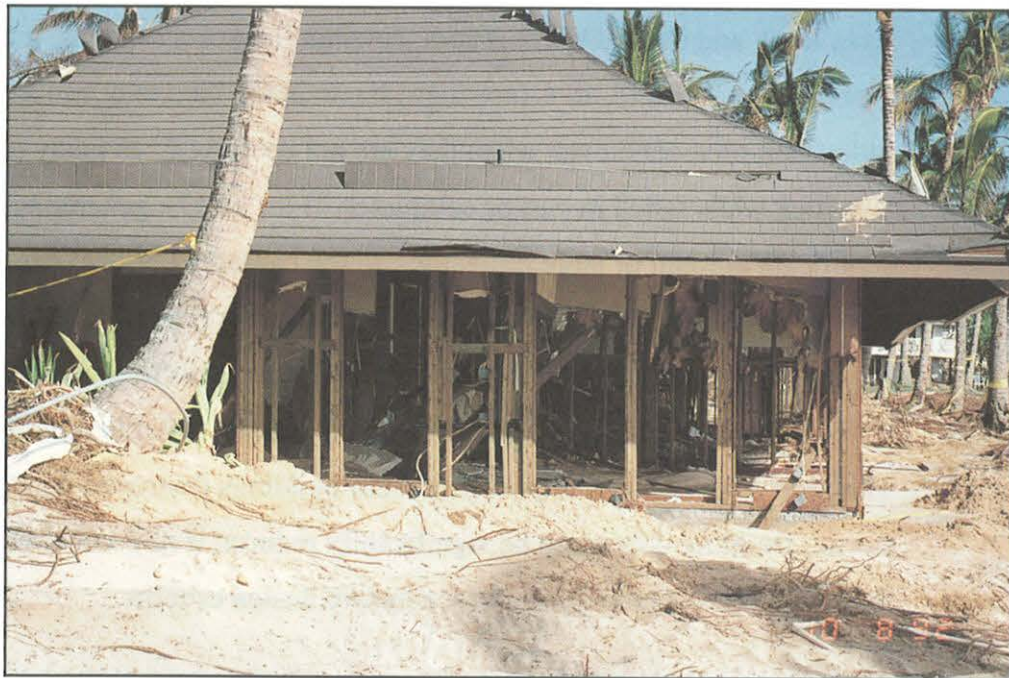
FIGURE 14. *Interior of non-elevated building at Poipu Beach destroyed by coastal flooding.*

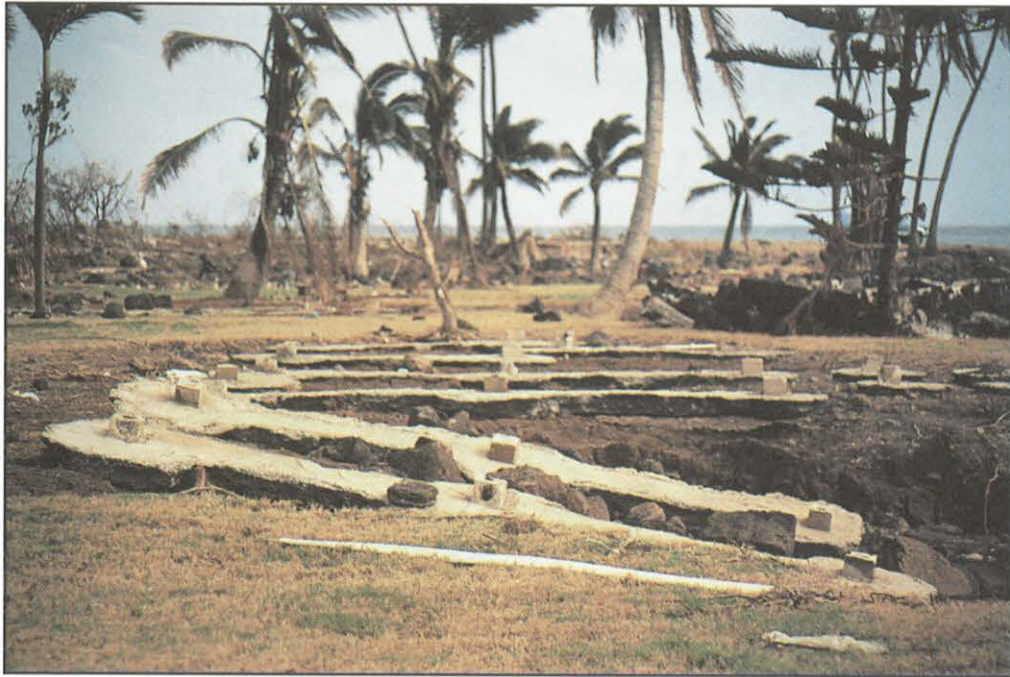
FIGURE 15. *Foundation at Poipu Beach undermined by erosion.*

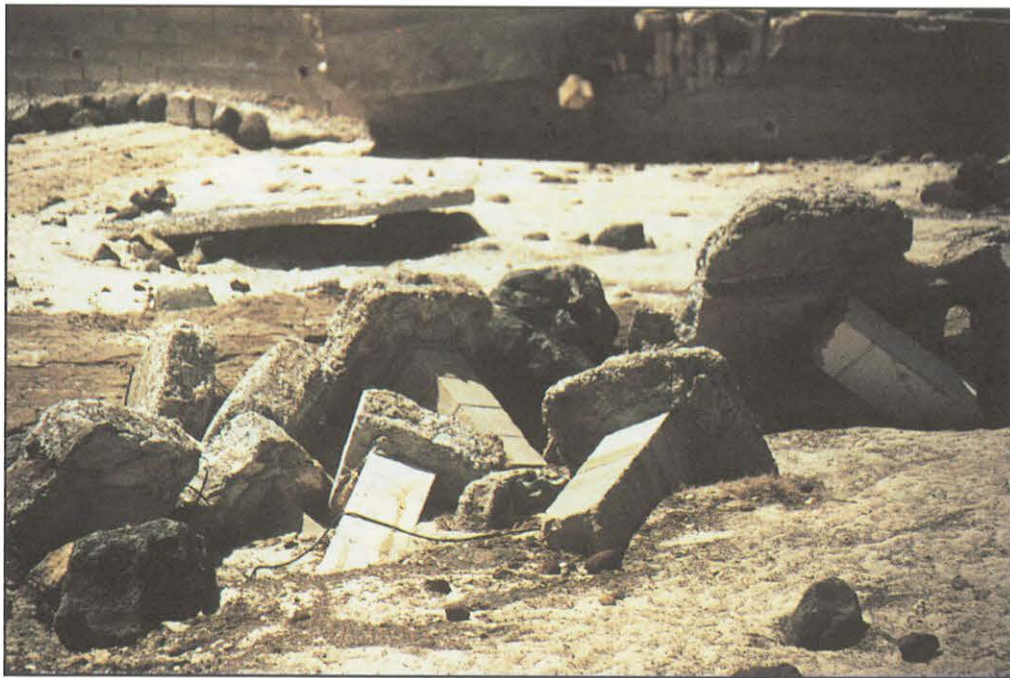
FIGURE 16. *Undermining of shallow pier foundation at Poipu Beach due to lack of sufficient embedment below erosion depth.*

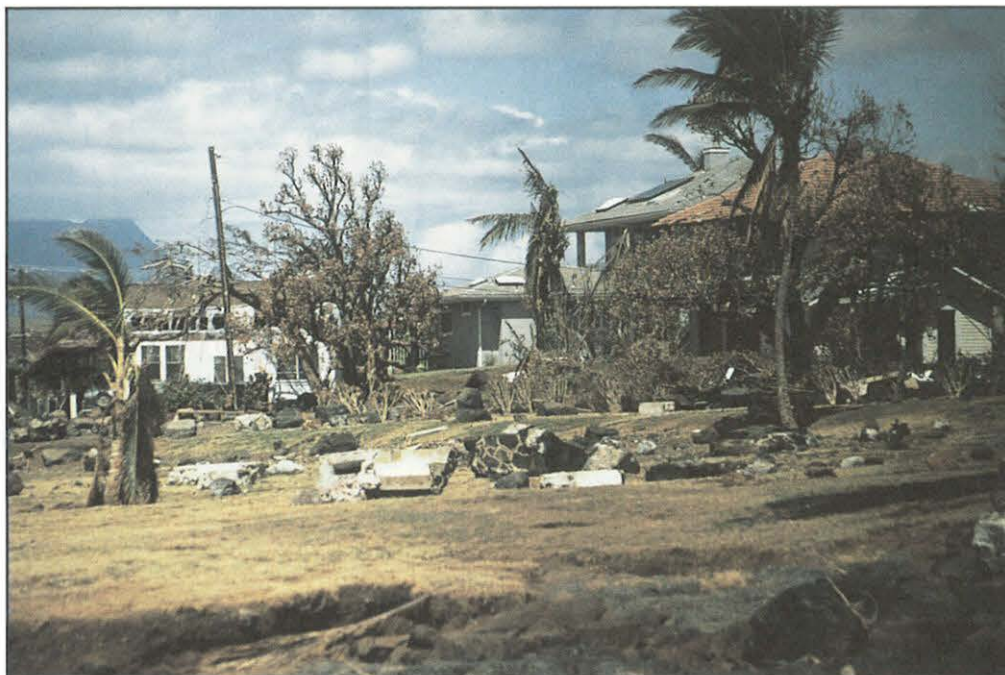
FIGURE 17. *Breakup of grouted lava rock walls at Poipu Beach generated waterborne projectiles.*

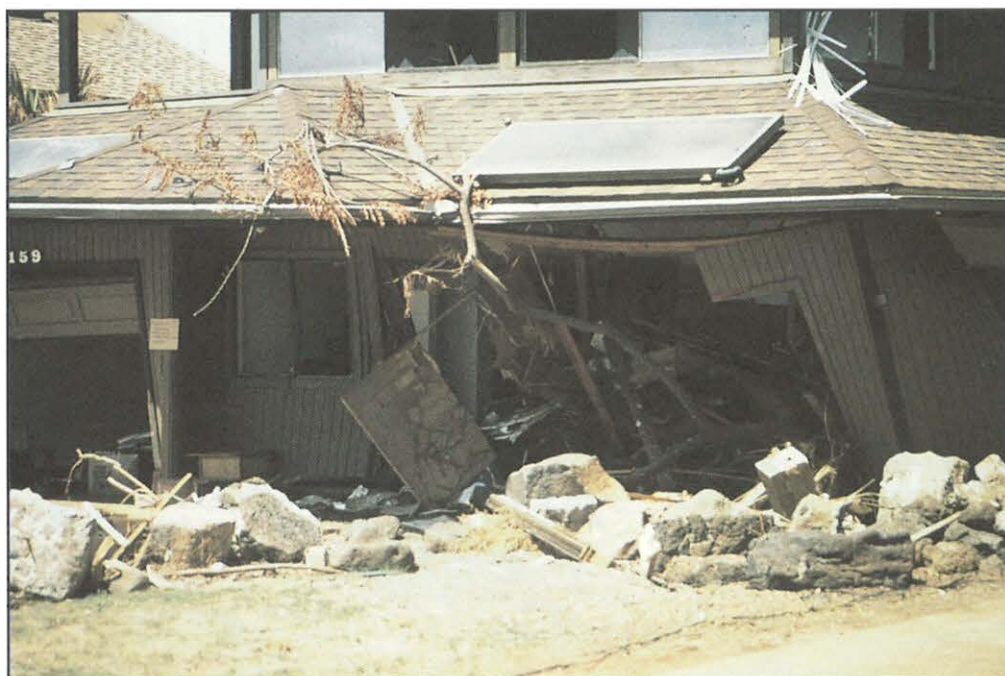
FIGURE 18. *Waterborne lava rock projectiles at Poipu Beach increased damage to non-elevated buildings.*

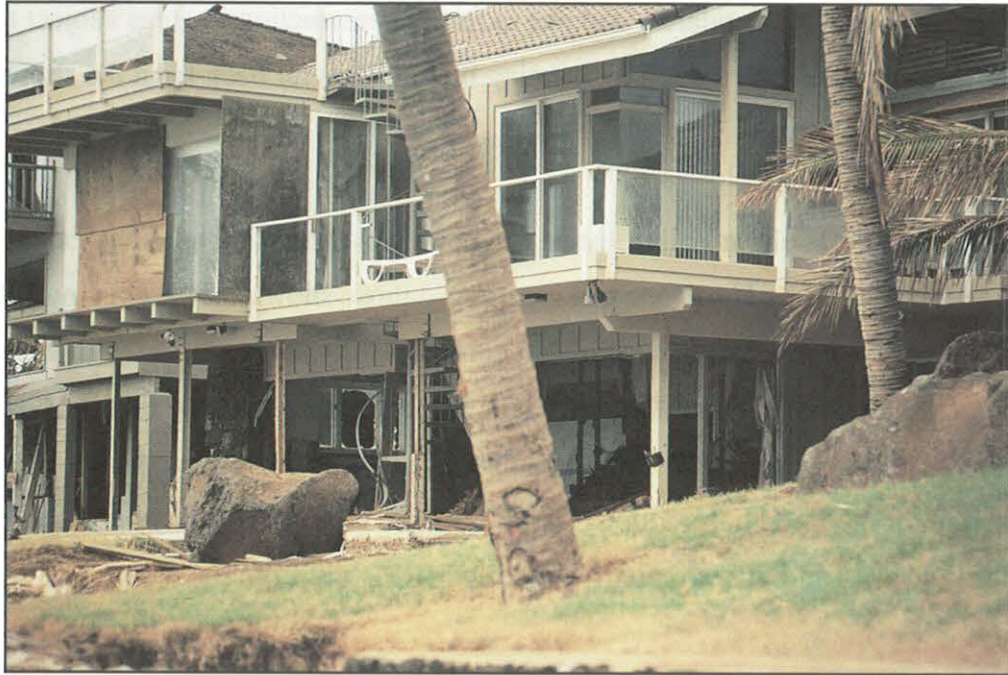
FIGURE 19. *Non-elevated buildings at Poipu Beach. Lower area gutted; upper area suffered much less flood damage. Note transported lava rock debris, which can cause additional damage.*

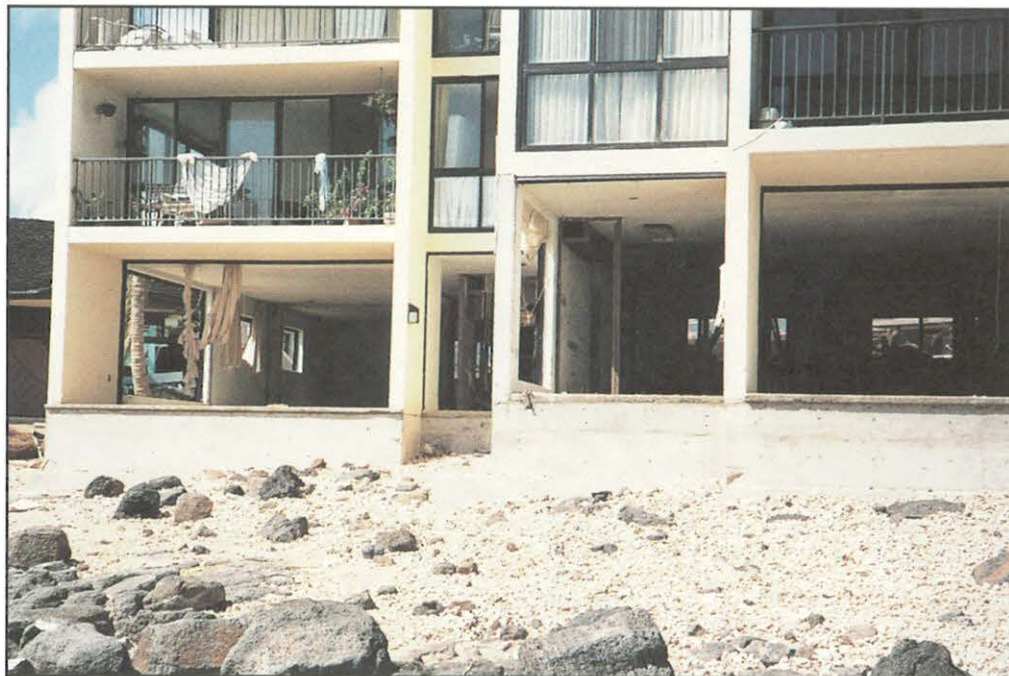
FIGURE 20. *Typical non-elevated condominium or hotel. Interiors of lower units destroyed; upper units suffered considerably less flood damage. Elevating a building's lowest floor and keeping lower areas clear to allow passage of velocity water can significantly reduce future flood damage.*

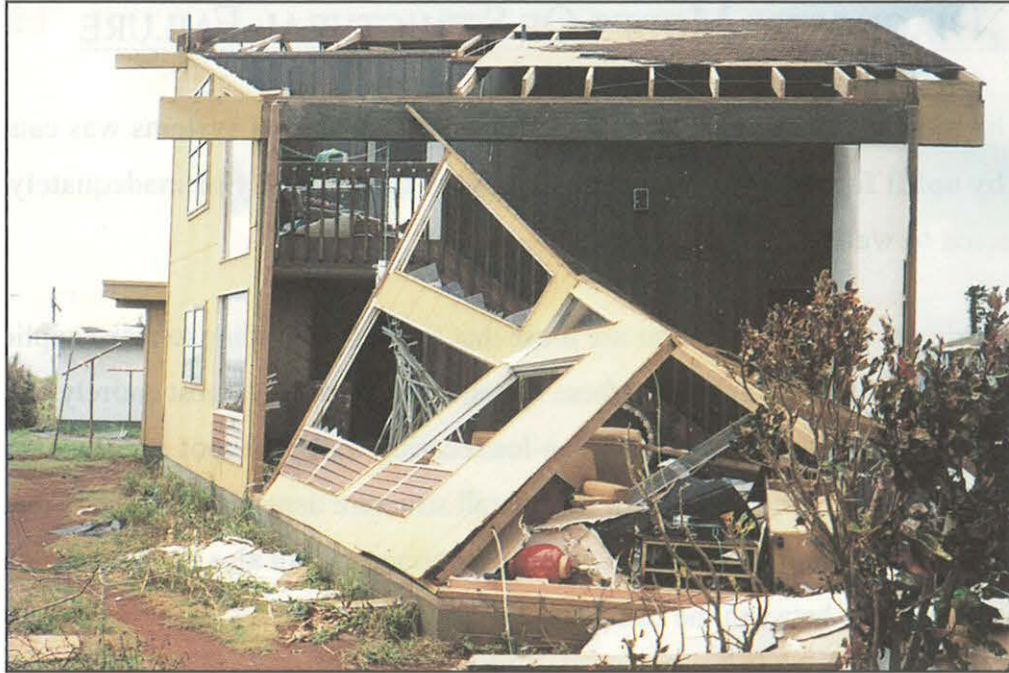
FIGURE 21. *Once the roof system is compromised, the ability of the wood-frame exterior walls to withstand external wind pressure is greatly diminished.*

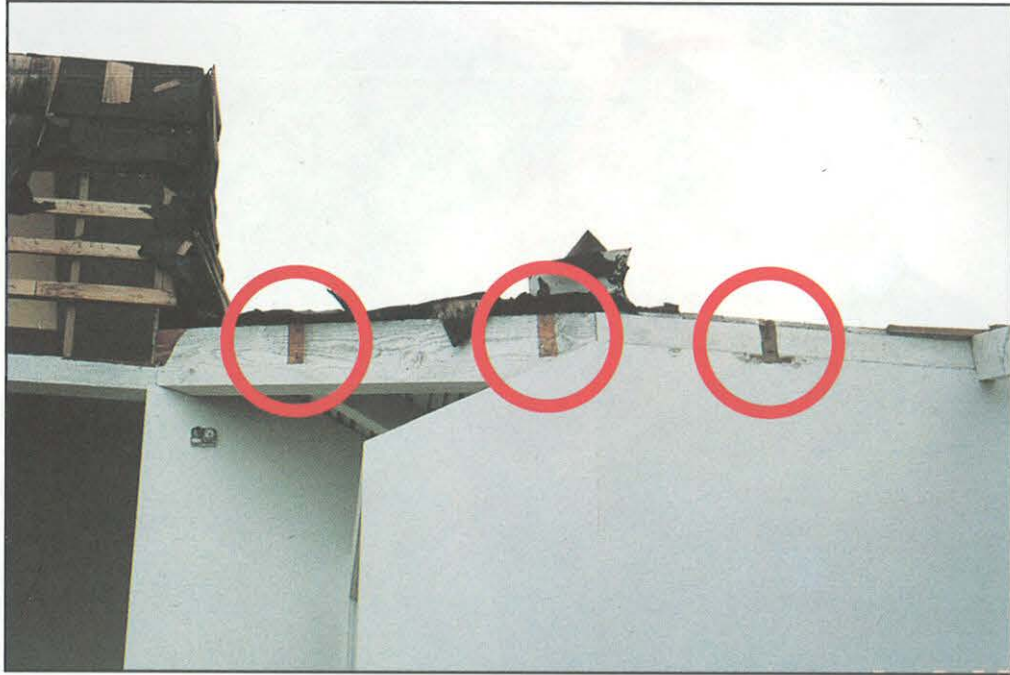
FIGURE 22. *Roof rafter construction with simple nailing or toenailing failed under uplift forces. Note two nails used to connect each rafter to hip beam.*

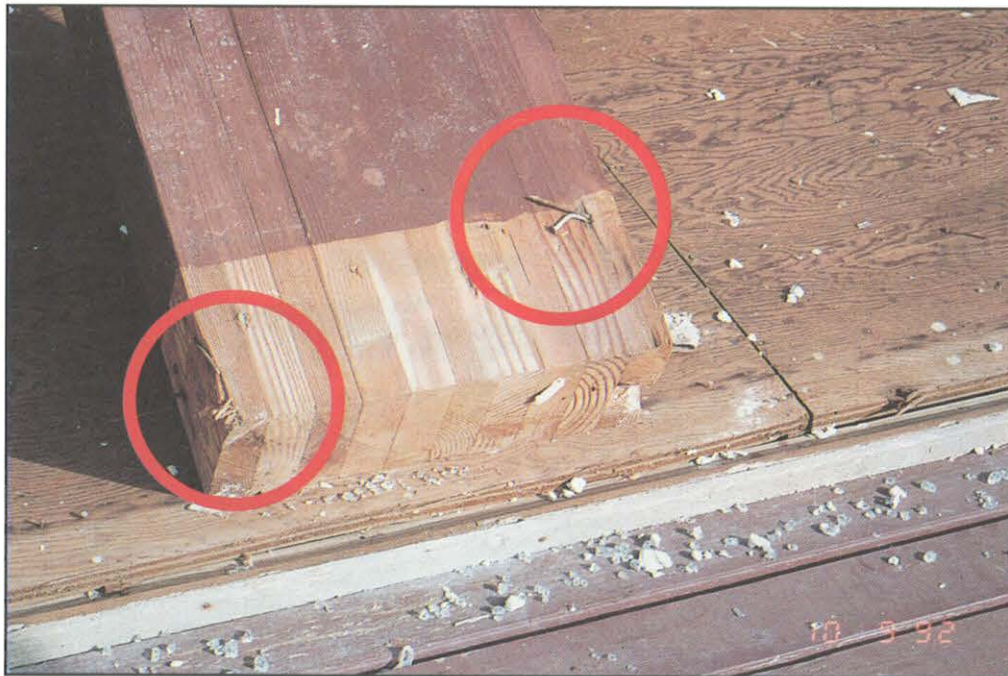
FIGURE 23. *Toenailing of ridge beam to gable-end support. Roof failure from uplift.*

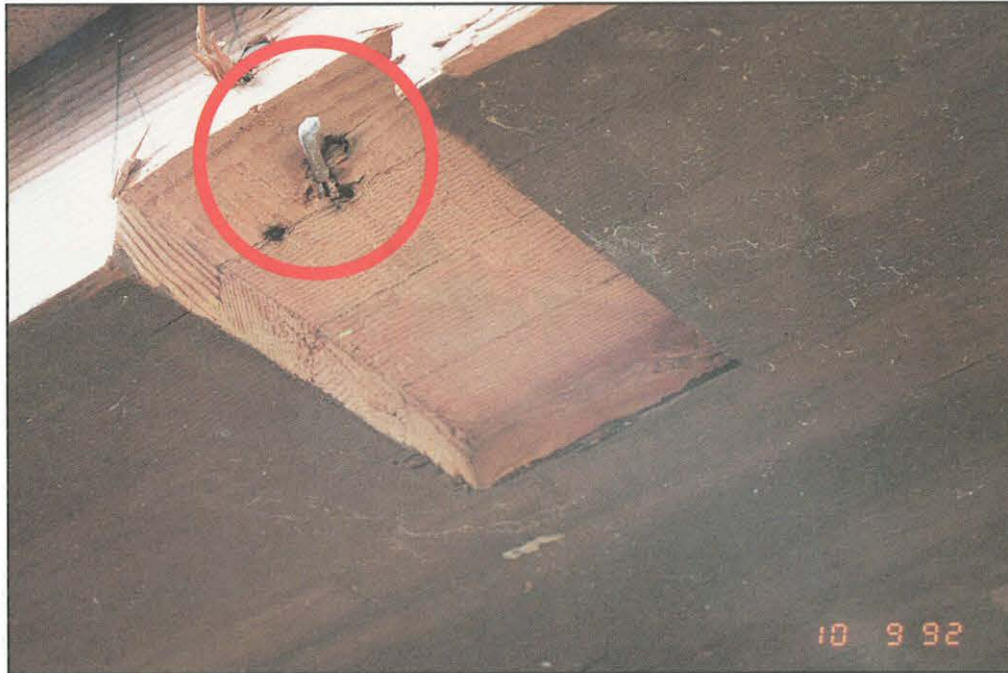
FIGURE 24. *Toenailing of rafter to ridge beam. Roof failure from uplift.*

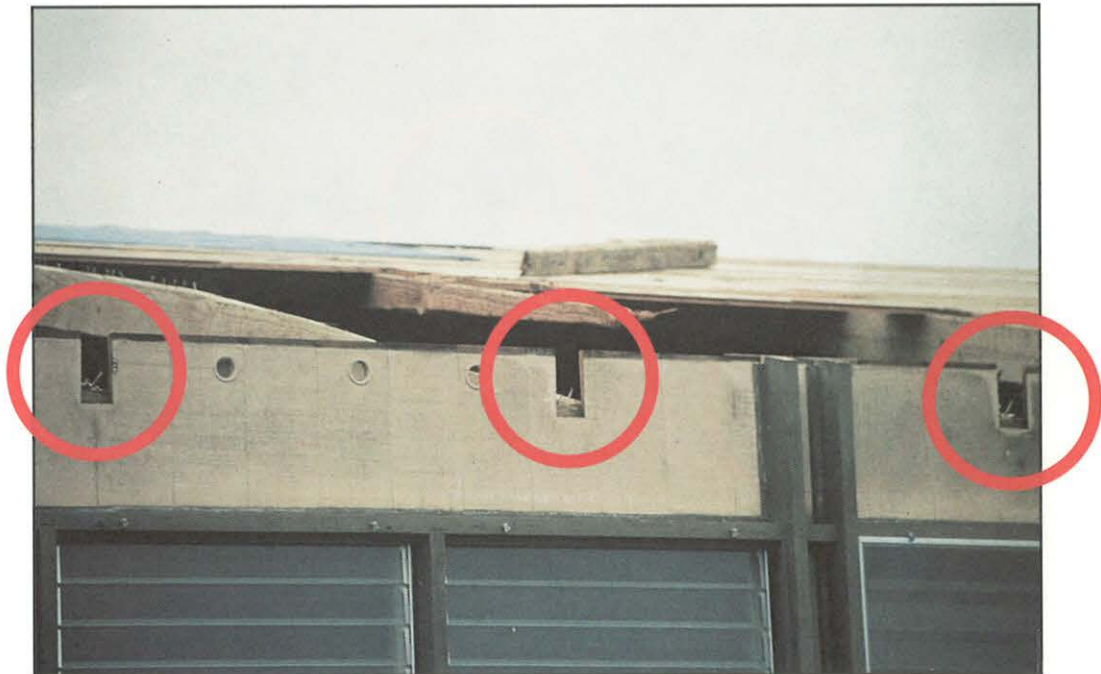
FIGURE 25. *Toenailing of roof rafters to wall system. At this critical connection, toenailing does not provide the load transfer path necessary to withstand uplift forces.*

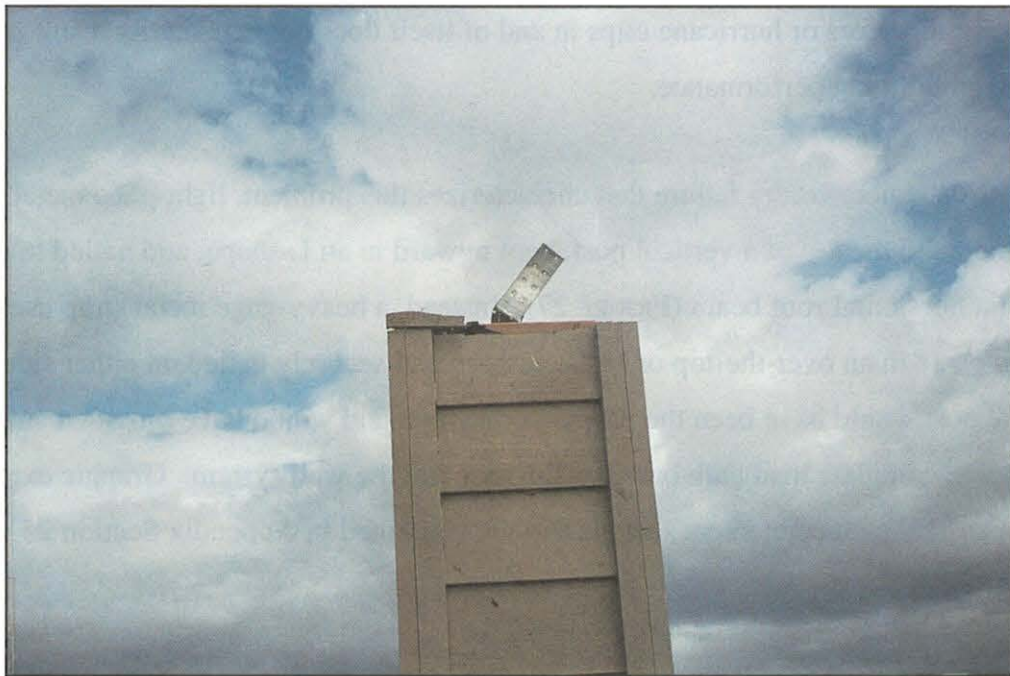
FIGURE 26. *Example of improperly sized and placed metal fastener, which led to roof failure from wind uplift forces.*

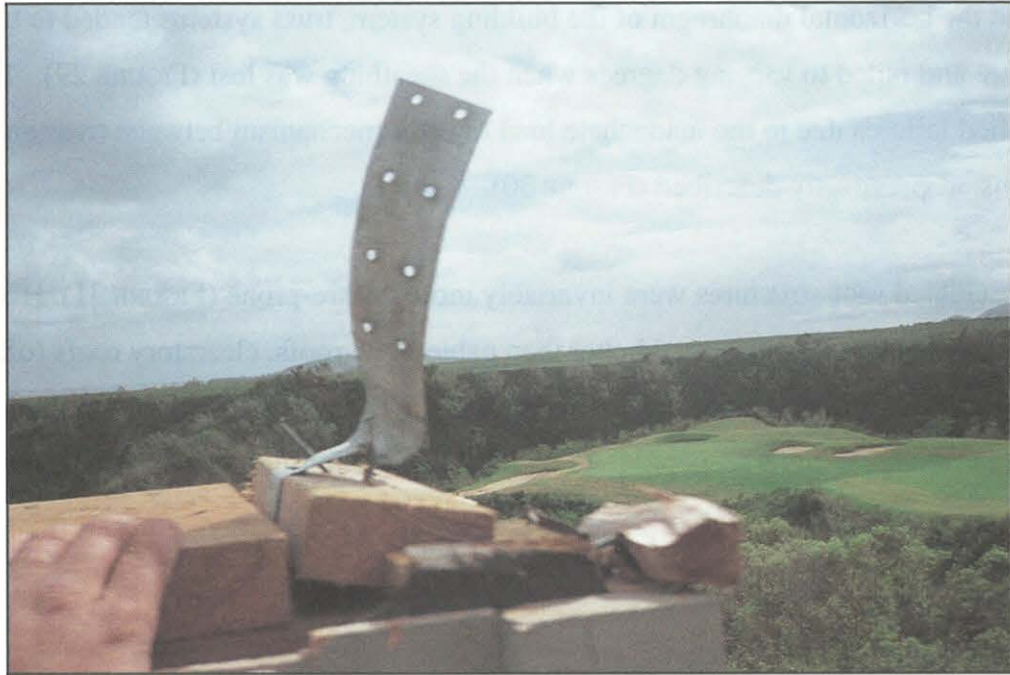
FIGURE 27. *Undersized and improperly attached metal fasteners led to roof damage from uplift forces.*

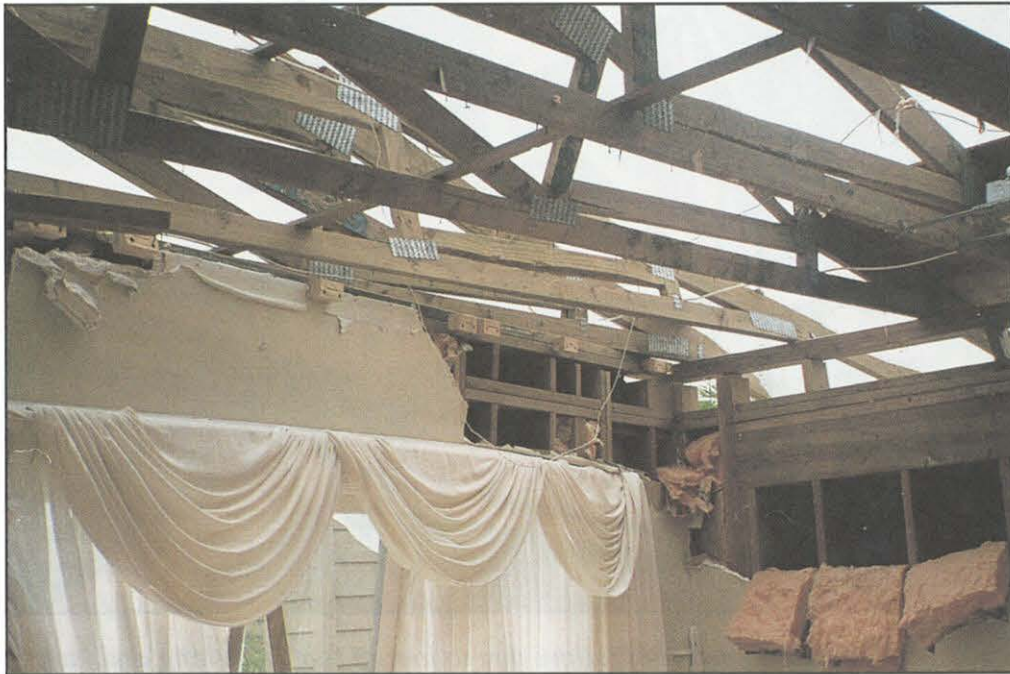
FIGURE 28. *Individual prefabricated wood roof trusses performed relatively well.*

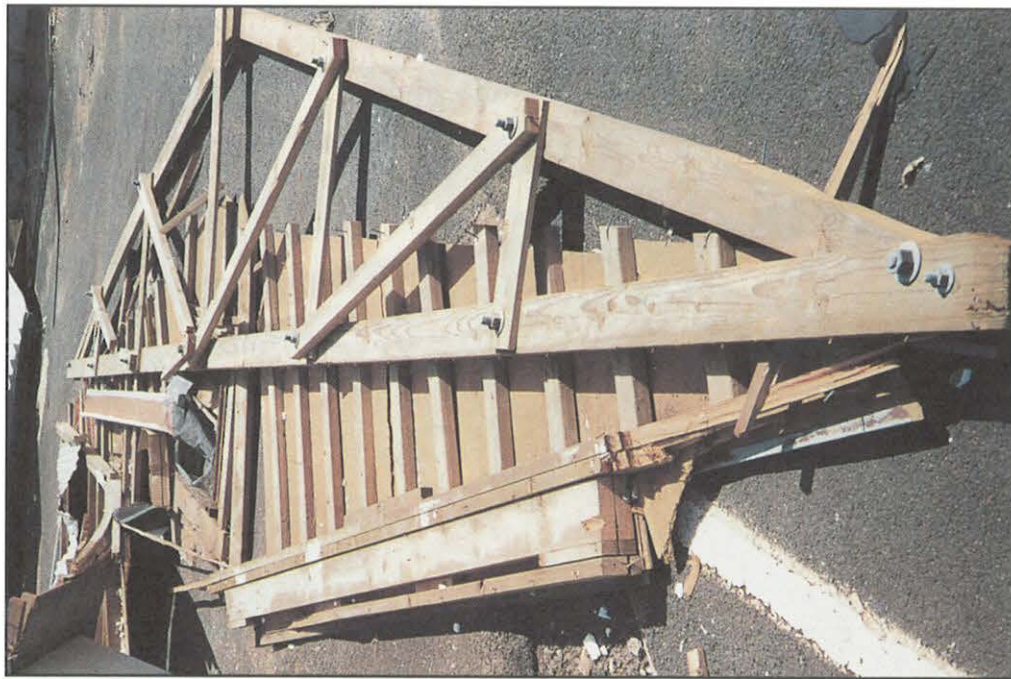
FIGURE 29. *Gable-end roof failure due to loss of roof sheathing and lack of gable bracing.*

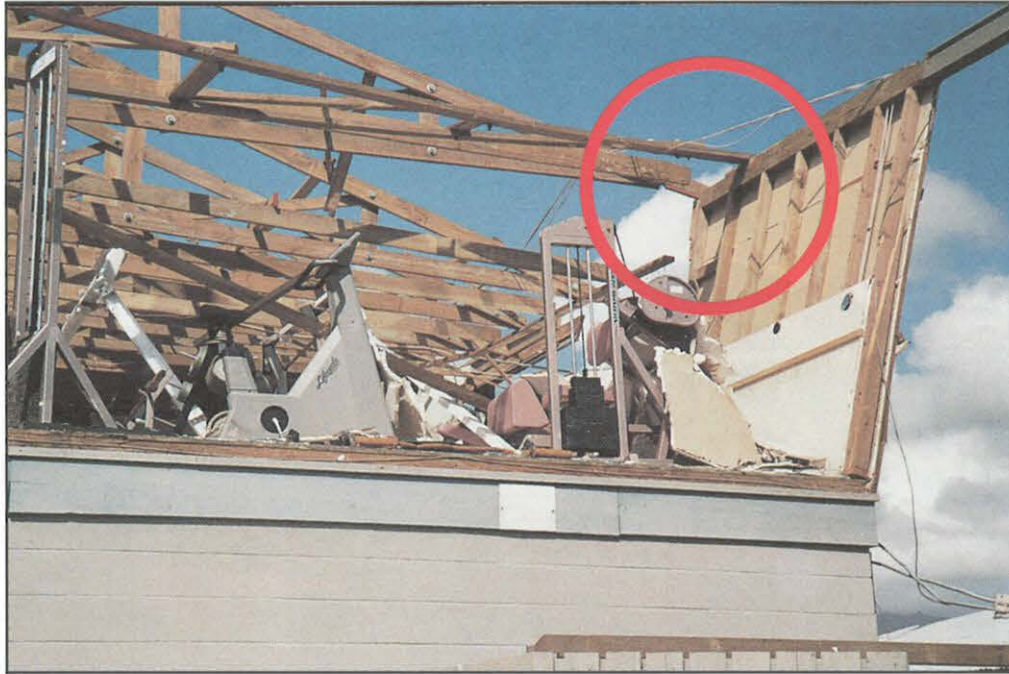
FIGURE 30. *Improper connection (toenailing) between roof trusses and wall systems. When roof sheathing was blown off by wind, unbridged trusses failed, as did the exterior wall.*

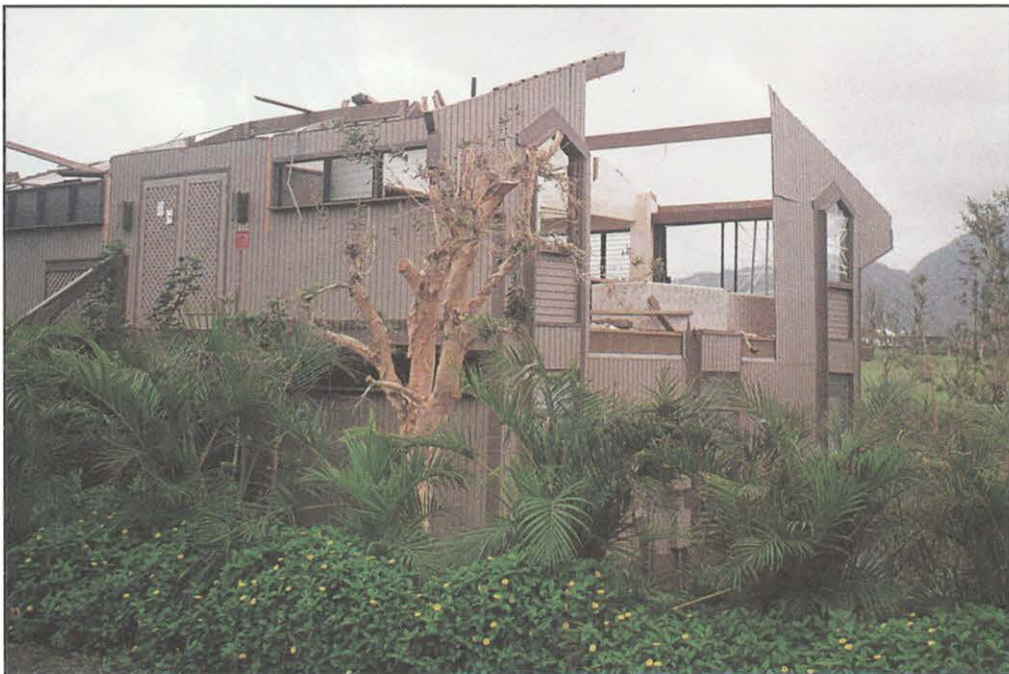
FIGURE 31. *Gable-end roof designs tended to be more failure-prone.*

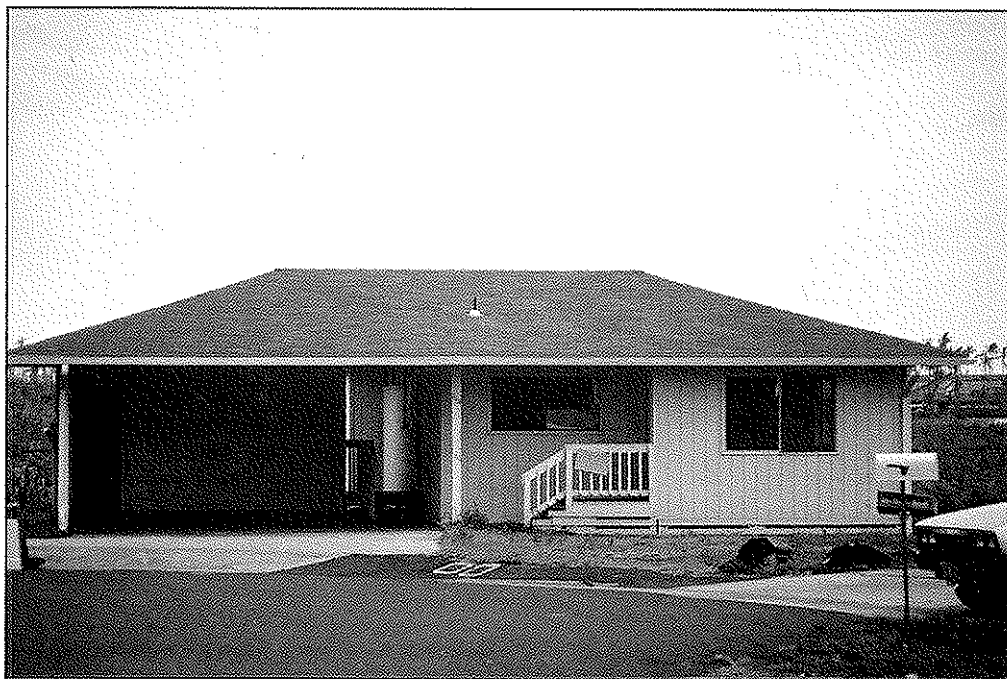
FIGURE 32. *Low-pitched hip roofs are aerodynamically superior and generally performed better than steeply pitched gable-end roofs.*

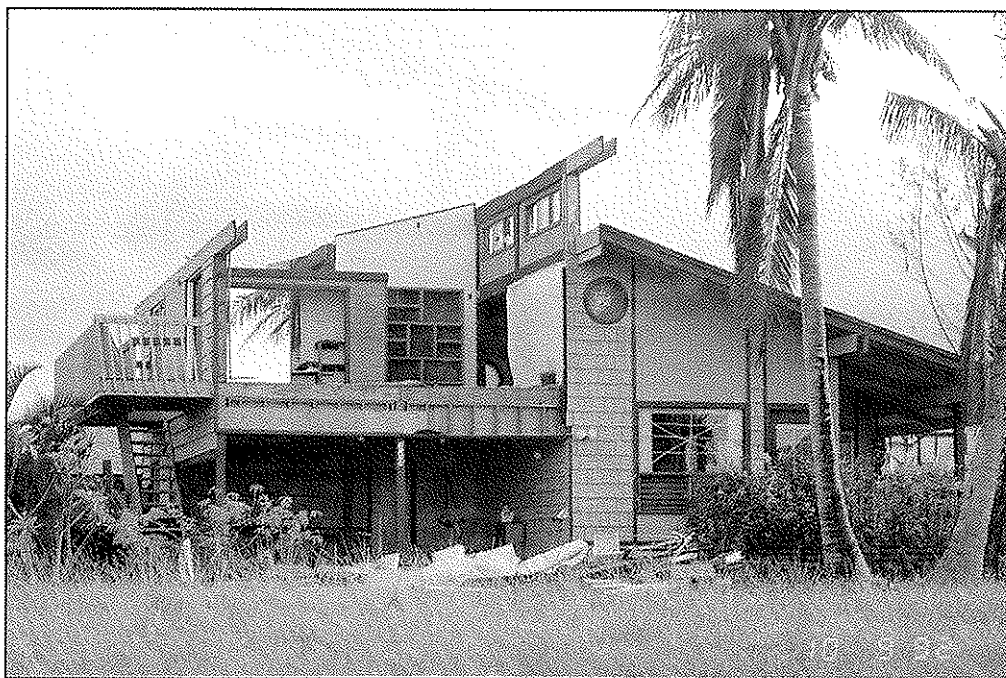
FIGURE 33. *Offset roof peak provides geometric discontinuity and results in greater localized wind-induced pressure, which can lead to roof and then wall failure.*

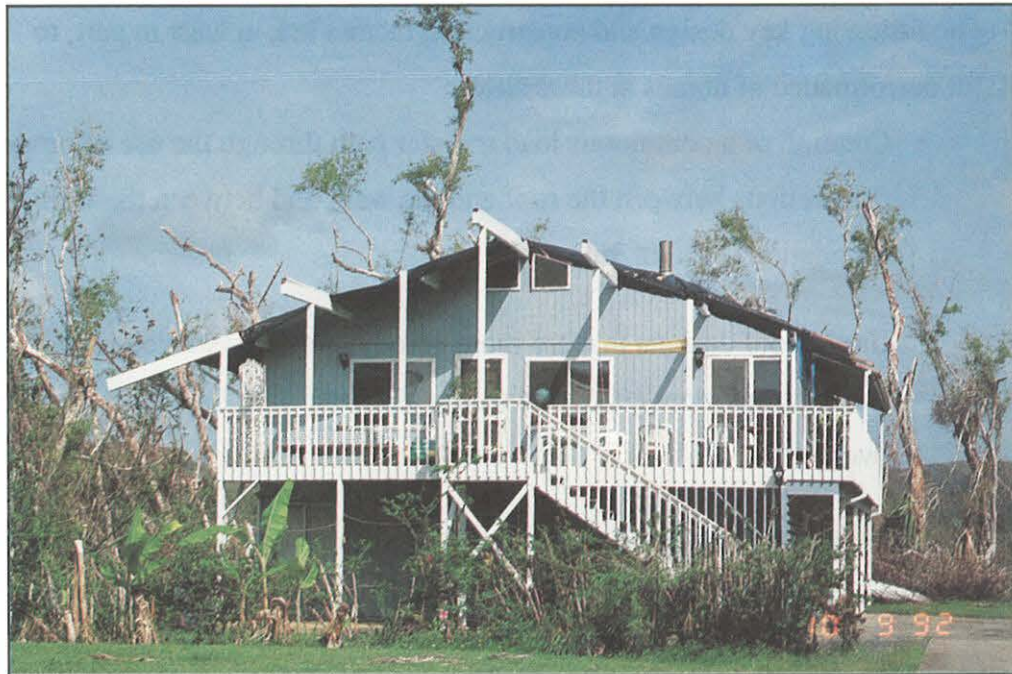
FIGURE 34. *Excessive roof overhang and poor connections in many instances led to roof failure.*

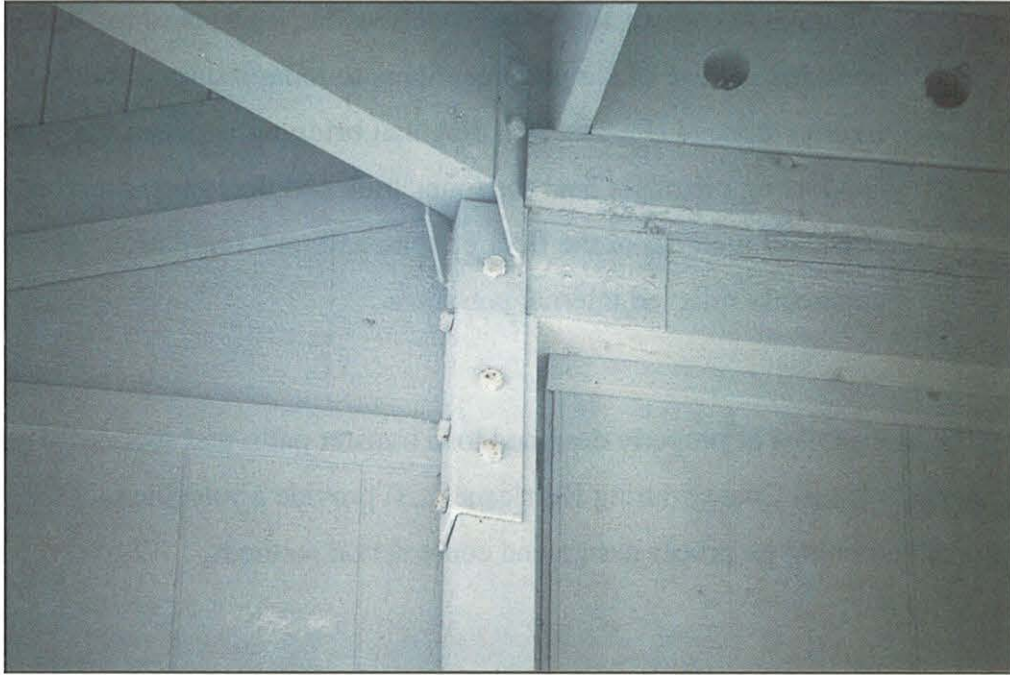
FIGURE 35. *Example of very successful heavy-gauge metal fastener connecting roof and wall systems. Note the over the top application and the number and size of lag bolts used for attachment.*

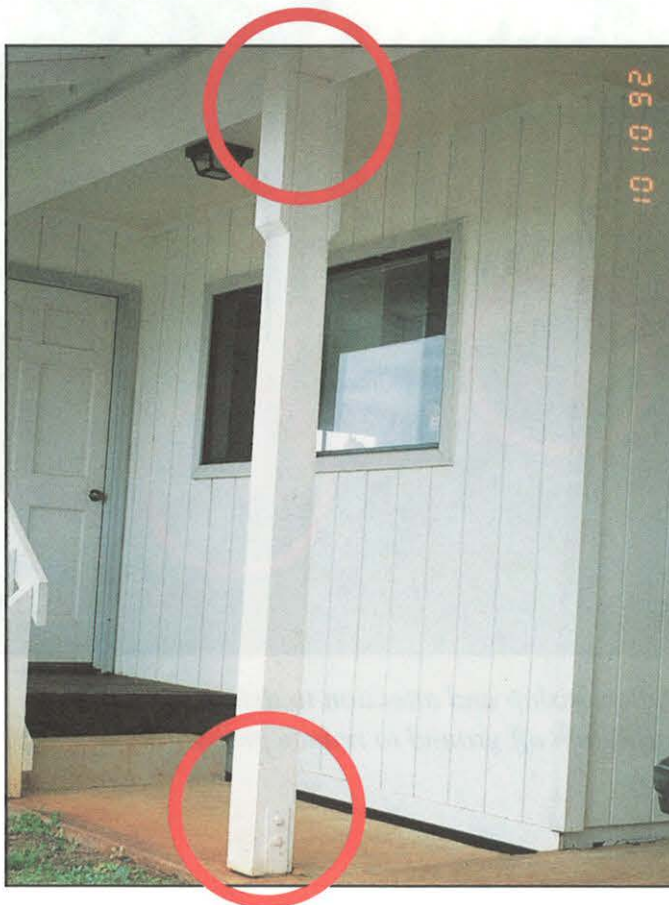
FIGURE 36. *Wood splice or strap provides a secure connection between wall and roof systems. Bolted metal anchor provides secure connection between vertical member and foundation. This is a fine example of a continuous load path.*

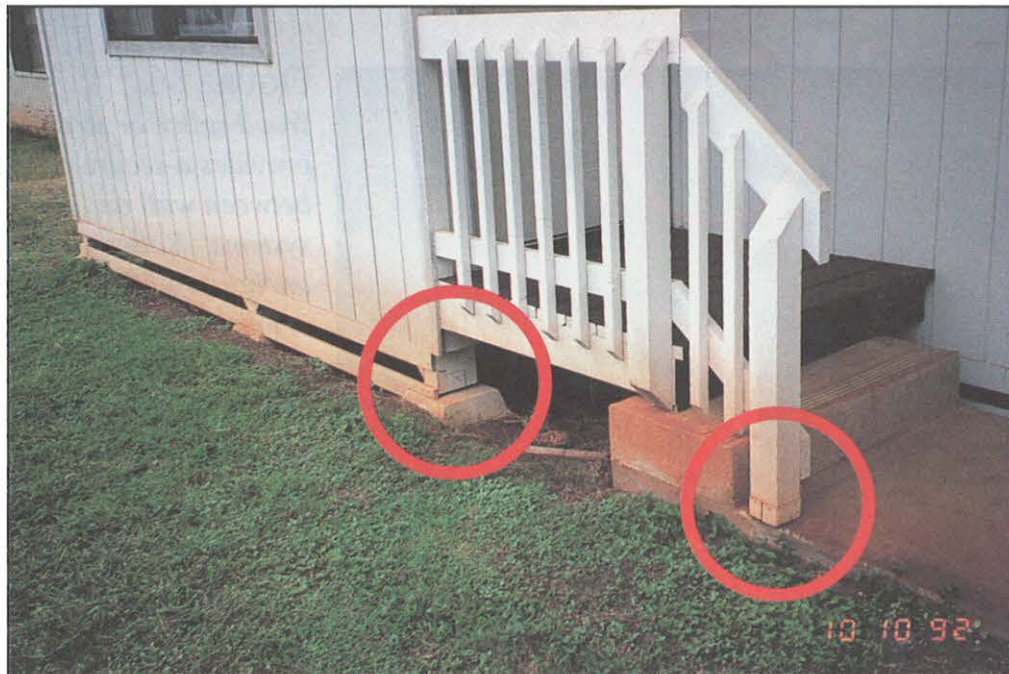
FIGURE 37. *Sensitive craftsmanship and attention to detail: Vertical preservative-treated posts 1/4 inch off ground to reduce probability of termite infestation and decay.*

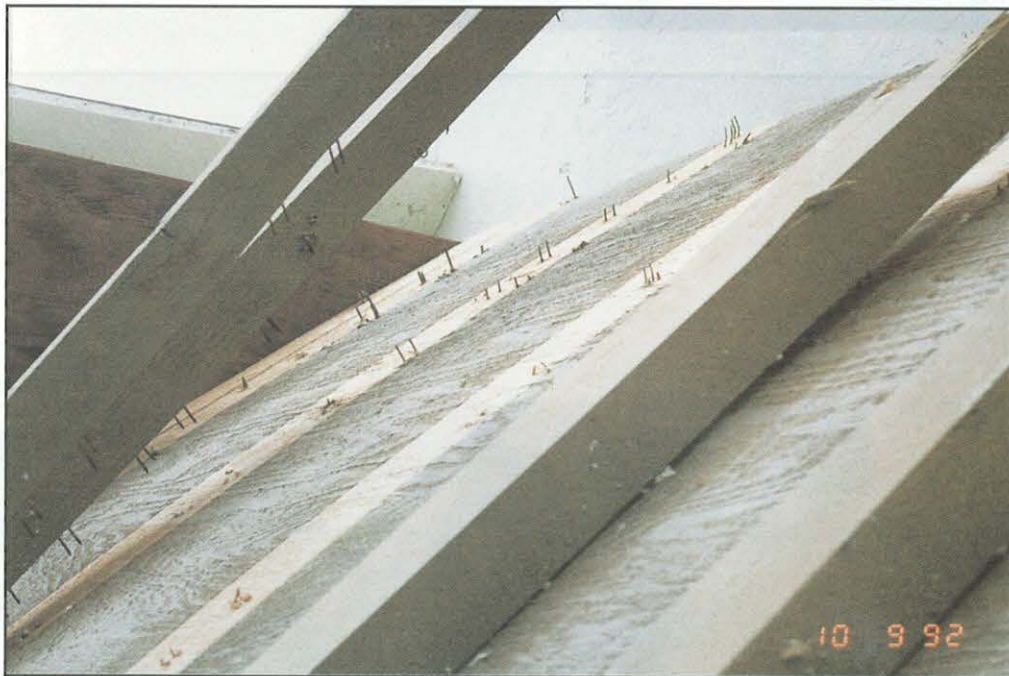
FIGURE 38. *Improper attachment of sheathing to purlins. Note wide spacing, shallow penetration, misalignment, and corrosion of staples.*
