BUILDING PERFORMANCE: HURRICANE INIKI IN HAWAII

OBSERVATIONS, RECOMMENDATIONS,
AND TECHNICAL GUIDANCE

FEDERAL EMERGENCY MANAGEMENT AGENCY
FEDERAL INSURANCE ADMINISTRATION

JANUARY 29, 1993

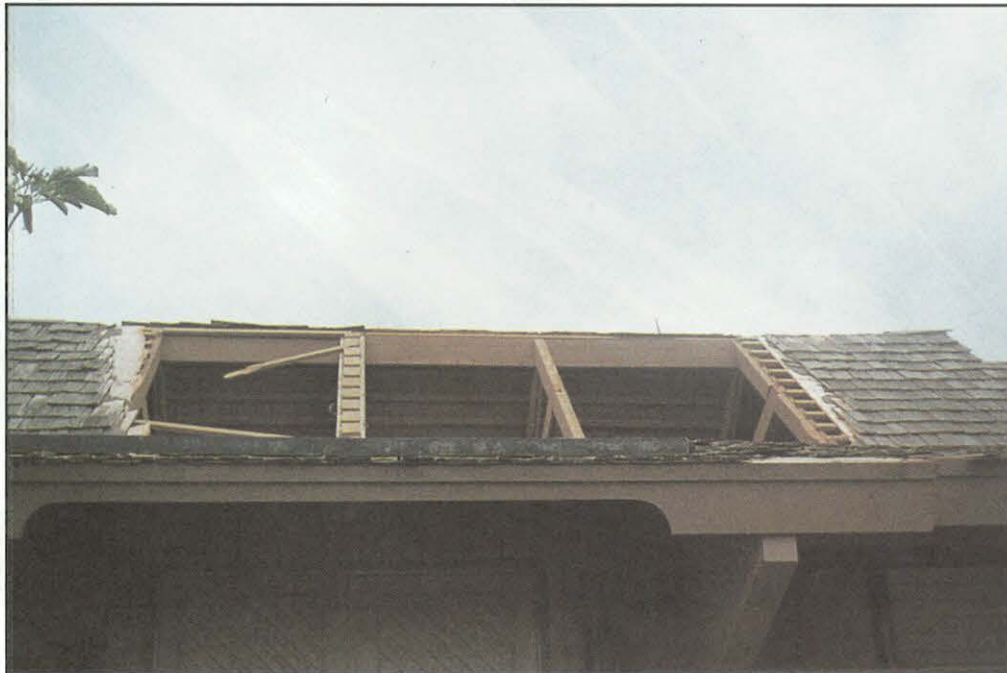
FIGURE 40. *Loss of roof sheathing due to improper nailing design and schedule.*

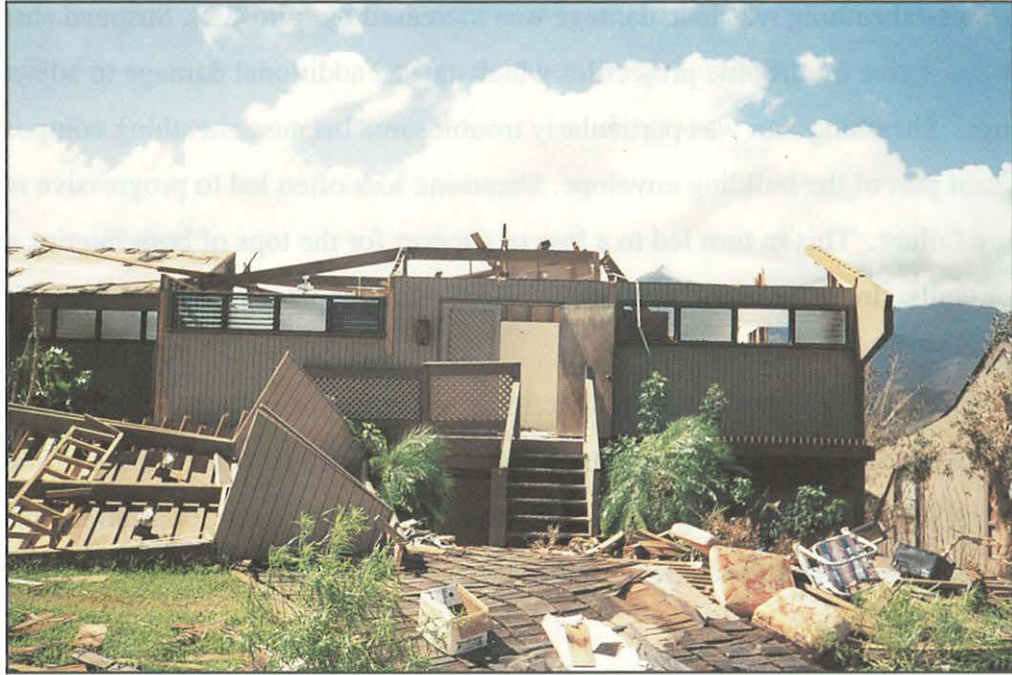
FIGURE 41. *Total roof failure due to loss of sheathing.*

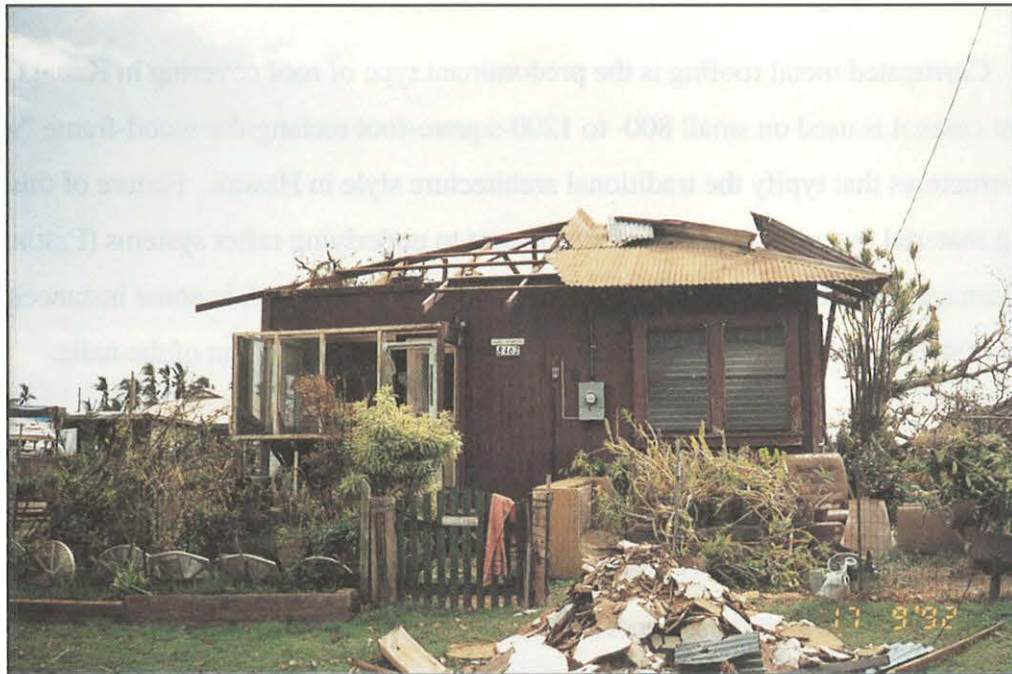
FIGURE 42. *Failure of corrugated metal roof at attachment points. These small, geometrically stable, “single wall,” rectangular structures with numerous interior partition walls often remained structurally intact after loss of metal coverings.*

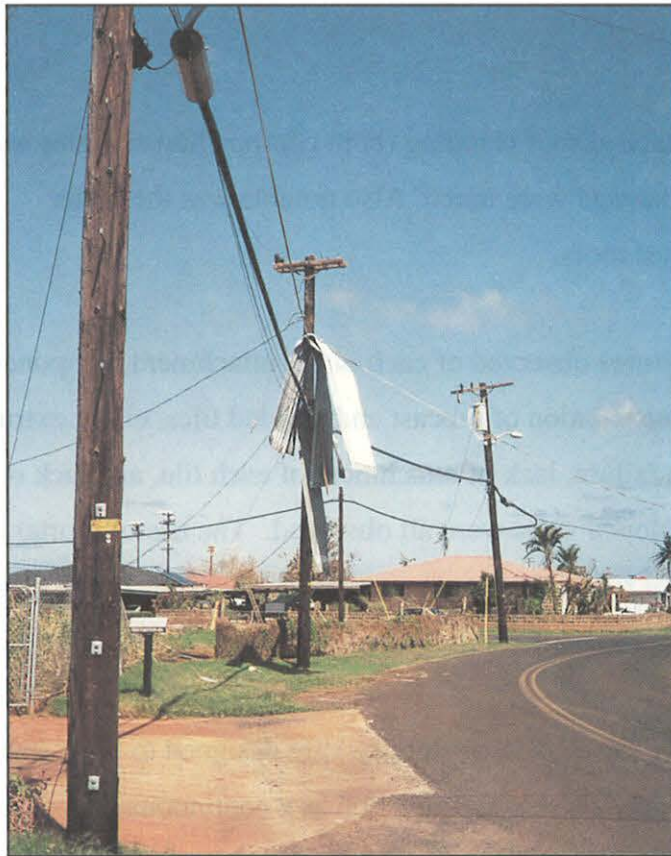
FIGURE 43.
Metal roof loss generates large airborne projectiles, which often cause additional damage.

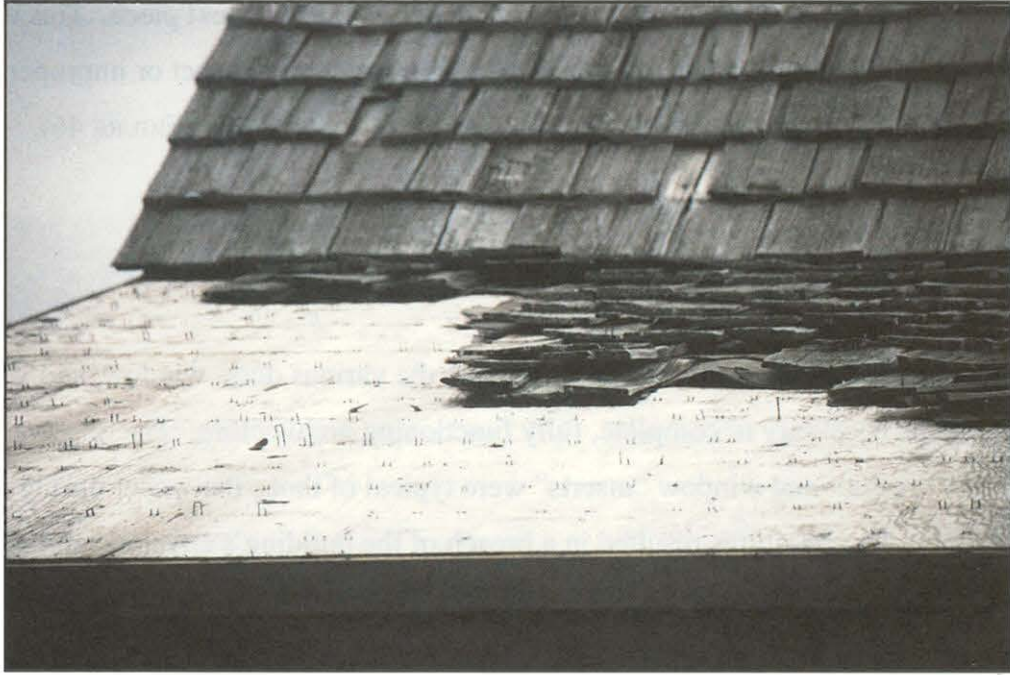
FIGURE 44. *Loss of roof cladding due to failure at attachment points. Notice that many staple crowns have corroded away on staples used to attach wood shake roofing to plywood roof sheathing.*

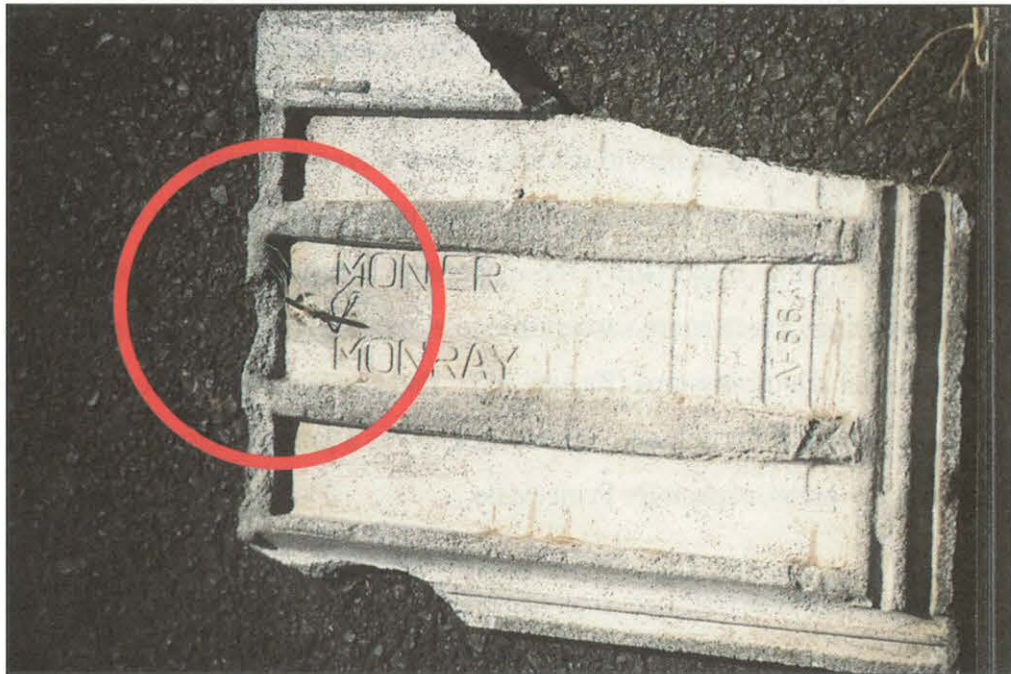
FIGURE 45. *Heavy concrete tile attached at one point with undersized nail. It was also observed that neighboring tiles had not been nailed.*

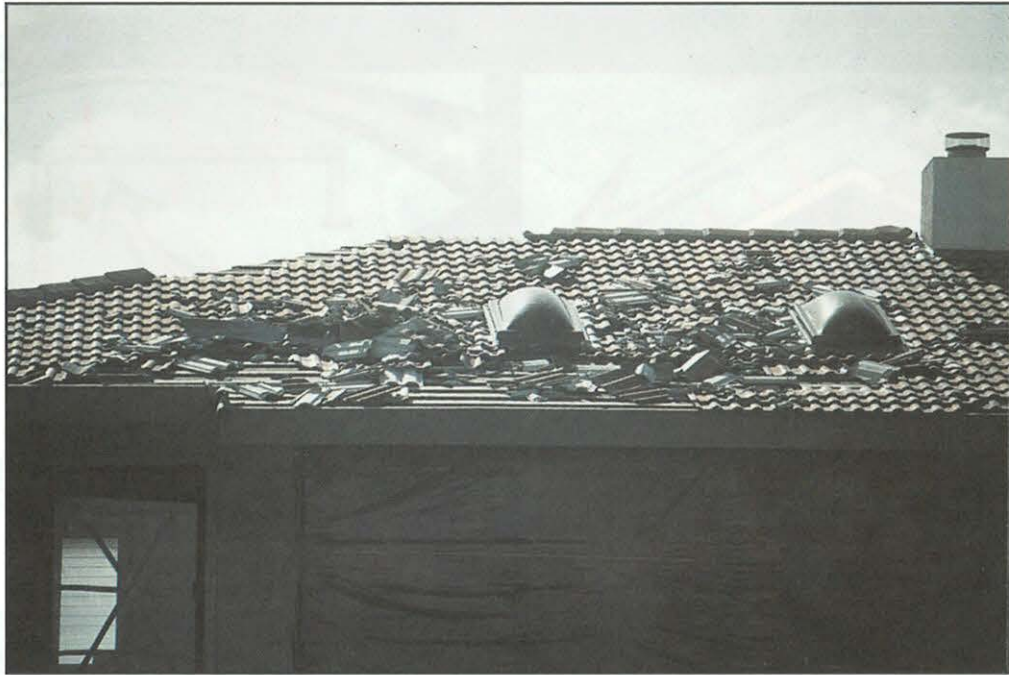
FIGURE 46. *Roof cladding system composed of interdependent elements. Failure of one tile led to failure of adjacent tiles in a “chain reaction” effect.*

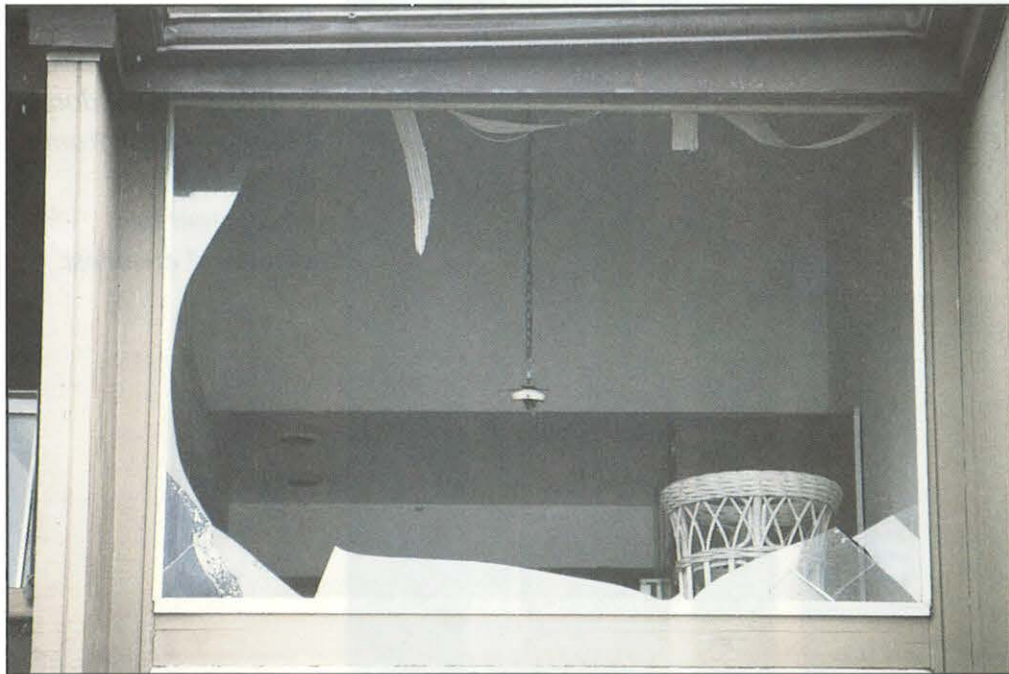
FIGURE 47. *Glazing broken by windborne debris or direct wind pressure.*

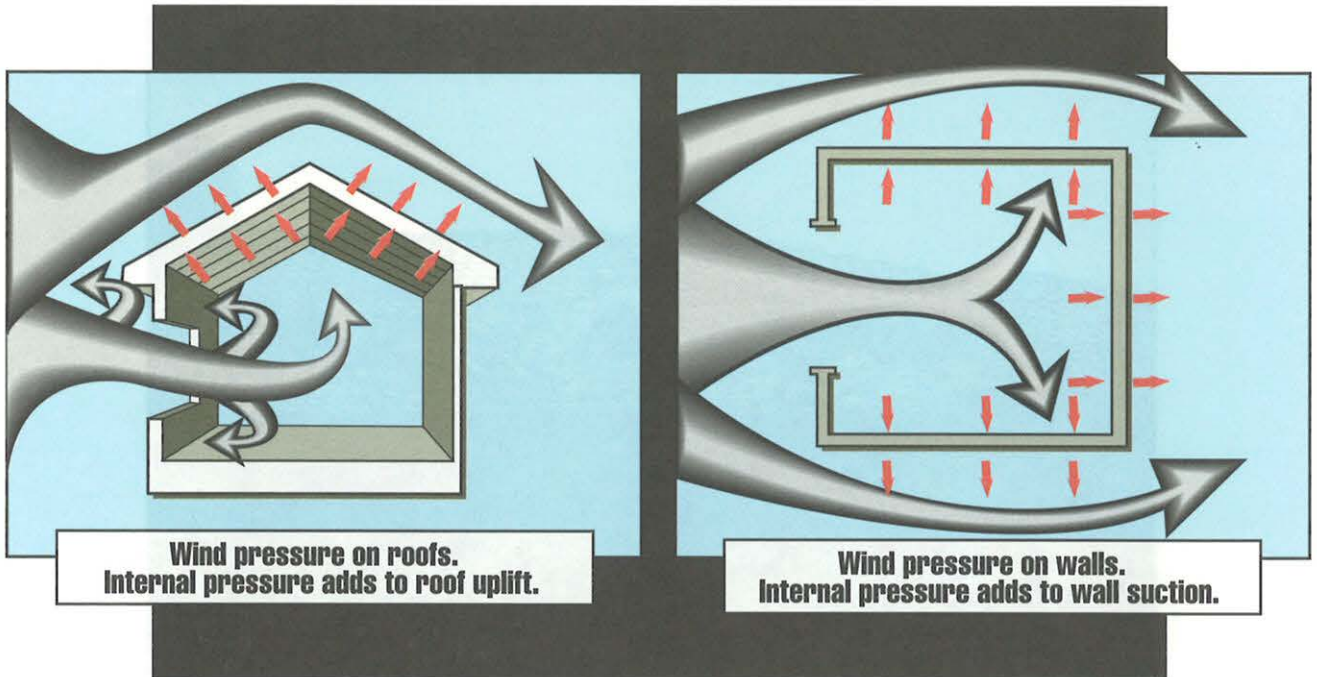
FIGURE 48. *Loss of opening protection allows wind entry and increases internal exposure.*

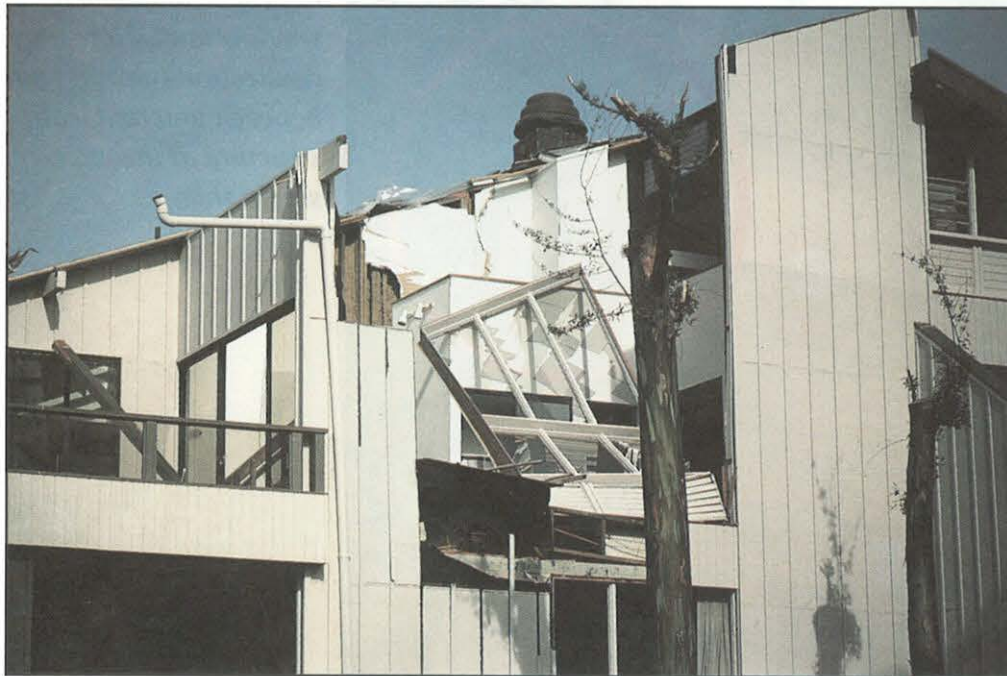
FIGURE 52. *Gable-end window unit as a whole was displaced inward by wind pressure. Apparently, this allowed wind entry, increased interior pressure, and caused roof uplift.*

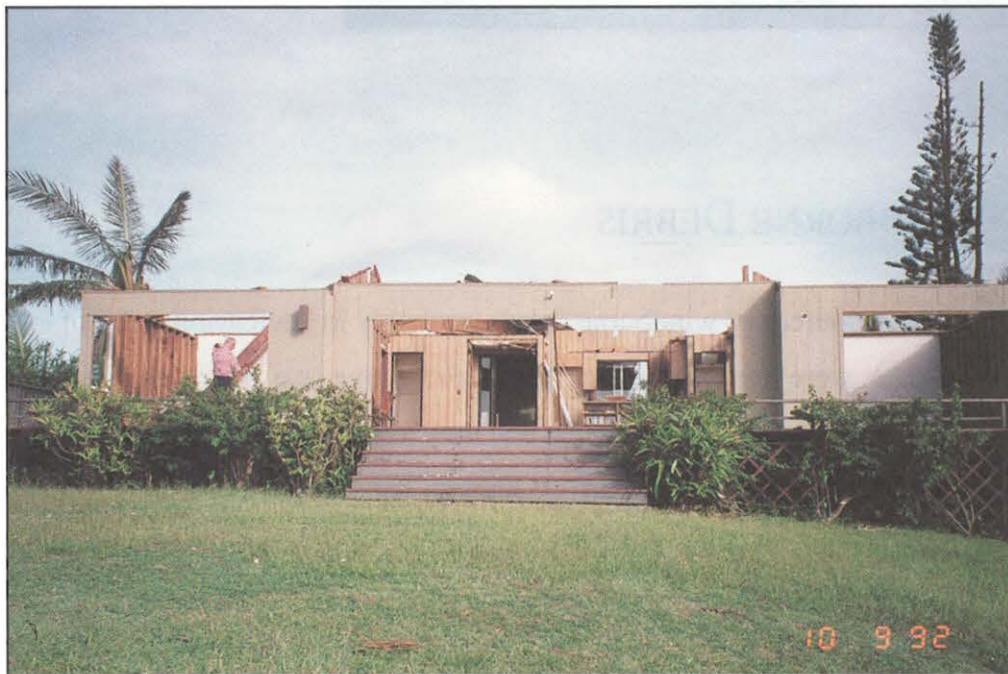
FIGURE 53. *Extensive use of glazing on windward side can significantly compromise a building's envelope and lead to roof failure.*

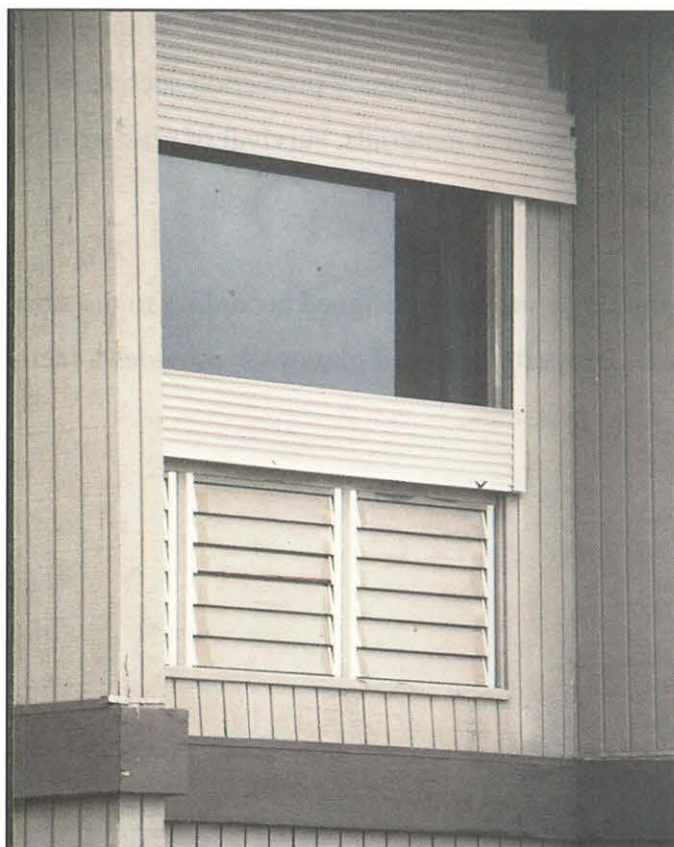
FIGURE 54.
*In-place protective devices
for glazing reduced the
occurrence of building
envelope failures.*

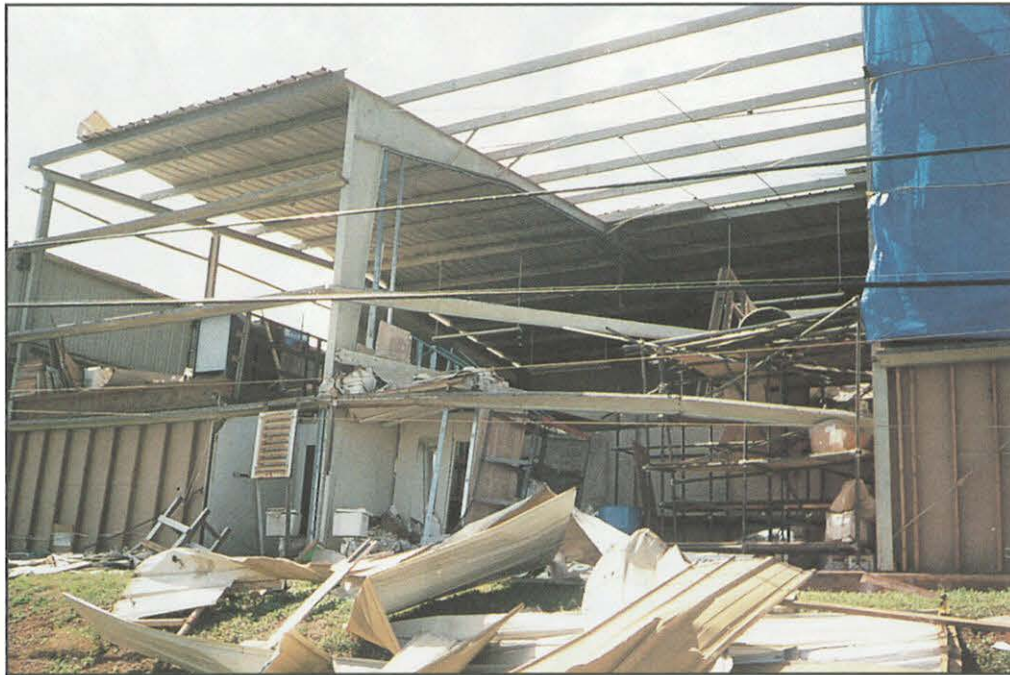
FIGURE 56. *Steel warehouse failure commonly was due to loss of light-gauge metal sheet cladding.*

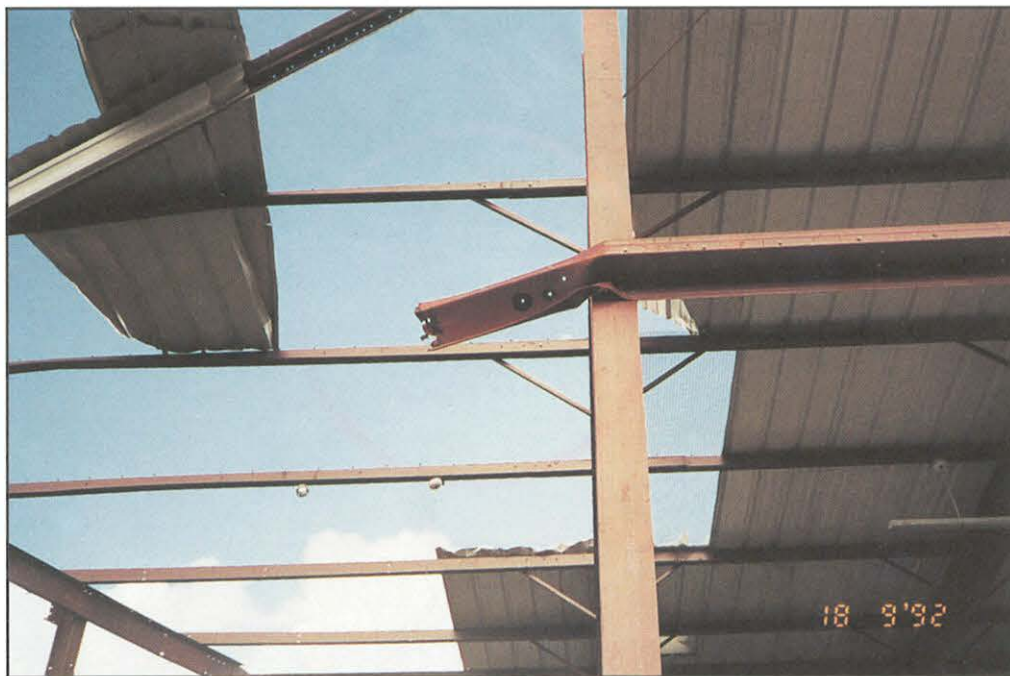
FIGURE 57. *Steel warehouse failure was also due to failure of structural steel members.*

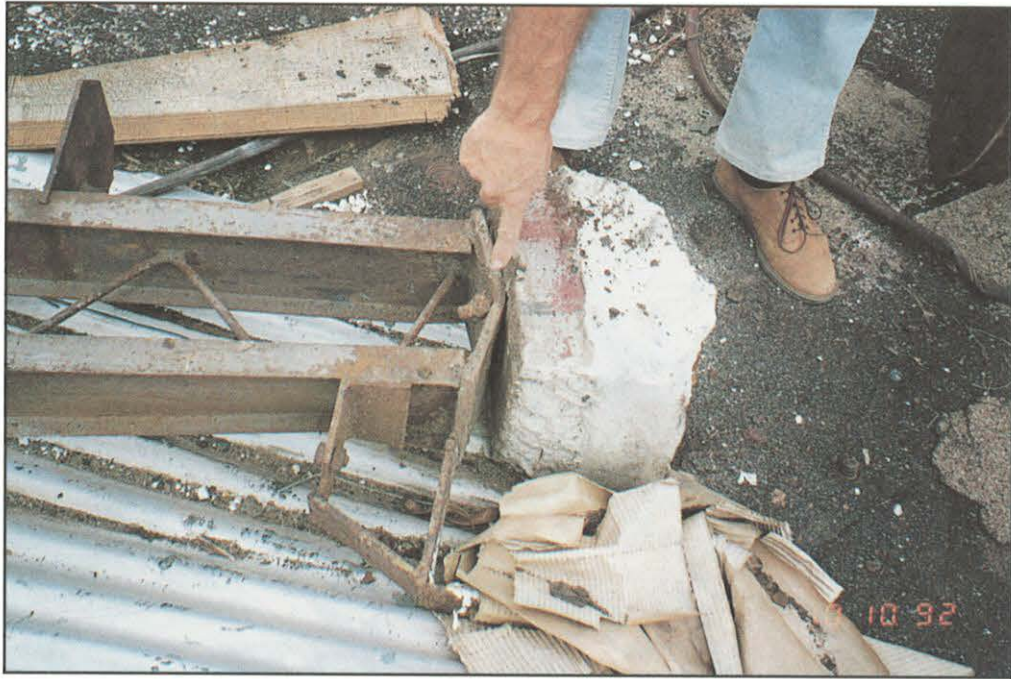
FIGURE 58. *Failure of steel warehouse due to age and weatherization and insufficient anchorage to resist uplift.*

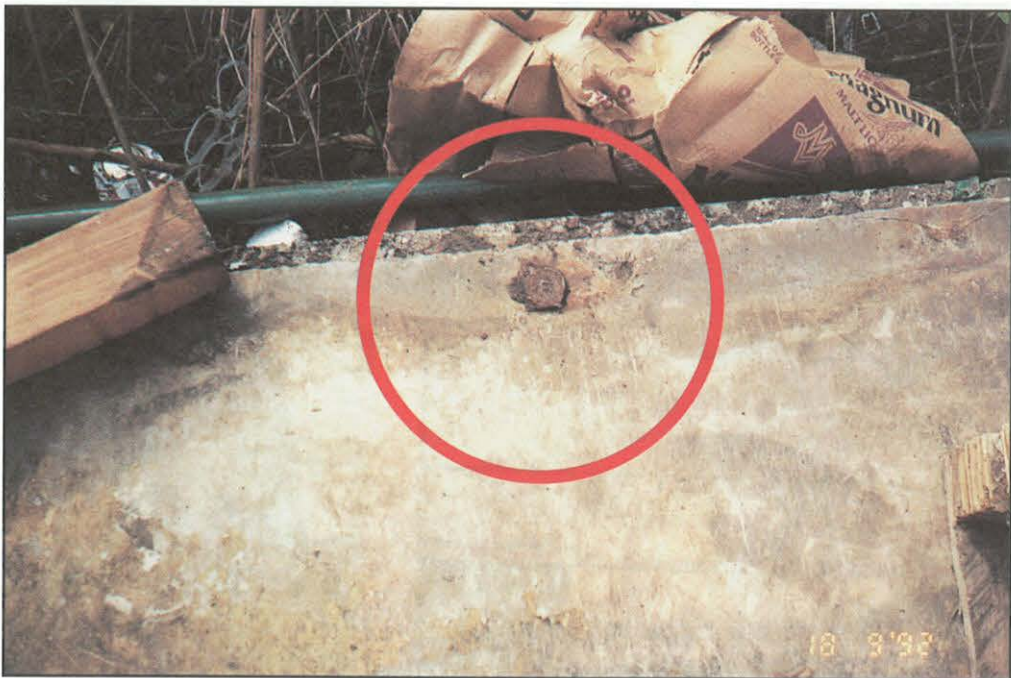
FIGURE 59. *Steel warehouse, sill-to-concrete-foundation failure at anchoring points.*
