BUILDING PERFORMANCE ASSESSMENT:

Hurricane Fran in North Carolina

OBSERVATIONS, RECOMMENDATIONS,
AND TECHNICAL GUIDANCE

FEDERAL EMERGENCY MANAGEMENT AGENCY
MITIGATION DIRECTORATE

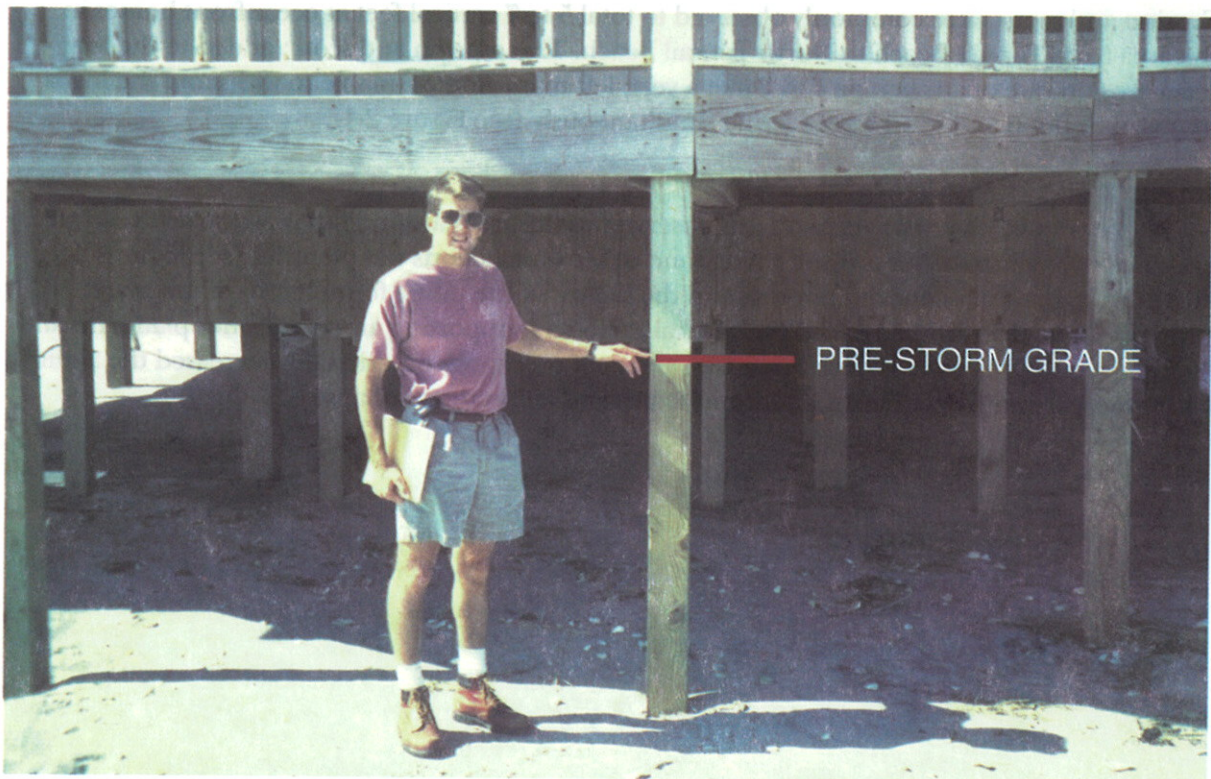
Figure 2-2 Erosion resulted in significant loss of supporting sand, averaging 4 to 6 feet, under oceanfront buildings.

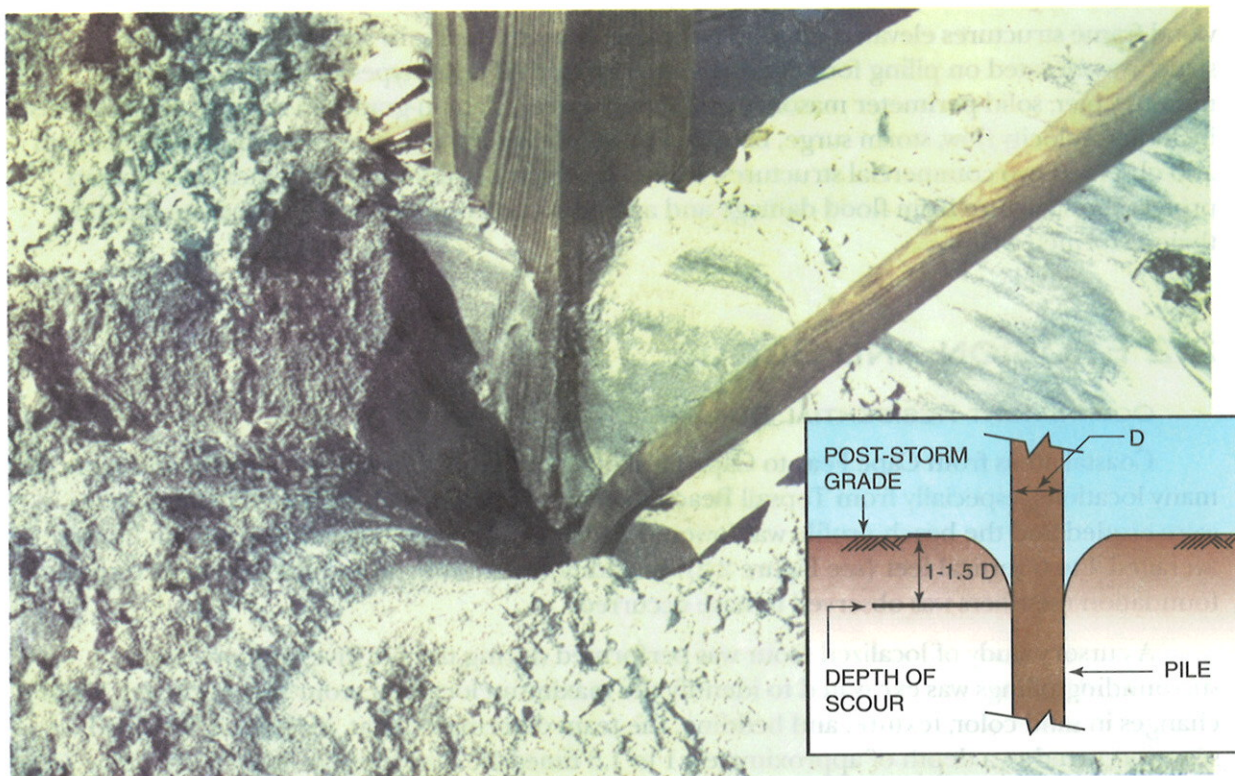
Figure 2-3 Determination of localized scour from changes in sand color, texture, and bedding.

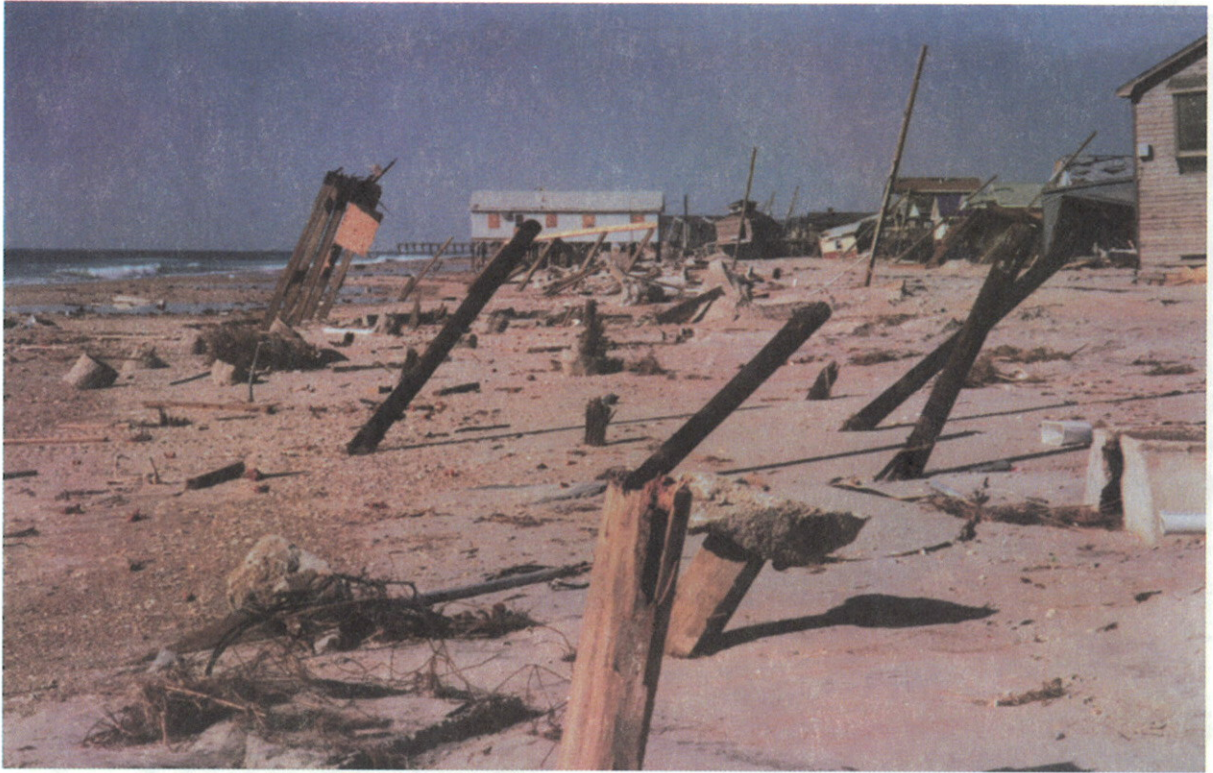
Figure 2-4 Loss of the frontal dune and the resulting erosion and scour left many coastal houses unable to resist wind and flood loads acting simultaneously.

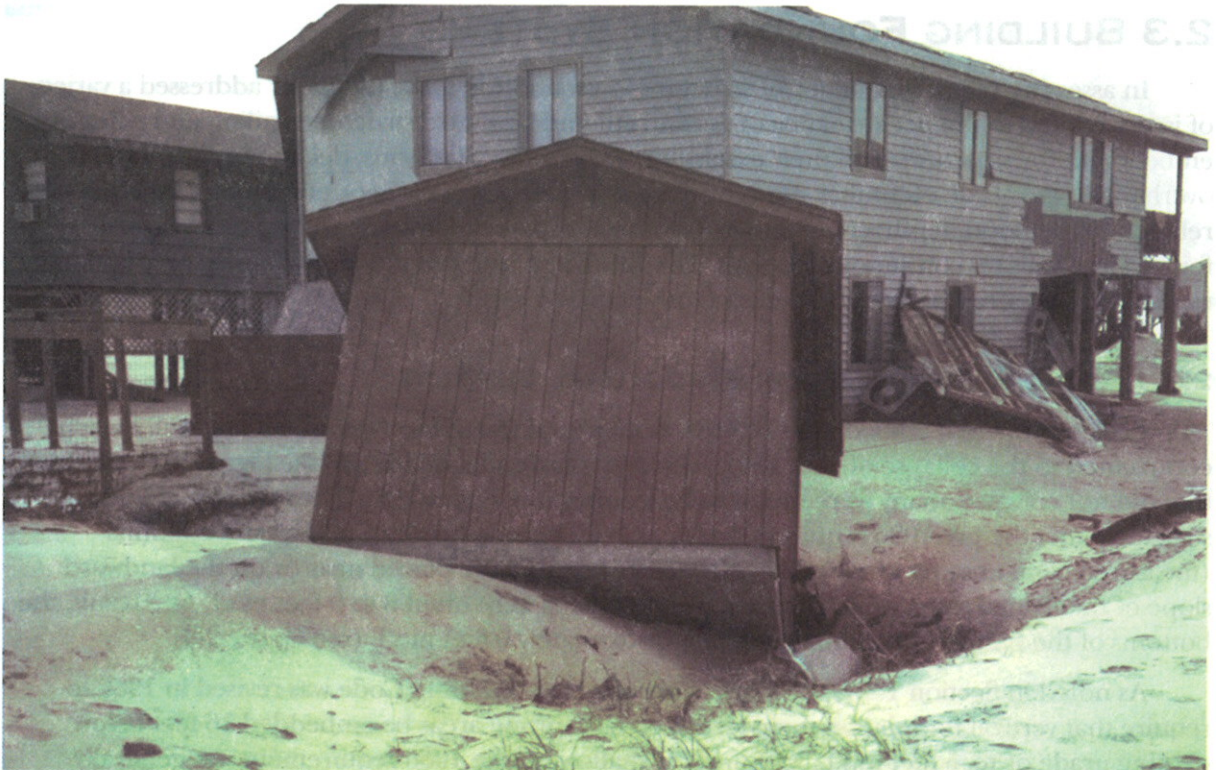
Figure 2-5 Overwash of barrier islands generated high-velocity flows that caused extensive scour adjacent to large objects.

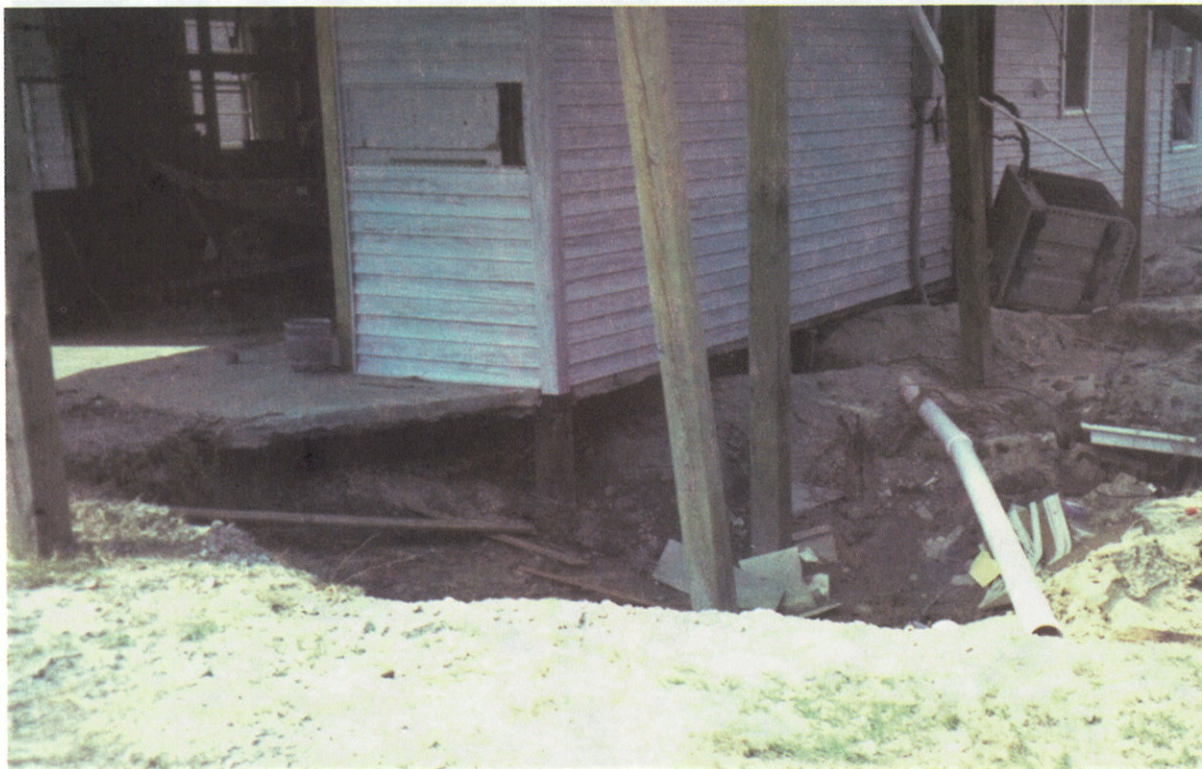
Figure 2-6 *The disruption of velocity flows by large, non-breakaway objects generated extensive scour that undermined vertical foundation members and slabs-on-grade.*

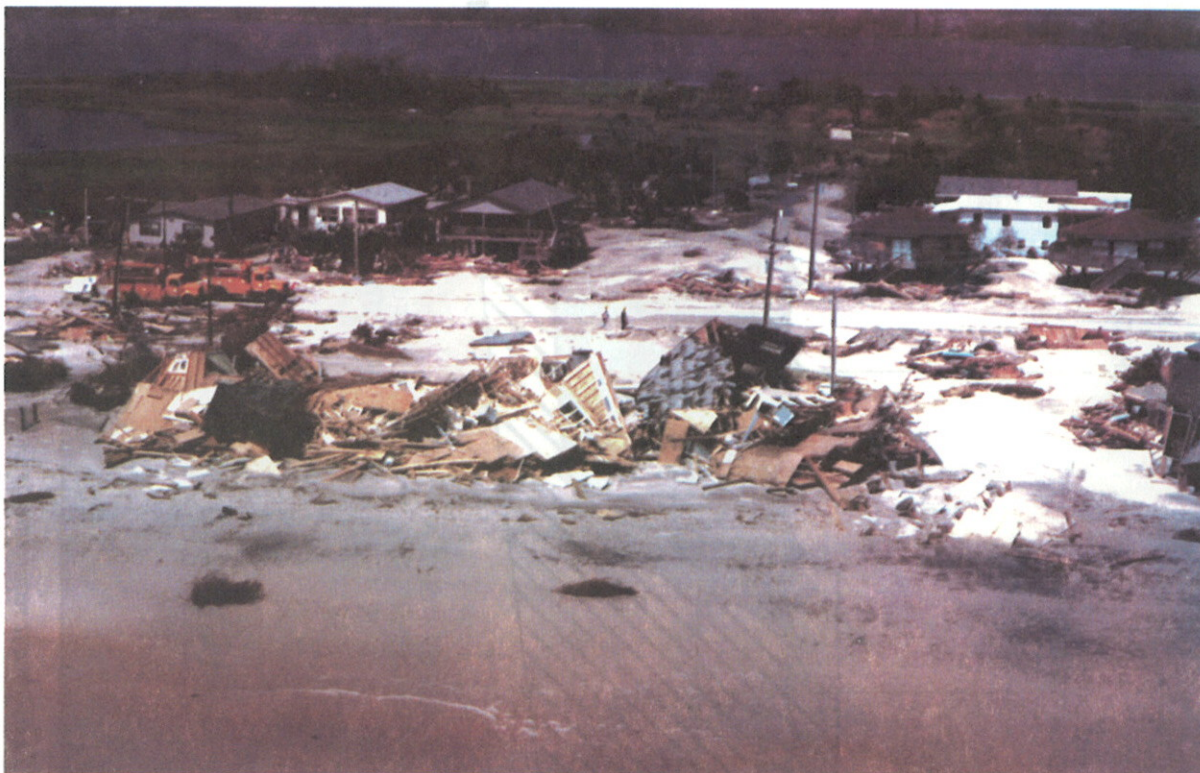
Figure 2-7 Over 100 oceanfront houses were washed off their foundations or completely destroyed.

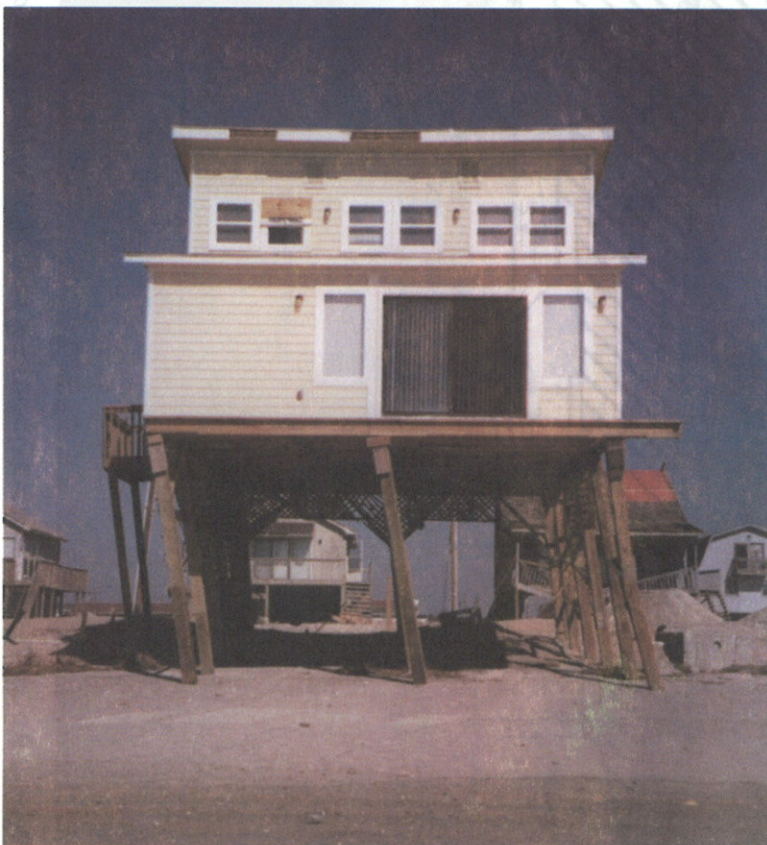
Figure 2-8 Many oceanfront houses built prior to current (1986) North Carolina State Building Code requirements were found to be leaning or destroyed.

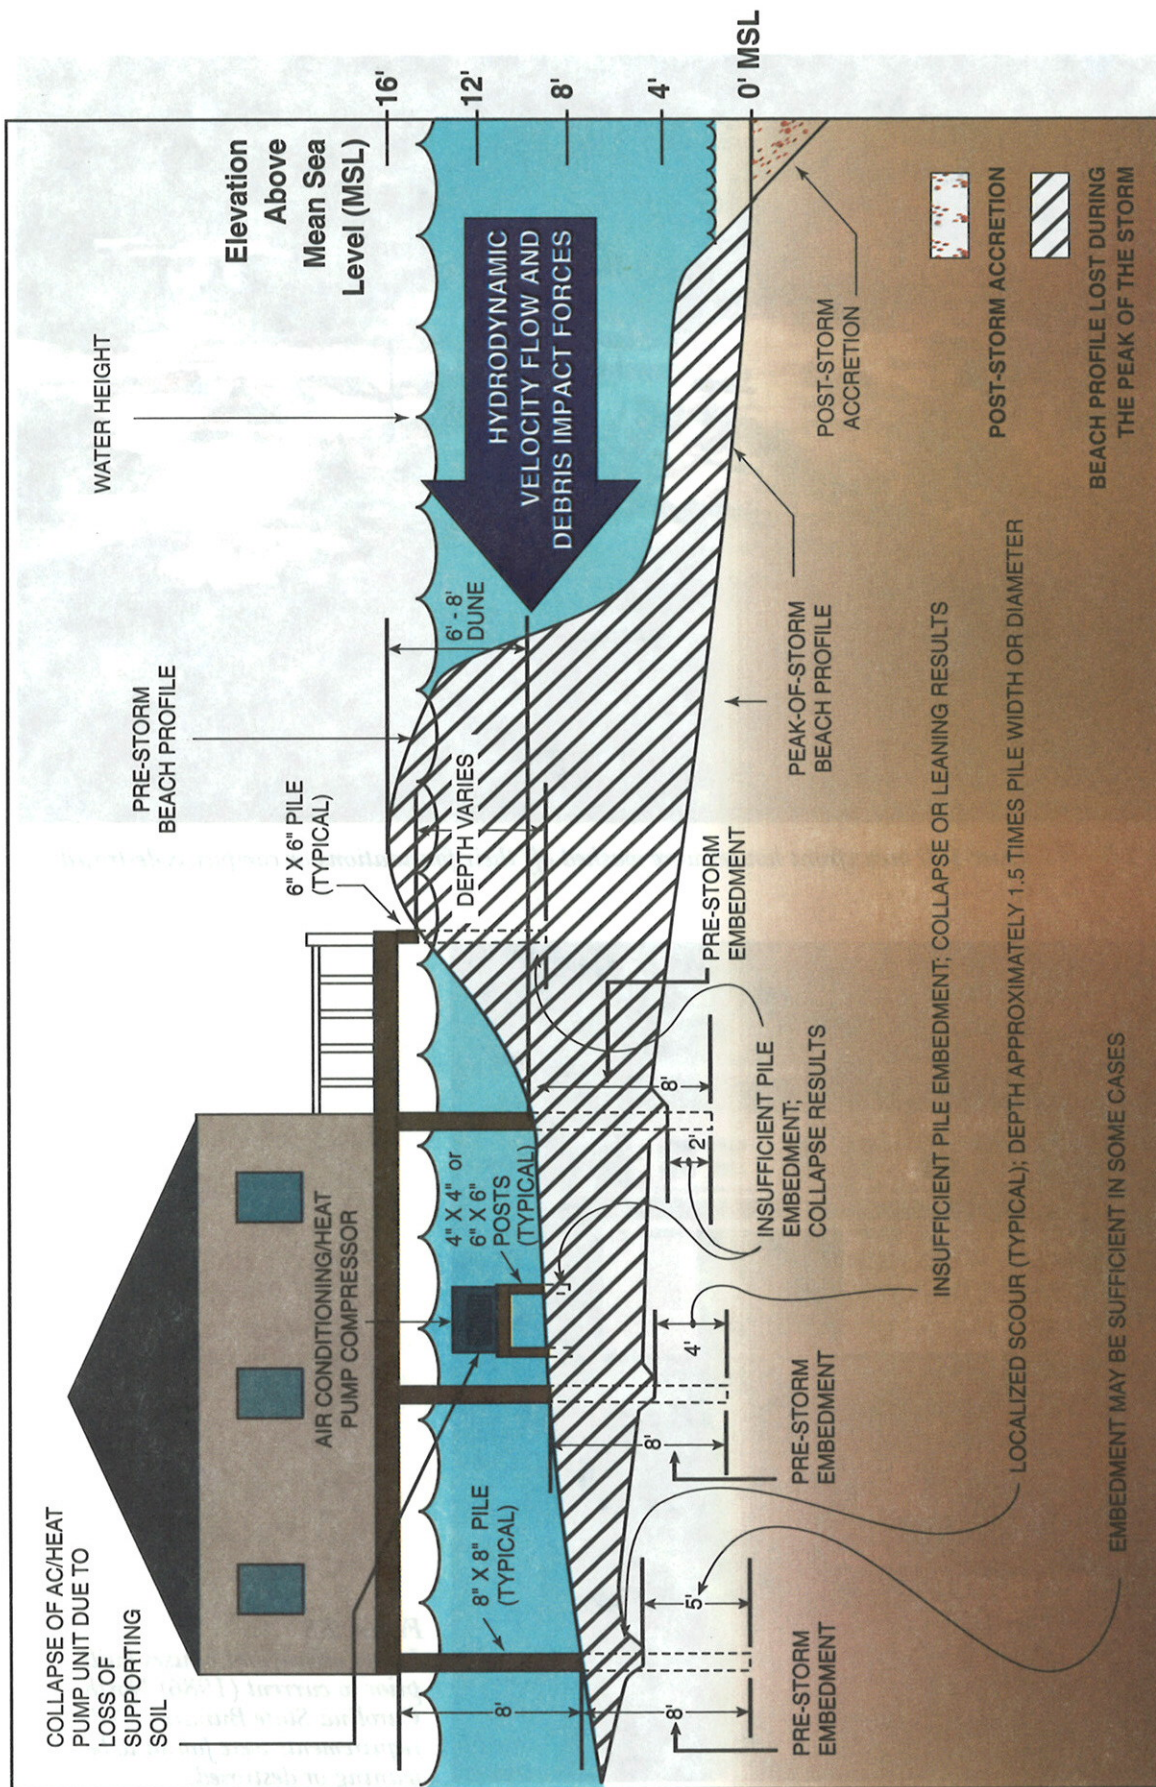
Figure 2-9 Typical collapse mechanism of post-FIRM building based on pre-1985 embedment requirements in North Carolina coastal areas.

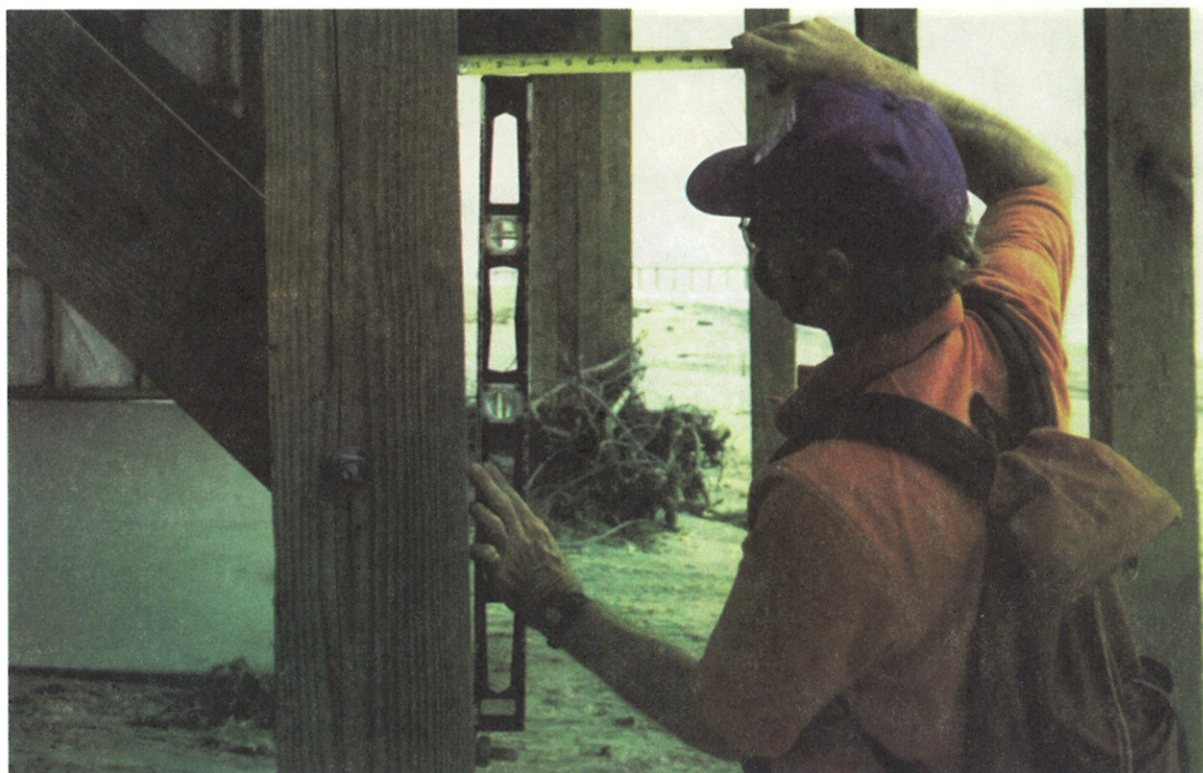
Figure 2-10 One of several buildings observed to be leaning landward that were suspected of having been constructed to current North Carolina State Building Code requirements.

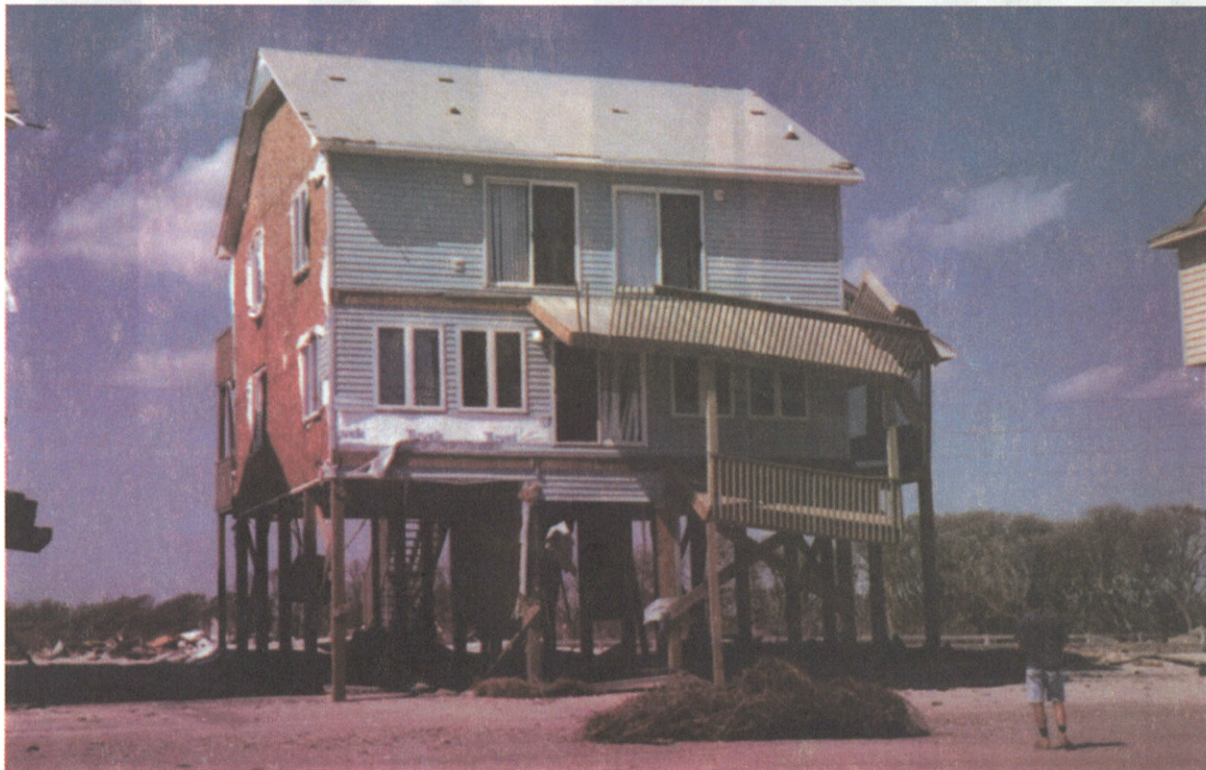
Figure 2-11 The BPAT observed several hundred decks and porches that collapsed as a result of insufficient foundation support.

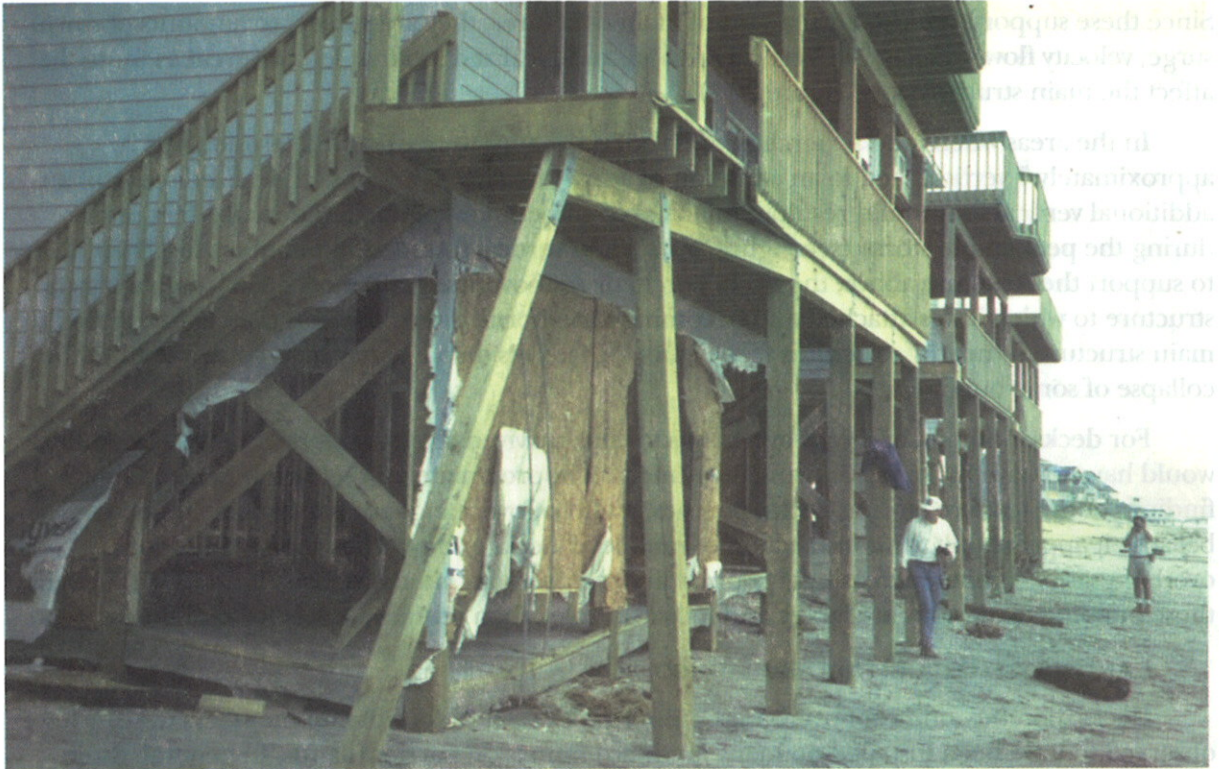
Figure 2-12 Example of building constructed to current North Carolina State Building Code requirements with insufficient embedment of piles/columns under two-story deck.

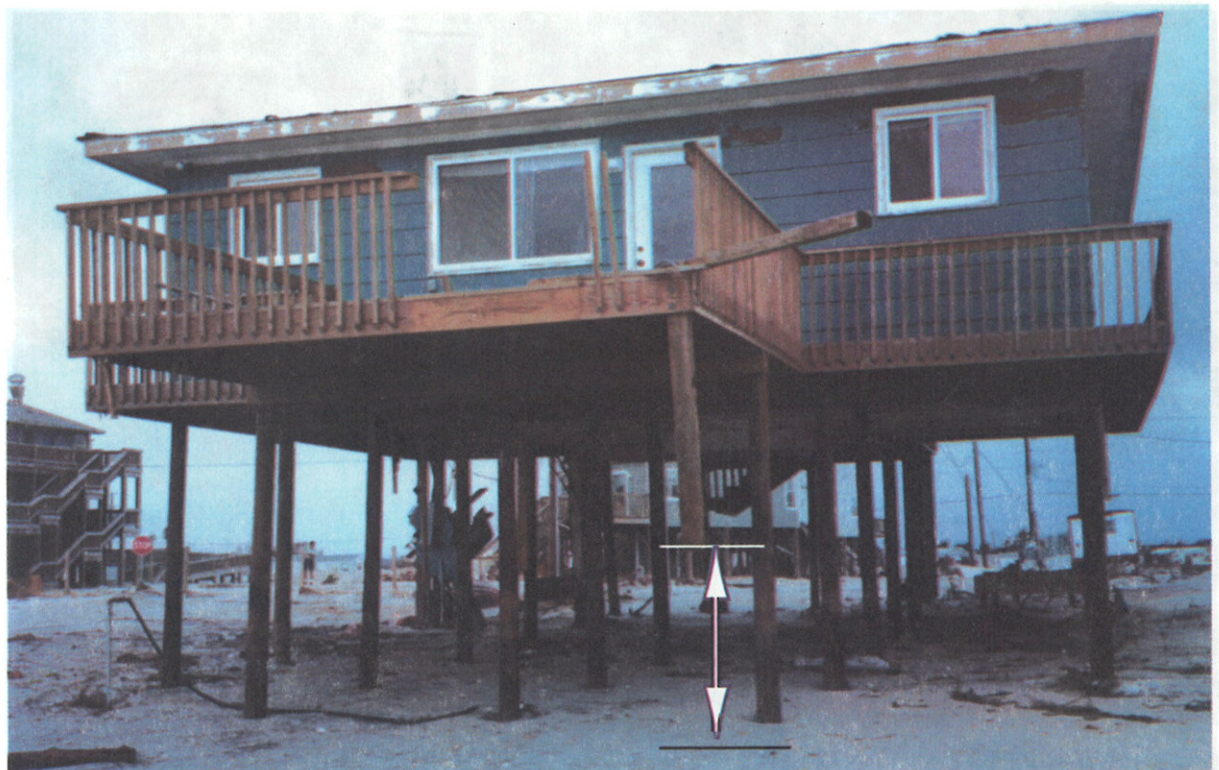
Figure 2-13 Embedment of deck supports into frontal dune was often shallow. After erosion of the dune, the bottom of the support for this deck was left several feet above grade.

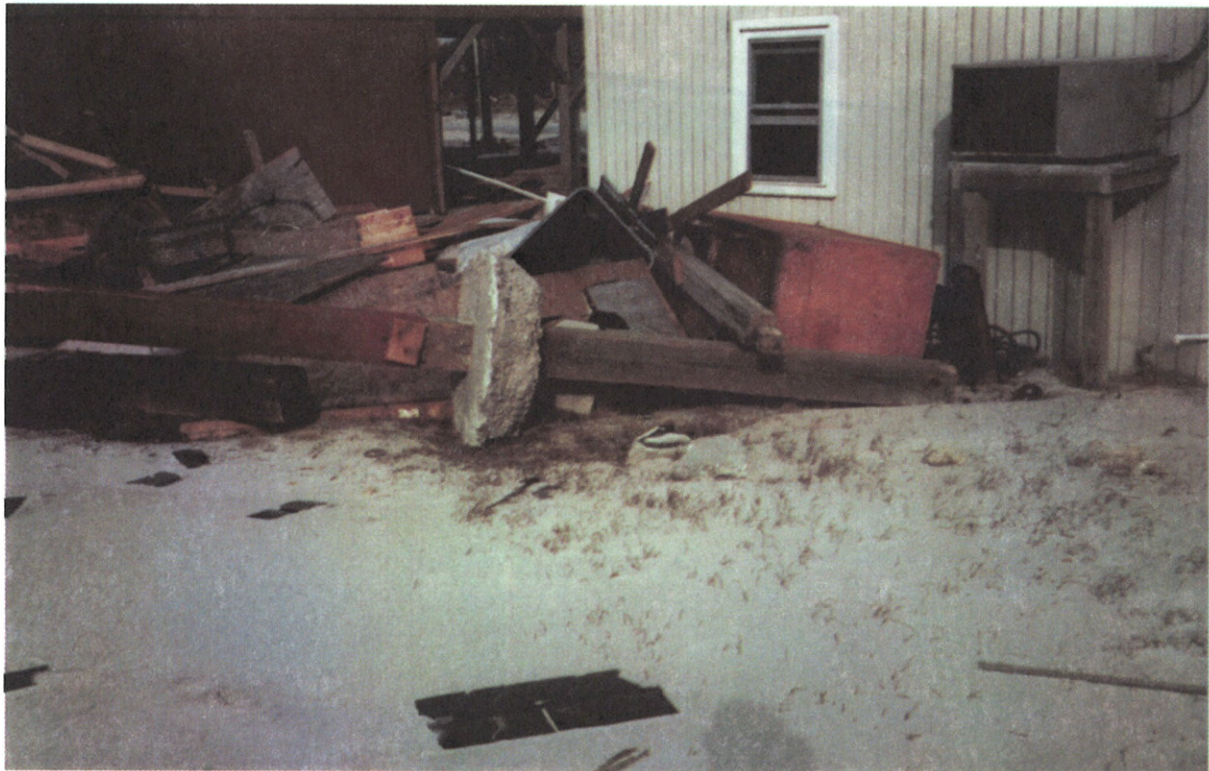
Figure 2-14 Storm-generated debris impacted nearby structure.

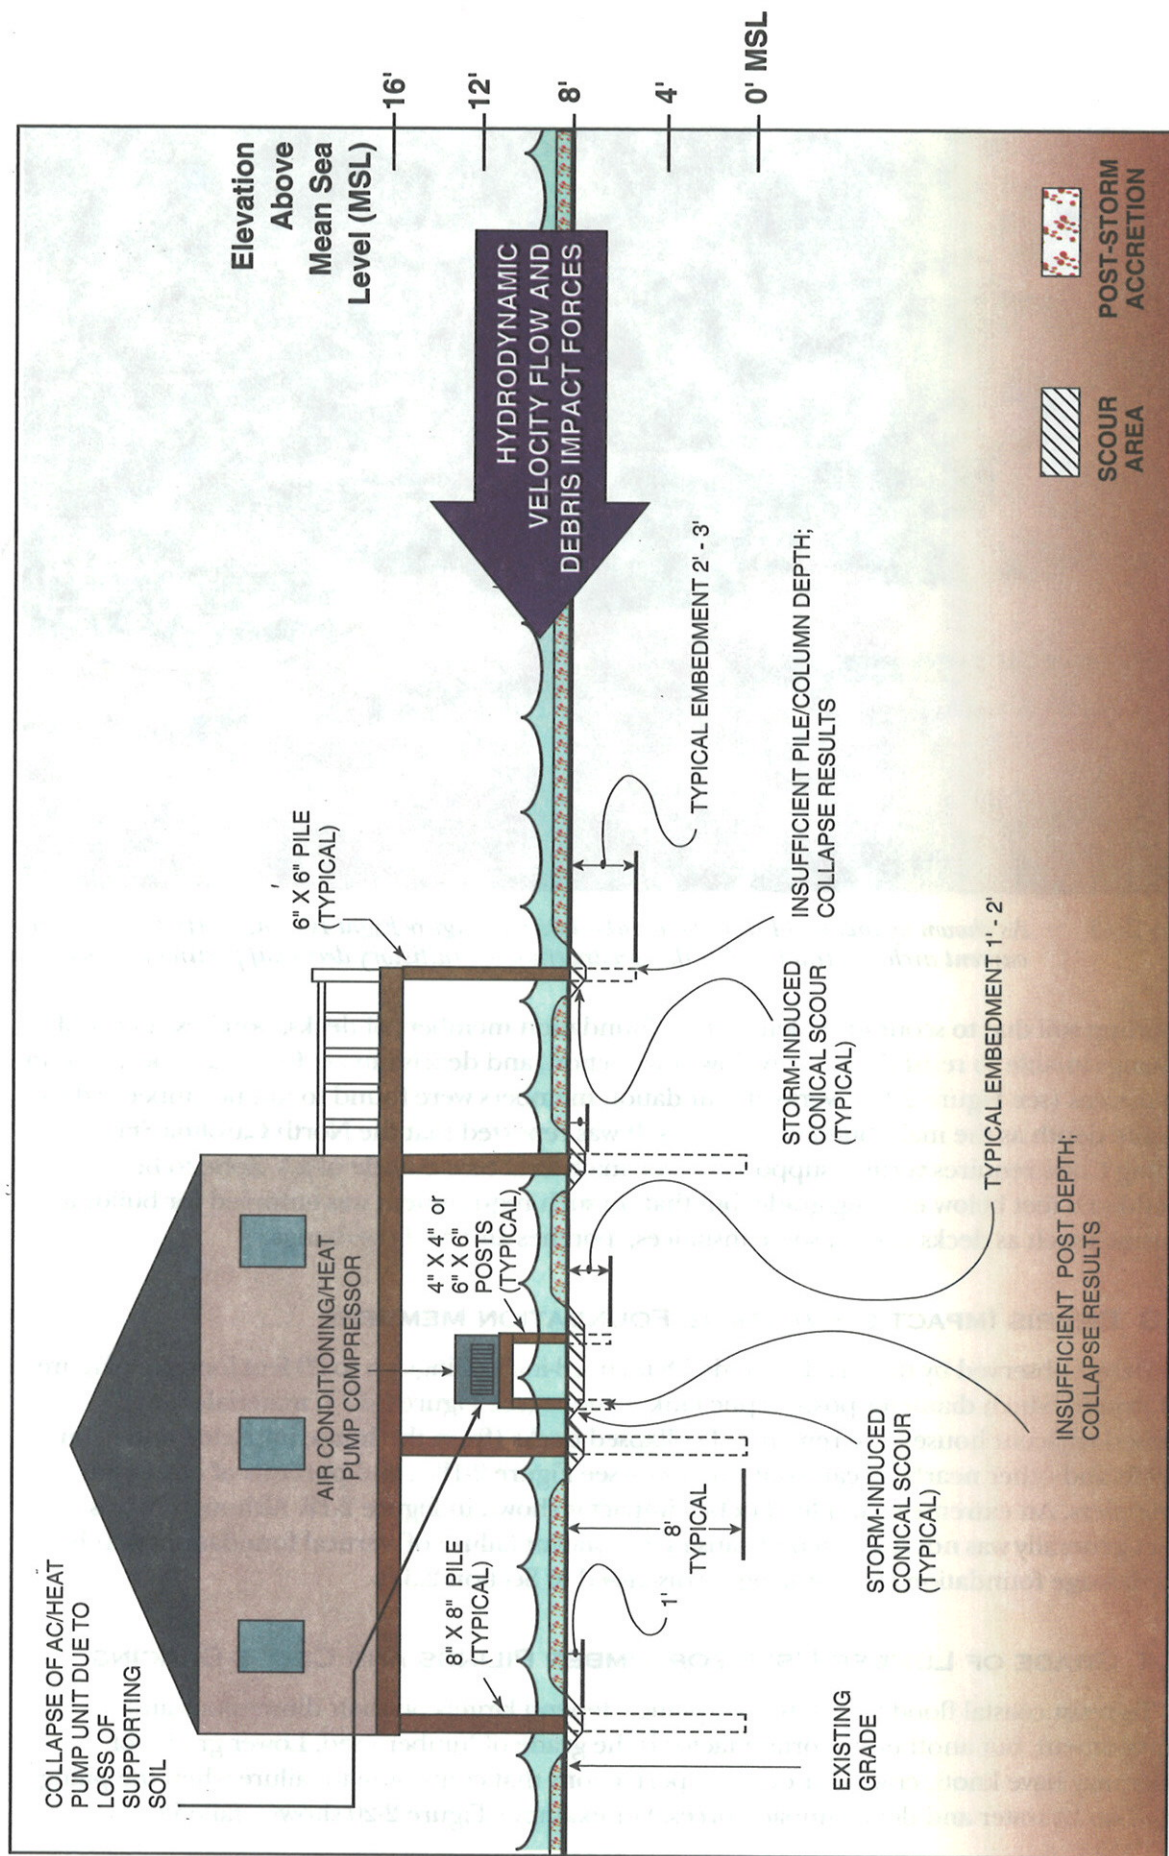
Figure 2-16 Typical failure of deck / roof overhang and air conditioning / heat pump compressor platform for landward home.

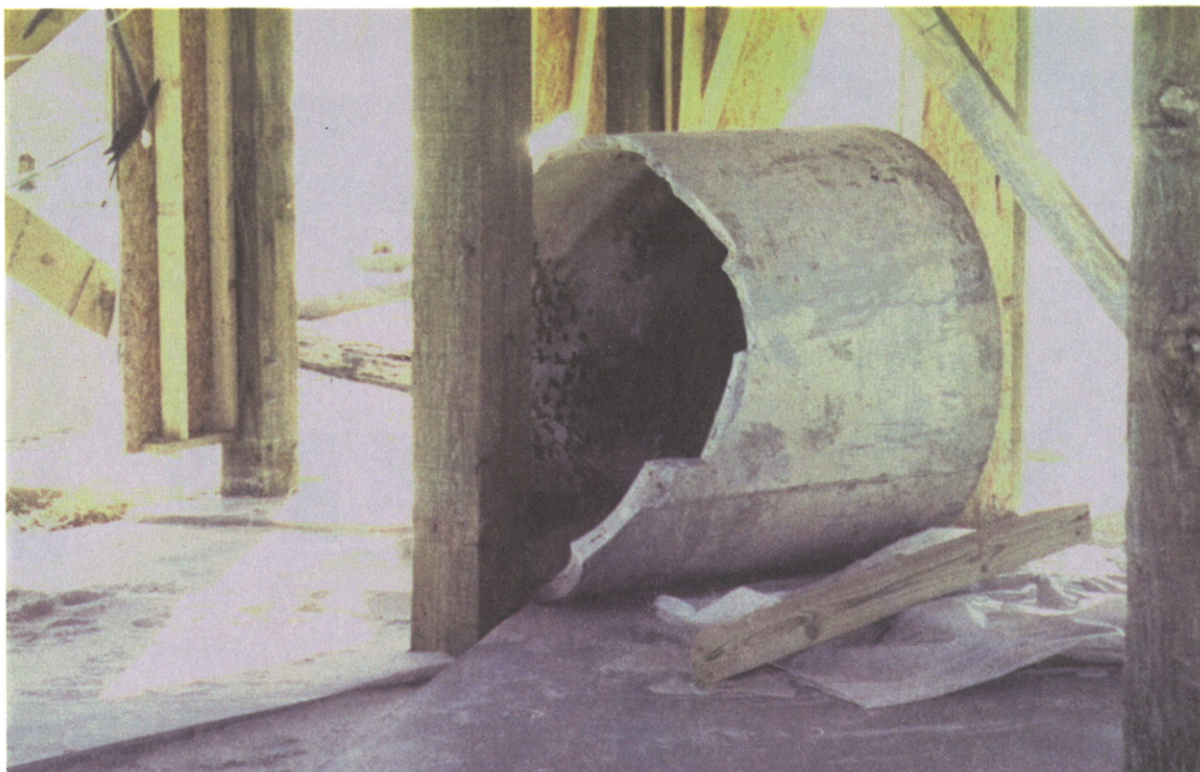
Figure 2-17 Precast concrete ring section of septic tank became waterborne debris, impacting building foundation members.

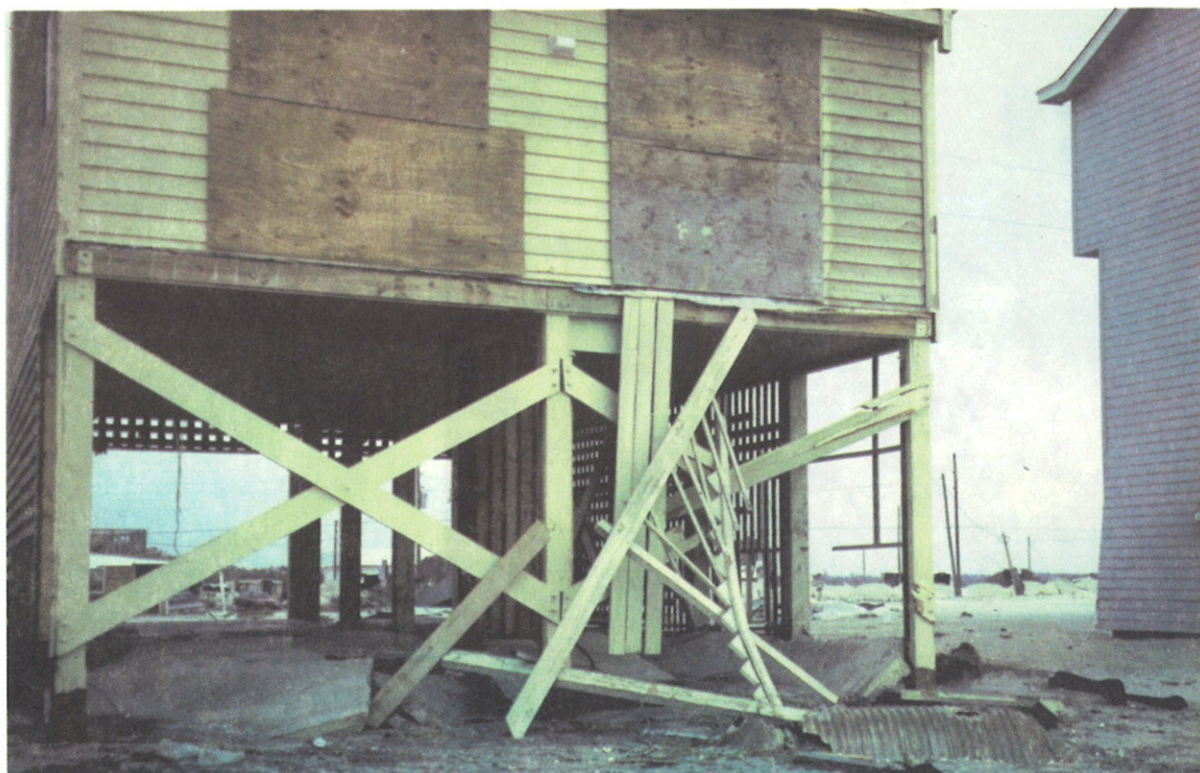
Figure 2-18 Impact of debris from a damaged deck appeared to have broken cross-bracing.

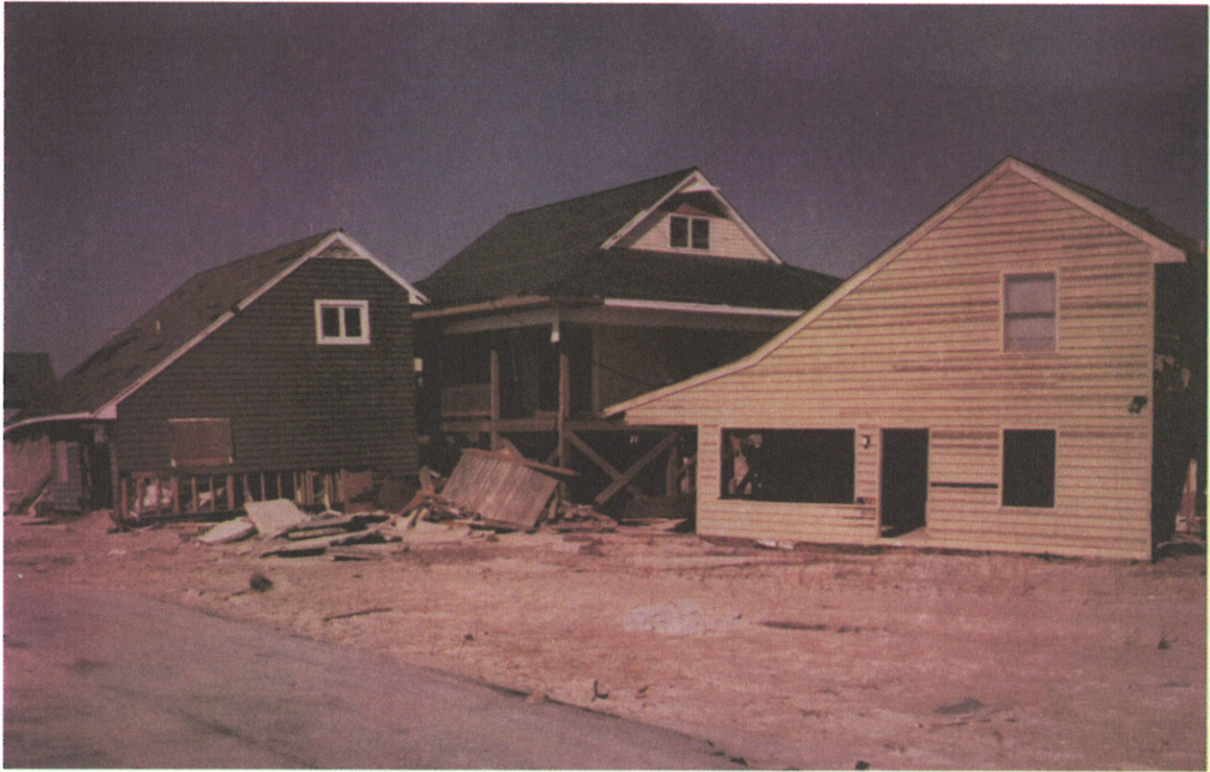
Figure 2-19 Example of extreme impact — two houses floated and pushed into another house.

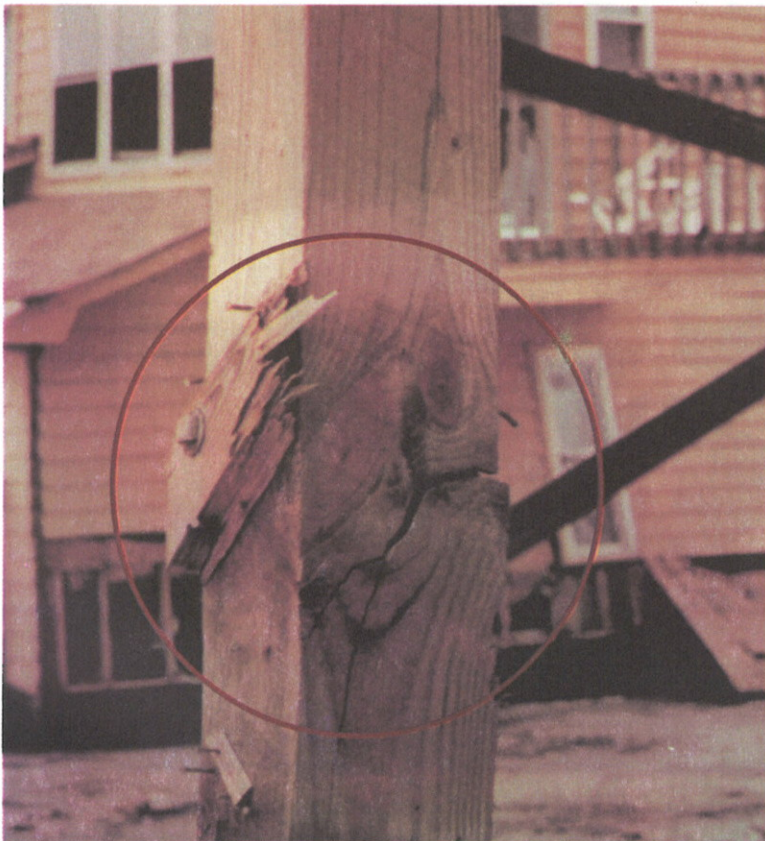
To resist coastal flood forces, timber pilings depend largely on their dimensions and depth of embedment, but another important factor is the grade of lumber used. Lower grades of lumber may have knots, cracks, or other imperfections that contribute to failure when the piling is acted on by water and debris impact forces. For example, Figure 2-20 shows a failed timber

Figure 2-20
Example of broken piling. The piling broke at the location of several knots (circle), where cross-bracing was attached (note remaining bolt and piece of bracing).

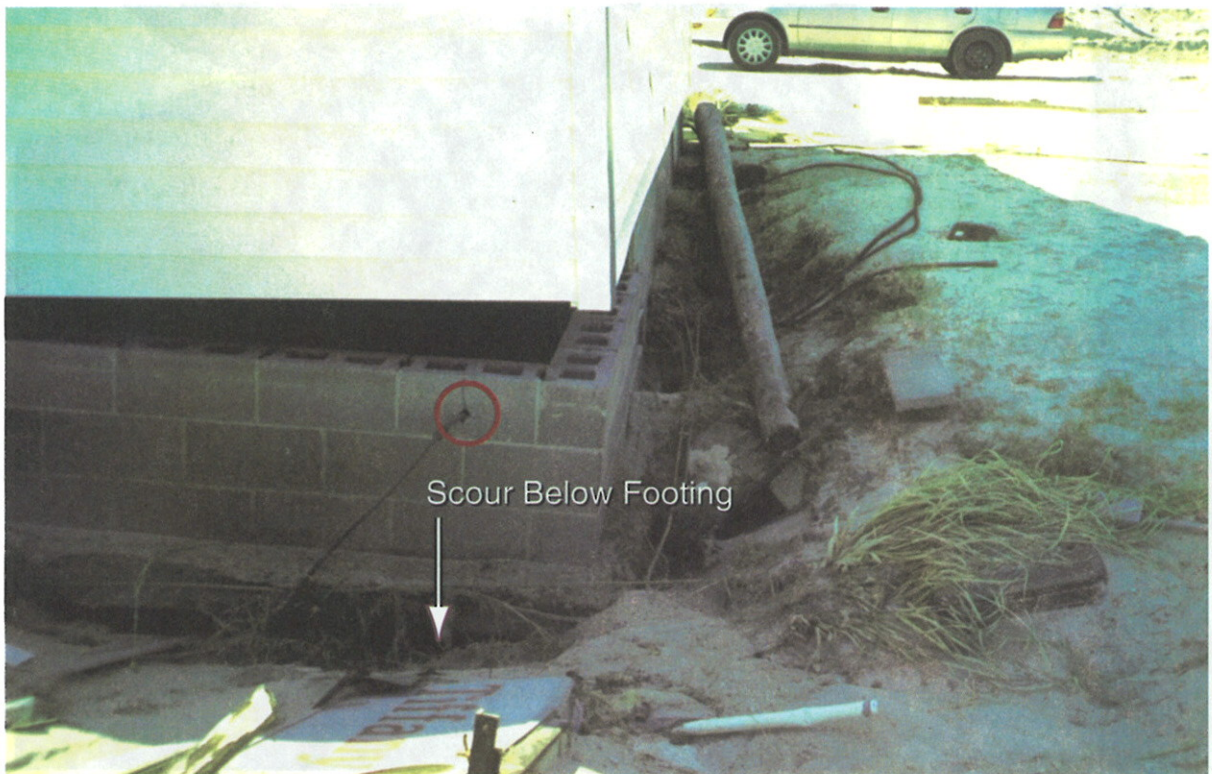
Figure 2-22 Collapse of footing and foundation wall under elevated wood-frame building. Collapse resulted because obstruction of flow by building caused scour to extend below the bottom of the footing (arrow). Note propane gas line (circled) extending through foundation wall.

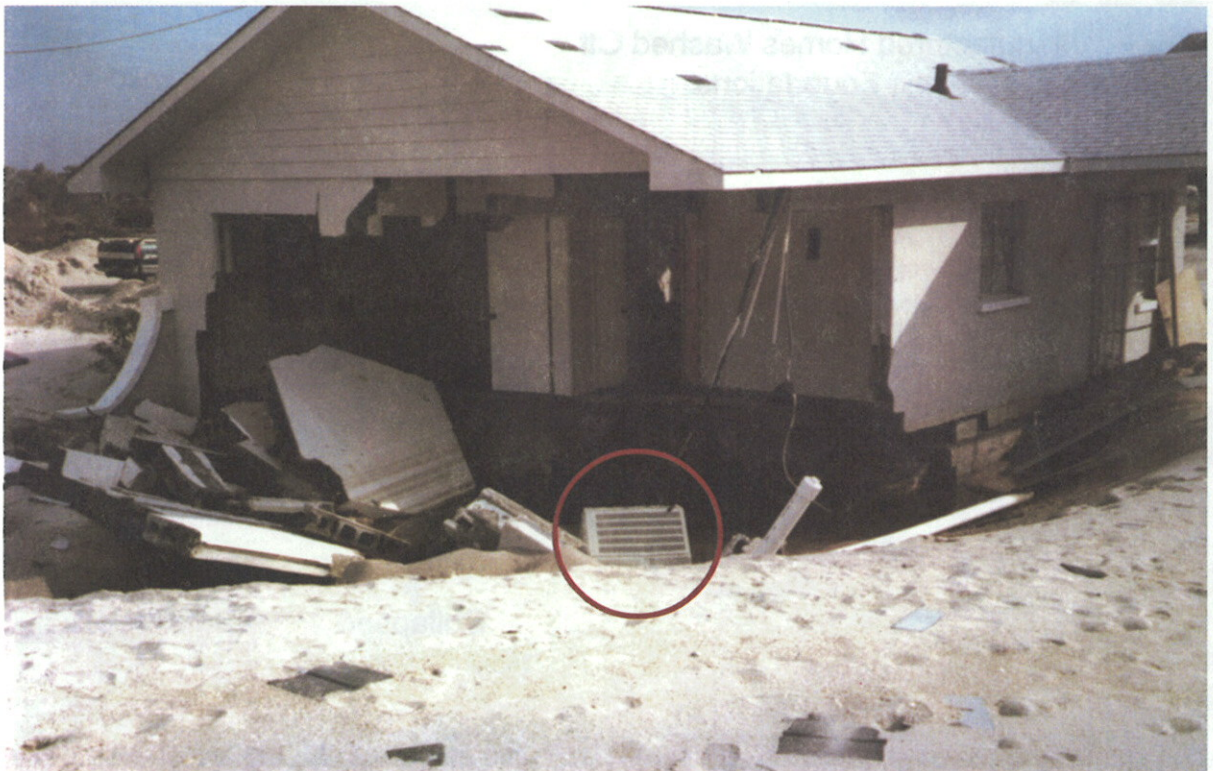
Figure 2-23 Catastrophic failure of landward building constructed on masonry wall and slab-on-grade foundation. Failure resulted because obstruction of flow by building caused extensive scour. Note compressor collapsed into scour hole.

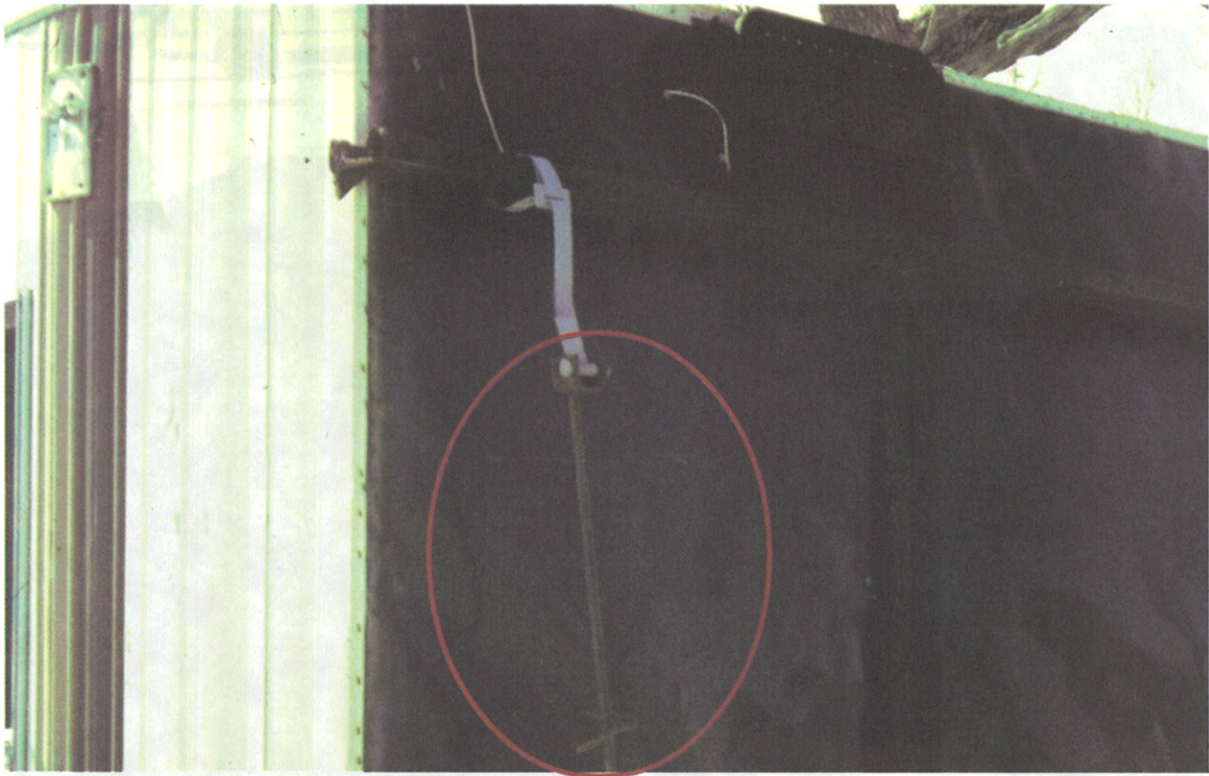
Figure 2-24 Permanently installed RV overturned as a result of anchor pullout. Anchor (circled) is 2 feet long.
