BUILDING PERFORMANCE ASSESSMENT:

Hurricane Fran in North Carolina

OBSERVATIONS, RECOMMENDATIONS,
AND TECHNICAL GUIDANCE

FEDERAL EMERGENCY MANAGEMENT AGENCY
MITIGATION DIRECTORATE

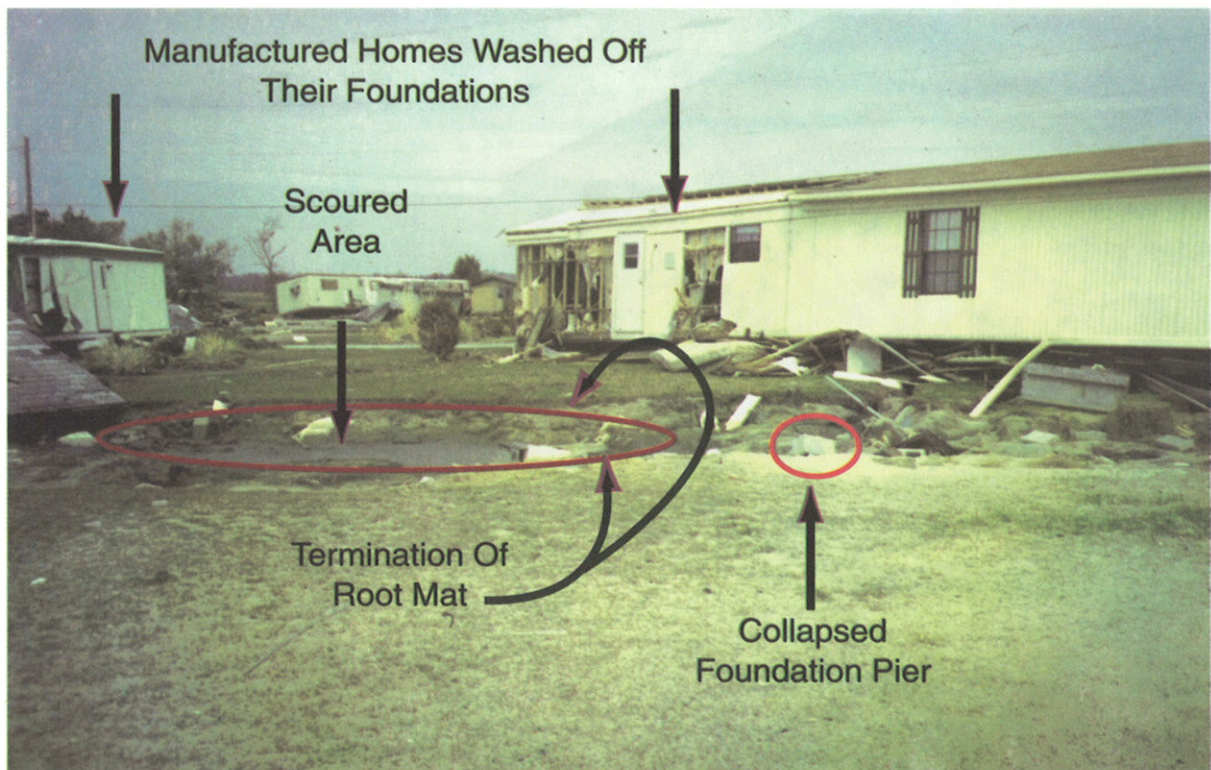
The team observed depressions from 1 to 2 feet deep left by localized scour within the original footprint of the structure (see Figure 2-25). The scour may have been caused by numerous factors, including a discontinuity between the stabilizing root mat provided by grass surrounding the site and the corresponding loss of unprotected sand beneath the home, the creation of a large obstruction by the solid skirt surrounding the foundation system, and localized scour around the dry-stack masonry piers supporting the structure.

Figure 2-25 Localized scour beneath pre-storm footprint of manufactured home. Note the collapsed dry-stack block foundation and termination of root mat, which otherwise would have helped stabilize the adjacent ground.

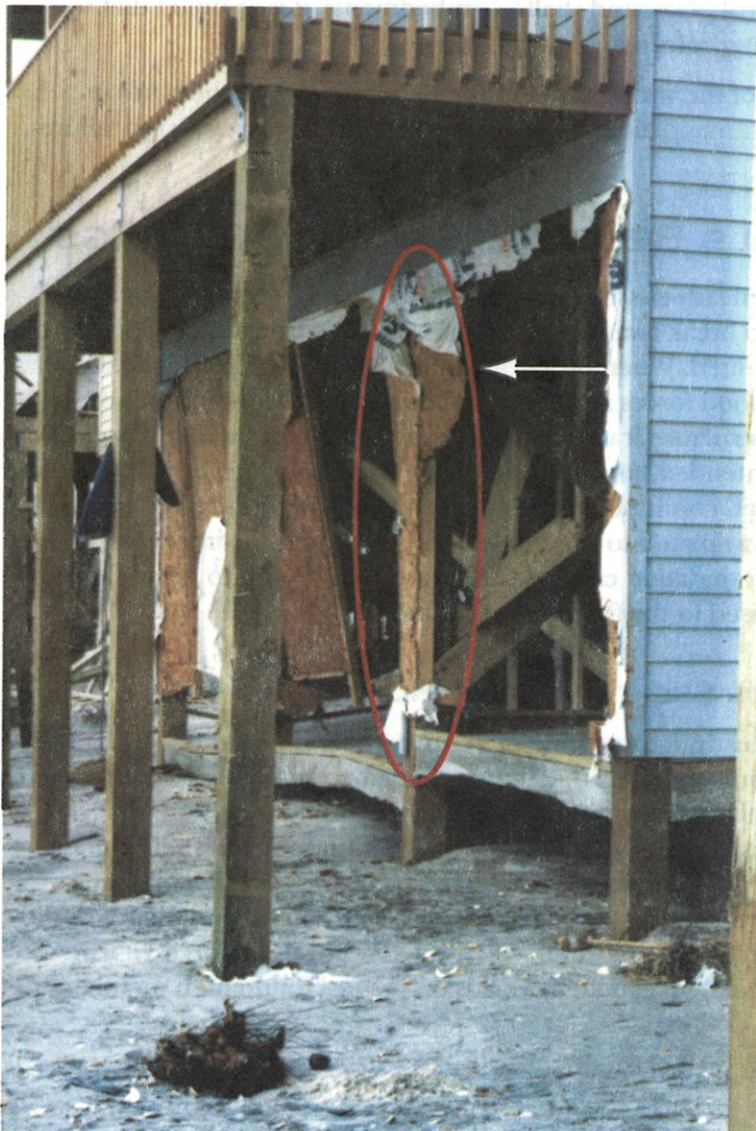
Figure 2-26
Exterior sheathing of breakaway
wall spanned piling.
Note torn sheathing (arrow).

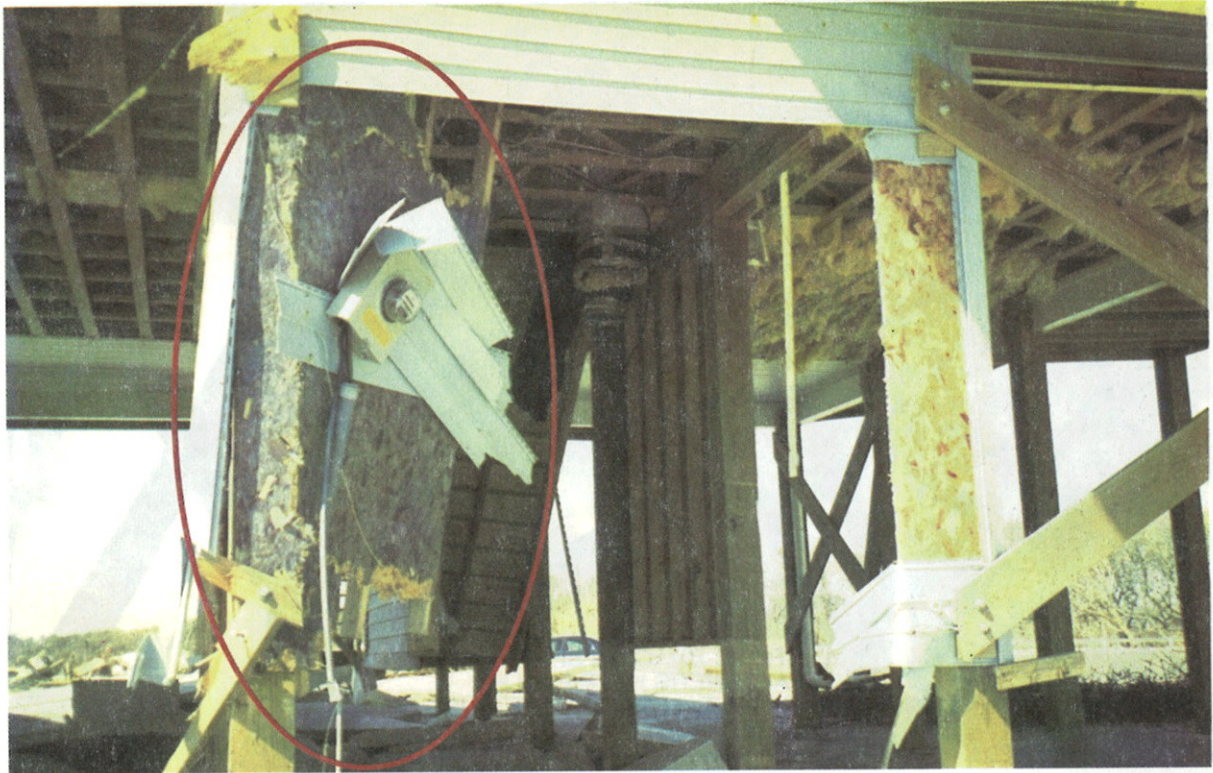
Figure 2-27 Breakaway wall panel failed to function as designed because continuous sheathing was installed across pilings. No structural damage was observed; however, note damage to utility components installed on breakaway wall panel.

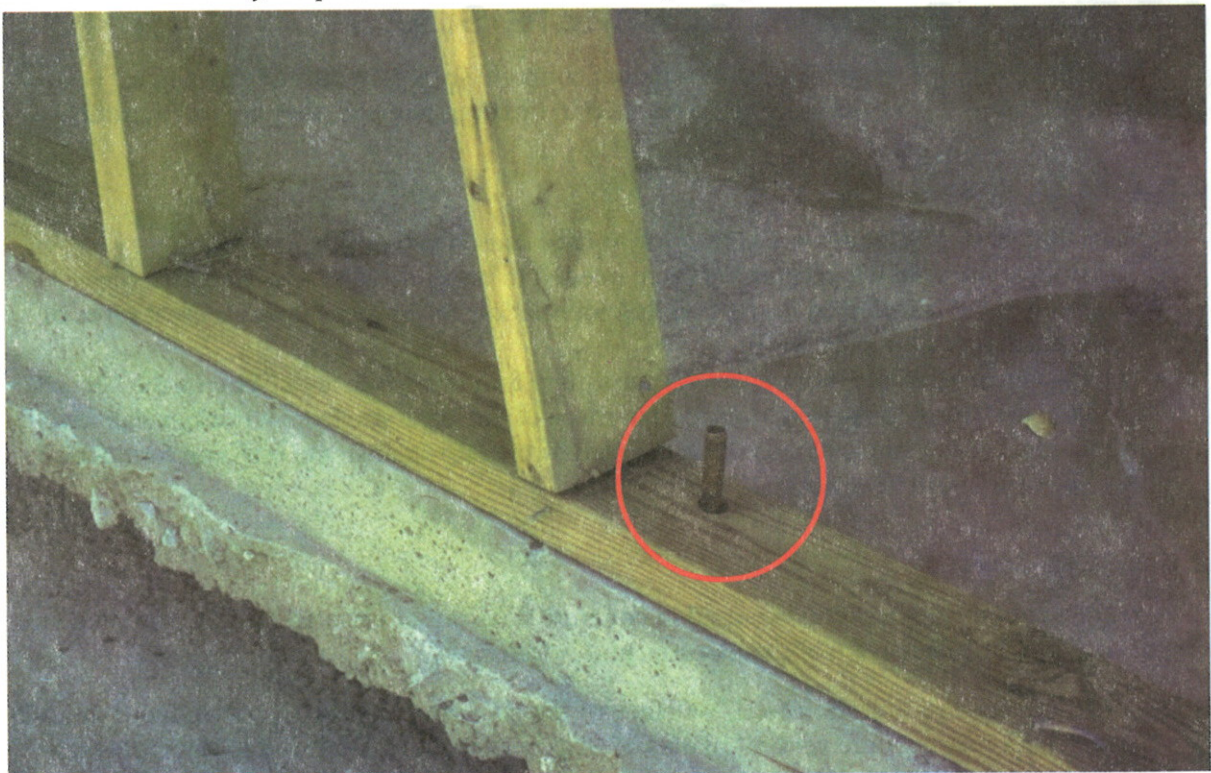
Figure 2-28 Use of anchor bolts through the sill plate of a breakaway wall is improper. Even though this bolt does not have a nut and washer, it prevented the wall from breaking away laterally.

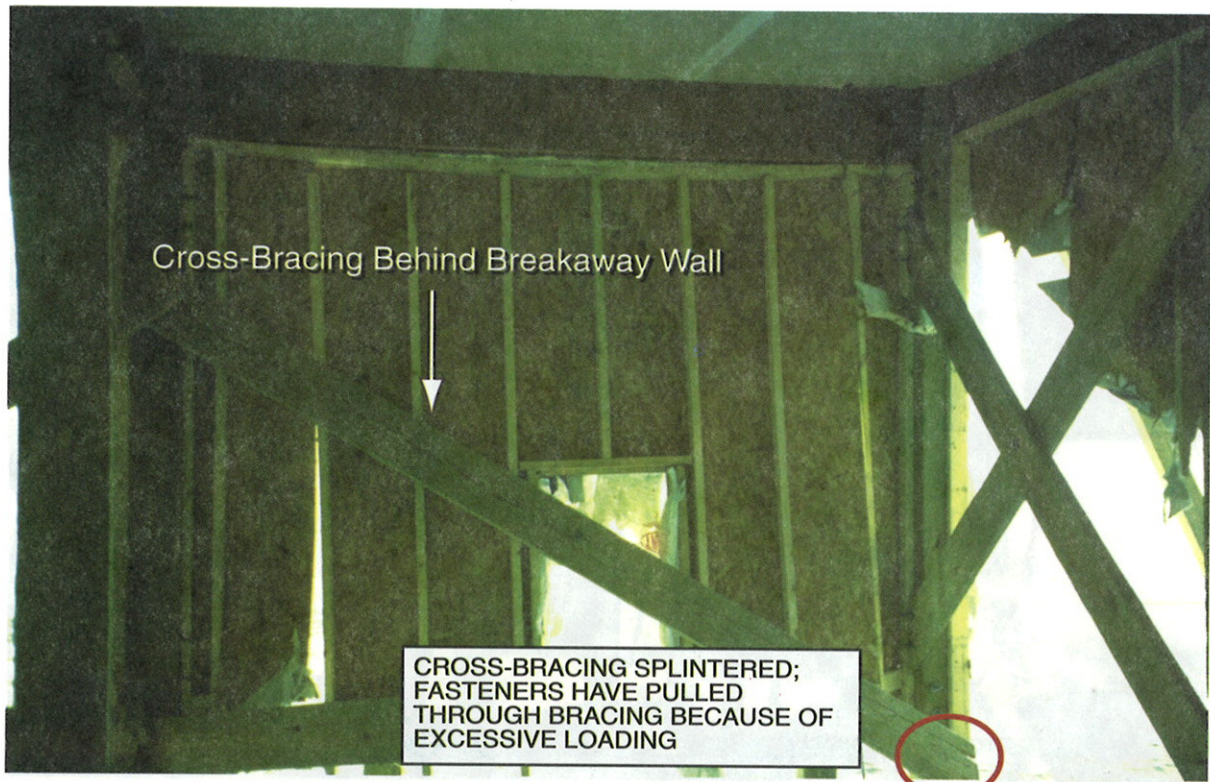
Figure 2-29 Improper installation of breakaway walls (on the seaward side of cross-bracing) resulted in failure of cross-bracing. Note breakaway wall pushed against cross-bracing.

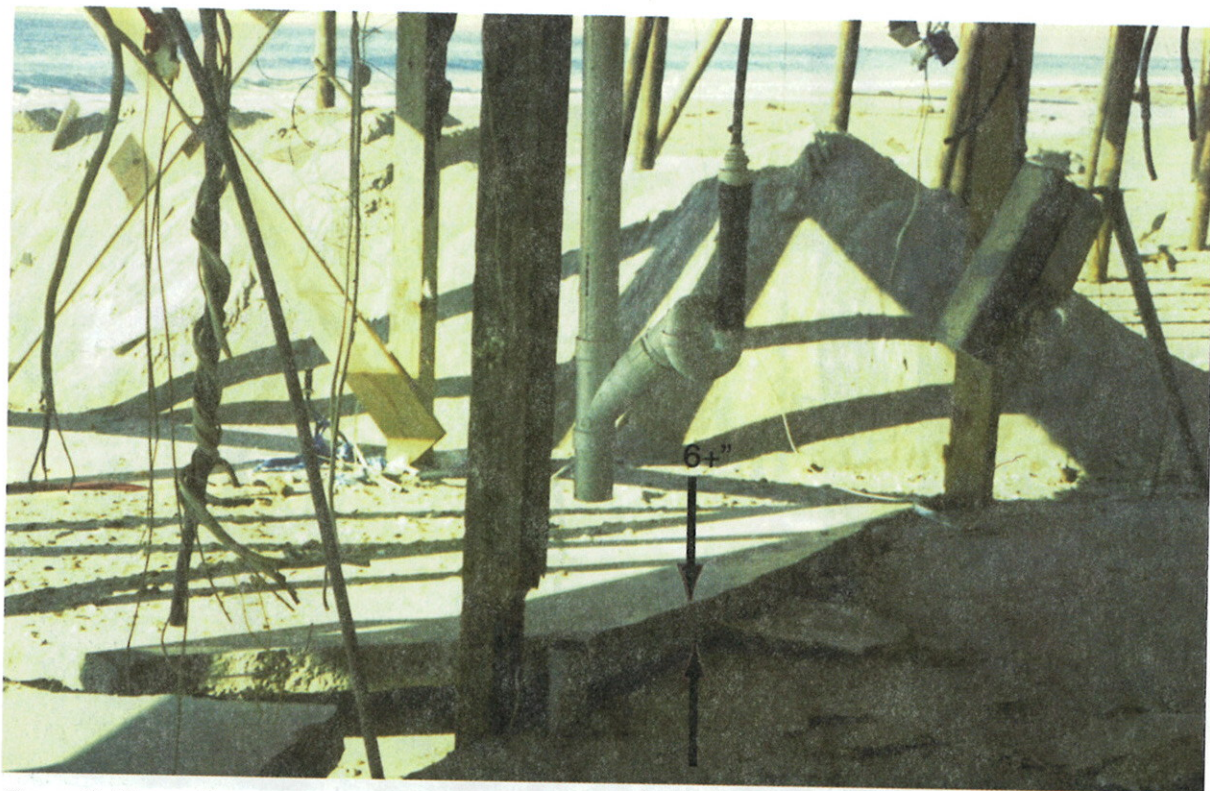
Figure 2-30 Example of unnecessarily thick slab.

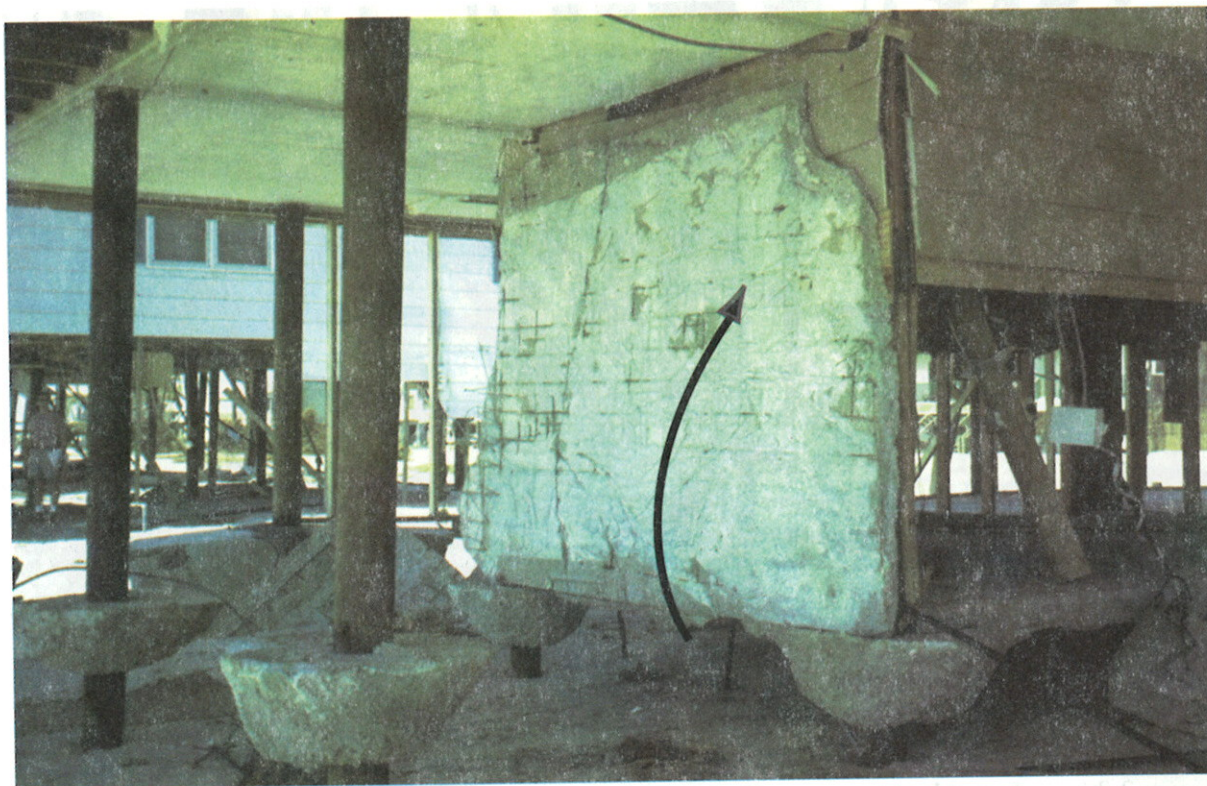
Figure 2-31 *Concrete slab-on-grade flipped up, probably by wave action, came to a rest against two foundation members, generating large, unanticipated loads on the foundation. Note slab is supported on concrete collars around piles and contains wire mesh.*

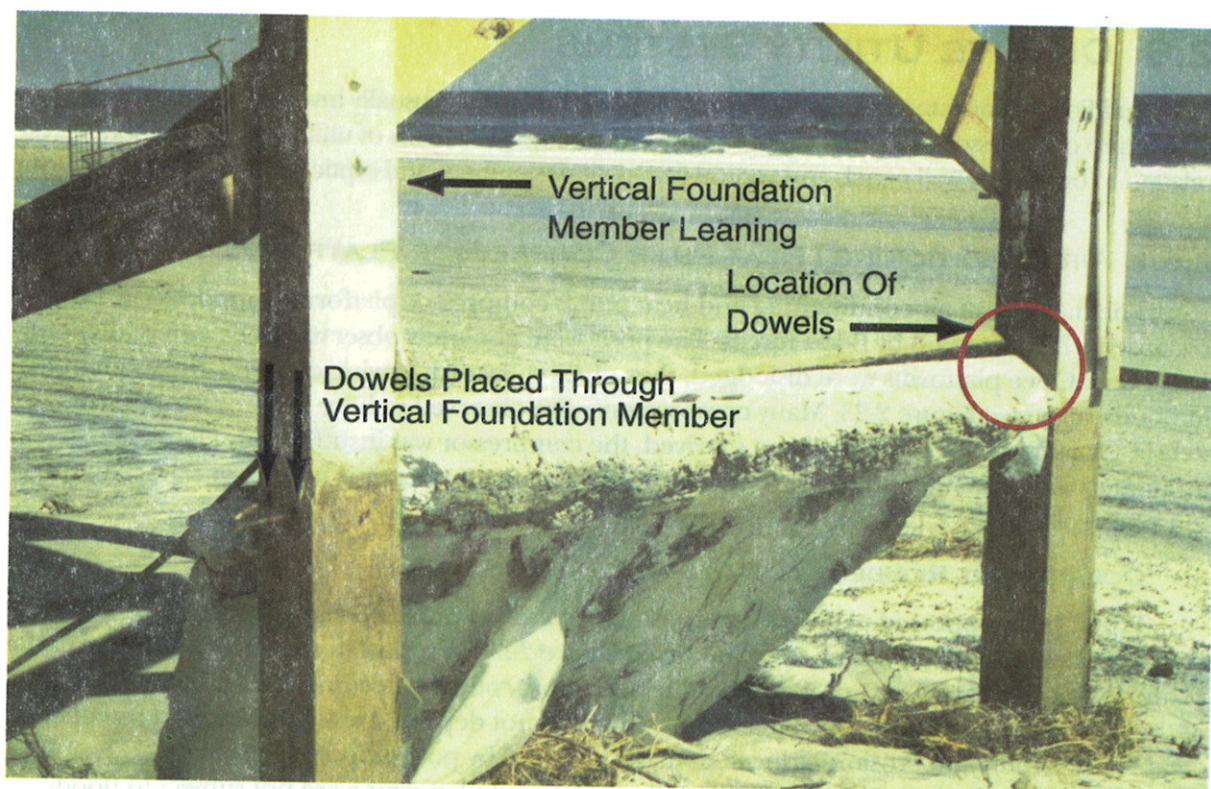
Figure 2-32 Use of steel dowels to tie slabs to vertical foundation members prevented the proper breakup of slab. A portion of the slab was left attached to the piling, resulting in large, unanticipated loads on foundation members. Note leaning vertical member, on right.

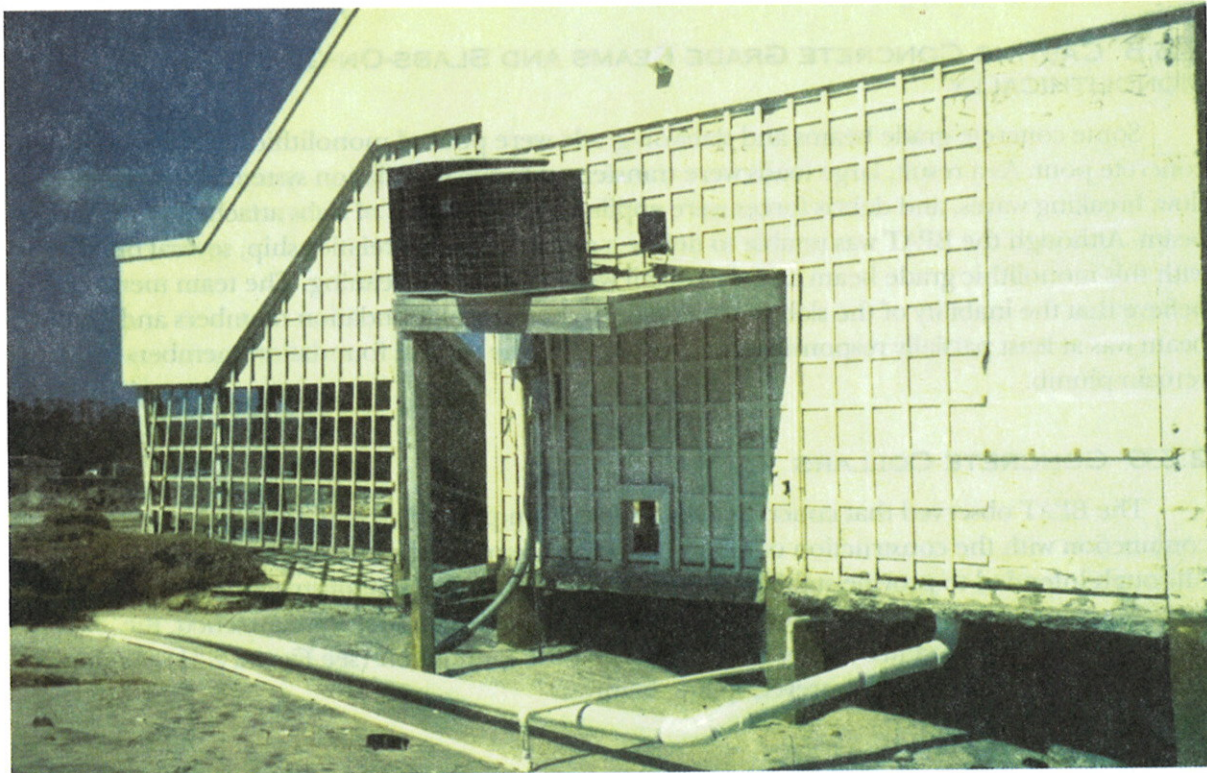
Figure 2-33 Air conditioning / heat pump compressor platform leaning because erosion and scour caused loss of one supporting column.

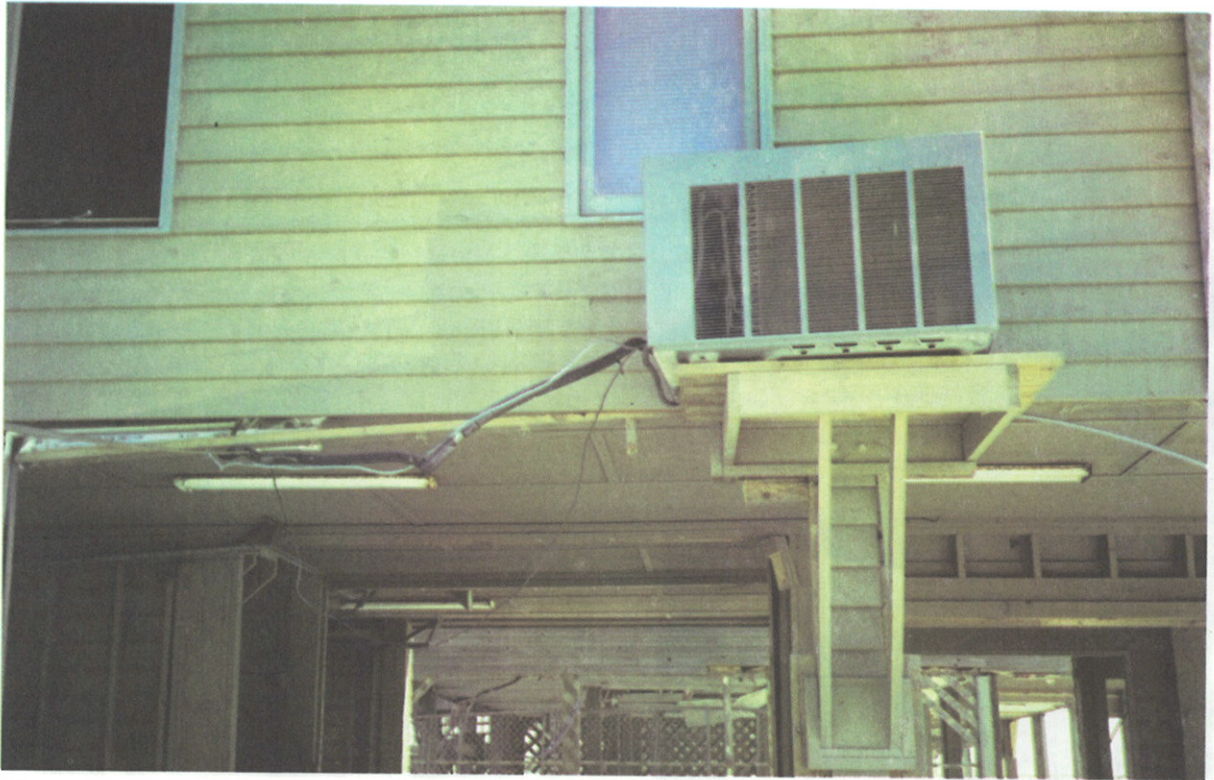
Figure 2-34 Although the air conditioning/heat pump compressor platform on this oceanfront house was adequately elevated with cantilever bracing, the compressor was almost pushed off the platform by wind because of the lack of the necessary attachment.

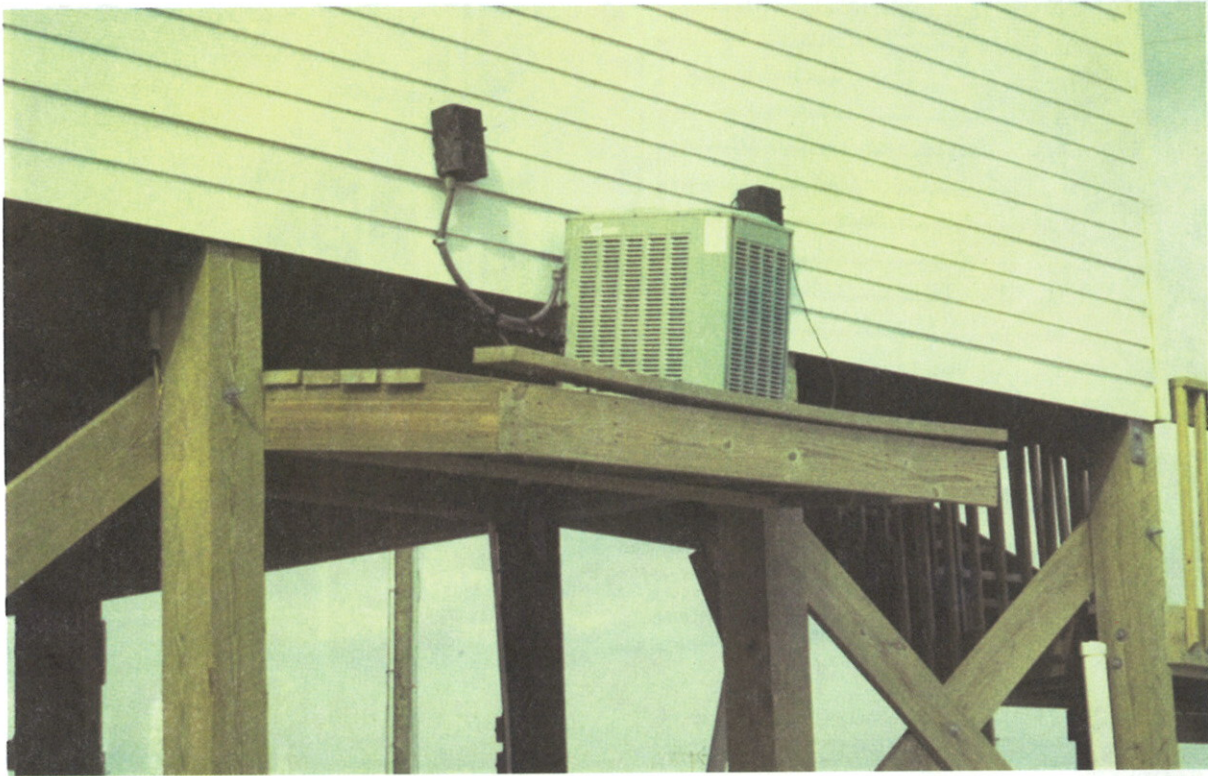
Figure 2-35 Air conditioning / heat pump compressor platform leaning because scour caused loss of two supporting posts.

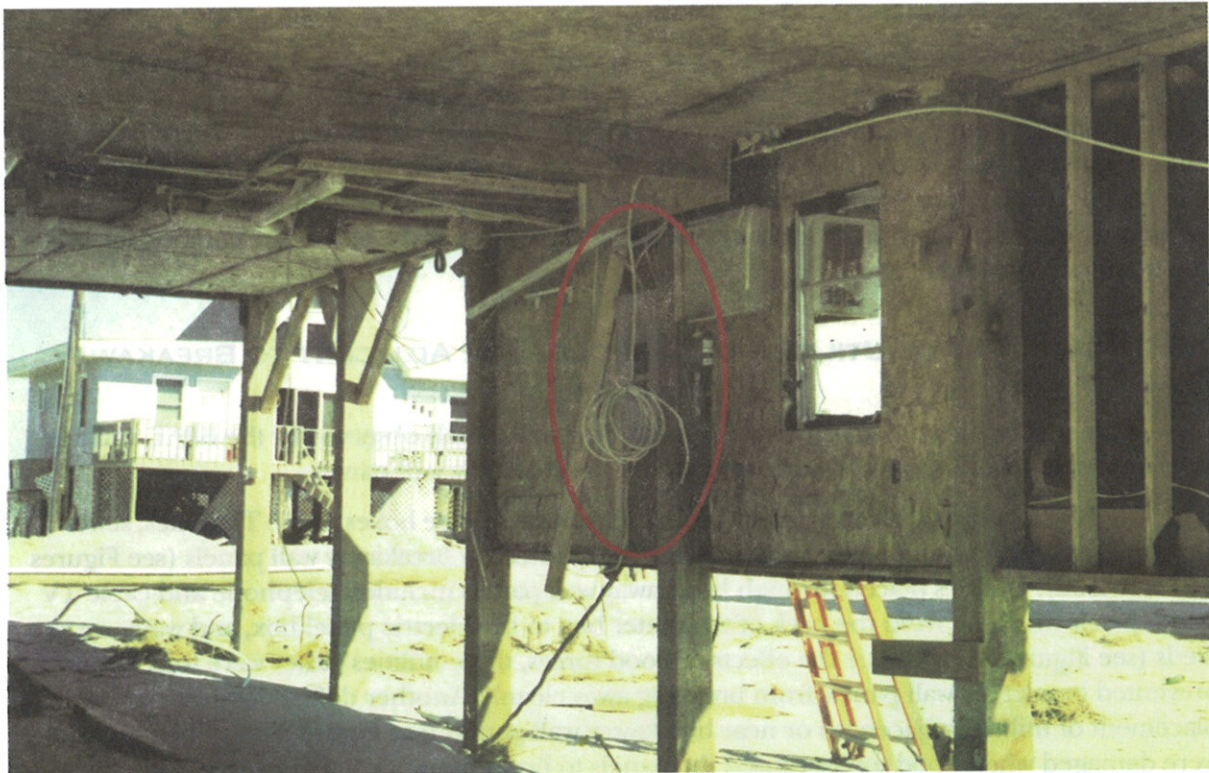
Figure 2-36 Example of utility component (electric panel box) installed on a breakaway wall panel.

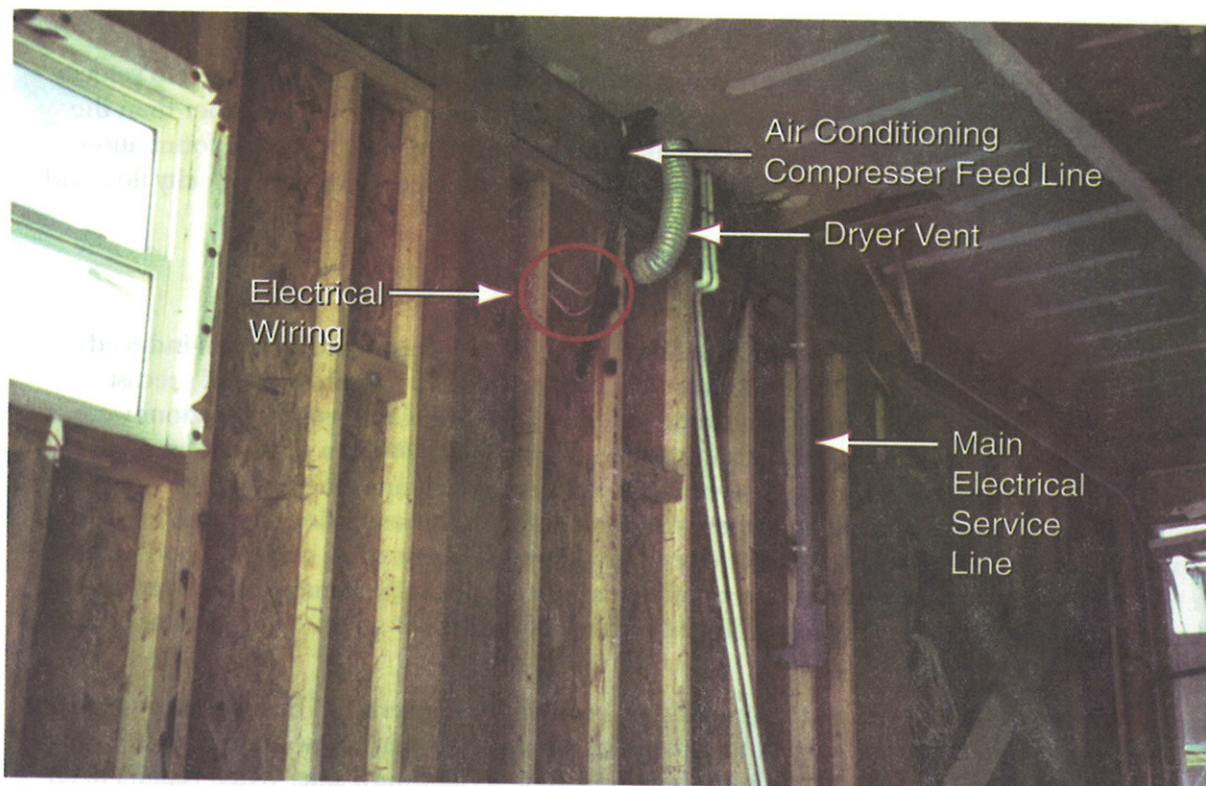
Figure 2-37 Utility components (dryer vent, air conditioning compressor feed line, main electrical line out of meter box, and electric wiring) penetrating breakaway wall panel.

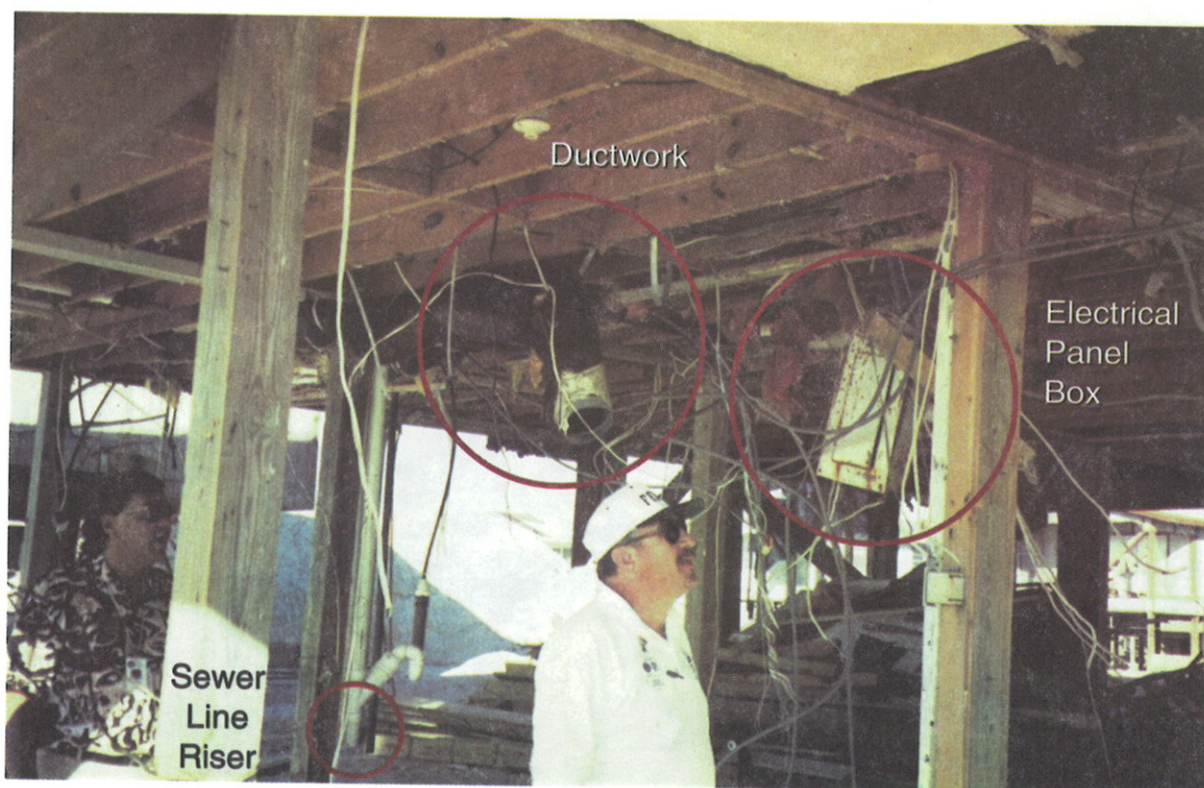
Figure 2-38 These utility components (wiring, electric panel box, ductwork, and sewer line) were installed adjacent to breakaway wall panel and were damaged when the walls broke away. Note broken sewer line riser pipe on seaward side of piling.

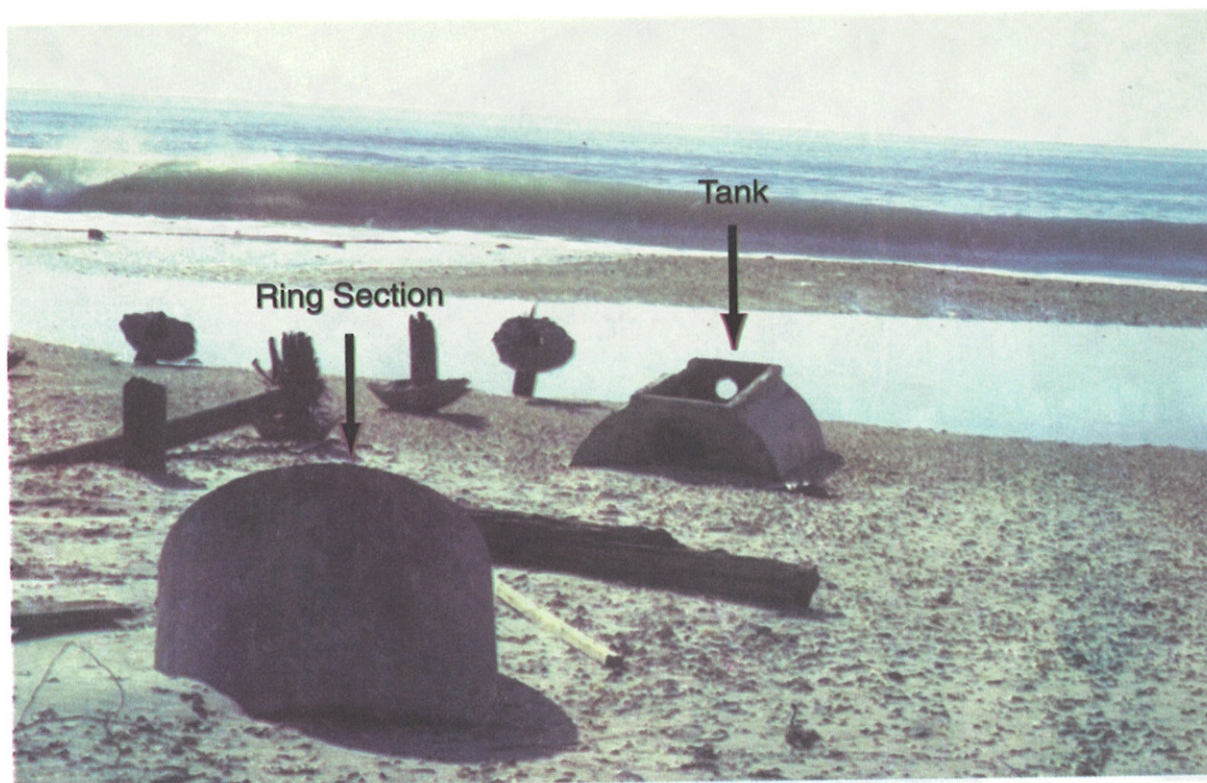
Figure 2-39 Oceanfront erosion and scour unearthed and damaged septic tanks and systems. Note precast ring section and precast tank.

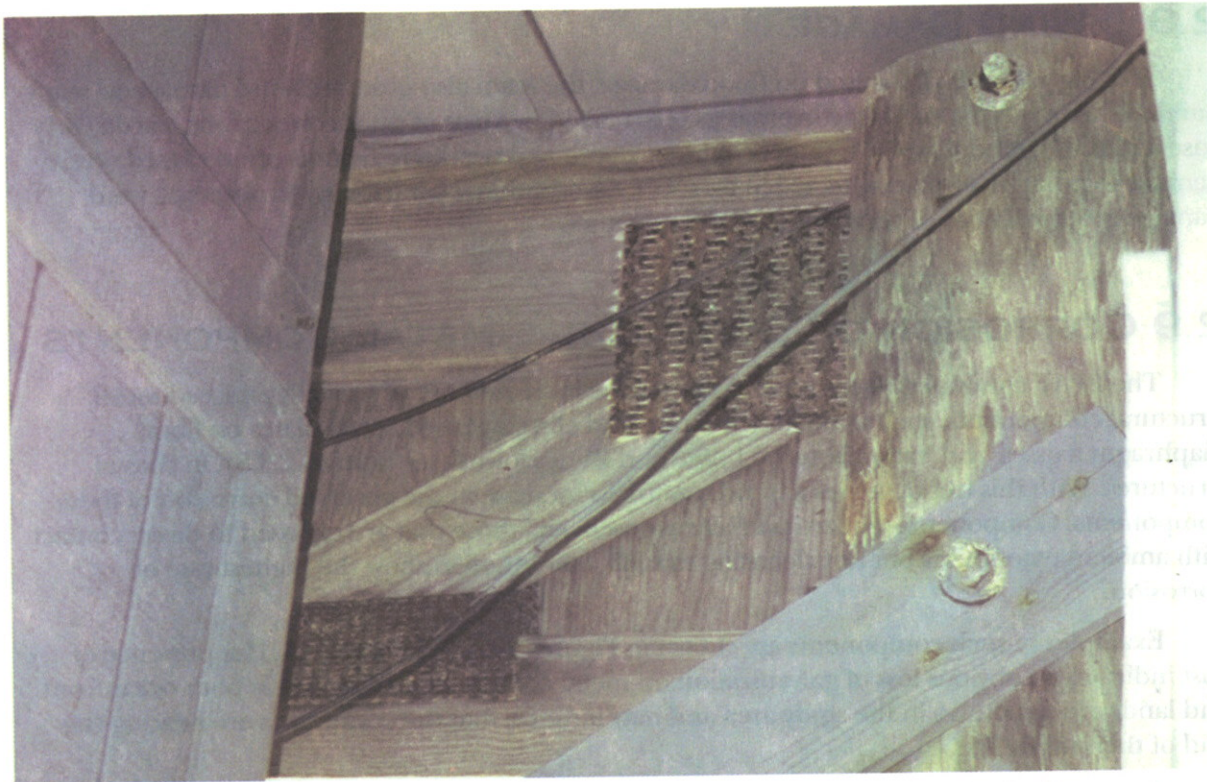
Figure 2-43 Corrosion of galvanized floor truss plates was observed in many buildings.

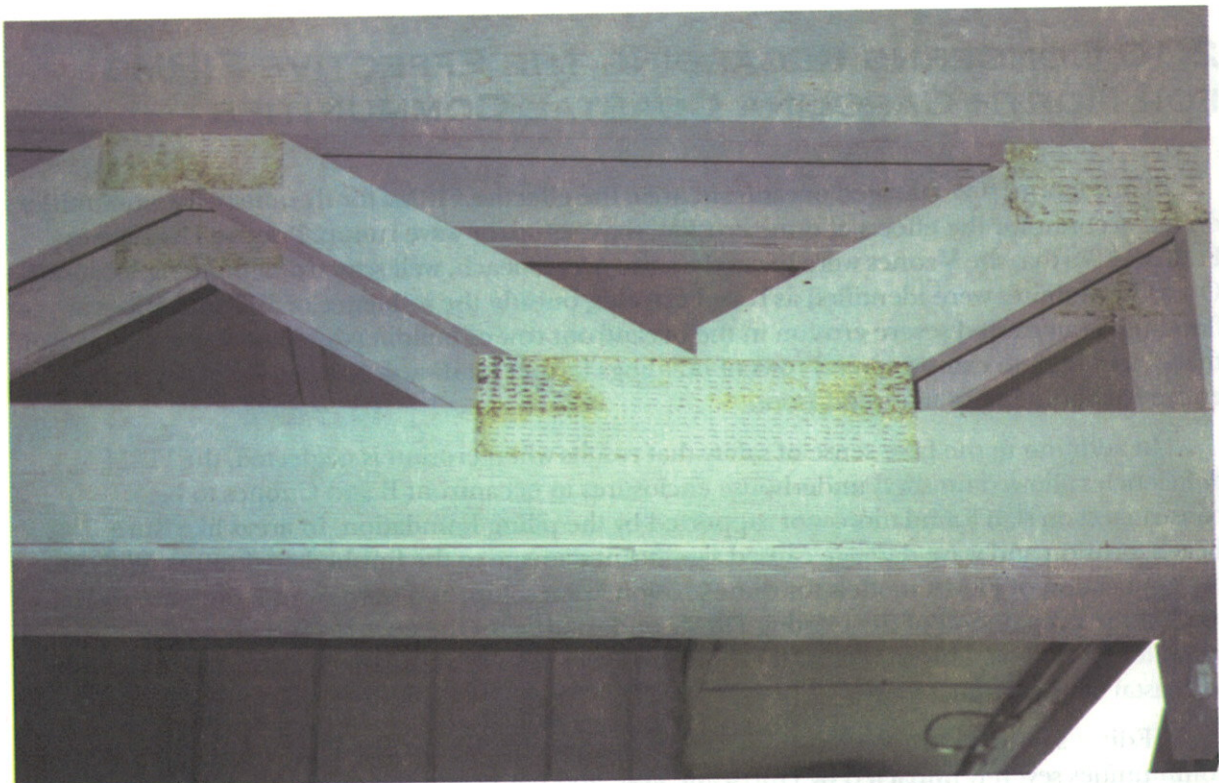
Figure 2-44 Corrosion of galvanized floor truss plates was observed in many buildings. Note that painting does little to slow the process of corrosion in coastal environments

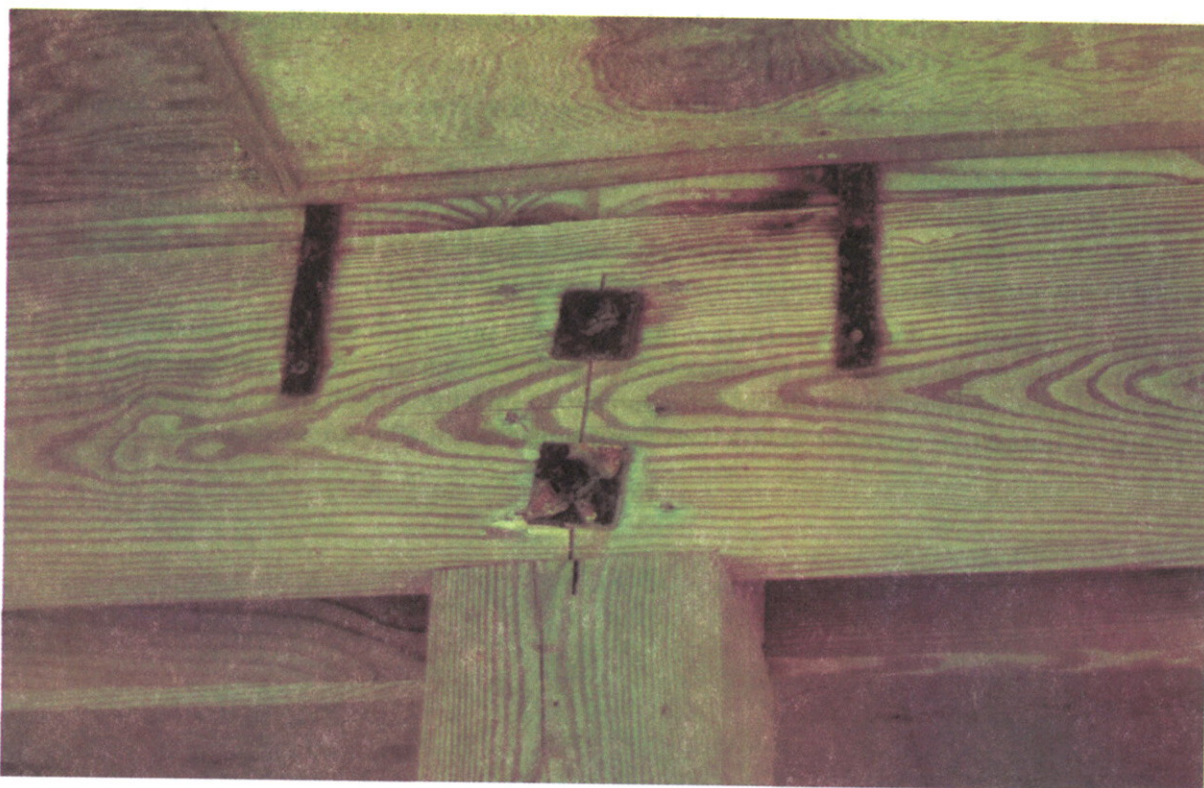
Figure 2-45 Corrosion of hurricane straps and steel plates was also observed in many locations.
