## 4. Structural Systems Performance

*The dominant causes of structural failure observed by the MAT included storm surge, waves, floodborne debris, and wind. Structural damage due to erosion was also common on the barrier islands. Damage occurred to residential buildings (single- and multi-family housing), commercial buildings, and critical and essential facilities.*

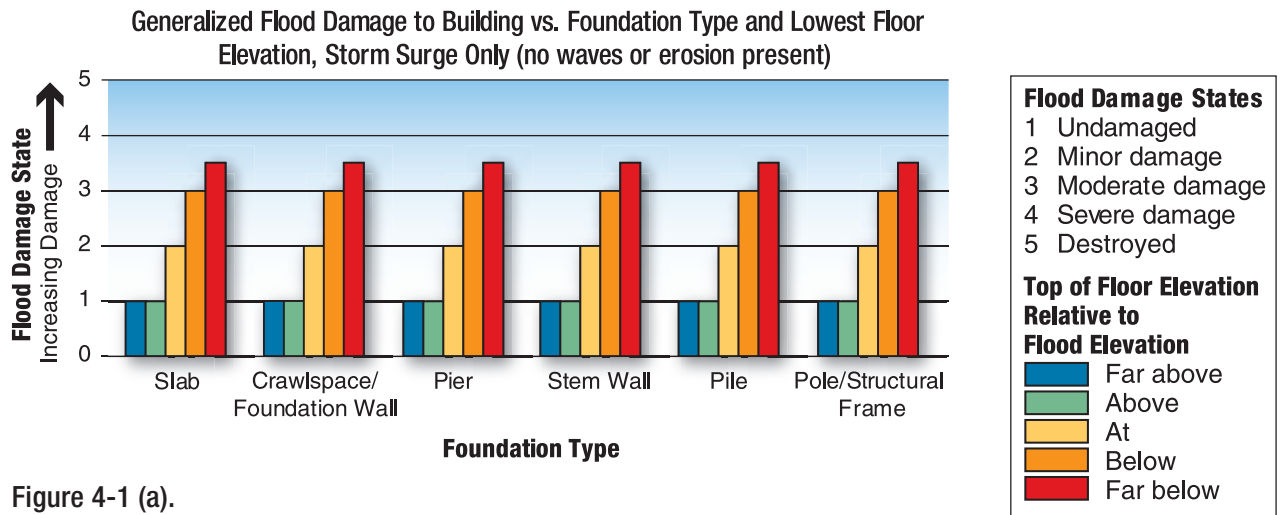
Figure 4-1 (a).

- Figure 4-1(a) shows observed damages for the case where inundation by storm surge occurred, but where waves and erosion were not present. In this case, damage tends to vary by floor elevation and be similar for all foundation types, as long as buildings are firmly attached to their foundations, buildings with the floor elevation far above the surge elevation tend to be undamaged and, as the floor elevation drops relative to the surge elevation, damage increases. This scenario is representative of much of the New Orleans area and in the areas of coastal Alabama and Mississippi where buildings are distant from the shoreline, and waves have dissipated.

- Figure 4-1(b) shows observed damages for the case where inundation by storm surge occurred and damaging waves were also present (erosion in these cases was non-existent or minor). A comparison with Figure 4-1(a) shows the effects of waves on buildings; as the wave crest rises to and above the floor level, building damage increases. Building damage does depend on foundation type in this case, with buildings supported on shallow foundations tending to sustain the greatest damage. The scenario depicted in Figure 4-1(b) was probably the most common situation observed by the MAT.

- Figure 4-1(c) shows observed damages for the case of inundation by storm surge with damaging waves and moderate erosion.<sup>1</sup> In this case, building damage is more closely associated with foundation type, even for situations where the floor level is far above the wave crest. Comparison of Figure 4-1(c) with Figure 4-1(b) shows that, when moderate erosion occurs to buildings with typical slab, crawlspace, foundation wall, pier, and stem wall foundations, severe building damage or destruction generally occurs, regardless of the floor elevation. Virtually all one-and two-family and other light-frame buildings will be destroyed when the floor level is far below the wave crest, with the possible exception of buildings with continuous structural frame systems; these buildings may survive, but will sustain severe damage.

Flood damage vs. foundation type and floor elevation (no waves or erosion)

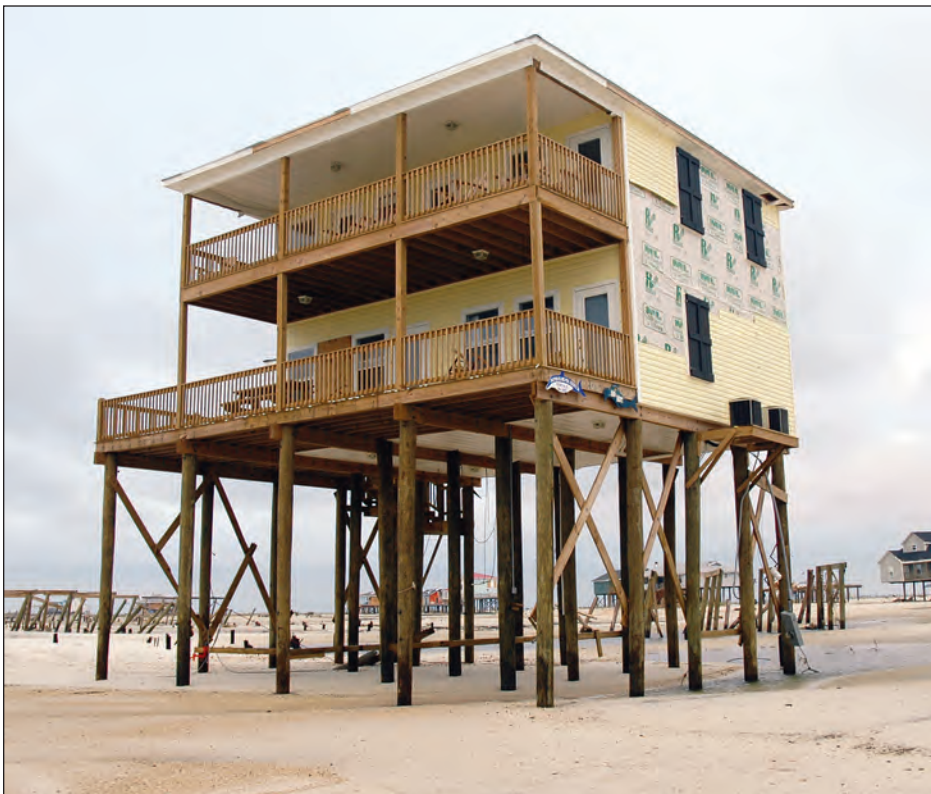
Figure 4-4.  
Another successful  
example of well-elevated  
and embedded pile  
foundation following  
Katrina. Note adjacent  
building failures where  
foundations were not  
high enough or where  
pile embedment was  
inadequate (Dauphin  
Island, Alabama).

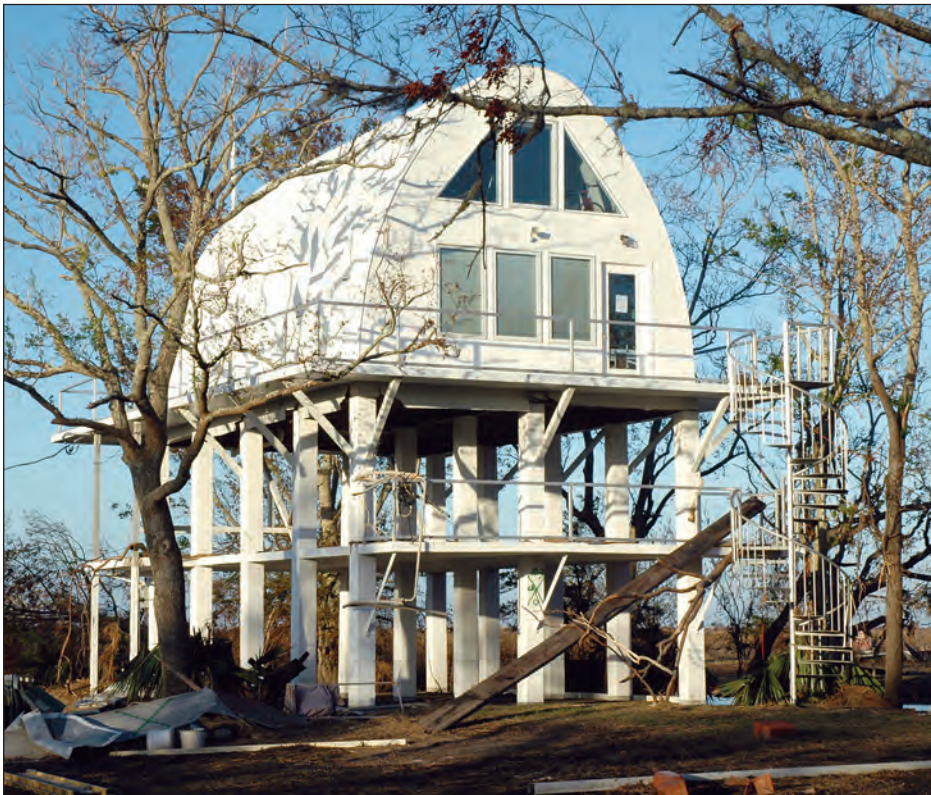
Storm surge and wave elevations were significantly higher than the BFEs shown on the FIRMs for much of the Mississippi Coast and sections of the Louisiana Delta. Successful, pile-elevated buildings that remained above Katrina's waves were observed in the fringes of the high storm surge areas, as shown in Figure 4-9.

Figure 4-9.  
Successful house on  
high pile foundations,  
well above the local BFE  
(Shell Beach, Louisiana)

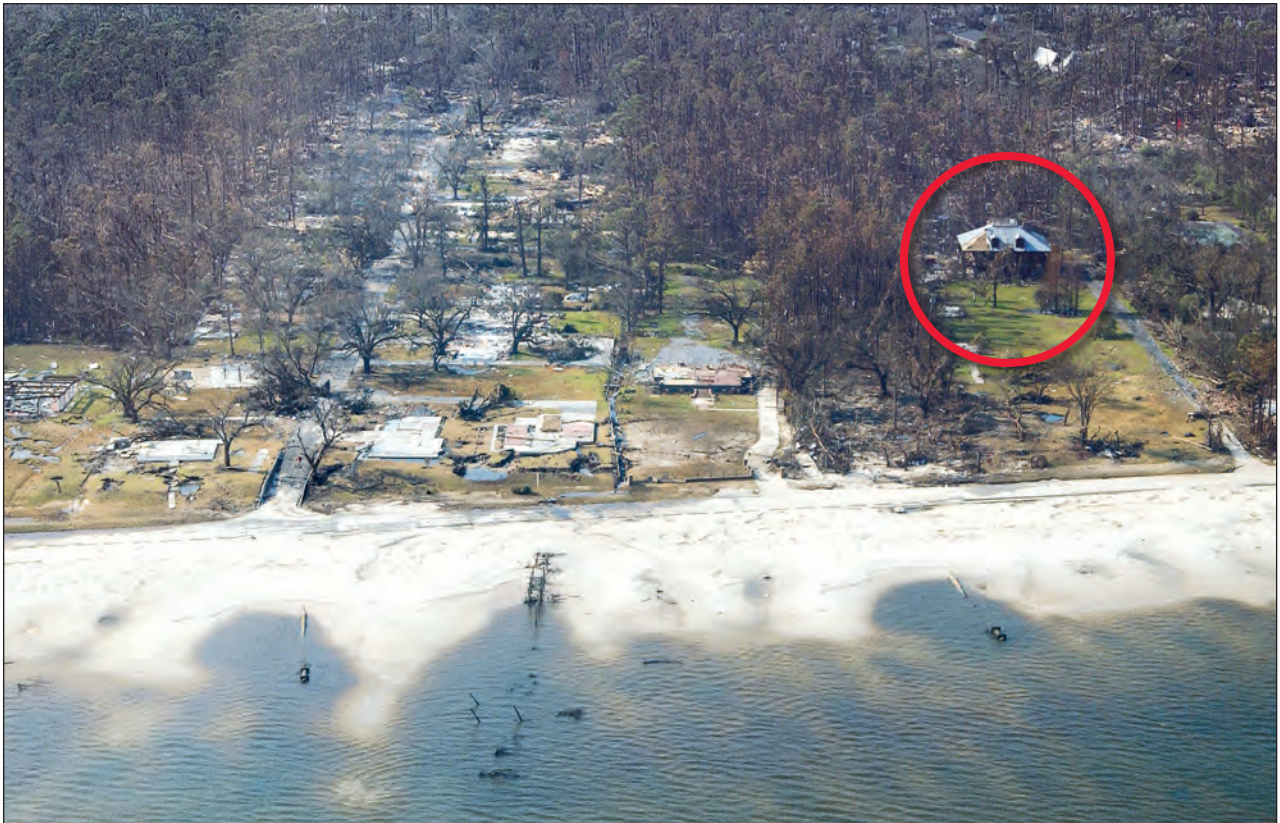
Figure 4-12.

Aerial view based on USGS imagery of the surviving pole constructed house shown in Figures 4-13 and 4-14 (circle). Note the many slabs and foundation remnants of destroyed houses nearby (Waveland, Mississippi).

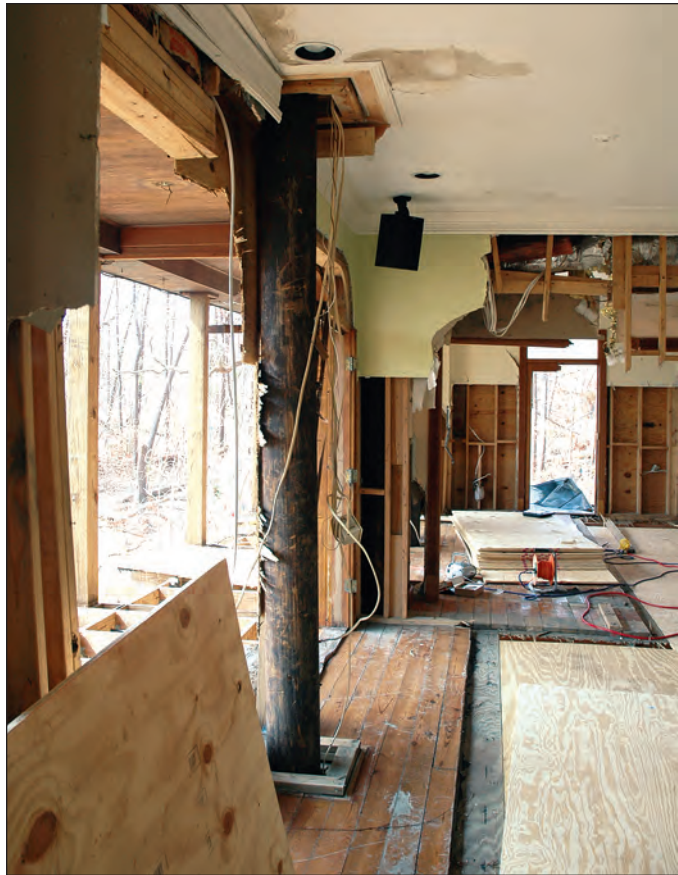
**Figure 4-14.**  
Wave damage to floors and walls, but pole construction left a repairable, surviving building (Waveland, Mississippi)

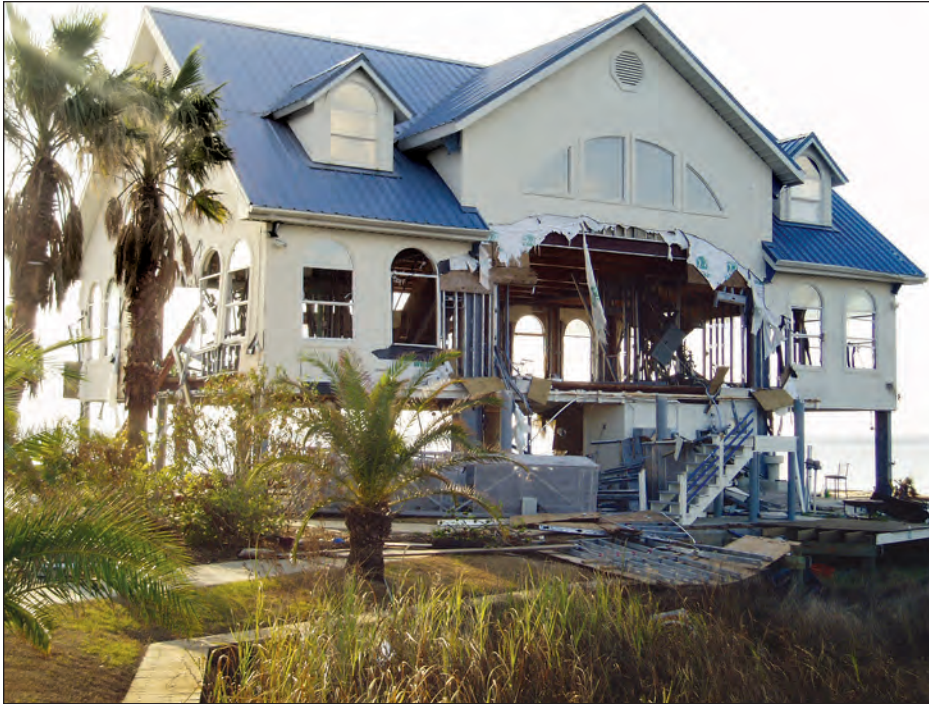
Figure 4-15.  
Steel-framed building on  
St. Louis Bay survived  
storm surge and wave  
action above the  
elevated floor level (Pass  
Christian, Mississippi)

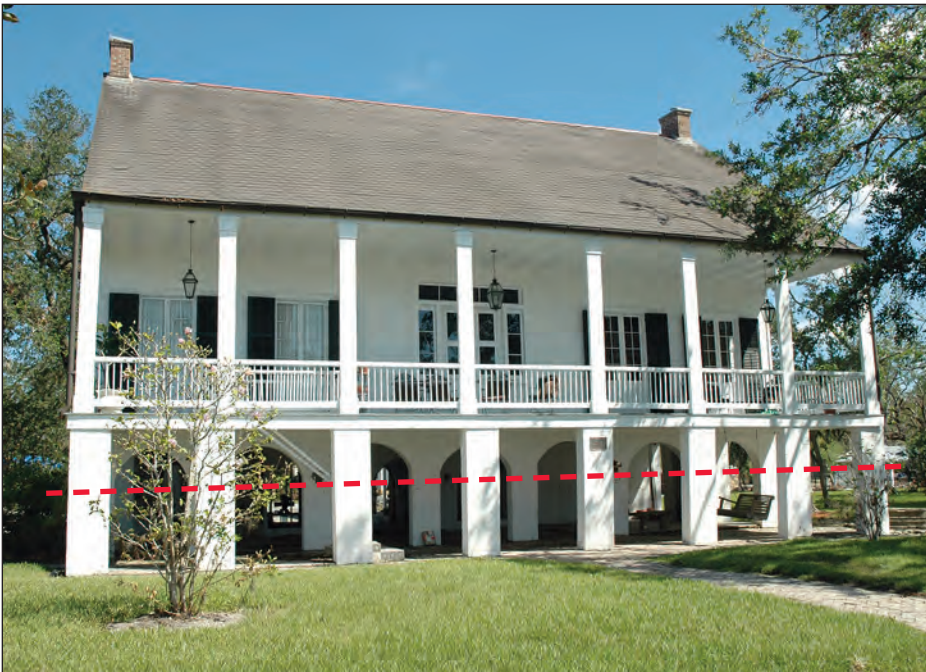
Figure 4-23.  
This 100-year-old  
building is on the  
National Register of  
Historic Places. It  
sustained minimal flood  
damage due to elevation  
on taller piers (an  
architectural choice, not  
a requirement when the  
building was constructed  
in 1905). Note the  
estimated flood depth in  
relation to the first floor  
(red line) (Mandeville,  
Louisiana).

Piers have been used to support buildings in the United States for centuries. In 1905, long before BFEs became a requirement, the builder of a house in Mandeville (see Figure 4-23) made the architectural choice to elevate on brick piers approximately 9 feet above grade. The foundation contained arches that provided some fixity and resistance to lateral forces. The building had damage to a few recently added under-house, breakaway walls, and minor damage to several columns, but was otherwise undamaged compared to older, lower houses.

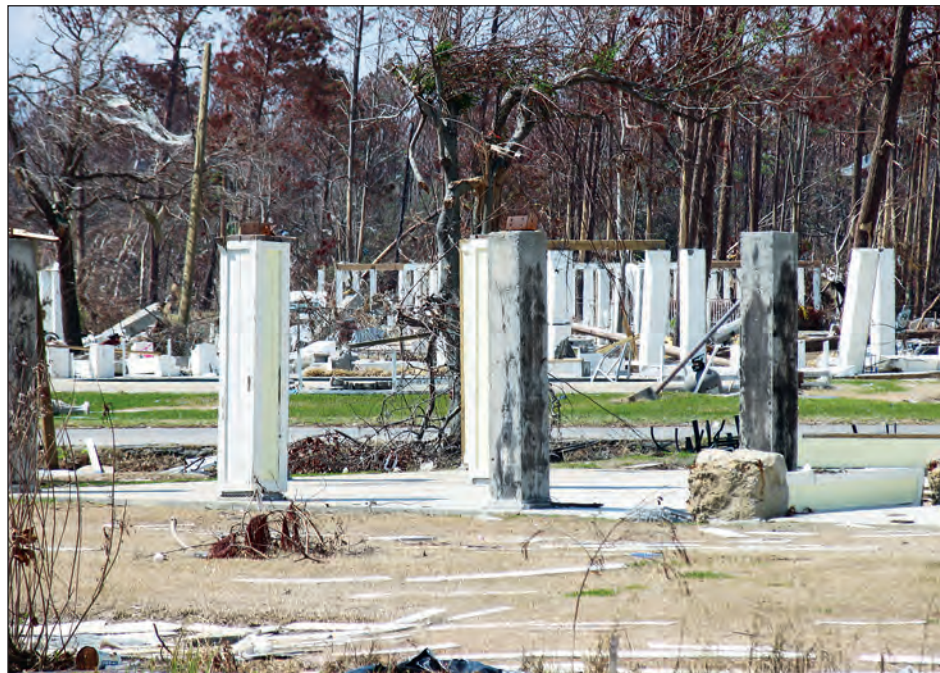
**Figure 4-24.**  
Typical building failures  
when surge and waves  
exceeded pier foundation  
height (Long Beach,  
Mississippi)

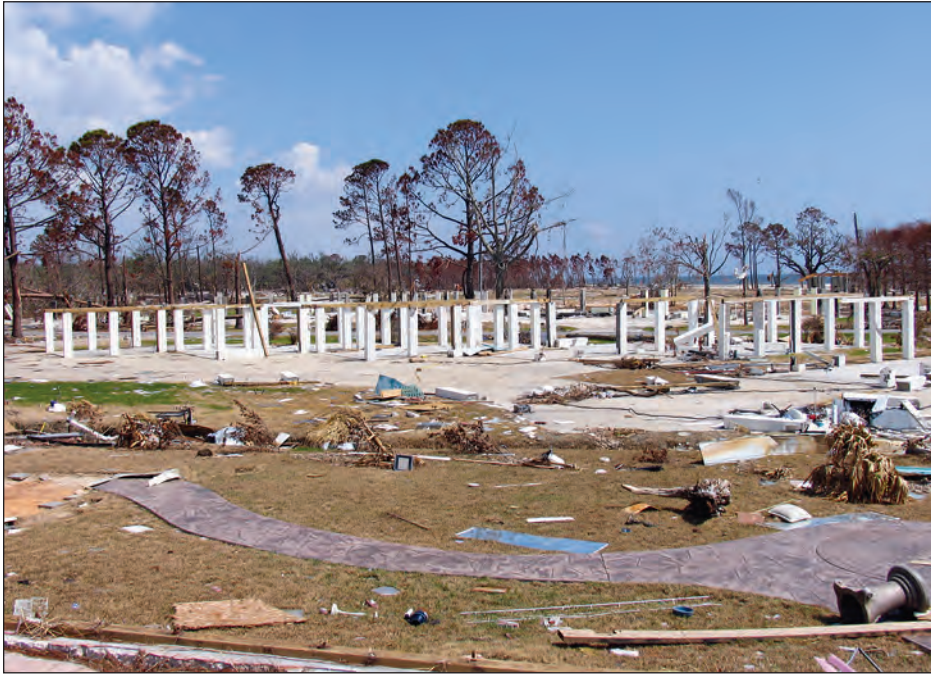
Figure 4-25.  
Another typical example  
of building failures  
when surge and waves  
exceeded pier foundation  
height (Long Beach,  
Mississippi)

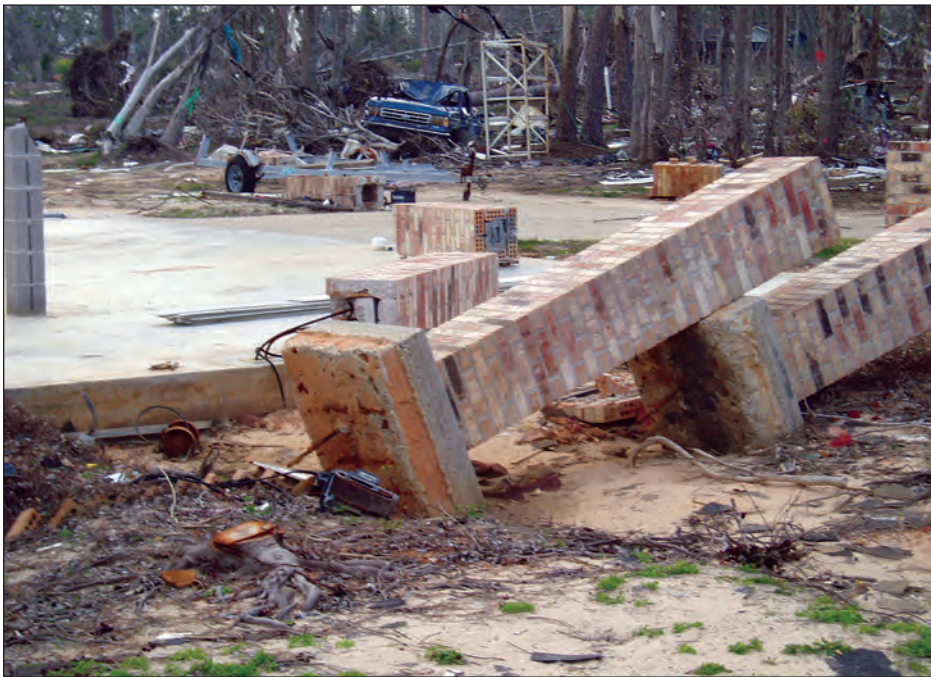
Figure 4-26.  
Failure of masonry piers  
on shallow footings (Pass  
Christian, Mississippi)

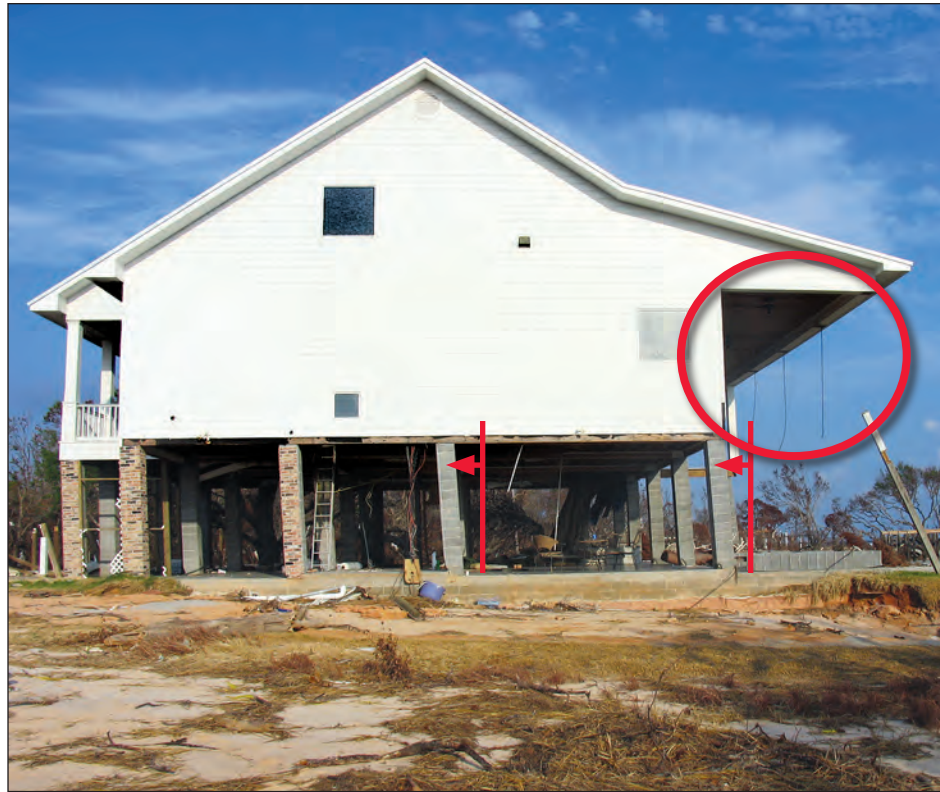
Figure 4-27.

Tops of piers have been pushed landward, probably due to wave effects on the foundation and lateral wind loads on the building. Note reinforcing bars hanging from the porch roof overhang (circle). These bars were placed through wood columns and attached to the foundation, apparently as a way of providing wind uplift resistance for the wide overhang (Belle Fontaine Point, Jackson County, Mississippi).

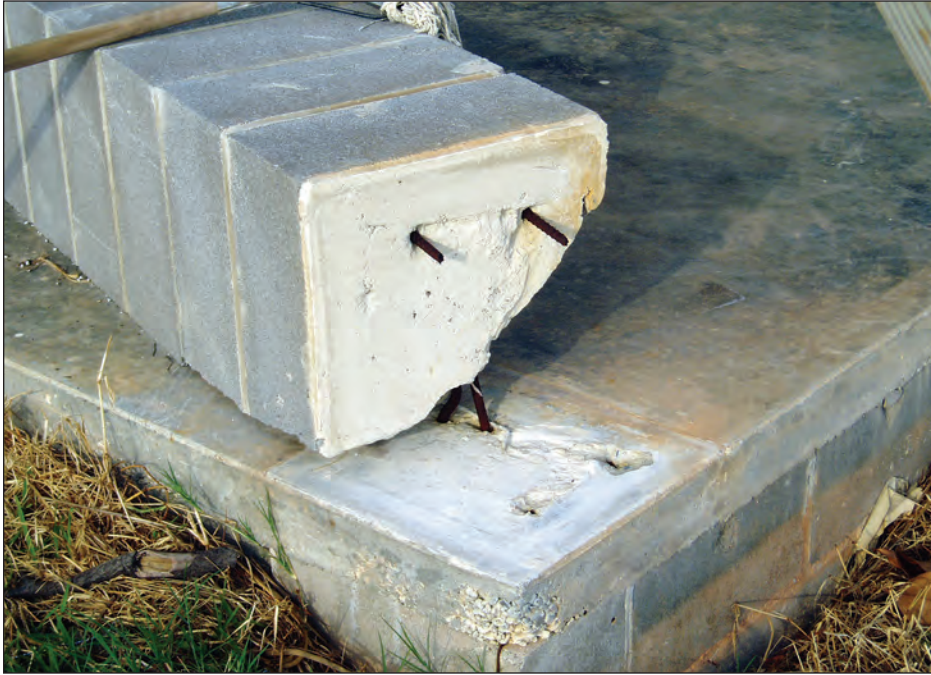
Figure 4-28.  
Pier connection failure  
(Belle Fontaine Point,  
Jackson County,  
Mississippi)

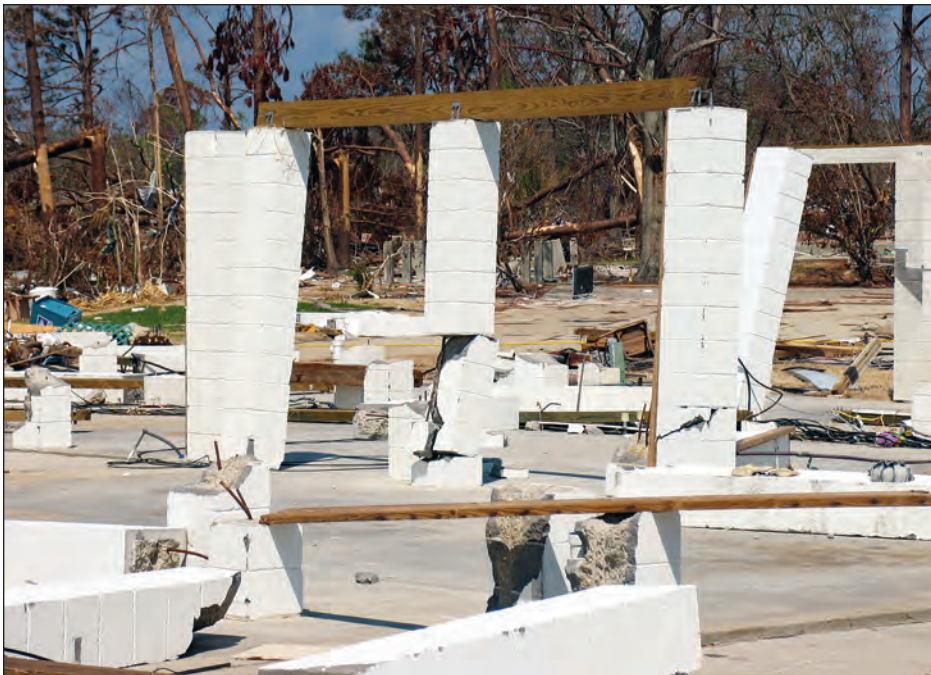
Figure 4-29.  
Pier breakage (Long  
Beach, Mississippi)

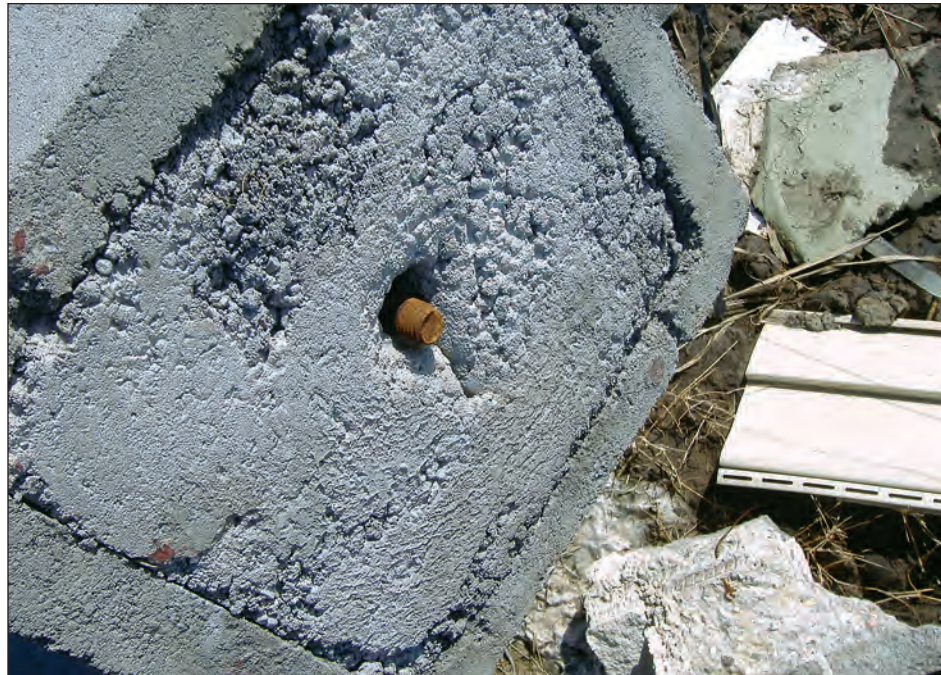
**Figure 4-30.**  
Failure from a poorly  
detailed pier to beam  
connection (Long Beach,  
Mississippi)

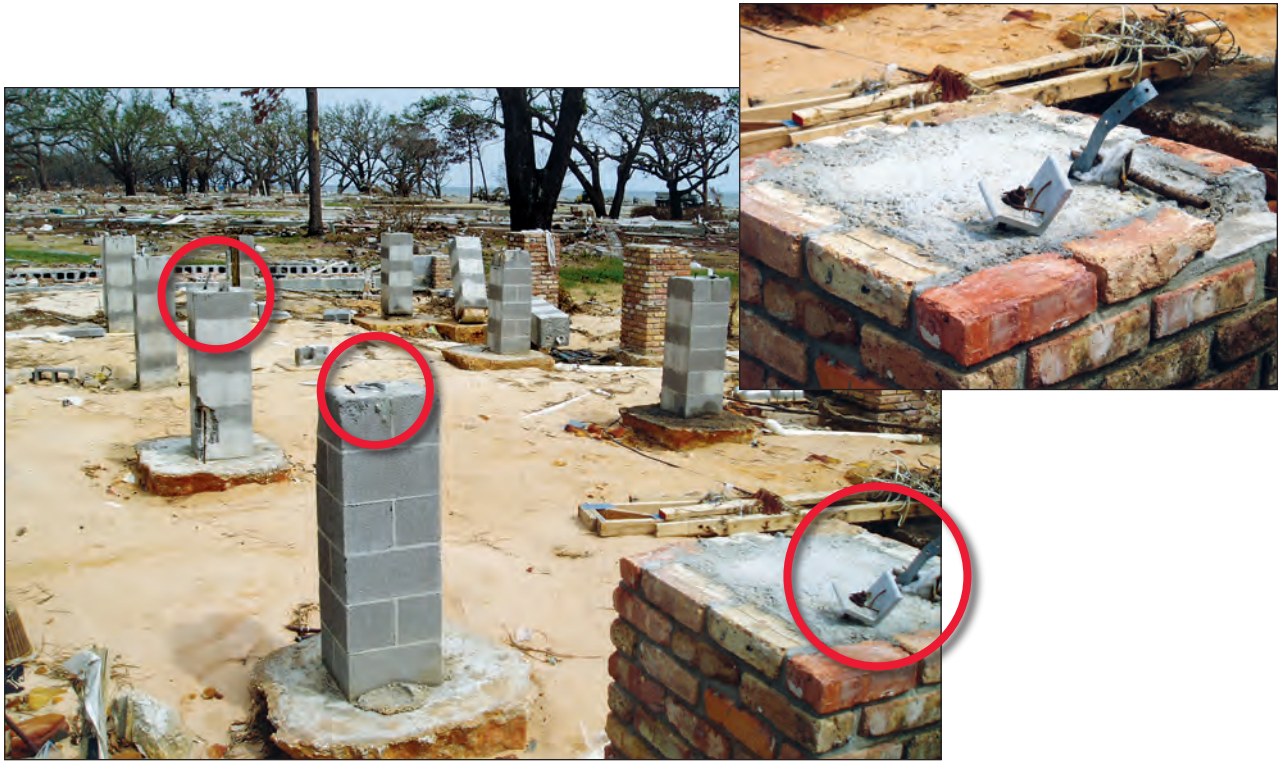
Figure 4-31.  
Failure of pier-to-beam connections due to wave and flood forces acting on the elevated building (Long Beach, Mississippi)

Each of the failures noted points out the importance of a continuous load path, from the top of the building, through the foundation, and into the ground. A continuous load path would have reduced flood damage to many buildings subject to storm surge only (no damaging waves), such as those shown in Figure 4-32, and would have had a mitigating effect on some of the buildings subject to wave forces (turning some failures into survivors).

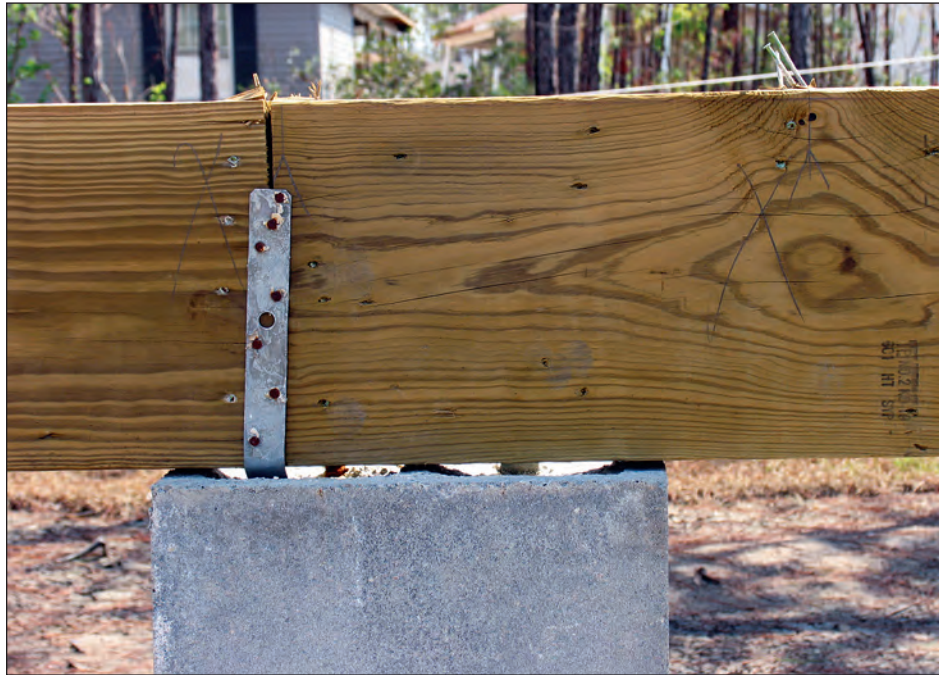
**Figure 4-33.**  
Poor pier-to-beam connection. Although this particular connection did not fail (because the wall and floor-to-beam connections failed first), this connection is poor. Note use of light gauge metal straps and nailing of strap at a joint in the beam (Pass Christian, Mississippi).

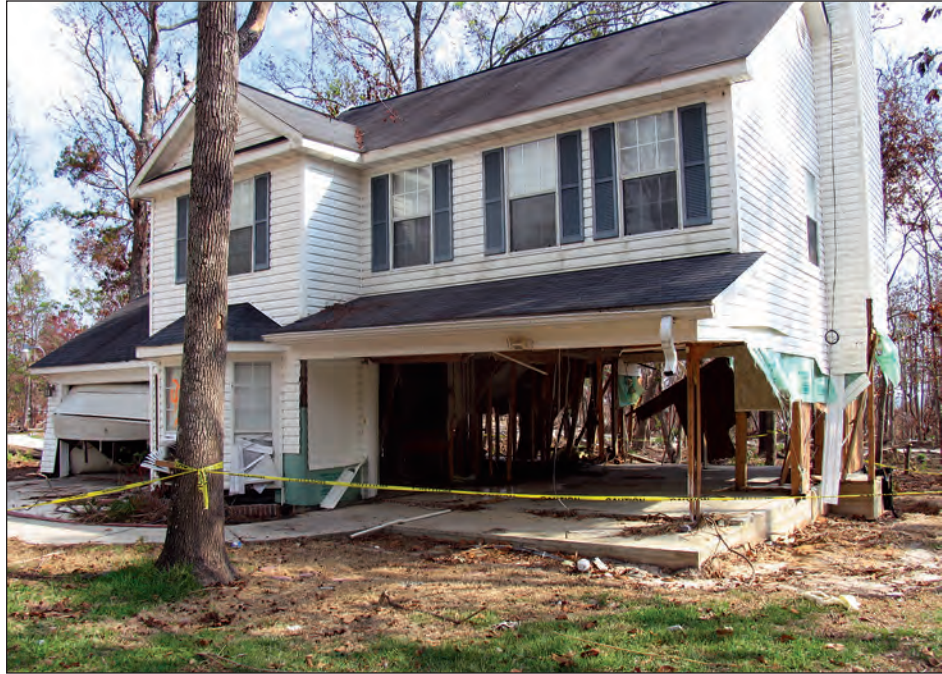
**Figure 4-37.**  
Waves, surge, and floating debris destroyed many single-family homes on slab foundations. Note debris from houses washed landward into other buildings (Biloxi, Mississippi).

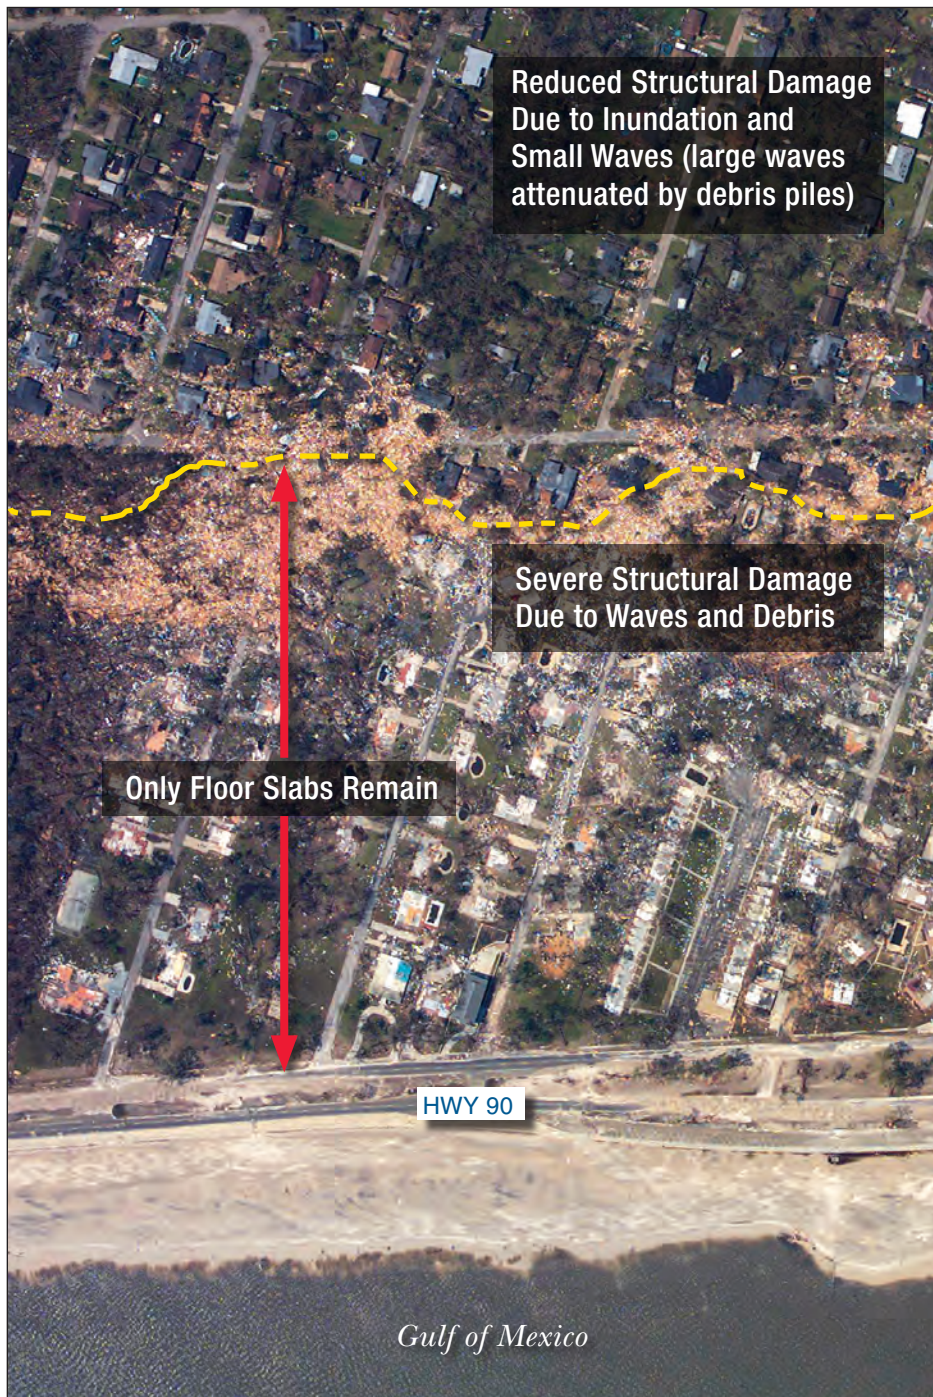
Figure 4-38.  
Typical zones of damage to homes supported on slab-on-grade foundations (Pass Christian, Mississippi)

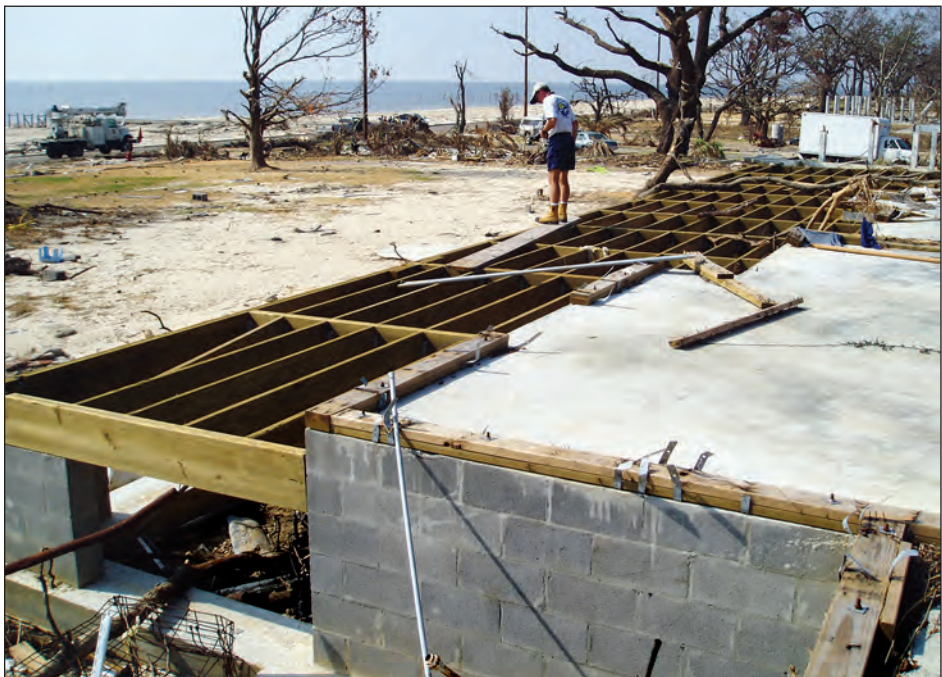
undermining due to erosion or localized scour. If undermined, the contained fill can be lost, removing support for the slab floor, as shown in Figure 4-39. Similar to buildings with slab-on-grade foundations, buildings with stem wall foundations experienced severe damage when flood levels and wave heights far exceeded the top of the slab (see Figure 4-40).

**Figure 4-40.**  
Stem wall foundation survived intact, but waves and surge above the floor destroyed the house, sweeping it off the foundation (Waveland, Mississippi).

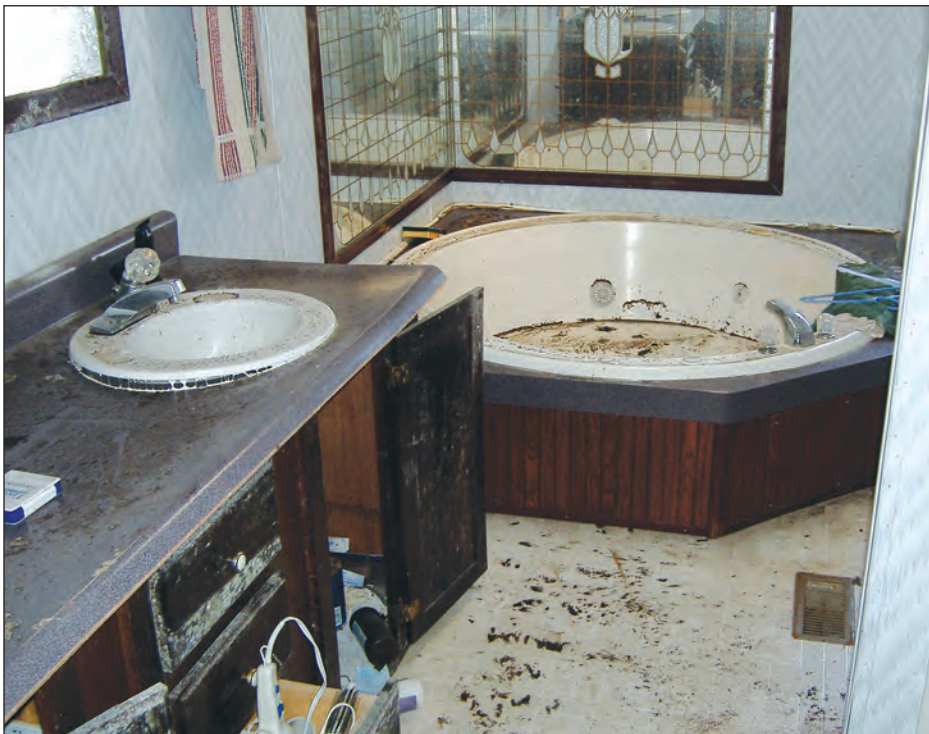
**Figure 4-44.** Interior photo of manufactured home shown in Figure 4-43 (Ocean Springs, Mississippi)

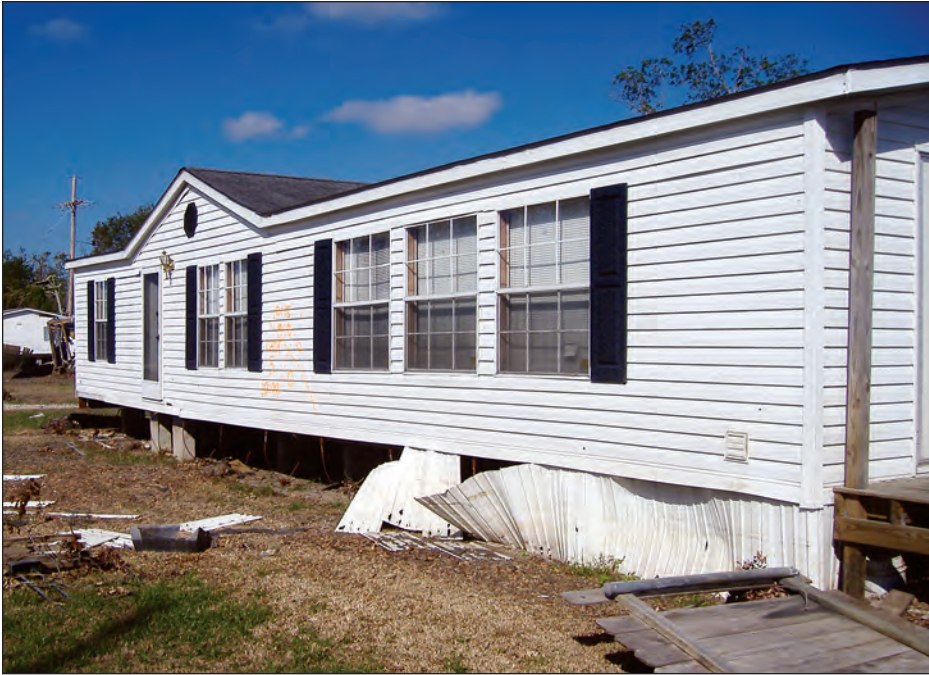
Figure 4-47.  
Flood-damaged  
manufactured home (St.  
Bernard Parish, Louisiana)

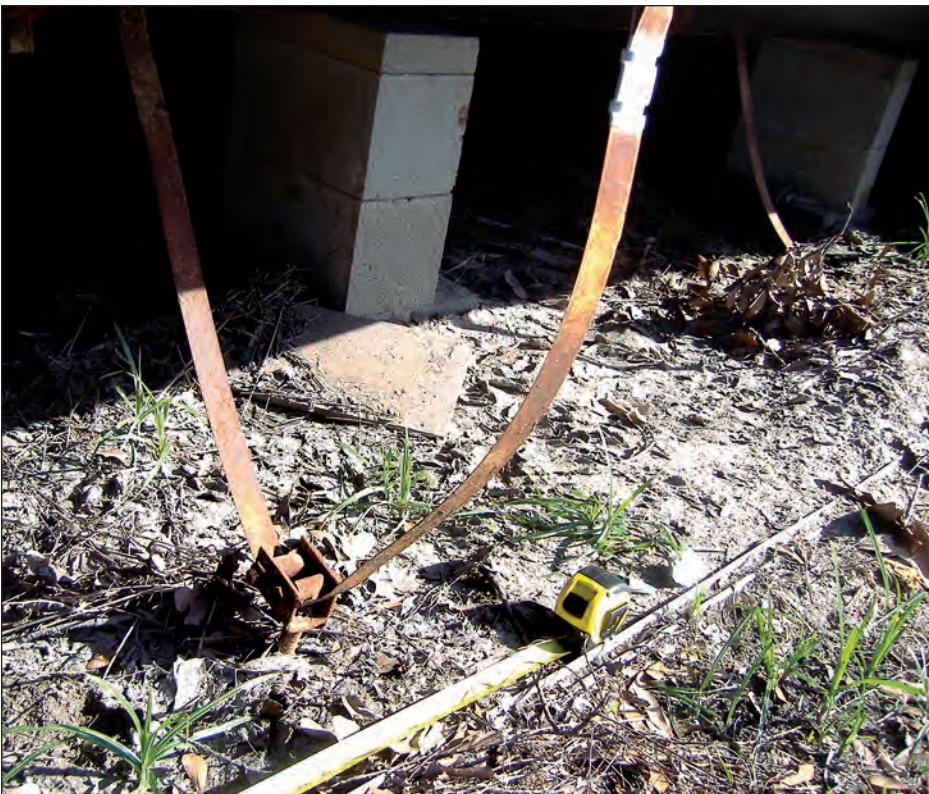
Figure 4-48.  
Foundation of home  
shown in Figure 4-47.  
The flood level rose  
above the floor, the  
ground anchors were  
apparently pulled up from  
the saturated soil, and  
the piers were displaced  
(St. Bernard Parish,  
Louisiana).

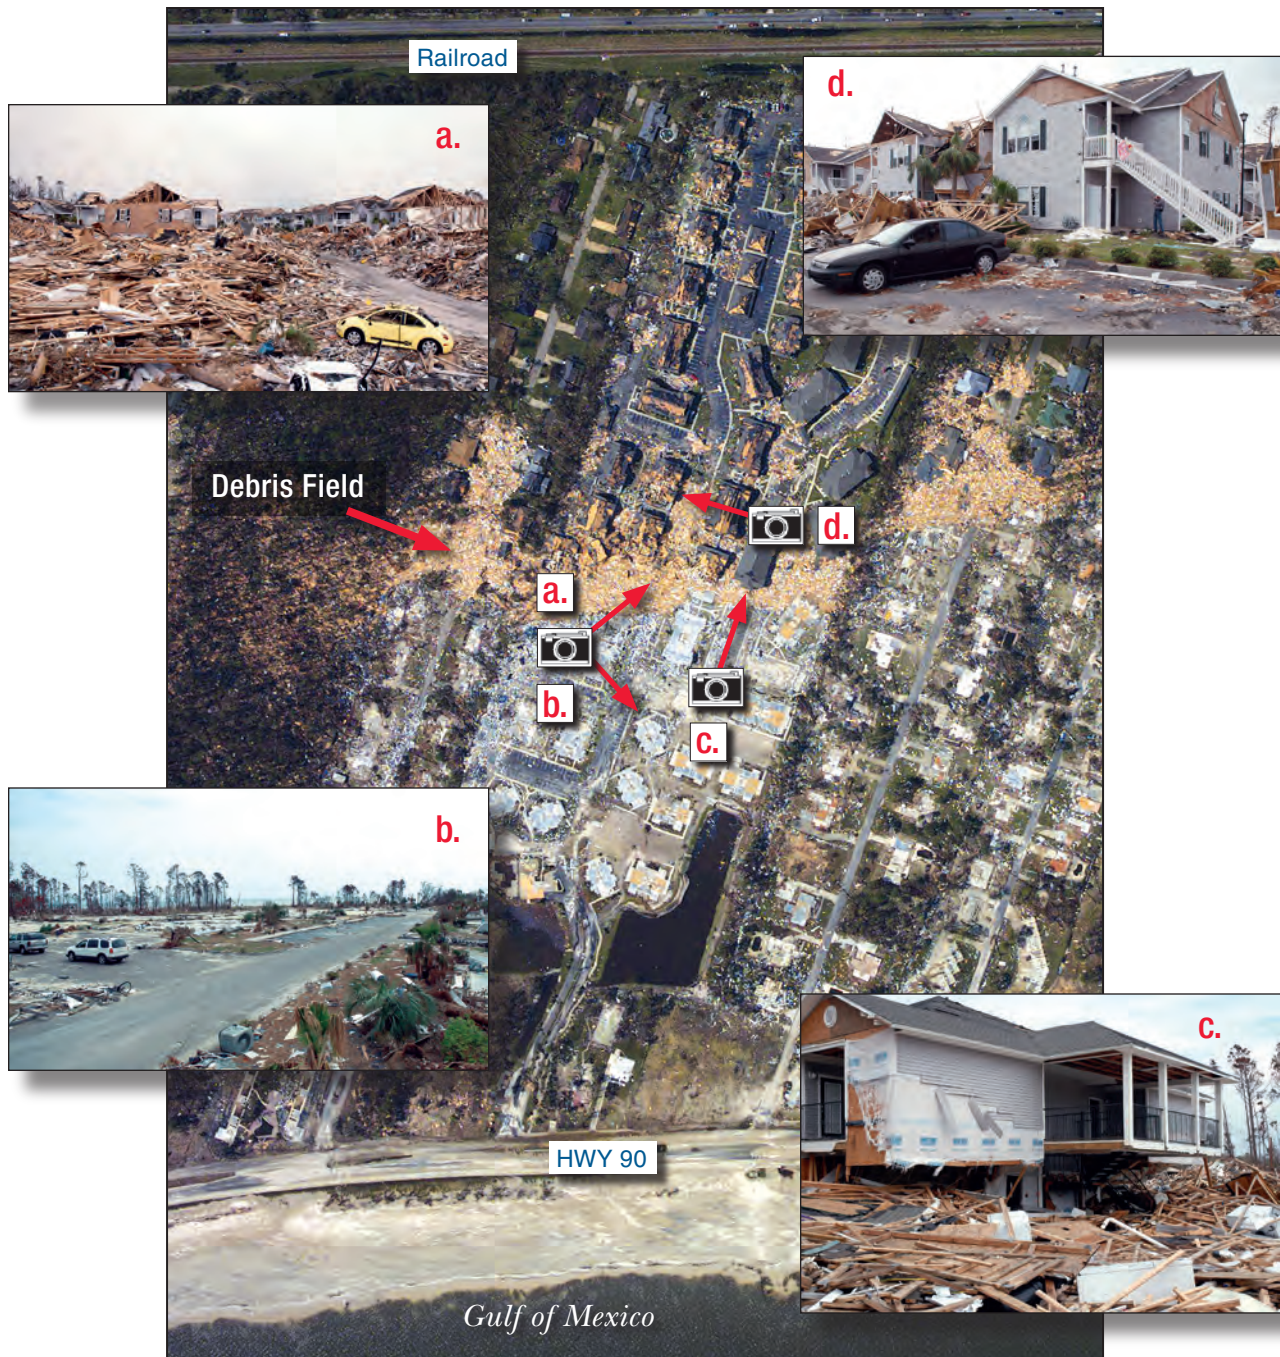
Figure 4-53.  
Multiple views of an apartment complex on slab foundations. The red arrows on the aerial image indicate the point of view of the labeled closeups (Pass Christian, Mississippi).

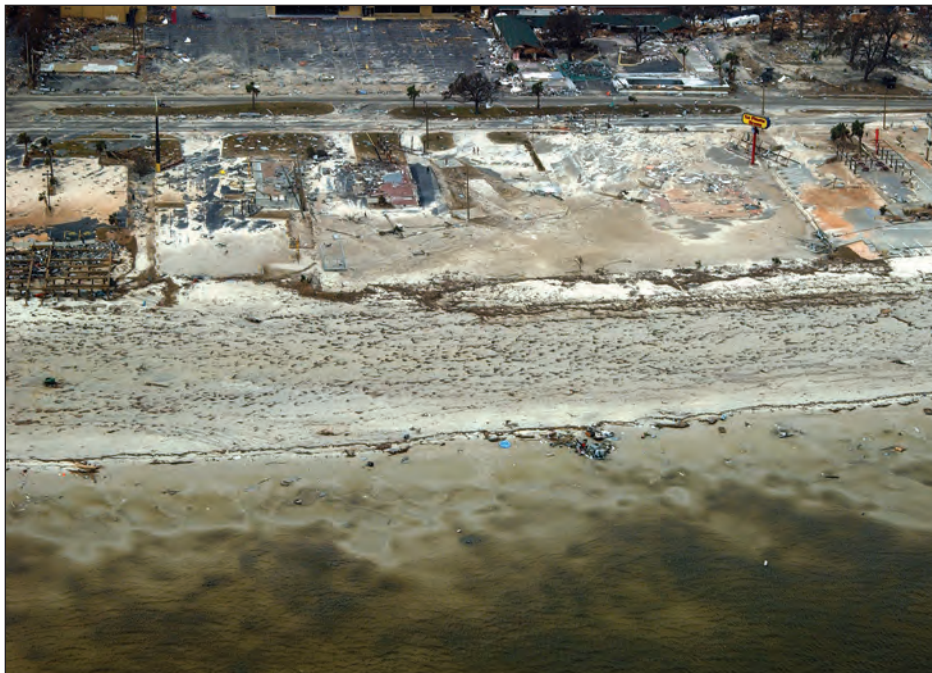
**Figure 4-54.**  
Commercial building  
destruction along the  
Mississippi coast

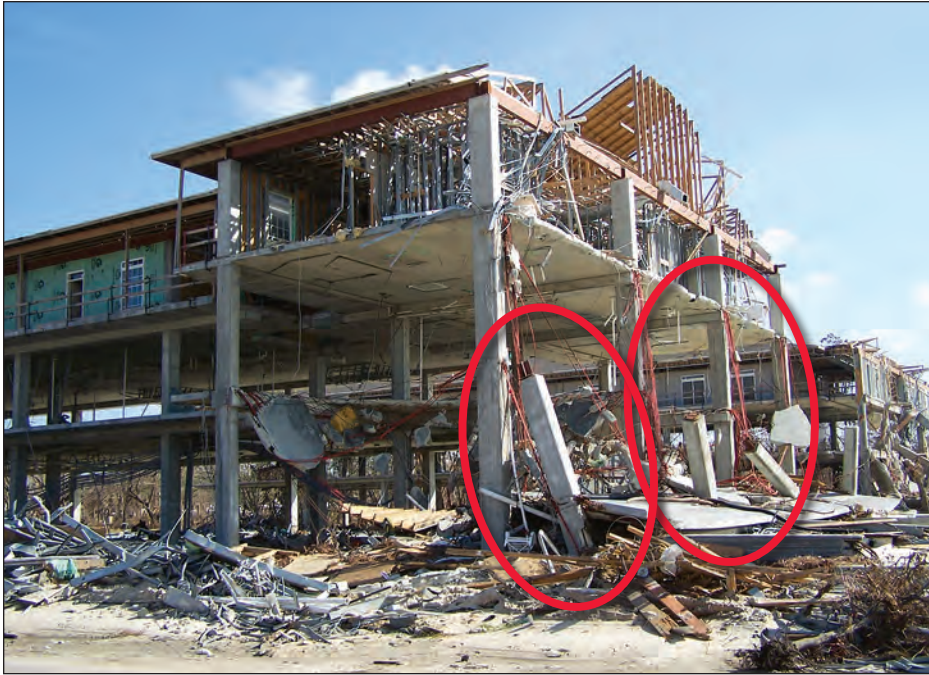
Figure 4-61.  
Multi-family property on  
Beach Boulevard with  
failed post-tensioned  
slabs and columns. Note  
the post-tensioning  
tendons (circles) (Pass  
Christian, Mississippi).

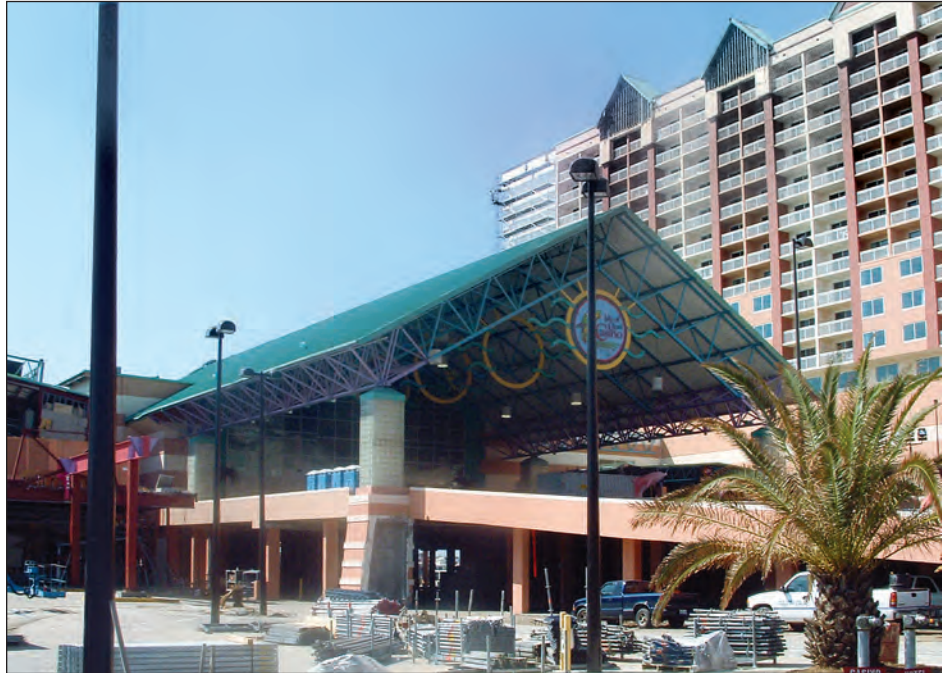
**Figure 4-63.**  
Elevated lower level  
parking deck in casino  
hotel (Biloxi, Mississippi)

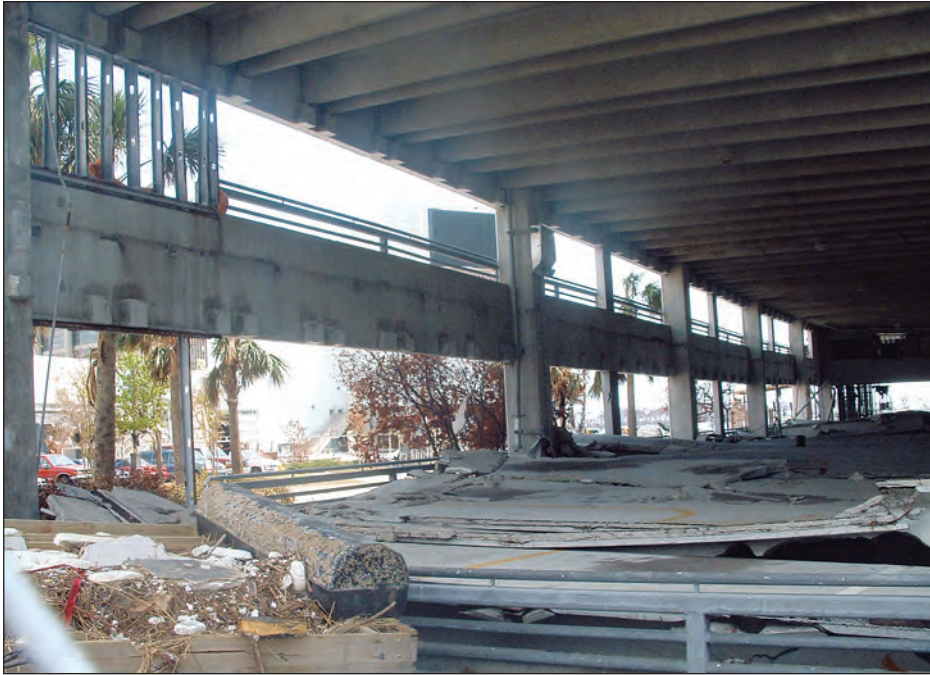
Figure 4-64.  
Collapse of first elevated level of pre-stressed parking decks due to poor column-to-beam gravity connections that failed when exposed to lateral and uplift wave forces (see Figure 4-65) (Biloxi, Mississippi)

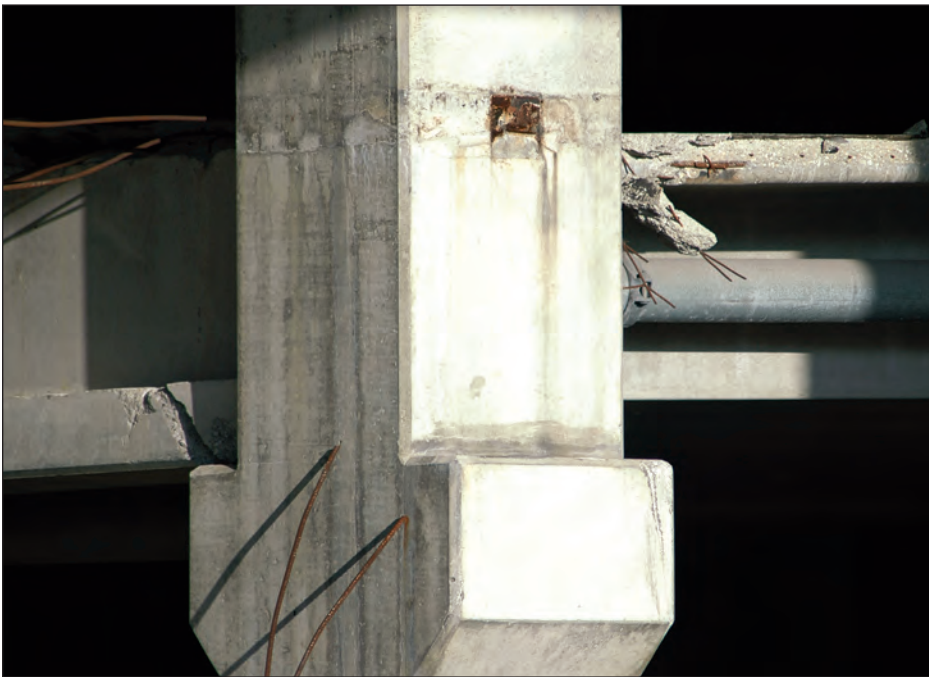
Figure 4-65.  
Another view of the collapse of first elevated level of pre-stressed parking decks shown in Figure 4-64 (Biloxi, Mississippi)
