## 4. Structural Systems Performance

*The dominant causes of structural failure observed by the MAT included storm surge, waves, floodborne debris, and wind. Structural damage due to erosion was also common on the barrier islands. Damage occurred to residential buildings (single- and multi-family housing), commercial buildings, and critical and essential facilities.*

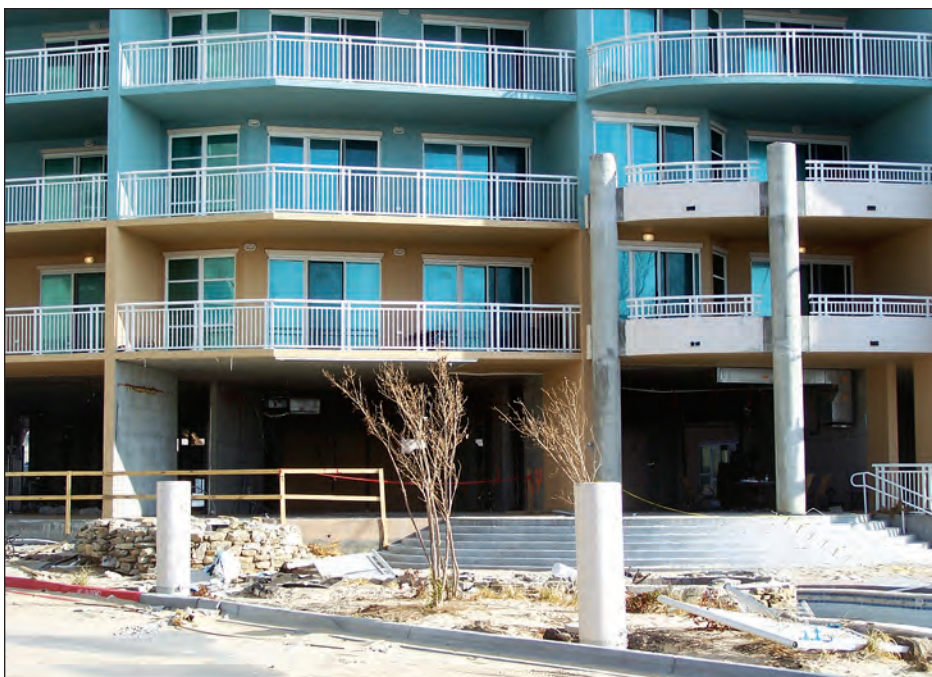
Figure 4-68.  
Another view of the  
high-rise building along  
Beach Boulevard shown  
in Figure 4-67 (Gulfport,  
Mississippi)

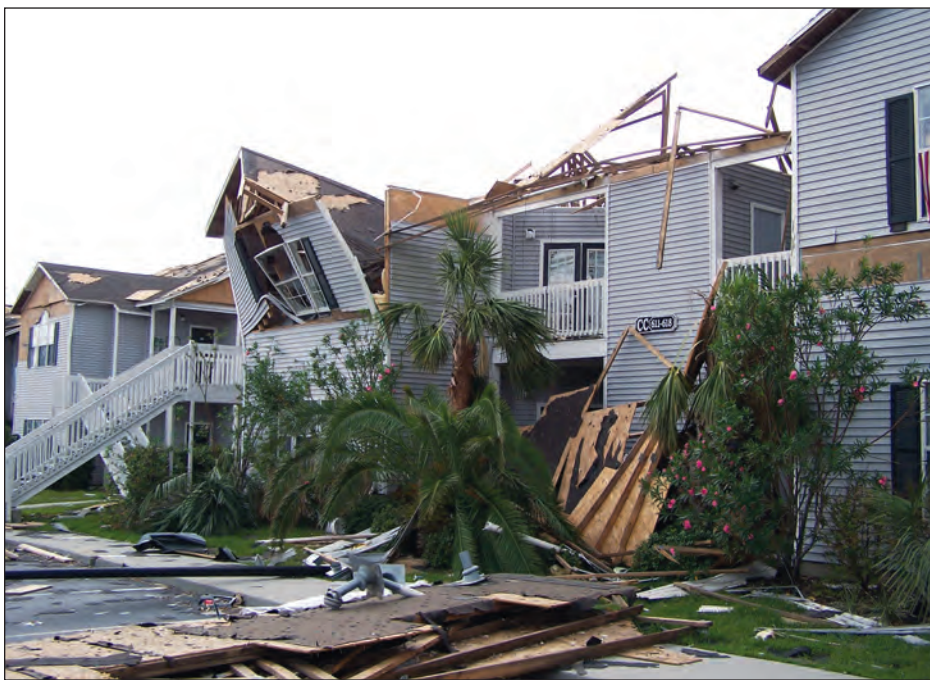
**Figure 4-74.**  
Two-story apartment  
building that lost its roof  
diaphragm and load path  
connections  
(estimated wind speed:  
120 mph. Ocean Springs,  
Mississippi)

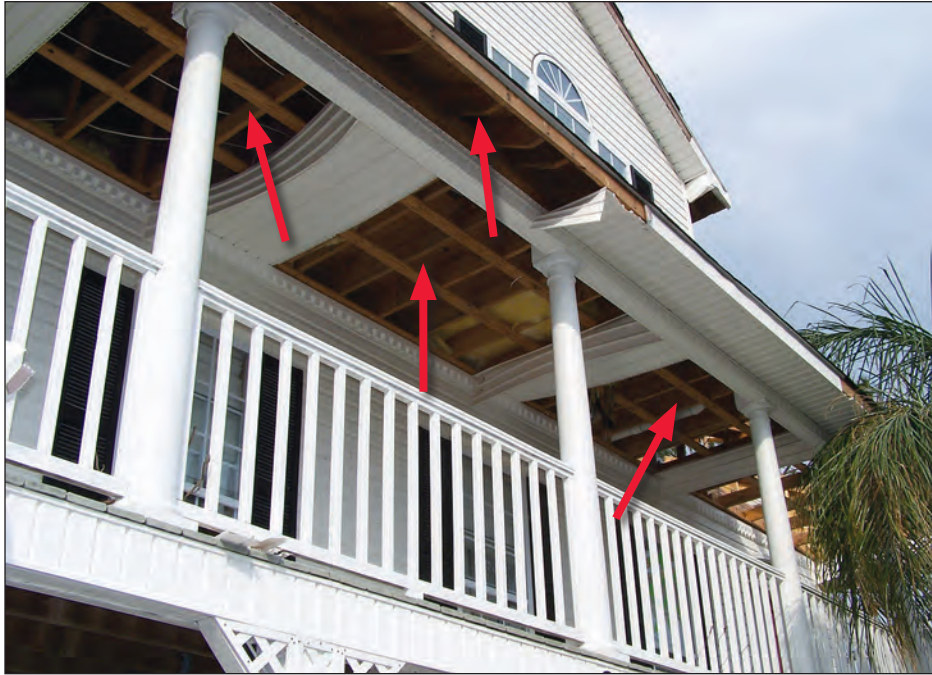
**Figure 4-77.** High pressures under overhangs often lead to progressive structural failures. Note the vinyl soffit material removed by high-wind pressures (arrows) (estimated wind speed: 130 mph. Pass Christian, Mississippi).

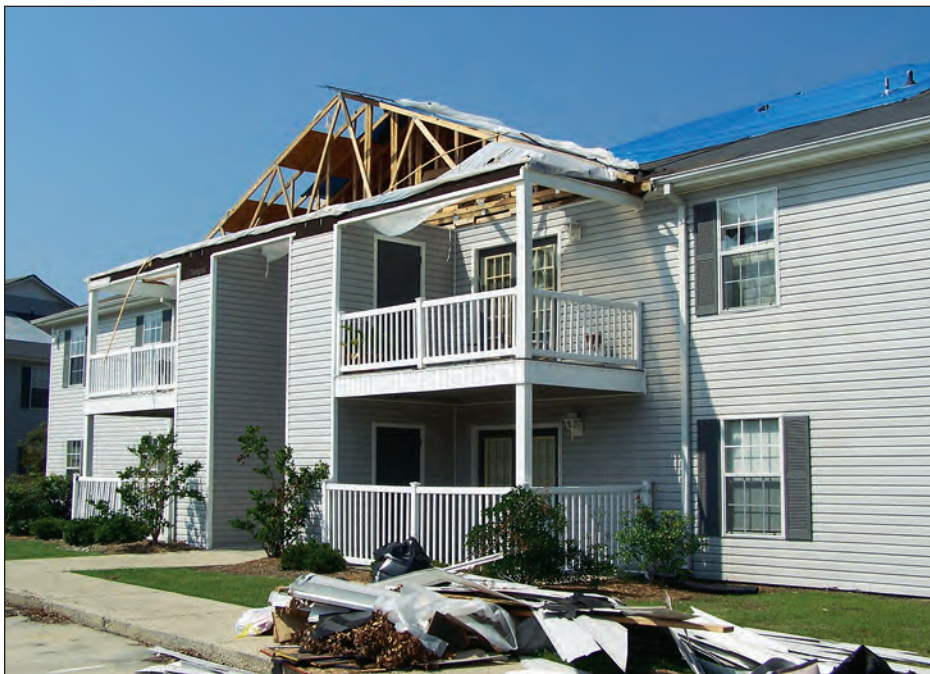
**Figure 4-78.** Pressurization of the second floor porch ceiling of this apartment led to soffit failure and loss of roof decking and other structural components (estimated wind speed: 120 mph. Ocean Springs, Mississippi).

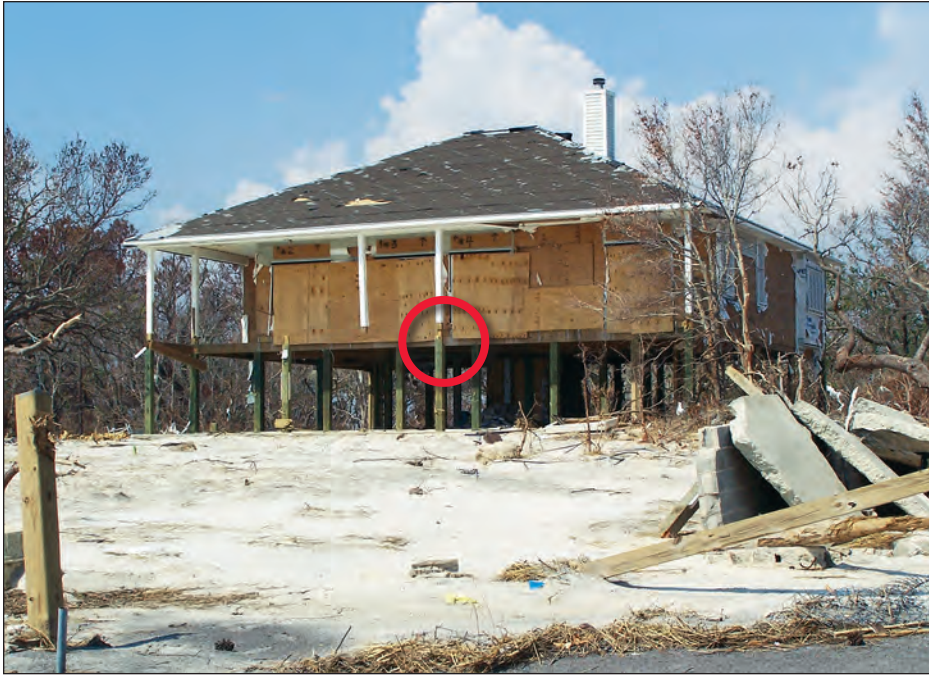
Figure 4-80. Coastal home located in Exposure C received significant surge damage into the habitable level and, although it lost its porch and three porch columns, the basic load path remained connected. Red circle indicates location of Figure 4-81 (estimated wind speed: 120 mph. Ocean Springs, Mississippi).

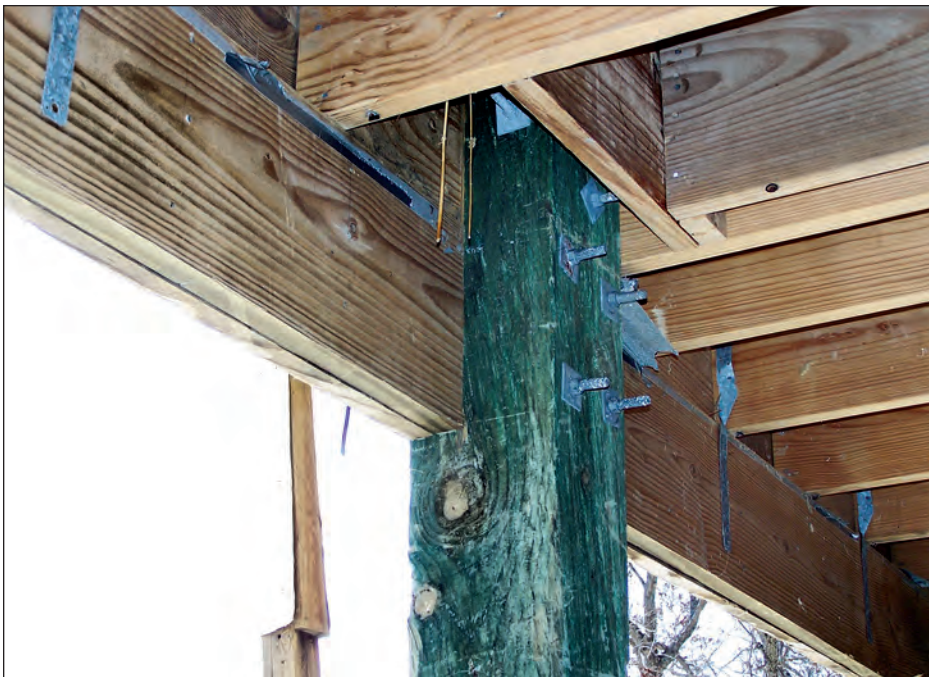
Figure 4-81. Coastal home located in Exposure C that is well connected with beam-to-column lap joints and galvanized bolts and straps (estimated wind speed: 120 mph. Ocean Springs, Mississippi)

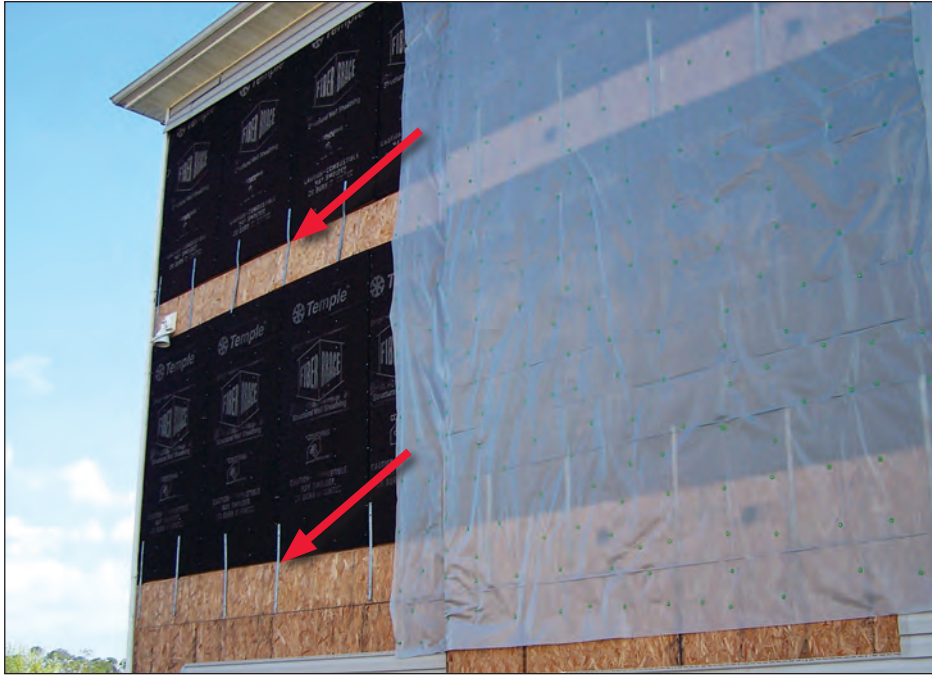
Figure 4-84.  
Two-story structure with floor-to-floor connectors (arrows) that are adequately spaced, but improperly attached (see Figure 4-83) (estimated wind speed: 120 mph. D'Iberville, Mississippi).

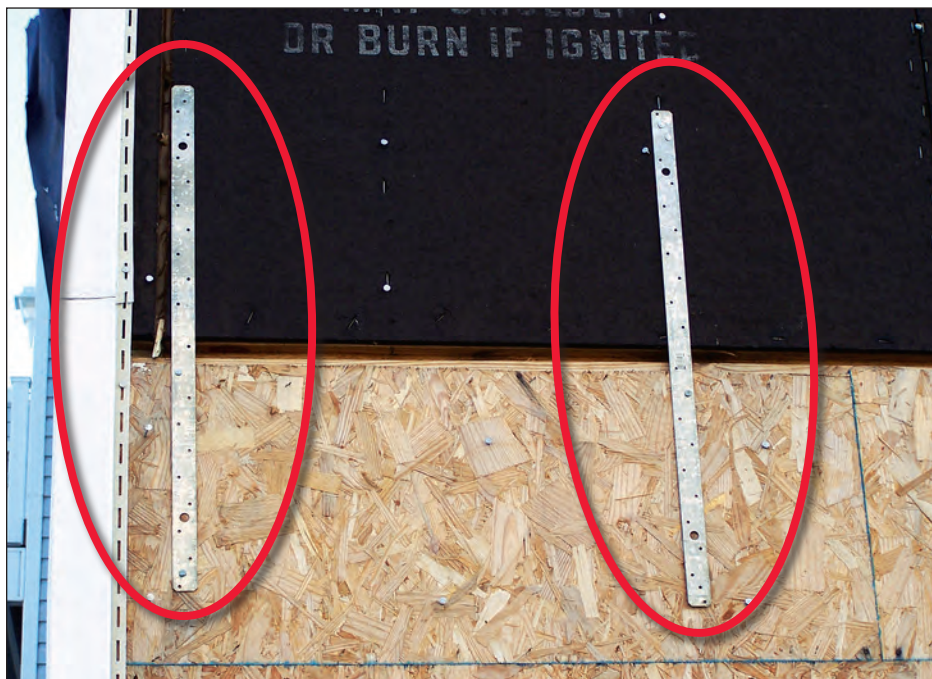
Figure 4-85.  
Two-story structure with floor-to-floor connectors that were adequately spaced, but were too short to extend into the wall framing above and below the floor level and were missing several fasteners (circles) (estimated wind speed: 120 mph. D'Iberville, Mississippi).

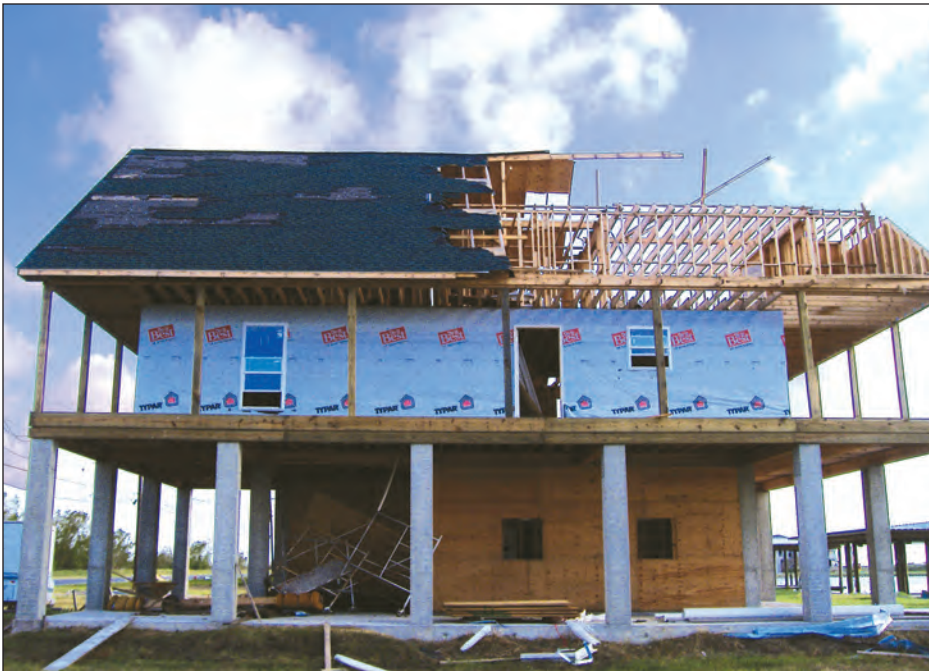
Figure 4-89.  
Home located in Exposure C that lost portions of its roof structure (estimated wind speed: 110 mph. Plaquemines Parish, Louisiana)

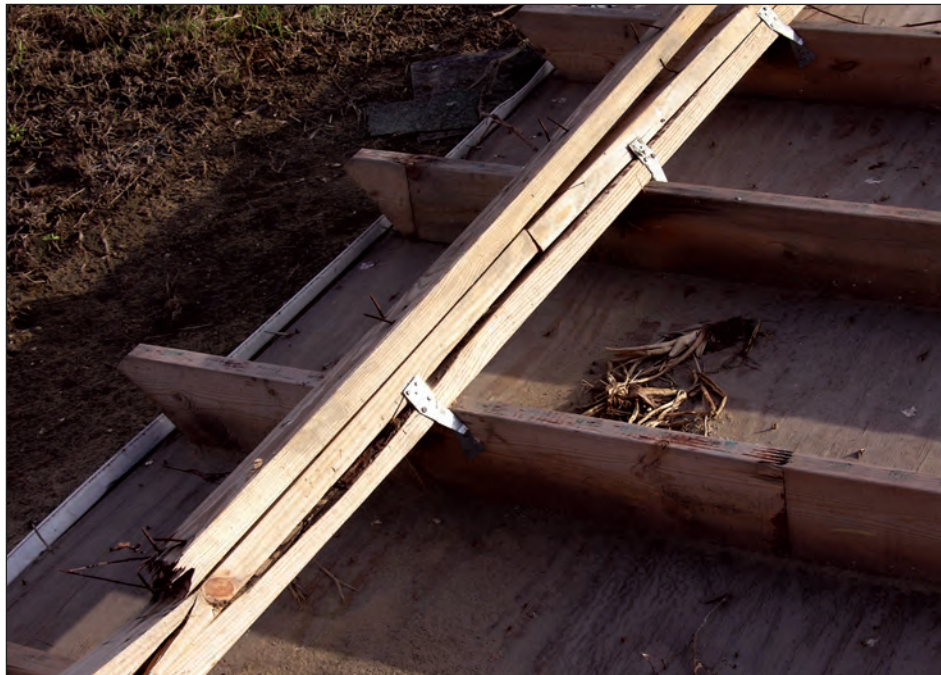
**Figure 4-91 (a) and 4-91 (b).**  
Wall framing was inadequately secured to the bottom plate with fasteners spaced over 32 inches on center. The presence of building wrap shows that no additional nailing was planned (estimated wind speed: 130 mph. St. Bernard Parish, Louisiana).

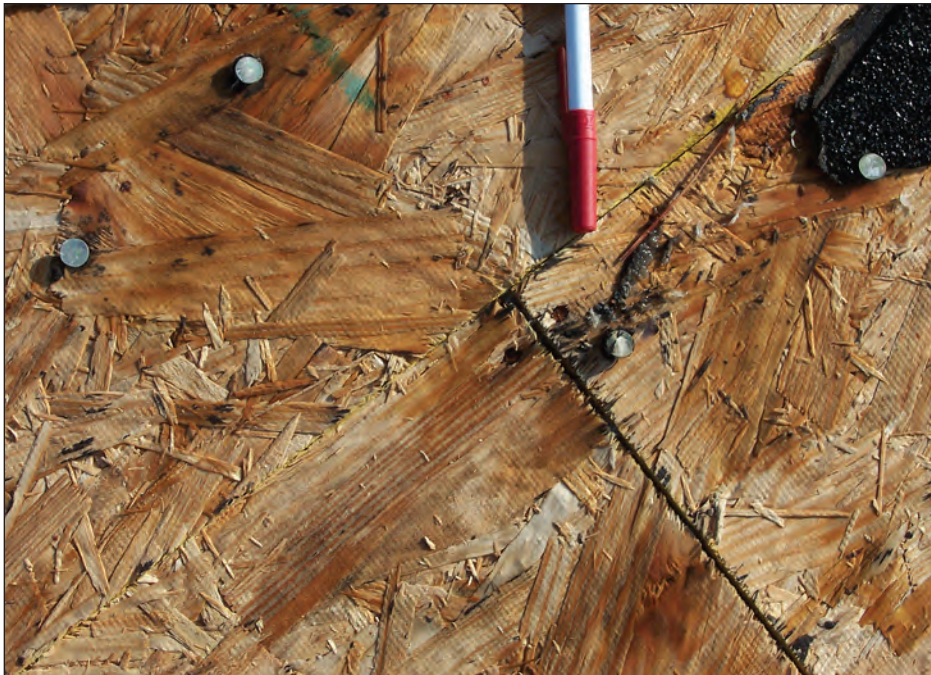
Figure 4-92.  
Roof sheathing nailed  
only at corners, and  
stapled in other areas  
(estimated wind speed:  
130 mph. Long Beach,  
Mississippi)

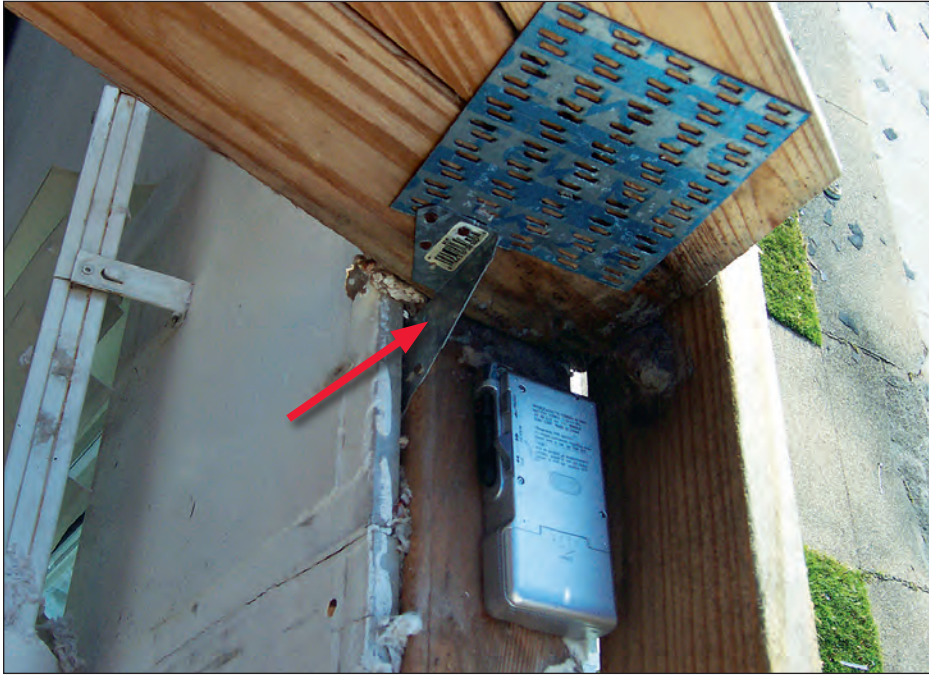
**Figure 4-95.**  
Metal connectors (arrow) were used on main trusses (estimated wind speed: 130 mph. inland Long Beach, Mississippi).

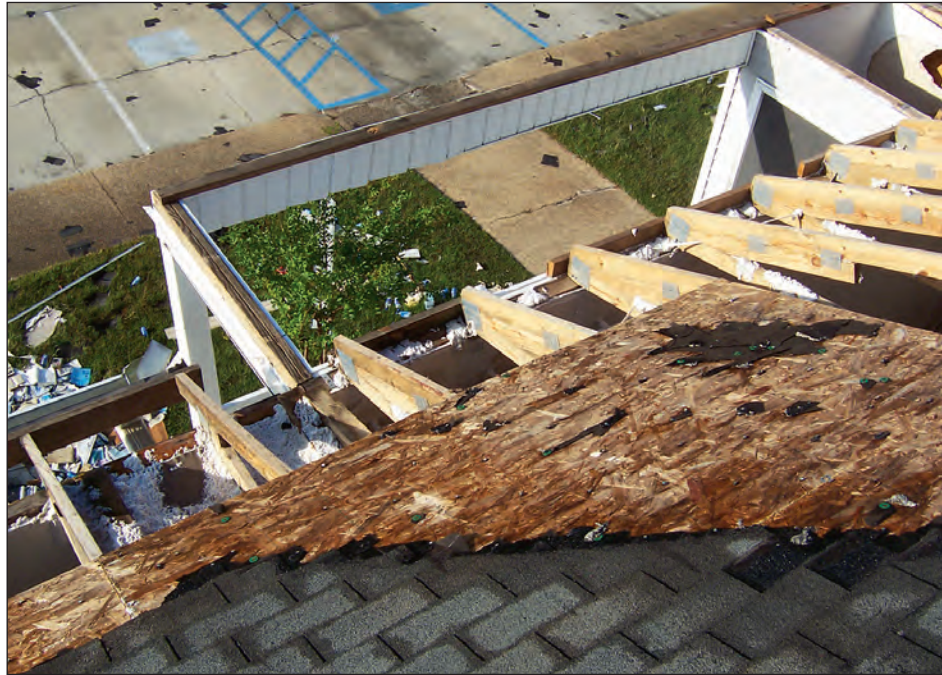
**Figure 4-98.**  
Apartment building's gable walls sheathed with insulation failed during Katrina (estimated wind speed: 130 mph. inland Long Beach, Mississippi)

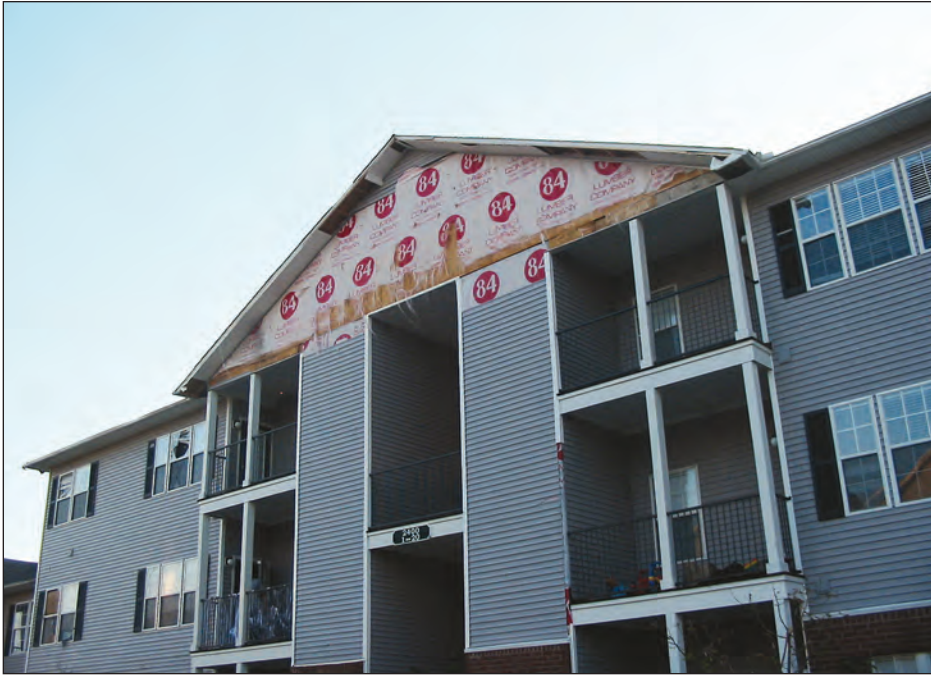
**Figure 4-99.**  
Apartment building with gable end walls that were constructed with OSB sheathing under housewrap (estimated wind speed: 120 mph. D'Iberville, Mississippi)

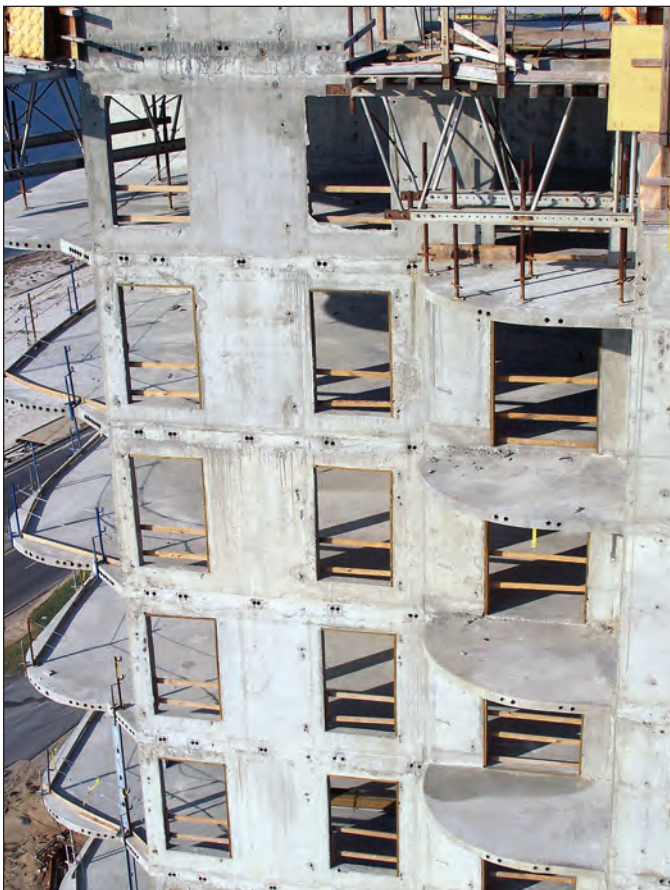
**Figure 4-111.**  
East tower located in Exposure C under construction with reinforced concrete and post-tensioned floor slabs. The east tower was water-inundated on the first floor and suffered only minor wind damage to the roof covering of the finished tower (estimated wind speed: 120 mph. Biloxi, Mississippi).

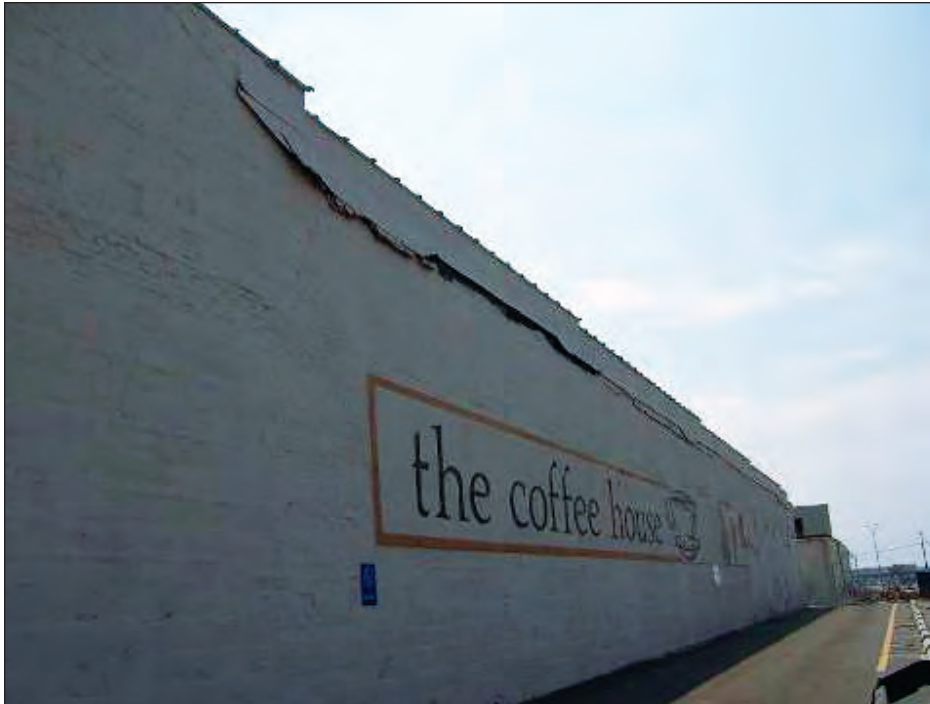
Figure 4-114.  
Unreinforced masonry  
parapet failure on a  
building located in  
Exposure C (estimated  
wind speed: 130 mph.  
Gulfport, Mississippi)

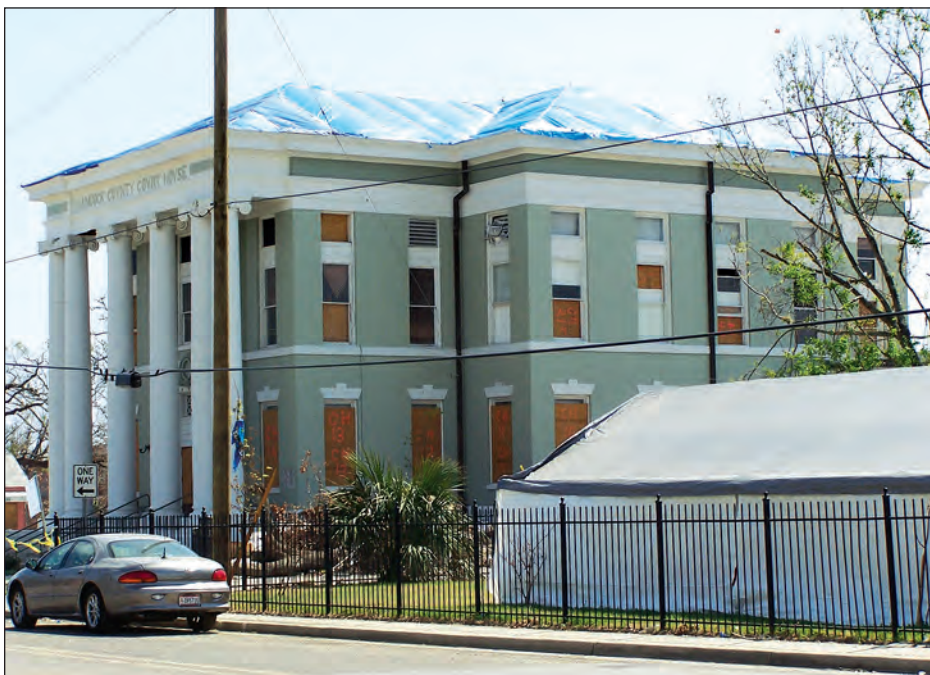
Figure 4-115.  
Hancock County  
Courthouse located in  
Exposure C with roof  
and windows damaged  
by wind and windborne  
debris (estimated wind  
speed: 125 mph. Bay St.  
Louis, Mississippi)

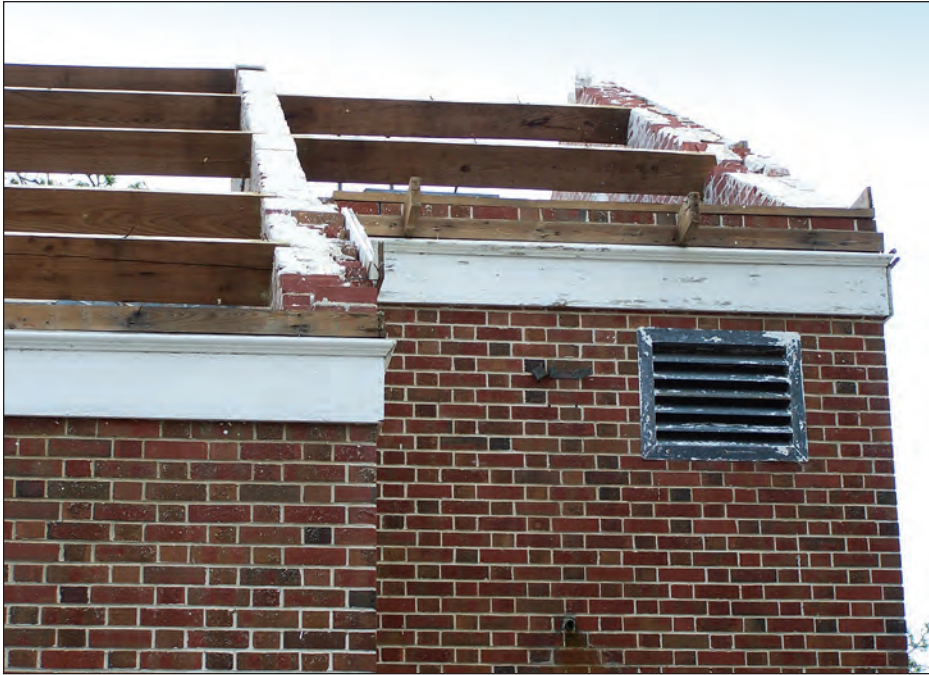
Figure 4-118.  
Grouted multi-wythe  
masonry walls. Note  
loss of roof decking  
(estimated wind speed:  
130 mph. Gulfport,  
Mississippi).

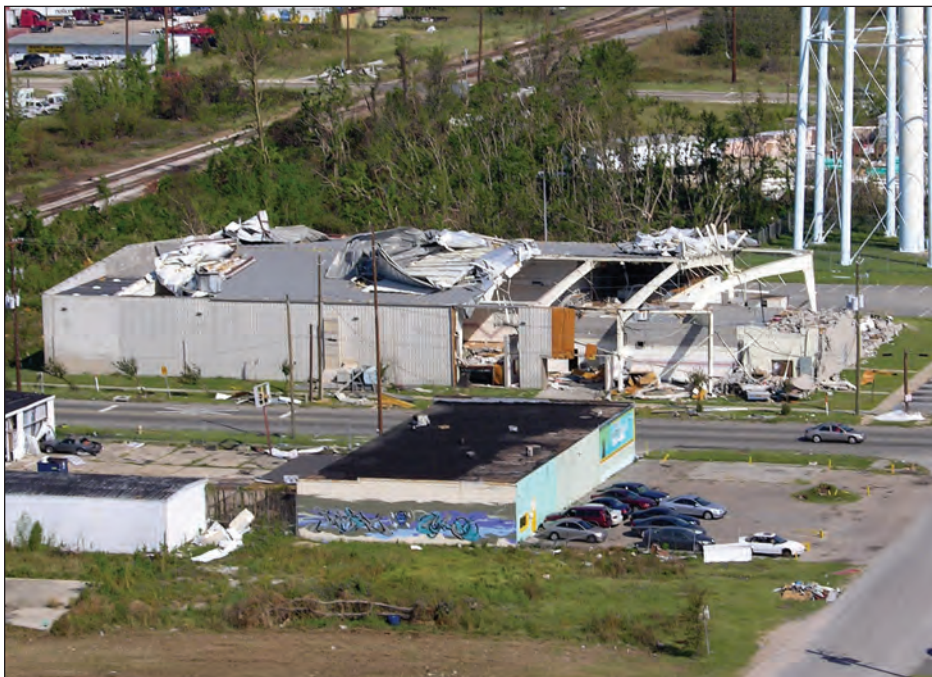
**Figure 4-122.**  
Failure of older (1974)  
pre-engineered metal  
building (estimated wind  
speed: 130 mph. Gulfport,  
Mississippi)
