Performance of Residential Buildings

Mitigation Assessment Team Summary Report and
Recommendations
State of Hawai'i
Maui Wildfires

February 2025

DR-4724

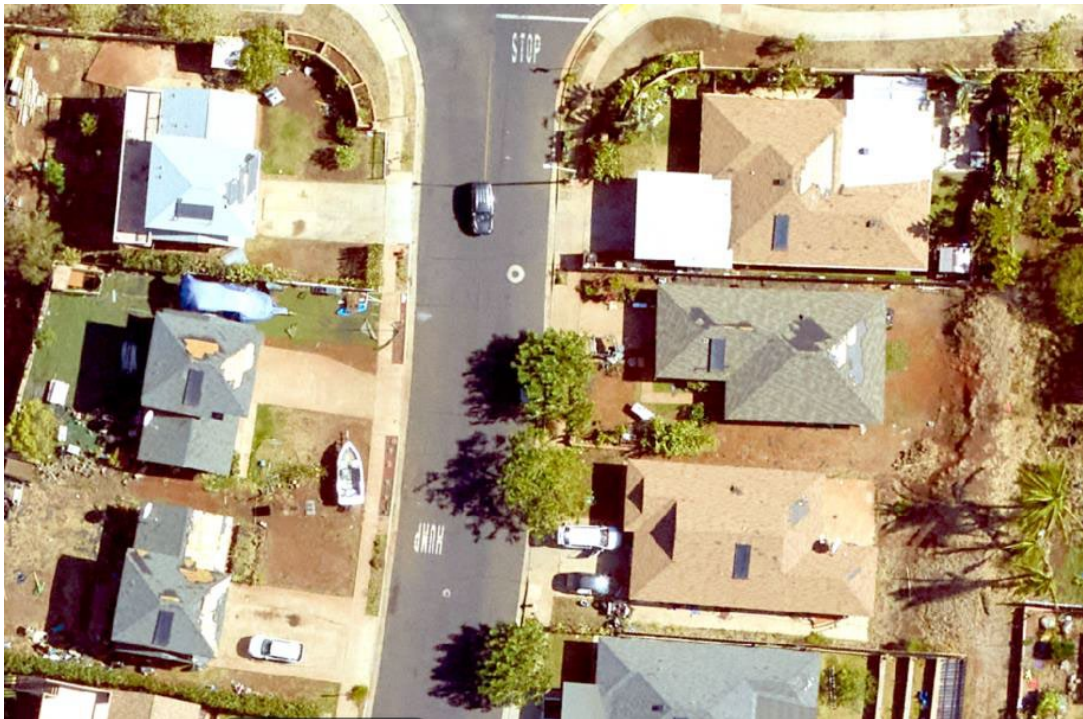
Kula during the fires, it was difficult to determine if roofs were damaged by wind prior to ignition. It was uncertain how roofing systems contributed to structure-to-structure fire spread. However, in reviewing immediate post-damage aerial images, it appears that significant roof damage occurred due to wind (Figure 6) both inside and outside of the fire footprint. The wind damage to roofs included missing roof shingles as well as limited photovoltaic (PV) panel and limited structural damage. Specifically, the MAT observed that many asphalt shingle roofs lost shingles along the centers of the roof surface rather than along roof edges and ridges (Figure 7). The observed pattern of roof shingle damage differed from the loss of roof shingles along roof edges and ridge lines traditionally associated with high wind uplift pressures from hurricanes and severe storms. This could be evidence of localized wind turbulence produced by the fires, but additional research is necessary to verify this hypothesis. Removal of shingles revealed that many residential roofs were not protected by an underlayment, exposing combustible wood sheathing making the roof deck and other roof materials vulnerable to ignition as well as water damage from heavy rains. Coupled with the presence of complex roof shapes trapping embers against combustible roof decks and underlayments, the probability of roof ignition and interior water damage was high in Lahaina.

Figure 6. Maui post-fire aerial image of roof cover damage to buildings.

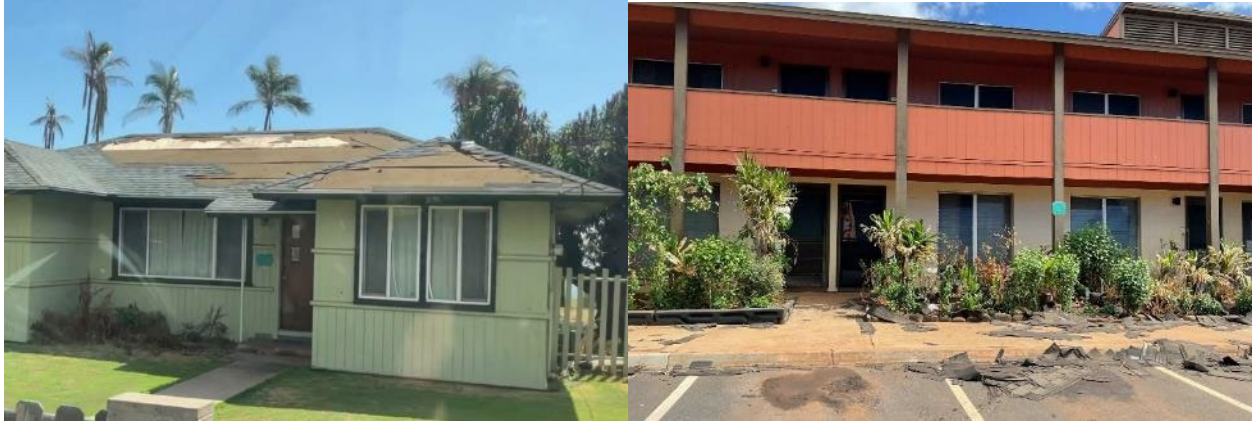
- The MAT observed many asphalt shingle roofs that appeared to be new, or in the process of being replaced, with new underlayment, in areas adjacent to buildings heavily damaged or destroyed by wildfire.
- The MAT observed many asphalt roof systems that had a tarp overlay in the post disaster aerial imagery, indicating likely roof cover loss.
- Discussion with local Lahaina residents indicated that roof pieces were detached and transported away from the home by the high winds.
- Many asphalt shingle roofs on residential buildings were found to have sections of shingles missing, and on other sites, loose shingles were found on the ground, where buildings remained intact (Figure 7).

Figure 7. Missing asphalt roof shingles were observed on an intact residential building in Lahaina (left). Asphalt shingles were scattered on the foreground adjacent to an intact multi-family residential building in Lahaina (right).

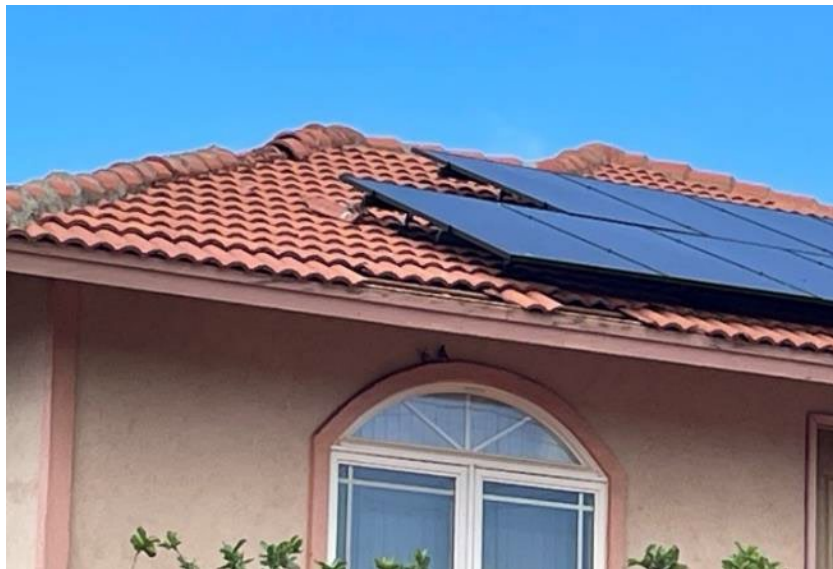
A few clay tile roof coverings on residential buildings were observed with missing or damaged tiles along roof edges and ridges (Figure 8), which suggests these roofs may have been damaged by high winds or windborne debris.

Figure 8. Missing clay roof tiles along roof ridge and edge of residential building in Lahaina.

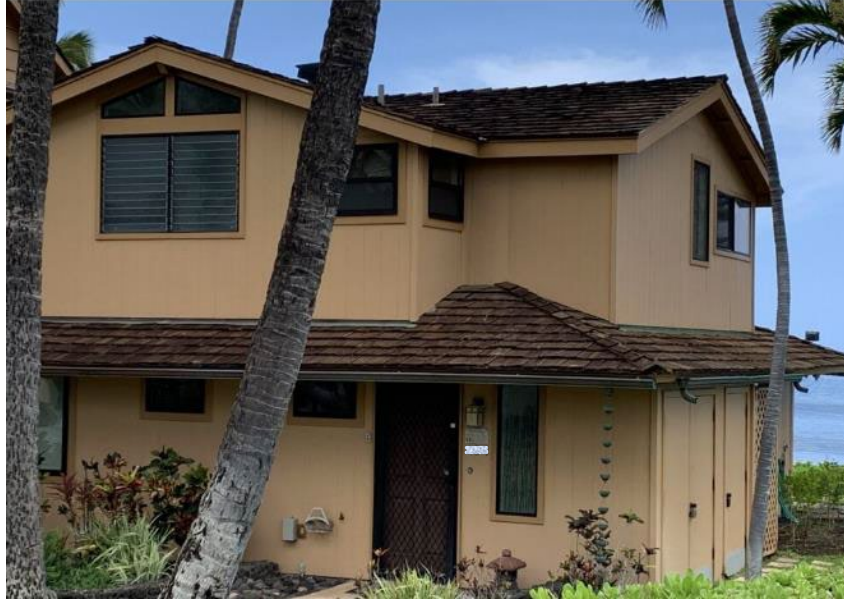
The few metal roof coverings observed by the MAT appeared to perform well. The MAT also observed several single and multi-family residential buildings with wood shake roof coverings. These roof coverings were composed of two or more layers of 3/4- to 1-inch wood shakes and showed evidence that some top surface shakes were charred but not consumed by the fire (Figure 9). Although this could suggest positive performance on selected structures, most current fire research discourages the use of wood shake roof coverings in fire-prone areas.

Figure 9. Wood shake roof on a residential building in Lahaina, showing evidence of some surface shakes charred by fire.

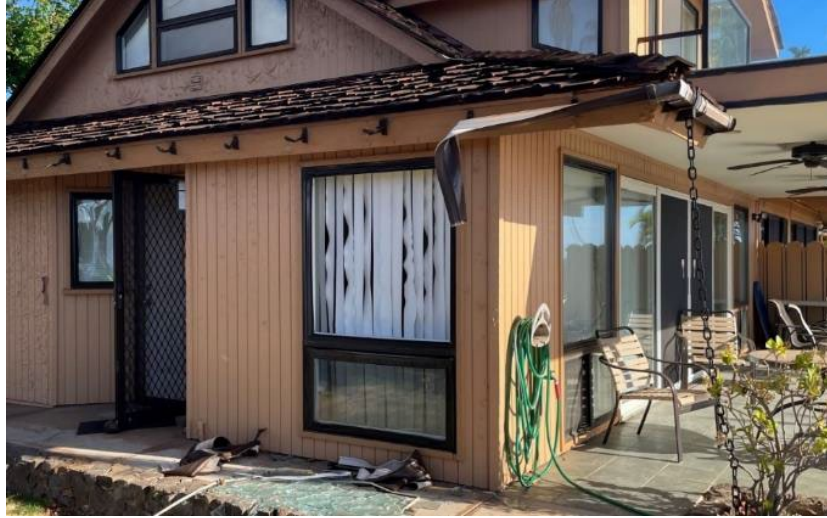
Figure 10. Melted vinyl gutters and melted window frame with lost glass pane on a residential building in Lahaina.

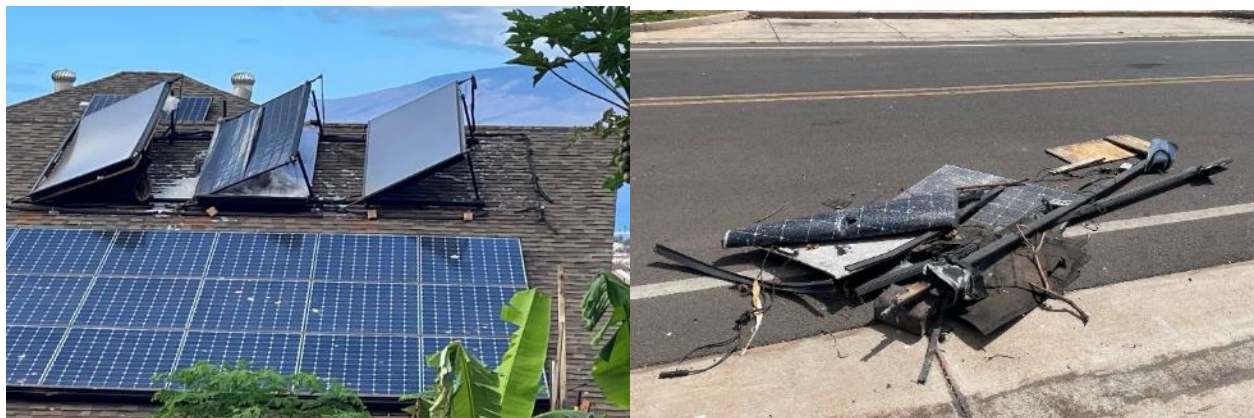
Figure 11. Damaged solar water heaters observed on a residential building in Lahaina (left). PV panels found on the ground along a street lined with single-family residential buildings in Lahaina (right).

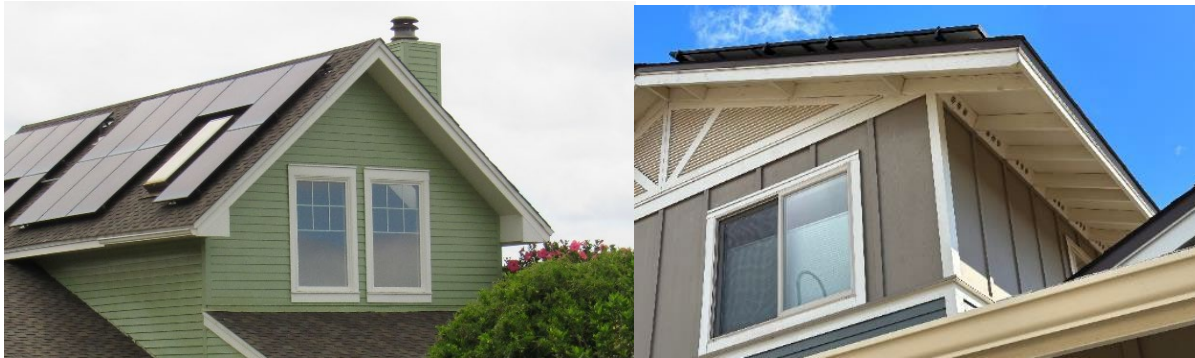
Figure 12. Typical closed Soffit on Maui residential building (left). Open soffits with small “birdhole” vents on residential units in Lahaina created by an extension of roof framing (right).

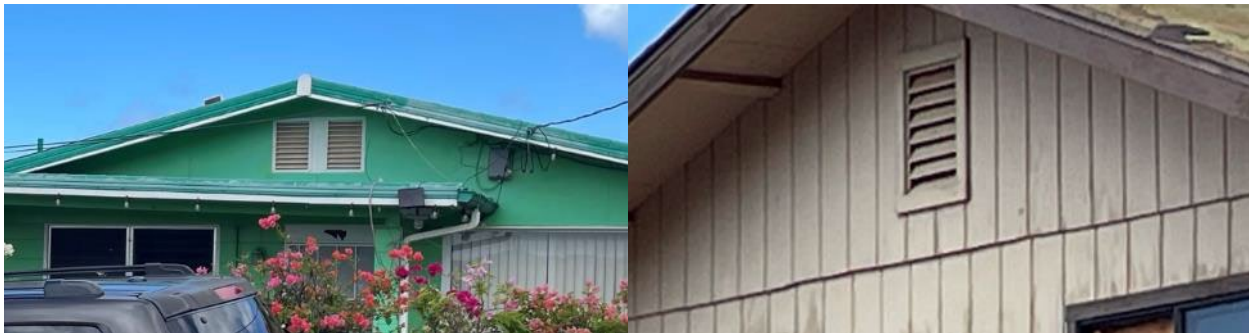
Vent openings covered by louvres were observed near the top of walls and along the gable ends of residential buildings (Figure 13), but fewer soffit or eave vents were observed. However, given the widespread destruction of buildings on Maui, the susceptibility of the vents trapping embers cannot be determined. Additionally, there were no indications that the louvred vents observed by the MAT were protected by noncombustible mesh to prevent ember intrusion.

Figure 13. Examples of gable end louvred vents.

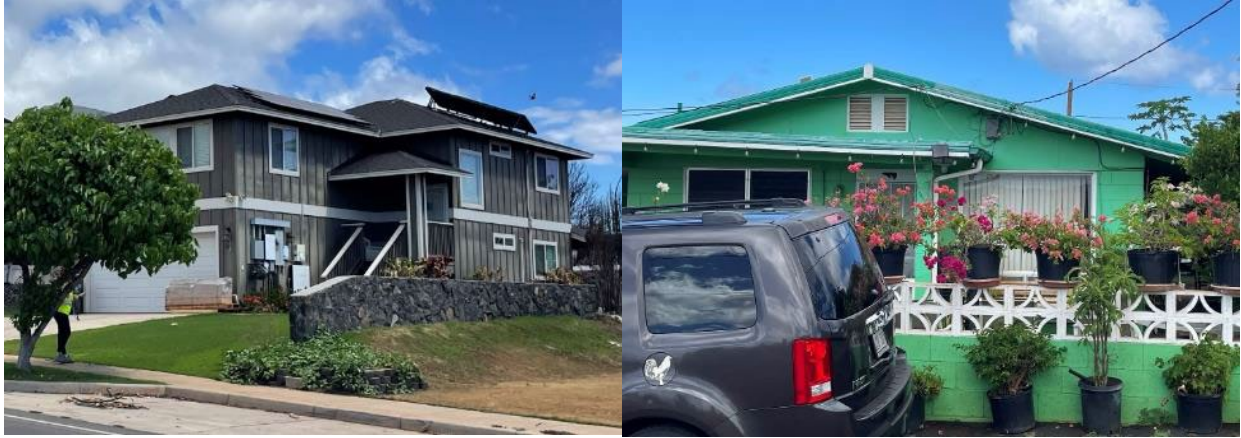
Figure 14. Wood-framed single-family residence with fiber cement siding in Lahaina (left) and painted masonry-framed single-family residence in Lahaina (right).

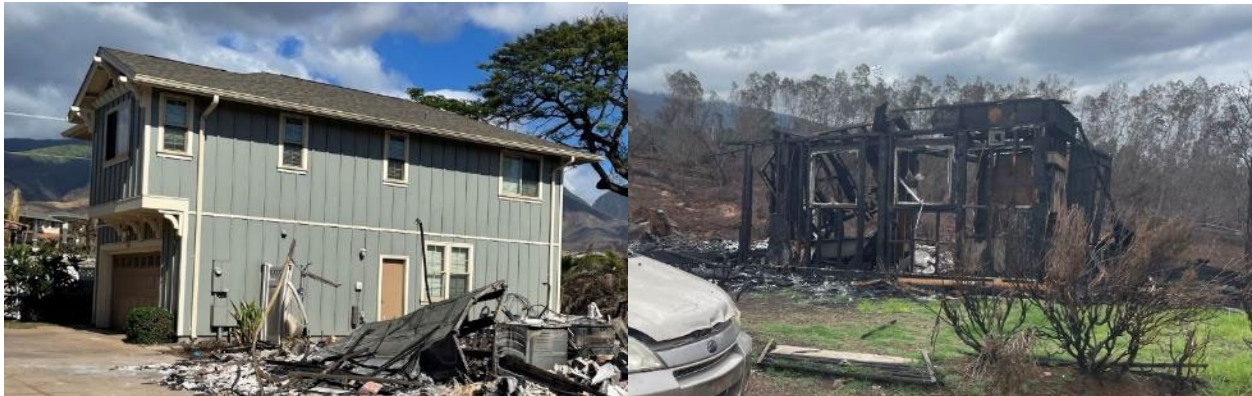
Buildings that had exterior walls covered with noncombustible exterior siding performed better than buildings sheathed with combustible wood or vinyl siding (Figure 15). This was especially critical in Lahaina, where many residential buildings were spaced closely together. The MAT observed combustible exterior cladding present throughout residential neighborhoods on Maui.

Figure 15. Comparison of residential buildings with noncombustible exterior siding (left) vs combustible exterior siding (right).

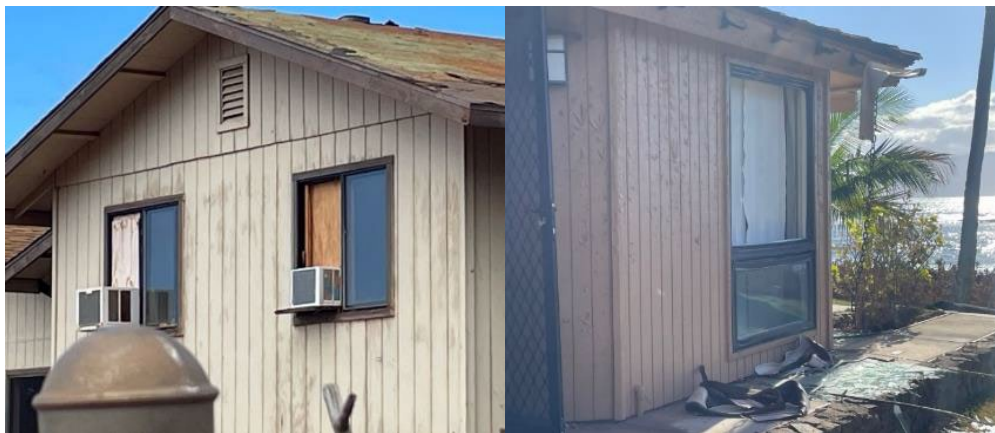
Figure 16. Examples of residential window damages from the Maui wildfires in Lahaina.

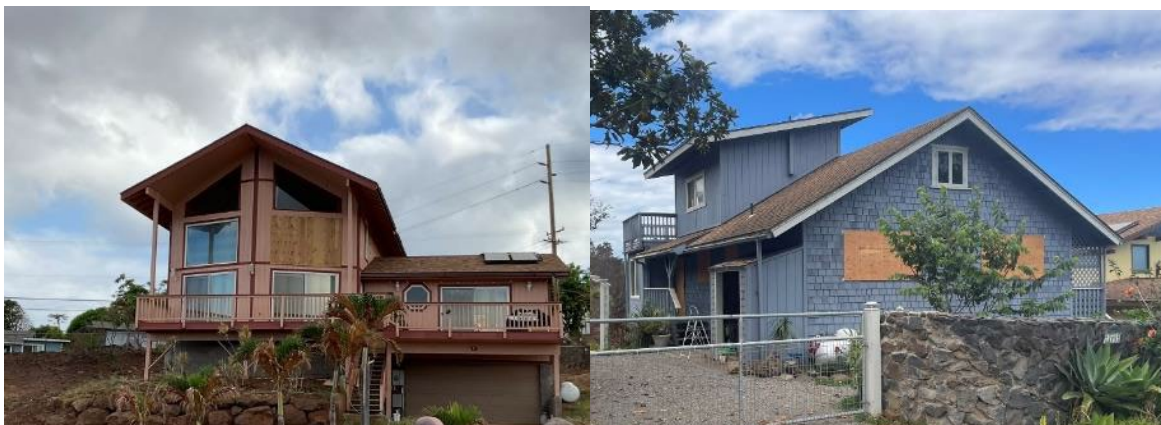
Figure 17. Large broken windows covered by plywood sheathing on residences in Lahaina (left) and Kula (right).

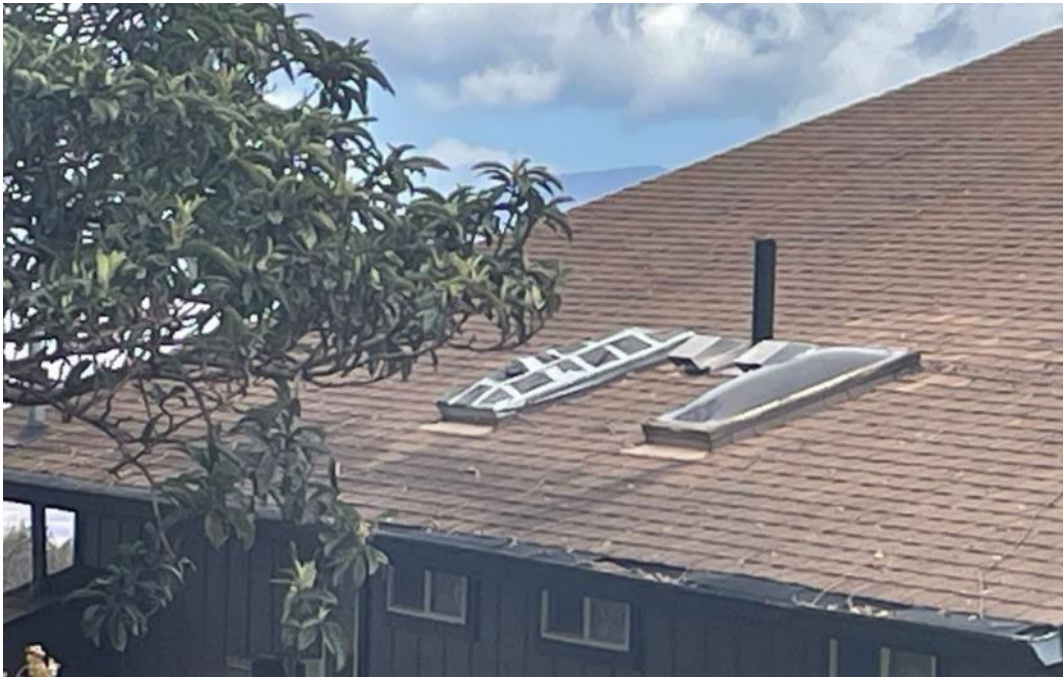
The MAT observed skylights in some residential buildings. Of the damaged skylights that were observed, it is unclear if they were properly designed to limit ember intrusion, if they may have been operable and left open, or if the frames failed and caused the skylight to fall out. A few older plastic skylights appear to have been damaged, but it is unclear if the damage was caused by radiant heat, windborne debris, or firebrands (Figure 18).

Figure 18. Older plastic skylight on a residential building in Kula damaged by wildfire.

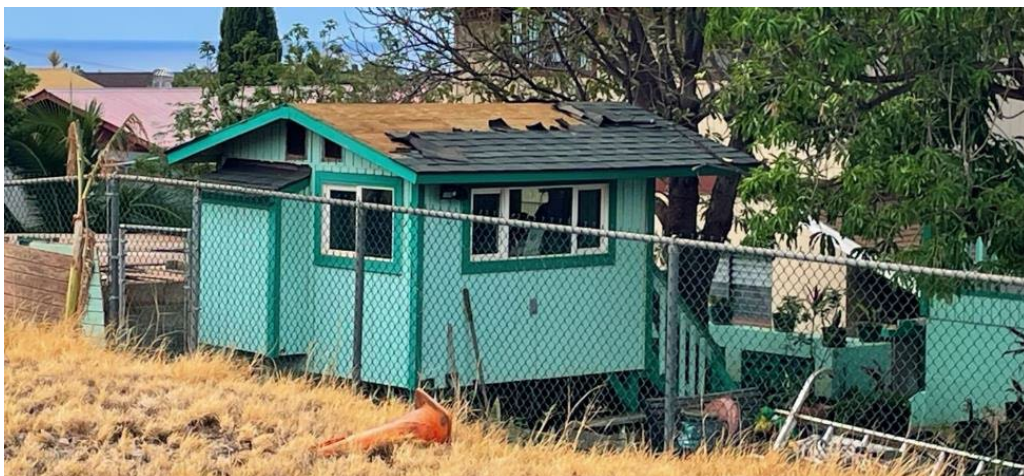
Many single-family homes observed by the MAT had accessory structures, such as storage sheds or accessory dwelling units (locally known as ‘ohanas). The 2018 State of Hawai‘i Building Code allows for an ‘ohana on residential lots of 10,000 square feet or greater. However, in 2019, Maui County adopted Ordinance 4936, which amended the Maui County building code to allow for one ‘ohana on residential and other selected zoning parcels up to 7,500 square feet and two ‘ohanas on parcels exceeding 7,500 square feet. Storage sheds constructed of vinyl were often melted by the fire, while other accessory structures composed of the same materials as the main residence experienced the same or somewhat greater fire and wind damage than the main residence (Figure 19).

Figure 19. Accessory dwelling unit (‘ohana) behind main residence in Lahaina damaged by high winds during wildfire.

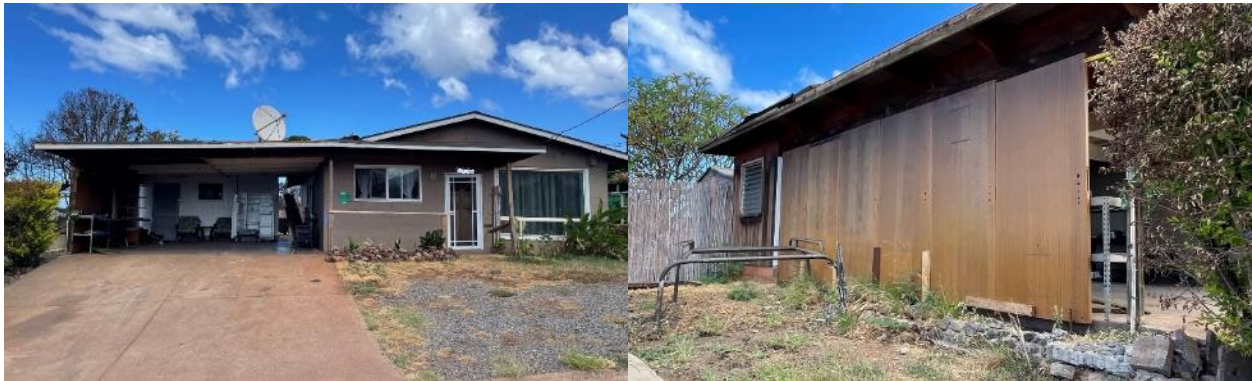
Figure 20. House with attached carport in Lahaina, with carport side support wall constructed or repaired using leftover door panels.

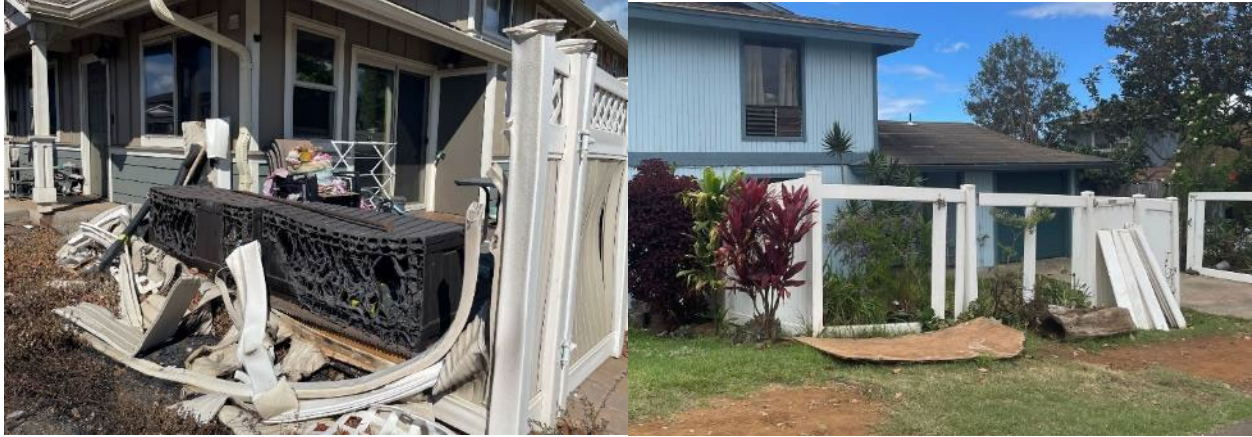
Figure 21. Residential buildings with vinyl property fences melted or warped by wind-driven wildfire.

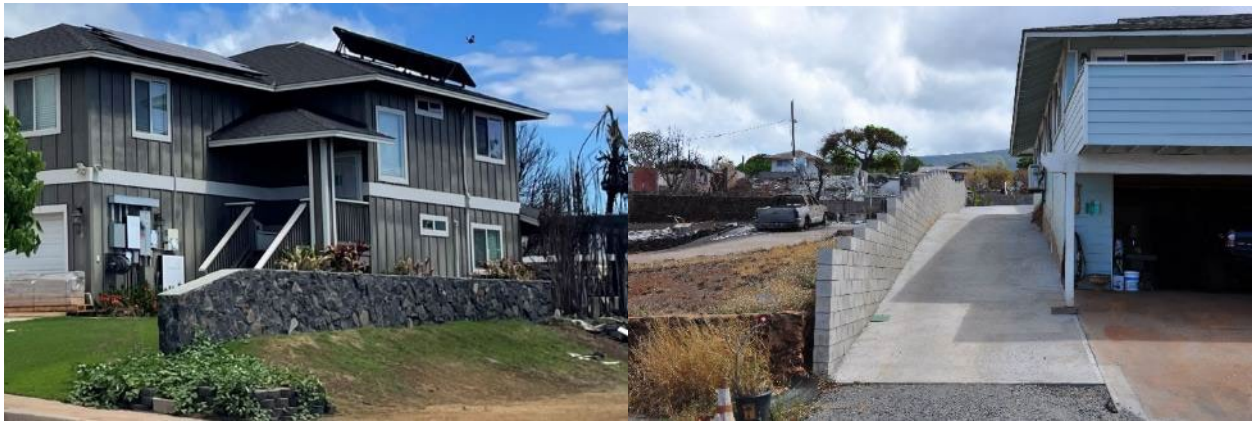
Figure 22. Homes with stone or masonry property fences that appeared to resist wildfire damage.

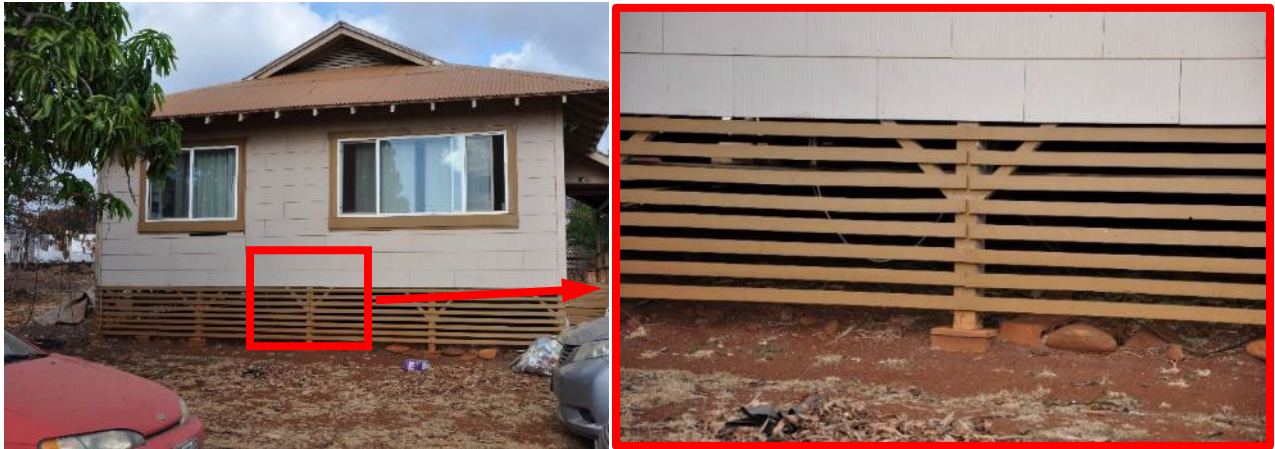
The MAT also observed several homes elevated with post and pier foundations consisting of timber posts resting on a foundation block at grade without connectors or fasteners between posts and the foundation block or between the foundation block and the ground other than the weight of the supported structure. These post and pier foundations were traditionally used to support old plantation-style modest dwellings throughout Hawai'i, but many remain on Maui and have been adapted over the years to support single-family homes (Figure 23). While post and pier foundations can resist gravity (dead and live) loads and small lateral and uplift forces, the lack of lateral support connections in these foundations make them highly vulnerable to damage or collapse during flood, high wind, or seismic events.

Figure 23. Maui residential building supported by post and pier foundation.

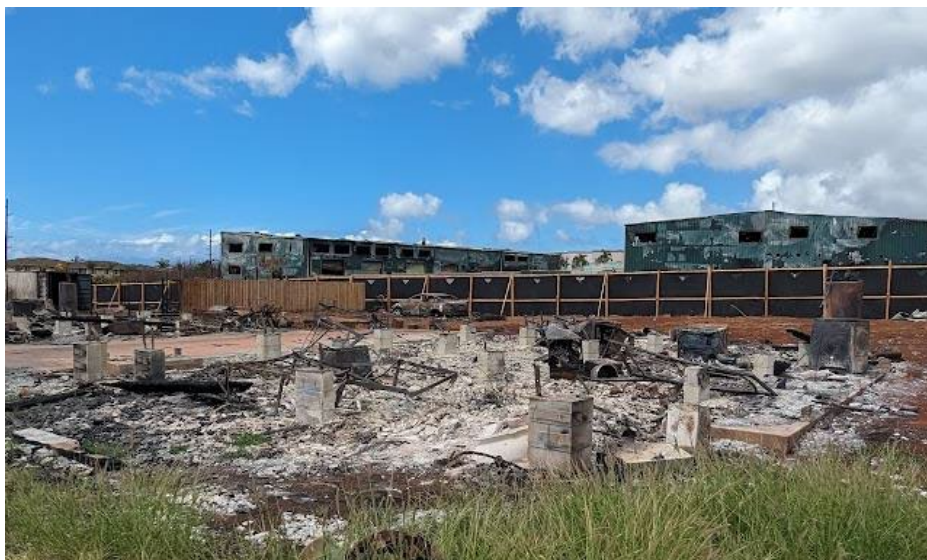
Figure 24. Home in Lahaina consumed by fire was elevated on masonry piers.

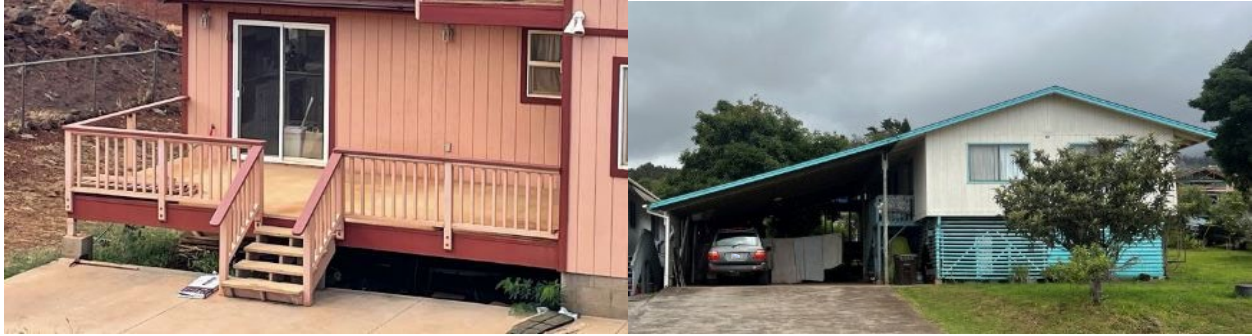
Figure 25. Elevated foundation homes with items stored underneath.

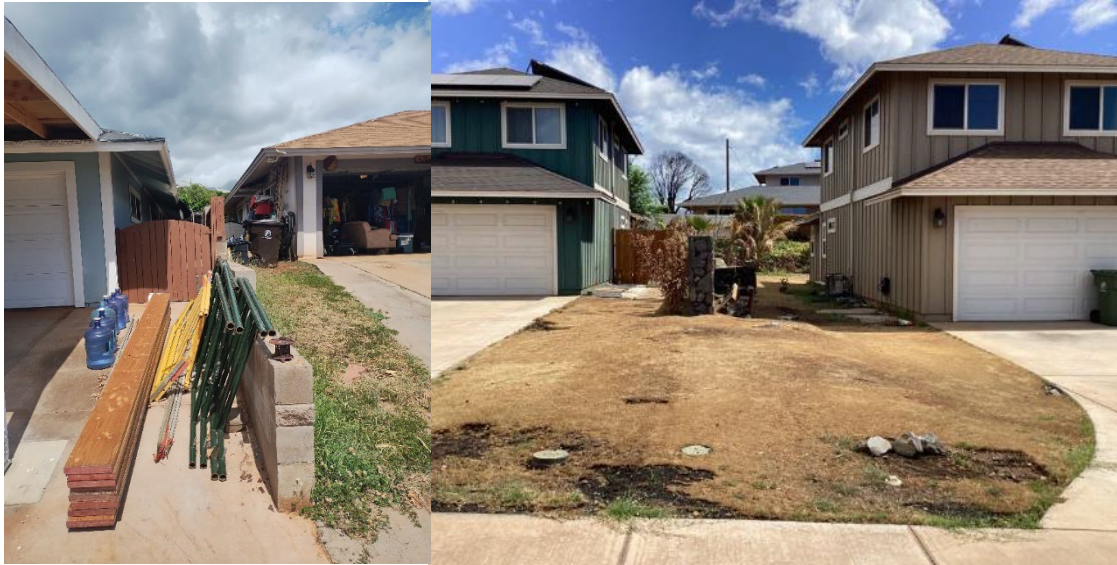
Figure 27. Examples of limited separation distances between residential buildings in Lahaina.

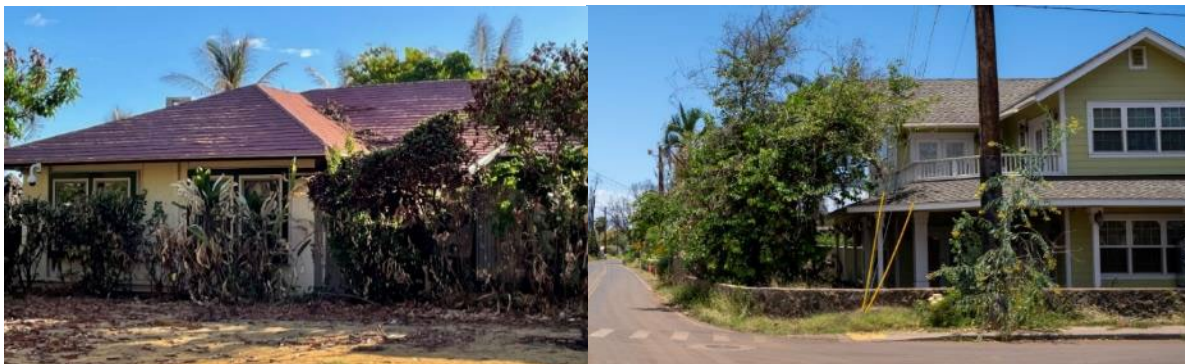
Observed overgrown vegetation between residential structures increases the risk of spot fire ignition from embers (Figure 28). This circumstance may lead to structure ignition and structure-to-structure fire spread. Non-native and invasive plants are prevalent in Maui County. During MAT interviews, it was noted that there is a lack of specific resources (and knowledge of existing resources) regarding fire-resistant plants recommended for use in Hawai'i.

Figure 28. Examples of homes in Lahaina with overgrown vegetation directly adjacent to the building.

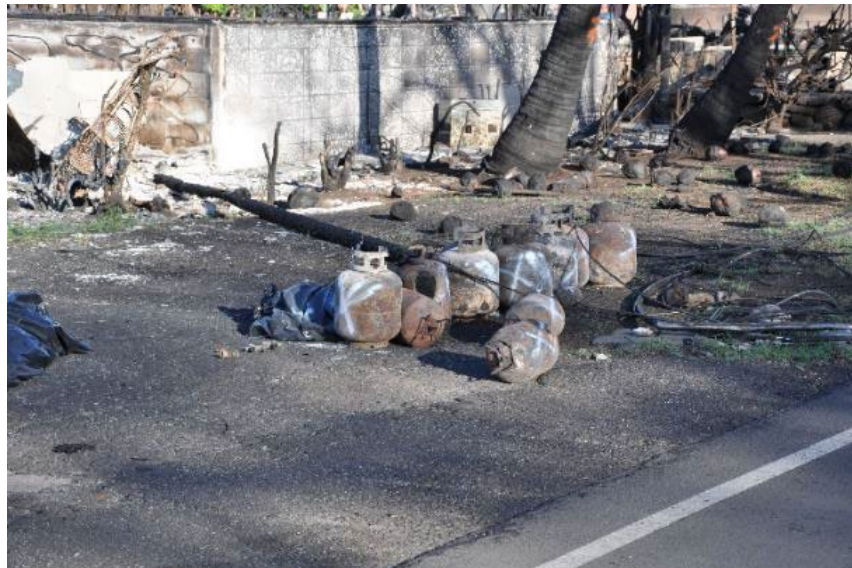
Figure 29. Propane tanks are commonly used in and around residential buildings.

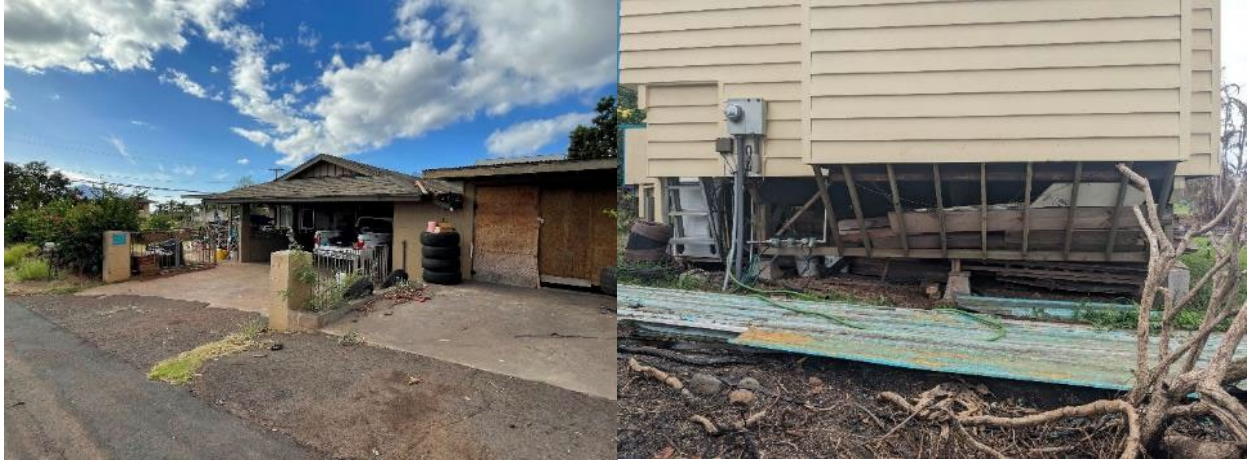
Figure 30. Examples of open storage of household items in carports and underneath floors.

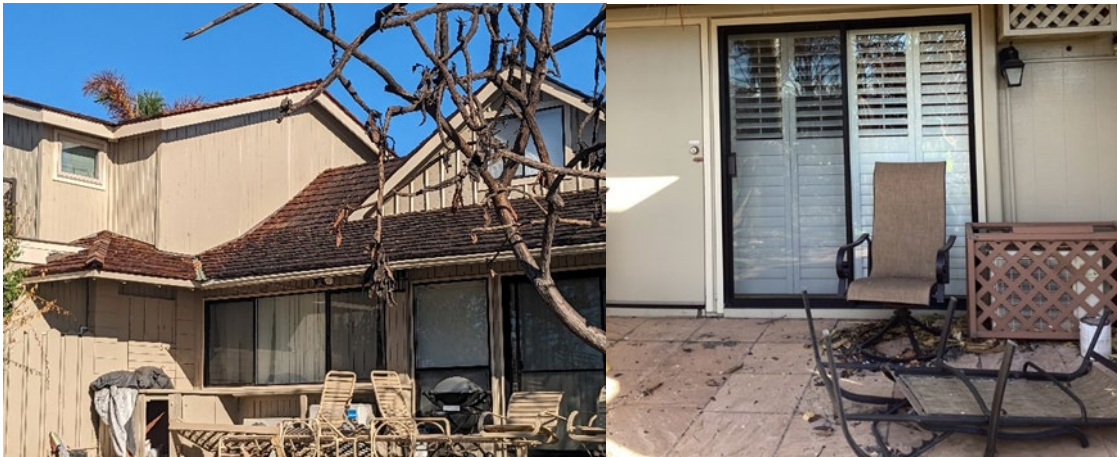
Figure 31. Examples of homes with outdoor furniture or other potentially combustibile material stored on patios and in yards.

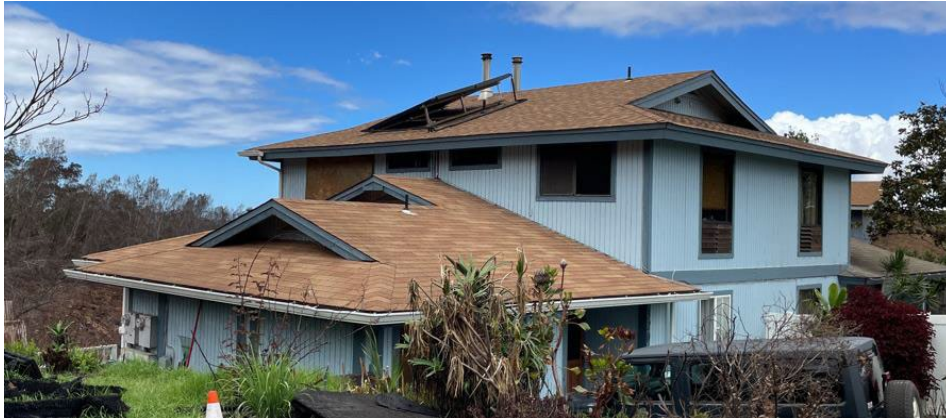
- Deferred home maintenance increased the risk of fire exposure. This included loose or missing roof shingles or tiles that were not repaired or replaced to help prevent embers from getting trapped, and gutters filled with vegetative debris (due to a lack of gutter covers) that may have ignited by embers and spread to the structure. Homes with complex roof shapes (Figure 34) or upcountry homes with chimneys can be particularly vulnerable to debris or ember accumulation.

Figure 34. Example of Maui home with complex roof shape subject to debris or ember accumulation.

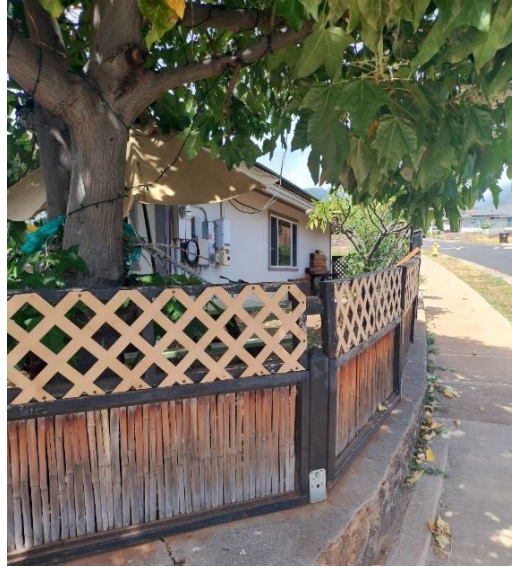
Figure 35. Maui home with lack of vegetation management from overhanging trees.

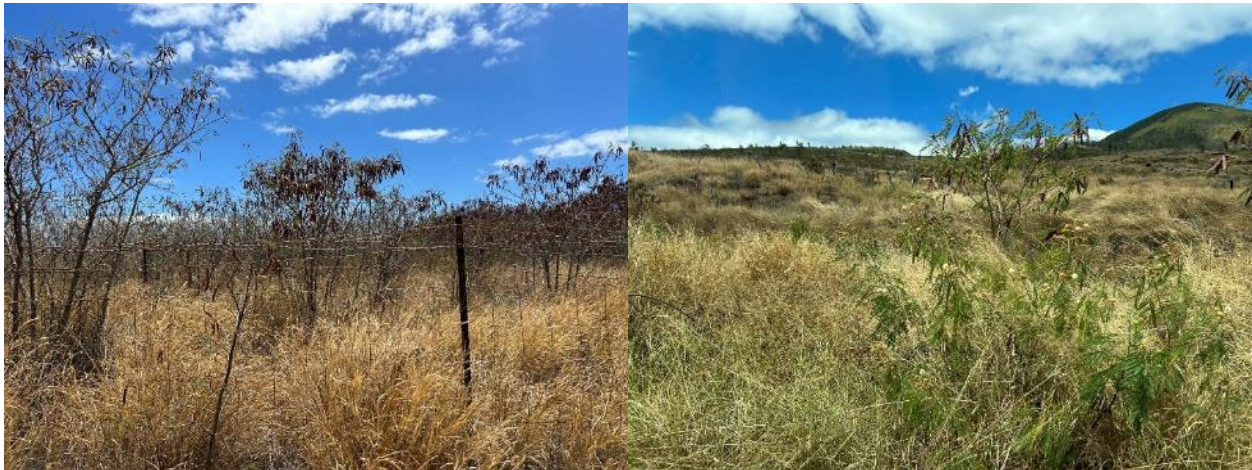
Figure 36. Examples of large parcels of unmanaged vegetation.
