# A.V. Watkins Dam Backward Erosion Piping Incident Update

National Dam Safety Program Technical Seminar | 2023

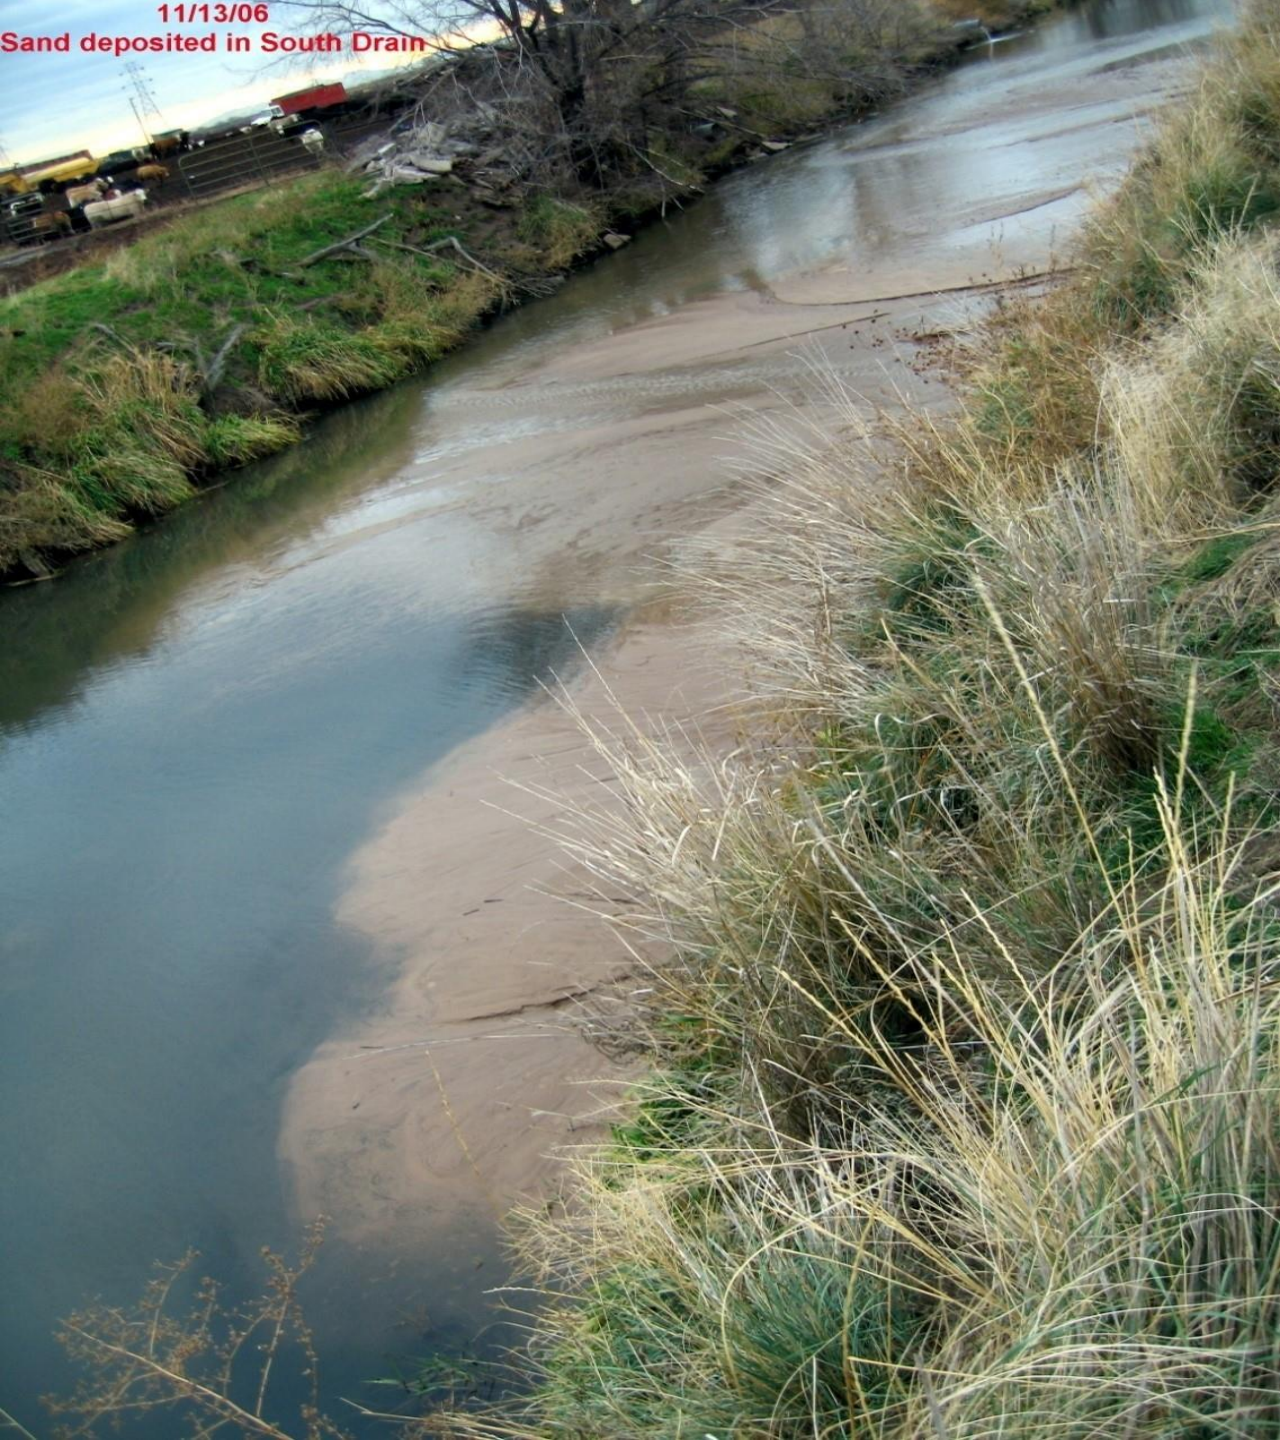
11/13/06

Sand deposited in South Drain

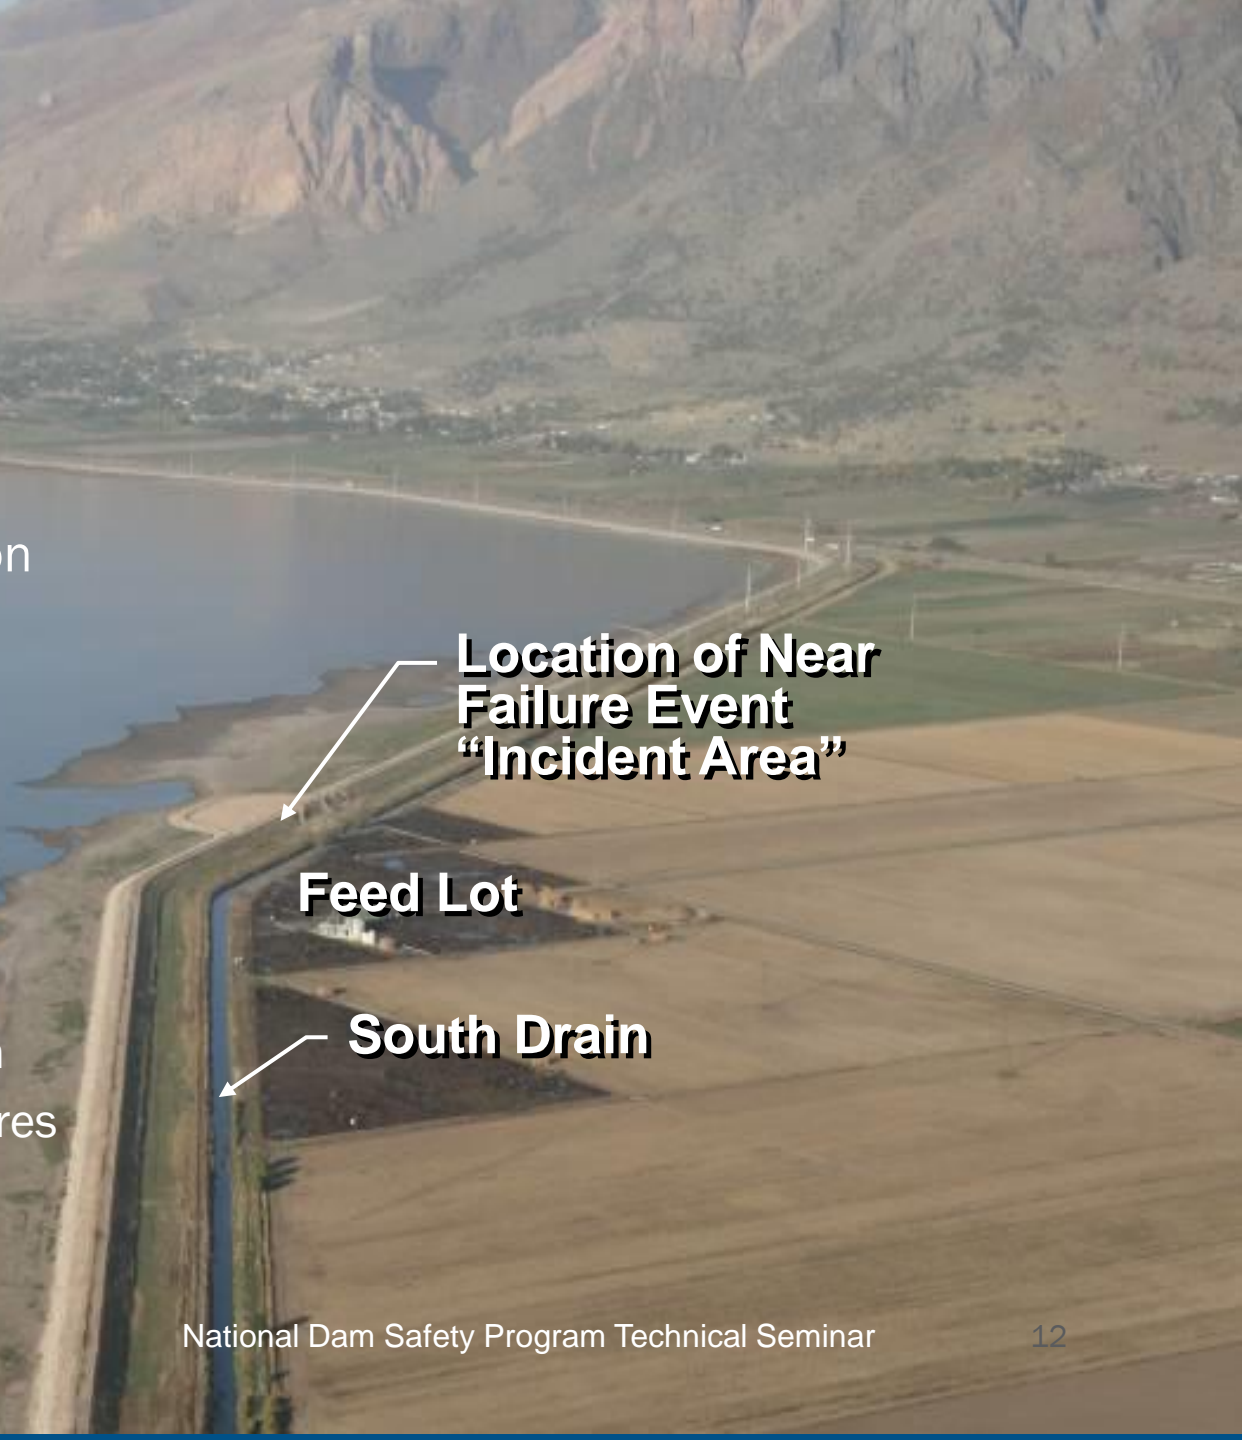
- 9.5 ft of head on upstream toe at time of incident
- Feed lot operator noticed cloudy seepage and sand eroding into South Drain (piping) on November 11, 2006
- Feed lot operator notifies water district of concerns on Monday-November 13 when seepage increased and “dark clay” observed exiting into South Drain
- Monday evening – November 13
  - Foundation piping observed by Reclamation and water district staff
  - Sand boils at toe of dam, sand deposits in South Drain and at toe of dam, sinkholes, cracking, and slope failures on downstream slope, transverse cracks in crest

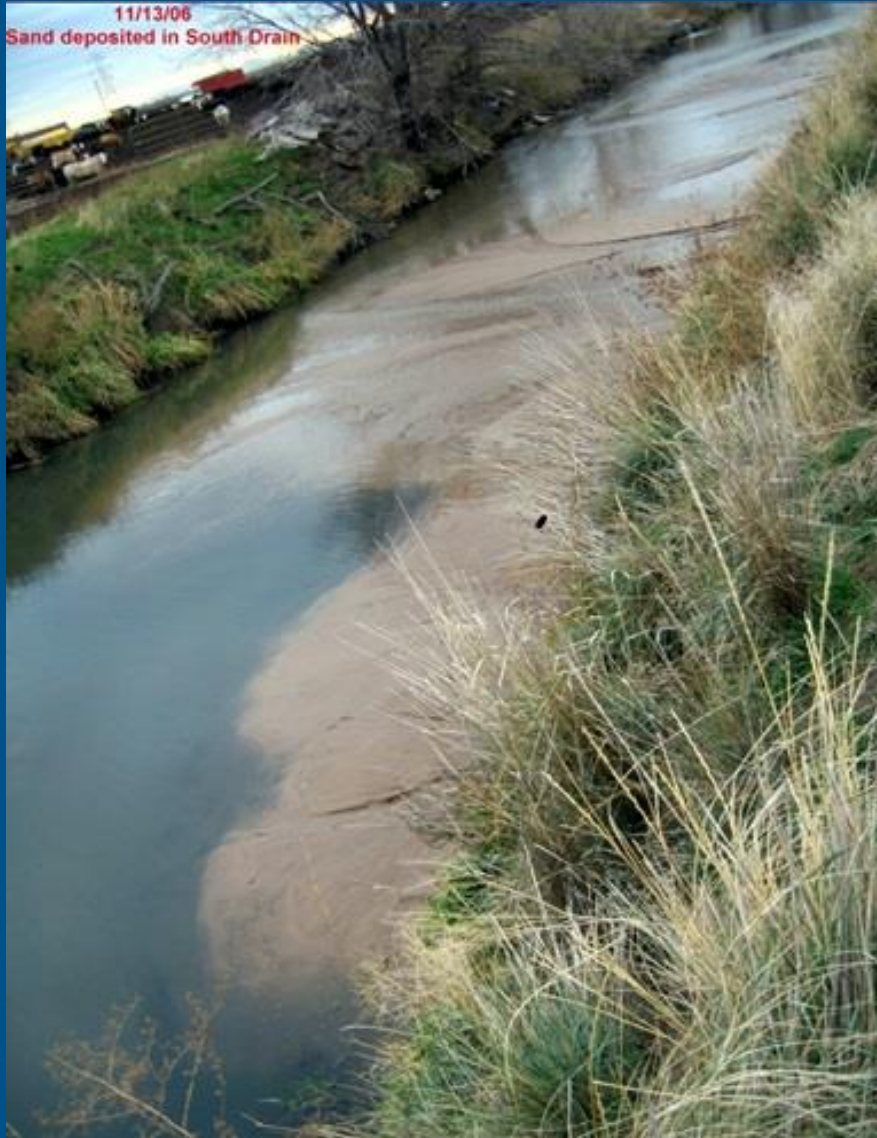
- ~200 gpm seepage flowing into the South Drain.
- ~250 CY of sediments
- This is ~130 ft downstream of the downstream dam toe

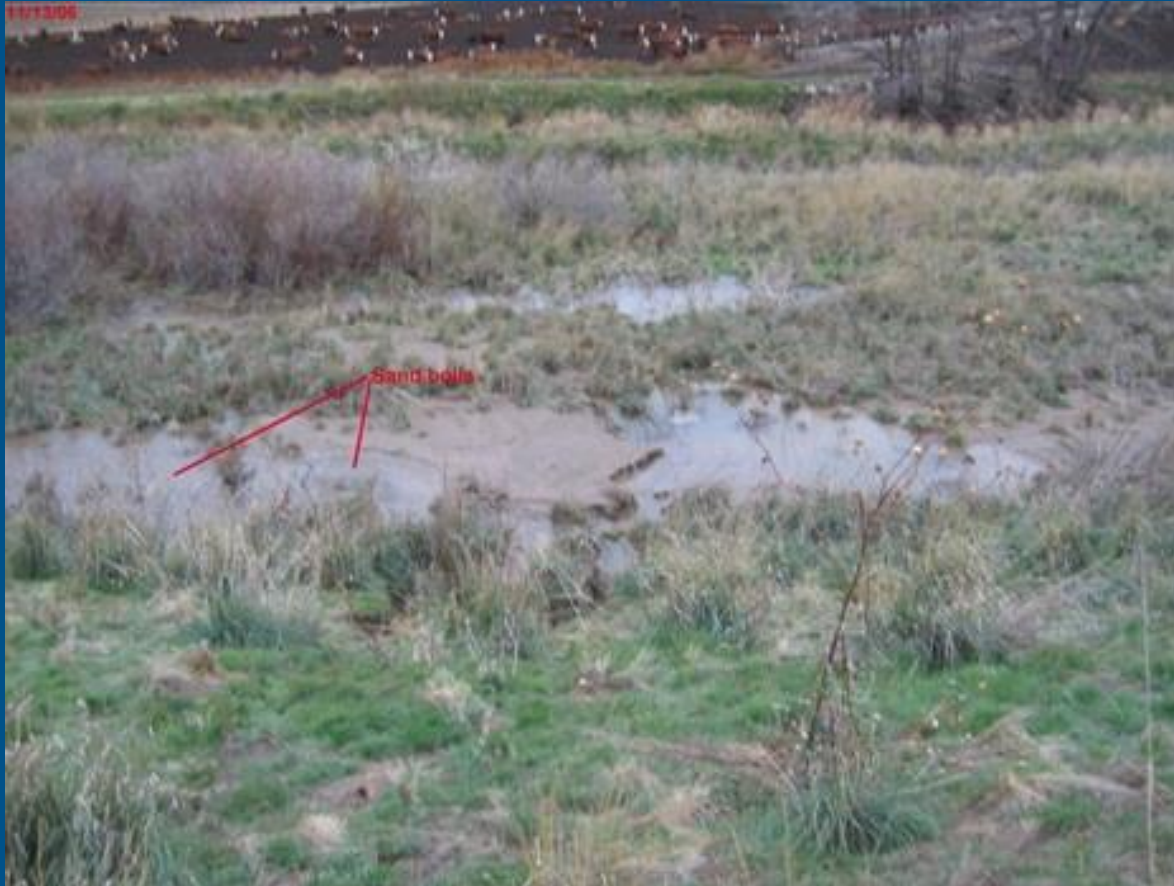
- View from dam embankment of sand boils immediately at the downstream toe

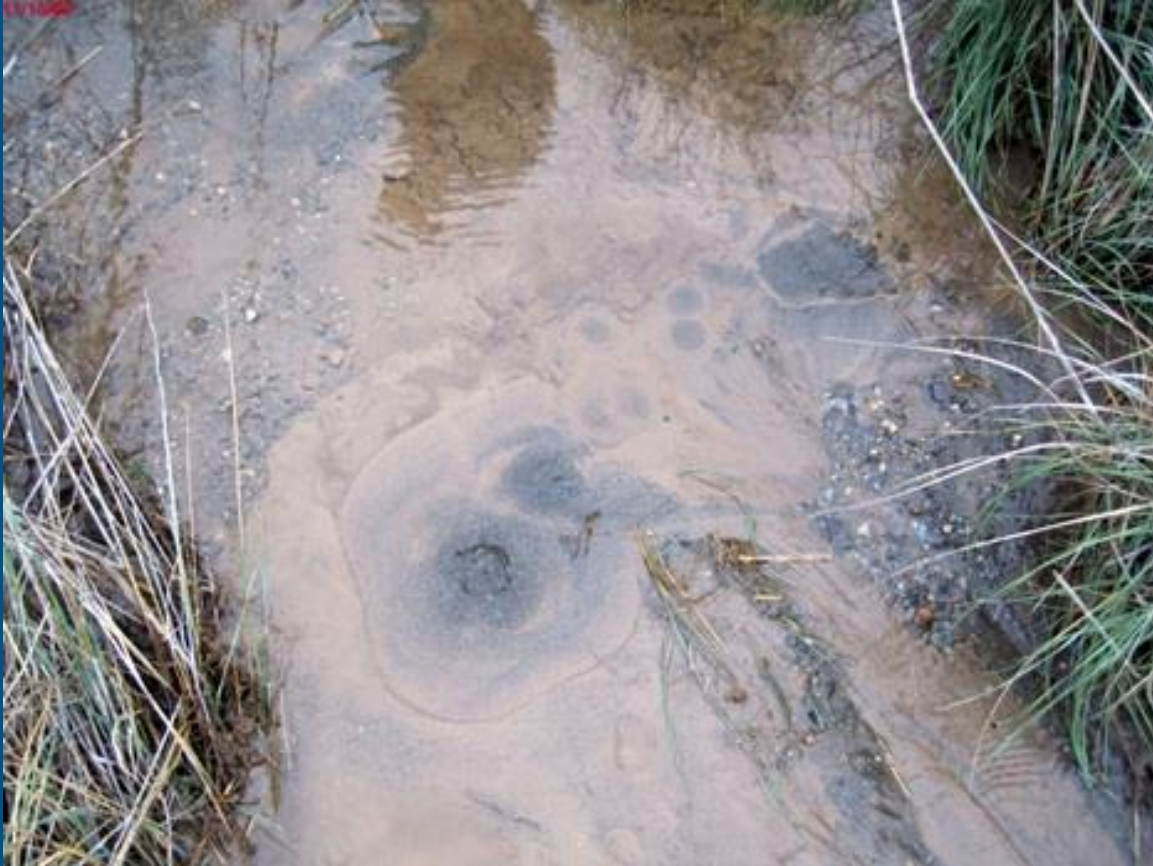
- Large sand boils at the downstream toe

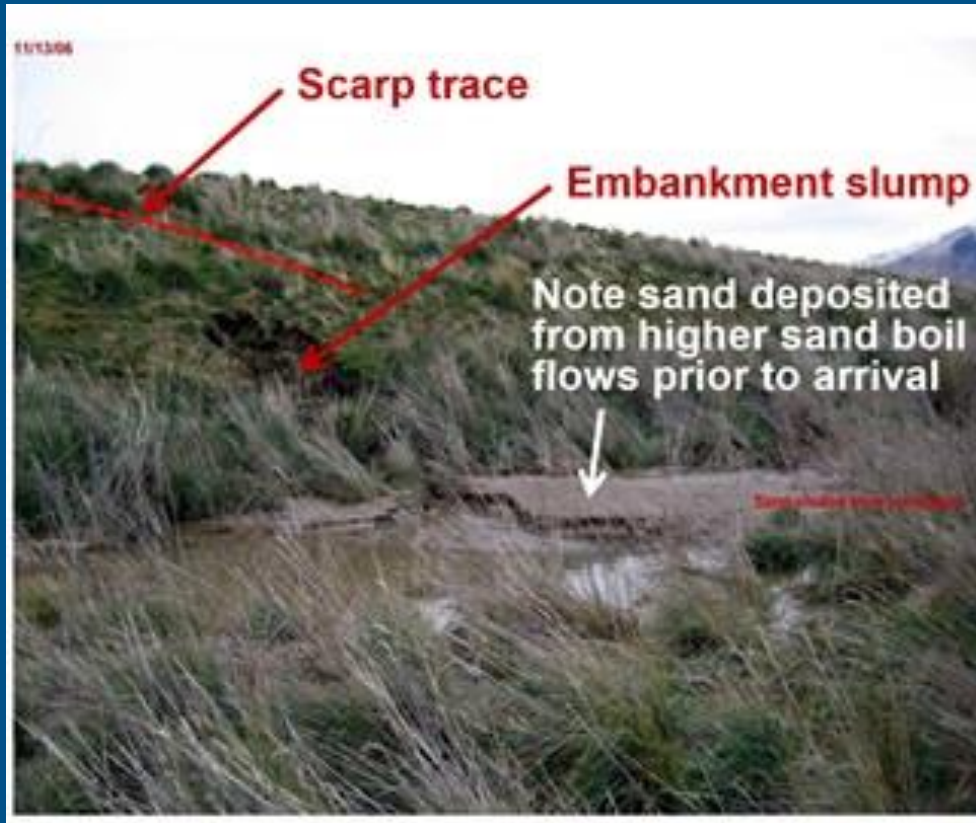
- 150-200 gpm coming from 1 large sand boil at the toe and several smaller sand boils a short distance from toe
- ~ 12 CY of sand sediment at downstream toe
- Sand deposit indicates that higher flows existed prior to Reclamation staff arrival
- Note embankment slump that indicated the downstream portion had dropped into a void in the foundation

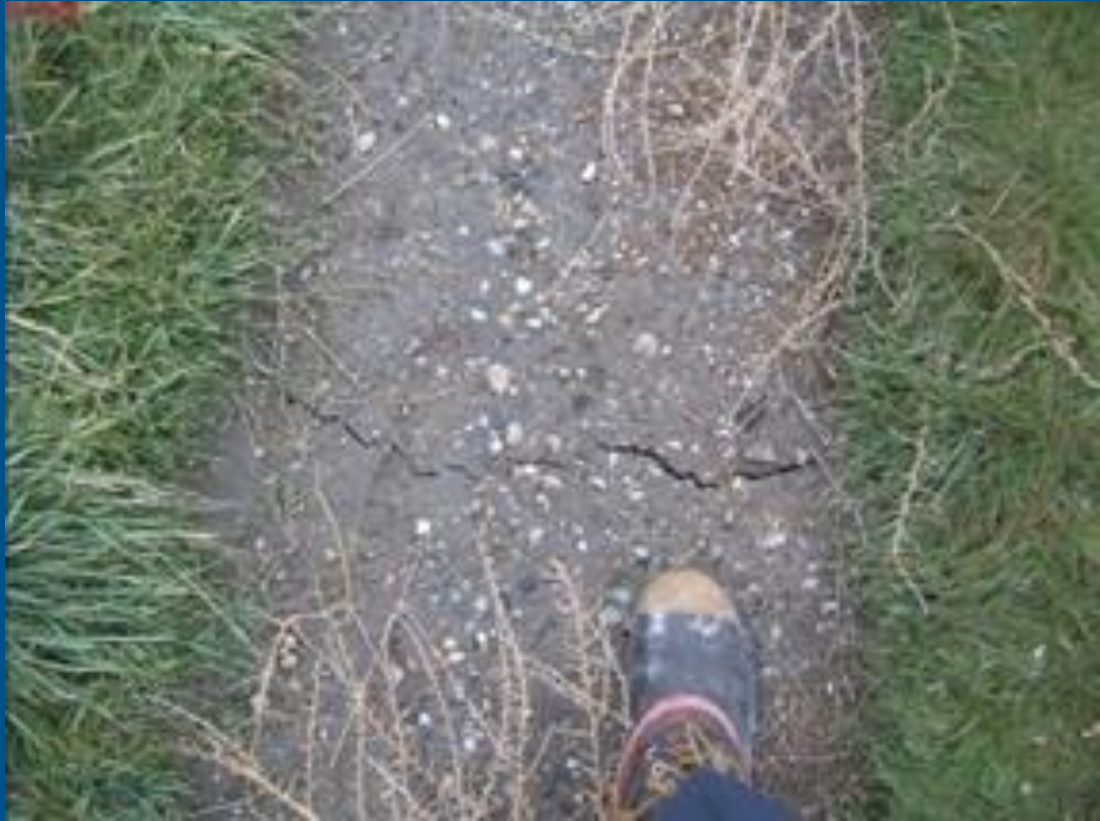
- Transverse crest crack in wheel path on crest
- Upstream of embankment slump area

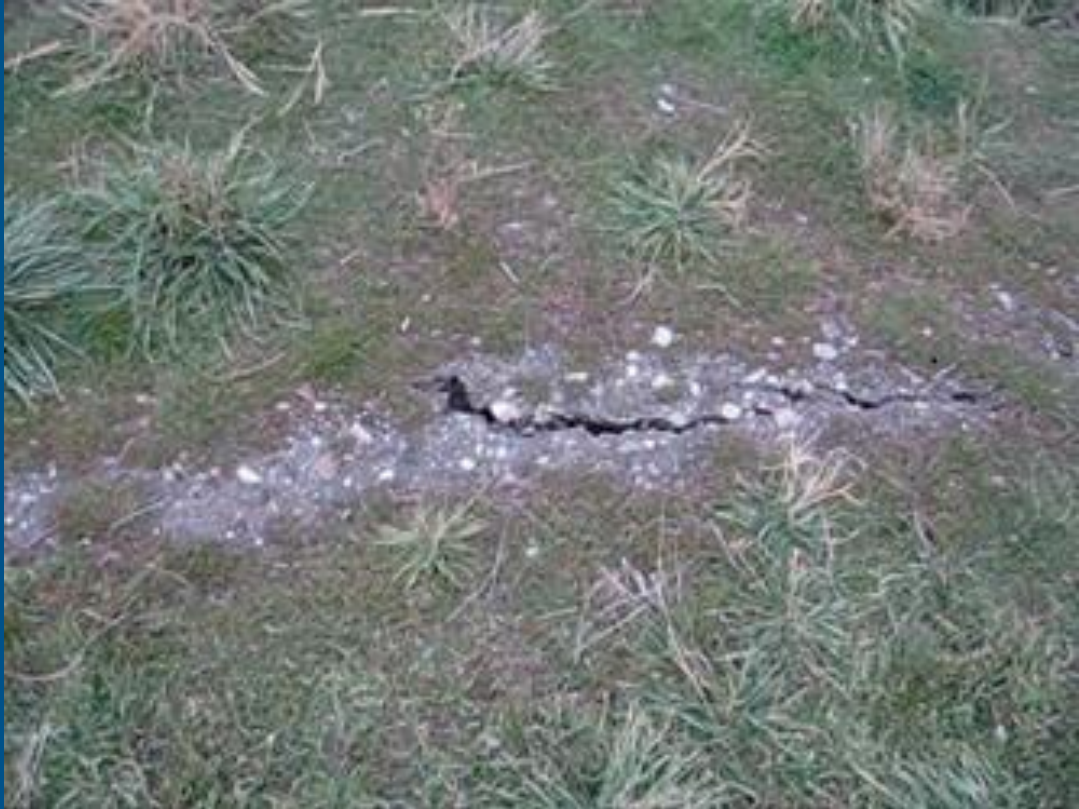
- Longitudinal crack in crest.
- Upstream of embankment slump area
- Additionally
  - Numerous sinkholes and depressions between the toe and the South Drain
  - Approximately 2 to 5 ft in diameter

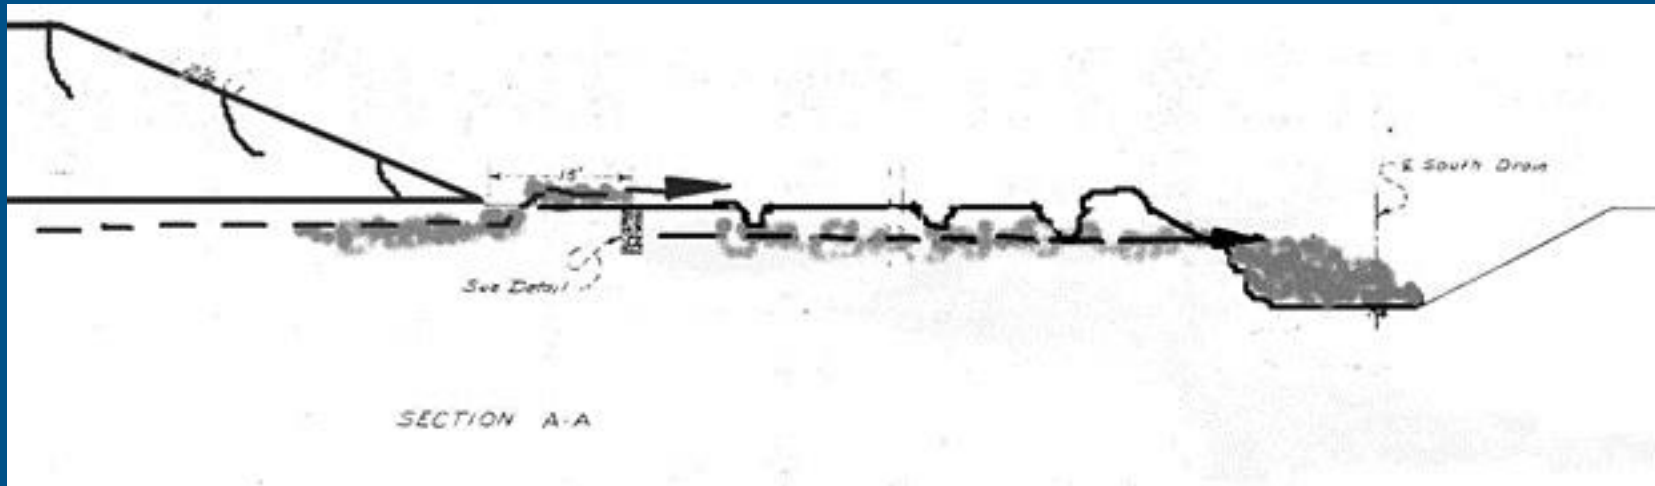
## Sketch of Conditions Upon Arrival (D. Grundvig, 2006)

- Blowout at dam toe with foundation soils being coming out of boils
- Concentrated flows carrying eroded soils over the ground surface and into sinkholes
- Transported sediments re-emerged in the South Drain

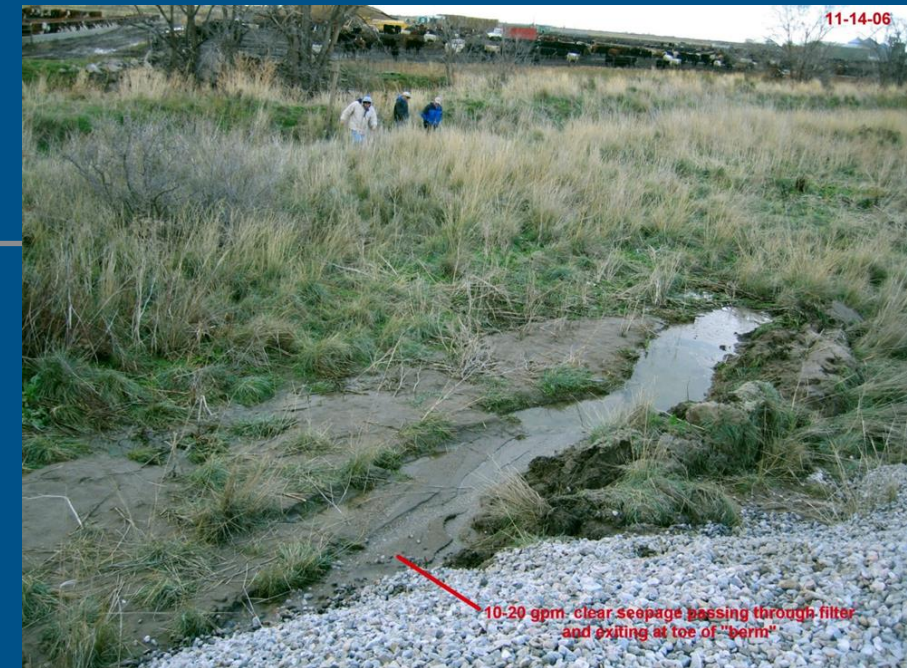
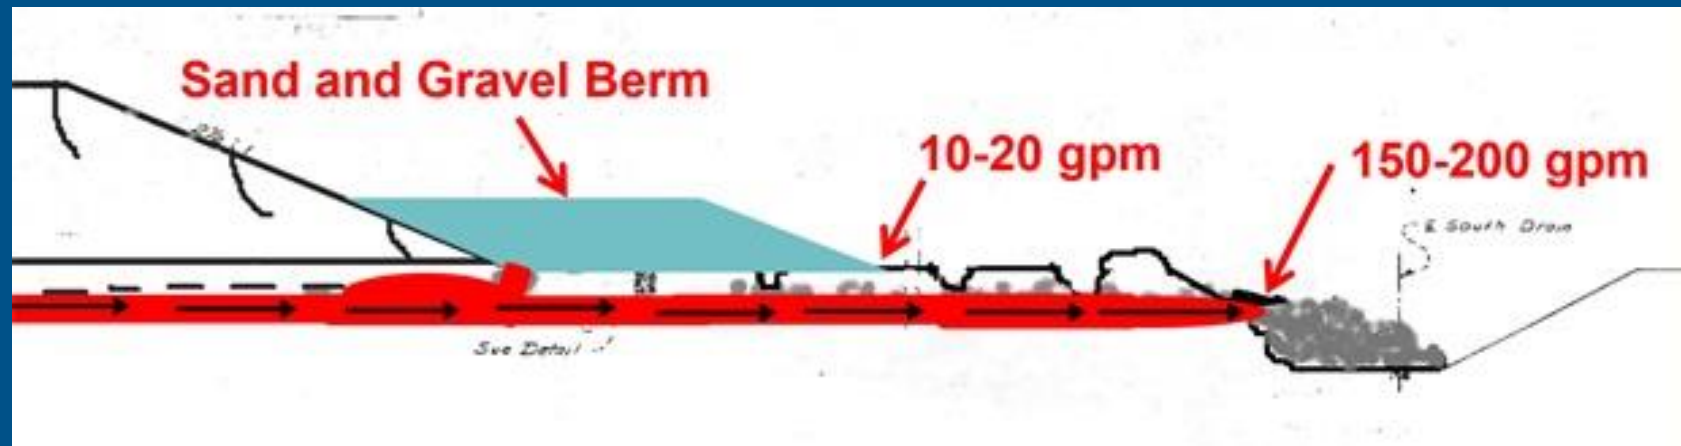
- 10 to 20 gpm of filtered seepage exiting toe of filter berm
- AND still 150-200 gpm cloudy seepage into South Drain
- Failure Still in Progress!

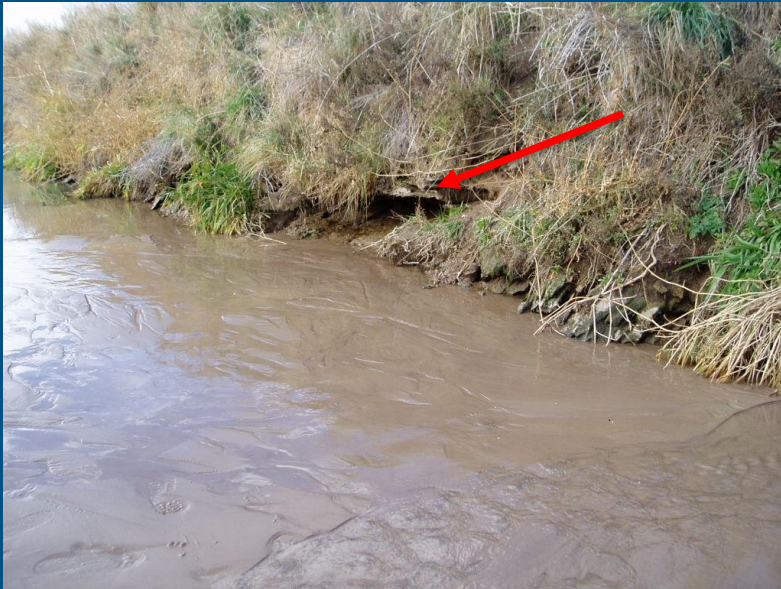
Hardpan layer several inches thick in the incident area on the dam side of South Drain

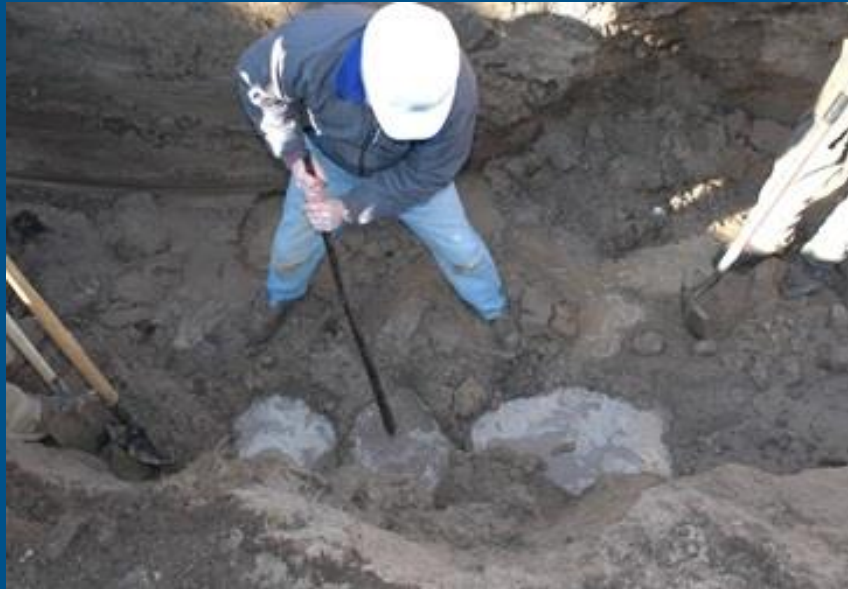
Steel rod used to break through the hardpan layer exposed in a trench. Note upward flowing water under pressure.

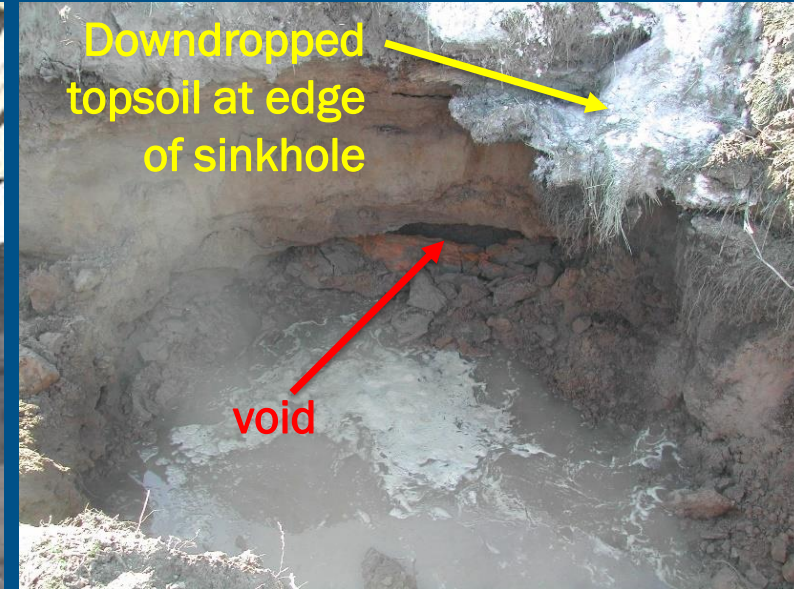
Shallow, wide void under hardpan exposed in test pit at a sinkhole

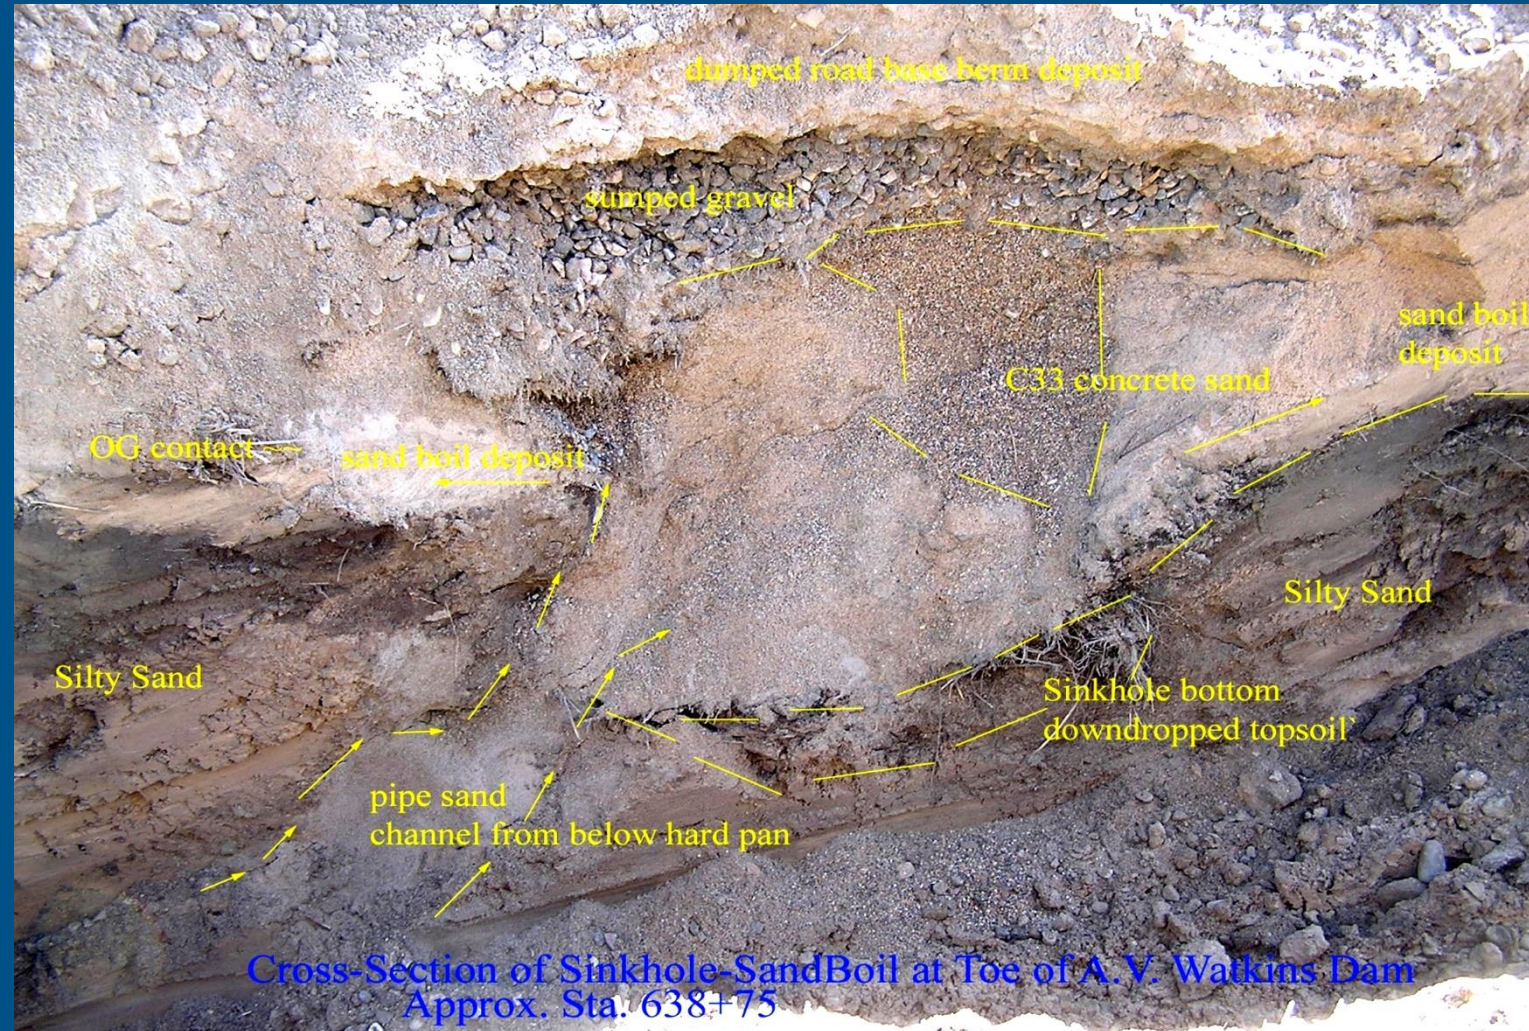
- Photo of trench excavated at the downstream toe showing down-dropped topsoil, piped sand from below the underlying hardpan.
- Upper materials are C33 concrete sand and gravel of the filter berm.

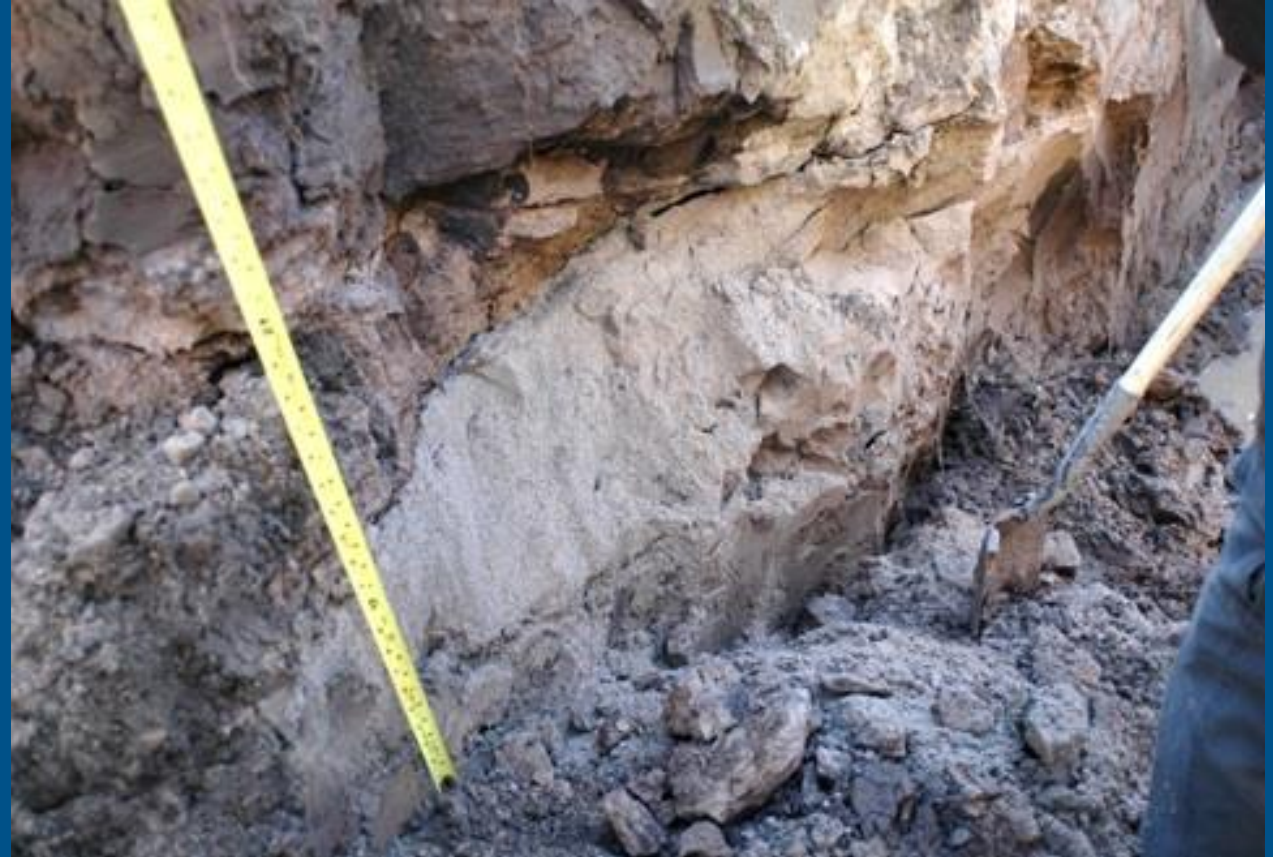
- Photo of trench sidewall below the hardpan
- Sand Deposited in erosion pathway after flow was choked off by collapse of the hardpan downstream of this location

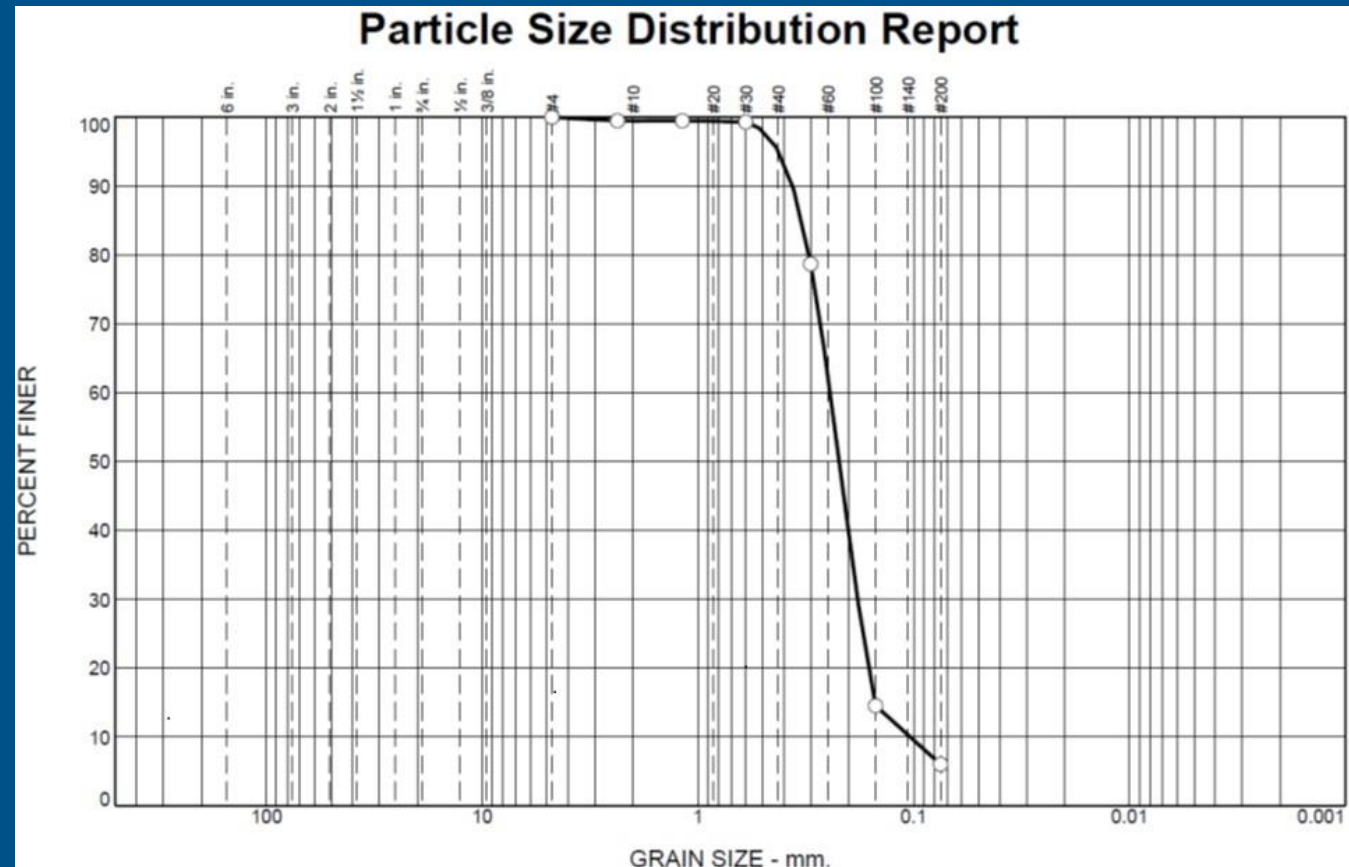
- Representative gradation of eroded soils collected in a forensic trench
- Relatively uniform, fine sand very susceptible to backward erosion piping

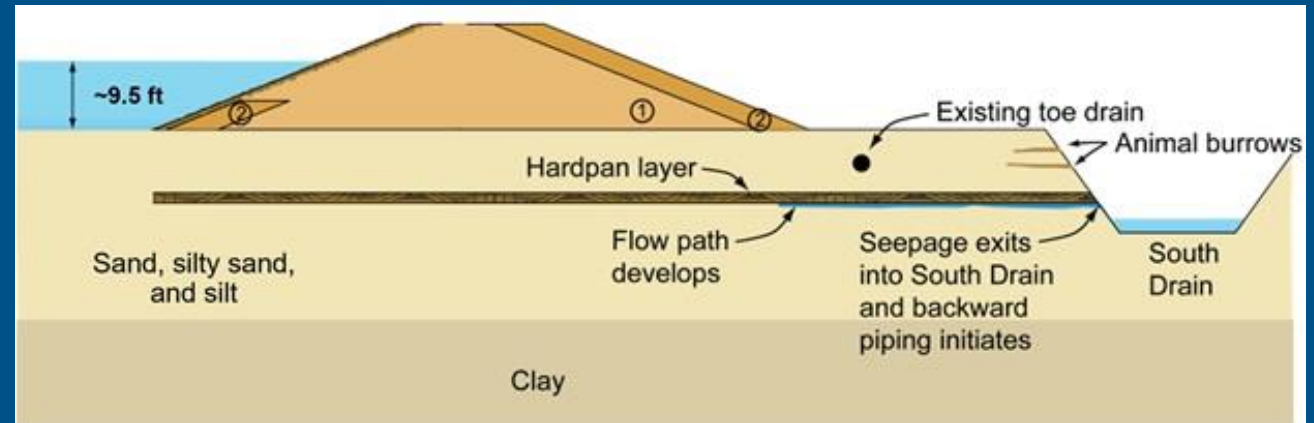
*Step 1. Unfiltered Exit and Initiation of Piping*  
Backward erosion piping initiates into south drain beneath continuous hardpan layer

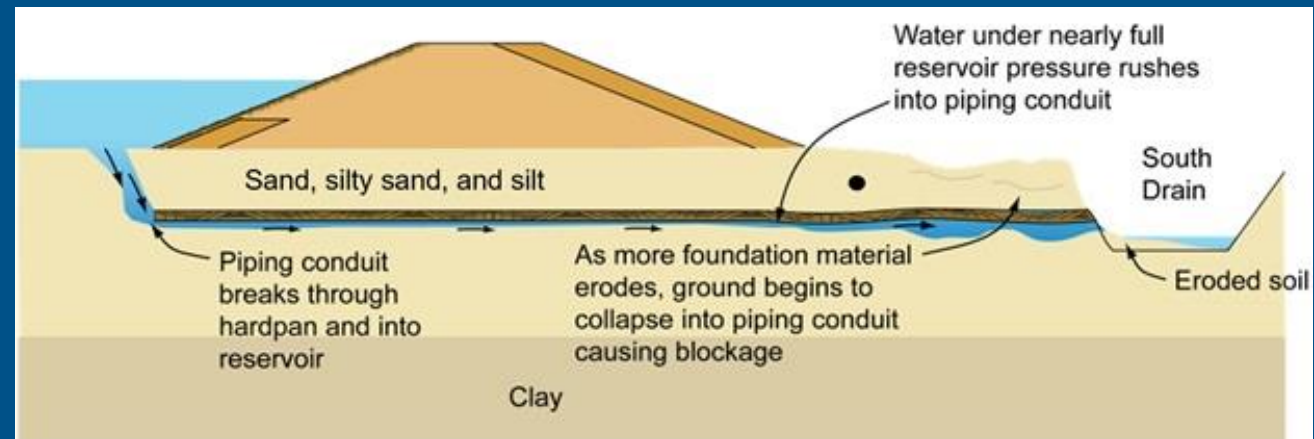
*Step 2. Progression of Erosion*  
Erosion progresses upstream beneath hardpan, eventually reaching the reservoir

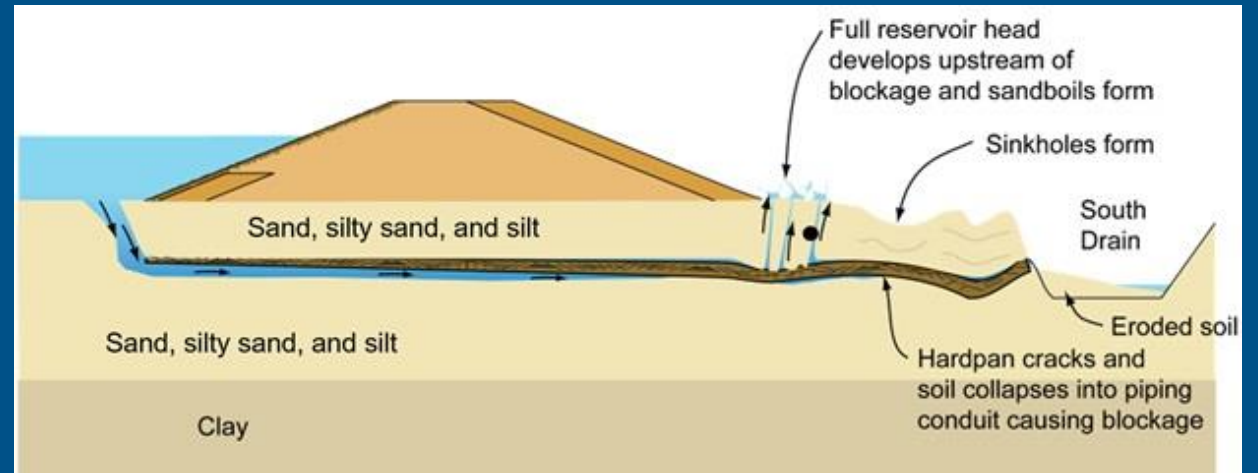
## Step 3. Collapse of Hardpan and Boil Formation at Downstream Toe

Voids enlarge and hardpan collapses, causing seepage and sand boils at the downstream toe

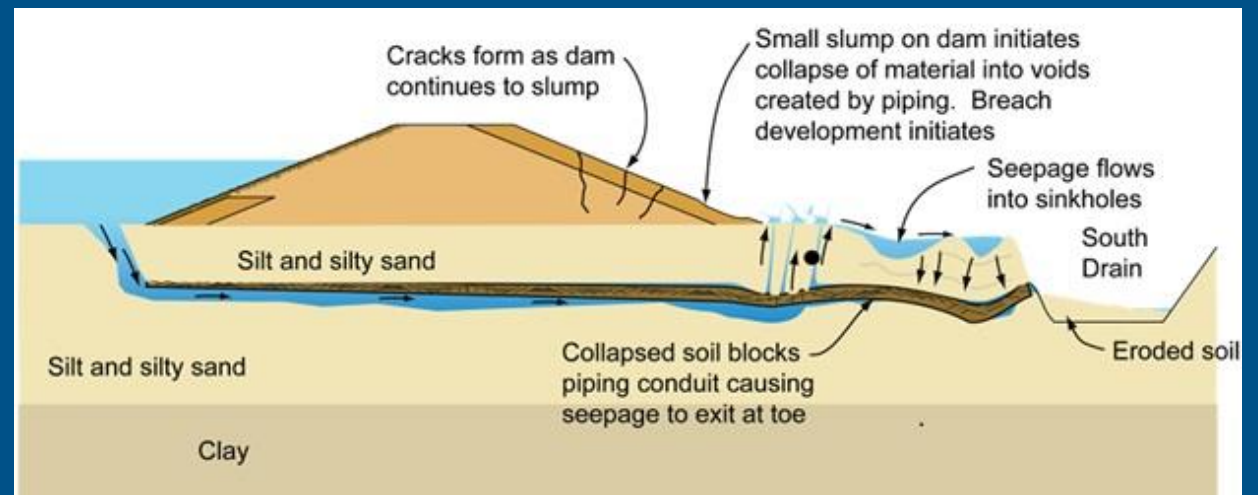
## Step 4. Distress to Overlying Embankment

Erosion and enlargement of voids cause the hardpan to collapse upstream of the downstream toe, causing slumping and cracking of the dam
