# BETHEL RECREATION FACILITY MASTER PLAN

Town of Bethel, Vermont

March 2013

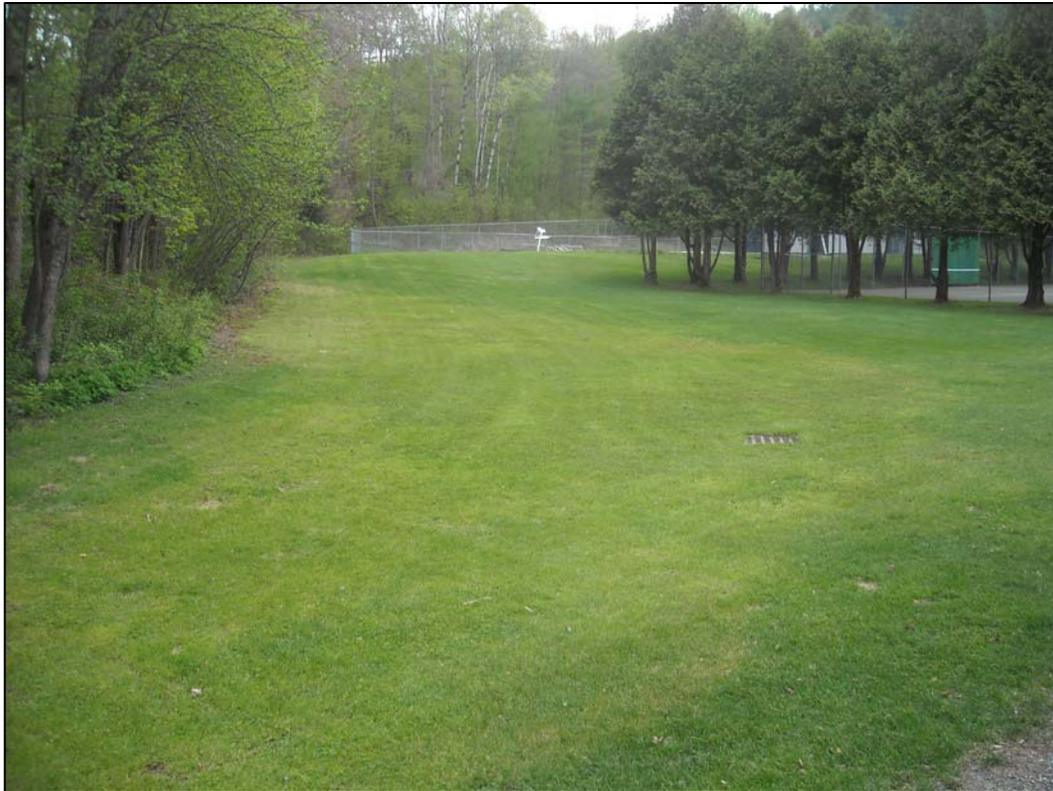
Photo 1. Lawn adjacent to tennis courts. Note storm drain inlet in the lawn, and fill around pool in the background. View to the south.

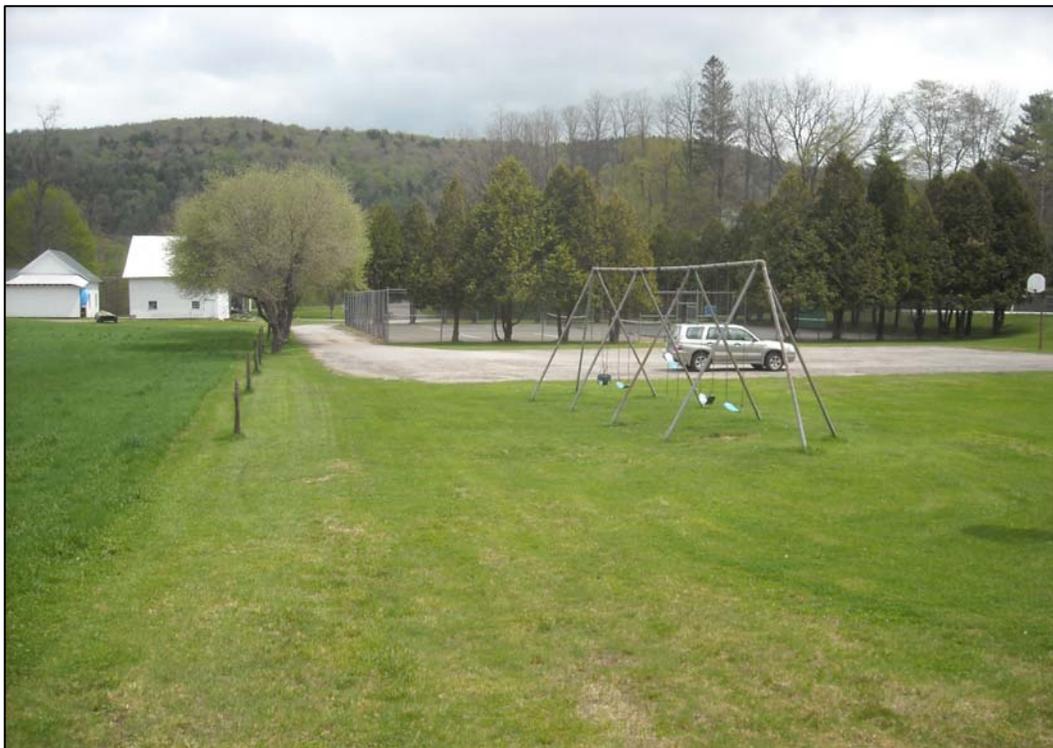
Photo 2. Parking lot and tennis courts. Note entrance road along the side of the tennis courts with Pleasant Street beyond. View to the northeast.

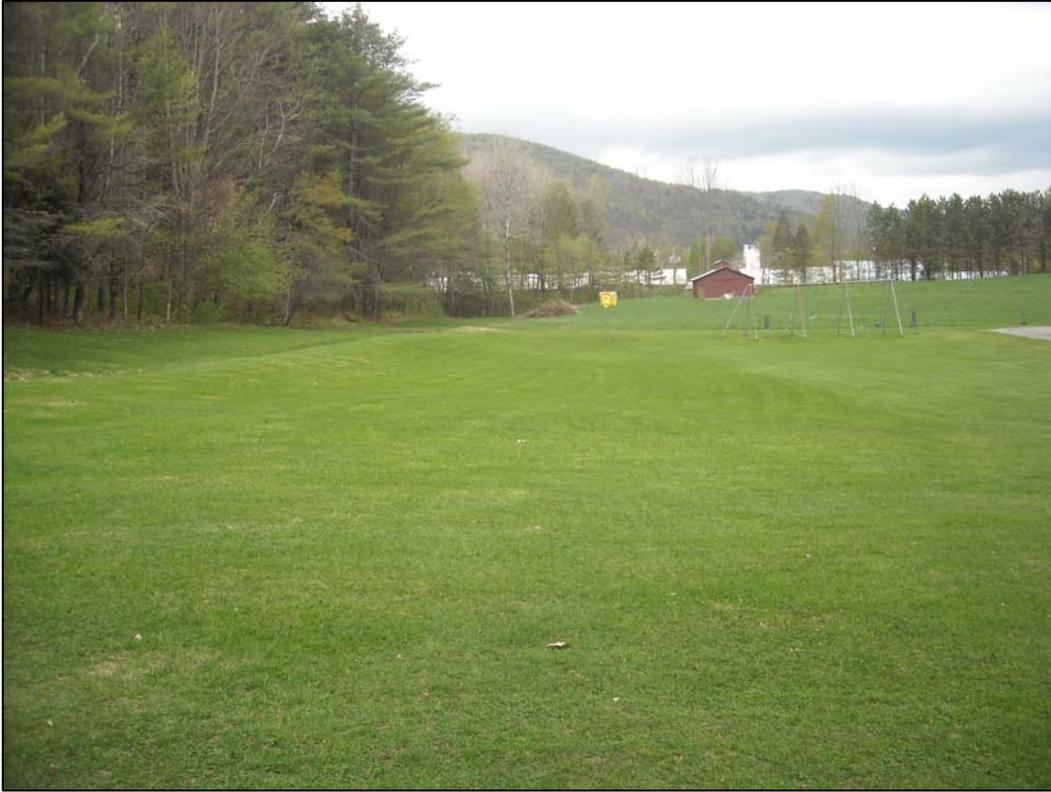
Photo 3. Modified lawn area at southwest corner of property. Note swing set in the background, drainage ditch at the base of the hill to the left and school in the distant background. View to the northwest.
