REPORT
ON
ENVIRONMENTAL SITE SURVEY
FOR
NORTH ELEMENTARY SCHOOL
EXCEL PROJECT

OWEGO, NEW YORK

**REPORT
ENVIRONMENTAL SITE SURVEY
OWEGO-APALACHIN CENTRAL SCHOOL DISTRICT – EXCEL PROJECT
OWEGO NORTH ELEMENTARY SCHOOL
OWEGO, NEW YORK**

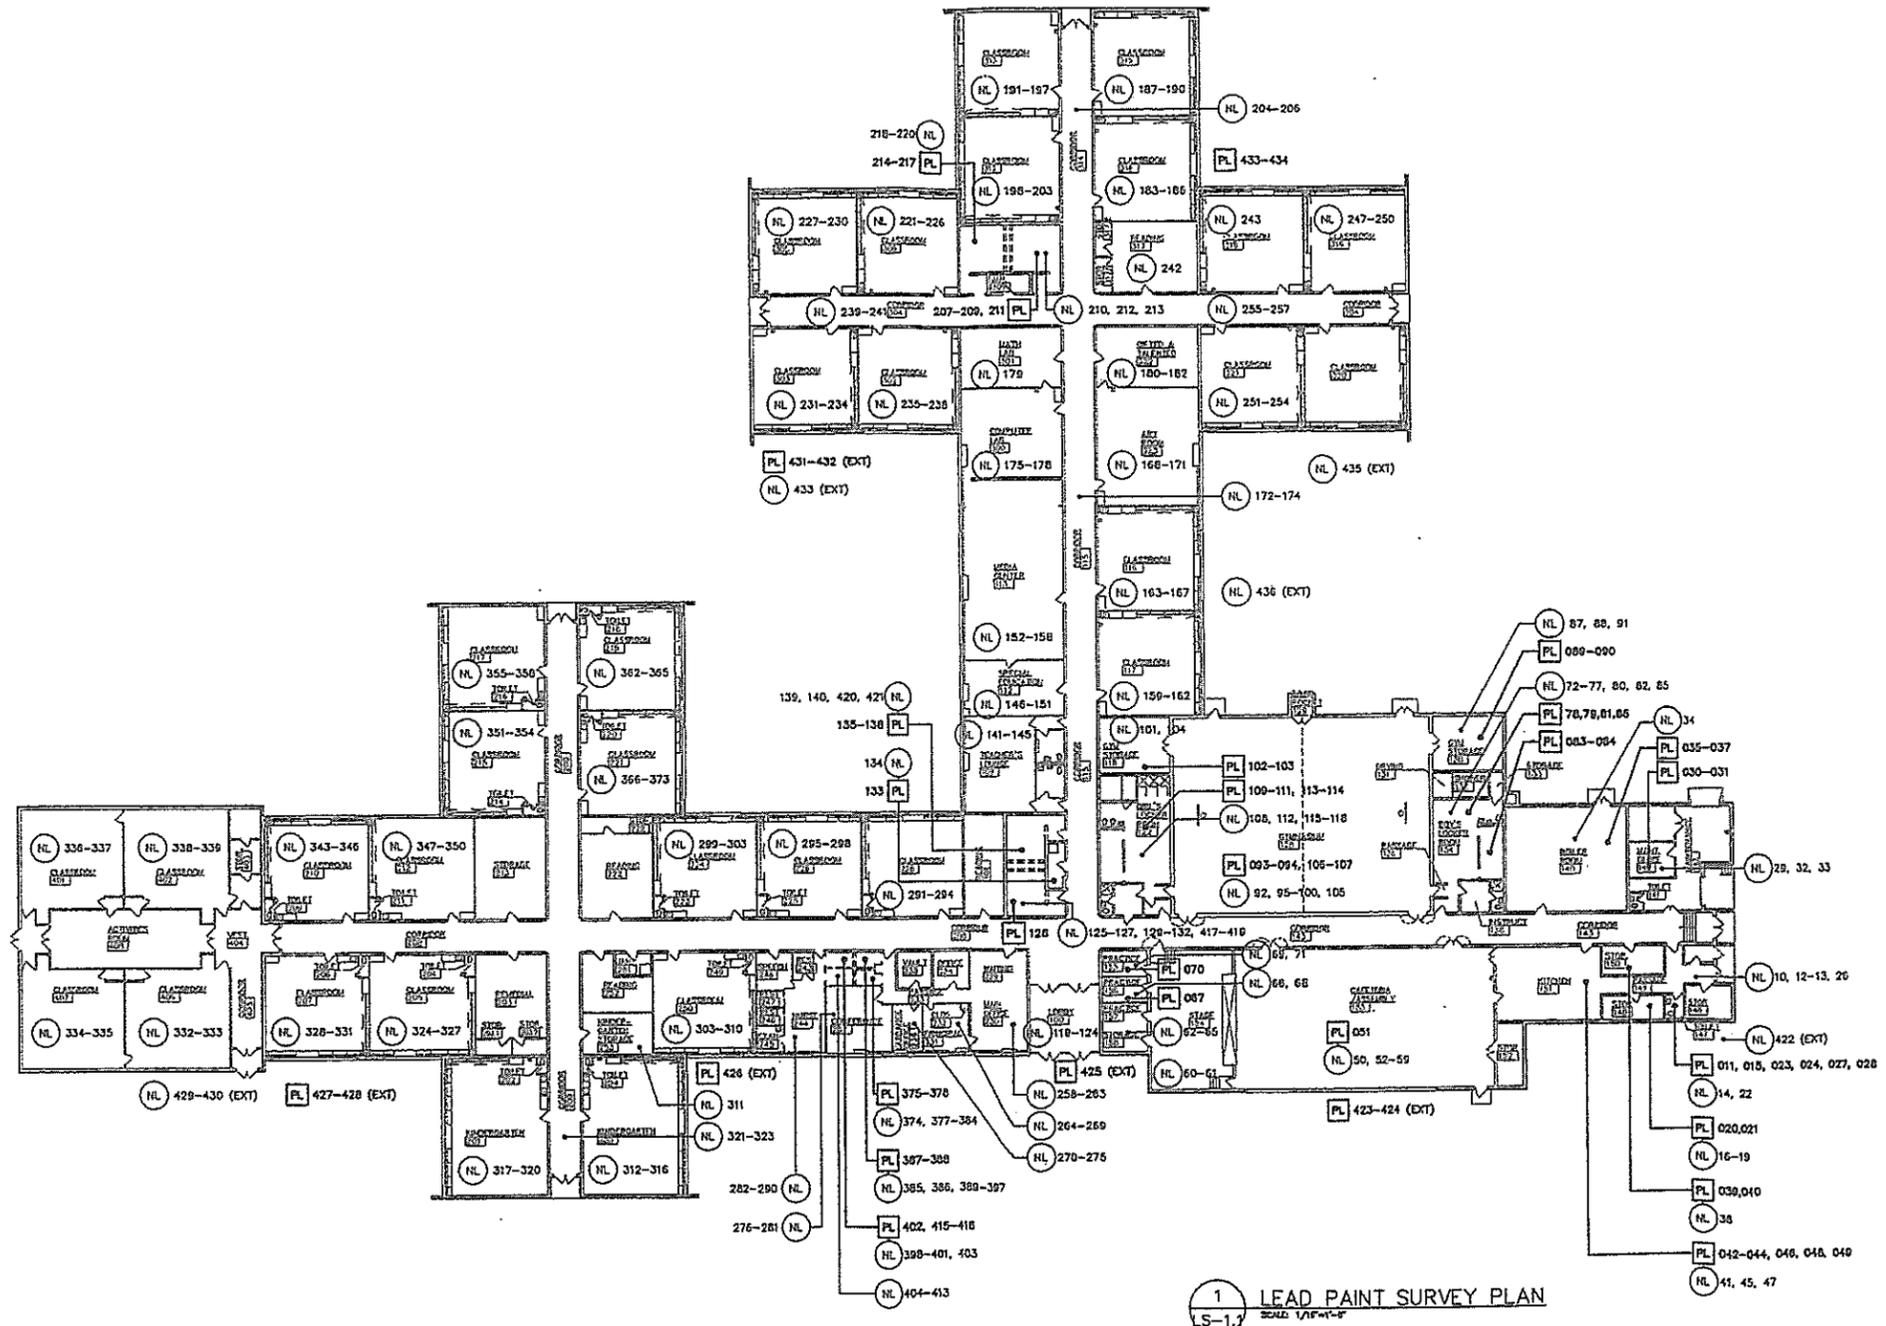
1 LEAD PAINT SURVEY PLAN
 S-1.1 SCALE: 1/8"=1'-0"

Appendix A includes all positive lead based paint readings, which indicate the components that were determined to have instrument readings at or over the HUD abatement level of 1.0 mg/cm^2 . *Our investigation at the Owego North Elementary found several applications of lead based paint applied to the specific areas tested.* Appendix B indicates each reading taken by the LPA-1 Lead Paint Analyzer. When dealing with a lead based paint hazard, it is recommended an EPA certified contractor perform the corrective response action.

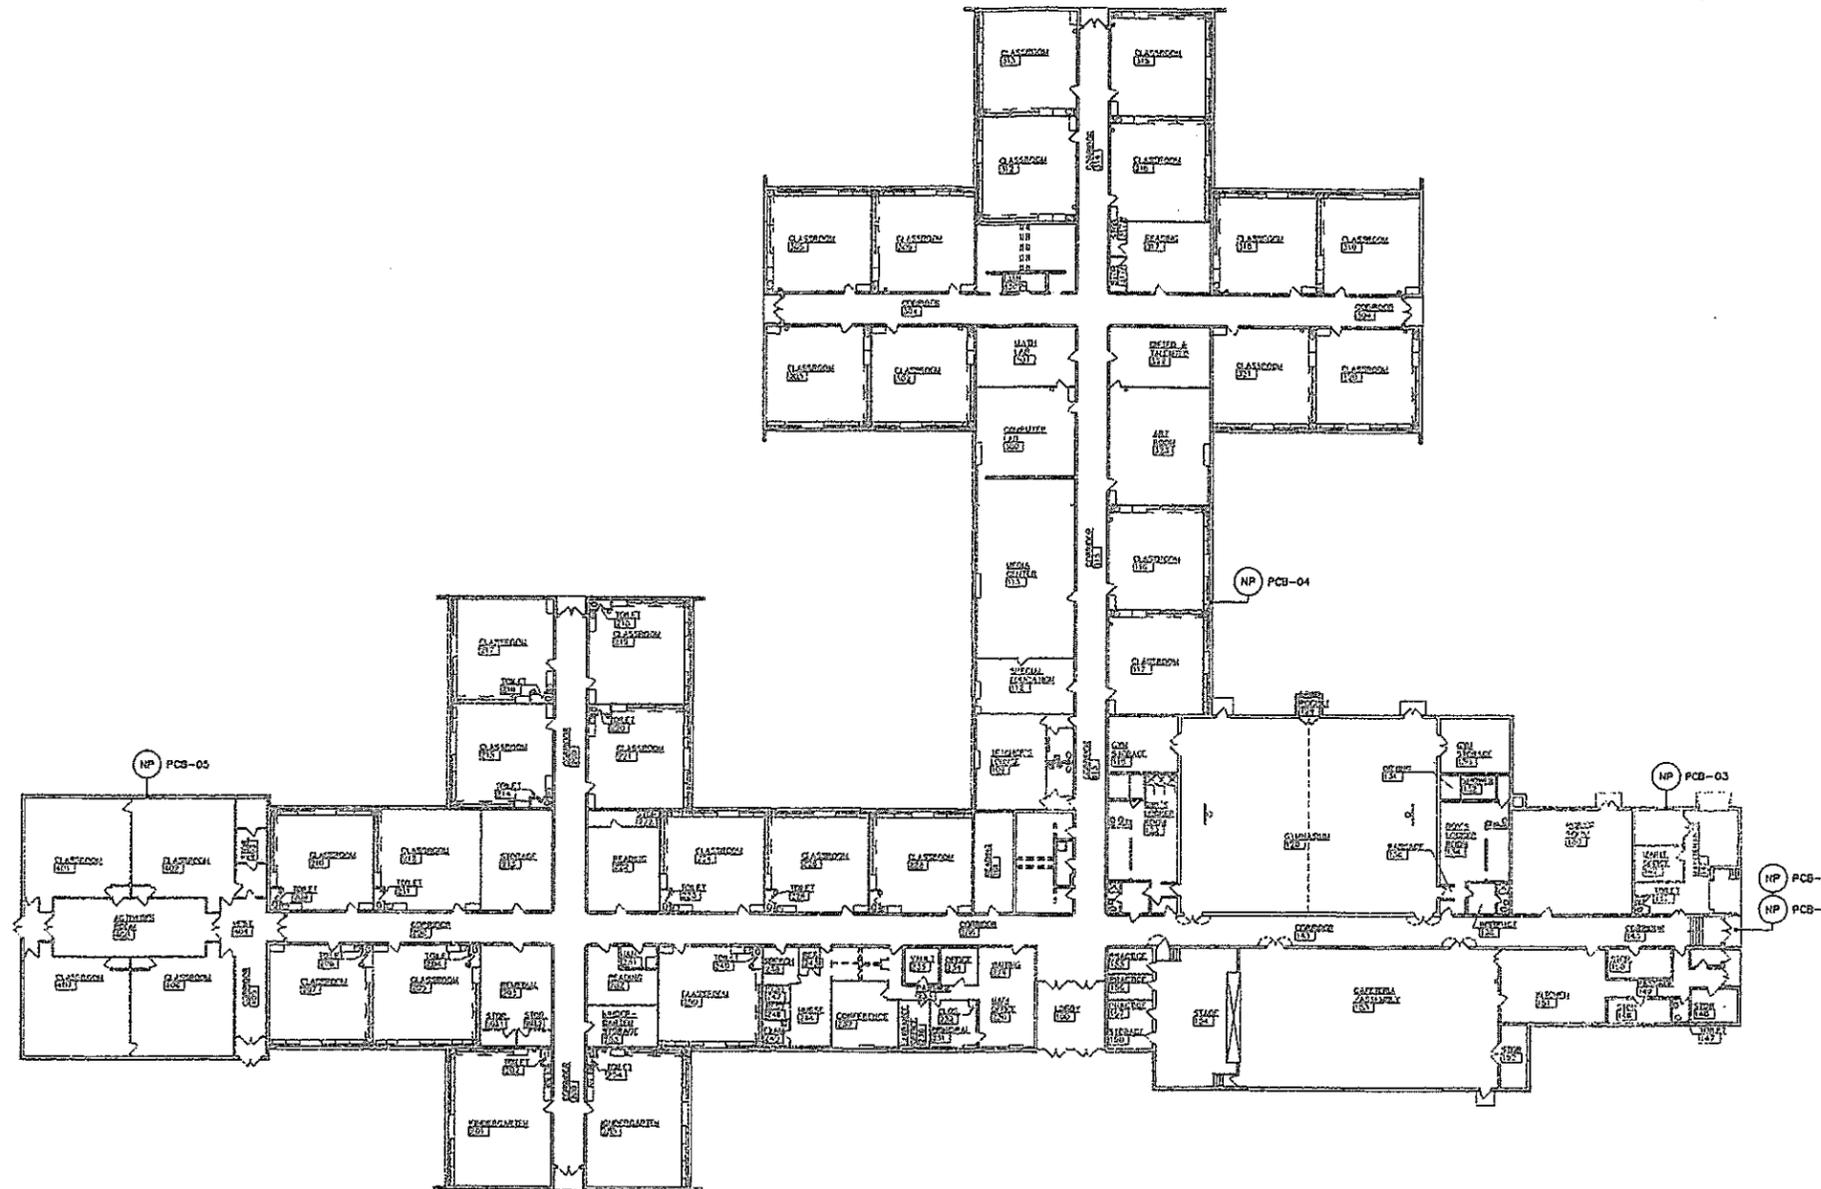
1 PCB SURVEY PLAN
PS-1.1 SCALE 1/8"=1'-0"

PCB was below detection level concentrations in all of the samples tested. However, it is noted that fluorescent light ballasts may contain PCB laden electrolytes.
