APPENDIX A
STUDY AREA PHOTOGRAPHS

ATTACHMENT A - PHOTO LOG

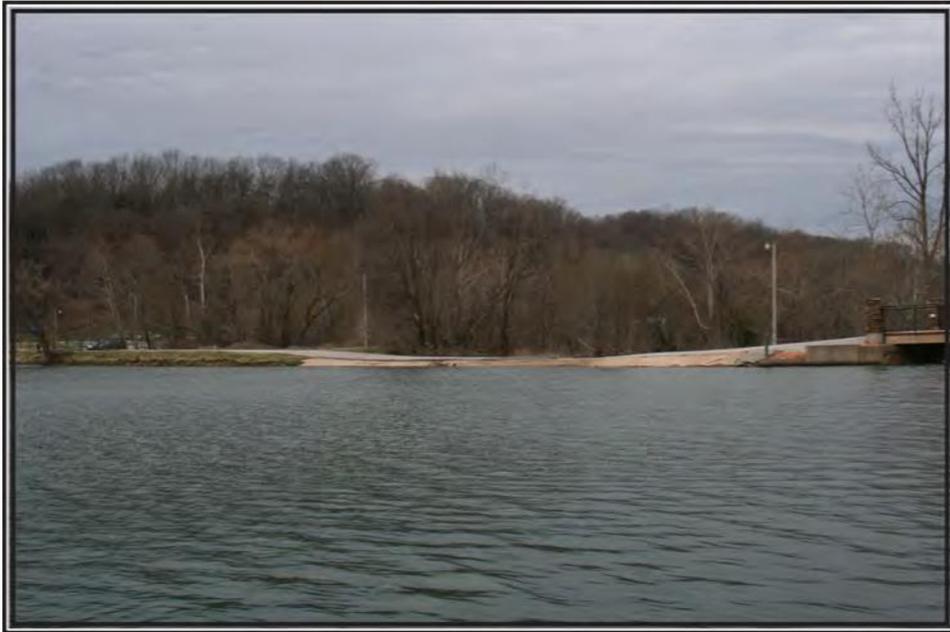
PHOTO 1: View of Lake Bella Vista, facing northeast towards the overflow.

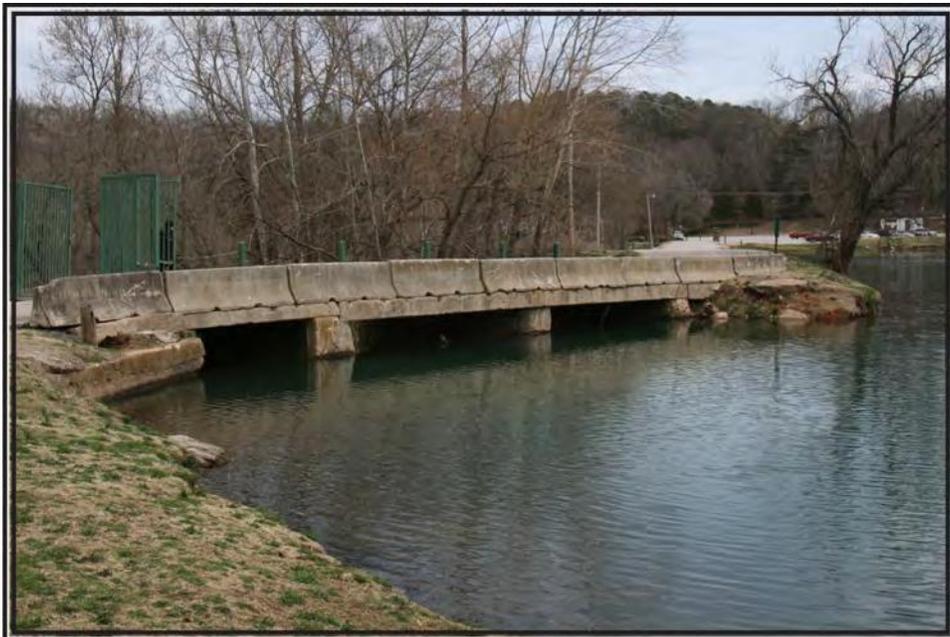
PHOTO 2: View of the dam and west spillway facing northeast.
Note the varying width of the concrete deck.

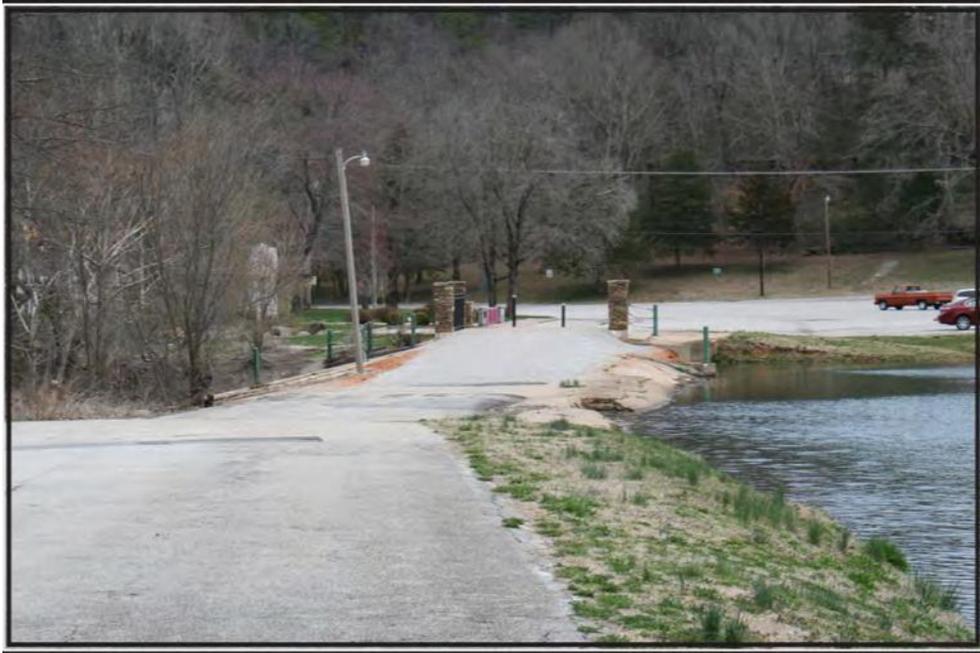
PHOTO 3: View of the top of the dam facing toward east spillway.

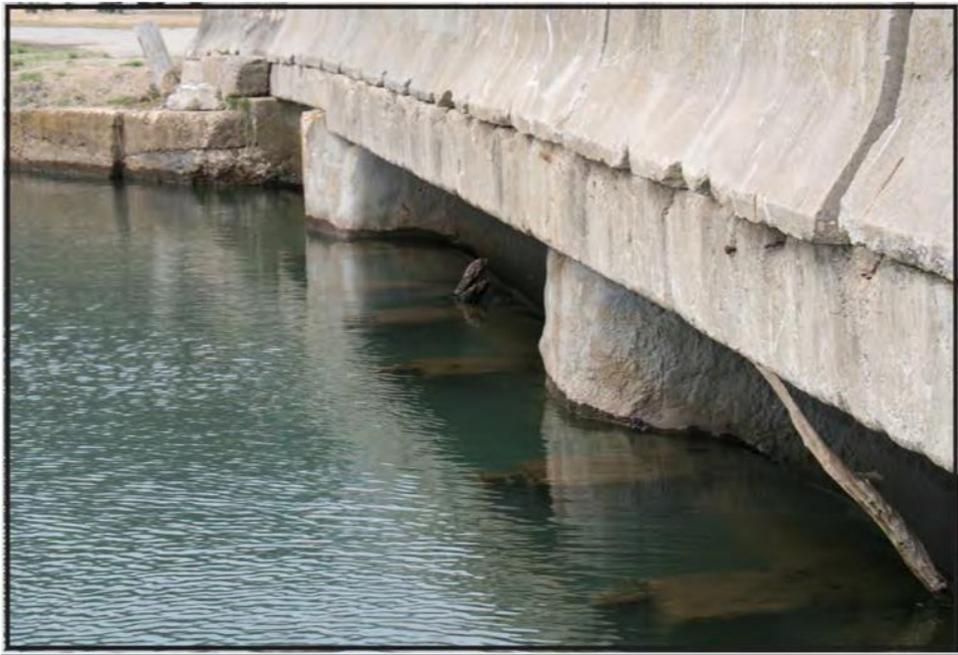
PHOTO 4: View of dam facing west.

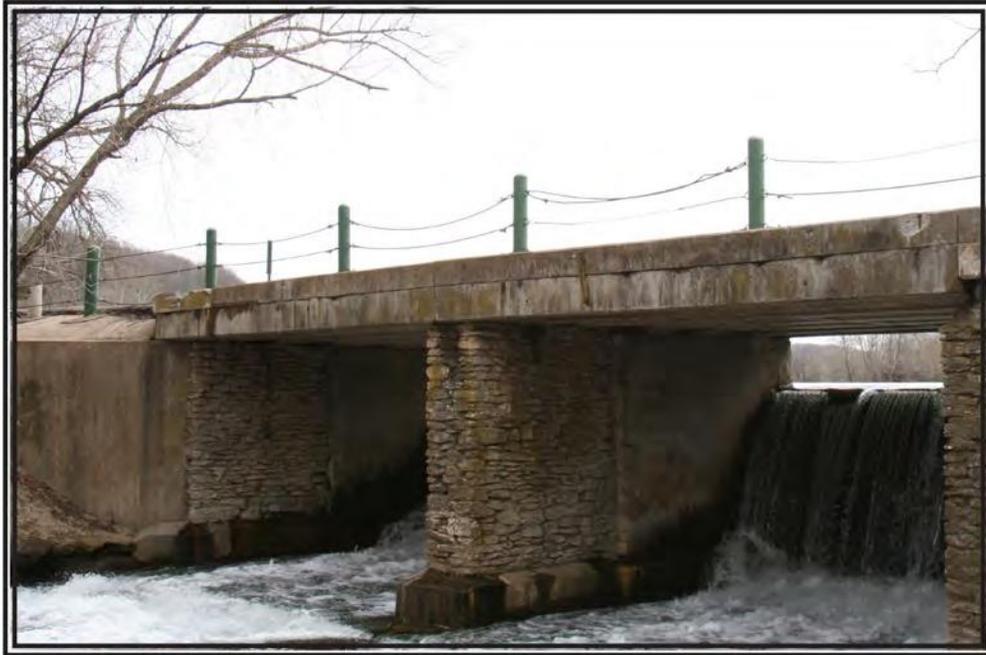
PHOTO 5: View of west spillway, facing southwest.

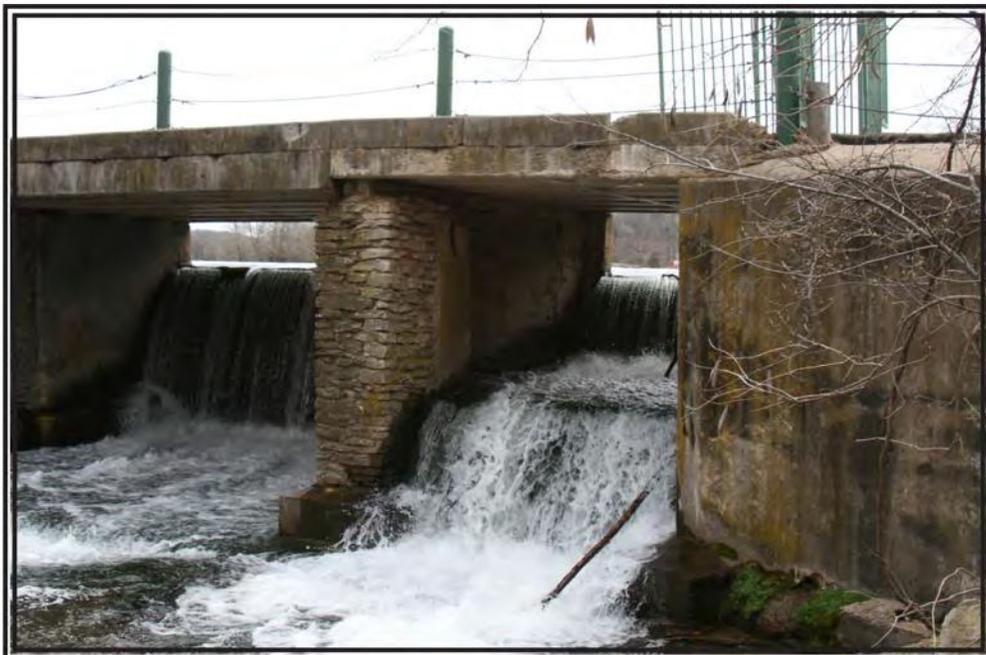
PHOTO 6: View of west spillway, facing south. Note the different construction of the pier walls.

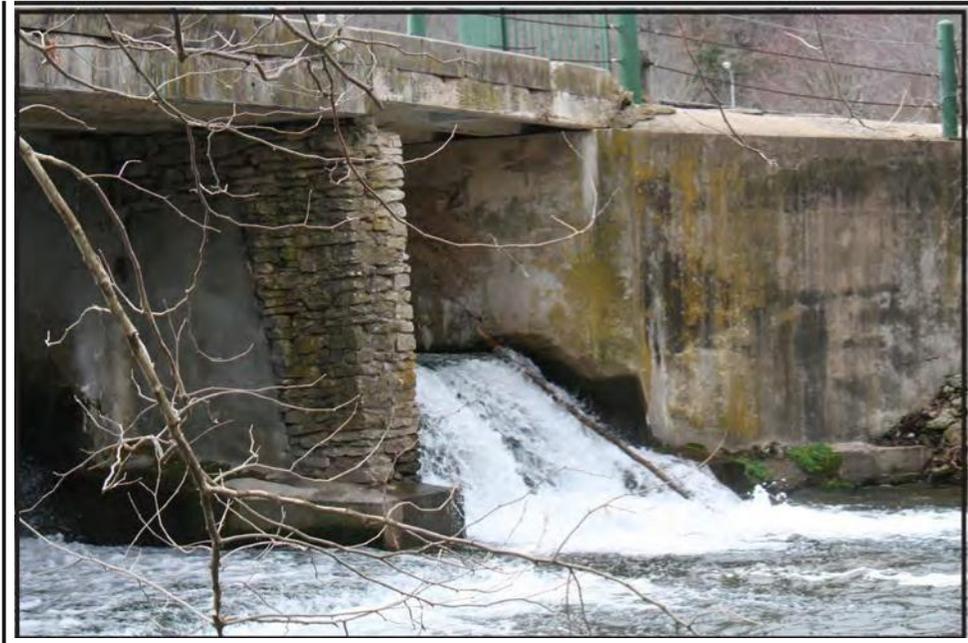
PHOTO 7: View of west spillway facing west towards western-most bay of the spillway and concrete wingwalls and abutments.

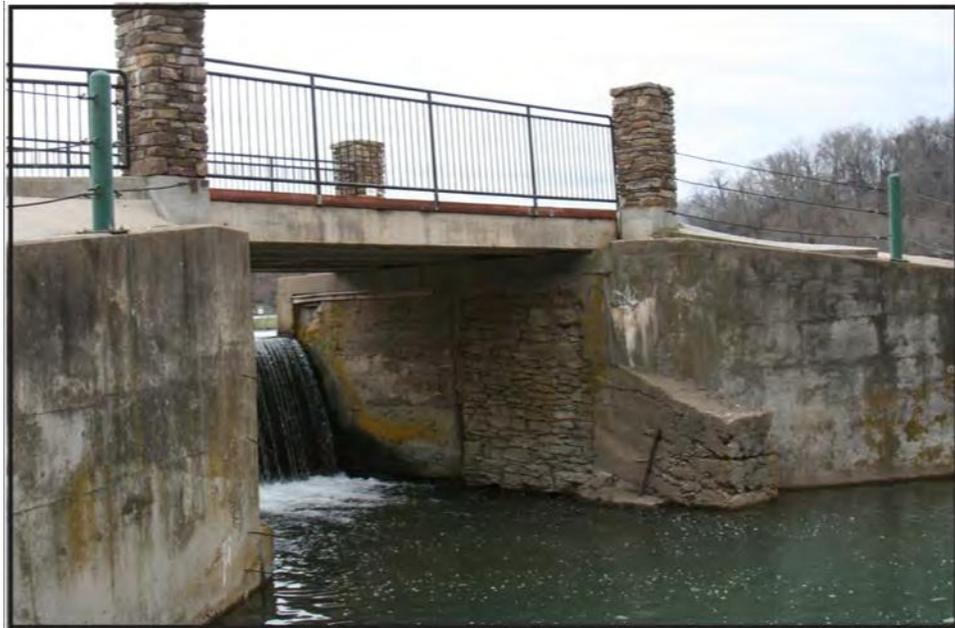
PHOTO 8: View of east spillway facing southwest toward the remaining original abutment wall. This spillway was reconfigured following the 1928 flood and in the 1950s.

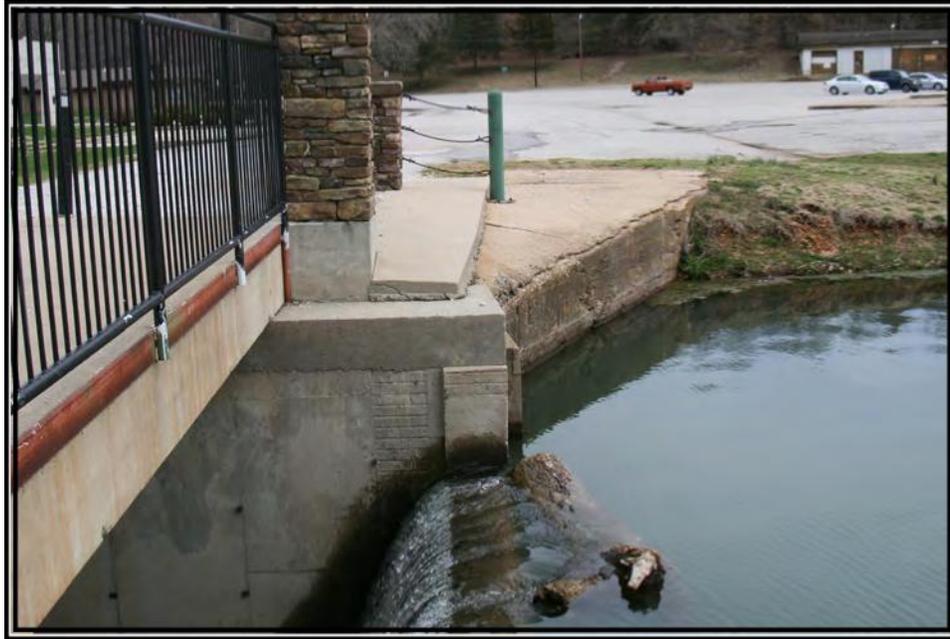
PHOTO 9: View of east spillway and retaining wall facing east. The proposed construction staging area is pictured in the background.

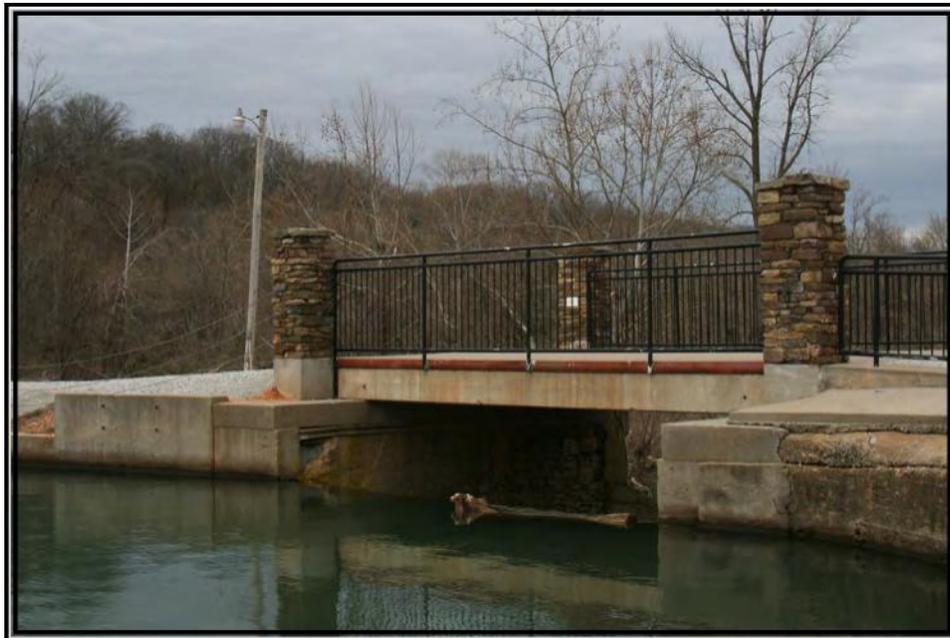
PHOTO 10: View of east spillway facing northwest.

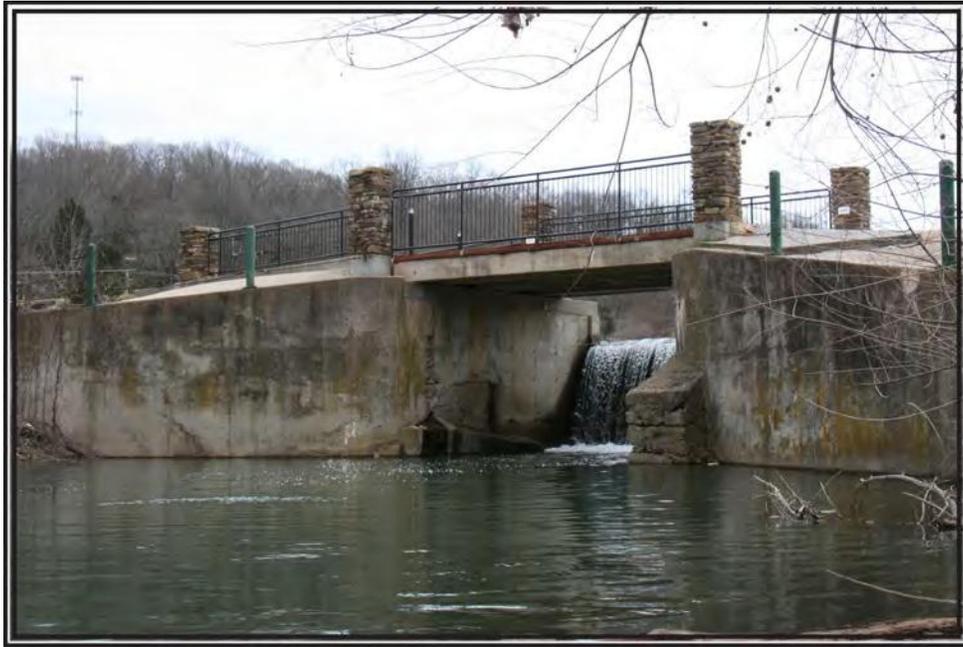
PHOTO 11: View of east spillway facing southeast. The substantial amount of concrete was added in the 1950s.

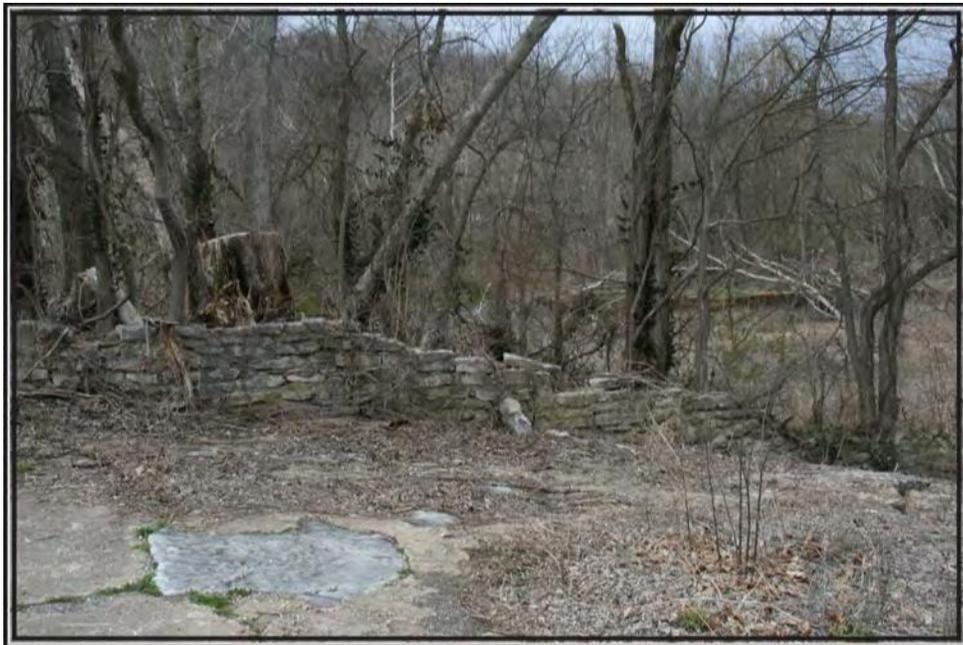
PHOTO 12: View of retaining walls downstream of the dam with poured concrete to stabilize embankments, facing west.

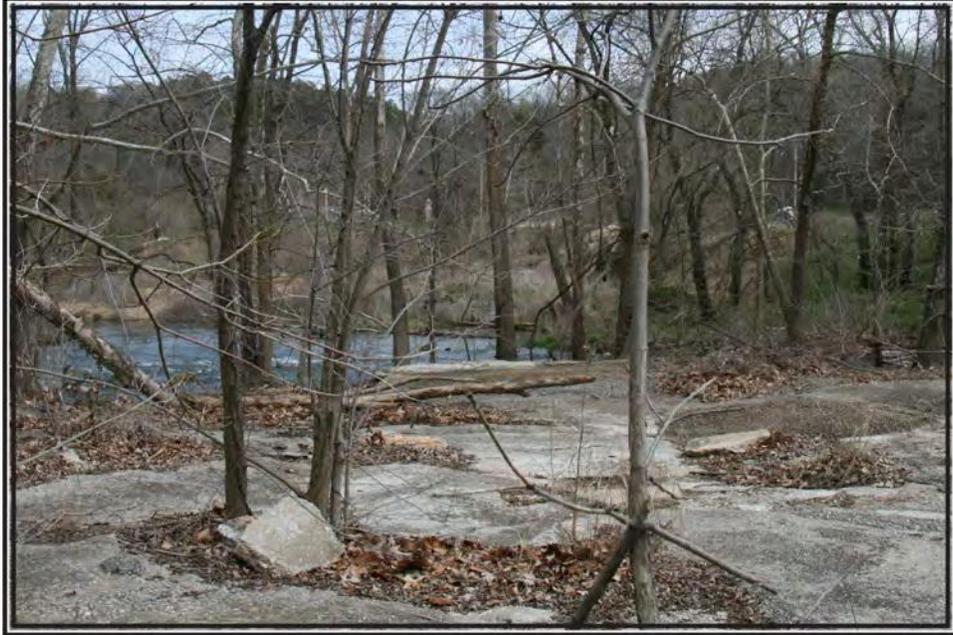
PHOTO 13: Downstream view towards Little Sugar Creek, facing northwest. Note concrete patching in attempts to stabilize embankment.

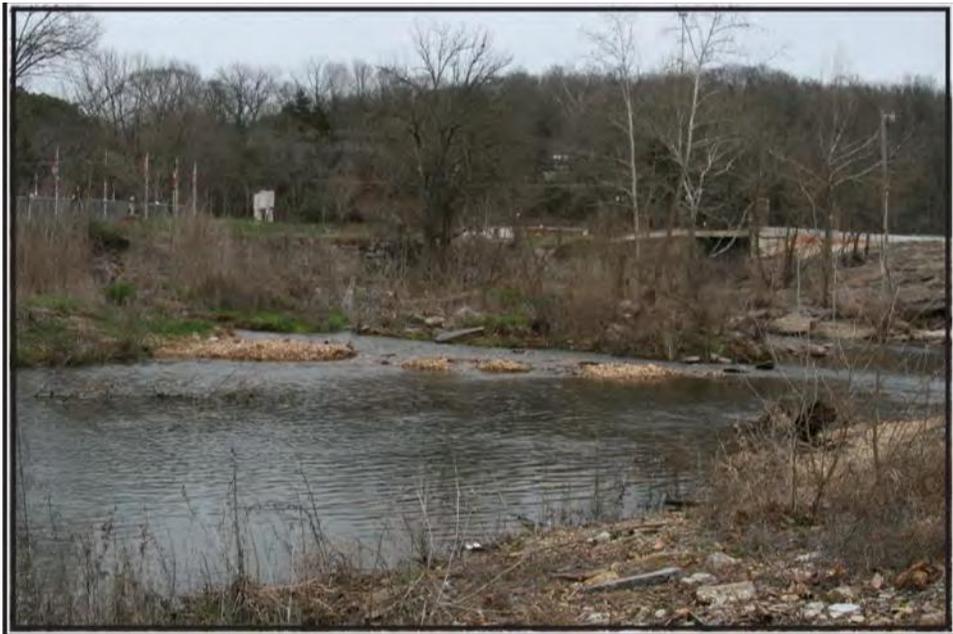
PHOTO 14: Downstream view facing southwest.
