**Fire Station #51  
Lots 17, 18 and 19  
Beckwith Boulevard, San Antonio, Texas**

**APPENDIX C**

**APPENDIX E**

**Site Photographs**

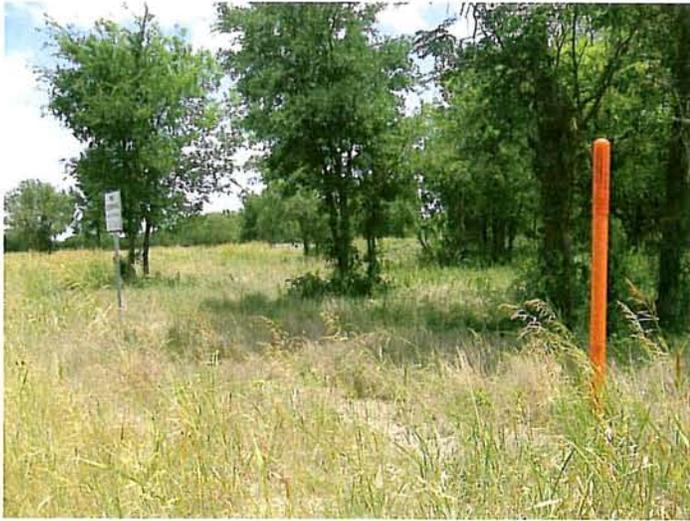
- View looking southeast towards lot 18 and 19. Buried cable line marker is visible in the foreground.

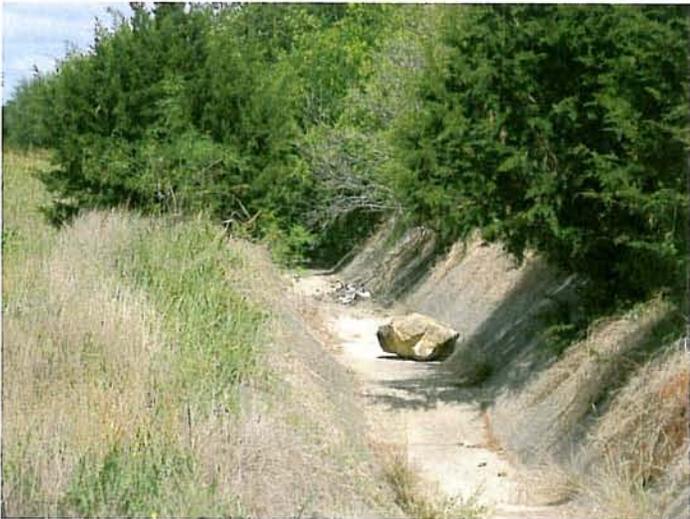
• View east down drainage culvert located on south property boundary.

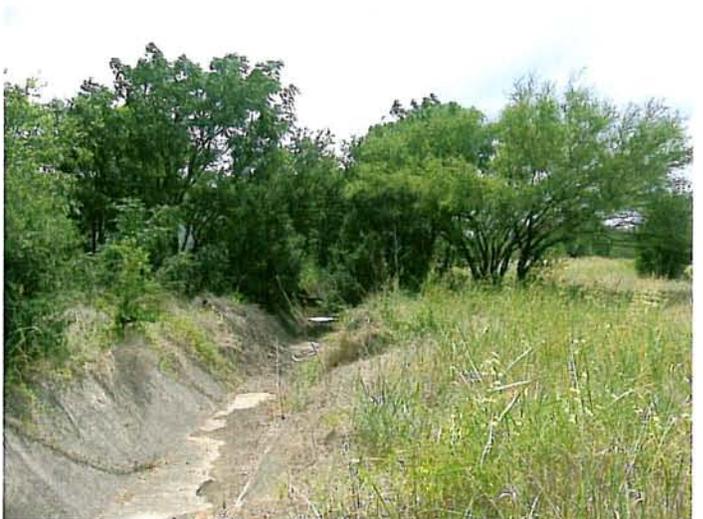
• View west down drainage culvert.

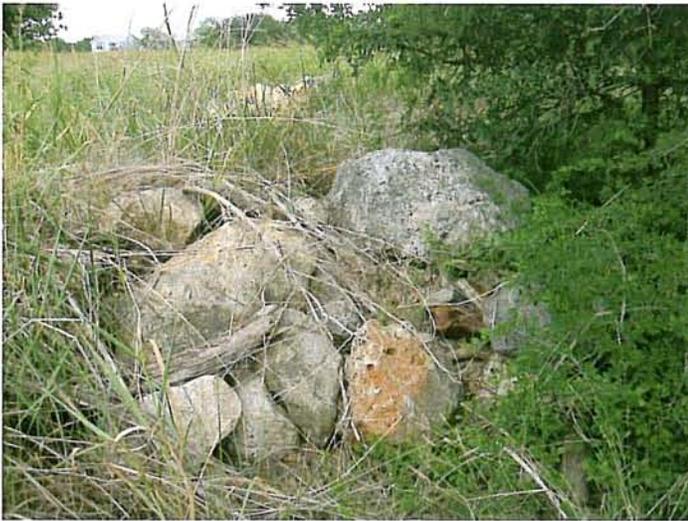
- View northeast at rock pile located in the southern half of the property.

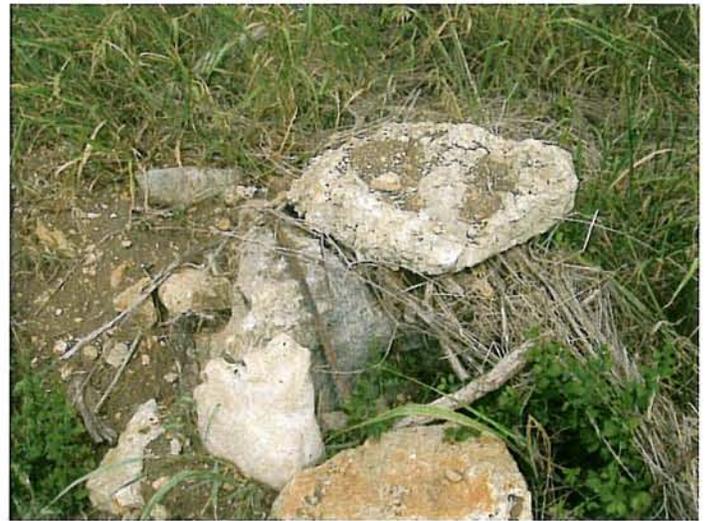
- View of additional rock and concrete pile with metal rebar.

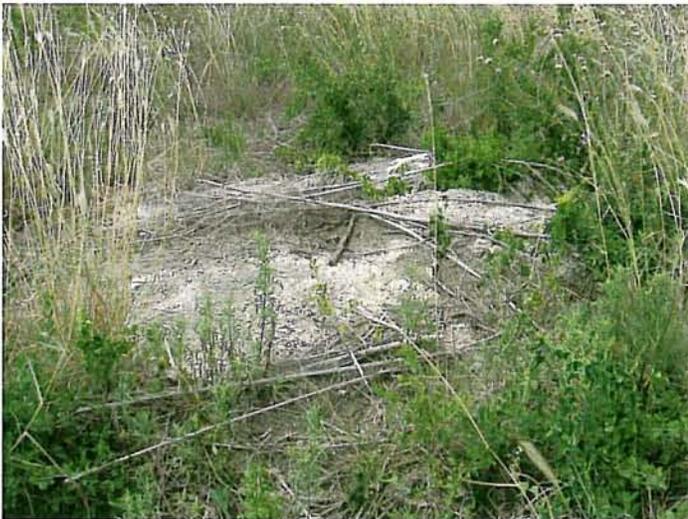
- View of concrete debris located within Lot 19.

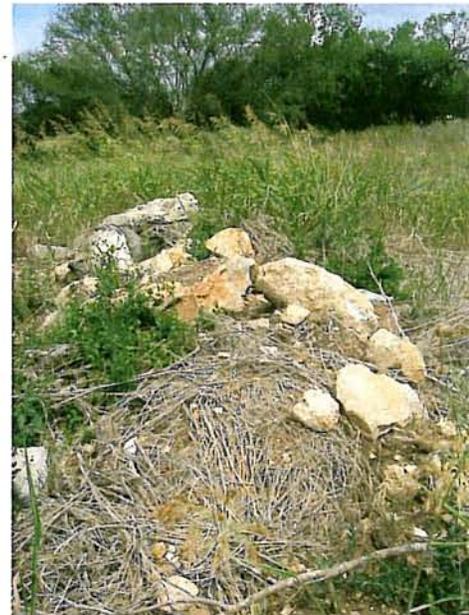
- View south at rock and soil pile located on property.

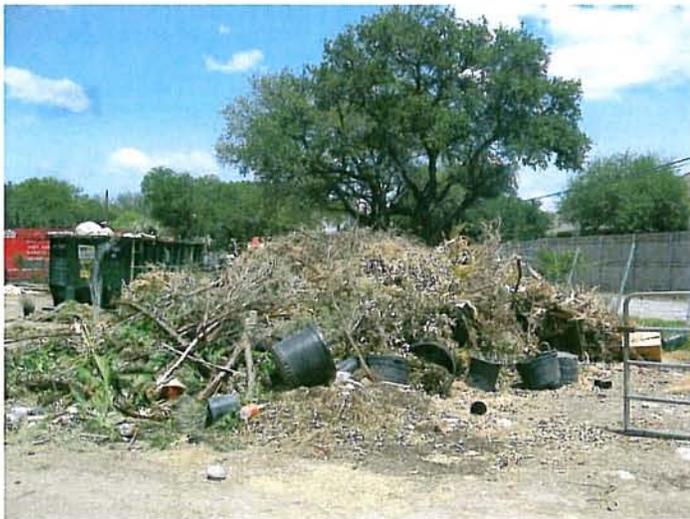
• View north at debris pile located on Texas Allied Landscaping property located south of the site.
