Precautionary Measures Save Home from Hurricane Damage

Full Mitigation Best Practice Story

Santa Rosa County, Florida

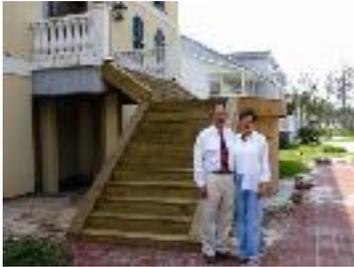
Hurricane Ivan's 12-foot storm surge flowed just below the floor joists, damaging the elevator shaft and stairway, but it did not flood the main floor of the Smiths' home. The surge tore away the Smiths' front steps and breakaway walls surrounding the parking area under the house. Both of these elements were designed to break away from the house in order to lessen the damage to the main structure. Ivan also caused minor damage to the windward roof fascia. The high waters lasted 36 to 48 hours and caused flood damage to many other homes in the area.

The Smiths stand in front of new steps constructed after Ivan's storm surge tore away the original steps.

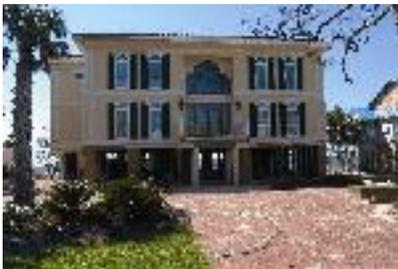
The Smiths elevated their home on pilings to more than five feet above the Base Flood Elevation.
