## Lessons Learned in Grand View Area of Hampton

### Full Mitigation Best Practice Story

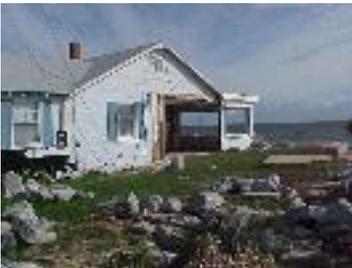
1940's home that received substantial damage.
